UNITED STATES ENVIRONMENTAL PROTECTION AGENCY

Subject: Transmittal of "Port of Stockton Municipal Separate Storm Sewer Audit Report"

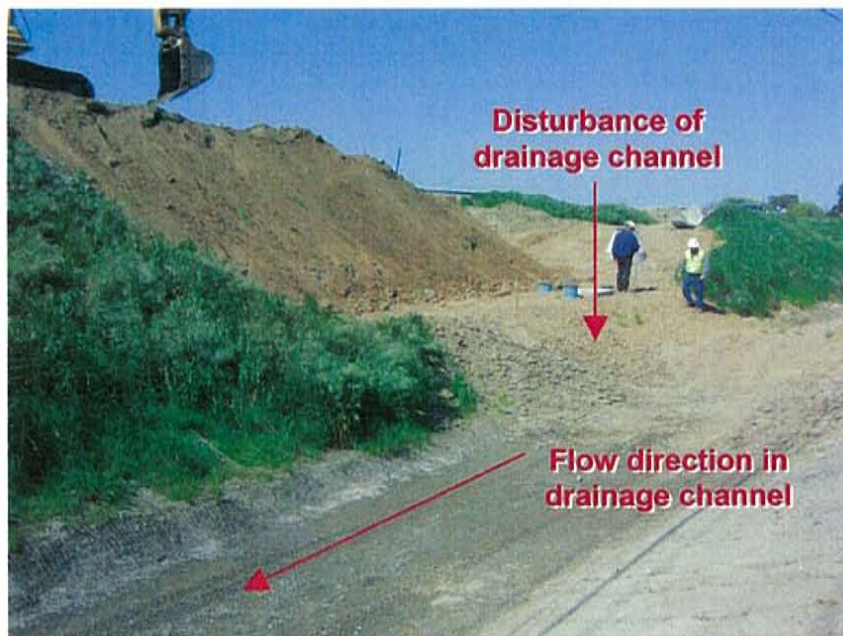
Photograph 2: BMPs were not implemented between the slope and the adjacent drainage channel or in the disturbed drainage channel itself, and the surface of the slope was not stabilized.

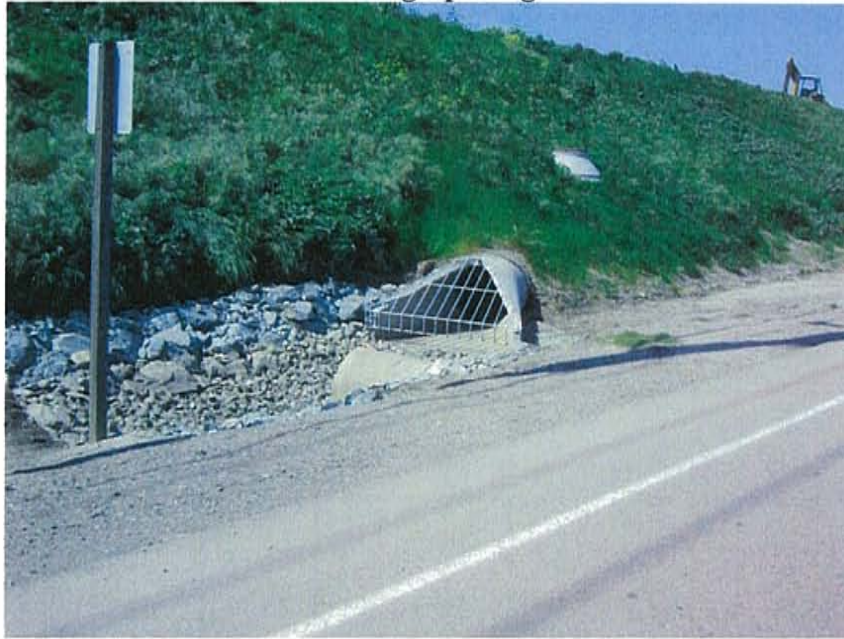
Photograph 5: Pacific Ethanol storm drain outfall into the drainage channel along Navy Drive.

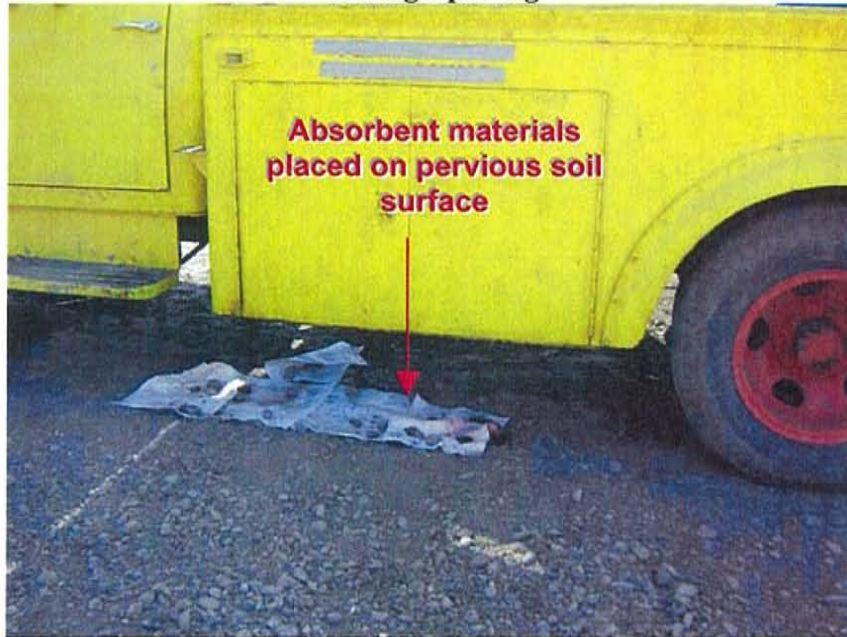
Photograph 9: A mobile fueling truck was actively leaking diesel fuel, and the source of the leak had not been addressed.

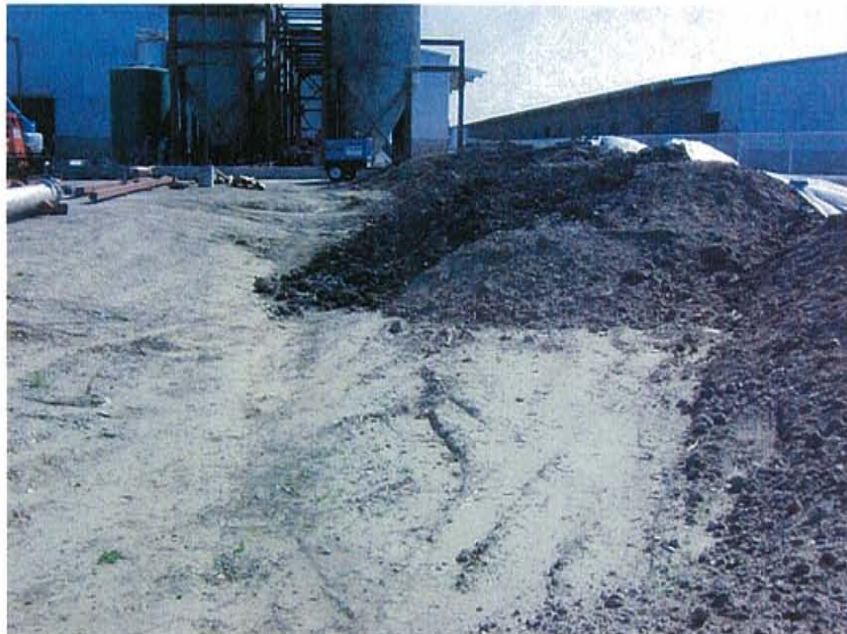
Snedeker Ave.) on March 19, 2008, the Port inspector noted soil stockpiles improperly placed in a drainage pathway and without down-gradient BMPs. In a follow-up audit activity on March 20, 2008, it was noted that these issues had not been corrected (Photograph 10). As a result, the Port exhibited a lack of adequate private construction oversight to prevent the contribution of pollutants to storm water from the aforementioned locations. These outstanding issues and Finding 2.4.2 were considered collectively in making this determination. The Port must correct the outstanding issues and Finding 2.4.2 through prompt and effective enforcement of its tenant agreements. *Furthermore, it is strongly recommended that the Port develop and implement an Enforcement Response Plan (ERP) to establish clear direction and procedures for enforcement based on Port inspections of construction and industrial sites and other compliance activities.*

Photograph 10: In a follow-up audit activity on March 20, 2008, soil stockpiles were still located in a drainage pathway and temporary perimeter controls had not been installed.

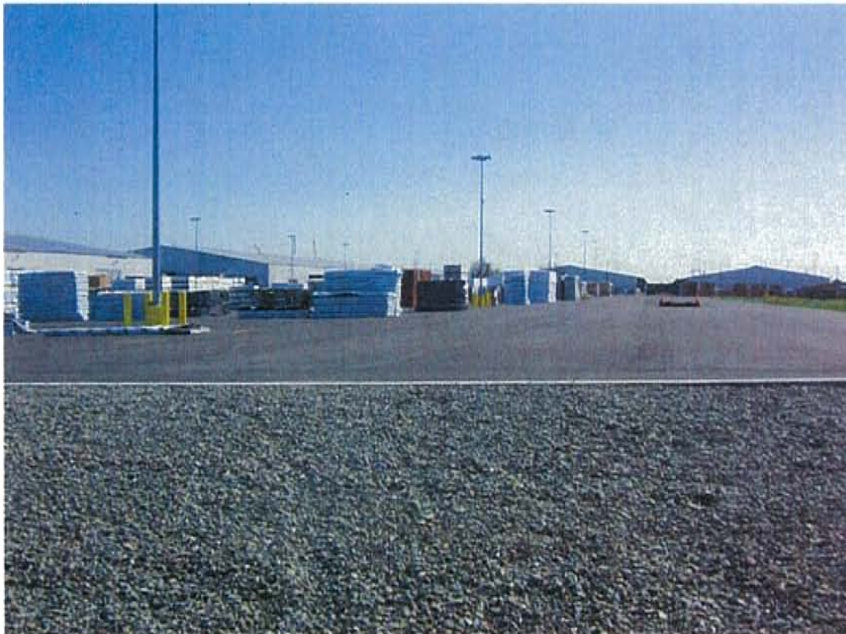
impervious parking improvements (Photographs 13 and 14). As a result, this project likely qualifies as a Priority Development Project under both the commercial and parking lot categories. Based on Port records provided during the audit, the Lowe's HIW, Inc., lease approval date (September 5, 2006) and construction start date occurred after the February 17, 2006, DSP compliance date (Exhibit 4) and therefore should have been reviewed and conditioned for compliance with the Development Standards.

Photograph 14: Impervious parking improvements at the Lowe's Distribution Center (looking east).

Furthermore, the Port must ensure that all current and future Priority Development Projects are reviewed for DSP applicability and that subsequent project plans are adequately conditioned and implemented for compliance with the Development Standards. This will become increasingly imperative because of the anticipated redevelopment of the West Complex.

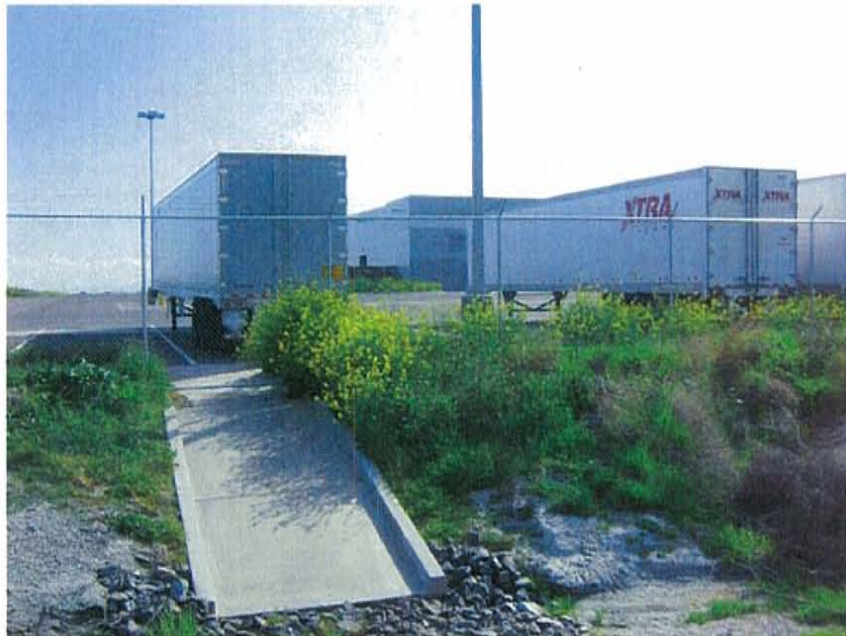
Photograph 16: Newly constructed parking improvements at the Ferguson Distribution Center (looking south).
