Picture 1: Overview of Pago Socio STP facing plant from front.

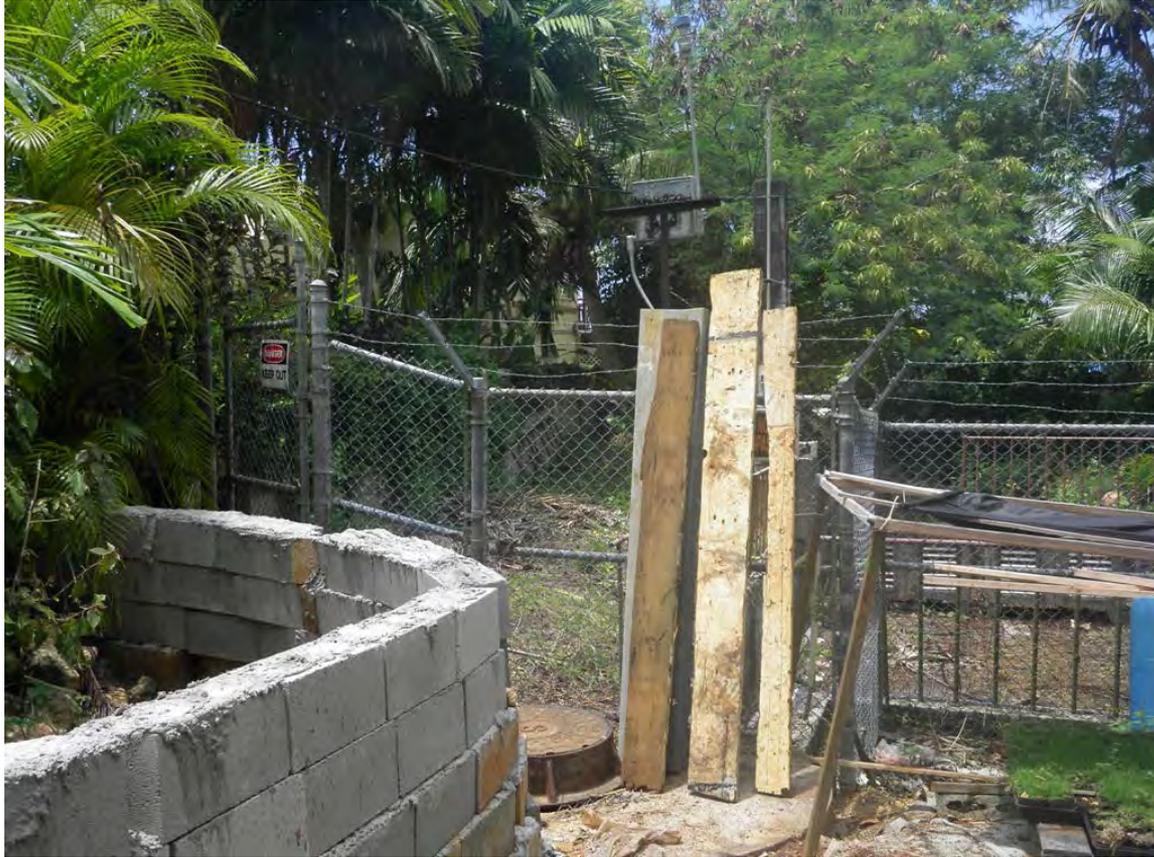
Picture 2: Entry to Pago Socio. Gate was blocked by concrete block wall.

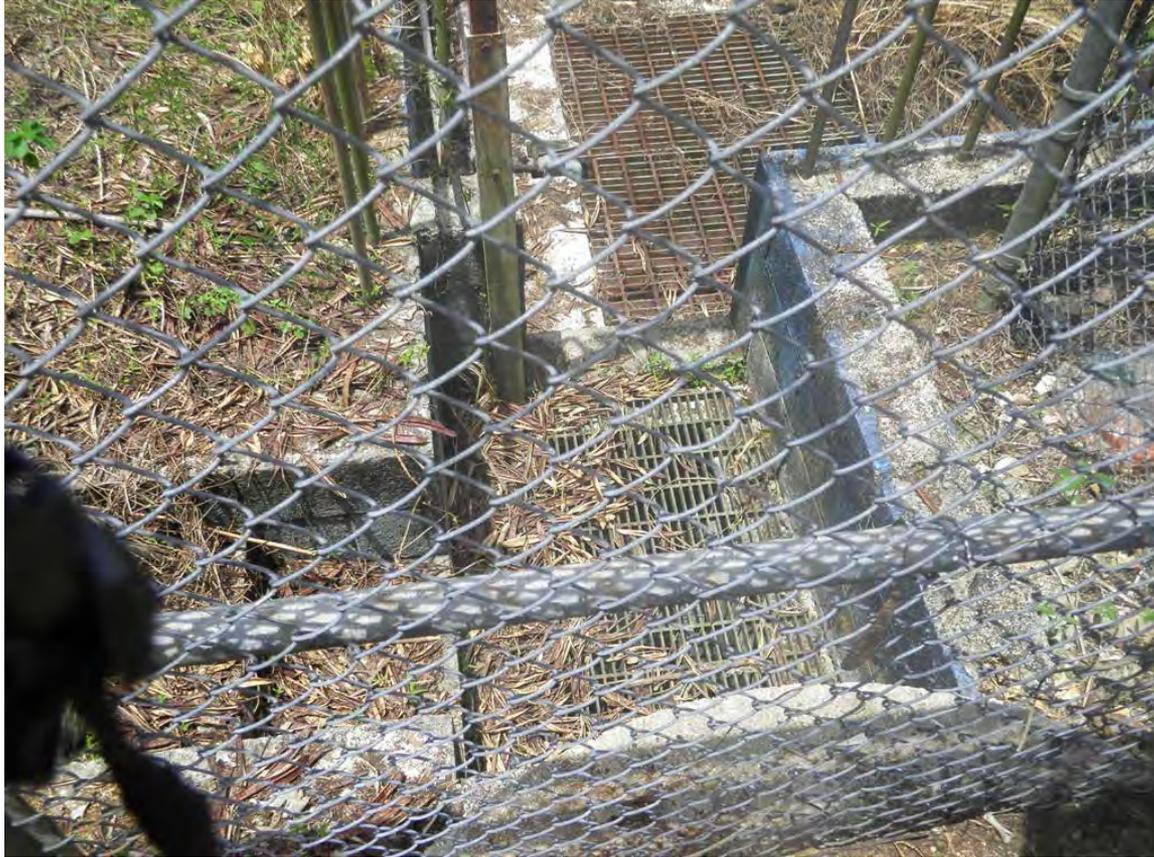
Picture 3: Influent channel.

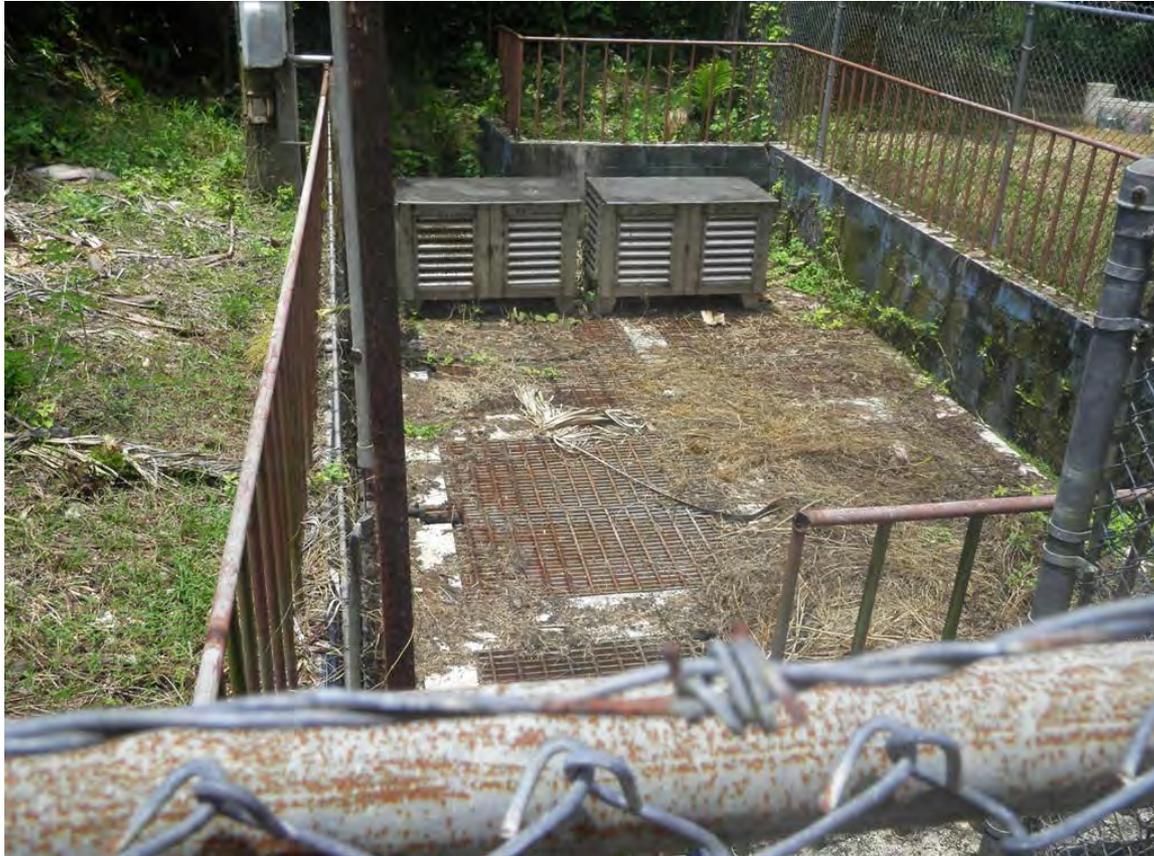
Picture 4: Blower housing for aeration system. Blowers were not operating.

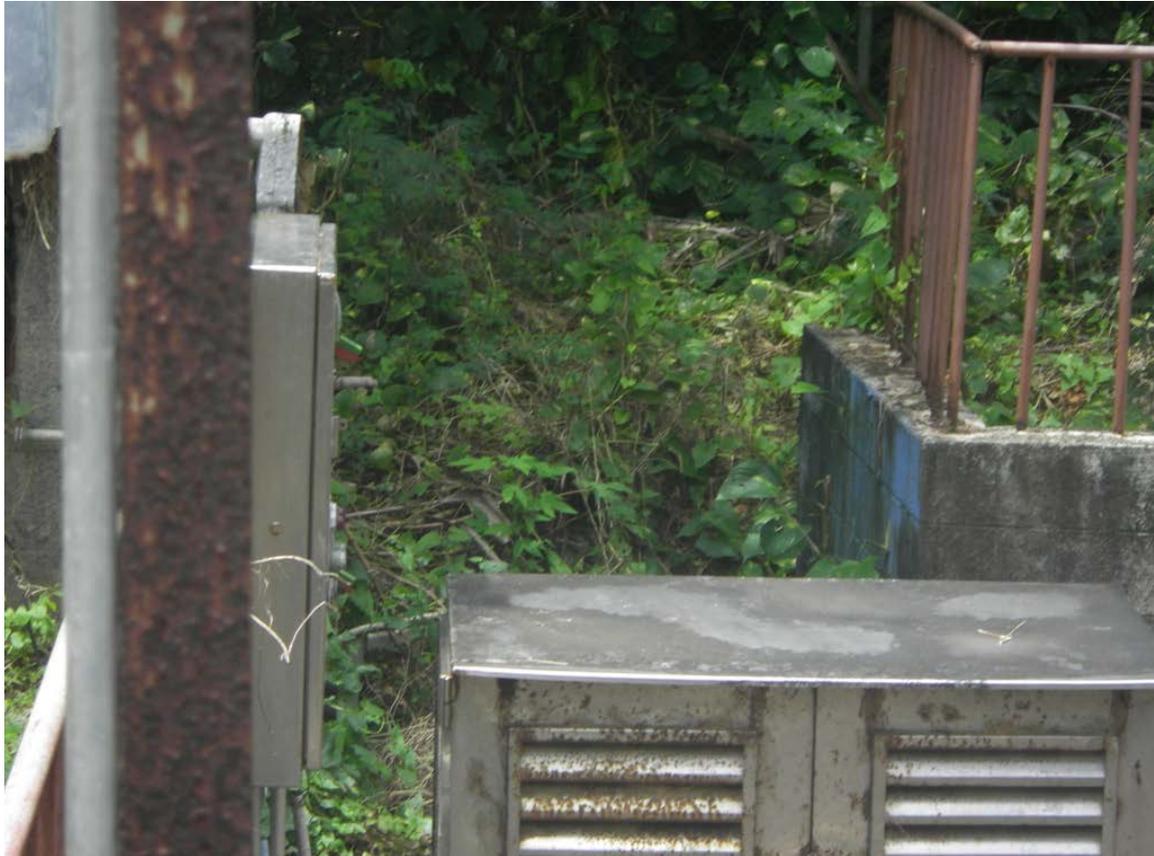
Picture 5: Channel under brush carries plant discharge to percolation field.

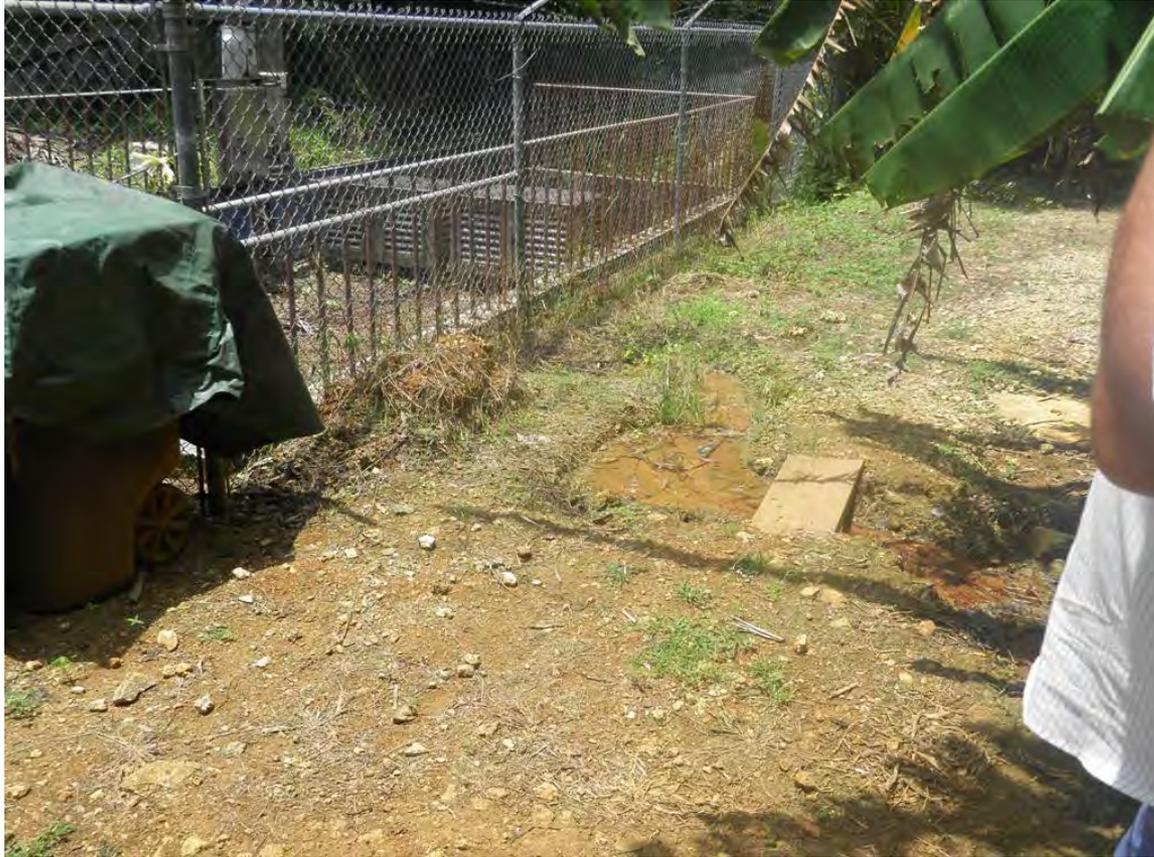
Picture 6: Water from a leaking potable water line was running in a shallow ditch into the plant. Ditch was bridged by the board in the middle right.

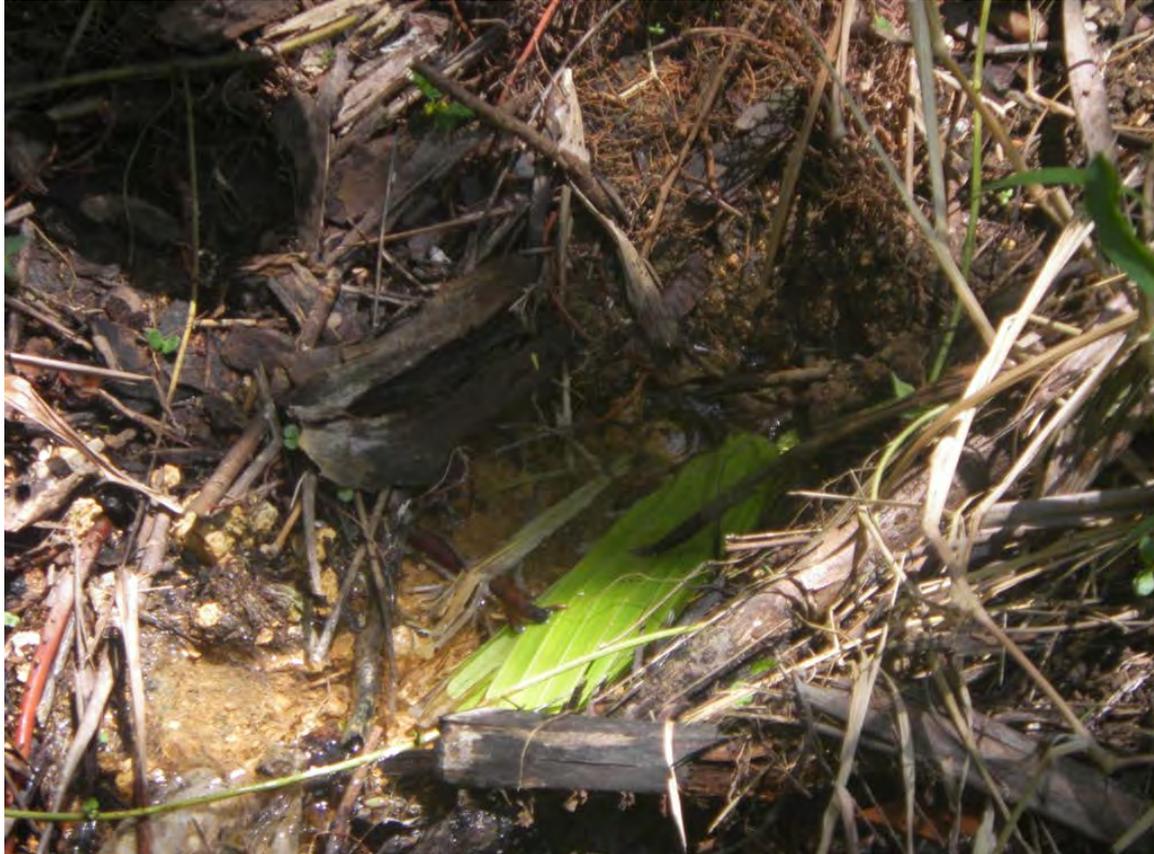
Picture 7: Leaking potable water line.

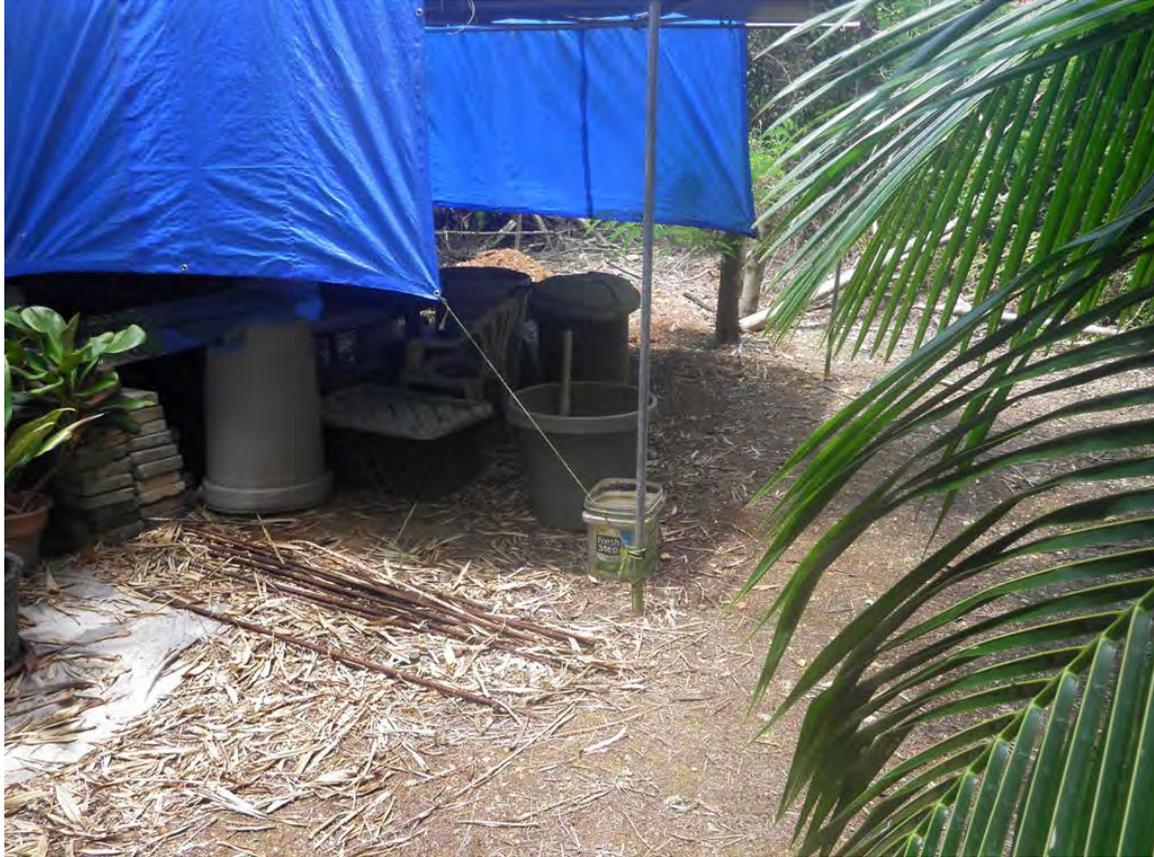
Picture 8: Gardening material stored on top of percolation field.

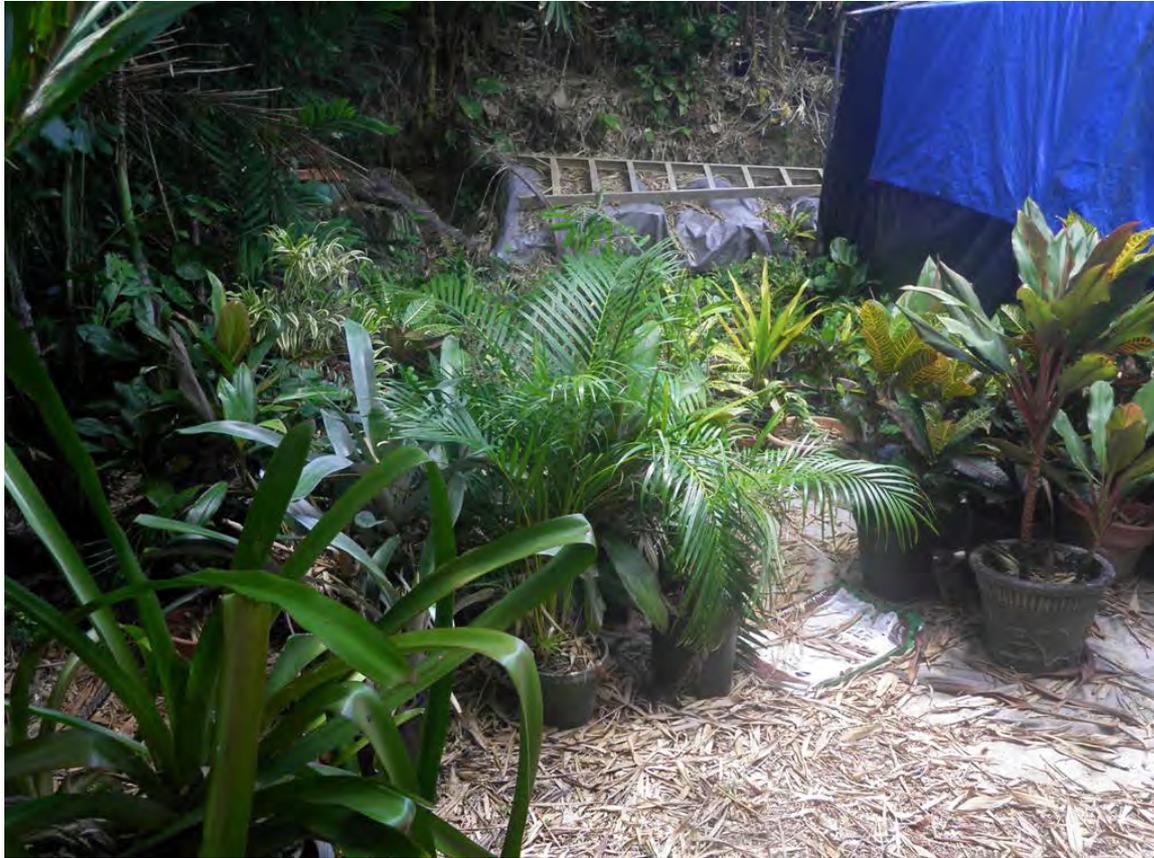
Picture 9: Planters on top of percolation field.
