SEWAGE COLLECTION SYSTEM INSPECTION FORM
City of Emeryville

GENERAL INFORMATION**Inspection Date: April 6, 2009**

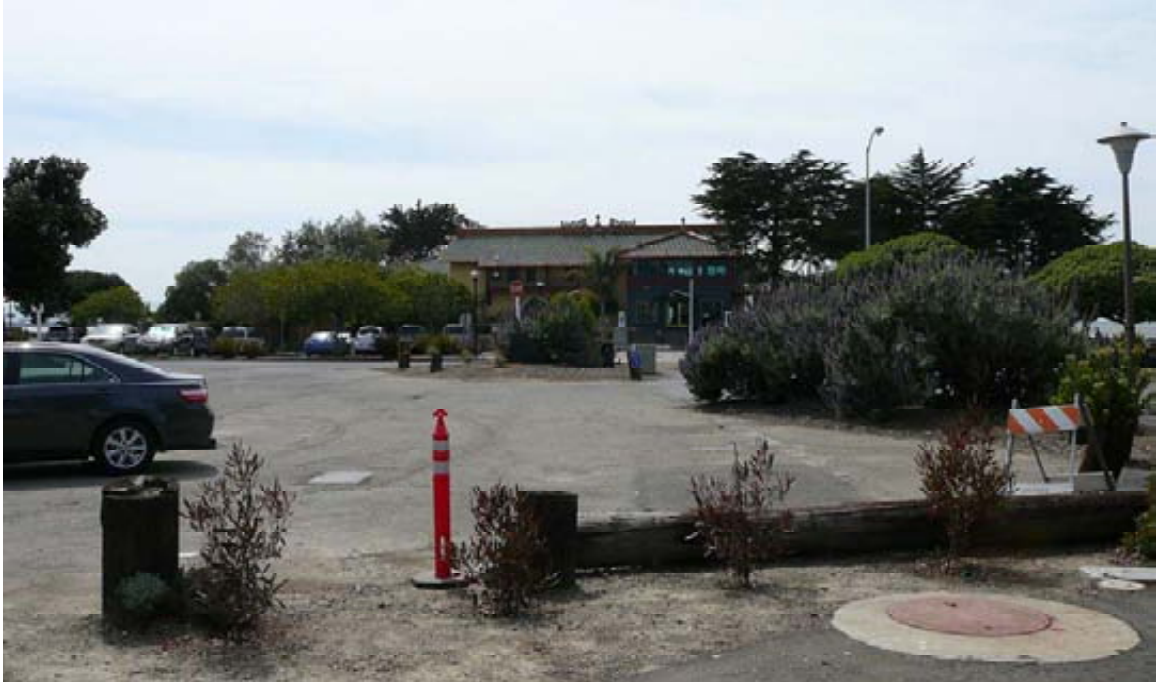
Emeryville Photo 3: View of Hong Kong restaurant from Marina pump station.

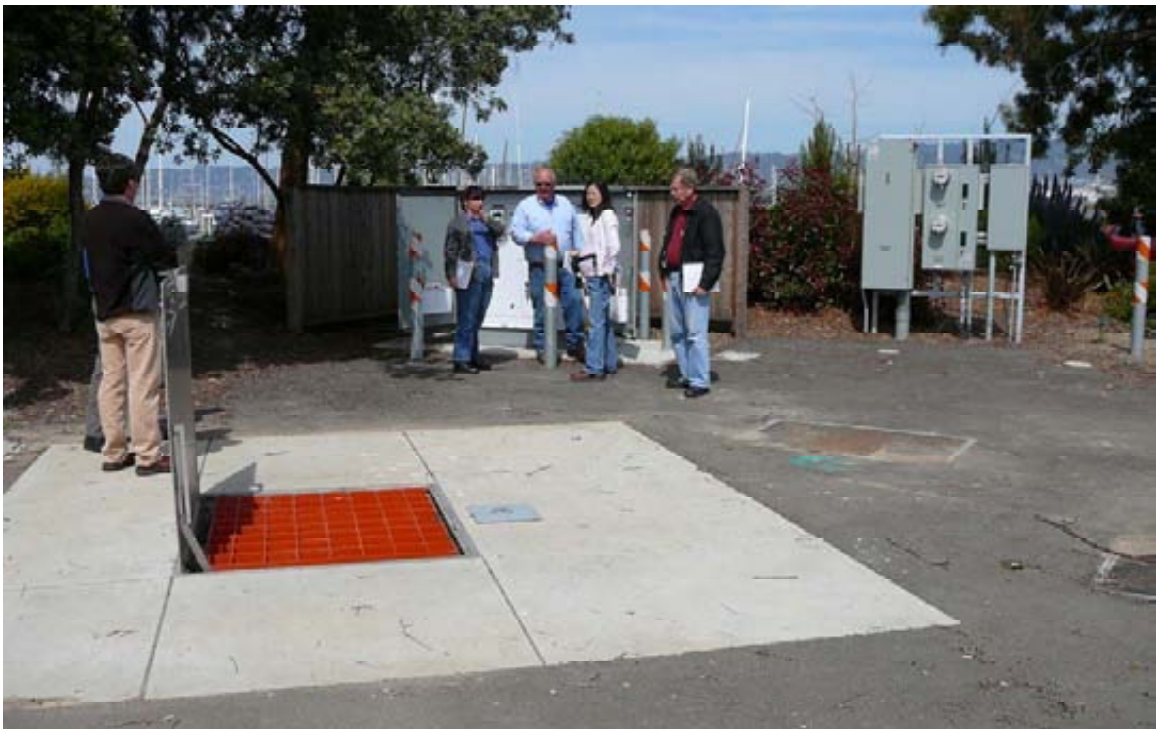
Emeryville Photo 4: Marina pump station and controller box.

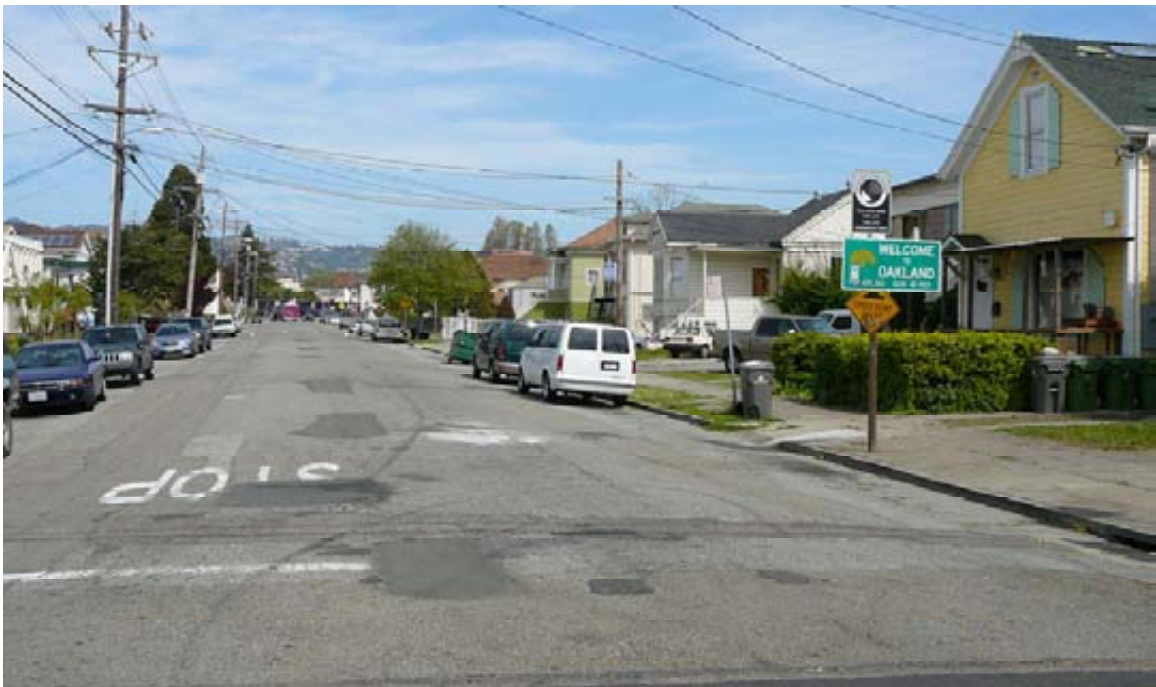
Emeryville Photo 8: 63rd Street spill site - Oakland boundary is just feet from the spill site.
