Appendix A
Storm Water Management Plan: Comments from NDEP and Co-Permittee Response

**Appendix B
Clark County**

**Appendix B.1
Documentation of Findings**

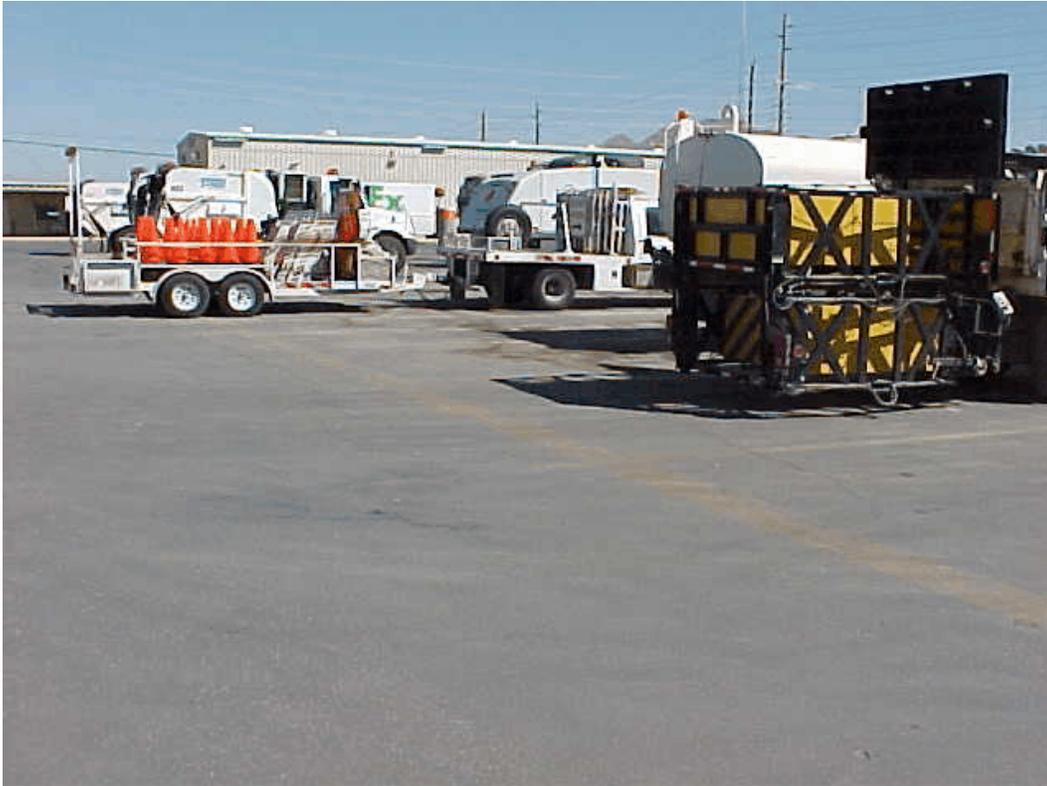
8. The Fleet facility had numerous locations with pavement staining due to petroleum product spills/leakage from parked vehicles.
9. The Vector Control facility had cut open 55-gallon drums of biological larvicide and spilled residue to the pavement.

Photo 7. Fleet (primary) facility: Truck parking area with spills/leakage staining on pavement.

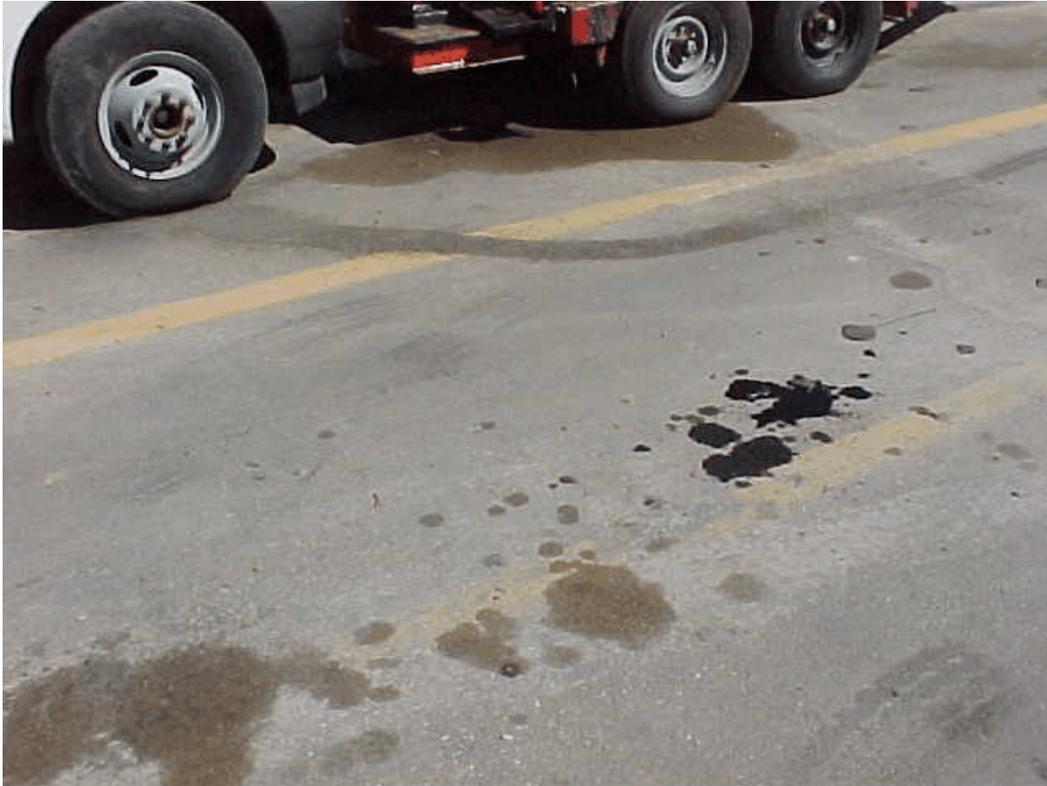
Photo 9. Fleet (primary) facility: Truck parking area with spills/leakage staining on pavement.

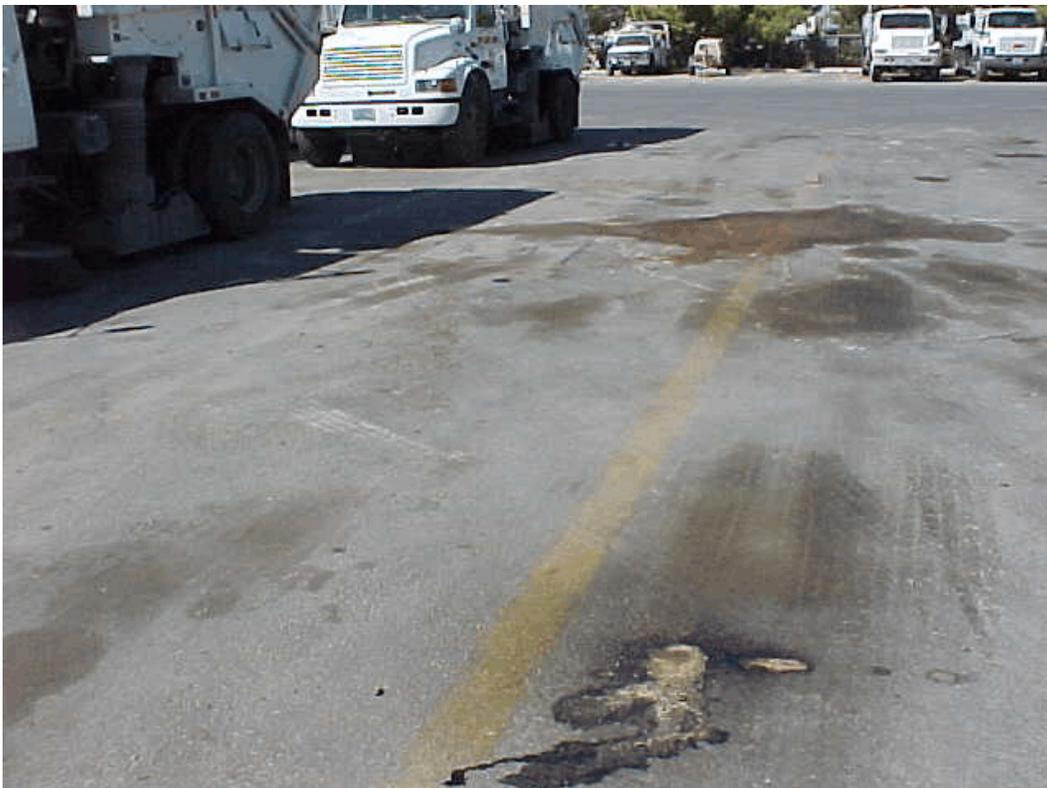
Photo 10. Fleet (primary) facility: Truck parking area with spills/leakage staining on pavement.

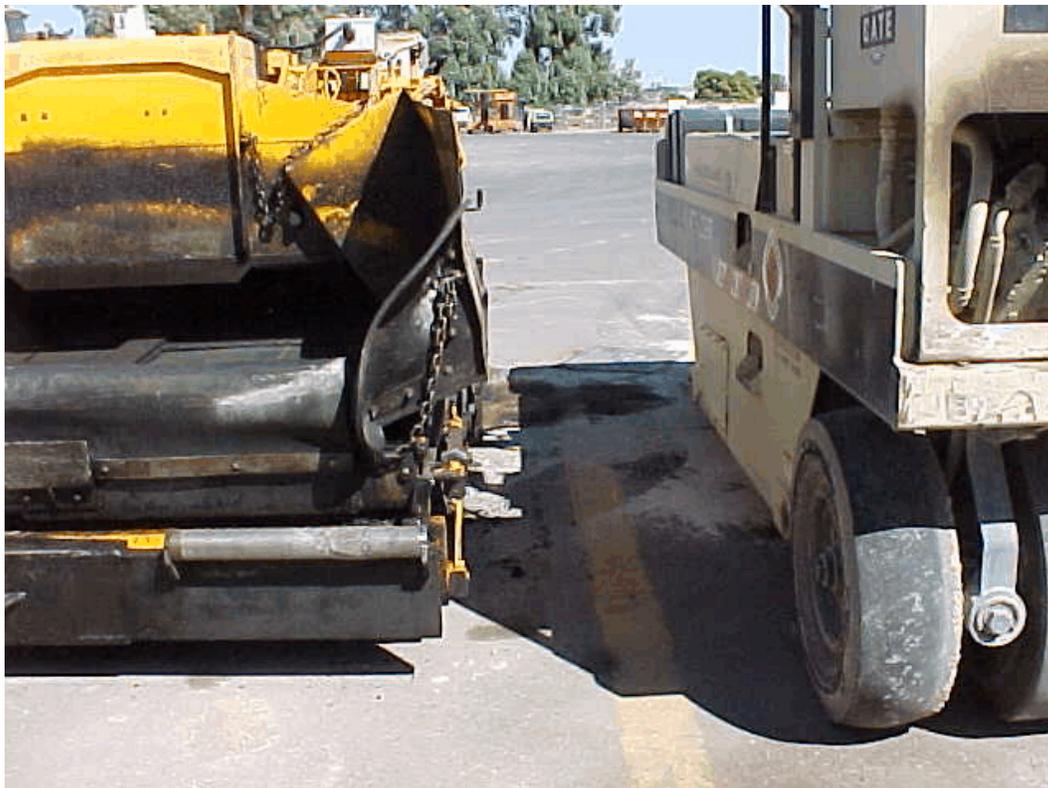
5. The secondary Fleet facility parking lot petroleum product pavement staining was upslope from offsite locations at the southern property boundary. The petroleum product would be carried in storm water runoff from the pavement.

Photo 11. Fleet (secondary) facility: Truck and paving equipment parking area with spills/leakage staining on pavement.

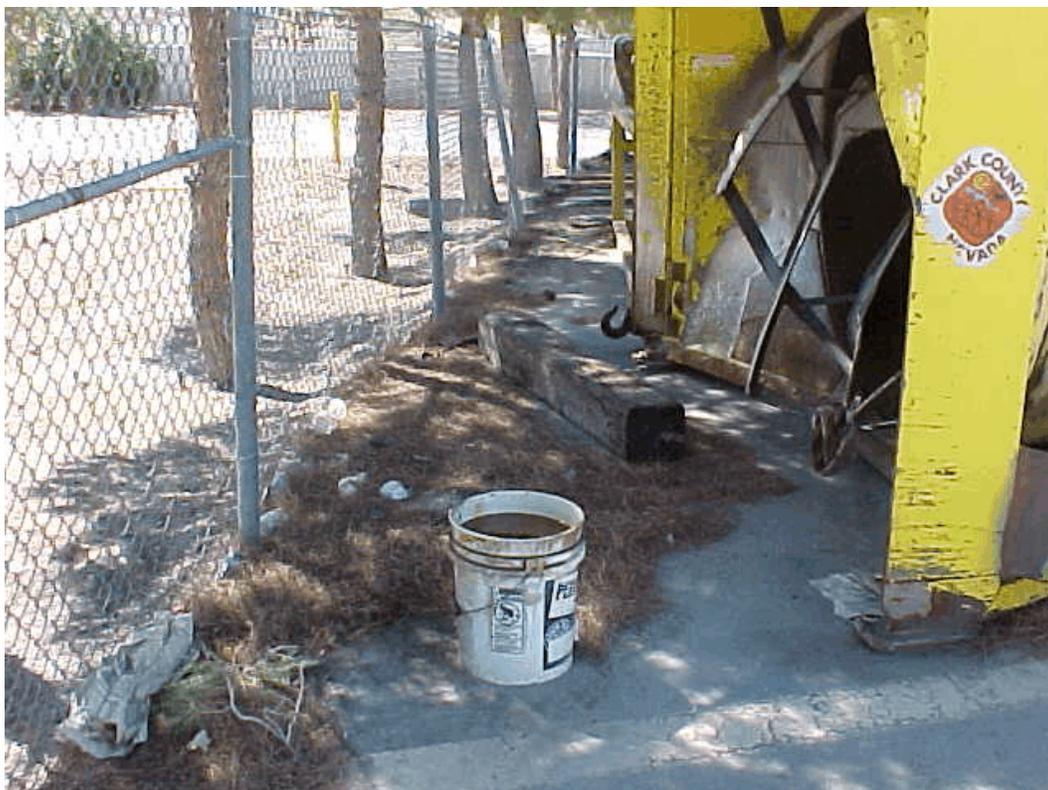
Photo 12. Fleet (secondary) facility: Open 5-gallon pail of oily water in truck and paving equipment parking area.

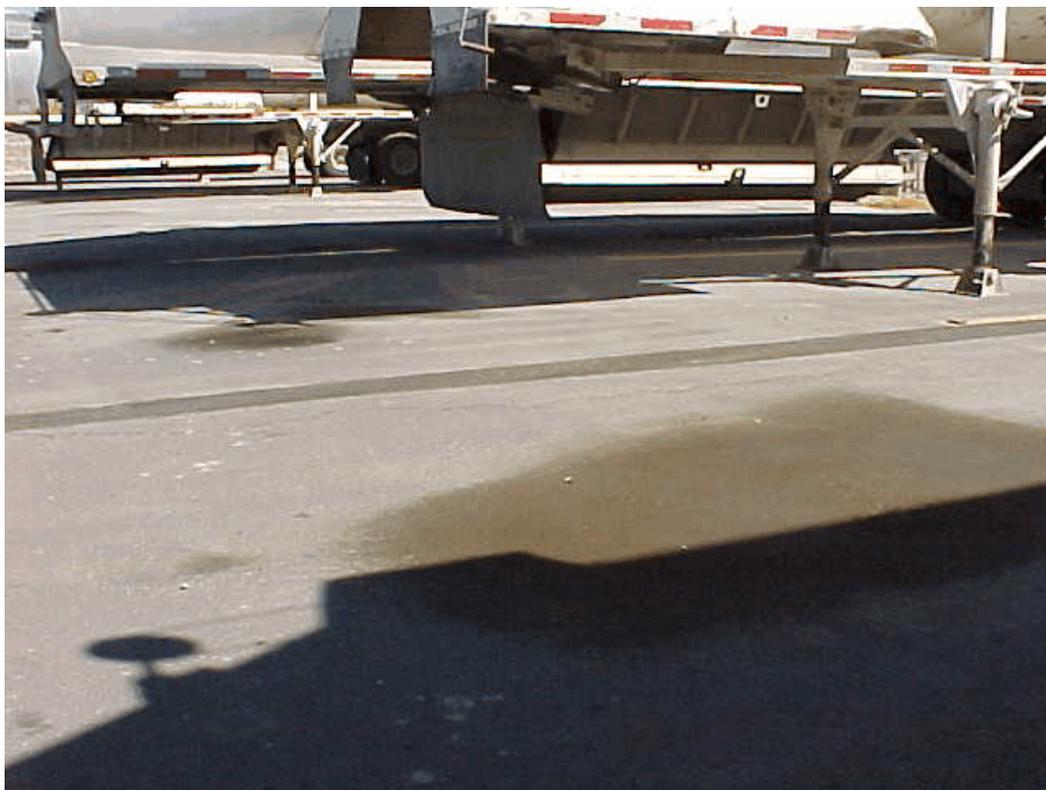
Photo 13. Fleet (secondary) facility: Truck and paving equipment parking area with spills/leakage staining on pavement.

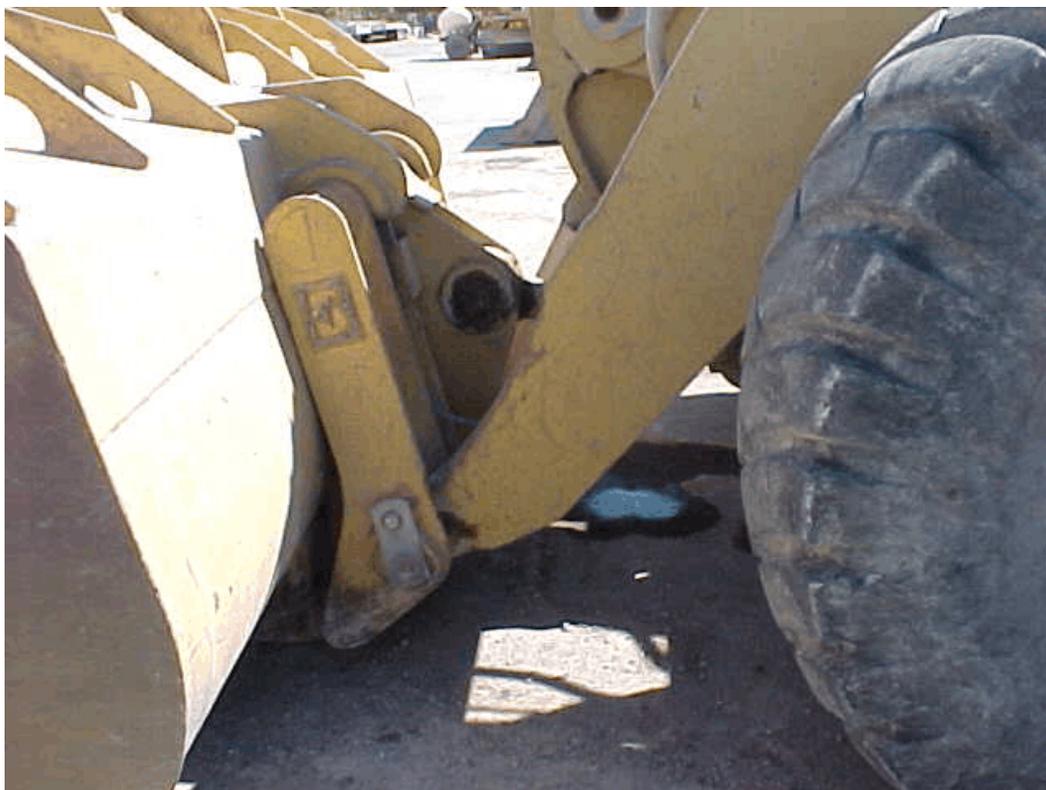
Photo 14. Fleet (secondary) facility: Front loader with an active leak.

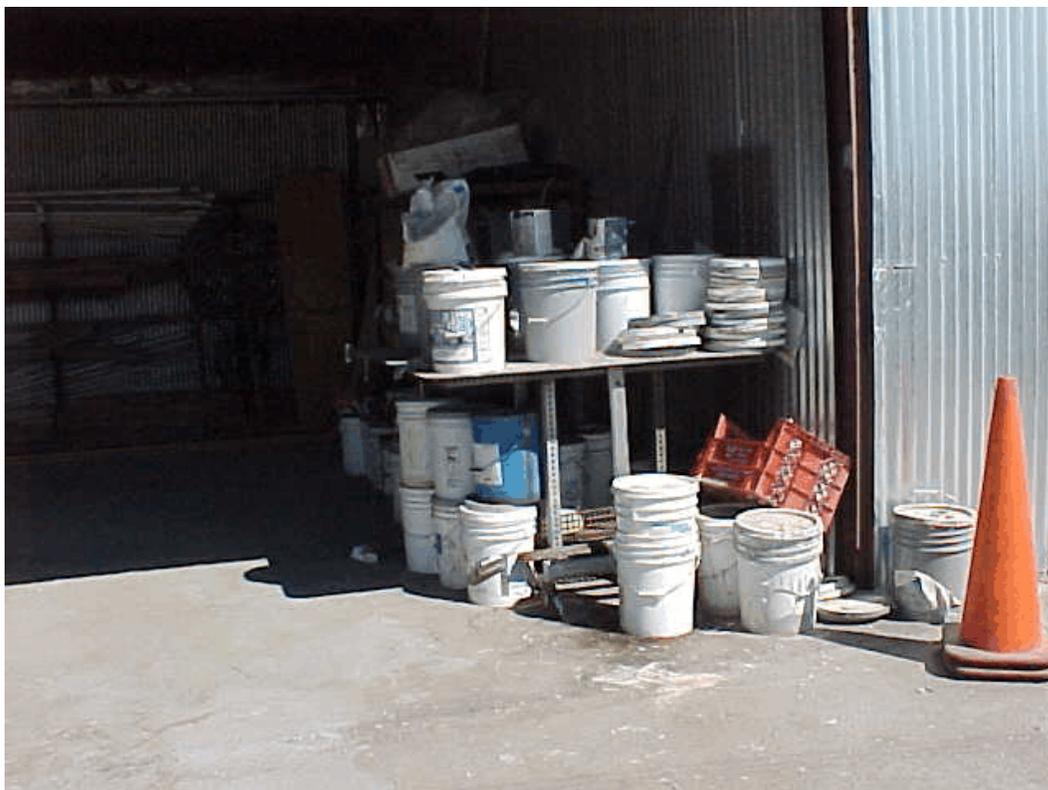
Photo 15. Fleet (secondary) facility: Full and partially full 5-gallon pails of stucco and form oil.

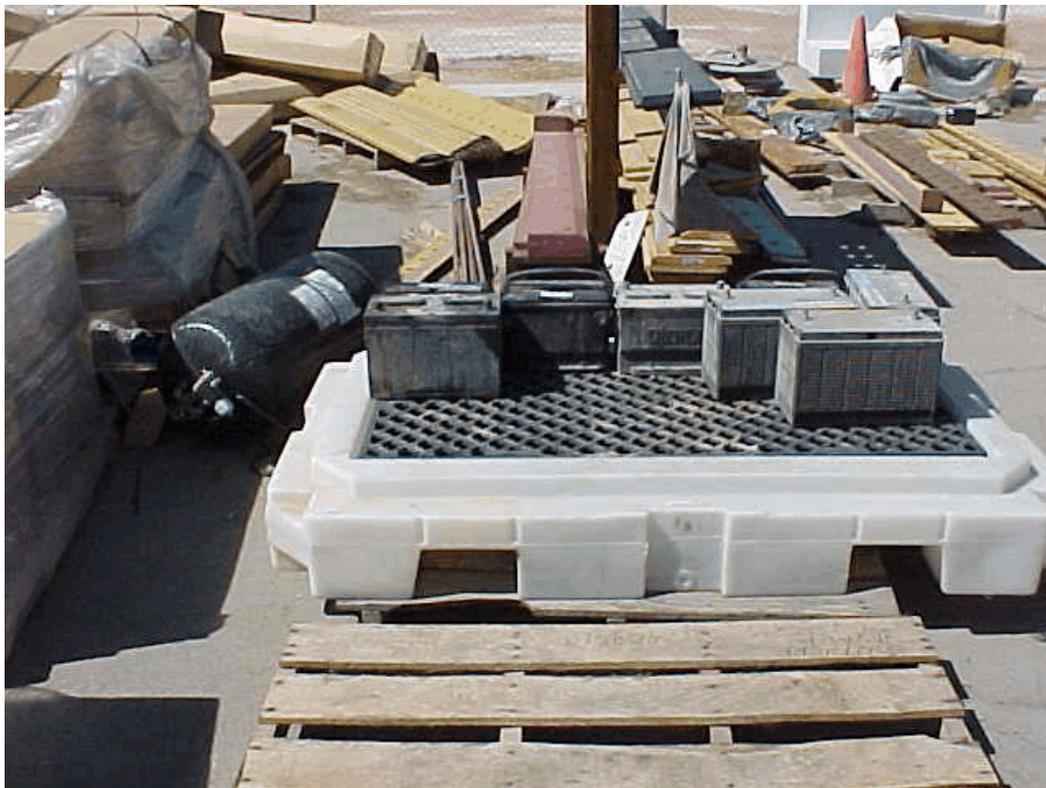
Photo 3. Exposed, but contained used batteries located outside the Automotive Repair facility.

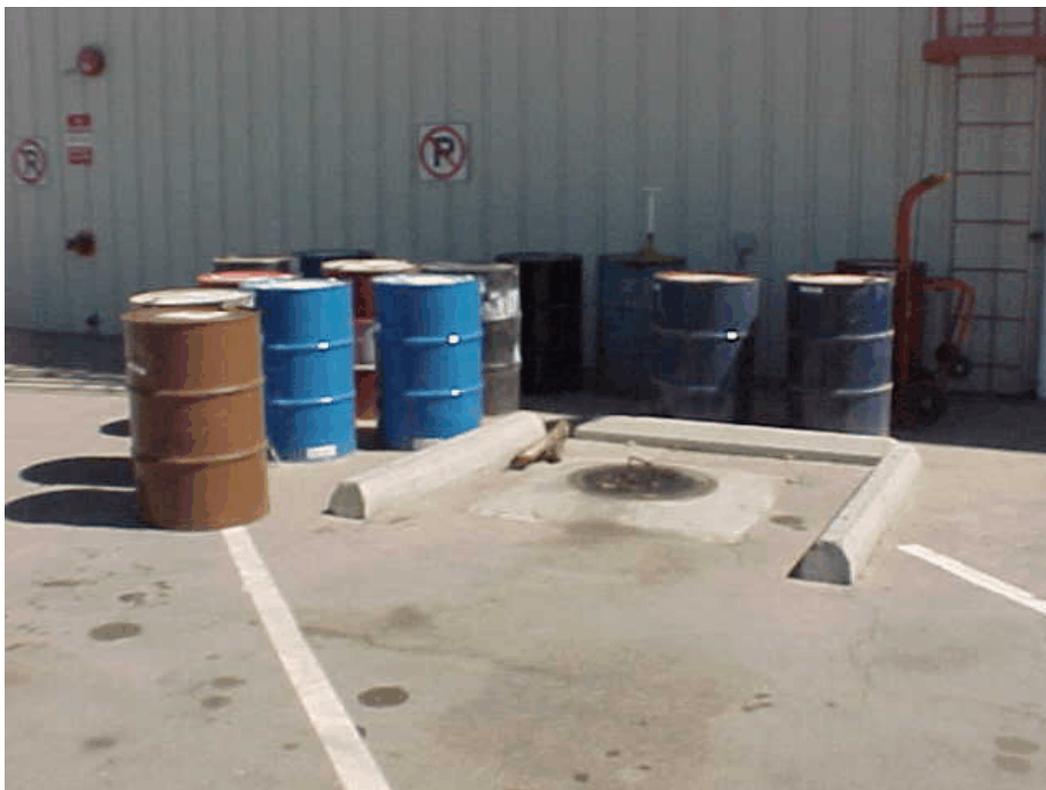
Photo 4. Waste oil pit and multiple 55-gallon drums that are full, partially full, and empty at the Automotive Repair facility.

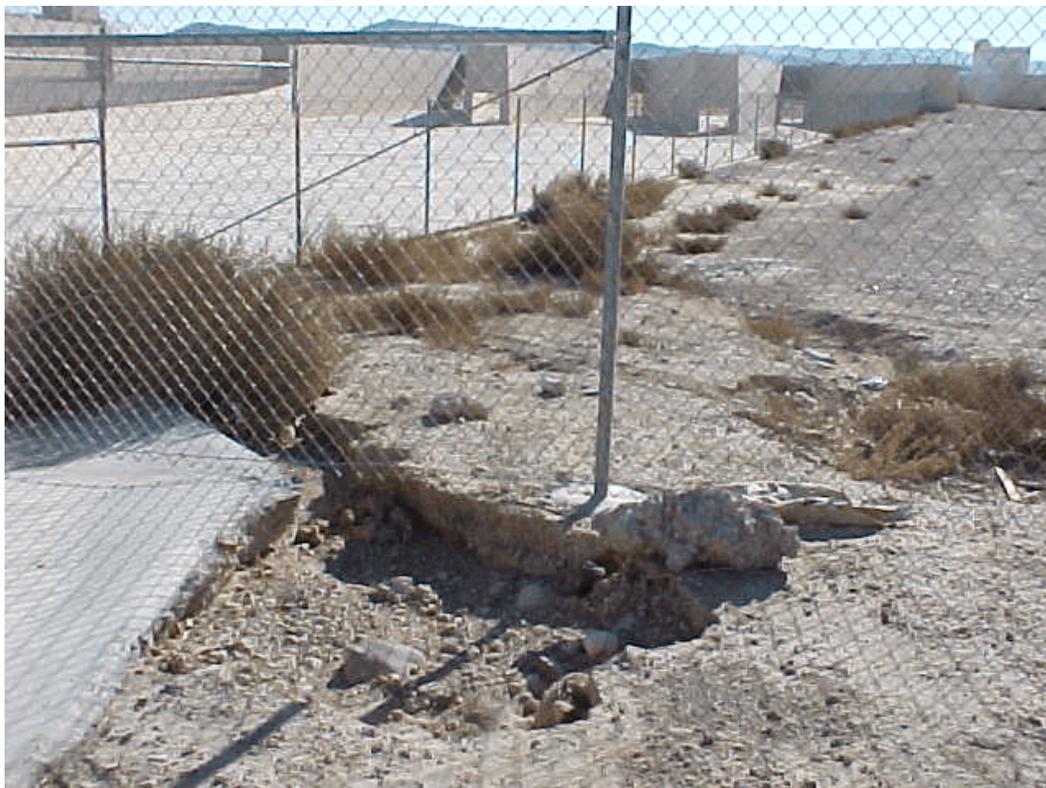
1. Erosion into the detention basin was observed at several locations. Some erosion channels in the west wall of the detention basin were at least four feet deep and six feet wide. Mr. Suckow stated that the erosion in the west wall had occurred several months ago.
2. Utility work was ongoing outside the east fence of the detention basin. The heavy equipment was parked inside a locked gate to the detention basin area. Mr. Suckow was unaware of the ongoing work.
3. An approximately 36-inch pipe for storm water discharge to the detention basin had recently been installed at the northwest corner of the detention basin. The pipe appeared to have been installed by the developer of an adjacent subdivision. Mr. Suckow was unaware of the installation.

1. Clark County is not actively repairing erosion into the detention basin and has not implemented Best Management Practices (BMPs) such as stabilization and/or riprap of the basin walls. Loose soils eroded into the basin will potentially be carried by storm water to the Duck Creek Channel when a rain event occurs.

Photo 1. Erosion to the detention basin at the northeast corner.

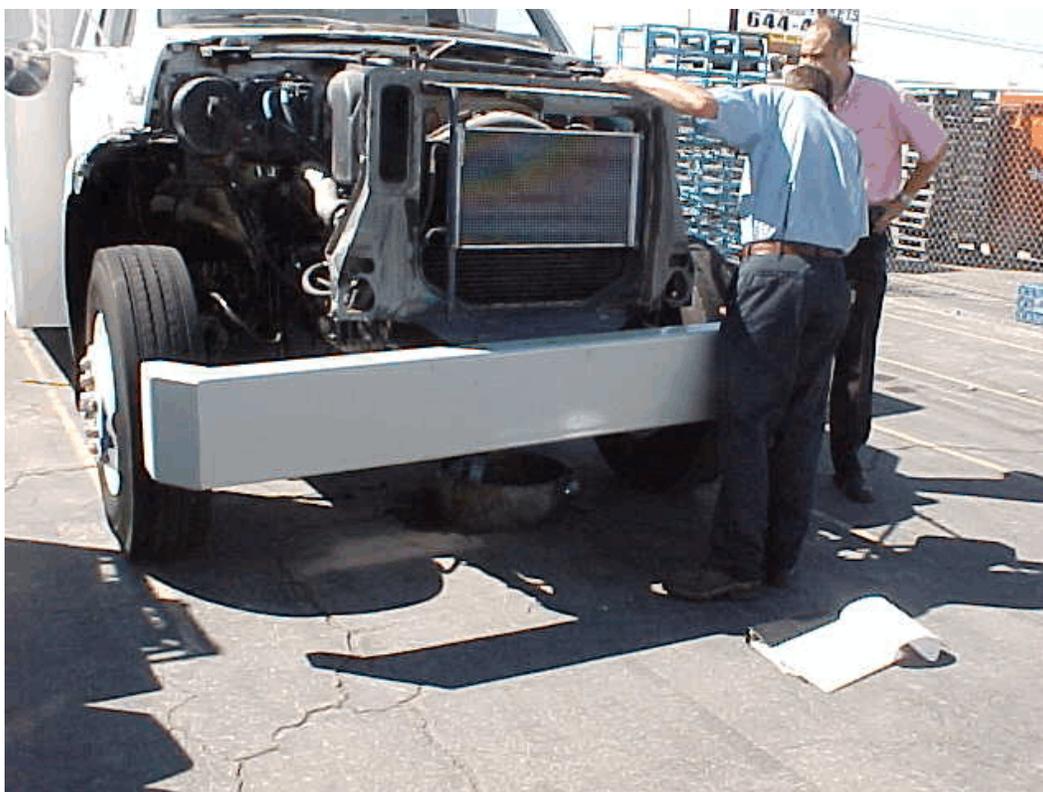
Photo 6. Mr. Palsgrove inspecting a truck that was being repaired. A drip pan was being used under the engine.

7. He directed the removal of the salvage drum materials within 30 days.
8. He inspected a truck stored outside that was under repair and directed the truck engine area be covered with a tarp to avoid contamination of storm water.

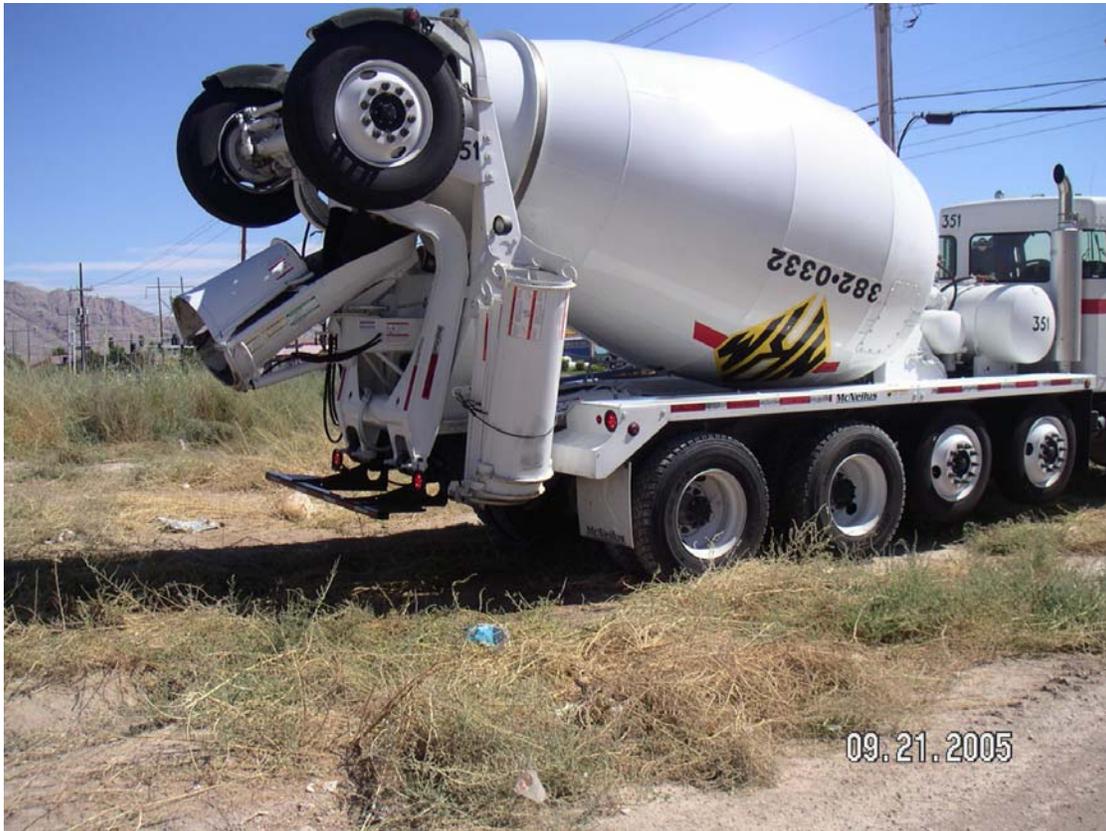
Photo 1. Concrete truck that just completed wash-out.

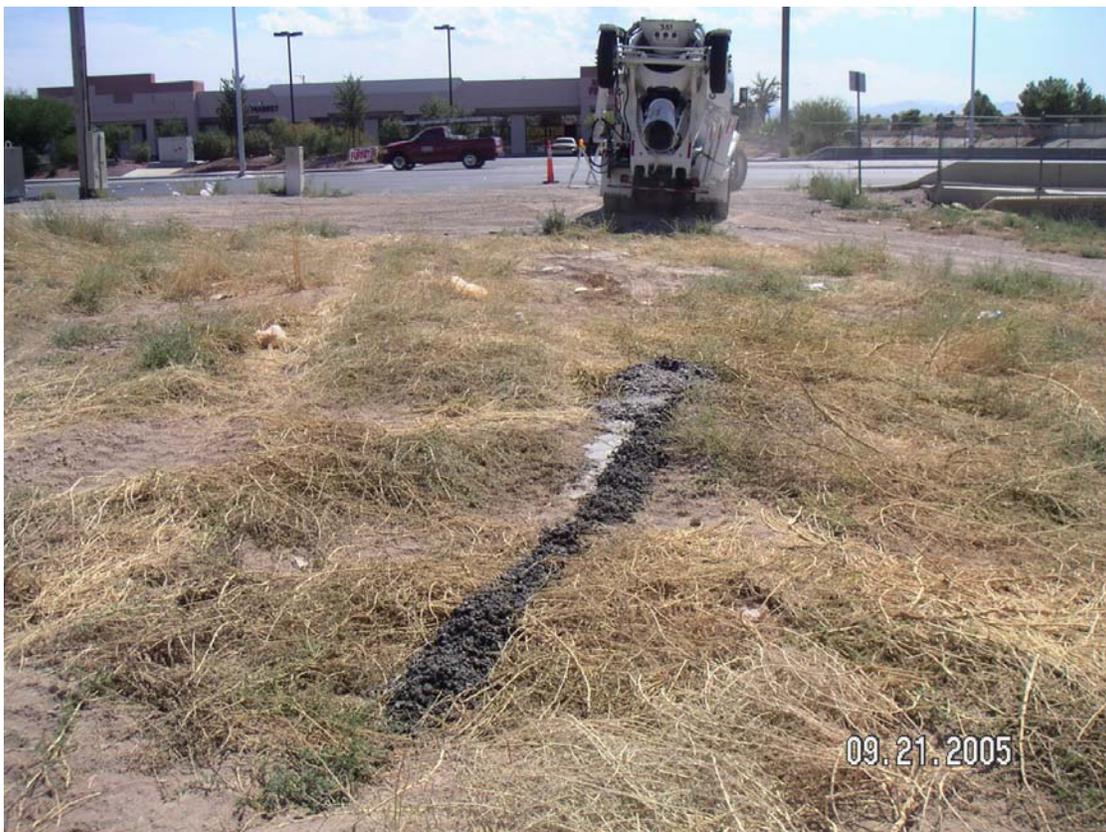
Photo 2. Wash-out material left by concrete truck.

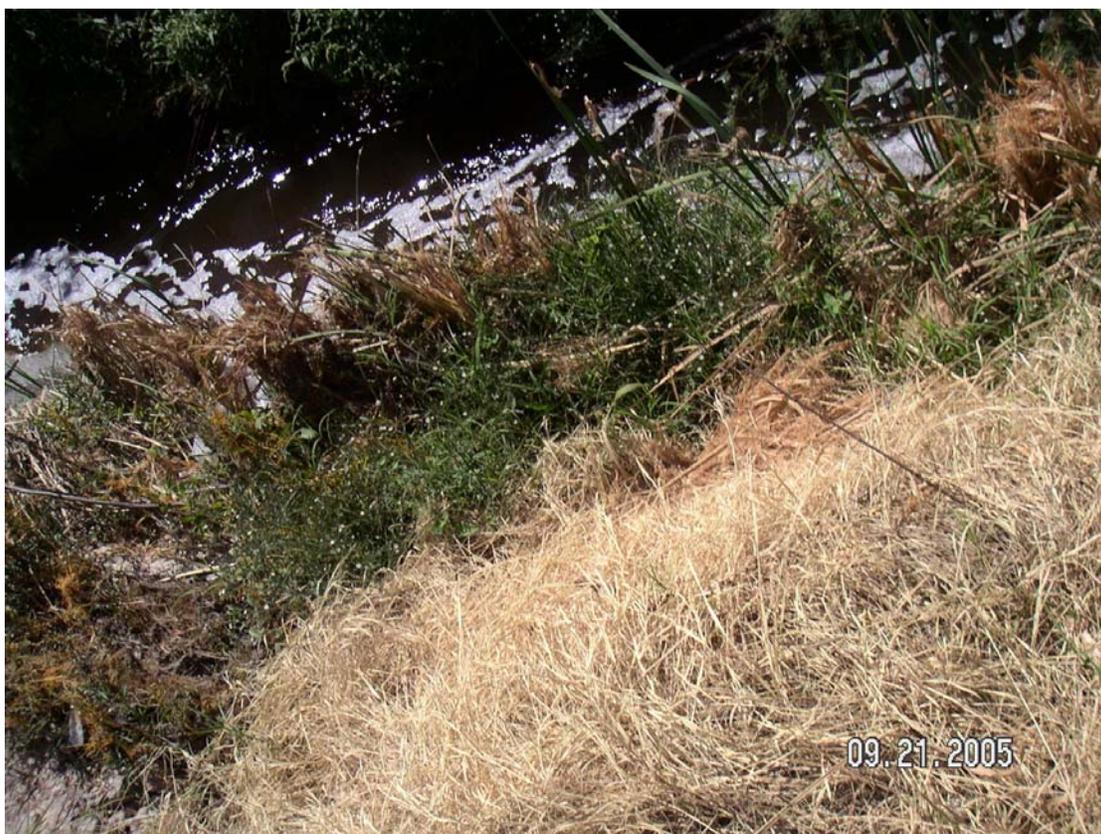
Photo 4. Las Vegas Wash - Appearance is brown with suds.

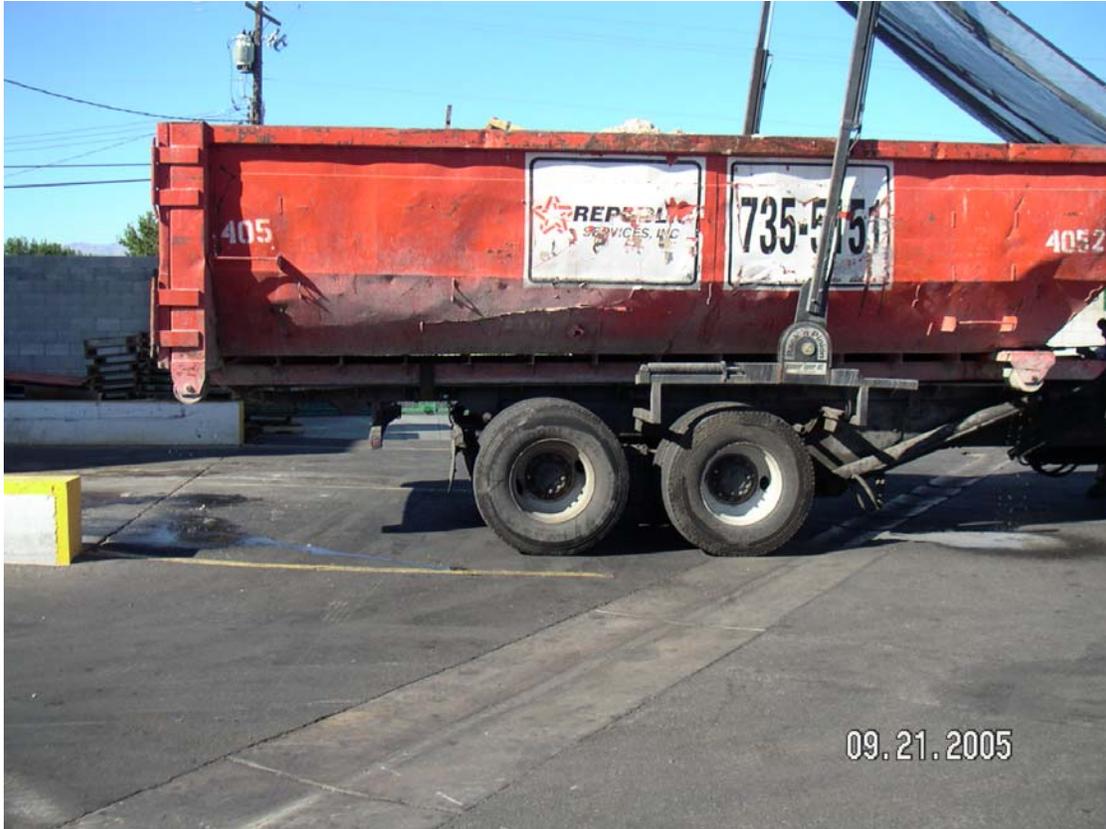
Photo 1. Roll-off container is leaking.

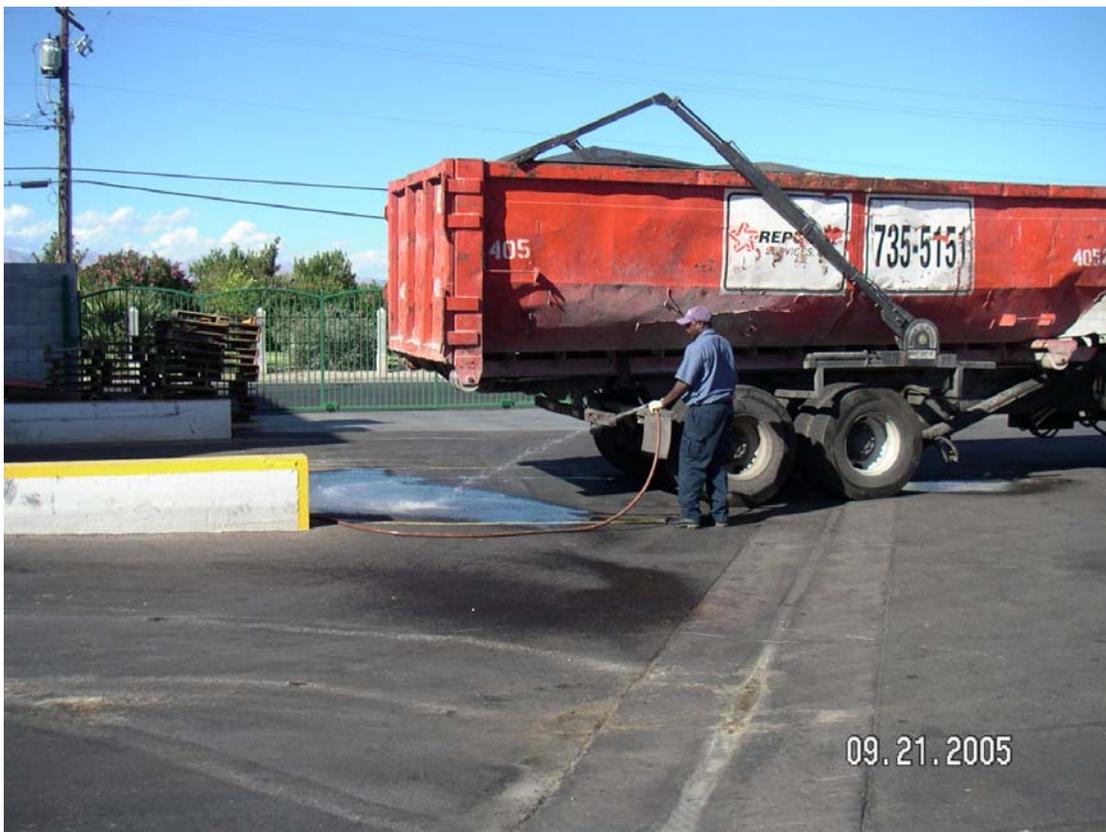
Photo 2. Roll-off container is leaking.

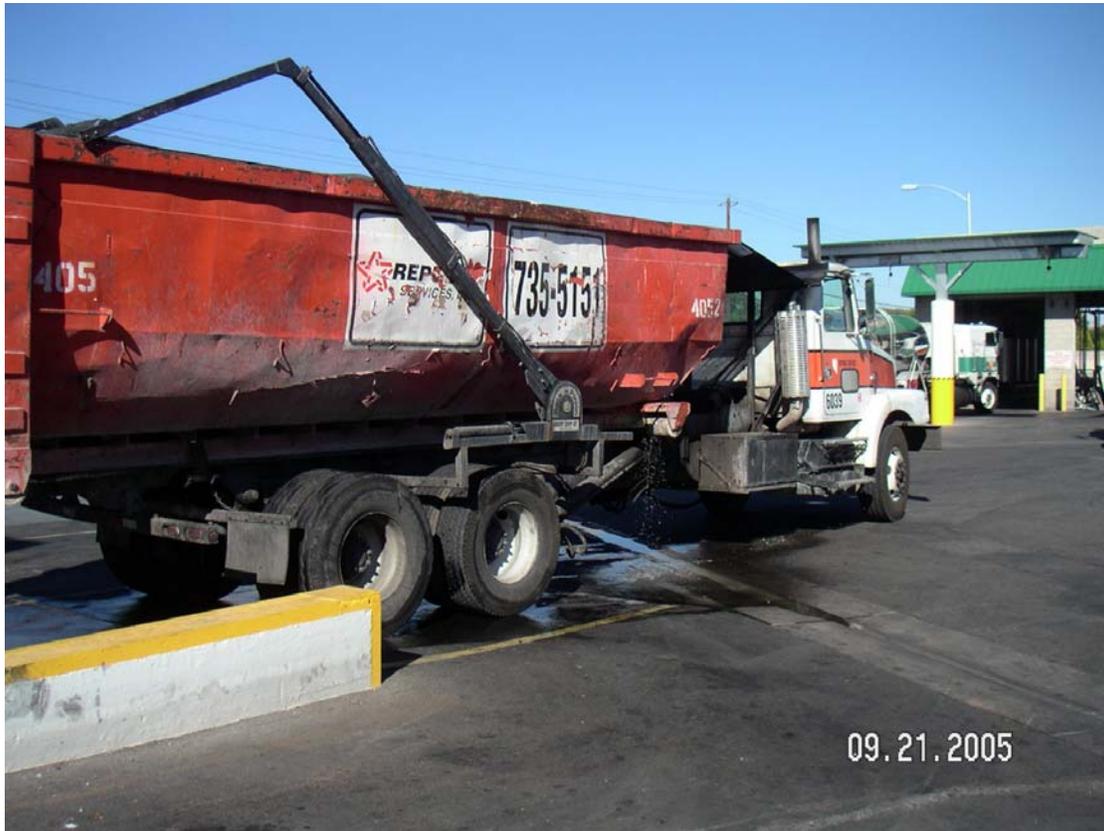
Photo 3. Roll-off container is leaking.

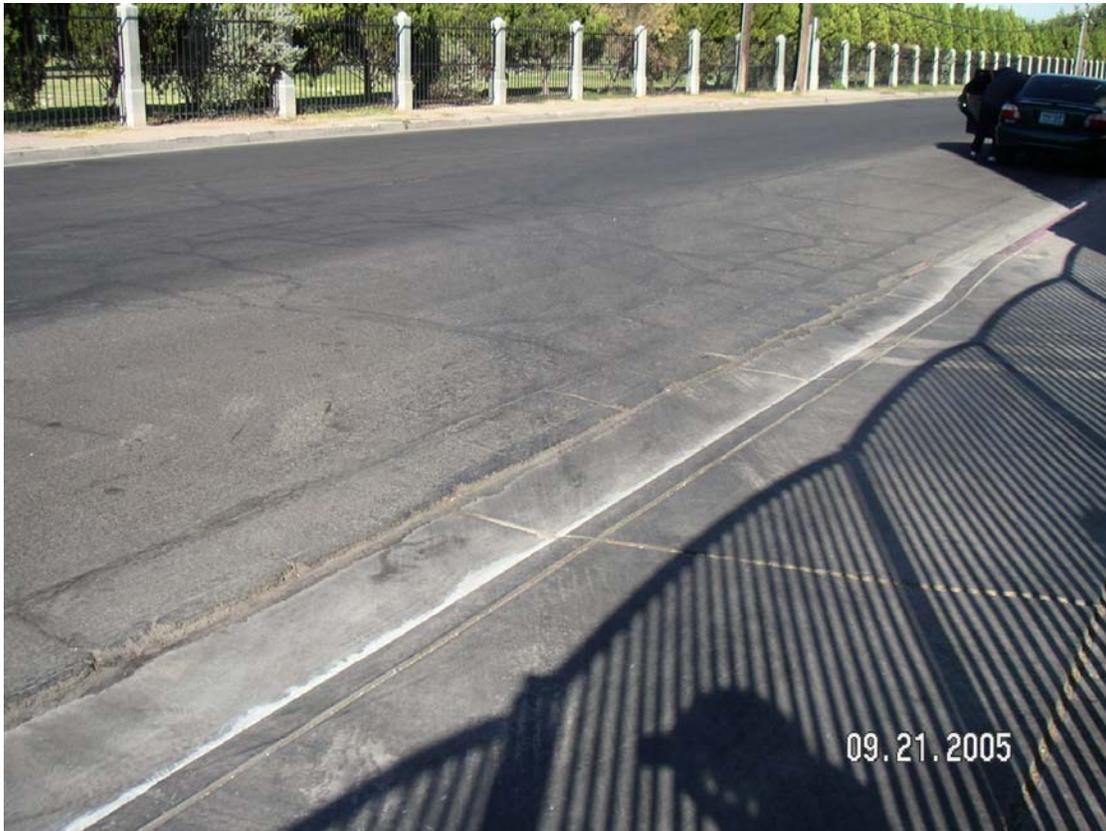
Photo 7. Dried milk solids in street gutter outside facility.

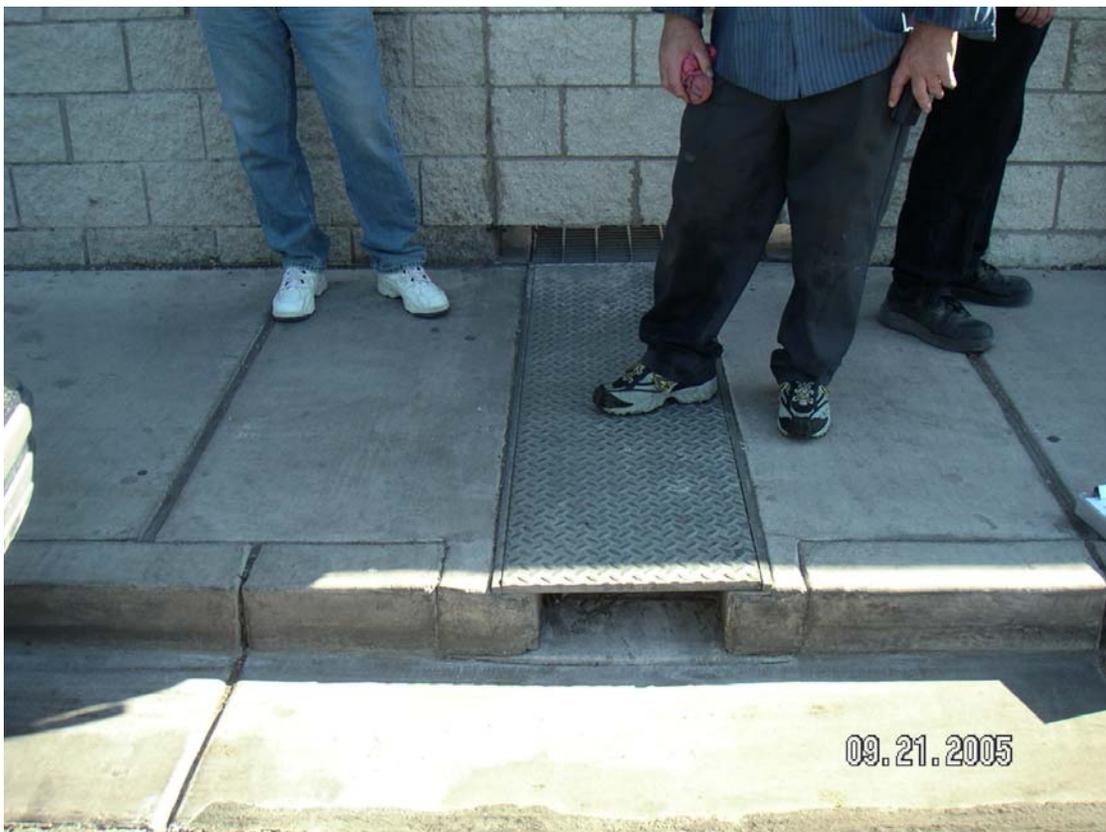
Photo 8. Dried milk solids entered street gutter from facility drain.

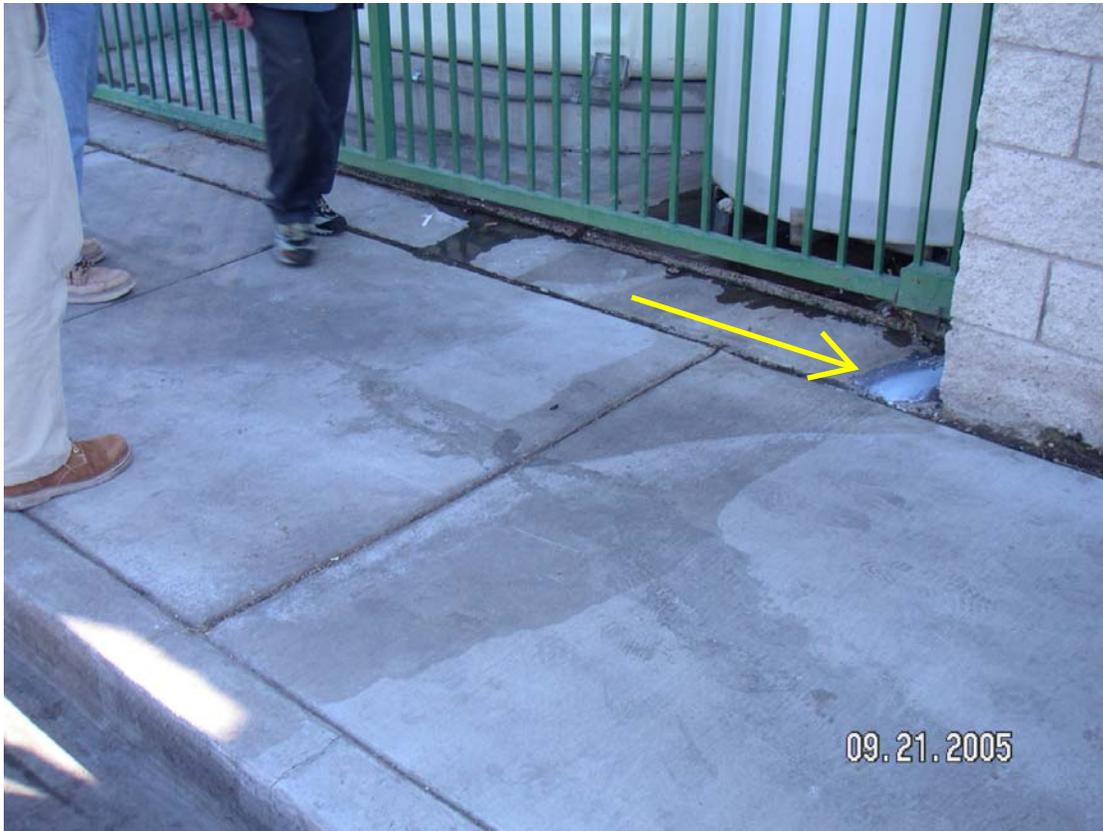
Photo 9. Discharge to street from leaking tank.

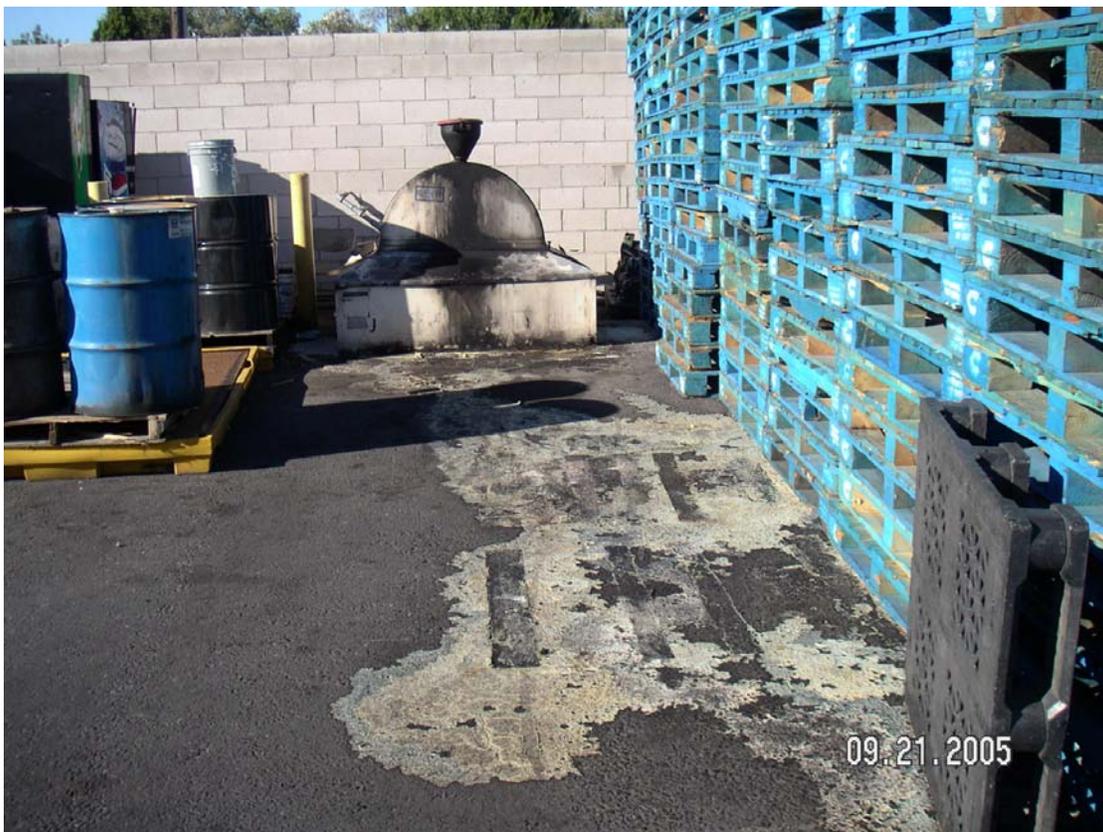
Photo 10. Dried milk solids on asphalt inside facility.

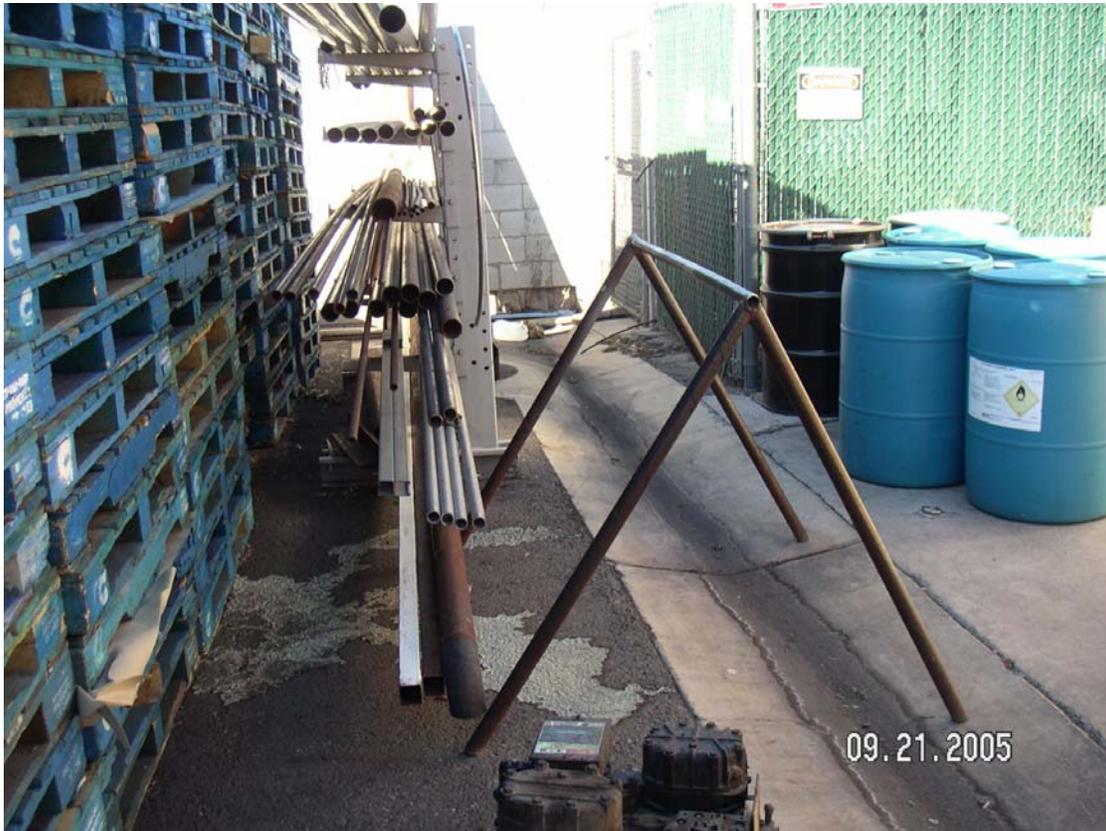
Photo 11. Dried milk solids spilled next to drain to street seen in Photo 8.

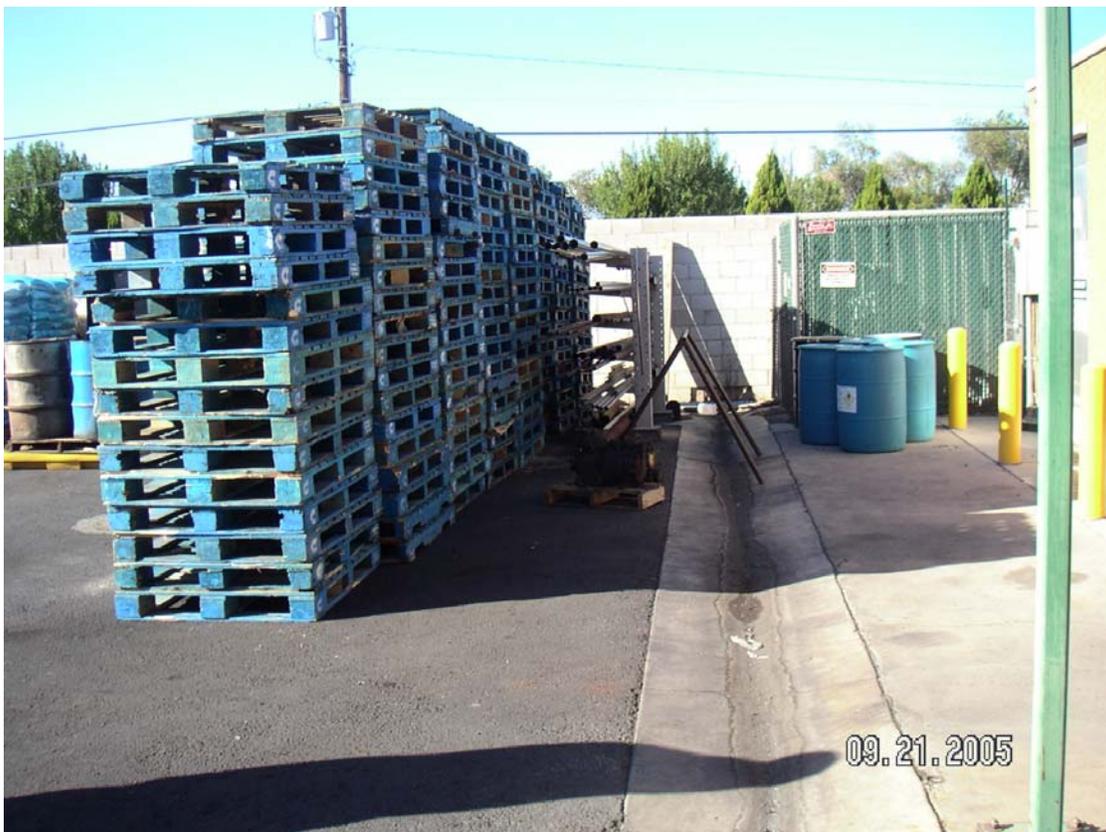
Photo 12. Dried milk solids spilled next to drain to street seen in Photo 8.

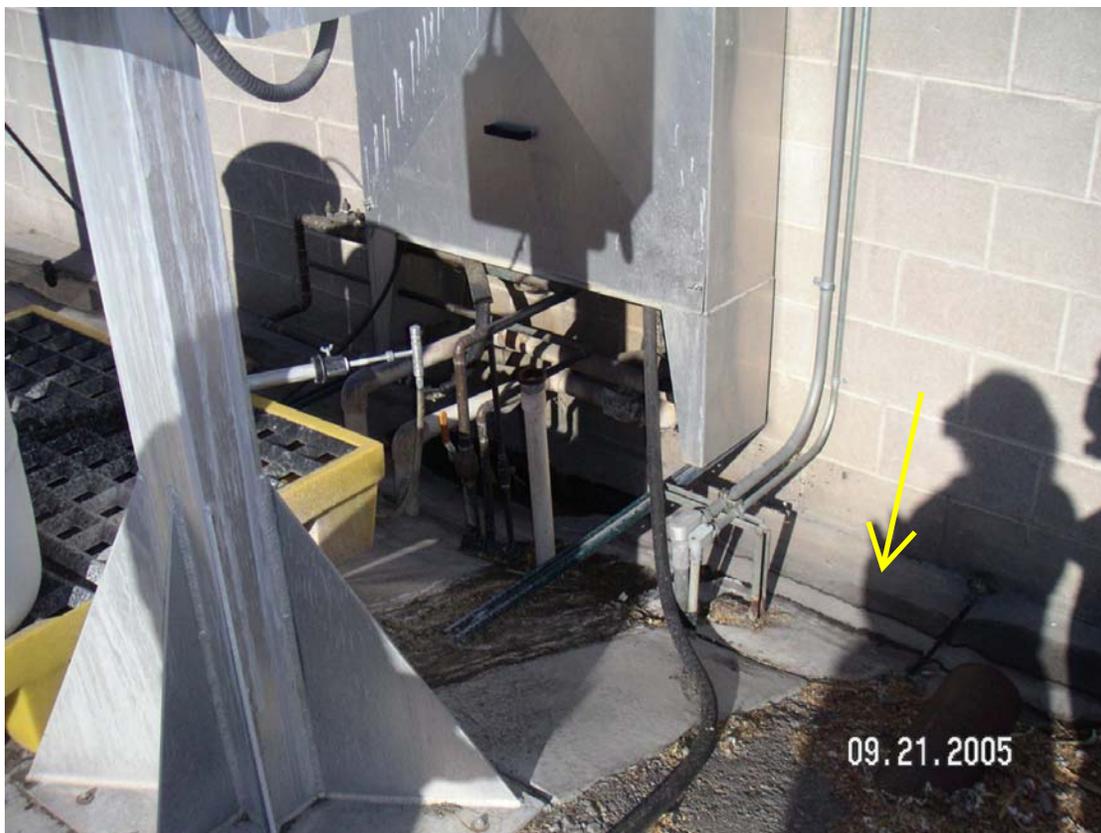
Photo 13. Detergent leaking from wash rack; drain to street in right foreground.
