Appendix A
Storm Water Management Plan: Comments from NDEP and Co-Permittee Response

**Appendix B
Clark County**

**Appendix B.1
Documentation of Findings**

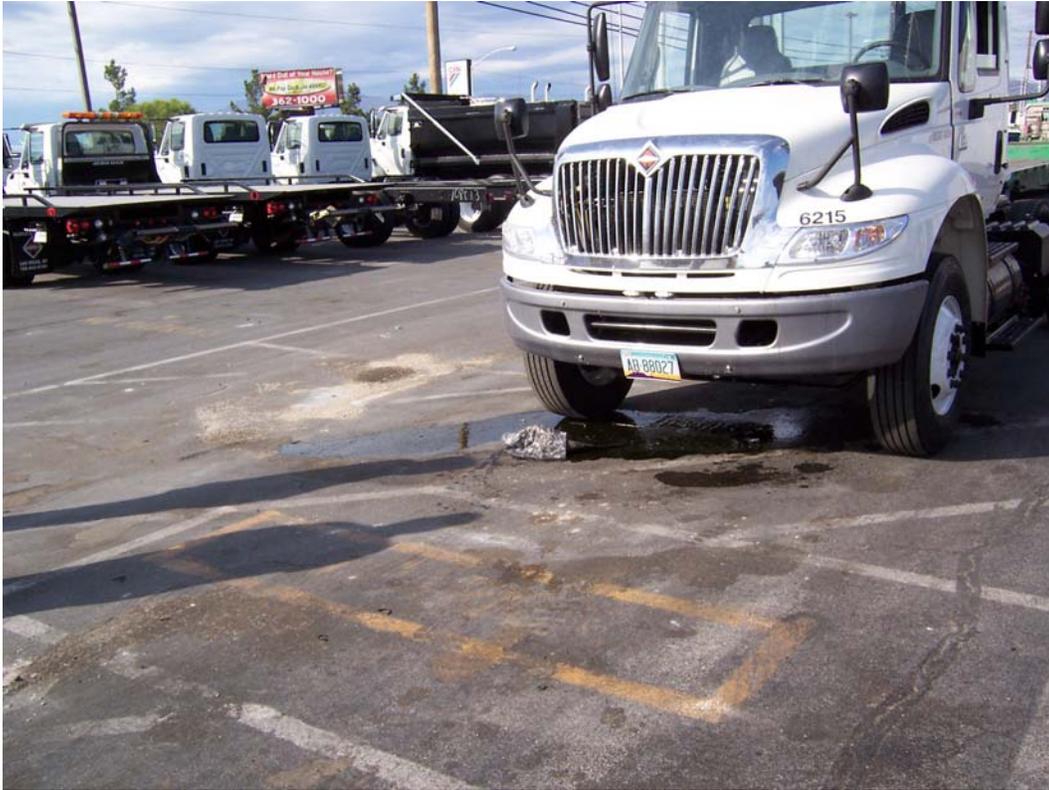
Photo 1. Oil leaking from truck stored in the parking area.

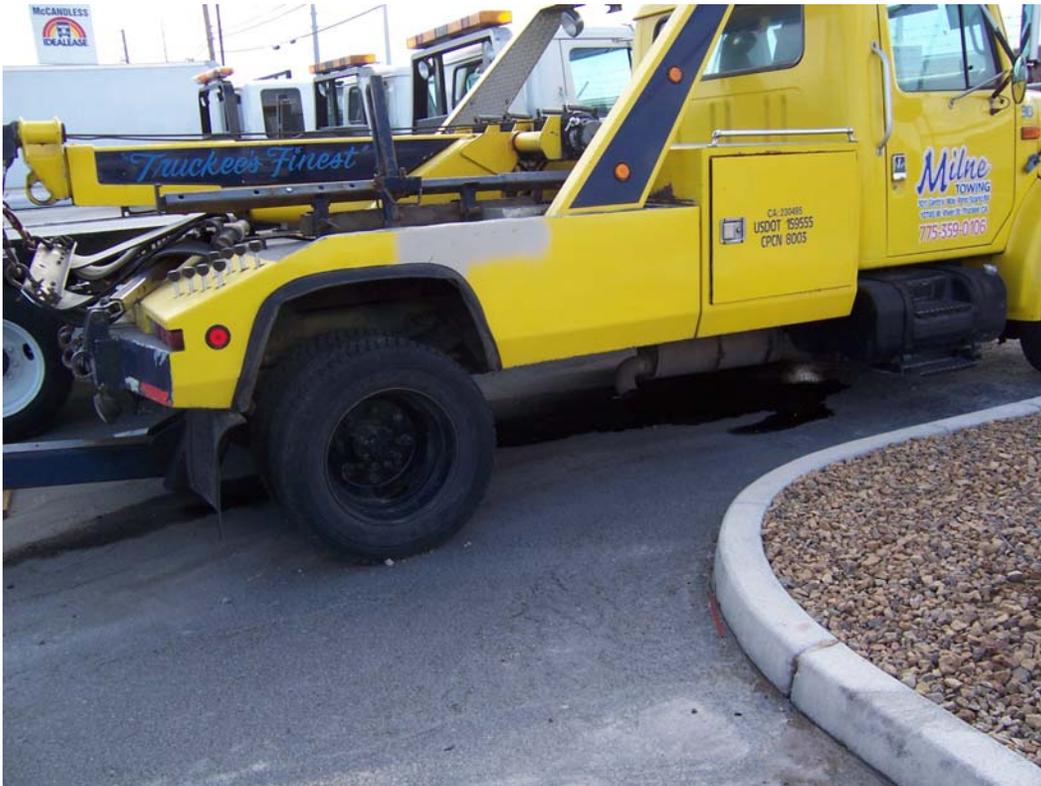
Photo 2. Oil leaking under tow truck stored in the parking area.

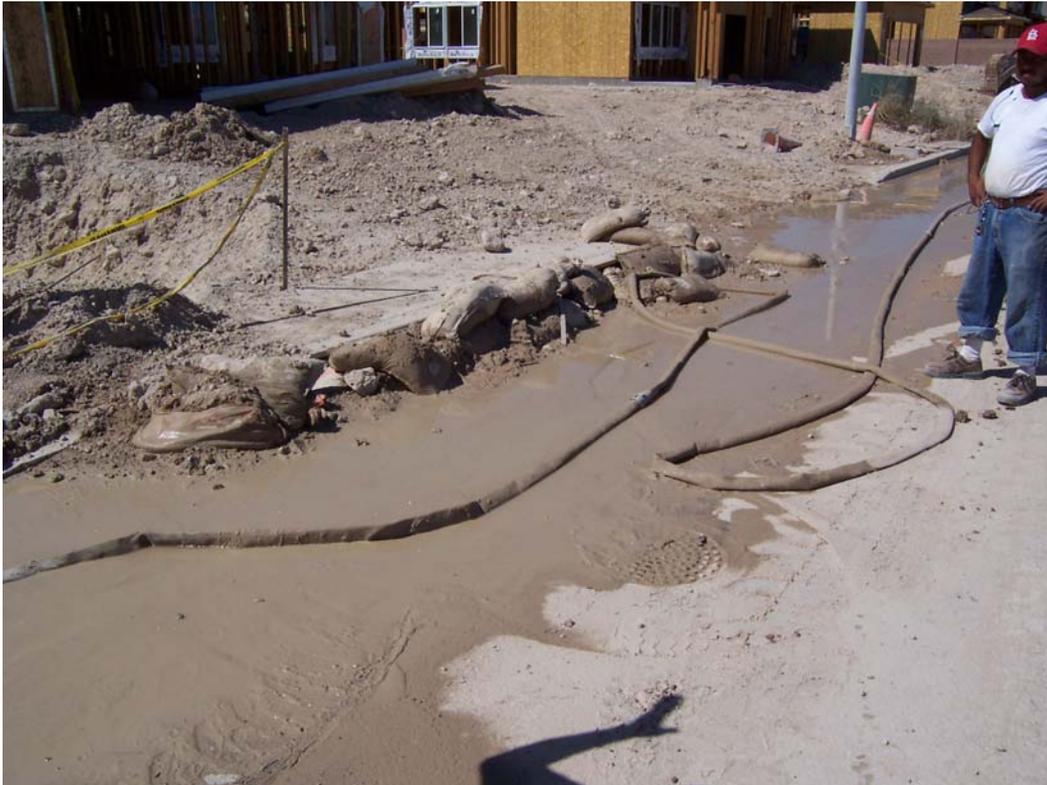
Photo 2. Storm inlet at the site. Sediment is also entering the storm sewer through the pick hole in the manhole in front of the inlet. Hose in the photo is the fire hose the site had been using to clean the street. Note poor condition of sand bags used for inlet protection and dirt extending past curb line.

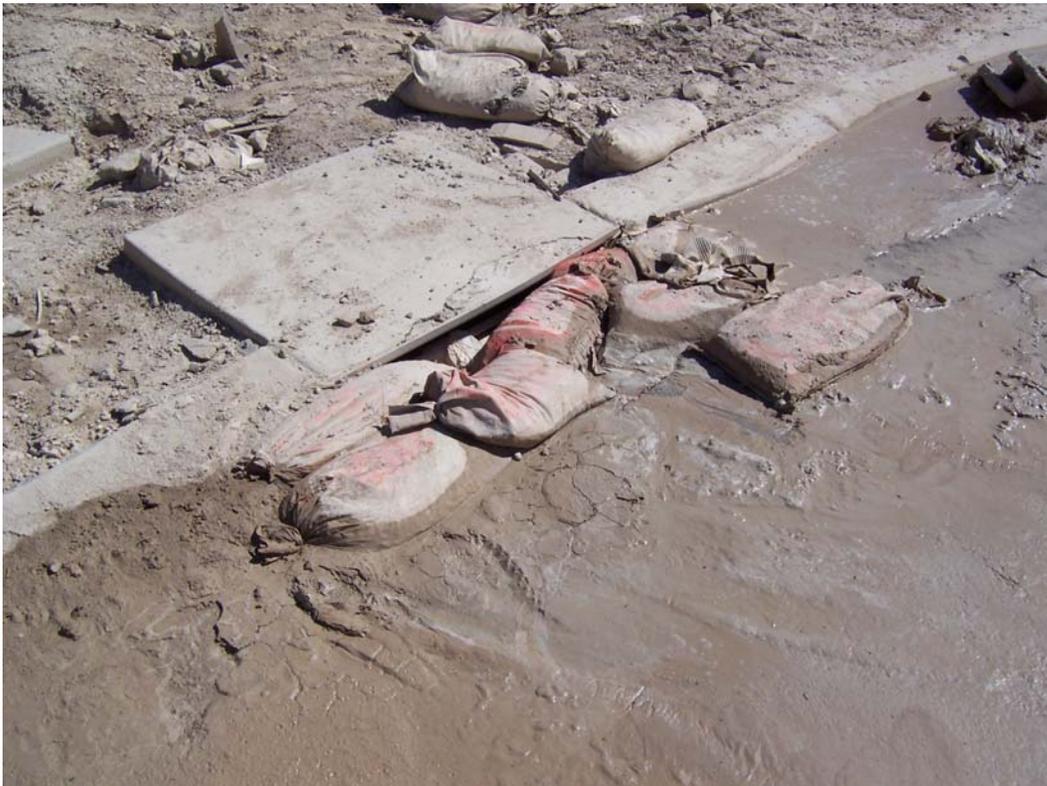
Photo 3. Different storm inlet at the site. Separation between sand bag at the right and curb allows sediment to enter the inlet.

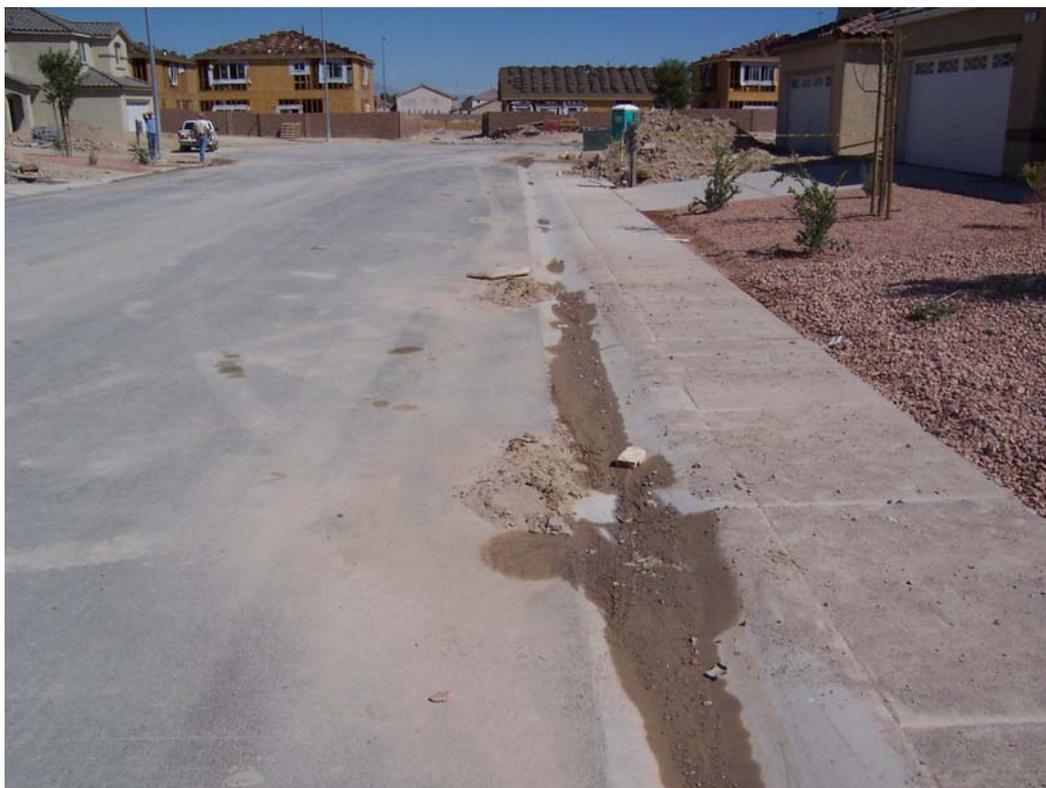
Photo 5. Sediment in the street. Moisture indicates street was washed earlier in the day. Note sand bag, center rear of photo, pulled back from the curb.

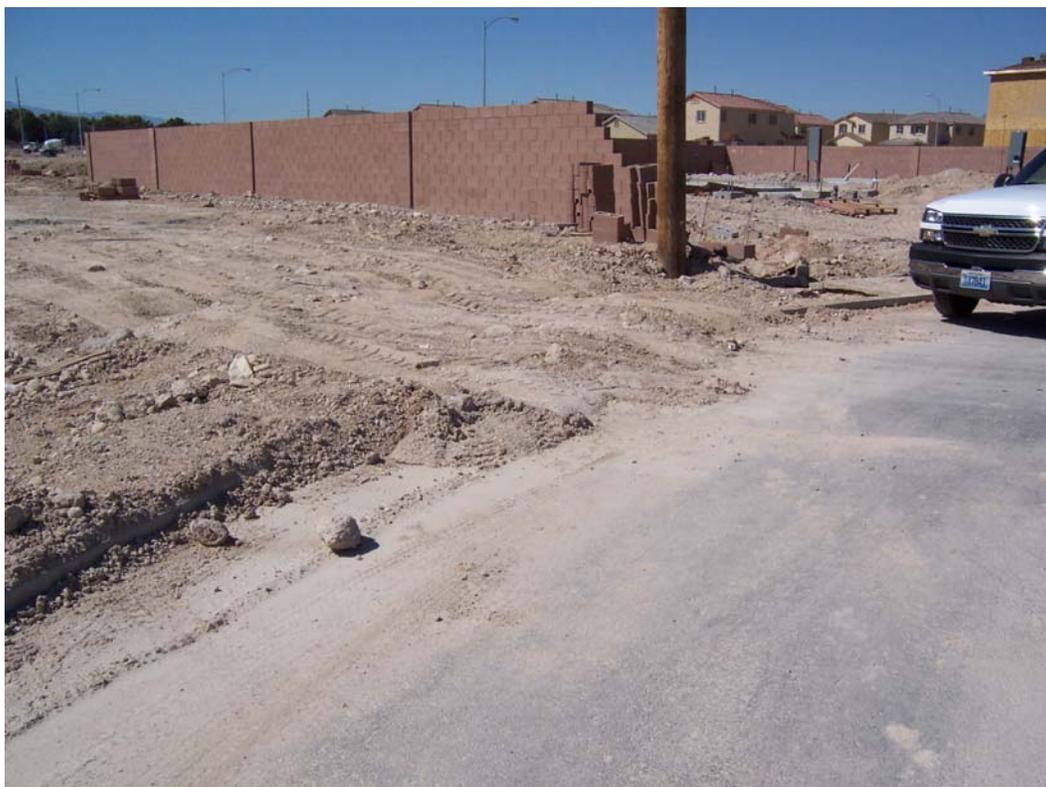
Photo 6. Absence of trackout controls at a site entrance. Note dirt extended past curb line into the street.

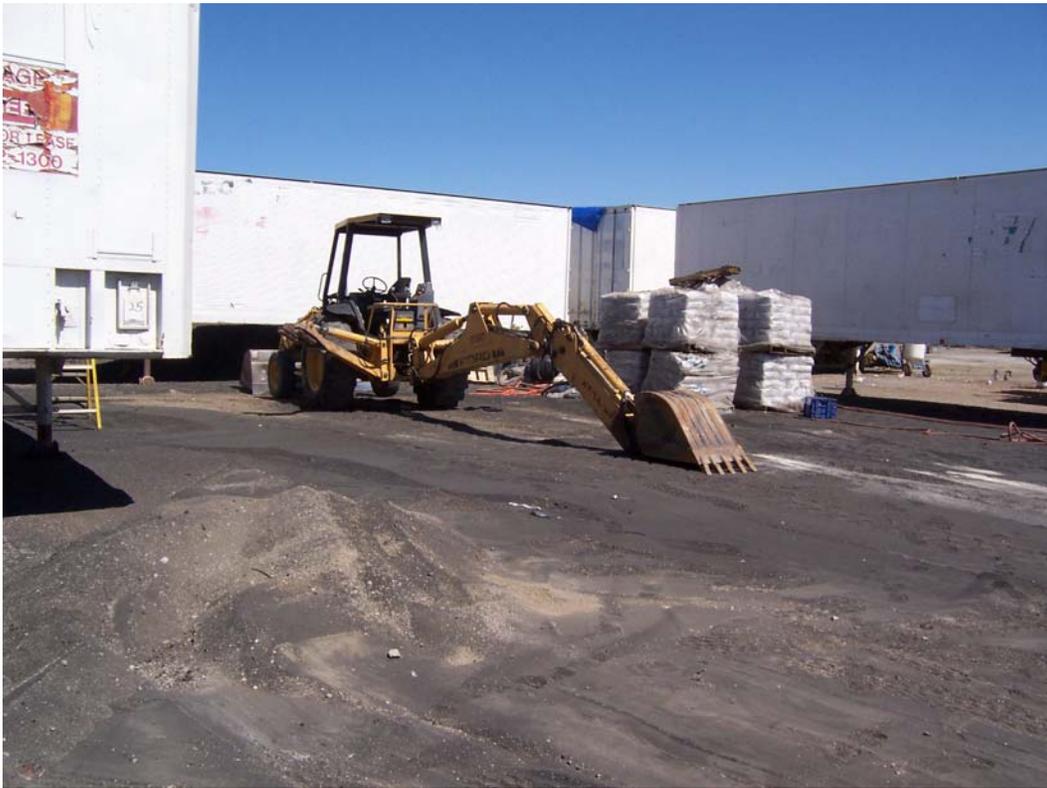
Photo 1. Open air sand blasting activity at the site. Dark material around the backhoe being sand blasted is spent sand blast grit. White bags on pallets at photo right are additional unused grit. No containment was provided around the area.

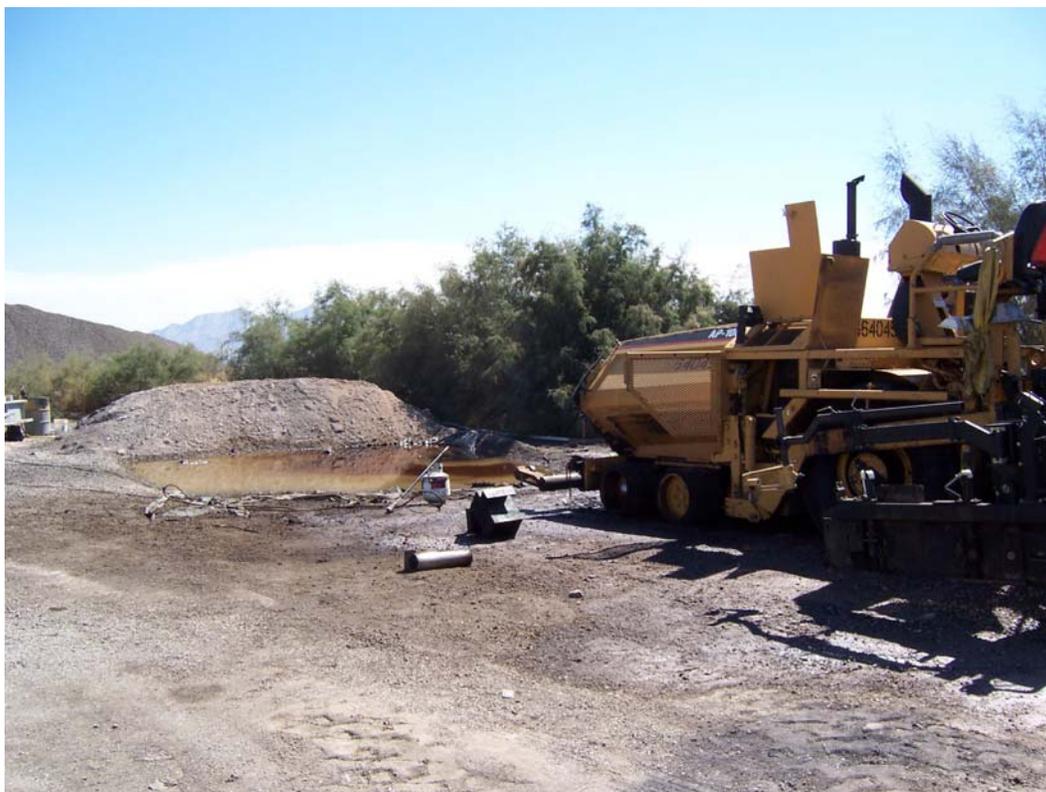
Photo 4. Paving machine being cleaned with wash water discharged to the pit shown in Photo 3. Note oil stains on the ground in front of and around the machine.

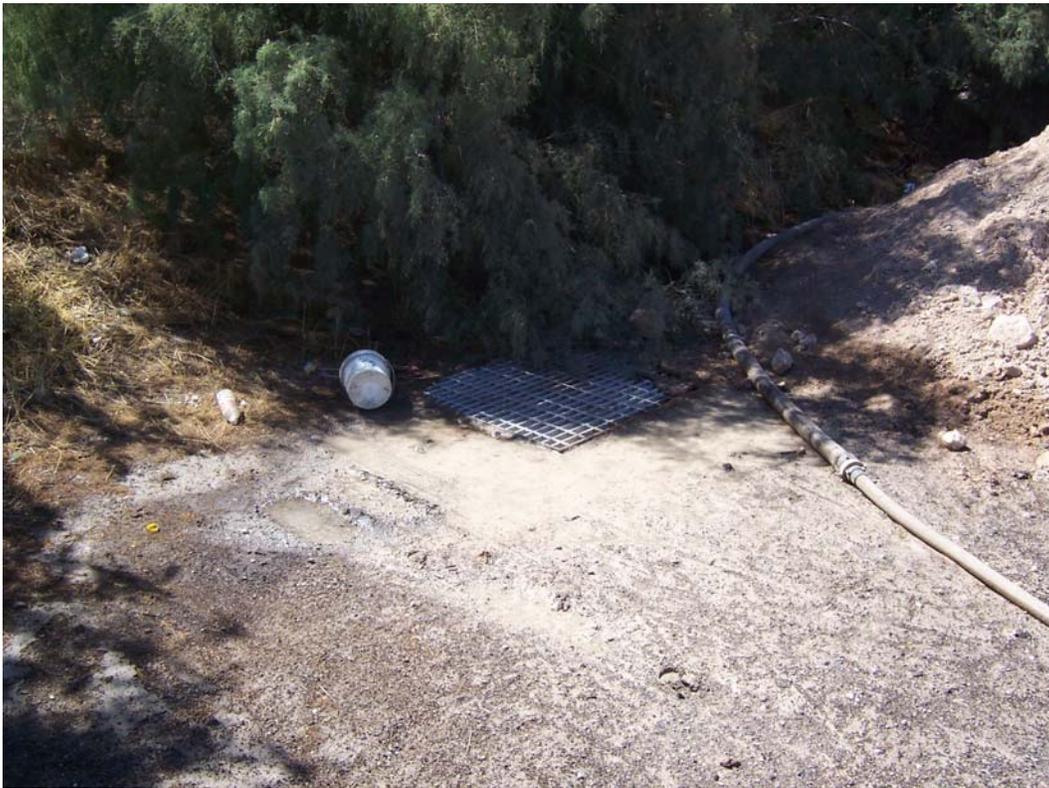
6. Contaminated water from the site was entering an inlet at the site. The discharge from this inlet went to Dehli Avenue, where it entered a storm sewer inlet.

Photo 5. Storm inlet located behind the pile of dirt shown in Photos 3 and 4. Note contaminated runoff from the site entering the inlet.

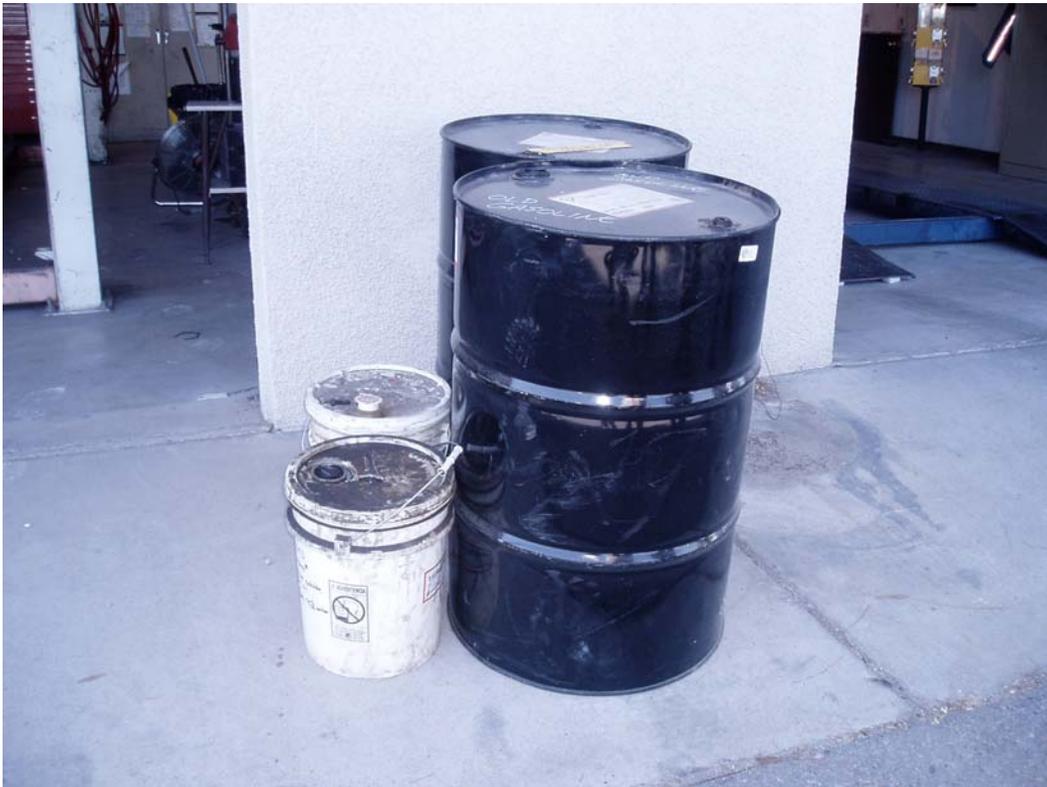
1. Self-inspections of the municipal facilities are not occurring.
2. Containers of used oil were observed outside without secondary containment.
3. The site was clean and well-maintained.

Photo 1. Two 55-gallon drums of used gasoline and two smaller buckets located outside the garage and without secondary containment.

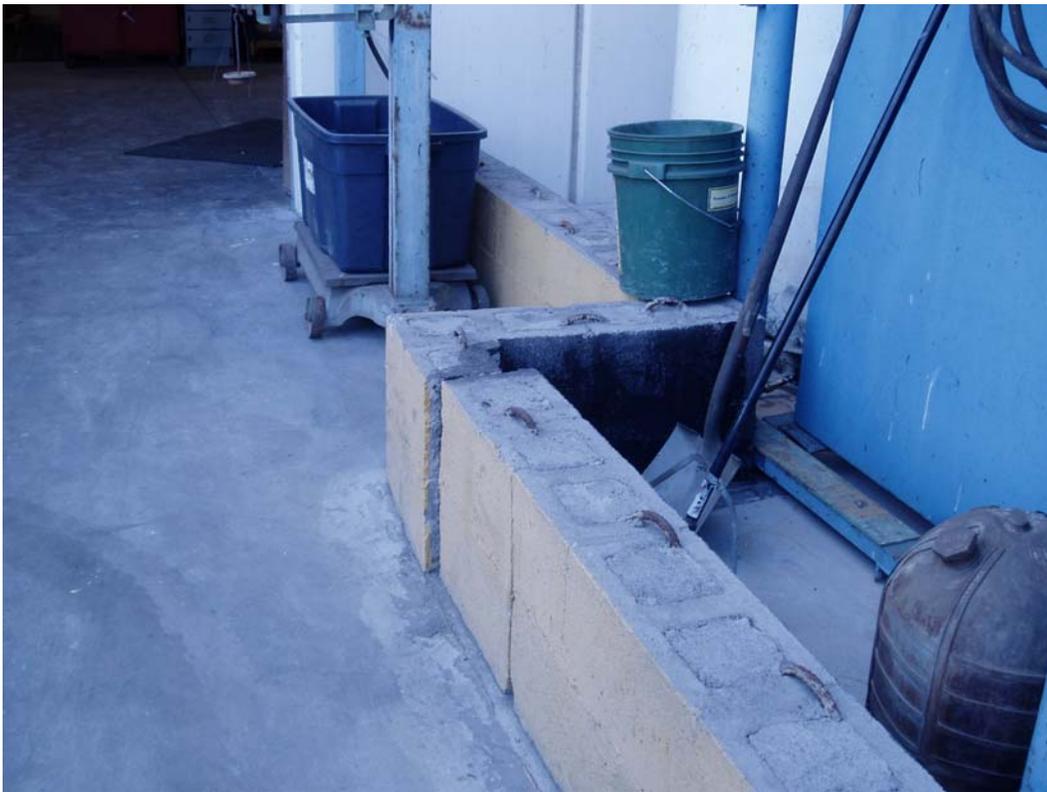
Photo 1. Crack in secondary containment.
