## Appendix B PHOTOGRAPH LOG

City of Mesa, AZ - Municipal Separate Storm Sewer System (MS4)  
(Permit No. AZS000004) Photograph Log  
Evaluated by: Scott Coulson (PG Environmental, LLC)

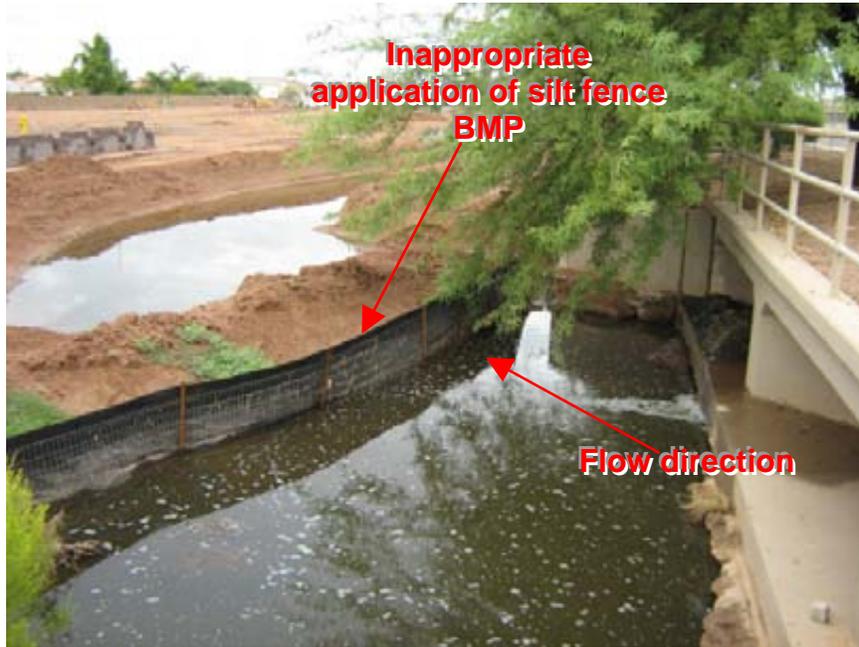
**Photograph 1: Mountain View Village Center**  
Drainage channel conveys flow into the northeast side of the site, where a silt fence BMP had been improperly implemented in an area of concentrated flow

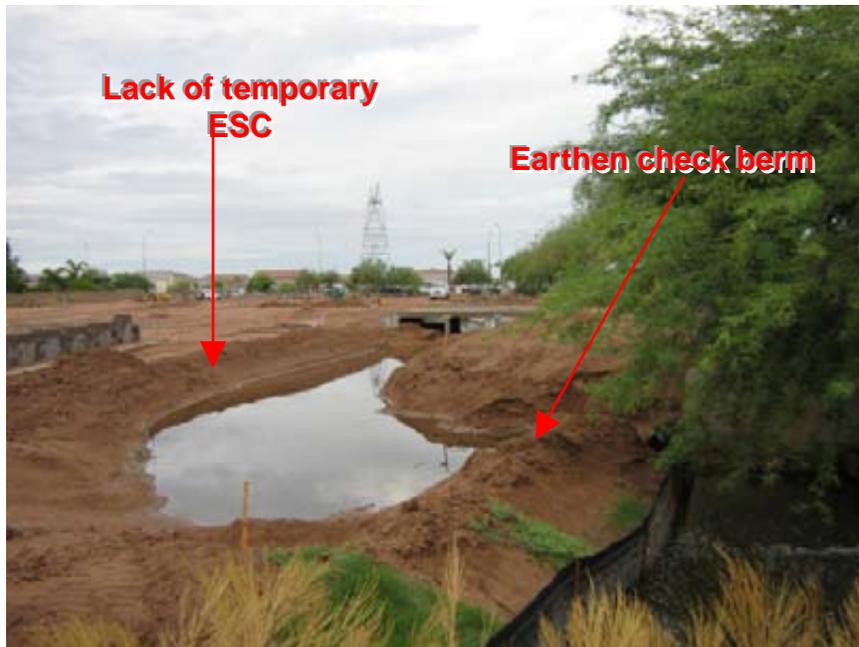
**Photograph 2: Mountain View Village Center**  
View of drainage channel leading west across the site and earthen check berms installed along this course

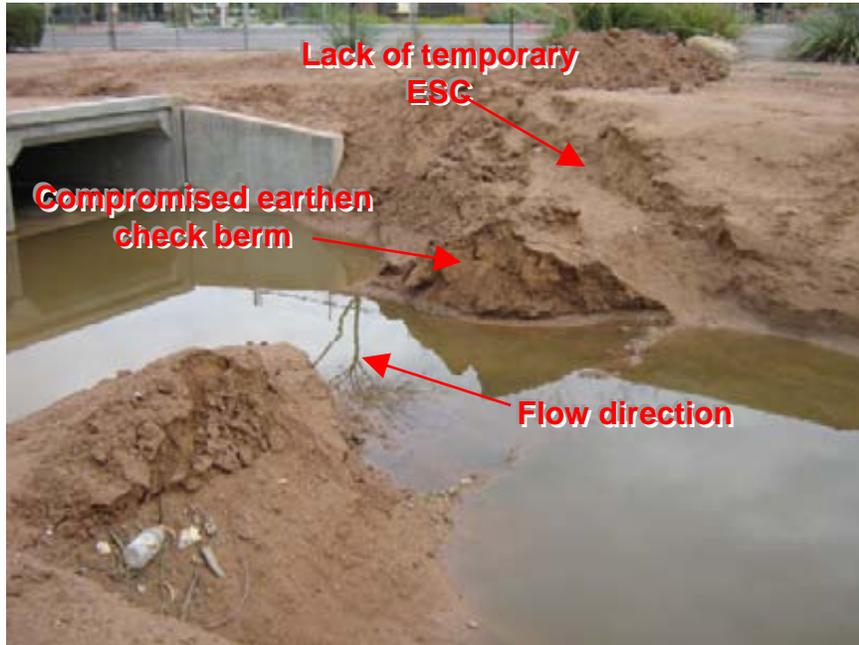
**Photograph 3: Mountain View Village Center**  
Earthen check berm consisting of unconsolidated fill had been placed within the drainage channel and was compromised by a recent flow event

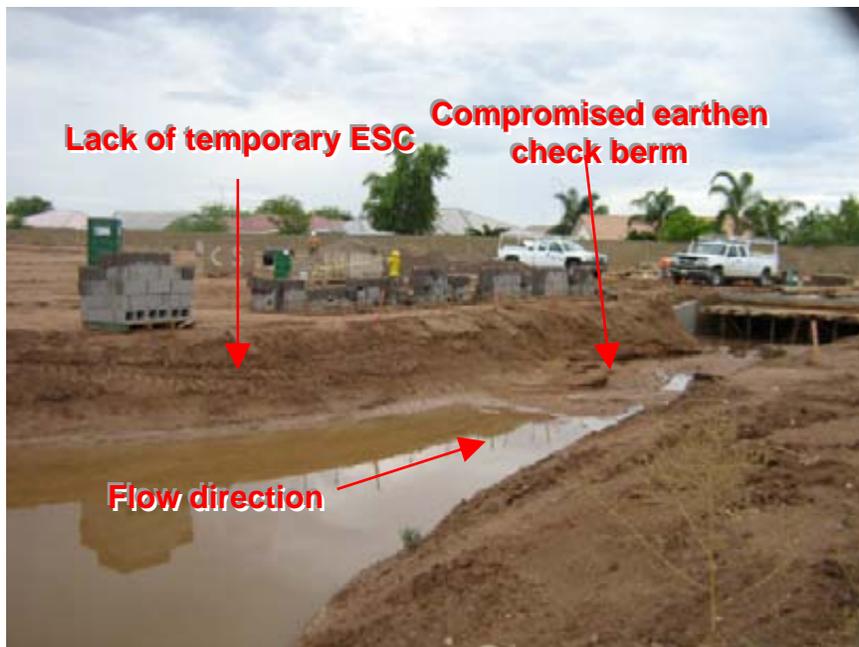
**Photograph 4: Mountain View Village Center**  
Lack of temporary ESC between the large expanse of disturbed construction site area and the flowing drainage channel

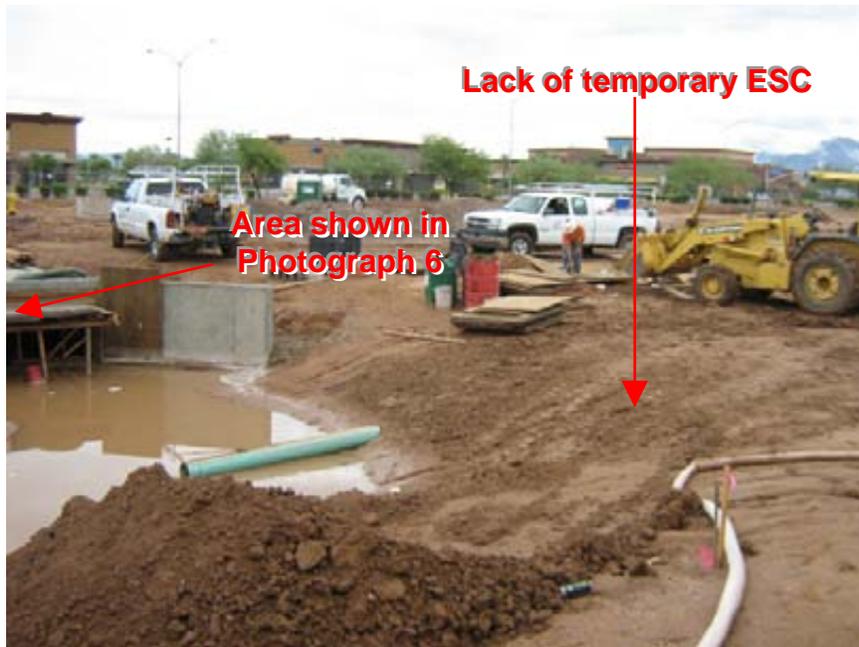
**Photograph 5: Mountain View Village Center**

Lack of temporary ESC between the large expanse of disturbed construction site area and the flowing drainage channel

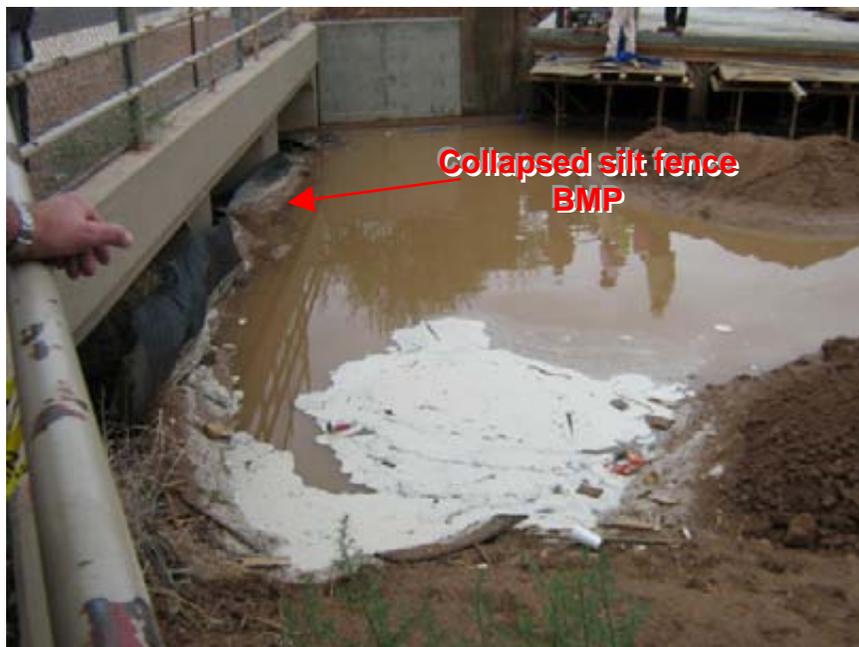
**Photograph 6: Mountain View Village Center**

Collapsed silt fence BMP installed within the concentrated flow of the drainage channel prior to exiting the site

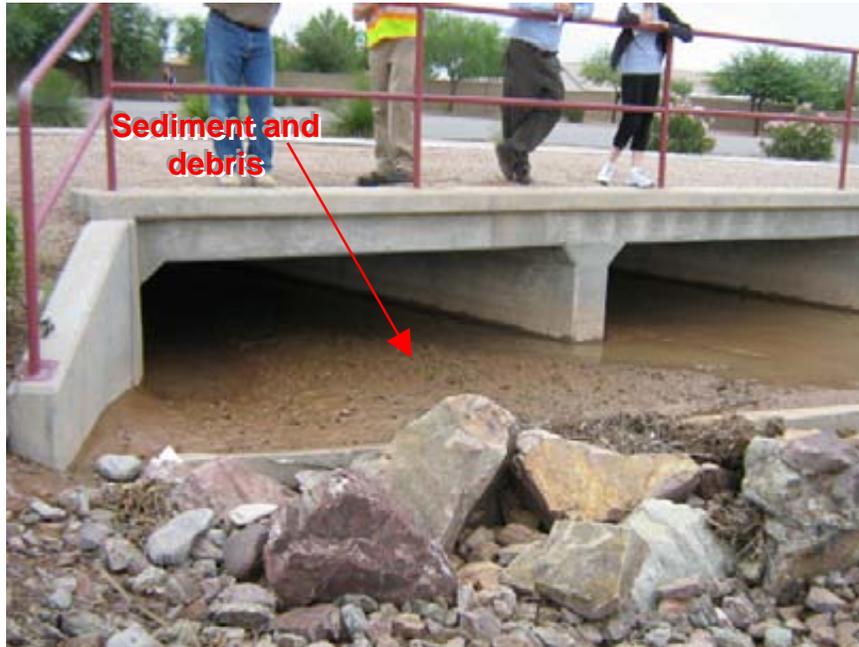
**Photograph 7: Mountain View Village Center**  
Sediment and debris were observed in the drainage channel  
above the flow control structure

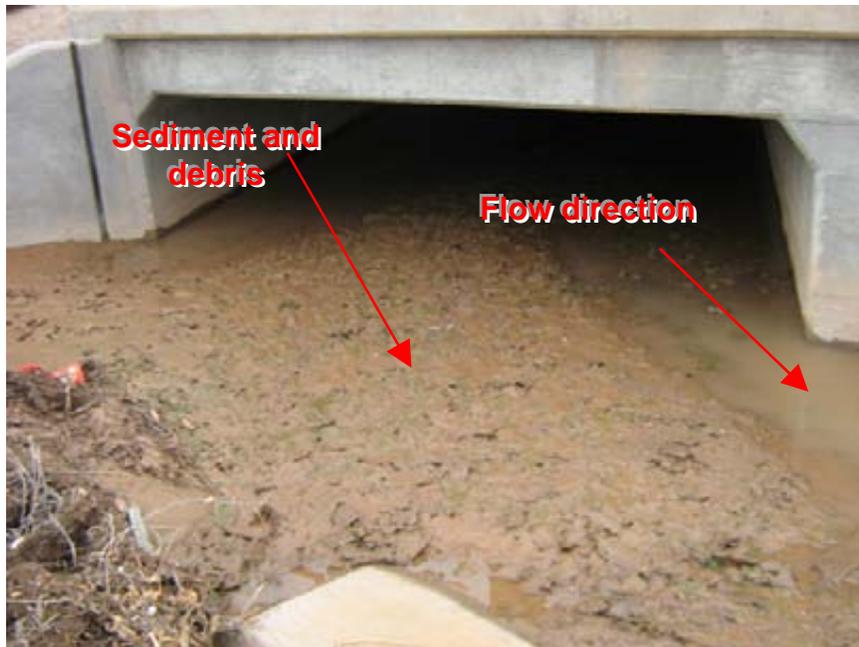
**Photograph 8: Mountain View Village Center**  
Close-up view of area shown in Photograph 7 depicting sediment deposition  
directly downstream of the failed silt fence shown in Photograph 6

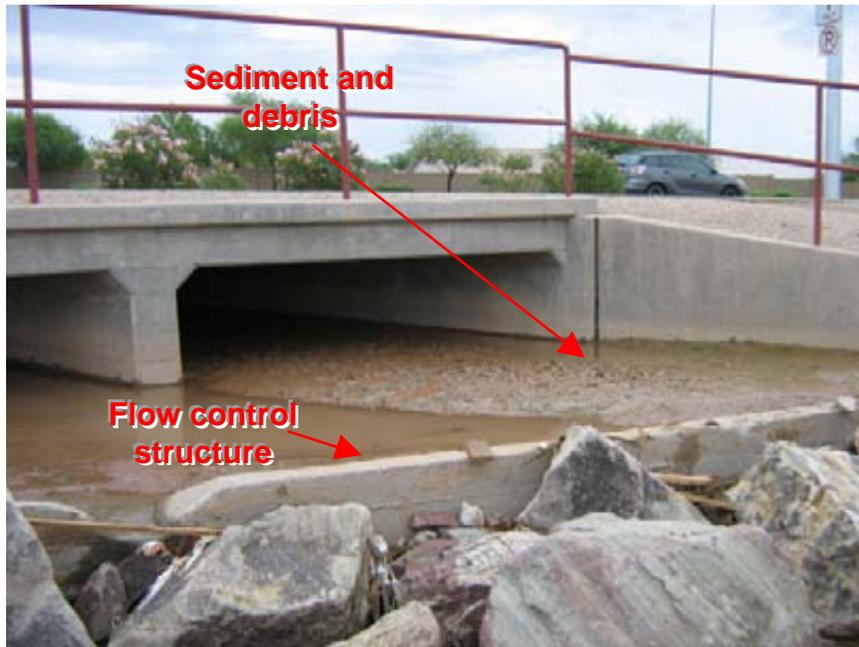
**Photograph 9: Mountain View Village Center**  
View of sediment deposition on the opposite side of the failed silt fence shown in Photograph 6

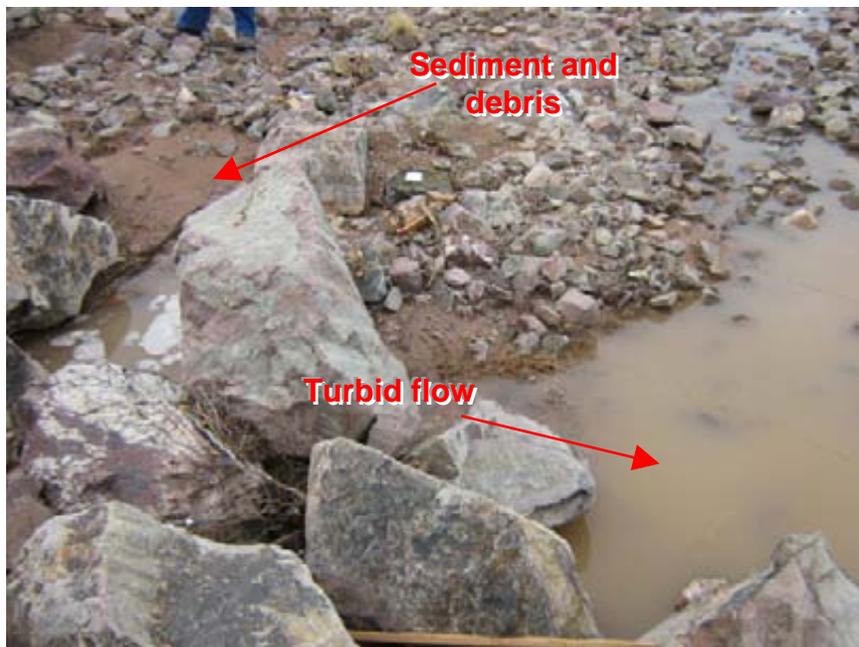
**Photograph 10: Mountain View Village Center**  
Sediment, debris, and turbid flow were observed in the drainage channel below the flow control structure shown in Photograph 9

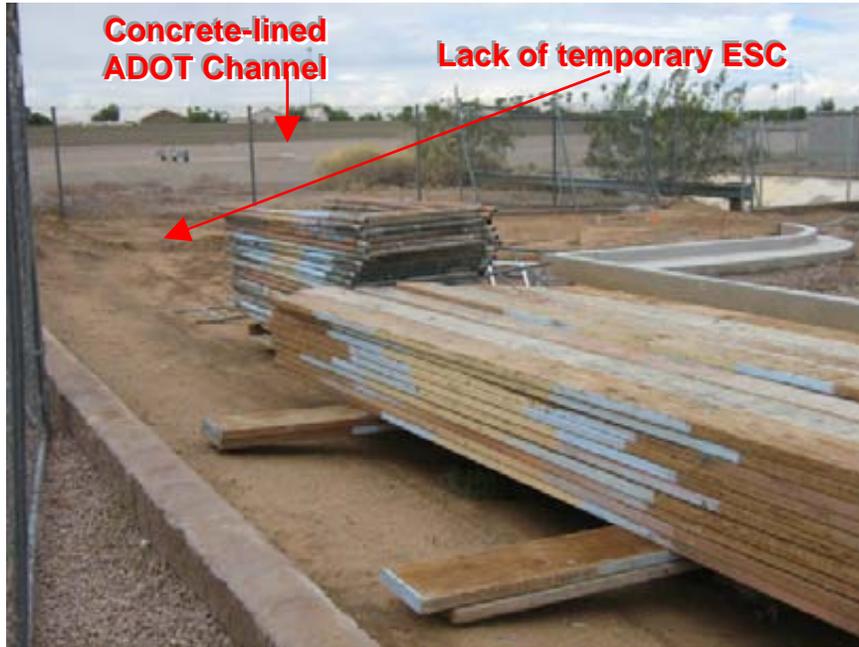
**Photograph 11: Superstition Springs Commerce Center**  
View showing proximity of site to the ADOT Channel and lack of BMPs

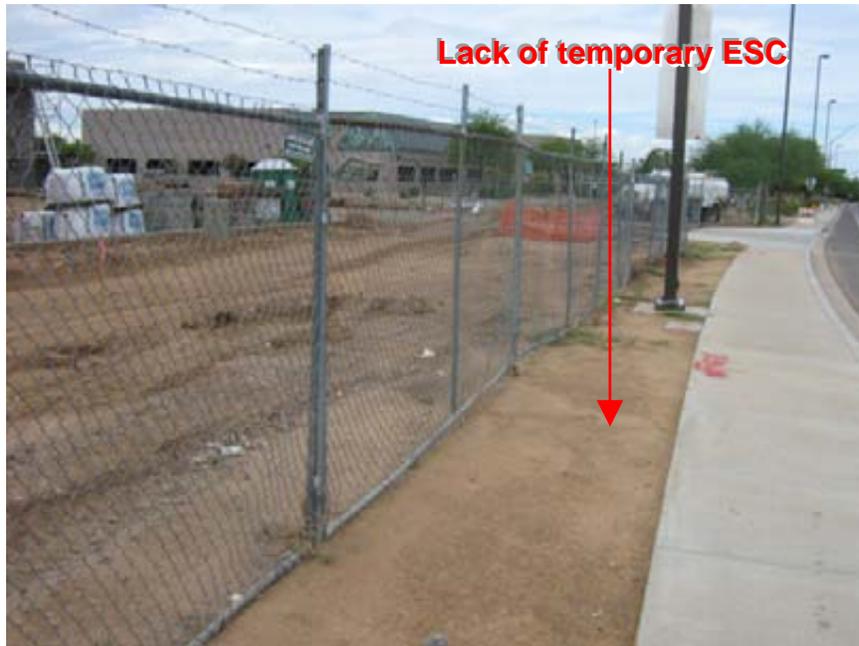
**Photograph 12: Superstition Springs Commerce Center**  
BMPs were not implemented as perimeter control along Hampton Avenue, between the disturbed area and the offsite curb and gutter flowline

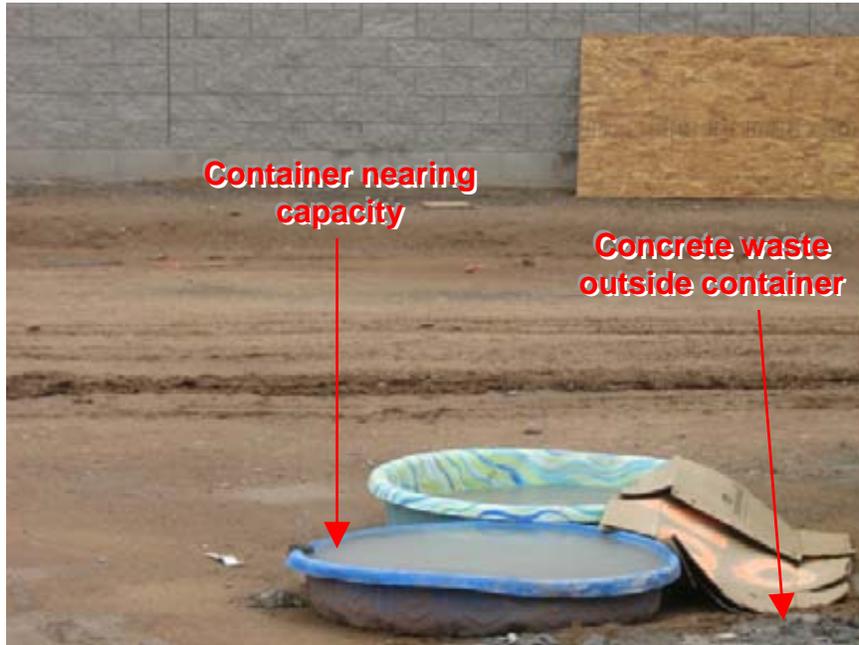
**Photograph 13: Superstition Springs Commerce Center**  
Concrete waste was observed outside the containers and one of the two containers was nearing capacity

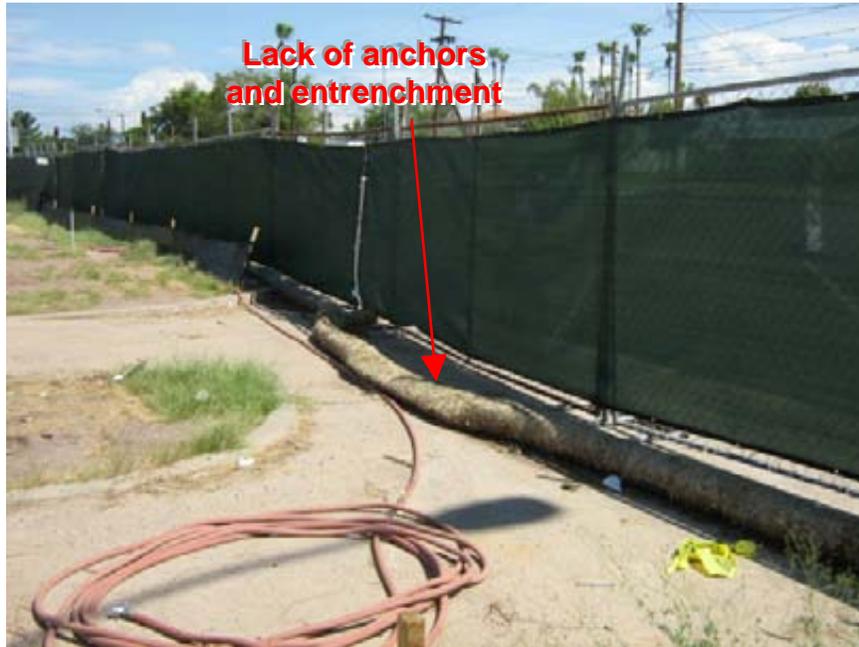
**Photograph 15: Mesa Municipal Court**

Straw wattles were installed on an impervious surface, and therefore were not properly entrenched or anchored to create an adequate seal

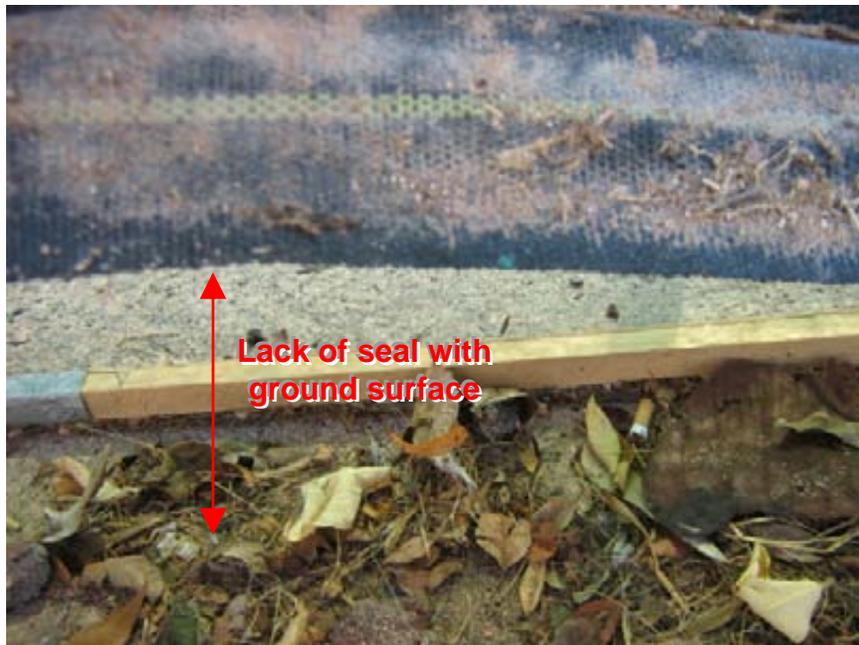
**Photograph 16: Mesa Municipal Court**

Sections of the silt fence along the southern perimeter were not maintained with adequate entrenchment

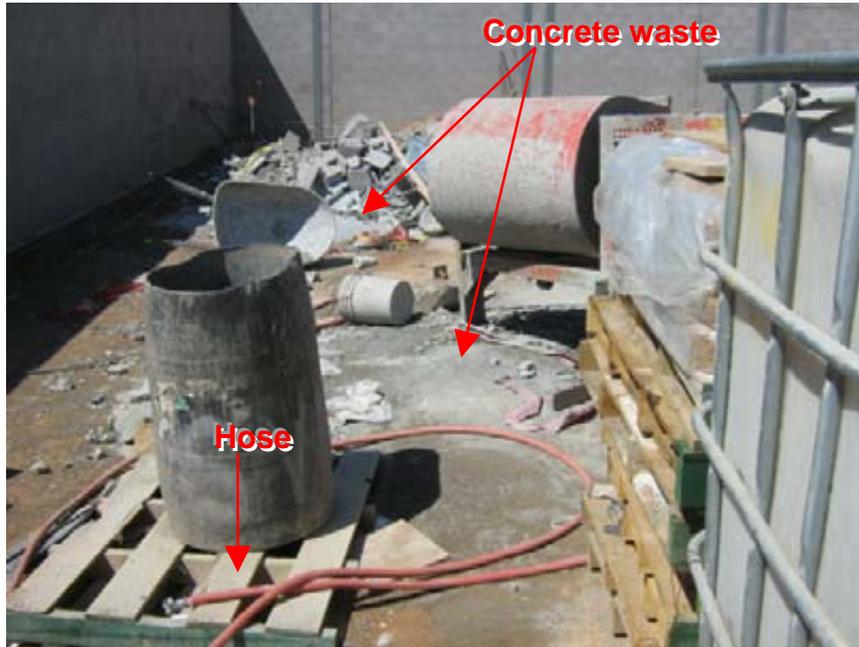
**Photograph 17: Mesa Municipal Court**  
Concrete waste and washout hose located near mixer

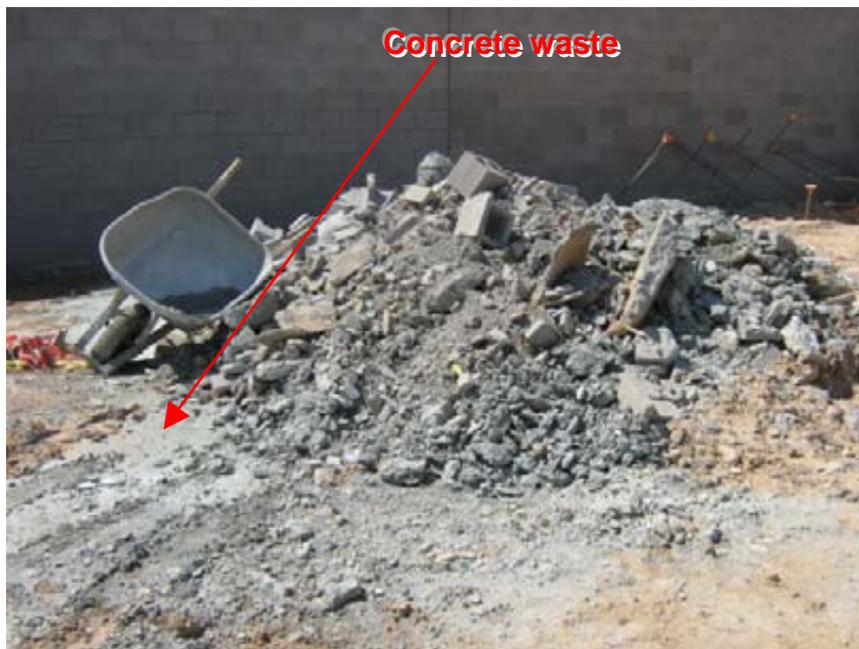
**Photograph 18: Mesa Municipal Court**  
Close-up view of concrete waste shown in background of Photograph 17

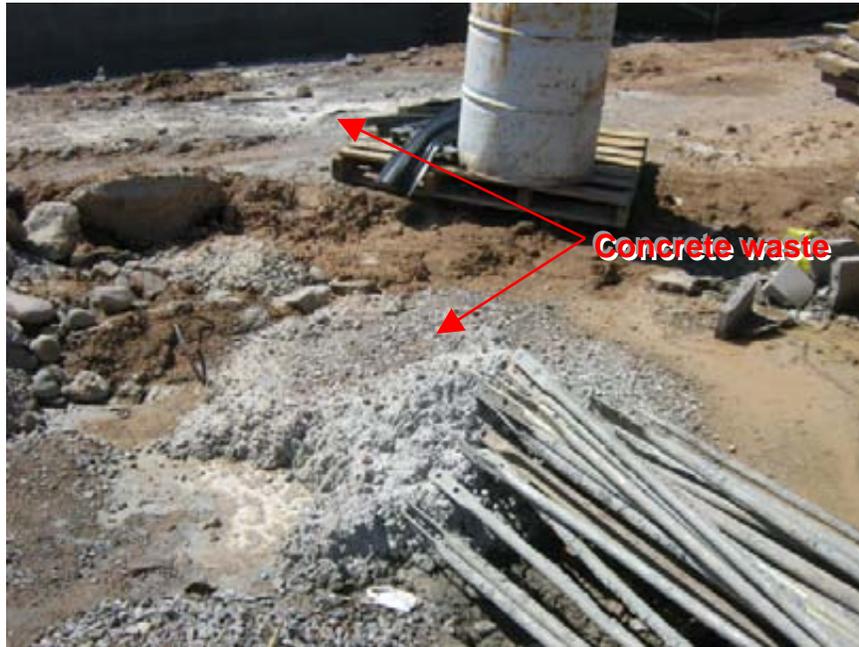
**Photograph 19: Mesa Municipal Court**  
View of uncontrolled concrete waste
