UNITED STATES ENVIRONMENTAL PROTECTION AGENCY  
REGION IX  
75 Hawthorne Street  
San Francisco, CA 94105-3901

Enclosed is the U.S. Environmental Protection Agency's (EPA) report of the Nevada Department on the Transportation (NDOT) Storm Water Management Program (Program) Audit. Representatives from EPA Region 9 and the Nevada Department of Environmental Protection (NDEP) conducted the Audit from August 9 – 12, 2011.

**MS4 Audit Report**

## **NDOT MS4 Audit Photo Log – Carson City Maintenance Facility 8.10.2011**

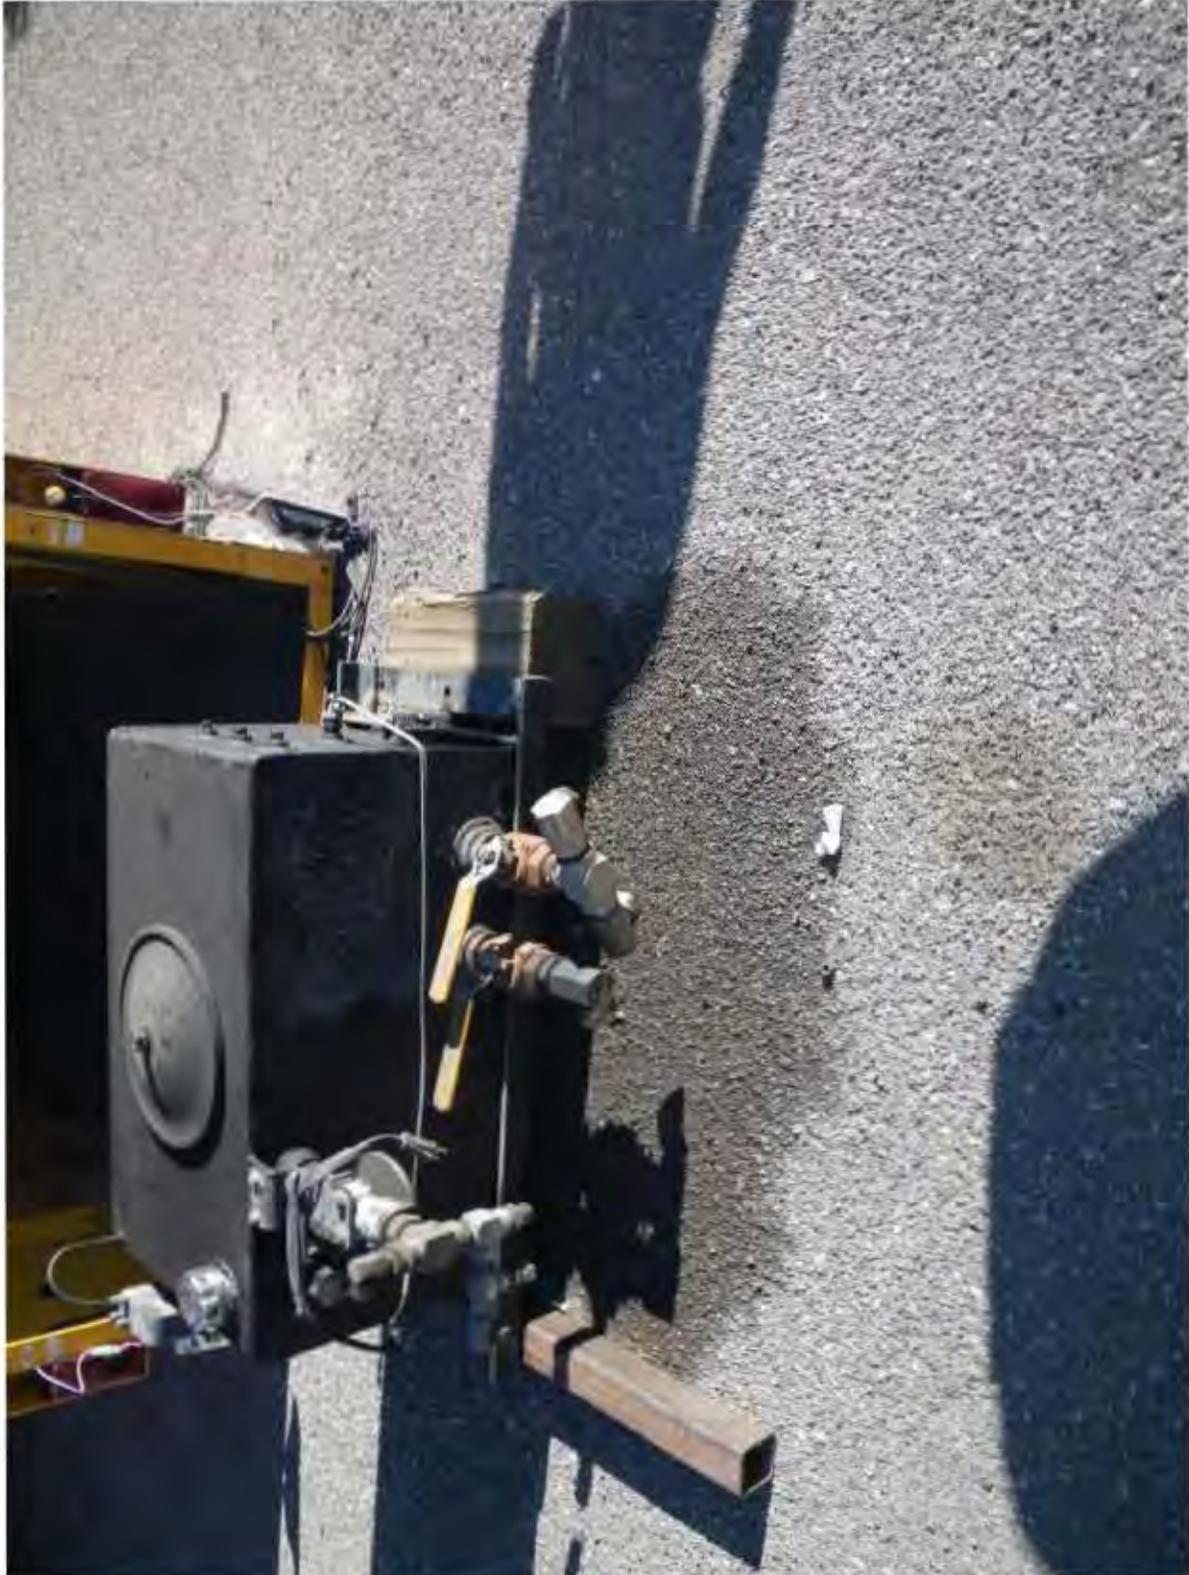
IMGP0579.JPG

**IMGP0579** – Accumulated salt residue at the discharge nozzle for the brine system, blistering paint and rust on the sand spreading chute.

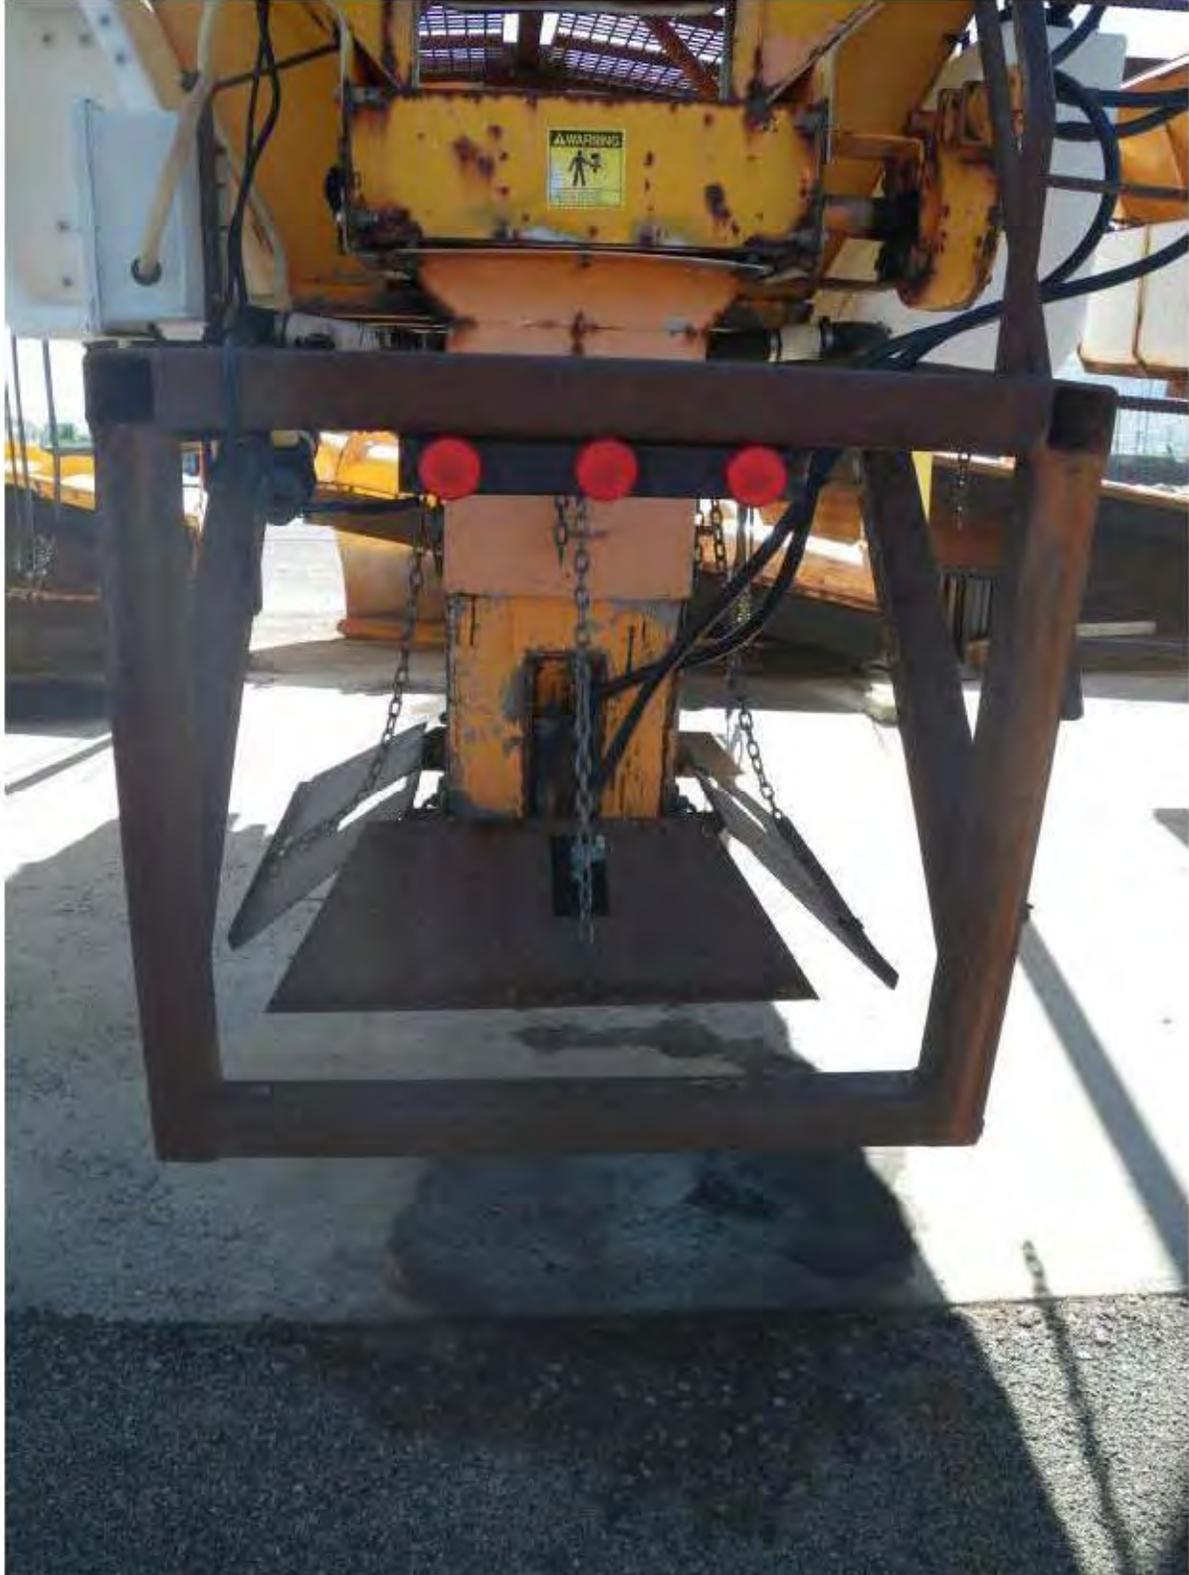
IMGP0599.JPG

**IMGP0600** – Rear of a sand/brine rig with oil staining beneath the sand spreader chute.

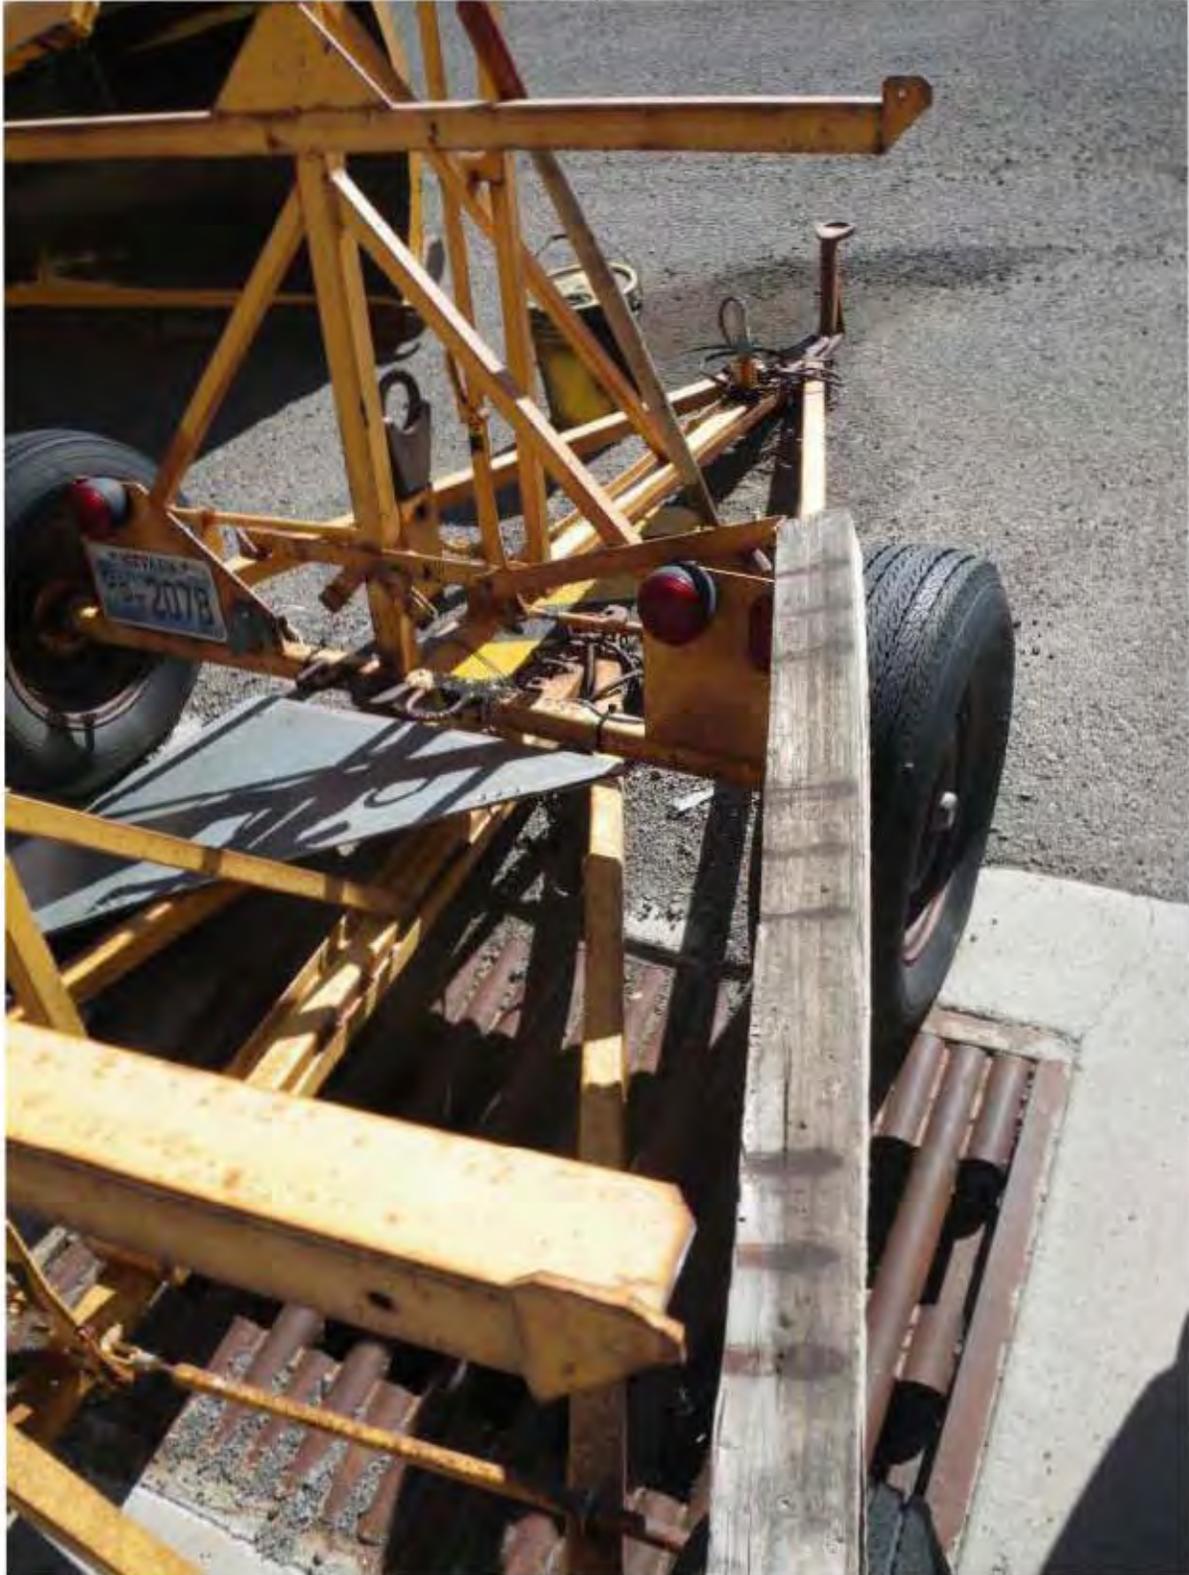
IMGP0603.JPG

**IMGP0603** – Bucket of ‘Tractor Oil’ with oil staining in the foreground. Trailers to the left of the bucket are situated over a drop inlet where flowing water has heard.

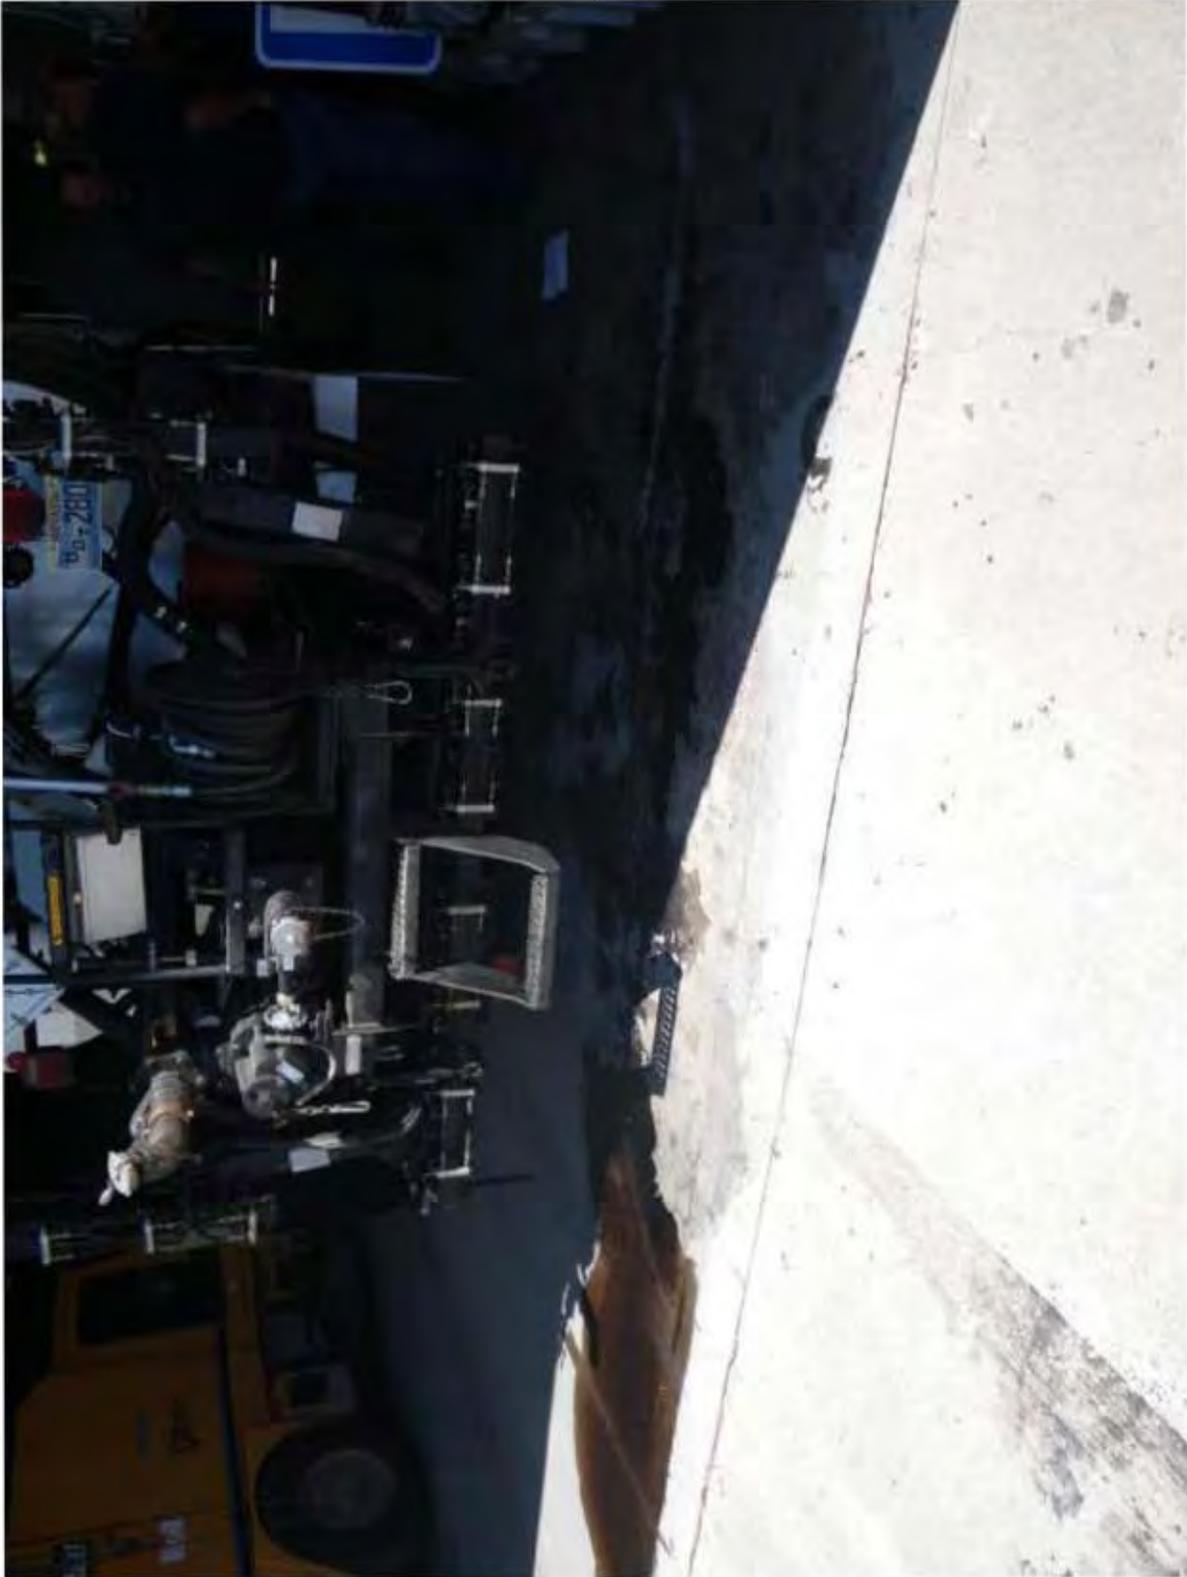
IMGP0611.JPG

**IMGP0611** – Source of fugitive oil identified in IMGP0586. A road oiler continued leaking after it was parked, and absorbent had been previously deployed for related issues.

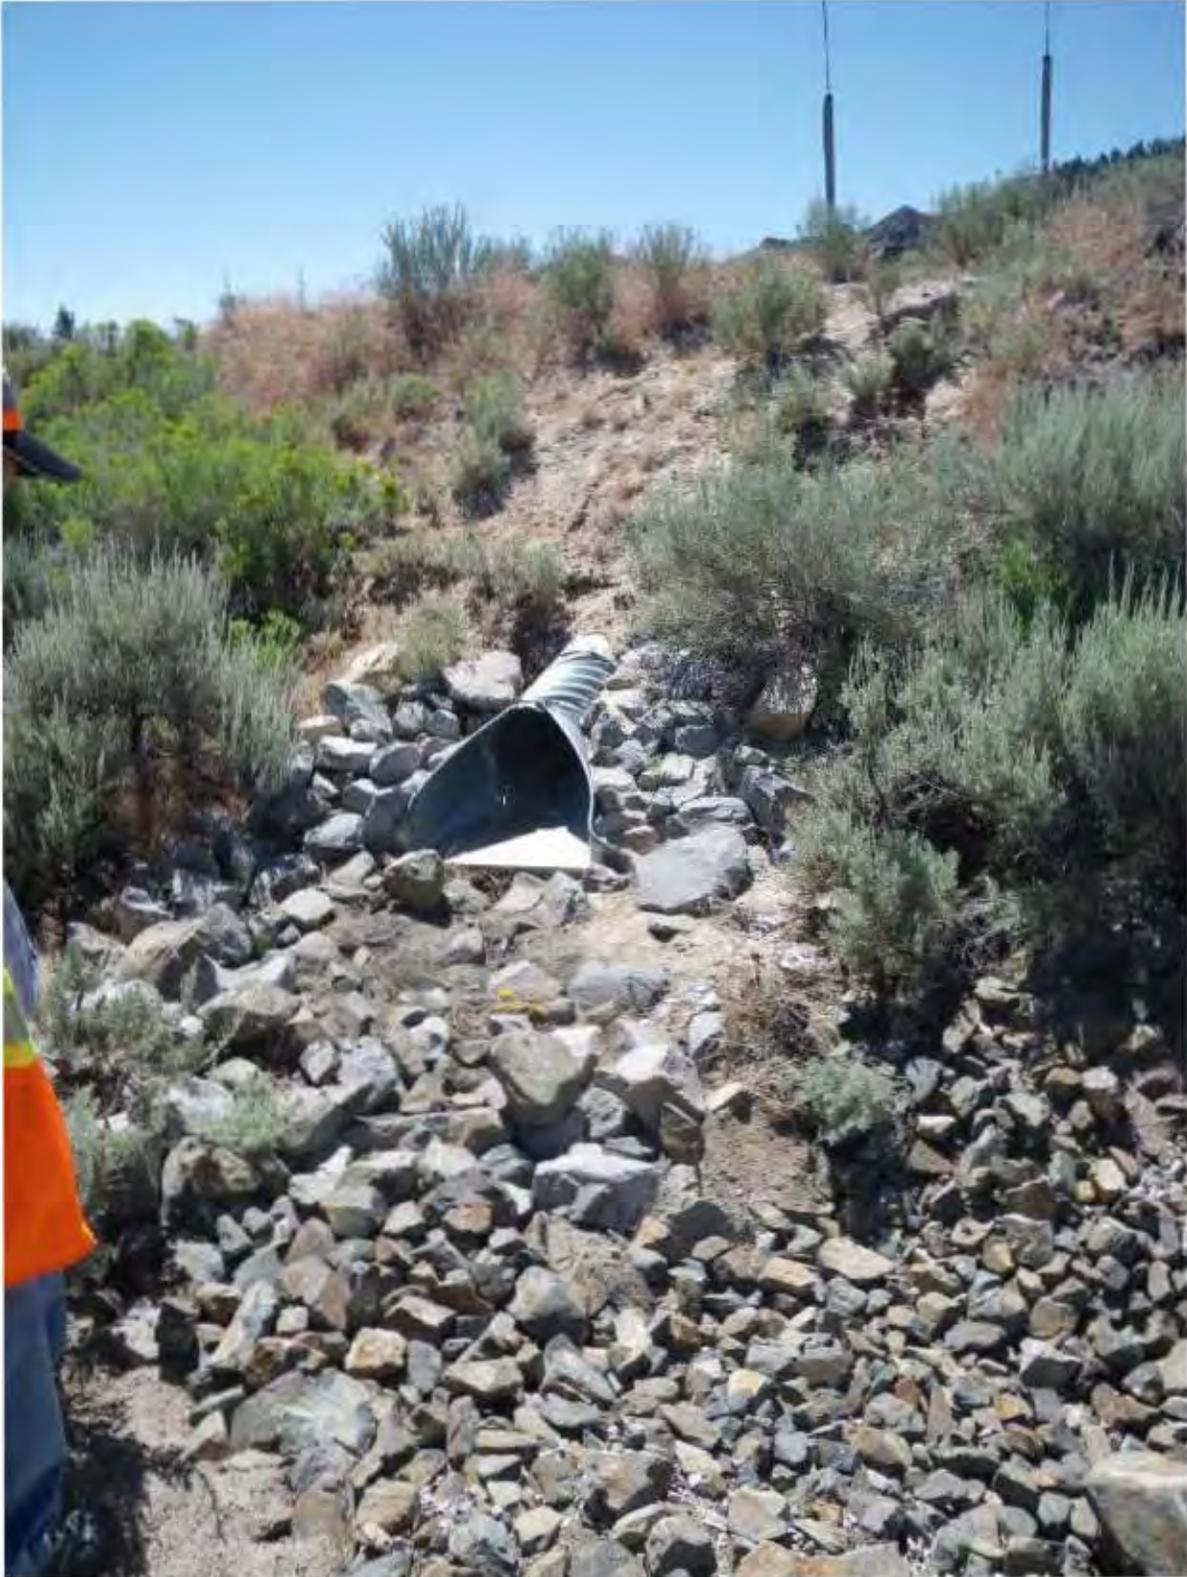
IMGP0621.JPG

**IMG0621** – (Area 1) Culvert outfall noted in IMG0620.

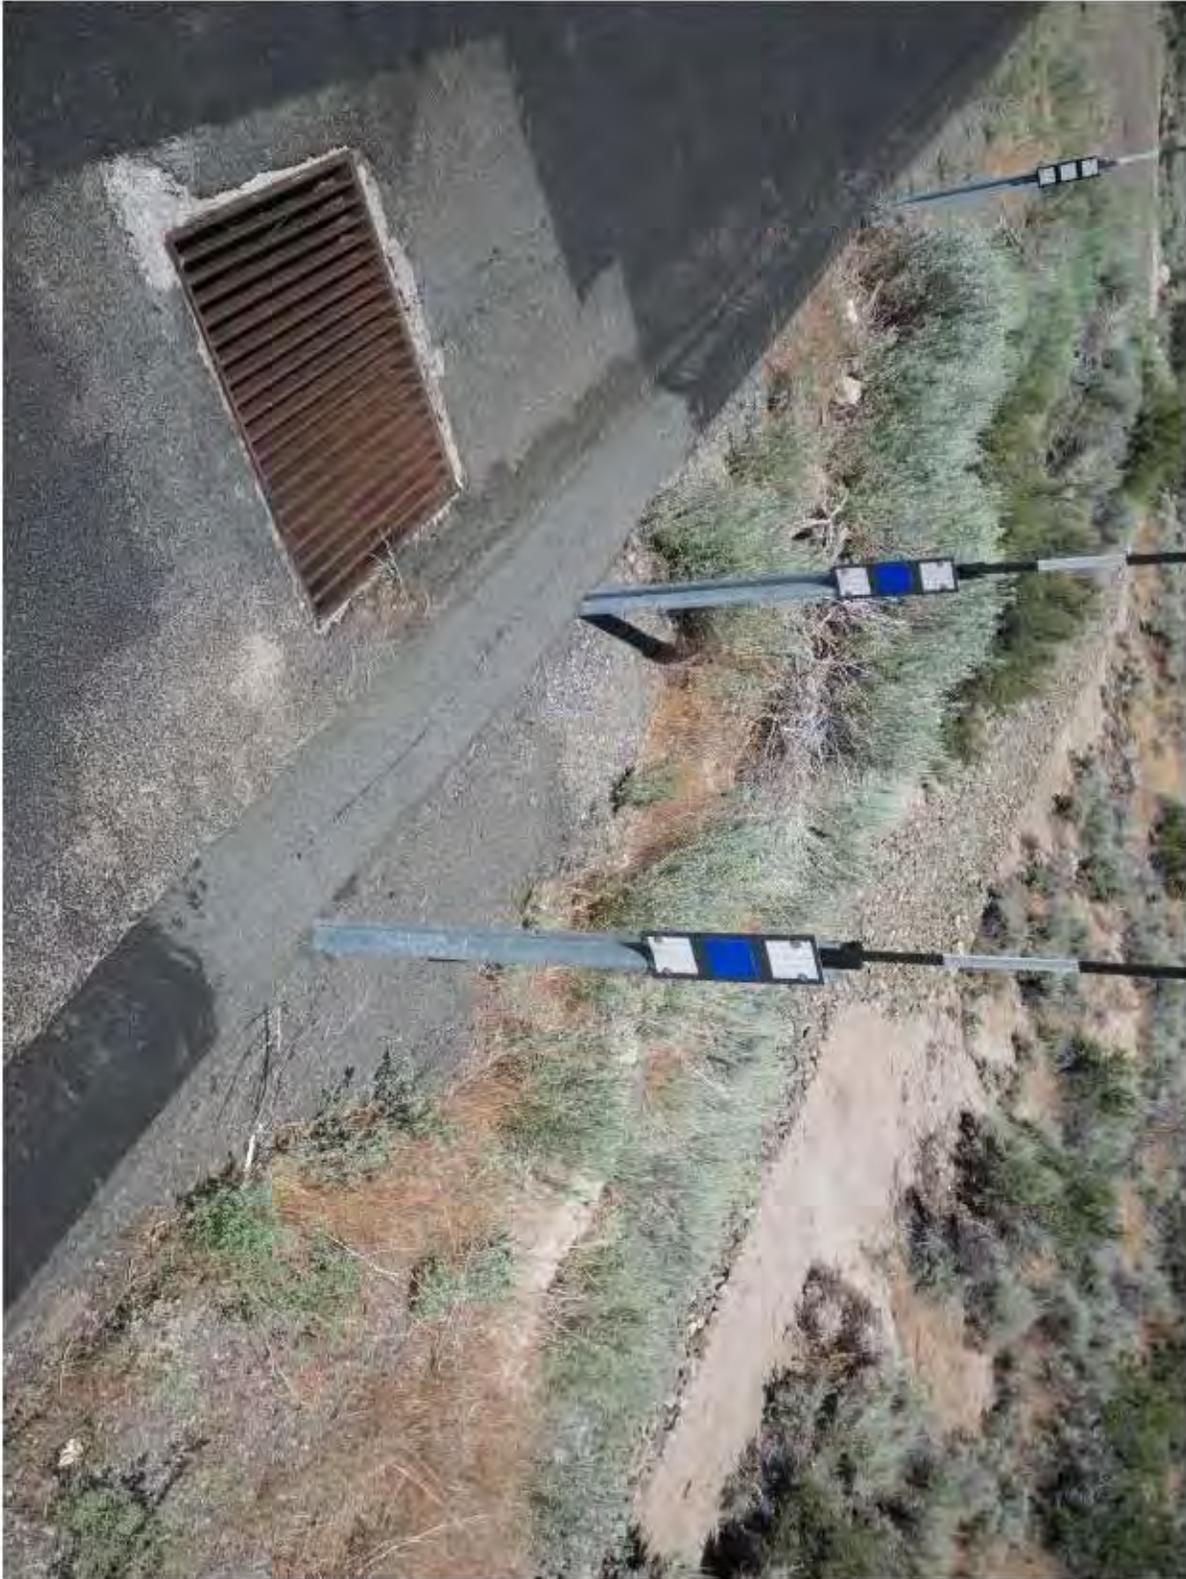
IMGP0622.JPG

**IMG0622** – (Area 1) Drop inlet that feeds the culvert and outfall noted in IMG0621.

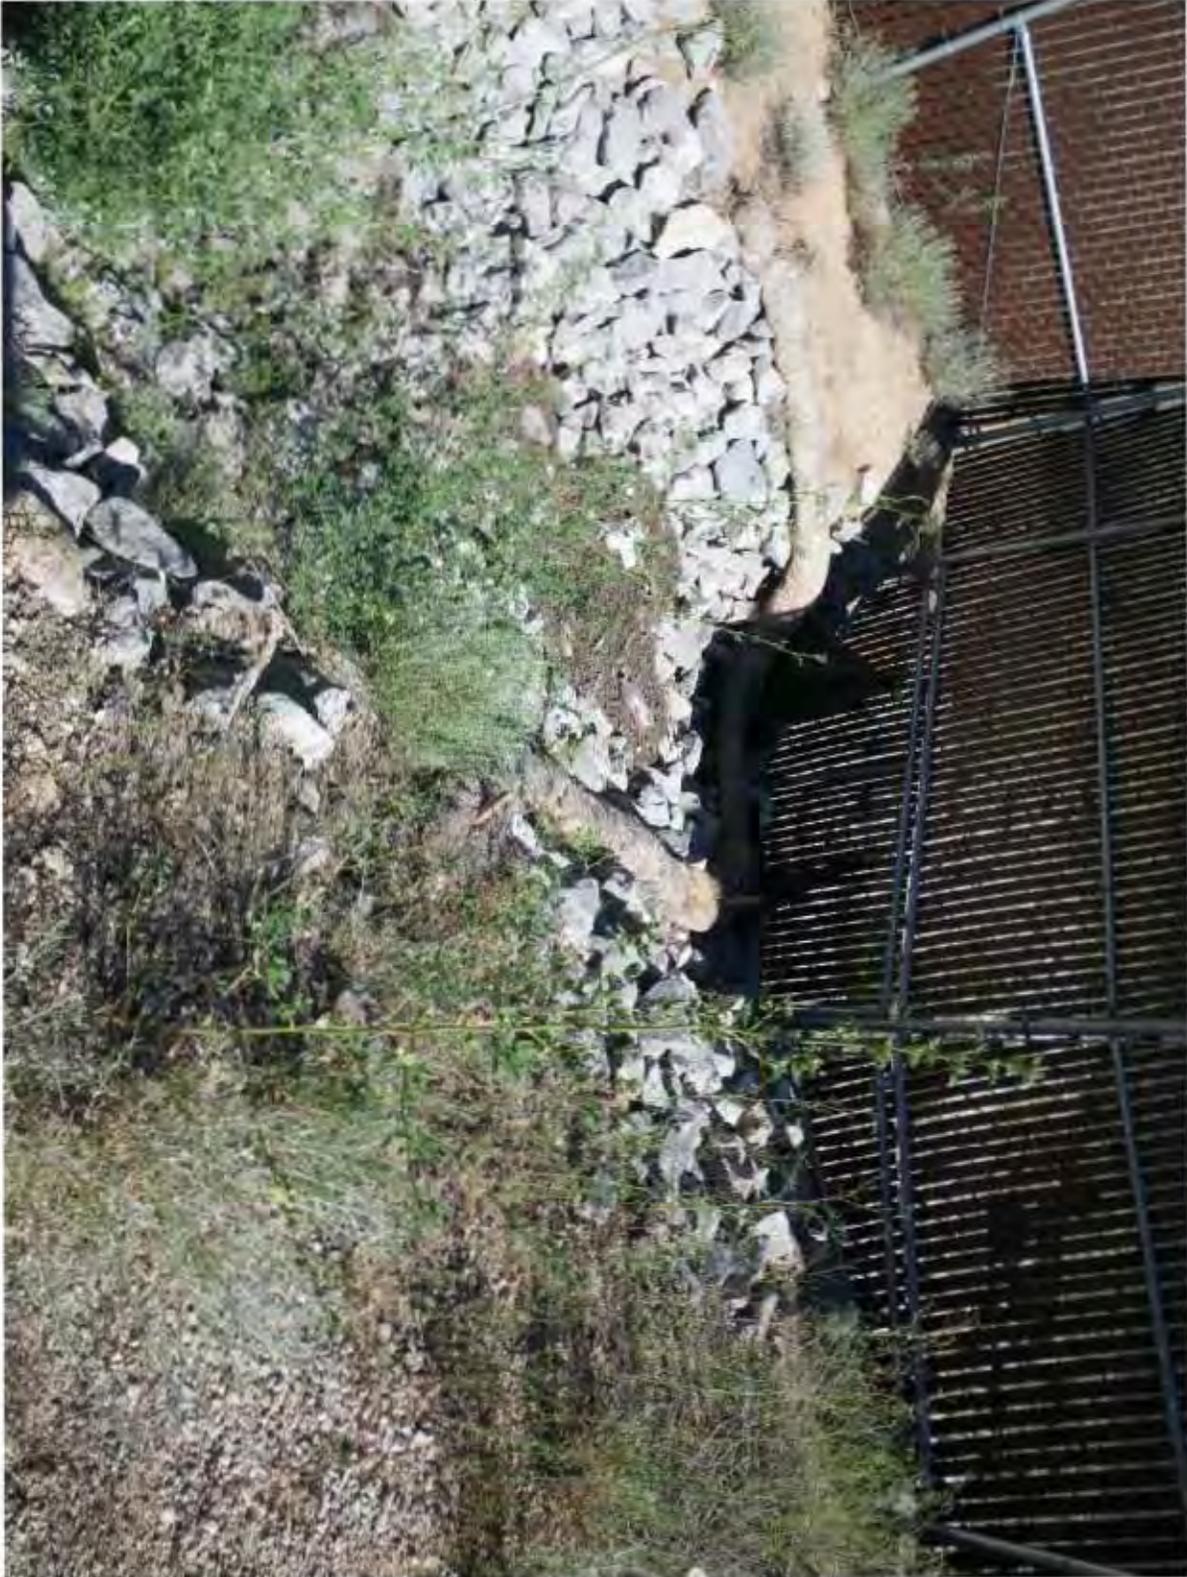
IMGP0644.JPG

**IMGP0644** – Drainage channel where it exits the facility to a culvert that will pass it under US 50 and into Clear Creek. Accumulated sediment and a fiber roll deployed in the channel at the fence line was observed.

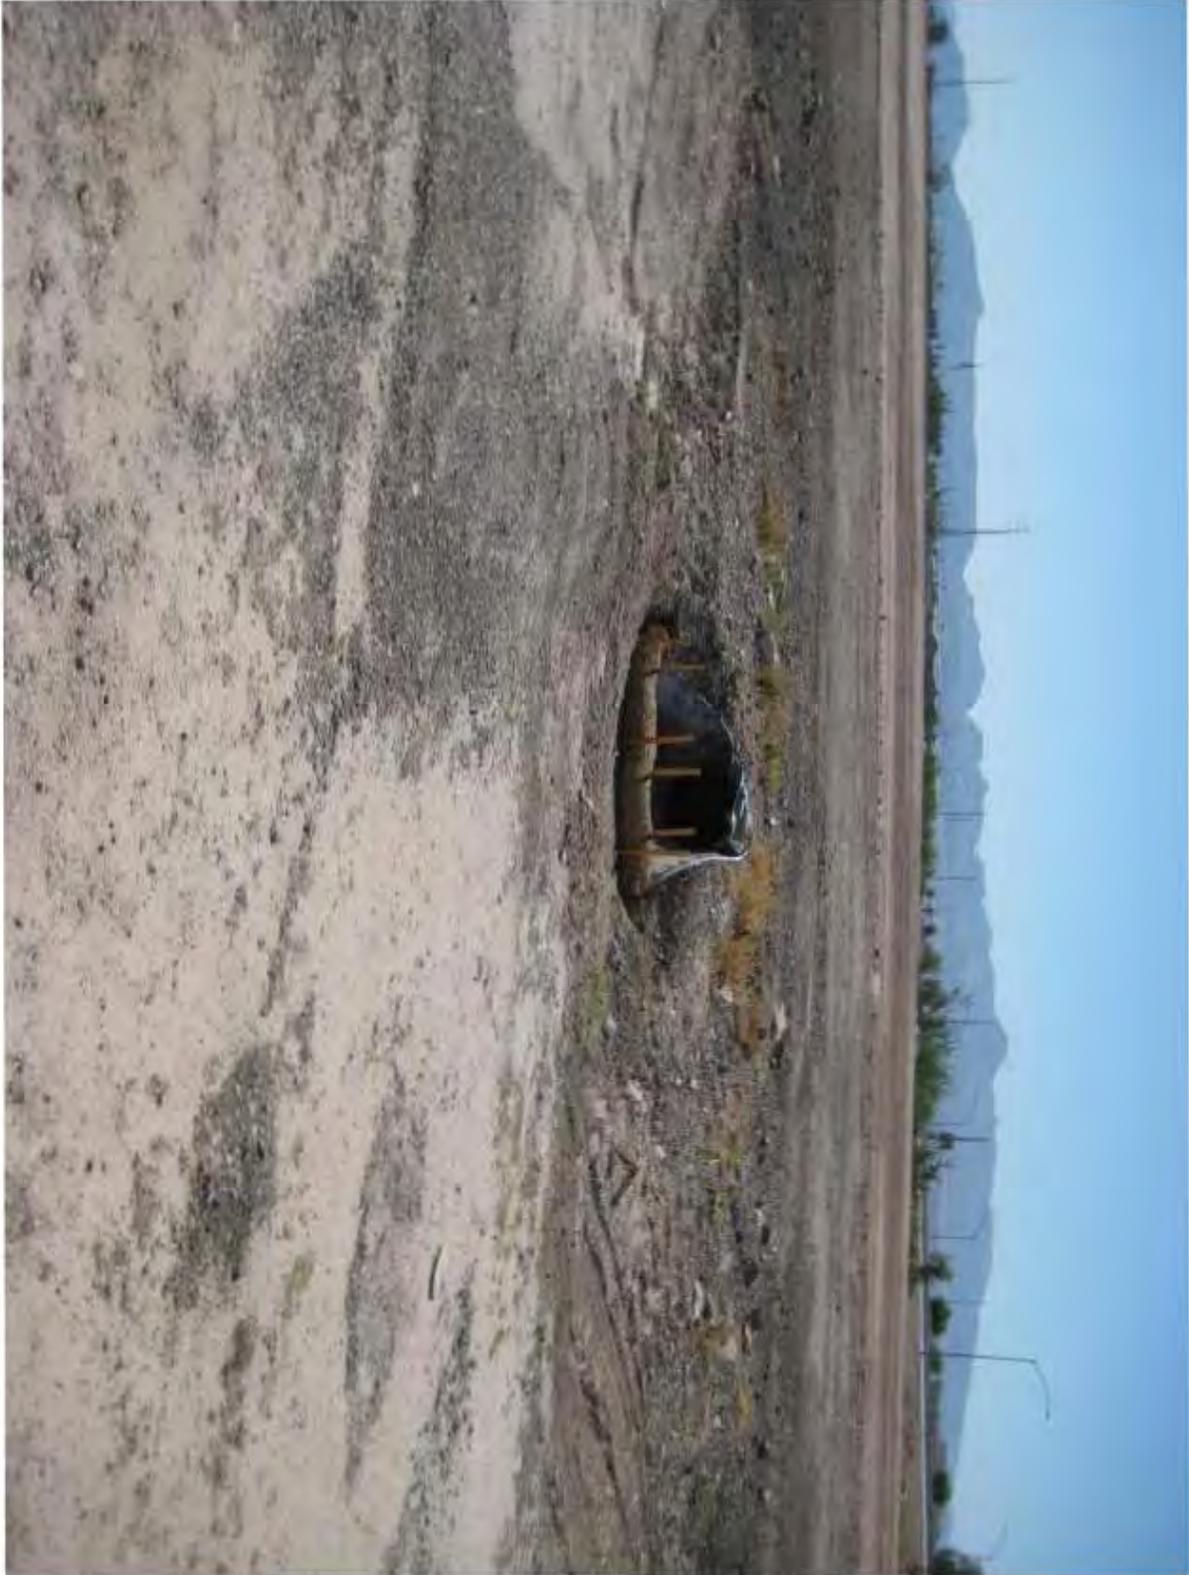
IMG\_4664.jpg

**IMG\_4664** BMP at staging area – outlet protection consisting of straw waddle. Straw waddle recently installed, improperly installed (stakes are placed in front of & behind waddle not through waddle, not trenched).
