UNITED STATES ENVIRONMENTAL PROTECTION AGENCY

Subject: Transmittal of "Port of Stockton Municipal Separate Storm Sewer Audit Report"

On March 18-20, 2008, representatives from EPA Region 9, the Regional Water Quality Control Board, Central Valley Region, and EPA contractors (PG Environmental, LLC) conducted a compliance audit of the Port of Stockton's implementation of its Municipal Separate Storm Sewer System (MS4) stormwater management program required by the NPDES permit issued by the Regional Board (NPDES Permit No. CAS0084077). File reviews, interviews of program staff, field verification of program activities, and compliance inspections of Port tenant facilities were conducted. I appreciate the excellent cooperation that our audit team received from your staff throughout this effort.

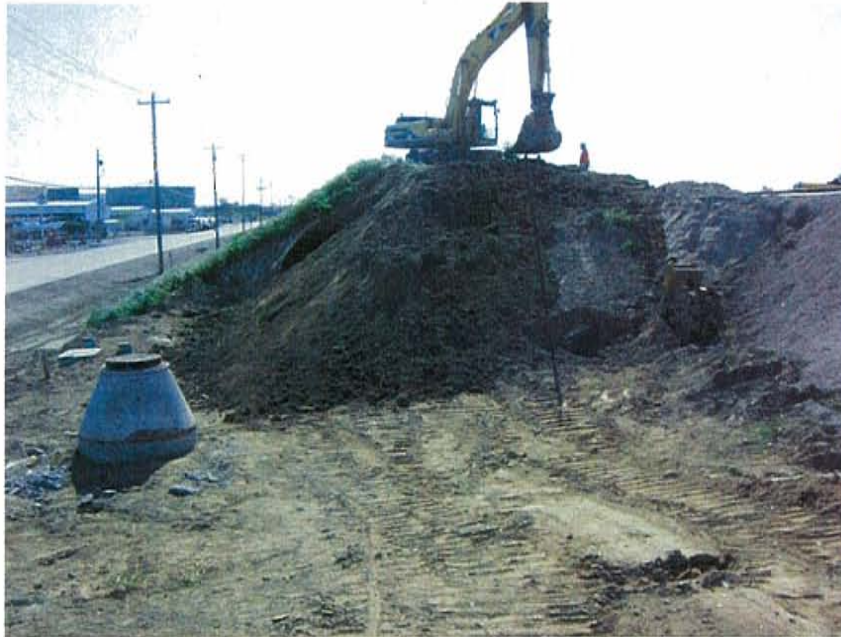
Photograph 1: An actively disturbed slope located adjacent to a drainage ditch along Navy Drive and southeast of the construction site entrance.

Section C.7.a.ii of the Order requires that Port inspections of construction sites ensure that sediments generated at a project site are retained on-site and that erosion from slopes and channels is controlled by implementing an effective combination of erosion and sediment control BMPs. It was observed during the audit that BMPs had not been implemented to prevent the discharge of sediment from a disturbed area surrounding a new railway crossing spanning an unnamed waterway north of the construction site entrance off Humphreys Drive (Photograph 6). No BMPs were present between the disturbed areas surrounding the railway crossing and the adjacent waterway (Photograph 7). Nor were run-on control BMPs implemented between the disturbed area on the southwest side of the railway crossing and the adjacent waterway (Photograph 8). Port personnel explained that the railway crossing and culverts had been installed approximately two weeks before the audit, and that the unnamed waterway flows southwest and is tributary to Burns Cutoff. BMPs must be installed, inspected, and maintained to prevent the discharge of sediment from the disturbed areas surrounding the new railway crossing to the unnamed waterway that is tributary to Burns Cutoff. Moreover, the Port must ensure that sediments generated at the Central California Traction project site are retained on-site using adequate source control and structural BMPs.

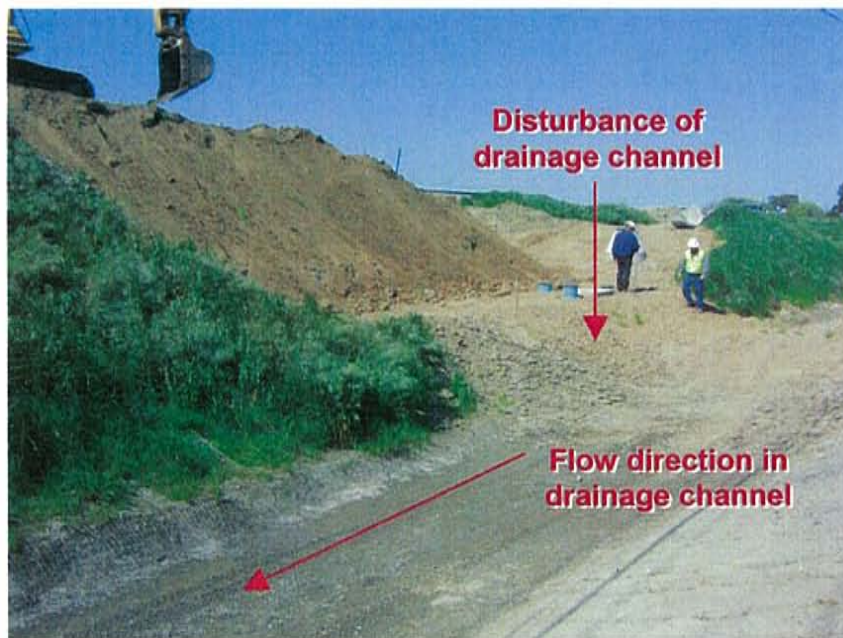
Photograph 2: BMPs were not implemented between the slope and the adjacent drainage channel or in the disturbed drainage channel itself, and the surface of the slope was not stabilized.

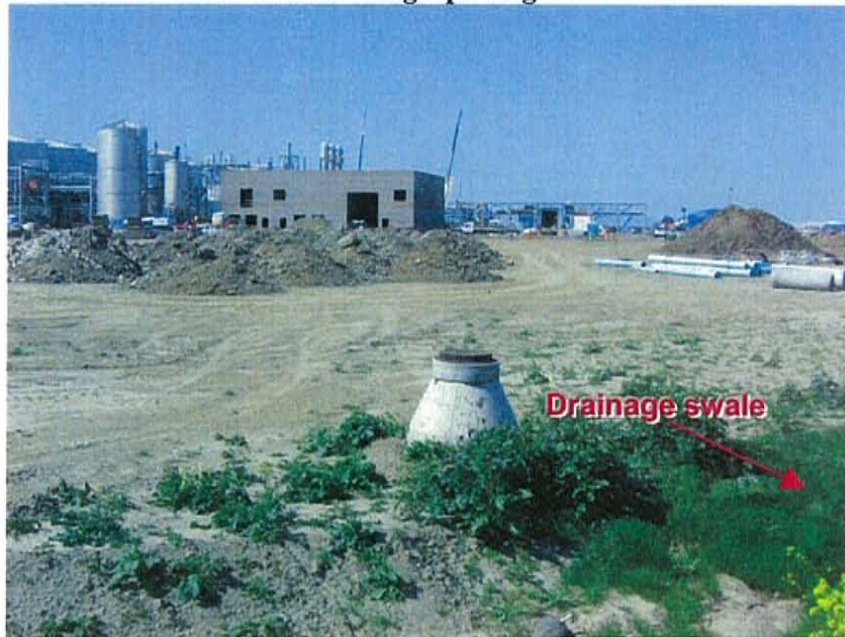
Photograph 3: BMPs were not implemented between a large expanse of disturbed soils, a number of uncontrolled soil stockpiles, and the adjacent drainage swale.

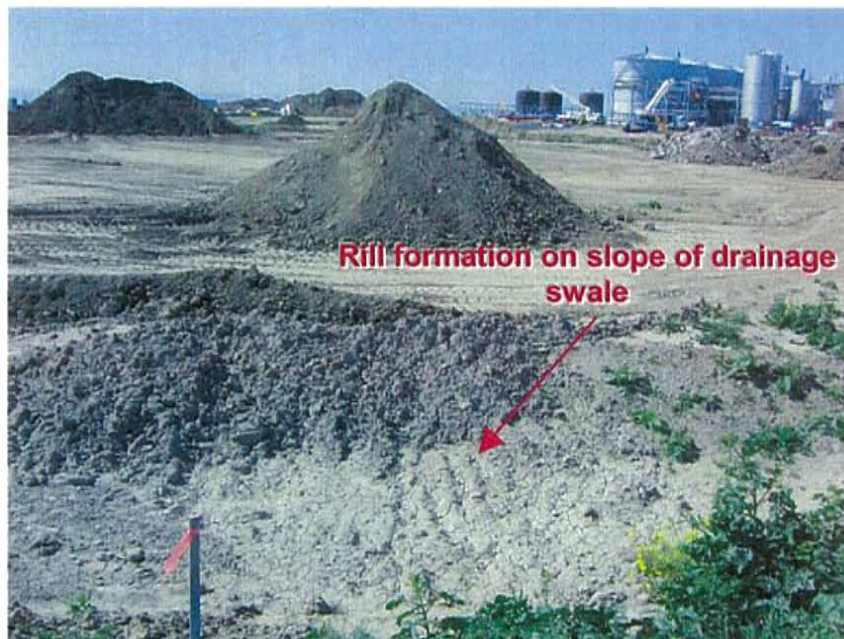
Photograph 4: Evidence of erosion was observed; including rill formation on the slope of the drainage swale.

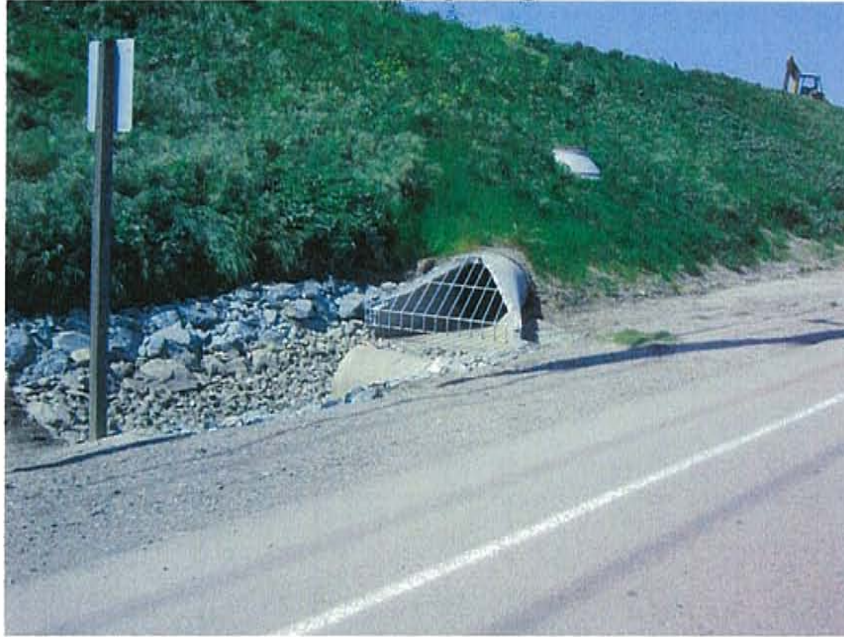
Photograph 5: Pacific Ethanol storm drain outfall into the drainage channel along Navy Drive.

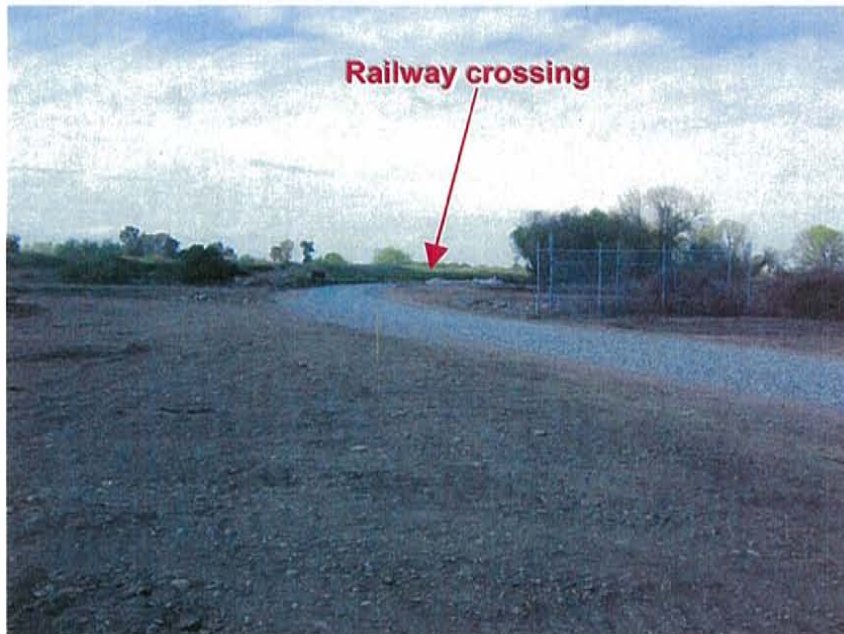
Photograph 6: Location of the new railway crossing spanning a unnamed waterway north of the construction site entrance off Humphreys Drive.

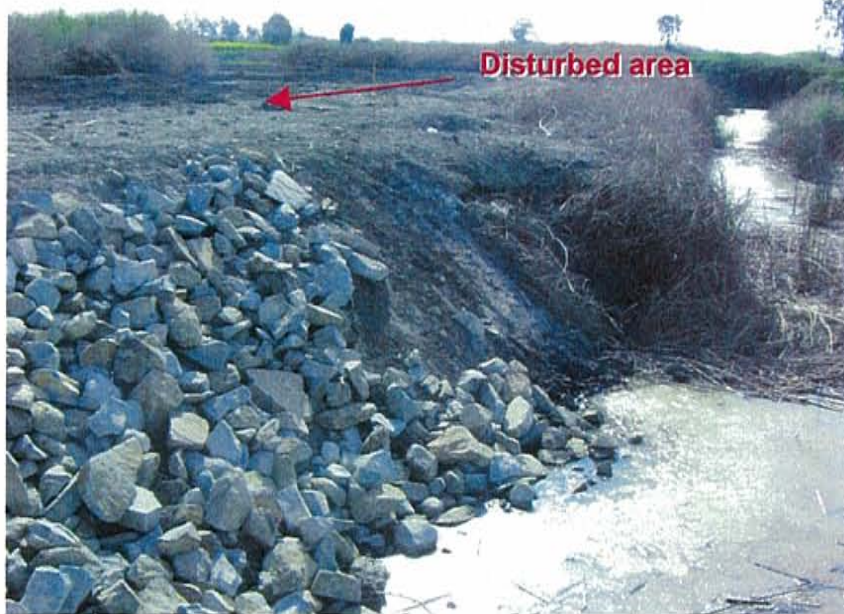
Photograph 7: BMPs were not implemented between the disturbed area on the northeast side of the railway crossing and the adjacent unnamed waterway.

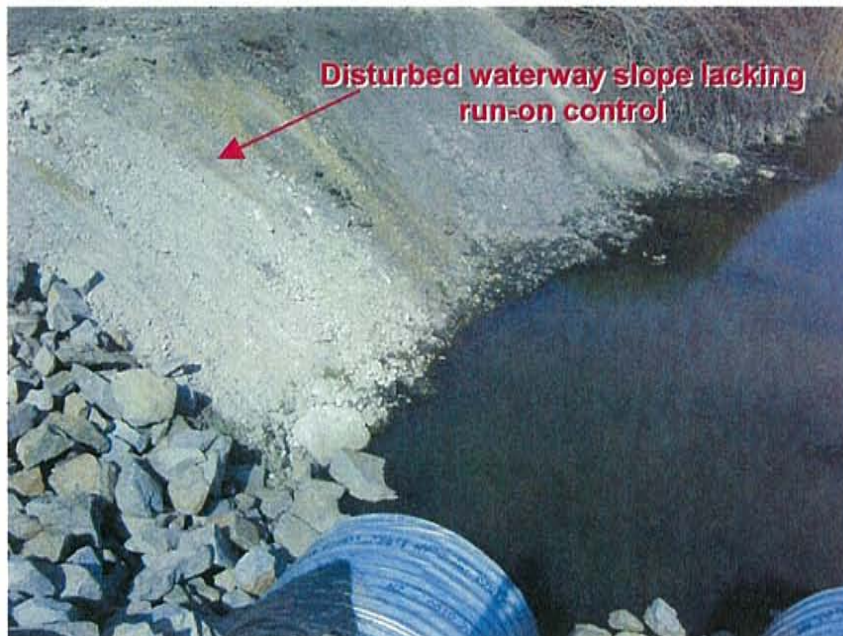
Photograph 8: Run-on control BMPs were not implemented between the disturbed area on the southwest side of the railway crossing and the adjacent unnamed waterway.

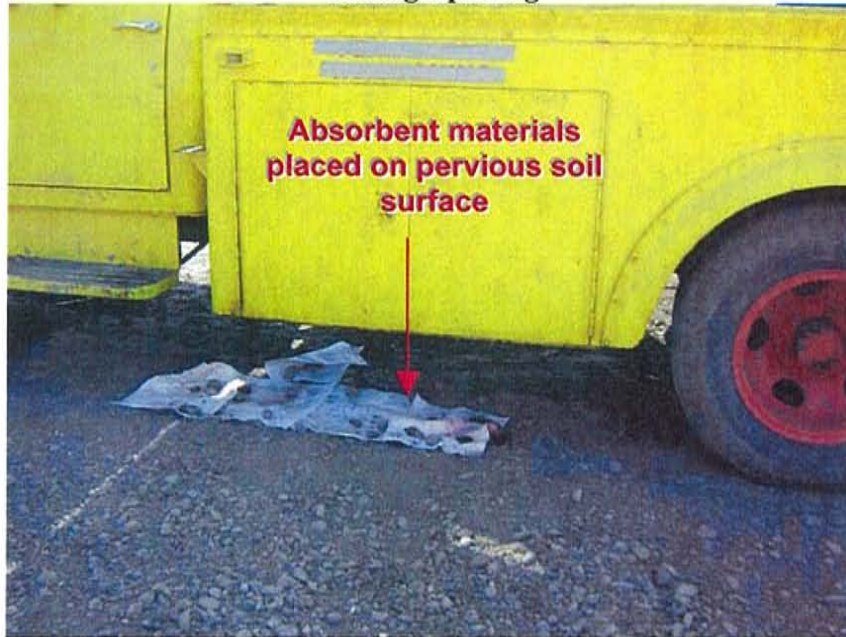
Photograph 9: A mobile fueling truck was actively leaking diesel fuel, and the source of the leak had not been addressed.

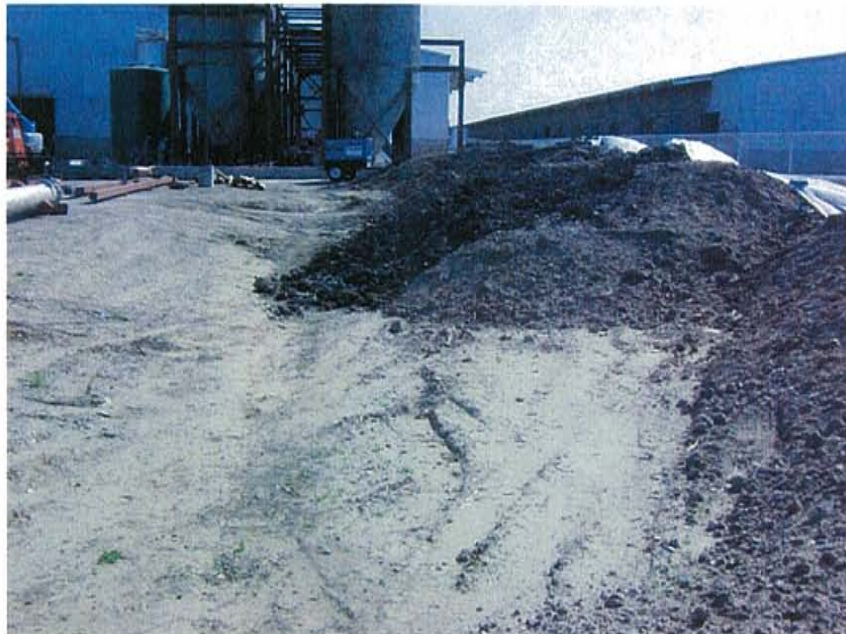
Snedeker Ave.) on March 19, 2008, the Port inspector noted soil stockpiles improperly placed in a drainage pathway and without down-gradient BMPs. In a follow-up audit activity on March 20, 2008, it was noted that these issues had not been corrected (Photograph 10). As a result, the Port exhibited a lack of adequate private construction oversight to prevent the contribution of pollutants to storm water from the aforementioned locations. These outstanding issues and Finding 2.4.2 were considered collectively in making this determination. The Port must correct the outstanding issues and Finding 2.4.2 through prompt and effective enforcement of its tenant agreements. *Furthermore, it is strongly recommended that the Port develop and implement an Enforcement Response Plan (ERP) to establish clear direction and procedures for enforcement based on Port inspections of construction and industrial sites and other compliance activities.*

Photograph 10: In a follow-up audit activity on March 20, 2008, soil stockpiles were still located in a drainage pathway and temporary perimeter controls had not been installed.

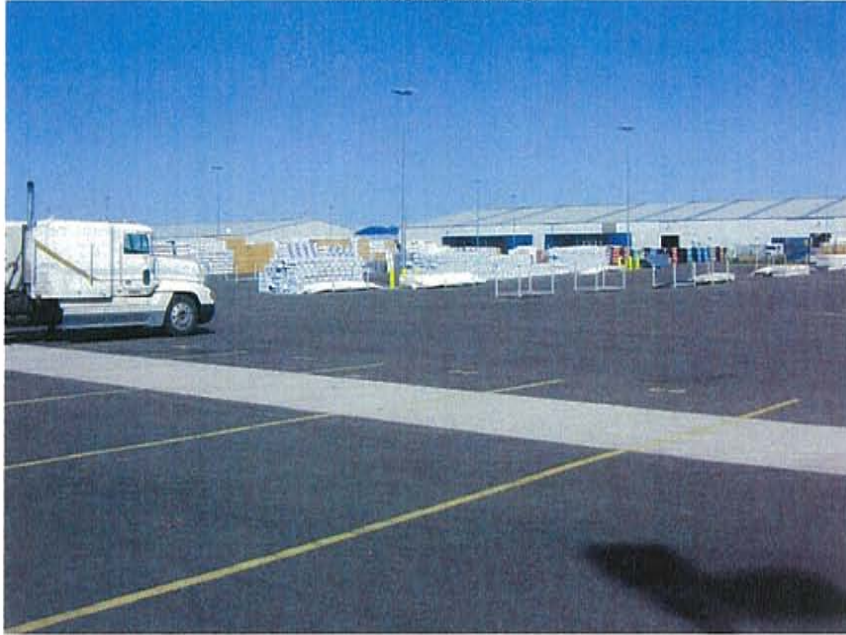
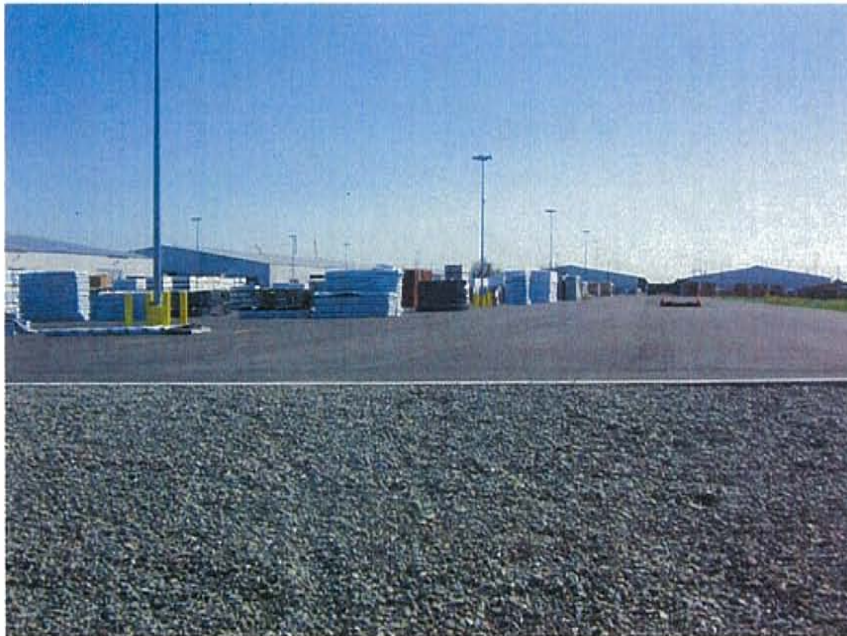
impervious parking improvements (Photographs 13 and 14). As a result, this project likely qualifies as a Priority Development Project under both the commercial and parking lot categories. Based on Port records provided during the audit, the Lowe's HIW, Inc., lease approval date (September 5, 2006) and construction start date occurred after the February 17, 2006, DSP compliance date (Exhibit 4) and therefore should have been reviewed and conditioned for compliance with the Development Standards.

Photograph 13: Impervious parking improvements at the Lowe's Distribution Center (looking north).

Photograph 14: Impervious parking improvements at the Lowe's Distribution Center (looking east).

Furthermore, the Port must ensure that all current and future Priority Development Projects are reviewed for DSP applicability and that subsequent project plans are adequately conditioned and implemented for compliance with the Development Standards. This will become increasingly imperative because of the anticipated redevelopment of the West Complex.

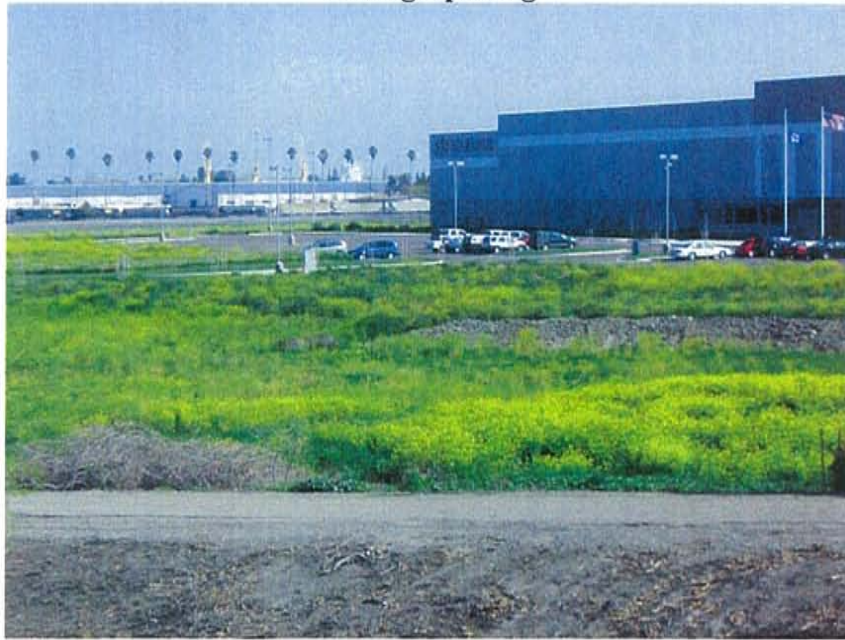
Photograph 15: Newly constructed warehouse structure and impervious parking improvements at the Ferguson Distribution Center (looking east).

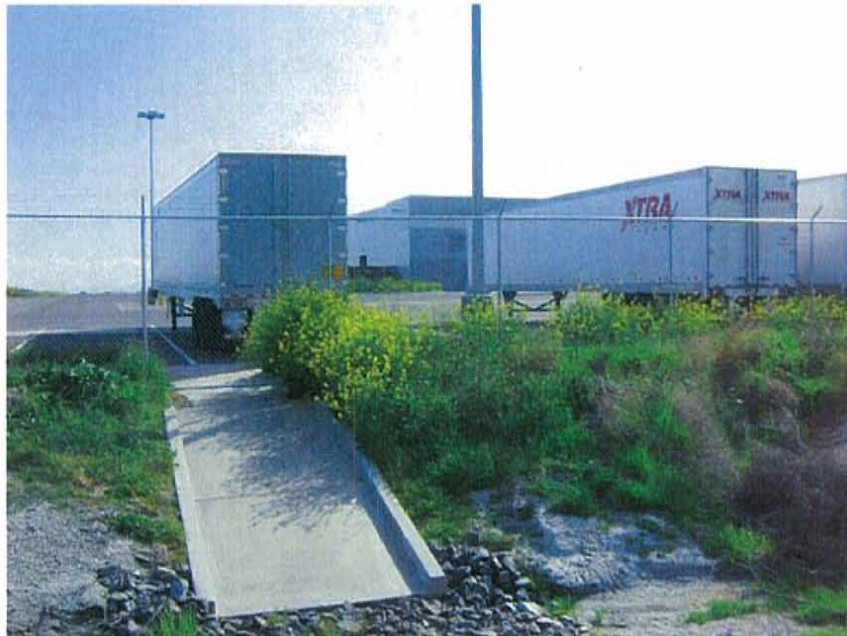
Photograph 16: Newly constructed parking improvements at the Ferguson Distribution Center (looking south).
