NPDES Storm Water Inspection Report

Facility Location Information			
Name/Location/ Mailing Address	Sims Metal Management (Sims) 699 Seaport Blvd. Redwood City, CA		
GPS Coordinates	Latitude	37° 30' 40.6"	Longitude 122° 12' 29.6"
Receiving Water(s)	Redwood Creek – Navigable estuary to San Francisco Bay		
	Name	Telephone	
Owner	Steven Shinn – Regional General Manager	510-412-5300	
Operator	Joe Barco – Operations General Manager	510-412-5300	
Environmental Coordinator	Matt Zeiter – On-site Rep	510-715-7569

General	
Inspection Objective, Attendees, and Opening Conference Summary.	<p>The inspection's objective was to determine compliance with the California Industrial General Permit No. CAS000001.</p> <p>In addition to EPA inspectors previously identified, the inspection was attended by Estuardo Montufar (650.372.6240) and Sabrina Mih (650.372.6235) with San Mateo County Environmental Health Services Division (Certified Unified Program Agencies – CUPA), and Matt Zieter (510.412.5300), Mariya Semeit (650.369.4161), Dale Leuer (650.369.4161), and Vistasp Patel (650.369.4161) with Sims Metals Management (Sims or Facility Representatives)</p> <p>Prior to commencing the inspection, an ope

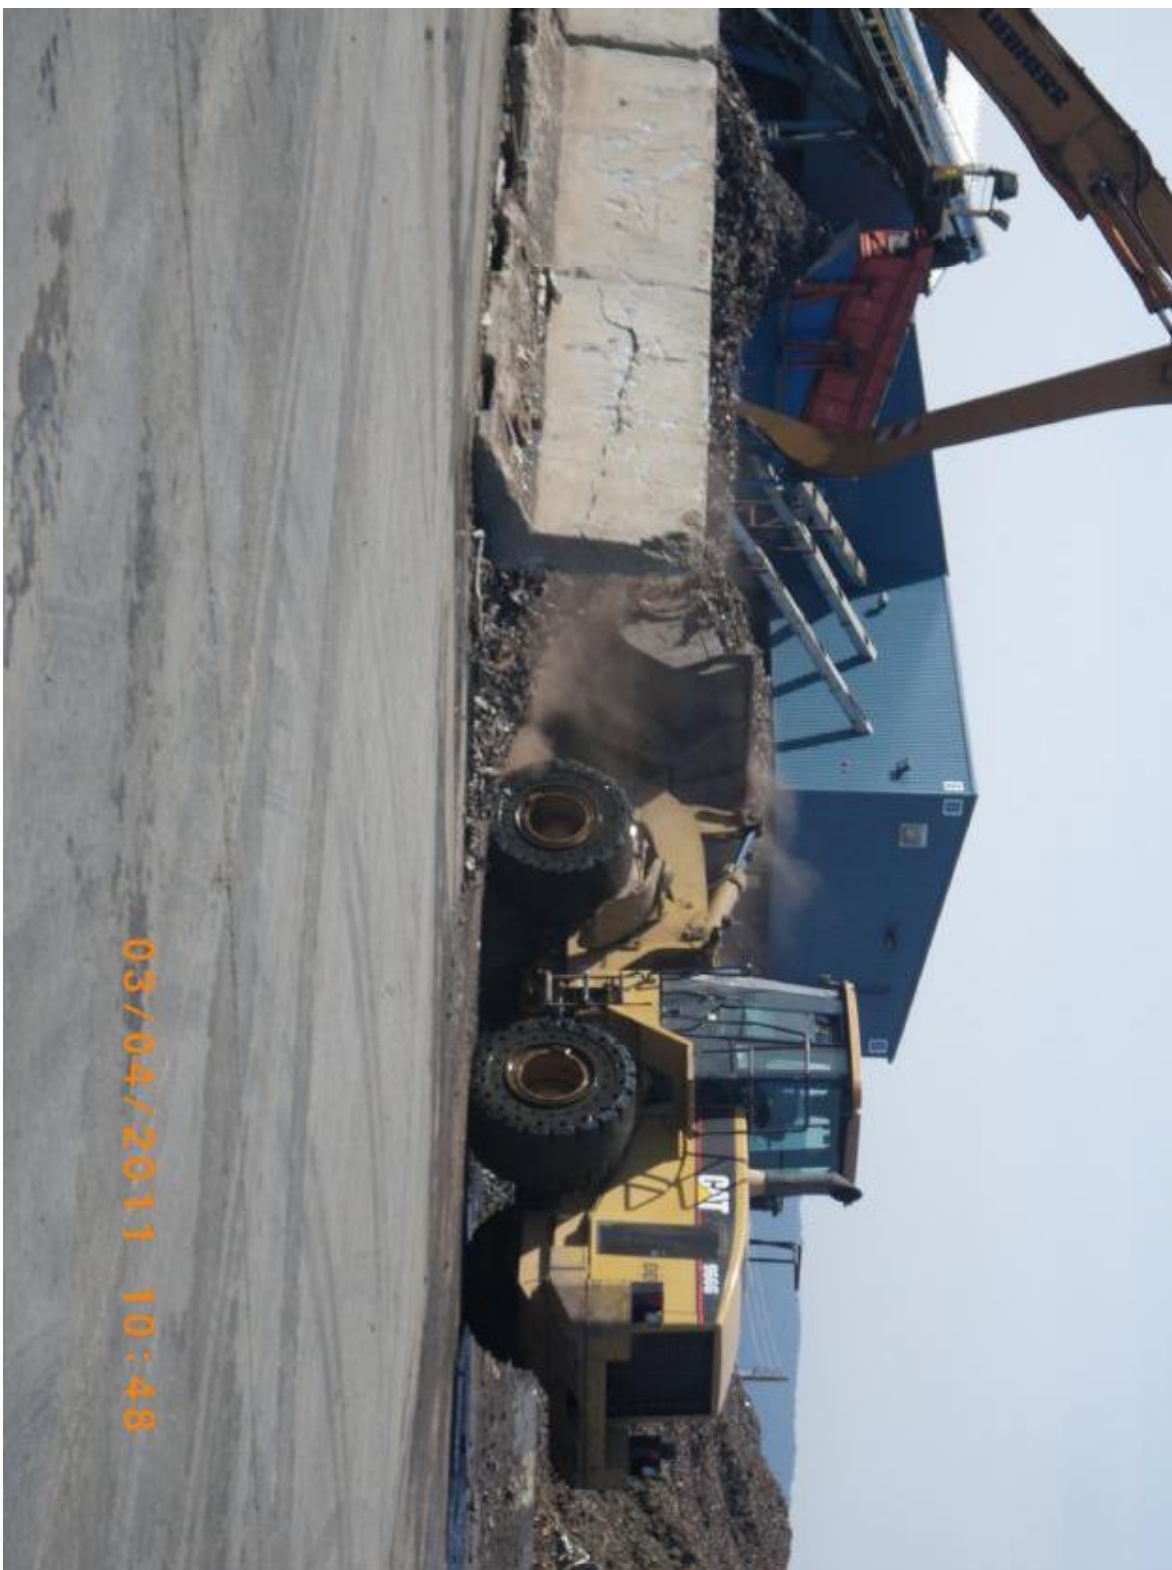
IMGP0197.JPG

IMGP0197 – Rubber-tired loader is moving shredded metals to a pile within pond 2. (Note: rust-colored dust was observed being generated by this operation.)

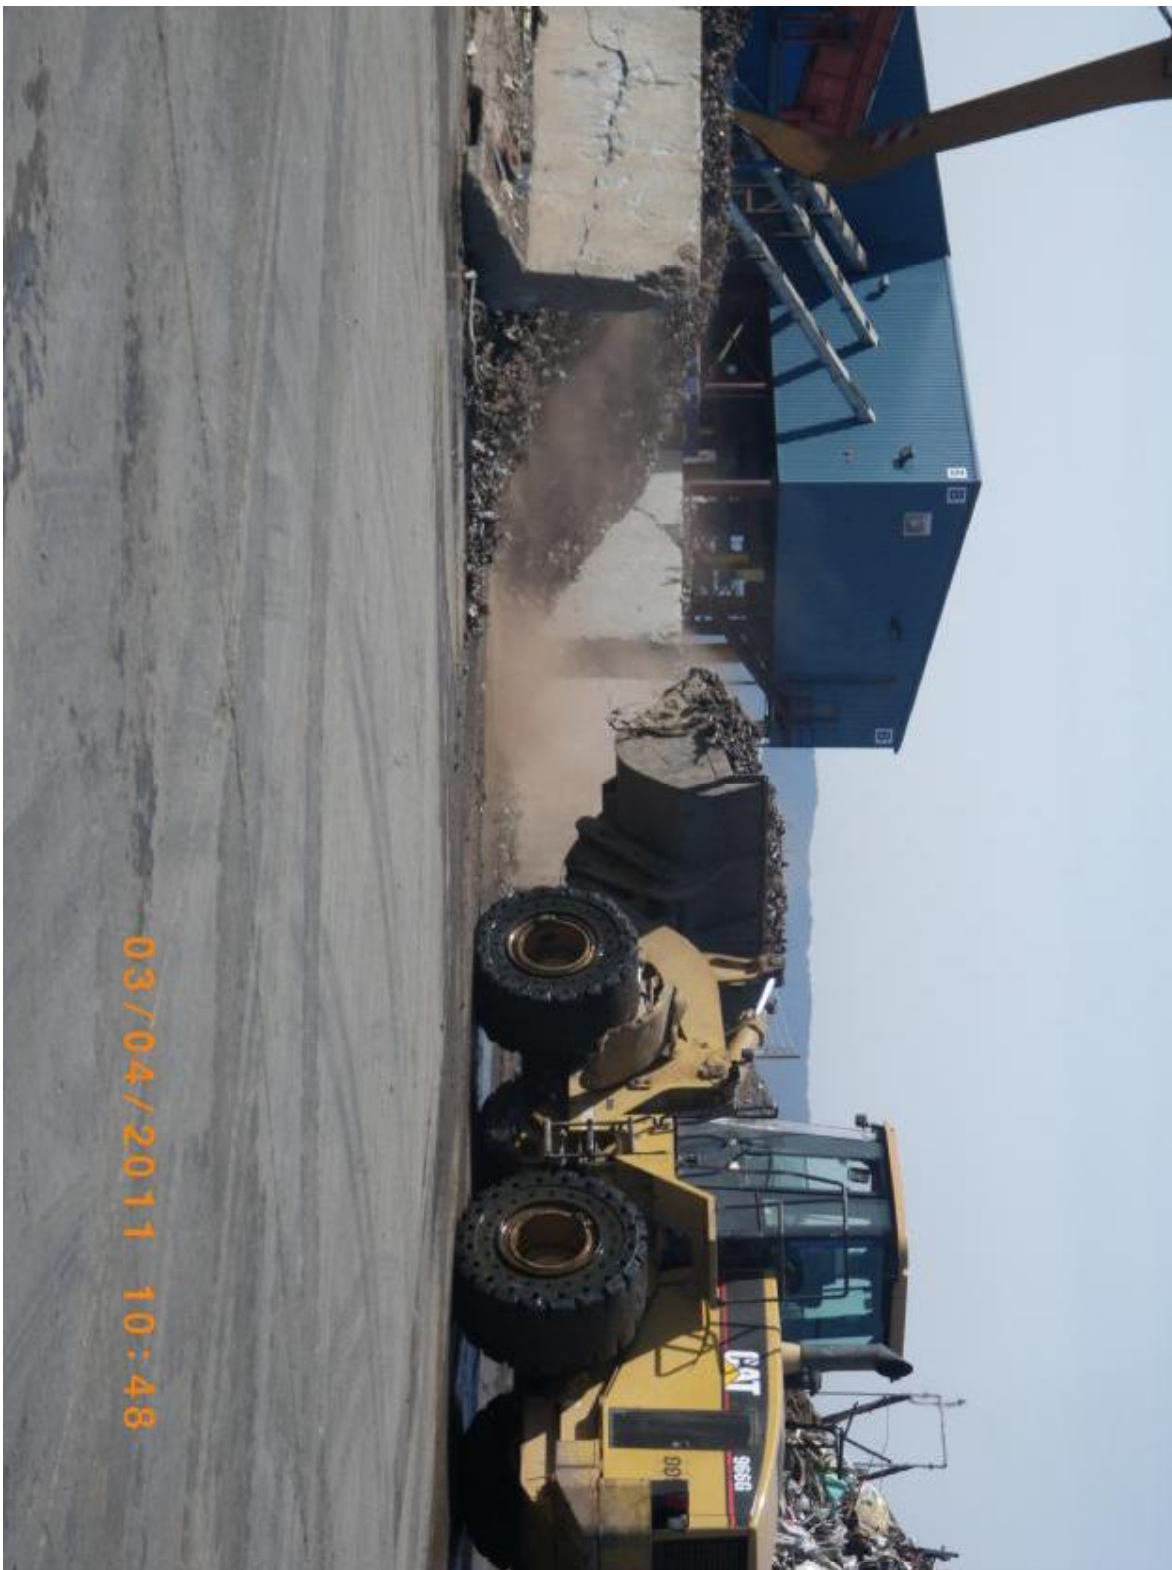
IMGP0198.JPG

IMGP0198 – Same location and activity as IMGP0197, and observed dust generation.

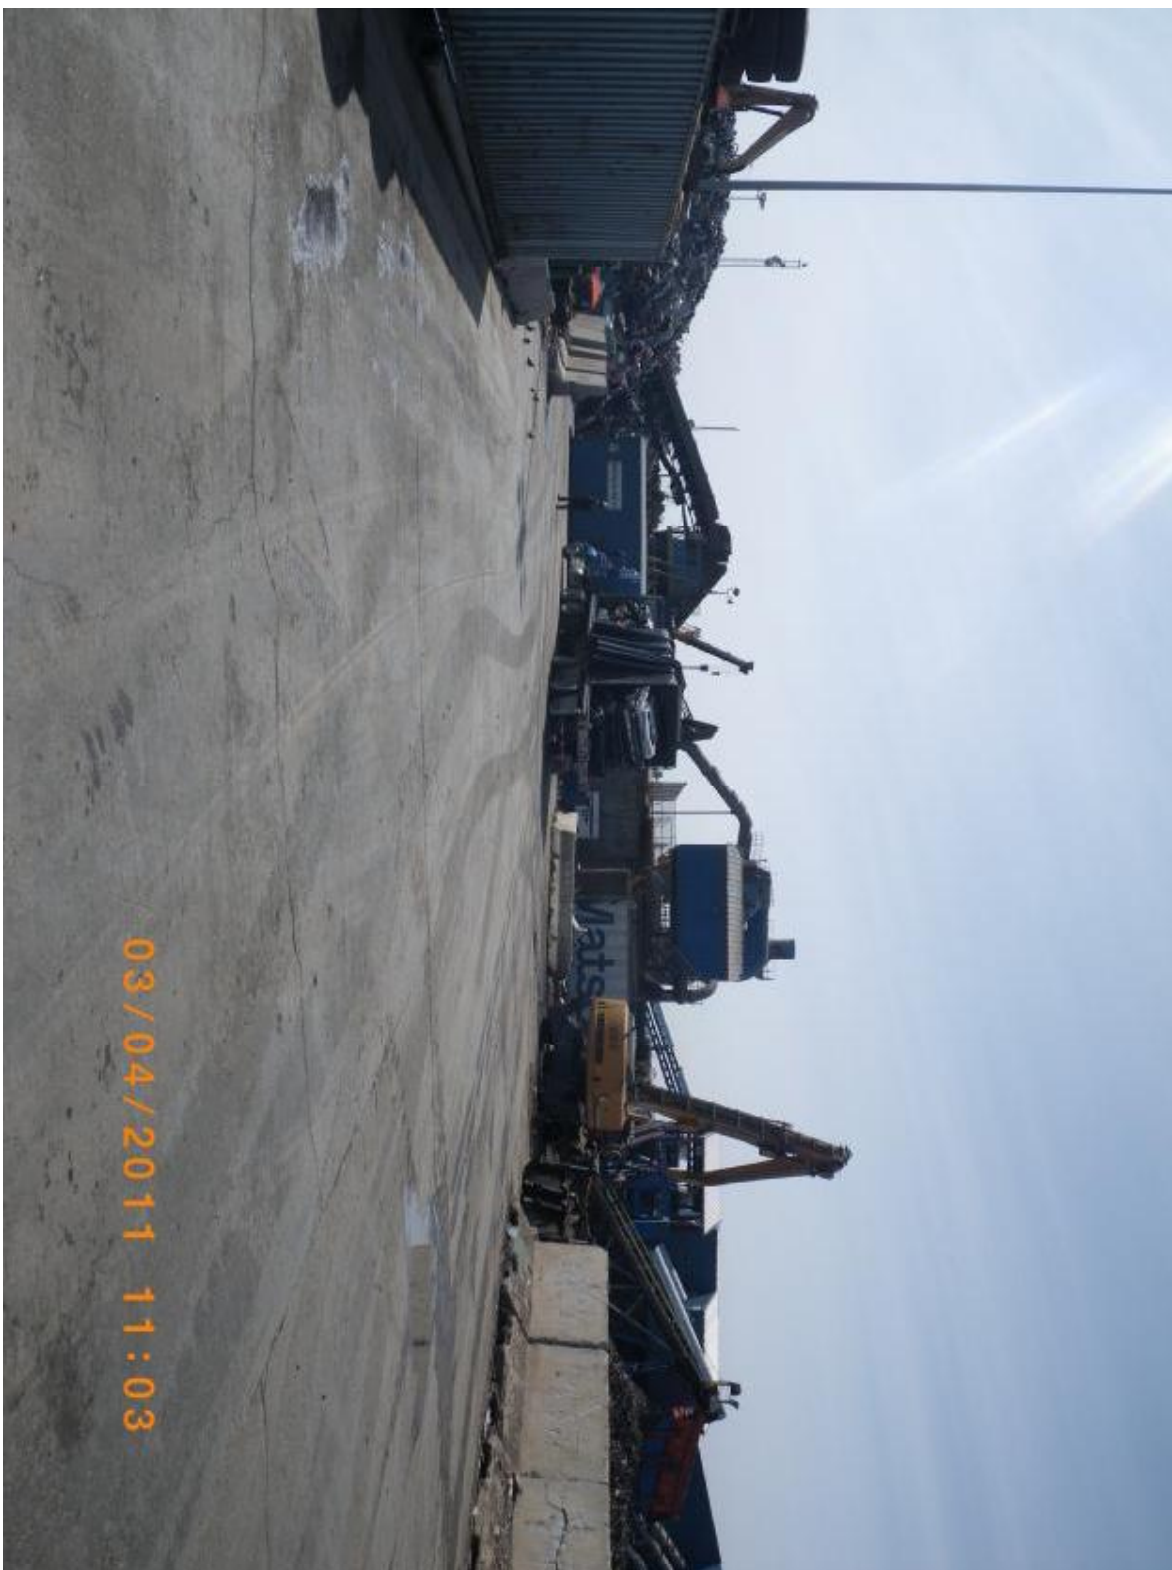
IMGP0199.JPG

IMGP0199 – Standing just to the west of the employee parking area and looking south. A truck with flattened vehicles is preparing to deliver materials to the metal shredding facility in the background. Pile of shredded metal is to the right in the photo, and pile of materials to be shredded is to the left of the photo. Ponded water and tire tracks were observed on the driving surface.

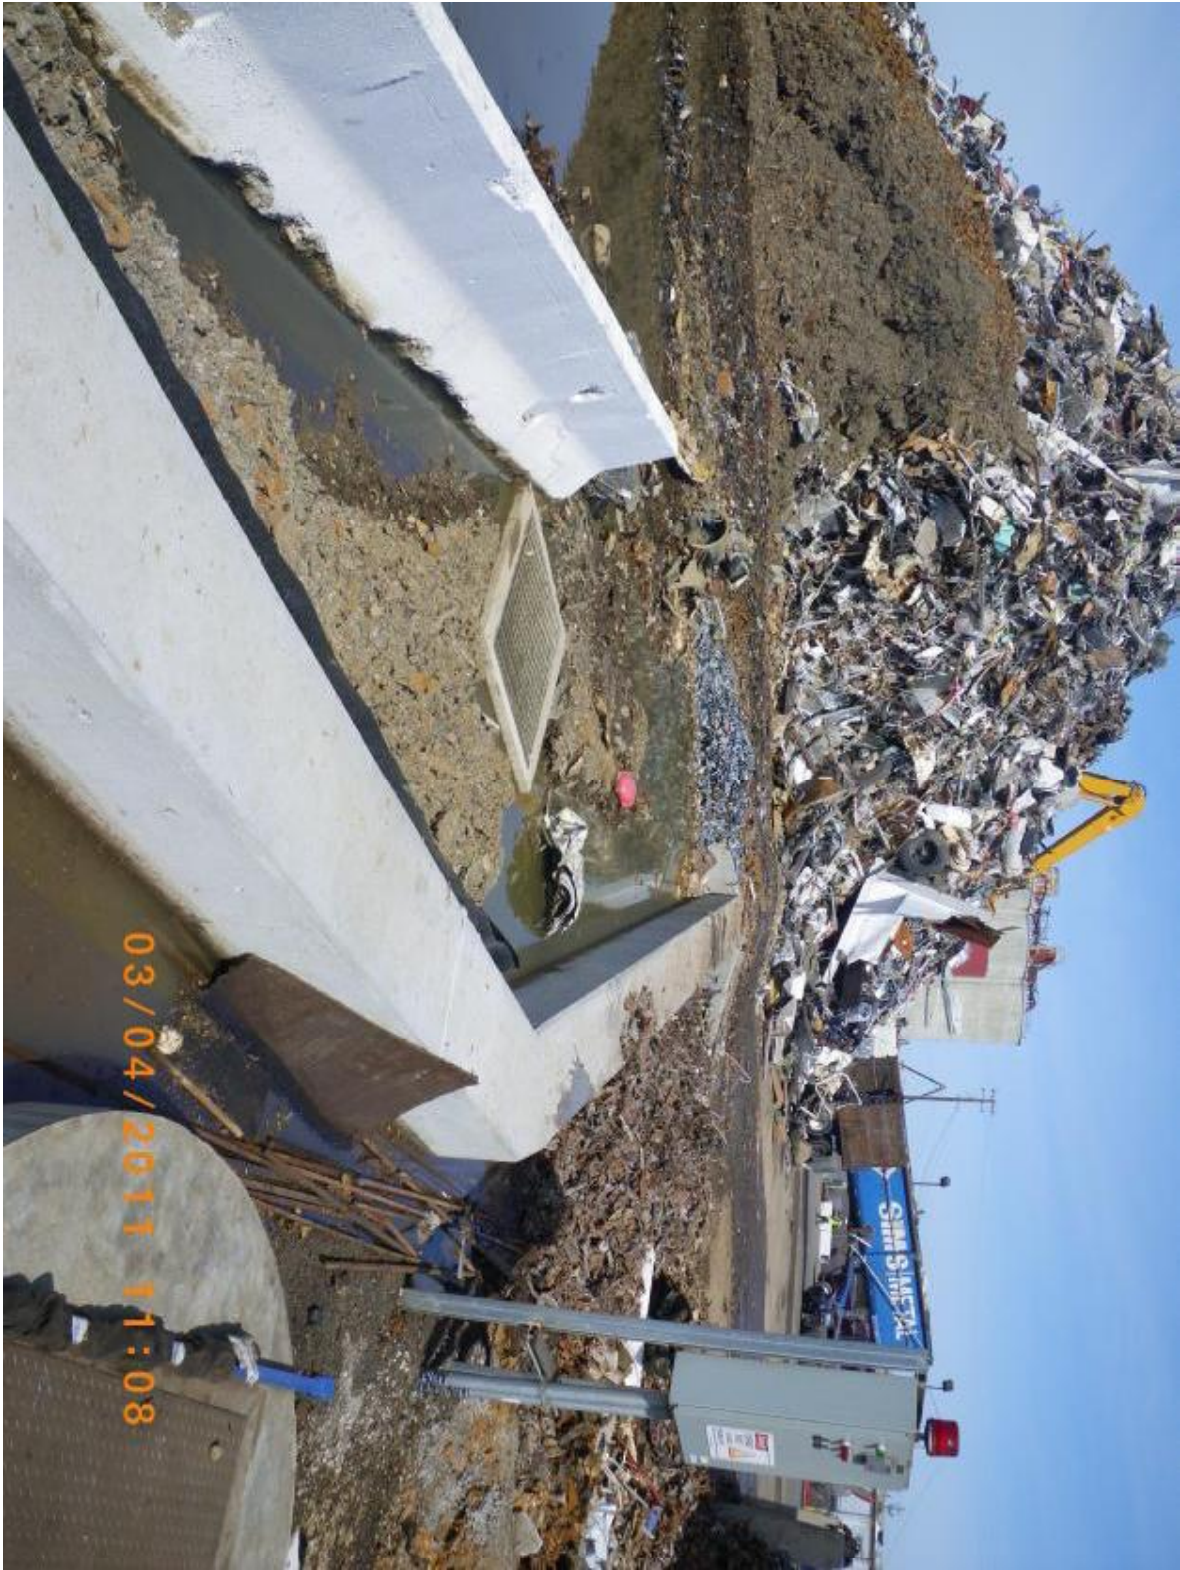
IMGP0203.JPG

IMGP0203 – Northwest corner of pond 2 with drain inlet in the foreground and drive-over berm for the loader to access piles within pond 2. Pond water track-out was observed.

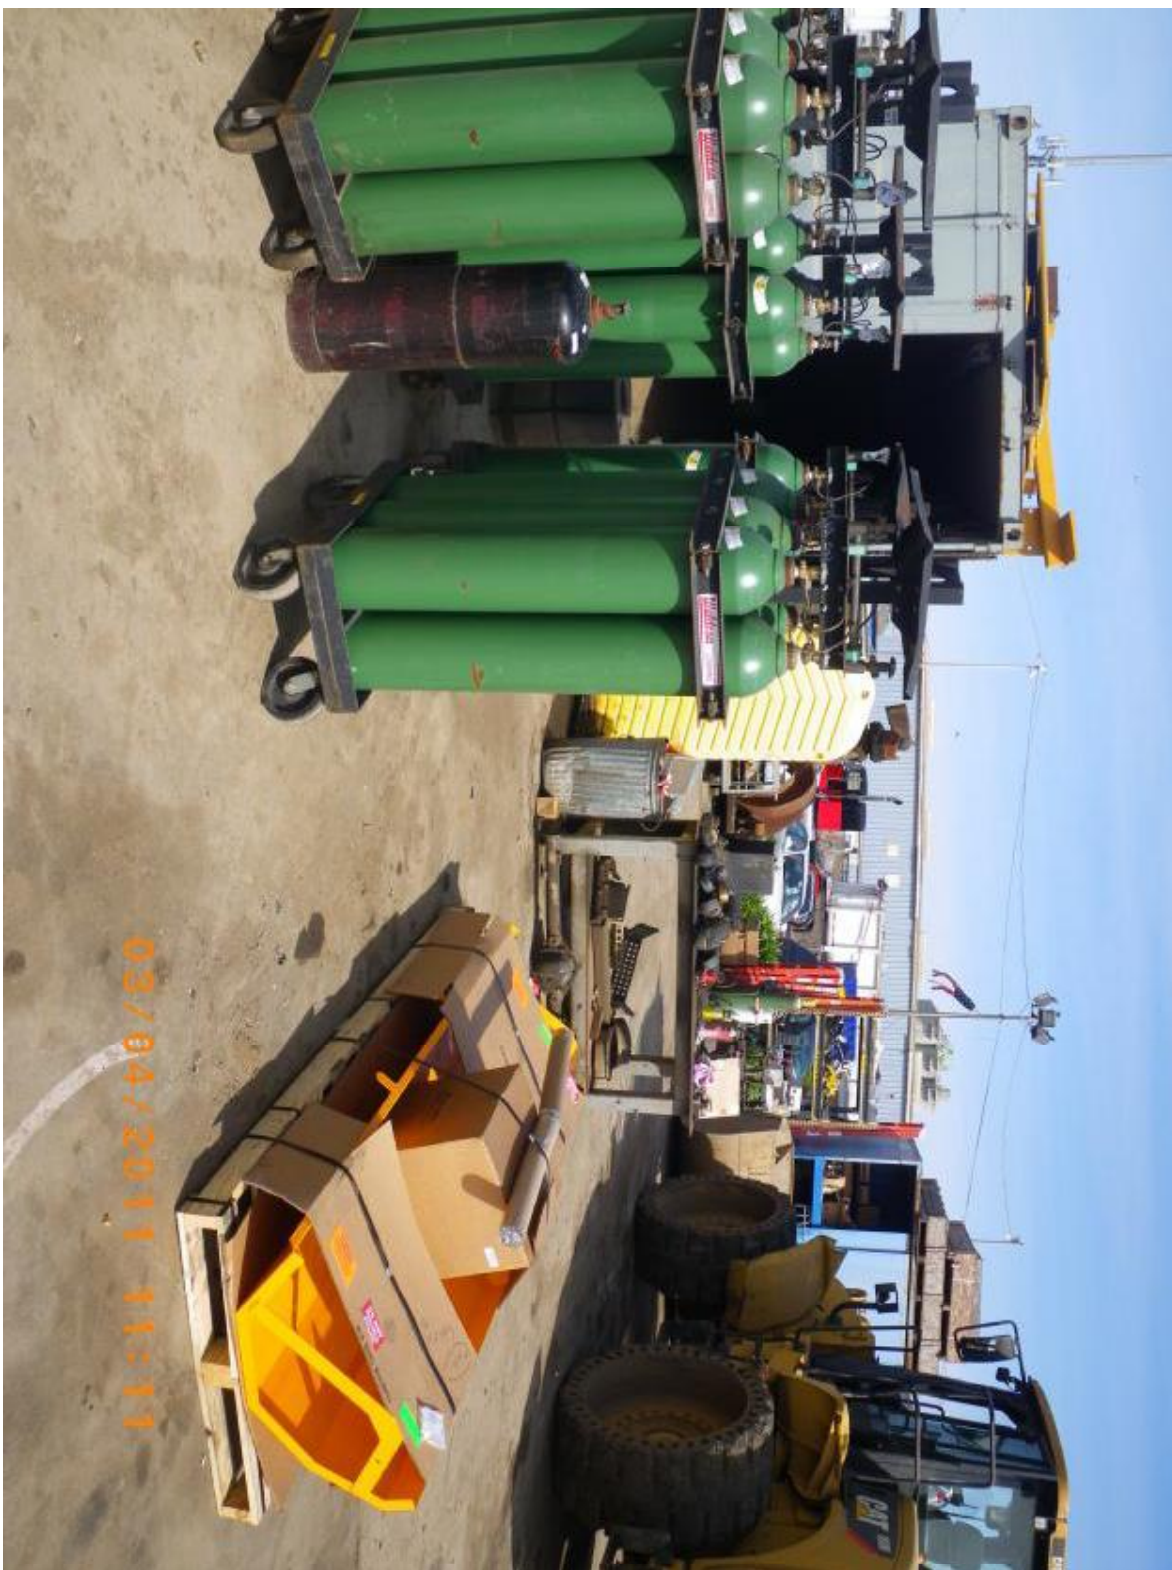
IMGP0204.JPG

IMGP0204 – Maintenance area (southwest corner looking north. Acetylene tanks, work tables, and parked equipment are depicted. Oil staining was observed.

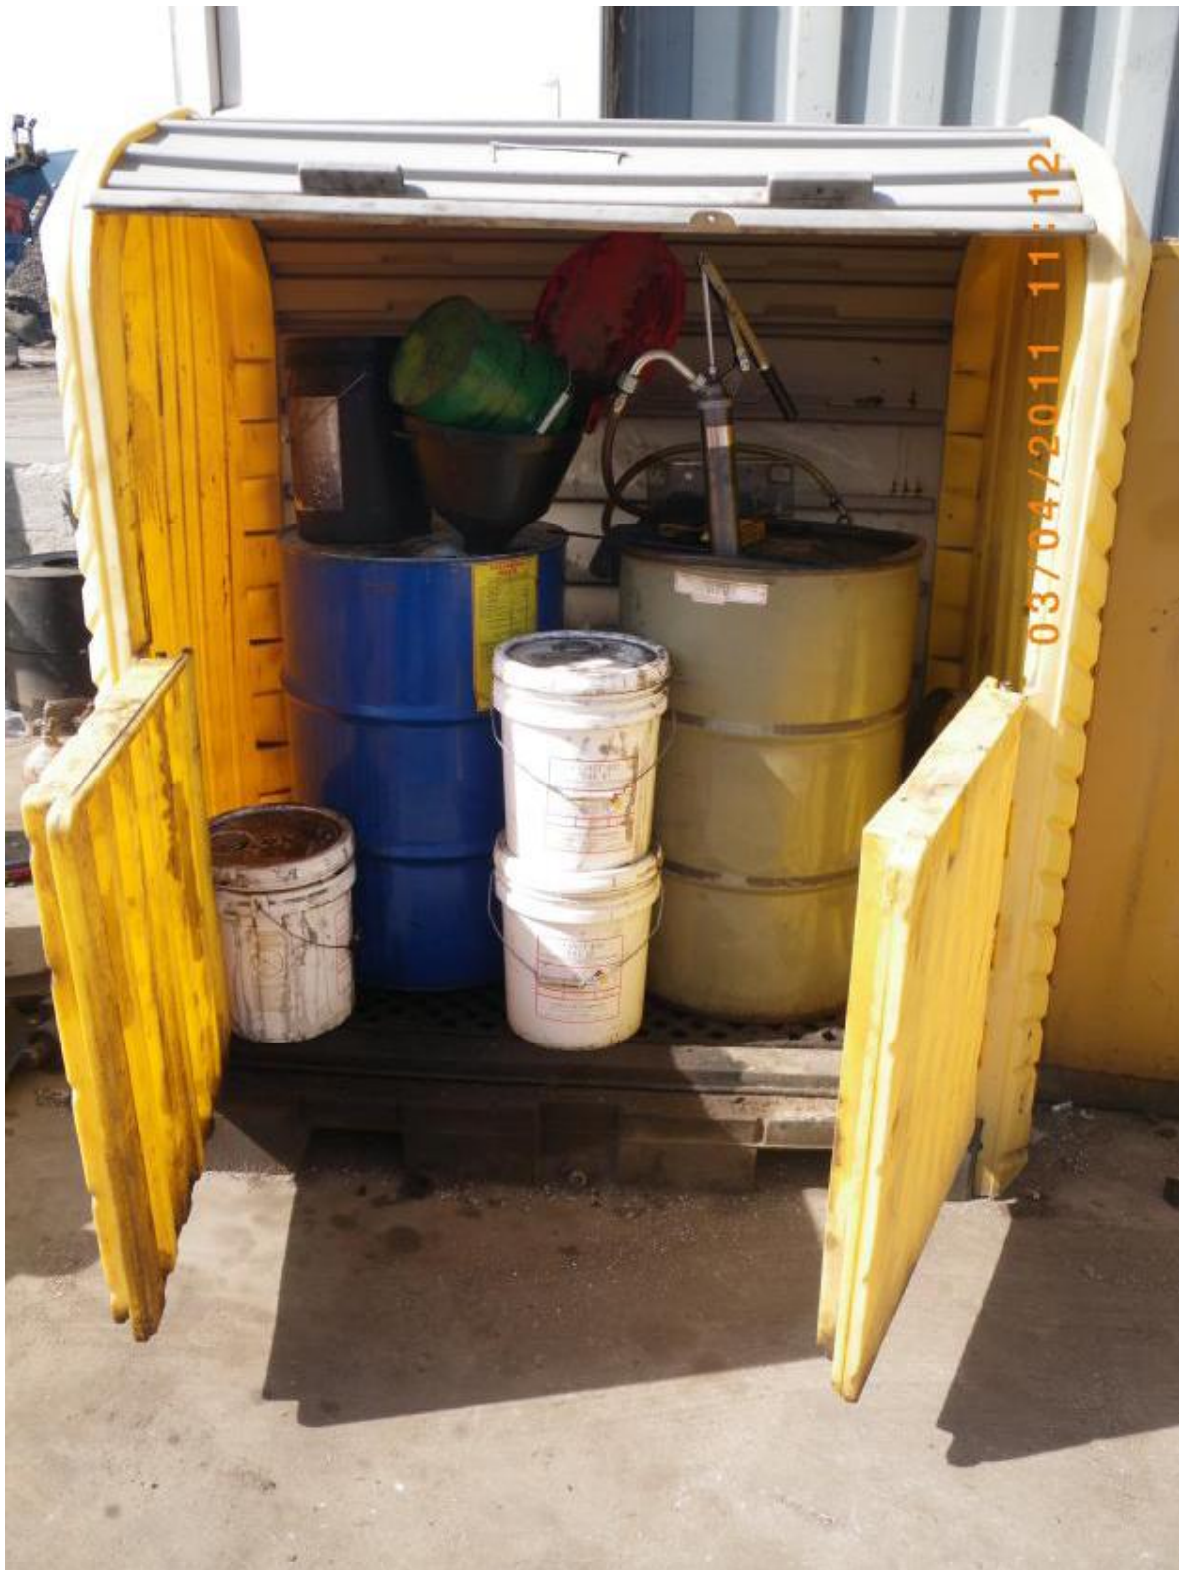
IMGP0205.JPG

IMGP0205 – Maintenance area; secondary containment equipped storage shed with barrels of new and used oil.) Oil staining and accumulated fugitive absorbent material was observed at the shed opening.

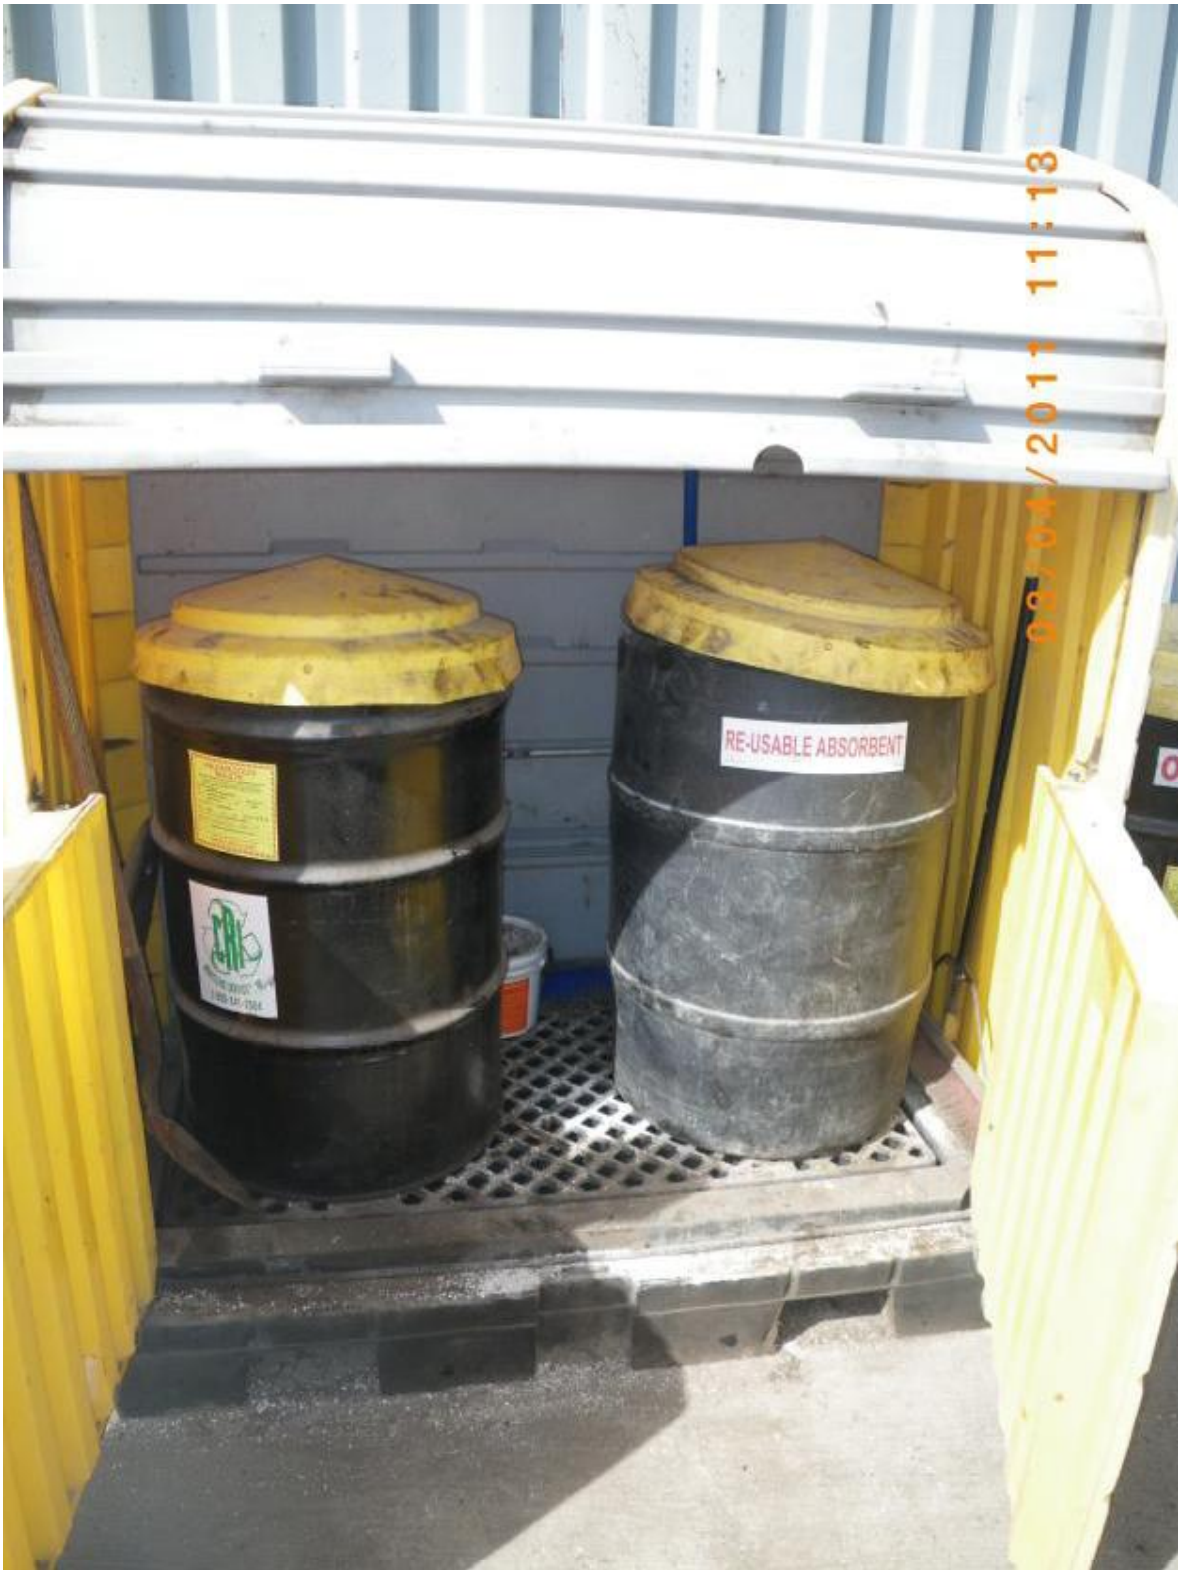
IMGP0207.JPG

IMGP0207 – Maintenance area; secondary containment equipped storage shed that contains the maintenance area's "spill-kit". Accumulated fugitive absorbent material at the opening of the shed was observed.

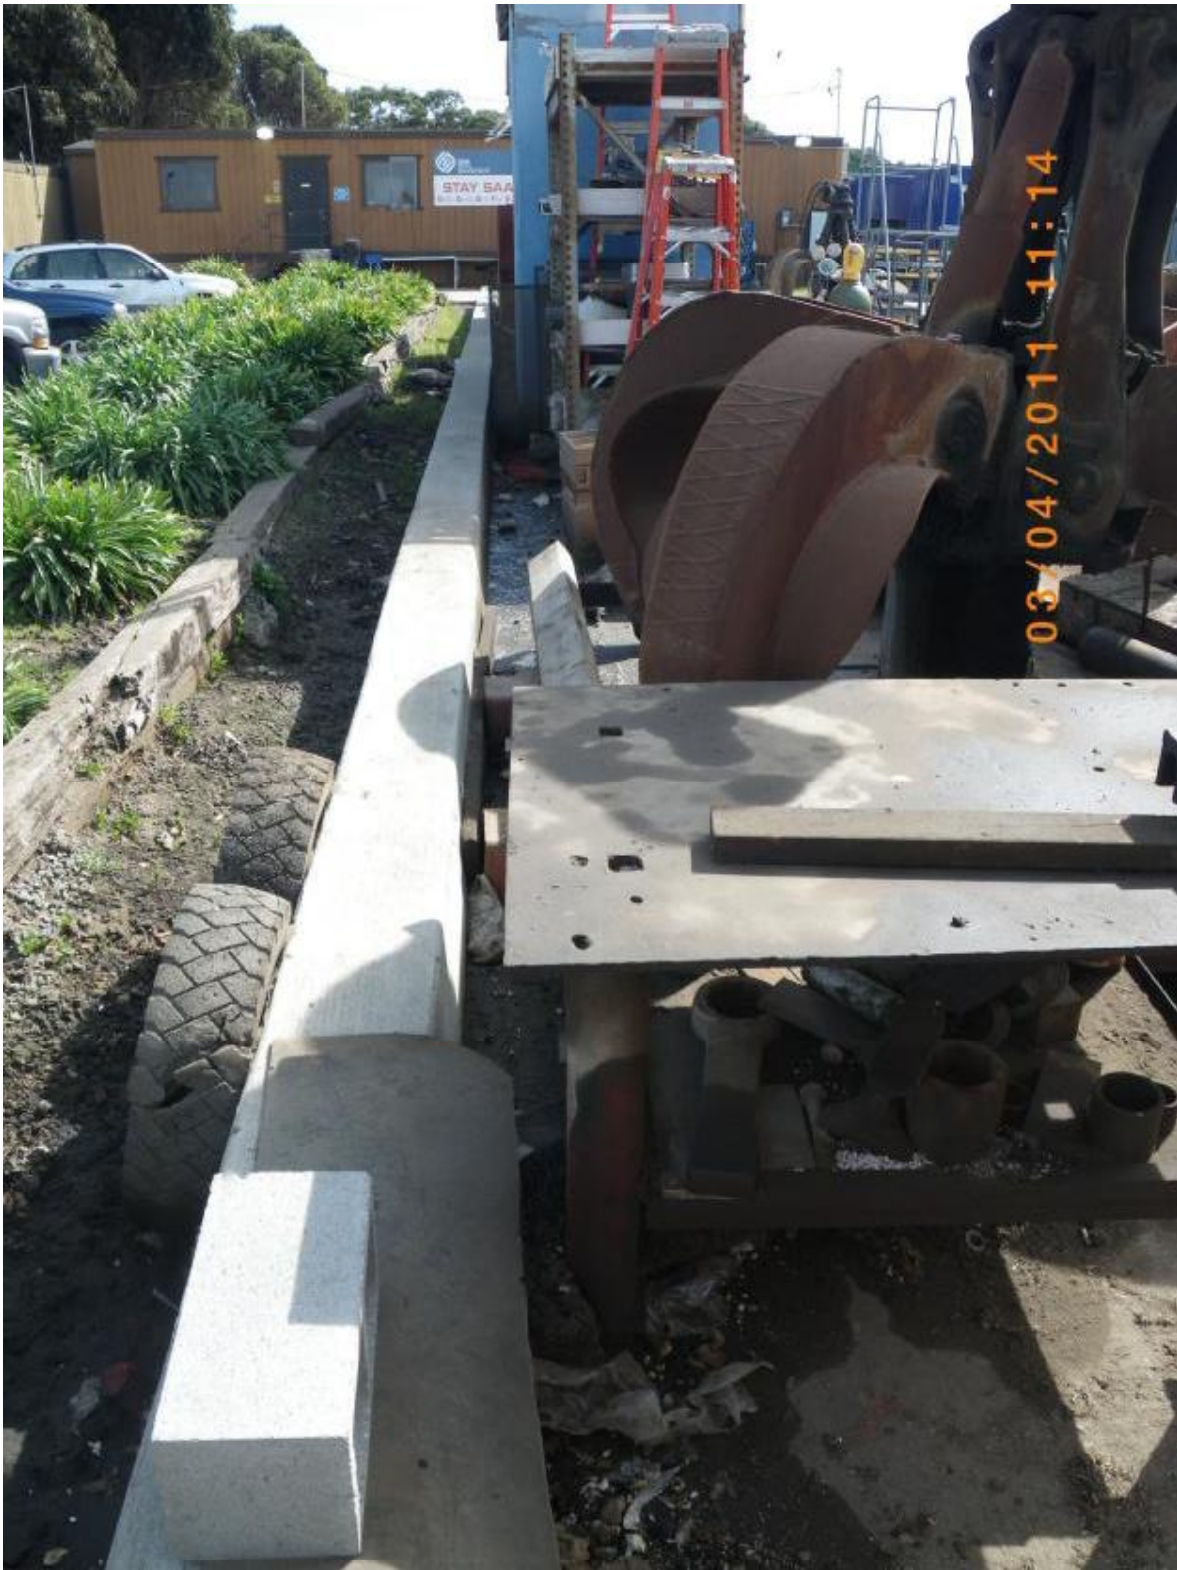
IMG0208.JPG

IMGP0208 – Maintenance area, northwest corner looking east; area is bermed and accumulated debris (absorbent material and trash) was observed.

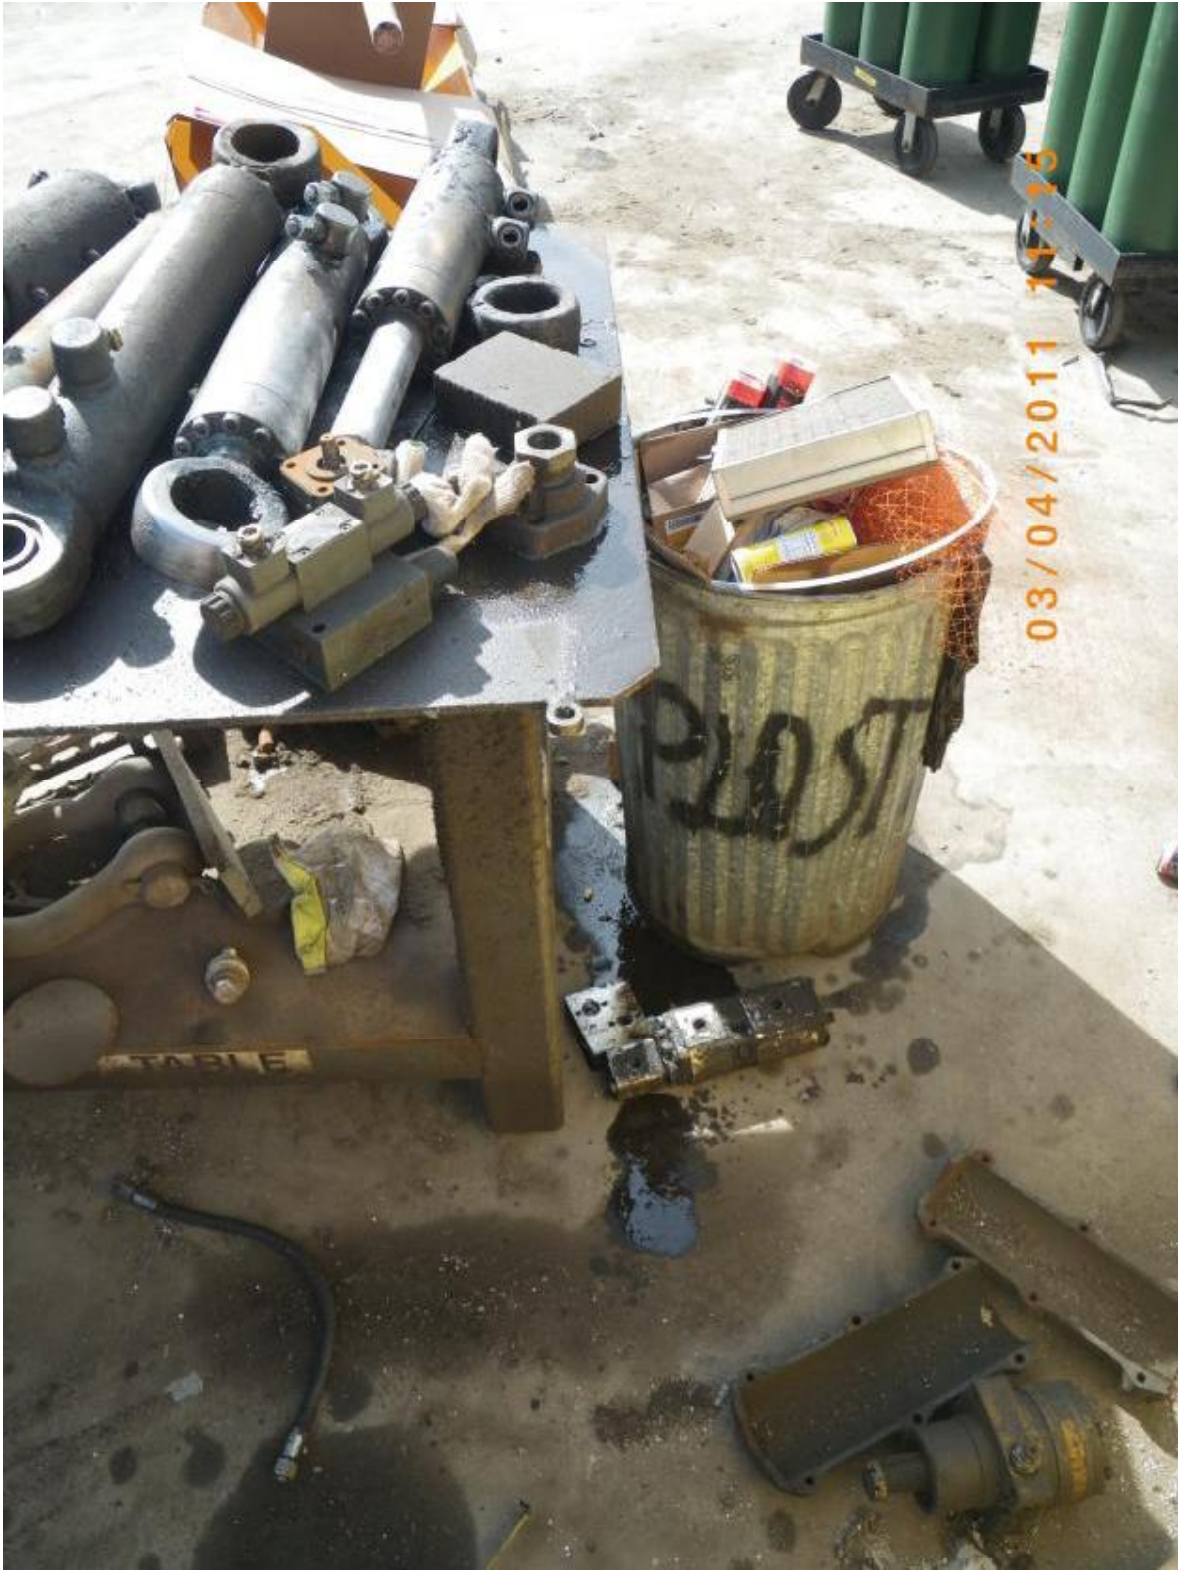
IMGP0209.JPG

IMGP0209 – Hydraulic table in the maintenance area (the table in the center of IMGP0204) with significant oil staining observed on the ground and active leaking oil observed.

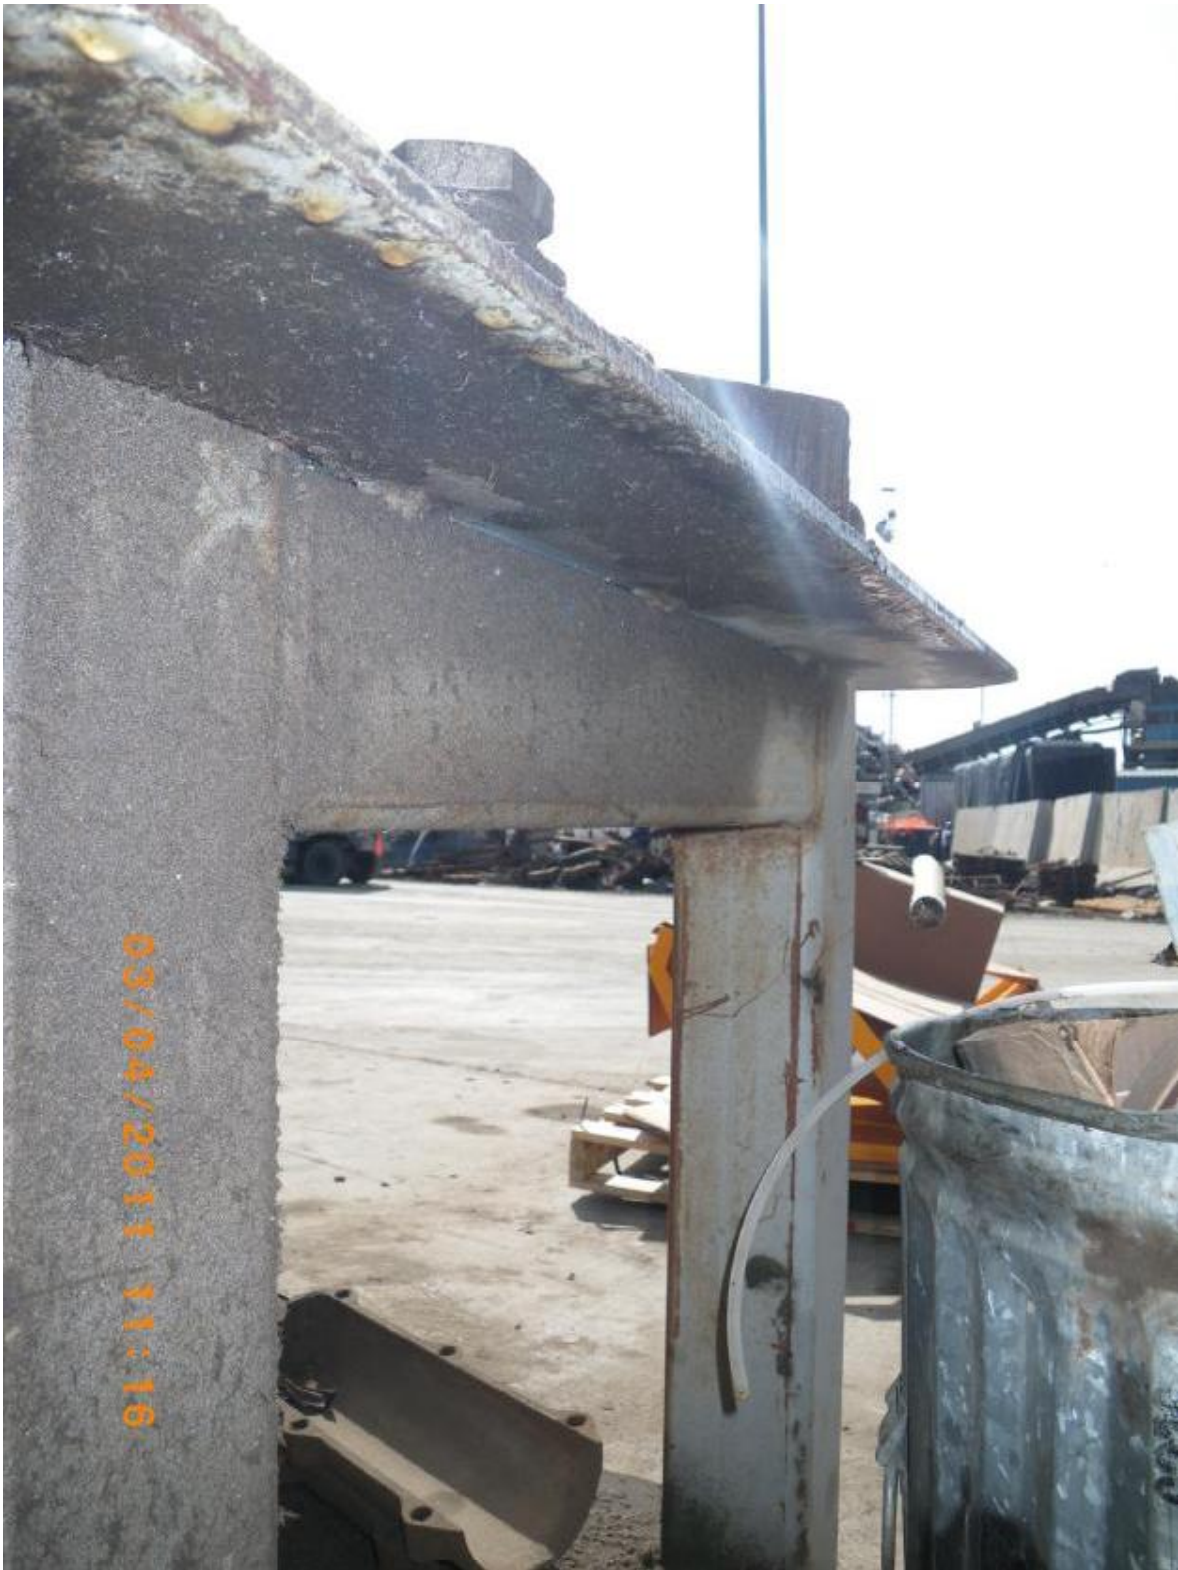
IMGP0210.JPG

IMGP0210 – Hydraulic oil drips that were observed discharging to the ground from the hydraulic table depicted in IMGP0209.

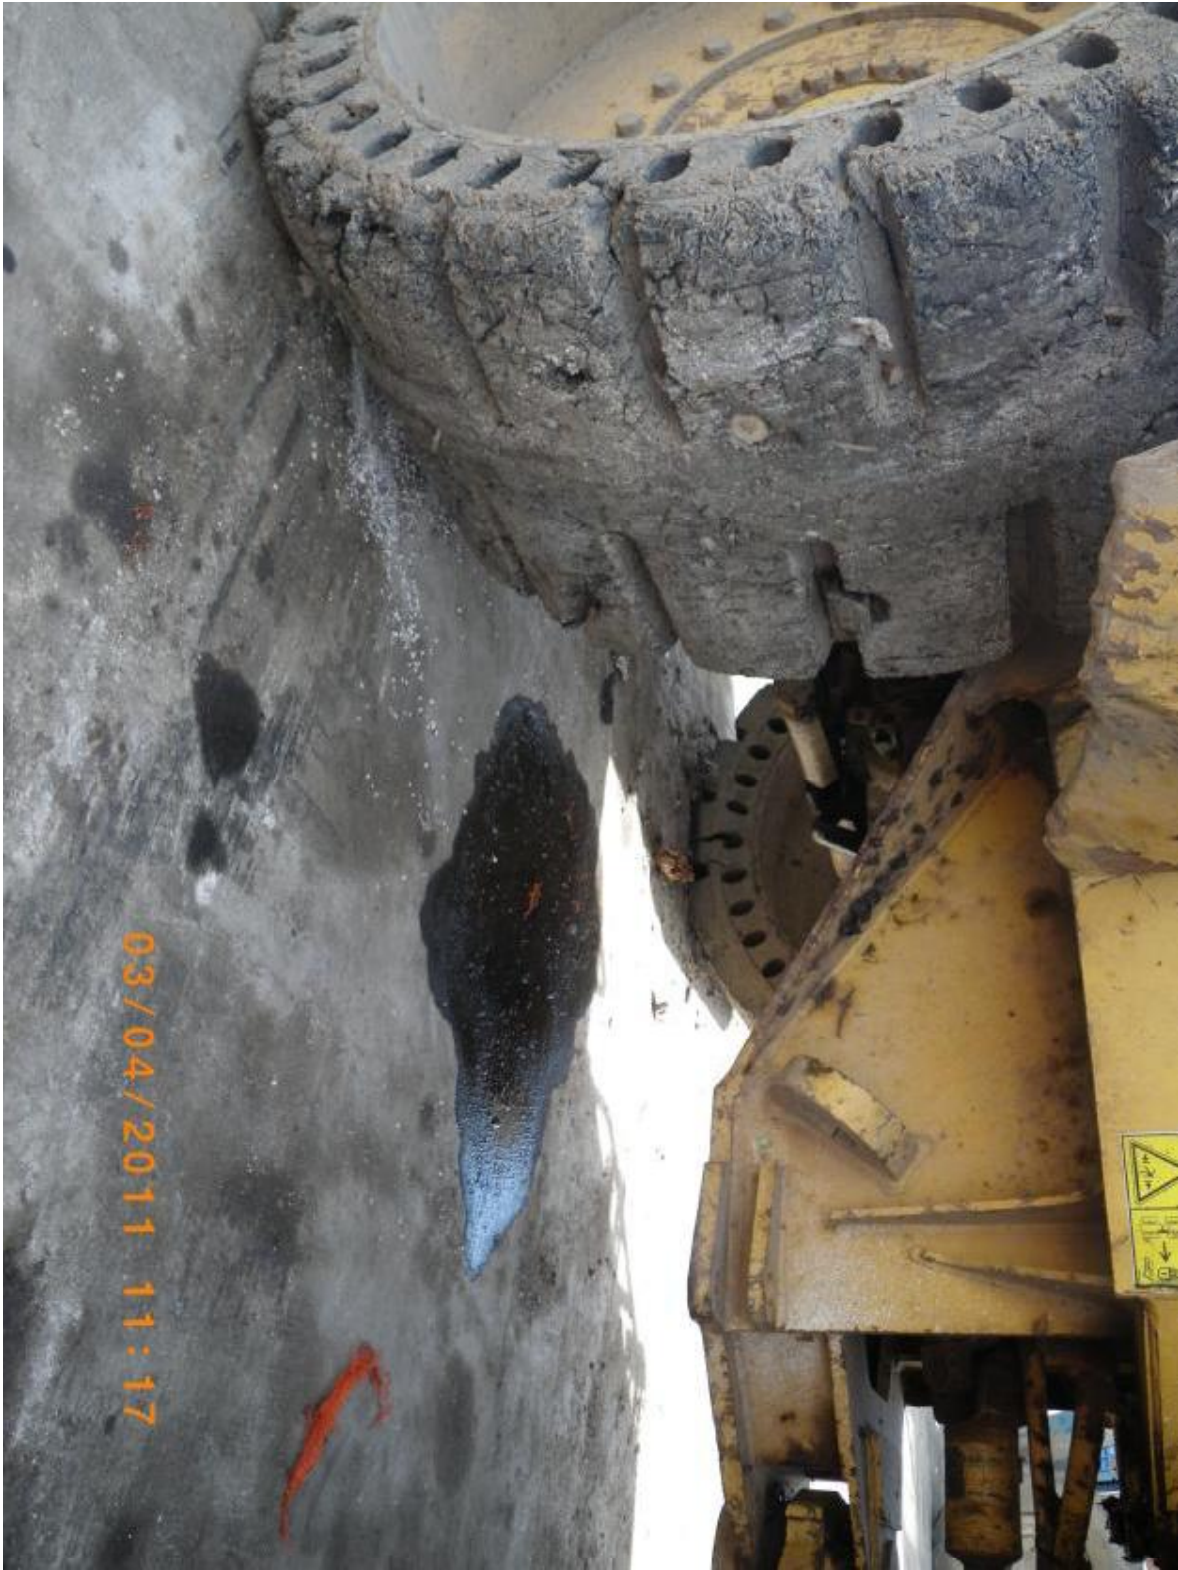
IMGP0211.JPG

IMGP0211 – Maintenance area, leaking oil from loader was observed on the ground.

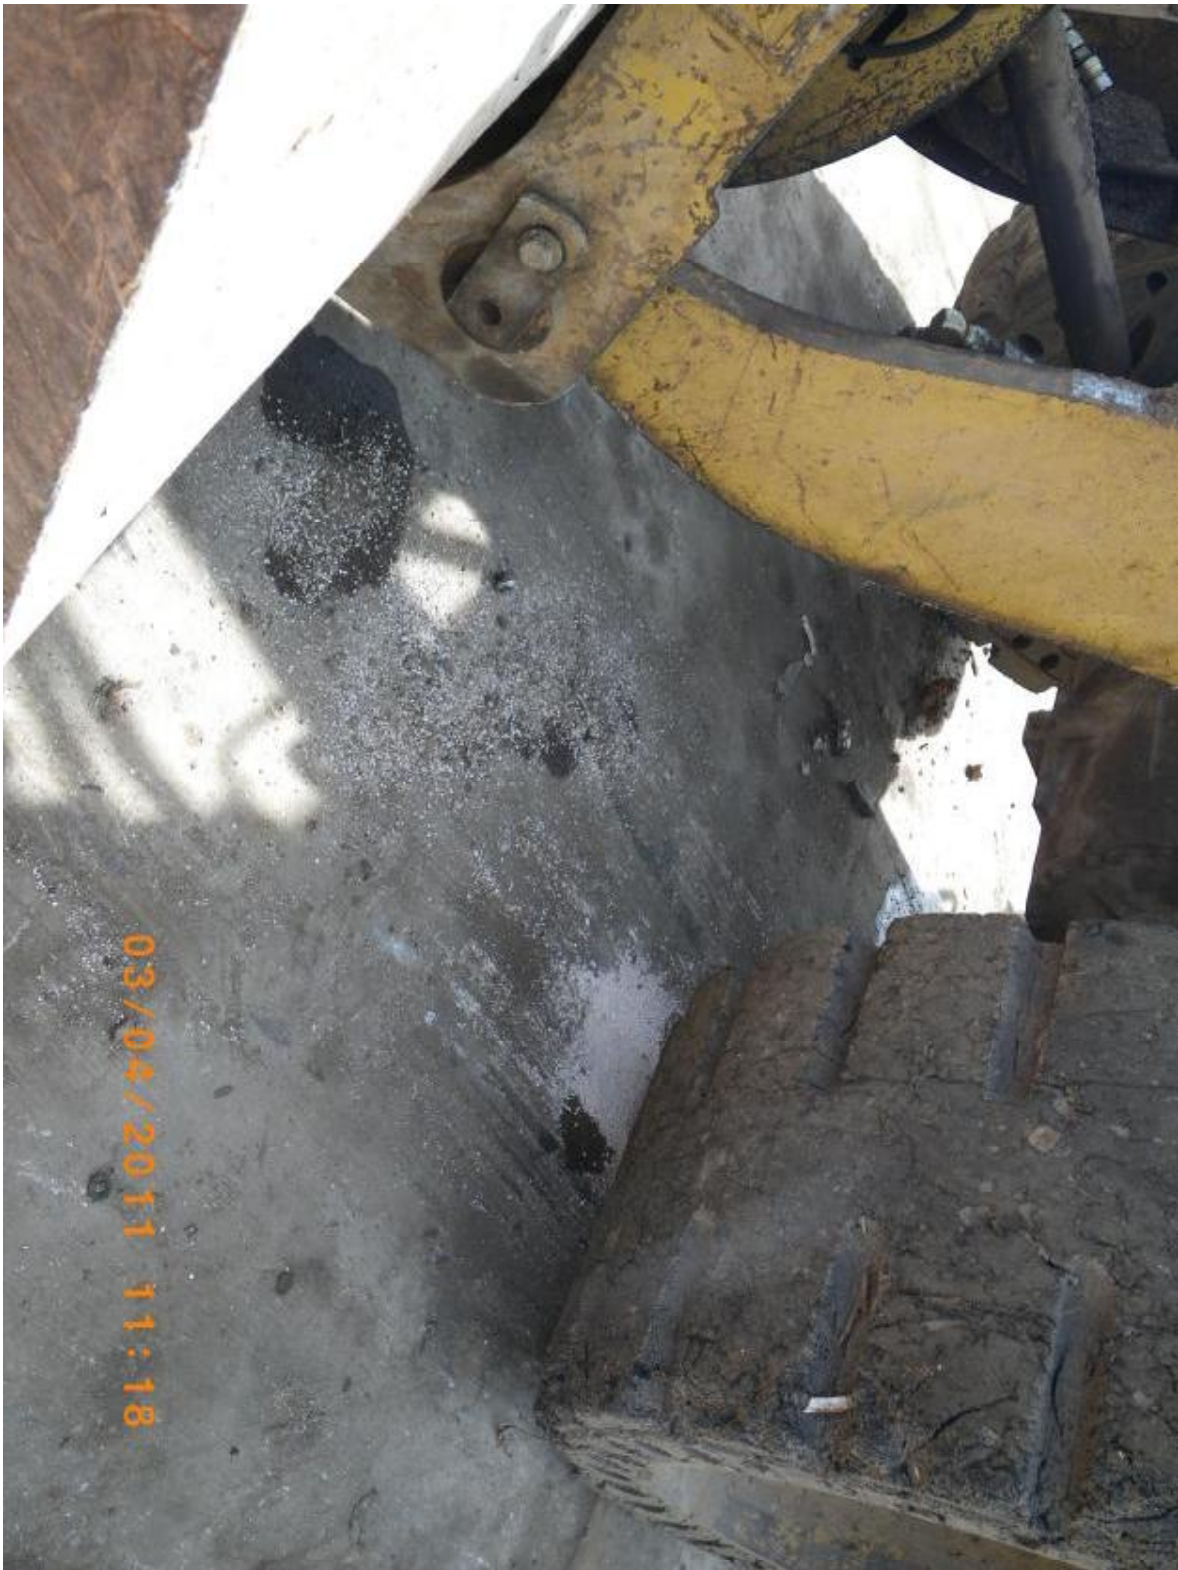
IMGP0212.JPG

IMGP0212 – Maintenance area, oil staining and deployed absorbent was observed.
