NPDES Storm Water Inspection Report

Facility Location Information			
Name/Location/ Mailing Address	Sims Metal Management (Sims) 699 Seaport Blvd. Redwood City, CA		
GPS Coordinates	Latitude	37° 30' 40.6"	Longitude 122° 12' 29.6"
Receiving Water(s)	Redwood Creek – Navigable estuary to San Francisco Bay		
	Name	Telephone	
Owner	Steven Shinn – Regional General Manager	510-412-5300	
Operator	Joe Barco – Operations General Manager	510-412-5300	
Environmental Coordinator	Matt Zeiter – On-site Rep	510-715-7569

General	
Inspection Objective, Attendees, and Opening Conference Summary.	<p>The inspection's objective was to determine compliance with the California Industrial General Permit No. CAS000001.</p> <p>In addition to EPA inspectors previously identified, the inspection was attended by Estuardo Montufar (650.372.6240) and Sabrina Mih (650.372.6235) with San Mateo County Environmental Health Services Division (Certified Unified Program Agencies – CUPA), and Matt Zieter (510.412.5300), Mariya Semeit (650.369.4161), Dale Leuer (650.369.4161), and Vistasp Patel (650.369.4161) with Sims Metals Management (Sims or Facility Representatives)</p> <p>Prior to commencing the inspection, an ope

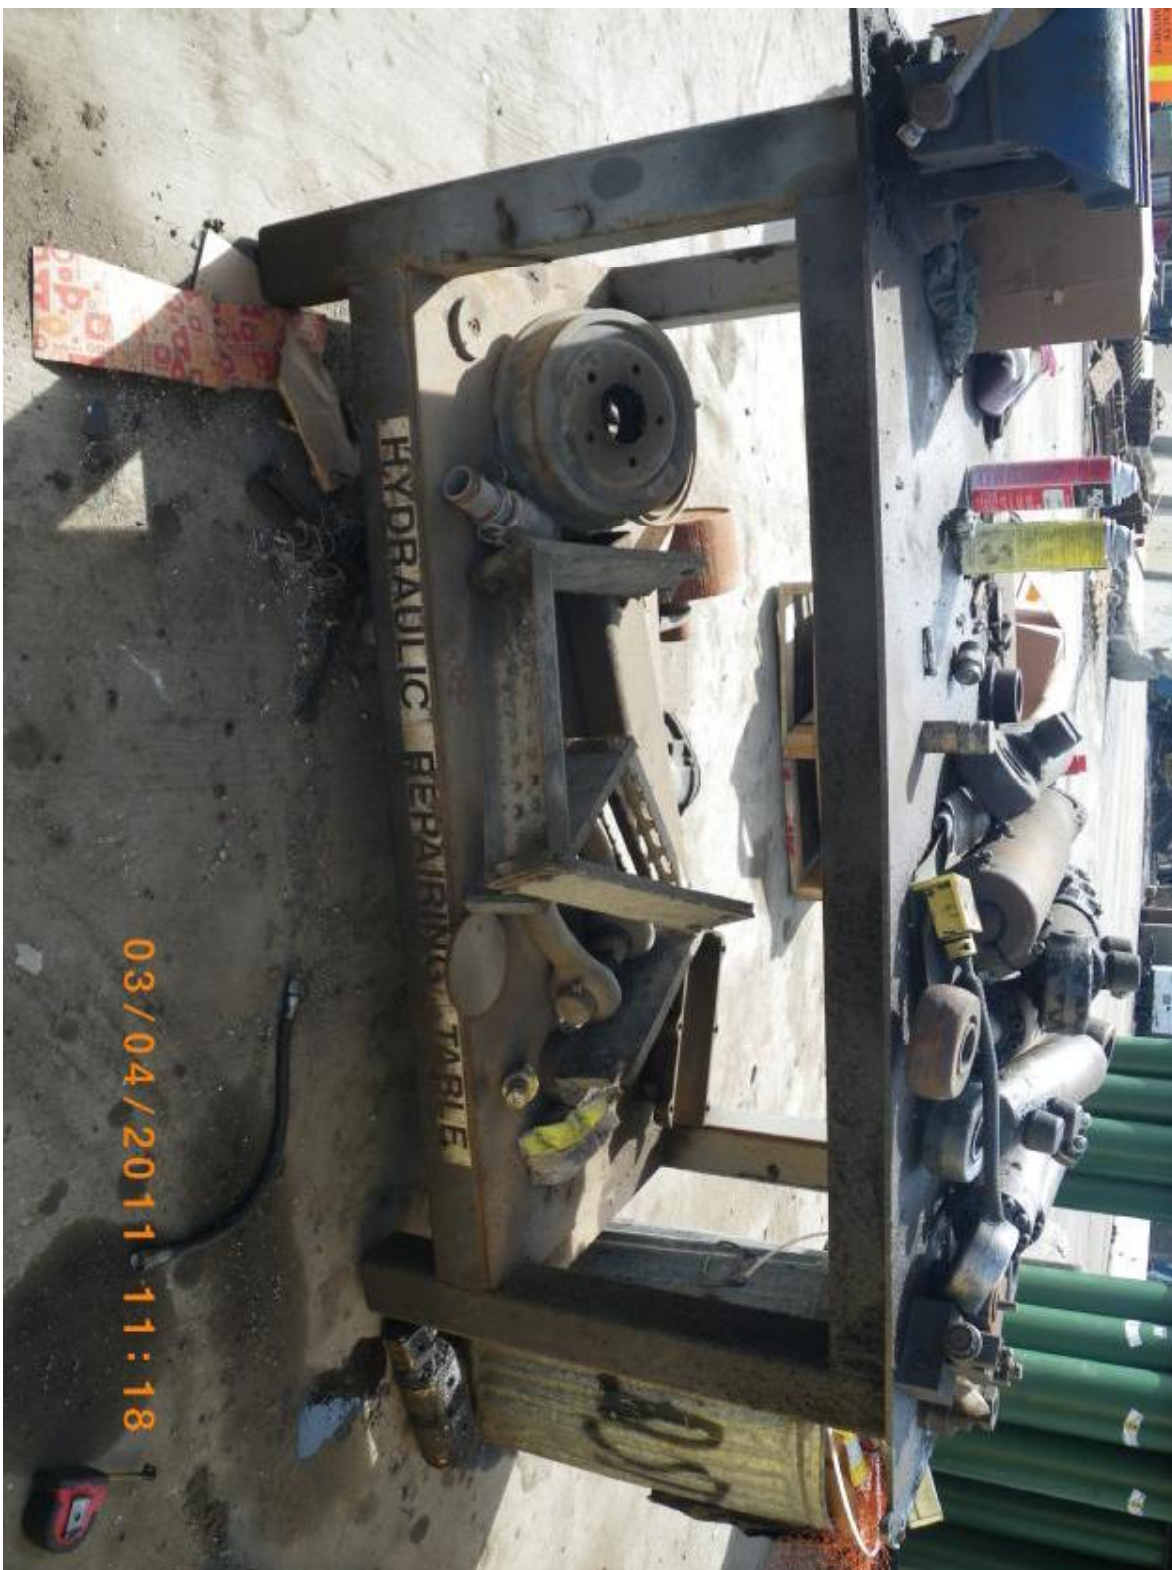
IMGP0213.JPG

IMGP0213 – Maintenance area, hydraulic repairing table depicted in IMGP020, 0209, and 0210 with oil staining and accumulated debris observed.

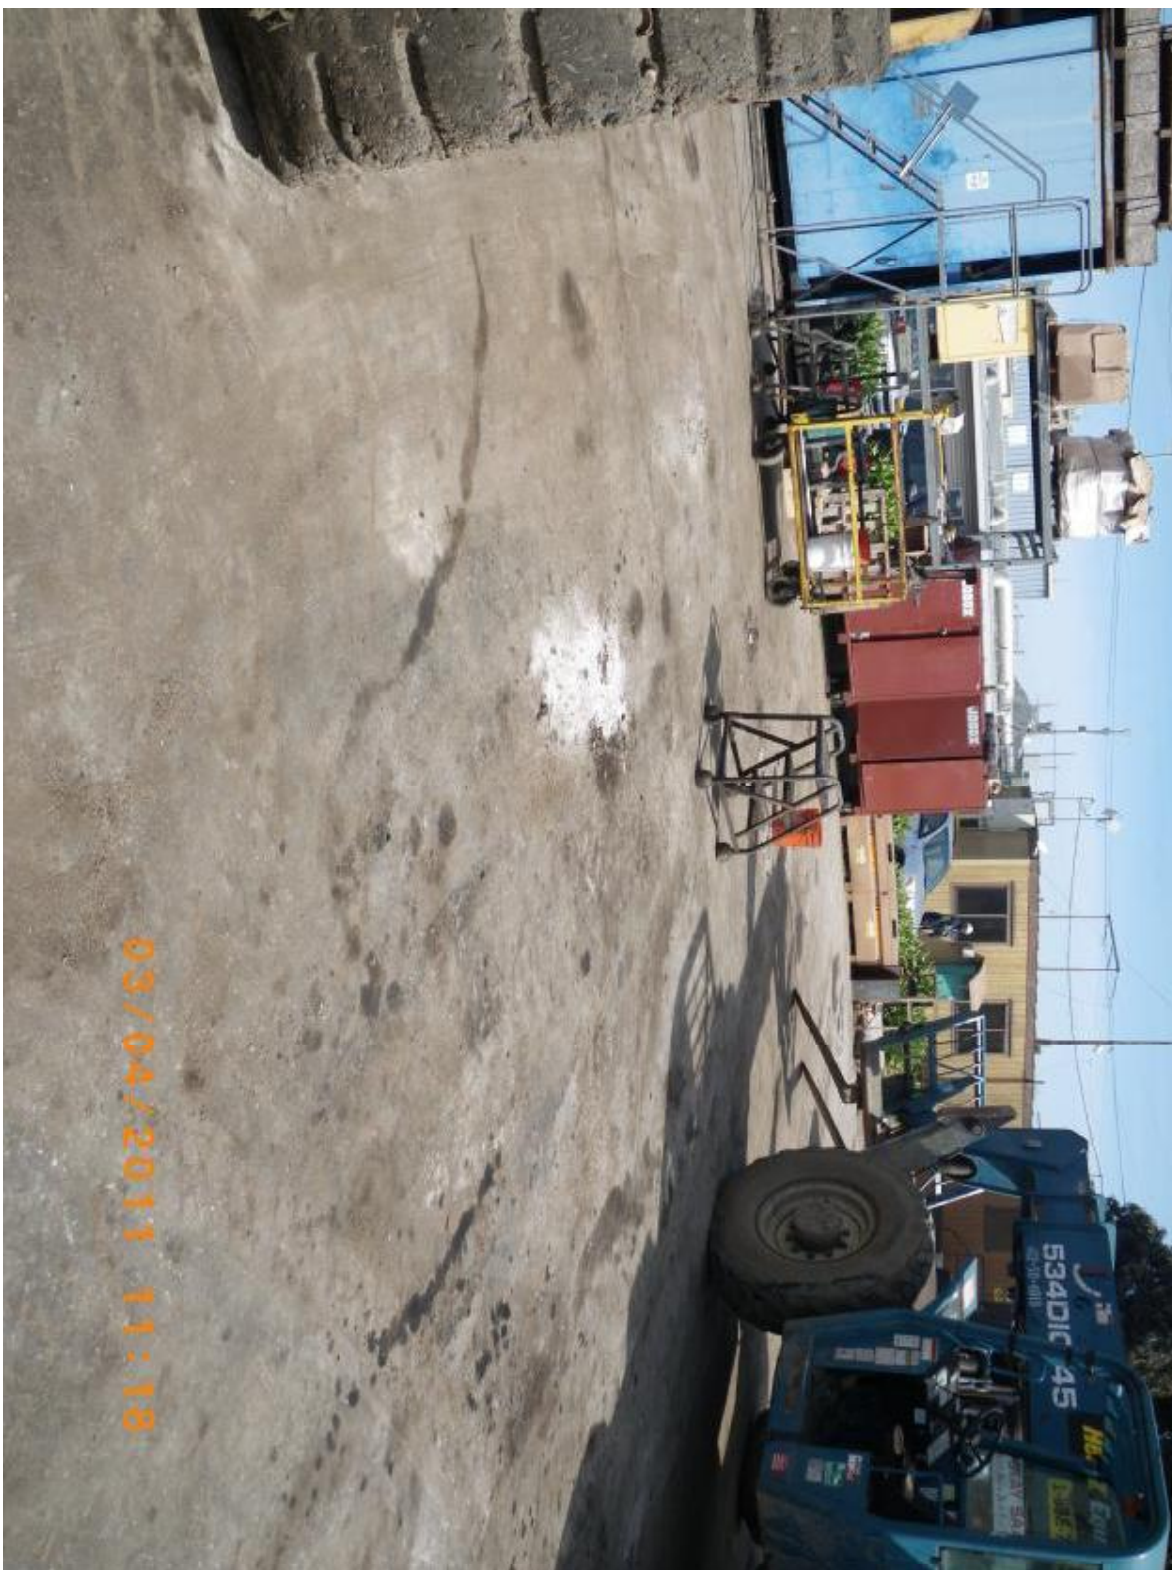
IMGP0214.JPG

- IMGP0214 – Maintenance area (center of the area looking north), with oil staining and deployed absorbent material was observed.
- IMGP0215 – Maintenance area (center of the area looking east), with oils staining and tire tracks through oil stains were observed.

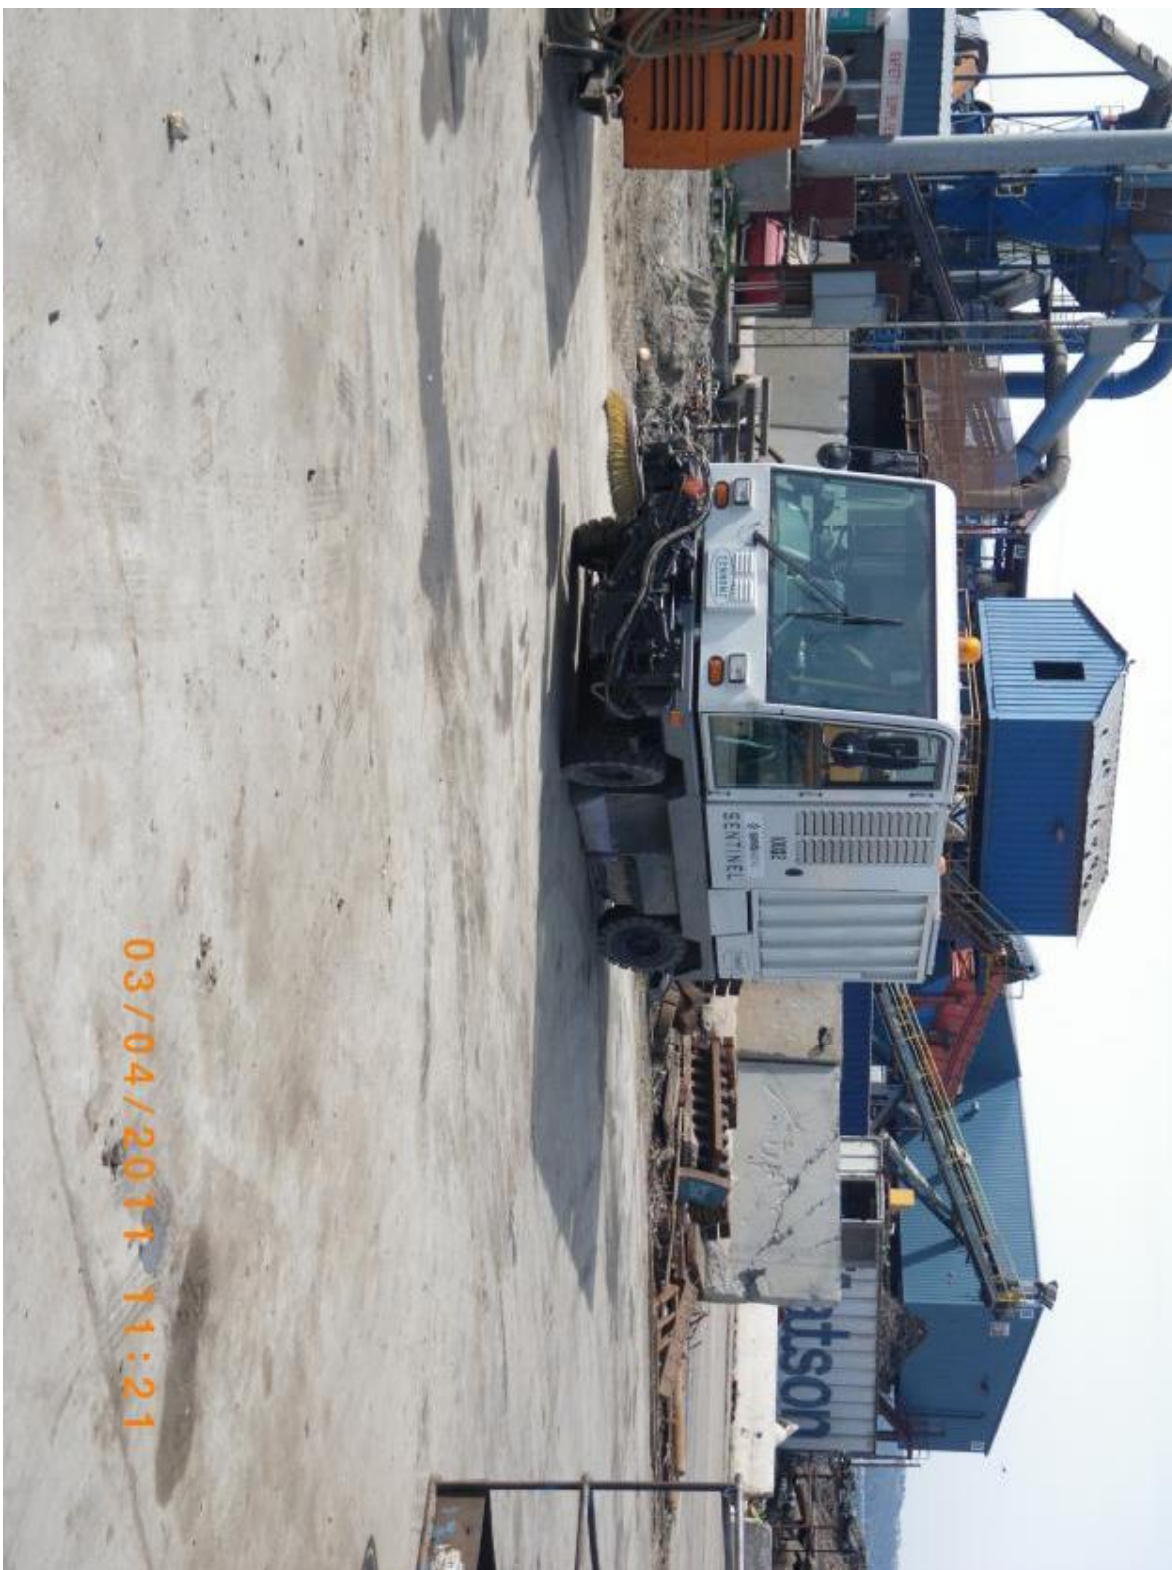
IMGP0218.JPG

- IMGP0218 – Same area as IMGP0216 with a wider angle, oil staining observed.
- IMGP0219 – Pond 1, western edge looking to the south east.
- IMGP0220 – Wash water treatment system 'bio-digester' for equipment washing station.

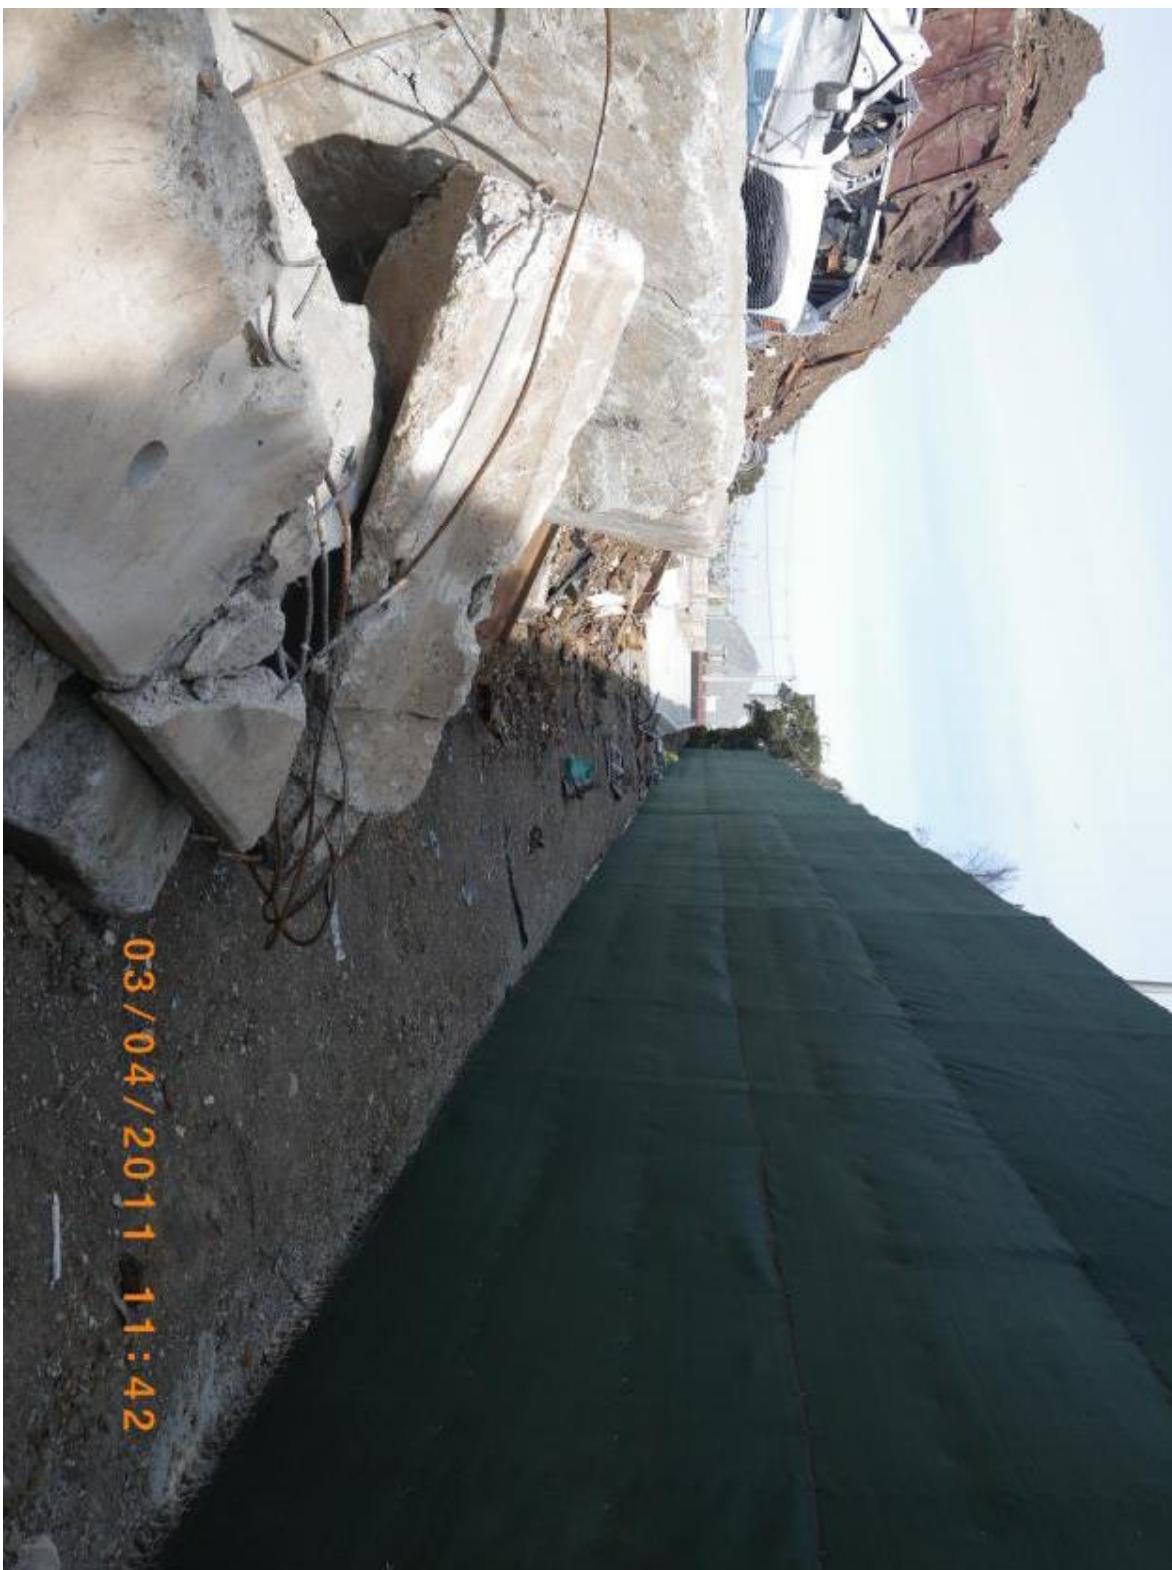
IMGP0227.JPG

- IMGP0225 – Screened inlet to the wash water treatment system.
- IMGP0226 – Stack of flattened cars to be shredded.
- IMGP0227 – Eastern perimeter of facility (approximately center of fence line) looking north. In-sloped berm in the shadow of the fence with scattered debris was observed.

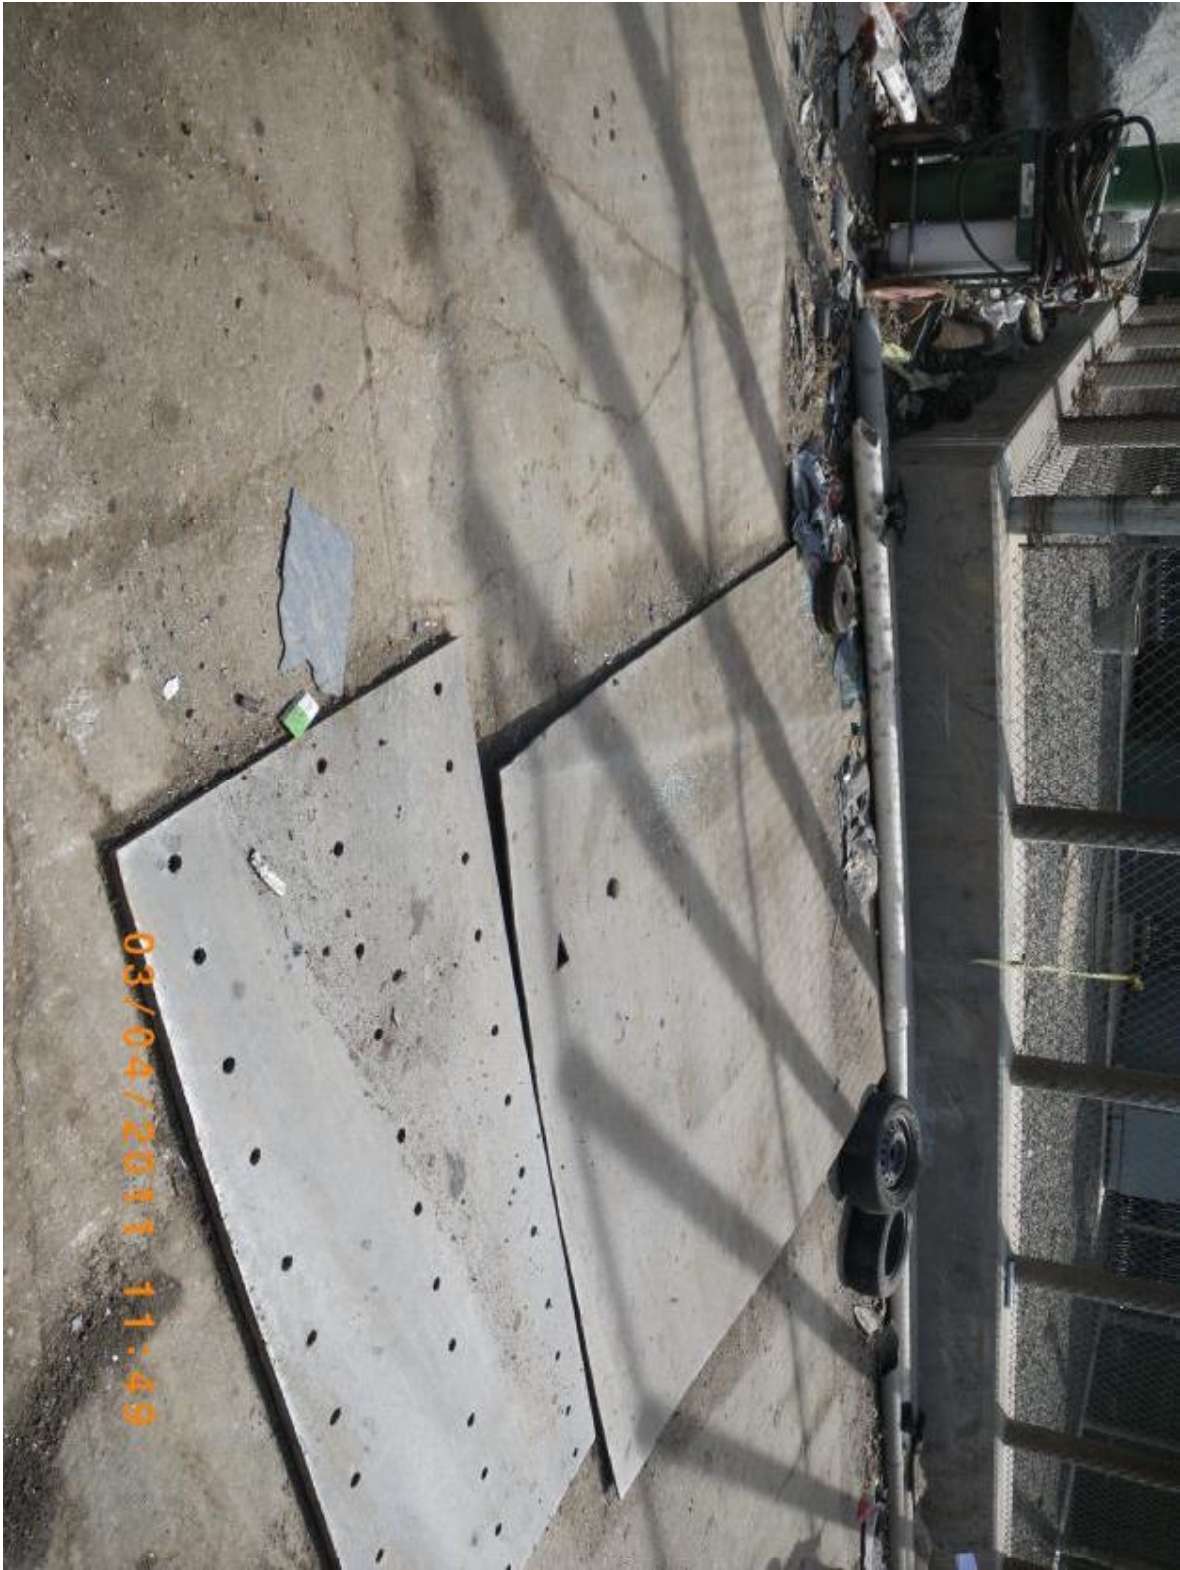
IMGP0230.JPG

<p>condition?</p>	<p>assessed. Inspectors observed covers on most of the inlets might prevent the introduction of debris (IMGP0230, 0236, 0238, and 0240), though it was unclear if the coverings might also impede the flow of storm water into the inlets. The ponds appeared to be retaining (or detaining?) water as designed, with the potential for greater capacity. IMGP0242 depicts minor seepage along pond 2's western berm. Site contouring would appear to direct any significant seepage to the storm sewer collection system, and subsequently back into the pond.</p> <p>Inspectors observed facility personnel washing a sweeper, and observed collection of the rinsate for treatment (IMGP0224 and 0225).</p> <p>Inspectors observed dust suppression controls, except "wetting" dust suppression was not observed in operation.</p> <p>As stated above, material and waste storage practices did appear appropriate and effective to minimize exposure of pollutant sources to storm water.</p> <p>Inspectors observed sediments with potential for track-out throughout a significant portion of the facility's driving surface area, despite representations made to inspectors that regular sweeping occurs. The sweeping that occurs is not sufficient to minimize the discharge of pollutants from track out.</p> <p>Inspectors observed multiple spill kits throughout the facility, and absorbent deployed in multiple locations. A significant amount of residual oil staining observed at the facility indicates that spill response measures and leak detection practices may not be adequate to sufficiently minimize the discharge of pollutants resulting from the track-out of oil residue or from leaking equipment parked, staged, or operating beyond the perimeter containment berm.</p> <p>Facility personnel provided training logs and syllabi for review during the inspection. Inspectors did not request copies during the inspection.</p> <p>Inspectors reviewed the facility inspection reports required by the permit, and found the reports were incomplete since the reports' focus was limited to only those areas within the perimeter containment berm, and did not address areas outside the perimeter containment berm where industrial activity and associated pollutant sources could also result in the discharge of pollutants in storm water to the Creek, such as from operation of the ship loading conveyor, its underlying catchment platform, and from the operation and maintenance of equipment associated with these industrial activities.</p> <p>As previously discussed, the ship loading conveyor's catchment platform was poorly maintained, and gaps in the containment wall were not cleared of debris (IMGP0262).</p>

- IMGP0230 – Along the eastern boundary the facility near an electrical station, steel plates cover an inlet for the onsite storm collection system. Scattered debris and welding torch were observed.

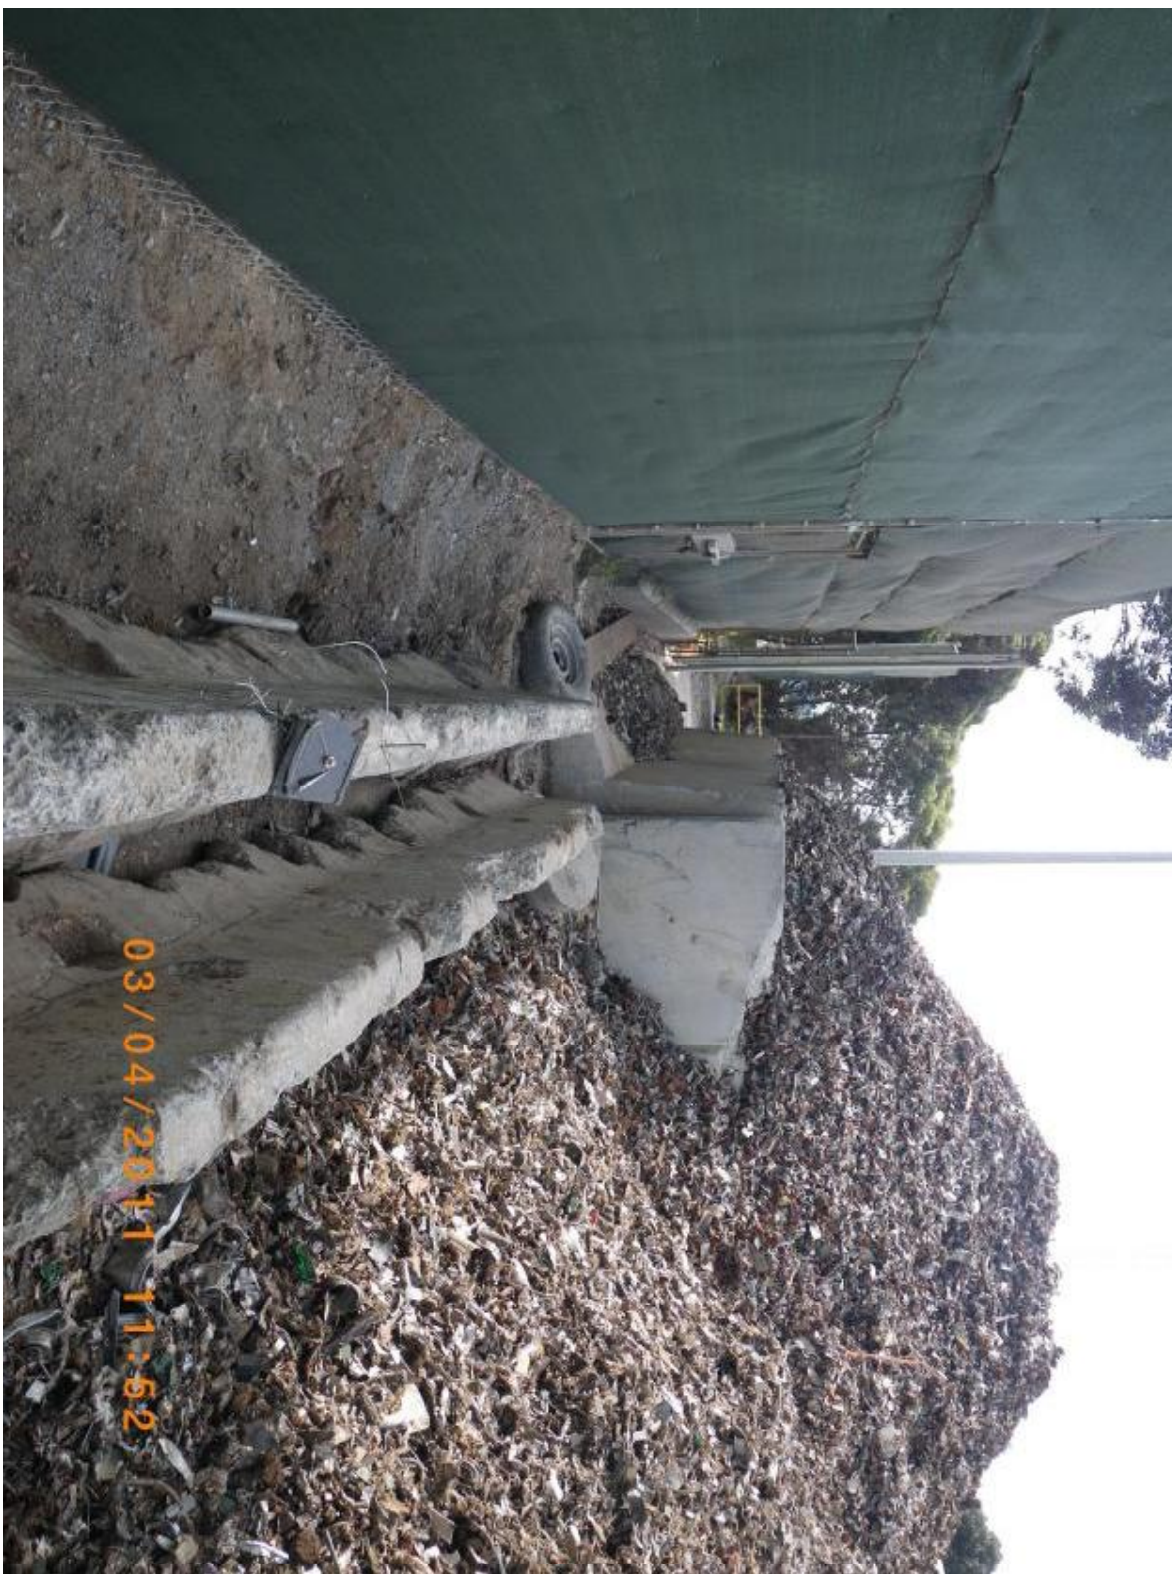
IMGP0231.JPG

- IMGP0231 – Eastern boundary of the facility looking south, in-sloped berm with scattered debris was observed.
- IMGP0232 – South east fire-access gate, break in the facility perimeter berm, scattered debris and ponded water were observed.

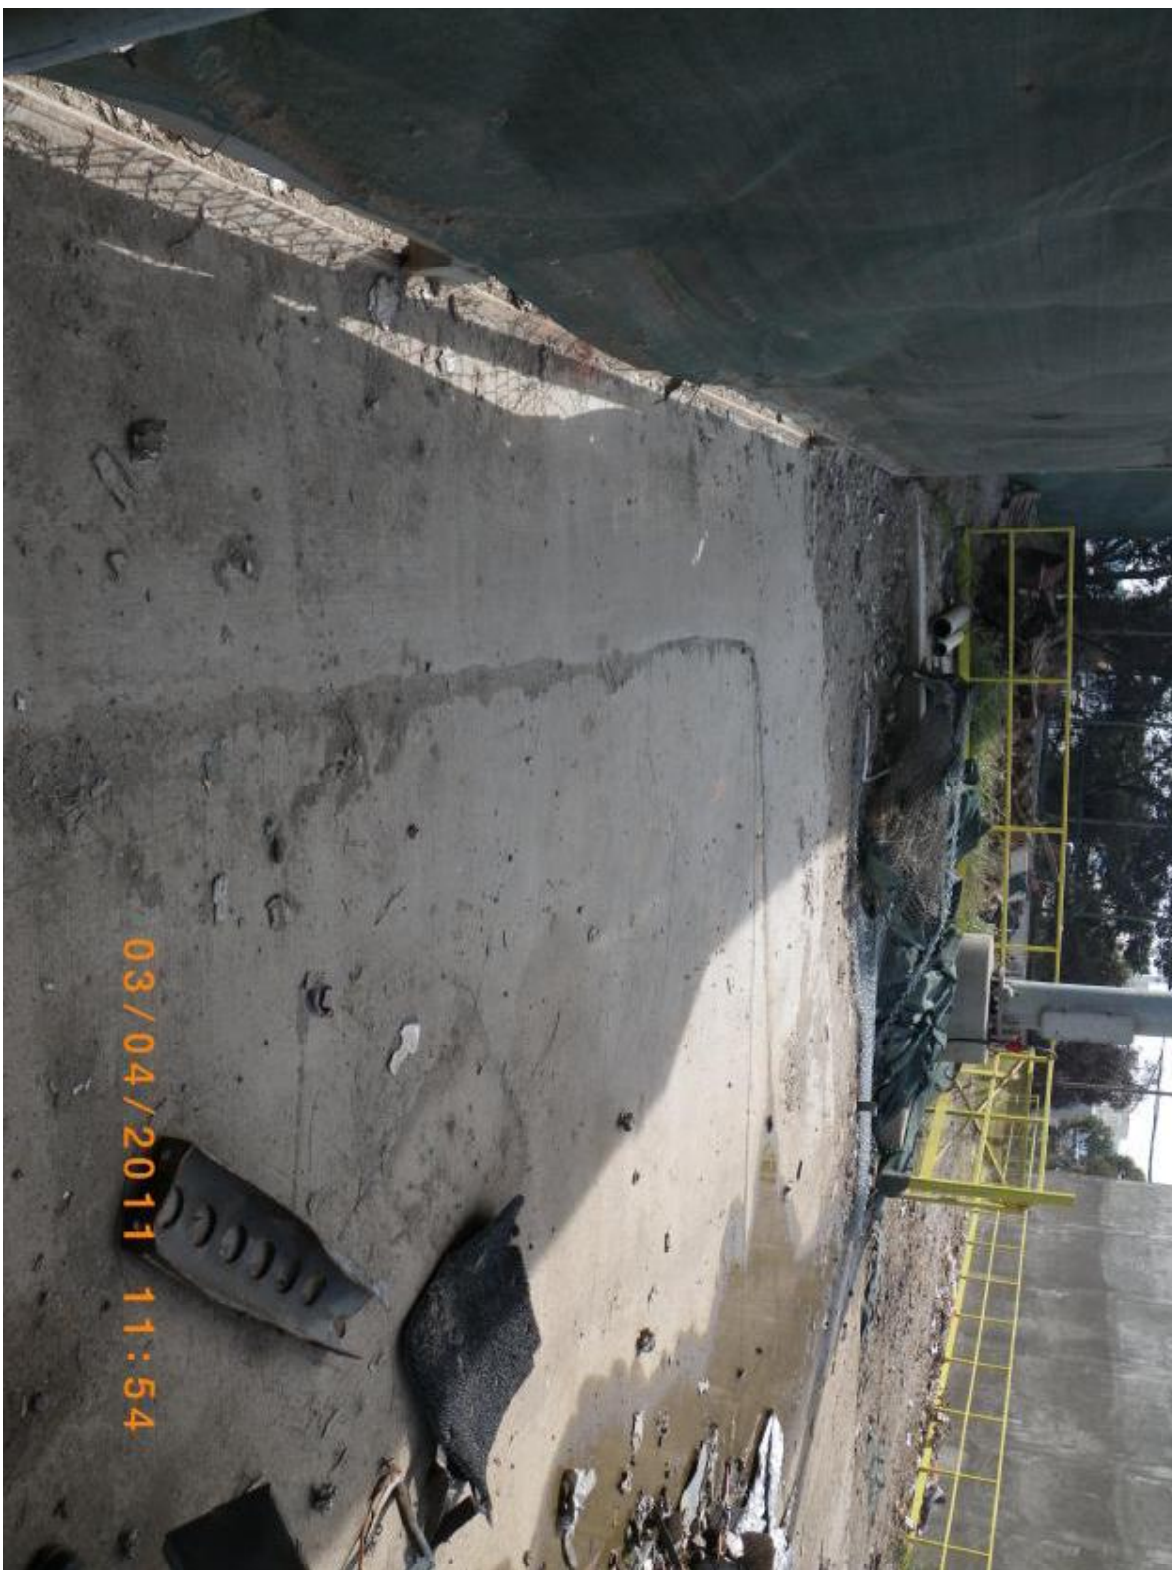
IMGP0232.JPG

The perimeter berm was not continuous, and not all-encompassing of facility-related activities. IMGP0232 demonstrates a break in the perimeter berm near the southeast emergency gate, and IMGP0273 also demonstrates a break in the perimeter berm near the northwest gate. IMGP0241 demonstrates facility-related utility work outside of the perimeter berm to the west of building B, adjacent to Herkner Rd. IMGP0242 and 0244 demonstrate ship loading activities also outside of the containment berm. The facility needs to make additional efforts to accomplish a continuous perimeter berm. The facility needs additional controls, which were either not identified by facility personnel or employed at the time of the inspection, to address activities occurring beyond the berm.

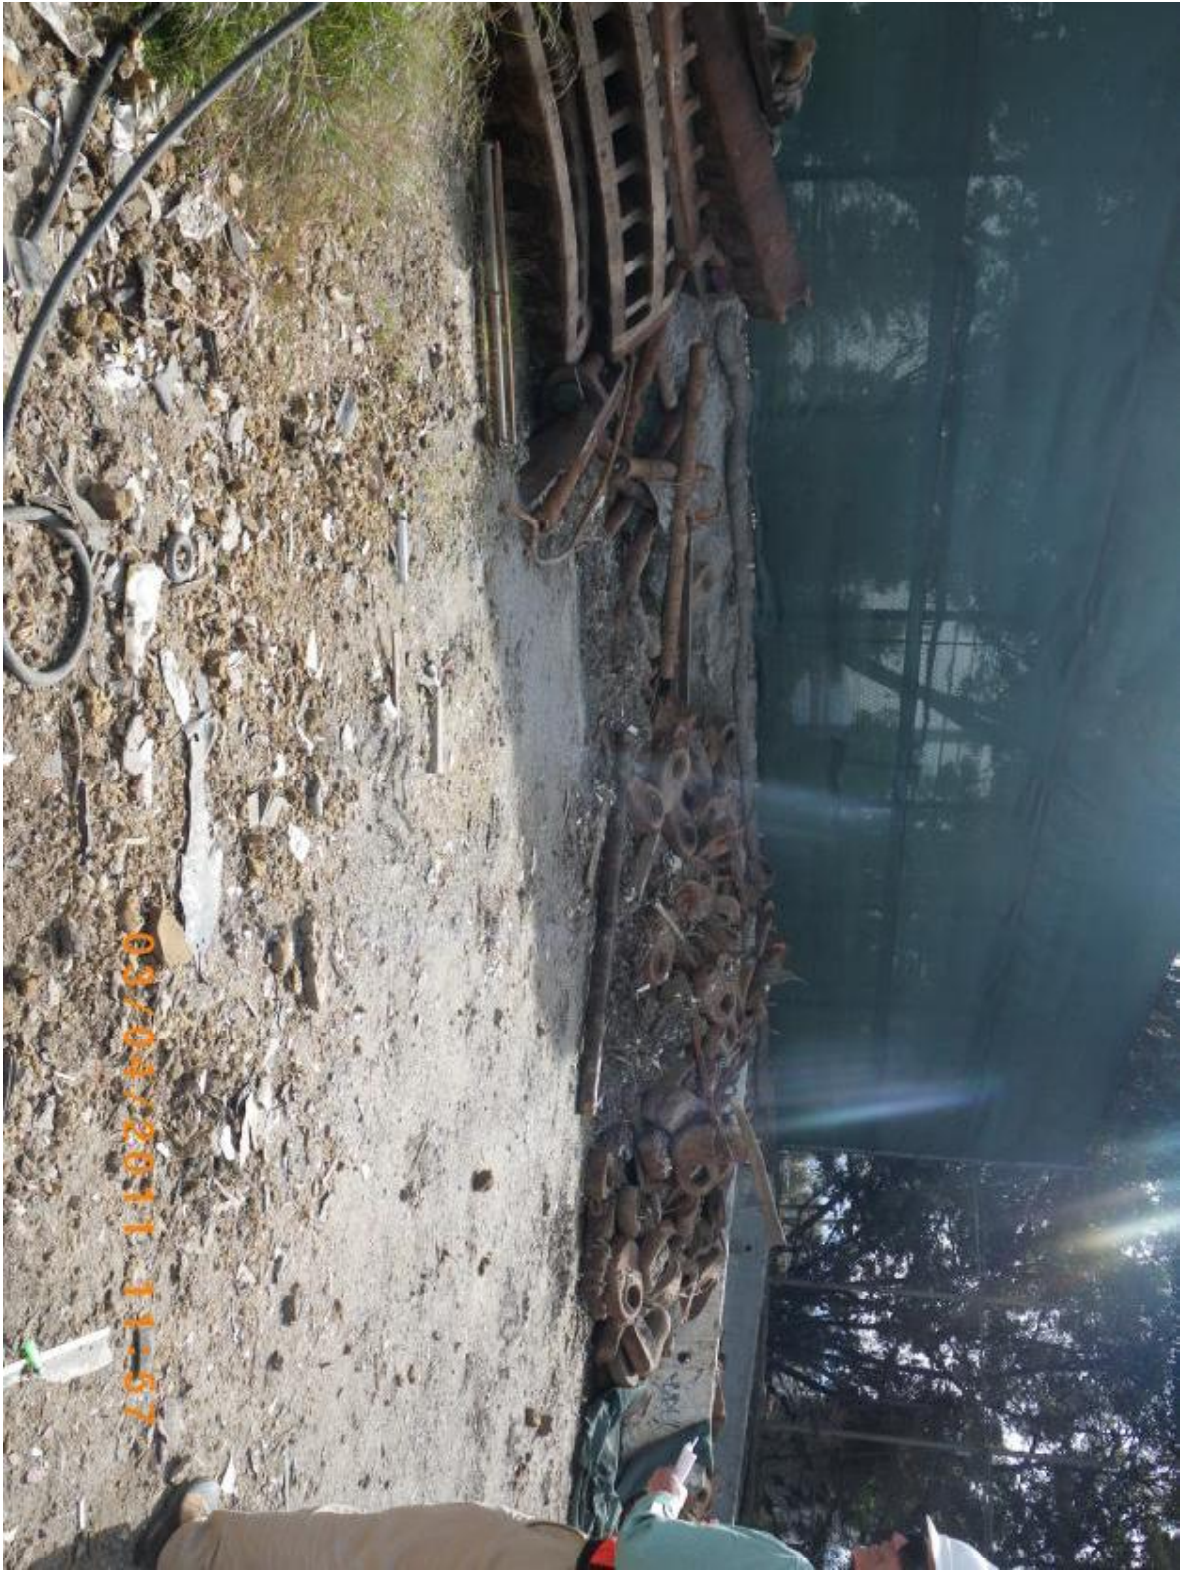
IMGP0233.JPG

- IMGP0233 – South east corner of the facility, in-sloped berm and scattered debris was observed.
- IMGP0234 – Southern facility boundary, looking west, in-sloped berm and scattered debris was observed. Photo was taken from the east side of the non-ferrous storage stalls.

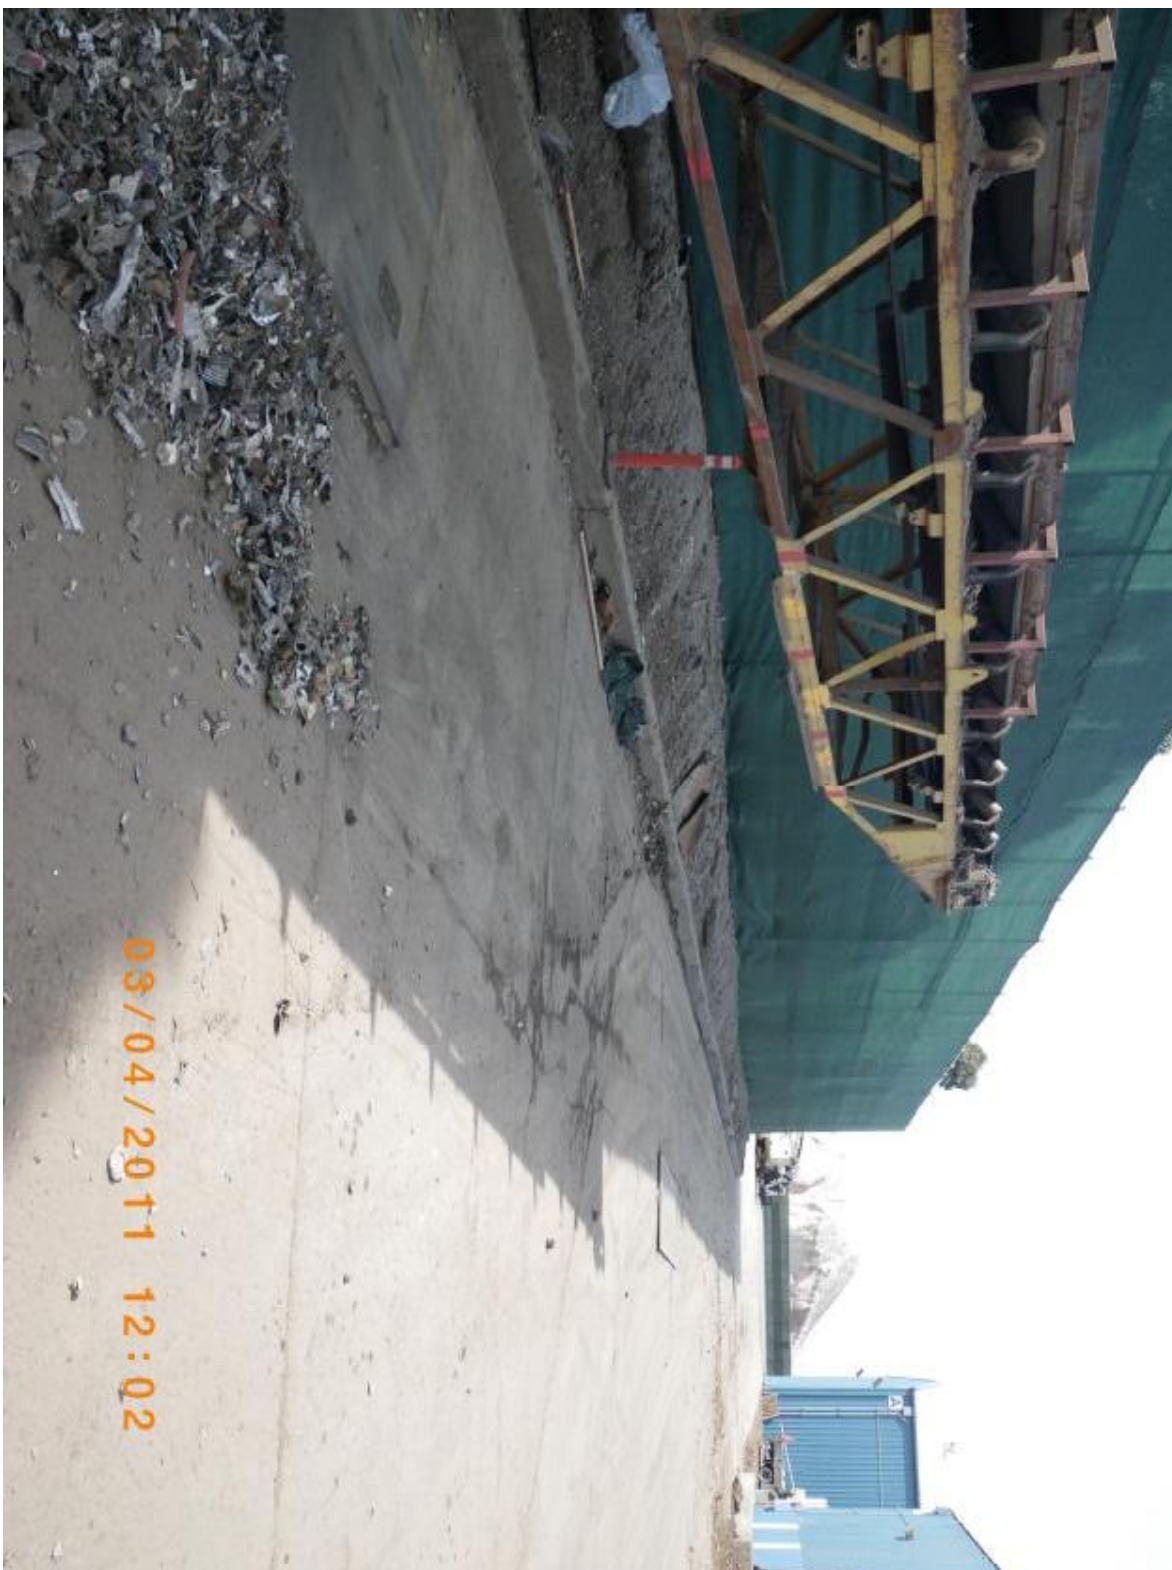
IMGP0235.JPG

- IMGP0235 – Southern facility boundary, looking west, in-sloped berm and scattered debris was observed. Photo was taken from the west side of the non-ferrous storage stalls.

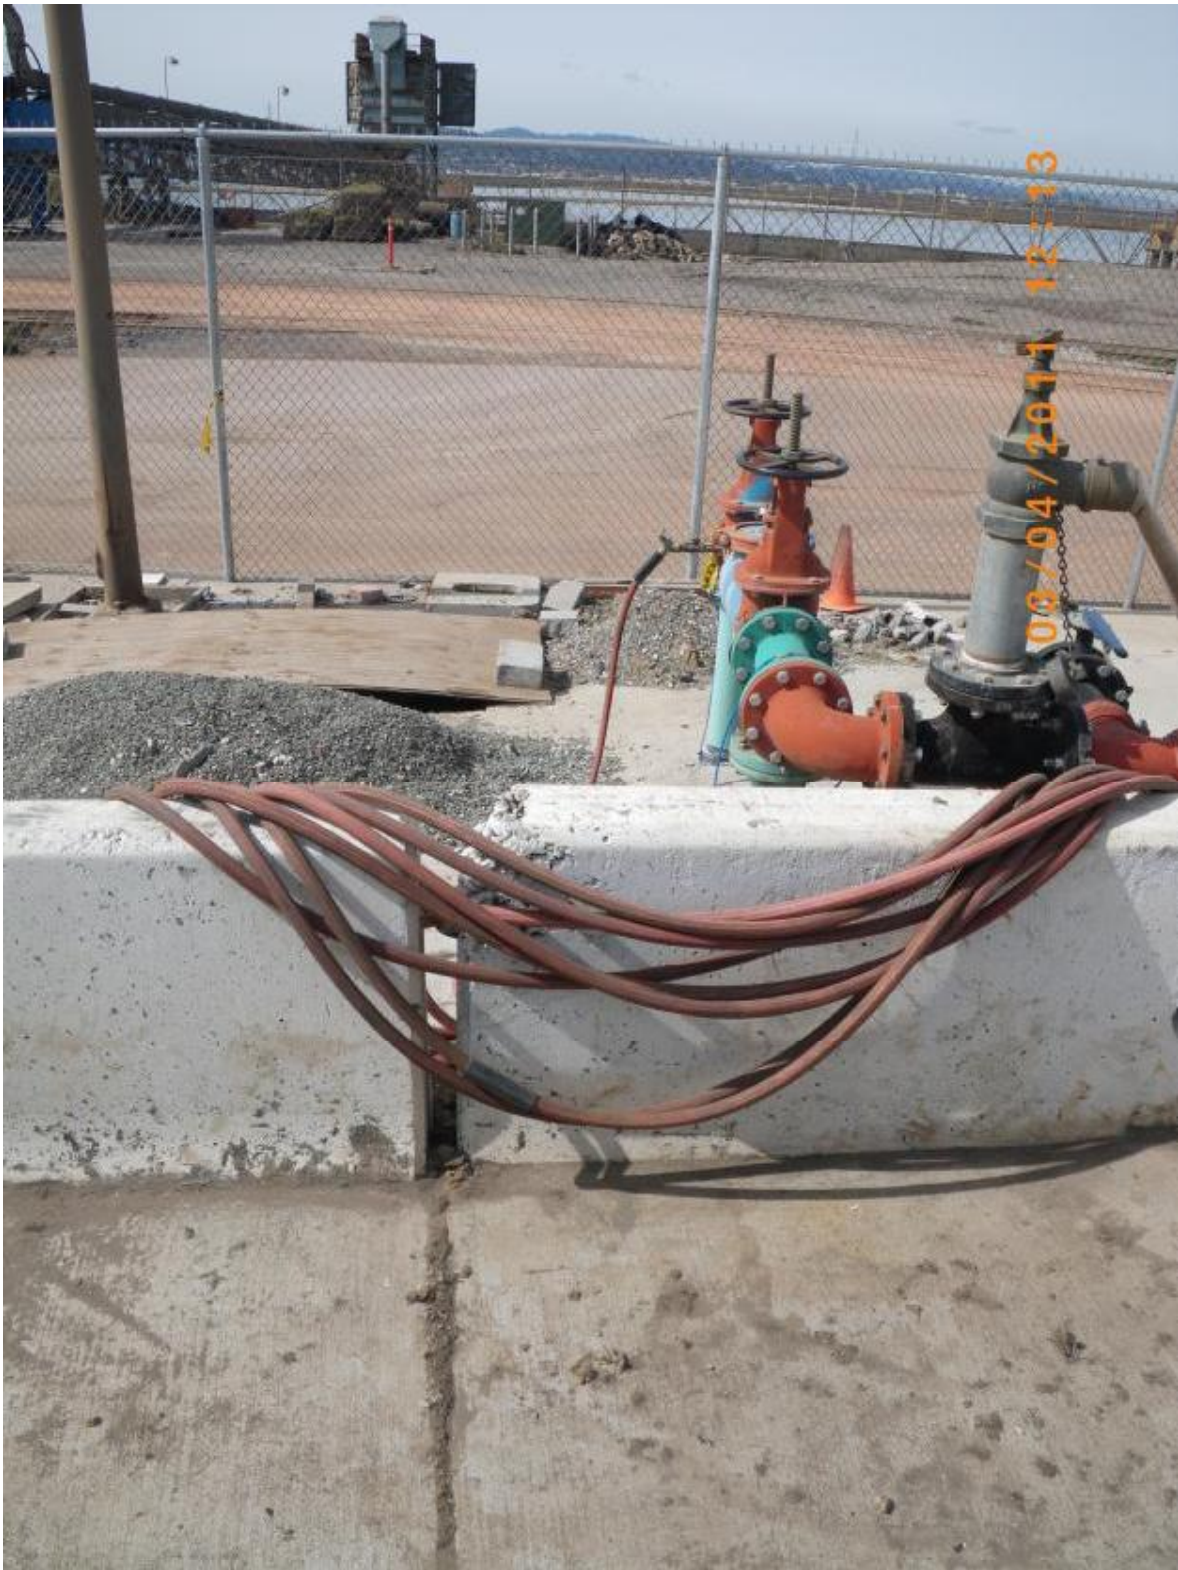
IMGP0241.JPG

- IMGP0241 – Western boundary of the facility looking west, gap in k-rail containment berm adjacent to water main. Gravels and other materials were observed on the water-side of the containment berm.

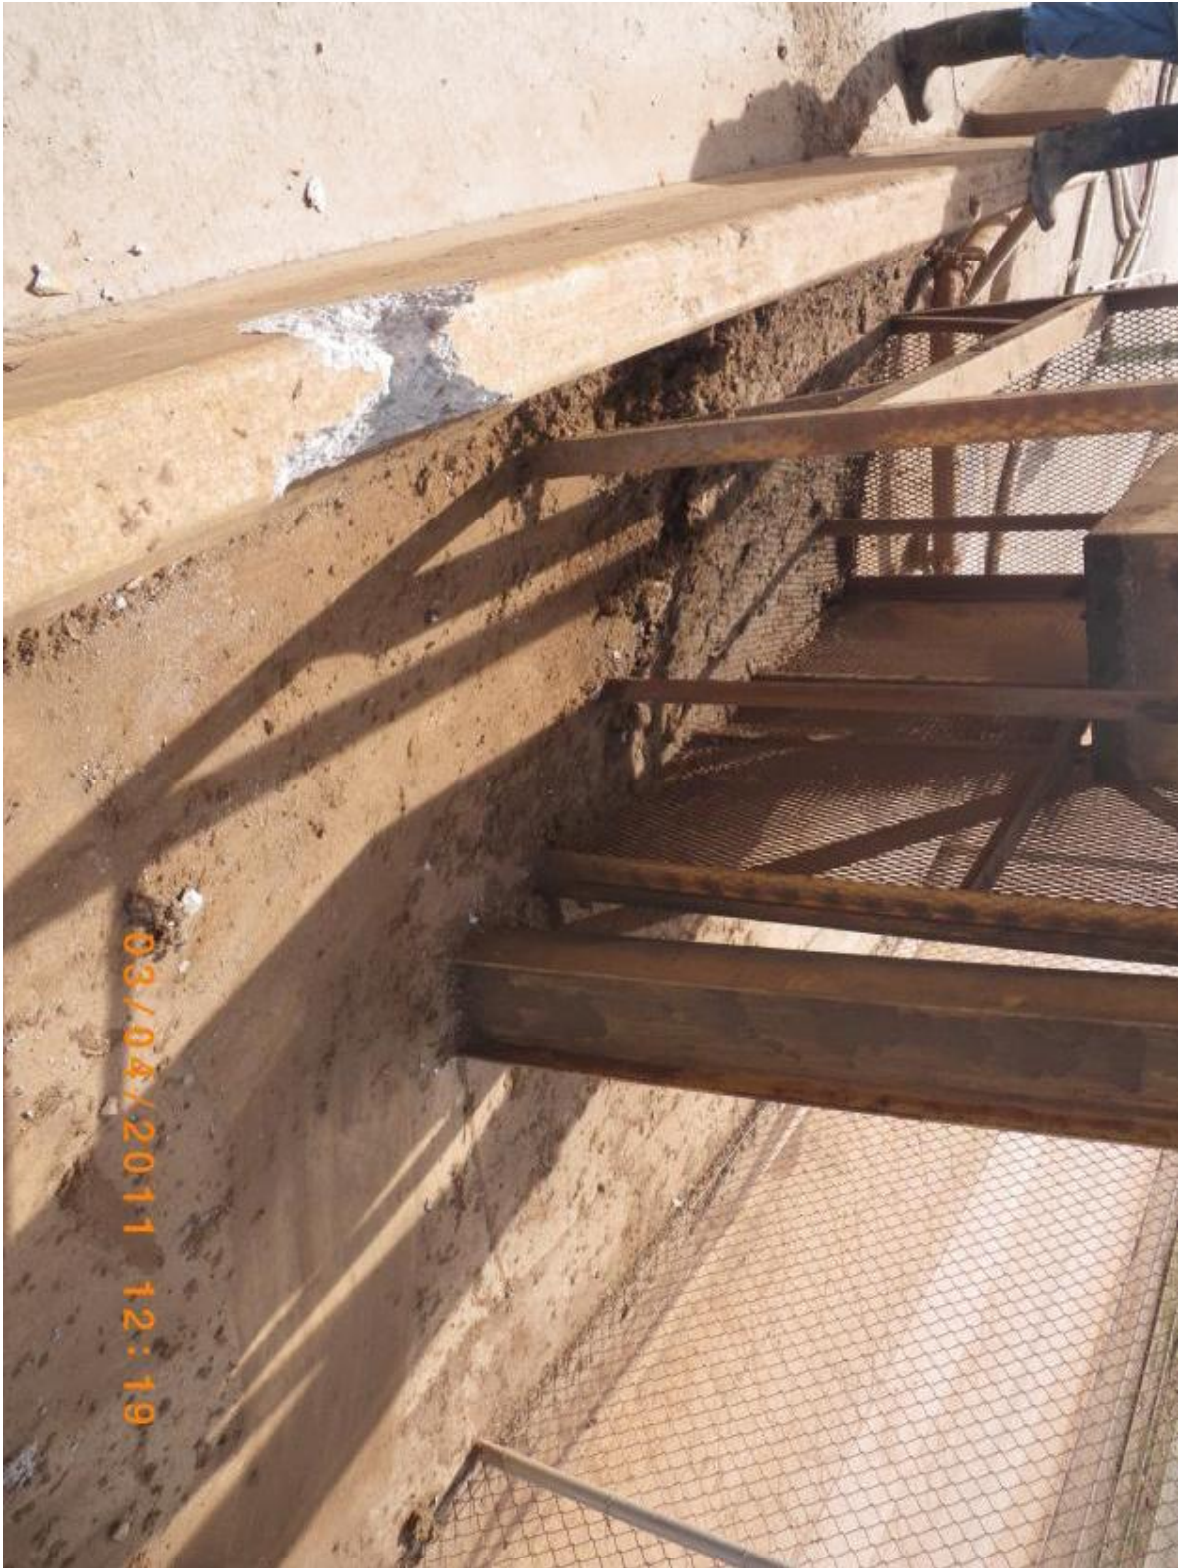
IMGP0244.JPG

IMGP0244 – Base of the conveyor belt tension system on the water-side of the k-rail containment berm. This photo was taken from the north side of the system, looking south. Accumulated rust-colored sediment was observed at the base of the tension system. IMGP0270 and 0271 were taken from west side of the chain-link fence and demonstrate how this accumulated material discharges off site.
