NPDES Storm Water Inspection Report

Facility Location Information			
Name/Location/ Mailing Address	Sims Metal Management (Sims) 699 Seaport Blvd. Redwood City, CA		
GPS Coordinates	Latitude	37° 30' 40.6"	Longitude 122° 12' 29.6"
Receiving Water(s)	Redwood Creek – Navigable estuary to San Francisco Bay		
	Name	Telephone	
Owner	Steven Shinn – Regional General Manager	510-412-5300	
Operator	Joe Barco – Operations General Manager	510-412-5300	
Environmental Coordinator	Matt Zeiter – On-site Rep	510-715-7569

General	
Inspection Objective, Attendees, and Opening Conference Summary.	<p>The inspection's objective was to determine compliance with the California Industrial General Permit No. CAS000001.</p> <p>In addition to EPA inspectors previously identified, the inspection was attended by Estuardo Montufar (650.372.6240) and Sabrina Mih (650.372.6235) with San Mateo County Environmental Health Services Division (Certified Unified Program Agencies – CUPA), and Matt Zieter (510.412.5300), Mariya Semeit (650.369.4161), Dale Leuer (650.369.4161), and Vistasp Patel (650.369.4161) with Sims Metals Management (Sims or Facility Representatives)</p> <p>Prior to commencing the inspection, an ope

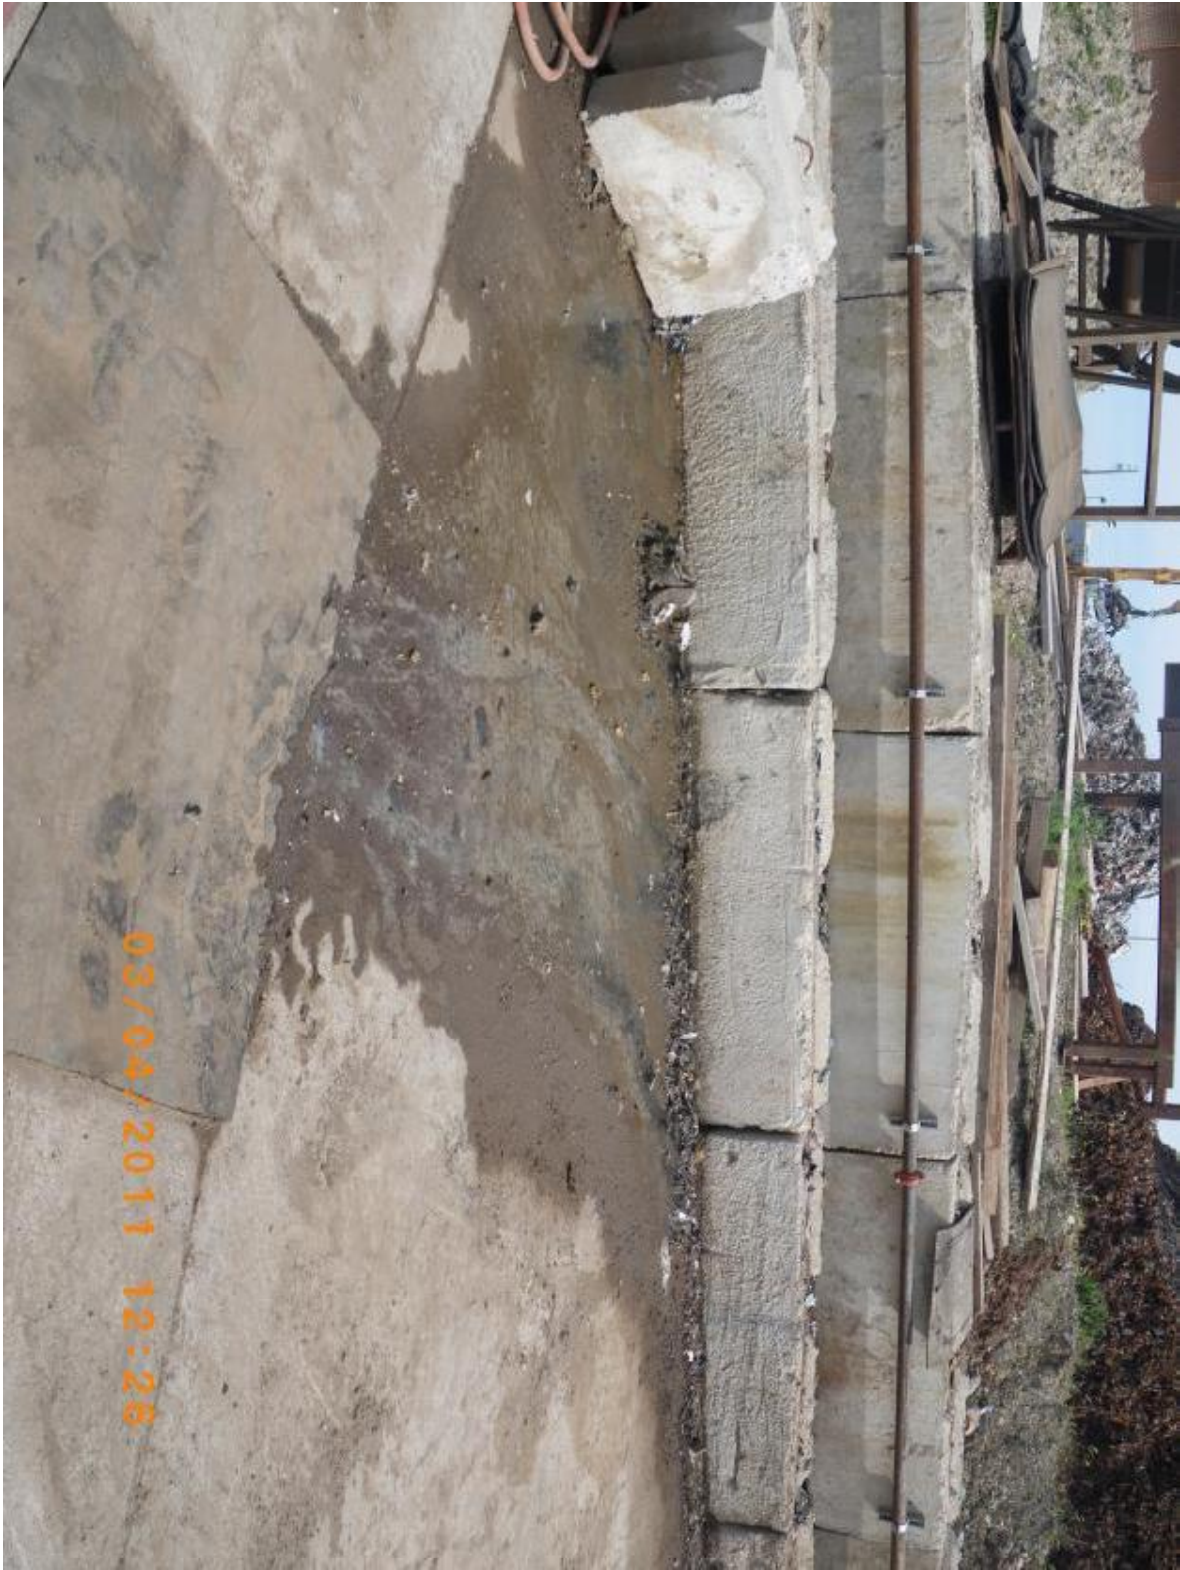
IMGP0249.JPG

IMGP0249 – Seepage from the western boundary of pond 2.

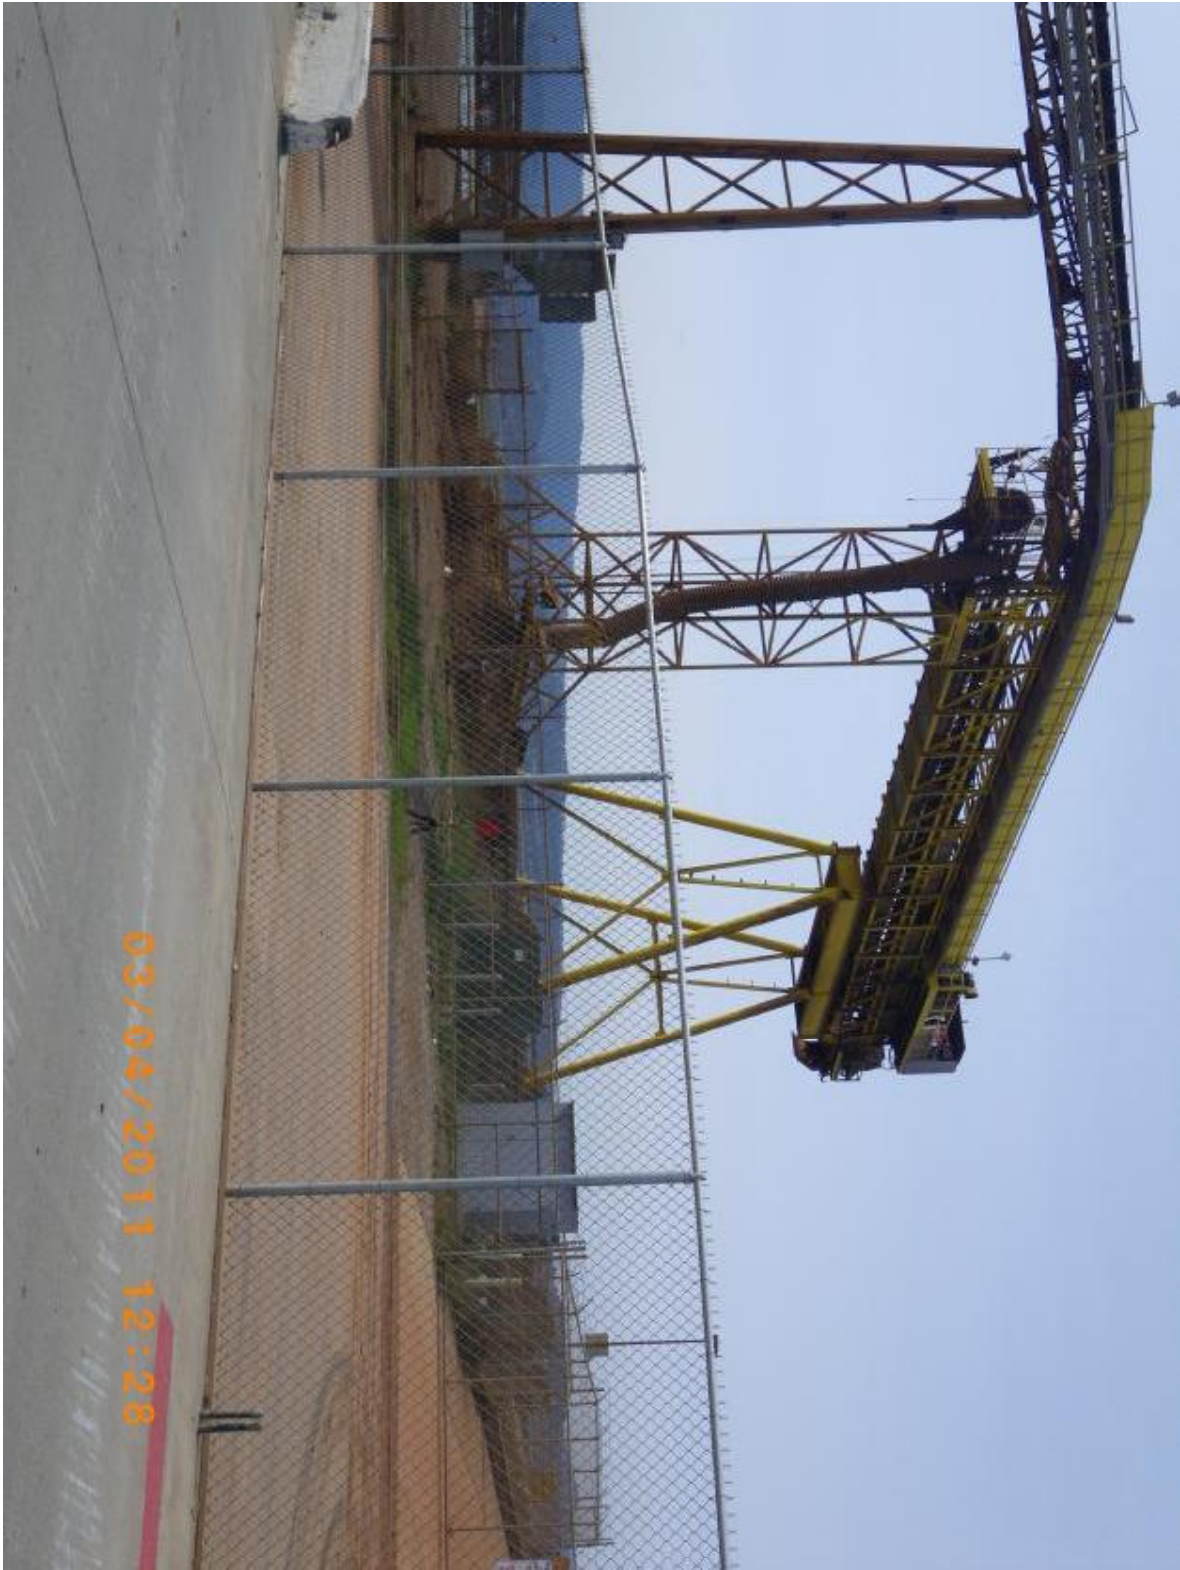
IMGP0250.JPG

IMGP0250 – Ship loading conveyor, photo taken from the north, looking south west. K-rail containment berms ends and vehicle tracks from maintenance equipment to and/or from the wharf was observed.

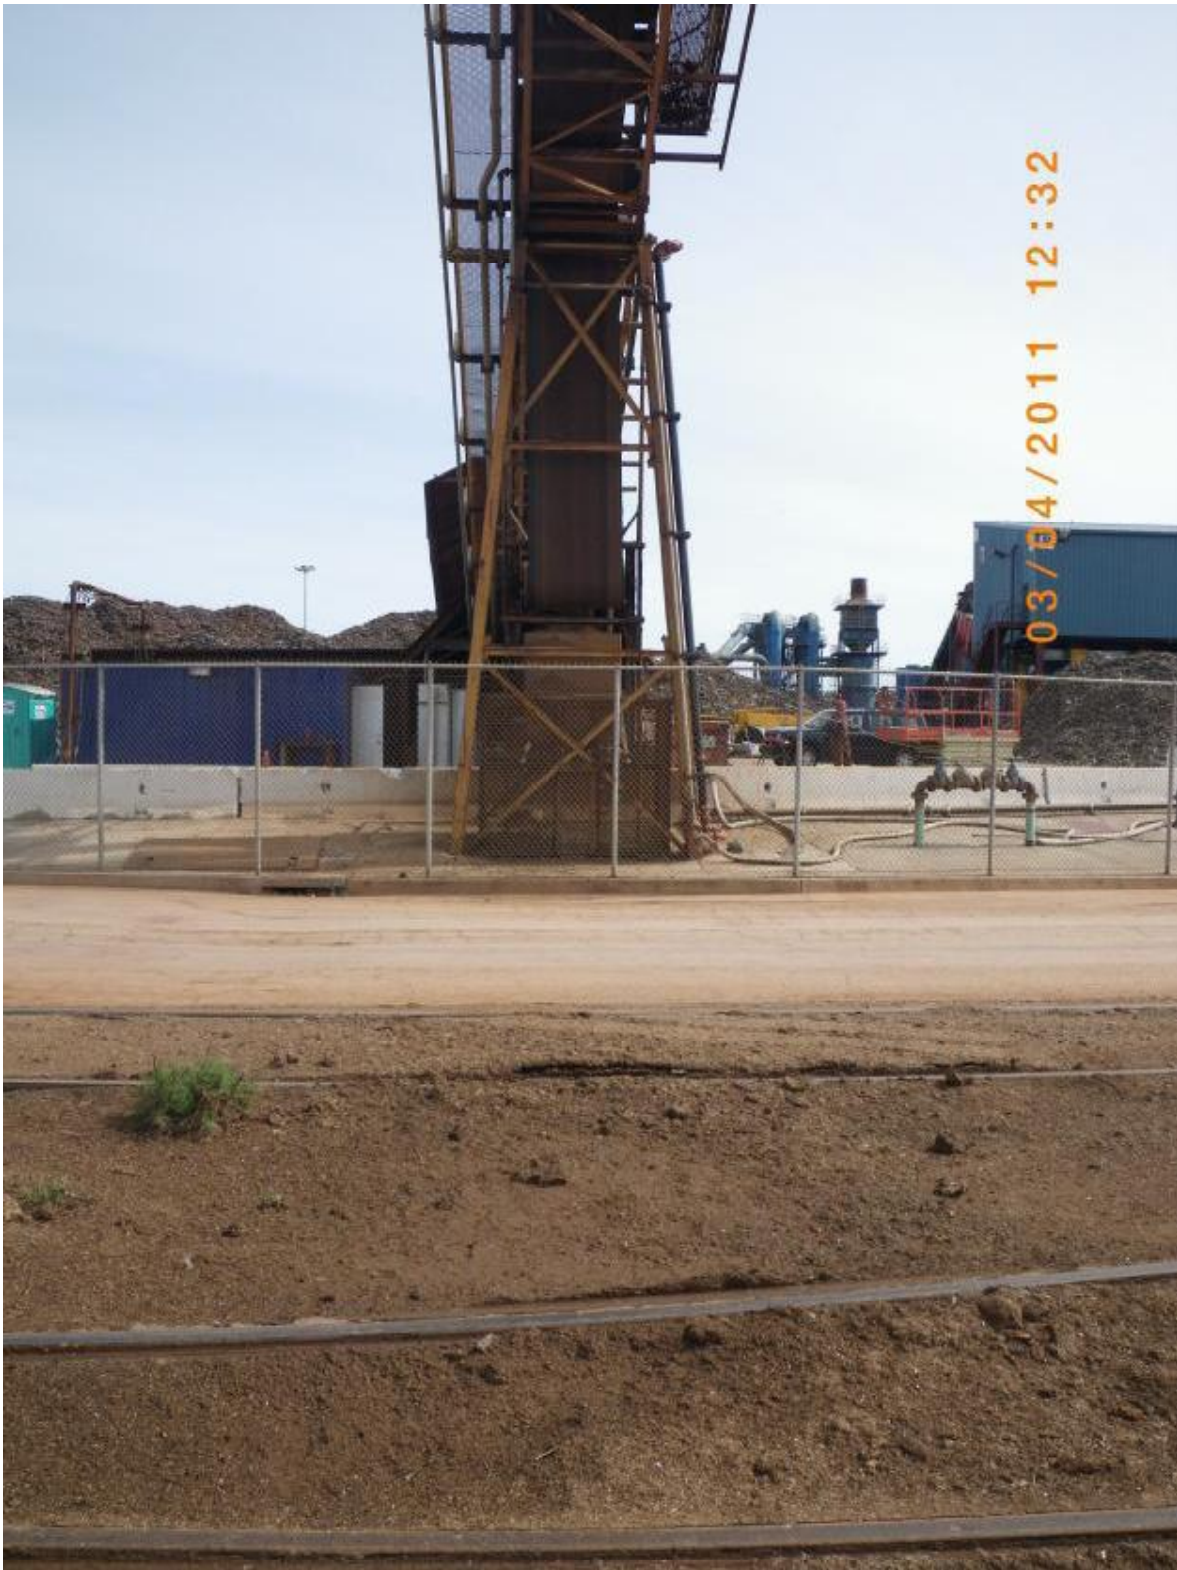
IMGP0252.JPG

IMGP0252 – Photo was taken standing directly underneath the ship loading conveyor looking east back towards the facility. Sediments along the rail lines and a storm sewer inlet were observed in this area.

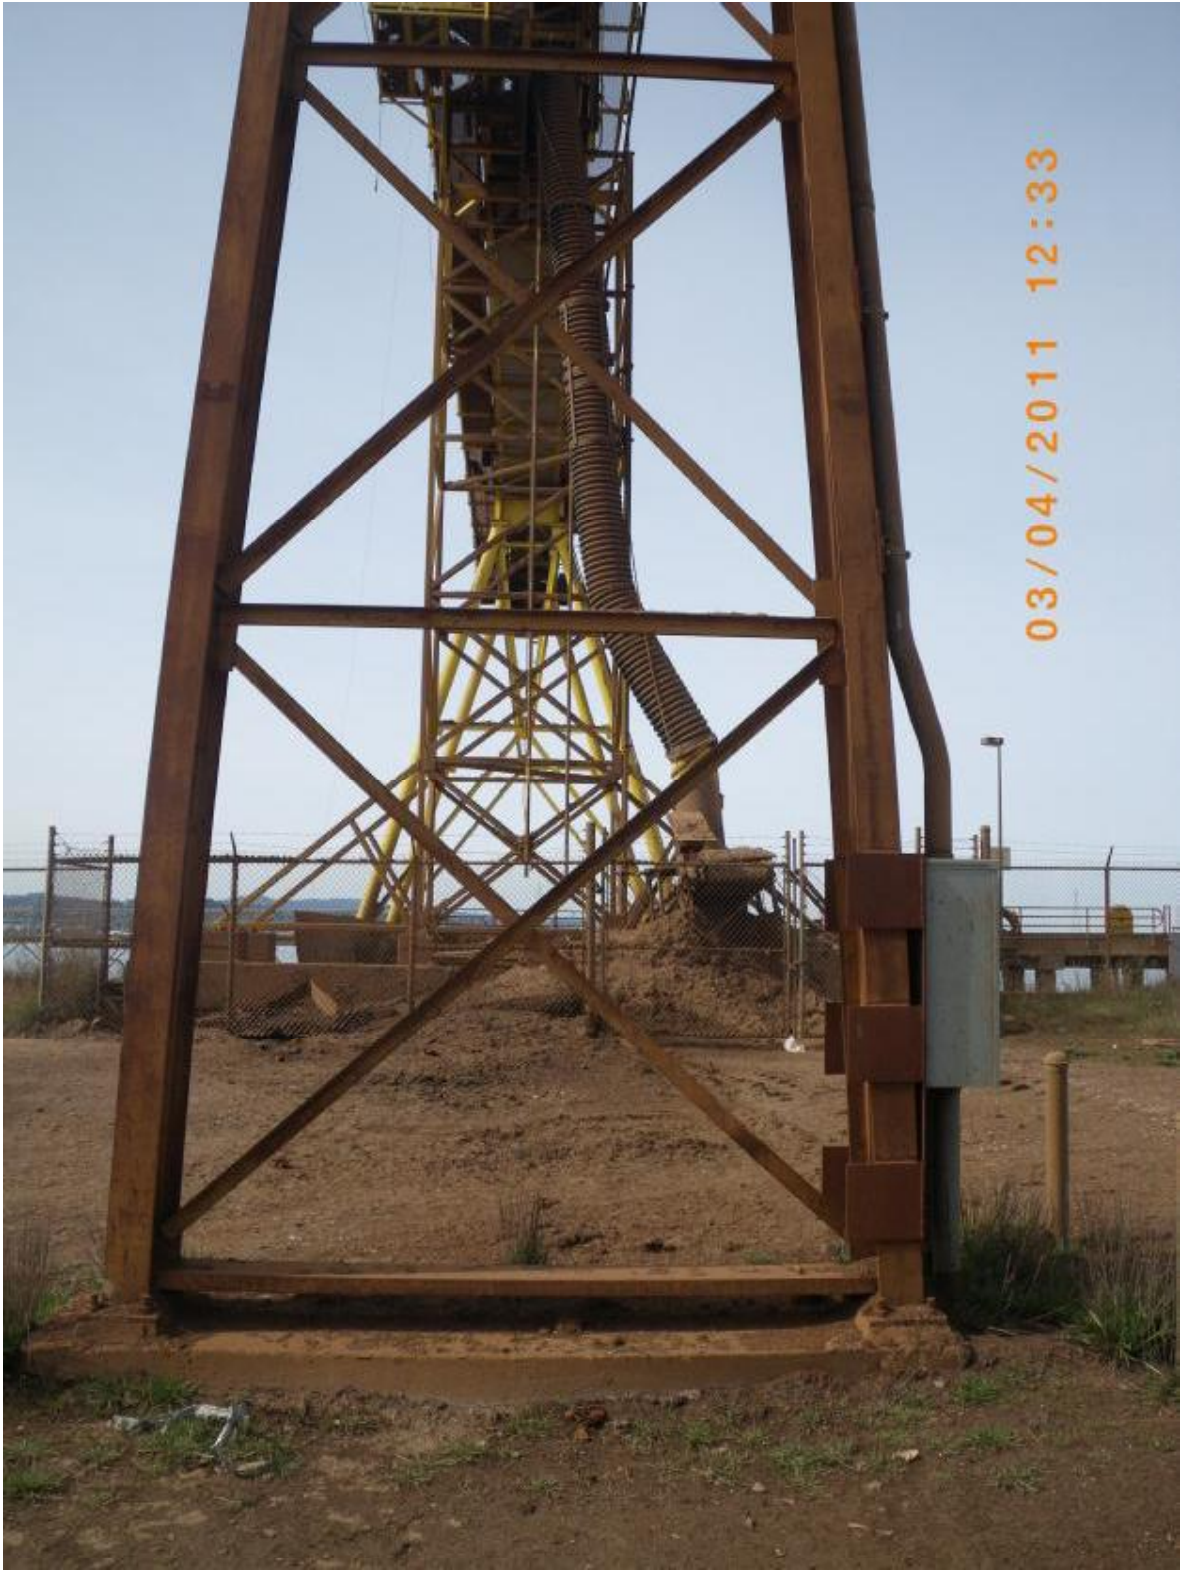
IMGP0253.JPG

IMGP0253 – Photo was taken standing directly underneath the ship loading conveyor looking west towards the water (180 degrees from IMGP0252). Accumulated sediments were observed along the ground.

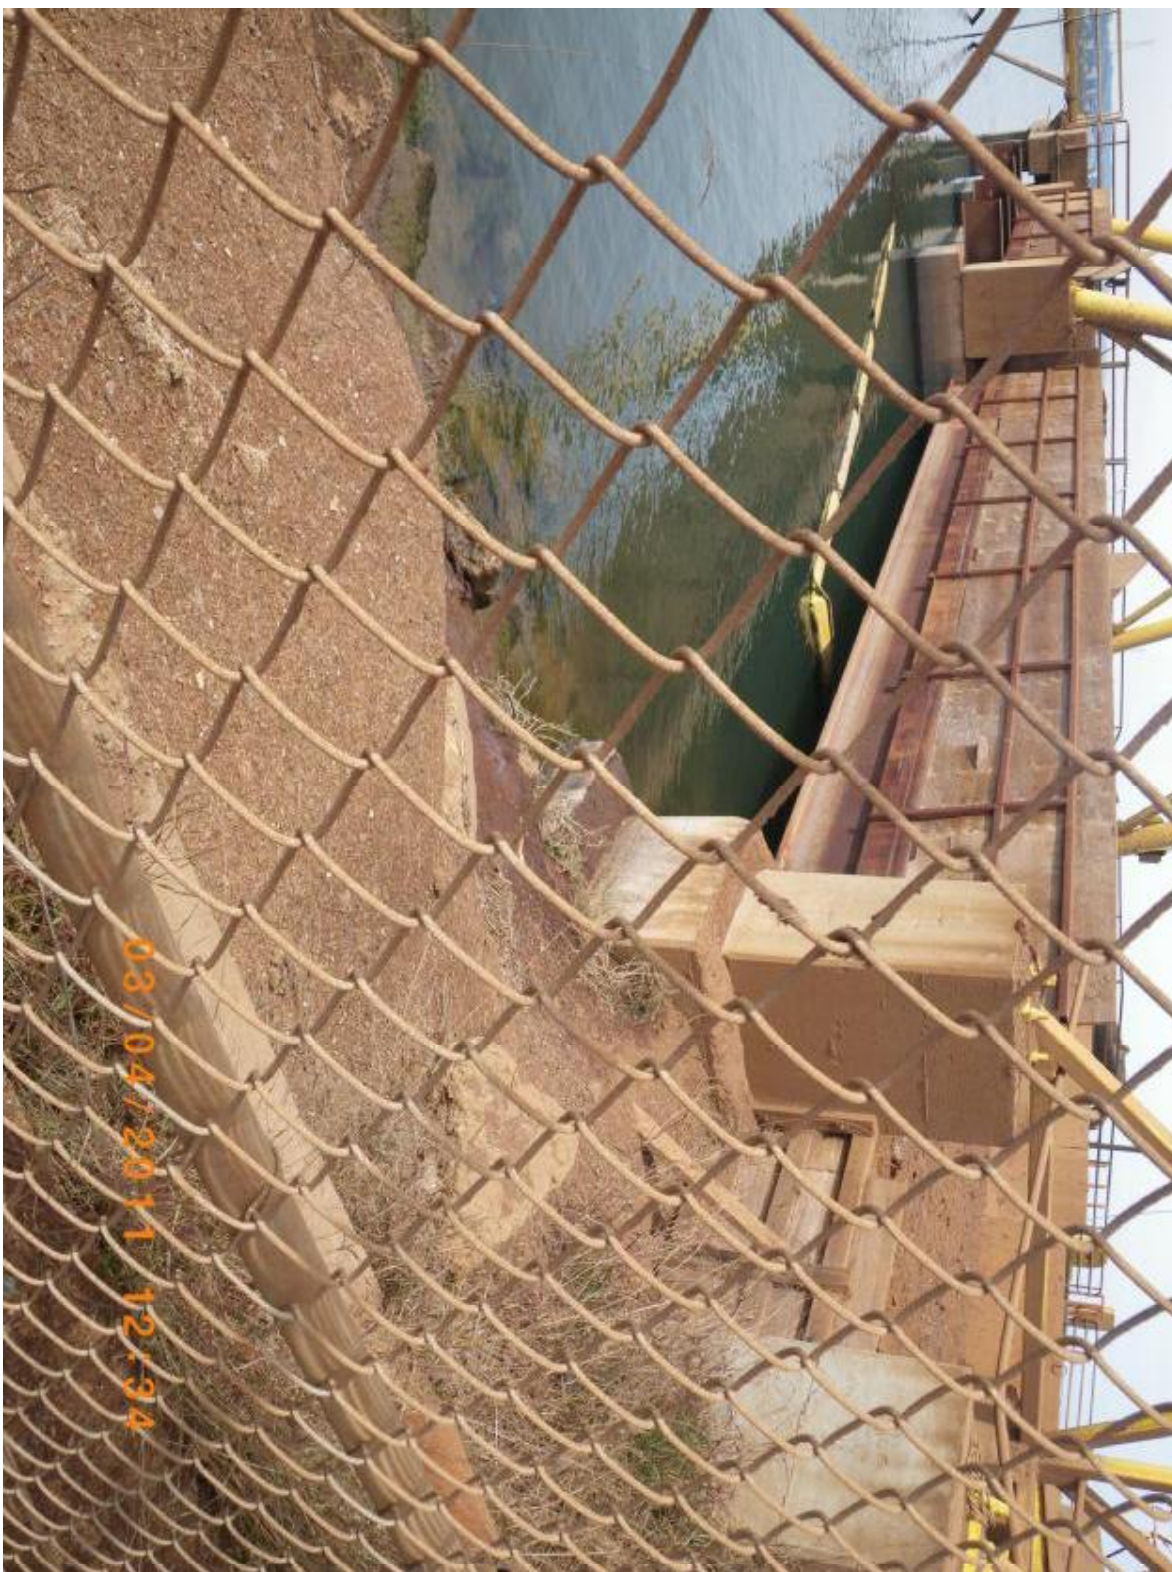
IMGP0255.JPG

Any evidence of Non-Storm water Discharge?	<p>Inspectors did not observe active non-storm water discharges during the inspection. However, IMGP0255-0269 shows rust-colored debris perched over or submerged in Redwood Creek indicating non-storm water discharge or potential discharge.</p>
Do the storm water inlets correspond with site map?	<p>The site map has no storm water inlets indicated. The site map should identify all storm drain inlets or other storm water outfalls that are on or adjacent to the facility, including inlets located at adjacent facilities or areas owned or operated by other tenants or the Port of Redwood City.</p>

IMGP0255 – Ship loading conveyor footings (south side) with accumulated debris along the footings and shoreline. A catchment platform with plywood walls has been placed over the water to catch materials that are cast off from conveyor maintenance and cleaning activities. A floating boom was observed in the water. Debris was also observed on the submerged rocks.

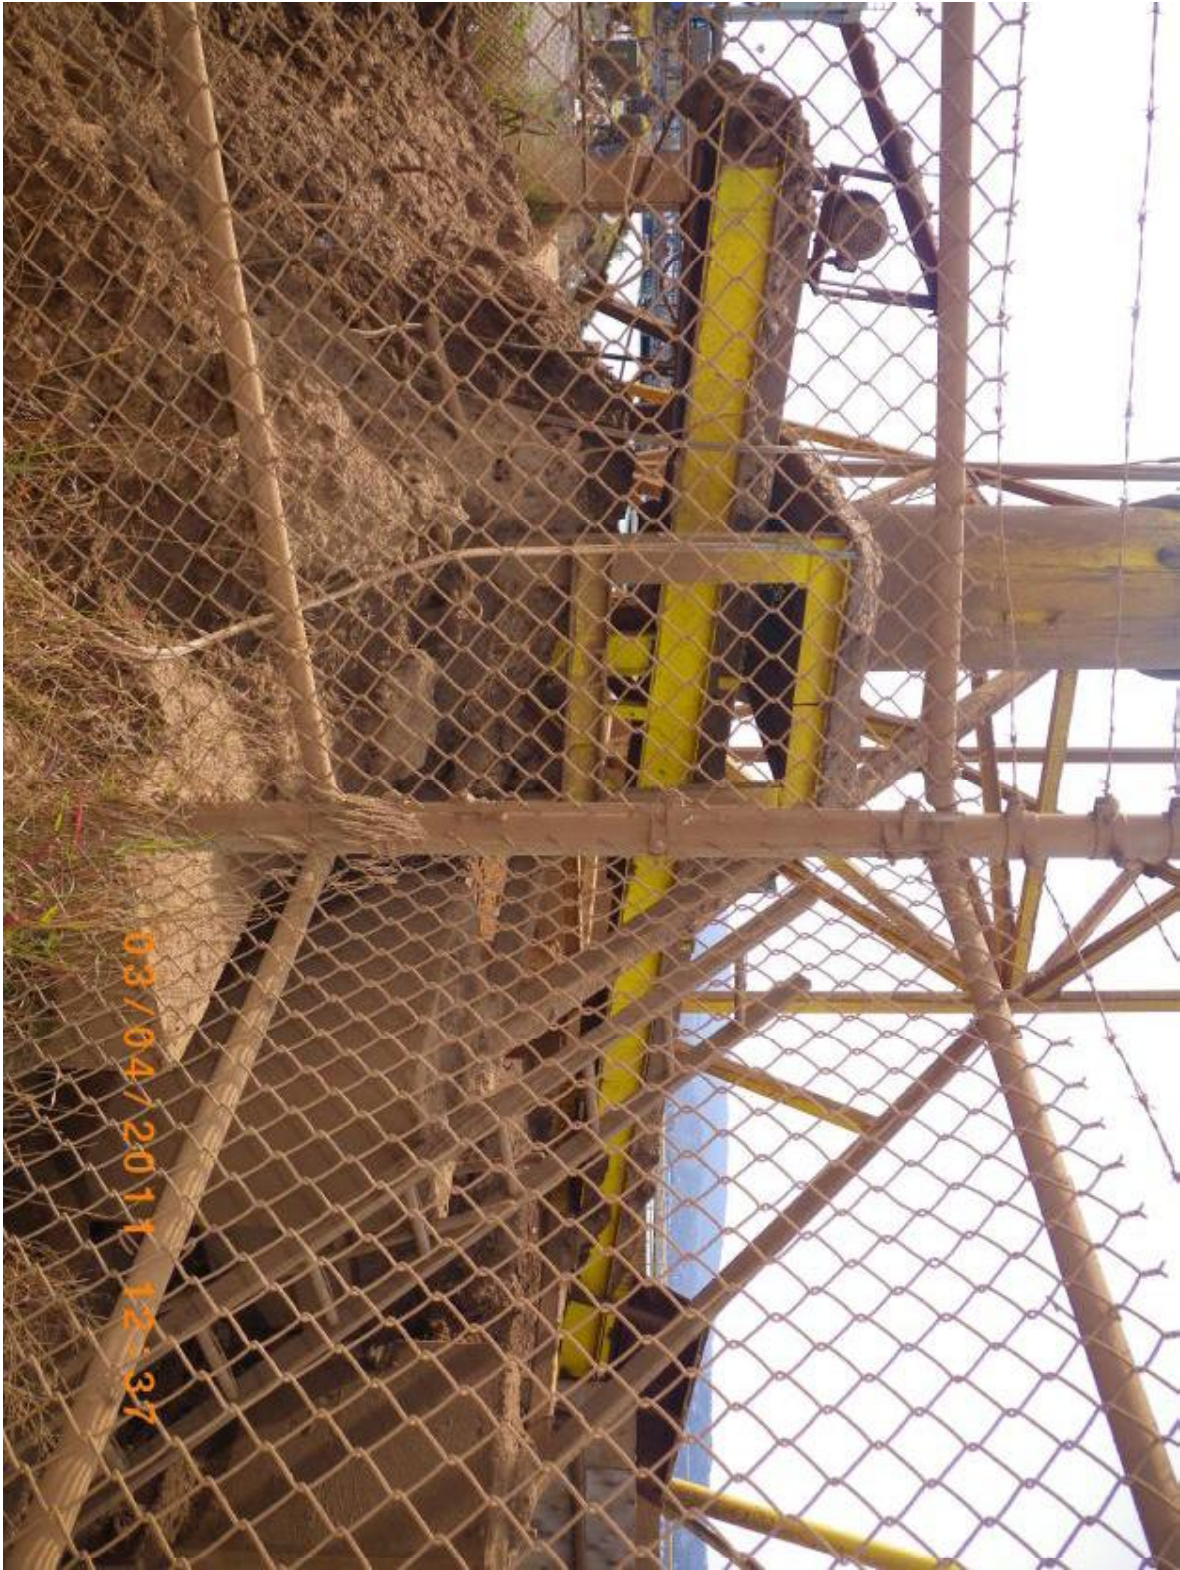
IMGP0257.JPG

IMGP0257 – The land-side footing of the ship-loading conveyor (north side). The conveyor in the photo is used to facilitate cleaning the catchment platform. Accumulated debris was observed at this location.

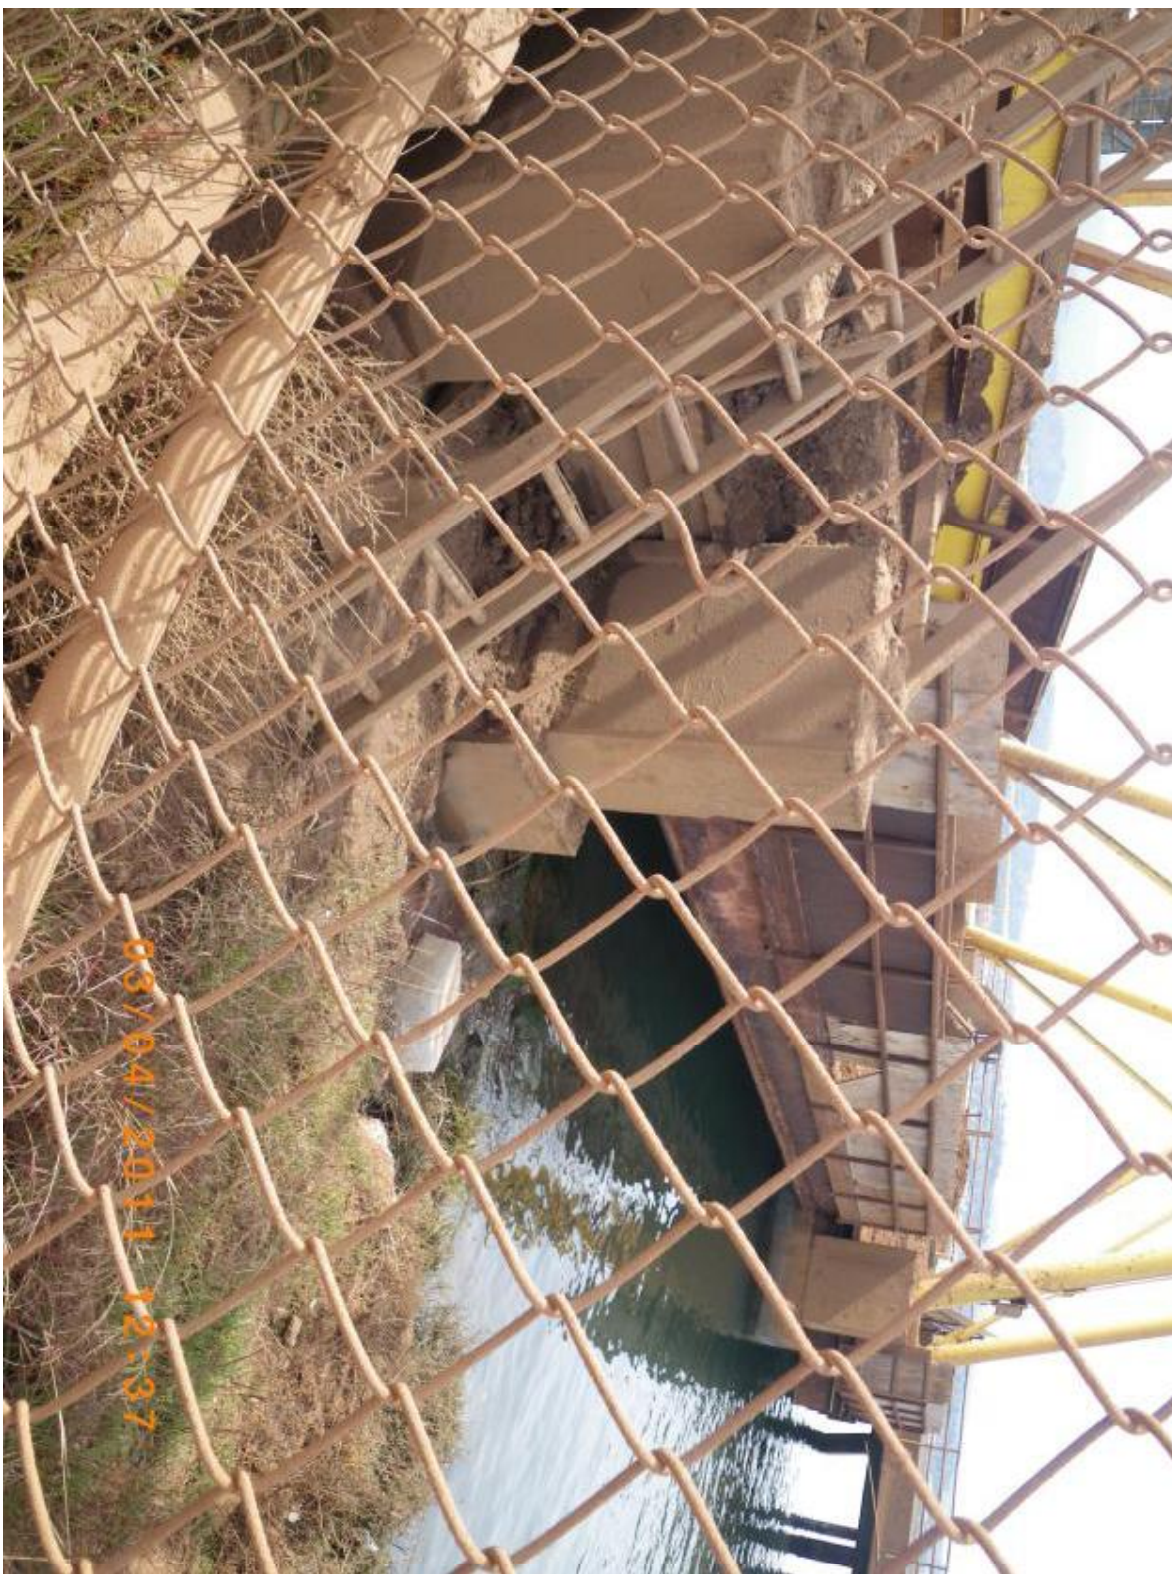
IMGP0258.JPG

IMGP0258 – This photo depicts the north side of the catchment platform, footings and small conveyor depicted in IMGP0257. Accumulated debris was observed on the water-side of the containment berm. Gaps in the plywood containment walls on the catchment platform were also observed with debris perched over receiving waters.

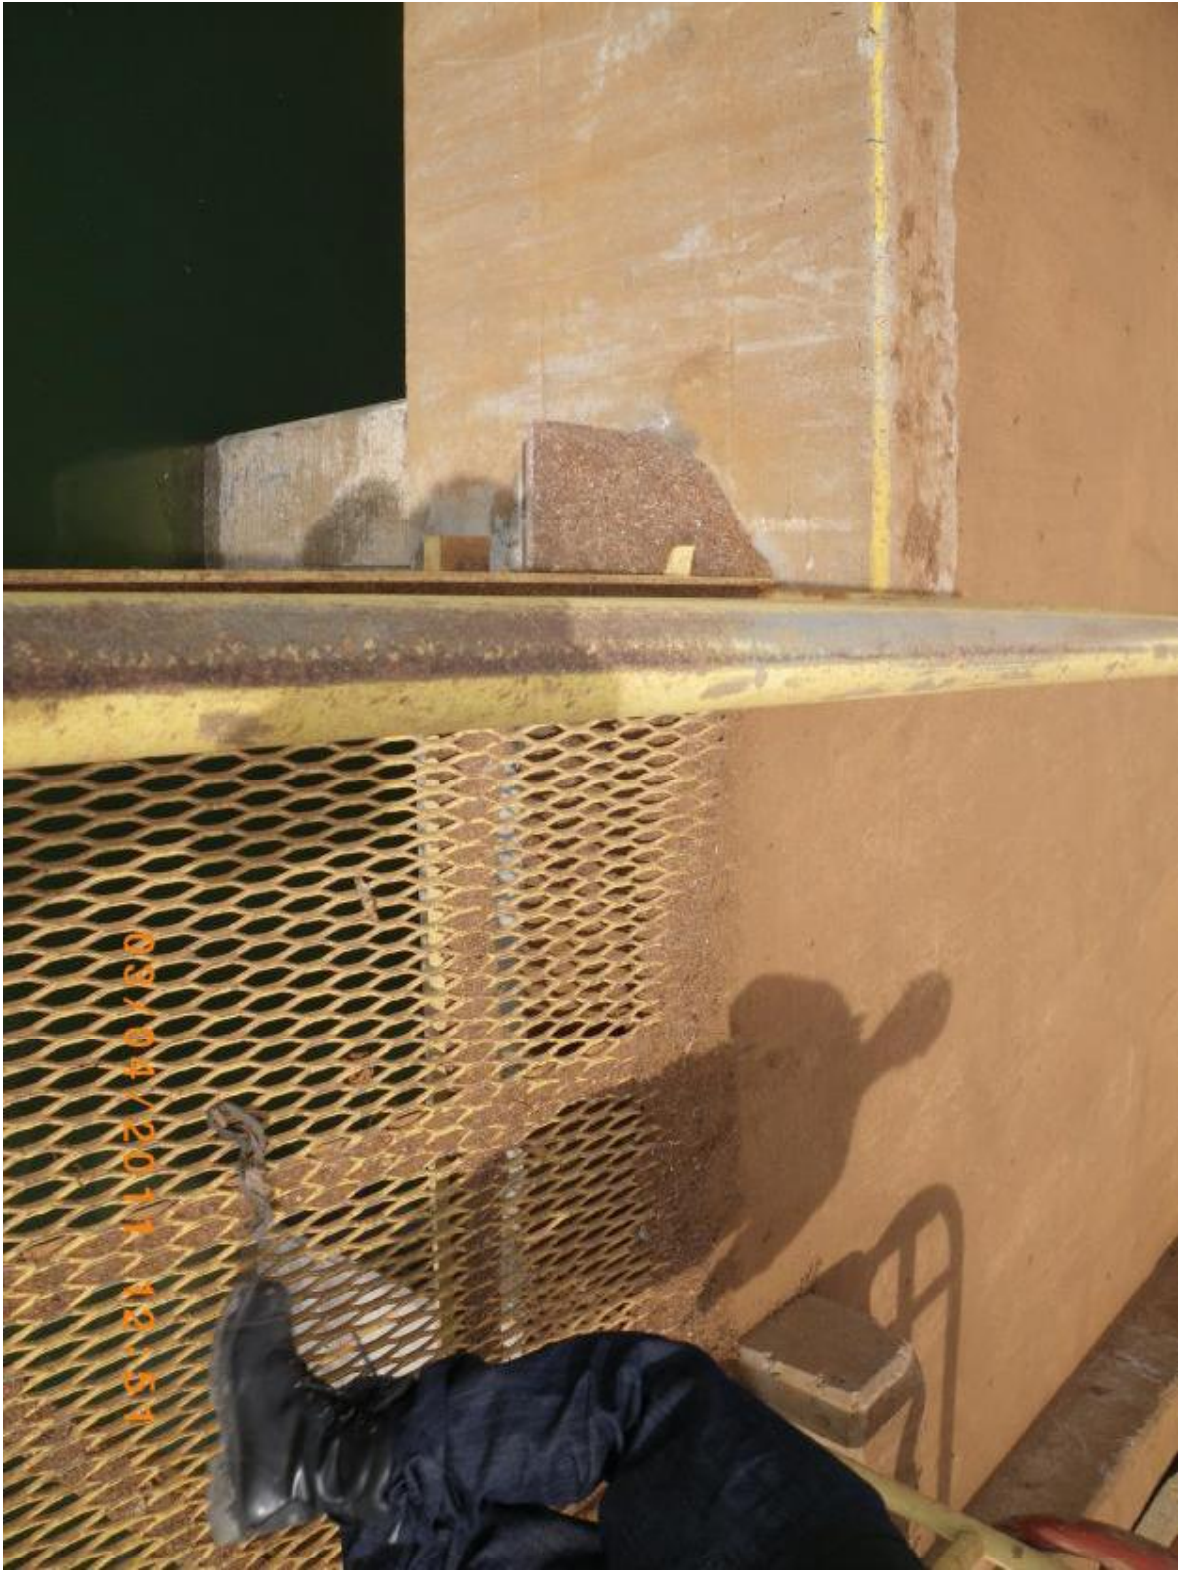
IMGP0265.JPG

IMGP0265 – Accumulated debris was observed on the west side of the catwalk structure to the south of the ship loading conveyor area.

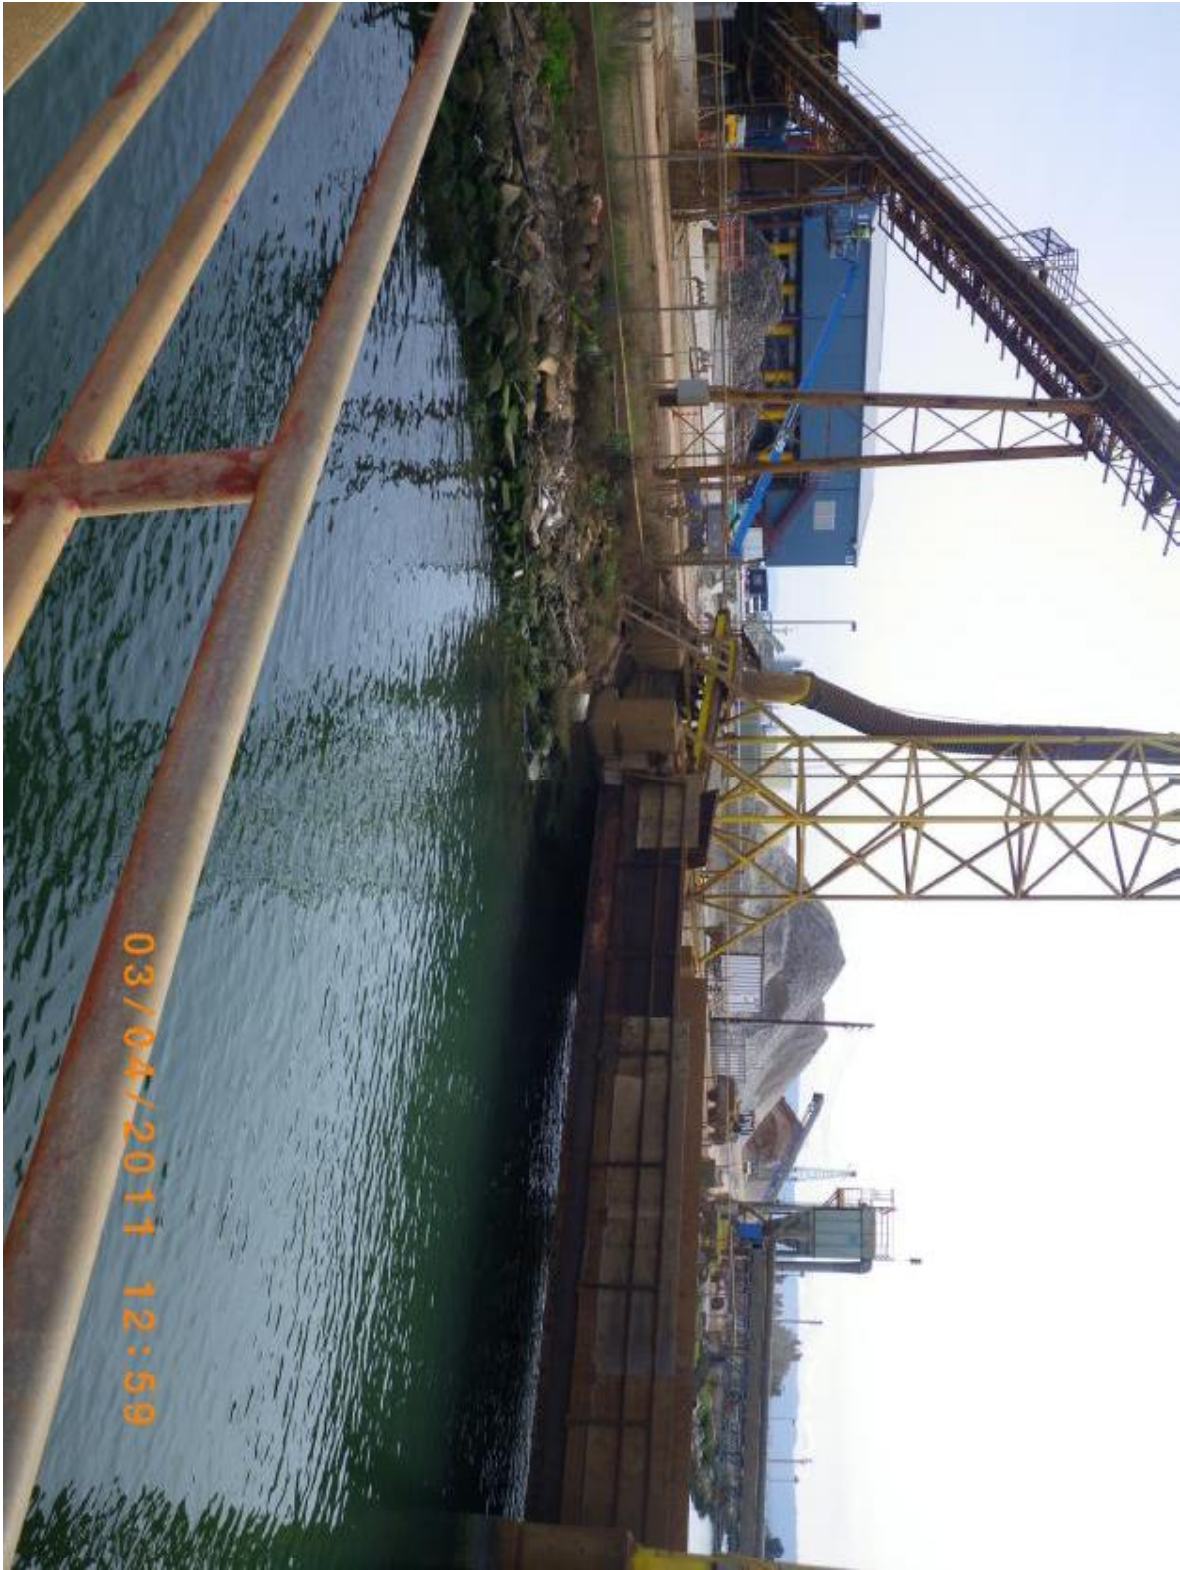
IMGP0269.JPG

IMGP0269 – Accumulated debris was observed on the north, land-side footings of the ship loading conveyor, looking south east.

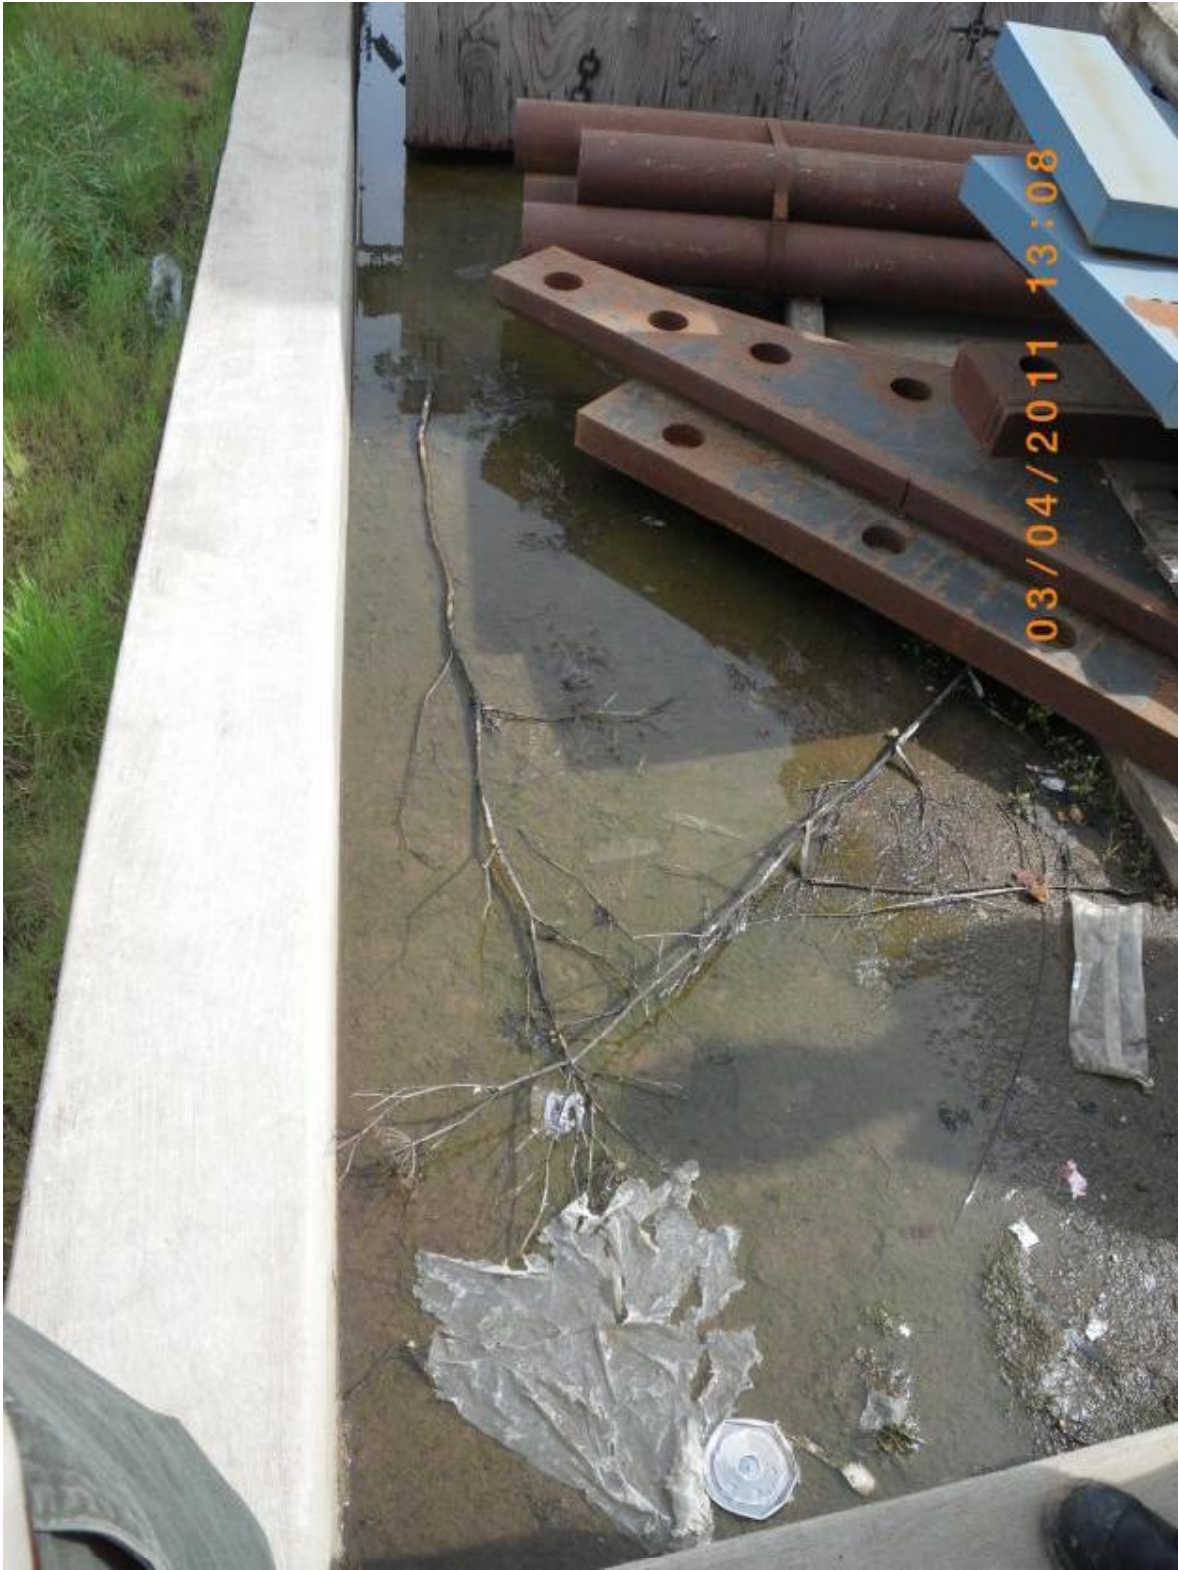
IMGP0274.JPG

IMGP0274 and 0275 – North west corner of the facility, berms, staged equipment and scattered debris were observed.

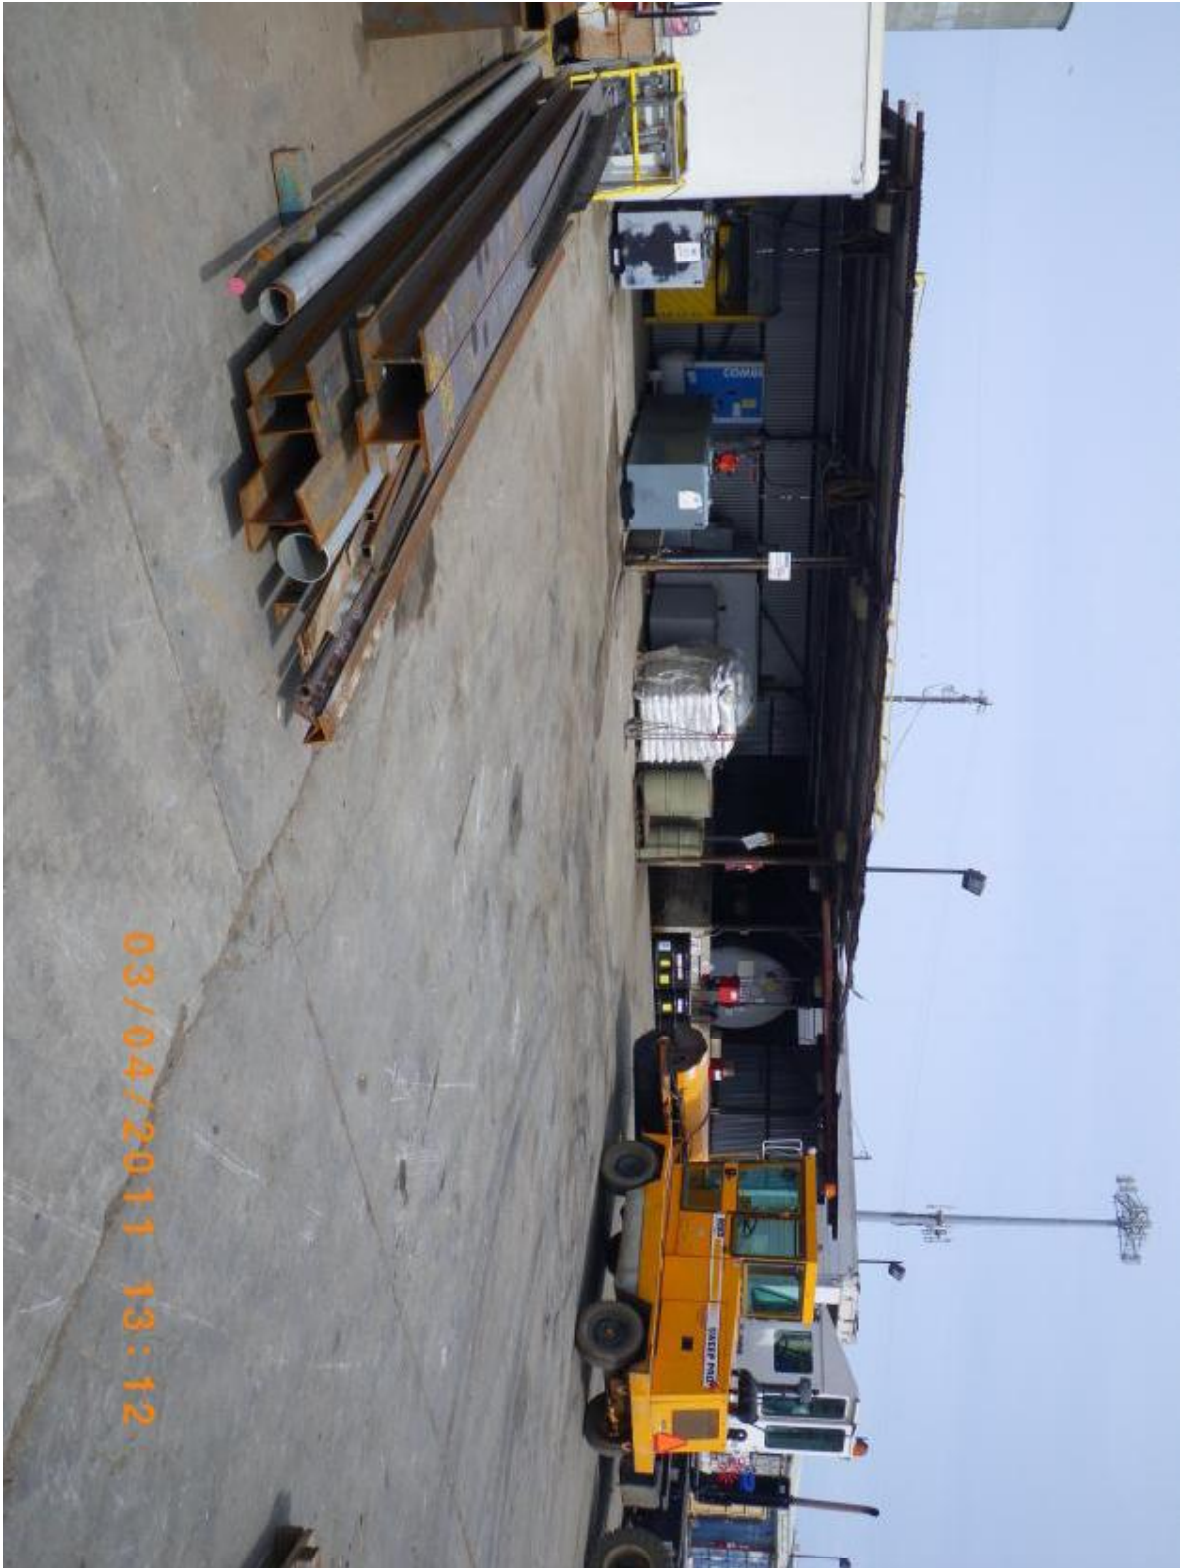
IMGP0277.JPG

IMGP0277 – Covered fueling and oiling depot. Oil staining was observed on the driving surface.
