NPDES Storm Water Inspection Report

Facility Location Information			
Name/Location/ Mailing Address	Sims Metal Management (Sims) 699 Seaport Blvd. Redwood City, CA		
GPS Coordinates	Latitude	37° 30' 40.6"	Longitude 122° 12' 29.6"
Receiving Water(s)	Redwood Creek – Navigable estuary to San Francisco Bay		
	Name	Telephone	
Owner	Steven Shinn – Regional General Manager	510-412-5300	
Operator	Joe Barco – Operations General Manager	510-412-5300	
Environmental Coordinator	Matt Zeiter – On-site Rep	510-715-7569

General	
Inspection Objective, Attendees, and Opening Conference Summary.	<p>The inspection's objective was to determine compliance with the California Industrial General Permit No. CAS000001.</p> <p>In addition to EPA inspectors previously identified, the inspection was attended by Estuardo Montufar (650.372.6240) and Sabrina Mih (650.372.6235) with San Mateo County Environmental Health Services Division (Certified Unified Program Agencies – CUPA), and Matt Zieter (510.412.5300), Mariya Semeit (650.369.4161), Dale Leuer (650.369.4161), and Vistasp Patel (650.369.4161) with Sims Metals Management (Sims or Facility Representatives)</p> <p>Prior to commencing the inspection, an ope

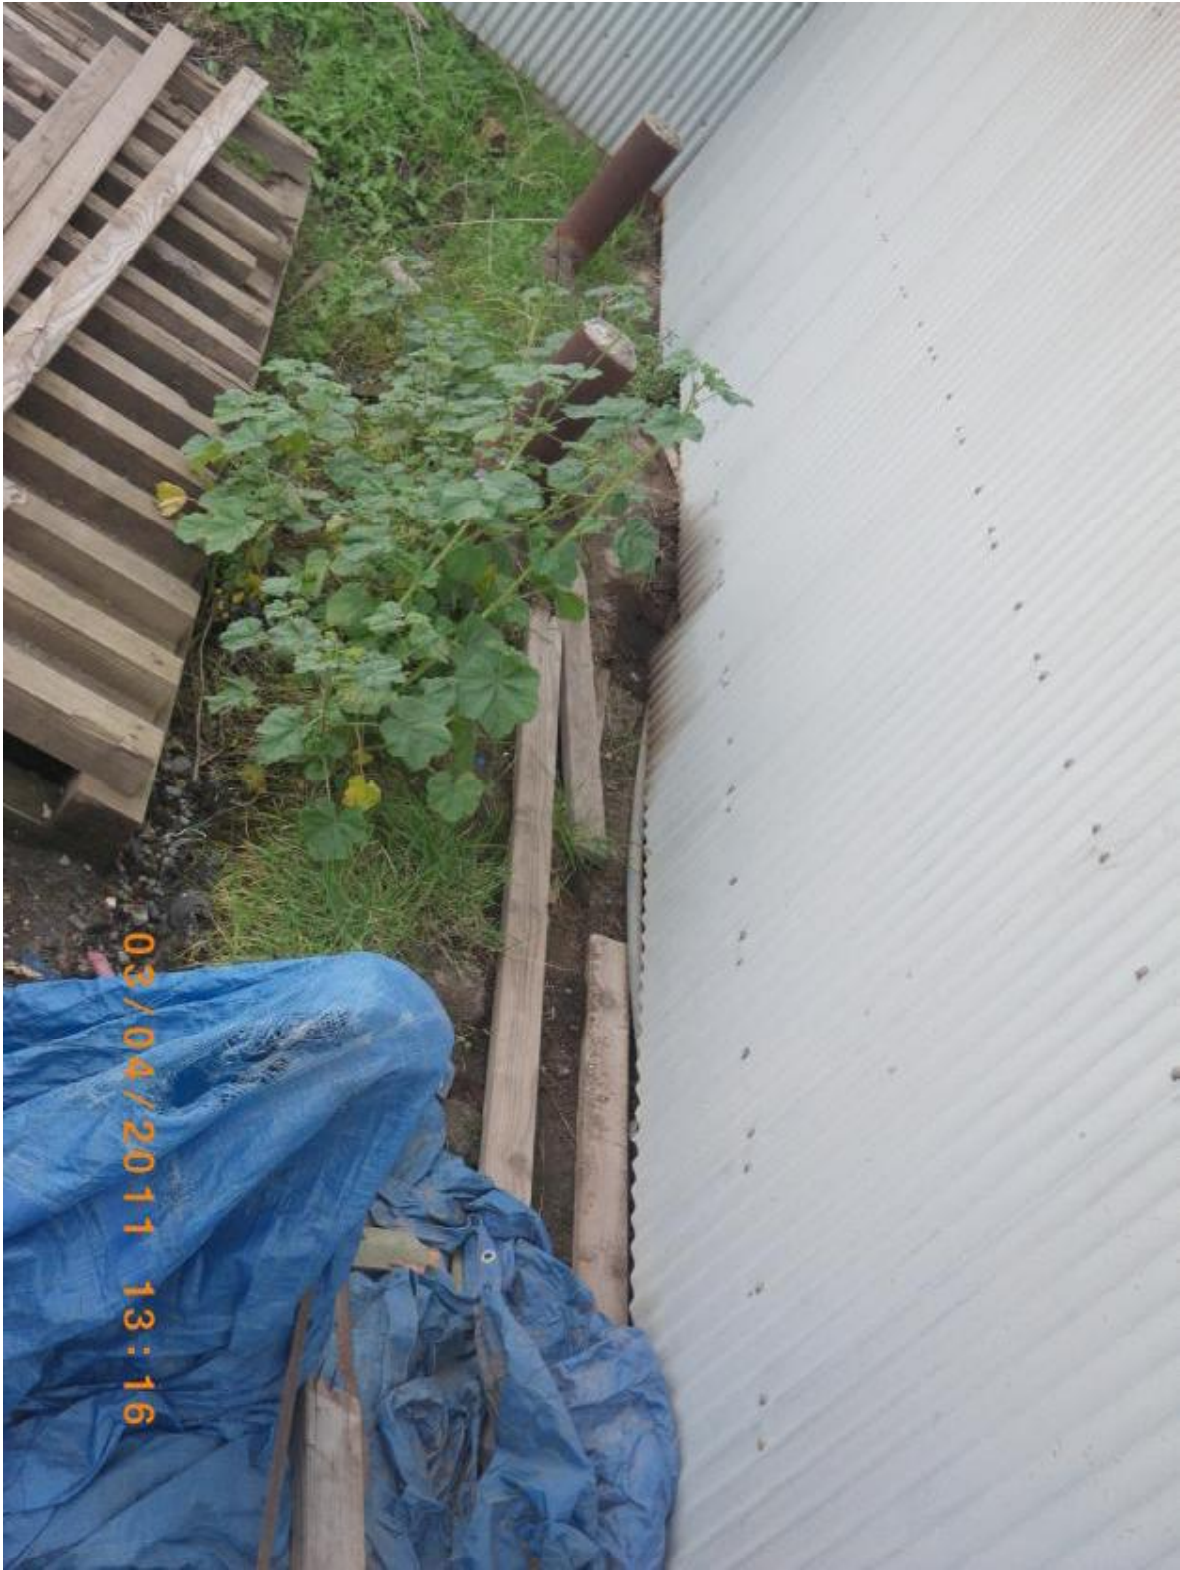
IMGP0282.JPG

IMGP0282 – Oil staining was observed on the exterior wall and earthen ground on the north side of the fueling and oiling depot. IMGP0285 and 0286 demonstrate that this area is exterior to the air compressor.

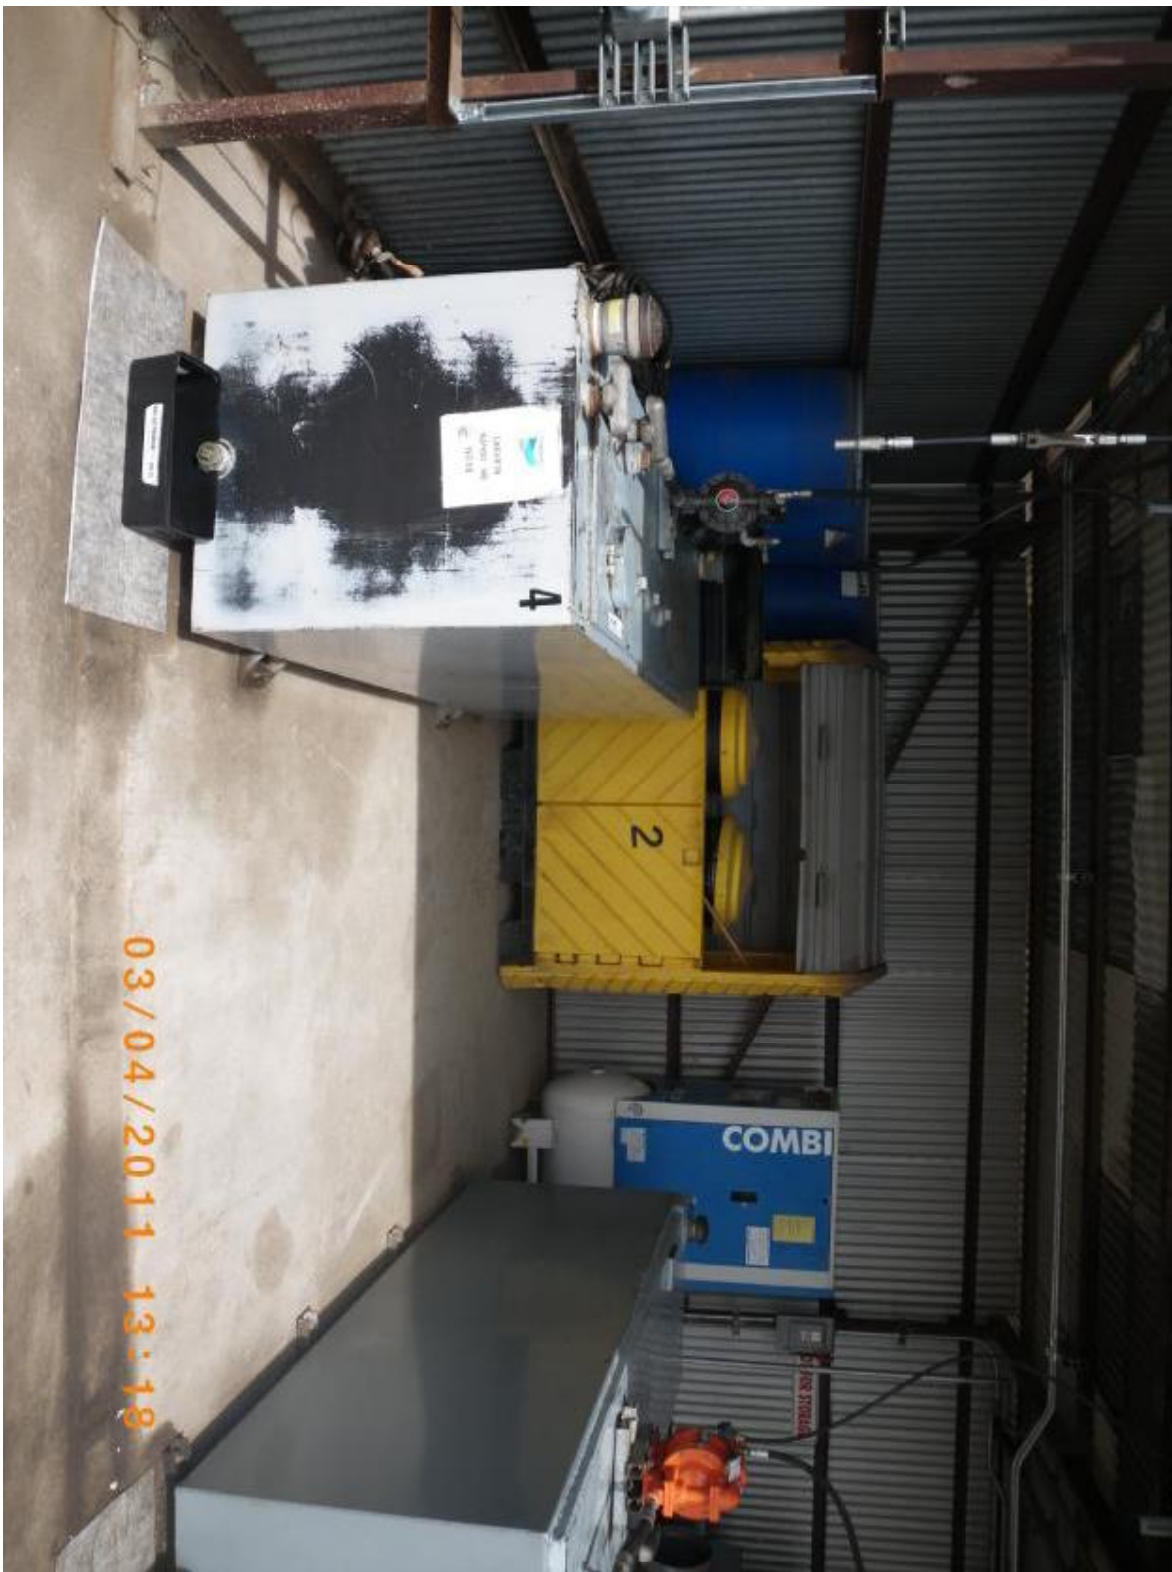
IMGP0283.JPG

IMGP0283 and 0284 – Bulk oil ASTs, spill kit, and air compressor were observed under cover. Oil staining was observed around the grey oil tank.

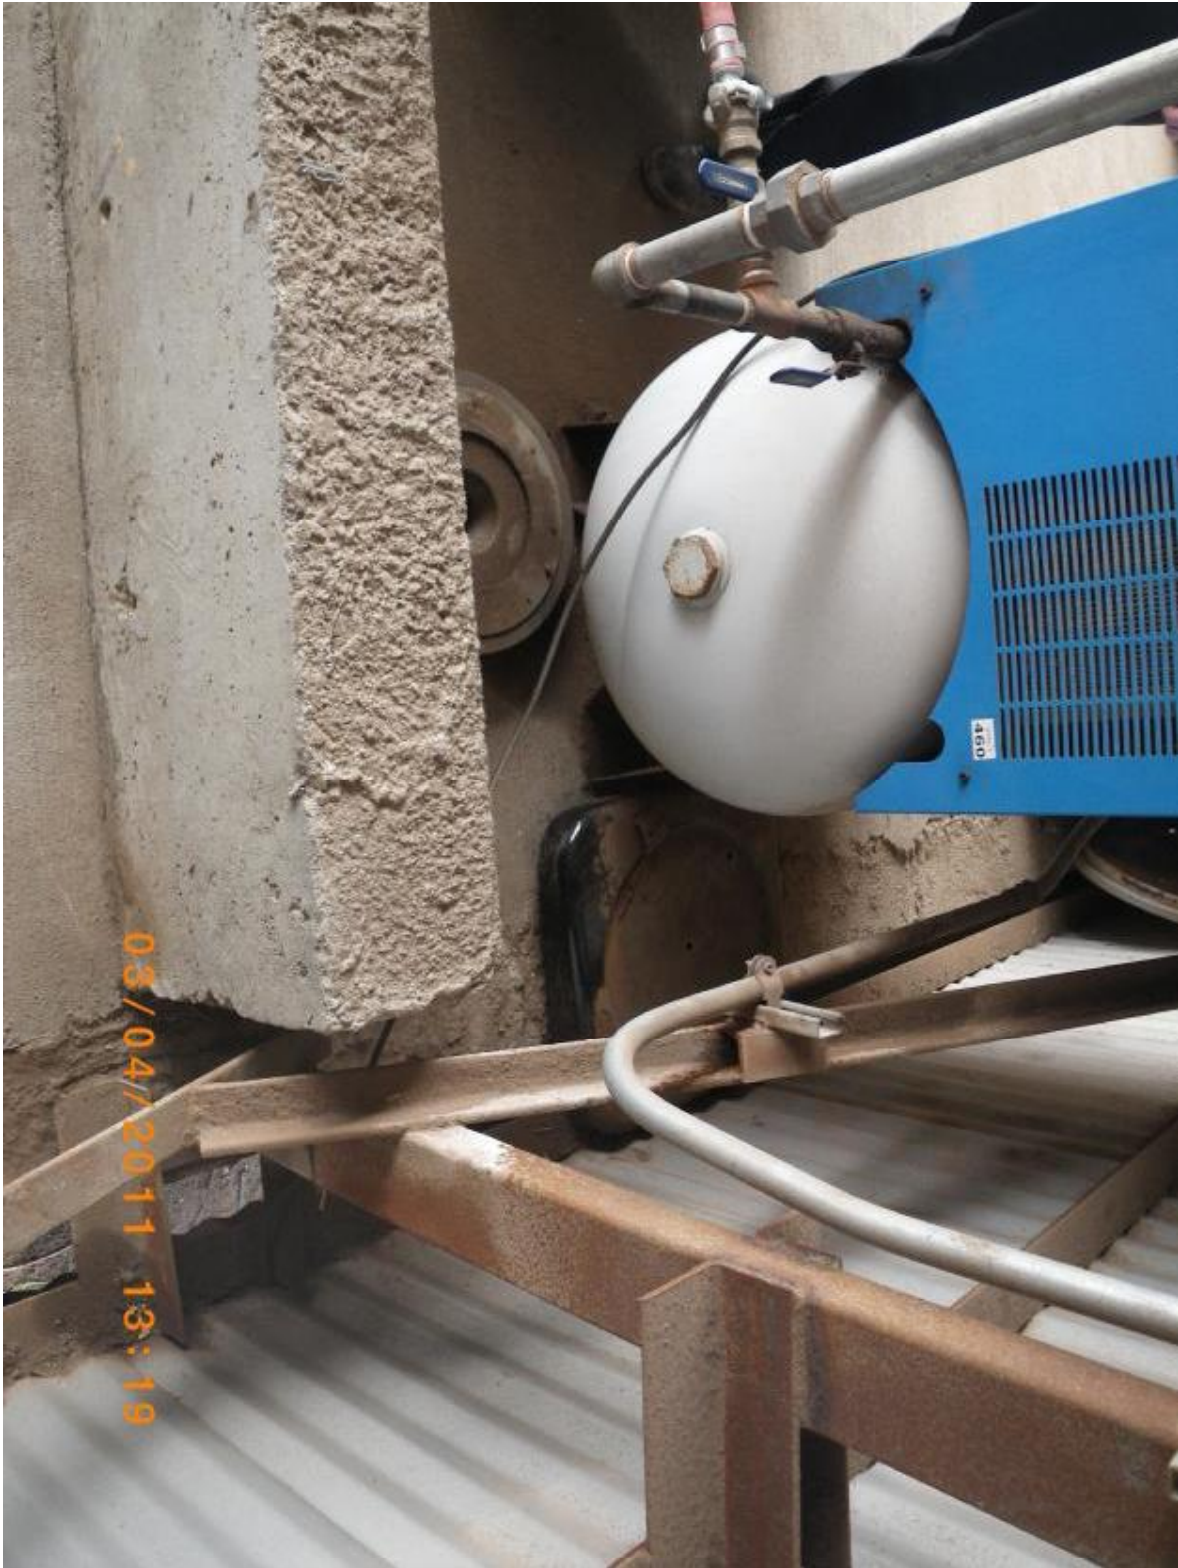
IMGP0286.JPG

IMGP0285 and 0286 – Area behind the air compressor where oil staining was observed as mentioned regarding IMGP0282.

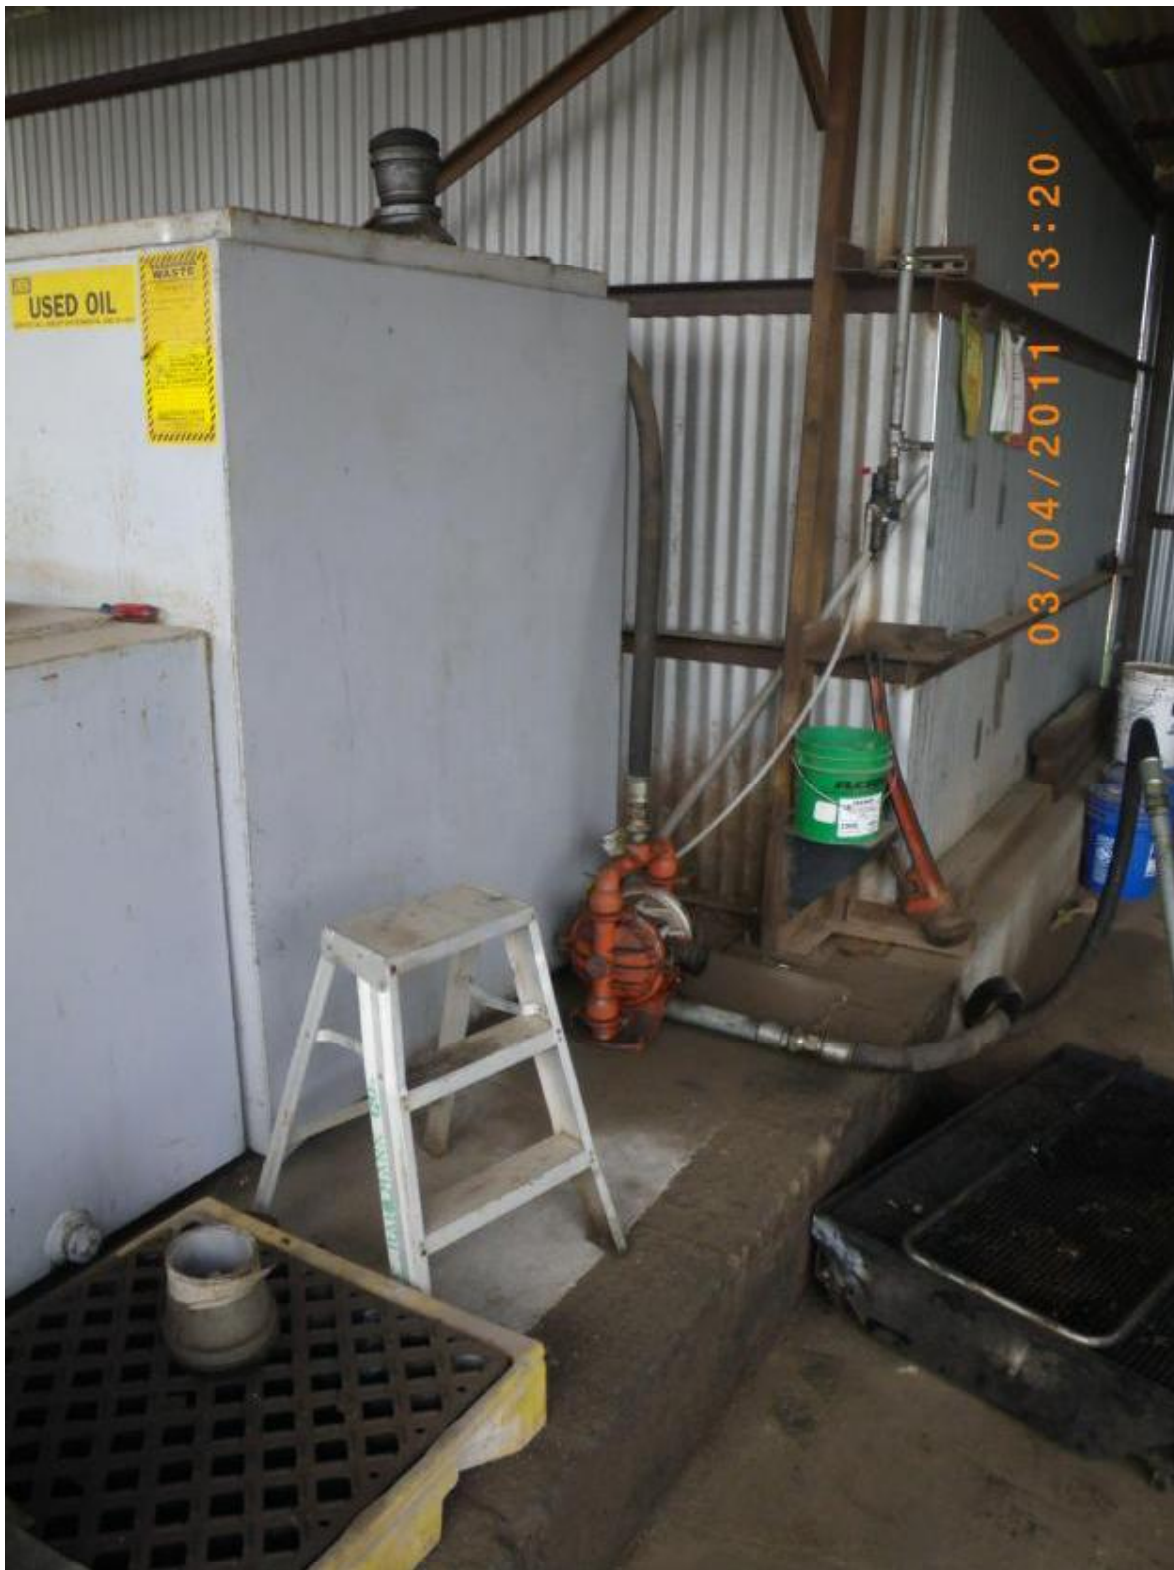
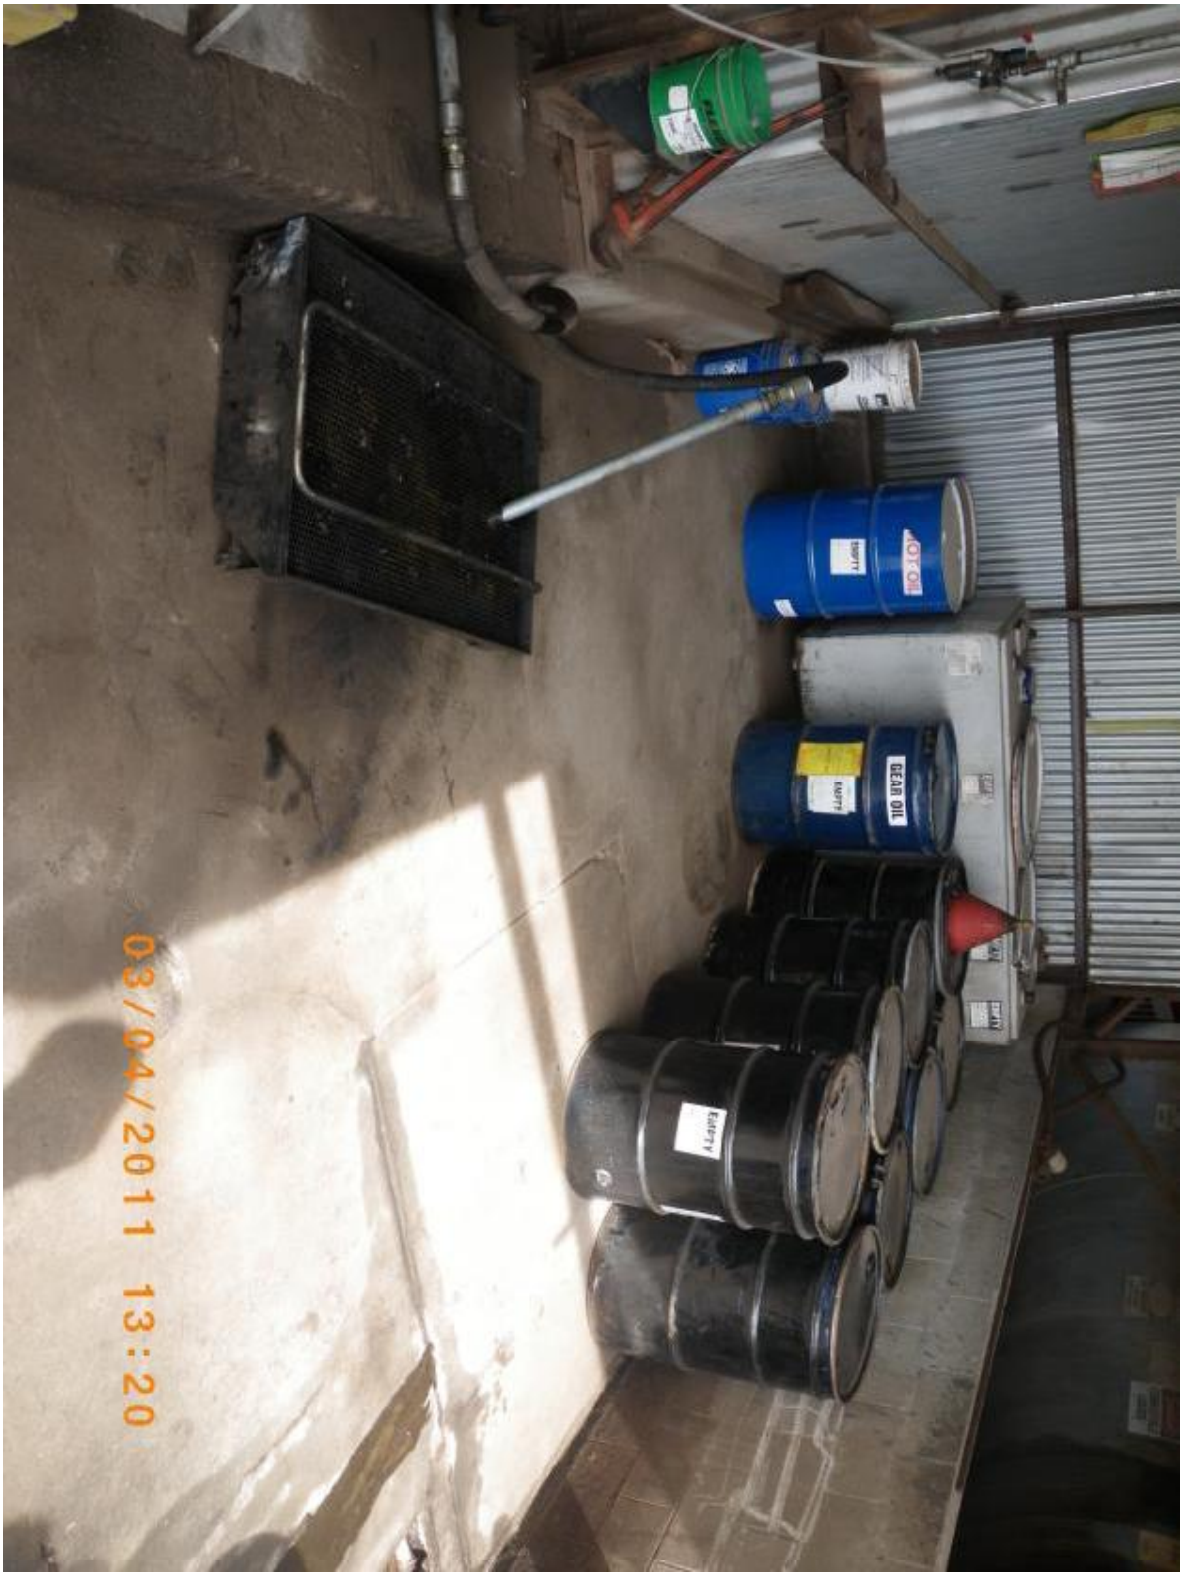
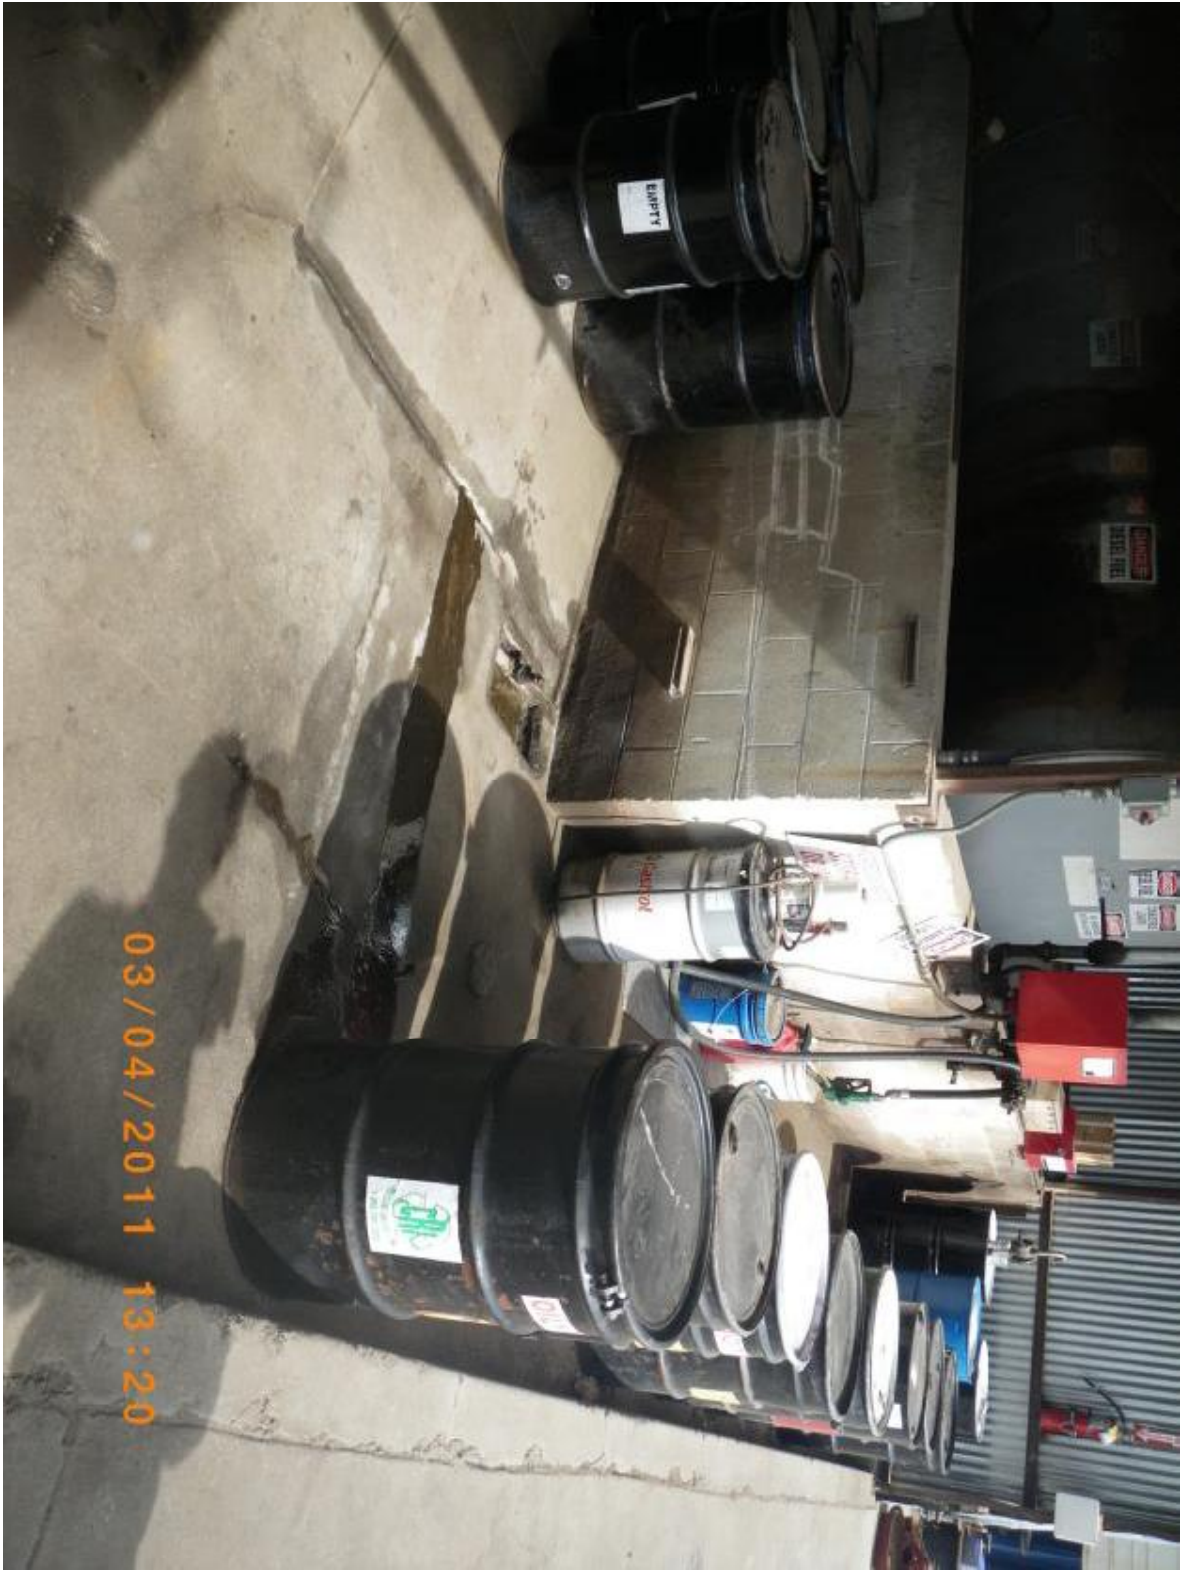
IMGP0288 thru 0293 – Oil lines, drums, and oil leaks observed within the covered fueling and oiling depot.

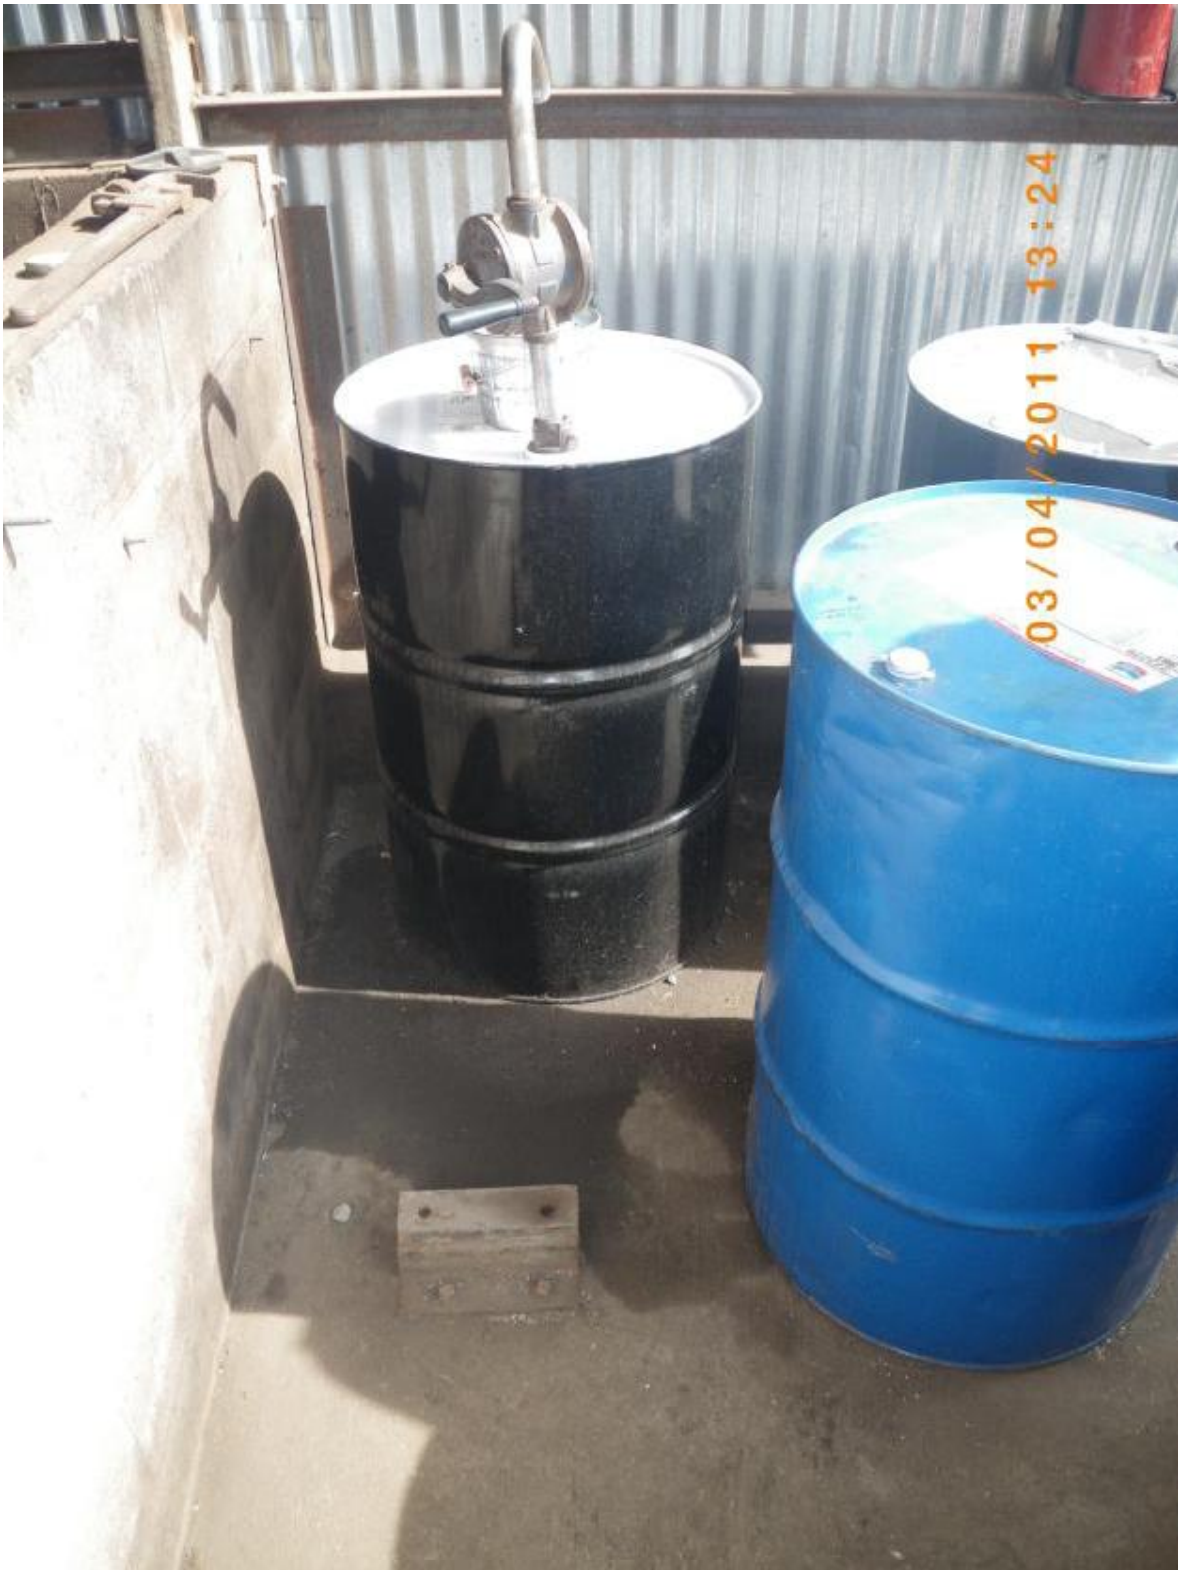
IMGP0299.JPG

IMGP0299 – Oil drums stored within the covered fueling and oiling depot. Oil staining was observed on the floor of this area.

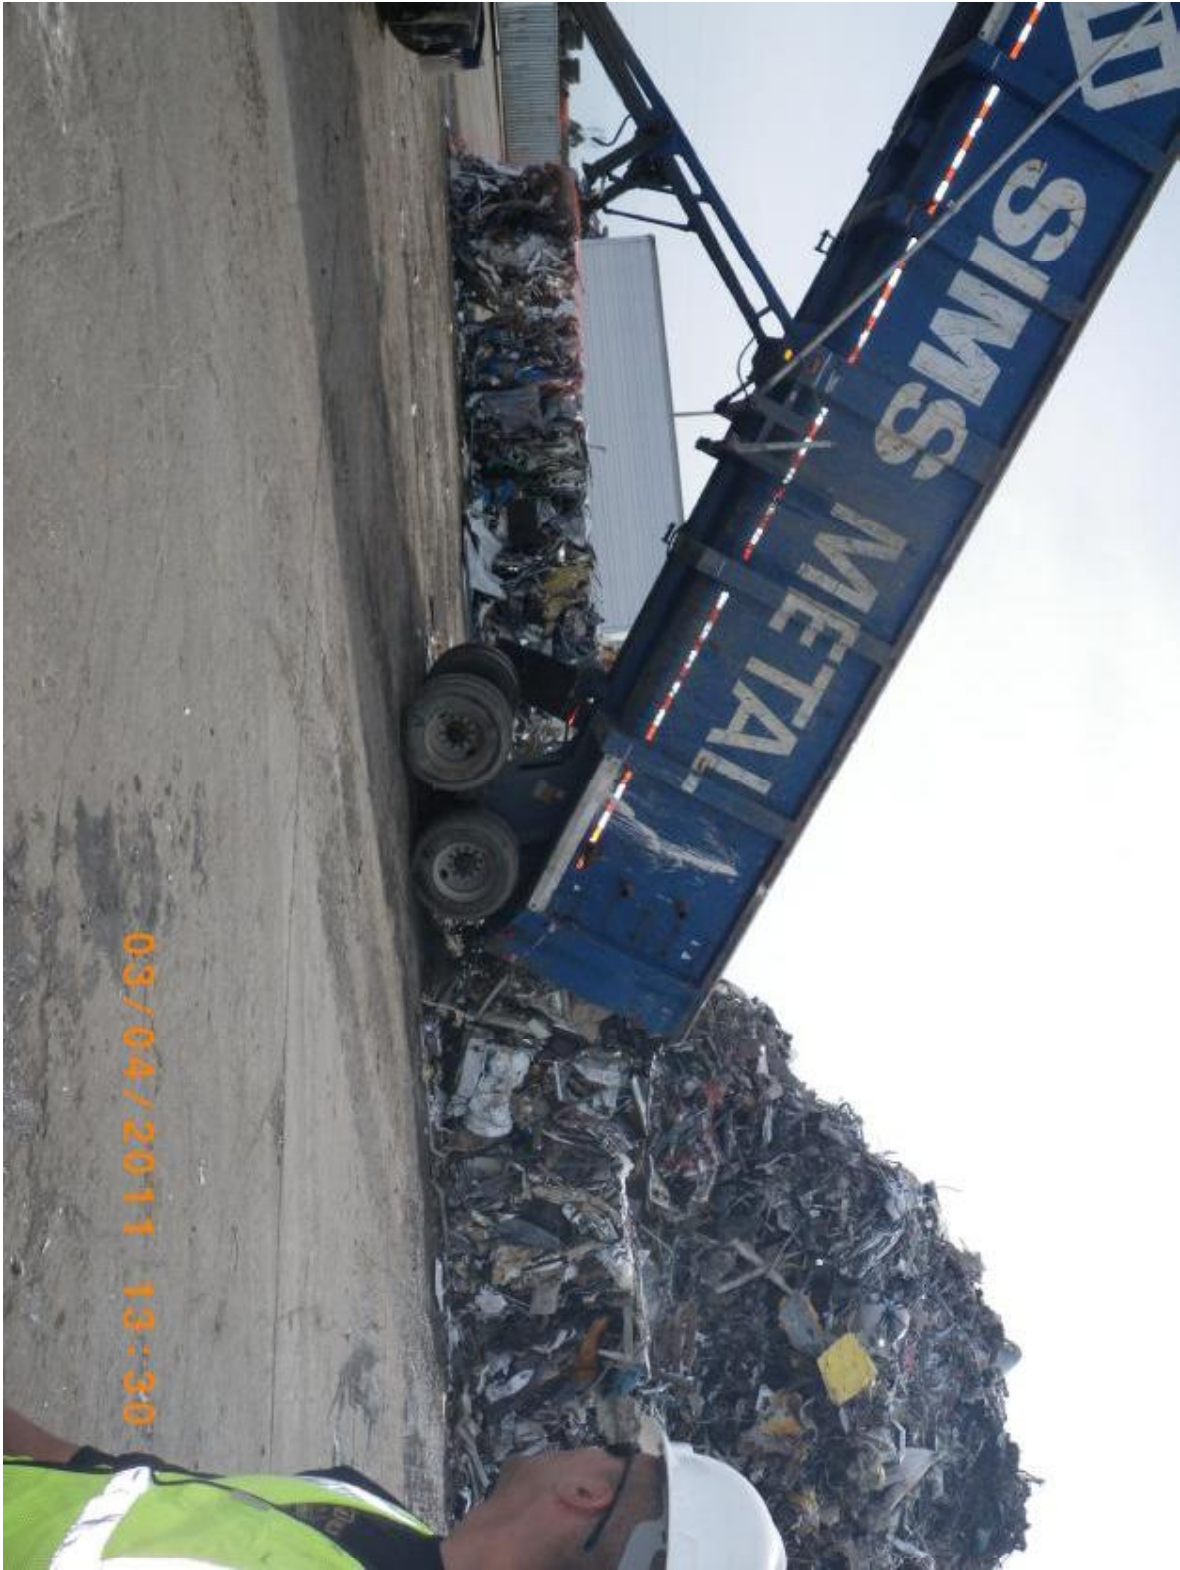
IMGP0301.JPG

IMGP0301 – Dump truck depositing transferred metal from another Sims facility. Vehicle tracks were observed on the driving surface.
