**SEWAGE COLLECTION SYSTEM INSPECTION FORM  
Stege Sanitary District**

Inspection Date: March 30 – 31, 2009

Utility Name: Stege Sanitary District (SSD)		
Address: 7500 Schmidt Lane El Cerrito, CA 94530		
Contact Person: Douglas Humphrey		
Phone: 510/524-4667	Cell:	Fax: 510/524-4697
Email: doug@stegesd.dst.ca.us

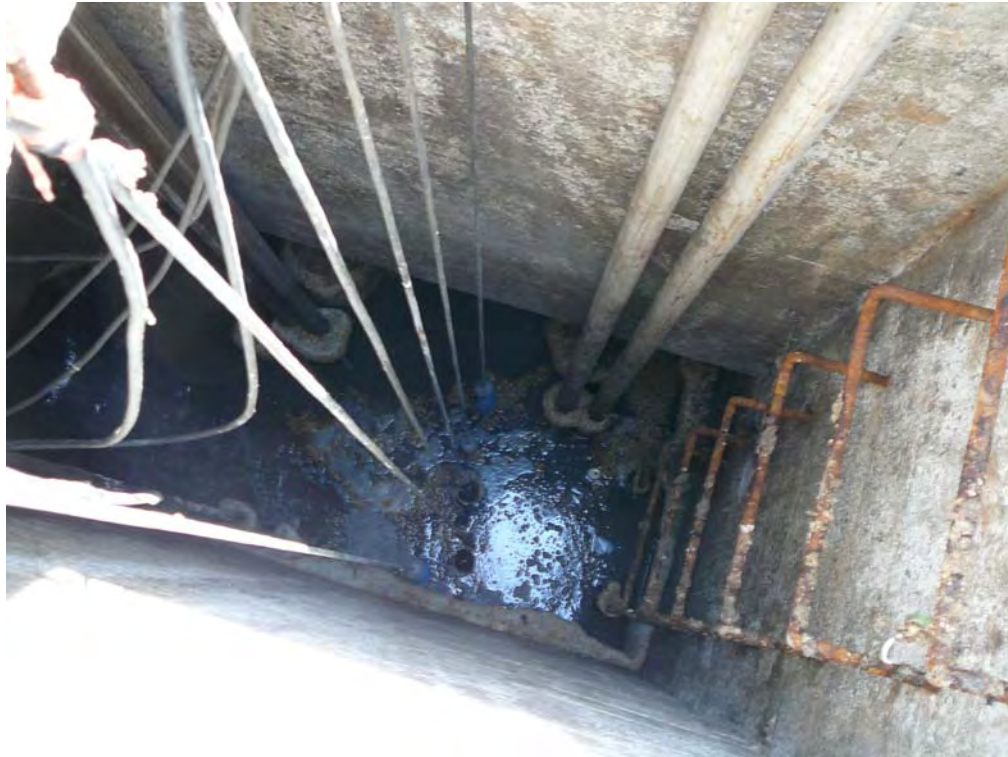
Photo 1 Burlingame pump station wet well

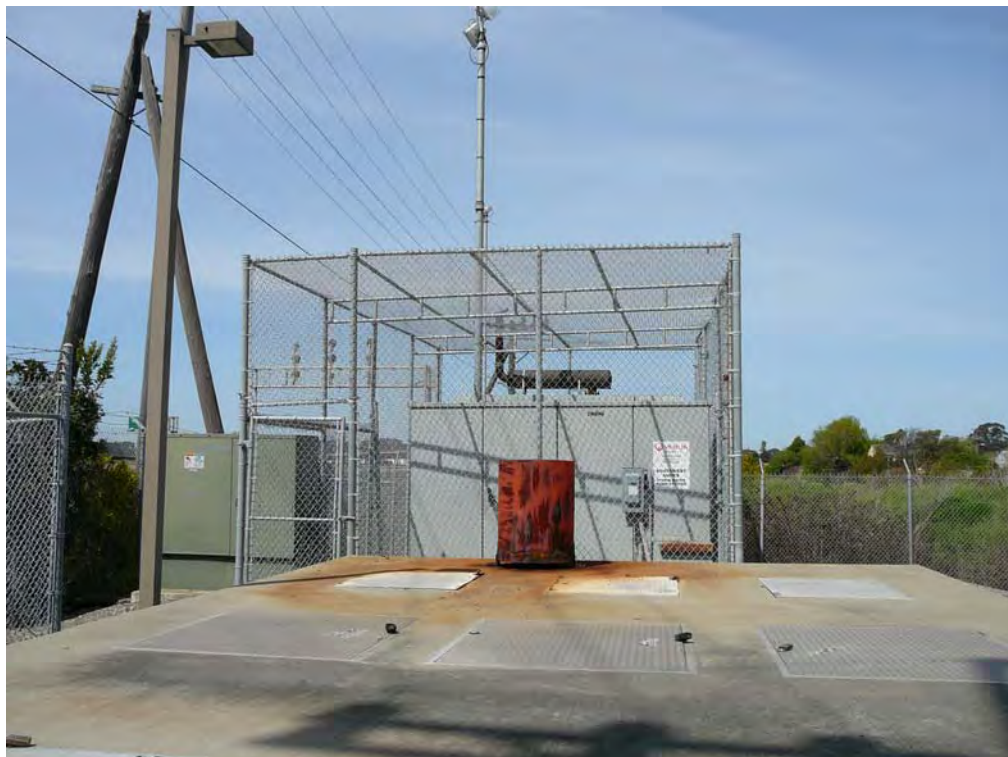
Photo 2 Generator for Burlingame pump station

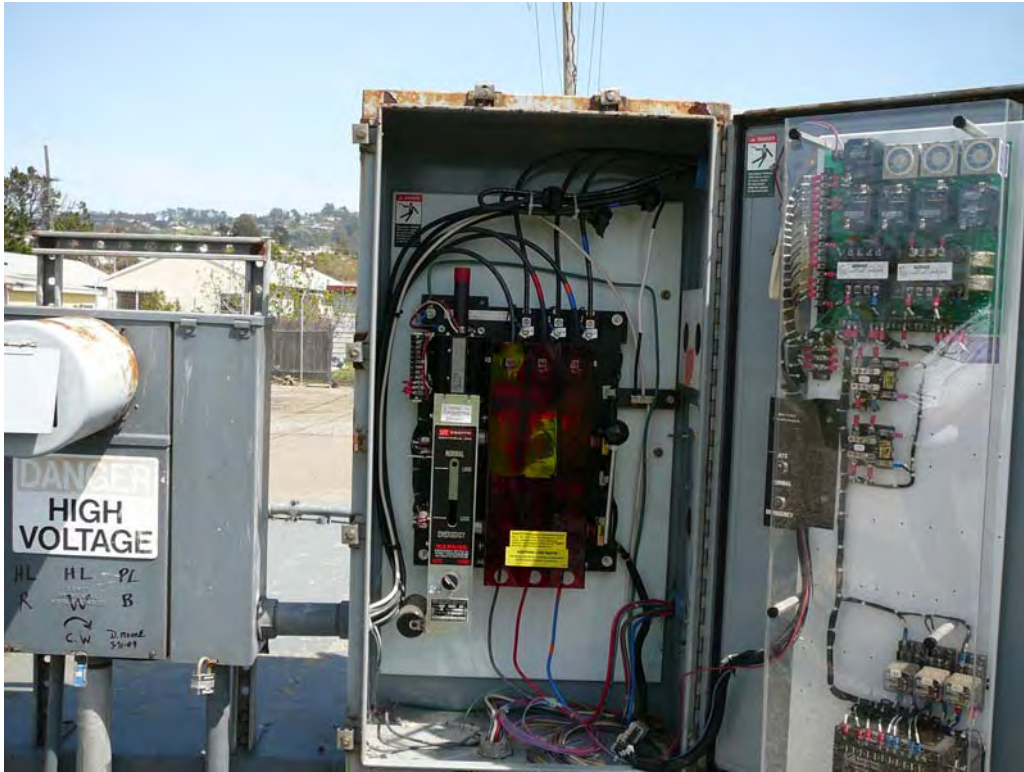
Photo 3 Controller and emergency switch at Burlingame pump station

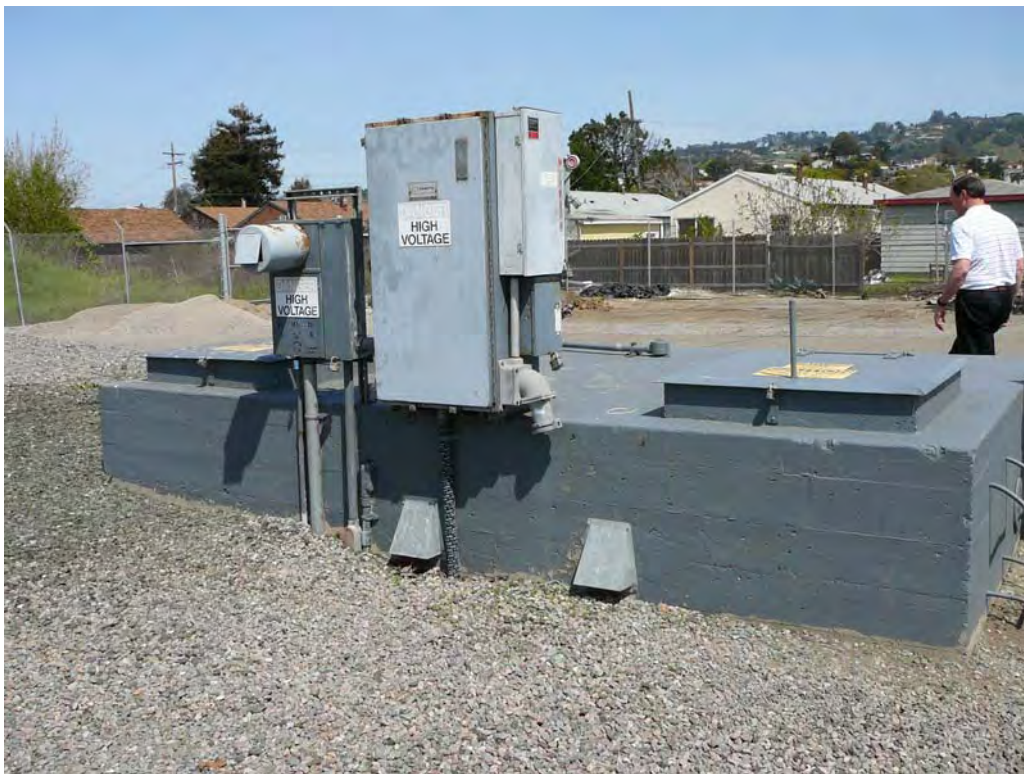
Photo 4 Outside view of Burlingame pump station

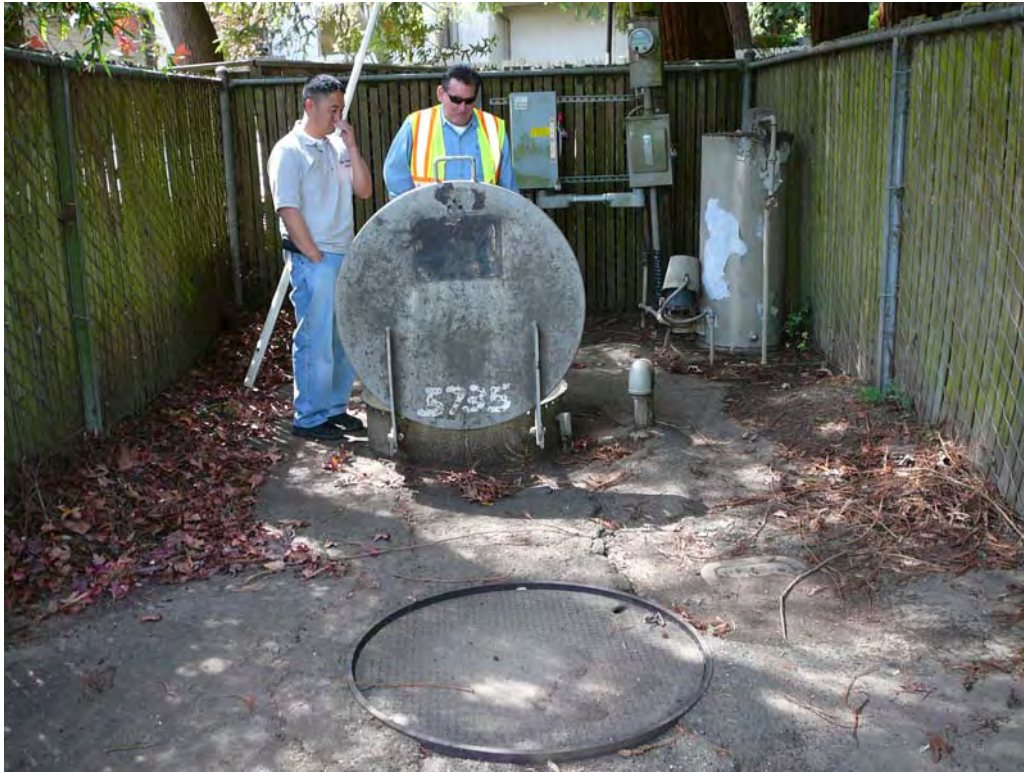
Photo 5 Cannon pump station

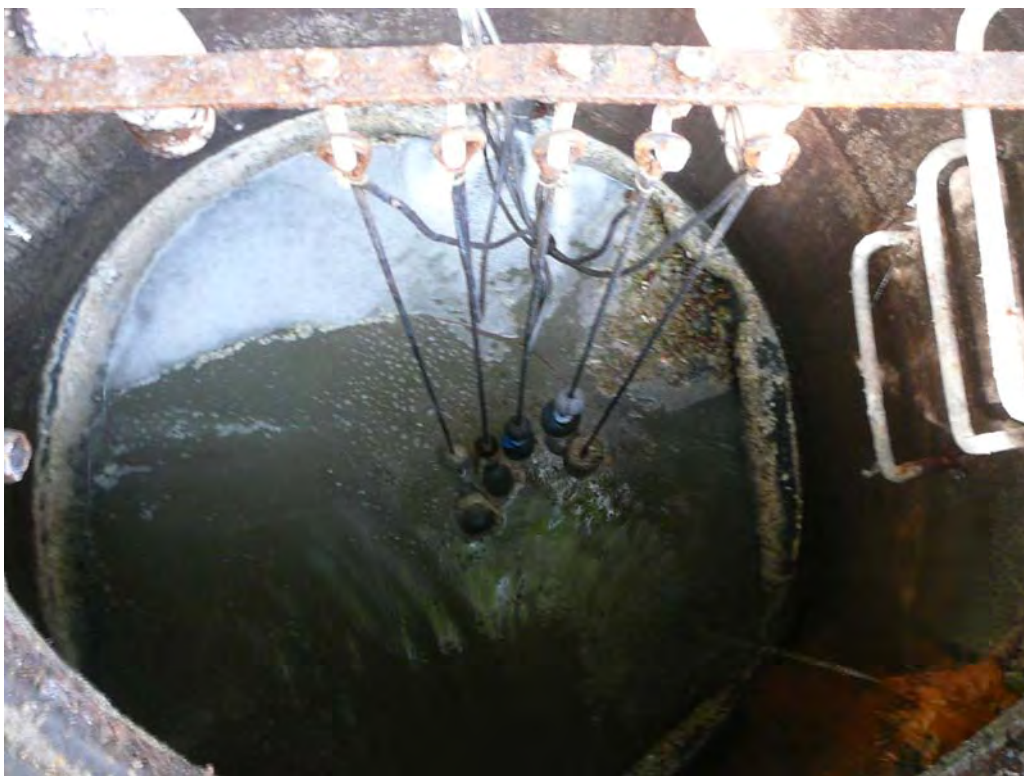
Photo 6 Cannon pump station wet well

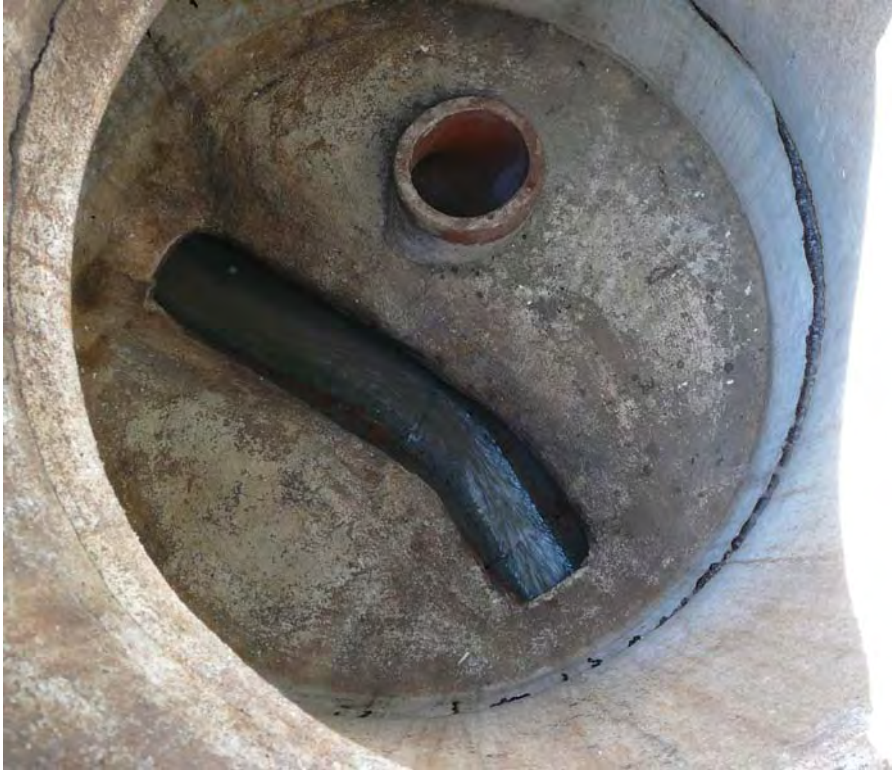
The inspection team also visited capacity spill sites at Stanford & Wellesley (Photos 7 and 8) and Ocean View & Coventry (Photo 9) where spills occurred in 2005. SSD performed work at these locations to prevent further spills. This may not have completely resolved the situation, however. SSD continues to look for ways to address these situations. They smoke tested the Stanford & Wellesley area last fall and found that laterals contribute heavily to I/I in this area. SSD tells the homeowner about the problem but can’t make them replace the laterals (outside of a change of ownership). They haven’t found many connected roof leaders or sump pumps. They believe that the problem is made worse by holes in the corrugated metal storm drain pipes, which allows storm water to seep into the sanitary sewer.

They have done three projects at the Stanford & Wellesley problem area. At the “4 Pomona” SSO location, the model indicates that the site can handle the flow, but it probably doesn’t account for the energy dissipation problem caused by its location at the end of a steep hill.

Photo 7 "Stanford & Wellesley" - Addition of underflow pipe to prevent overflows from this manhole

- Wellesley & Stanford Avenues – believe to be corrected in 2008, increased downstream capacity and added manholes
- 4 Pomona Avenue – replaced downstream line, SSO in 2008 caused by combination of flow and blockage – not really capacity problem

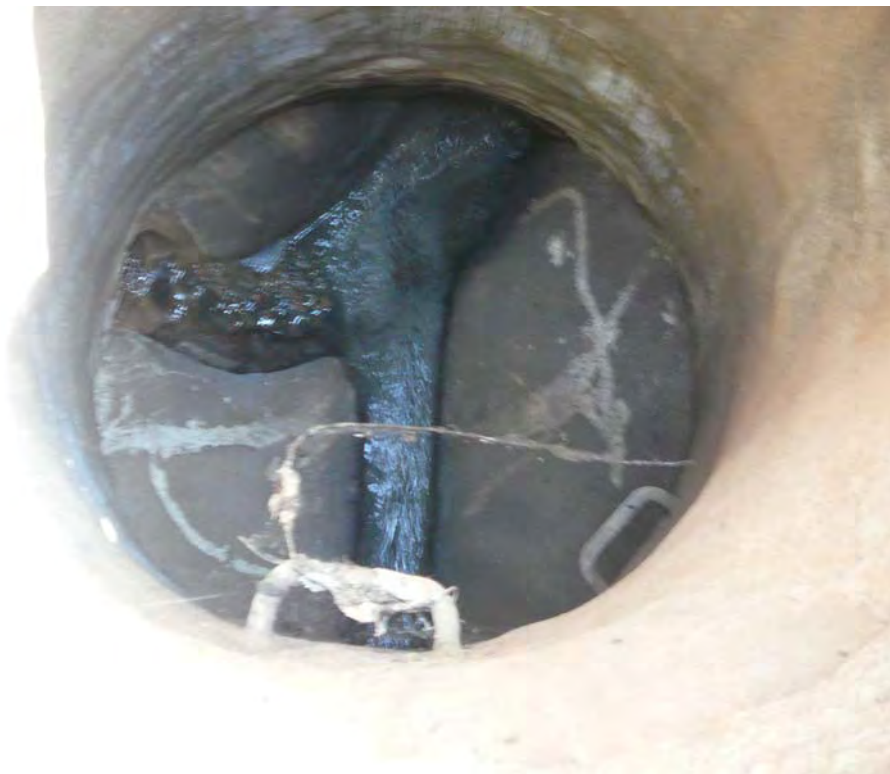
Photo 8 "Stanford & Wellesley" - this is the manhole that now overflows

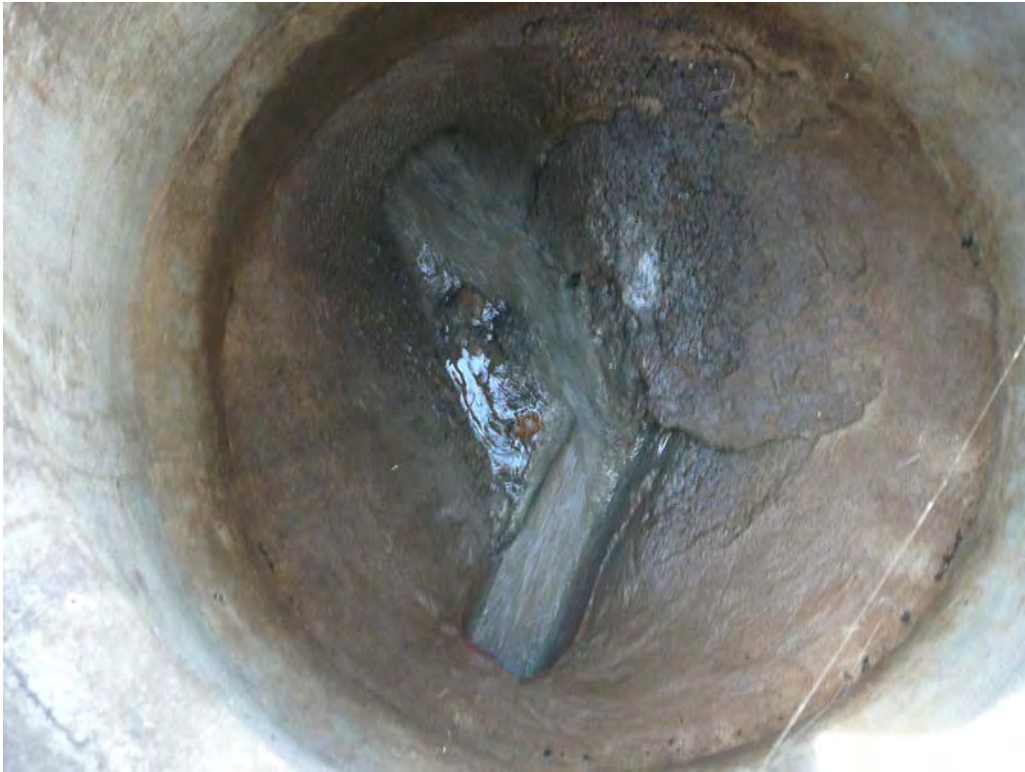
Photo 9 "Ocean View & Coventry" - reduced 90 degree bend in pipe to prevent overflows

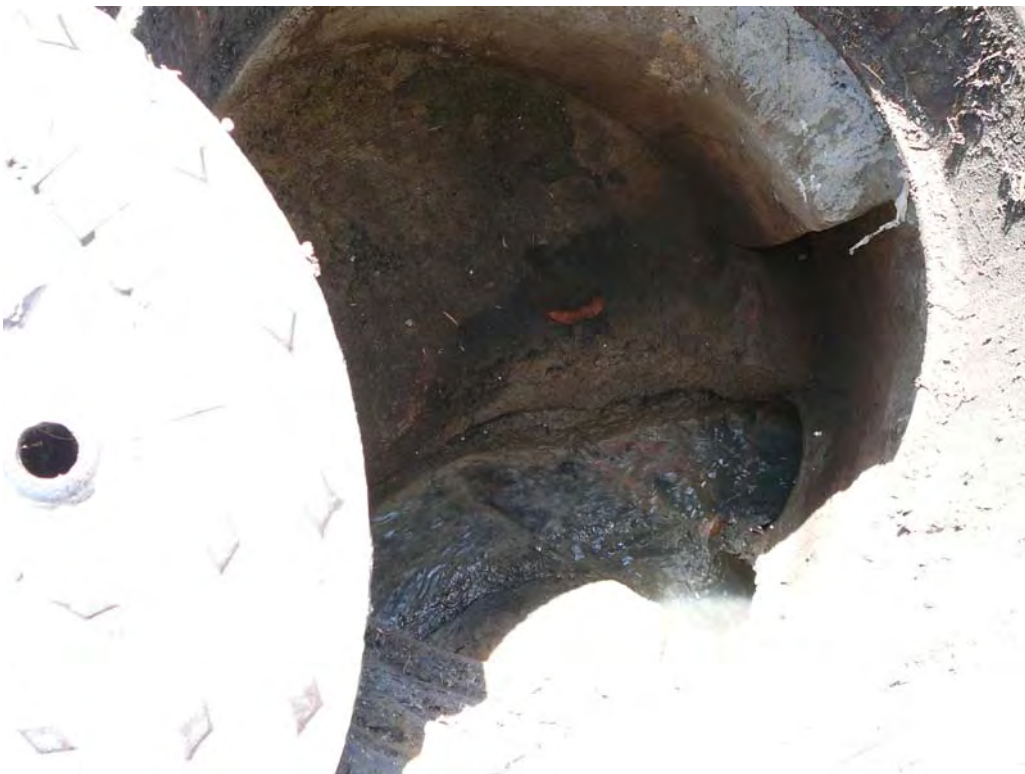
The inspection team visited the “4 Pomona” spill site (see Photo 10). This site also overflowed in 2004 and 2005. The manhole here is only two feet deep. SSD believes the spills occur because of an obstruction, but they have televised the pipes and not found an obstruction. SSD is continuing to investigate.

Photo 10 "4 Pomona" - capacity spill site
