**Memorandum**

**Date:** July 9, 2009  
**Subject:** Whitney Barrel Inspection, 256 Salem Street, Woburn, MA  
**From:** Joseph F. LeMay, RPM  
**To:** Cindy Lewis, EPA  
Susan Scott, EPA  
Heather Cote, EPA  
Jim Israel, EPA  
Bob Cianciarulo, EPA  
Jerry Keefe, EPA  
Dan Granz, EPA  
File

Superfund Records Center  
SITE: Wells G+H  
BREAK: 119  
OTHER: Whitney Barrel

**FIGURES – EPA Inspection of Whitney Barrel Property, Woburn, MA**

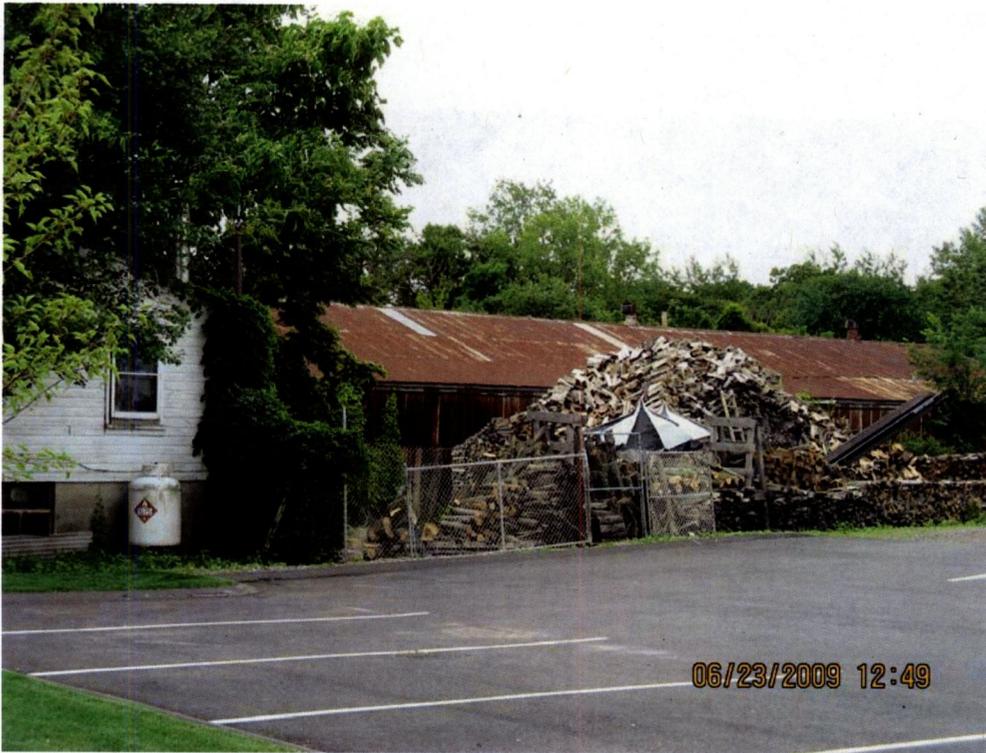
After our meeting inside the Wynn Trucking facility, we walked over to the Whitney Property for a tour/inspection. During the walk, EPA asked Mr. Whitney how many tenants he currently has on the property. Mr. Whitney stated approximately a dozen. He said most of them are associated with landscaping, tree service, and wood splitting businesses. See photograph 1.

**1: The East side of Whitney Barrel as seen from Holland Arena**

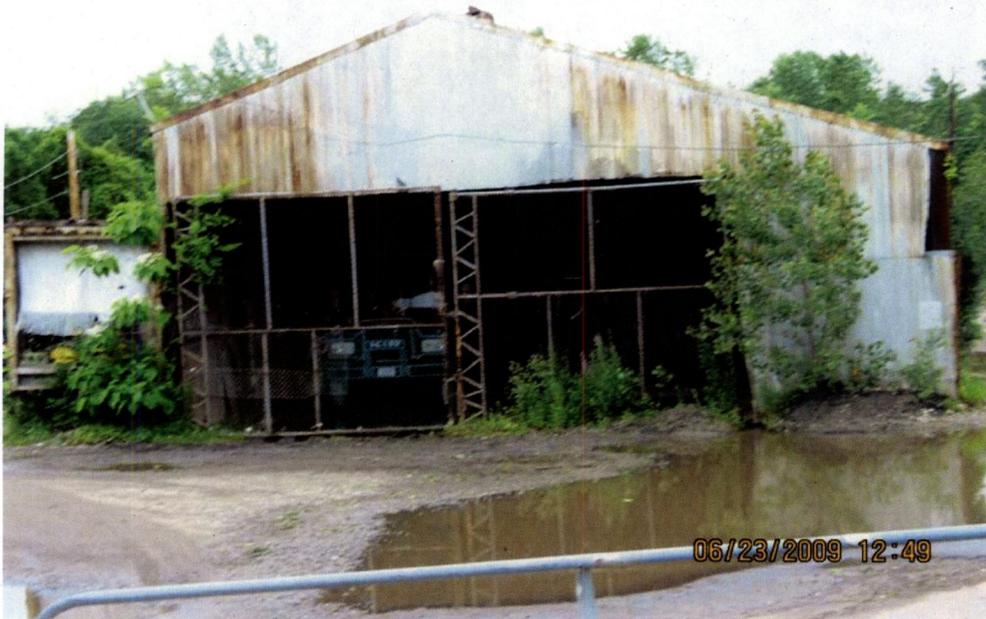
**2: The South side of Whitney Barrel as seen from Salem St. (former front platform)**

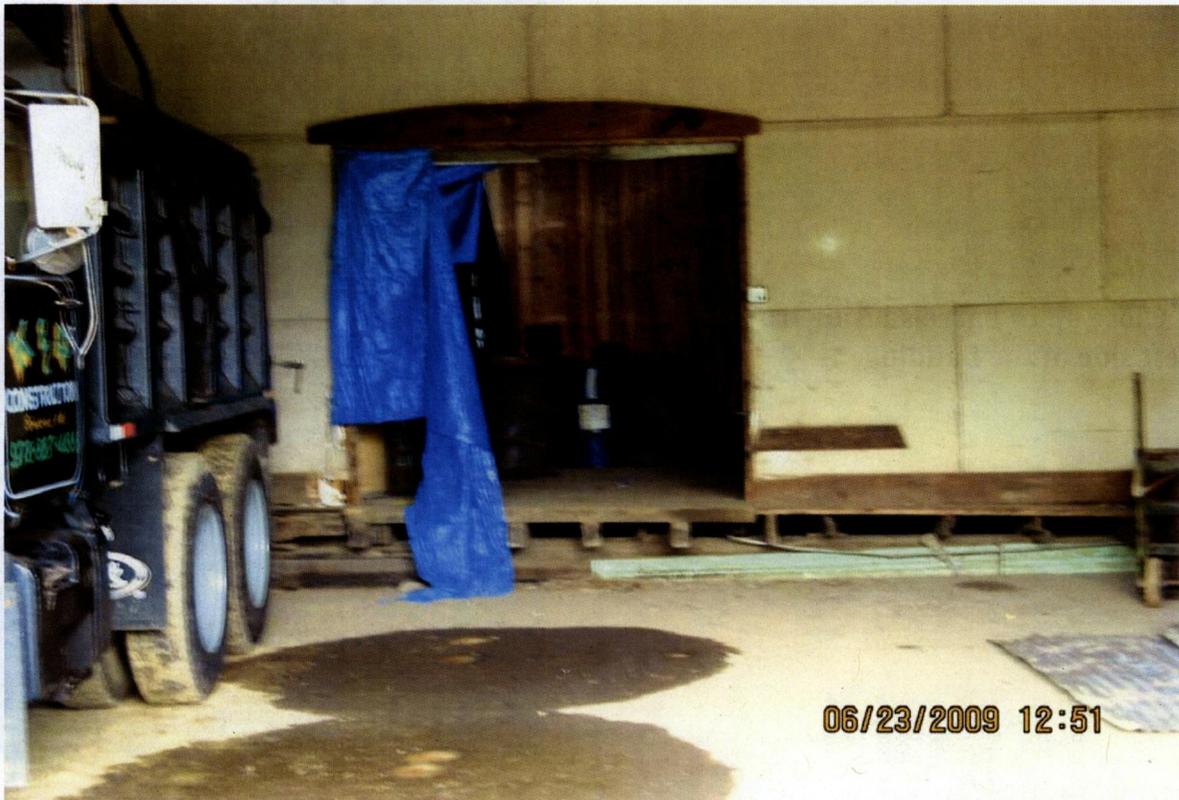
**3: The Interior of Whitney Barrel from the south entrance (former front platform)**

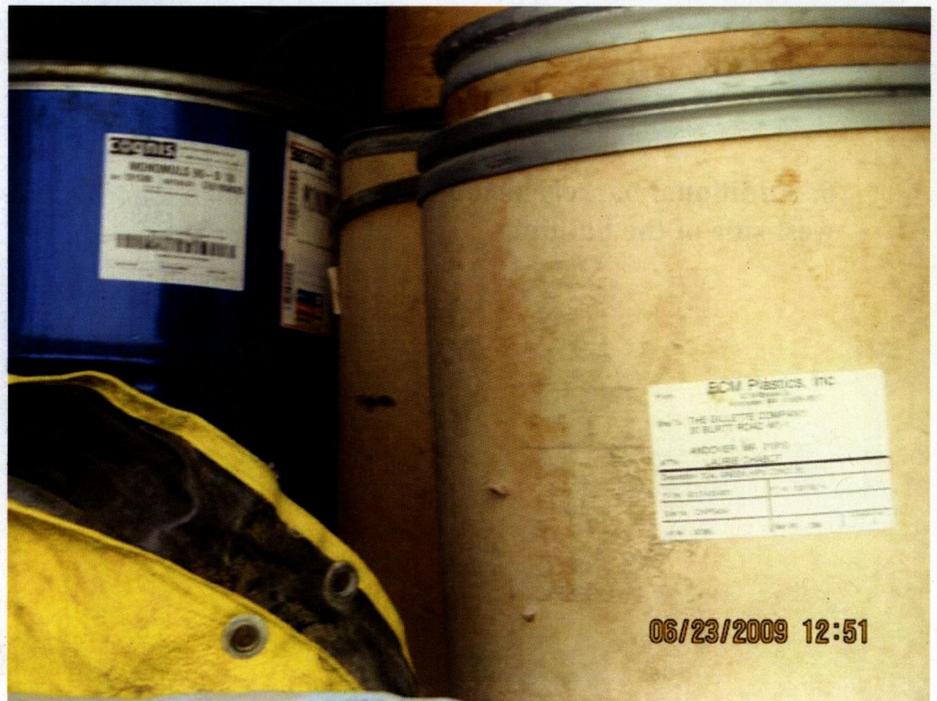
**4: Barrels inside trailers located on the west side of the building**

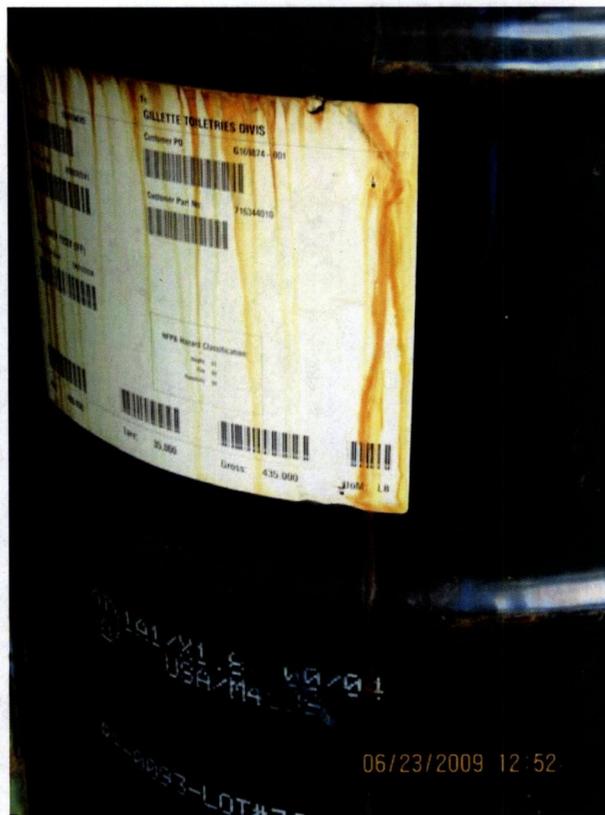
**5: Close up of barrels inside trailers on the west side of the building**

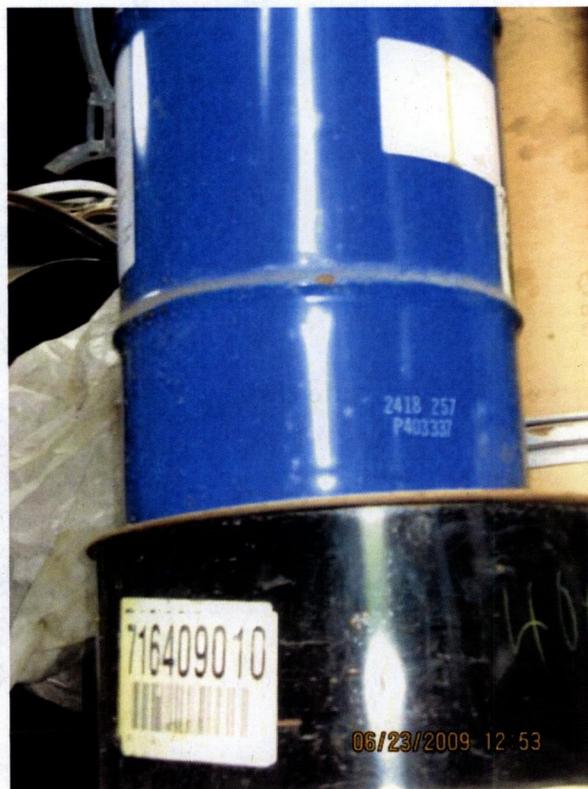
**6: Additional barrels inside trailers along the west side of the building**

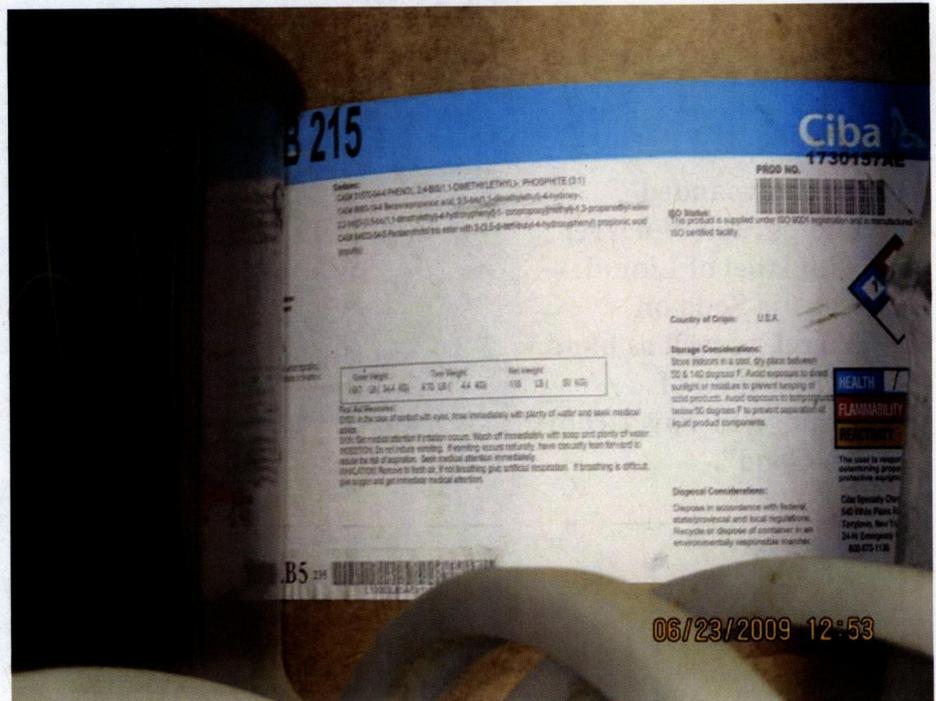
**7: A close up of a label on barrel inside trailer on the west side of building**

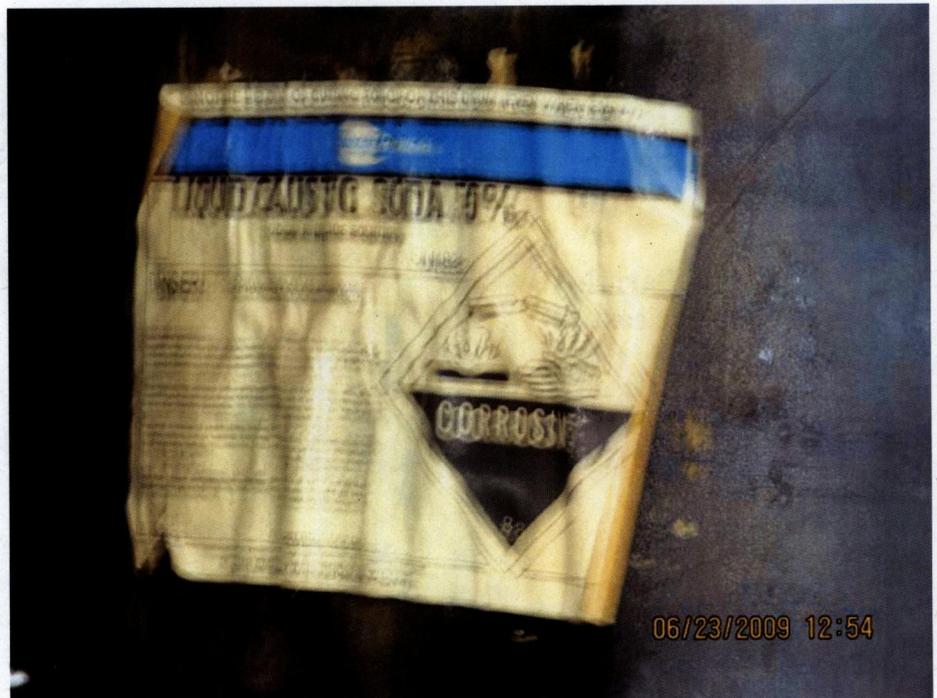
**8: A label of liquid Caustic Soda on a barrel inside a trailer along the west side of the building**

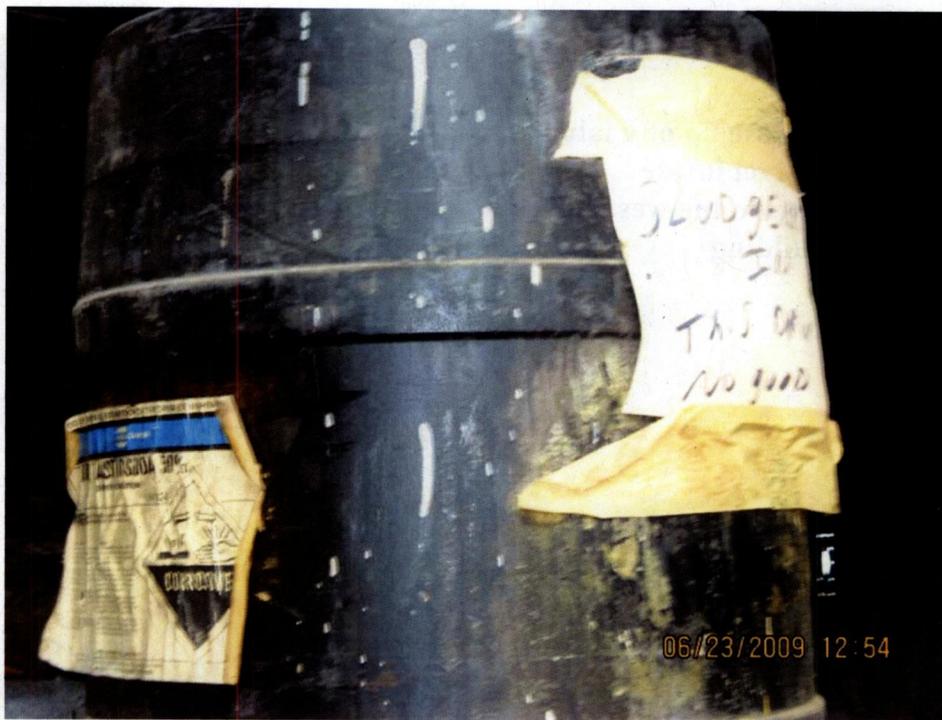
**9: An expanded photograph of barrel with label of Liquid Caustic Soda on barrel, as well as hand written sign of "Sludge In This Drum No Good".**

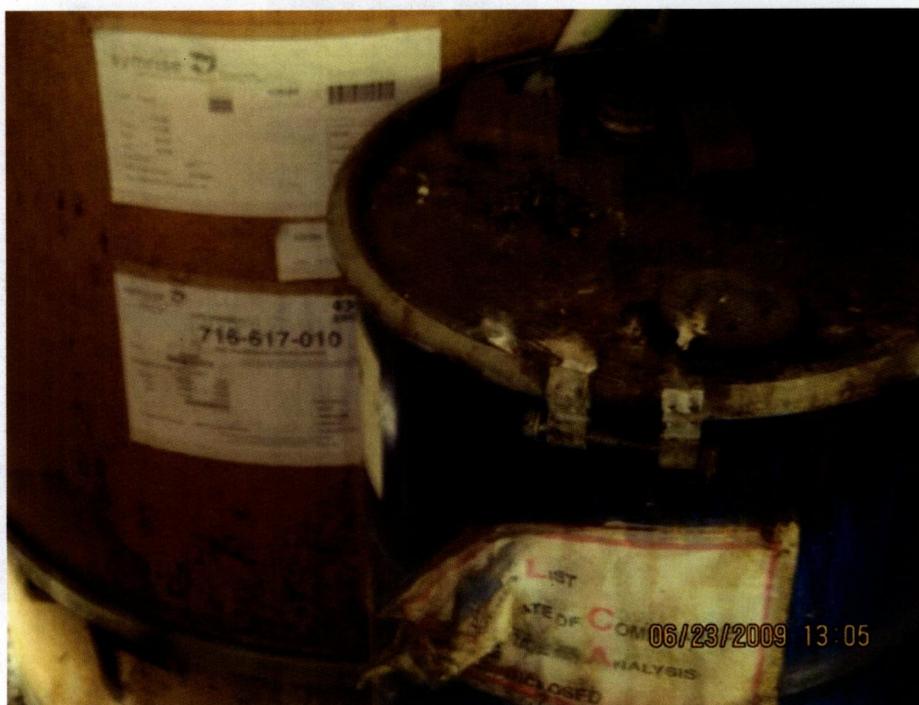
**11: The same barrels with more visible labels**

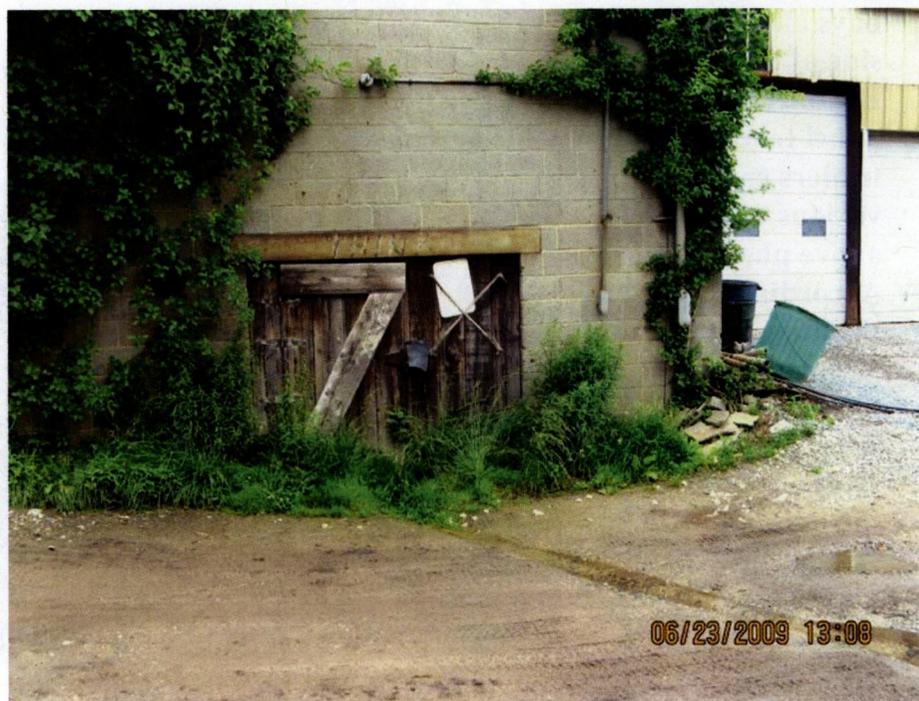
EPA met an occupant of the property, Mr. Hans Christian Anderson (Mr. Anderson lives in a trailer on the property). Mr. Anderson had a key to the boiler room, and unlocked the door for EPA to inspect the boiler room. As mentioned previously, the floor consisted of broken up stone and soil. It was very muddy and musty inside. Some surface water was inside the room. Portions of the surface water entered the room from the south, exited the room to the west, and discharged into a portion of the Murphy Wetland. The boiler and oil tank appeared to have been removed long ago from the room. There were windows on the south and north side of the room and concrete block wall to the east (there was no connection to the existing northern building – although, uncertain what the access conditions were in the original building prior to northern building being constructed in 1978). Currently, the boiler room was used for storage by Mr. Anderson. It did not look like things have been moved around the boiler room for some time. Much of the metal items within the room were rusted. A couple of four-draw metal filing cabinets were inside being used as table legs. The draws did not appear to

**12: Former Boiler Room situated in the northeast corner of the building, with standing water leading from the door and flowing west to the Murphy Wetland.**

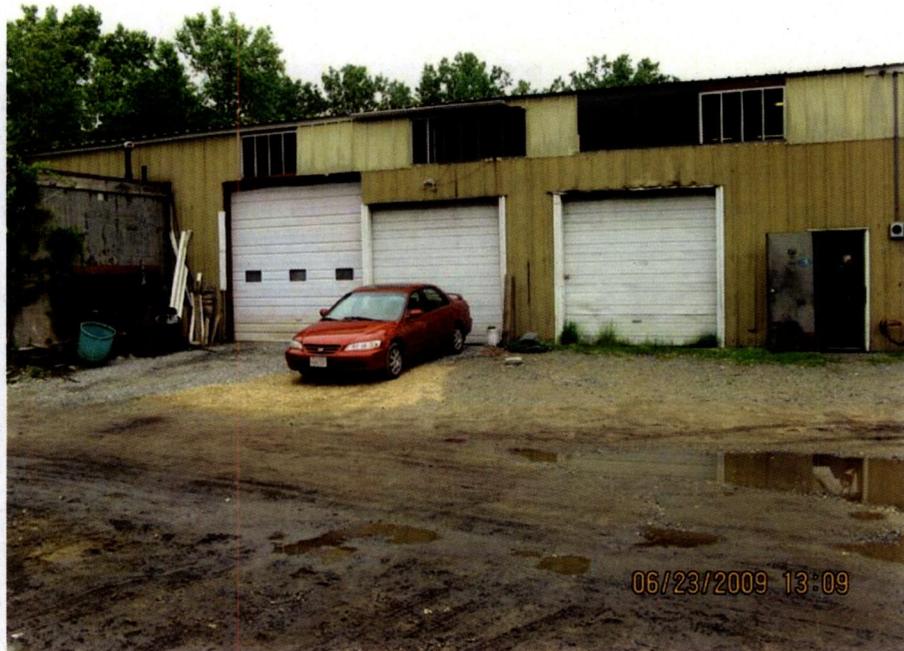
**13. Garage bay along the west side of the building, just south of Boiler Room. The foundation in this northern portion of the building contains a concrete slab and foundation (100' x 40').**

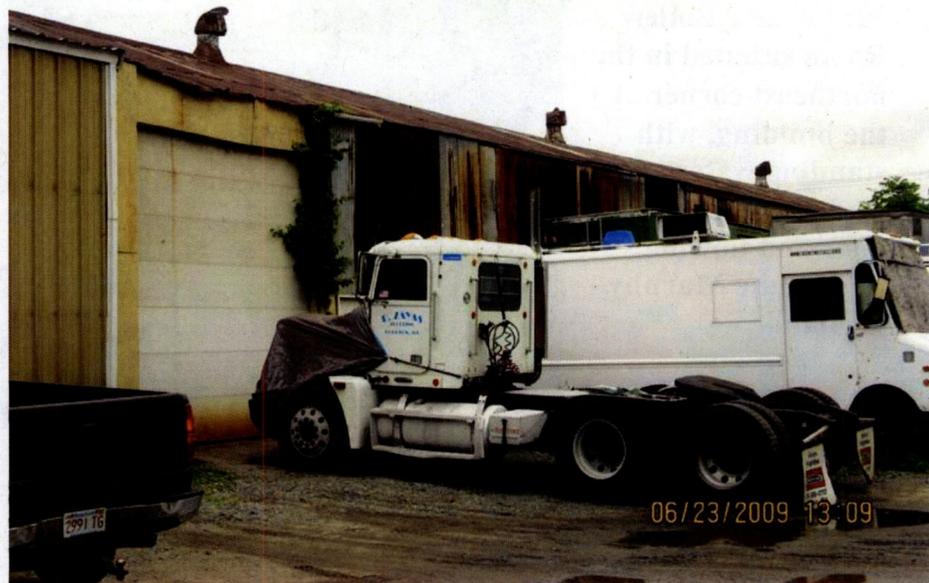
**14. Trucks and additional garage bays along the west side of the building. Behind the white panel truck are 3 trailers containing various drums (see above photographs). According to Mr. Whitney, all drums are empty. The photograph also illustrates the southern portion of the building with rusted sheet metal and roof vents, and containing a plywood floor.**

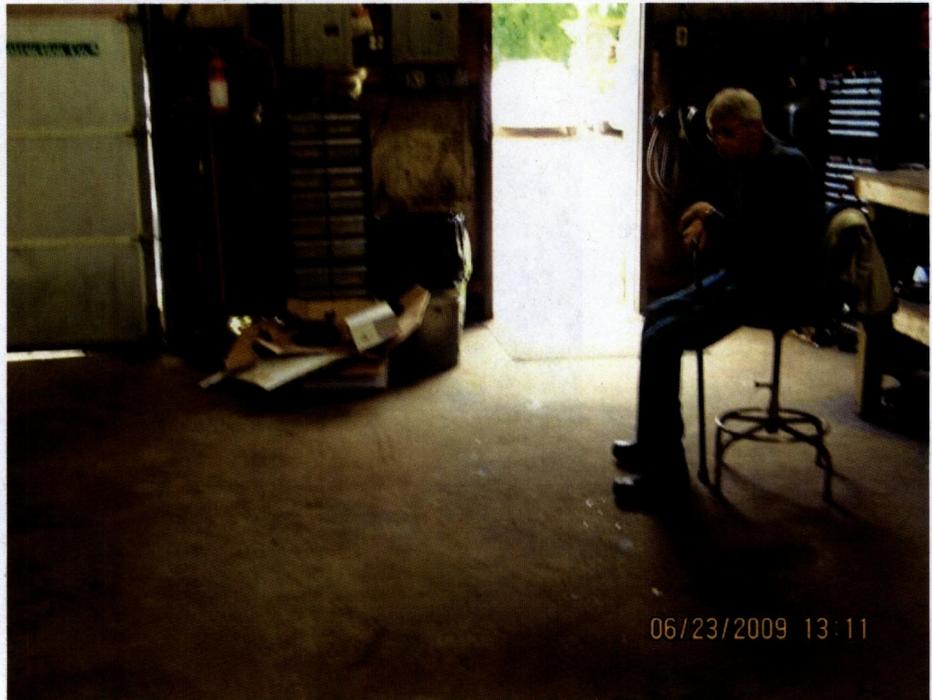
**15. Interior of the west side of the building (inside one of the garage bays). The floor is a concrete slab connected to a concrete foundation along the exterior walls.**

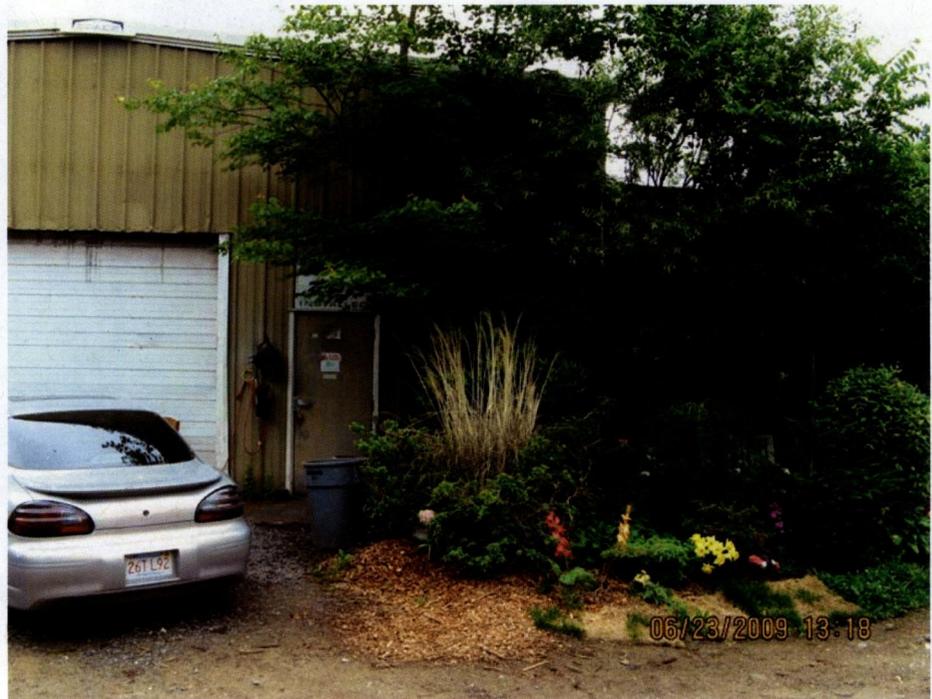
**16. The exterior of the north side of the building. The boiler room is to the right (west) extending off the building and hidden behind some vegetation. Historically, this garage door bay was where drums were brought into the building to be cleaned.**

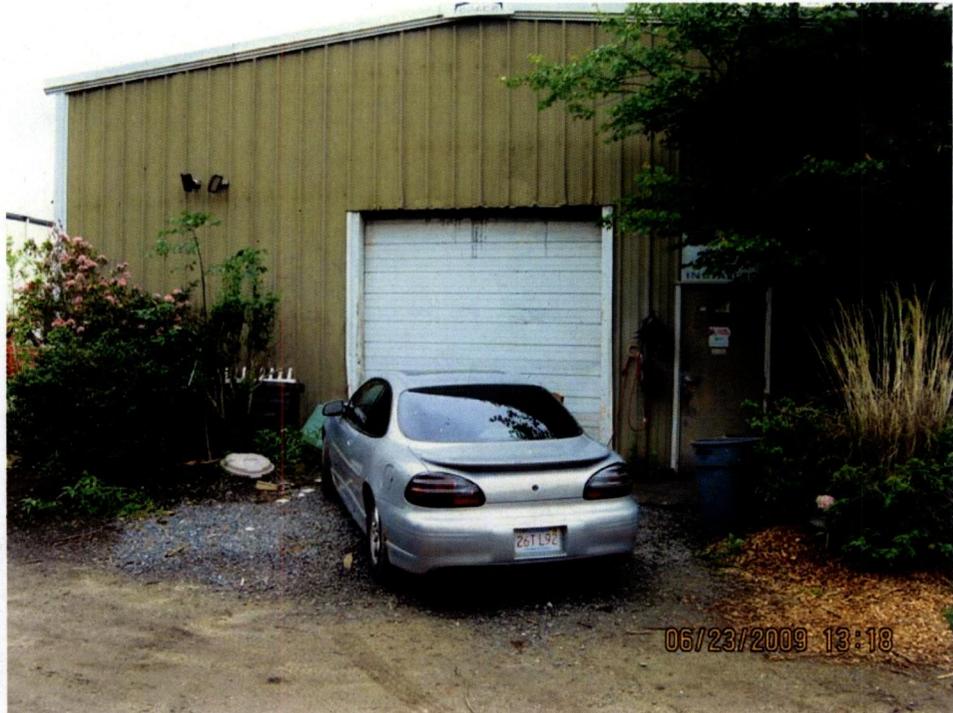
**17. Garage bay at the north side of the building. This garage bay was where drums were historically brought into the building to be cleaned.**

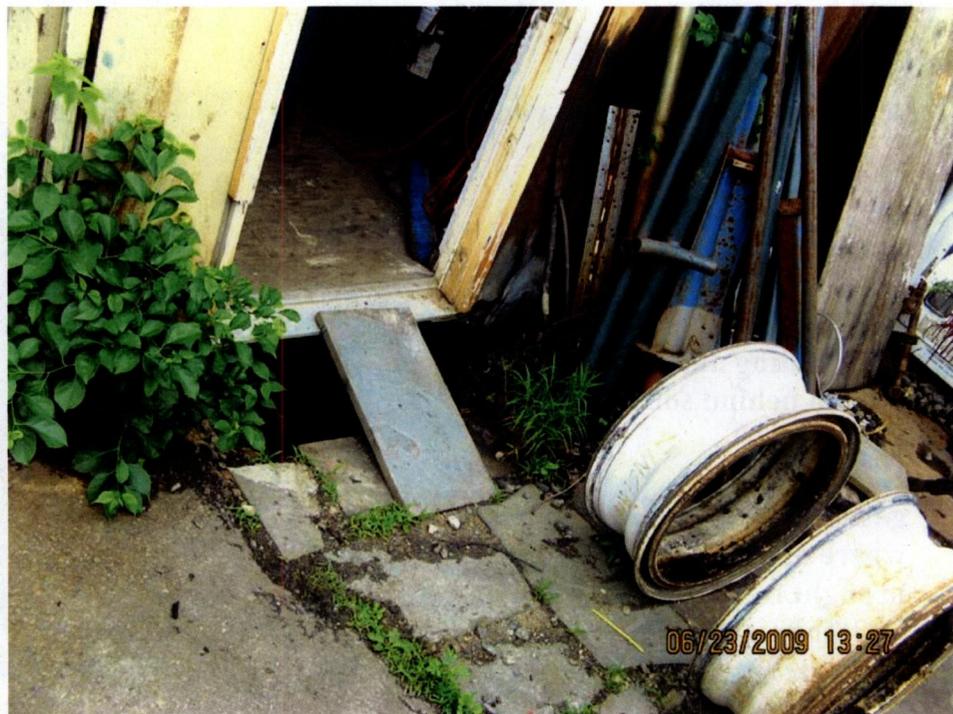
**18. A doorway on the west side of the southern portion of the building showing gap in foundation. The foundation appears to be on the ground.**

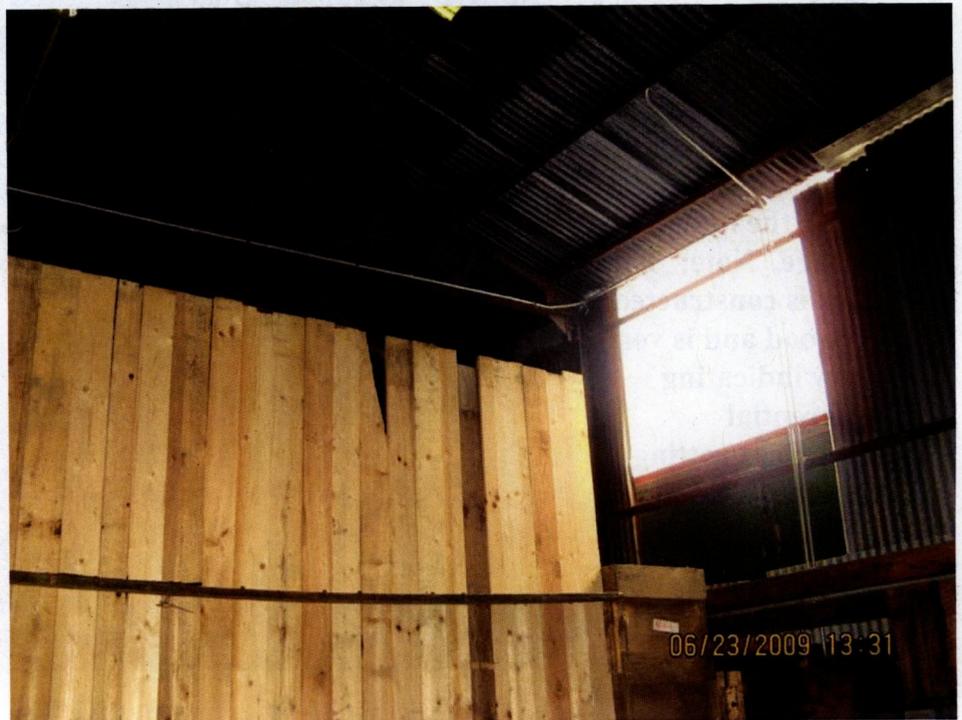
**19. The interior of the southern portion of the building facing south. The southern interior was divided with wooden planks (separating it from the southern entrance of the building). Sheet metal is missing along the west side of the southern portion of the building.**

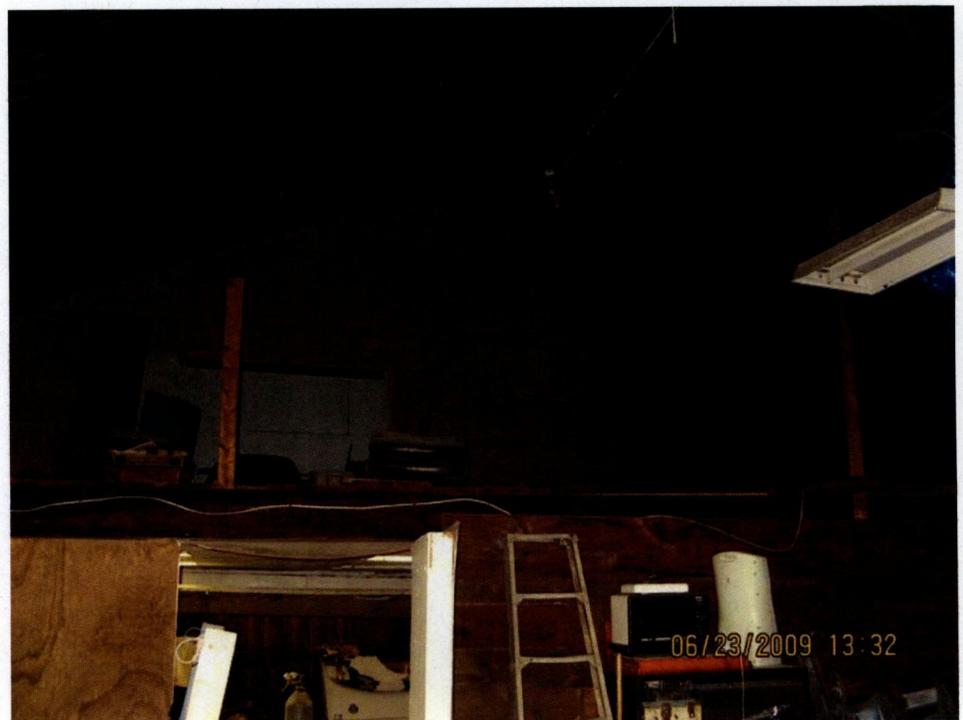
**20. The interior of the southern portion of the building facing north, showing a lofted storage area.**

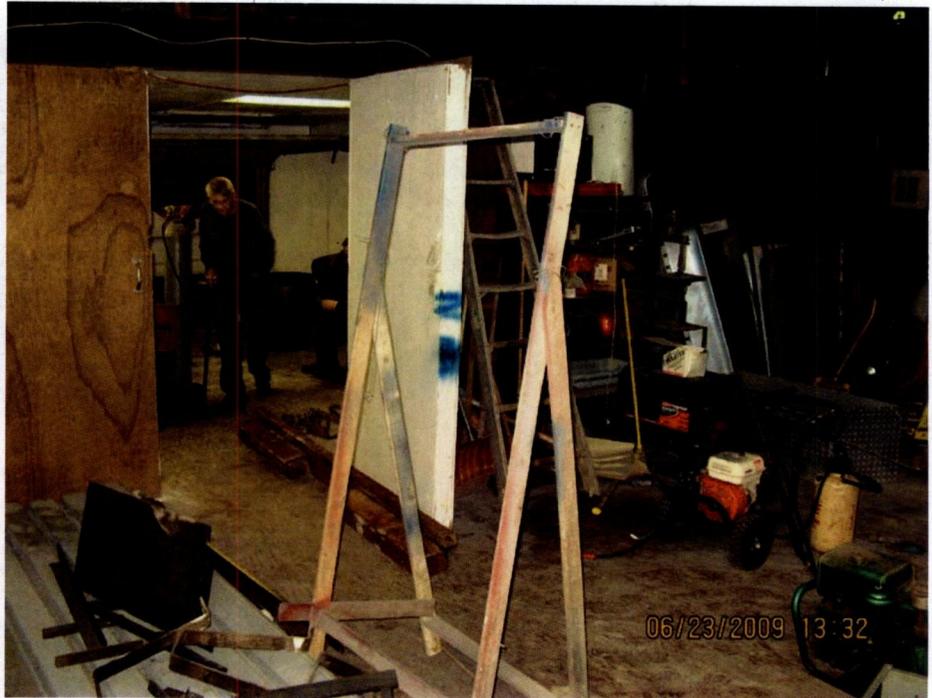
**21. The interior of the building facing north, showing work area under the lofted storage. Note: The floor is constructed of plywood and is very wavy indicating differential settlement/rotting wood.**

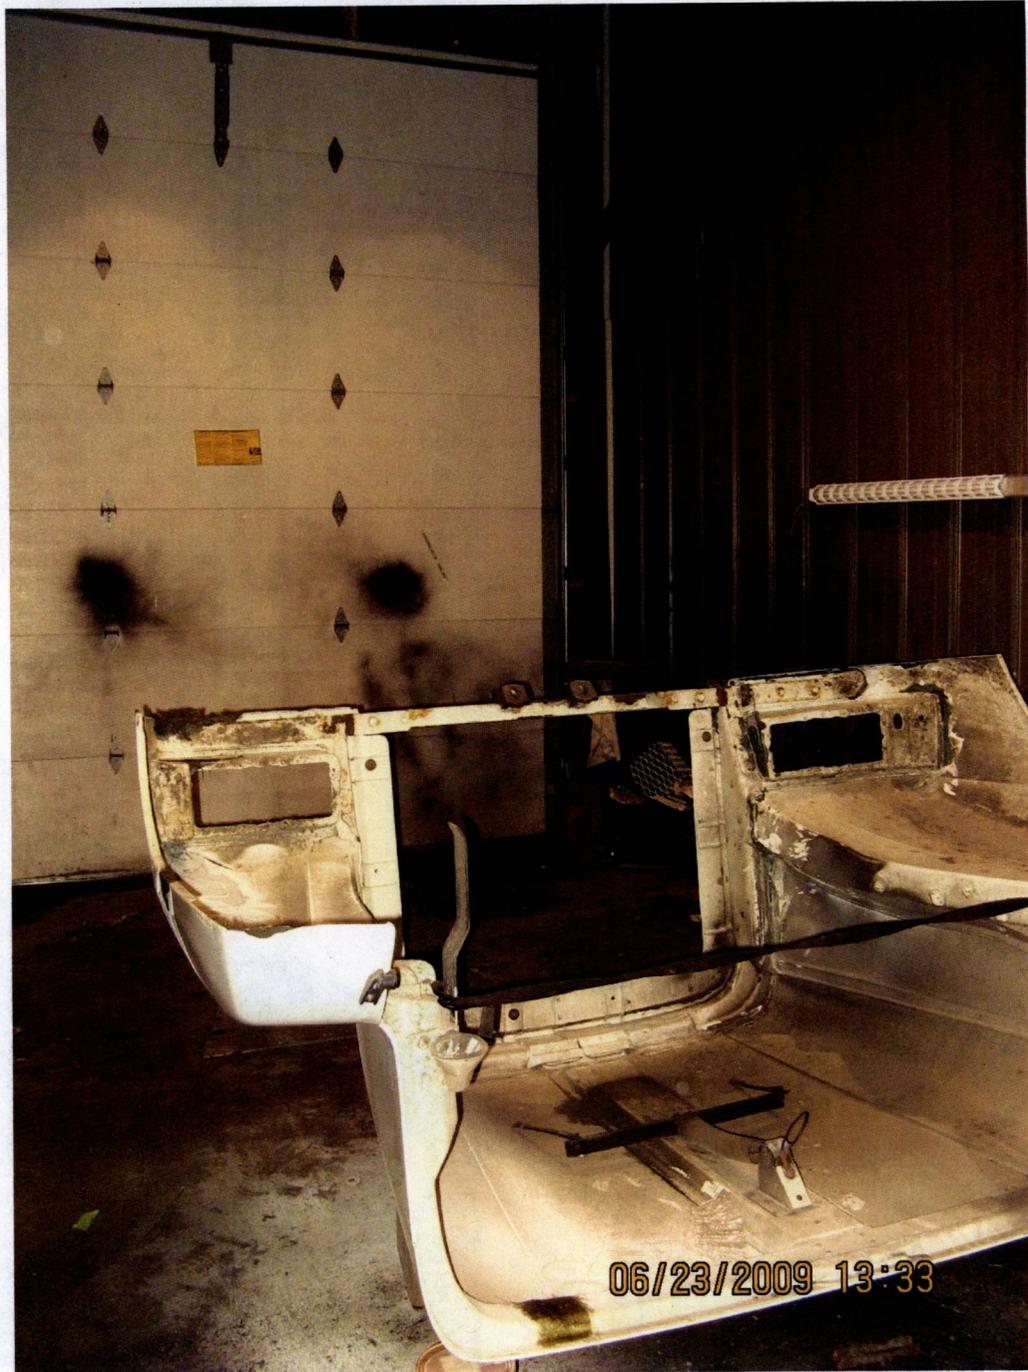
22. A garage bay door on the west side of the southern portion of the building. The hood of a truck is on the plywood floor.

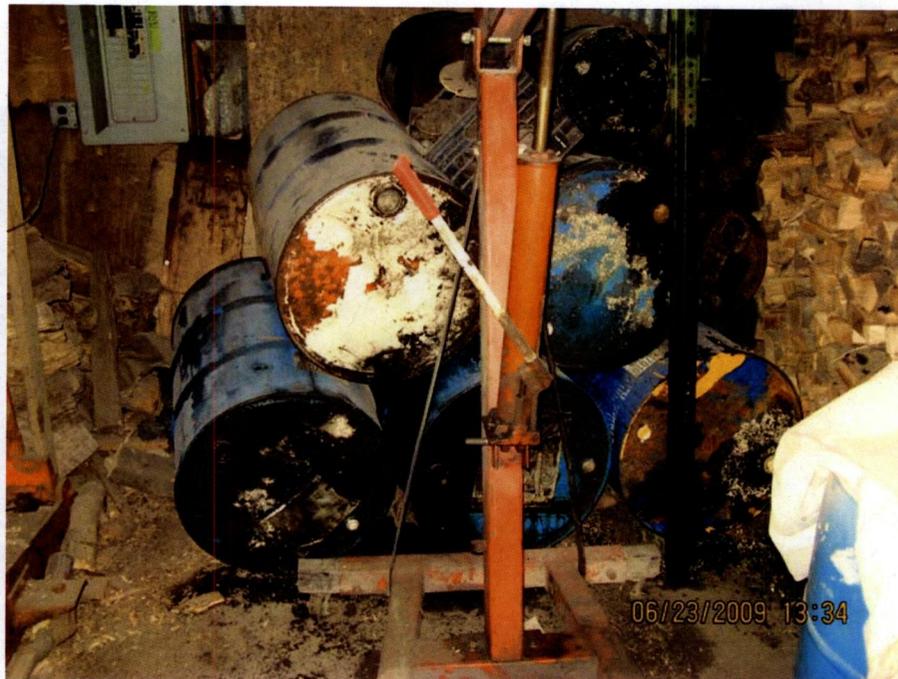
**23. Decaying barrels stored along the interior of the east side of the southern portion of the building. Lessee suggested the barrels belonged to Mr. Whitney (obtained from the property), but he used them for storing waste oil. According to the lessee, the barrels were currently empty.**

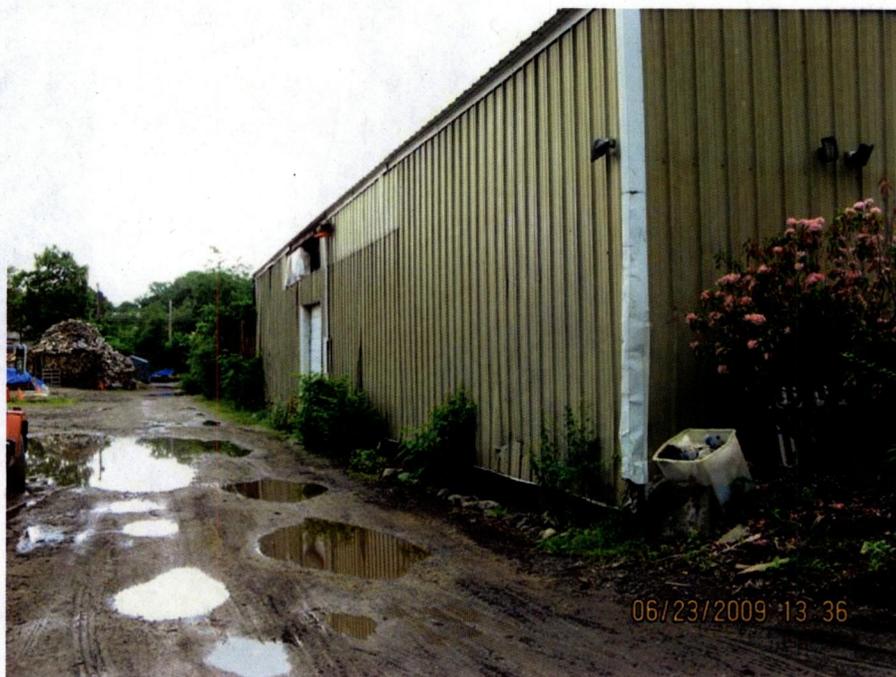
**24. The exterior east wall of the building, facing south. Painted sheet piling exterior denotes northern portion of building with concrete slab and foundation.**

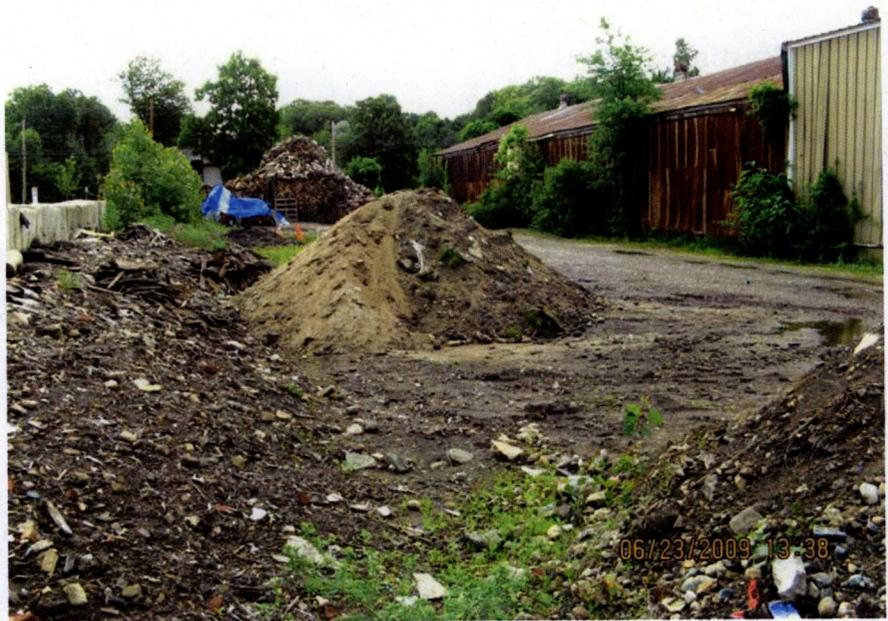
**25. Piles of debris along the eastern edge of the property. It appears much of the historical debris, equipment and vehicles from this east side of the property have been removed over the past couple of years. Rusted sheet piling exterior denotes southern portion of building with plywood flooring and likely earthen foundation.**

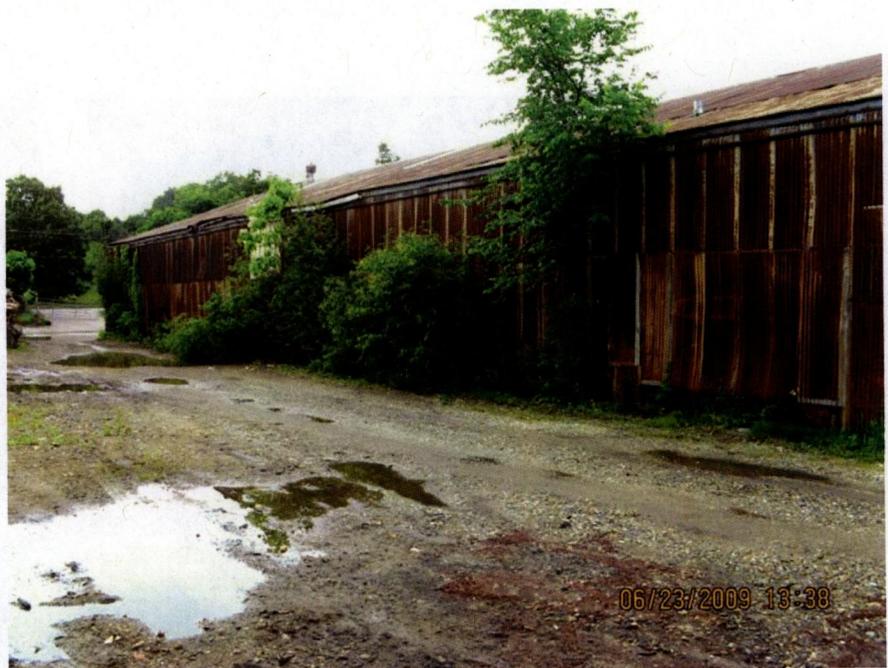
**26. Rusting corrugated sheet metal that makes up the eastern wall of the southern portion of the building. The foundation is exposed in areas where sheet metal does not extend to the ground. In these exposed areas water is pooled under the building (see photographs below).**

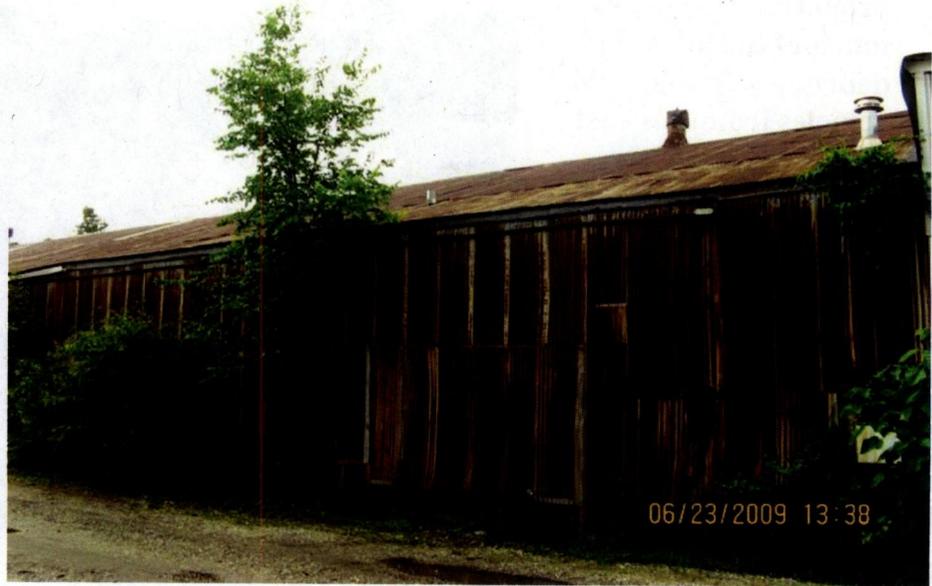
**27. Rusting sheet metal exterior of the southern portion of the building, as well as various roof vents and holes in the bottom sheet metal exposing areas of the foundation.**

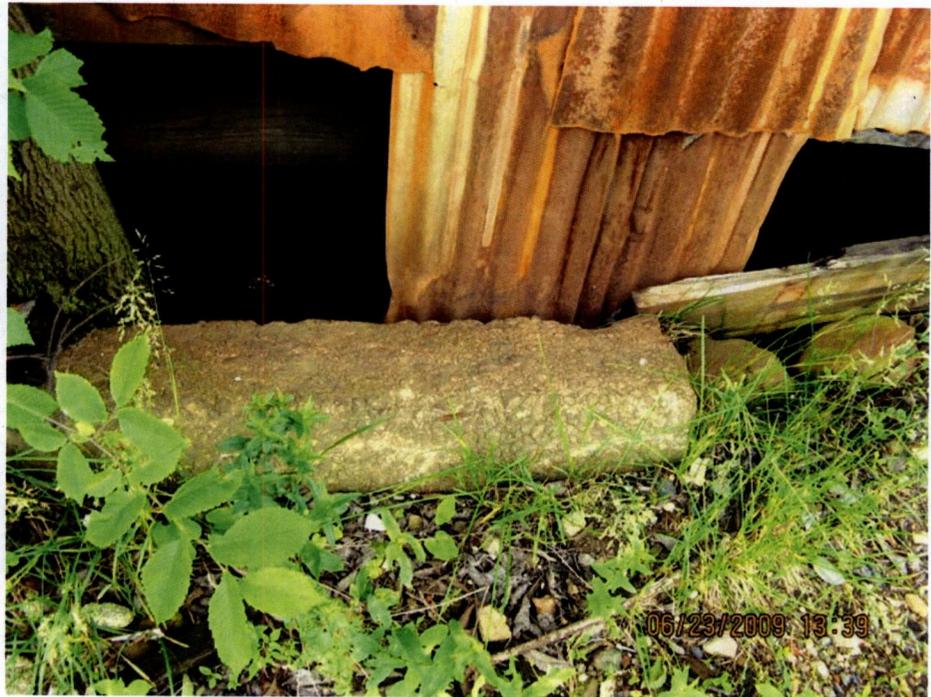
**28. Gap between the building and foundation showing standing water underneath the building.**

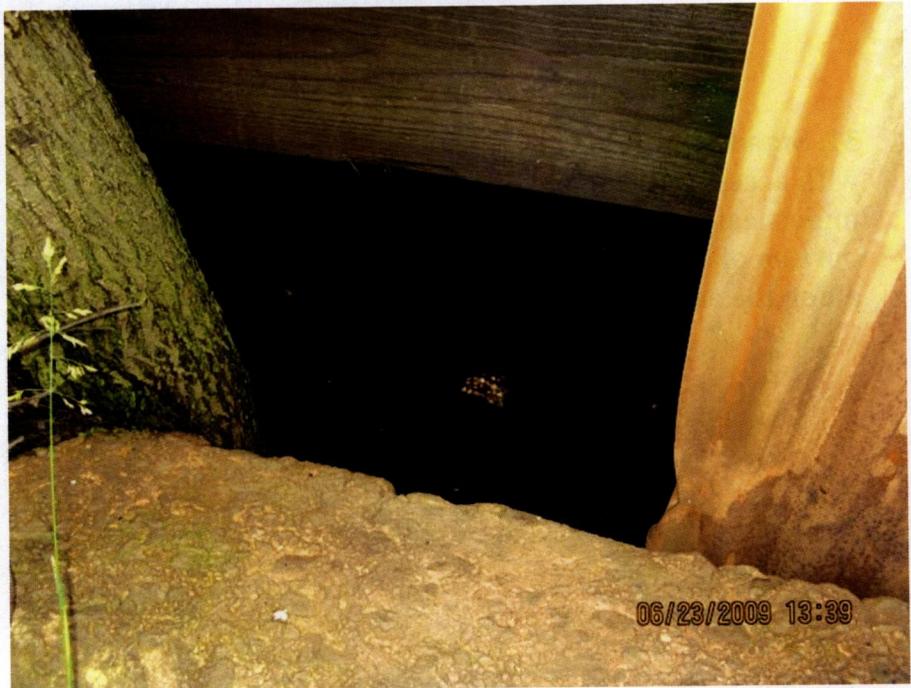
**29. Same gap showing standing water directly underneath the building**

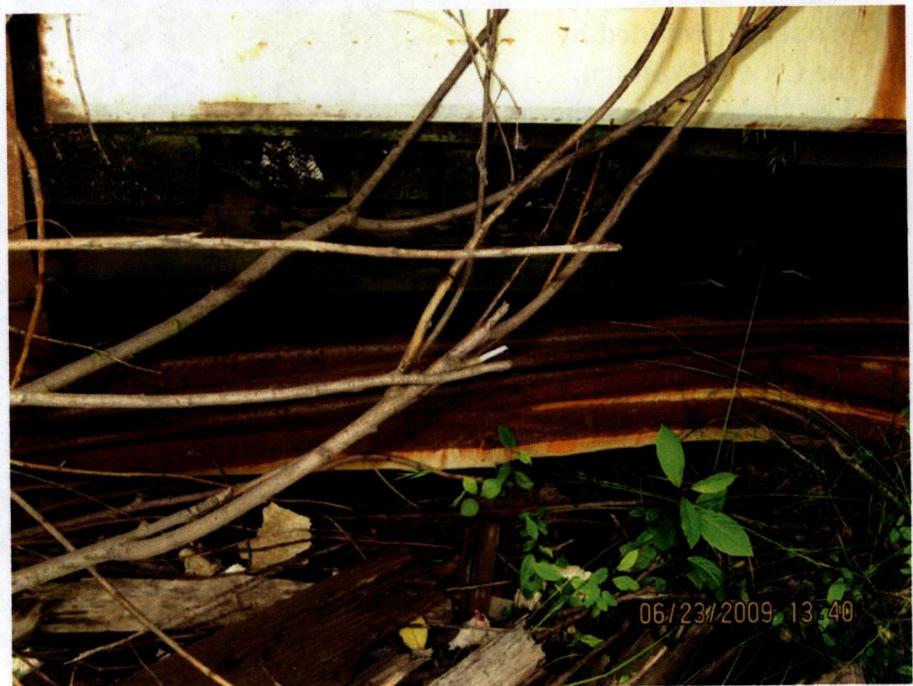
**30. Debris in front of another gap between the building and foundation along the eastern side of the building**

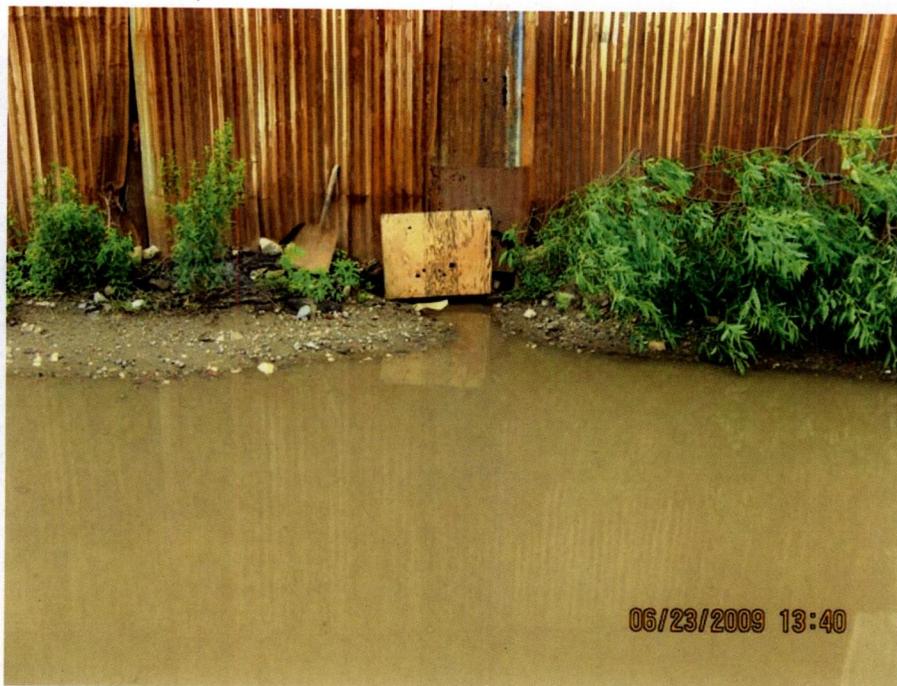
EPA walked along the east side of the building. Since construction of the adjacent hockey rink, it appears Mr. Whitney has removed some vehicles/equipment/ trailers from this area. There were a few piles of dirt/debris, but generally this east side was clearer than it has ever been in the past. Surface water was observed pooled against and under sections of the southern portion of the building (rusted sheet metal exterior). Looking through holes in the sheet metal at the ground underneath the plywood flooring, surface water was observed standing under the building. See photographs 24-31.

**31. Standing water with access to the gap underneath southern portion of building along the eastern wall**

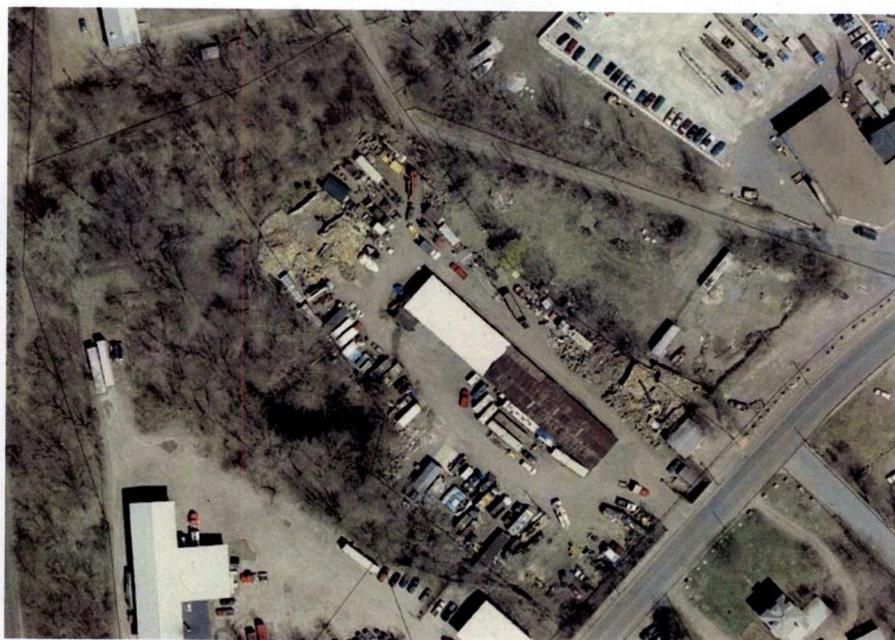
**32. 2006 aerial photograph of Whitney Barrel property provided by the City of Woburn. The rusted roof of the southern portion of the building and white roof of the northern portion of the building are clearly visible in the photograph. The 4 trailers (3 side by side) are visible at the southwest corner of the southern portion of the building, and represent their current location on the property. A greater degree of debris is visible along the east side of the property.**
