DEPARTMENT OF THE ARMY  
NEW ENGLAND DISTRICT  
CORPS OF ENGINEERS  
CONCORD, MASSACHUSETTS

INVESTIGATION OF LYMANSVILLE AND MANTON DAMS  
WOONASQUATUCKET RIVER, RHODE ISLAND

MAY, 2005

LYMANSVILLE AND MANTON DAMS  
WOONASQUATUCKET RIVER, RHODE ISLAND

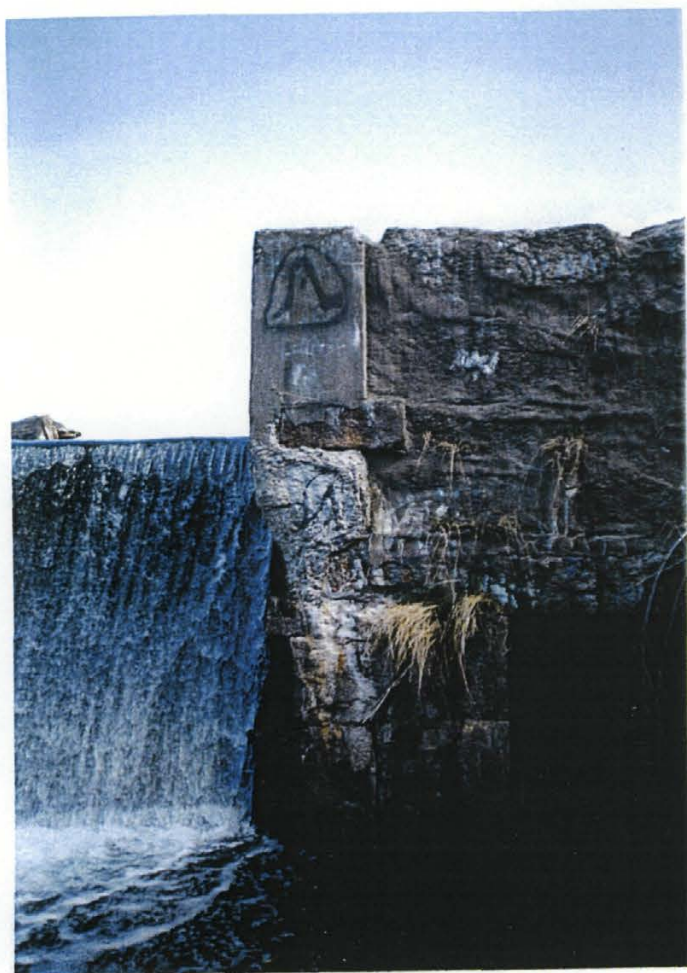
The east abutment is a concrete wall poured against the stone blocks of gate structure 2. There is a 7' long x 1.5' wide and 9" deep spall at the left end of the abutment. A moderate amount of abrasion has exposed the aggregate where the abutment joins the spillway. The downstream portion of the wall is in good condition. The stones are well bonded and aligned.

| TEAM MEMBER CHECKLIST FOR INSPECTION | | |
|---|---|---|
| Spalls | | 7' long x 1'-6" wide x 9" deep spall at the corner of the wall |

Photo 2: 7' long x 1'-6" wide x 9" deep spall at the corner of the east abutment of the spillway. *Note: the vegetation growing at the joints of gate structure #2.*

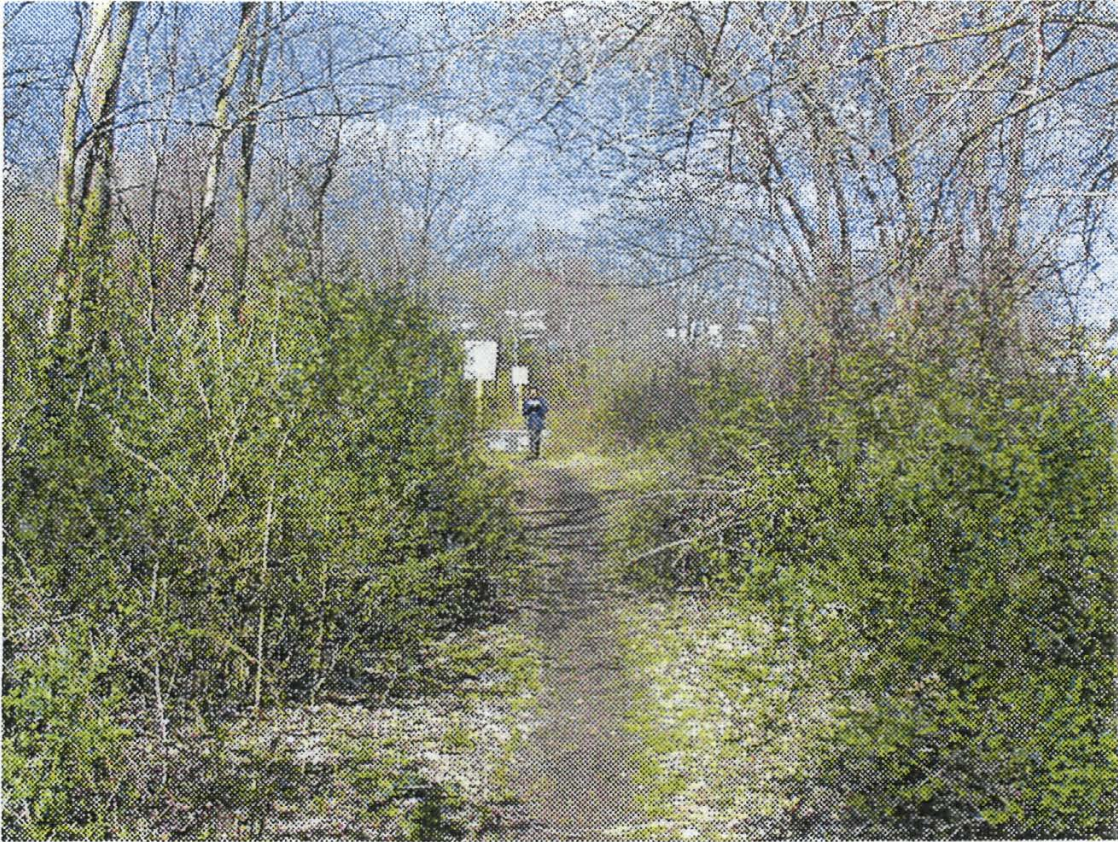
Photo 3 – Dam crest on left embankment showing heavy tree and brush growth.

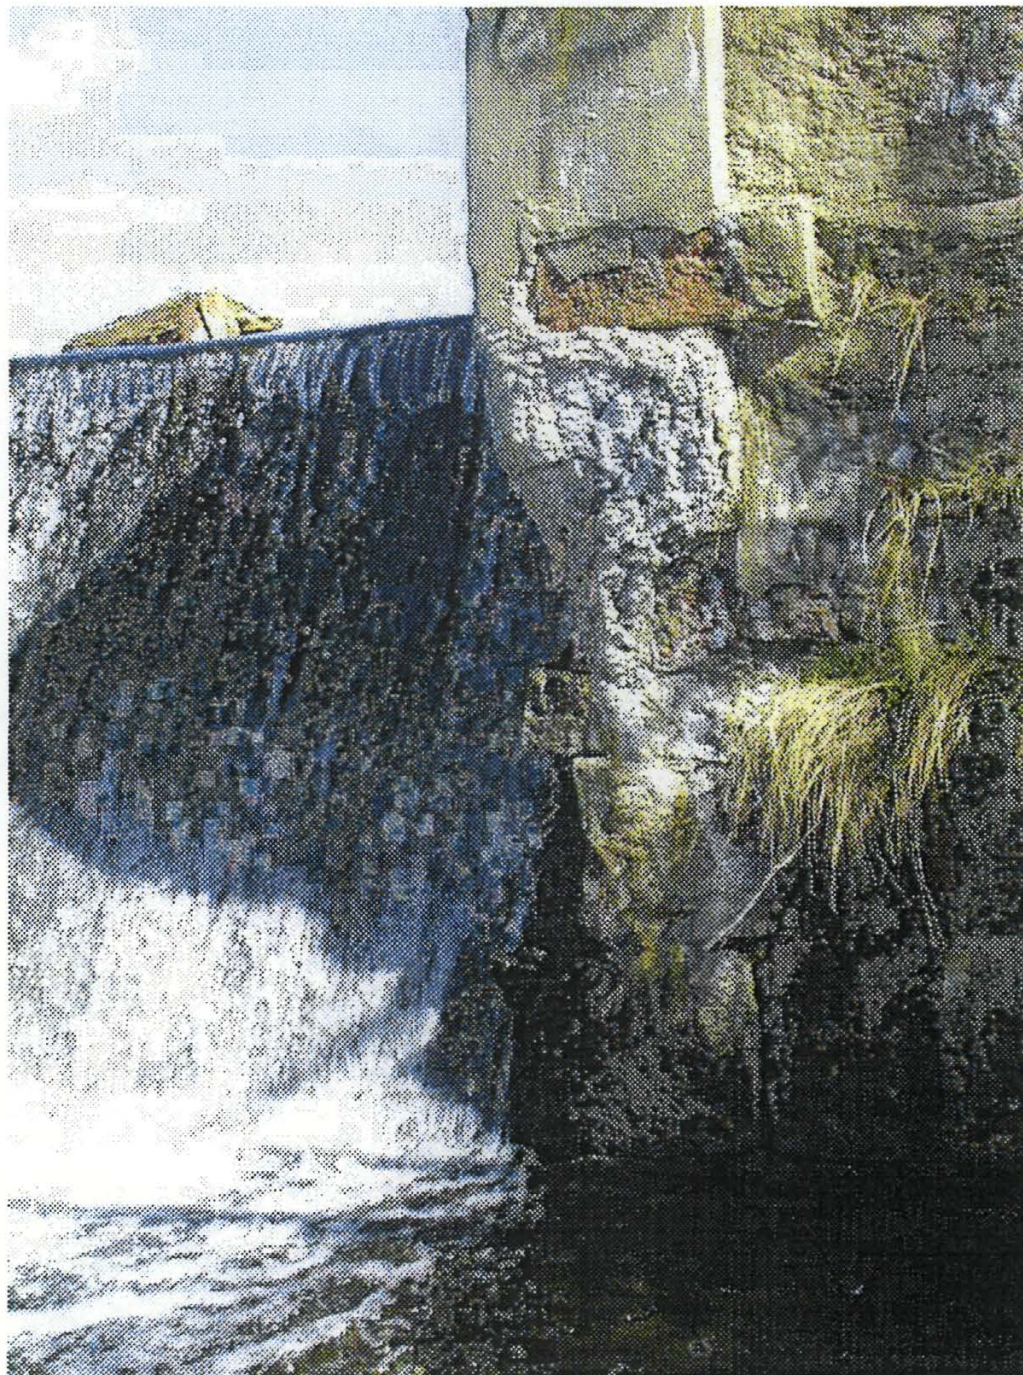
Photo 7 - Spalling concrete on outlet works on left side of spillway.

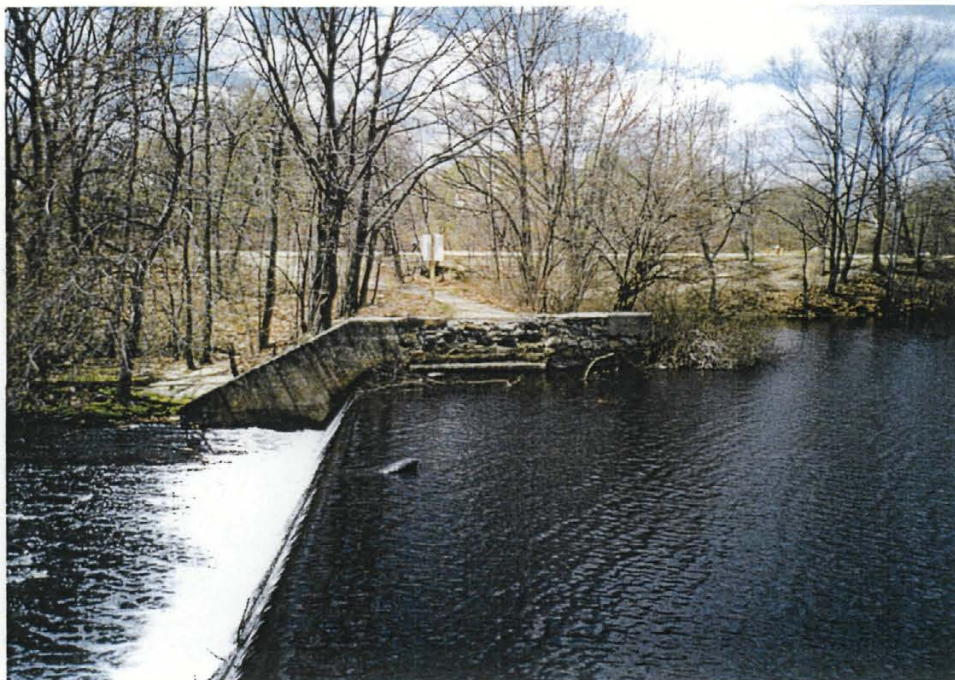
The overall condition of the west abutment is good. The concrete facing over the existing stonewall has spalled off of the inside face of the wall for a length of approximately 10'-0", exposing the inner stone core. The stone core is well bonded and shows no signs of movement or deterioration. The facing is also missing for the full width of the wall and for 4'-0" +/- along the top surface of the wall. Otherwise, the concrete is sound and in good condition elsewhere along the wall. There is minor abrasion of the wall at the intersection with the spillway, both at the crest and on the downstream face.

| TEAM MEMBER CHECKLIST FOR INSPECTION | | |
|---|---|---|
| Spalls | | Concrete facing covering the original stone abutment has spalled away exposing 10' of wall. Concrete is also missing from the entire horizontal portion fo the west abutment. |

Photo 1: Concrete facing of the stone core wall has spalled off at the west abutment wall. Note: the debris caught at the 12x12 timber beam of the old spillway wall.

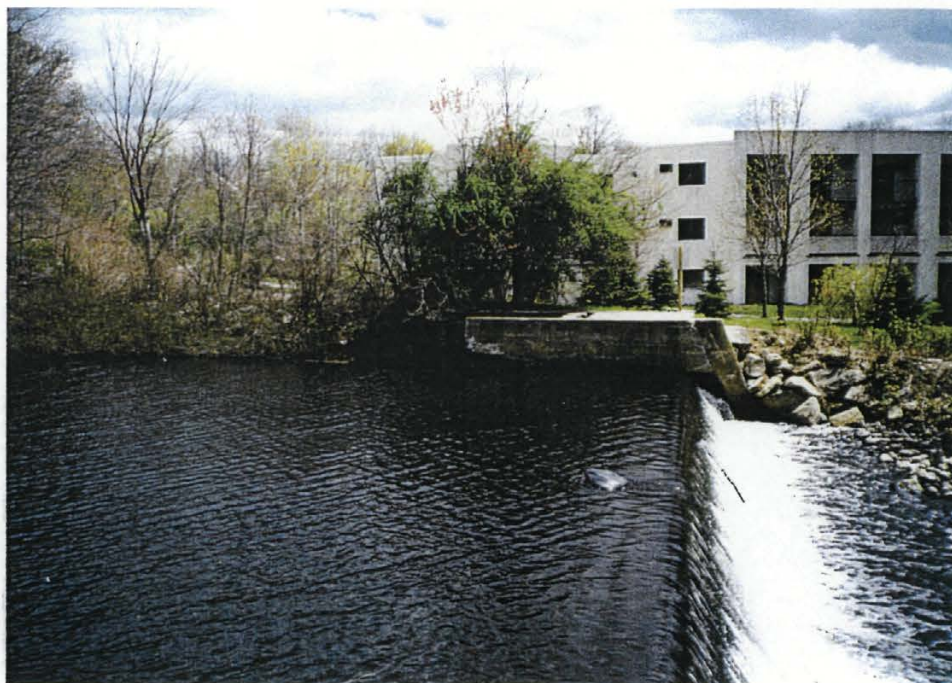
The overall condition of the east abutment is poor. There is a spall with exposed rebar starting at the upstream end of the wall that continues along the water line the length of the spillway. The concrete around the spall is unsound and severely abraded at the water line. There is a 2'-0" by 2'-0" triangular spall between the horizontal and vertical portions of the east abutment. Hairline cracks with minor efflorescence spider web across the spillway face of the wall. Erosion has undermined the upstream end of the east abutment.

Photo 2: East abutment wall. Note: the spall with exposed rebar at the upstream/leading end of the wall.

- a. Repair the east abutment. Replace the missing concrete. Remove and replace any unsound concrete. Repair the cracks.
- b. Replace the gates and their support structure. The flow through the gate will be stopped. New gates will facilitate operations during emergencies, inspections and future construction/repair operations.

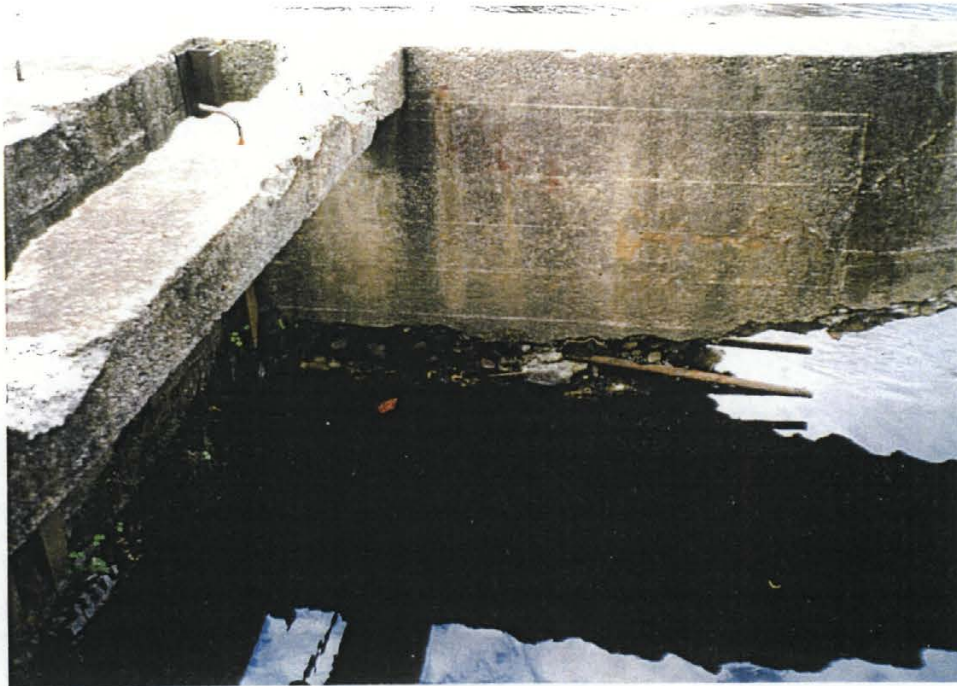
Photo 3: 6' long x 3' high x 1'-4" deep spill with exposed rebar at the east abutment wall. *Note: the deteriorated concrete around the gate stem opening of the gate structure.*

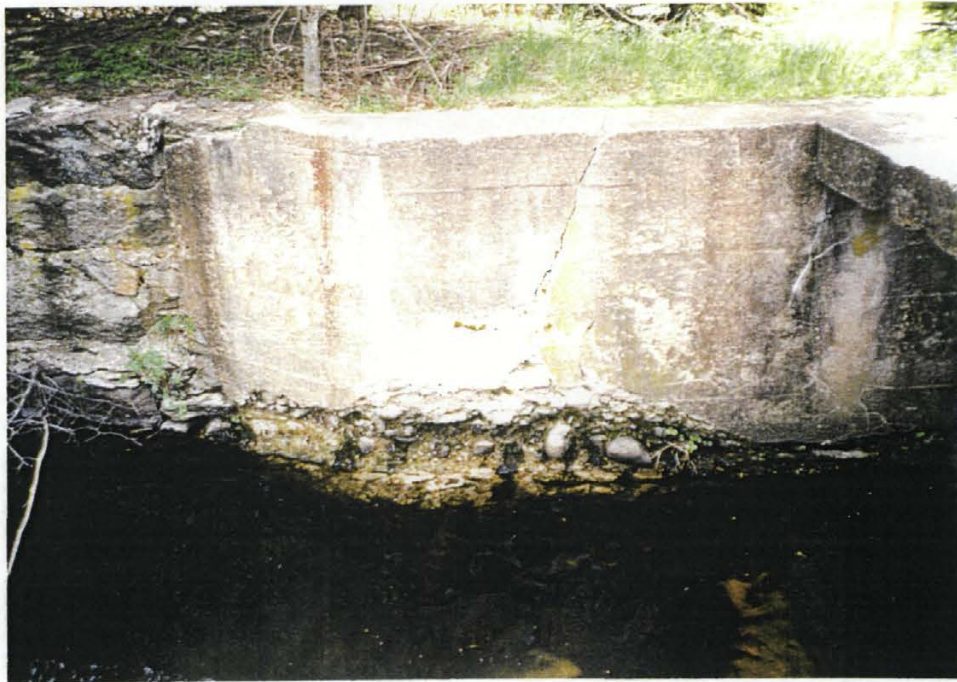
Photo 4: Two full height cracks, measuring up to 1/2" thick x 1'-4" deep at the east training wall of the gate structure. *Note: the deteriorated concrete, up to 3" deep, at the bottom of one of the cracks.*

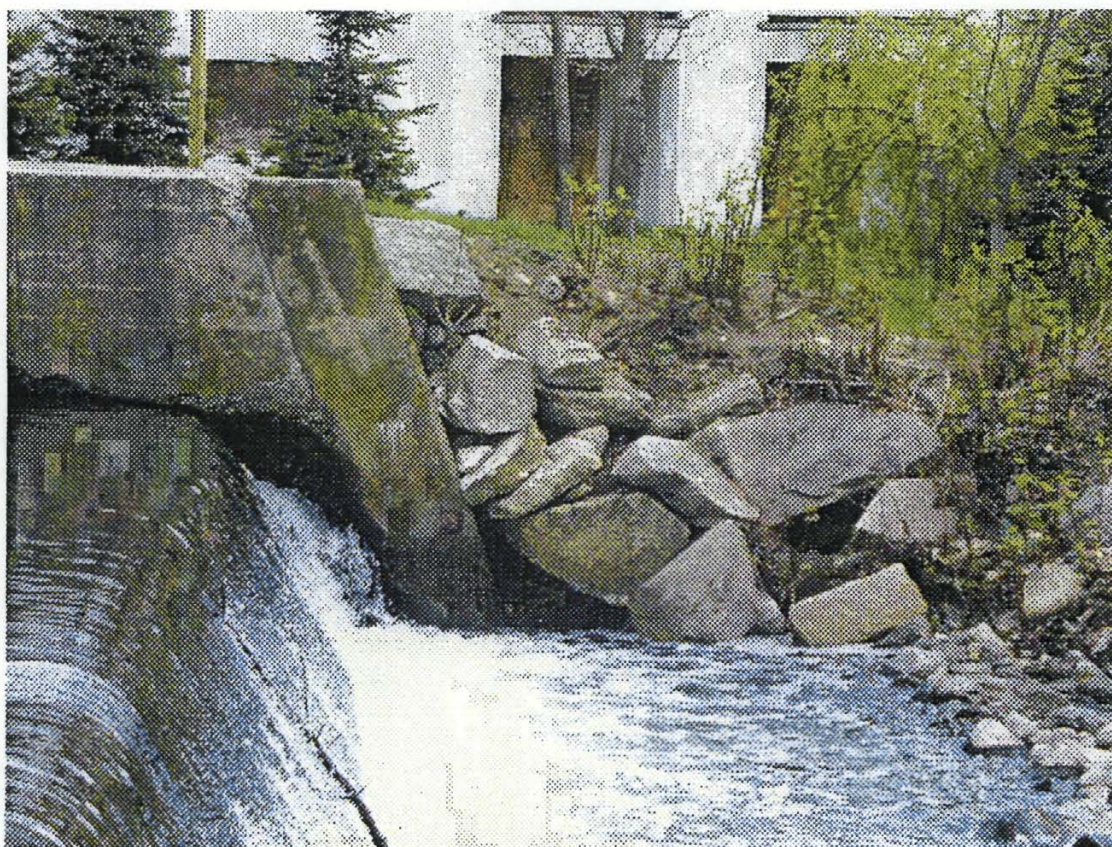
Photo 6 – Boulders and soil blocking outlet works outlet.

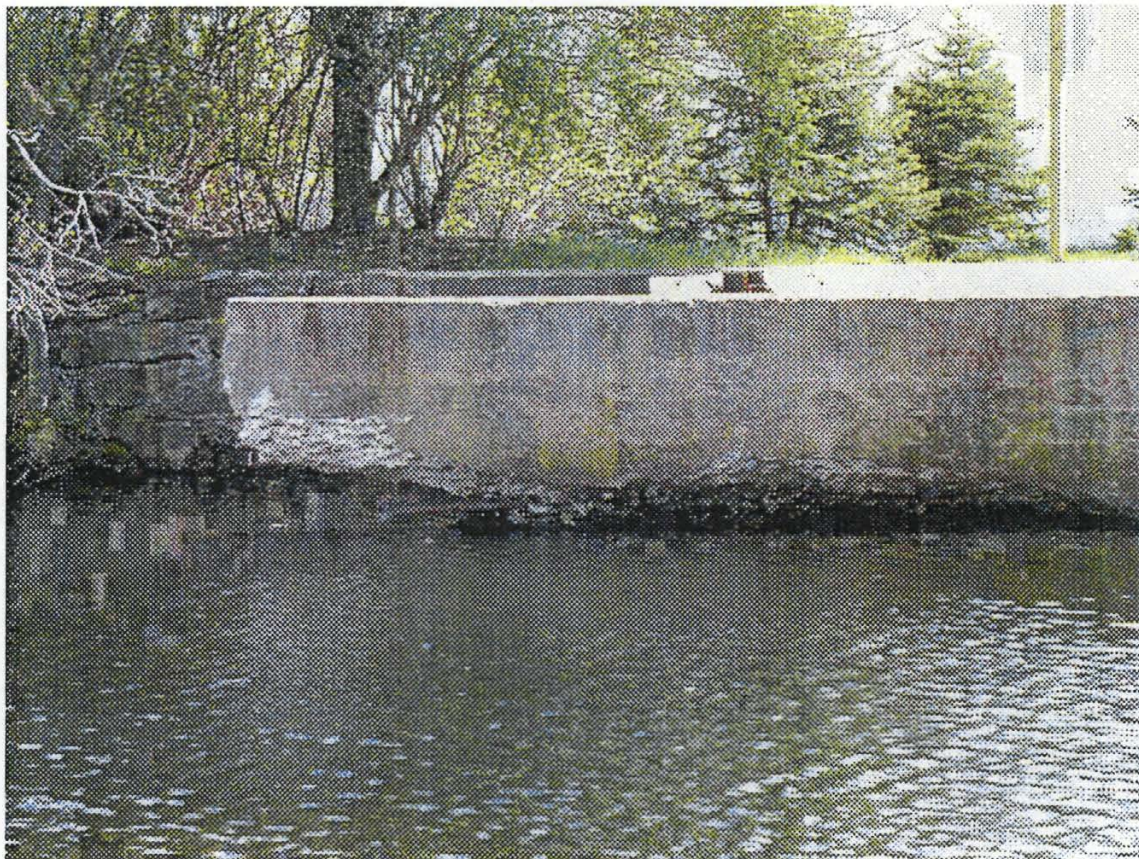
Photo 7 – Concrete spalling on outlet works wingwall.

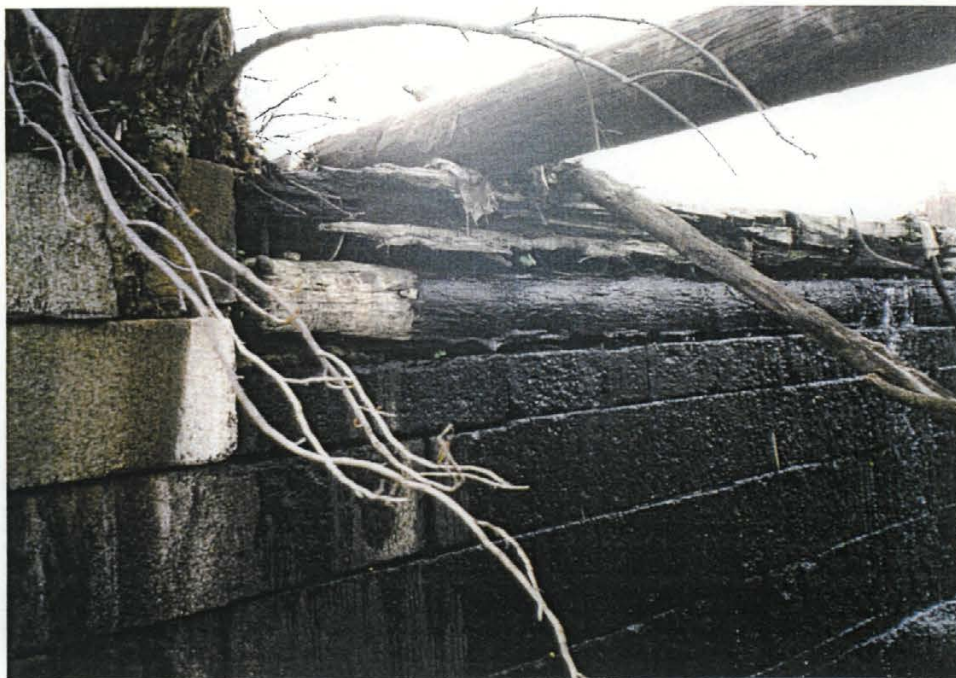
Photo 3: Severely weathered and cracked 10x10 timber at the top of the spillway adjacent to the outlet structure.

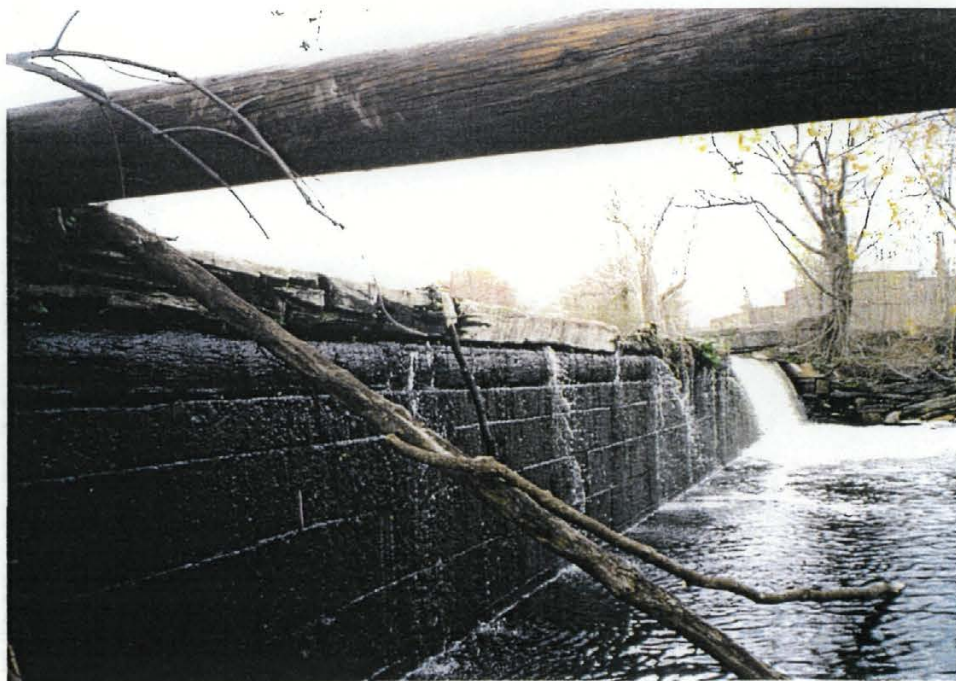
Photo 4: A large telephone pole and other minor tree debris caught at the top of the spillway. Note: seepage through the gaps between the 10x10 and the tree trunk.

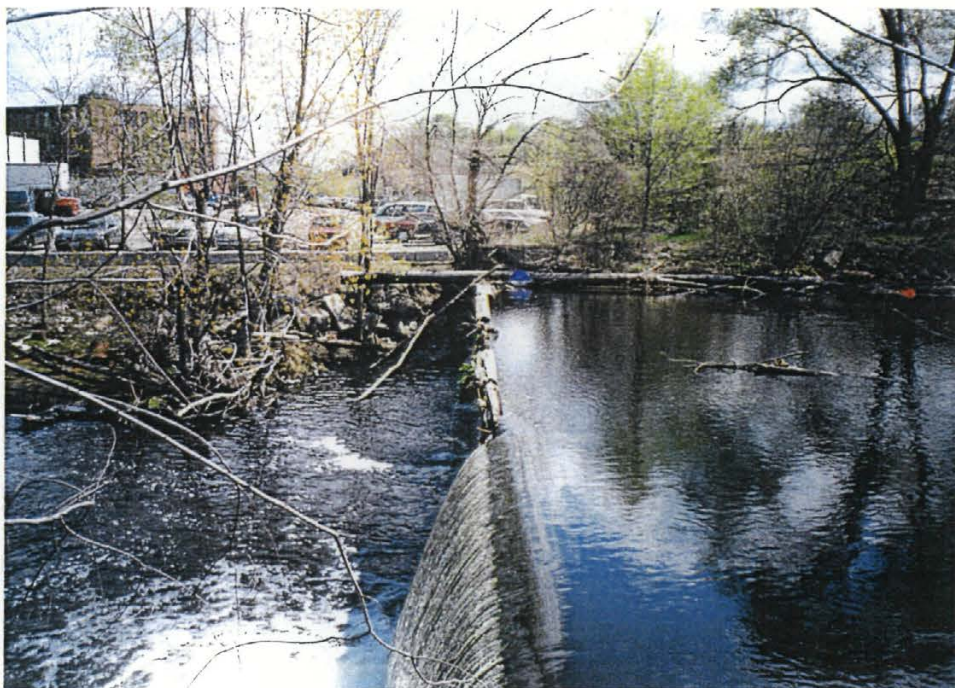
Photo 5: Missing 2x8 timber at the left side of the spillway, allowing water to flow over the spillway.

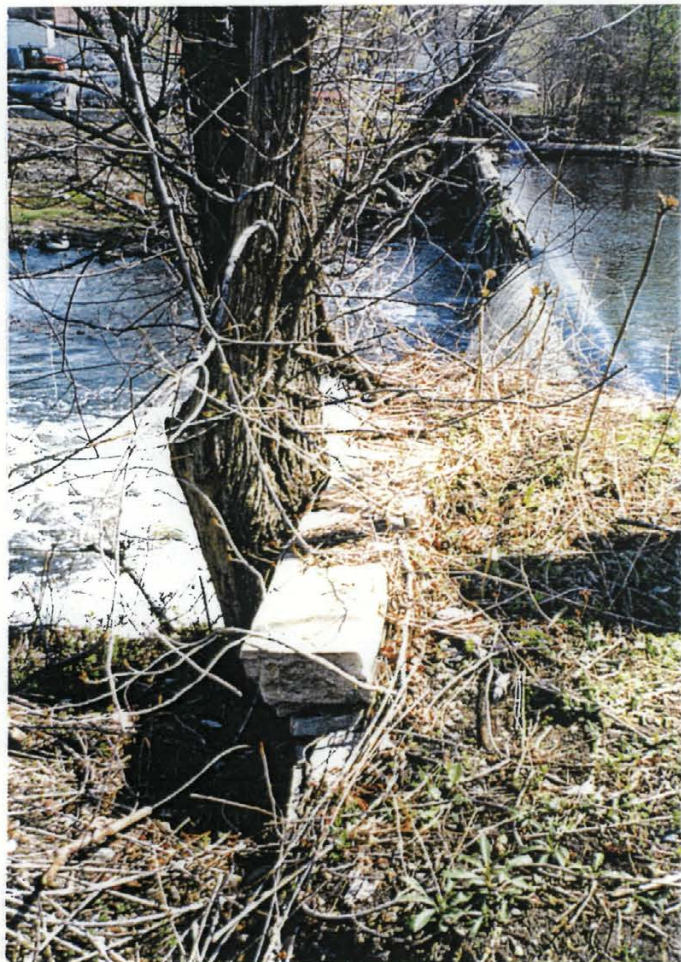
Photo 6: Movement of up to 6" at the left abutment due to the growth of a large tree through the joints of the stone blocks.

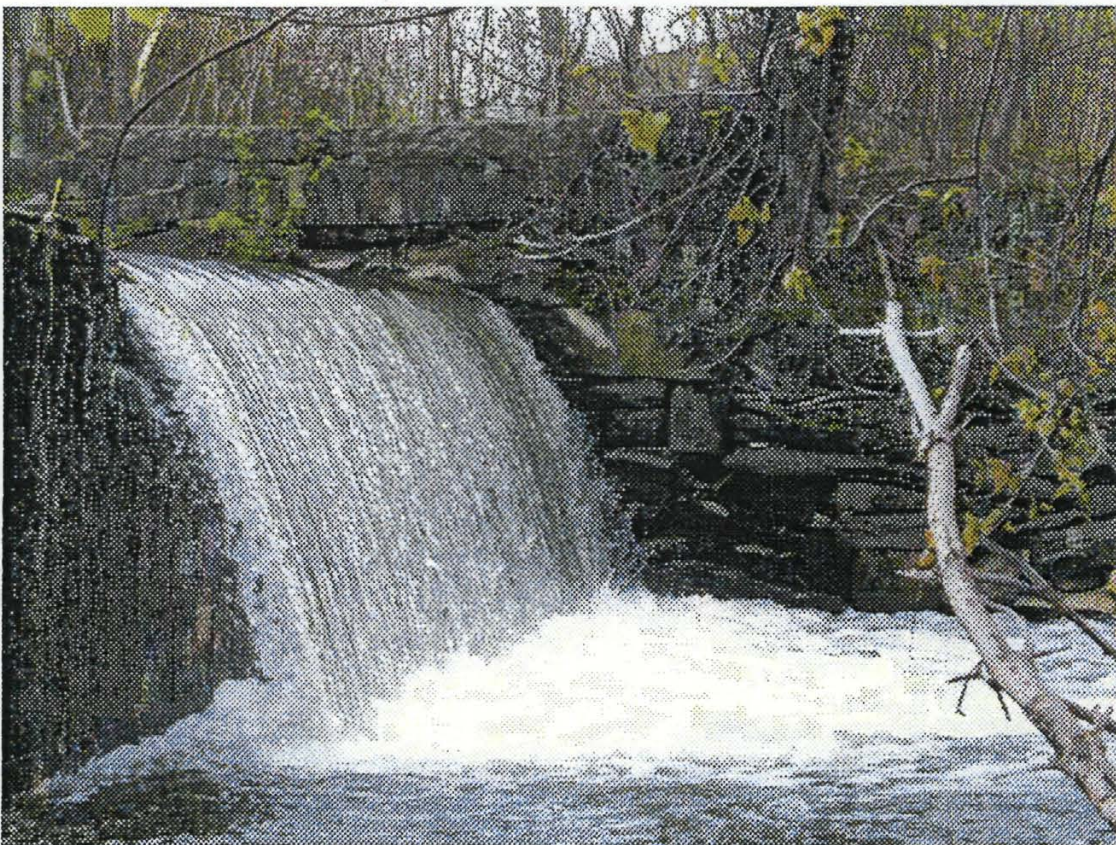
Photo 2 – Left wingwall and water flowing over missing timber on spillway.

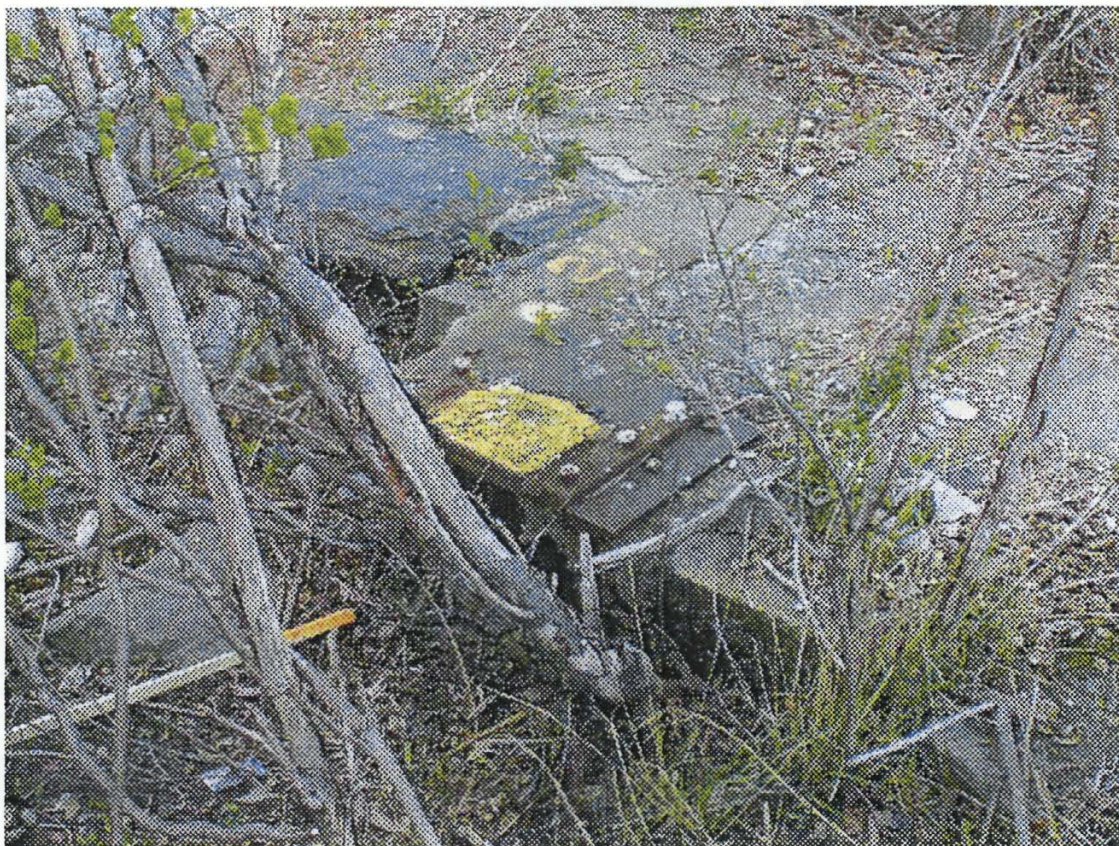
Photo 3 – Outlet works are filled in with earth.

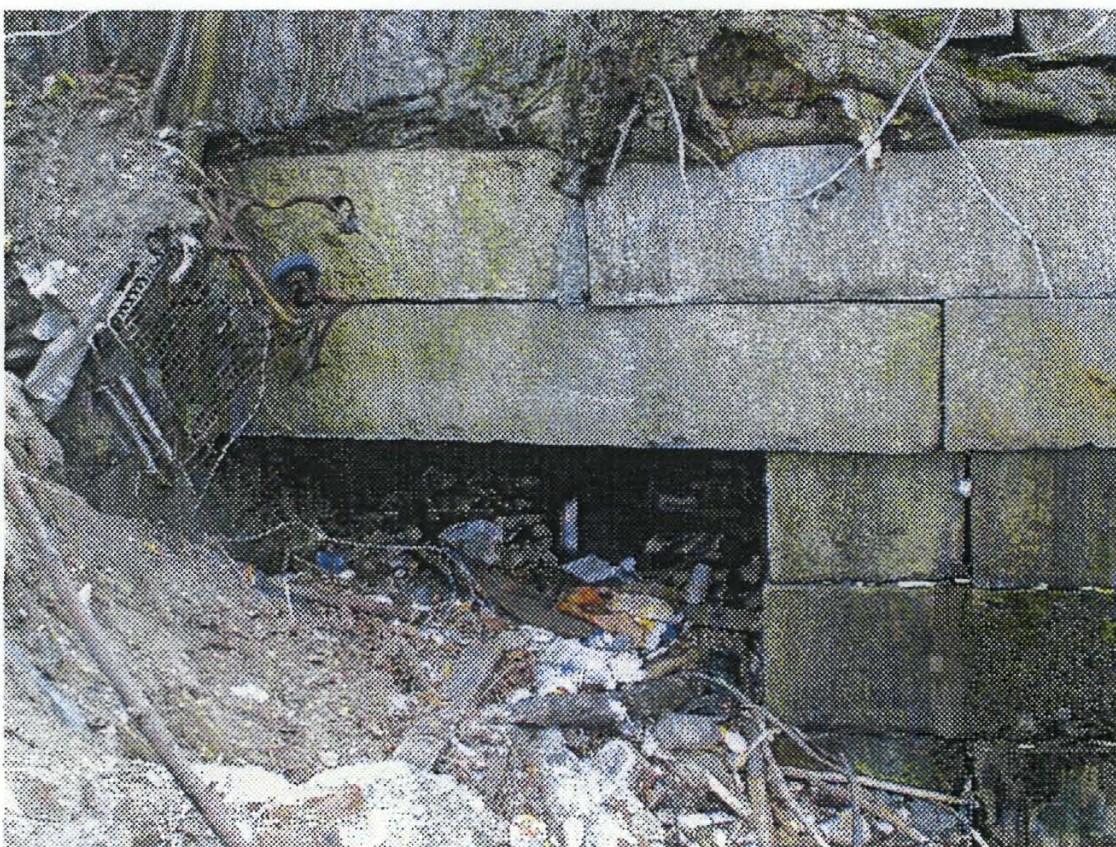
Photo 4 – Outlet works are filled with debris and earth.

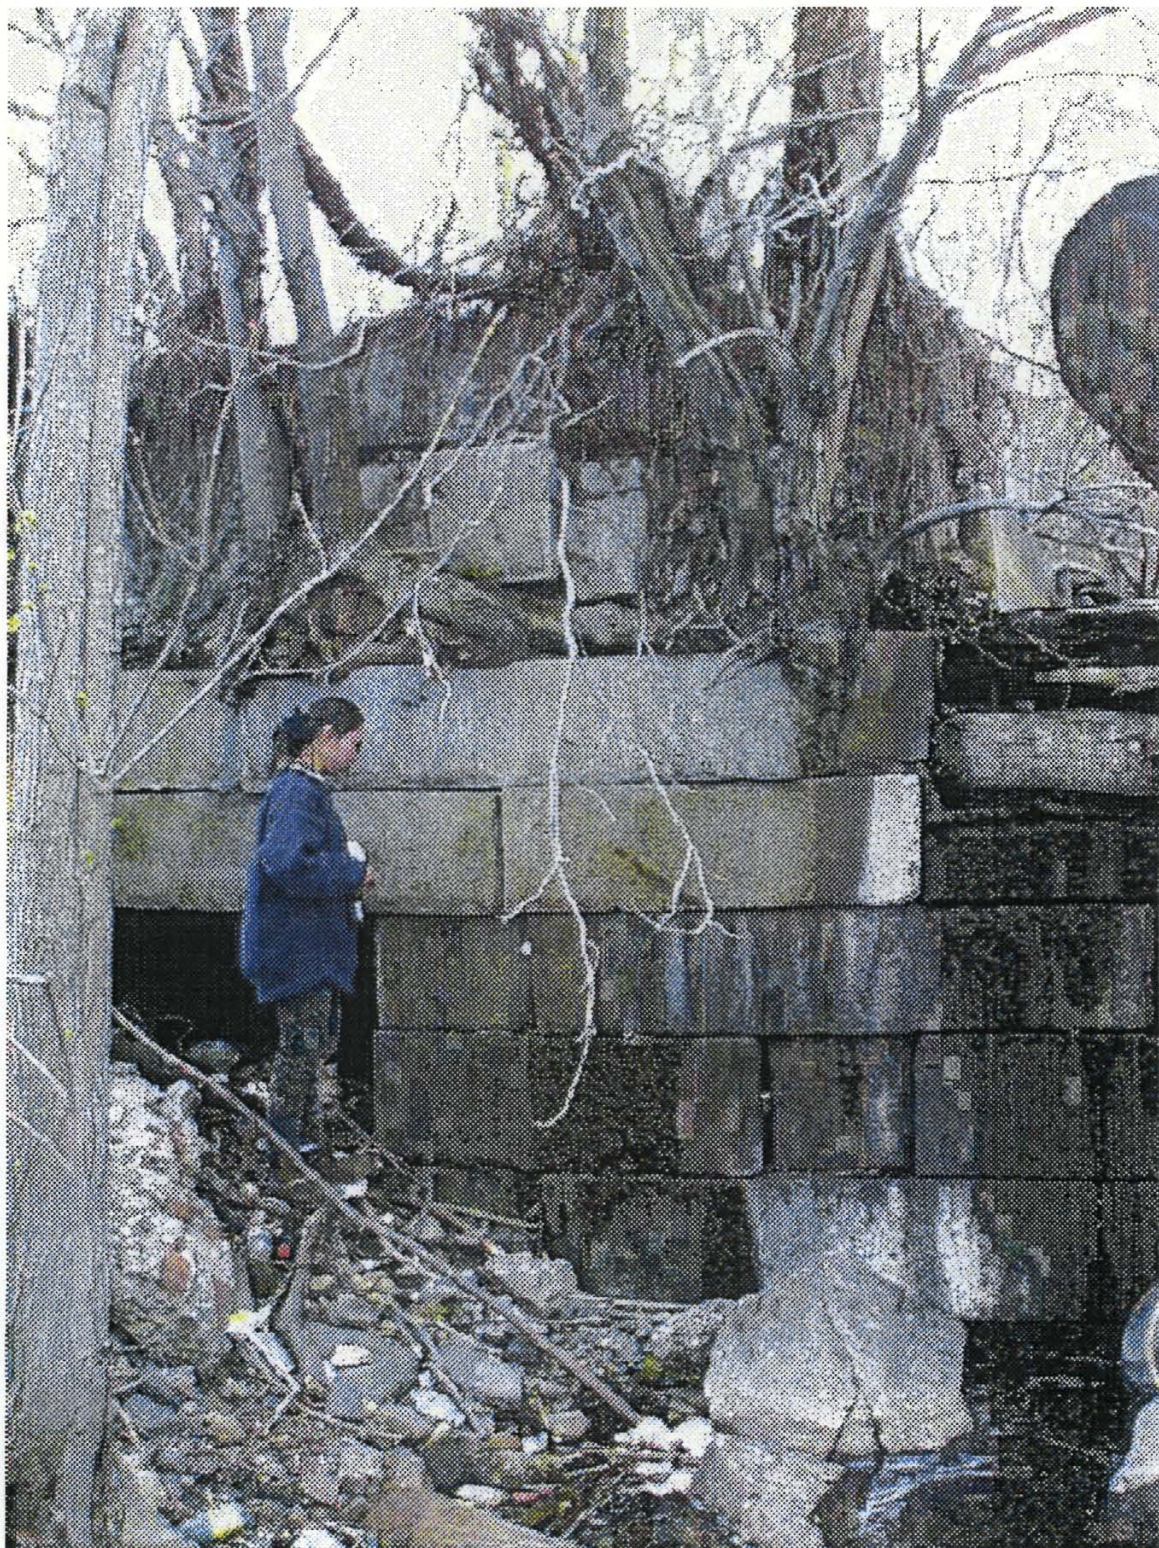
Photo 5 – Shifted blocks on right embankment and downstream side of outlet works.

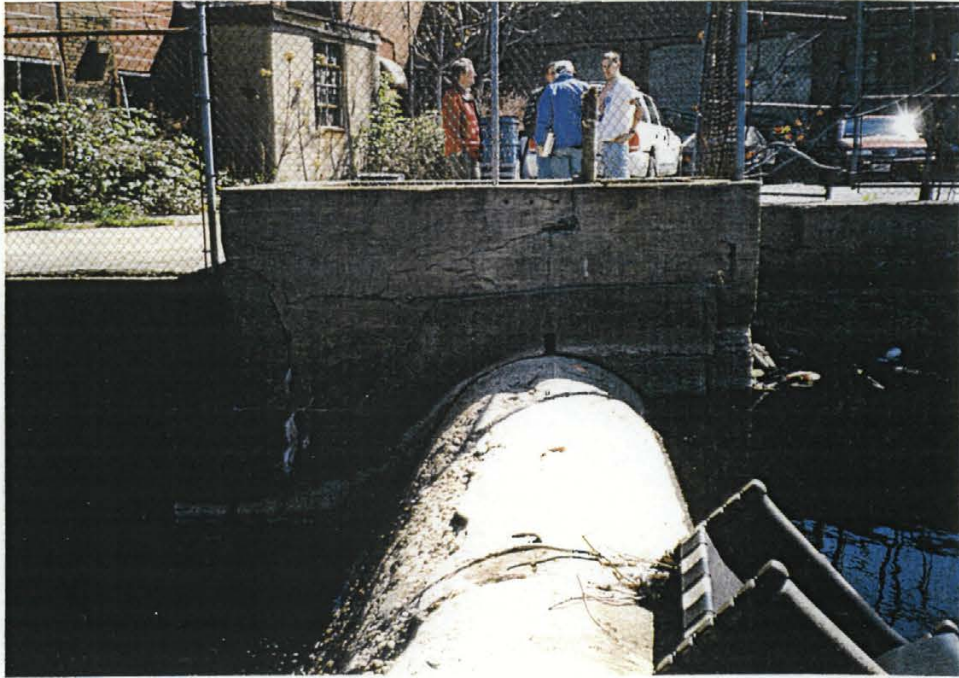
Photo 1: Numerous hairline cracks with efflorescence on the left wall of the outlet structure.

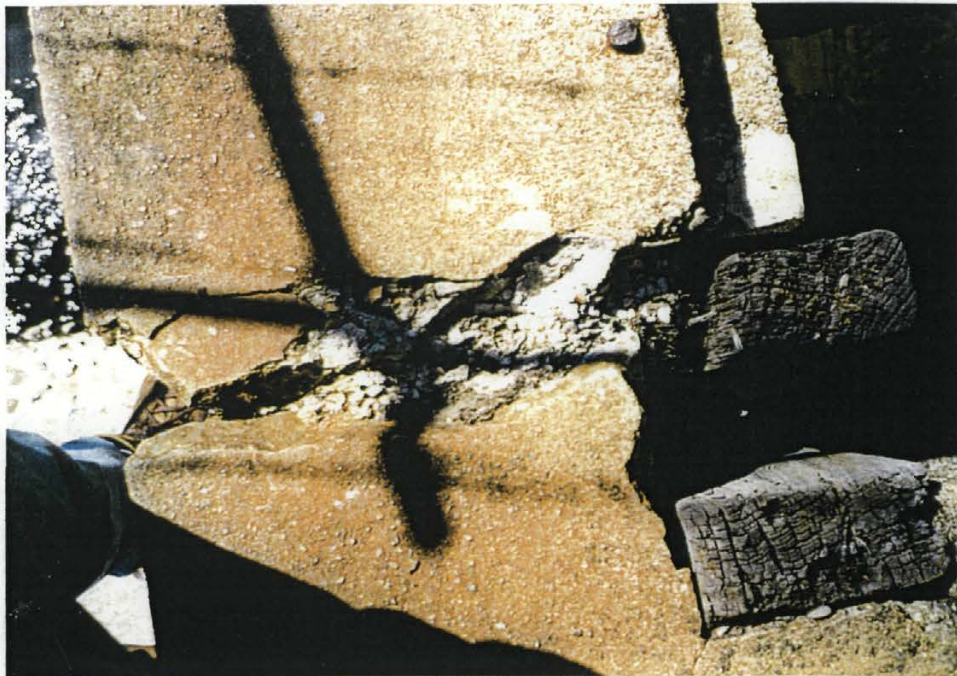
Photo 2: Severe concrete deterioration of the concrete at the timber gate guides of the left outlet structure.

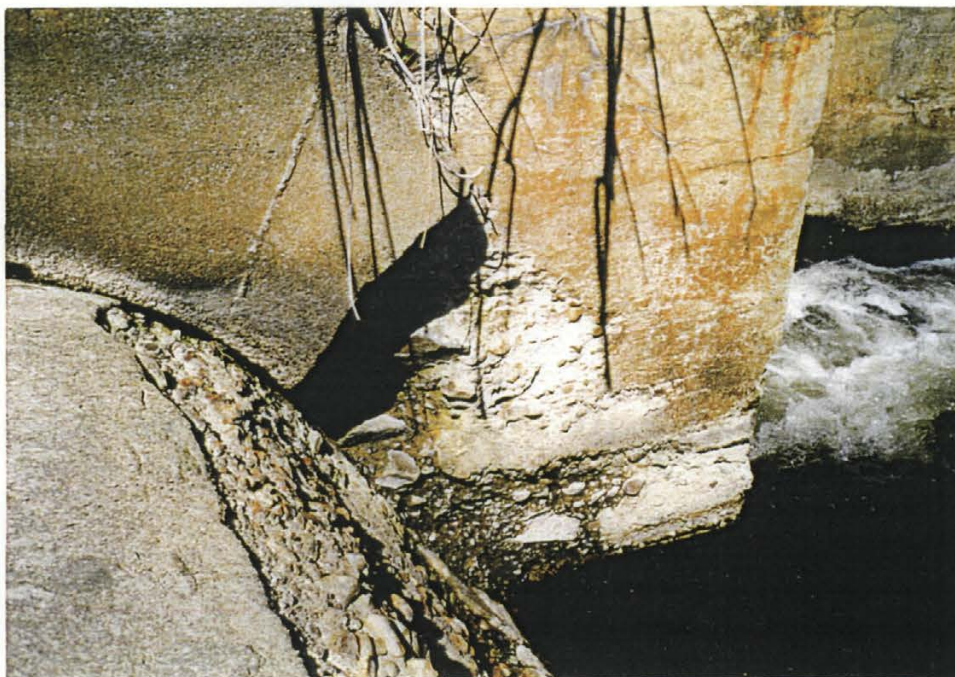
Photo 3: Downstream of the spillway weir, a 4sf x 1" deep spall at the right wall of the left outlet structure. Note: there are numerous cracks with efflorescence at this wall.

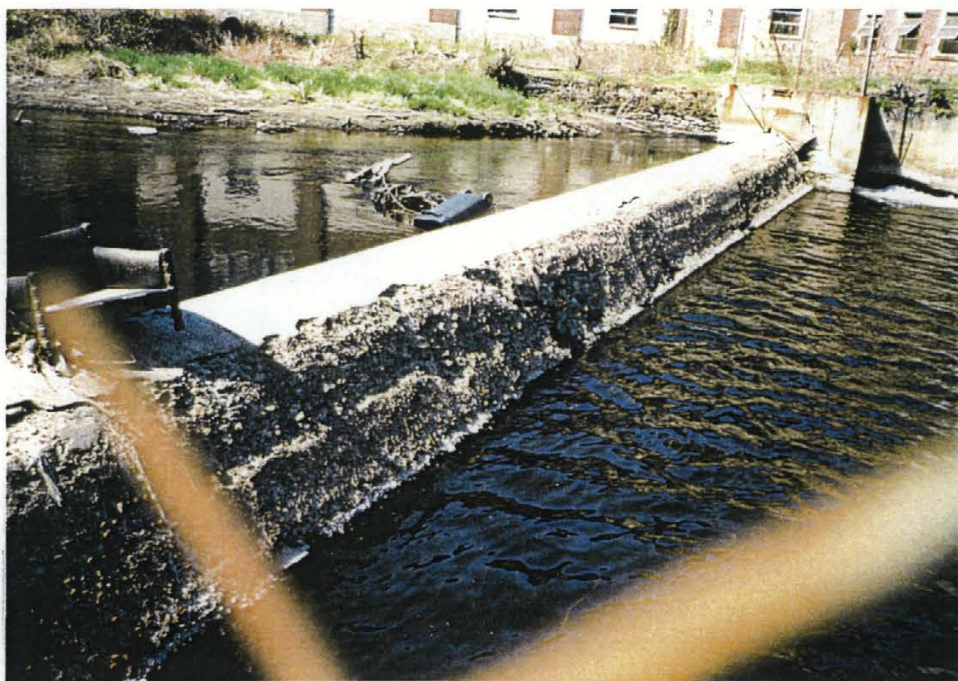
Photo 4: Downstream view of the spillway. Note: the debris upstream of the spillway.

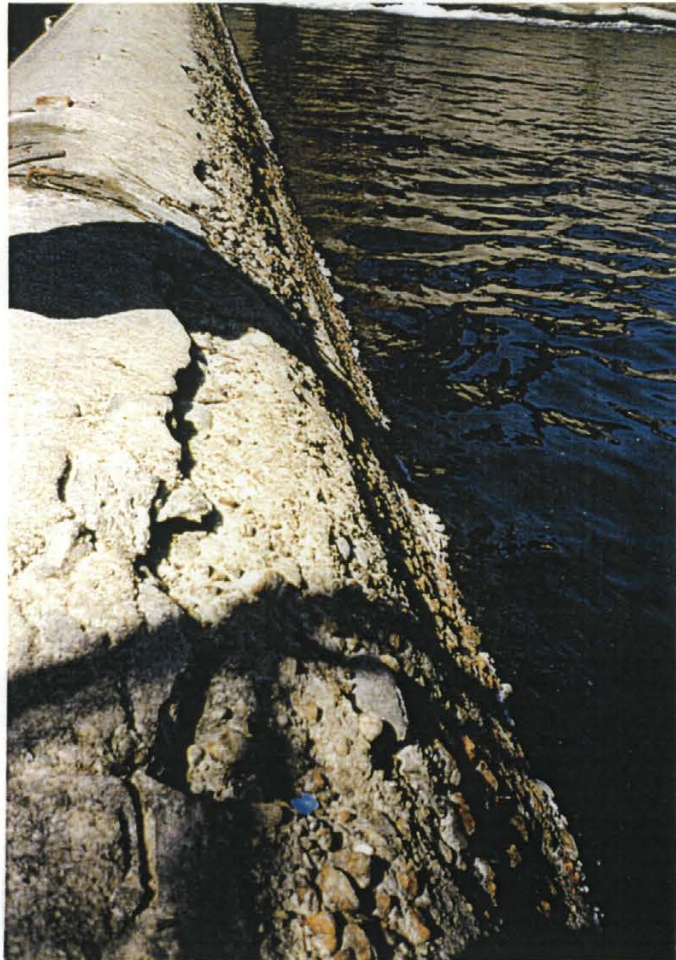
| TEAM MEMBER CHECKLIST FOR INSPECTION | | |
|---|---|---|
| <p>CONCRETE/STRUCTURAL</p> <p>SPILLWAY, CONT'D</p> <p>Concrete Deterioration</p> <p>Cracks</p> | <p>JL</p> <p>↓</p> <p>JL</p> | <p>Severe and extensive spalling, up to 8" deep, of the downstream face of the spillway. Crest is generally in good condition with some areas of unsound concrete.</p> <p>Up to 1/4" thick, at every 1/3 points of the spillway crest.</p> |

Photo 5: Severe and extensive spalling, measuring up to 8" deep, on the downstream face for the entire length of the spillway.

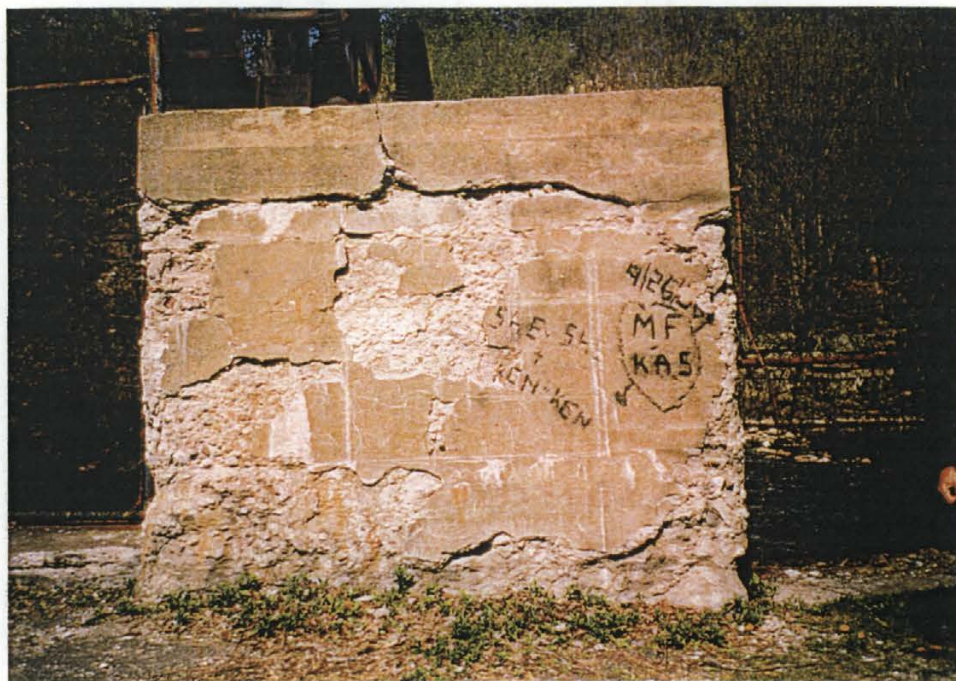
Photo 1: Extensive spalling and concrete deterioration of the gate operator stand at the right side of the spillway.

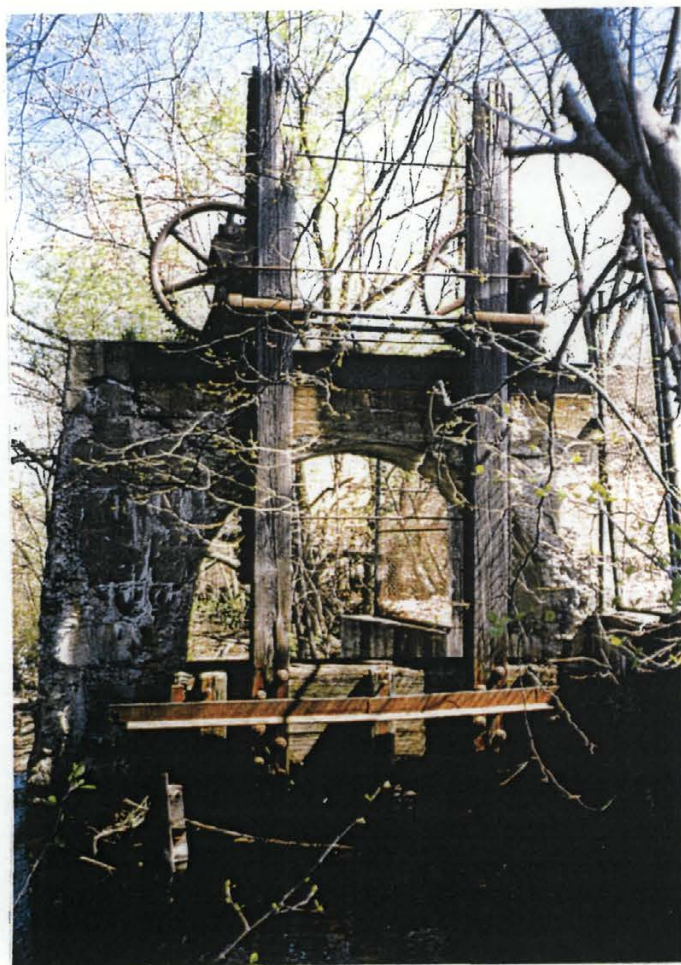
Photo 2: Numerous cracks with efflorescence at the arch portion of the gate structure. Note: the weathered and cracked vertical timbers of the gate lifting mechanism.

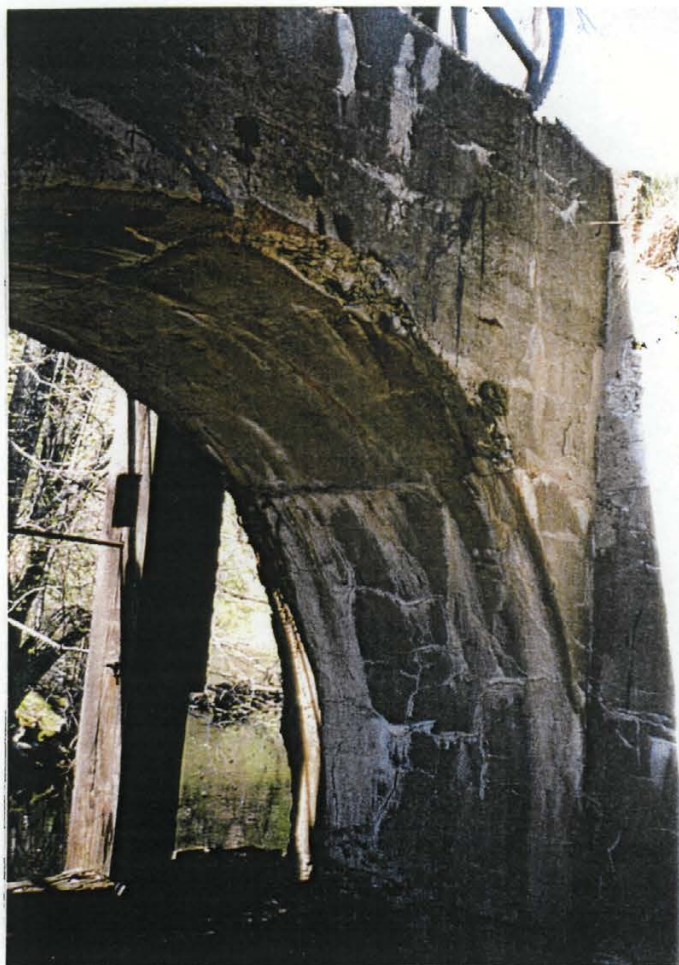
Photo 3: Numerous crack with efflorescence at the training wall of the gate structure.

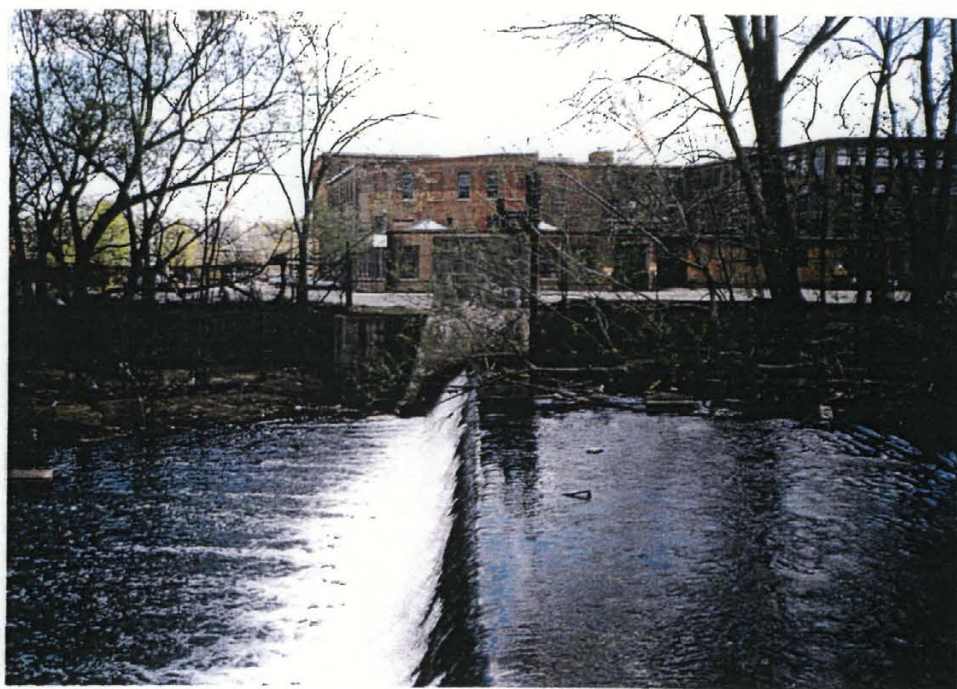
Photo 4: View of the spillway and the outlet structure. Note: debris (branches) at the spillway on the right side.

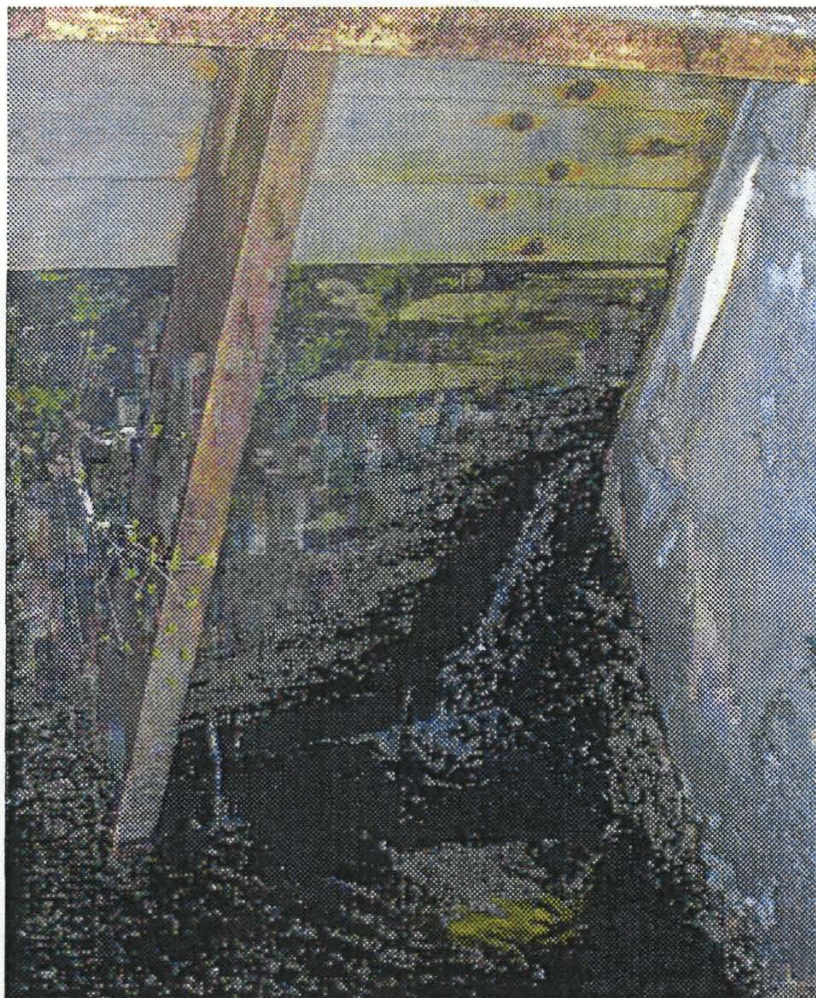
Photo 5 – Wooden gate with small amount of leakage in outlet works.
