SITE: Centredale

CONTRACT NO. DACW33-01-D-0004

SUBMITTAL OF DELIVERABLE – Interim Final Letter Report, *October 2005 Storm Evaluation*, Centredale Manor Restoration Project Superfund Site

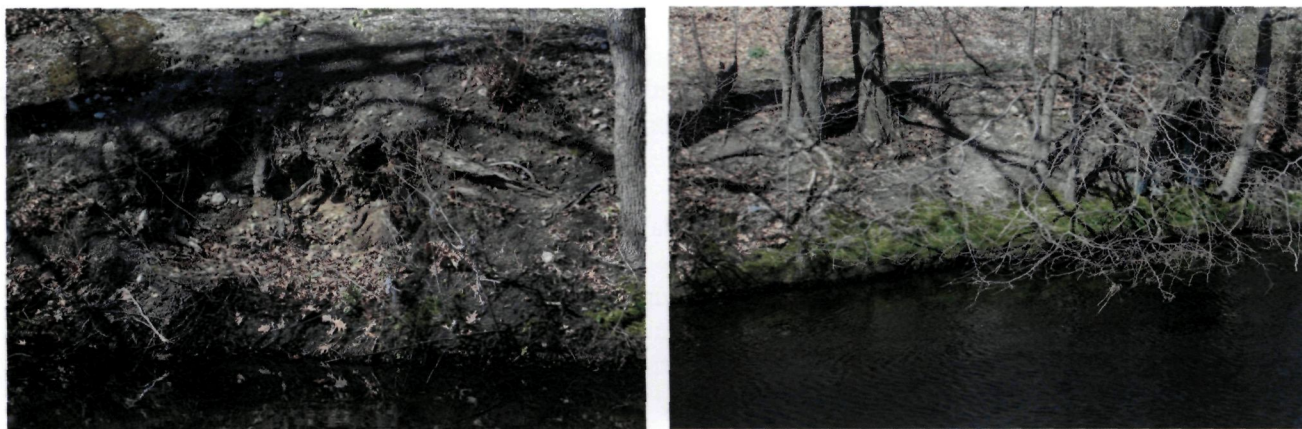
The site visit was conducted from north to south, beginning in the Cap Area 1, which is located at the southern end of the source area, and ending at Lyman Mill Dam (Figure 1). Evidence of a high-flow event was observed in the source area, but it was not extensive. For example, in some areas, the fence separating the parking lots from the cap area had grass and leaves trapped within the chain-link. In addition, many of the trees and shrubs along the Woonasquatucket River had debris in branches two to three feet above the normal water level. This debris may be associated with the October 2005 event, which resulted in over-bank flooding in some areas. The narrow, steep section of river channel adjacent to the source area was inspected for possible erosion. There was only one small area that showed any evidence of recent erosion, which was located on the west bank, approximately two-thirds of the way from Rt. 44 to the end of Cap Area 1. This spot was in a very sandy/gravelly area and appeared to be an area where a tree had previously grown and been blown over (Figure 3). There was little evidence of recent growth surrounding this area; however, the type of soil surrounding it does not appear to be conducive to supporting vegetation. Additionally, in most areas along the western bank of the Woonasquatucket River, a relatively thick, and undisturbed, mat of moss was present near the water line (Figure 3). It should be noted that the black mesh textile that was installed under the topsoil as part of the cap is exposed in many areas of the Cap Area 1.

**Figure 3. View looking toward the western bank of the Woonasquatucket River, adjacent to the source area, April 18, 2006. Left – the disturbed area in the central portion of the photograph appears to be where a tree had been up-rooted. Right – evidence of abundant, thick moss growth.**

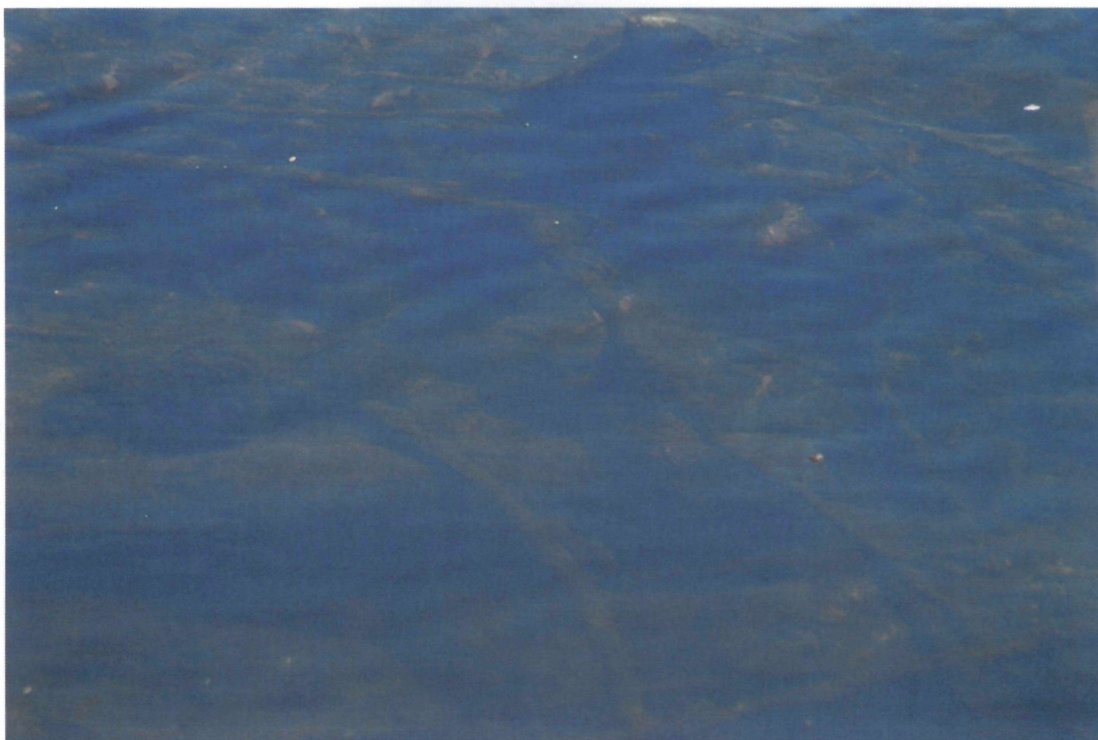
Field staff walked down the sewer commission easement on the west side of Allendale Pond to obtain a closer view of the area of potential scour. From this vantage point, it did not appear that the flow patterns in the channel had shifted from site visits conducted prior to the October 2005 flood. The water level was lower than normal during this site inspection, due to a relatively dry spring, and the channel bottom could be observed in many areas. There was an abundance of vegetation along the bottom of the channel/pond, which appeared to be older, established growth (Figure 4). Areas absent in vegetation were not visually obvious. Due to the low water levels, the bottom of the rip-rap and cap liner was visible along the western edge of the source area.

**Figure 4. Photo of the river bottom at the upstream inlet to Allendale Pond, April 18, 2006.**

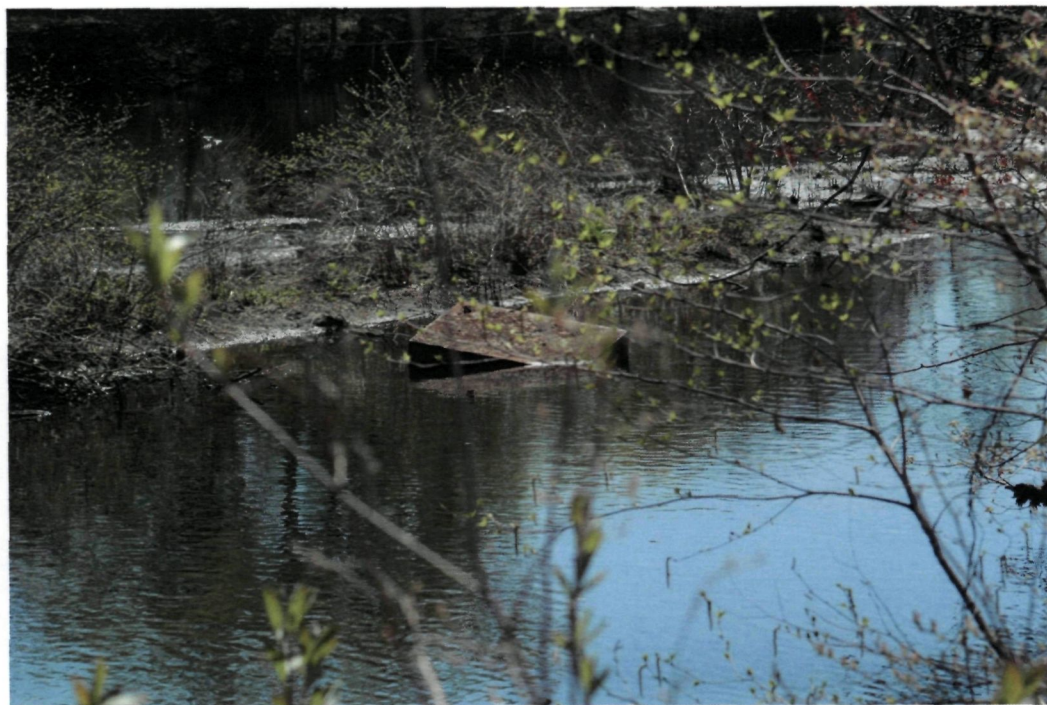
A large amount of trash and debris was observed in the northern section of Allendale Pond. A soda machine was observed submerged on the western side of the pond, near the marshy area south of Cap Area 1, as well as an apparent steel fuel or oil tank (fuel tank shown in Figure 5). Additionally, two or three drums were noted (and photo documented) in the marshy area. Several old tires and other debris were scattered throughout the study area.

**Figure 5. Photograph taken from the western bank of the Woonasquatucket River on April 18, 2006. The object in the center of the image appears to be a steel fuel or oil storage tank.**

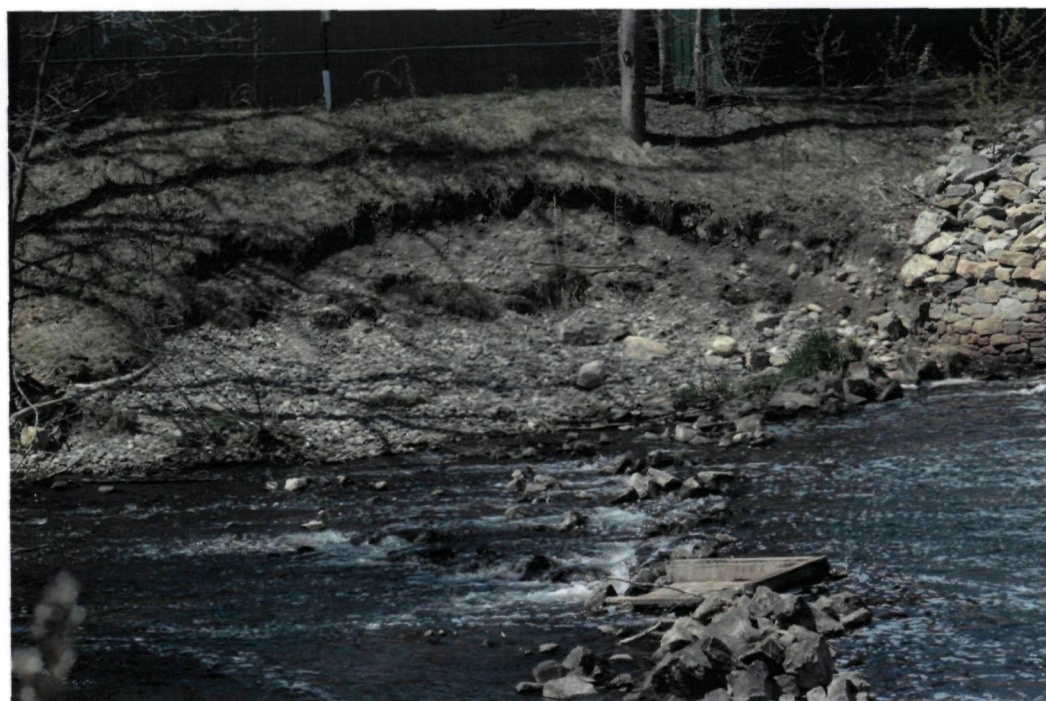
The area in the immediate vicinity of Allendale Dam was also visually assessed for signs of erosion; the only noticeable change from previous site visits was the slumping of bank material on the west side of the channel, immediately downstream from Allendale Dam (Figure 6).

**Figure 6. Scarp immediately below Allendale Dam on the west side of the Woonasquatucket River, April 18, 2006.**

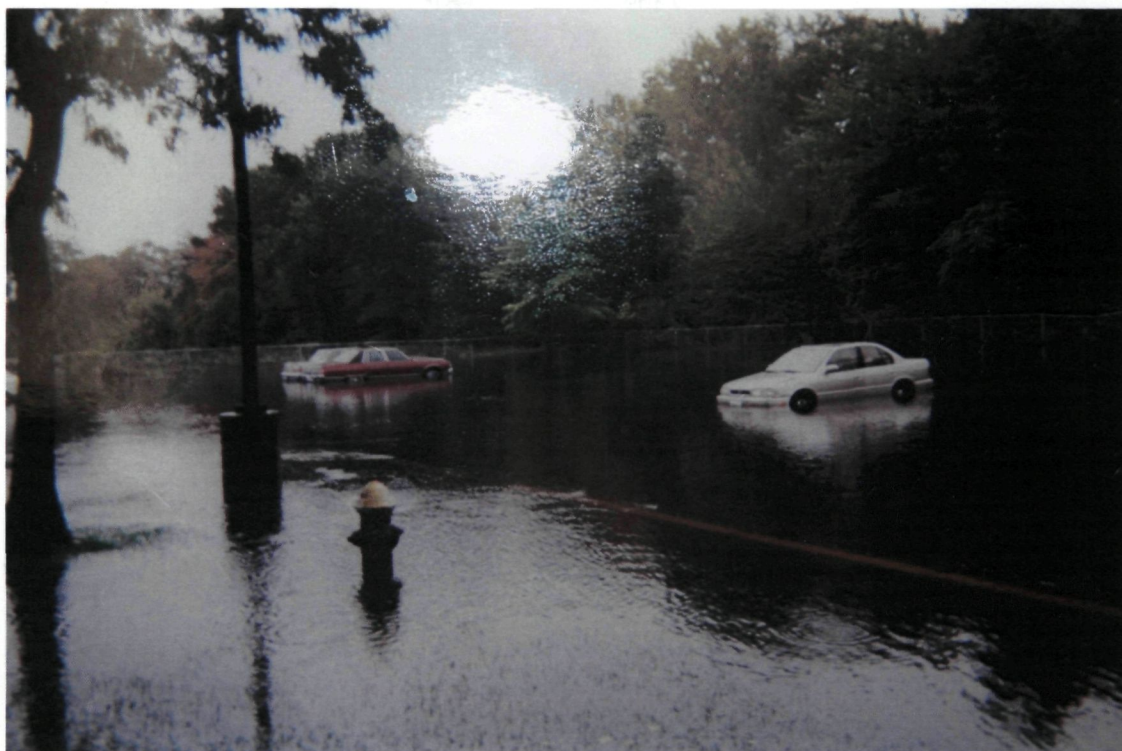
**Figure 7. Picture of Centredale Manor South Parking Lot on October 15, 2005 (looking toward Cap Area 1). According to the as-built plans, the central section of this parking lot (center right of photo) has an elevation of 97 ft.**

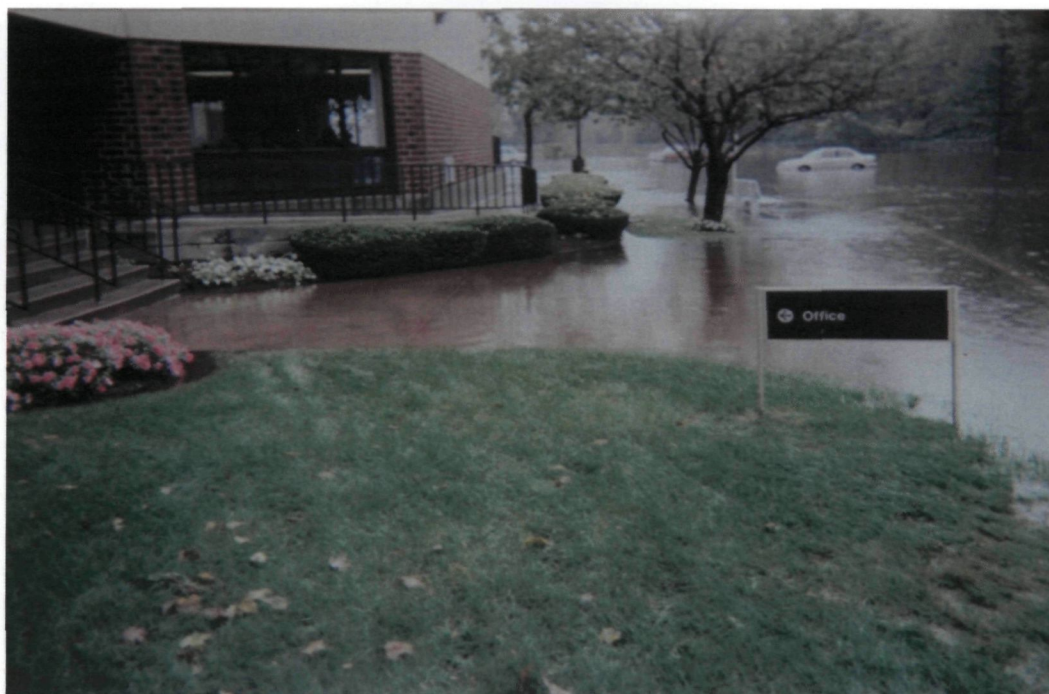
**Figure 8. Entrance to Centredale Manor on October 15, 2005. Note that water did not reach the steps to the building; the elevation of the curb near the office sign is approximately 98 ft according to the building as-built plans.**

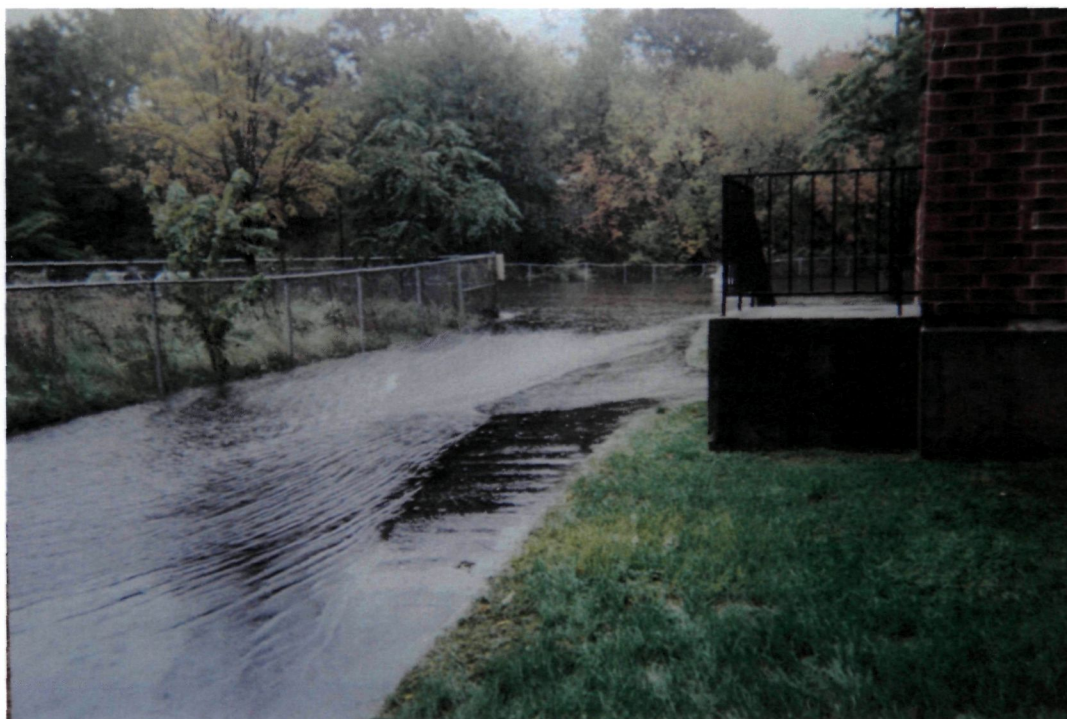
**Figure 9. Service drive on south side of Centredale Manor on October 15, 1005. The elevation of the flooded area of the driveway is approximately 97.5 ft according to the as-built plans.**

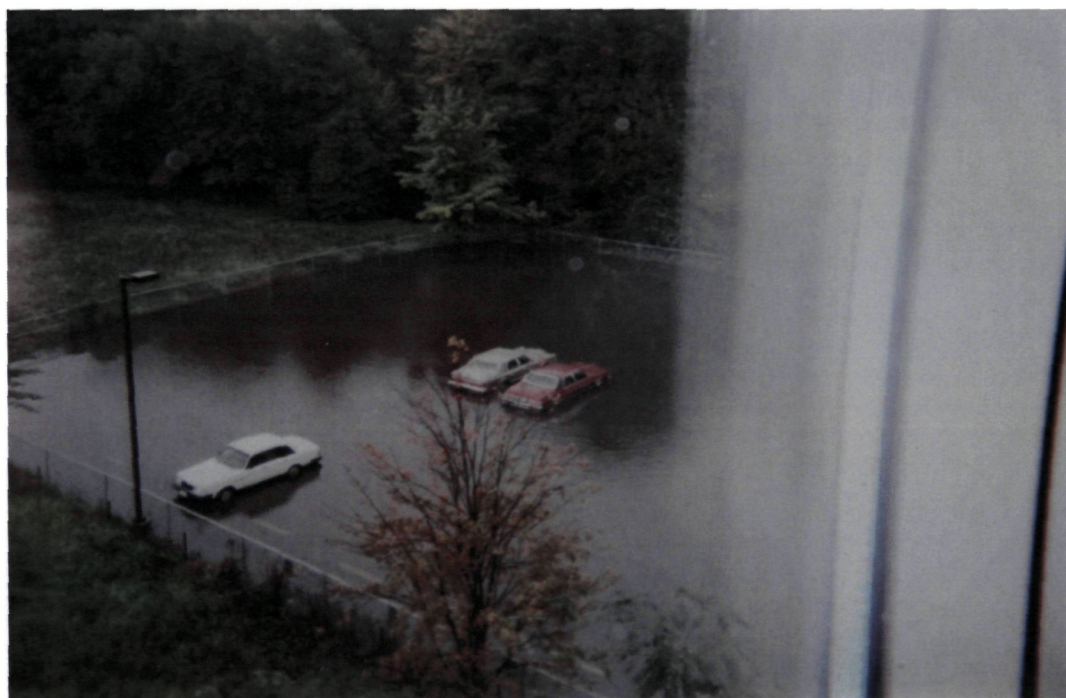
**Figure 10. Centredale Manor South Parking lot on October 15, 2005.**

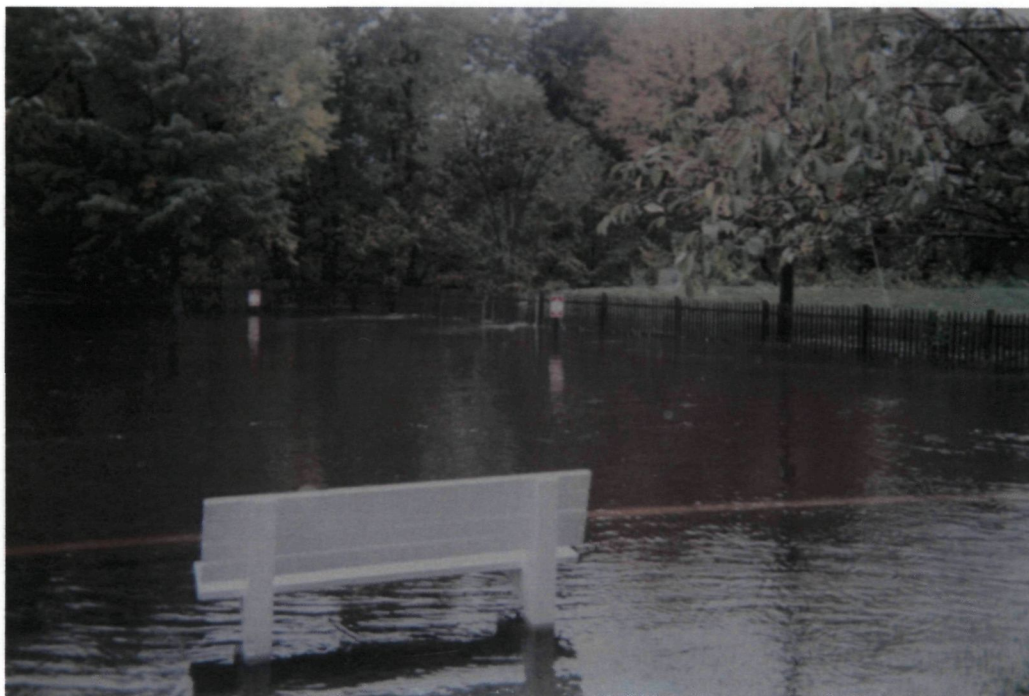
**Figure 11. Centredale Manor South Parking lot on October 15, 2005. Cap Area 2 is visible in the right center section of the photo. According to the Centredale Manor building as-built plans, the elevation of the top of the curb in front of the bench is approximately 98 ft. Additionally, the curb elevation on the opposite side of the driveway in the right side of the photo is between 97.08 ft and 97.25 ft according to the as-built plans.**

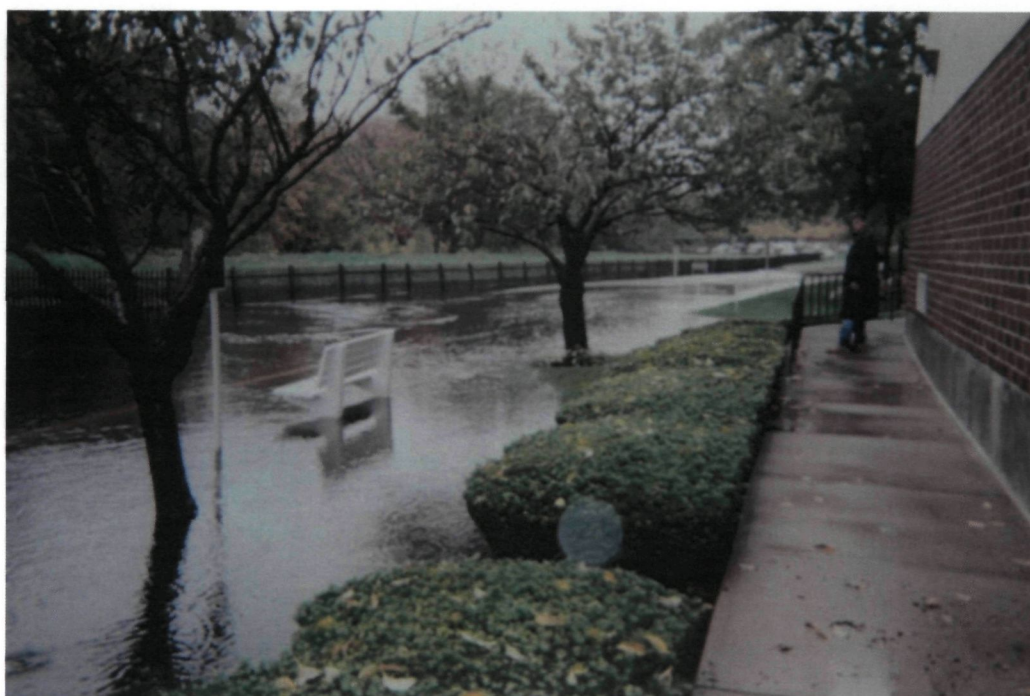
**Figure 12. West side of Centredale Manor on October 15, 2005.**
