# AERIAL PHOTOGRAPHIC ANALYSIS OF CENTREDALE MANOR SITE SUBAREA North Providence, Rhode Island

## Addendum Report

TS-PIC-20201153S  
December 2001

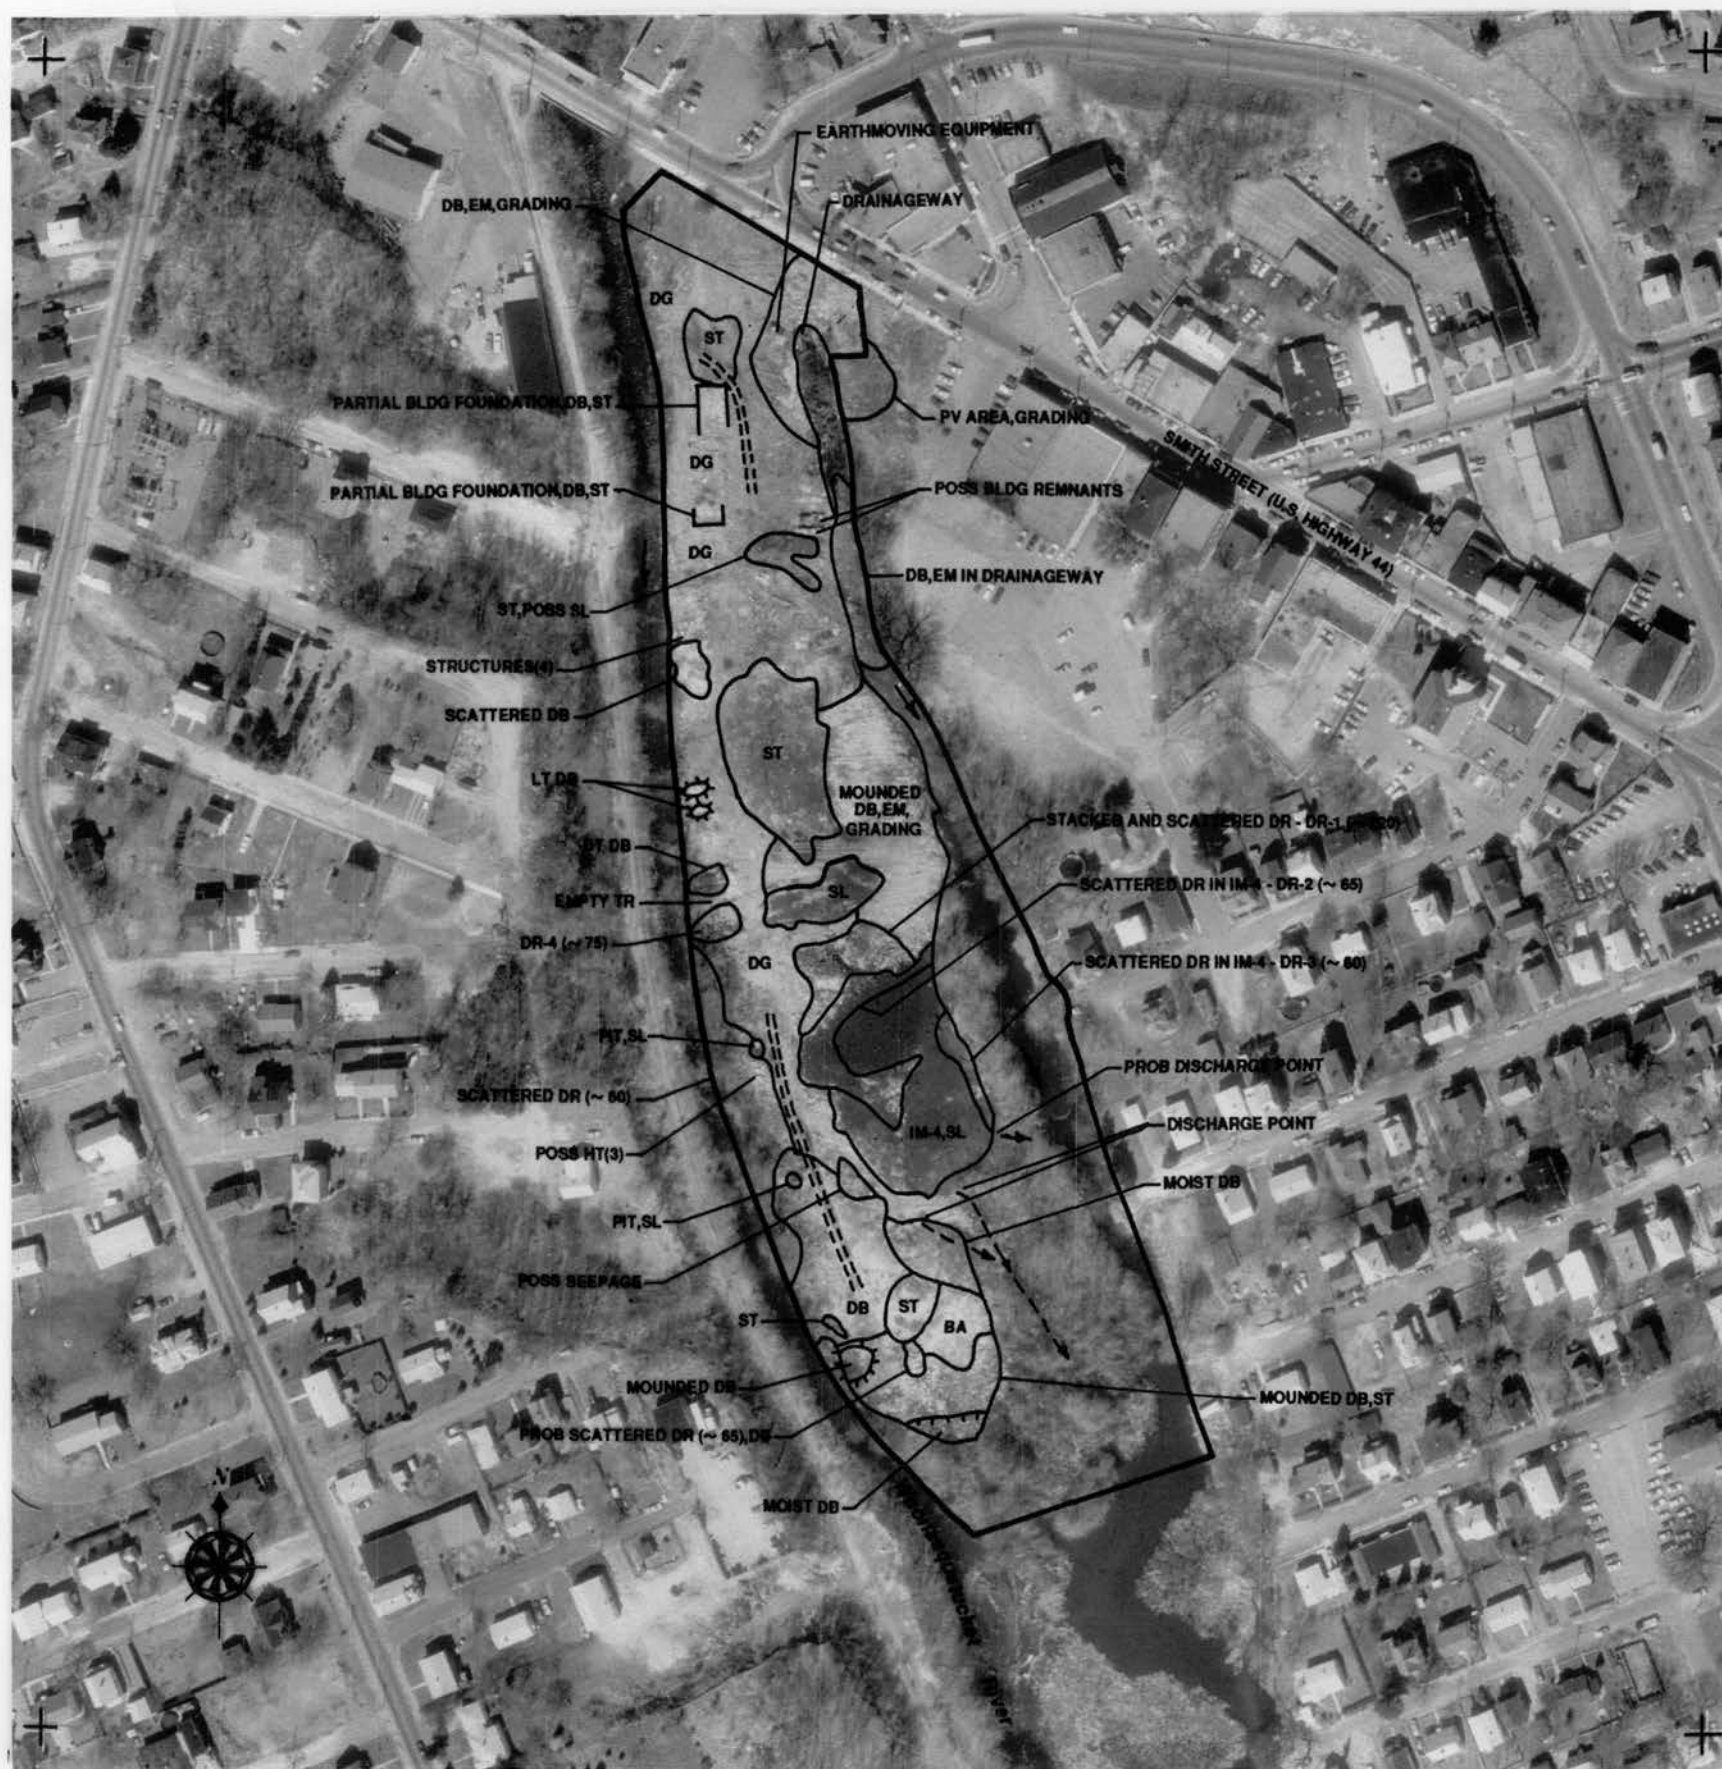
Figure 3. Centredale Manor site subarea, March 25, 1974. Approximate scale 1:2,250.

Photographic resolution of this photodate is excellent, thus enabling a detailed assessment of all features in the subarea.

All five site buildings (not annotated) have been removed from the northern portion of the subarea since 1970. One partial building foundation is observed as well as an area of staining (ST). An access road leads north to this stained area. The ground around these former building locations has been disturbed (DG; partially annotated) and a portion of the debris (DB) and some earthen material (EM) resulting from the demolition of the buildings have been deposited in the vicinity of the northern portion of the drainageway. Grading, as evidenced by the presence of bulldozer blade marks (not annotated), is apparent in this area and also within a partially vegetated (PV) area on the east side of the drainageway. An additional accumulation of debris and earthen material has been deposited in the drainageway east of two possible remnants of the former buildings. A large area of staining and possible standing liquid (SL) is noted directly south of the possible building remnants. Continuing to the south another very large area of staining and an area of standing liquid are noted adjacent to a large accumulation of mounded debris and earthen material. Grading is also in evidence within this area. Other isolated areas of staining (not annotated) are located throughout this portion of the subarea.

Further to the south, a large impoundment (IM-4) containing standing liquid is now present where the former Impoundment 1 (IM-1) and a portion of a stained area were noted in 1970 (not annotated). An area of stacked and scattered drums (DR-1; approximately 220 in number) is located on the north side of the impoundment and scattered drums are present within and along the northwestern and eastern sides of the area. Two areas of drums, one with approximately 65 drums (DR-2) and the other with 60 drums (DR-3) are within impoundment IM-4. A berm (not annotated) is present along the south side of impoundment IM-4 and two discharge points and a probable discharge point are evident and permit flow of liquid material from this impoundment to the nearby drainageway and to the Woonasquatucket River. An area of possible seepage is also noted near the southwest corner of the impoundment.

At the southern terminus of the north-south oriented access road (partially visible and annotated) that leads south from the former building complex is the large waste disposal area (not annotated) observed in 1970. The area now contains debris, mounded debris, moist debris, staining, approximately 15 probable scattered drums, a small pit with standing liquid, and a bare area (BA).

South of the partial building foundation observed in Section 1 and adjacent to the Woonasquatucket River are four small structures and scattered debris. Continuing south along the river, two piles of light-toned debris (LT DB), an empty trench (TR), an area of dark-toned (DT DB) debris, and an area containing approximately 75 drums (DR-4) are observed. This accumulation of drums is located directly adjacent to the river. South of these drums is an area where approximately 60 additional drums are scattered. A small pit with staining and three possible horizontal tanks (HT) are also located within this area.

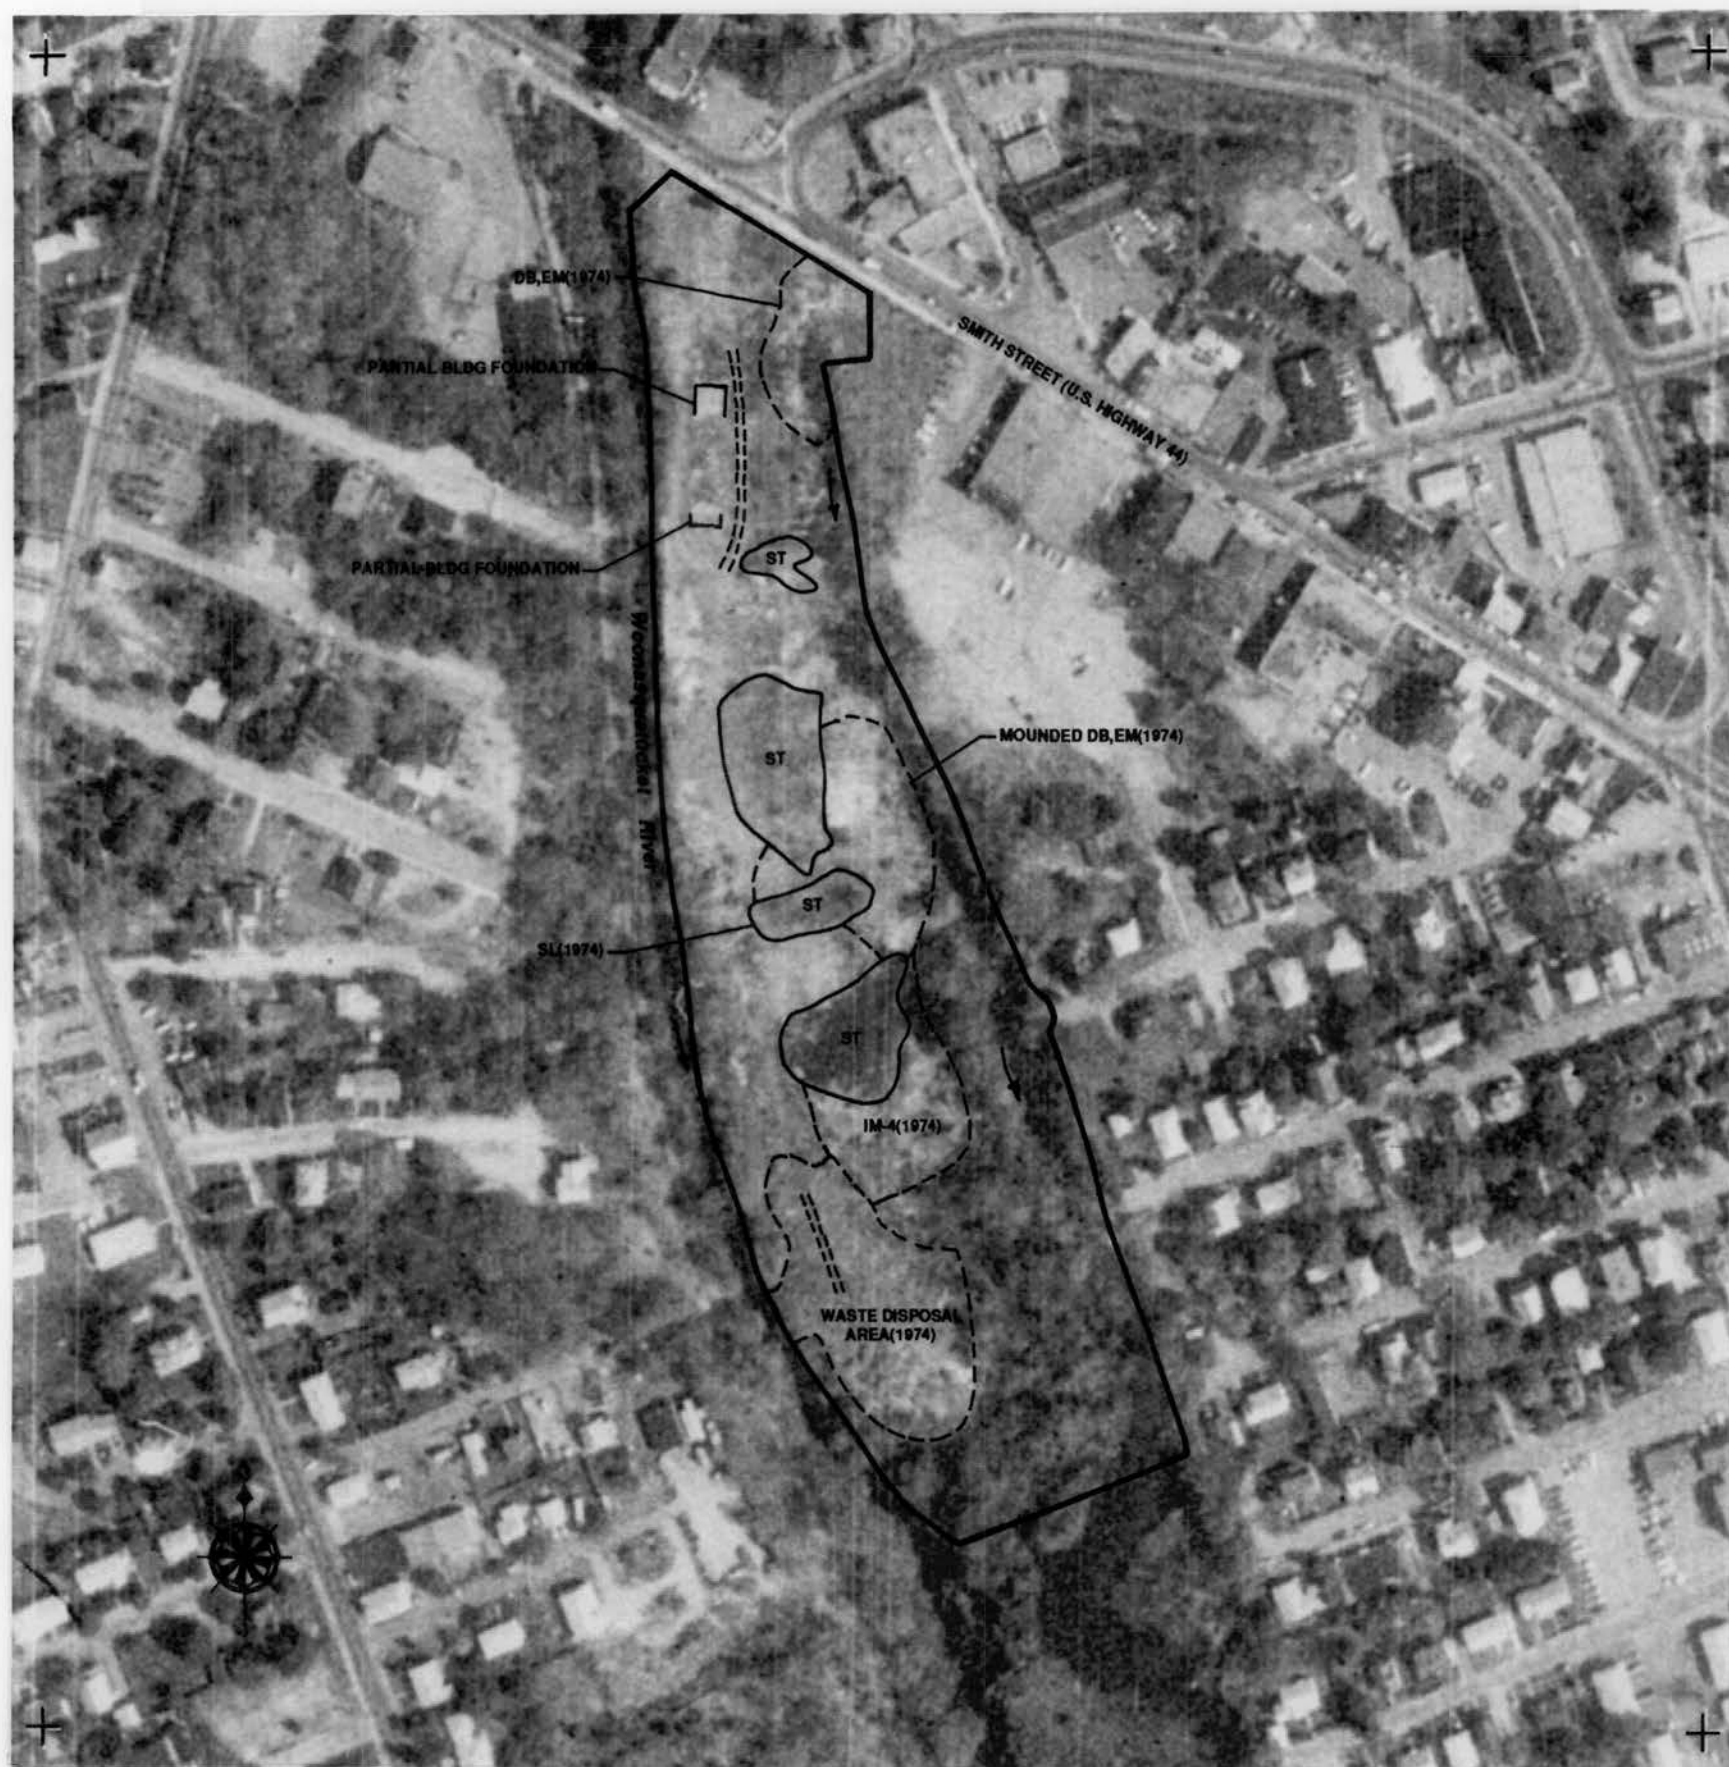
Figure 4. Centredale Manor site subarea, May 5, 1976. Approximate scale 1:2,215.

Resolution of this photograph is poor, which precludes assessment of smaller features such as drums, structures, and possible horizontal tanks, noted in the 1974 photographs. Thus, only larger environmentally significant features such as areas of staining are discernable. Additionally, stereographic photographs were not available for this date of photography; therefore, the analysis was conducted monoscopically.

No new environmentally significant features or activities are noted since 1974. The site is partially vegetated throughout the large disturbed area located in the northern and central portions of the site (not annotated) and no new areas of disturbance, access roads, or routes are apparent. This indicates that the site is apparently inactive. The location of debris and earthen material noted at the north end of the drainageway in 1974 is depicted. The partial building foundation remains visible, as does a large stain immediately to the southeast along the access road. Further to the south, two other areas of staining are noted. To the east of these stains is a former location of debris and earthen material. Continuing to the south there is another large stained area that was part of impoundment IM-4 noted in 1974. The dashed outline depicts the remainder of the areal extent of the former impoundment. The location of the former large waste disposal area at the southern end of the north-south access road in 1974 is also depicted.
