Loureiro Engineering Associates, Inc.

January 23, 2002

**RE: Centredale Manor Restoration Project, North Providence, Rhode Island  
Review of Historic Topographic Maps and Aerial Photographs  
Summary Report**

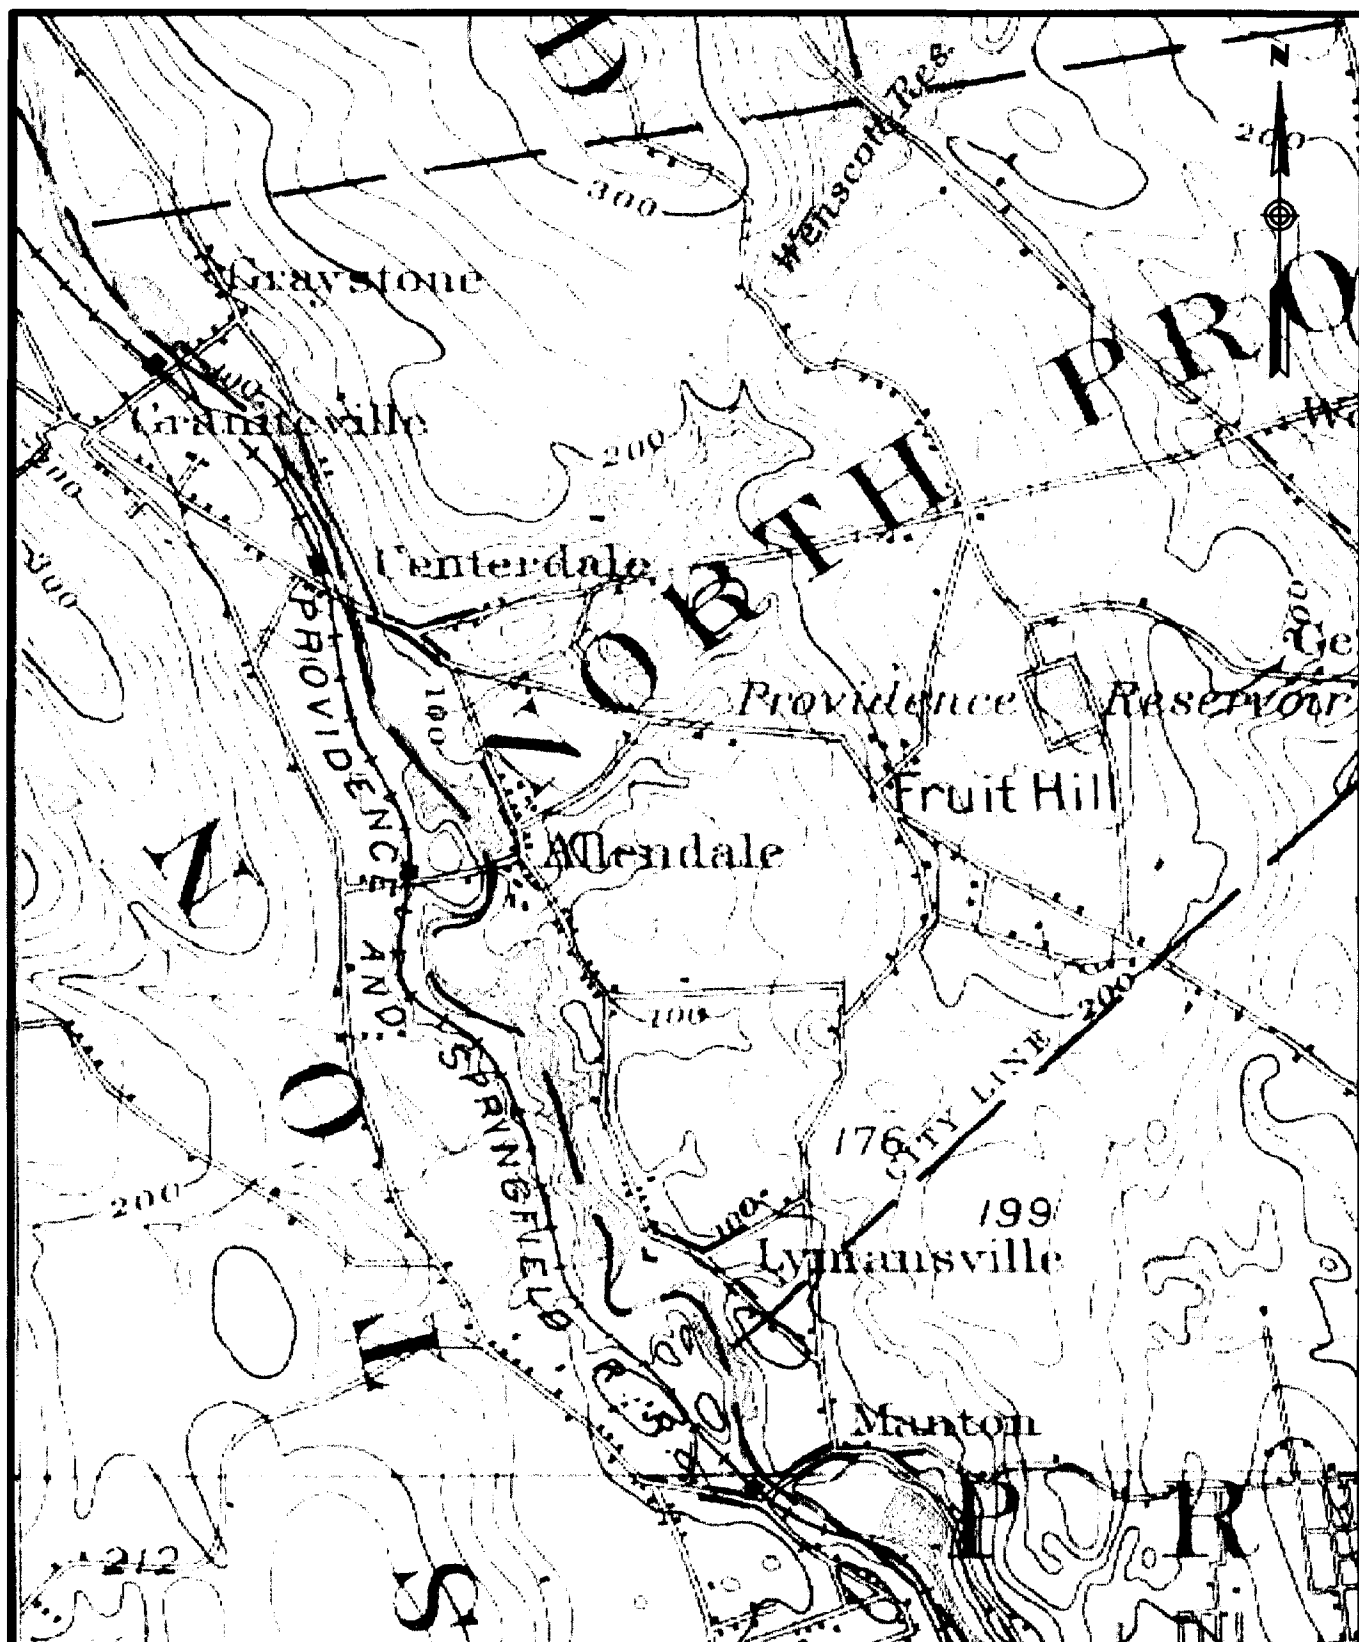
MAP REFERENCE: SCALE IN FEET  
USGS 7.5 MINUTE SERIES QUADRANGLE FOR  
PROVIDENCE, R.I., DATED 1894

*1894 (reprinted 1932) Providence, Rhode Island Quadrangle, USGS 15-Minute Series*

Allendale Pond and Lymansville Pond are clearly defined on this map. As of yet, the site proper (2072 and 2074 Smith Street) has not been developed. The properties adjacent to Allendale Dam and at Lymansville Dam have been developed. Properties along Woonasquatucket Avenue have also been developed between Smith Street and Lymansville Dam. Allendale Way (Allendale Avenue) is the only crossroad that has been developed. Several buildings exist along this road at this time.

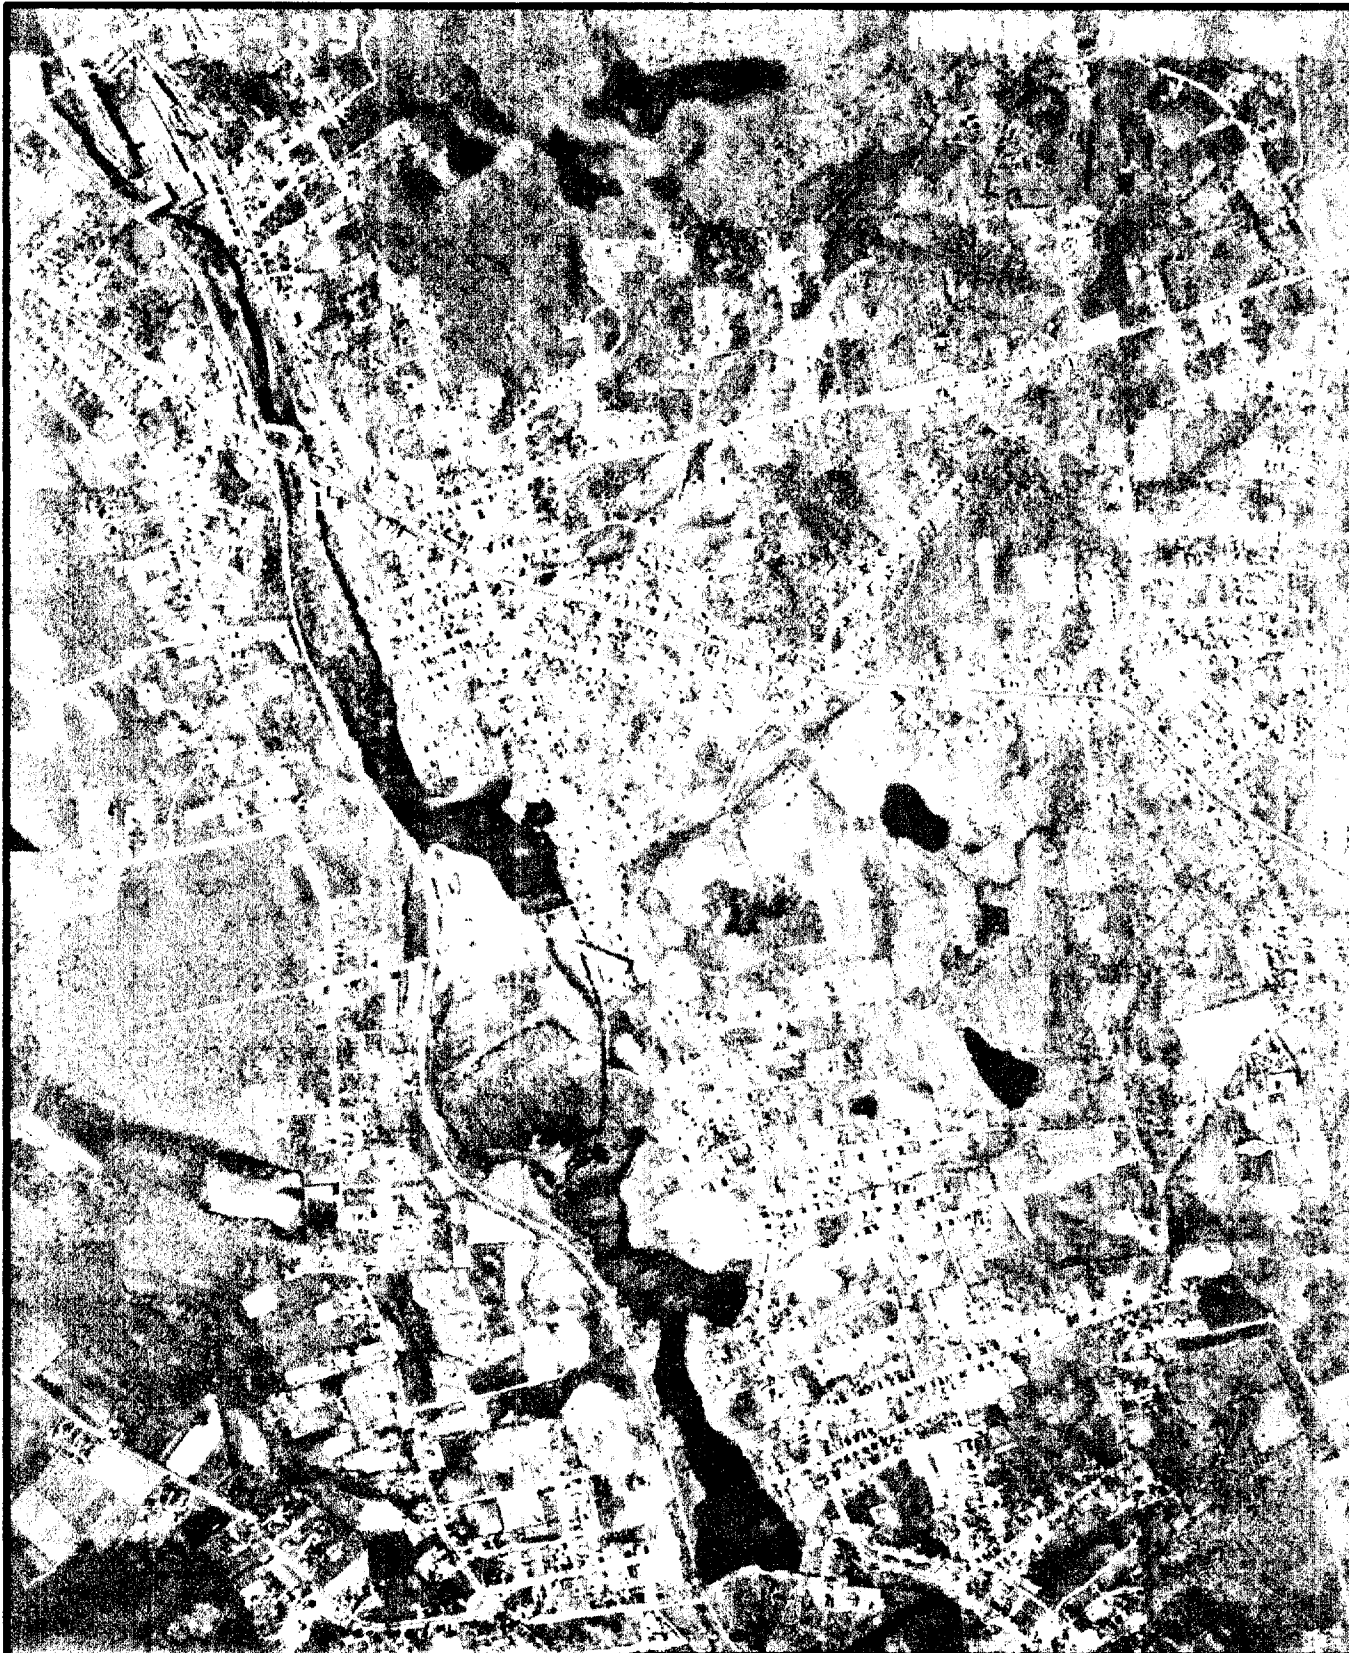
AERIAL PHOTOGRAPH  
05-15-39

In general, the area surrounding Allendale Pond has been fairly well developed by 1939. At this time, development of the land south of Centredale and in the vicinity of Lymansville Pond was less extensive. As shown in the 1939 photograph, much of the land abutting Allendale Pond, Lymansville Pond, and the Woonasquatucket River was not being utilized. By 1951, the Site proper and land immediately adjacent to Allendale Pond, Lymansville Pond, and the Woonasquatucket River had undergone significant development. The development of adjoining land is exemplified by the landform changes observed at the northern extent of Allendale Pond and the west end of George Street. In this area surface water is no longer present apparently due to filling activities. The development of adjoining land is further exemplified by the change in the appearance of the land defined by "Action Area 6" and "Action Area 7". By 1951, it appears that clearing and construction activities have occurred in these areas.

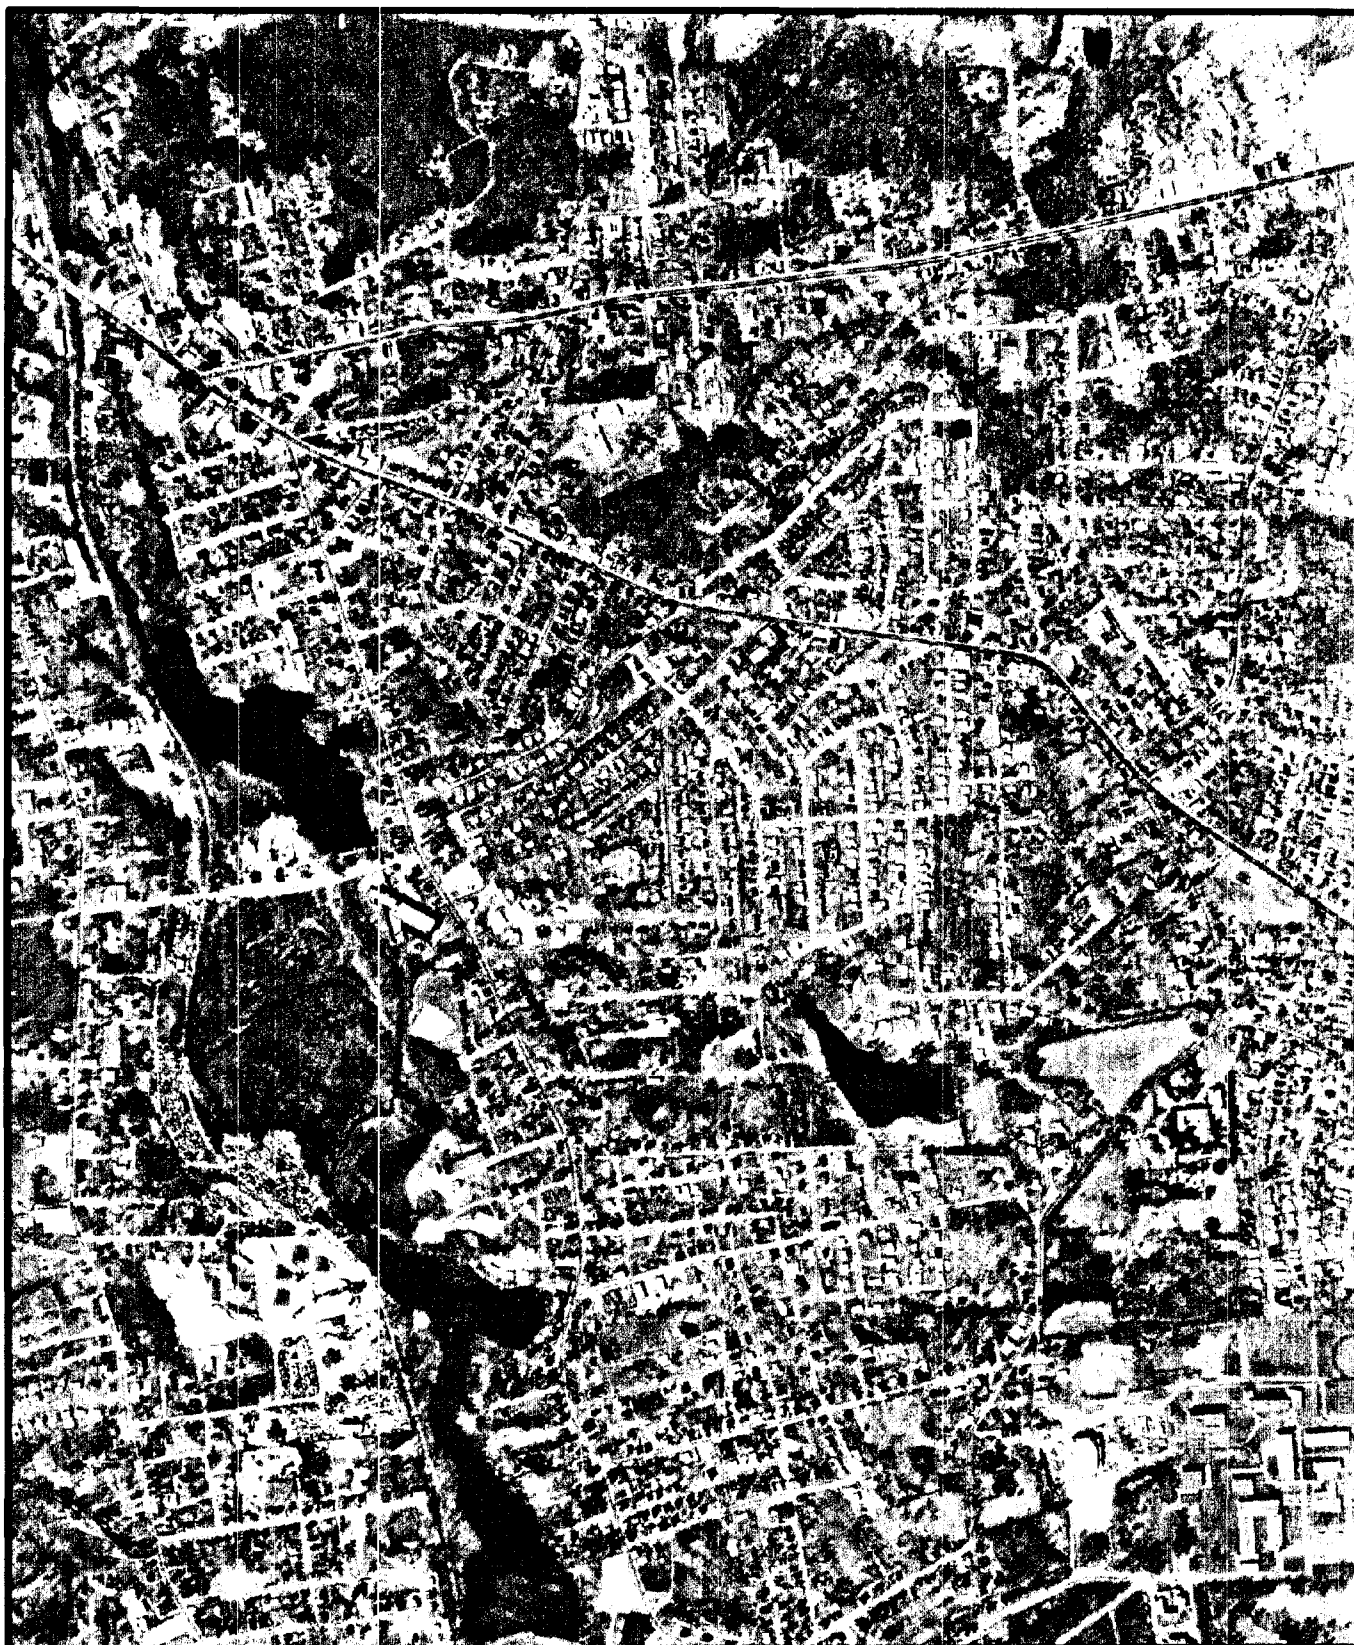
AERIAL PHOTOGRAPH  
4-19-65

By 1965, continued development and use of the land abutting Allendale Pond is evident. In general, land that had previously been cleared to the edge of Allendale Pond appears to have been overgrown or filled, as is evident in the vicinity of "Action Area 2" (Steere Avenue). This general observation is also made for "Action Area 4", where additional filling activities appear to have occurred at the west end of George Street. By 1965, it is also evident that land defined by "Action Area 6" has been substantially disturbed.

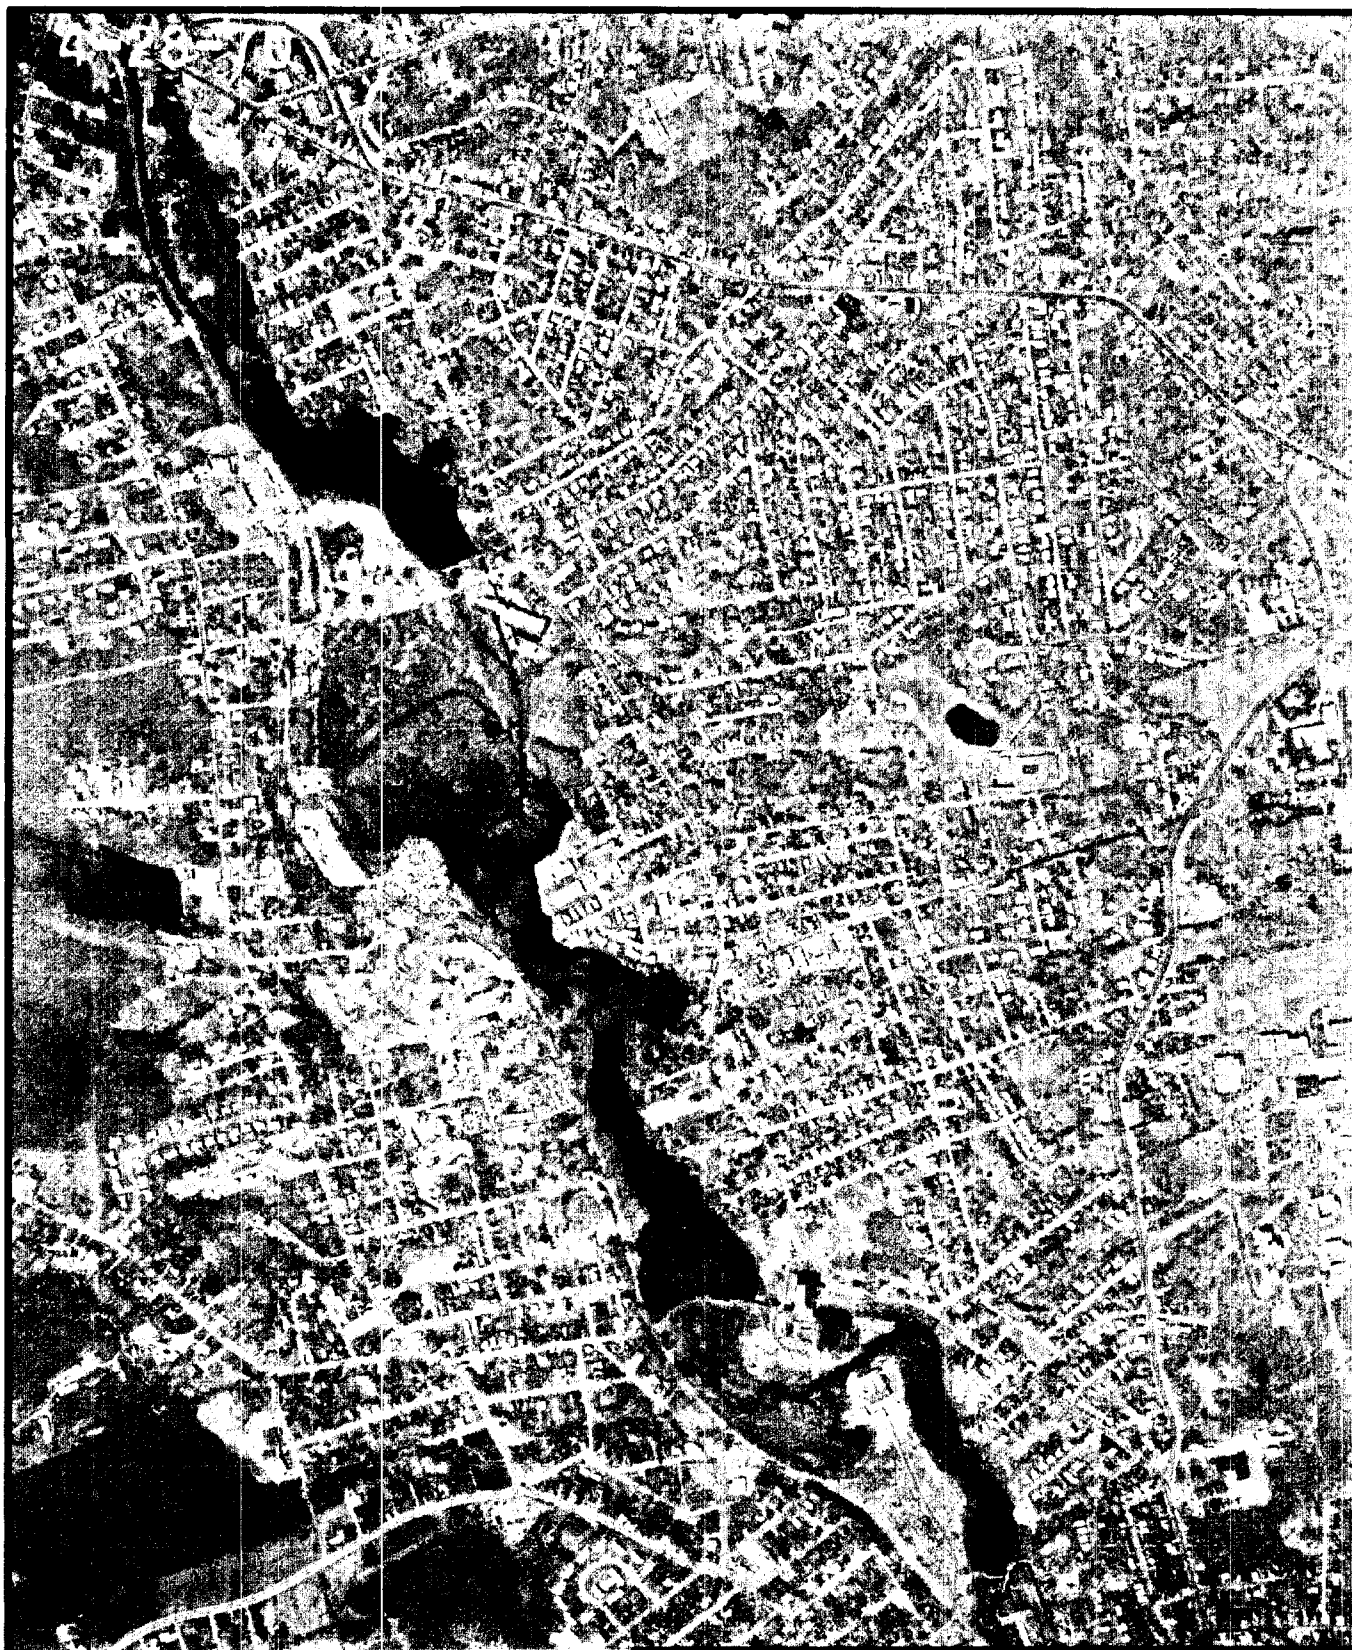
AERIAL PHOTOGRAPH  
04-28-70

Landform changes in the vicinity of Lymansville Pond are also evident, and by 1970 the land defined by "Action Area 9" has been cleared and developed with residential buildings. This area of the Site appears to have been uniformly graded to the edge of Lymansville Pond. In the area
