**PHOTODOCUMENTATION**  
**CENTREDALE MANOR RESTORATION PROJECT SUPERFUND SITE**  
**North Providence, Rhode Island**

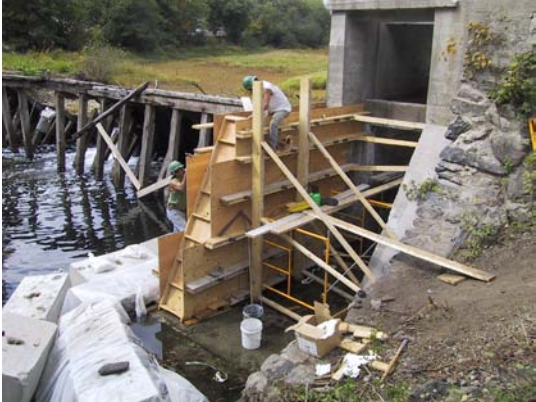
| Photograph | Date | View Point | View Direction | Description |
|---|---|---|---|---|
| | 09.19.2001 | East side of embankment, downstream of gate structure | NW | Forming extension of wing-wall |

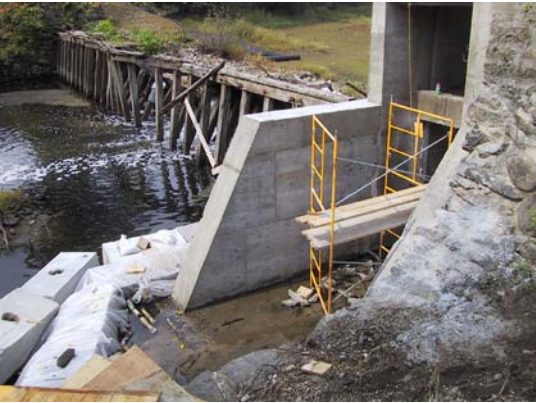
| Photograph | Date | View Point | View Direction | Description |
|---|---|---|---|---|
| | 09.24.2001 | East side of embankment, downstream of gate structure | NW | Finished wing-wall |

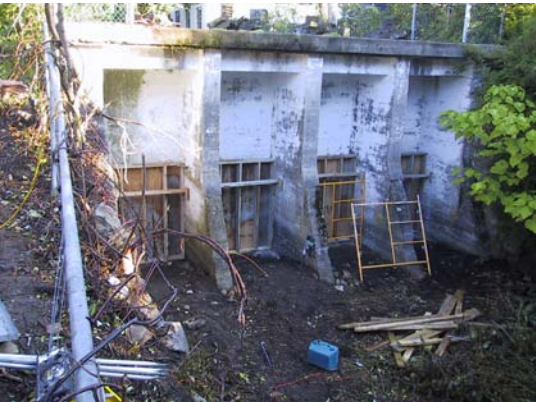
| Photograph | Date | View Point | View Direction | Description |
|---|---|---|---|---|
| | 09.26.2001 | West side of tailrace, standing in construction parking lot | NE | Forming plugs for tailrace |

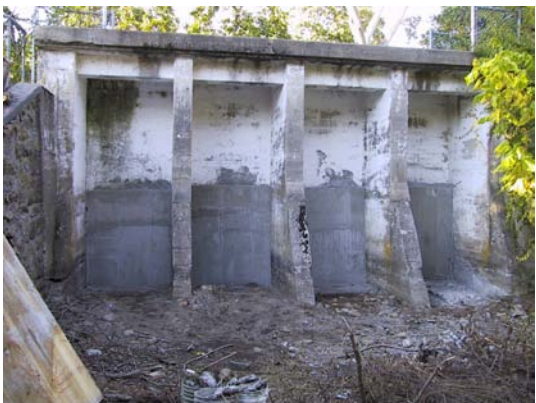
| Photograph | Date | View Point | View Direction | Description |
|---|---|---|---|---|
| | 10.04.2001 | West side of tailrace | NNE | Plugged tailrace |

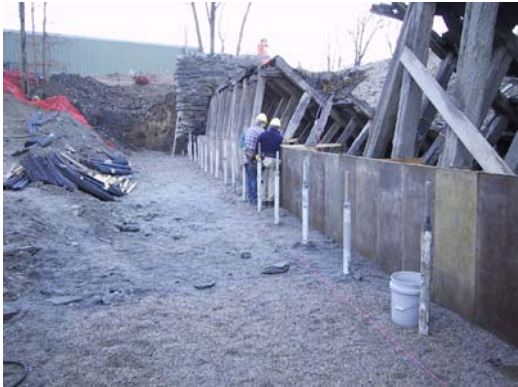
| Photograph | Date | View Point | View Direction | Description |
|---|---|---|---|---|
| | 11.30.2001 | East side of embankment, immediately downstream of existing gate structure | W | Concrete Formwork:<br>Section of formed wall for dam footing<br><br>Note: Rock anchor bolts on downstream side of formed wall |

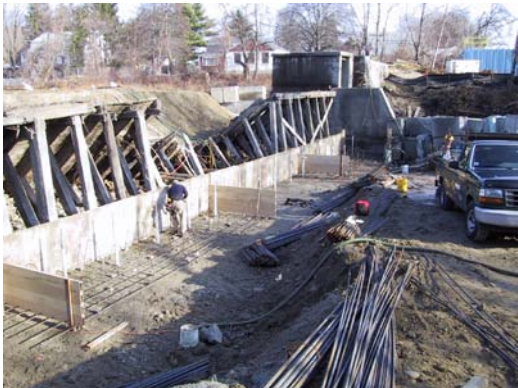
| Photograph | Date | View Point | View Direction | Description |
|---|---|---|---|---|
| | 12.01.2001 | West end of downstream cofferdam | NE | Concrete Formwork:<br>Installation of forms and reinforcing steel bars for dam footing |

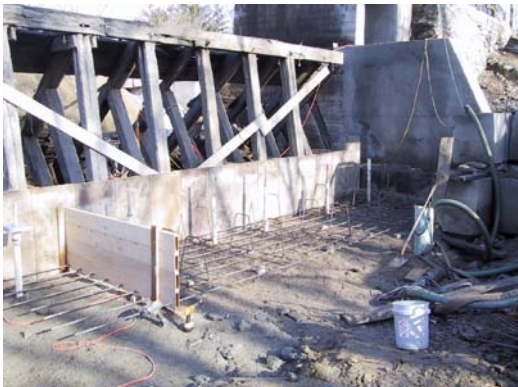
| Photograph | Date | View Point | View Direction | Description |
|---|---|---|---|---|
| | 12.01.2001 | Downstream cofferdam | NE | Concrete Formwork:<br>Installation of forms and reinforcing steel bars for dam footing<br><br>Note: Wing-wall and gate structure in background |

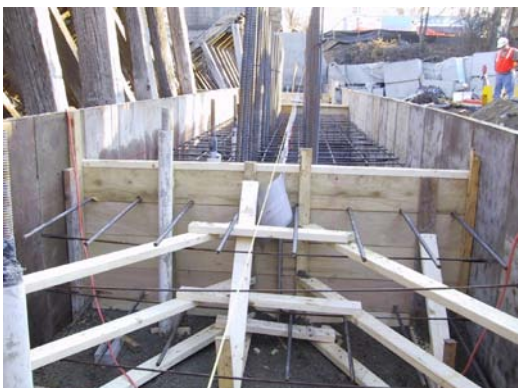
| Photograph | Date | View Point | View Direction | Description |
|---|---|---|---|---|
| | 12.05.2001 | West end of proposed dam | E | Concrete Formwork:<br>Installed forms and reinforcing steel bars for dam footing |

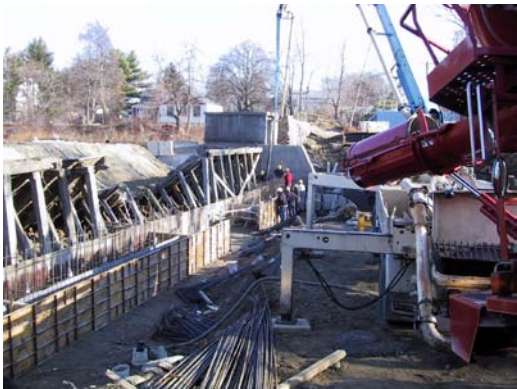
| Photograph | Date | View Point | View Direction | Description |
|---|---|---|---|---|
| | 12.05.2001 | Downstream cofferdam | E | Dam footing concrete pour |

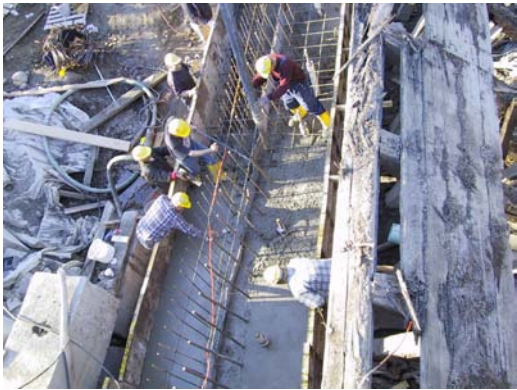
| Photograph | Date | View Point | View Direction | Description |
|---|---|---|---|---|
| | 12.05.2001 | Standing on top of existing gate structure | W | Dam footing concrete pour |

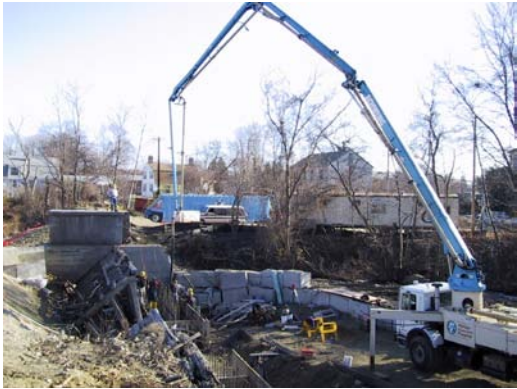
| Photograph | Date | View Point | View Direction | Description |
|---|---|---|---|---|
| | 12.05.2001 | West abutment of existing dam structure | E | Dam footing concrete pour |

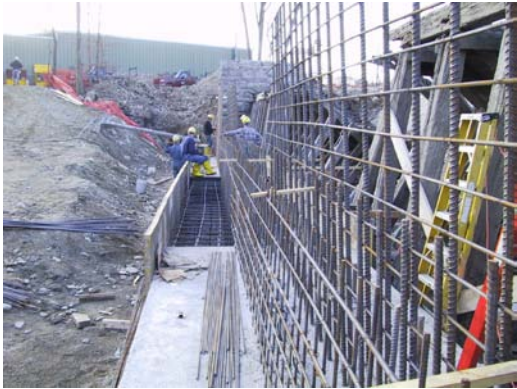
| Photograph | Date | View Point | View Direction | Description |
|---|---|---|---|---|
| | 12.07.2001 | Eastern embankment downstream of existing gate structure | W | Concrete Formwork:<br>Installed forms and reinforcing steel bars for dam footing<br><br>Note: Reinforcing steel bars for concrete wall tied to reinforcing steel bars of poured footing |

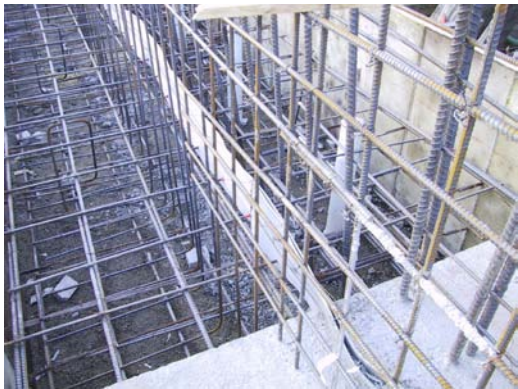
| Photograph | Date | View Point | View Direction | Description |
|---|---|---|---|---|
| | 12.07.2001 | Downstream of center section of dam structure | W | Concrete Formwork:<br>Installed forms and reinforcing steel bars for dam footing |

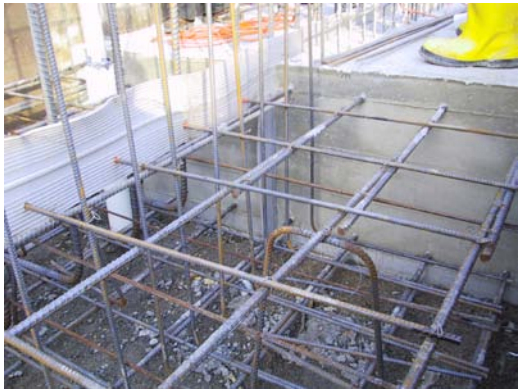
| Photograph | Date | View Point | View Direction | Description |
|---|---|---|---|---|
| | 12.07.2001 | Downstream of center section of dam structure | E | Concrete Formwork:<br>Installed forms and reinforcing steel bars for dam footing<br><br>Note: PVC waterstop placed between reinforcing steel bars |

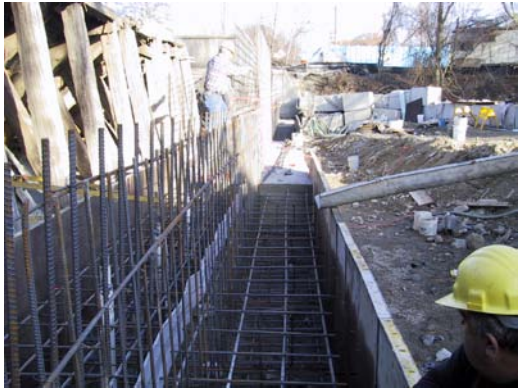
| Photograph | Date | View Point | View Direction | Description |
|---|---|---|---|---|
| | 12.07.2001 | West end of dam structure | E | Concrete Formwork:<br>Installed forms and reinforcing steel bars for dam footing<br><br>Note: Just prior to concrete pour |

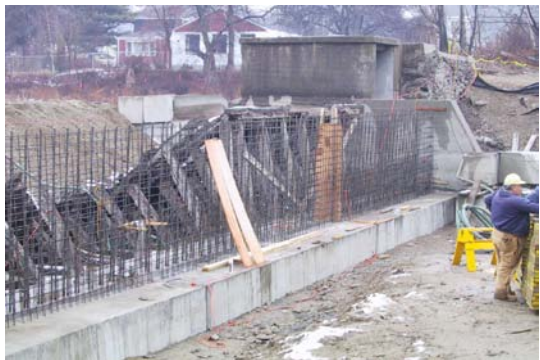
| Photograph | Date | View Point | View Direction | Description |
|---|---|---|---|---|
| | 12.11.2001 | Downstream cofferdam | NE | Placement of fabricated bar mats and reinforcing steel bars for dam wall construction |

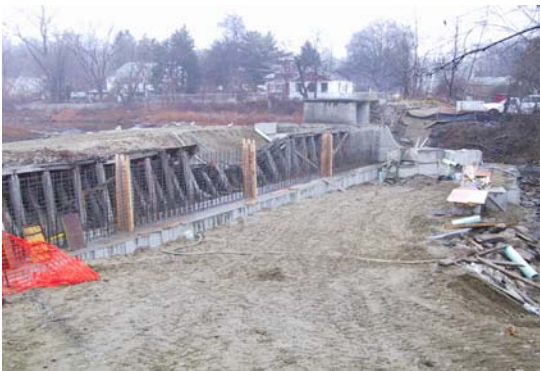
| Photograph | Date | View Point | View Direction | Description |
|---|---|---|---|---|
| | 12.13.2001 | Downstream cofferdam | NE | Placement of fabricated bar mats and reinforcing steel bars for dam wall construction |

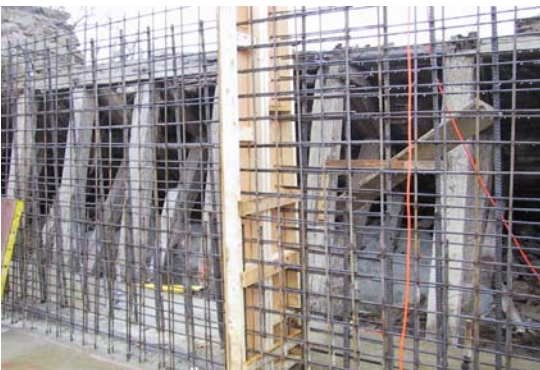
| Photograph | Date | View Point | View Direction | Description |
|---|---|---|---|---|
| | 12.13.2001 | Downstream of dam wall | NW | Placement of fabricated bar mats and reinforcing steel bars for dam wall construction |

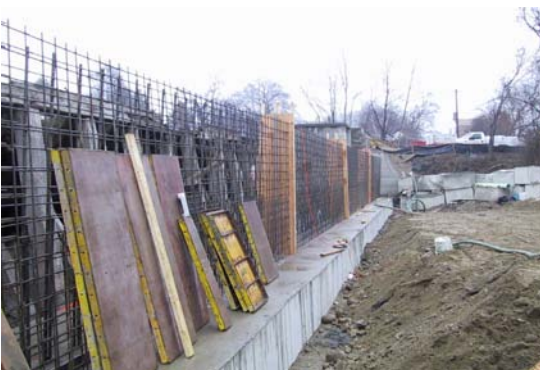
| Photograph | Date | View Point | View Direction | Description |
|---|---|---|---|---|
| | 12.13.2001 | Downstream of dam wall at west end | E | Placement of fabricated bar mats and reinforcing steel bars for dam wall construction |

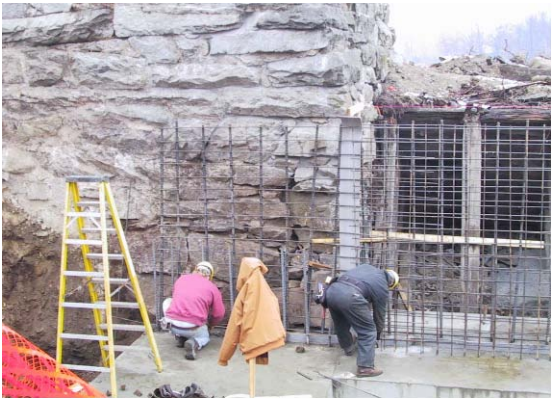
| Photograph | Date | View Point | View Direction | Description |
|---|---|---|---|---|
| | 12.11.2001 | Downstream cofferdam at west abutment | N | <p>Placement of fabricated bar mats and reinforcing steel bars for dam wall construction</p> <p>Note: PVC waterstop along abutment with existing granite stone wall</p> |

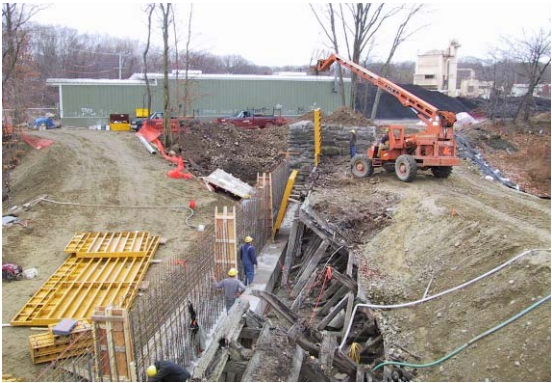
| Photograph | Date | View Point | View Direction | Description |
|---|---|---|---|---|
| | 12.14.2001 | Standing on top of existing gate structure | W | <p>Placement of forms for concrete dam wall</p> |

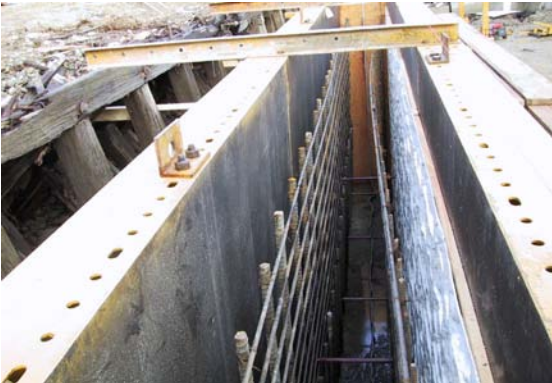
| Photograph | Date | View Point | View Direction | Description |
|---|---|---|---|---|
| | 12.18.2001 | West side of dam | E | <p>Close-up view of forms for concrete dam wall</p> |

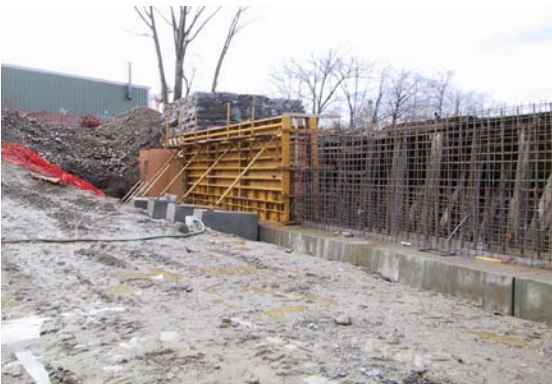
| Photograph | Date | View Point | View Direction | Description |
|---|---|---|---|---|
| | 12.18.2001 | Downstream of dam along east side | NW | <p>Placement of forms for concrete dam wall where it abuts existing granite stone wall</p> |

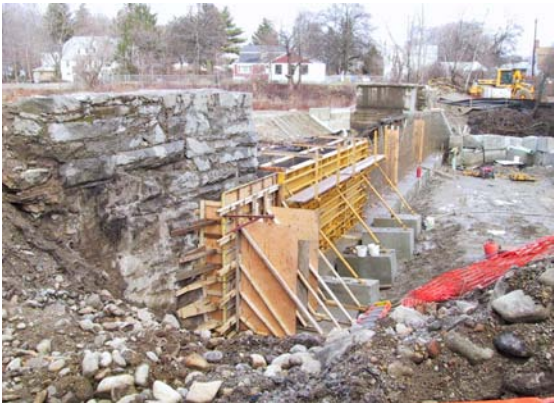
| Photograph | Date | View Point | View Direction | Description |
|---|---|---|---|---|
| | 12.18.2001 | Downstream cofferdam | NE | Placement of forms for concrete dam wall where it abuts existing granite stone wall |

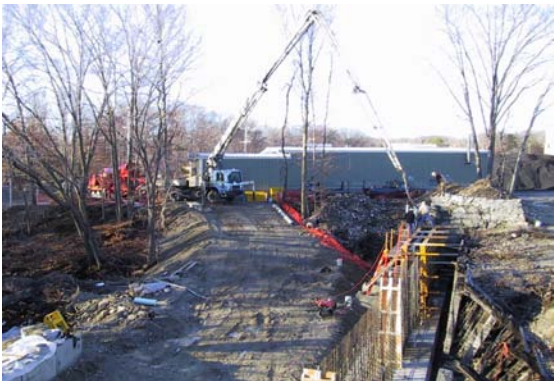
| Photograph | Date | View Point | View Direction | Description |
|---|---|---|---|---|
| | 12.19.2001 | Standing on top of existing gate structure | W | Dam wall concrete pour |

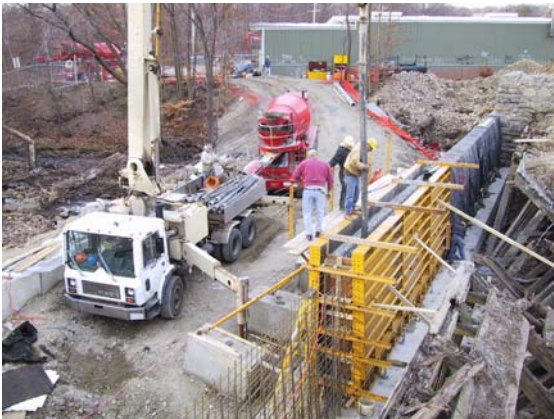
| Photograph | Date | View Point | View Direction | Description |
|---|---|---|---|---|
| | 12.26.2001 | Standing on top of existing gate structure | W | Dam wall concrete pour (2 <sup>nd</sup> section of wall)<br><br>Note: Placement of concrete curing mat |

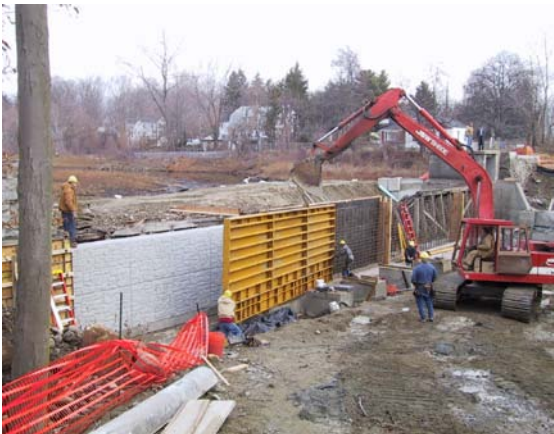
| Photograph | Date | View Point | View Direction | Description |
|---|---|---|---|---|
| | 12.20.2001 | Downstream cofferdam | NE | Removal of first section of forms for concrete dam wall |

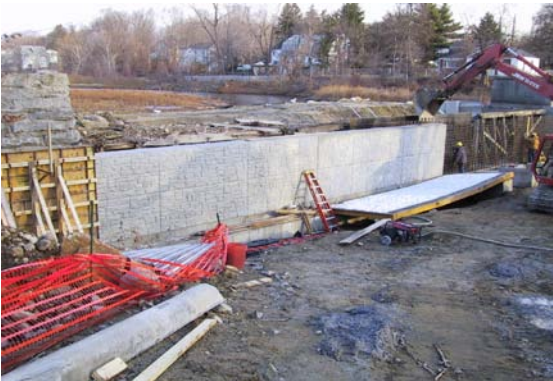
| Photograph | Date | View Point | View Direction | Description |
|---|---|---|---|---|
| | 12.21.2001 | Downstream cofferdam | NE | Removal of forms for concrete dam wall<br><br>Note: Factory fabricated elastomeric textured concrete form liner |

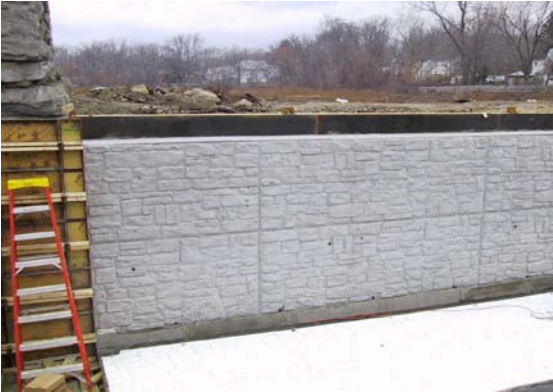
| Photograph | Date | View Point | View Direction | Description |
|---|---|---|---|---|
| | 12.21.2001 | Downstream of concrete dam wall where it abuts the existing granite stone wall | N | Exposed face of the stem of the dam<br><br>Note: Ashlar Stone Texture pattern |

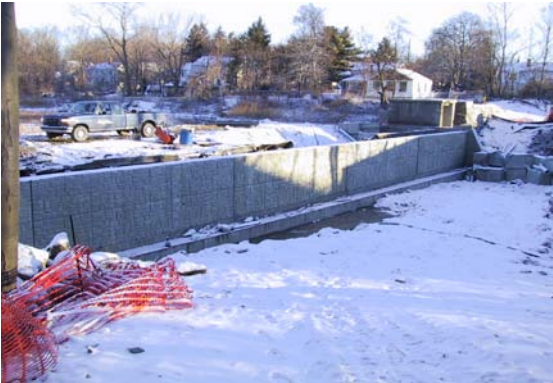
| Photograph | Date | View Point | View Direction | Description |
|---|---|---|---|---|
| | 01.08.2002 | Downstream cofferdam | NE | Exposed face of the stem of the dam |

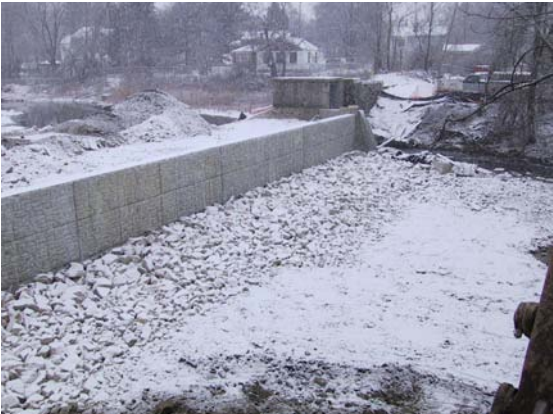
| Photograph | Date | View Point | View Direction | Description |
|---|---|---|---|---|
| | 01.17.2002 | Downstream cofferdam | NE | Exposed face of the stem of the dam<br><br>Note: Riprap placed at the foot of the concrete wall |

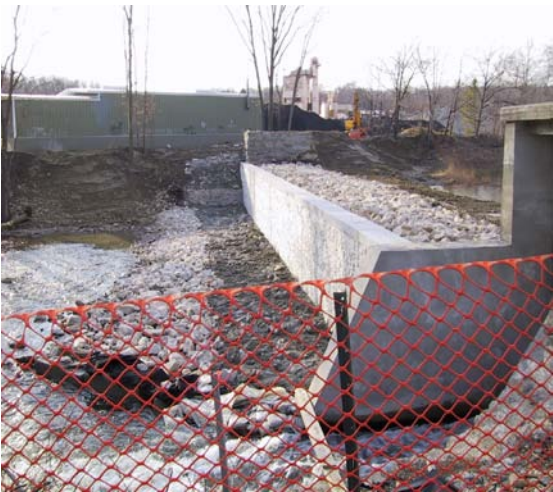
| Photograph | Date | View Point | View Direction | Description |
|---|---|---|---|---|
| | 01.29.2002 | Eastern embankment | W | Concrete dam wall<br><br>Note: Capstones on top of the wall and grouted riprap at the foot of the wall |

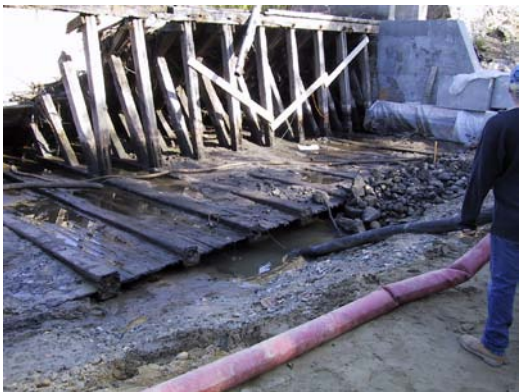
| Photograph | Date | View Point | View Direction | Description |
|---|---|---|---|---|
| | 10.10.2001 | Downstream of Allendale Dam structure on downstream cofferdam | NE | Exposed timber structure of former Allendale Dam |

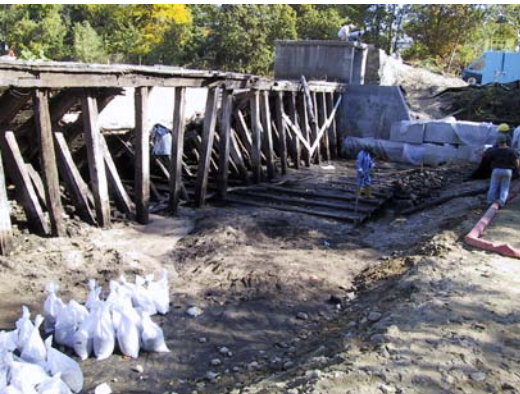
| Photograph | Date | View Point | View Direction | Description |
|---|---|---|---|---|
| | 10.10.2001 | Downstream cofferdam | E | Exposed timber structure of former Allendale Dam |

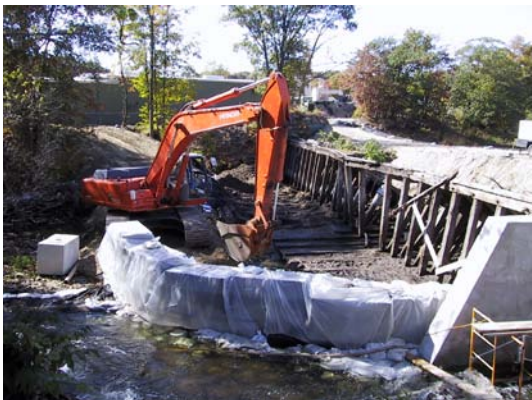
| Photograph | Date | View Point | View Direction | Description |
|---|---|---|---|---|
| | 10.11.2001 | East embankment | WNW | Removal of debris below the former Allendale Dam structure |

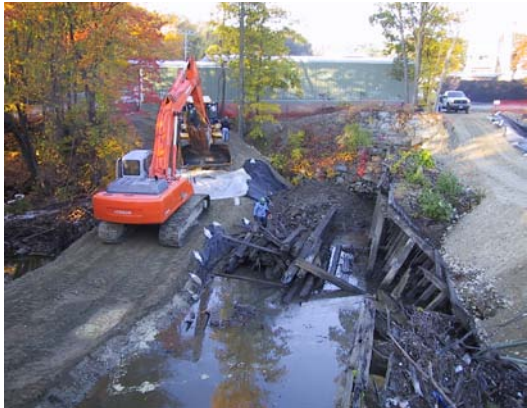
| Photograph | Date | View Point | View Direction | Description |
|---|---|---|---|---|
| | 10.16.2001 | Existing gate structure | W | Removal of debris below the former Allendale Dam structure |

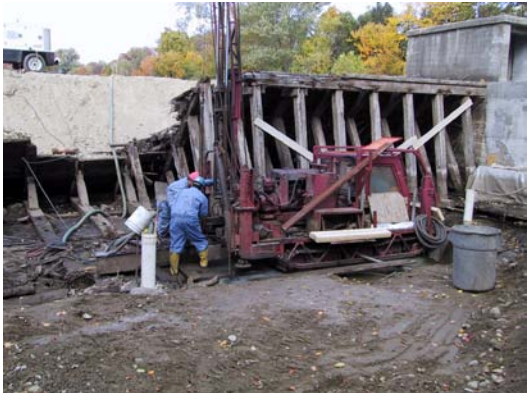
| Photograph | Date | View Point | View Direction | Description |
|---|---|---|---|---|
| | 10.16.2001 | Downstream cofferdam | NE | Rock coring activities (30 ft rock core) |

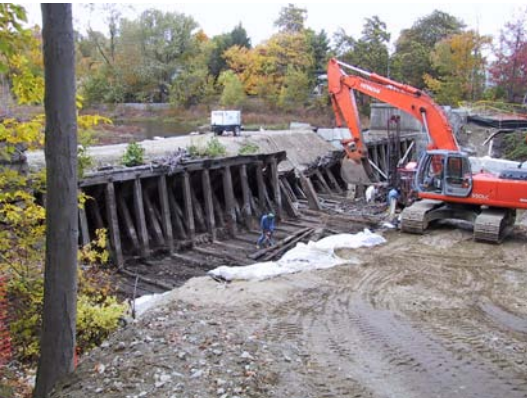
| Photograph | Date | View Point | View Direction | Description |
|---|---|---|---|---|
| | 10.17.2001 | Downstream cofferdam along The Town Asphalt Company property | ENE | Removal of timber of former Allendale Dam structure and rock coring activities |

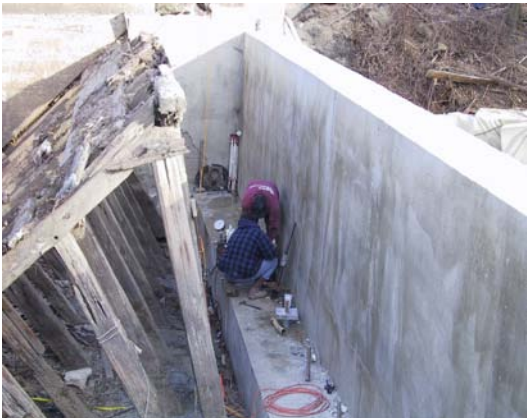
| Photograph | Date | View Point | View Direction | Description |
|---|---|---|---|---|
| | 01.04.2002 | Western embankment at dam abutment | E | Rock anchor bolt testing |

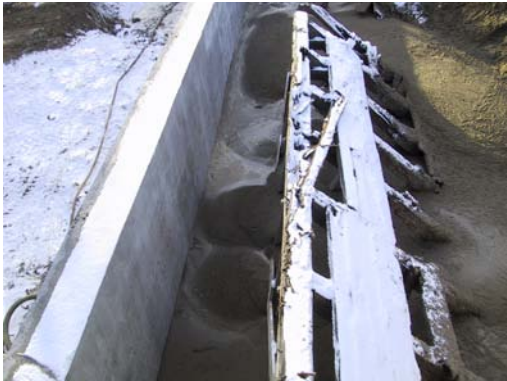
| Photograph | Date | View Point | View Direction | Description |
|---|---|---|---|---|
| | 01.08.2002 | Standing on top of existing gate structure | W | Placement of concrete flowable fill between concrete dam wall and old dam structure |

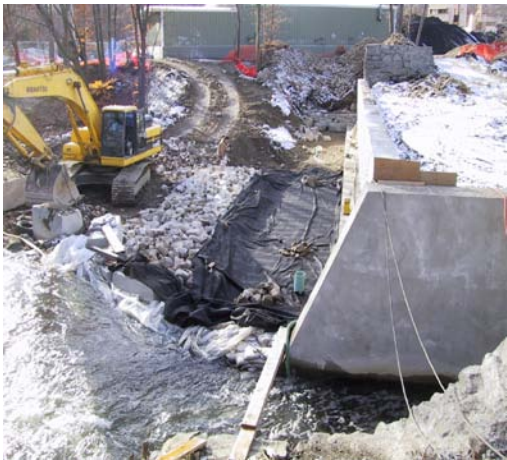
| Photograph | Date | View Point | View Direction | Description |
|---|---|---|---|---|
| | 01.14.2002 | Eastern embankment | W | Installation of filter fabric for toe drain |

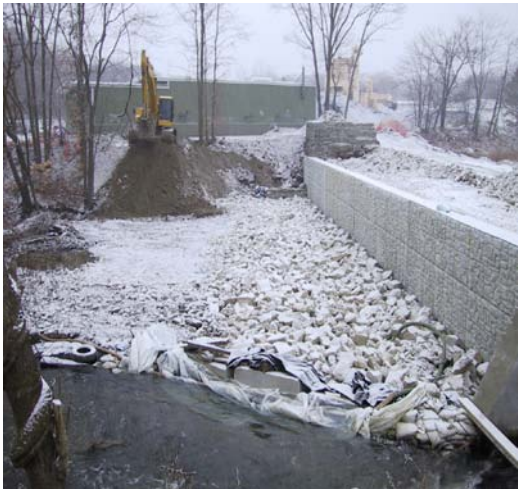
| Photograph | Date | View Point | View Direction | Description |
|---|---|---|---|---|
| | 01.17.2002 | Eastern embankment | W | Removal of downstream cofferdam following placement of riprap at foot of concrete dam wall |
