TS-PIC-20901104S  
May 2009

AERIAL HISTORICAL PHOTOGRAPHIC ANALYSIS,  
LAND USE/LAND COVER ANALYSIS, AND WETLANDS/DRAINAGE  
ANALYSIS OF CENTREDALE MANOR RESTORATION PROJECT  
STUDY AREA

Johnston, Rhode Island

ENVIRONMENTAL SCIENCES DIVISION  
NATIONAL EXPOSURE RESEARCH LABORATORY  
OFFICE OF RESEARCH AND DEVELOPMENT  
U.S. ENVIRONMENTAL PROTECTION AGENCY  
LAS VEGAS, NEVADA 89193-3478

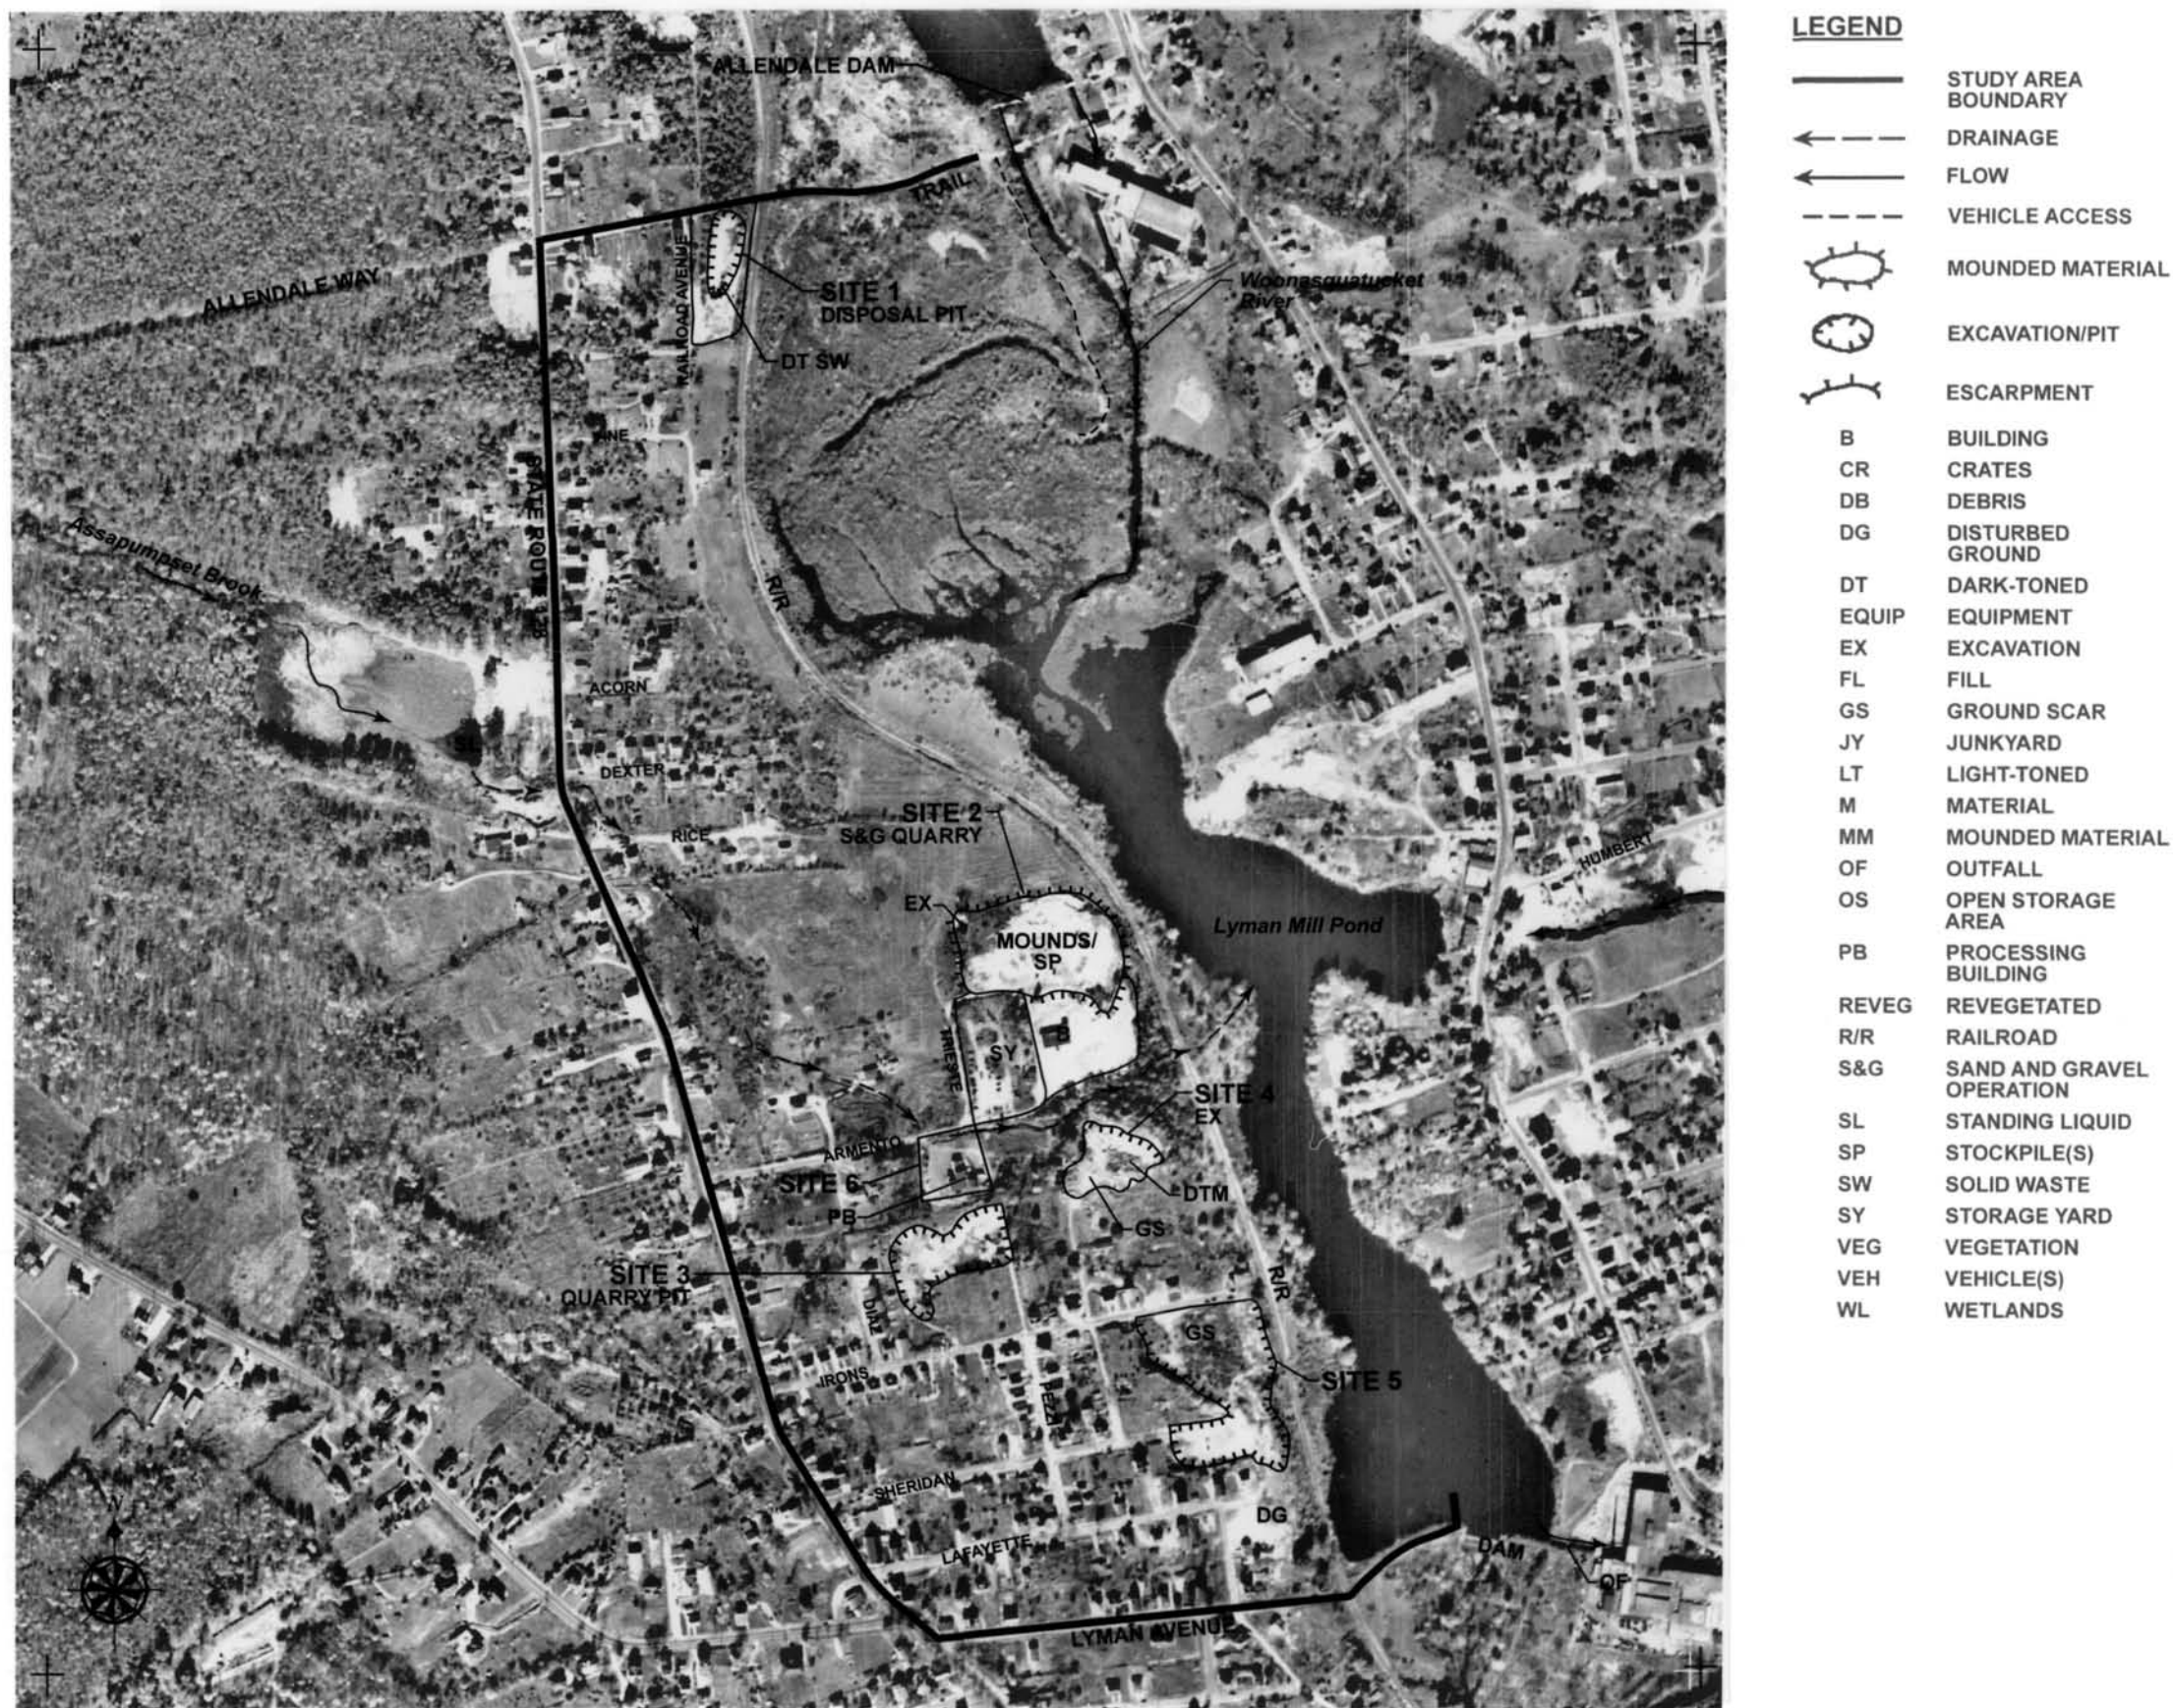
Figure 3. Centredale Manor Restoration Project study area, historical photographic analysis, October 26, 1951. Approximate scale 1:6,450.

Site 1 - A waste disposal pit is observed along the southern side of Allendale Way. The waste pit is accessed via Railroad Avenue and is bounded to the east by the raised railroad bed of the adjacent railroad (R/R). Dark-toned solid waste (DT SW) is visible along the rim and within this pit. A bottom-lining material is not discerned in the pit. Surface runoff that does not enter the disposal pit would drain south. Runoff leaving this disposal area is likely to flow to the southeast, along the base of the raised railroad bed, and eventually into Lyman Mill Pond.

Site 2 - An active sand and gravel quarry (S&G), with associated earthmoving vehicles, is visible on the west side of Lyman Mill Pond at the eastern end of Armento Street. Mounds of earth (not annotated) and stockpiles (SP) of sand and gravel are observed at the quarry. A storage yard (SY) for equipment and vehicles is on the western portion of the quarry adjacent to Trieste Street. The quarry is bounded on the east by the raised railroad bed that runs parallel to the western perimeter of Lyman Mill Pond. This raised railroad bed diverts drainage leaving the quarry south to the culvert under the tracks. Once through the culvert (not annotated) drainage merges with the east-flowing Assapumpset Brook that empties into Lyman Mill Pond.

Site 3 - A quarry pit is observed north of Irons Avenue between Diaz and Pezzi streets. No vehicles are discerned at the pit indicating that quarrying operations have ceased. Surface runoff at this location appears to remain at the pit and accumulated standing liquid is visible in the pit.

Site 4 - An excavation (EX) is observed near the eastern end of Armento Street. No vehicles or structures are discerned at this location. The excavation contains dark-toned material (DTM) and is apparently being used as a dump area. Runoff leaving this location would drain east and likely reach Lyman Mill Pond.

Site 5 - A partially overgrown excavation is observed along the western perimeter of Lyman Mill Pond, between Irons Avenue and Lafayette Street. This excavation appears to be a construction site. No vehicles or structures are discerned. The raised railroad bed to the east forms a barrier to runoff. Consequently runoff is likely to remain within the excavation.

Site 6 - The commercial company operates a large multistory processing building (PB) and a small parking lot (not annotated). The type of processing could not be determined from the photograph. The site is of interest due to its proximity to Assapumpset Brook which flows parallel to Armento Street and enters Lyman Mill Pond. Pollutants from spillage at the site could pose a threat to the adjacent brook.

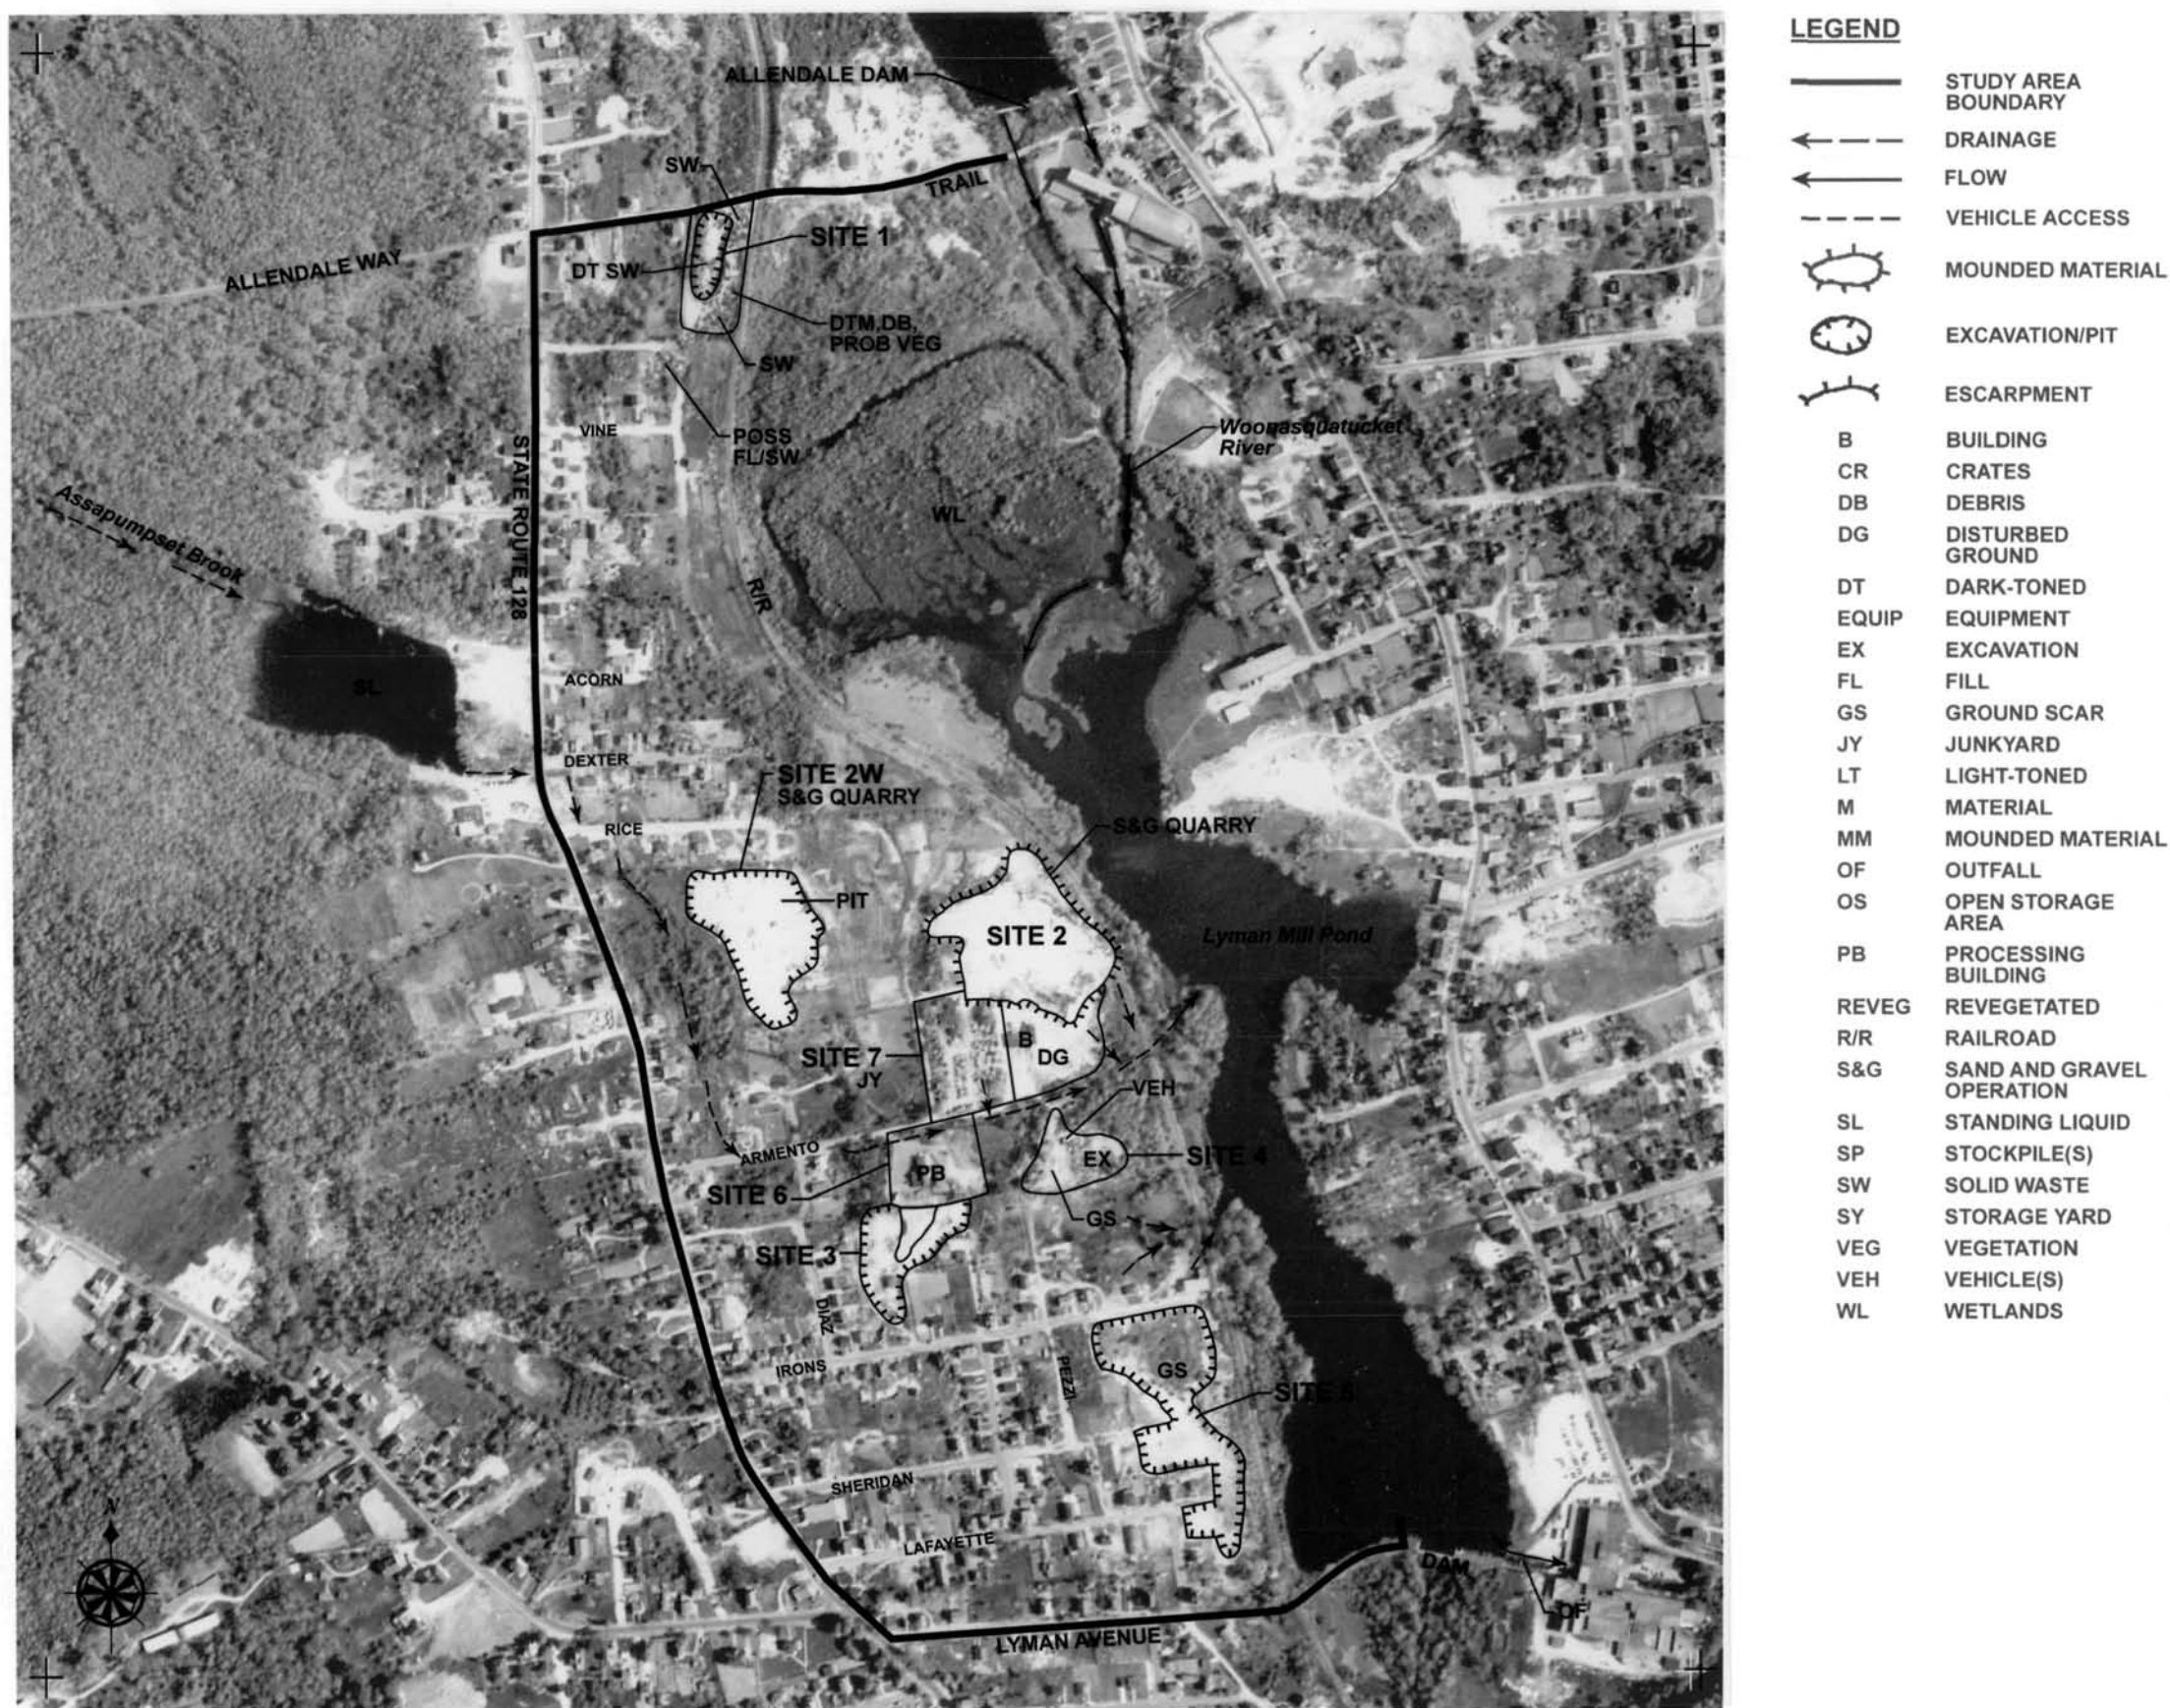
Figure 4. Centredale Manor Restoration Project study area, historical photographic analysis, May 19, 1955. Approximate scale 1:6,450.

Site 4 - The view of the excavation is partially obscured by vegetation overgrowth. The dark-toned material observed in 1951 is not discerned.

Site 6 - The commercial processing building appears to remain operational.

Site 7 - Since 1951 a junkyard (JY) has been established at the storage yard, noted in 1951 near Site 2. The junkyard is located along the north side of Armento Street and contains several derelict vehicles. Pollutants from the junkyard operations and potential spillage could enter the natural drainage via rain water transport into the nearby east-trending Assapumpset Brook that flows along the south side of Armento Street.

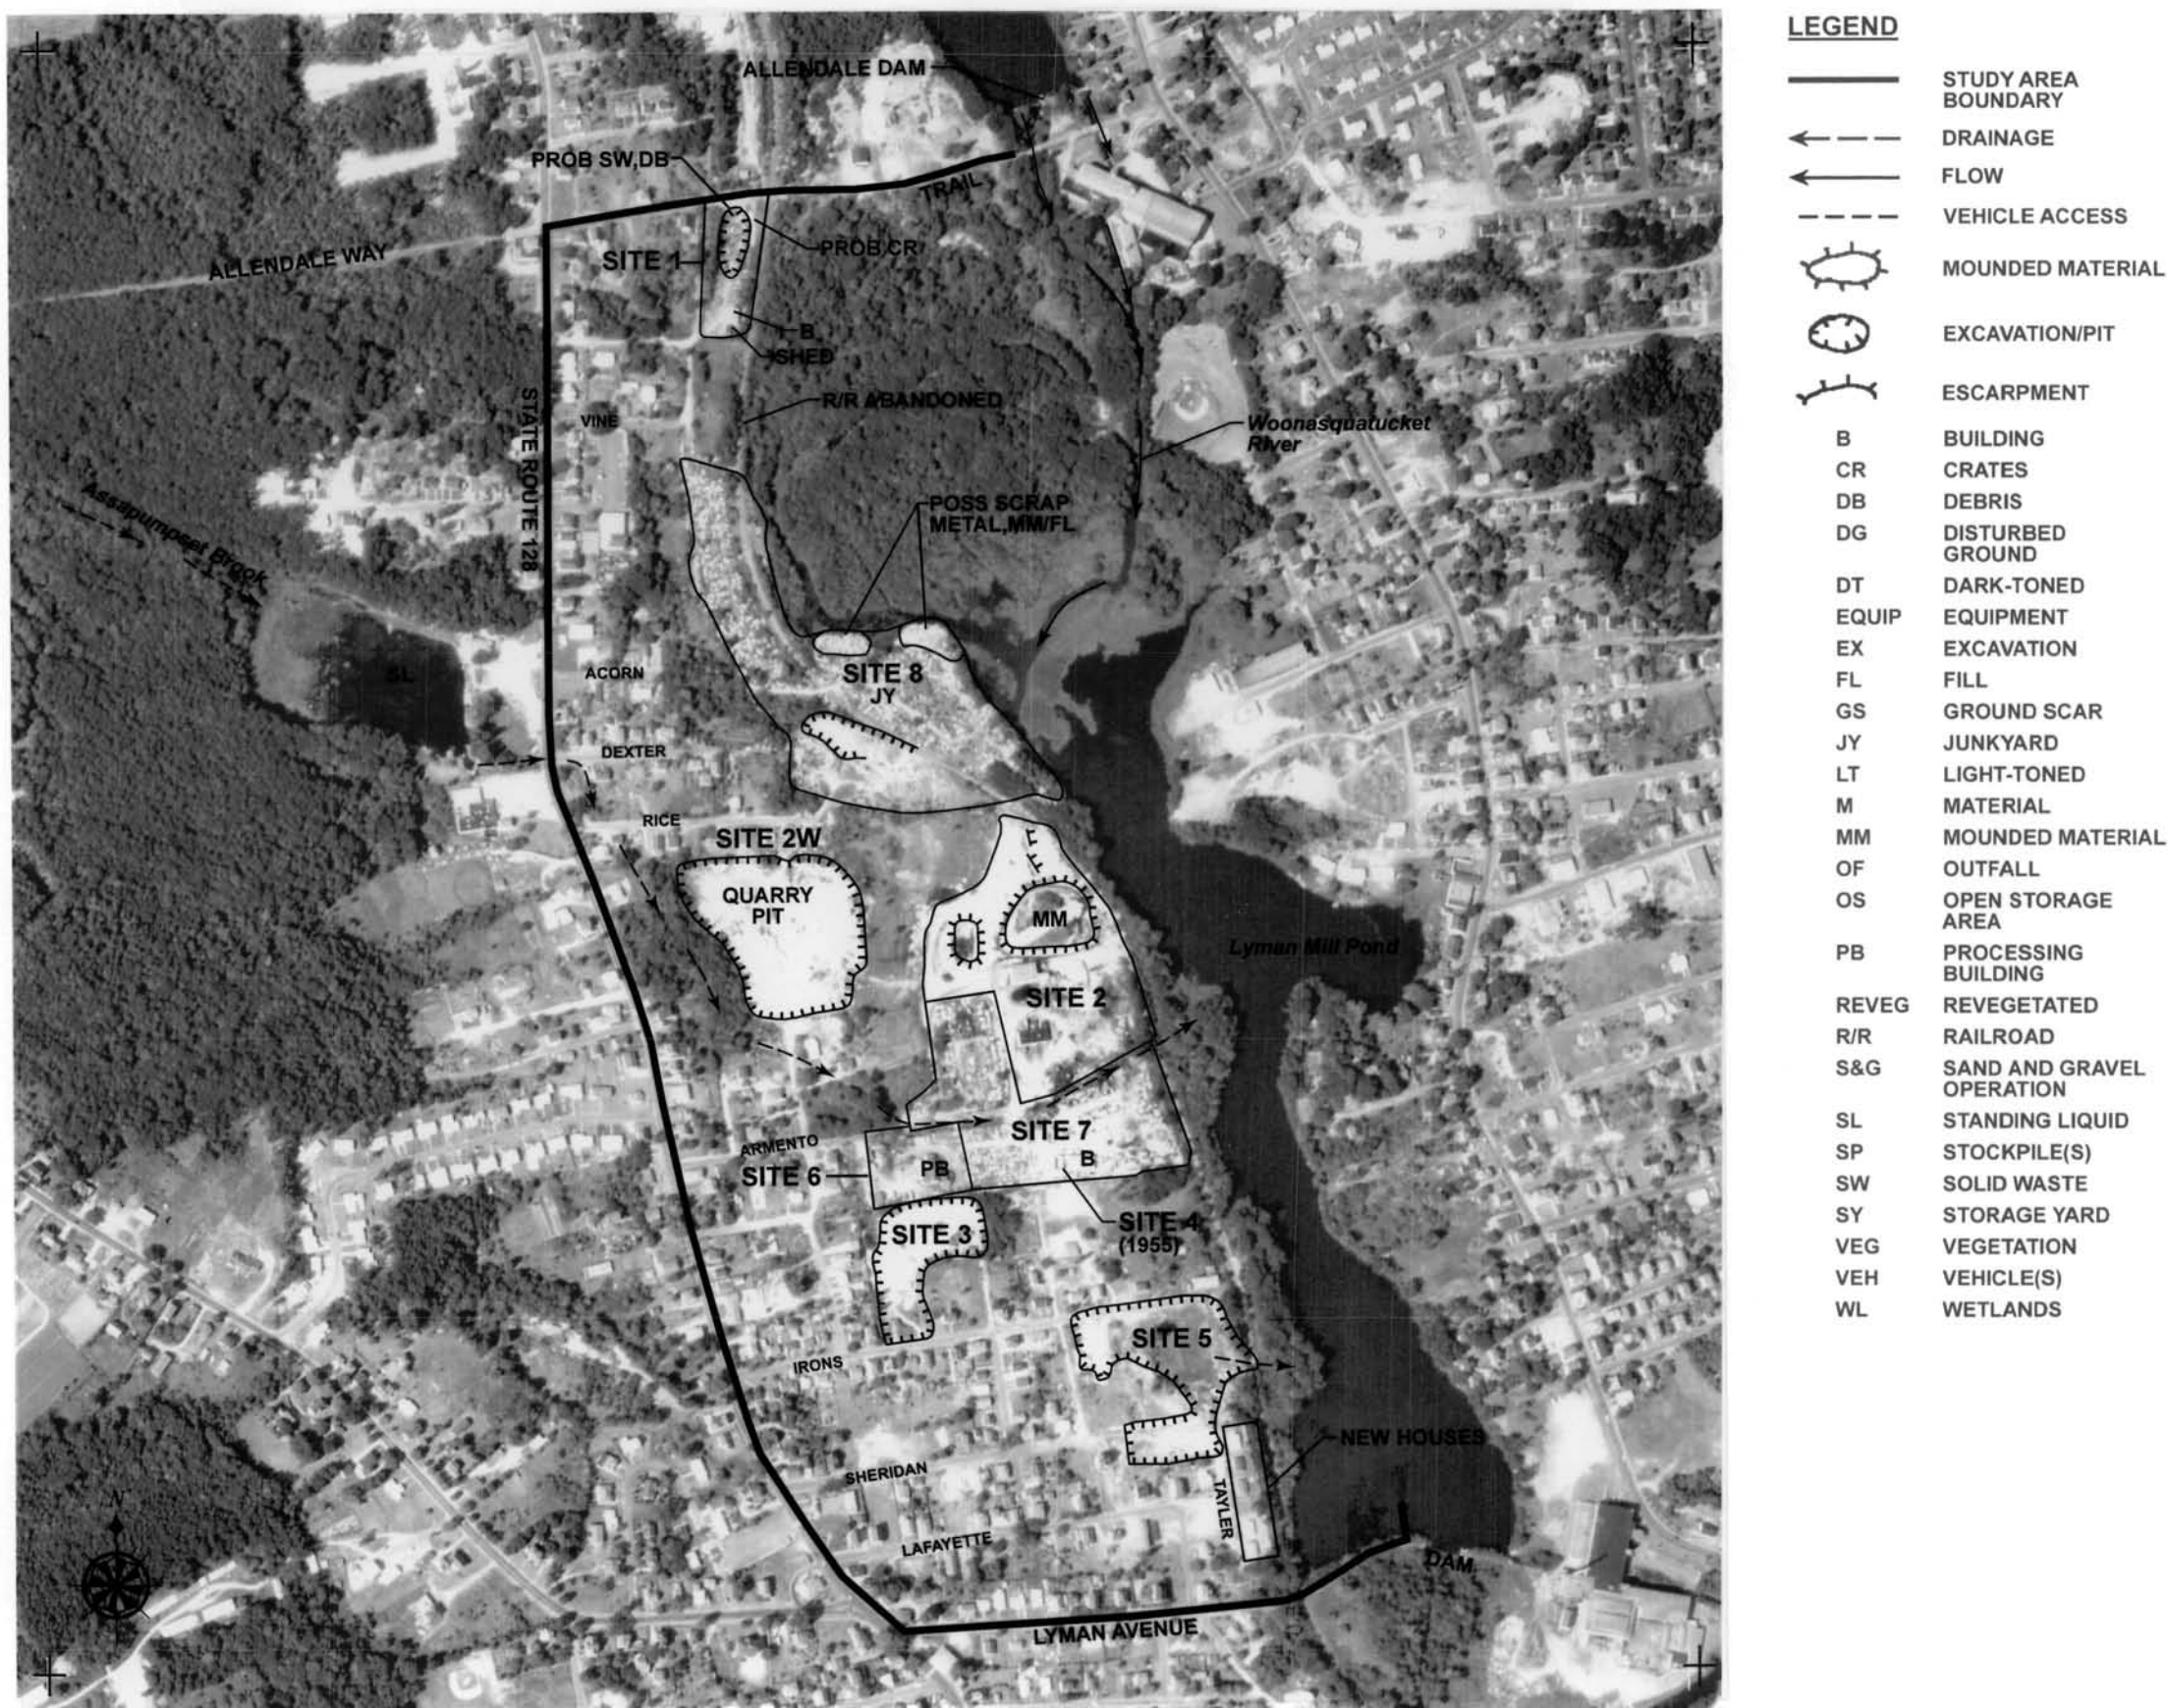
Figure 5. Centredale Manor Restoration Project study area, historical photographic analysis, September 2, 1963. Approximate scale 1:6,450.

Site 4 - The excavation noted in 1955 has been filled and the area is part of the enlarged junkyard at Site 7. The conditions at this location will be discussed under Site 7.

Site 7 - The junkyard adjacent to Site 2 has been enlarged to the south and east. Numerous derelict vehicles are observed throughout the site. A large building, a probable vehicle maintenance shop, has been constructed in the

southern portion of the junkyard. Potential pollutants from this site could pose a potential threat to the Assapumpset Brook which runs through the junkyard and empties into Lyman Mill Pond.

Site 8 - Another junkyard, established north and east of Rice Street, contains numerous derelict vehicles. The junkyard extends east across the abandoned railroad track to the western shore of Lyman Mill Pond on filled land that was wetland in 1955. Two large mounds of fill (MM/FL) and/or possible scrap metal are visible along the western bank of Lyman Mill Pond. Potential pollutants from junkyard operations could flow east via surface flow into Lyman Mill Pond.

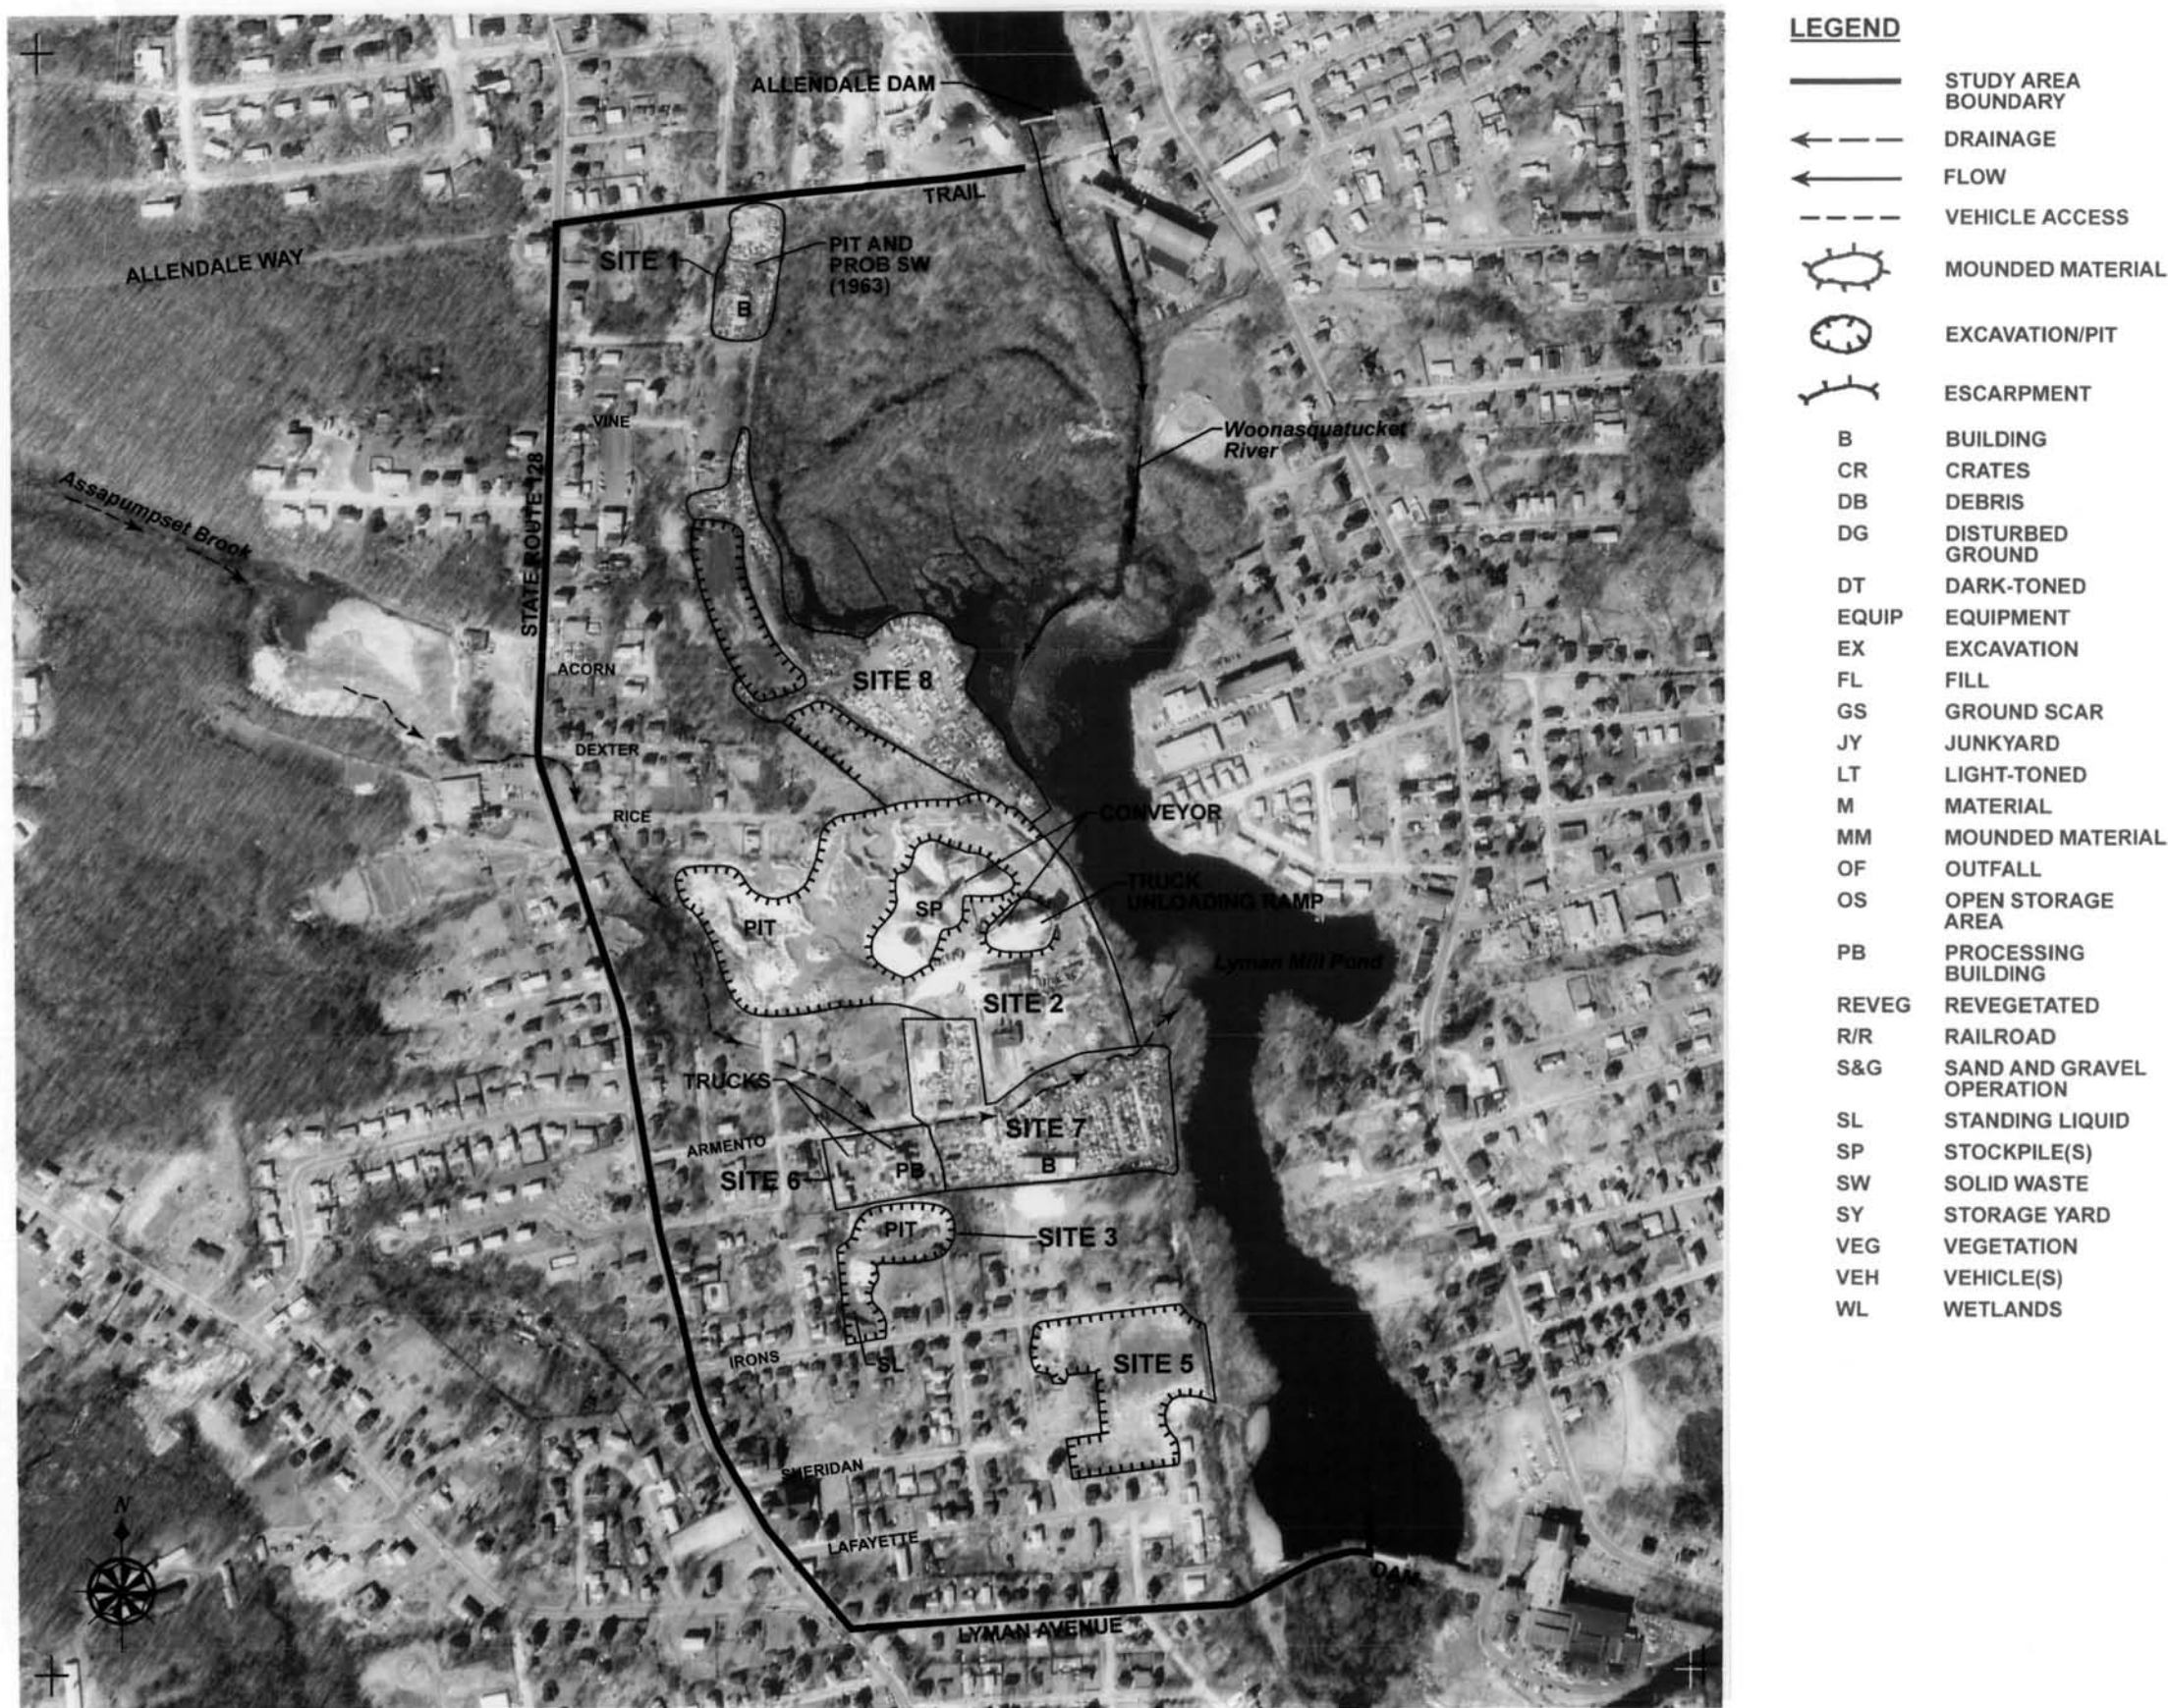
Figure 6. Centredale Manor Restoration Project study area, historical photographic analysis, March 9, 1970. Approximate scale 1:6,450.

Site 1 - The former disposal pit has been closed and the site is probably an open storage and salvage yard. No waste disposal activity can be confirmed. Numerous vehicles are present but the probable crates, debris, and dark-toned material noted in 1963 are not discerned.

Site 2 - The two separate sand and gravel quarry pits noted in 1963, Sites 2 and 2W, located between Rice and Armento streets, have been enlarged and merged together. Large light-toned sand and gravel stockpiles have been created and large conveyor systems have been installed. The large mound observed near the eastern side of the site is a truck unloading ramp.

Site 3 - Earthmoving vehicles are observed at the northeastern portion of the pit and standing liquid is noted at the southern end of the pit.

Site 6 - The parking areas has been enlarged and numerous parked trucks are observed at near the processing building.

Site 7 - The junkyard remains operational and numerous derelict automobiles are observed adjacent to the western shore of Lyman Mill Pond.

Site 8 - The extent of the junkyard has been enlarged to the northeast into the adjacent wetlands. The two large mounds of fill and/or possible scrap metal, visible along the bank of Lyman Mill Pond in 1963, are not discerned. Numerous derelict vehicles are stacked along the western bank of Lyman Mill Pond which was previously a wetland in 1963.

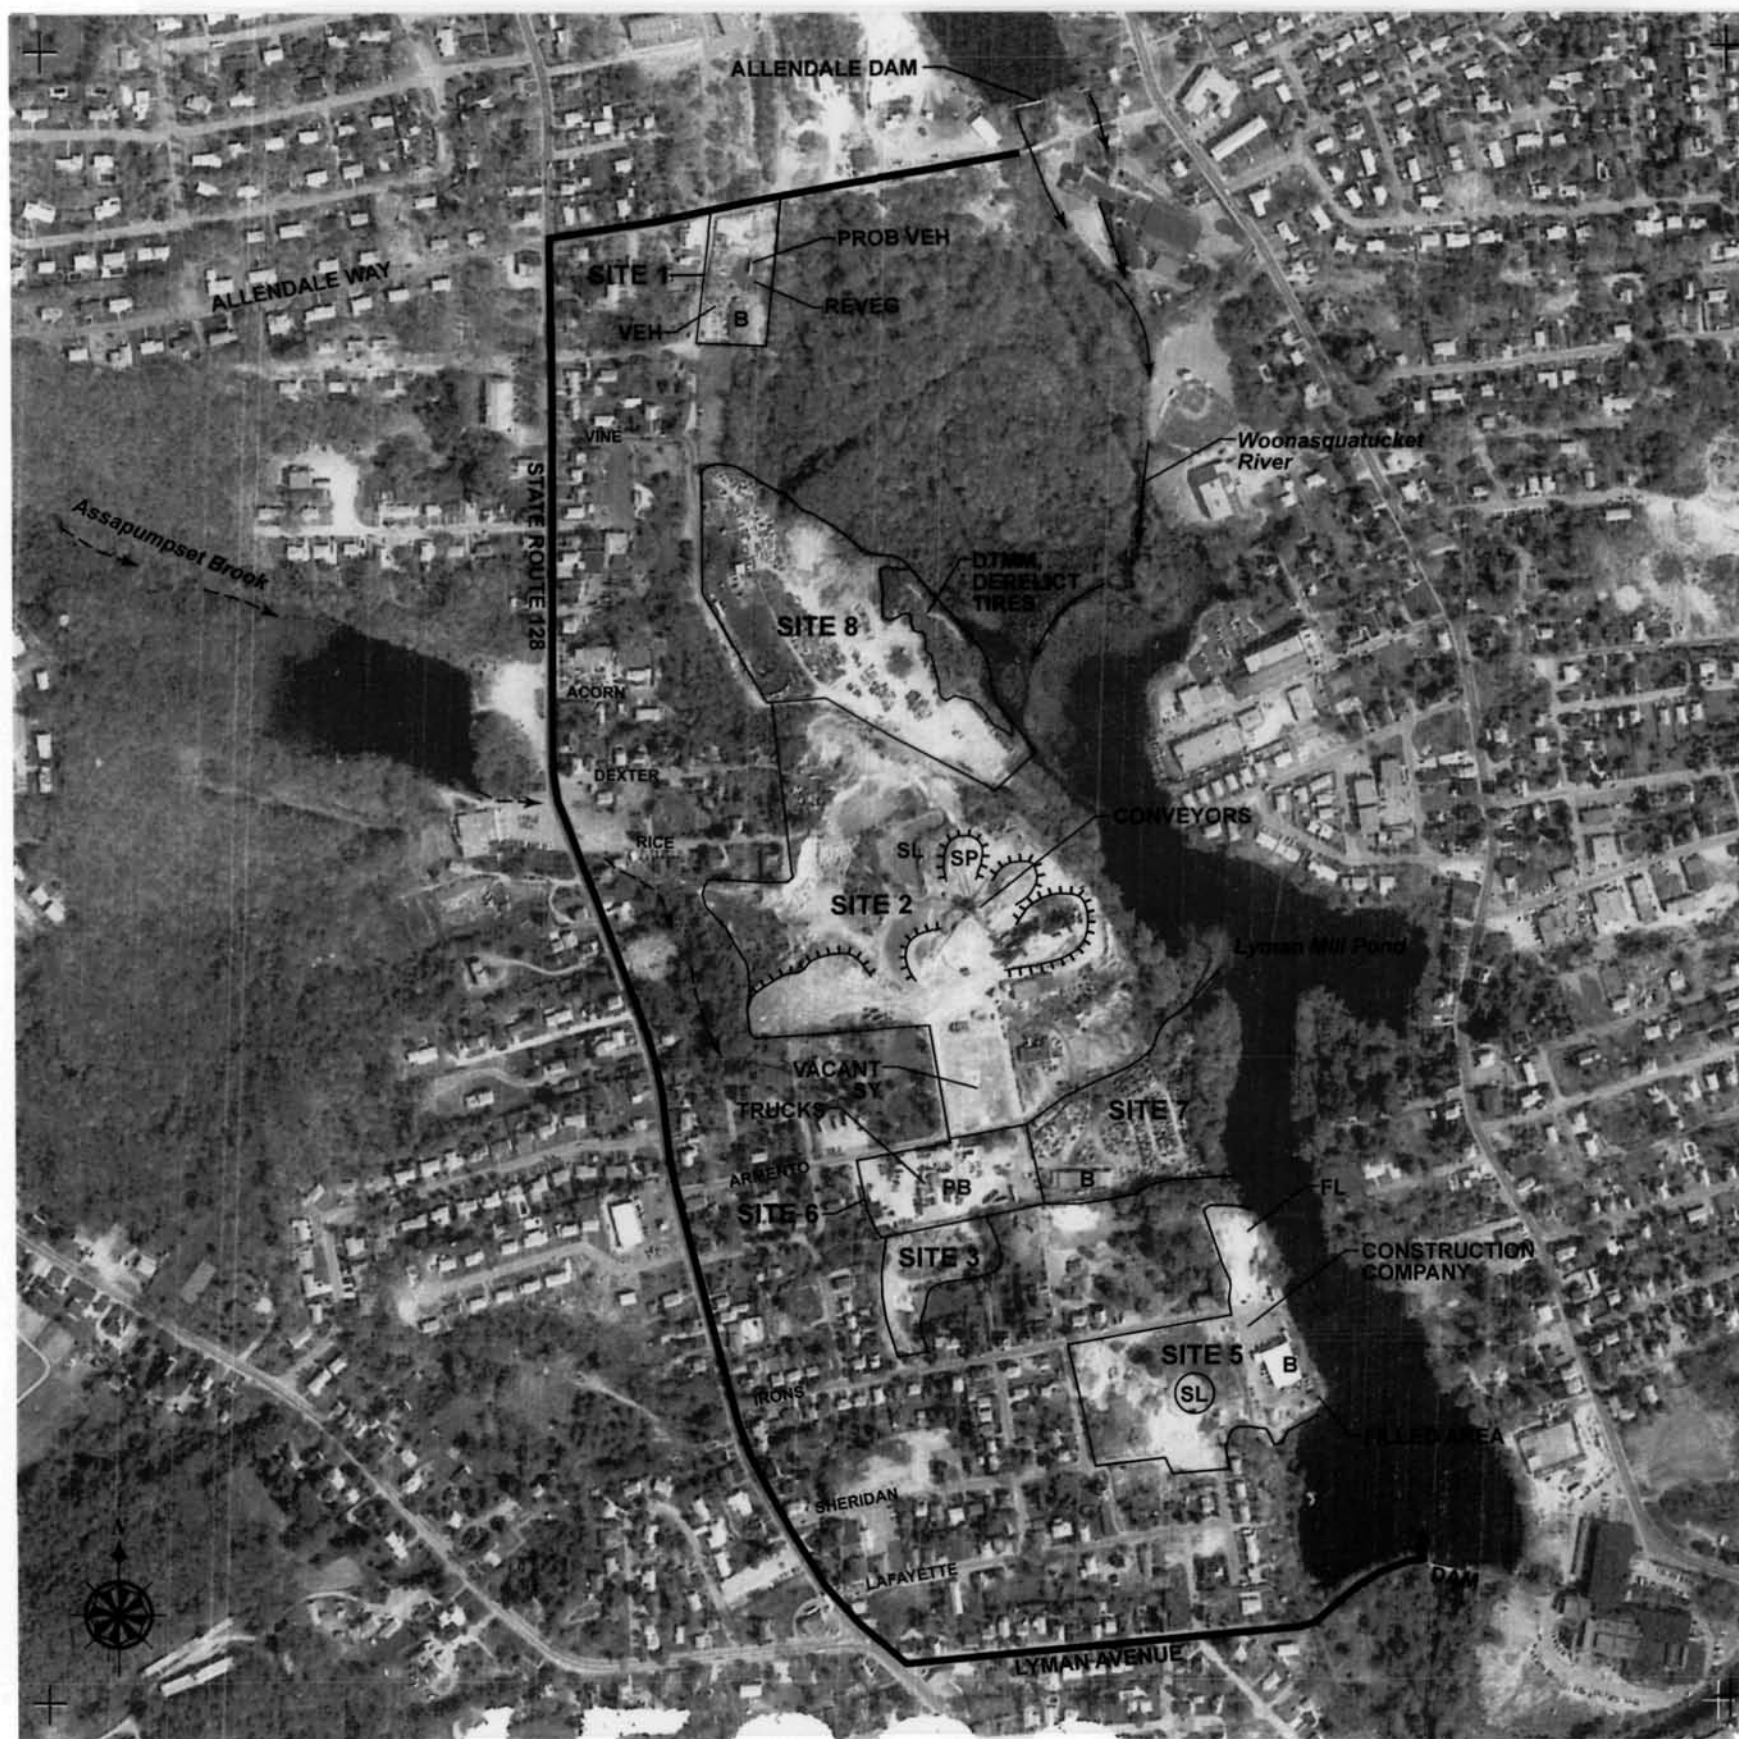
MAY 5, 1976 (FIGURE 7)

Monoscopic photographic coverage was used to perform the 1976 analysis. Because stereoscopic coverage was not used the features and conditions visible on photographs from other years of analysis may not be discerned on the 1976 photograph and the following analysis is not as detailed.

Site 1 - The site, described as a probable open storage and salvage yard in 1970, now appears to be a commercial construction or trucking facility. Vehicles are observed next to the building. The location of the closed pit has become revegetated (REVEG).

Site 3 - The sand and gravel pit remains open and no environmentally significant changes are noted since 1970.

Site 6 - The site remains active and parked trucks are observed near the processing building.

Site 7 - The junkyard remains operational. The northern section of the junkyard has been cleared of derelict vehicles and now appears to be associated with the sand and gravel operations of Site 2. The conditions at this storage yard will be discussed under Site 2.

Site 8 - The junkyard remains operational. Fewer vehicles are observed in the southern portion of the junkyard compared to those observed in 1970. Derelict vehicles are predominately observed in the northern portion of the site. Due to the lack of stereo viewing the depressions observed in 1970 are not discerned. A large accumulation of dark-toned mounded material (DTMM), probable derelict tires, is visible along the shoreline of Lyman Mill Pond.
