TS-PIC-20901104S  
May 2009

AERIAL HISTORICAL PHOTOGRAPHIC ANALYSIS,  
LAND USE/LAND COVER ANALYSIS, AND WETLANDS/DRAINAGE  
ANALYSIS OF CENTREDALE MANOR RESTORATION PROJECT  
STUDY AREA

Johnston, Rhode Island

ENVIRONMENTAL SCIENCES DIVISION  
NATIONAL EXPOSURE RESEARCH LABORATORY  
OFFICE OF RESEARCH AND DEVELOPMENT  
U.S. ENVIRONMENTAL PROTECTION AGENCY  
LAS VEGAS, NEVADA 89193-3478

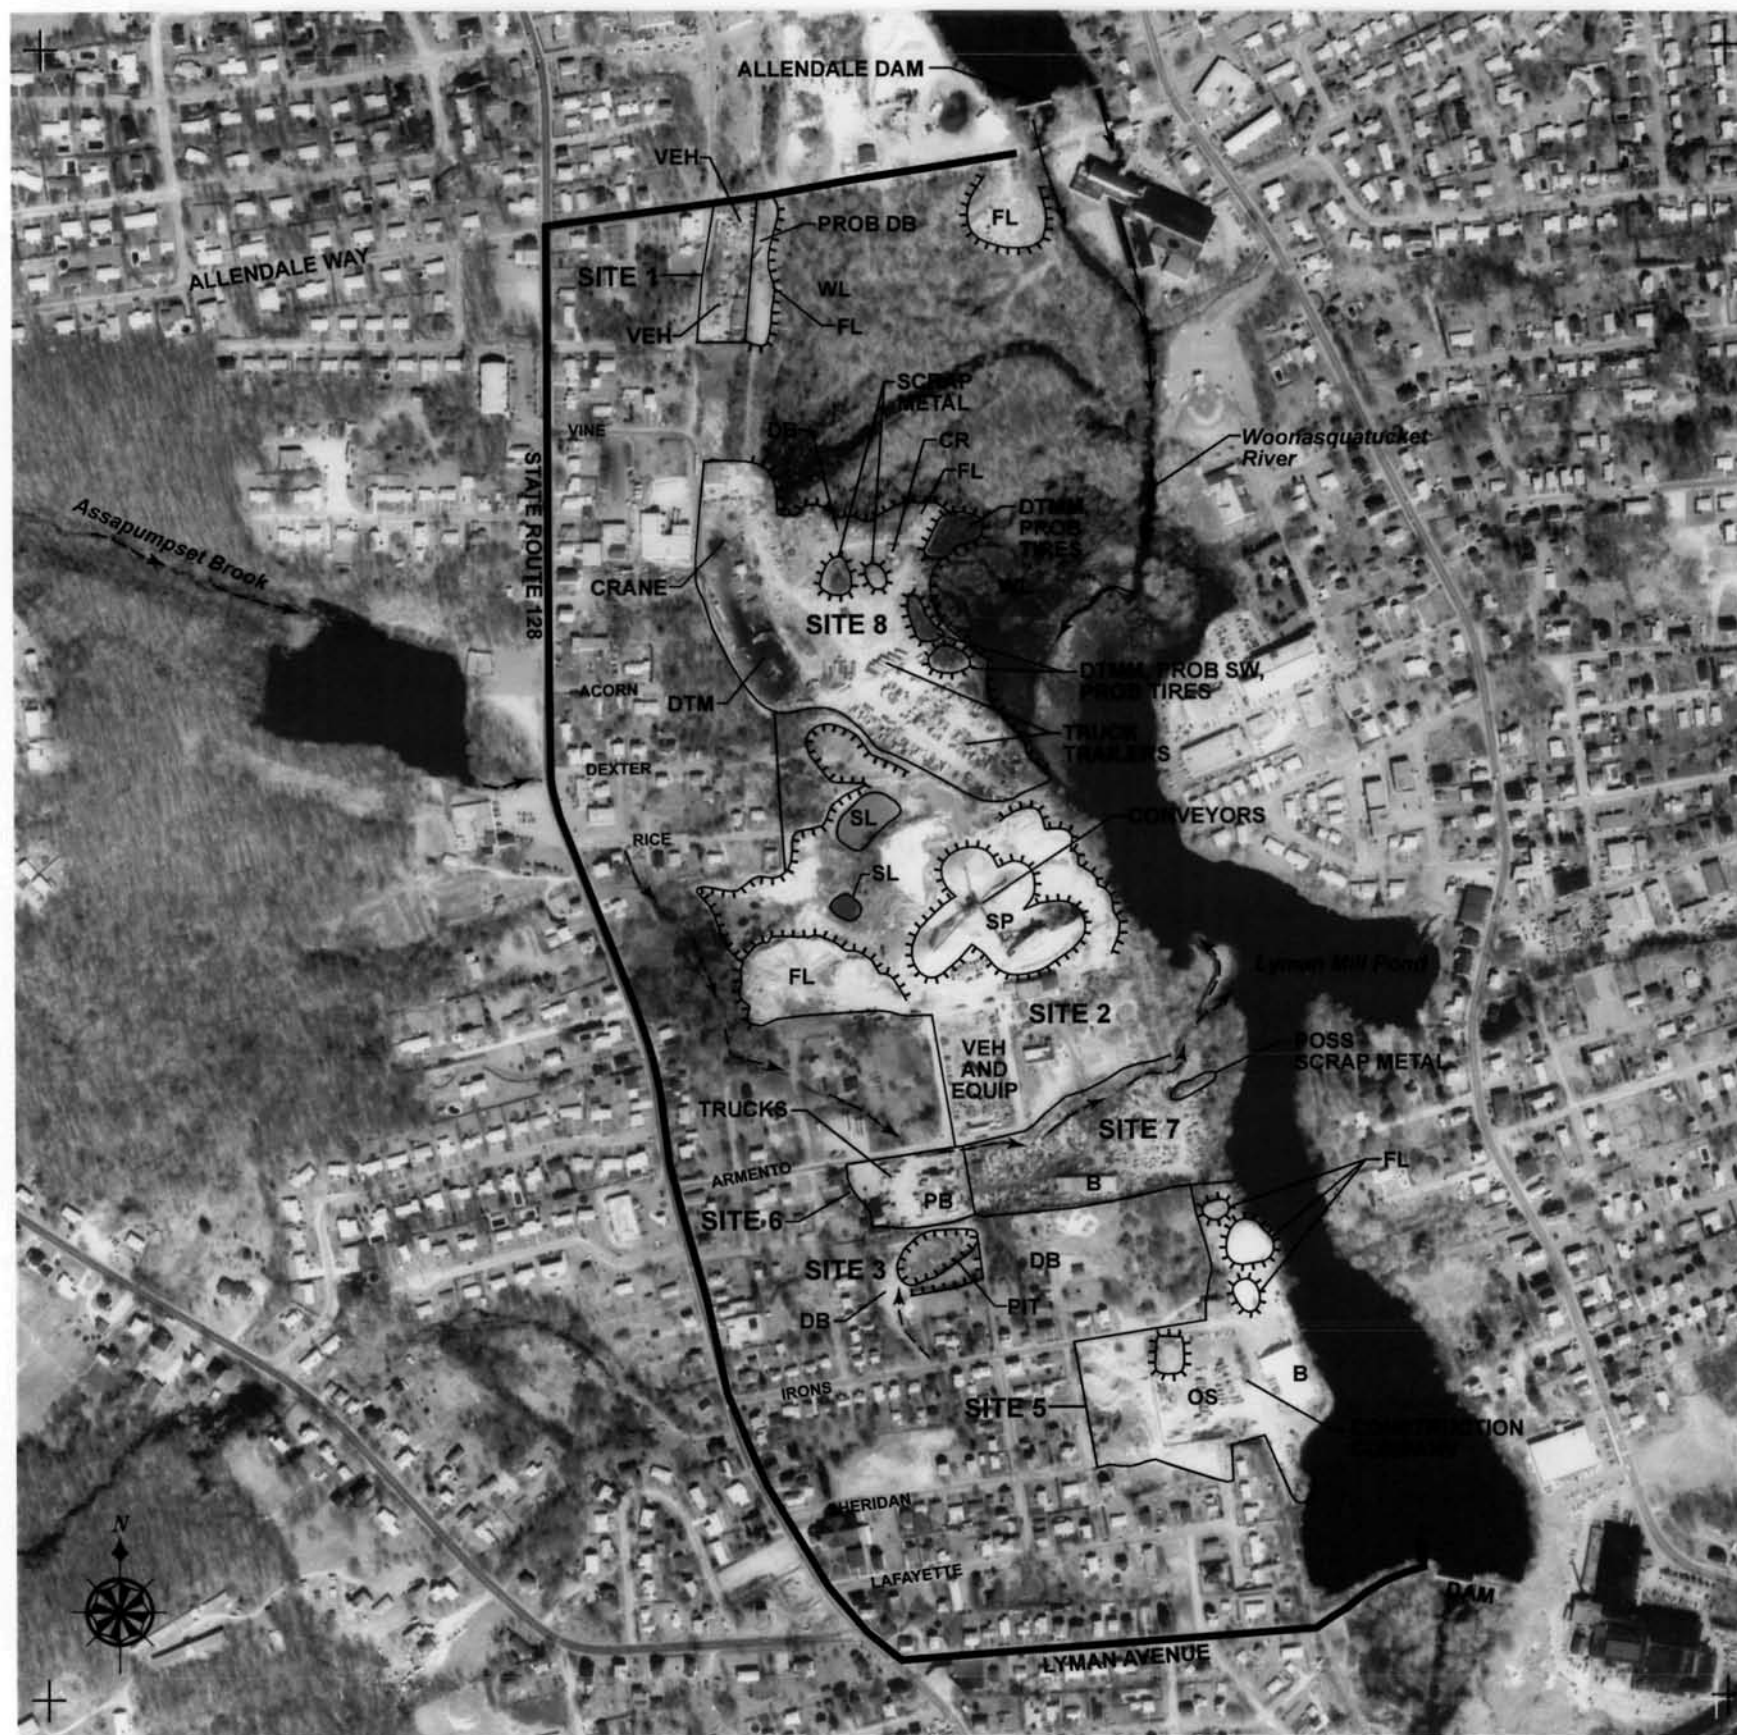
Site 1 - More vehicles are present at the commercial facility compared to those observed in 1976. Probable debris and fill material have been dumped along the eastern edge of the site.

Fill material is observed along the southern side of Allendale Way, east of Site 1. This filling encroaches on the wetlands along the northern portion of Lyman Mill Pond.

Site 2 - The sand and gravel quarry remains active. Large light-toned sand and gravel stockpiles and large excavations containing bodies of standing liquid are noted. The light-toned sand and gravel stockpiles on the eastern side of the site reach the west shore of Lyman Mill Pond. The storage yard, formerly operated as part of Site 7, contains vehicles (VEH) and equipment (EQUIP) likely associated with the sand and gravel operations.

Site 3 - The pit has been partially filled. Debris is noted near the western rim of the smaller pit. Drainage would flow into the pit and remain.

Site 5 - Earthmoving has continued at this construction company. A large open storage yard (OS) for supplies and equipment has been filled and leveled in the center of the site where liquid was noted in 1976. Fill material has been deposited along the west shore of Lyman Mill Pond.

Site 6 - The site remains active and parked trucks are observed near the processing building.

Site 7 - The junkyard remains operational and contains numerous derelict automobiles. A pile of possible scrap metal is observed near the eastern end of the site.

Site 8 - The junkyard remains operational and has been expanded northeast into the wetlands along the northwestern shore of Lyman Mill Pond. There are fewer derelict vehicles observed compared to those observed in 1976. A crane, piles of probable scrap metal, and containers are noted in the northern portion of the site. Numerous truck trailers are observed in a storage yard in the southern portion of the site. Dark-toned mounded material remains visible at the eastern side of the site and along the shoreline of Lyman Mill Pond. These deposits appear to consist of probable solid waste and derelict tires.

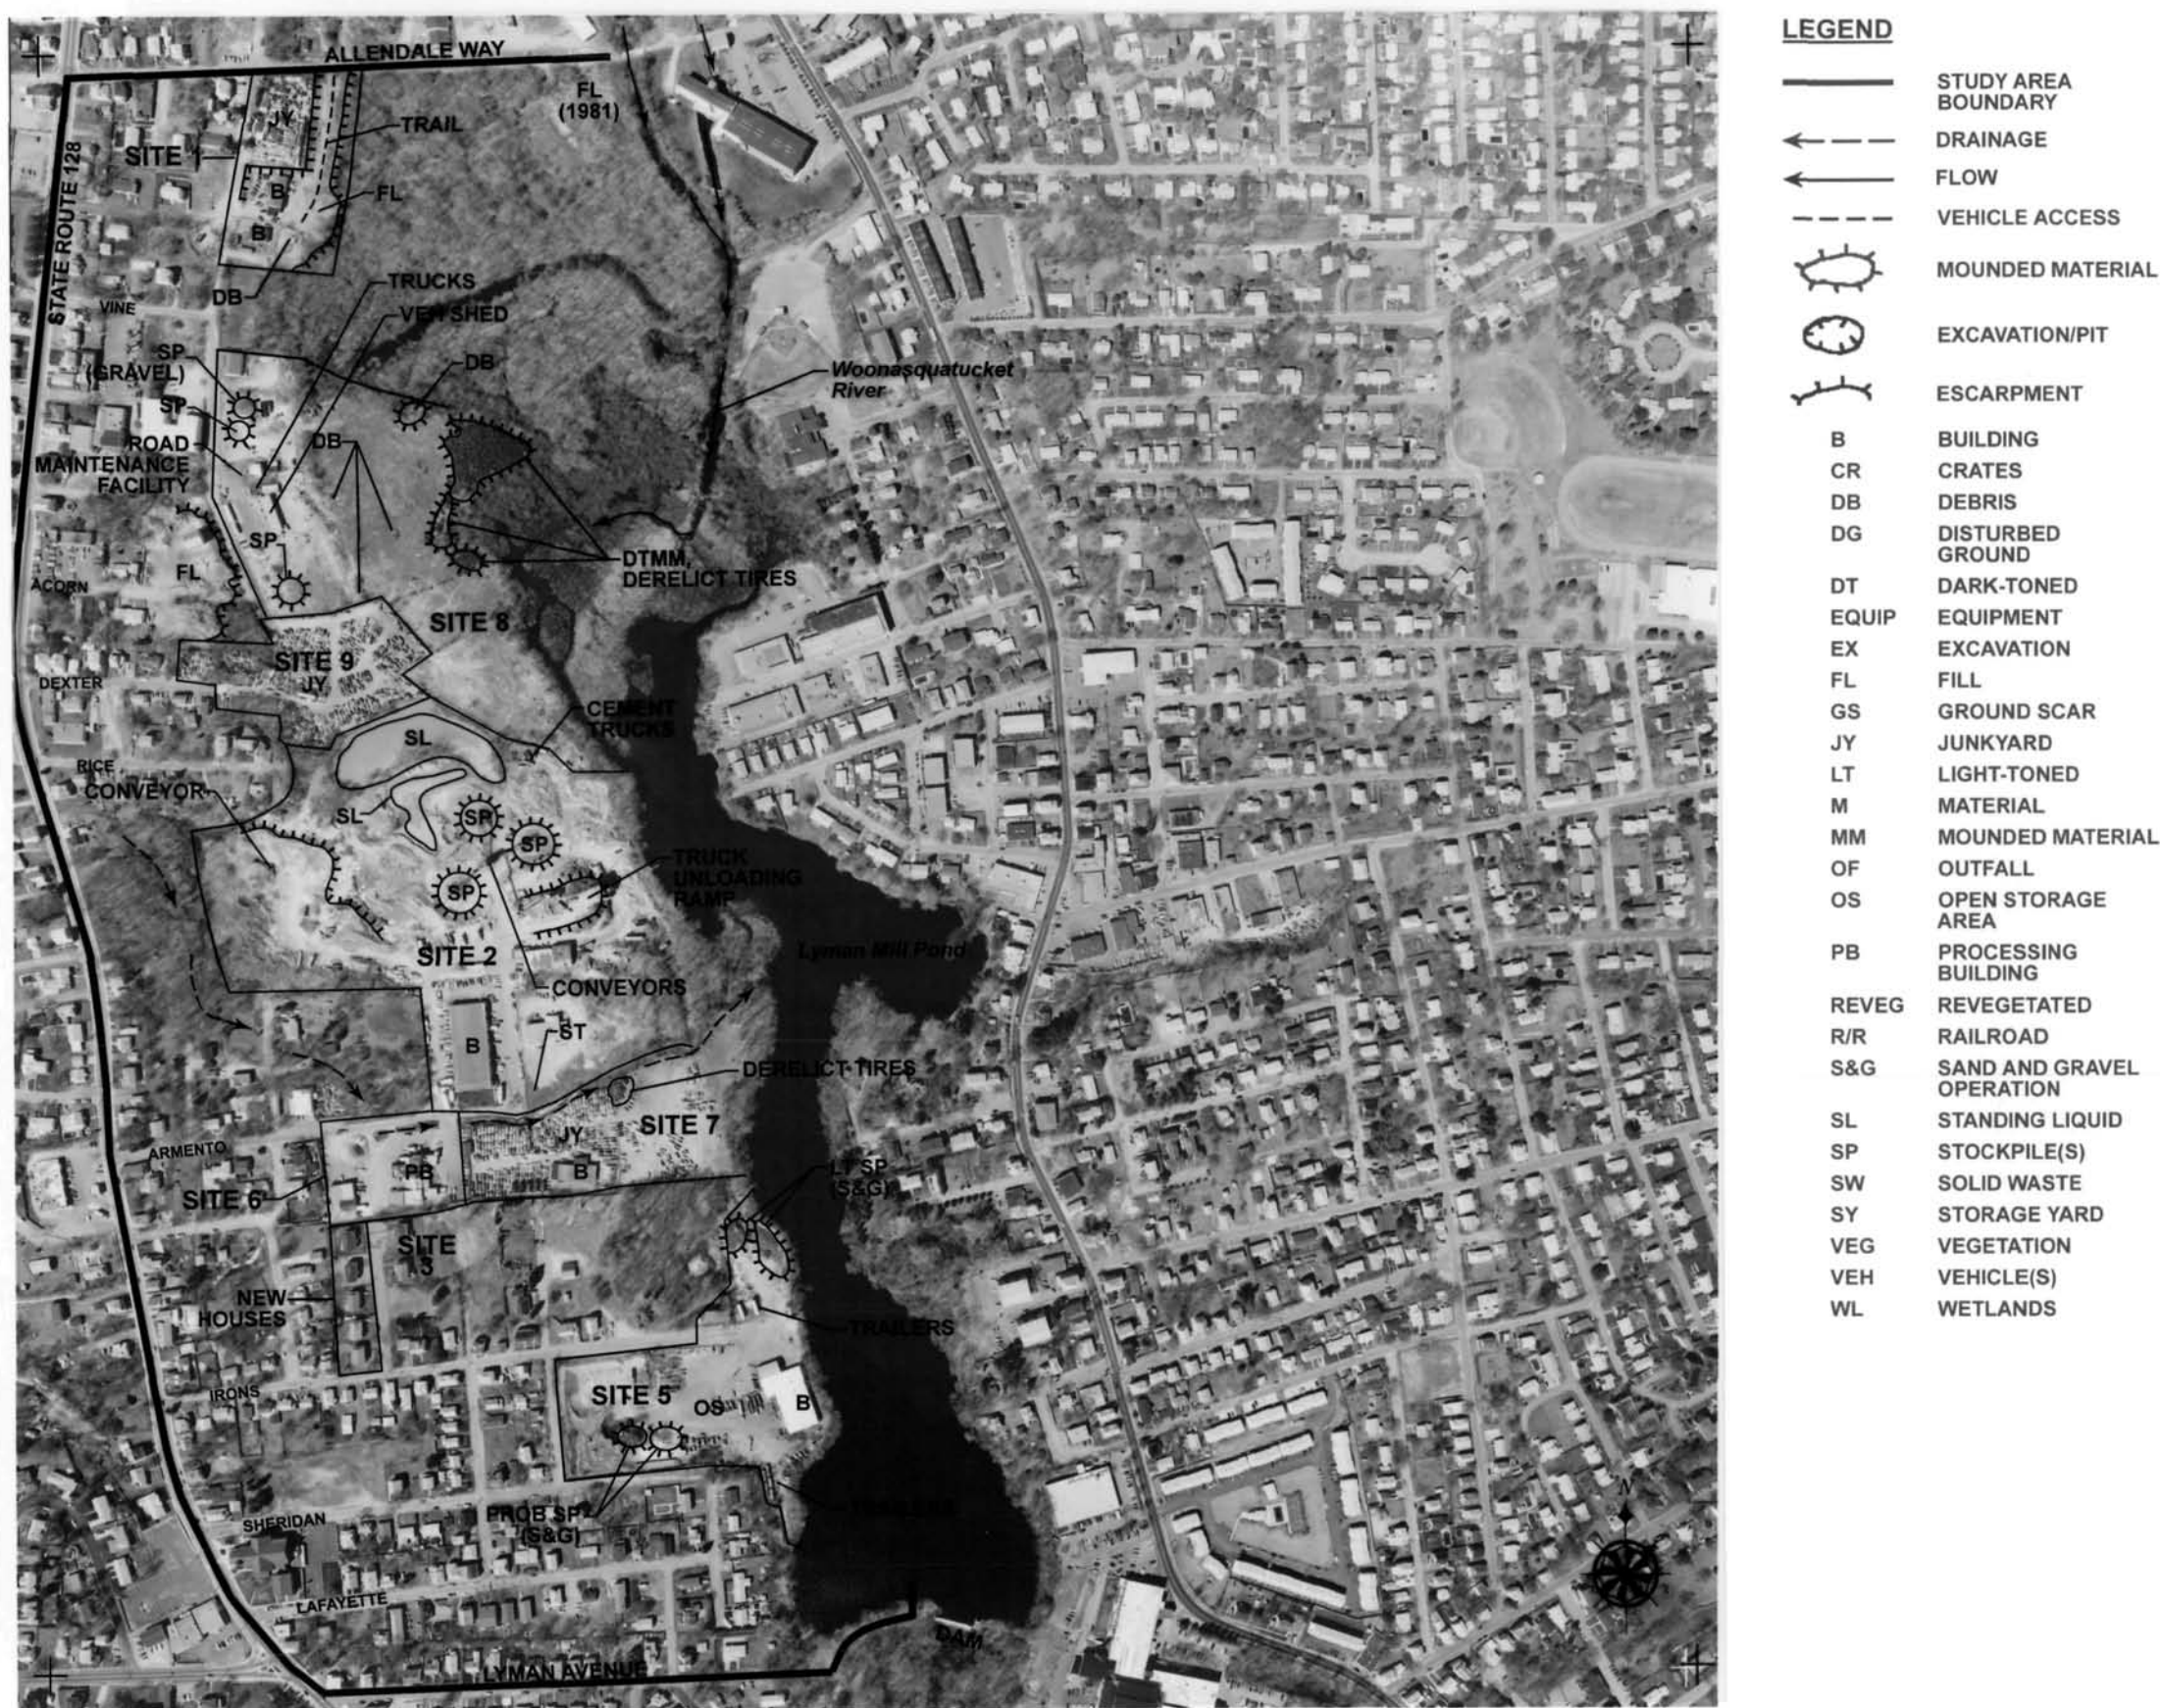
Figure 9. Centredale Manor Restoration Project study area, historical photographic analysis, April 17, 1995. Approximate scale 1:5,640.

Site 1 - Filling to raise the ground level is evident in the northwestern portion of the site. Debris noted in 1981 is not evident. The fill material may have included debris and construction rubble. A small automobile junkyard occupies the northwestern portion of the site. A trail/dirt road into the fill area on the eastern side of the site connects to Allendale Way. The two buildings in the southern portion of the site appear to be associated with a construction contractor.

The deposit of fill material observed in 1981, east of Site 1 along the southern side of Allendale Way, now appears to be covered by vegetation.

Site 2 - The sand and gravel quarry remains active. Large light-toned sand and gravel stockpiles remain visible. A large excavation containing standing liquid is observed at the northern end of the site. The excavation appears larger than what was observed in 1981. A large building has been constructed in the area formerly used as a storage yard and a part of the junkyard at Site 7.

Site 3 - The excavation, noted in 1981 between Armento Street and Irons Avenue, has been filled, leveled, graded, and new homes have been constructed on the site. The conditions at this location will not be discussed on subsequent dates of photography.

Site 5 - No significant earthmoving is noted at the construction company at the eastern end of Irons Avenue. The facility maintains an open storage yard for supplies, equipment, and vehicles (not annotated). Light-toned (LT) stockpiles of probable sand or gravel are also maintained at the site in its northeast and southwestern corners.

Site 6 - There are fewer trucks observed at the processing building compared to 1981. The processing building appears to be operational.

Site 7 - The junkyard remains operational. Numerous automobiles are tightly parked in the central portion of the site. Since 1981 the material noted in

Site 8 - The several open storage yards on the eastern portion of the site have been reorganized and cleared. The numerous truck trailers noted in 1981 have been removed. The crane and containers, noted in 1981 at the northern portion of the site, are no longer on the site. Scattered piles of debris are present. Large mounds of derelict tires have been concentrated at the eastern edge of the site, along the west shore of Lyman Mill Pond.

A road maintenance facility with stockpiles of gravel, trucks, earthmoving equipment (not annotated), and a vehicle shed has been established on the western portion of the site.

Site 9 - A junkyard has been established at the eastern end of Dexter Street on filled and graded land that was undeveloped woodland in 1981. The derelict vehicles at this location may have been relocated from the southern portion of Site 8.

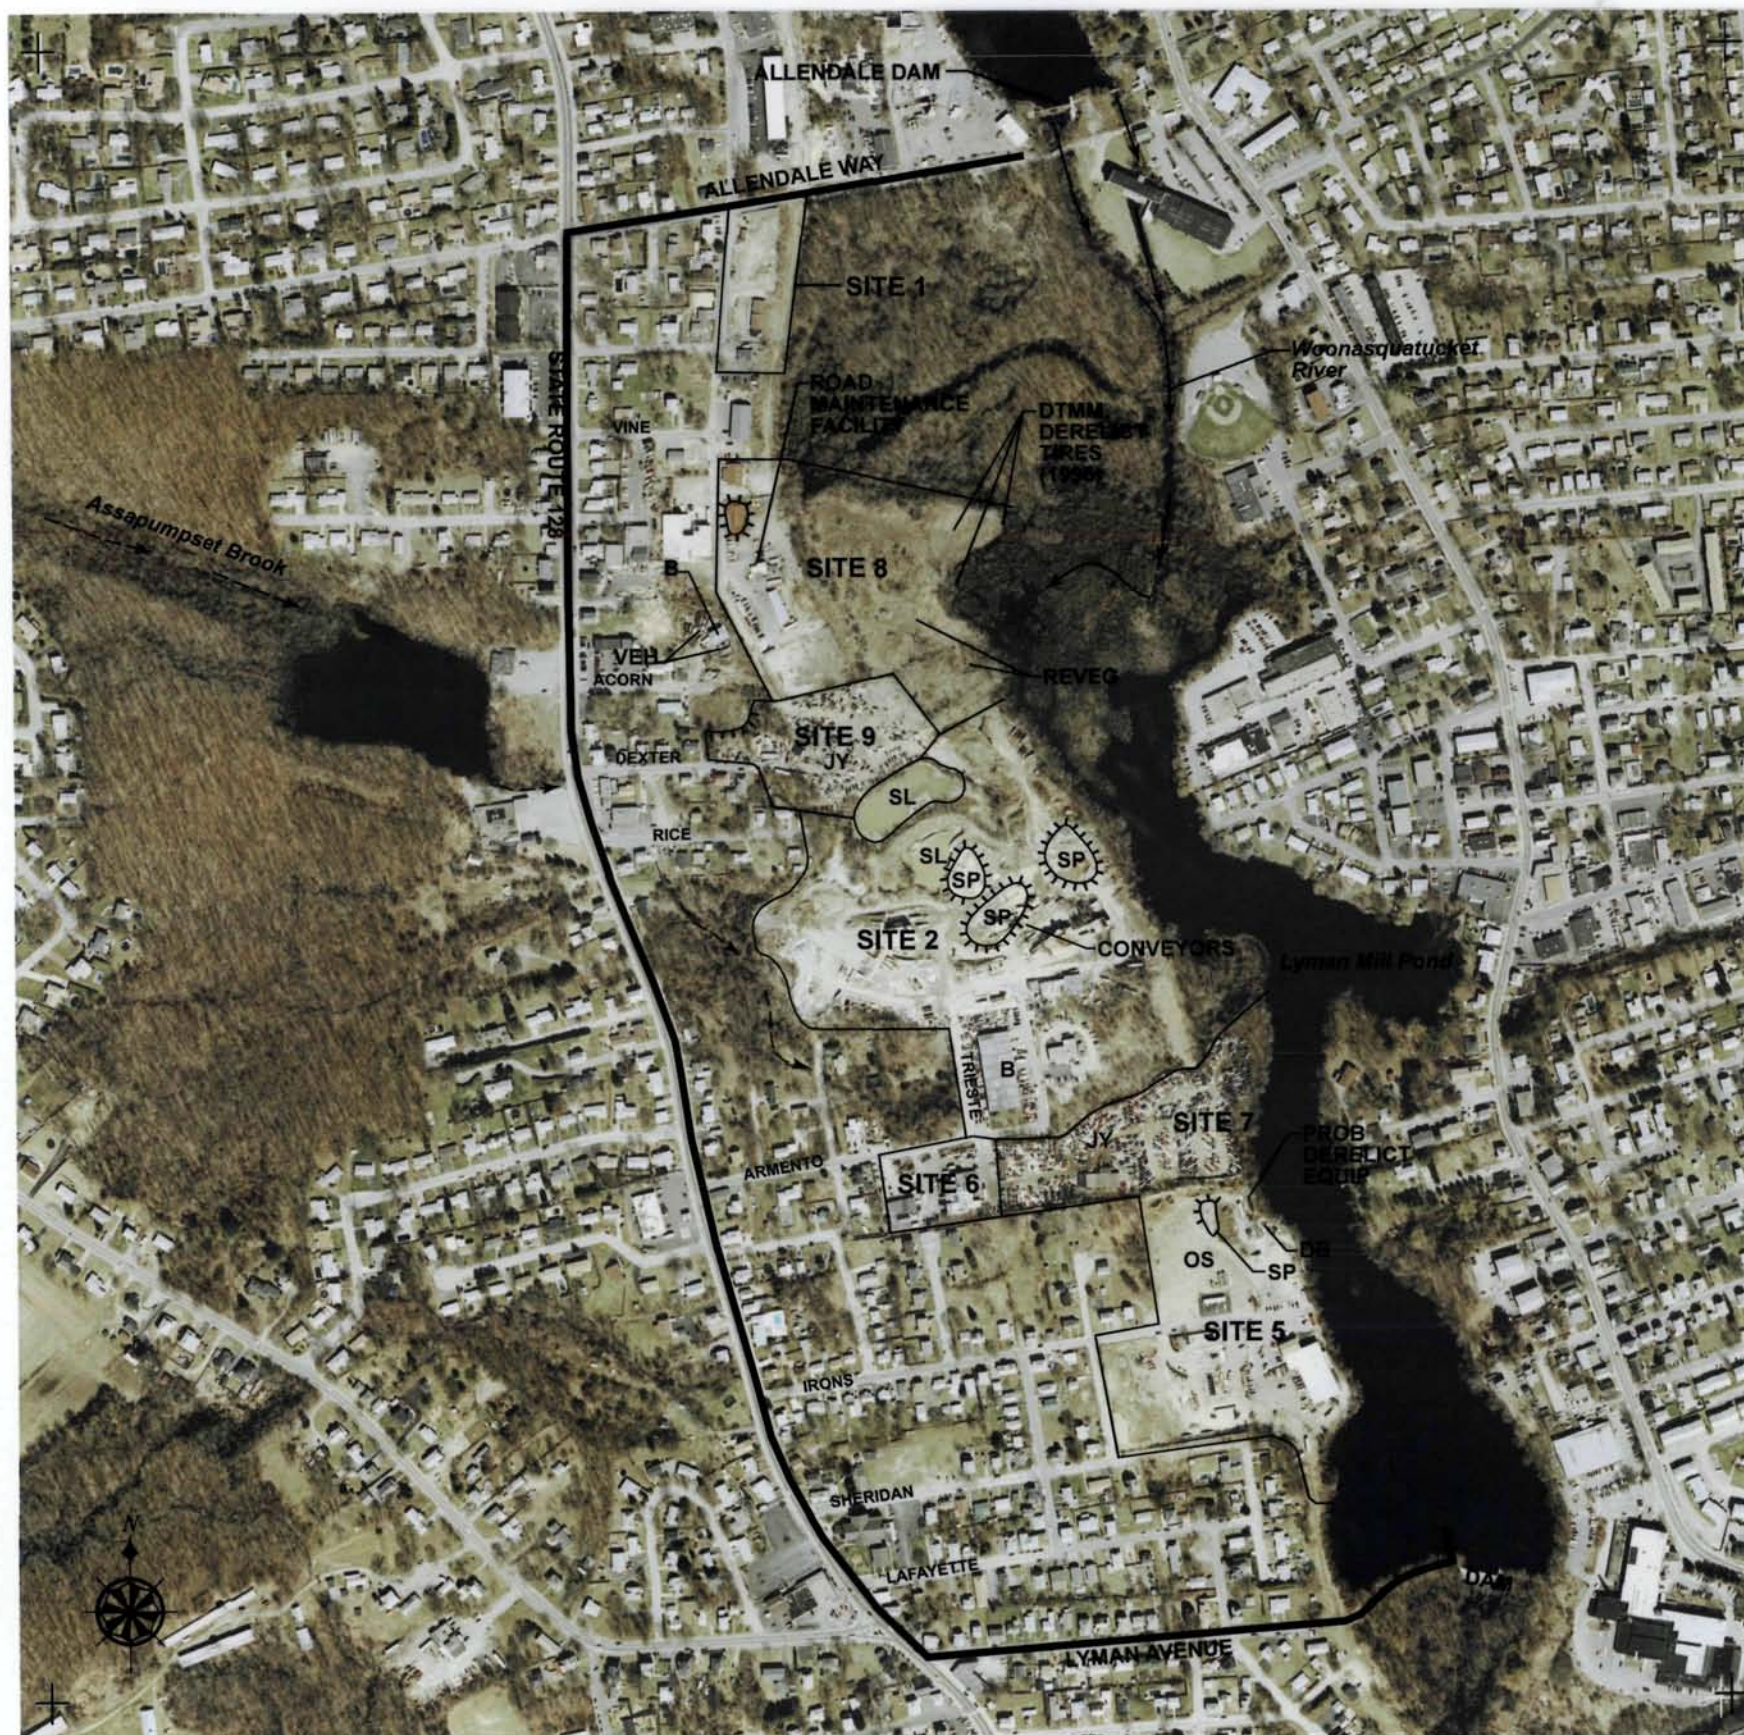
2003 (FIGURE 10)

Site 1 - The automobile junkyard observed in the northwestern portion of the site in 1995 appears to be closed. All of the automobiles have been removed. No vehicles are present at the two buildings in the southern portion of the site.

Site 5 - Brush and trees have been cleared from the northern portion of the construction company resulting in a larger open storage area for supplies, equipment, and vehicles (not annotated). No significant earthmoving is noted. A light-colored stockpile, debris, and probable derelict equipment are visible in the northeastern corner on the site.

Site 6 - There are fewer trucks observed at the processing building compared to 1995. The processing building appears to be operational.

Site 7 - The junkyard remains operational and more derelict vehicles are present compared to those observed in 1995.

Site 8 - The road maintenance facility on the western portion of the site remains operational. The eastern portion of the site appears vacant. The large mound of derelict tires observed on the eastern edge of the site and along the western shore of Lyman Mill Pond in 1995 is not discerned. This location is vacant and appears to have been graded. Portions of the vacant storage yard in the southern portion of the site appear to be revegetated.

Site 9 - The junkyard at the eastern end of Dexter Street remains operational.

A small construction company established off Acorn Street, near the western perimeter of Site 8, contains one building and several vehicles.

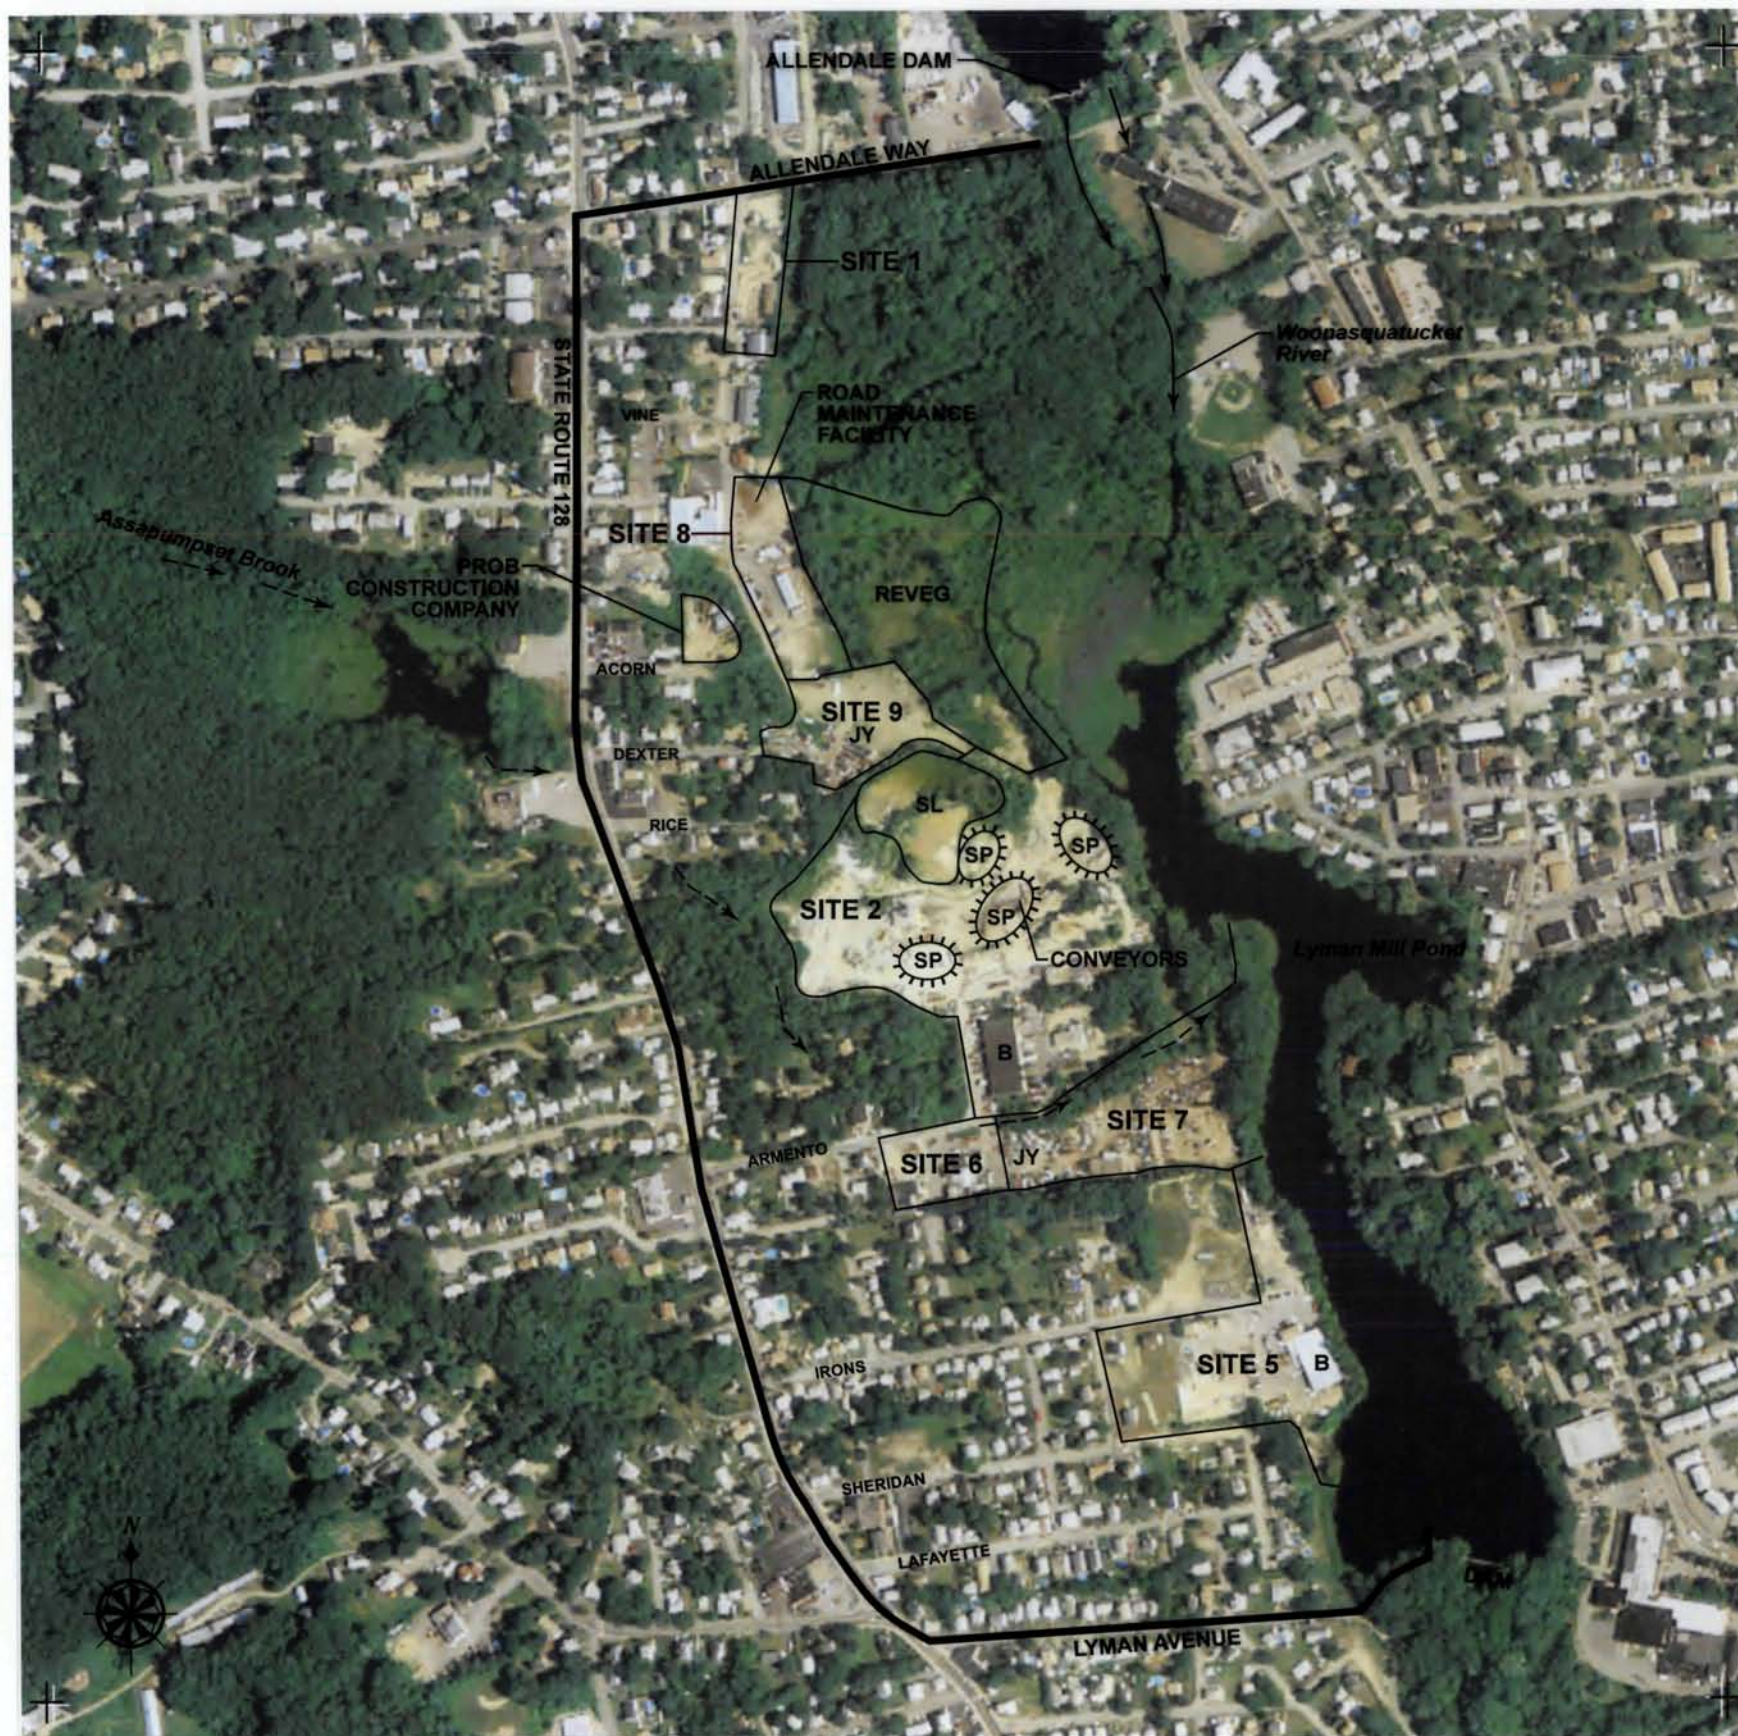
Site 5 - The storage yard in the northern portion of the site is not used and has become revegetated. No significant earthmoving is noted. Additional vegetation overgrowth along the shore of Lyman Mill Pond obscures the view of the area that contained debris and probable derelict equipment in 2003.

Site 7 - The junkyard remains operational and fewer derelict vehicles are observed compared to 2003.

Site 9 - The junkyard at the eastern end of Dexter Street remains operational; however, fewer derelict vehicles are noted compared to what were observed in 2003.

The small probable construction company west of the perimeter of Site 7 remains active and no waste disposal activity is discerned at this location.

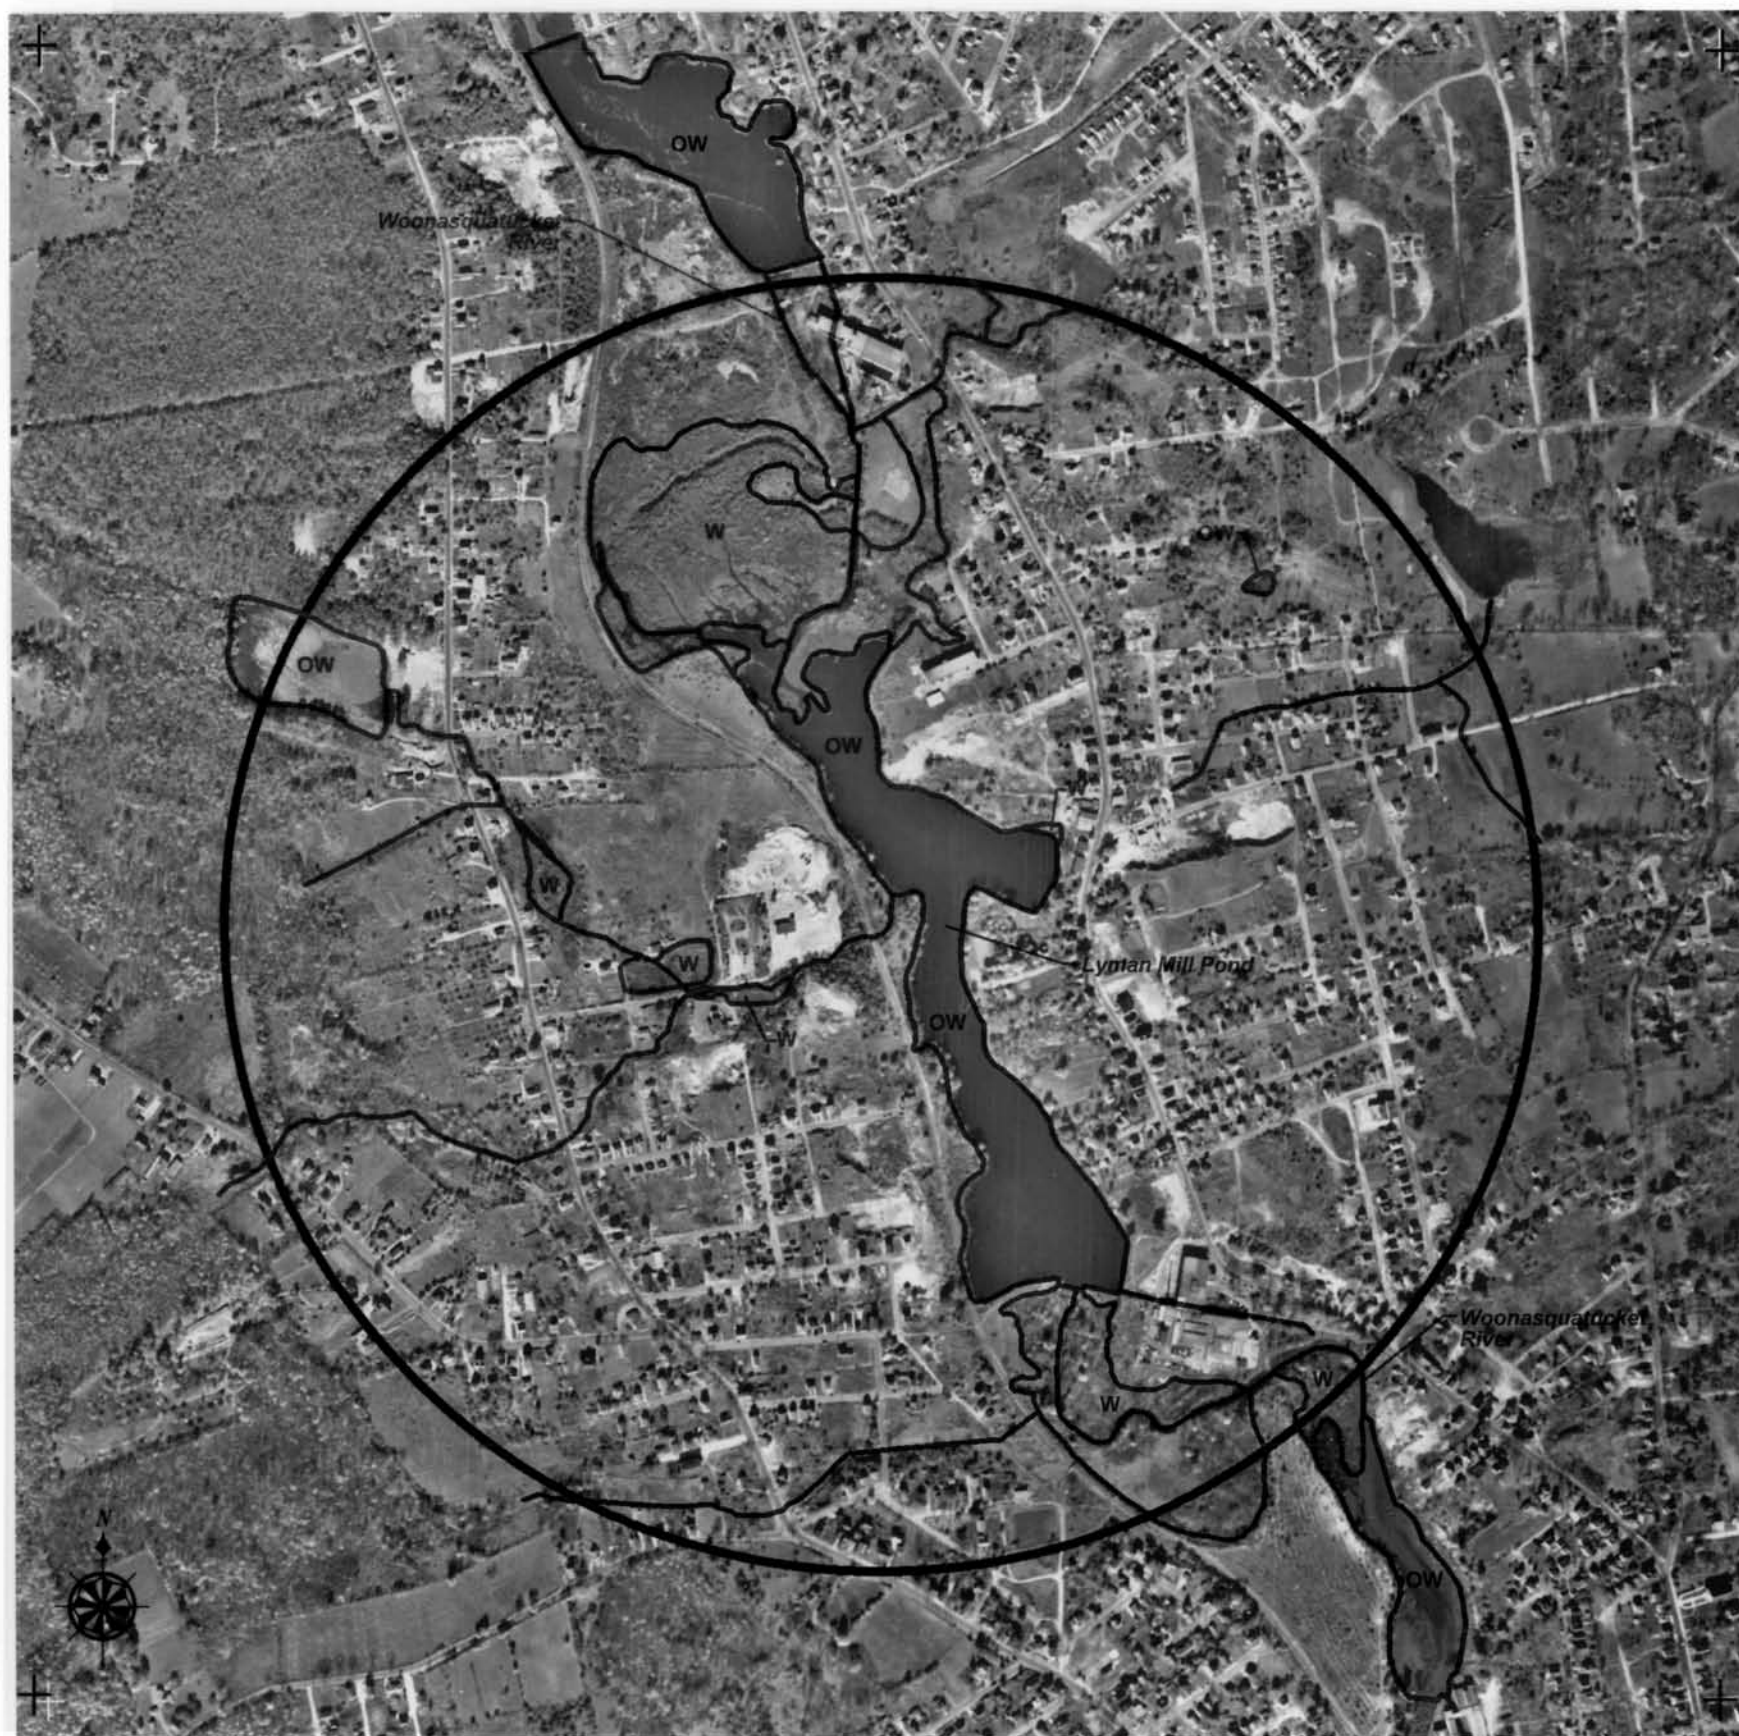
OCTOBER 26, 1951 (FIGURE 14)

Three lakes, or bodies of open water (OW), are located within the Woonasquatucket River in this vicinity. Wetland areas (W) are located both north and south of Lyman Mill Pond, the centrally located lake. Two additional areas of open water are visible in the northern portion of the wetlands/drainage analysis study area. The area of open water located west of the Woonasquatucket River has a surface drainage connection to the river. Three wetland areas are located along this drainage. The area of open water located east of the Woonasquatucket River is not associated with a visible surface drainage. Additional drainage pathways into the Woonasquatucket River are noted within the study area.

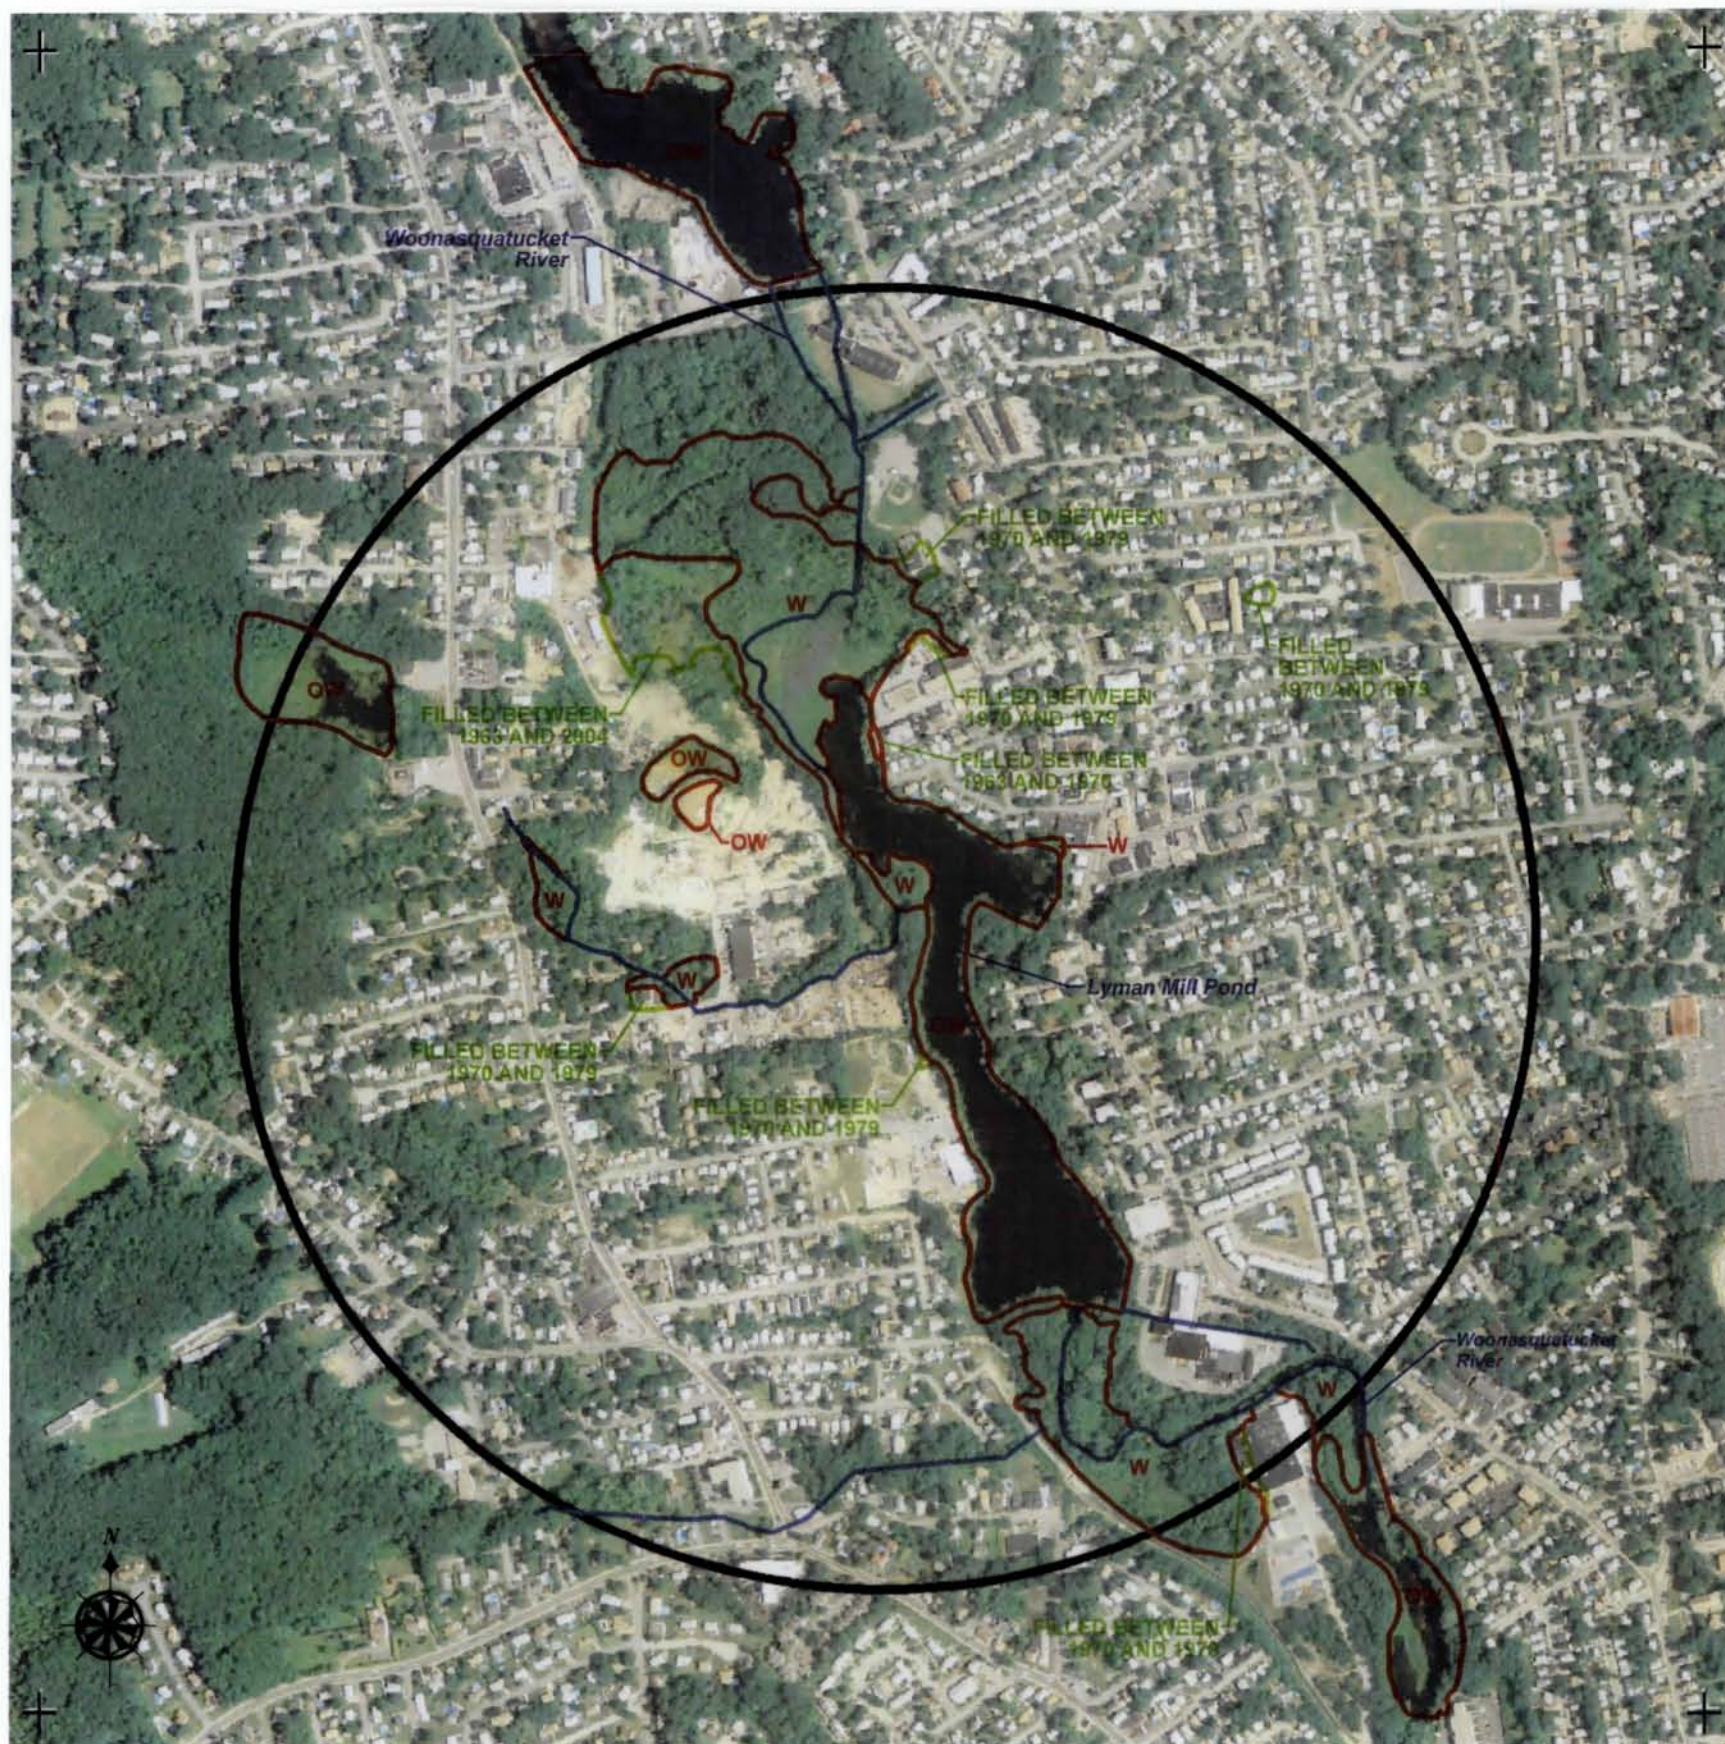
AUGUST 3, 2006 (FIGURE 16)

Other than a somewhat lower water level in the centrally located lake (Lyman Mill Pond), the three lakes located within the Woonasquatucket River appear much as they did in 1951 and 1963. The additional area of open water in the western portion of the wetlands/drainage analysis study area remains visible. The area of open water in the eastern portion of the study area and some of the drainage pathways into the Woonasquatucket River are no longer present due to development in these areas. Additional portions of the wetland area north of Lyman Mill Pond have been filled. The larger fill area northwest of Lyman Mill Pond had ongoing fill activity first noted in 1963 until sometime between 1995 and 2004. See the other figures in this report during that time period for the progression of this fill area over time. Additional portions of the wetland areas in the central and southern portions of the study area were also filled. The time period in which the fill activity took place is noted for each of the fill areas on the overlay attached to this figure.
