SITE: Centredale

Memorandum

Date: April 27, 2010

Subject: Post-flood Inspection of April, 15, 2010

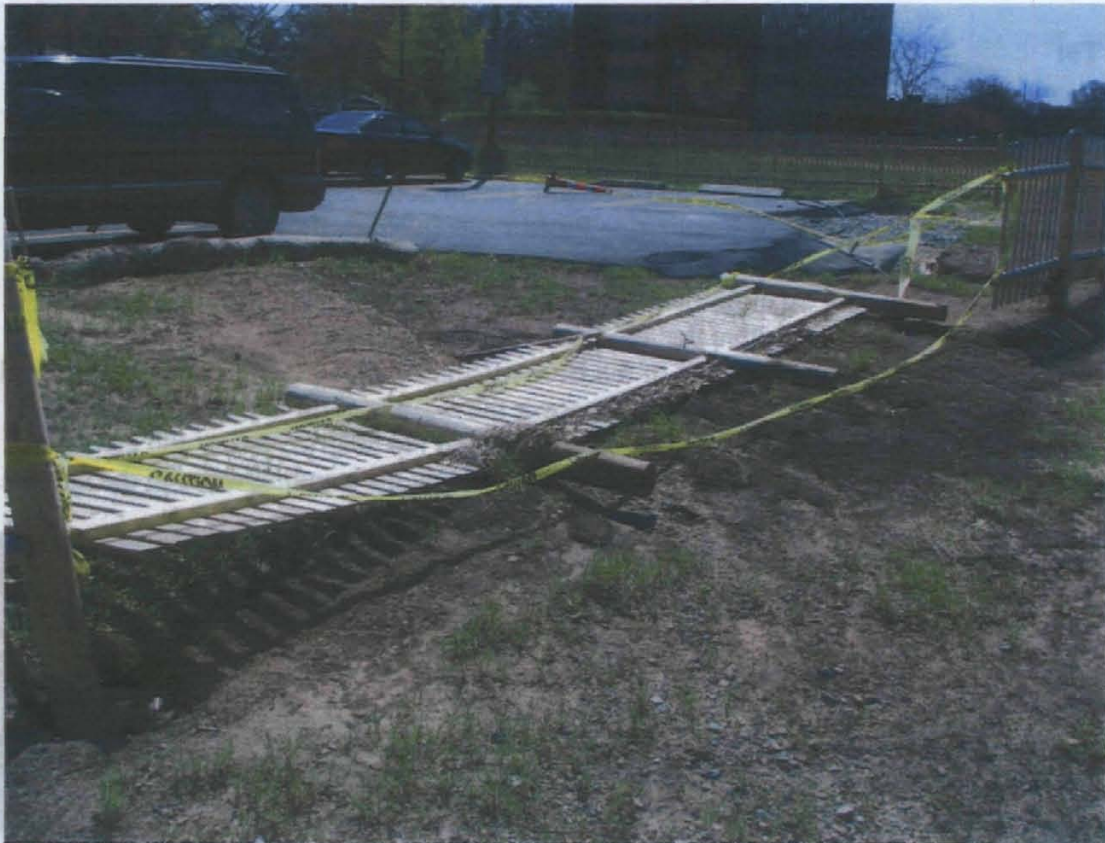
Some erosion occurred on the steepest gradients where water velocity was highest. Several fence posts washed out, causing three sections of new fence on the riverbank to collapse. This was likely caused by the turbulent flow of water around the posts, causing the soil to erode. Although some excavation had occurred in this area last fall, erosion did not penetrate the geosynthetic fabric that was placed over clean fill in this area.

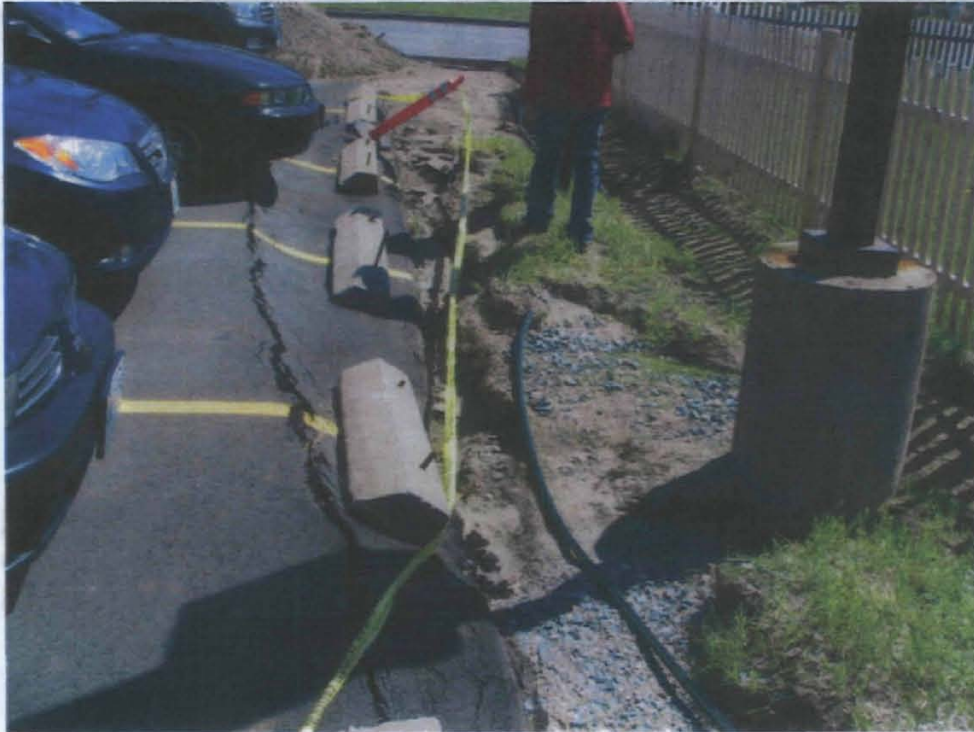
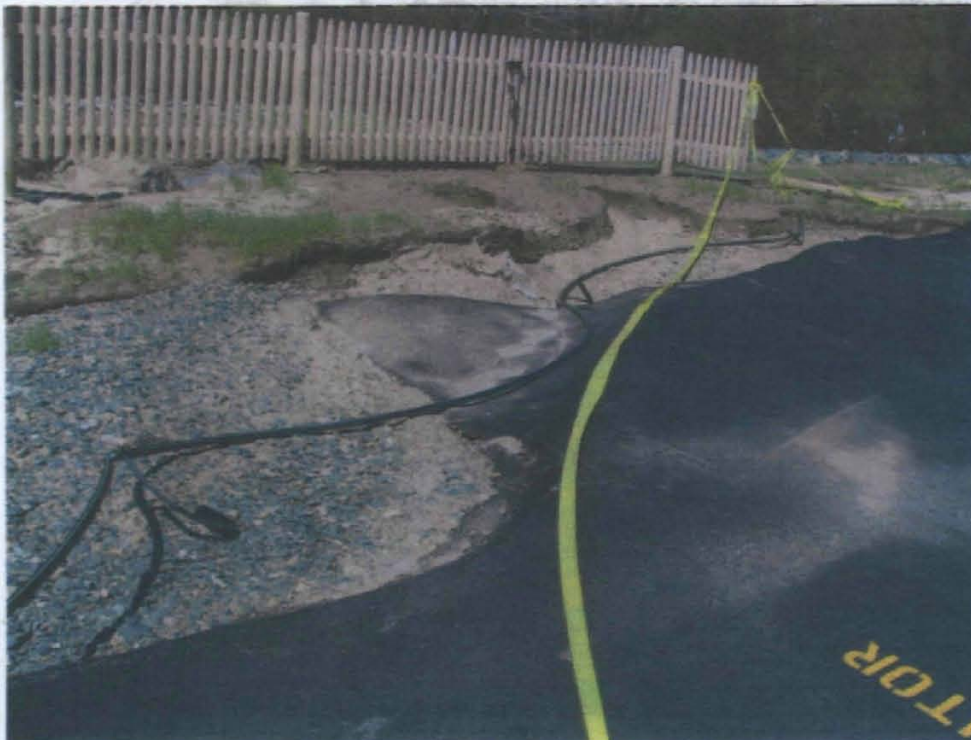
Swiftly moving water did erode the base materials for the parking lot pavement in several areas, but again did not impact underlying fill materials. Concerns that the earthen cap #'s 1,2,3,4 had been compromised by the water and current were unfounded. Visual inspection showed that although the river water had flowed near the caps, no evidence of erosion or other impact were seen. No contaminated soils were eroded, released, or otherwise impacted by the flood waters.

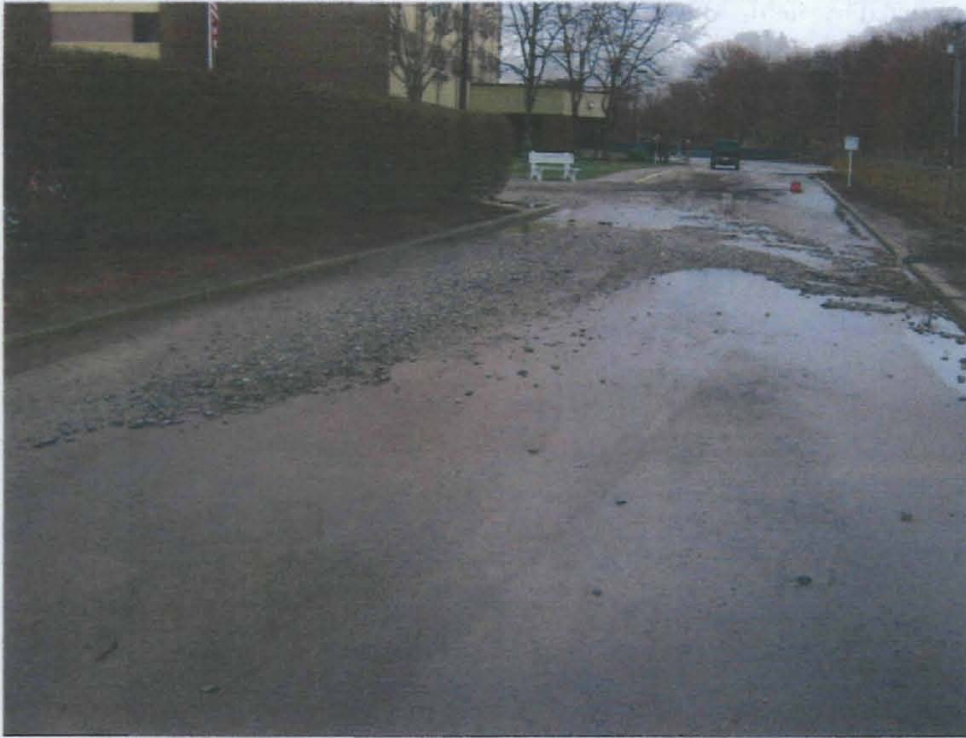
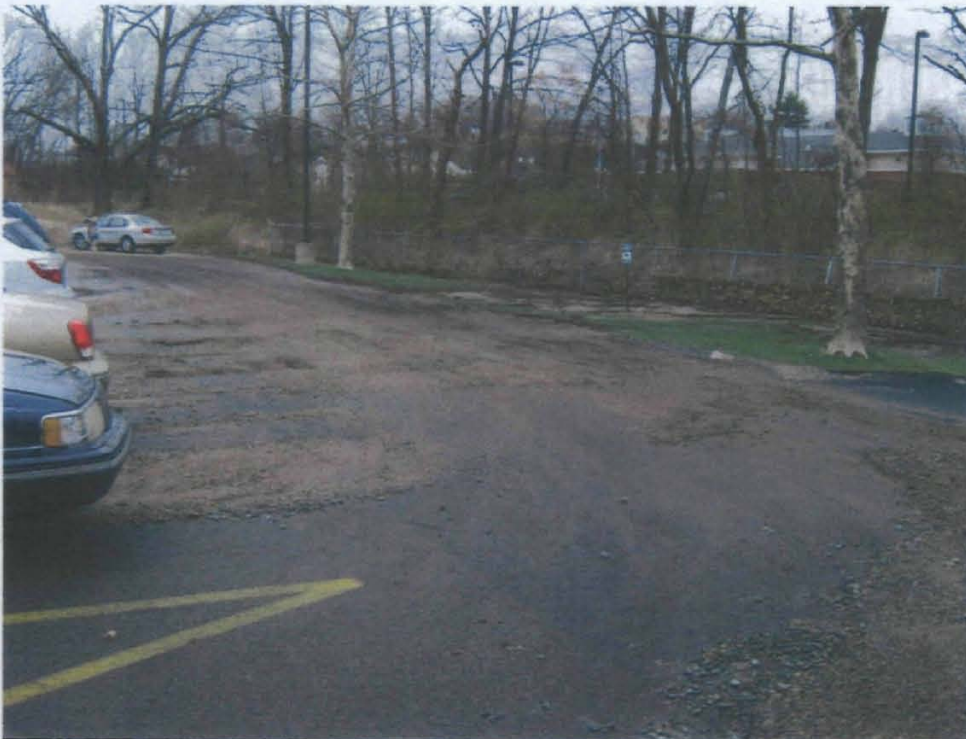
Some sedimentation did occur on the main driveway. The deposited materials were fairly coarse grained and resembled the clean backfill used to regrade the parking lot following excavation last fall.

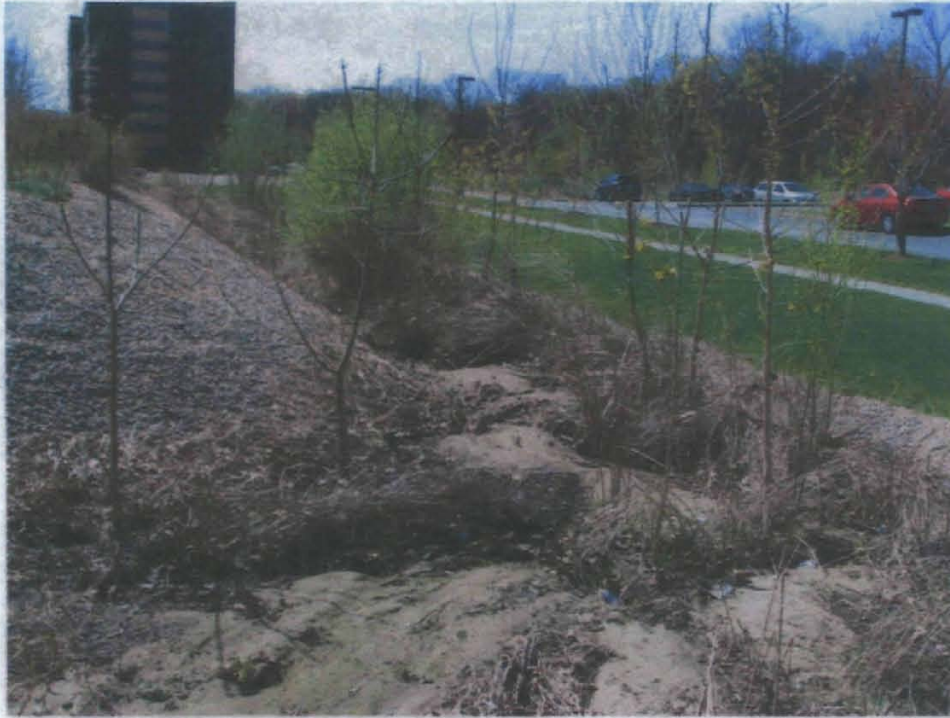
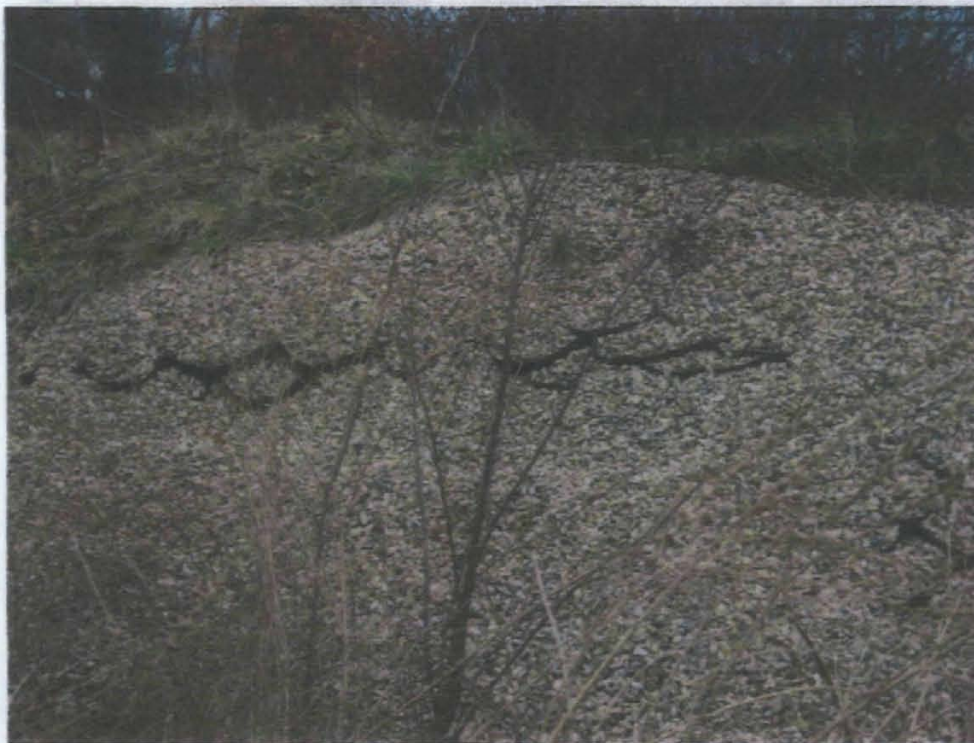
The tailrace outfall and drainage channel did not appear to be significantly impacted by the floodwaters. Some stone on the steepest slope had slumped in a few areas, exposing the anchoring web system, but no erosion occurred. The drainage channel is overgrown with vegetation and should be cleared. Although there was evidence that the water had risen to several feet deep, the gravel in the channel did not appear to be disturbed.

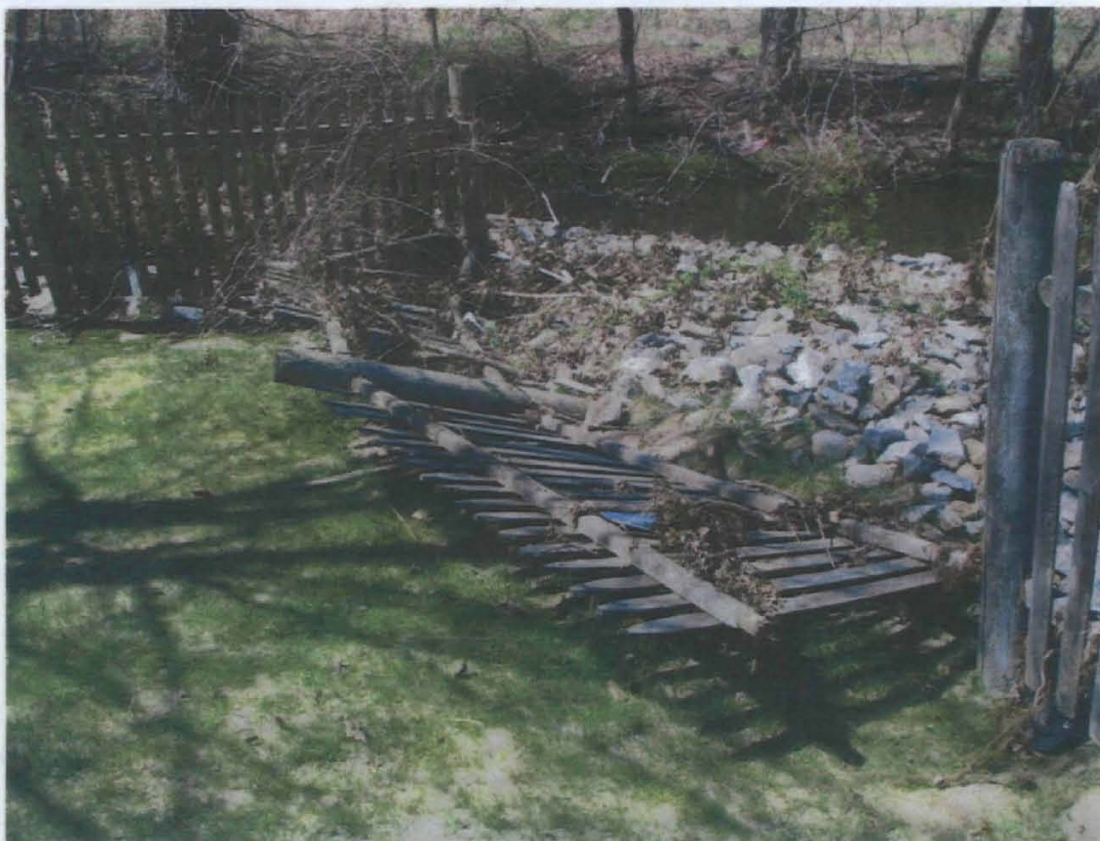
One other section of fence was disturbed near the riverbank at the Centredale Manor parking lot. This was an older section of fencing and likely required replacement regardless of the flood impact.
