**CENTREDALE MANOR RESTORATION PROJECT  
IMPLEMENTATION OF INTERIM REMEDIAL ACTION  
NORTH PROVIDENCE, RHODE ISLAND**

**CONSTRUCTION COMPLETION  
CERTIFICATION REPORT**

**March 2014**

**CERCLIS ID No. RID981203755**

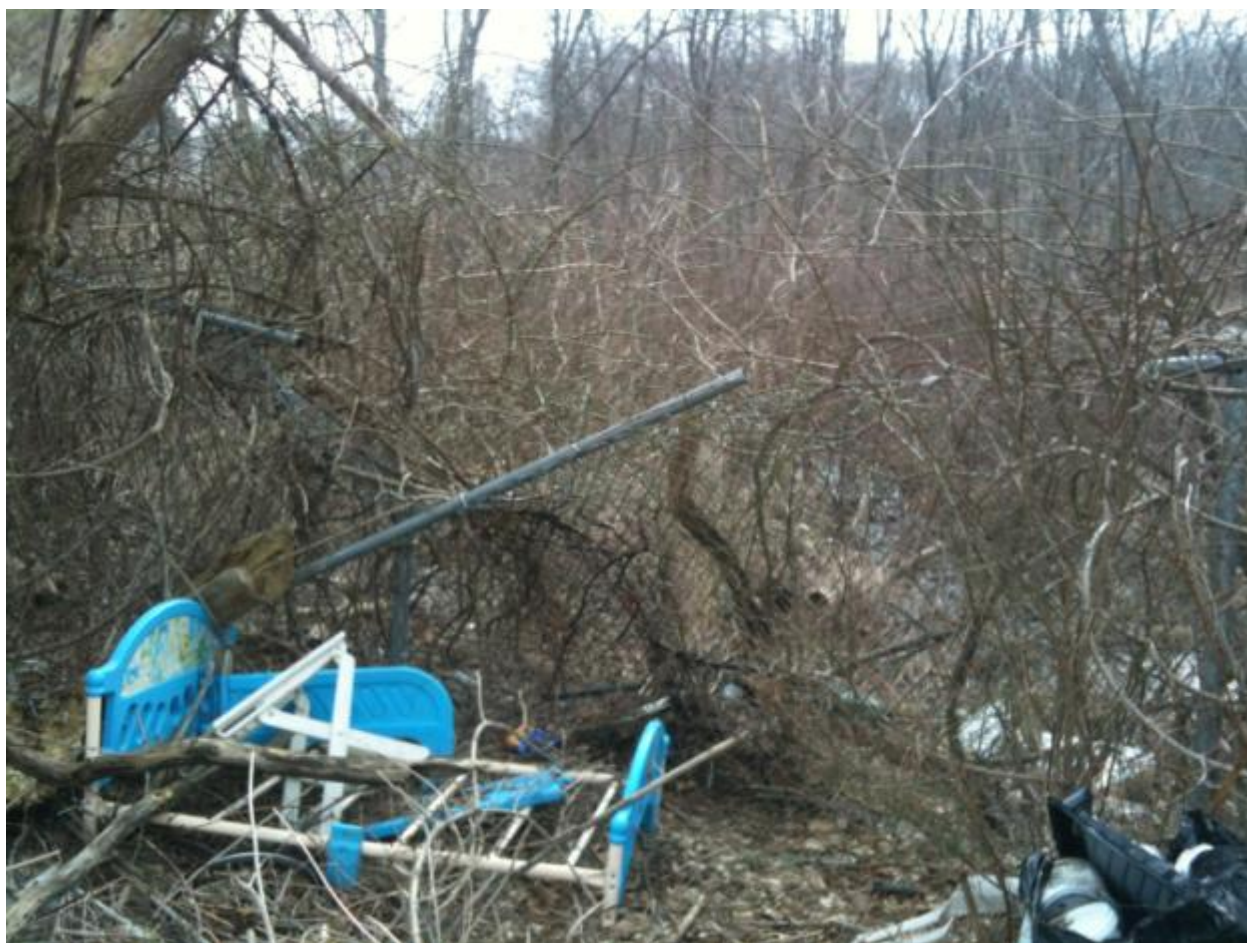
The existing EPA chain link fence is heavily overgrown with vegetation, and somewhat damaged by fallen trees. Based on mapping, the existing fence is inland of the floodplain.

Vegetation will be cleared from the fence and damaged portions of the fence will be replaced. New signage will also be installed.

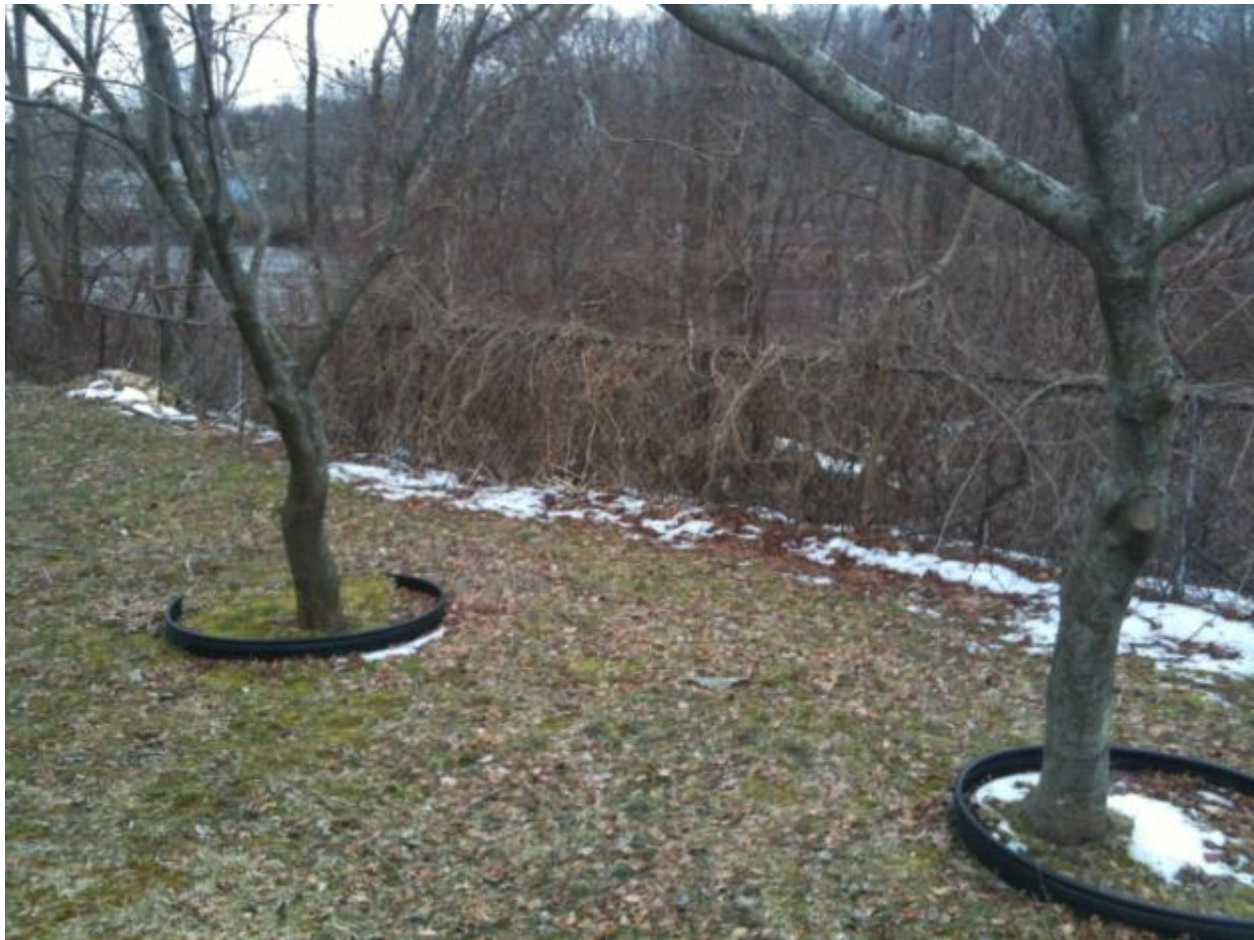
Lou Maccarone, Jim Murphy, and Samantha Hogan met with Polly Reynolds on January 8, 2013. Ms. Reynolds' brother and sister-in-law were also present. Ms. Reynolds has an existing EPA fence which has been severely damaged by a fallen tree. Ms. Reynolds stated that her backyard flooded regularly.

Based on this meeting, an approximately 110 LF length of damaged chain link fence will be removed and a new approximately 100 LF length of new chain link fence will be installed slightly inland of the existing fence. In addition, an approximately 1,700 square foot portion of the backyard will be loamed and seeded. Debris clean-up and some vegetation clearing will be required prior to covering and seeding the yard.

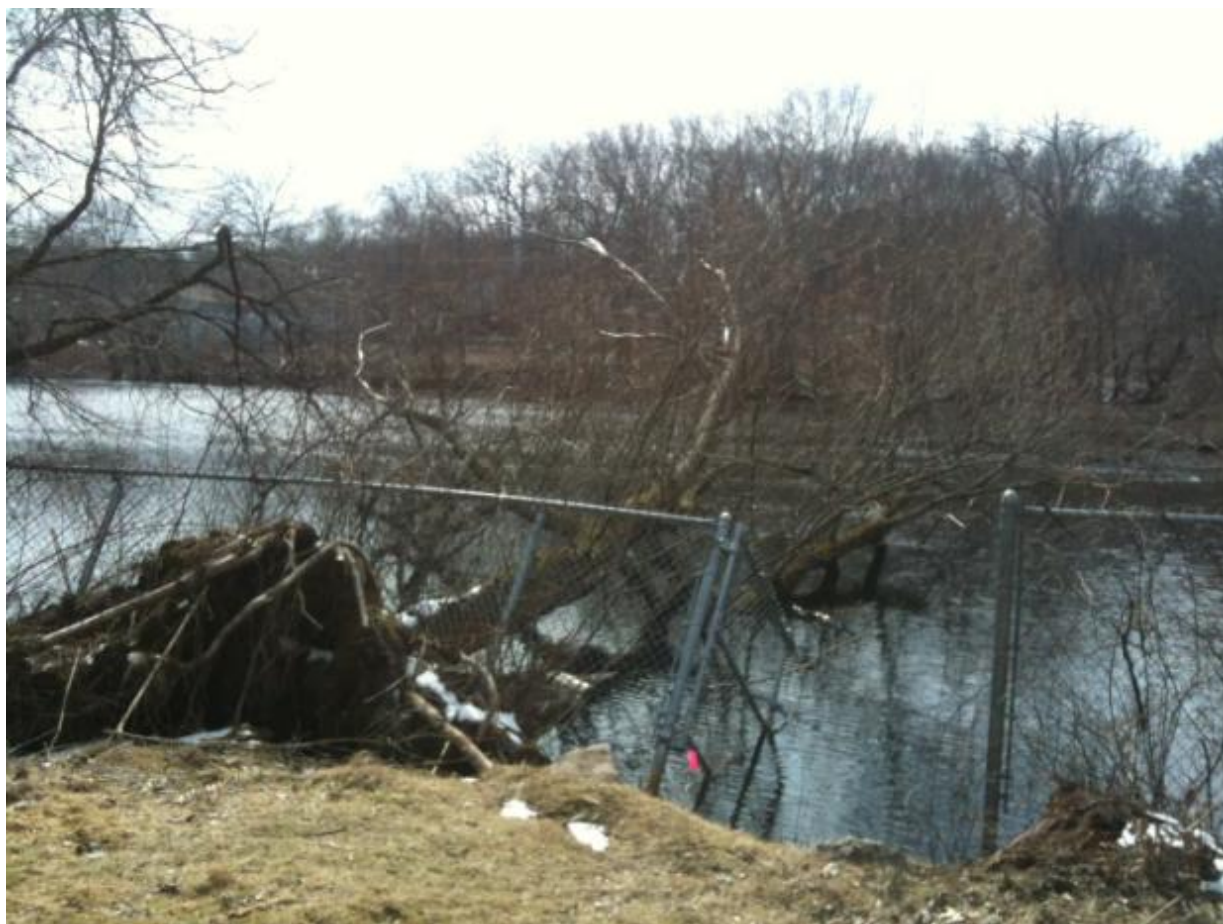
The existing approximately 45 LF chain link fence at the western end of the Stevens Street is damaged due to heavy overgrowth and a fallen tree. The damaged fence will be repaired or replaced, as required. Significant vegetation clearing is required prior to repair or replacement.

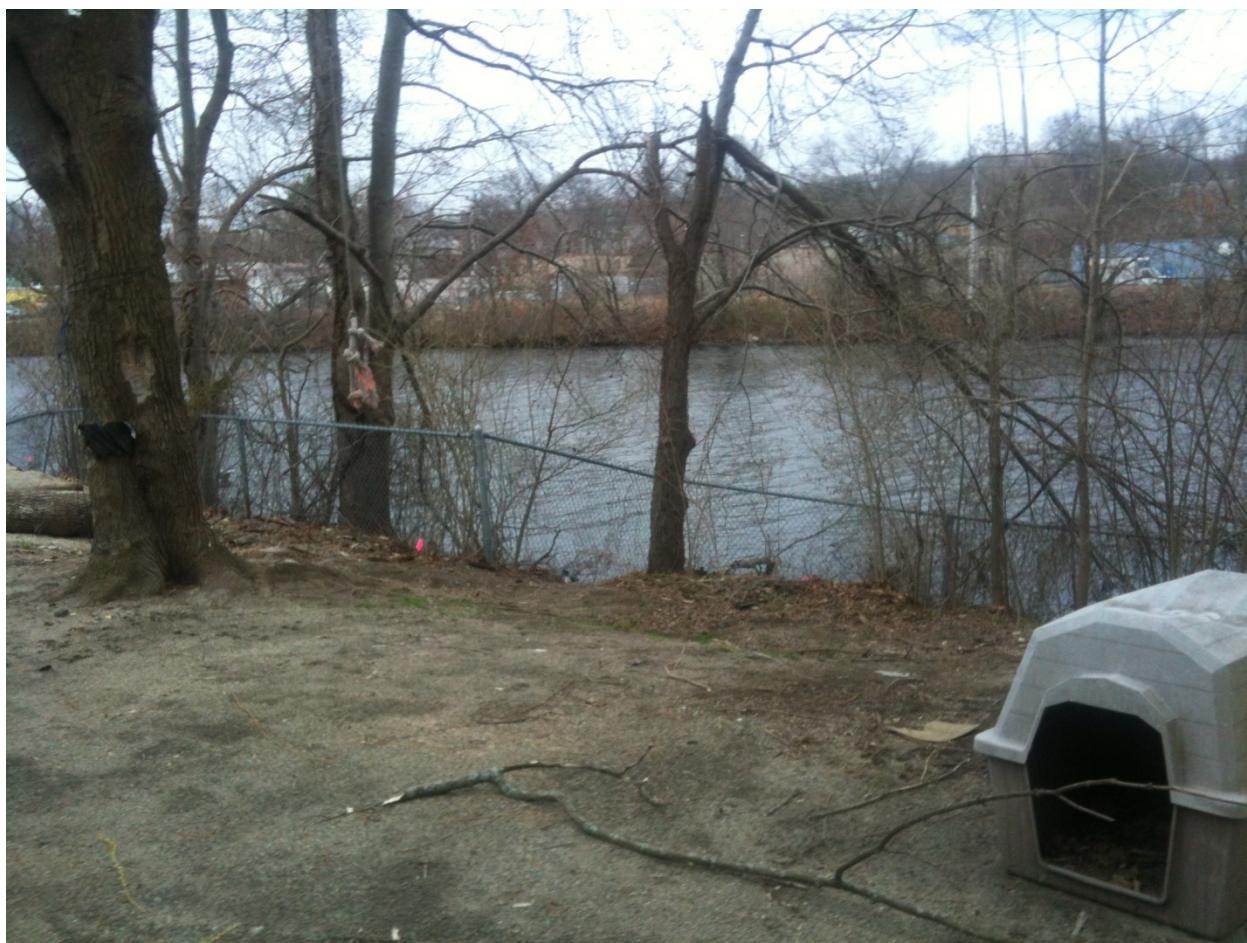
The existing EPA chain link fence at the western end of the Aldrich Street ROW is heavily damaged. Based on mapping, flooding occurs approximately 8 to 10 feet inland of the existing fence.

The existing chain link fence will need to be removed, and a new 40 foot section of chain link fence with a gate installed inland. The new section of fence will be installed next to the edge of pavement of the ROW to simplify installation and avoid trees and other vegetation. Care needs to be taken not to encroach on 22 Aldrich Street to the south, as access to that property has been prohibited.

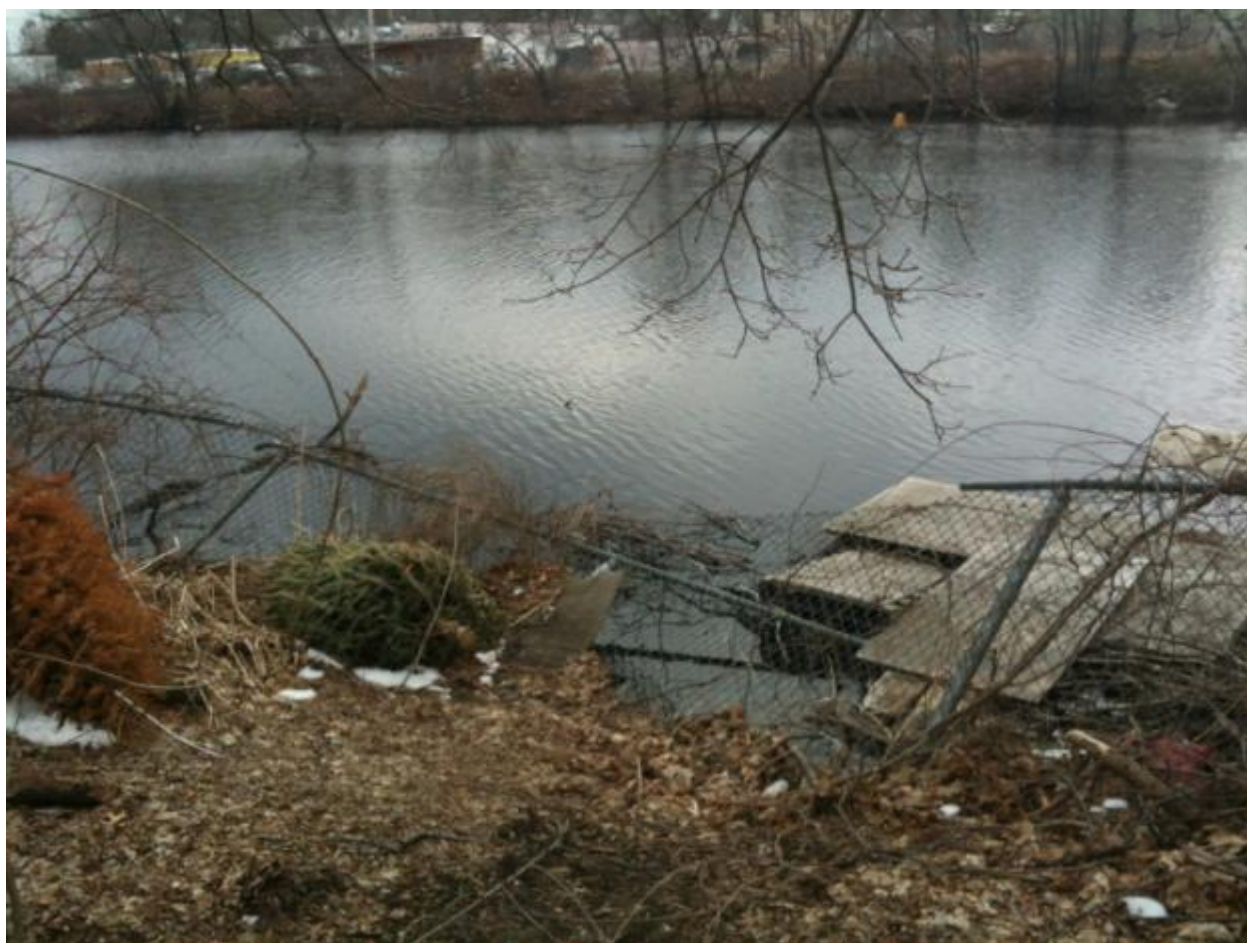
The existing chain link fence is in good condition. The mapped floodplain is approximately 25 LF inland of the existing fence; however, the fence cannot be moved that far inland as the driveway to 15 Centerdale Avenue is approximately 12 LF feet inland of the existing fence.

Based on a site visit, the existing fence will be removed, an approximately 12 LF section of chain link fence will be installed along the western edge of pavement, a 30 LF section with a gate and signage will be installed along the southern edge of pavement, and an 8 LF section will be installed along the eastern edge of pavement. An unregistered car is sometimes parked adjacent to the fence and may need to be moved prior to installation of the fence.

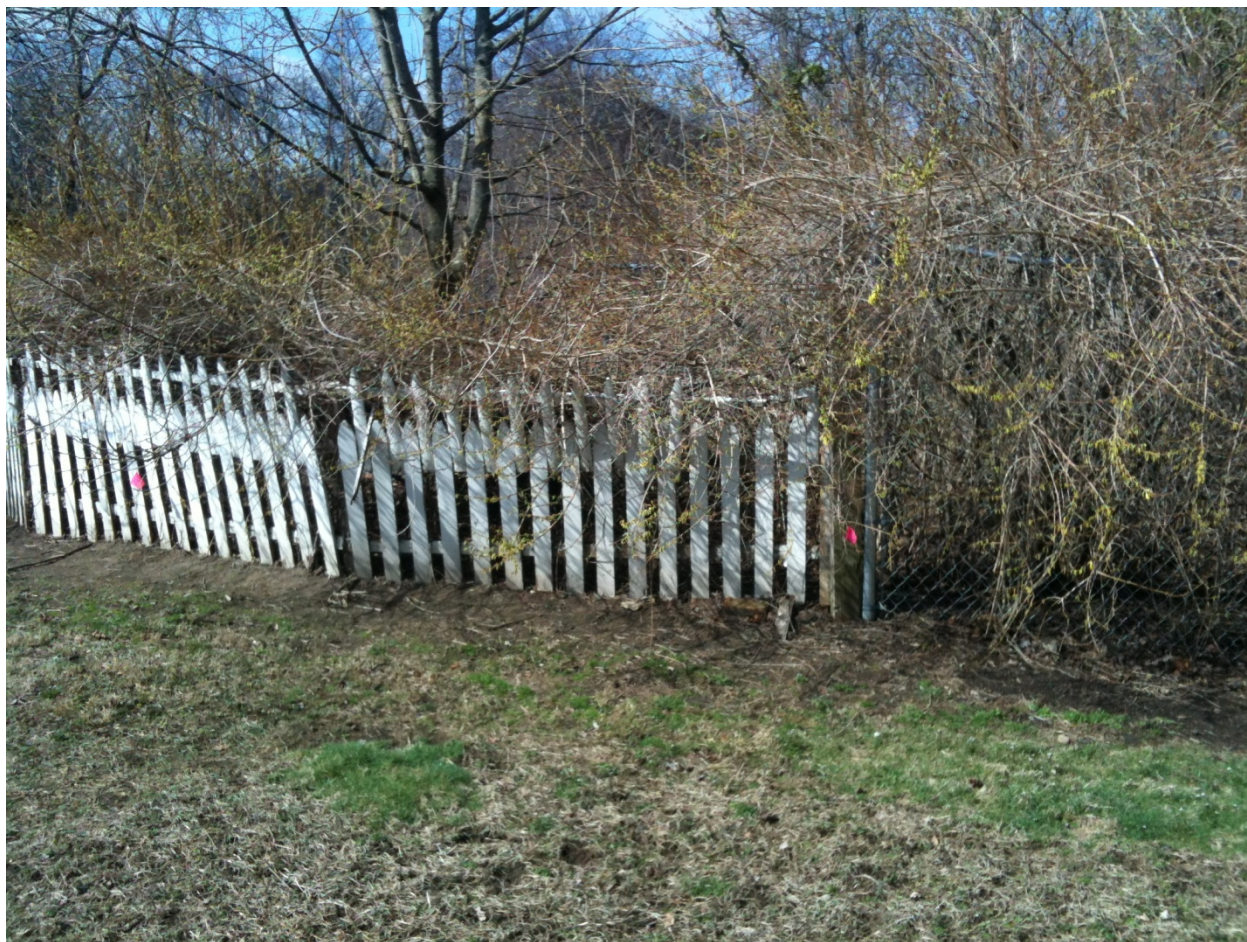
Based on a site visit, a portion of the chain link fence near the south side of the building has some minor damage. The damaged section of fence will be repaired.
