# AERIAL PHOTOGRAPHIC ANALYSIS CENTREDALE MANOR SITE SUBAREA

## North Providence, Rhode Island

TS-PIC-20001120S  
July 2000

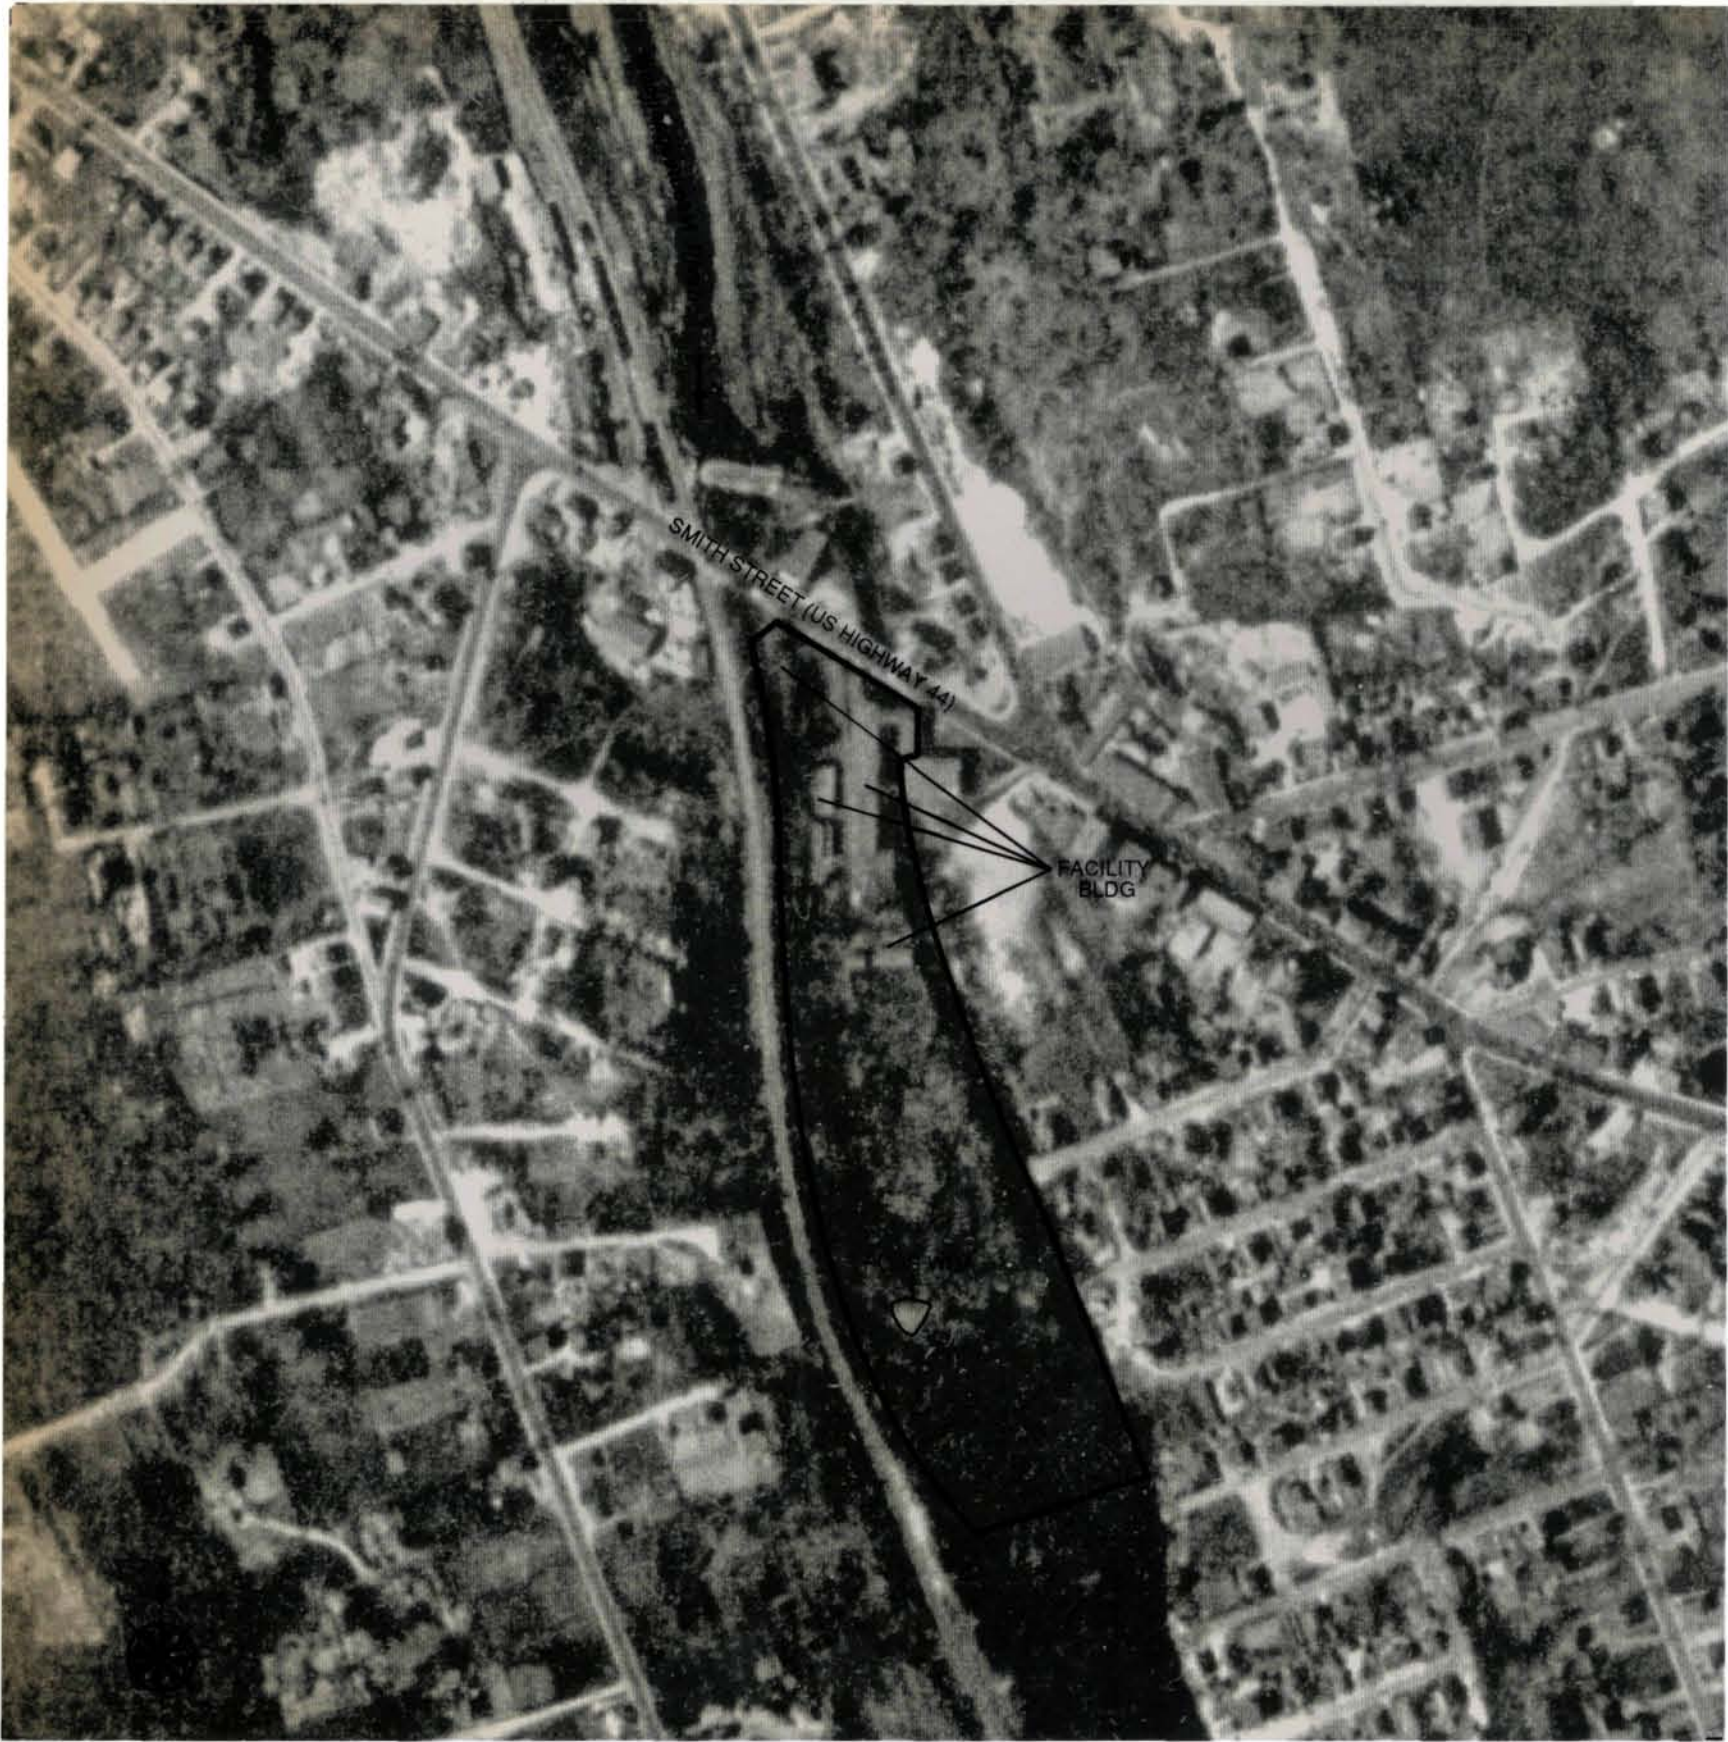
Figure 3. Centredale Manor site subarea, May 15, 1939. Approximate scale 1:3,970.

A monoscopic ozalid paper copy of the original 1939 photograph was available for analysis of the subarea; however, photographic resolution was poor and very little information was obtained from it. The northern portion of the subarea consists of industrial facilities while the southern half was comprised primarily of herbaceous, shrub, and forested wetlands. The surrounding area consists of commercial, industrial, and residential properties. The larger facility buildings are visible and one area south of the buildings appears to coincide with the location of a waste disposal area (WDA) observed in 1951 (Figure 4). There do not appear to be any other disturbances of the natural landscape south of the buildings.

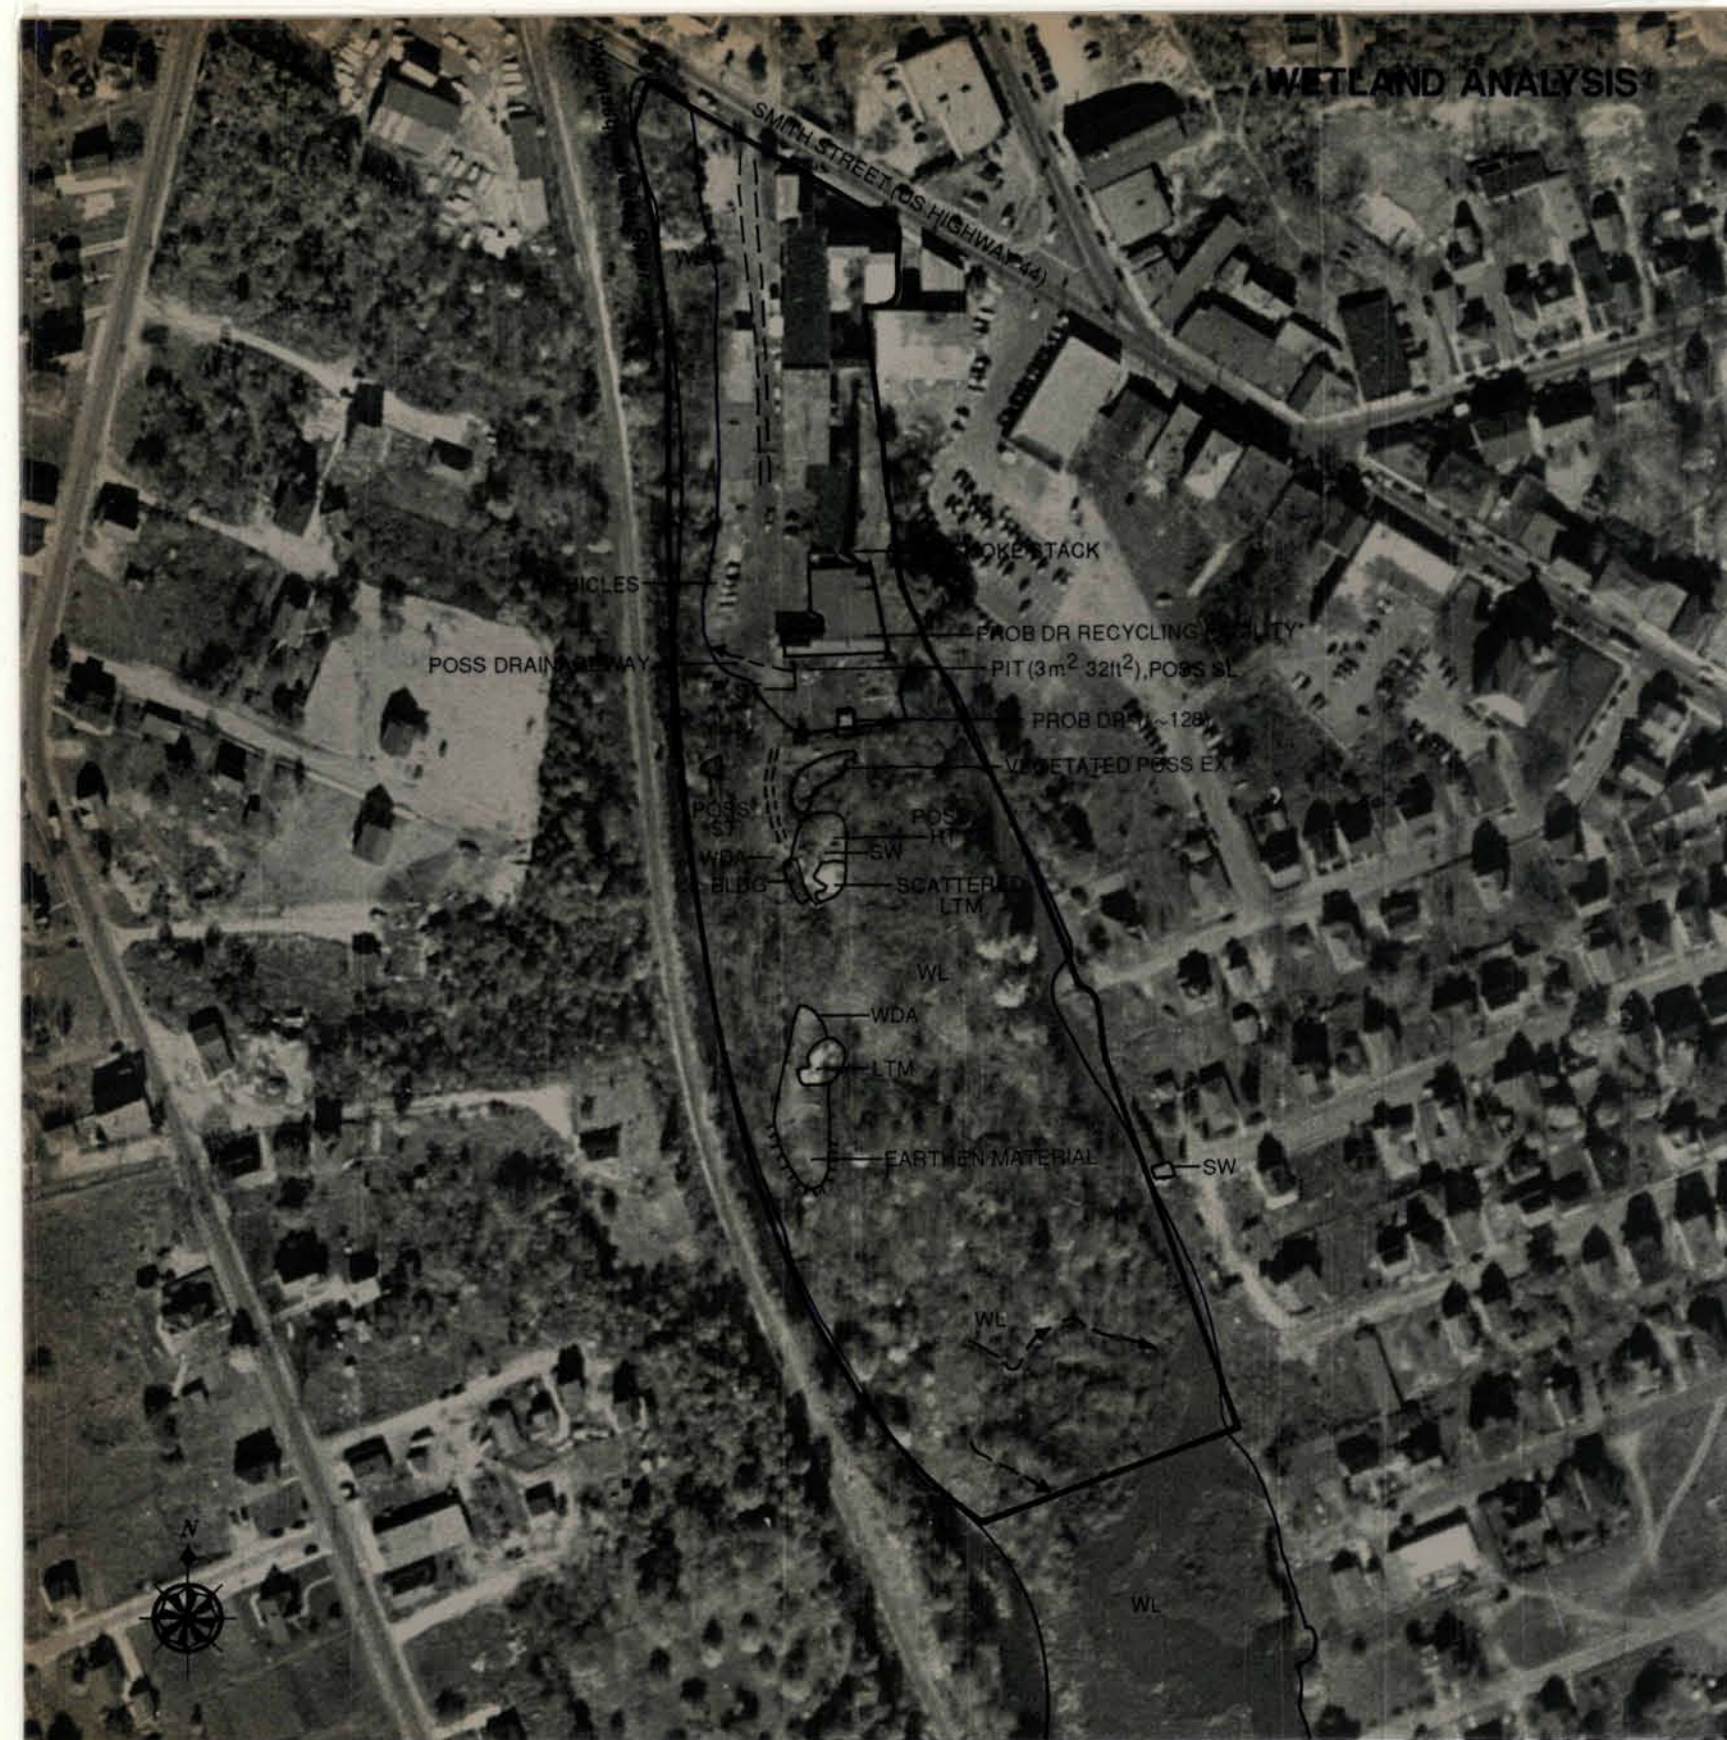
OCTOBER 26, 1951 (FIGURE 4)

In the northern portion of the subarea, the southernmost building in the building complex is probably the drum recycling facility referenced in the collateral information (EPA 1999). On the south side of the facility is a stain (ST) and a small pit containing possible standing liquid (SL). The pit is approximately 3 square meters (32 square feet) in extent. A possible drainageway leads west from the pit towards the Woonasquatucket River. A smokestack is also observed adjacent and north of the drum recycling facility. To the west of the probable drum recycling facility\* are vehicles parked at the end of an access road that leads to Smith Street. Approximately 128 stacked probable drums (DR-1) are located to the south. An access road leads south to a waste disposal area where solid waste (SW), scattered light-toned material (LTM), a possible horizontal tank (HT), and a small building are located. North of the waste disposal area is a vegetated possible excavation (EX) where waste-related activities may have taken place between 1939 and 1951. A small area of possible staining is present to the west. South of the waste disposal area is a second waste disposal area with a deposit of earthen material that is elevated at its southern end. Light-toned material is also present. This is the approximate location of the possible waste disposal observed in 1939. To the east of the subarea is a small deposit of solid waste at the west end of a residential street.

The entire subarea south of the probable drum recycling facility is a combination of herbaceous, scrub, and forested wetlands. Wetlands also extend north along the Woonasquatucket River to Smith Street. The areal extent of the wetlands is approximately 3 hectares (7.3 acres).

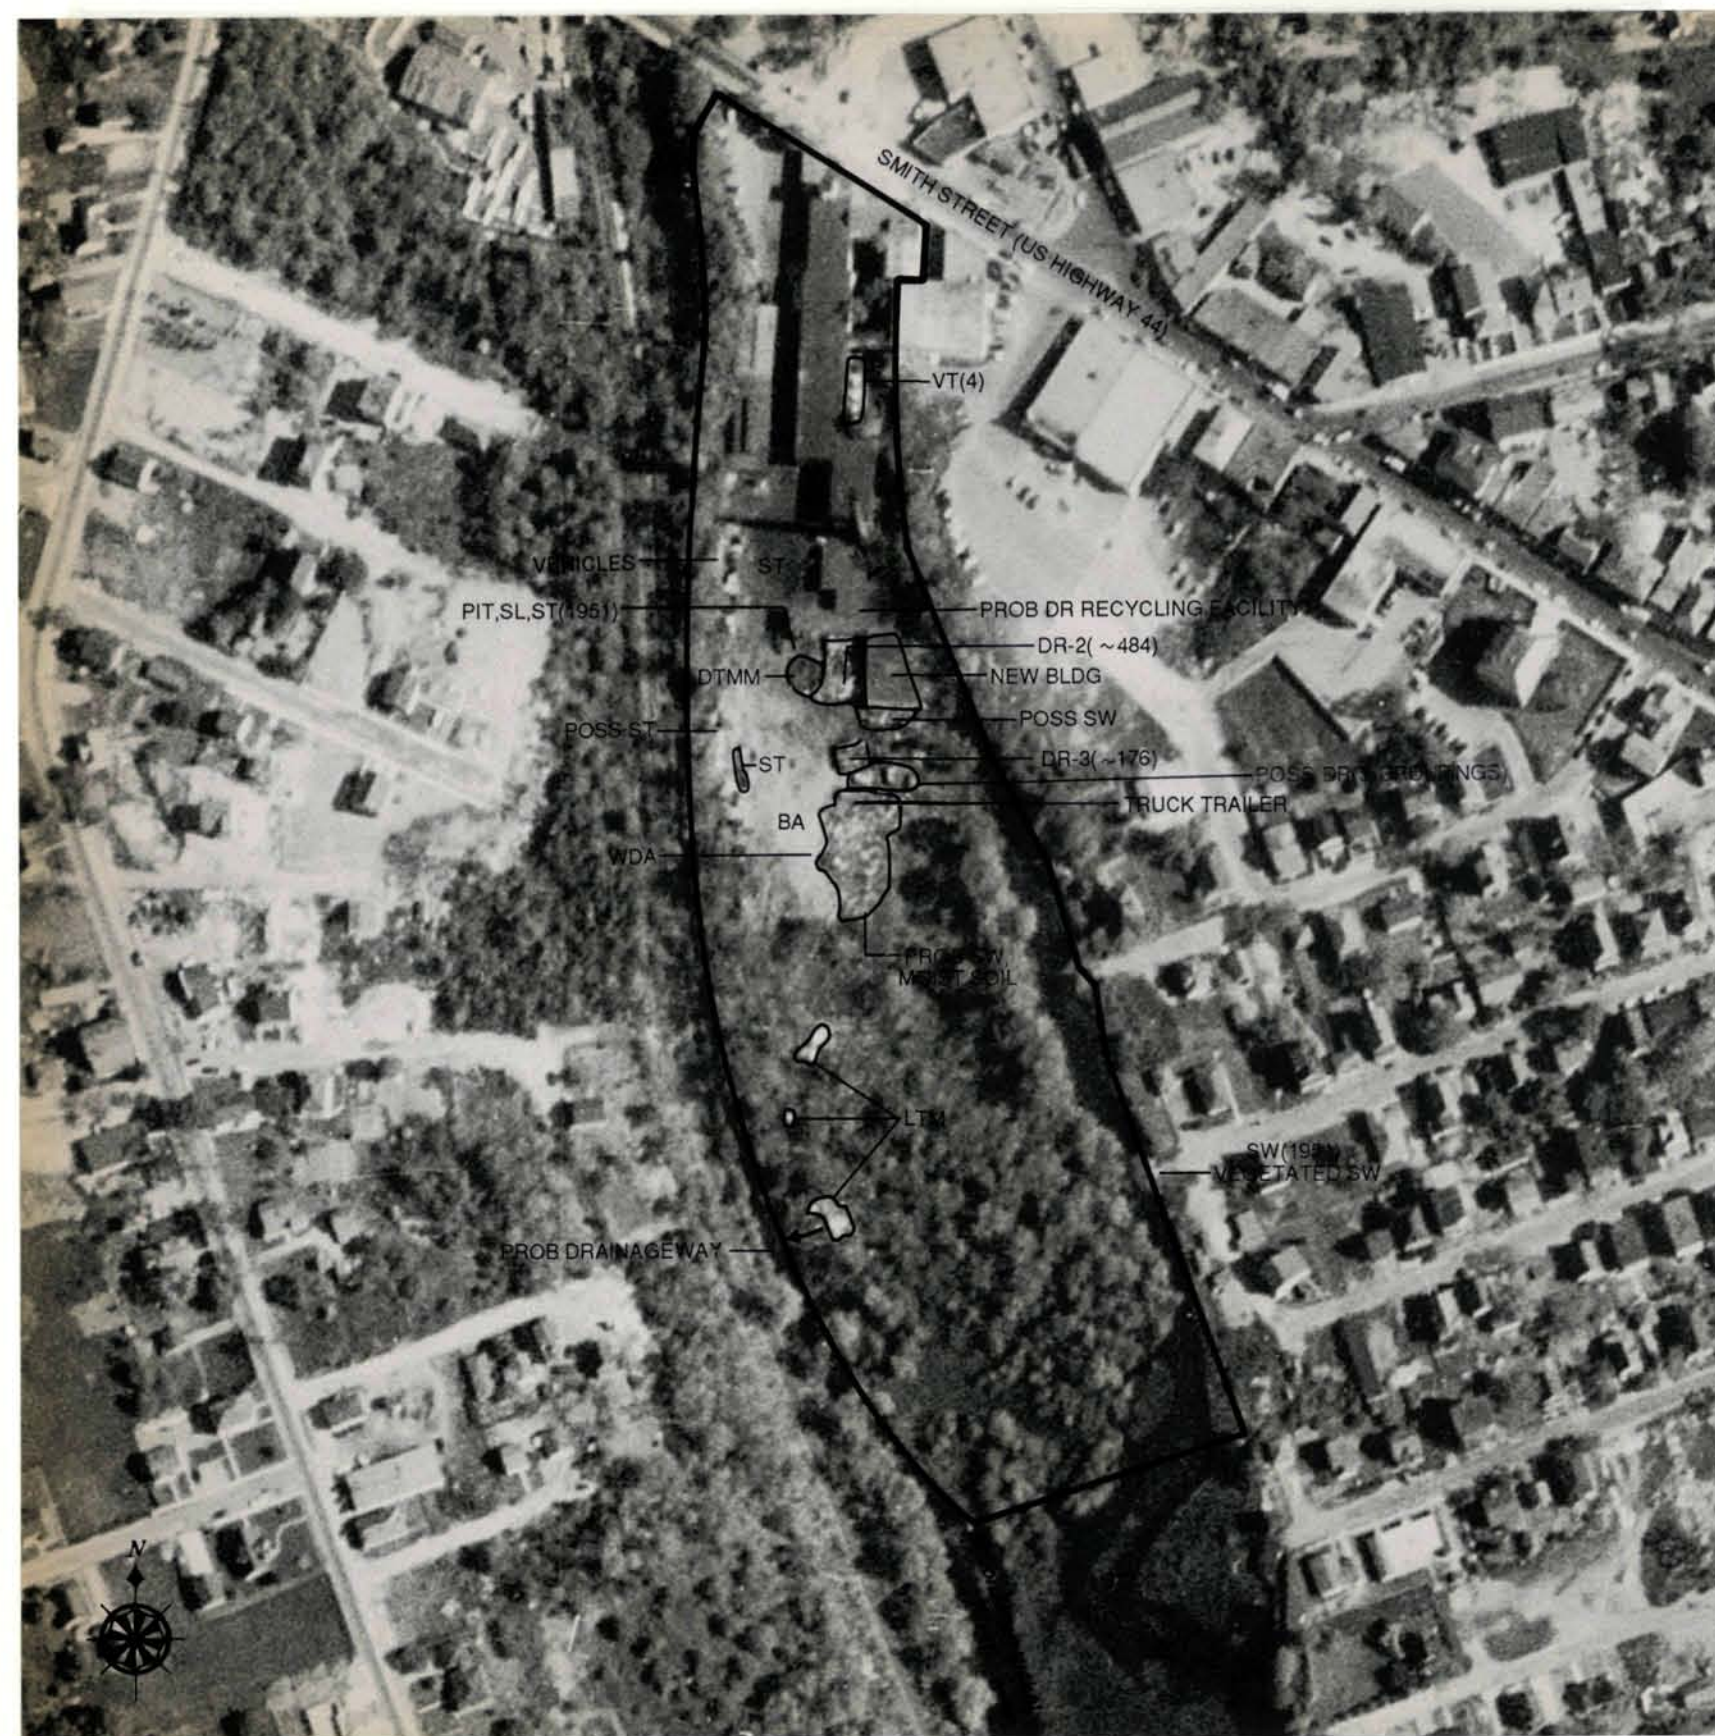
Adjacent to a facility building in the northern portion of the subarea are four process-related vertical tanks. Staining is present in the lot west and south of the probable drum recycling facility. A separate stain is visible on a bare area (BA) to the southwest. The small pit, standing liquid, stain, and small drainageway observed in 1951 are not present. A new building has been constructed to the south of the probable drum recycling facility. Immediately west of this new building is a large stack of probable drums (DR-2) containing approximately 484 drums. Dark-toned mounded material (DTMM) is evident next to DR-2. Possible solid waste is evident at the south end of the new building. South of DR-2 is DR-3 which contains approximately 176 drums. Unidentified objects (not annotated) are observed to the east and south of DR-3. South of DR-3 are three groupings of possible drums. West of DR-3 is an area of possible staining and an area of confirmed staining. Further to the south is a large area of probable solid waste, moist soil, and a truck trailer. This is the approximate location of the northernmost waste disposal area observed in 1951. Tree canopy precluded a detailed assessment of the southernmost waste disposal area discussed in the 1951 analysis year; however, three areas of light-toned material are in the general vicinity of this waste disposal area. A probable drainageway leads from the southernmost of these areas of light-toned material to the Woonasquatucket River. To the east of the subarea, the solid waste observed in 1951 at the end of a residential street is now covered with vegetation.

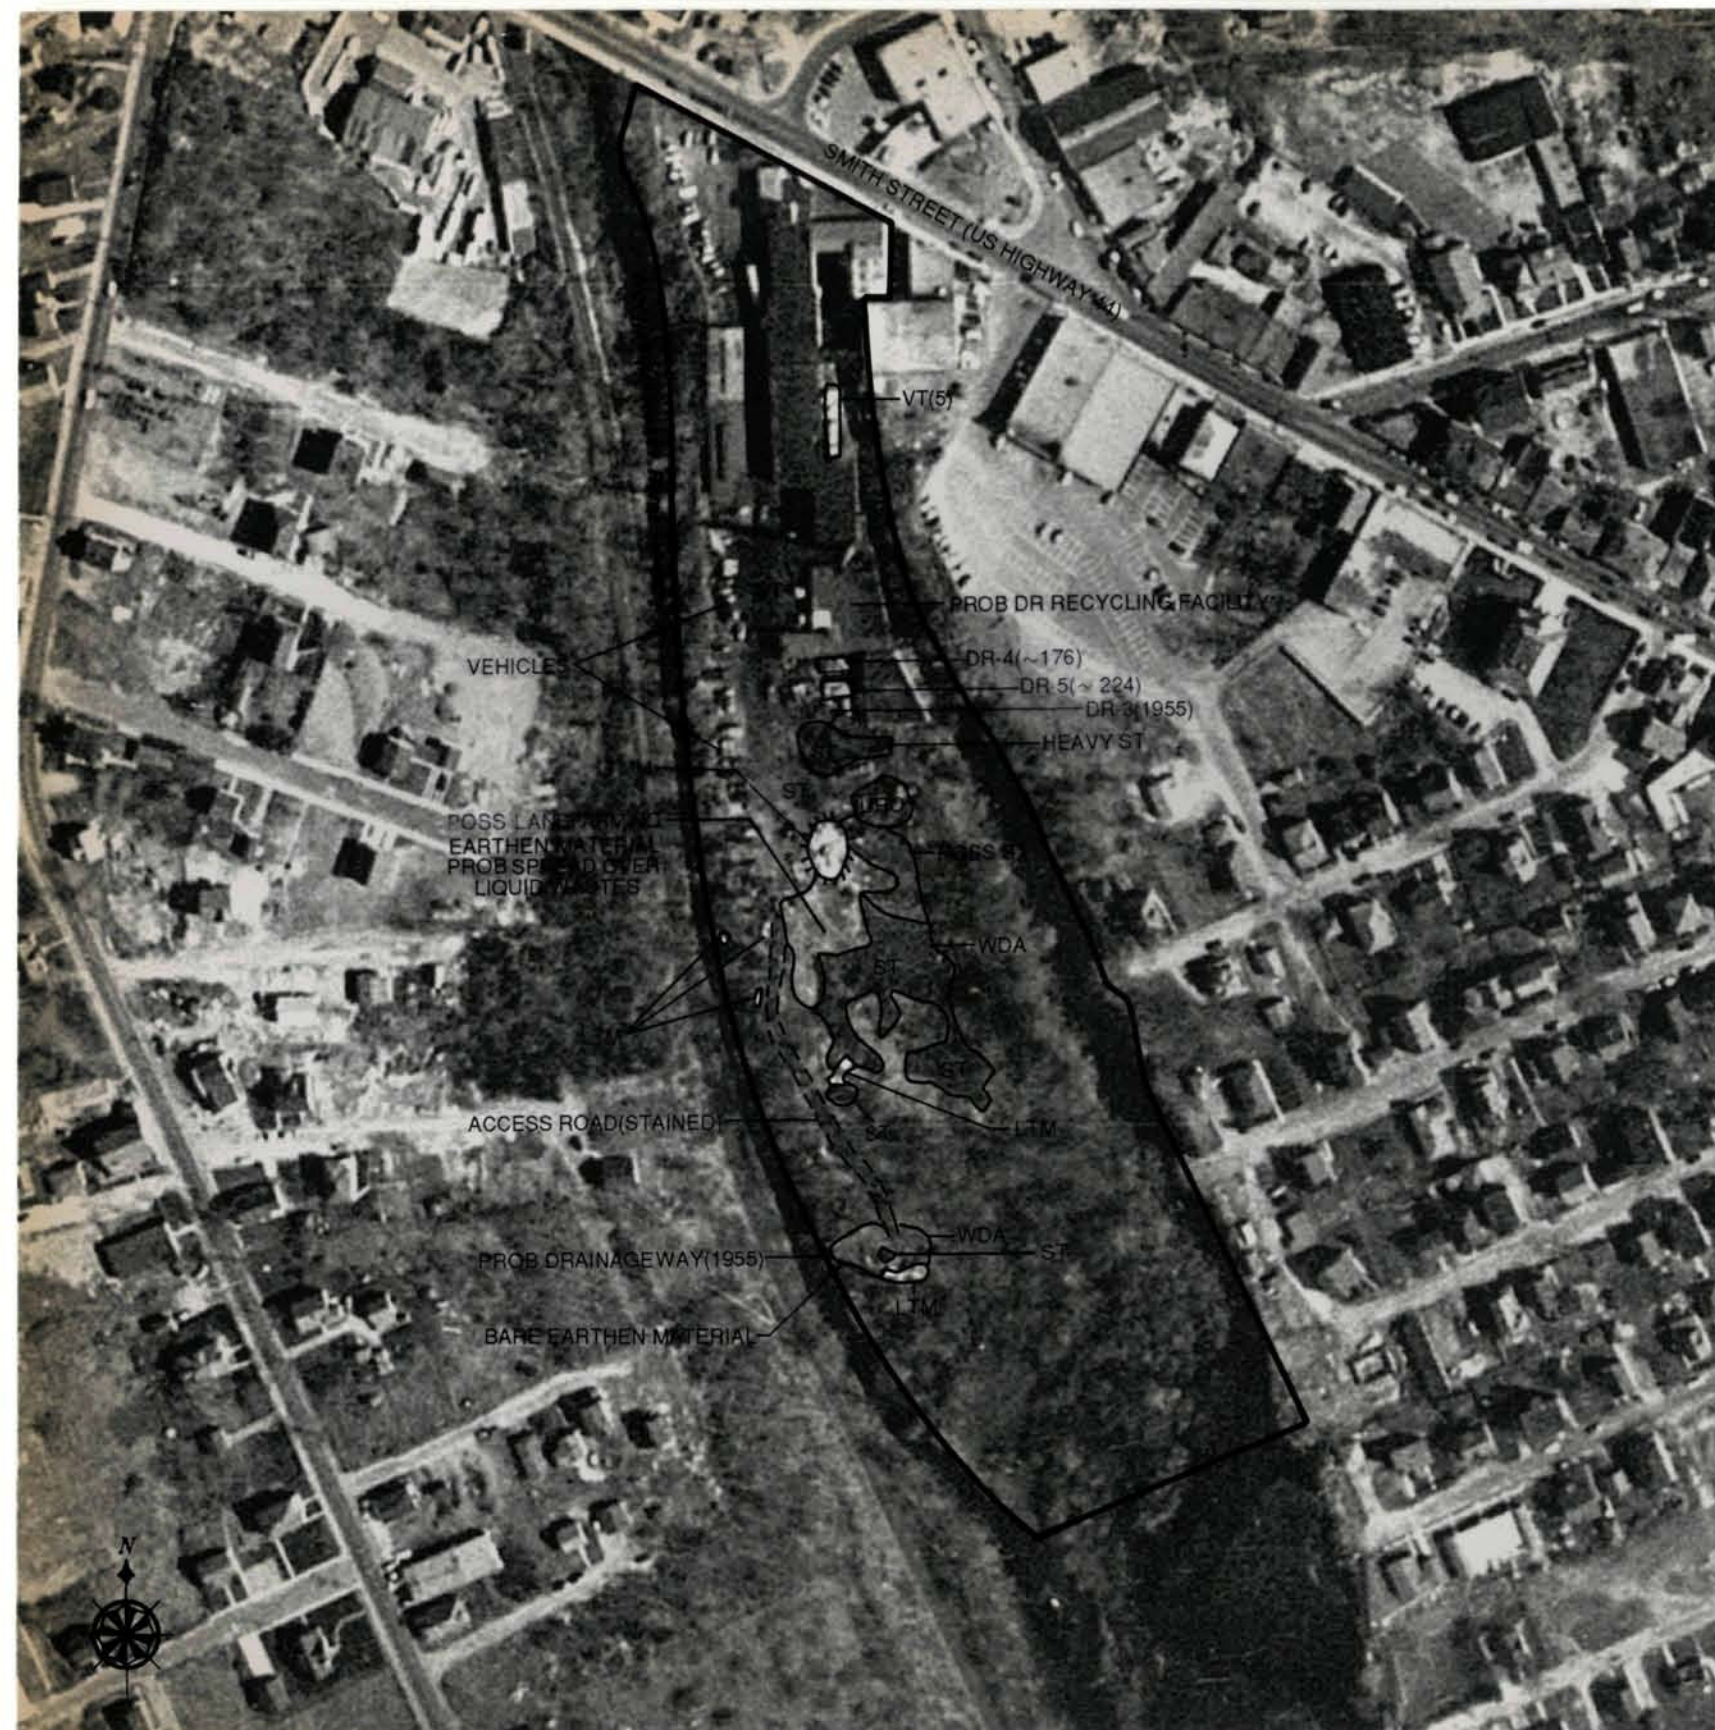
The 1956 photographs were acquired during leaf-off conditions allowing for a more detailed subarea assessment in the wetland area in the southern portion of the subarea as compared to the 1955 assessment.

A total of five process-related vertical tanks are now discerned next to the large building in the northern portion of the subarea. Staining observed in 1955 in the facility lot remains. Adjacent to the probable drum recycling facility are two new groupings of stacked probable drums (DR-4 and DR-5). These groupings are situated at the approximate location of DR-2 in 1951. Approximately 176 and 224 probable drums, respectively, are present at DR-4 and DR-5. Further to the south a large heavy stain is evident at the former location of DR-3 in 1955, and unidentified rectilinear objects (URO) are observed nearby. Continuing south, waste disposal area operations in the central portion of the subarea continue to expand and now consist of possible landfarming, possible staining, light-toned mounded material (LTMM) and large areas of staining. A stained access road leads to the south. West of this road is light-toned material and to the east is additional staining and light-toned material. At the end of the road is an apparently new waste disposal area where bare earthen material, staining, and light-toned material are evident. The bare earthen material extends to the riverbank. The probable drainageway seen at this location in 1955 is not observed in this 1956 photograph.

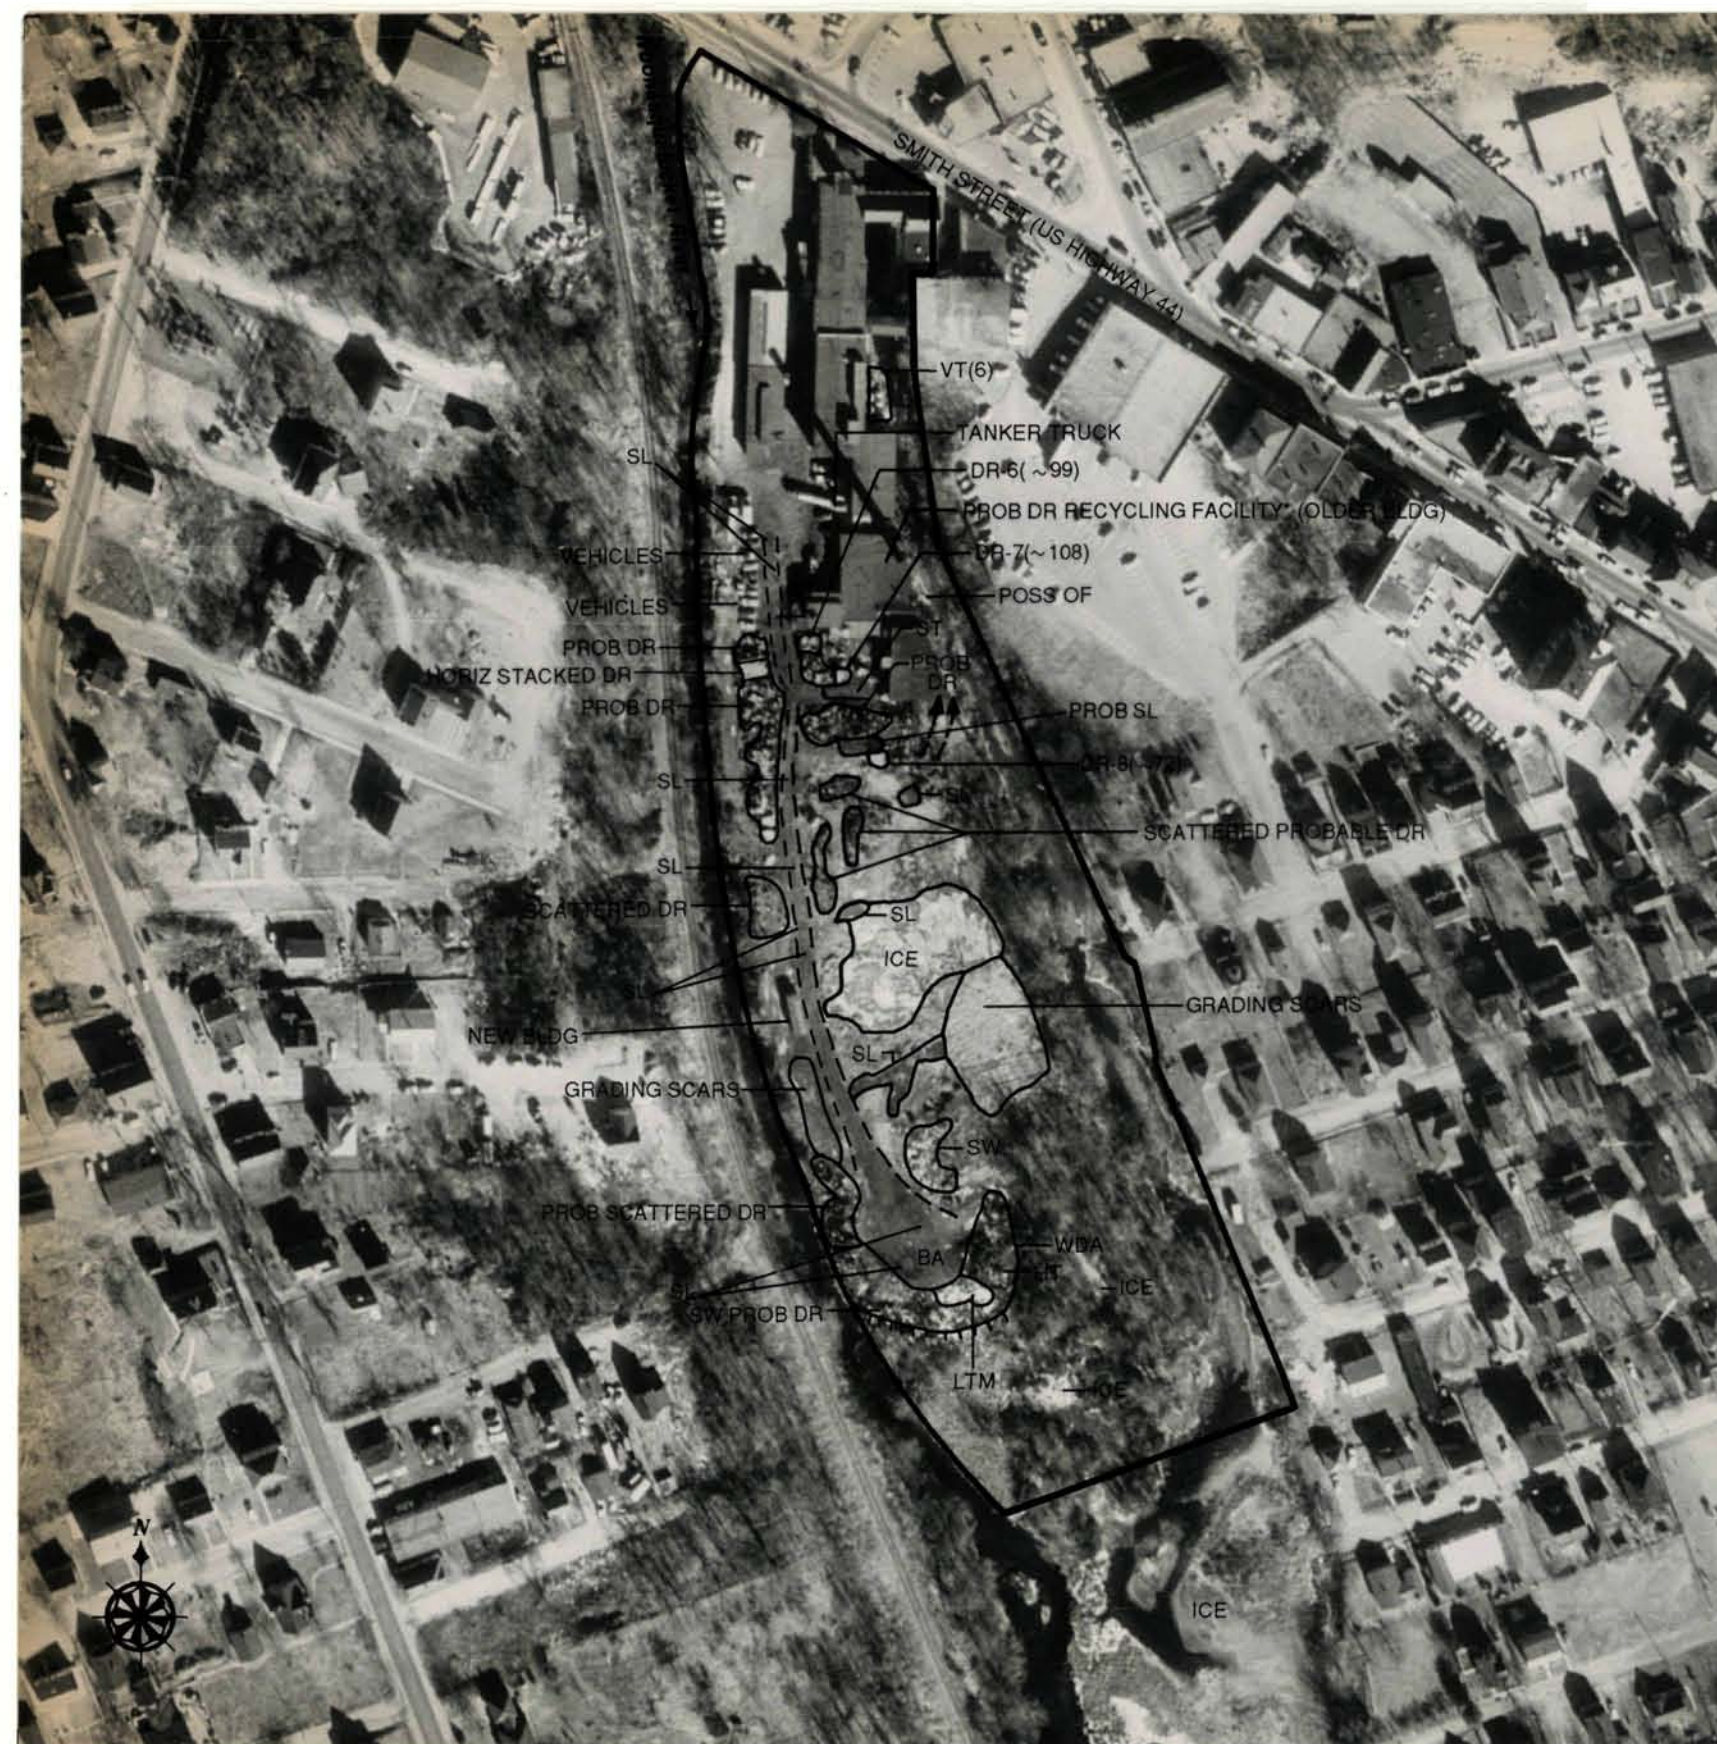
The number and complexity of features and activities present at the subarea has increased since 1956; therefore, the subarea is divided into three sections for discussion purposes. These sections are Section 1 - northern and central portions of the subarea, Section 2 - extreme southern portion of the subarea, and Section 3 - area west of the subarea access road. Due to the complexity and number of features, these sections are not delineated. There are numerous areas of standing liquid and moist soil (some locations not annotated) present at the subarea. This is probably at least partially attributable to recent precipitation or snow or ice melt. Ice is observed in the river near the bottom edge of this photograph.

Six process-related vertical tanks are now present next to the large building in the northern portion of the subarea. To the south is a parked tanker truck. West of the probable drum recycling facility (older building) standing liquid is observed on the subarea access road. The facility lot continues to be stained. A possible outfall (OF) is observed at the east side of this older building. Probable drums are located to the west and south of the building; however, only three locations of vertically stacked probable drums (DR-6, DR-7, and DR-8) are observed. The approximate number of probable drums at DR-6, DR-7, and DR-8 are 99, 108, and 72, respectively. Adjacent to DR-8 is a large area of probable standing liquid. East of DR-8 are two small drainageways which trend into the drainageway at the east side of the subarea (not annotated). South of DR-8 are groupings of scattered probable drums, areas of standing liquid, a large area of ice, and an area where grading scars are evident. The areas of ice and grading scars are located where, in 1956, liquid wastes were being spread on the ground and covered with earthen material. South of the ice and grading scars is a large area of standing liquid and a deposit of solid waste. Other areas of standing liquid are noted on the access road that is parallel to and east of the river and leads to the southern portion of the subarea.

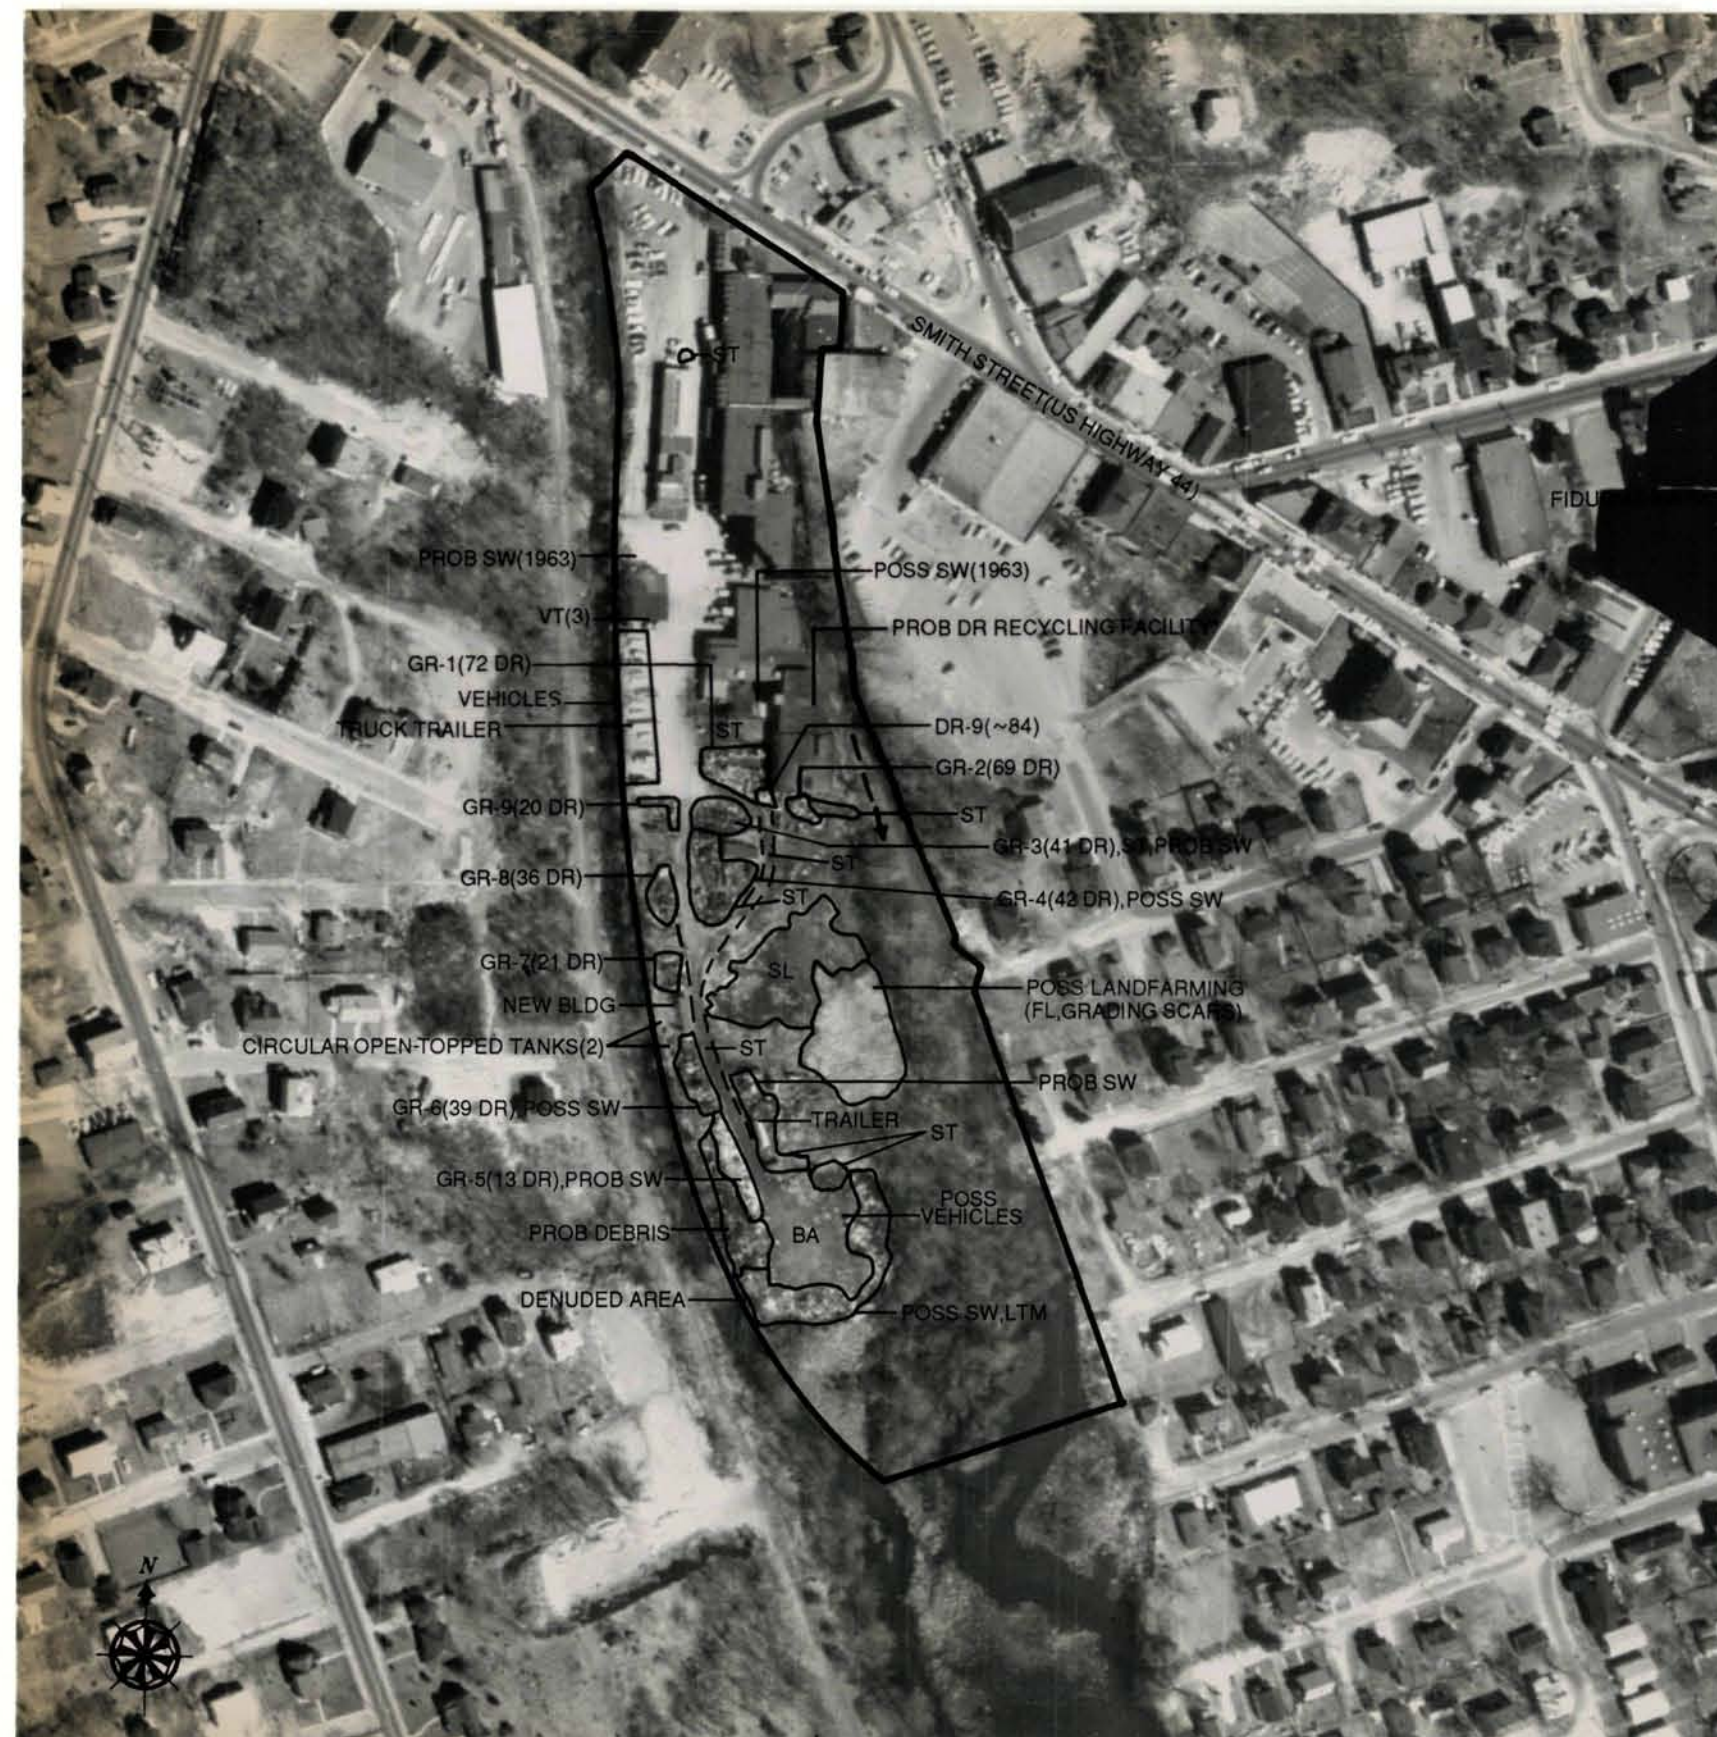
Staining is evident north and south of a large building in the northwestern portion of the subarea. Possible solid waste is located adjacent to the facility. Probable drums (three groupings) are noted to the south; however, due to the random distribution of the drums stacked approximate counts could not be ascertained. A deposit of probable solid waste is present at the southern end of a new facility building. Immediately adjacent to the probable solid waste is a denuded area where drainageways were evident in 1962. Continuing south is a diagonally trending cleared area, unidentified rectilinear objects, vegetated solid waste, and a large revegetated area. In 1956 the large revegetated area had been utilized as a waste disposal area and in 1962 scattered drums, solid waste, standing liquid, and an area of grading scars were observed.

On the west side of the subarea from north to south near the Woonasquatucket River are areas of probable solid waste, two vehicles, a probable truck trailer, another deposit of probable solid waste, staining, possible staining, possible drums, possible solid waste, and two additional areas of possible drums. The grading scars evident in 1962 are no longer present.
