# AERIAL PHOTOGRAPHIC ANALYSIS CENTREDALE MANOR SITE SUBAREA

## North Providence, Rhode Island

TS-PIC-20001120S  
July 2000

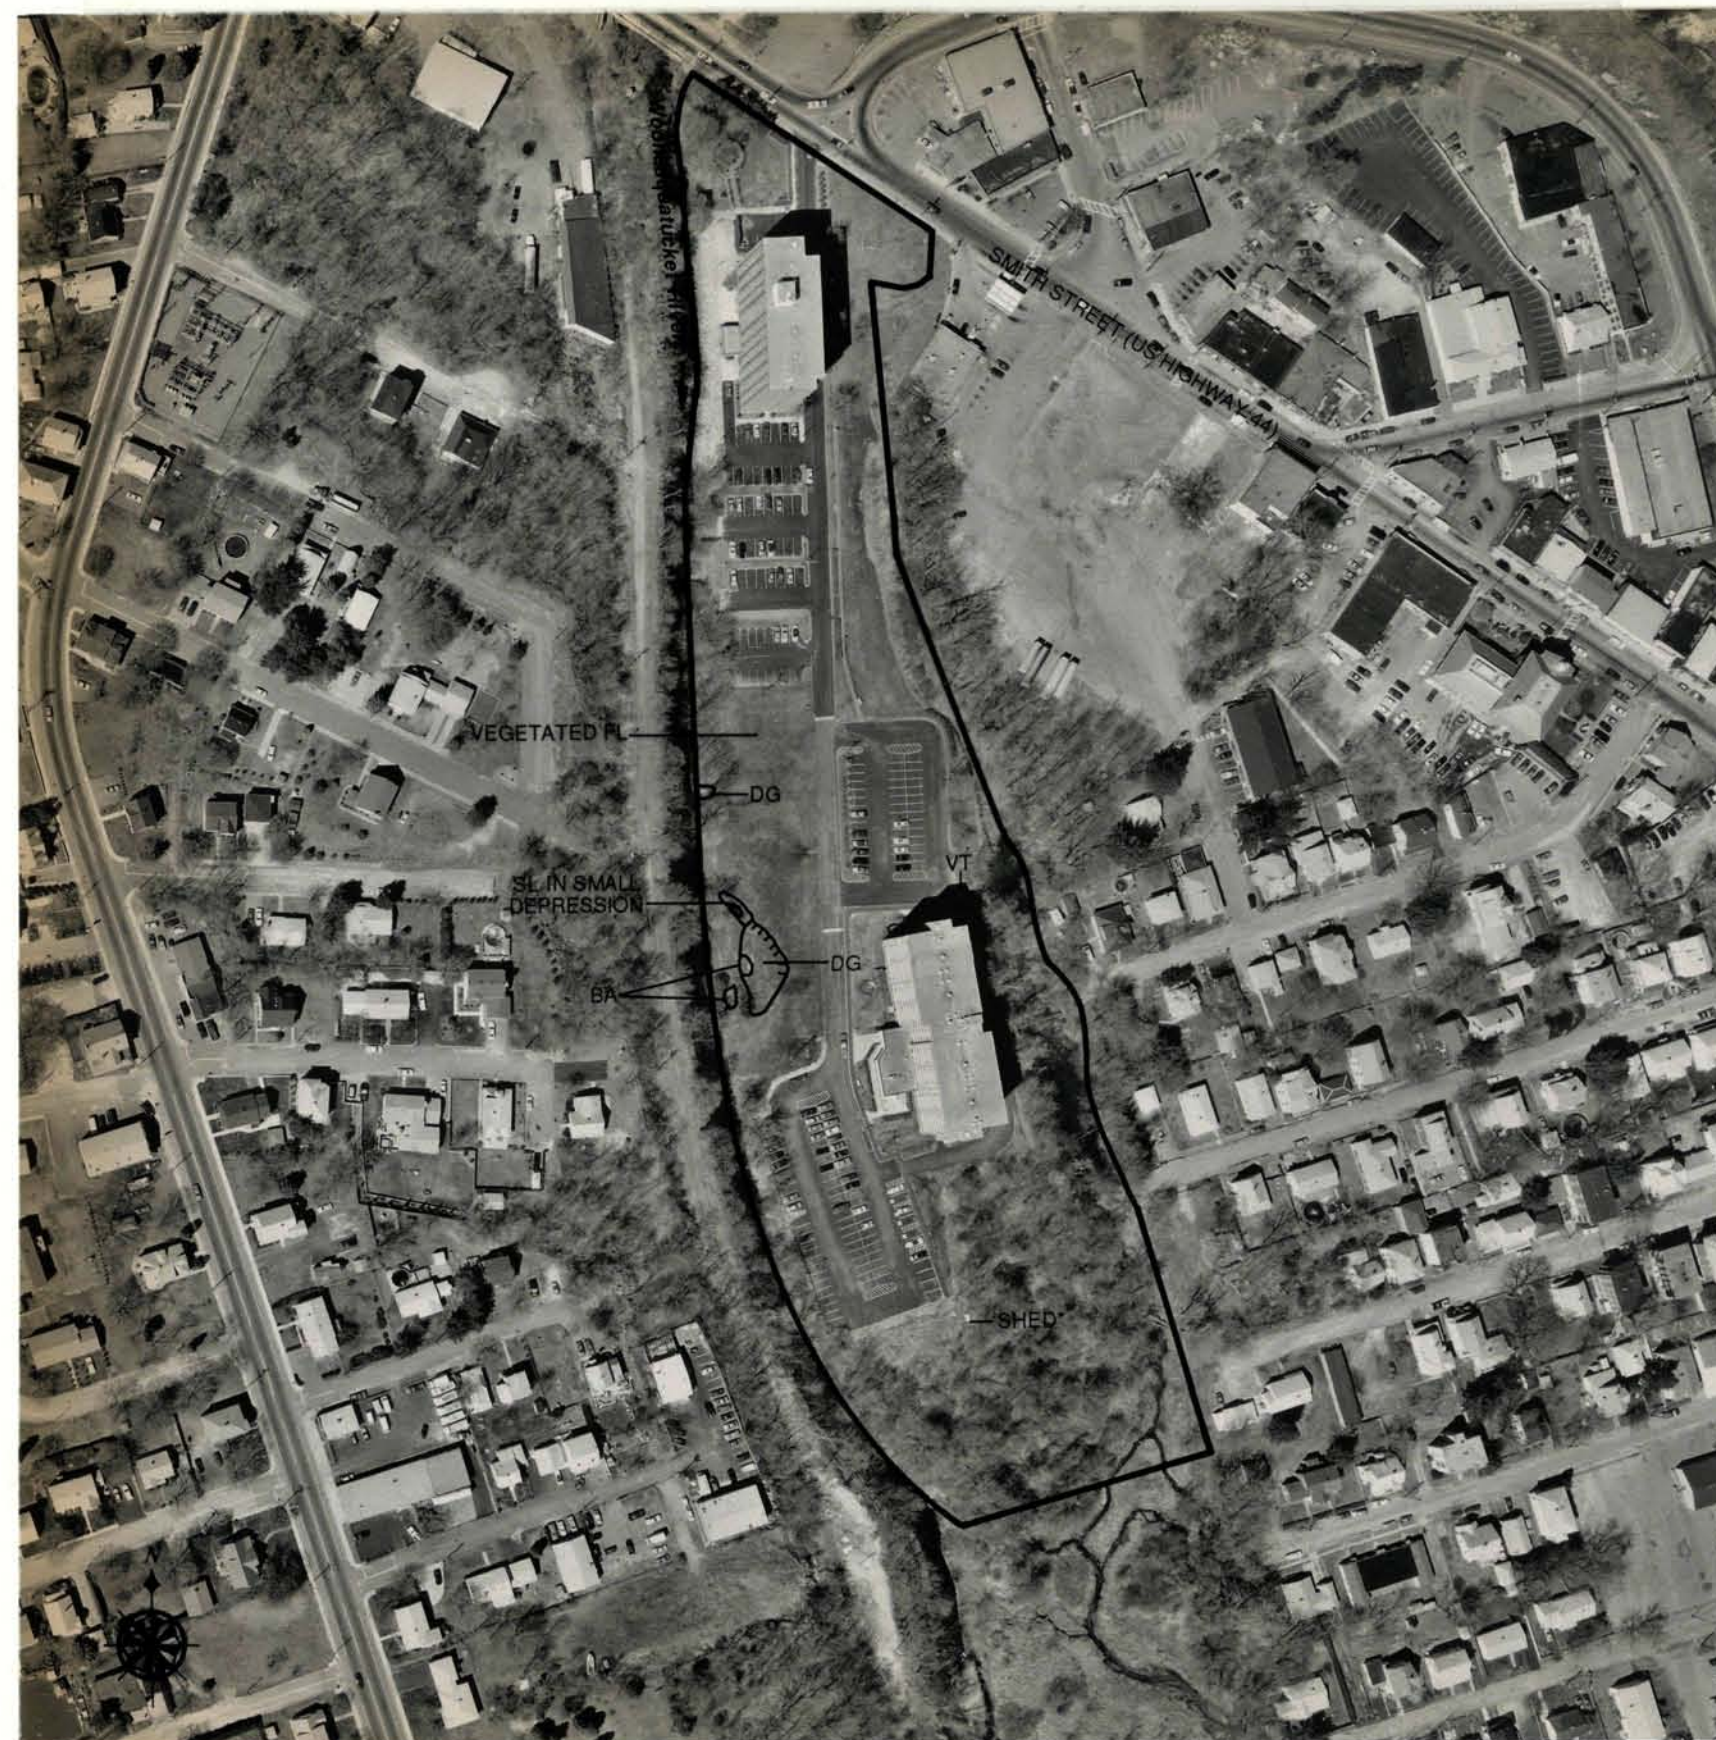
The Brook Village property parking lot has been extended to the south and partially vegetated fill (FL) is observed adjacent to it. To the south near the river are several areas of sparse vegetation that may be indicative of vegetation stress. One small area of standing liquid is also present. A small possible shed is observed south of the parking lot of a new large building (Centredale Manor\*) that has been constructed since 1981.

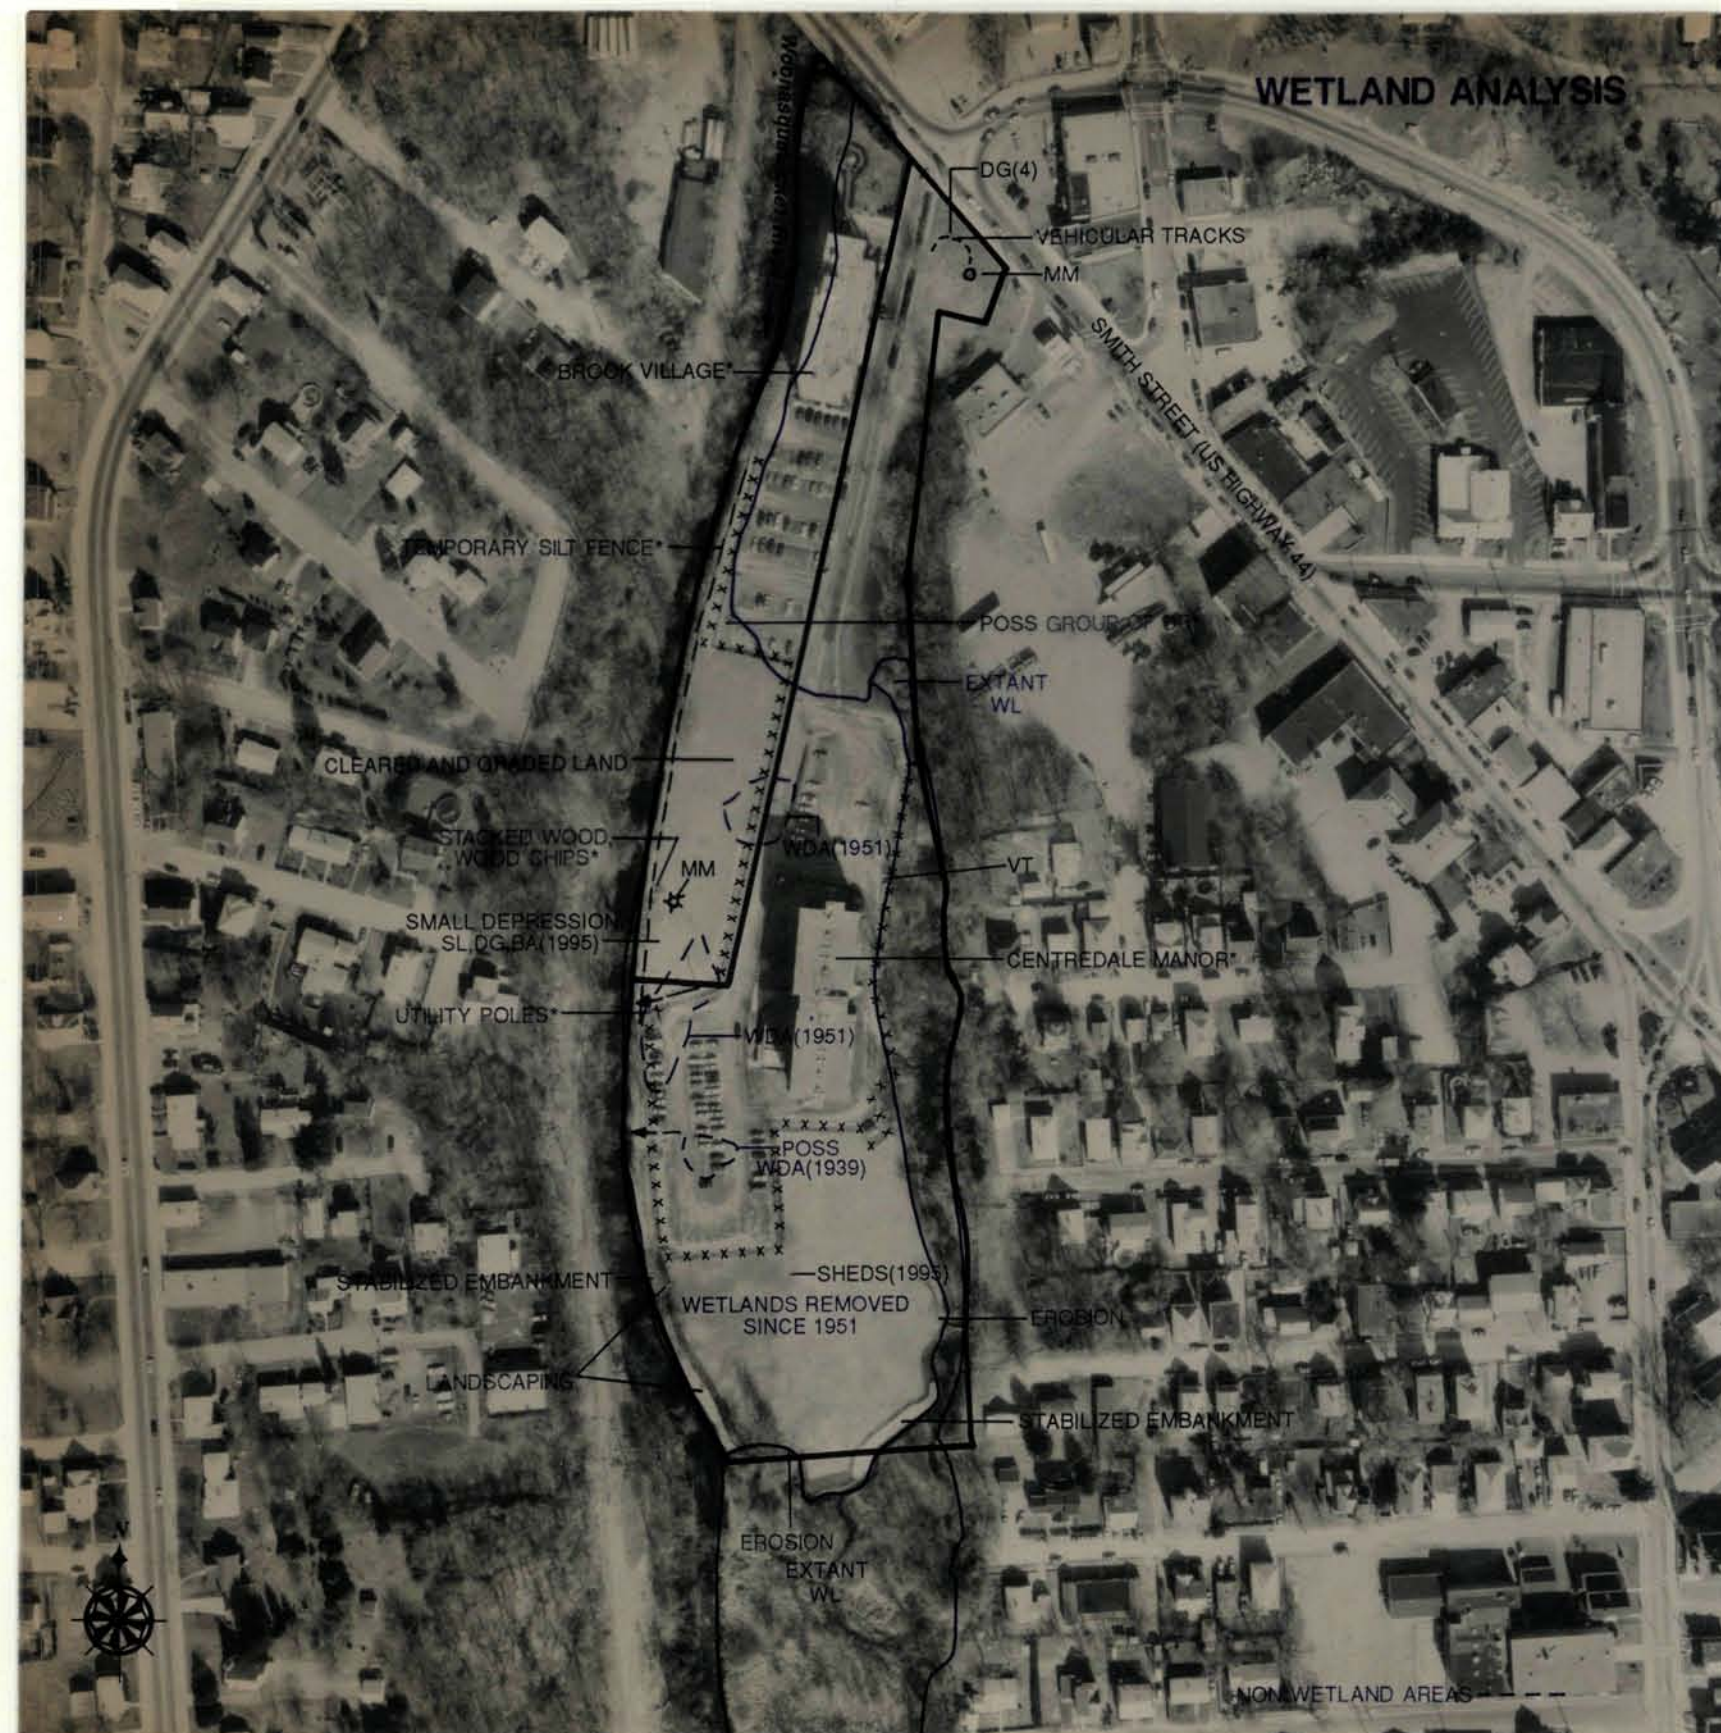
APRIL 7, 1995 (FIGURE 14)

West of the Centredale Manor building is disturbed ground (DG), bare areas, and standing liquid within a small depression. This is the same area where sparse vegetation and standing liquid were noted in 1985. A small area of disturbed ground is evident to the north. The possible shed present in 1985 is now confirmed as the shed cited in the collateral information (EPA 1999. A single vertical tank (VT) is present on the north side of the Centredale Manor building. The partially vegetated fill noted in 1985 south of the Brook Village parking lot is now completely vegetated.
