**PHOTOGRAPHY LOG SHEET**  
**Centredale Manor Restoration Project • North Providence, Rhode Island**

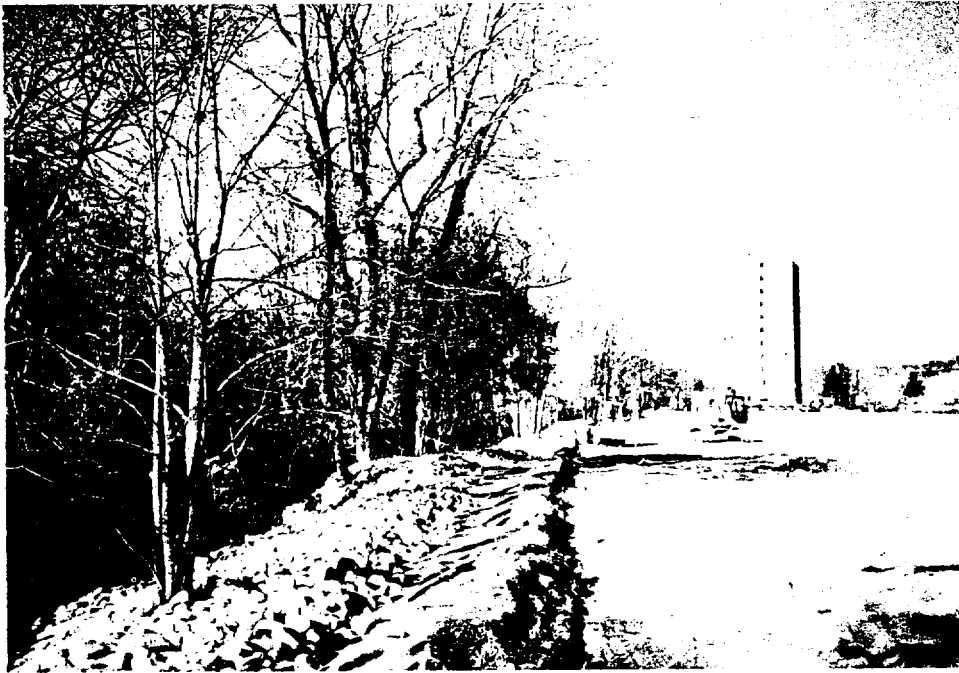
**FRAME NUMBER:** 6    **DATE:** 17 November 1999

**SCENE:** View of construction activities in Interim Cap No. 2. The Woonasquatucket River is located on the left. Photograph taken facing north.

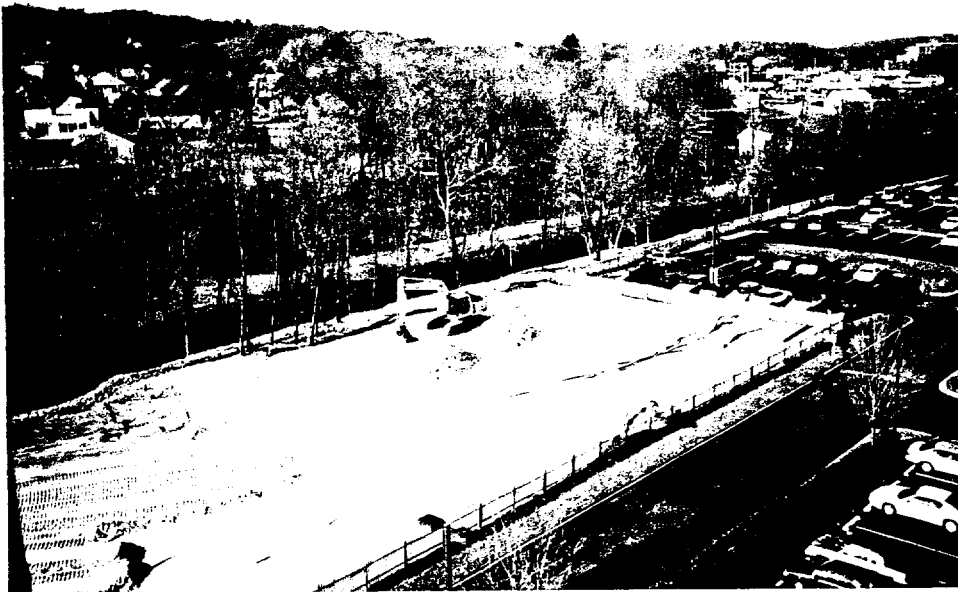
**FRAME NUMBER:** 11    **DATE:** 19 November 1999

**SCENE:** View of ongoing construction activities in Interim Cap No. 2. Photograph taken facing northwest.

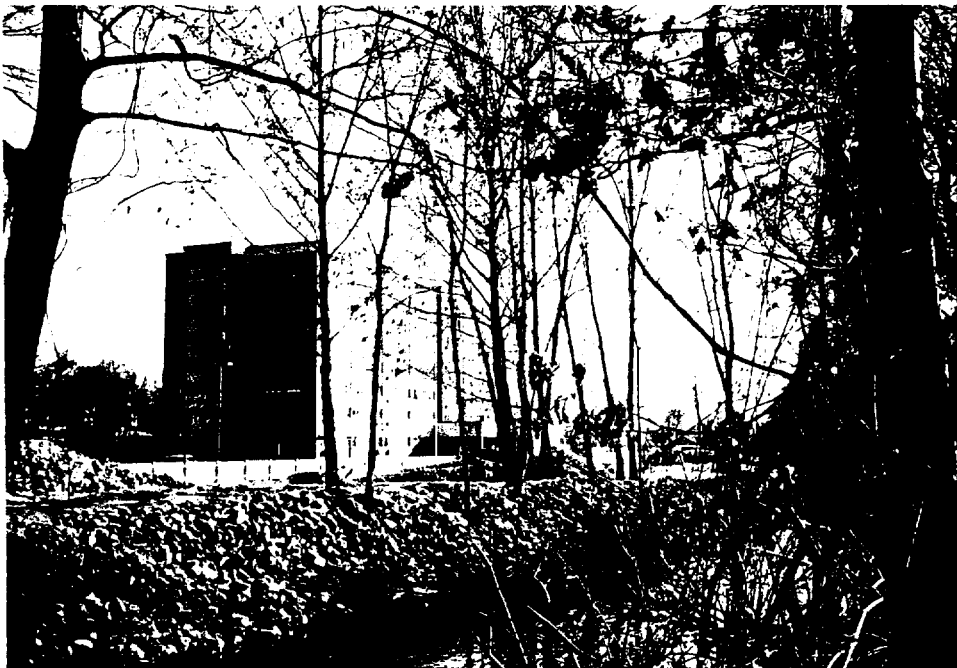
**FRAME NUMBER:** 17 **DATE:** 22 November 1999

**SCENE:** View of covered riverbank area in Interim Cap No. 2. Photograph taken facing southeast.

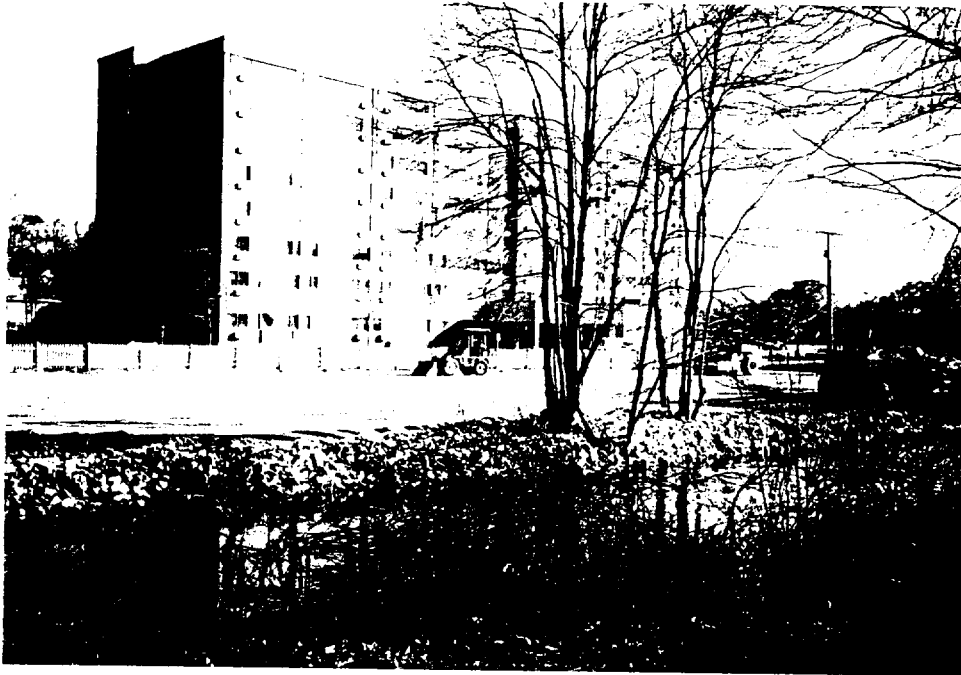
**FRAME NUMBER:** 18    **DATE:** 22 November 1999

**SCENE:** View of construction activities in Interim Cap No. 2. The Woonasquatucket River is located in the foreground. Photograph taken facing southeast.

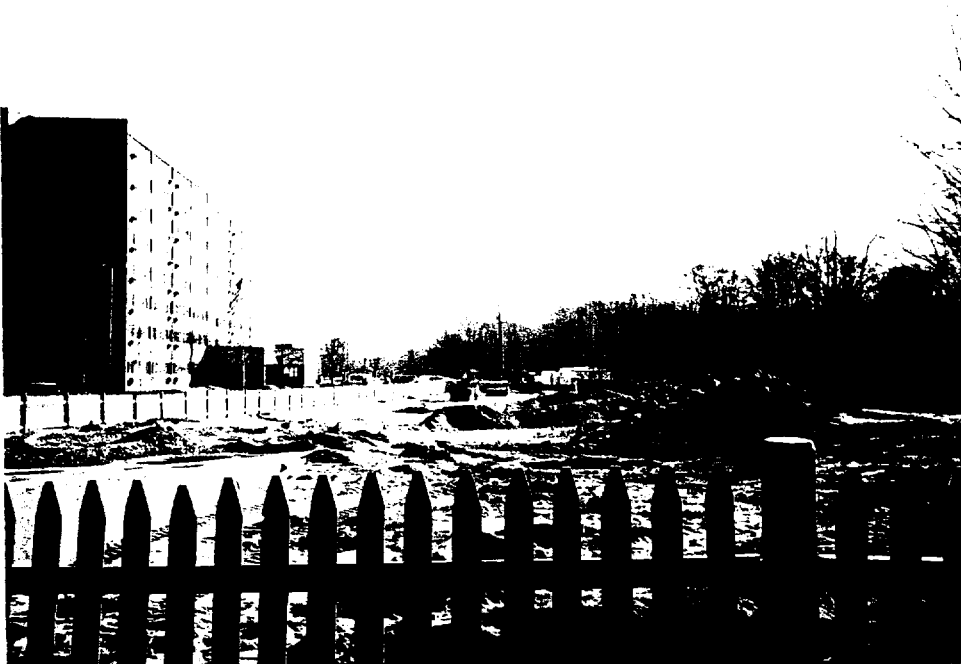
**FRAME NUMBER:** 19    **DATE:** 22 November 1999

**SCENE:** View of Interim Cap No. 2 during construction activities. Photograph taken facing south.

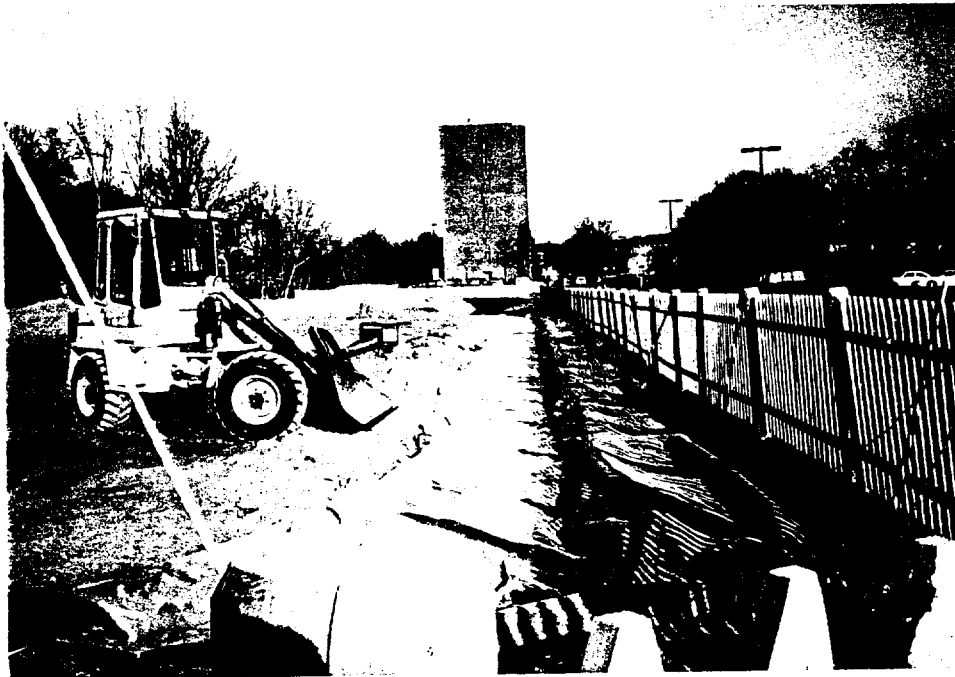
**FRAME NUMBER:** 0    **DATE:** 2 December 1999  
**PHOTOGRAPH BY:** Renata Wynnyk  
**CAMERA:** Minolta    **SETTING:** Automatic

**SCENE:** View of drainage channel construction in Interim Cap No. 2. Photograph taken facing north.

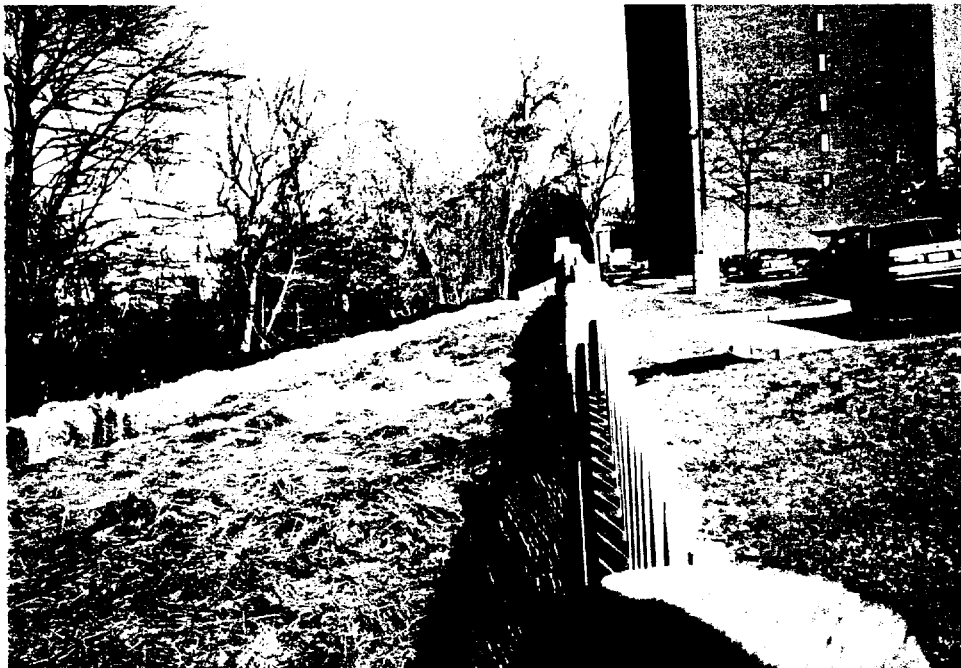
**FRAME NUMBER:** 15    **DATE:** 10 December 1999  
**PHOTOGRAPH BY:** Renata Wynnyk  
**CAMERA:** Minolta    **SETTING:** Automatic

**SCENE:** View of secured riverbank area. Note enhanced stormwater drainage cut. Photograph taken facing north.

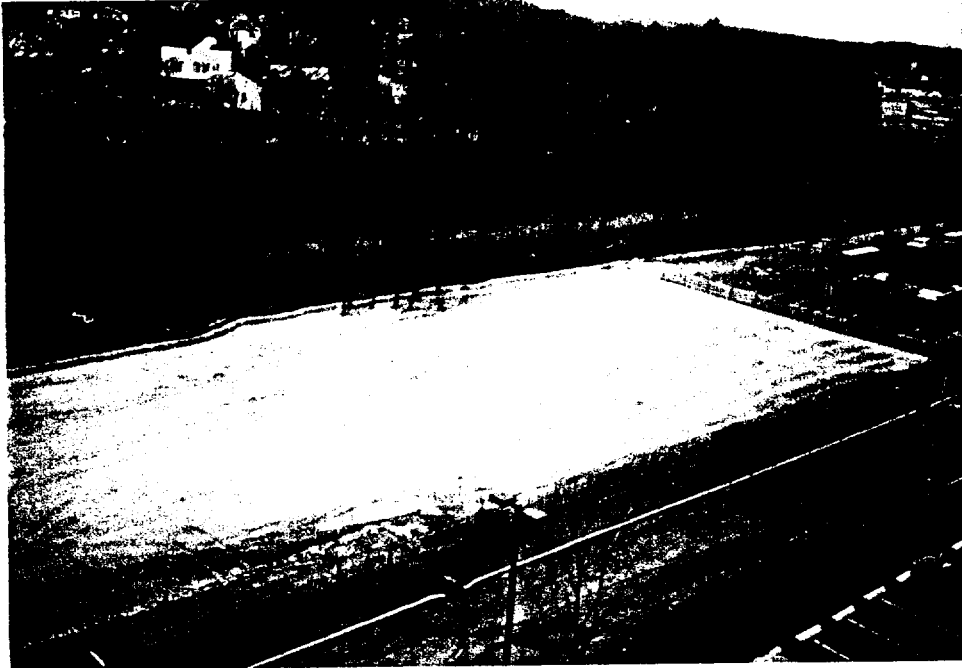
**FRAME NUMBER:** 16 **DATE:** 14 December 1999

**SCENE:** View of secured Interim Cap No. 2. Note the constructed drainage channel located in the foreground. Photograph taken facing northwest.

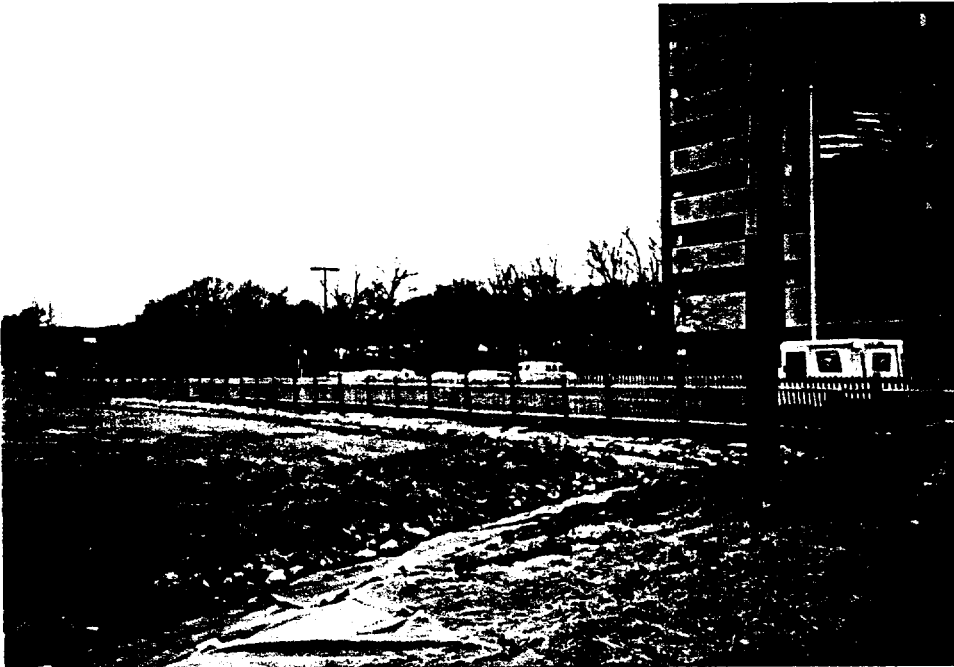
**FRAME NUMBER:** 18 **DATE:** 14 December 1999

**SCENE:** View of secured Interim Cap No. 2 from ground level. Photograph taken facing northeast.

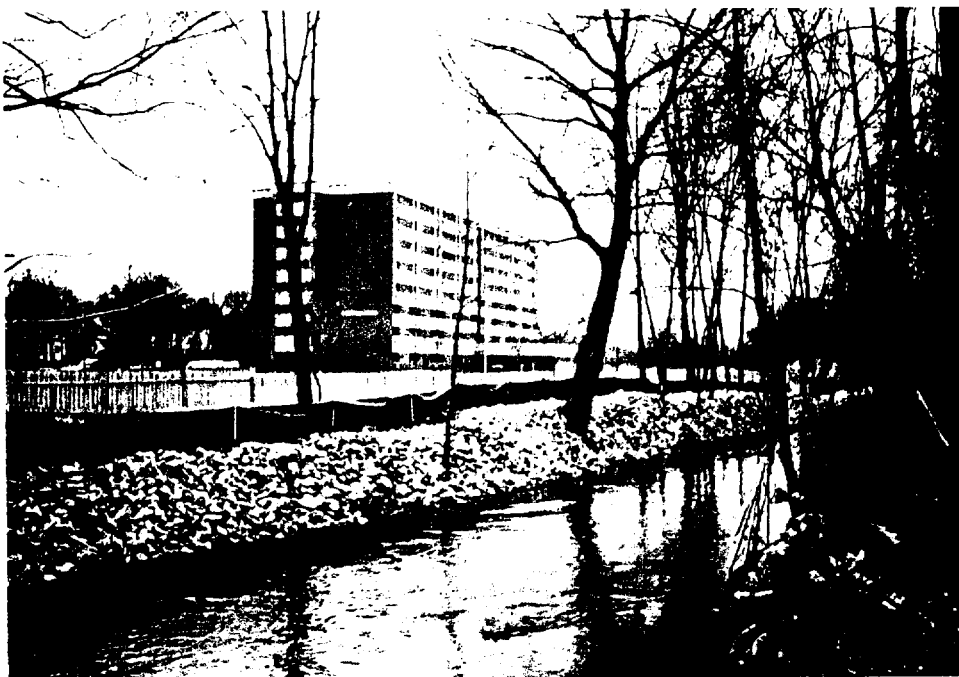
**FRAME NUMBER:** 21 **DATE:** 14 December 1999

**SCENE:** View of installed silt fence and rip-rap along the Woonasquatucket River. Note Centredale Manor located in the background. Photograph taken facing southeast.

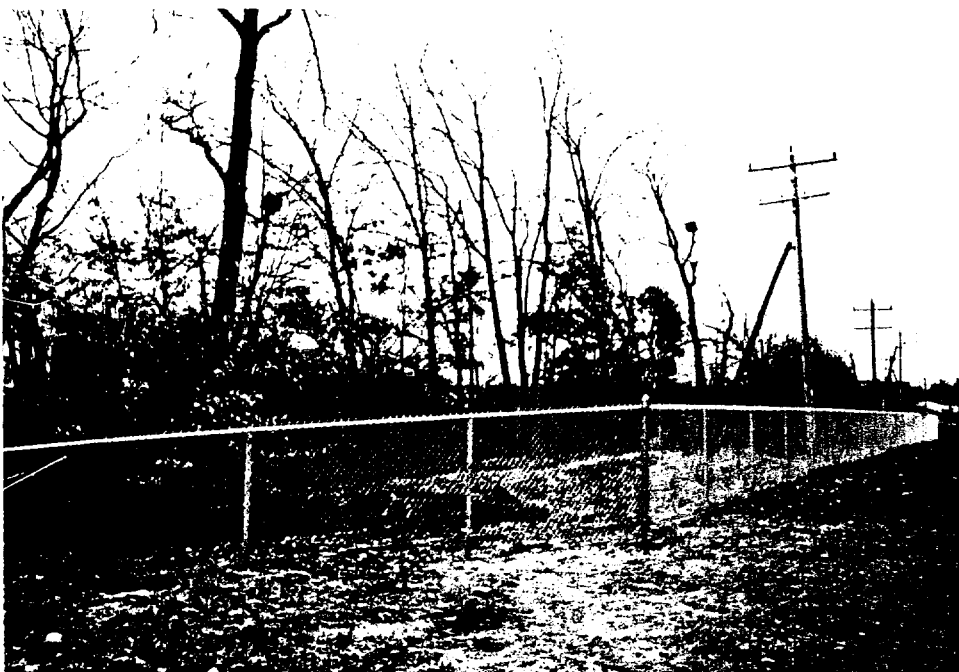
**FRAME NUMBER:** 25 **DATE:** 14 December 1999

**SCENE:** View of the installed chain-link fence on the NEC greenway. Photograph taken facing south.
