#### **East Water Way (EWW), U.S. Coast Guard Station – Derelict Pier and Bottom Debris Removal Pre-Survey for Puget Sound Initiative, March 2008**

**What:** The Superfund Environmental Cleanup Office requested assistance from the EPA Region 10 Dive Team to assist in a survey of debris within the Duwamish East Waterway, which is part of the Harbor Island Superfund Site.

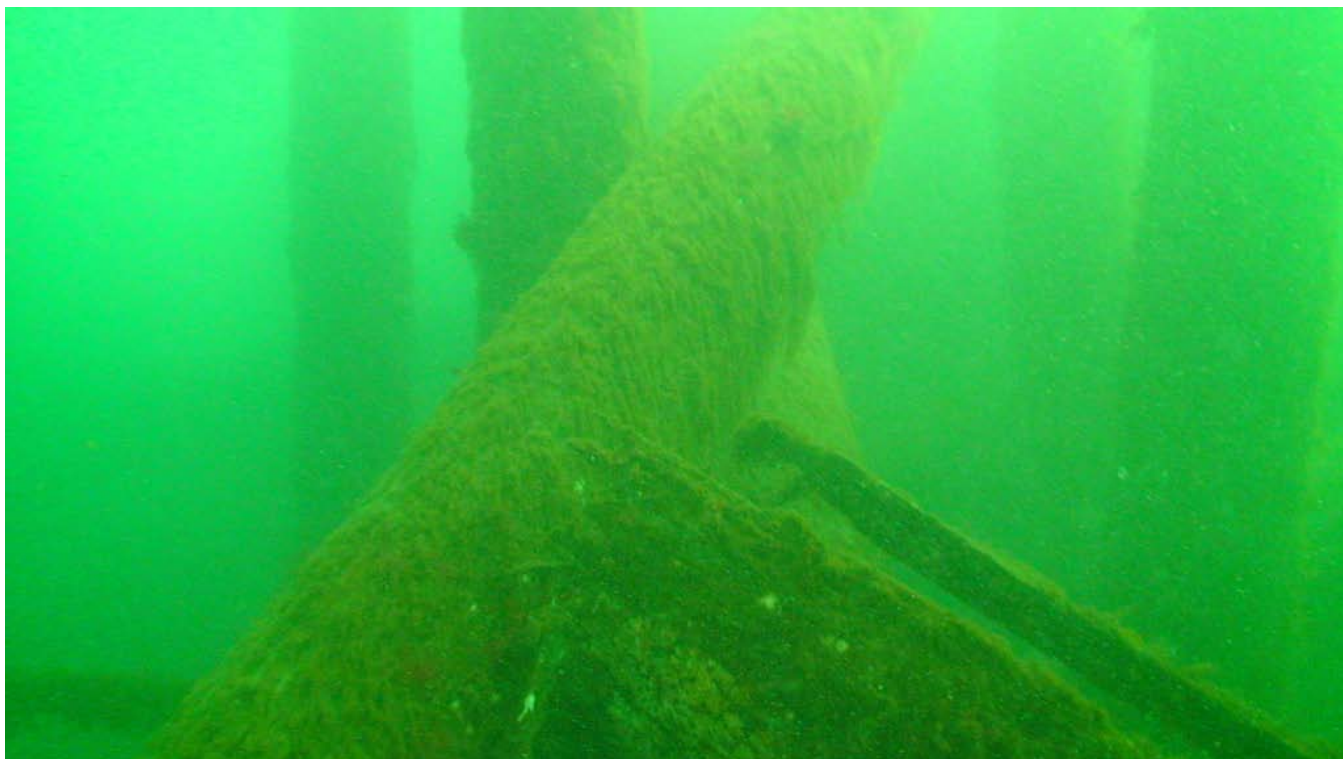
Photo of piling which has broken off and fallen into the remaining dock structure.

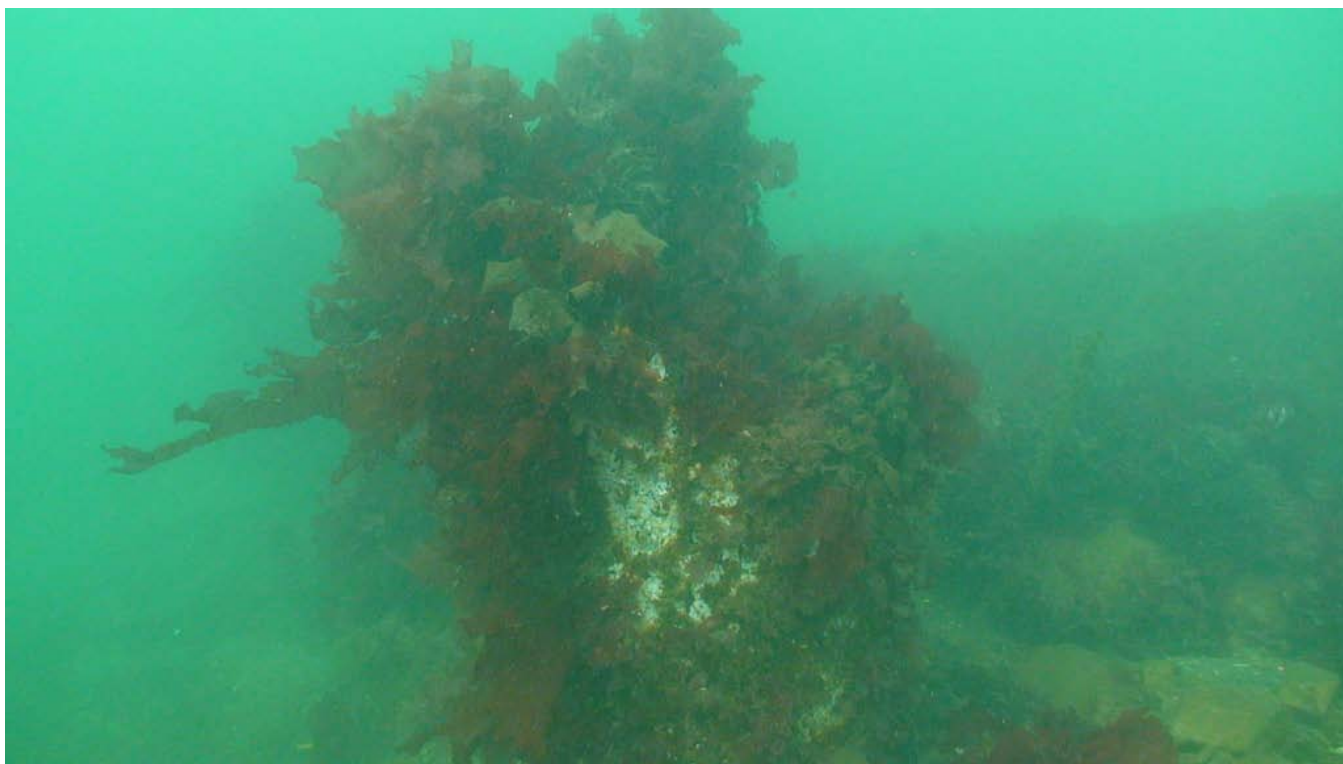
Close up view of a piling, broken off near the bottom.

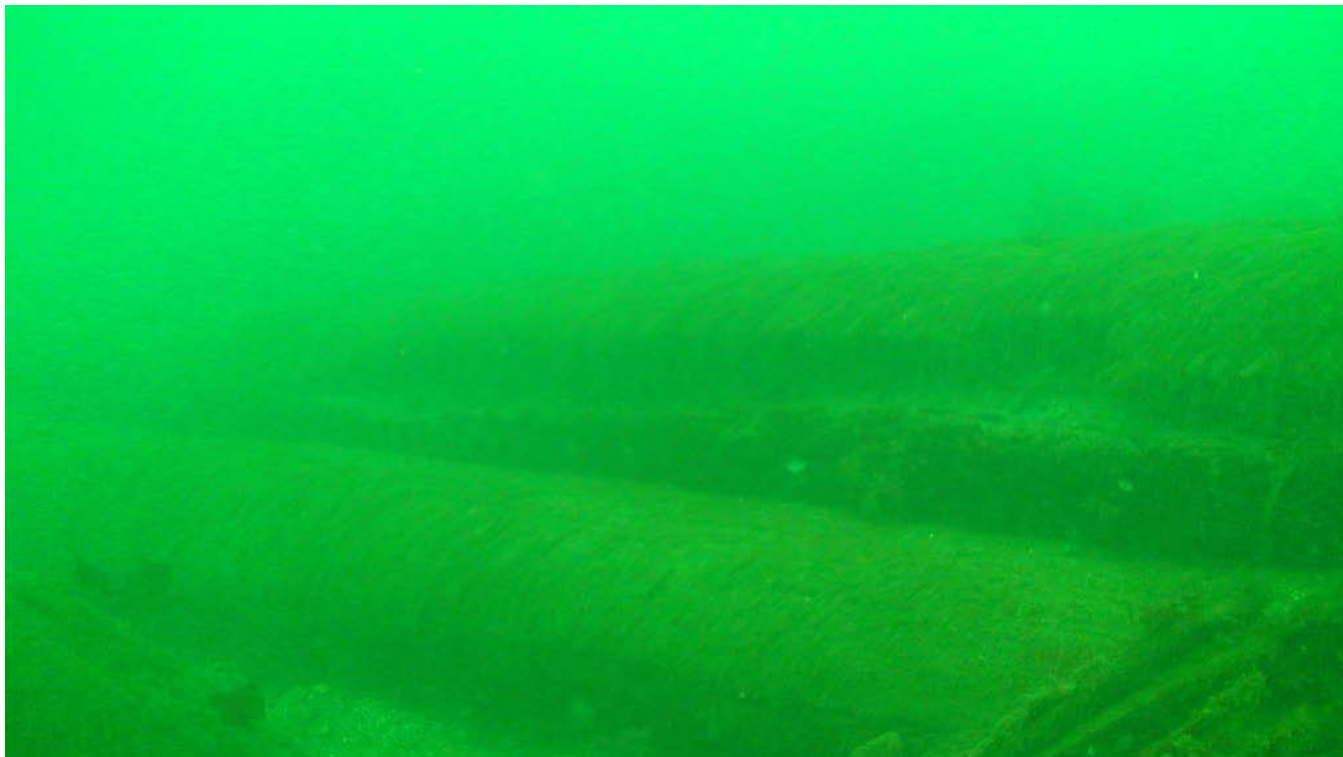
Multiple pilings that have broken off the dock and rolled down the slope east toward the channel.

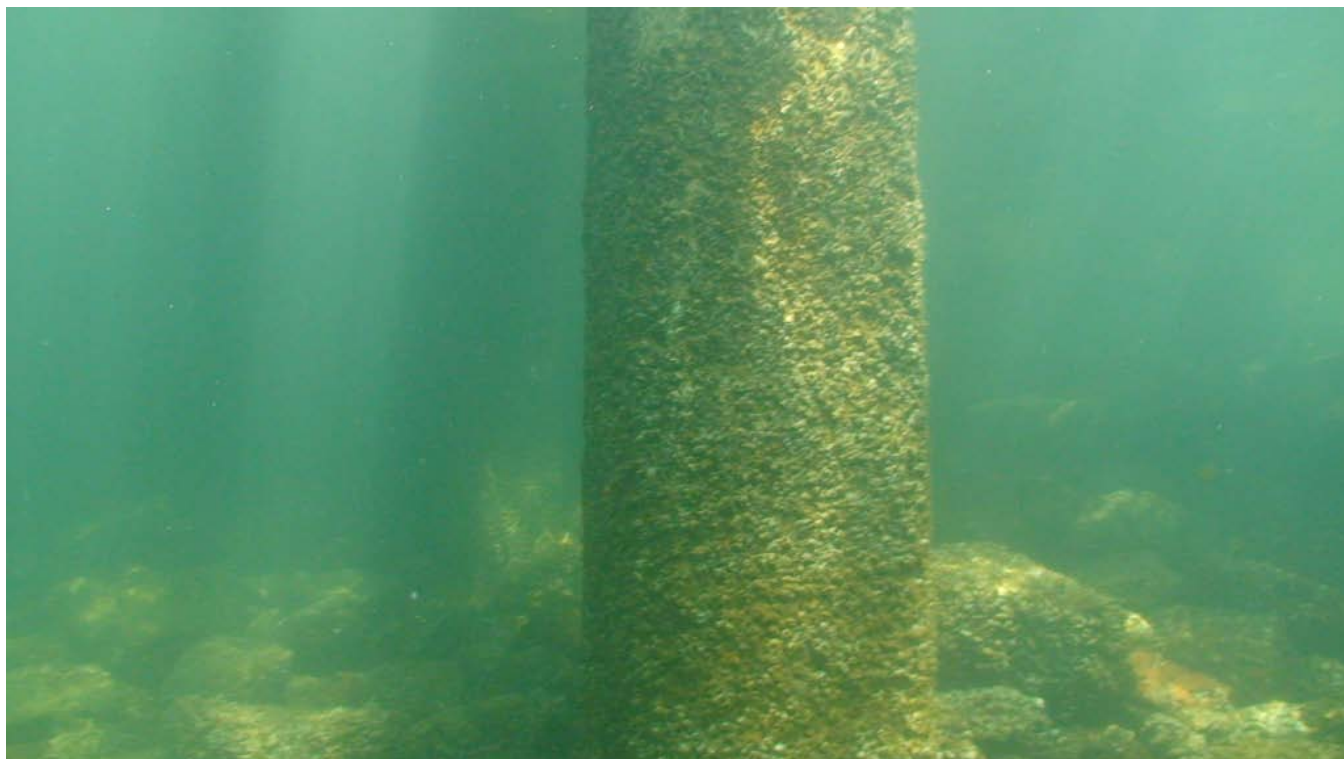
Photo of concrete piling in the South dock area.
