Survey of moorage buoys systems for potential impacts to aquatic reserve habitat

Where/When: June 5 – 7, 2012, Quartermaster Harbor – Vashon and Maury Island, WA

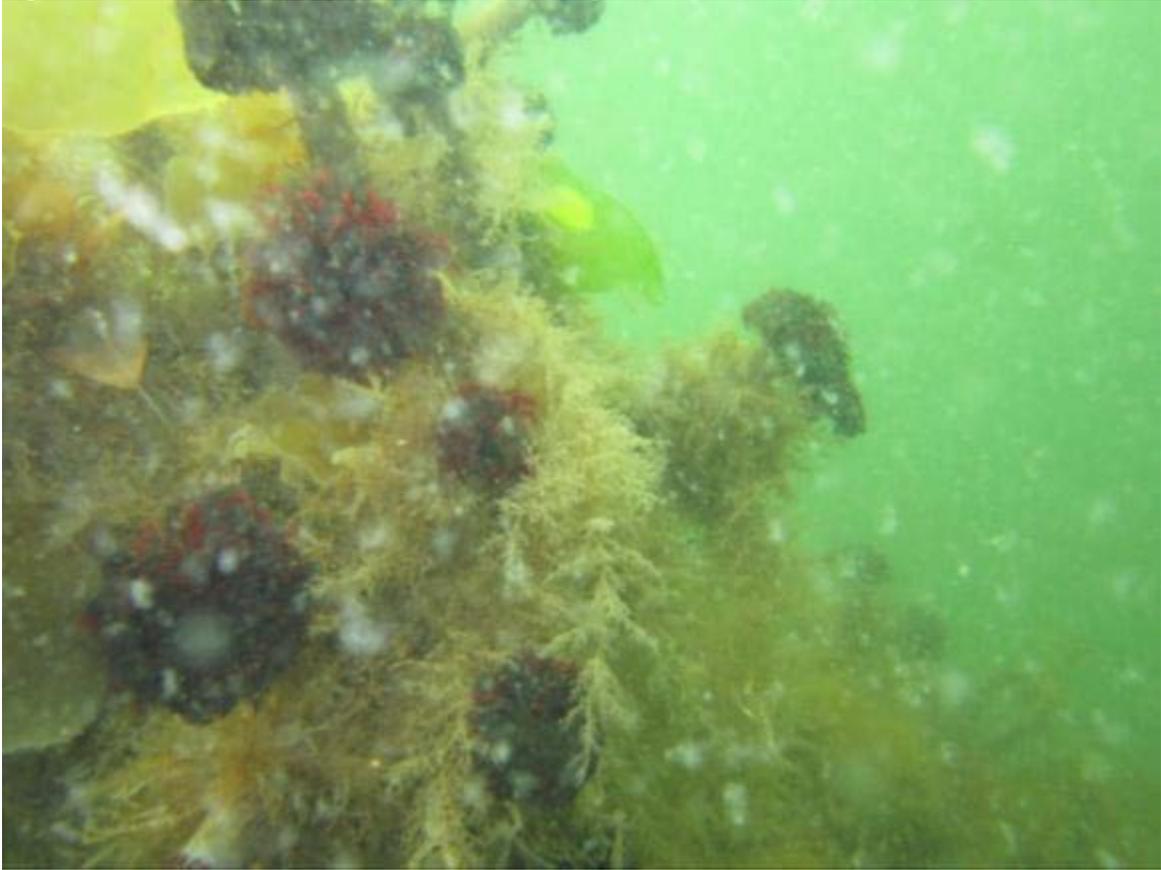
Figure 5: Marine life on shallow part of mooring line.

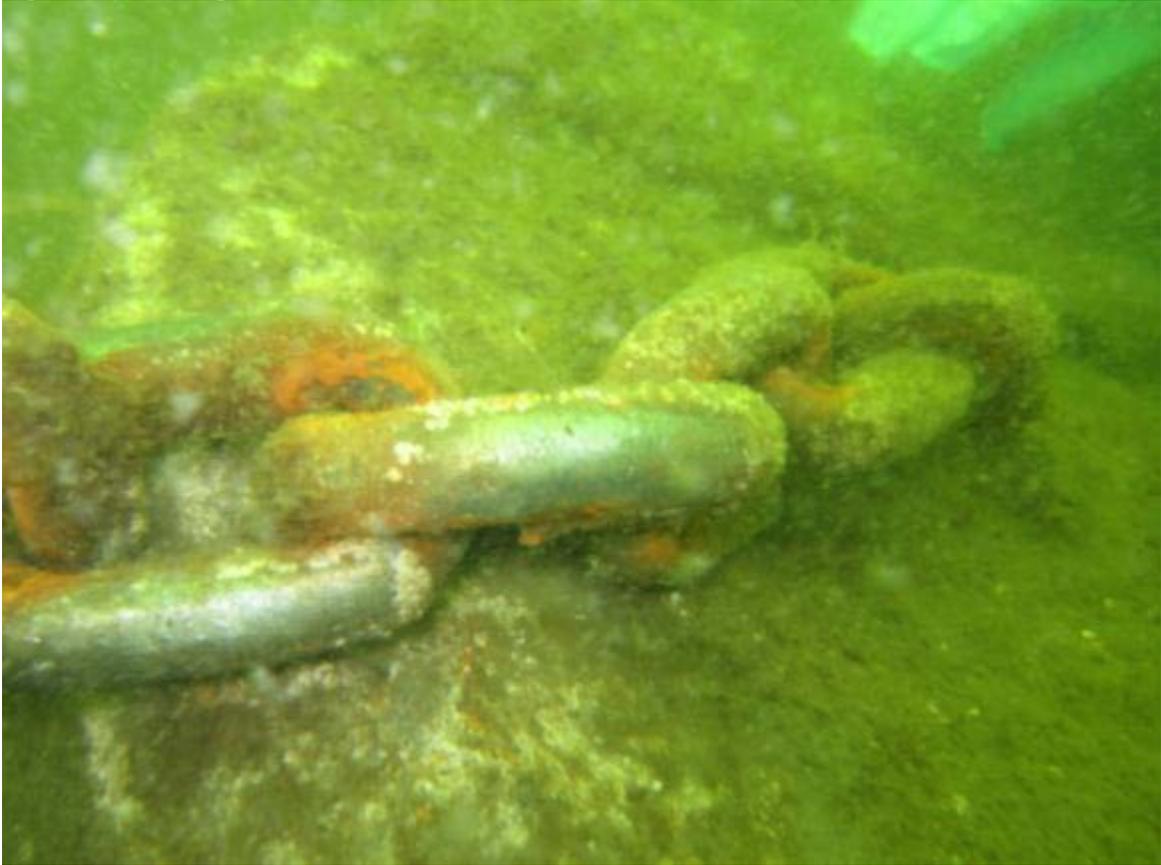
Figure 6: Mooring chain on an anchor.

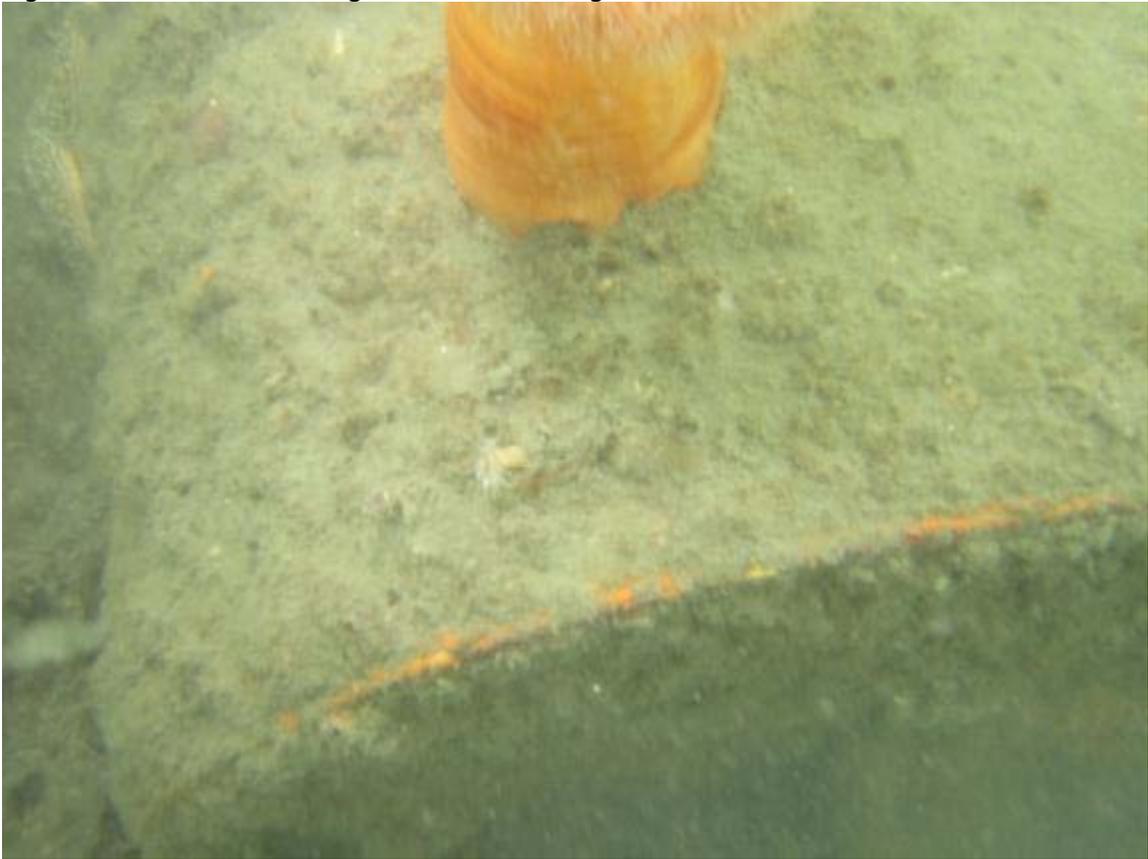
Figure 7: Concrete filled 55 gal. drum – mooring anchor.

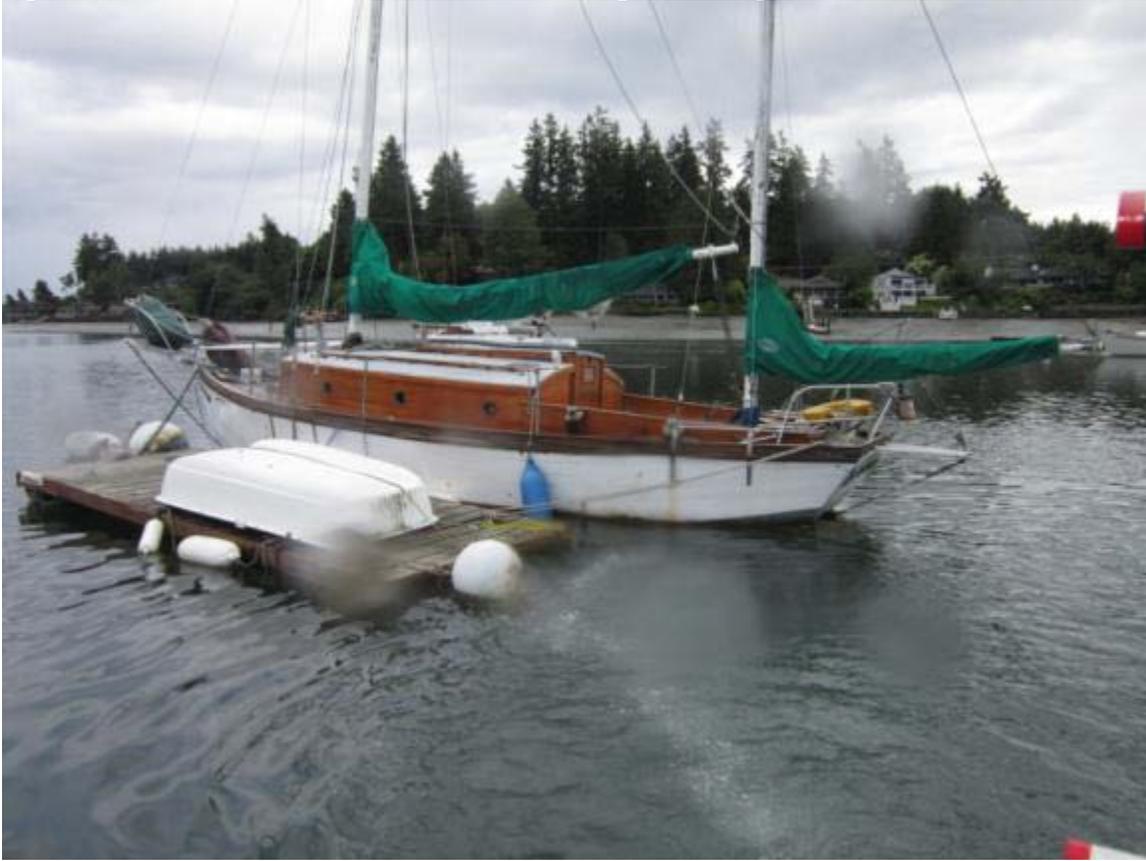
Figure 8: Burton Cove – boat and float with multiple mooring anchors.

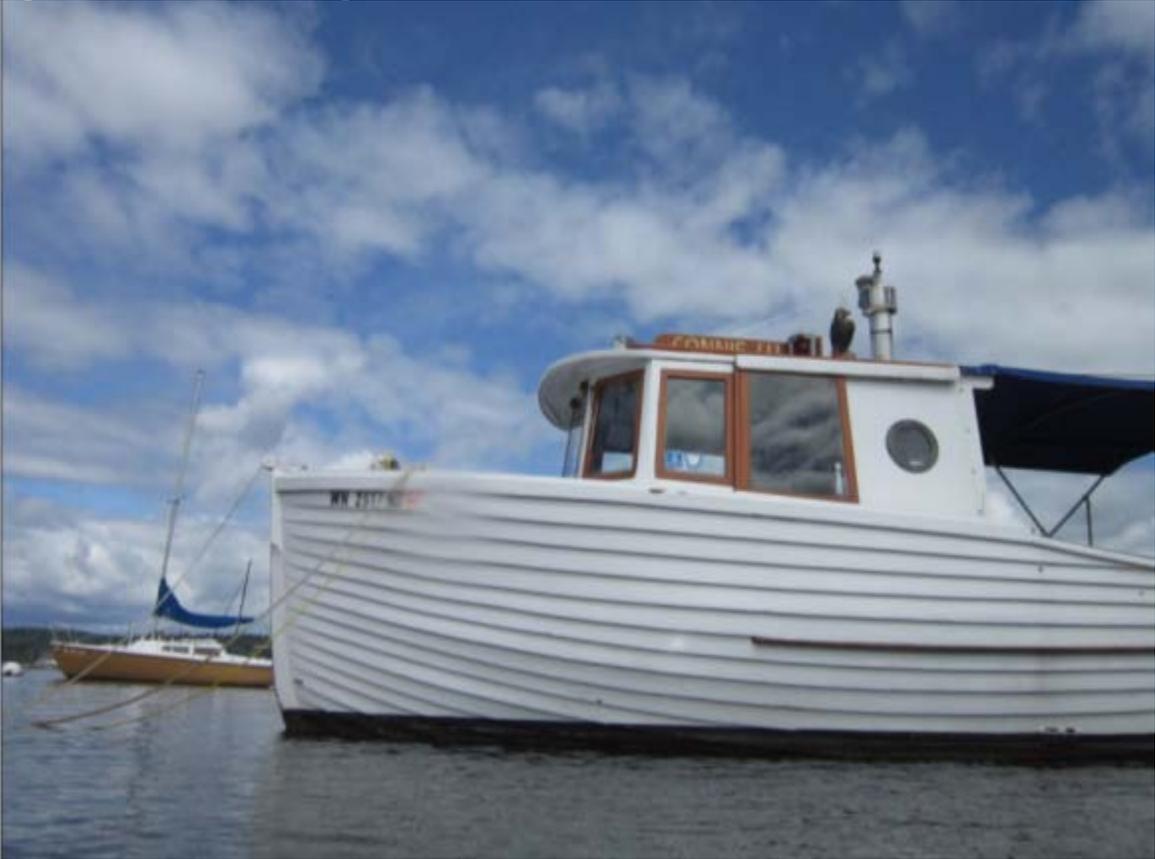
Figure 9: Boats and mooring floats, Dockton Cove.

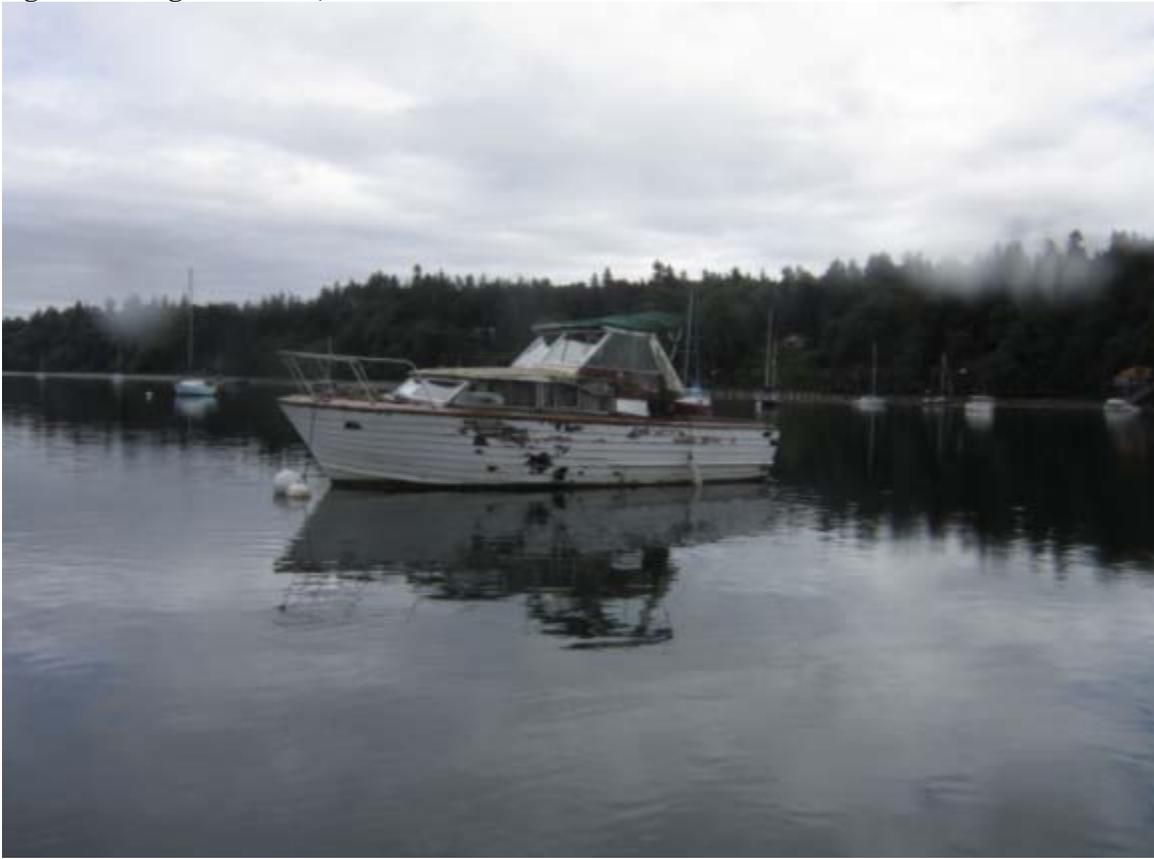
Figure 10: Neglected boat, Dockton Cove.
