Onondaga Vessel Survey, Seattle, WA

What: The Region 10 dive team was asked to conduct a survey of the former USCG vessel Onondaga by USCG and the State of Washington Department of Natural Resources (WADNR).

Why: The [EPA Region 10 dive unit](#) was asked to characterize the extent of hazmat contamination in the sunken vessel. This information will be used by a variety of entities for prioritization of resources in dealing with the large number of derelict vessels in and around Puget Sound.

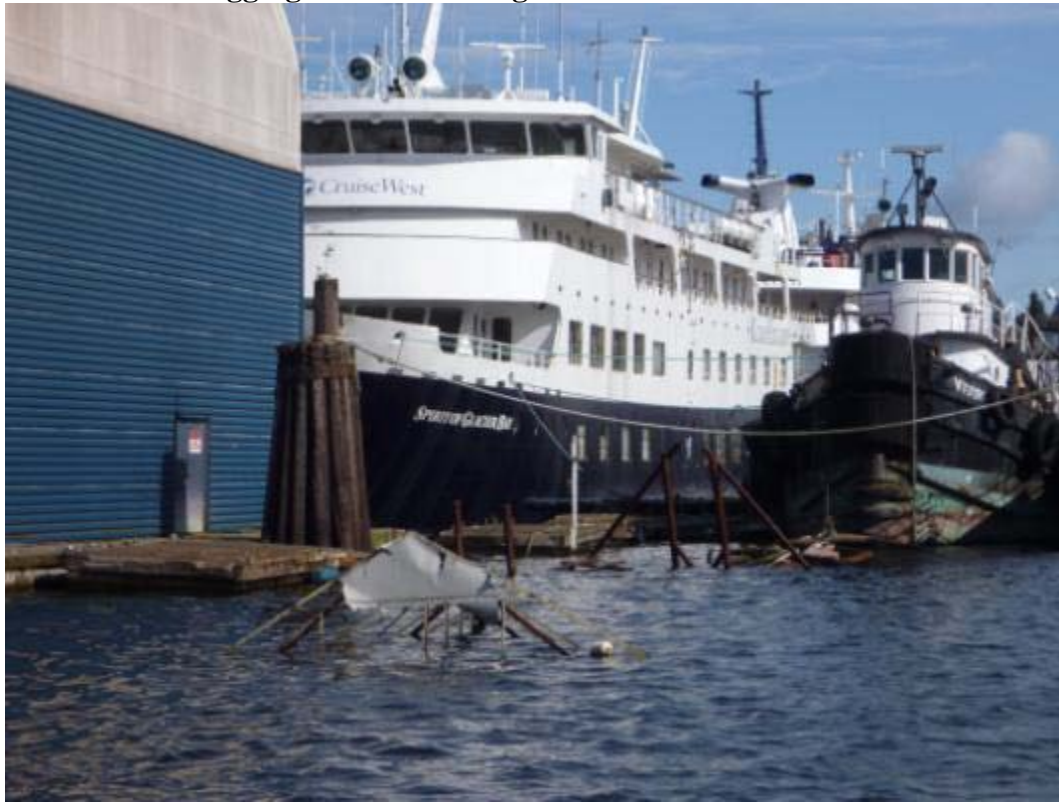
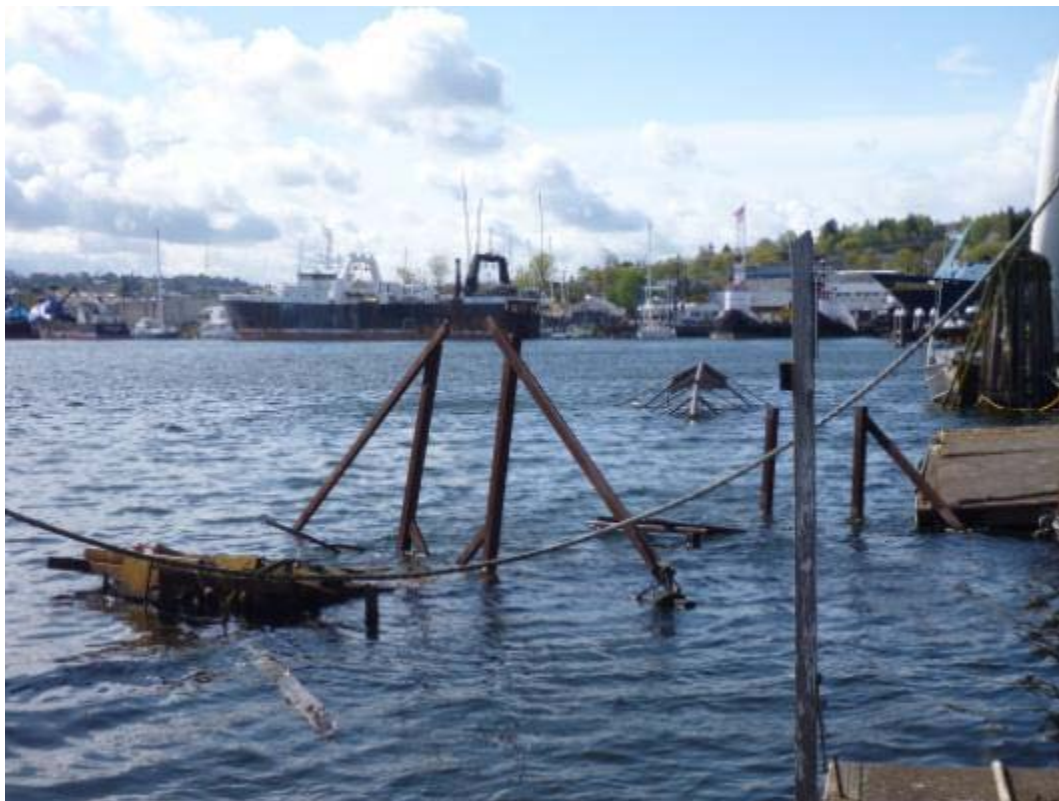
Above surface rigging on the Onondaga.

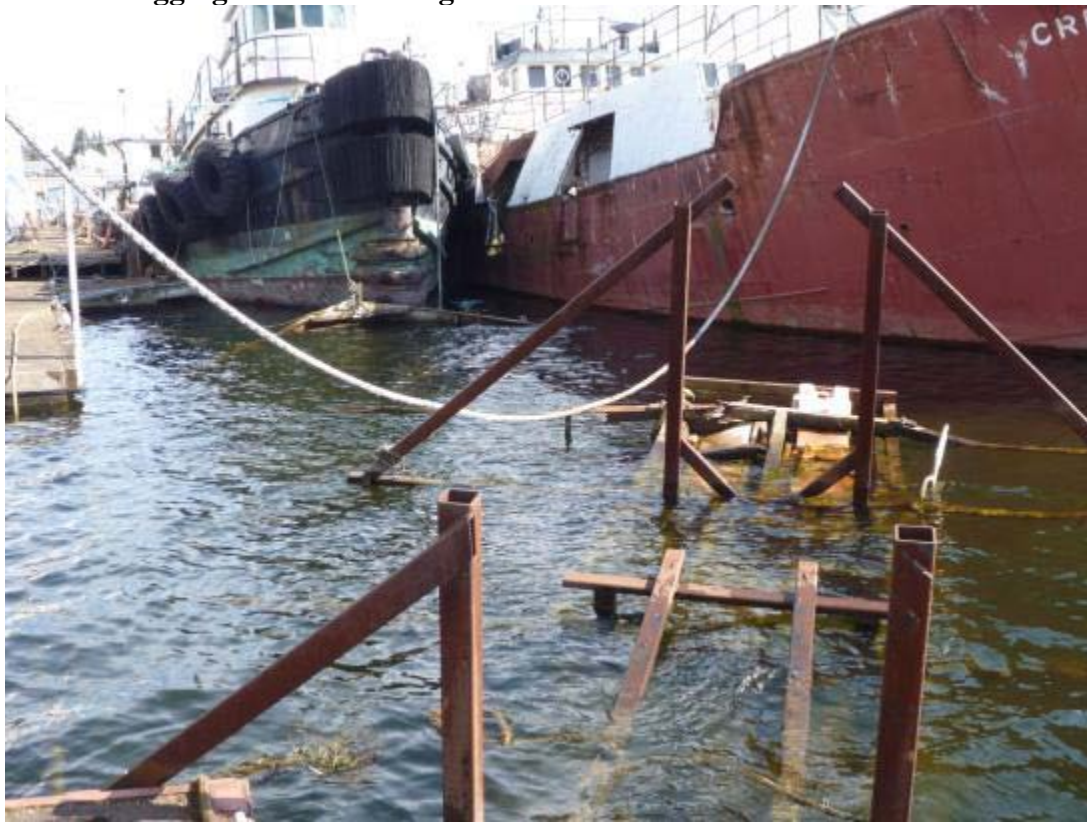
Forward rigging on the Onondaga.

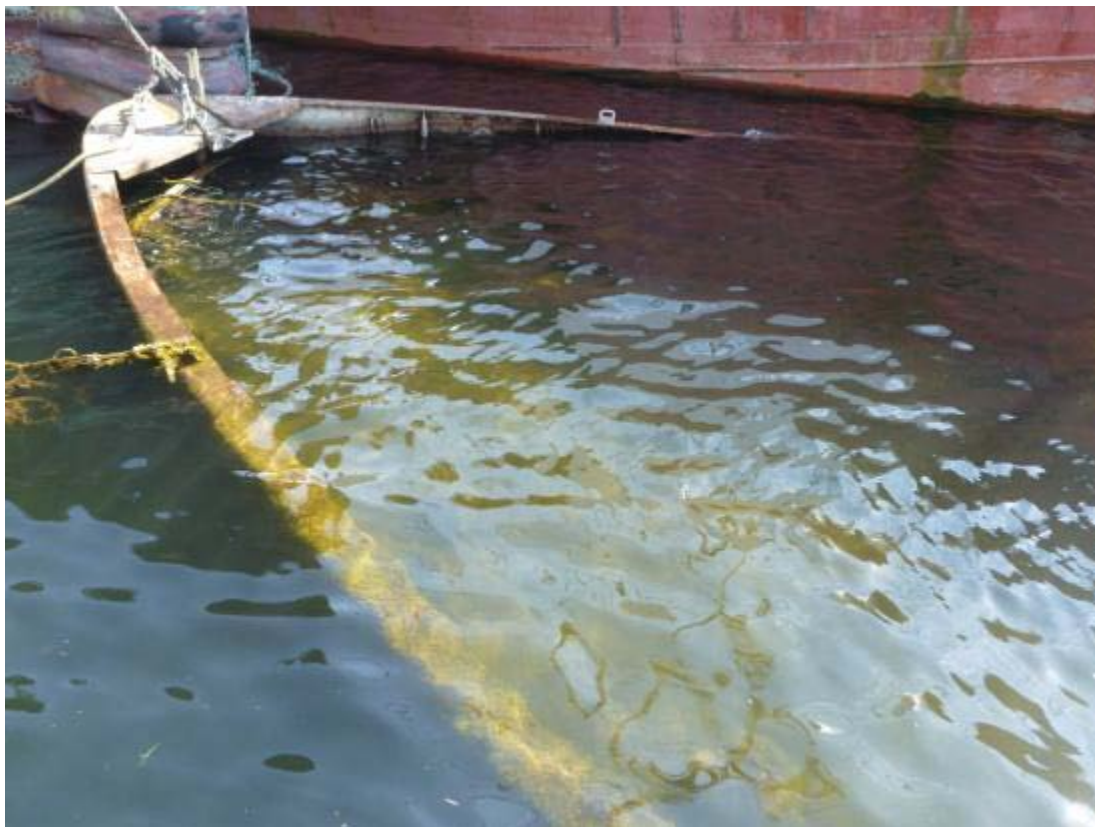
Bow.

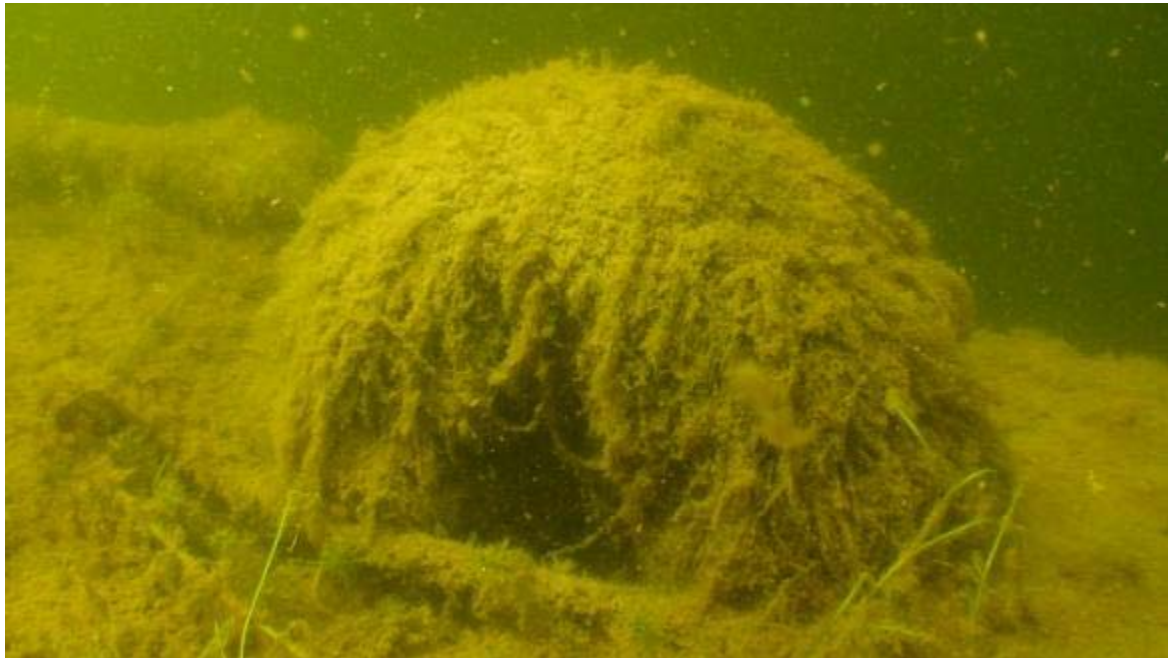
Metal tie down on forward deck.

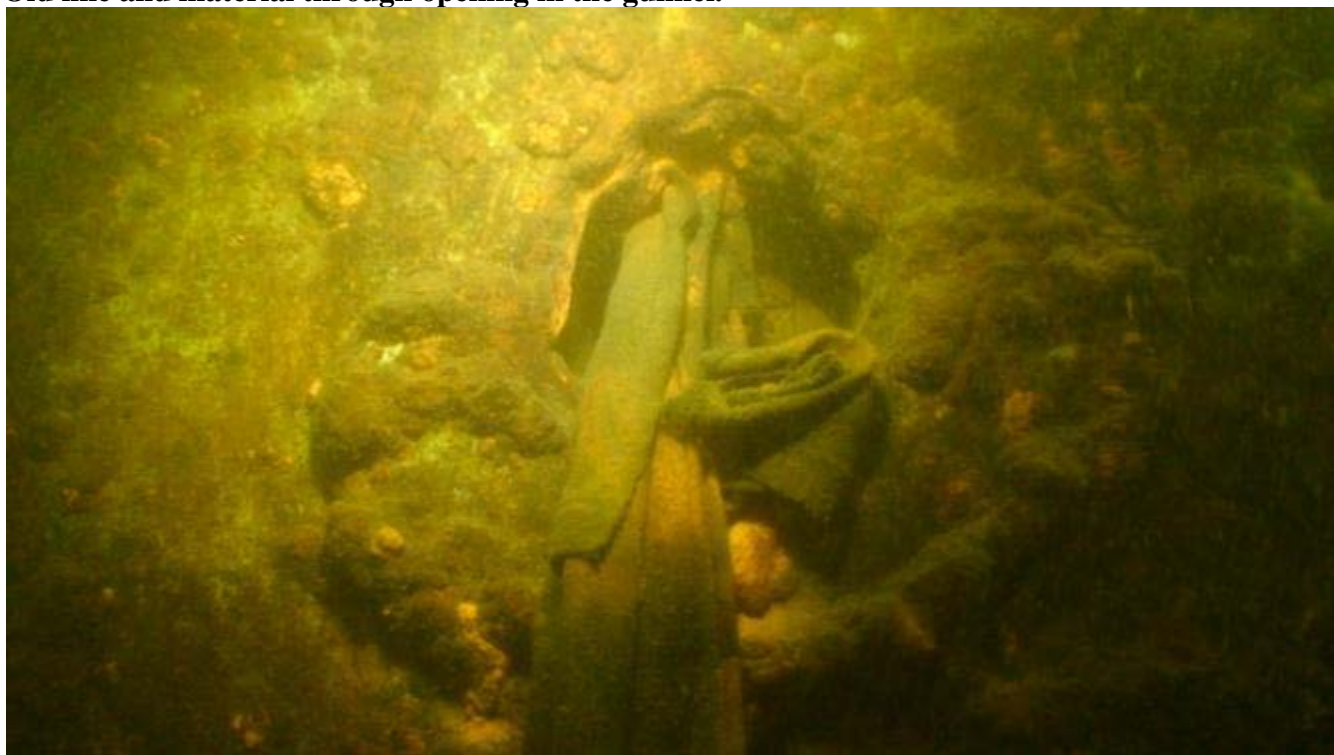
Old line and material through opening in the gunnel.

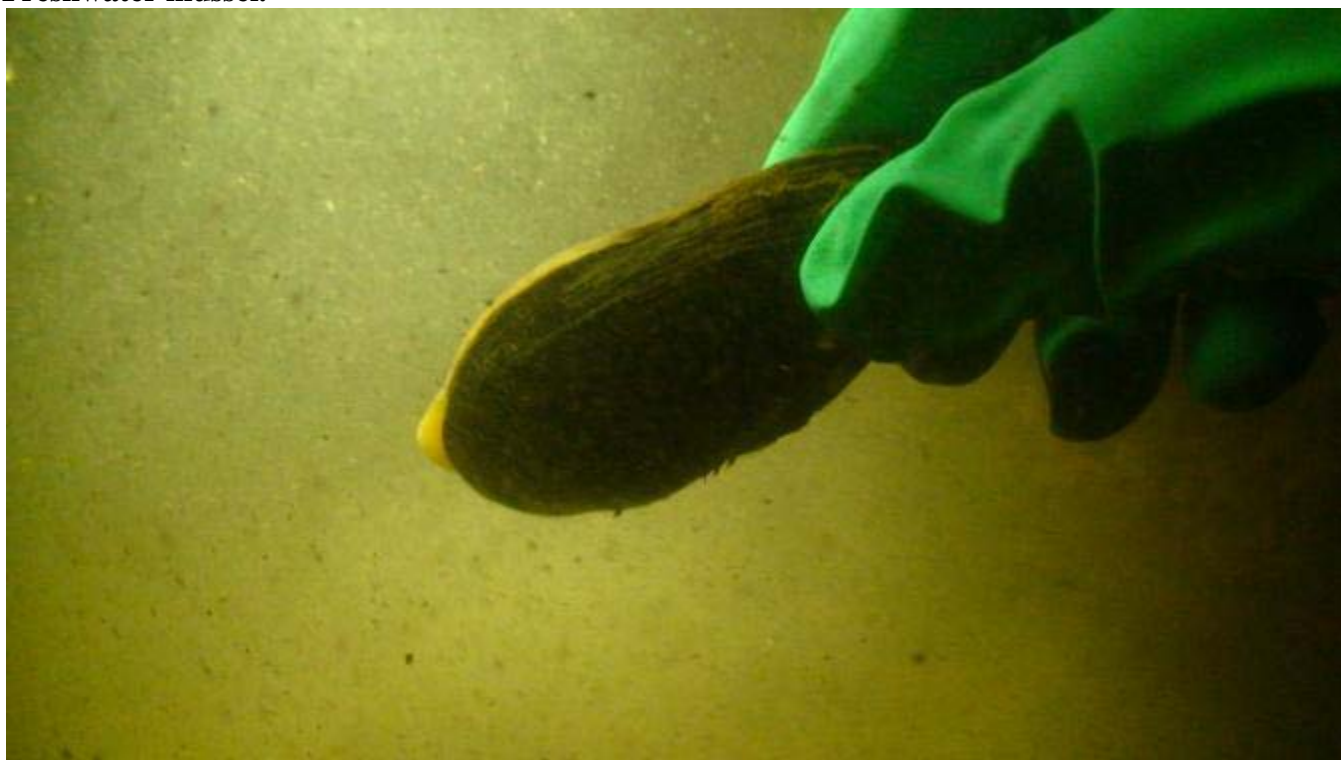
Freshwater mussel.

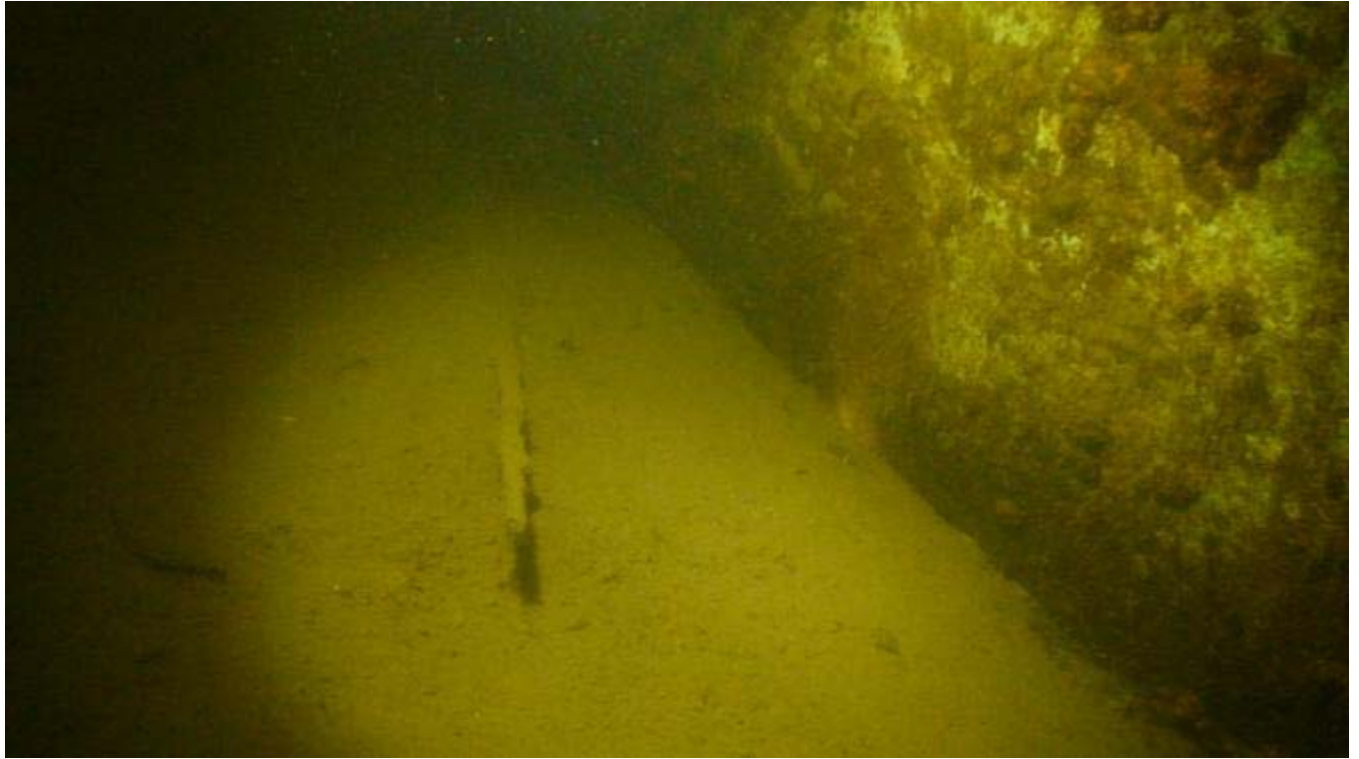
Hull and bottom sediment.

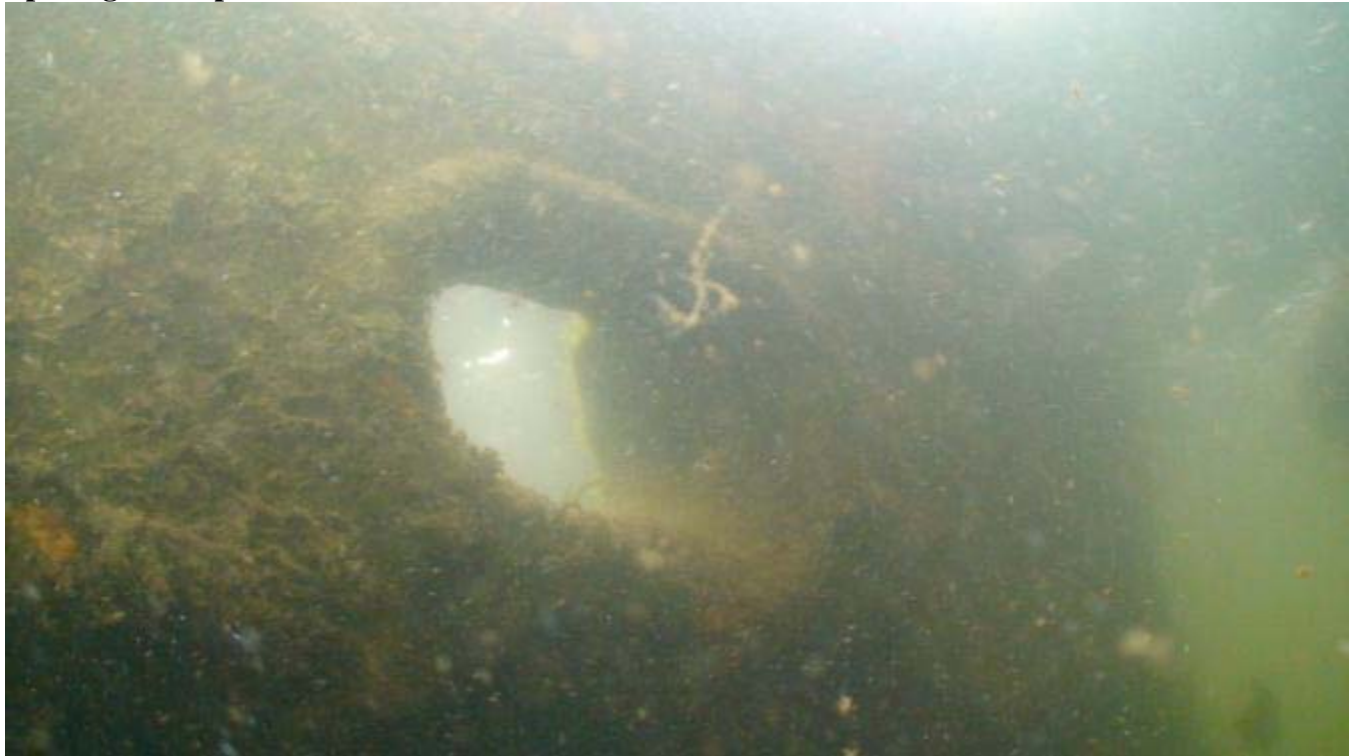
Opening for ship's line.

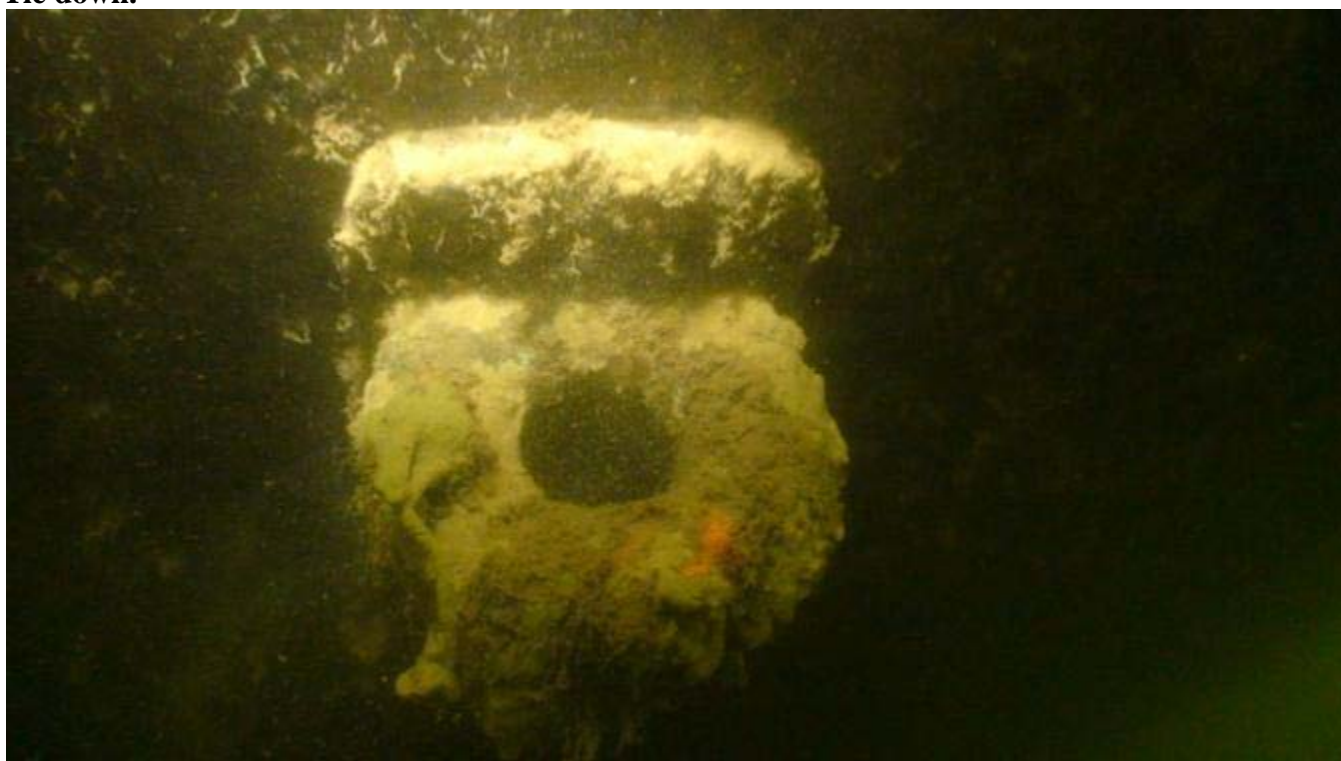
Tie down.

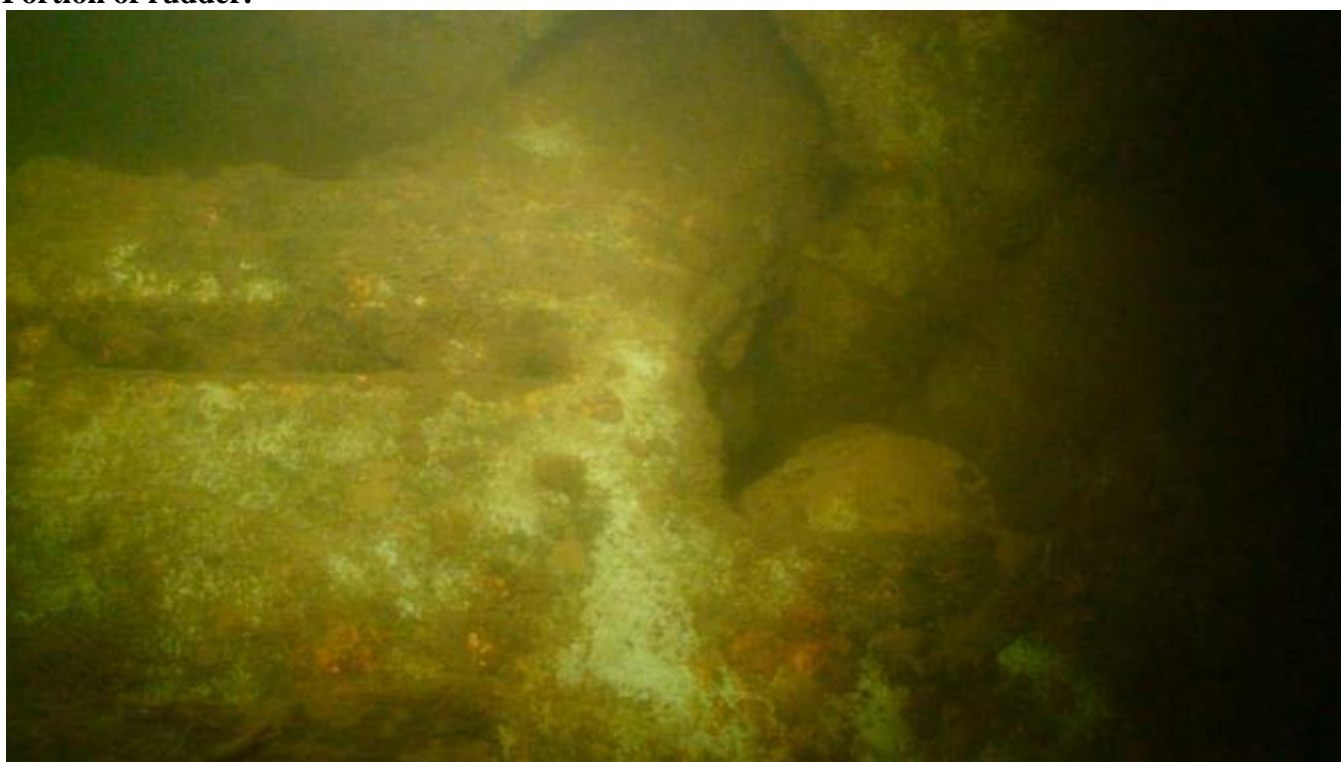
Portion of rudder.
