## [EPA Region 10 Dive Team](#)

### **Quendall Terminals Superfund Site, Diver Groundwater Sampling, Renton, WA**

**What:** The EPA Region 10 Dive Team conducted a hydrogeologic and habitat survey of the site in April and May of 2009.

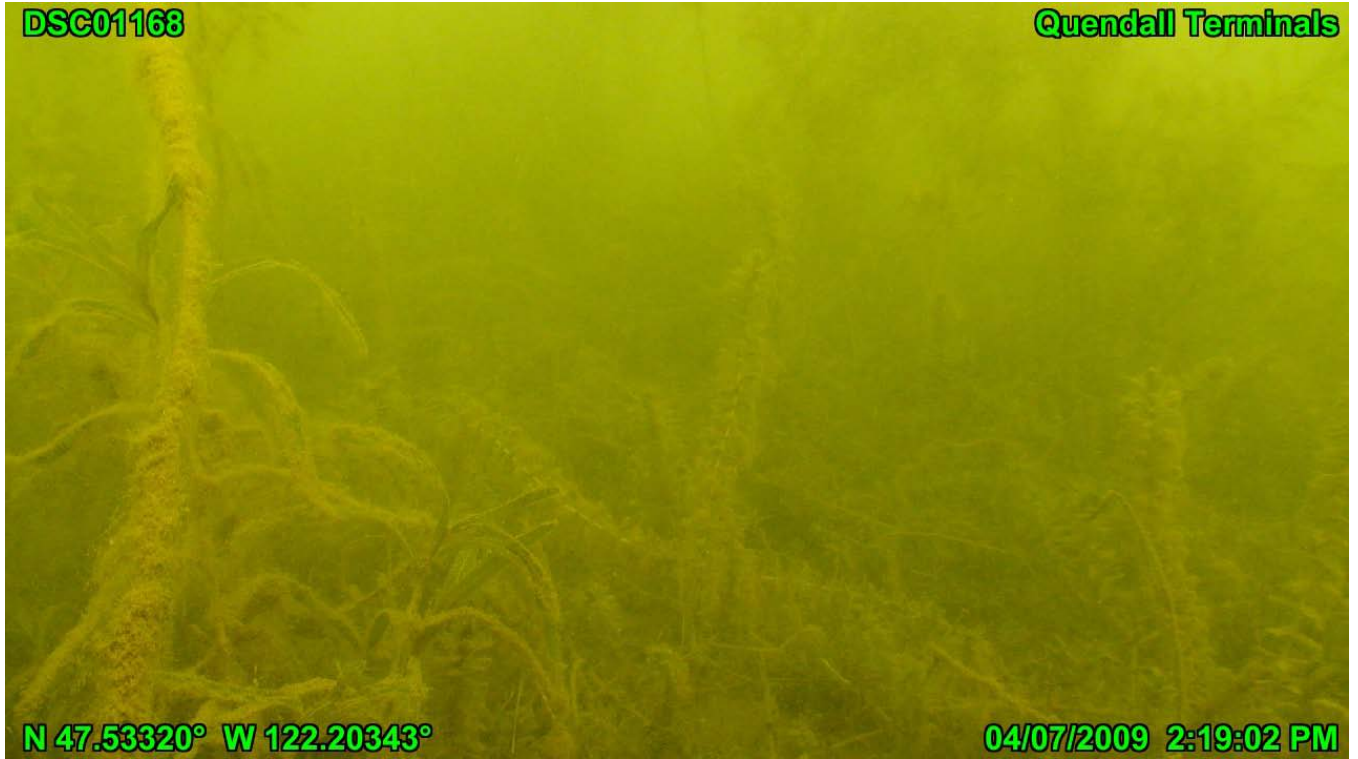
Photo showing milfoil typical of areas offshore.

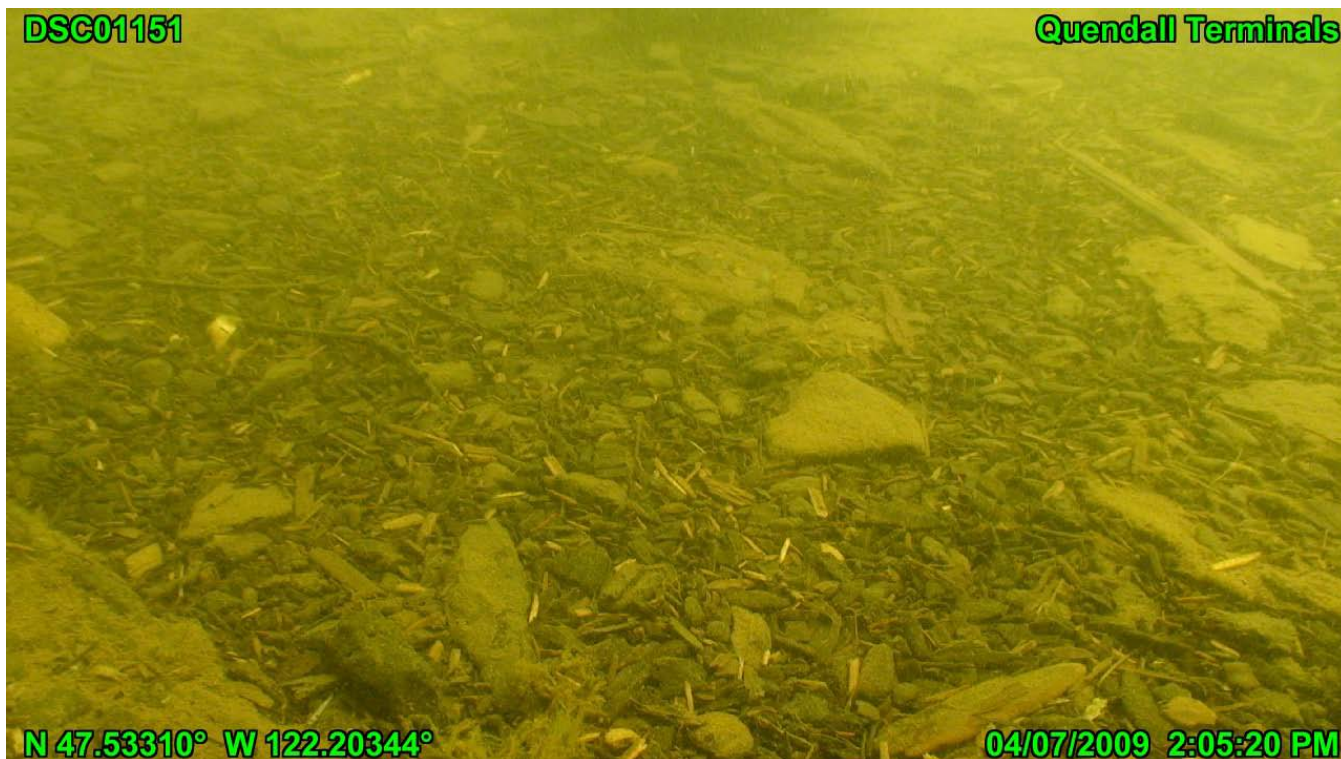
DSC01151

Photo of bottom gravels with wood debris mixed in.

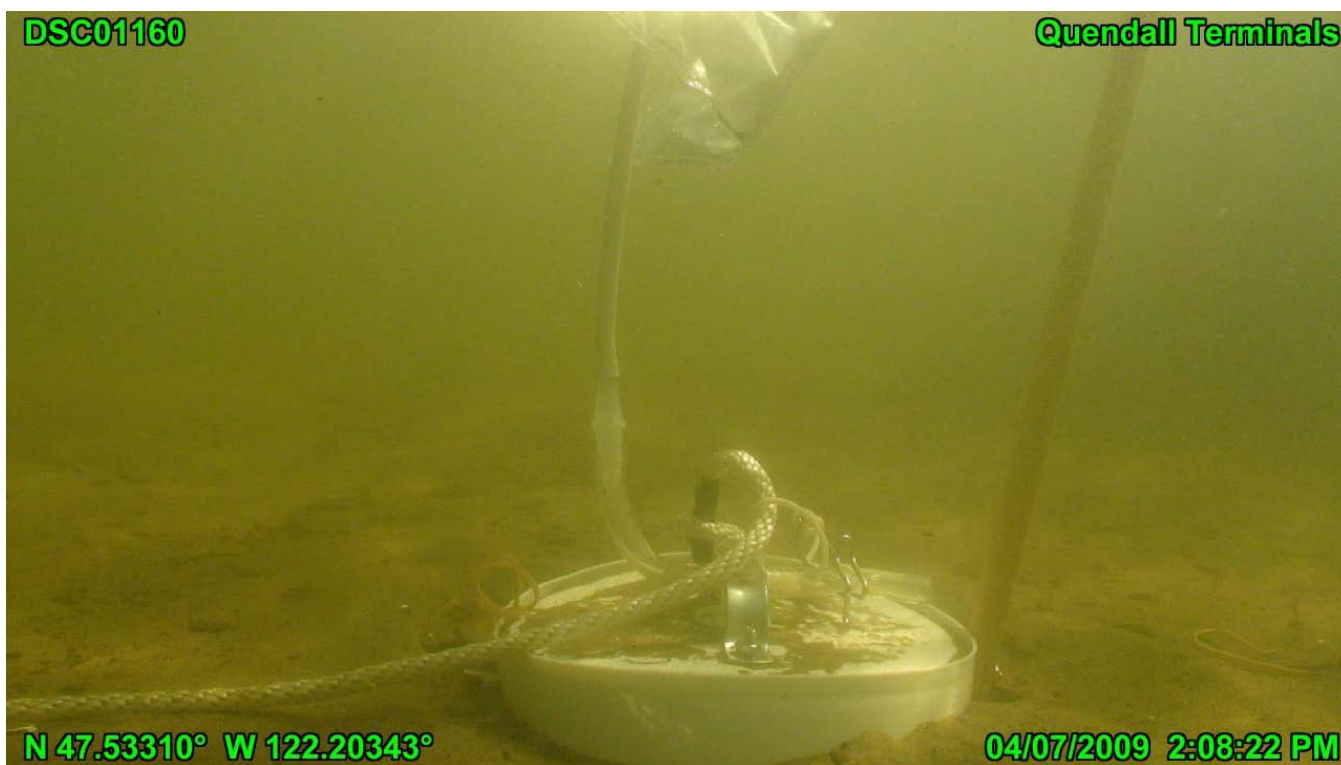
DSC01160

Photo of seepage meter bucket

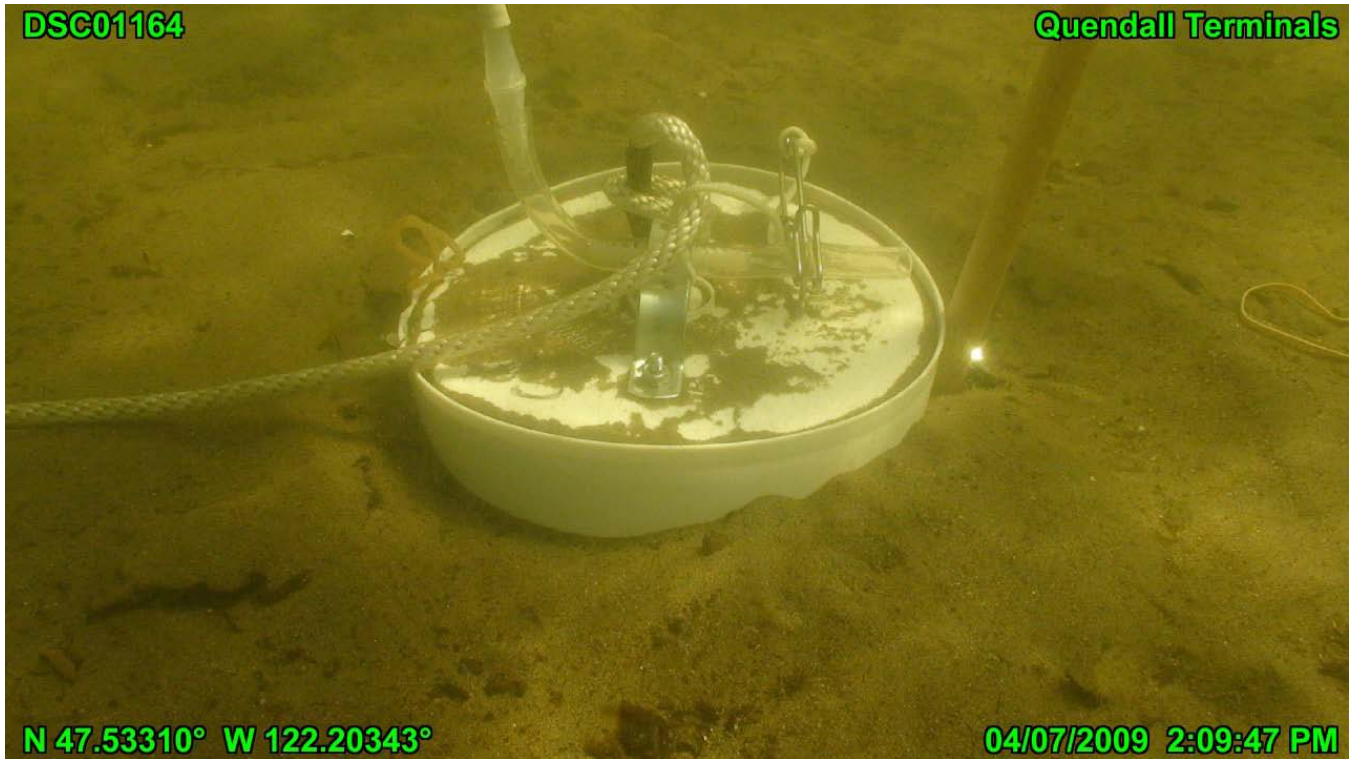
DSC01164

Seepage meter detail showing purge line which is open during installation and closed for sample collection with a hose clamp.
