EPA Region 10 Dive Team Compliance Inspections of Permitted Discharges at Seafood Processors and Log Transfer Sites

What: The EPA Region 10 Dive Team has conducted compliance inspections of pollutant discharges permitted under the National Pollutant Discharge Elimination System (NPDES) at seafood processors and log transfer facilities (LTF) in coastal Alaska.

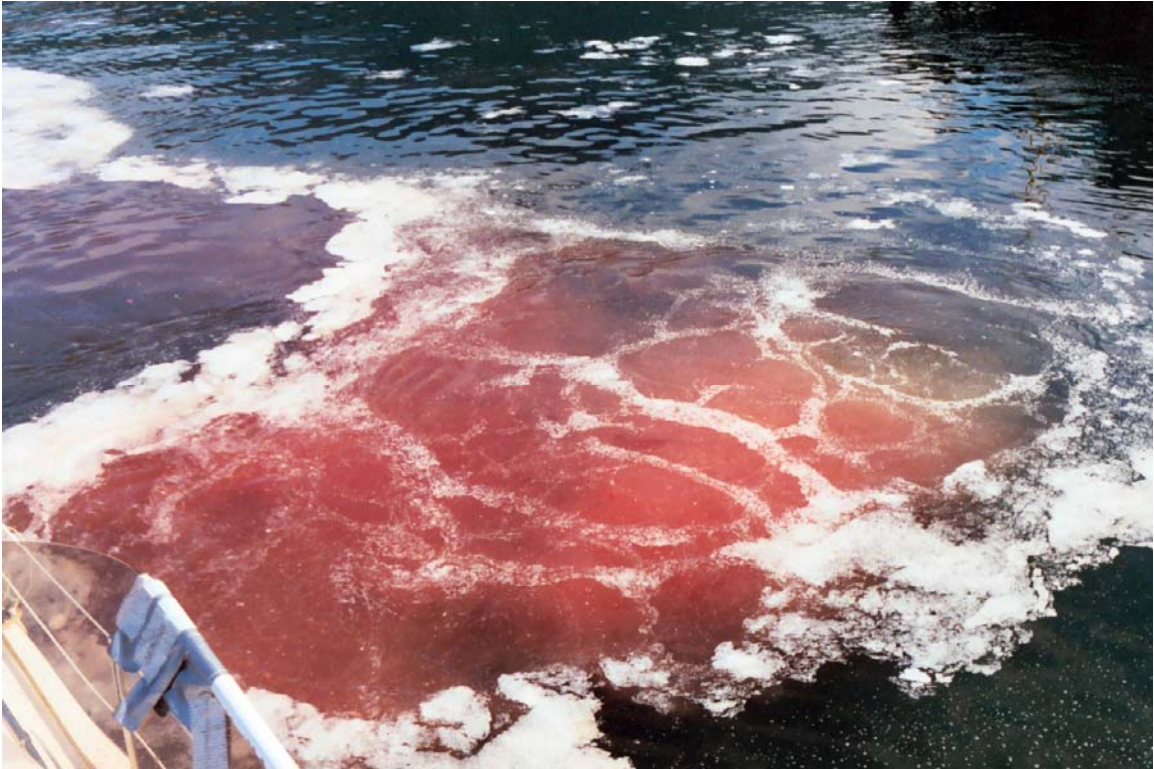
Typical discharge from a seafood processing plant, Sitka, 2003.

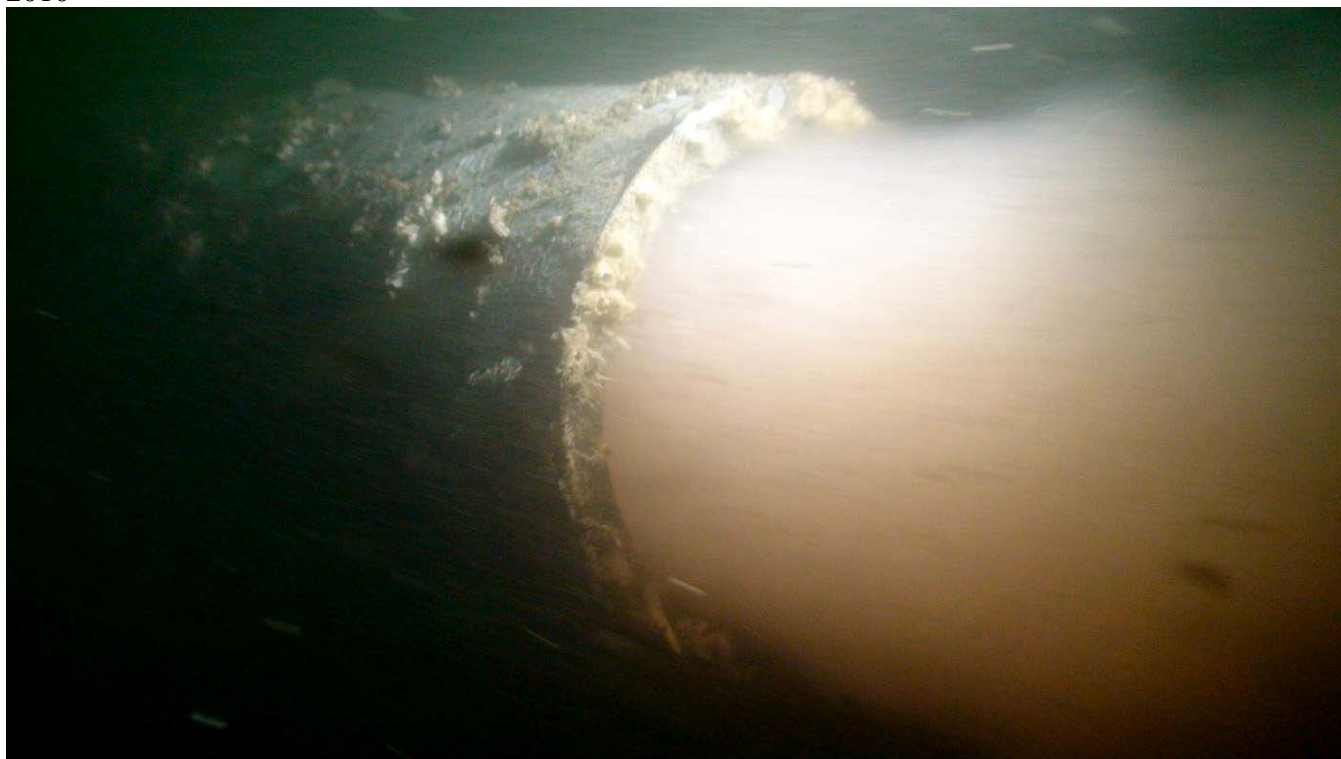
View of a seafood outfall underwater, Cordova, 2010

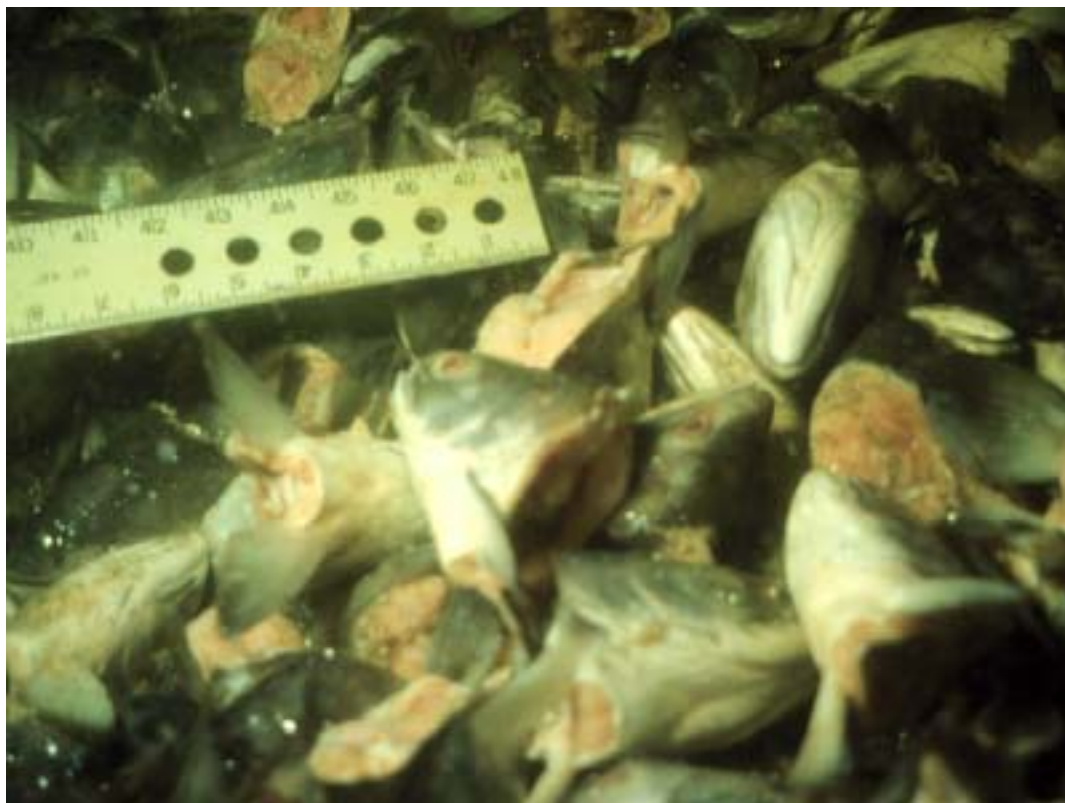
Discharged waste on the bottom near a seafood processing plant.

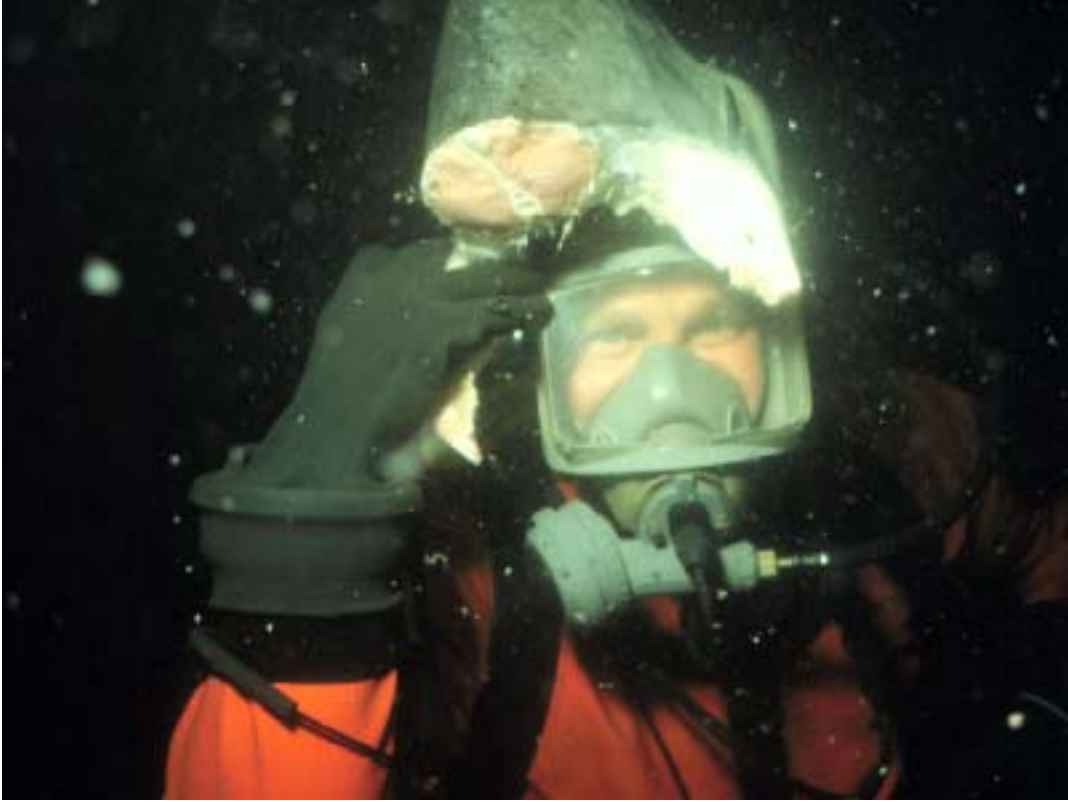
Occasionally large size pieces of salmon are discharged from the seafood processors.

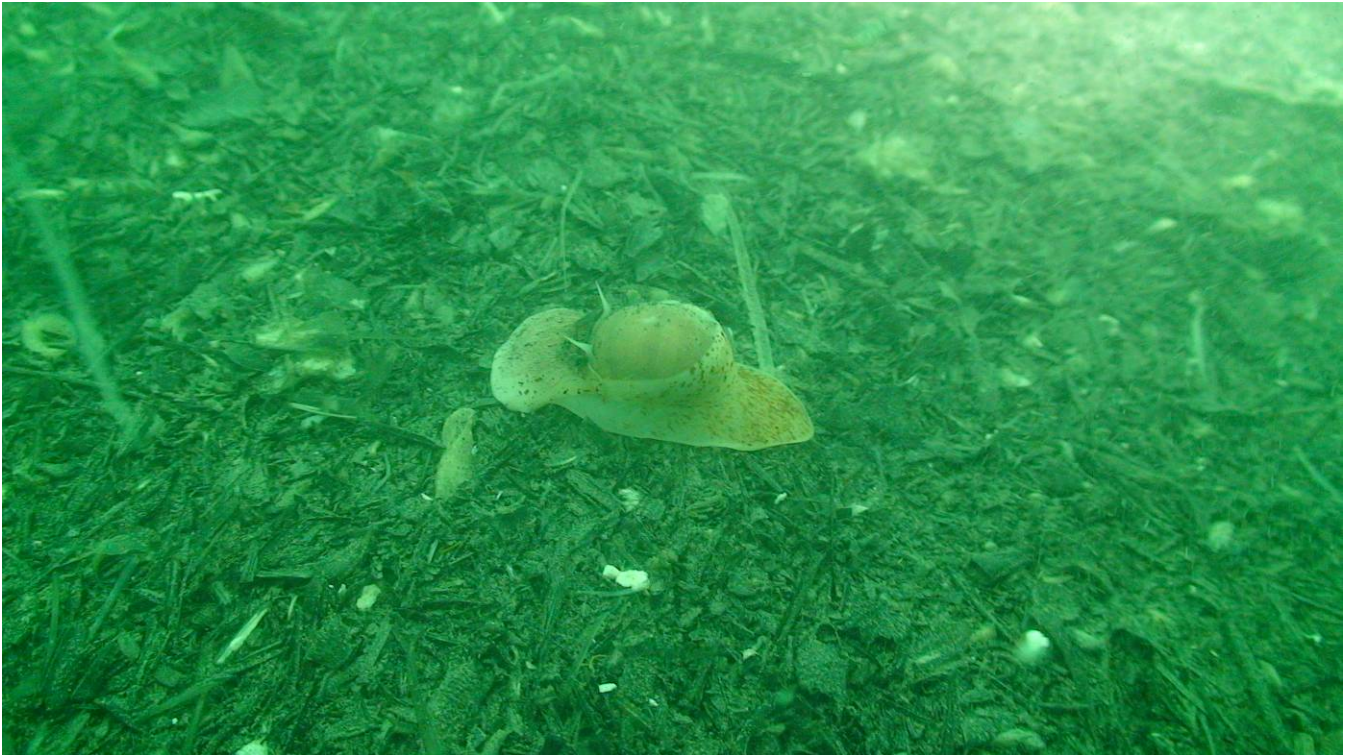
Mollusk on top of old waste near Trident North - (Moon snail – *Polinices sp.*), Cordova, 2010.

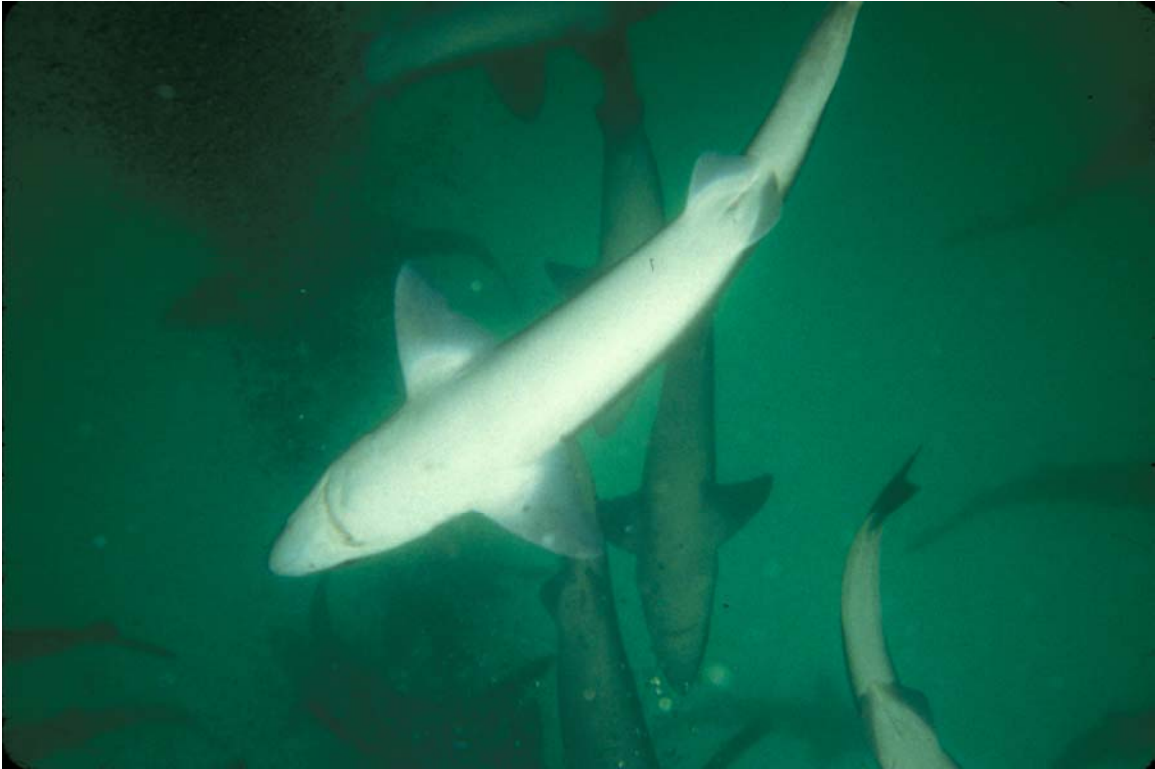
Looking for a meal: Sharks circling above seafood discharge, Ketchikan, 2000.

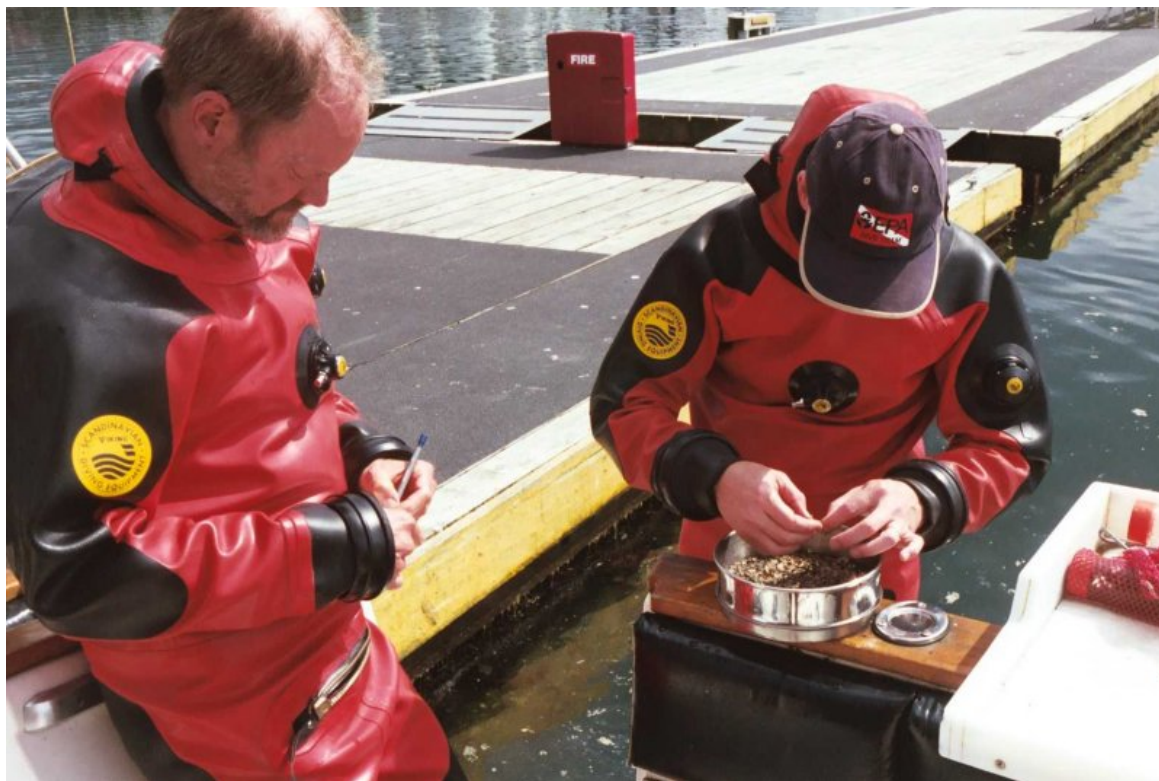
Sediment core analysis conducted to determine seafood waste impact on benthic life, Sitka, 2003.
