Wyckoff Eagle Harbor Superfund Site Scientific Diving Support 1980-2013

Where: Eagle Harbor, Bainbridge Island, WA.

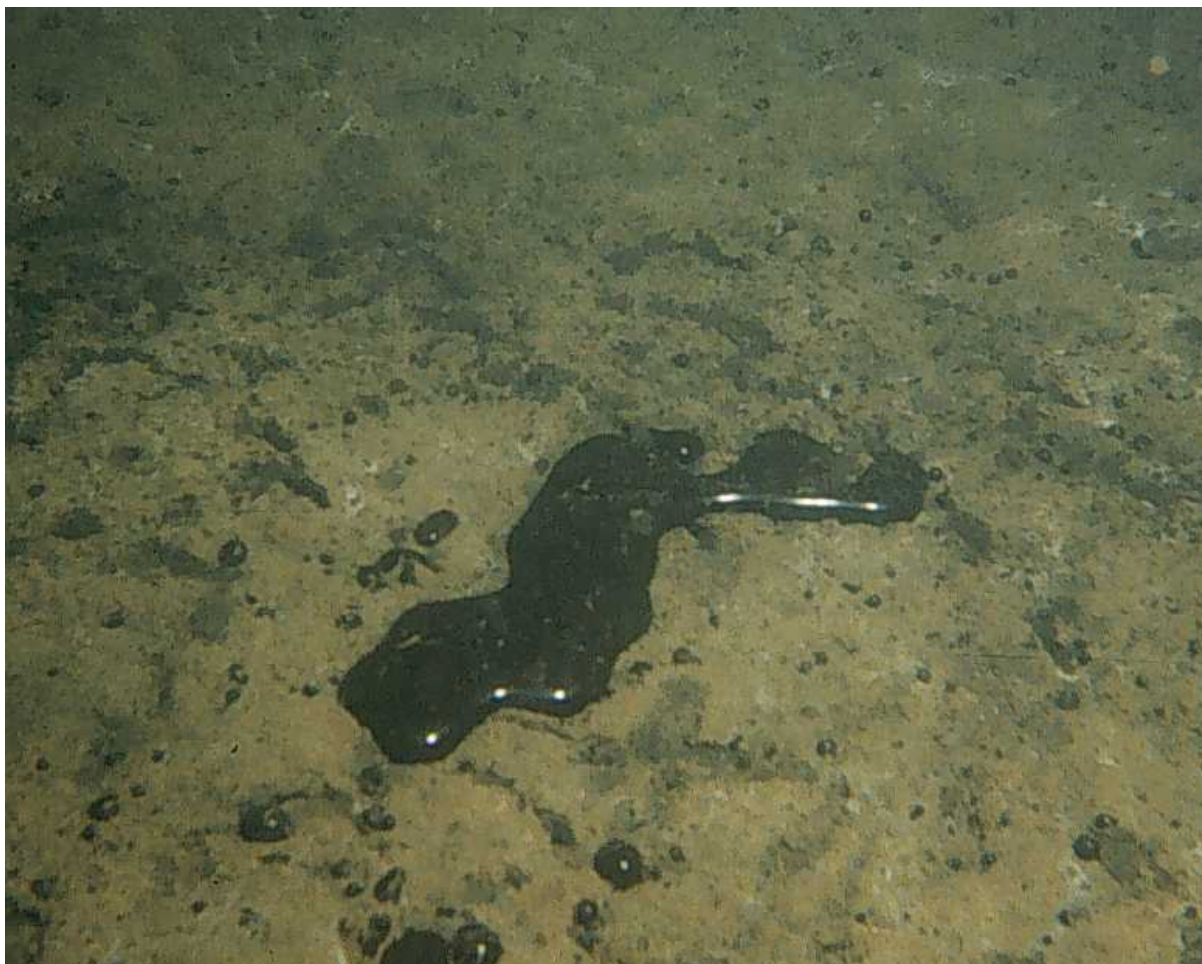
Cap surveys that took place between 2001 and 2007 found that the cap was smooth in the south part of the harbor and “hummocky” in the north. A lot of woody debris was present. Creosote "marbles" were observed in the south on two occasions (see pictures below). Some settlement plates were lost (tipped over, broken, dragged, buried). Divers could feel the difference in substrate type (sand placed over mud). Recovery by macrofauna was rapid. Anemones pulled up through the cap and crab, flatfish, and drift algae were common. Polynuclear aromatic hydrocarbons (PAHs) were detected in samples from the sediment traps (see photo below) at times. Only minor accumulations of sediment occurred around stakes in a nearby marina. Nearby eelgrass beds were probably not affected. A survey was conducted in December, 2003 of areas that formerly seeped or pooled creosote (Area 4 within figure below) which was capped in 2000-2001. Life on the cap included various types of anemones including the frilled anemone (*Metridium senile*), seastars including the sunflower star (*Pycnopodia helianthoides*) sea lettuce (*Ulva*), unidentified bivalves, unidentified tube worms, and sporadic eel grass (*Zostera marina*). Several fish including unidentified sole, ratfish (*Hydrolagus colliei*), and other unidentified small fish were seen on the bottom or above the cap in addition to various crab- including dungeness (*Cancer magister*). “No anchor zone” buoys were placed in 2006 and replaced in 2007.

Creosote pools that were prevalent in nearshore areas before dredging/capping that divers were asked to photo document and map.

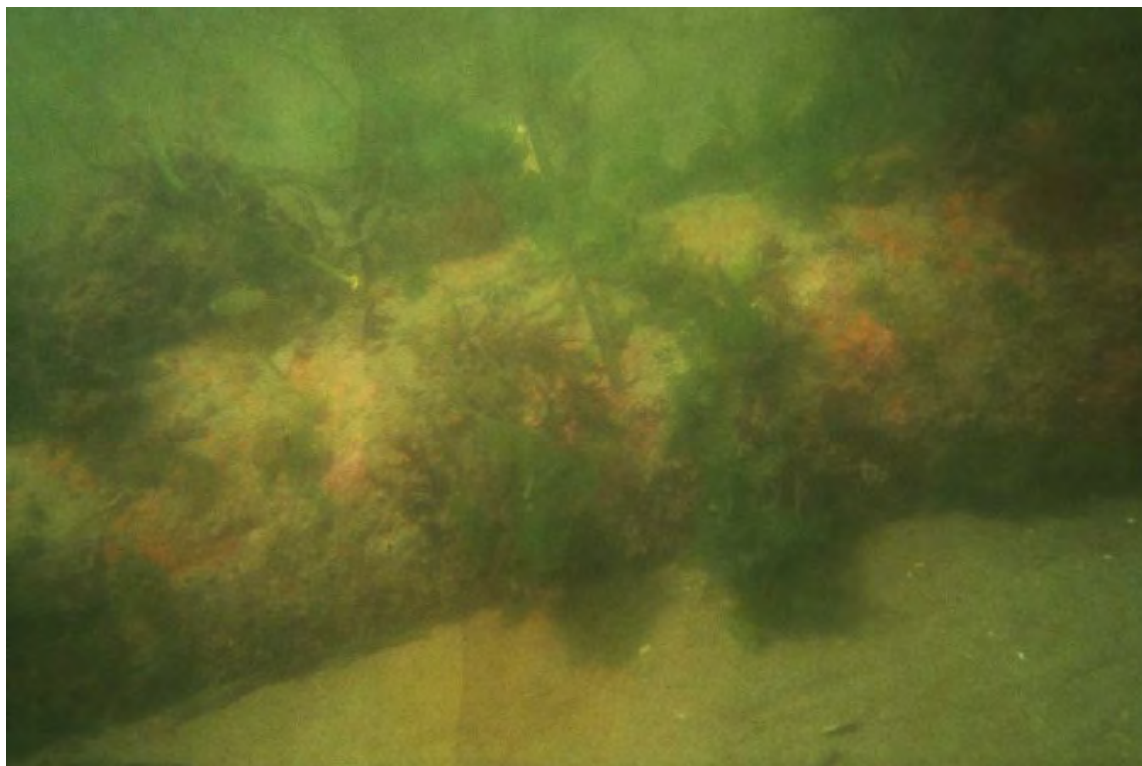
View of algal growth along the treatment plant outfall

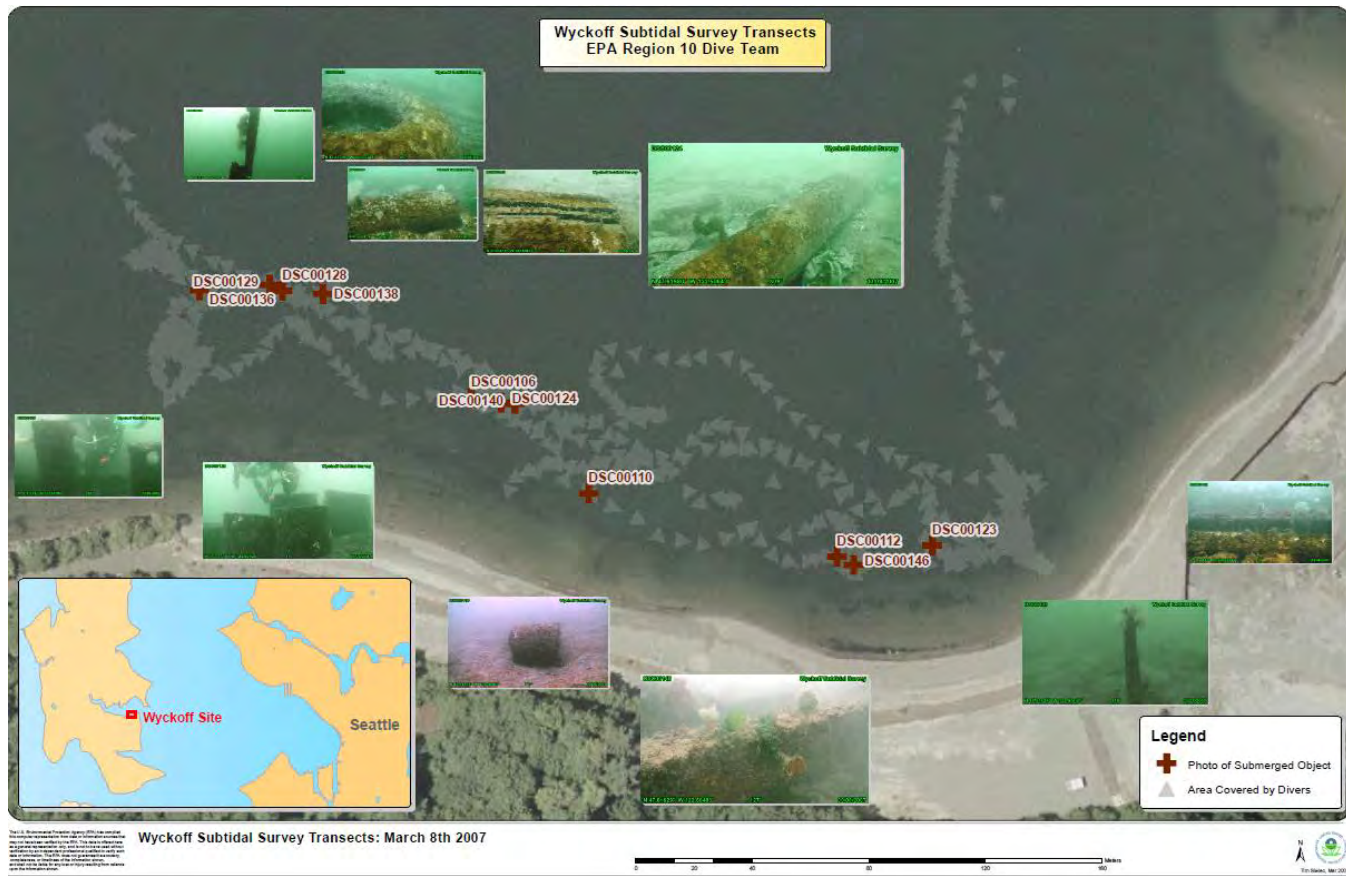
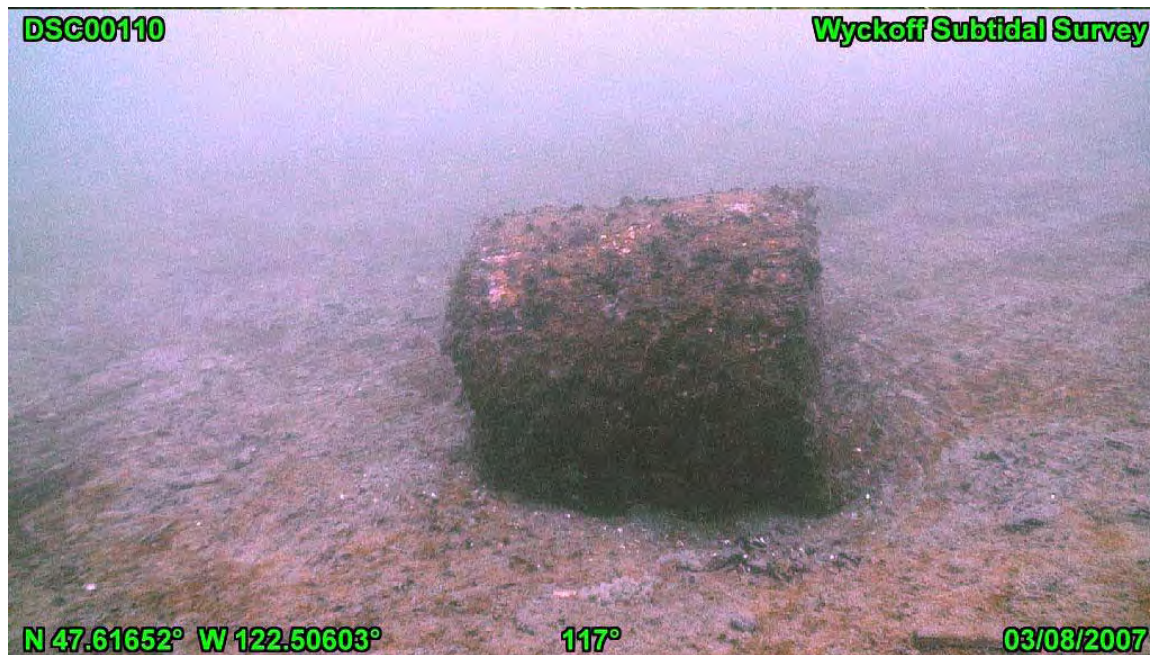
An object located as part of the pre-capping survey in 2007.

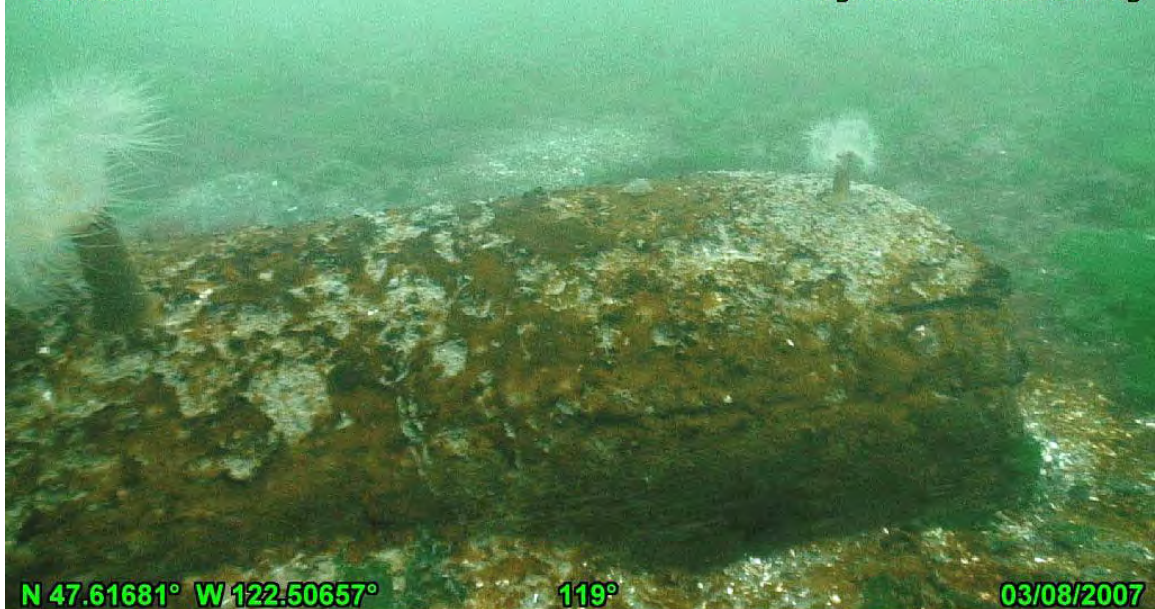
DSC00106

An object located as part of the pre-capping survey in 2007.

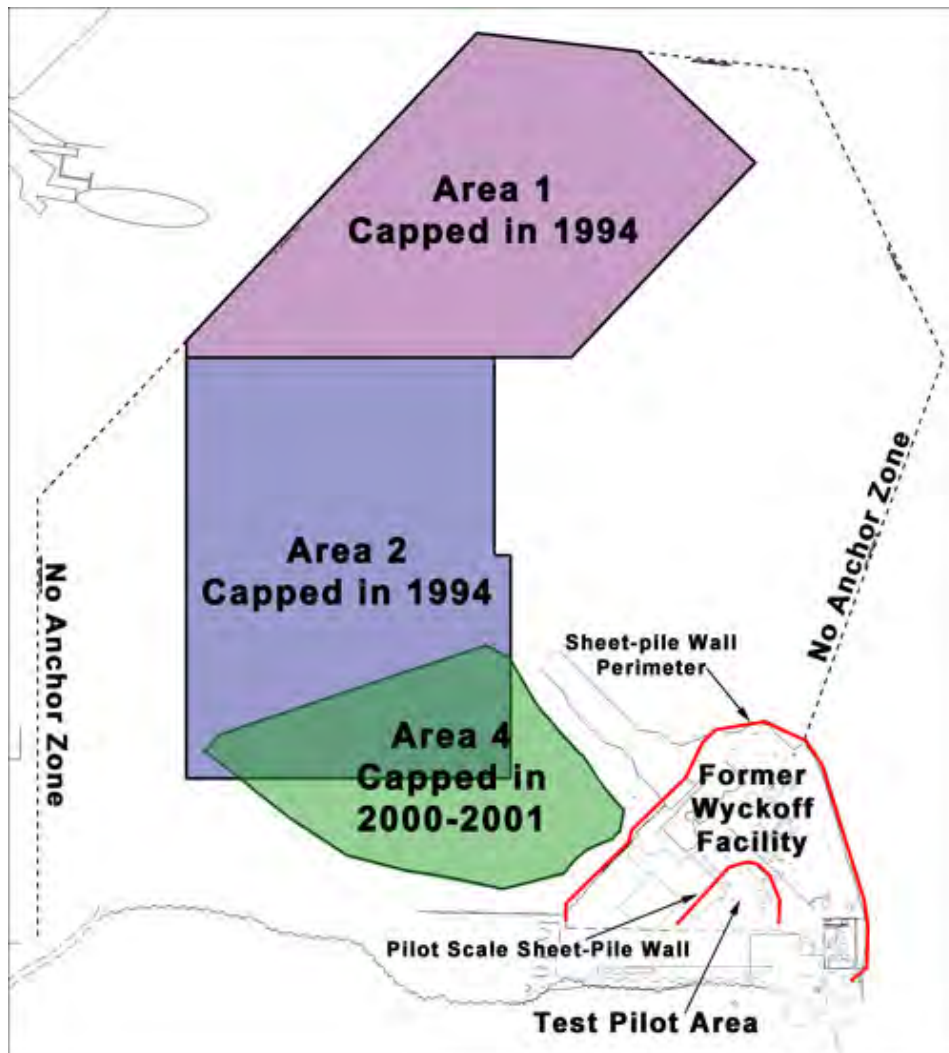
Map of areas capped at the Wyckoff Site. Note that parts of Area 4 were capped again in 2008.

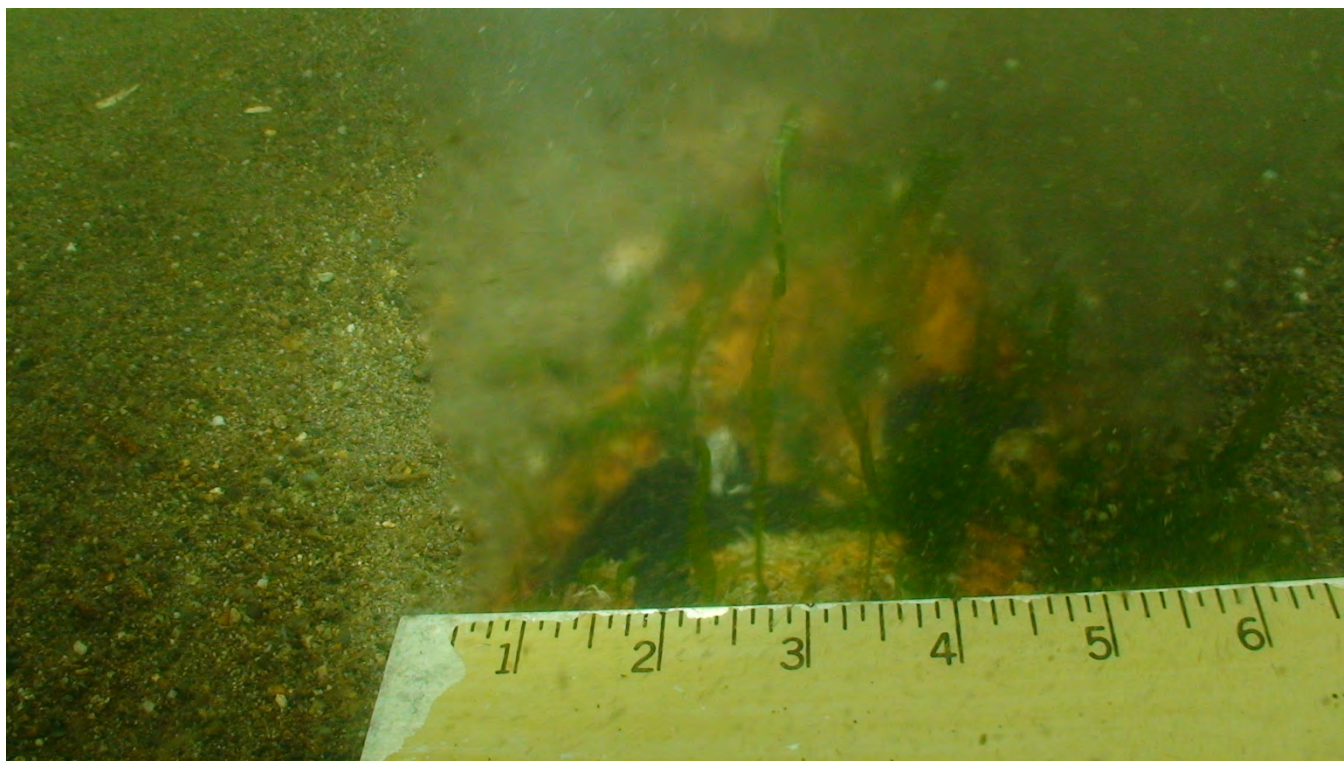
Documenting outfall leakage. Note the freshwater diffracts ambient light differently than the saltwater.
