Enbridge Incorporated  
Hazardous Liquid Pipeline Rupture and Release  
Marshall, Michigan  
July 25, 2010

NTSB/PAR-12/01  
PB2012-916501

# Pipeline Accident Report

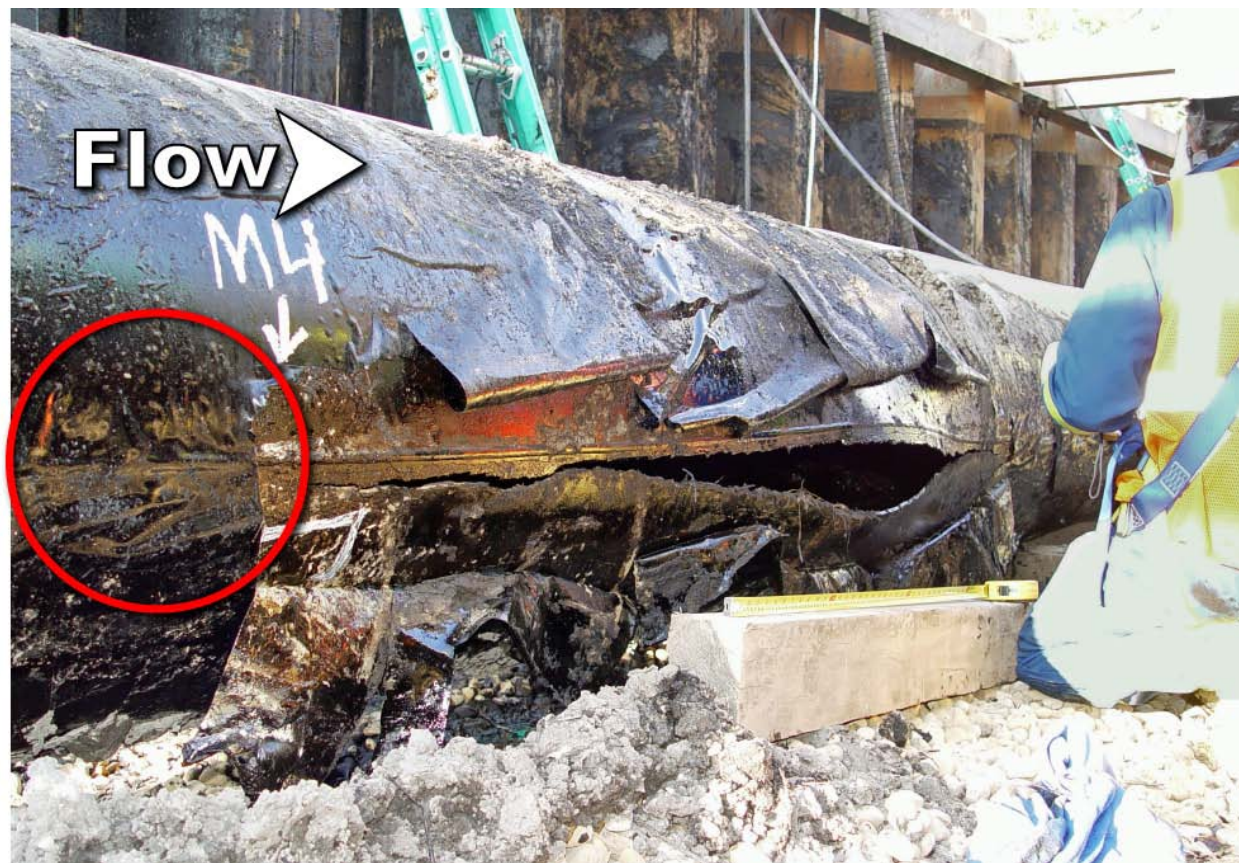
The fracture in the ruptured segment measured 6 feet 8.25 inches long and up to 5.32 inches wide. (See figure 2.) External corrosion was present along the longitudinal weld seam and in areas where the adhesive bond between the pipe and its protective polyethylene tape coating had deteriorated (disbonded). The coating was wrinkled and had separated from the pipe surface as shown in the red circle in figure 2.

**Figure 2.** The ruptured segment of Line 6B in the trench following the July 25, 2010, rupture. The fracture face measured about 6 feet 8.25 inches long and was 5.32 inches wide at the widest opening. The fracture ran just below the seam weld that was oriented just below the 3 o'clock position. A red circle shows a location where the coating was wrinkled and had separated from the pipe surface.

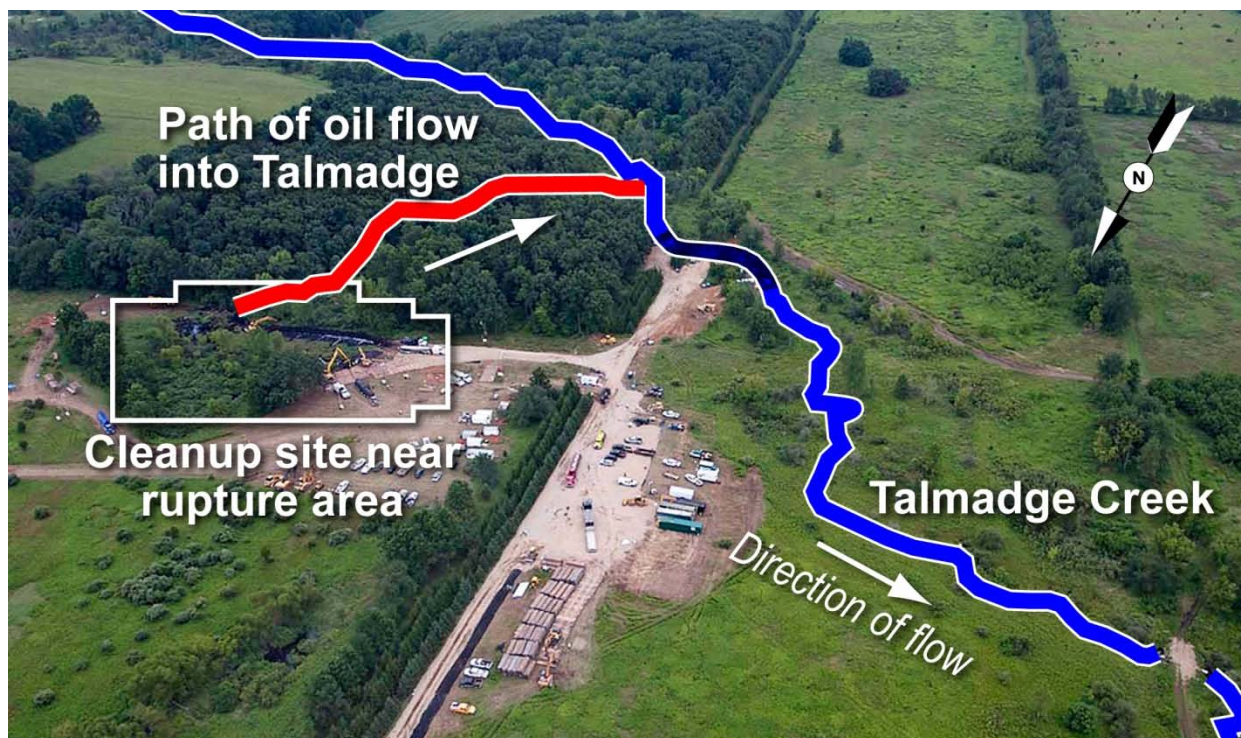
The crude oil release soaked the rupture site and the surrounding wetlands, eventually spreading to the Talmadge Creek and the Kalamazoo River. Enbridge's early response efforts were focused downstream of the rupture. Recent heavy rainfall had increased the flow of the Talmadge Creek and the Kalamazoo River, which spread the oil faster, hindering the response efforts. (See figure 3.)

**Figure 3.** Aerial view of the accident location showing the rupture site to the left and the Talmadge Creek flowing west toward the Kalamazoo River.

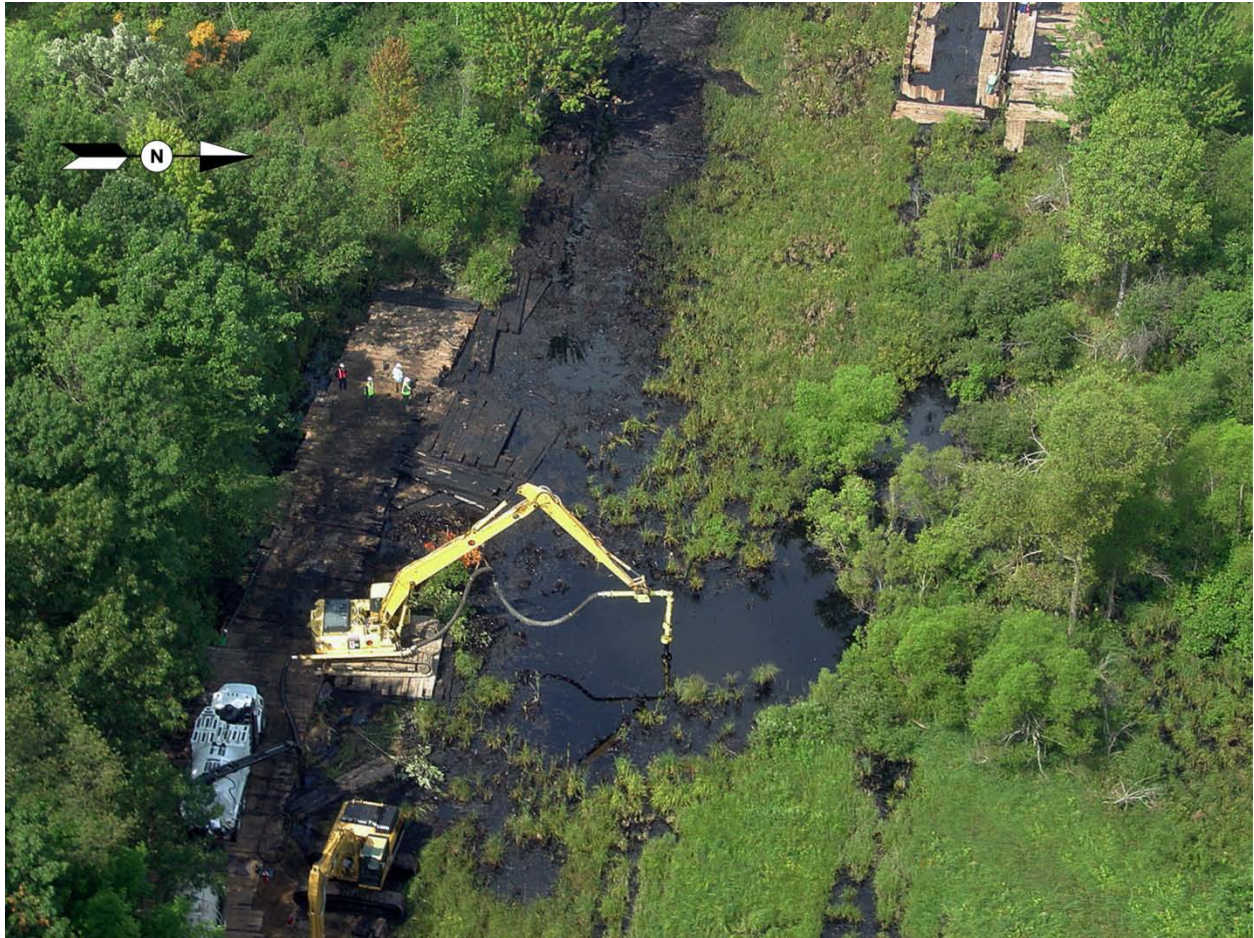
The wetland conditions in addition to the crude oil release made it difficult for vacuum trucks and excavators to get near the rupture location. Large wooden matting had to be placed around the rupture location to bring heavy equipment close to the release. (See figure 4.) The conditions at the accident site also delayed efforts to extract the pipe and to contain the oil near the rupture source.

**Figure 4.** Cleanup efforts in an oil-soaked wetland near the rupture site. Saturated soil complicated the cleanup and excavation efforts. An excavator with a vacuum attachment is shown situated on wooden matting near the rupture site.

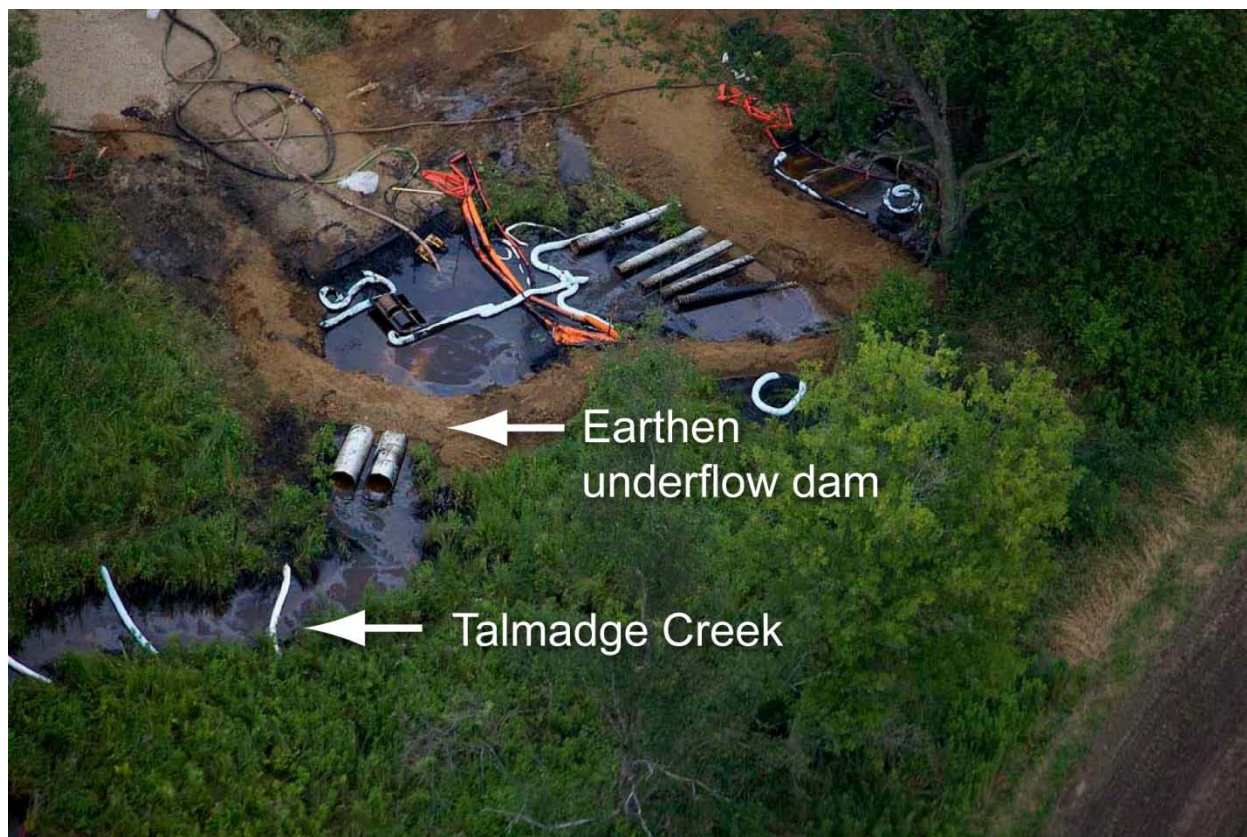
Working with a six-person crew, the Marshall PLM supervisor constructed an earthen underflow dam, which consists of a mound of soil holding back oil-contaminated water with pipes submerged on the dam side and rising toward the discharge end. The angle of the pipe allows the deeper water in the dam to flow downstream, preventing the contaminated surface waters from flowing into Talmadge Creek. (See figure 10.)

**Figure 10.** Underflow dam on Talmadge Creek on July 30, 2010.

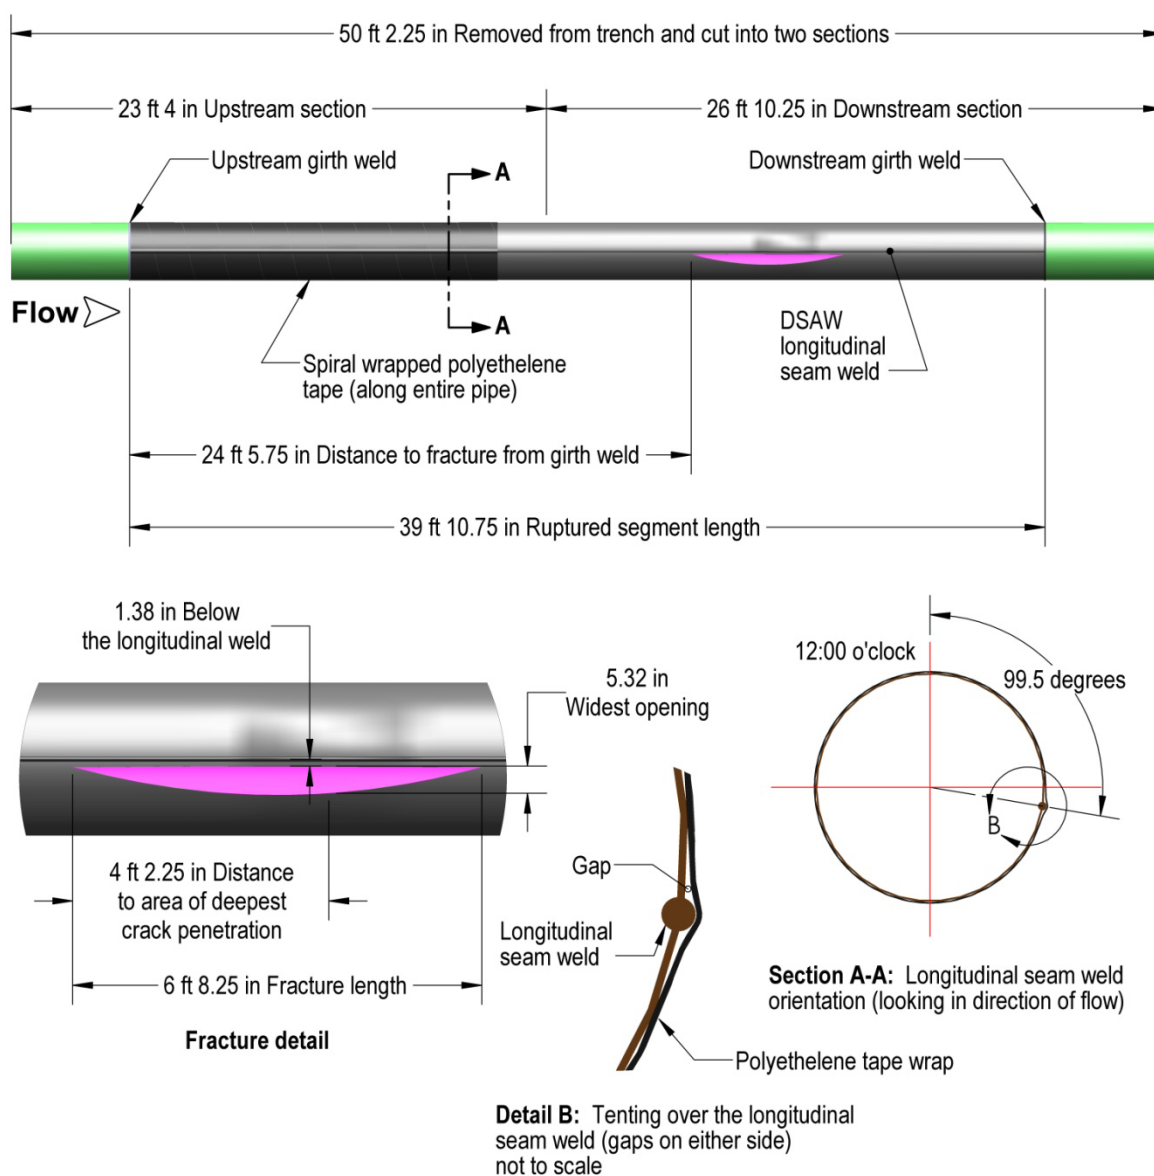
The ruptured pipe segment was 39 feet 10.75 inches long. The longitudinal seam was oriented at 99.5° clockwise.<sup>43</sup> A 50-foot length of pipe that included the rupture was removed and cut into two sections for shipping to the NTSB's Materials Laboratory for examination. The upstream section measured 23 feet 4 inches. The downstream section measured 26 feet 10.25 inches. (See figure 11.)

**Figure 11.** Line 6B ruptured segment showing upstream and downstream sections used for Materials Laboratory examination. Detail B shows tented coating over the longitudinal seam weld.

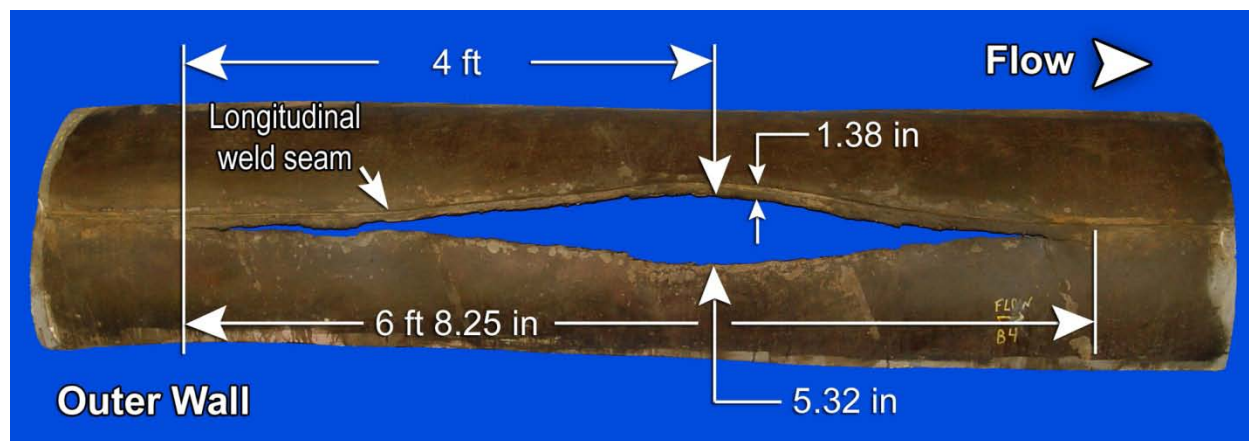
The fracture measured 6 feet 8.25 inches in length with the upstream end of the fracture located 24 feet 5.75 inches away from the upstream girth weld. The widest point along the fracture measured 5.32 inches and was about 4 feet from the upstream end of the rupture. The upper fracture face at the widest opening was measured at 1.38 inches below the longitudinal seam weld away from the heat-affected zone, with this offset ranging from 0.5 to 1.5 inches below the longitudinal weld seam for the length of the fracture face. (See figure 12.)

**Figure 12.** The outside surface of the pipe looking at the fracture area cut for lab examination.

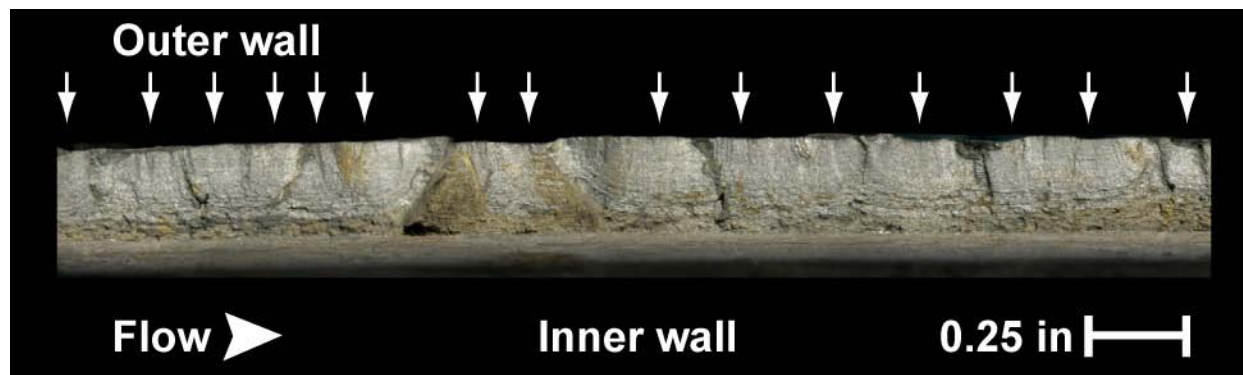
Examination of the fracture face revealed features on slightly offset planes consistent with preexisting cracks initiating from multiple origins in corroded areas on the exterior surface. Evidence of preexisting cracks at various penetration depths was observed across nearly the entire length of the fracture surface. The area of deepest preexisting crack penetration, relative to the original local wall thickness, was located 50.25 inches from the upstream end of the rupture.

**Figure 13.** Curving arrest lines of preexisting cracks along the upper fracture face shown after cleaning to remove oxides. White arrows indicate multiple origin areas of preexisting cracks.

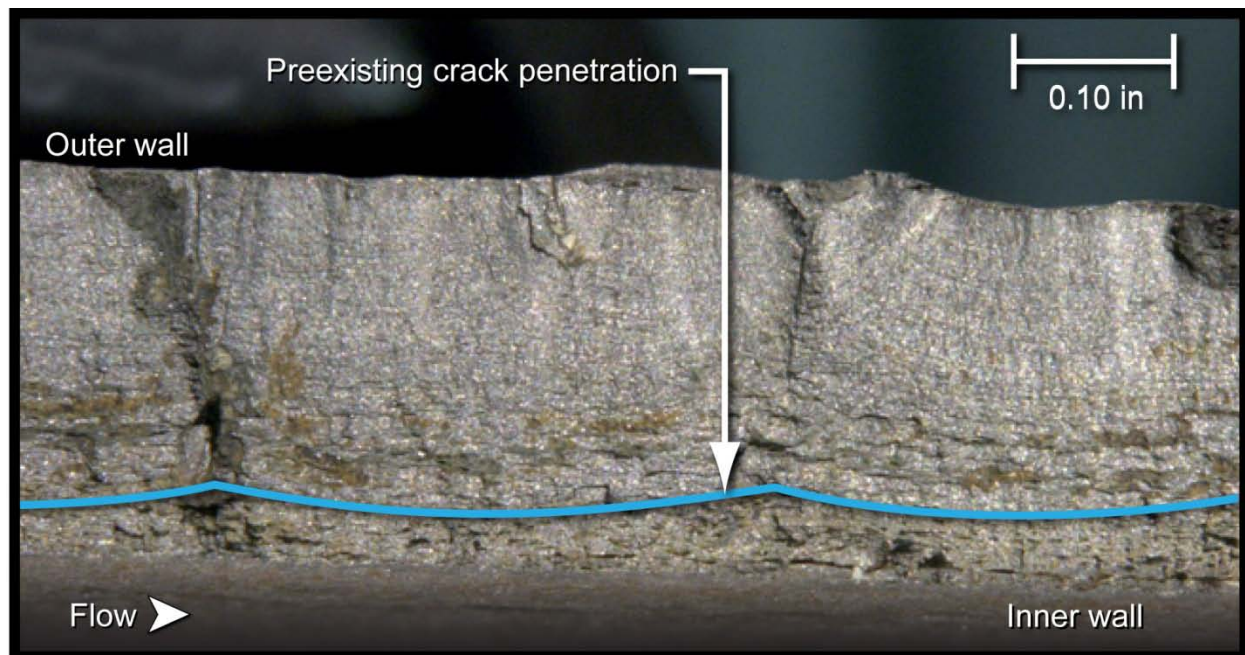
At the deepest crack penetration (see figure 14), the preexisting cracks extended 0.213 inch deep into the wall of the pipe relative to the original exterior surface, or 83.9 percent of the original wall thickness of 0.254 inch. The curving line in figure 14 indicates the extent of preexisting crack growth near the deepest penetration. The remainder of the fracture face had rough, matte gray features consistent with an overstress fracture. The preexisting cracks had fracture features perpendicular to the outside surface, consistent with corrosion fatigue<sup>46,47</sup> or near-neutral pH stress corrosion cracking (SCC).<sup>48</sup> Fine crack arrest features were present within about 0.015 inch of the crack origins with broader crack arrest features appearing farther away from the origins. These crack arrest features were indications of progressive crack growth and can be associated with corrosion fatigue or near-neutral pH SCC.

**Figure 14.** Close view of fracture surface area in the area of deepest crack penetration. The solid blue line indicates the extent of the preexisting crack penetration.

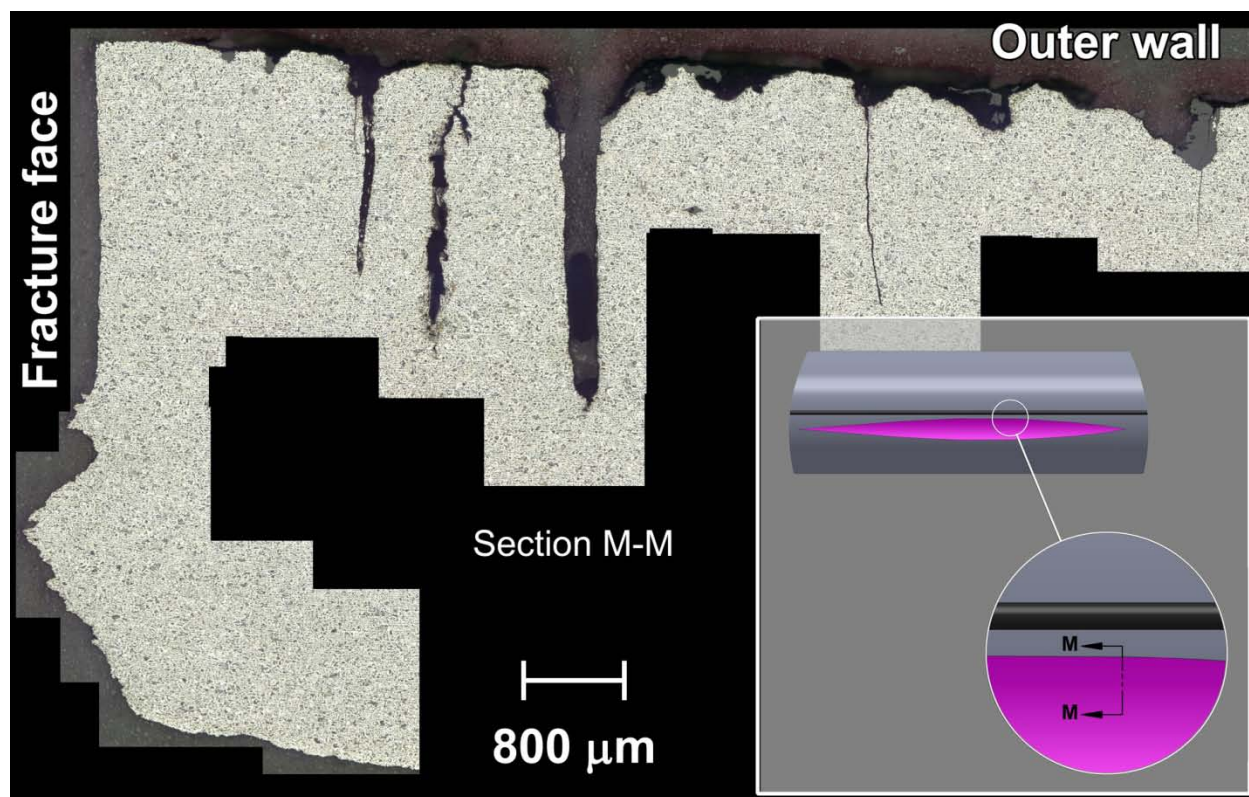
A cross-section through the fracture was prepared as shown in figure 15. The preexisting crack portion of the fracture showed a transgranular<sup>49</sup> fracture path with limited crack branching, consistent with near-neutral pH SCC or corrosion fatigue. Multiple closely spaced and parallel secondary cracks (with transgranular propagation paths and limited crack branching) emanated from corrosion pits on the outside wall near the fracture face, also consistent with corrosion fatigue or near-neutral pH SCC. The deepest secondary crack extended through about 43 percent of the wall thickness.

**Figure 15.** Transverse section through the top of the fracture showing multiple parallel cracks emanating from corrosion pits on the outside surface.

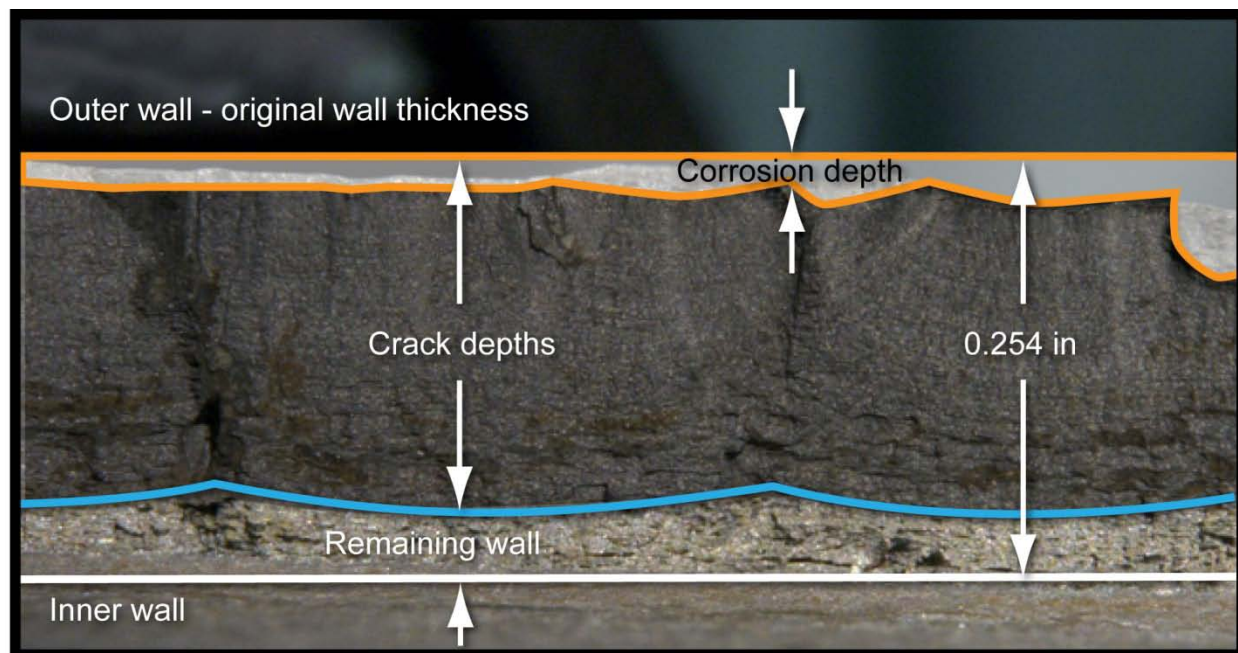
**Figure 16.** Lab measurements of crack and corrosion depths along the fracture face measured from images similar to figure 14 near area of deepest penetration (about 344 inches from upstream girth weld).

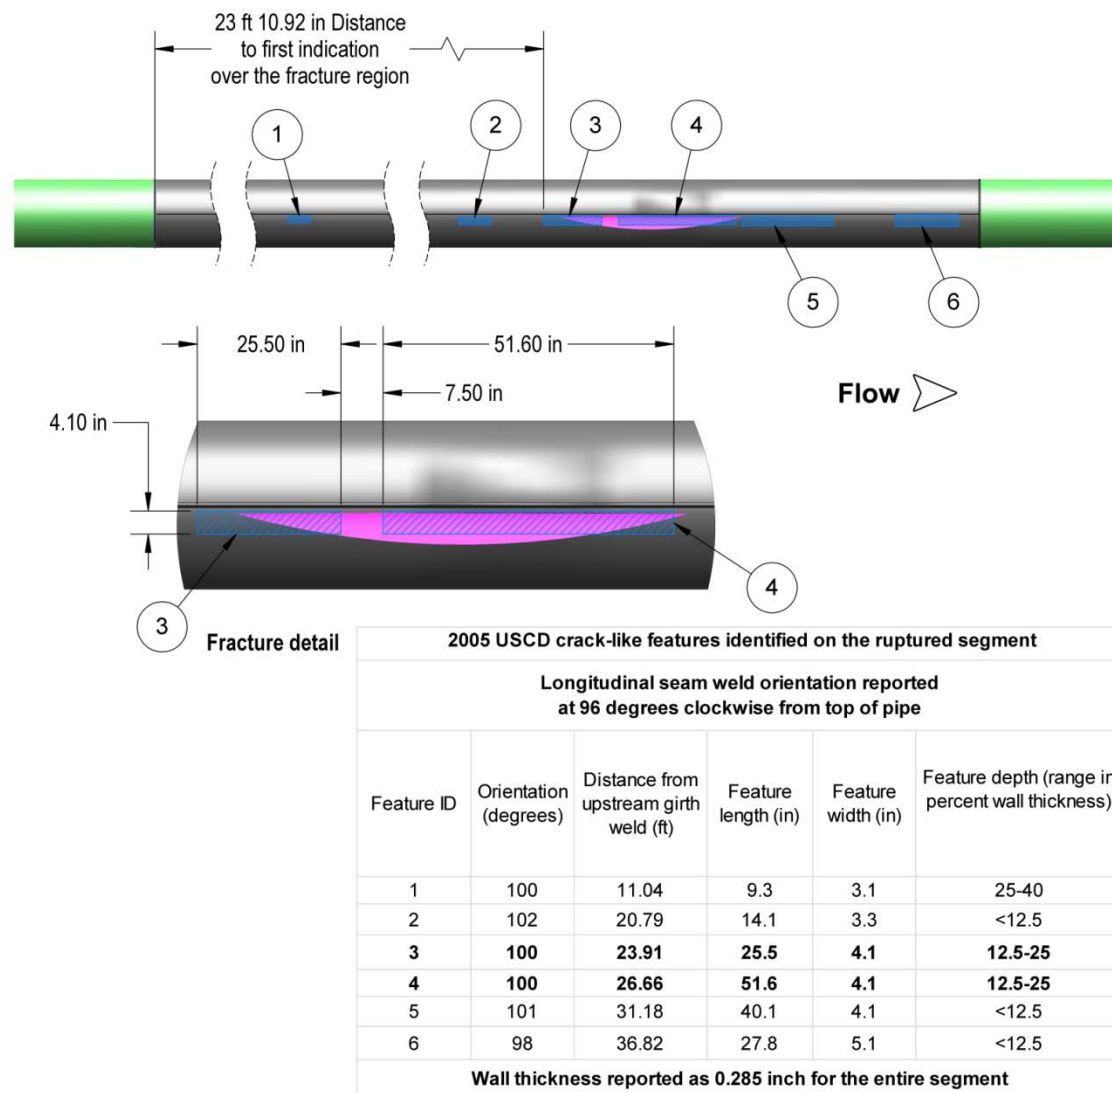
**Figure 18.** 2005 in-line inspection regions where crack-like characterizations were reported by PII on the ruptured segment of Line 6B.

According to PII, all six features identified on the ruptured segment, including the 51.6-inch-long crack, were originally characterized as crack-field indications by a junior analyst; however, a supervisor changed the analyst's characterizations to crack-like defects during a final quality check.

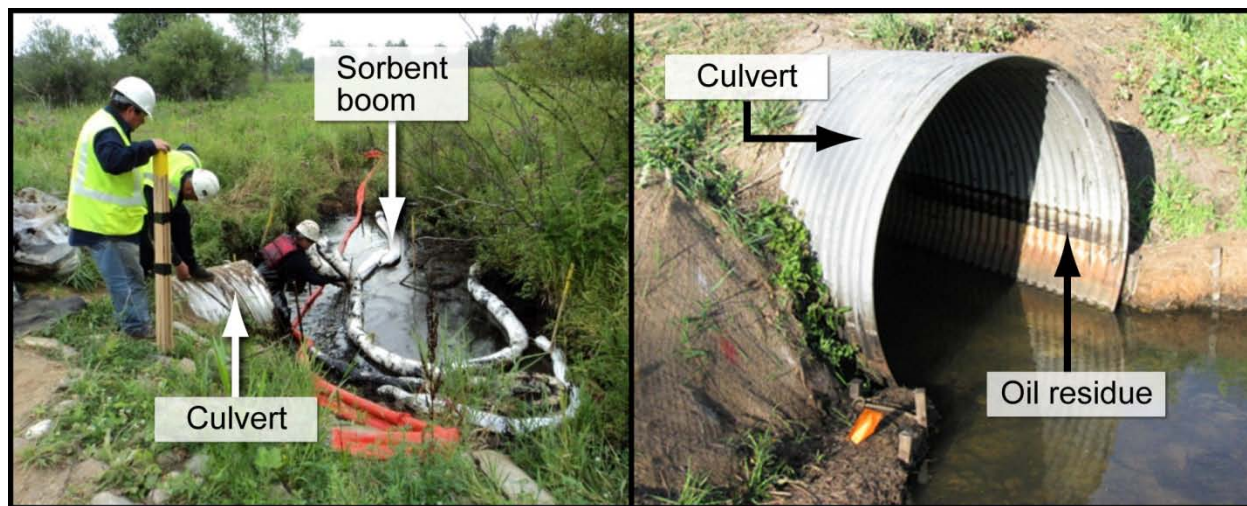
learned from the response, the Bay City PLM supervisor told NTSB investigators that, in the future, he would ensure that sheets of plywood are included in Enbridge's boom trailers so that adjustable underflow dams can be constructed over culvert pipes.

**Figure 21.** (Left) Enbridge employees install sorbent boom in front of a culvert at Division Drive. (Right) Oil residue marks the level of the oil carried through this culvert following the Enbridge release from Line 6B.
