# Situation Photo Log

Friday, March 2, 2012

Kalamazoo River / Enbridge Spill

Matthew Haak  
START-USEPA  
Situation Unit Leader

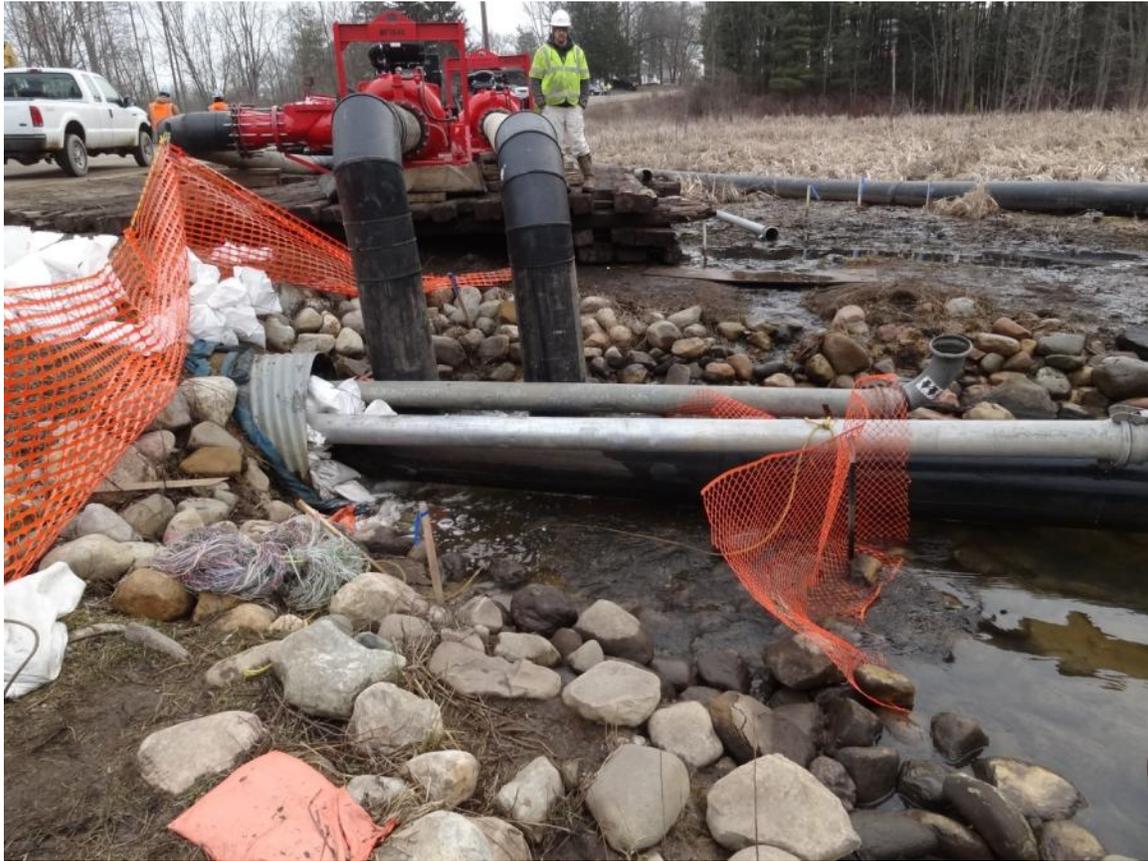
1. Talmadge Creek: Pump-around operating on south side of A Drive.

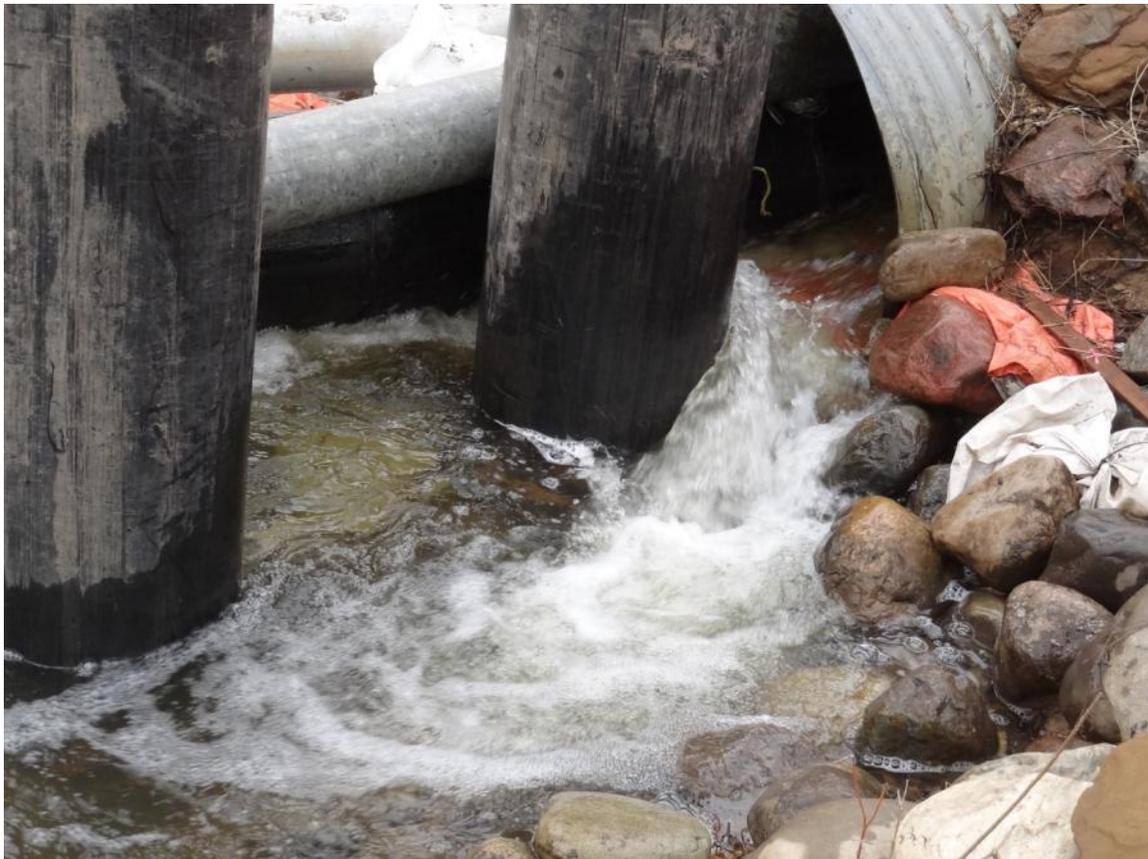
2. Talmadge Creek: Back-flow observed from A Drive culvert.

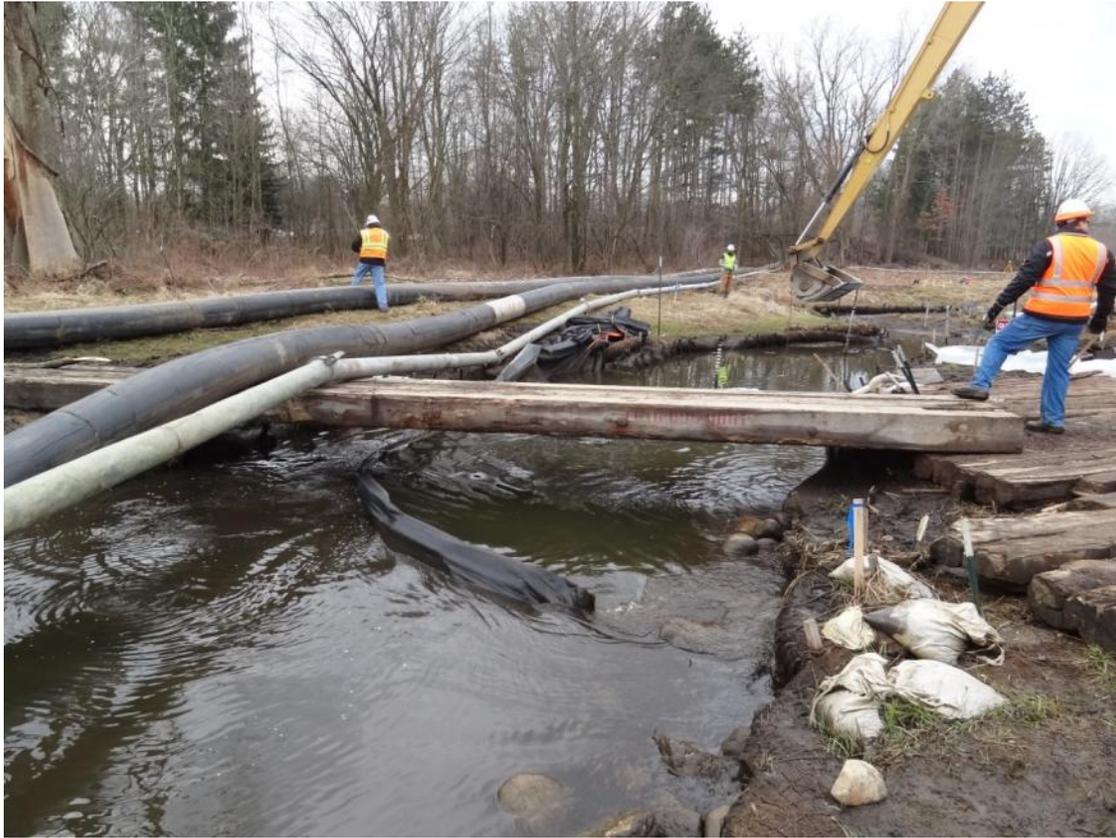
3. Talmadge Creek: Sediment trap removal activities

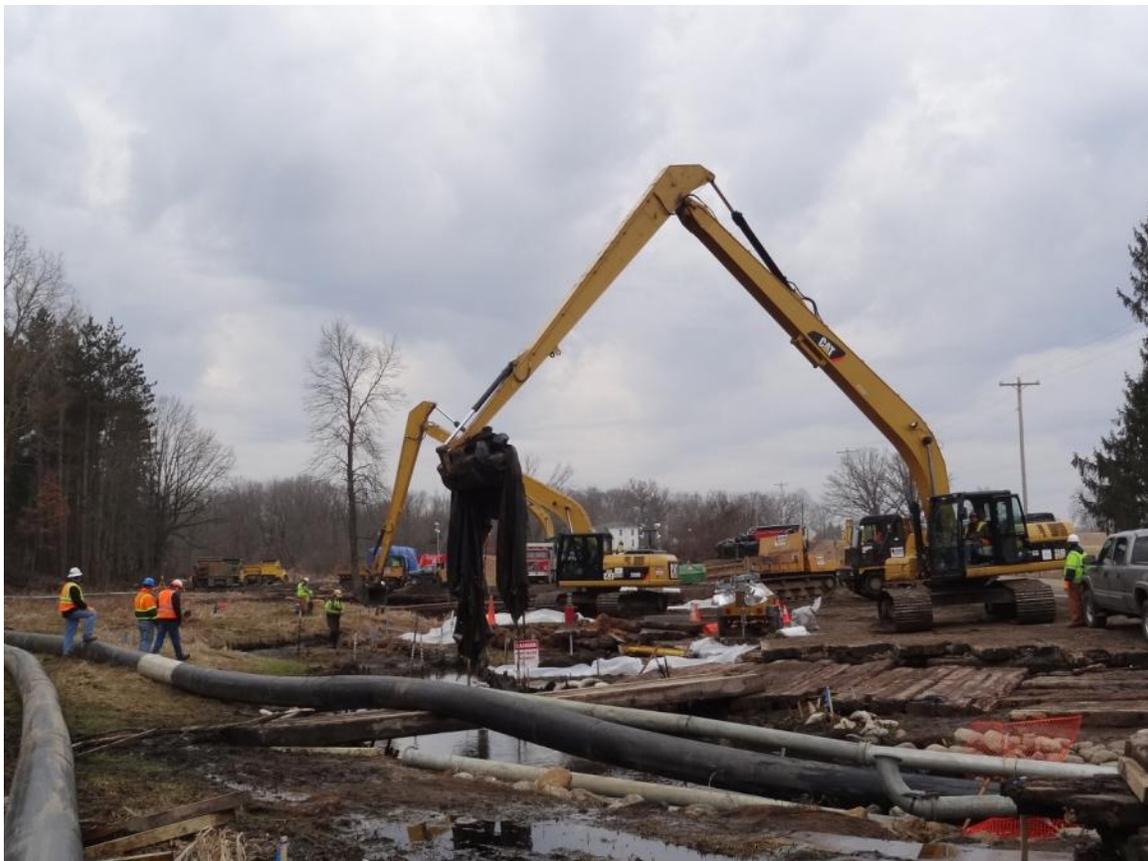
4. Talmadge Creek: Observed crews removing the Sediment Trap.

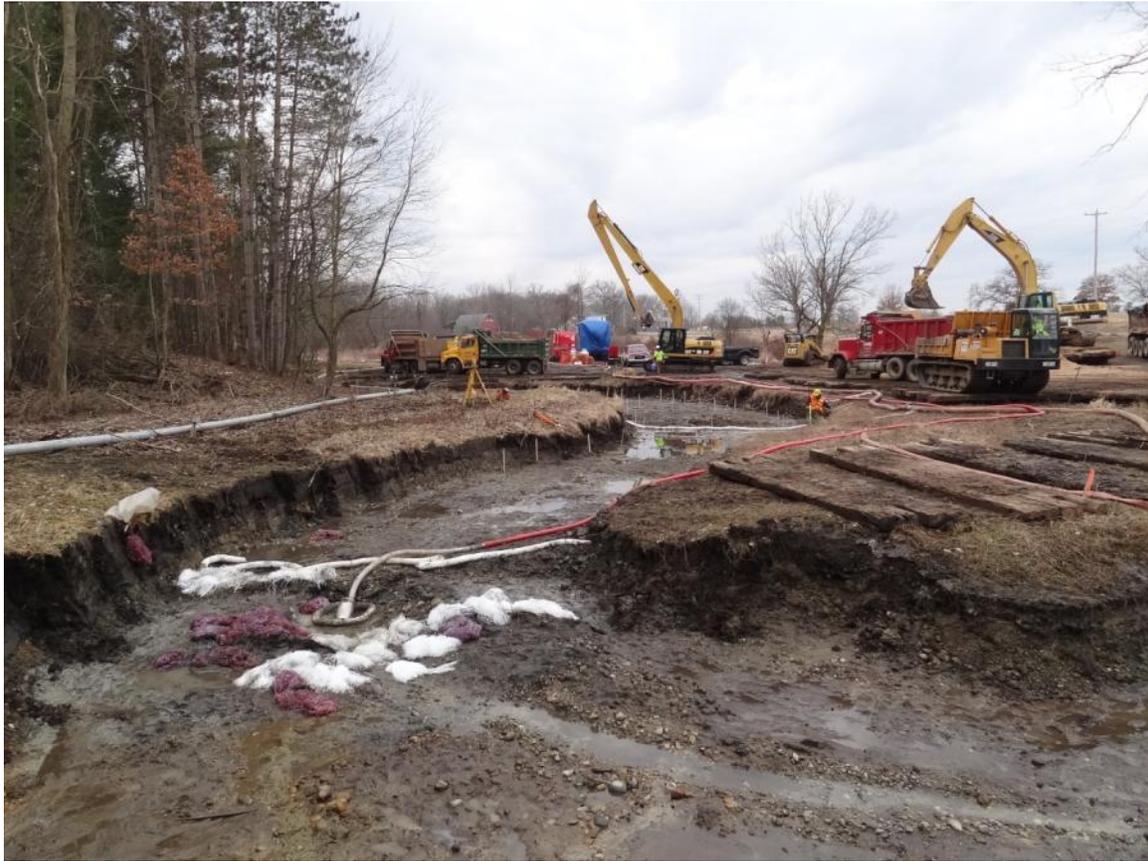
5. Talmadge Creek excavation work observed near MP1.85.

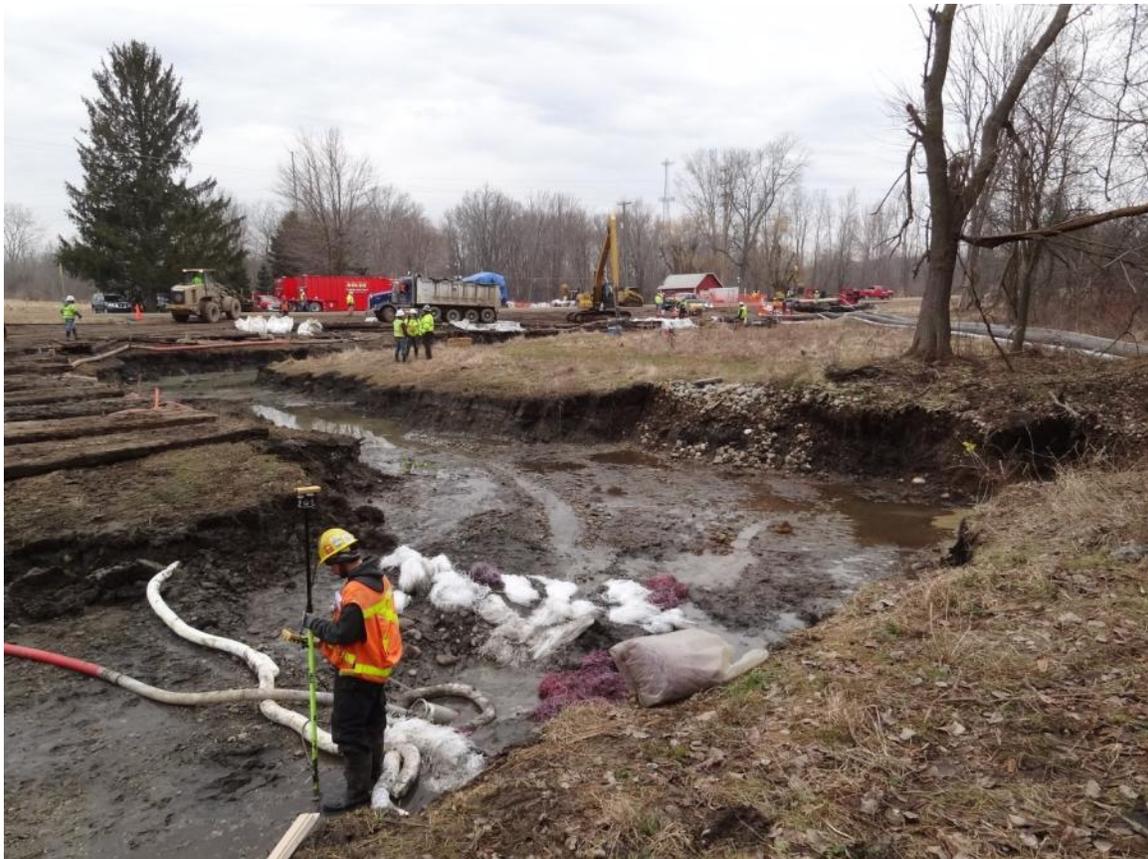
6. Talmadge Creek: Observed stakes being placed for restoration.

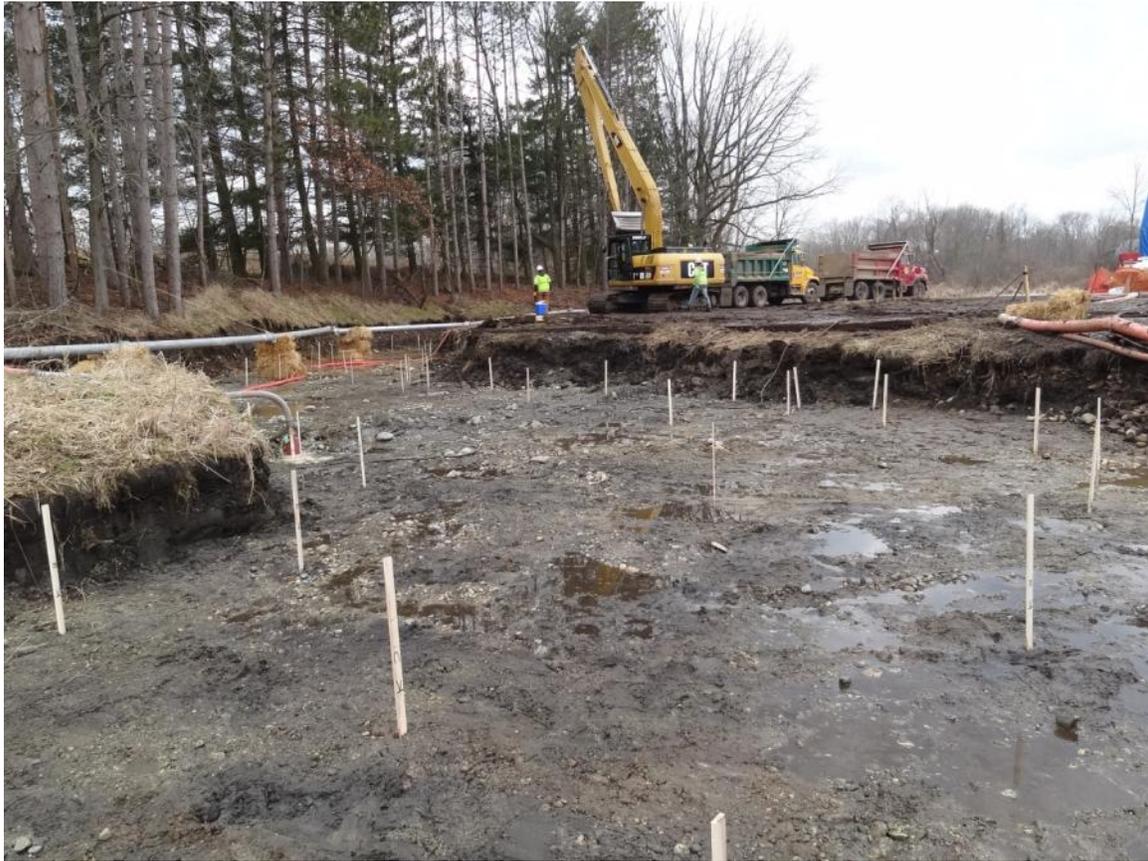
7. Talmadge Creek: Observed stakes being placed for restoration.

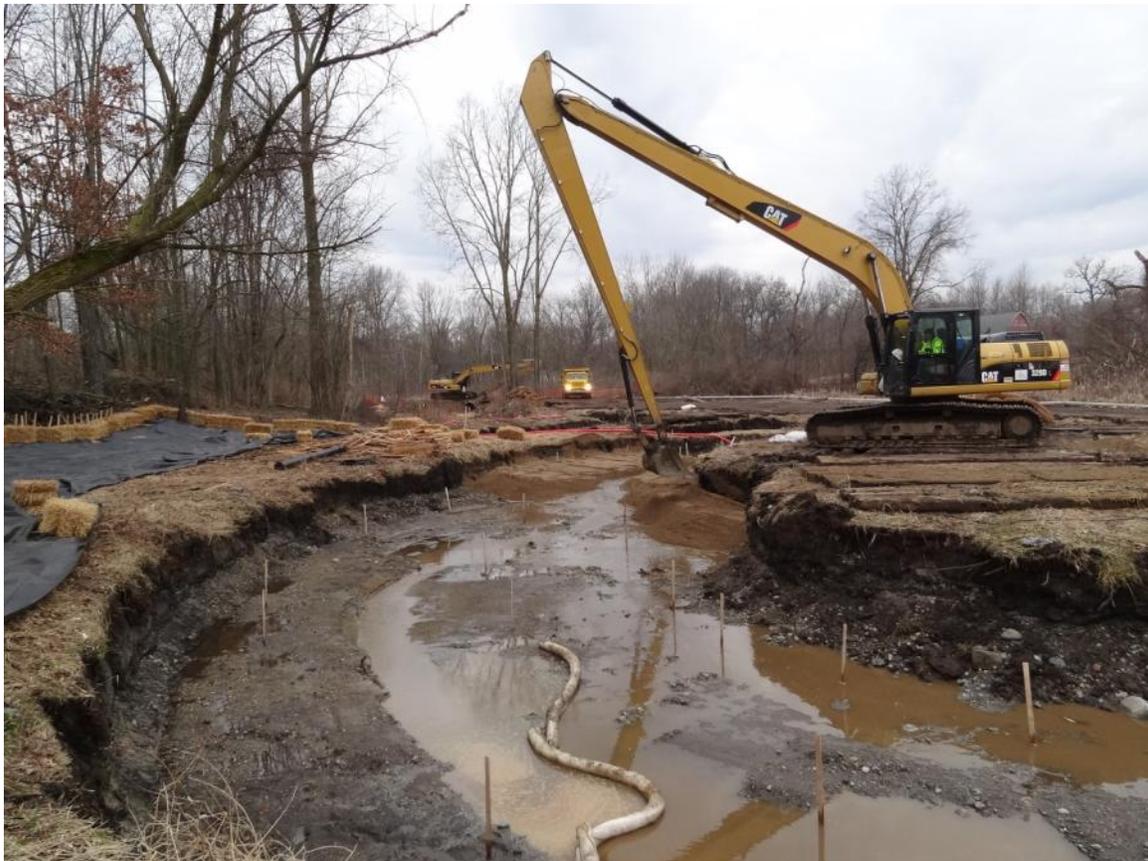
8. Talmadge Creek restoration work near MP1.5.

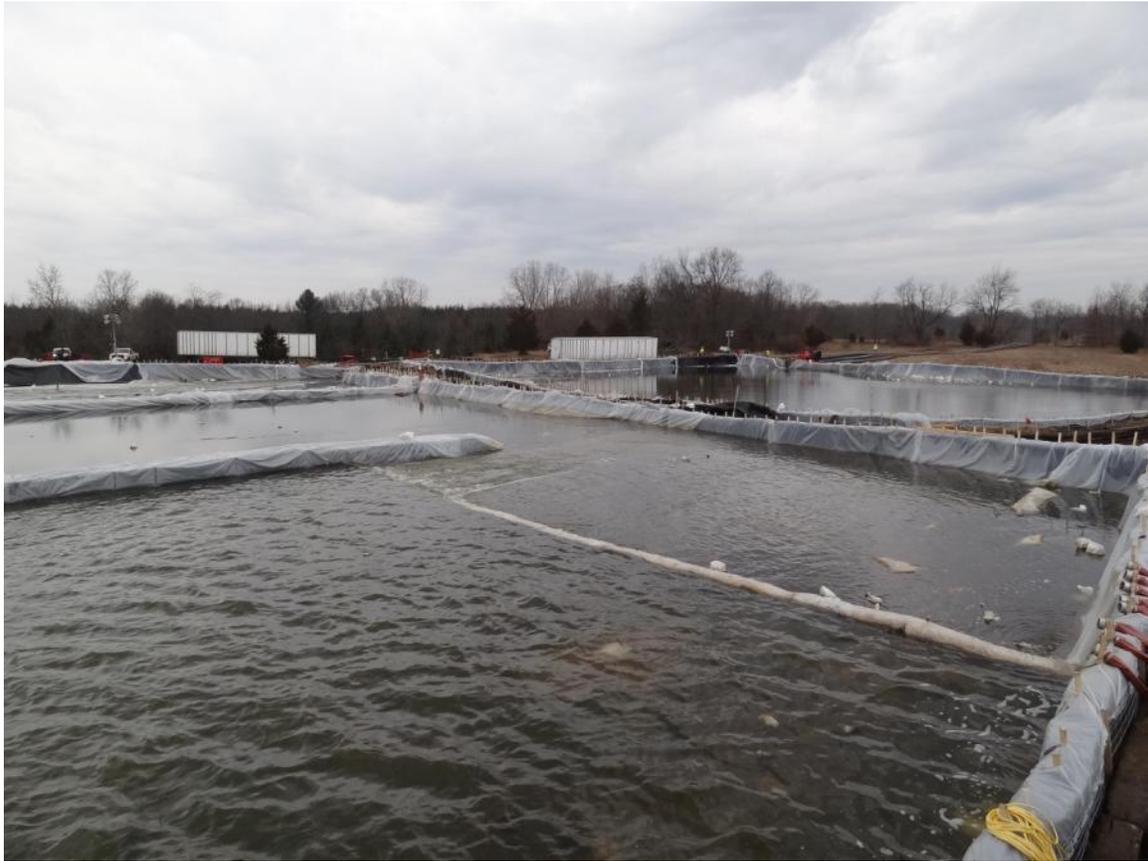
9. Turbidity control structure.

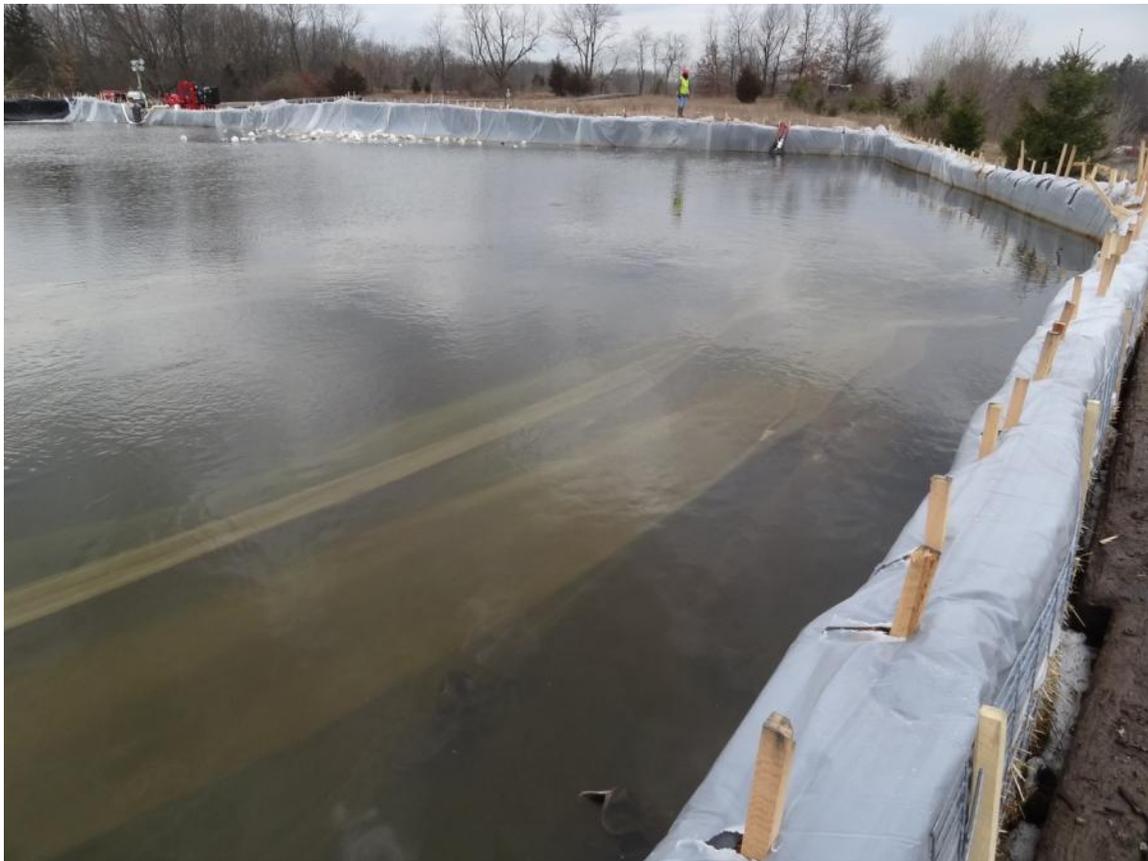
10. Turbidity control structure liner.

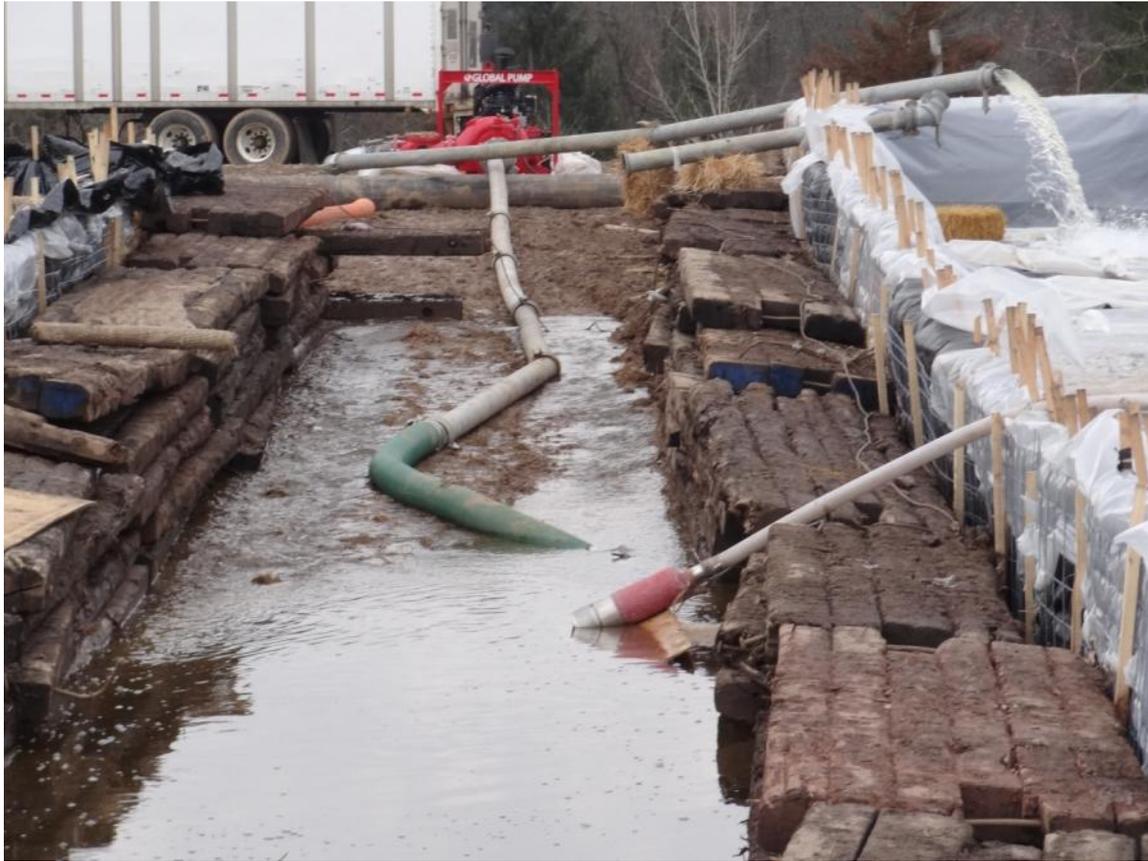
11. Water management at turbidity control structure.

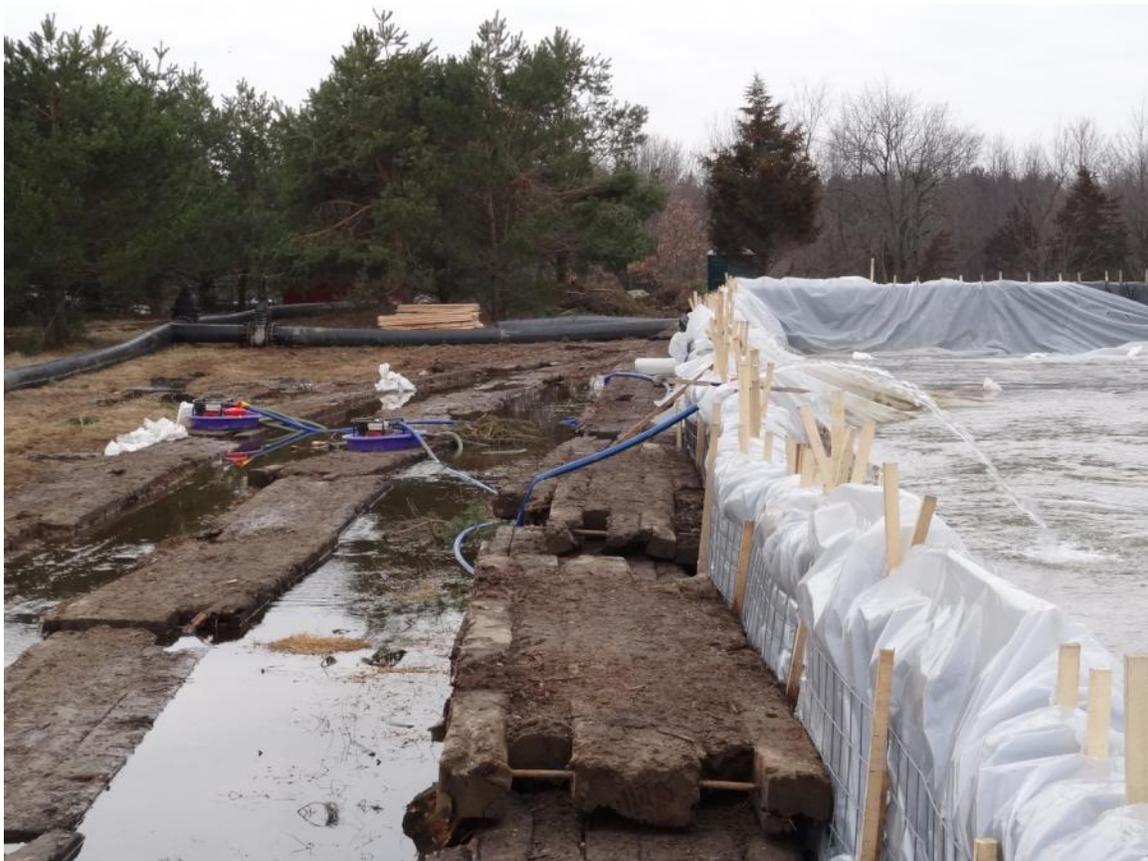
12. Water management at turbidity control structure

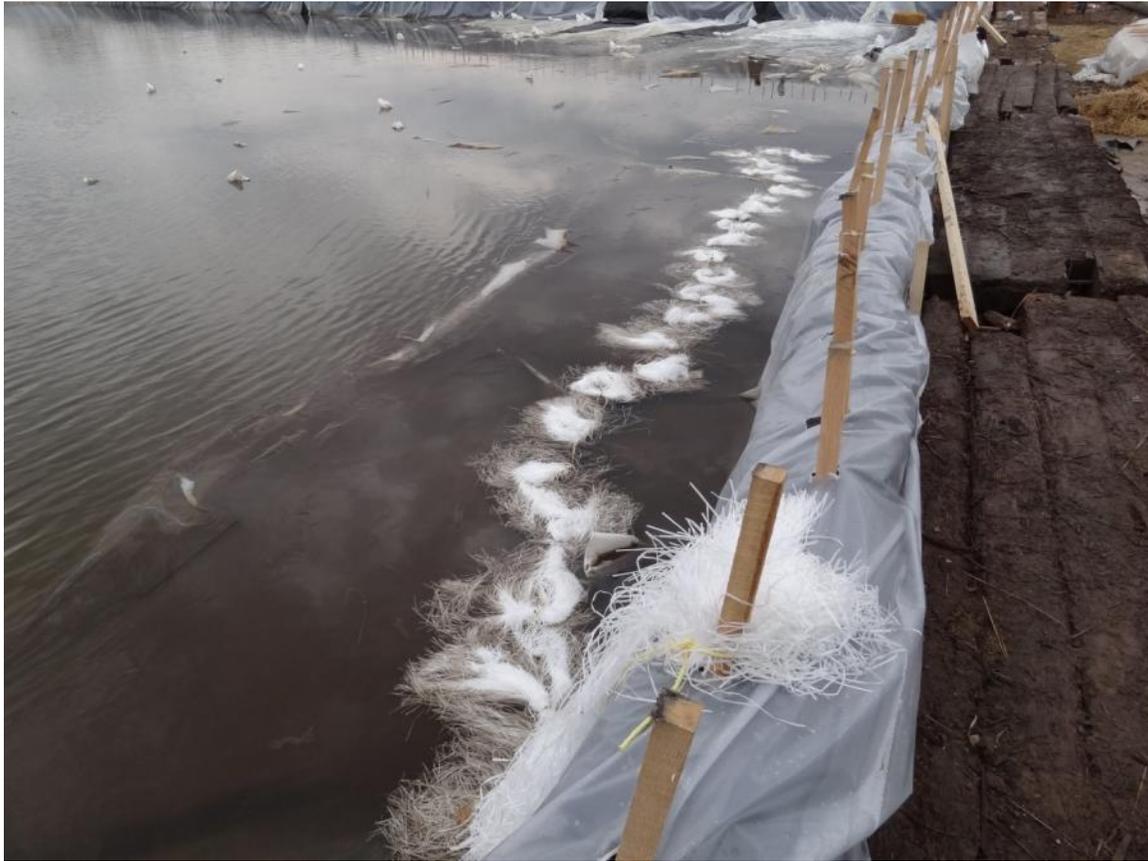
13. Observed snare absorbent within the turbidity control structure.

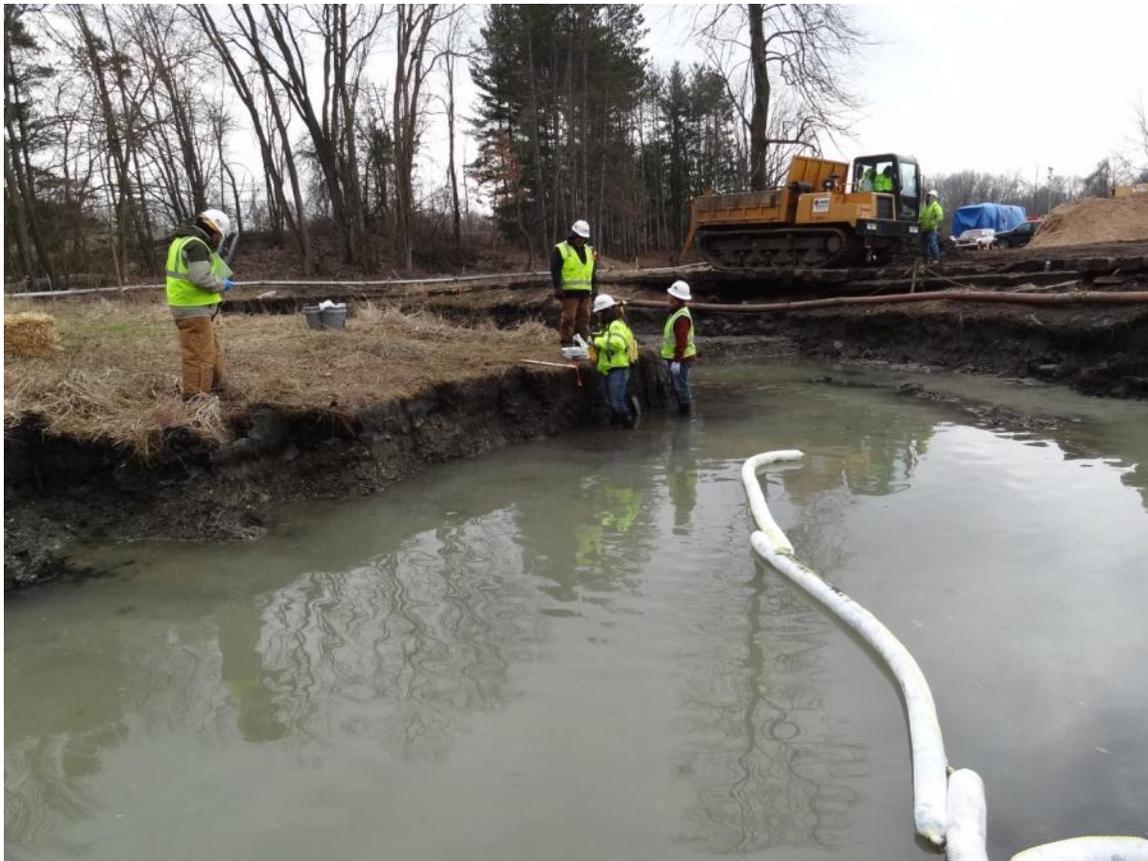
14. Talmadge Creek sampling crew near MP1.85.

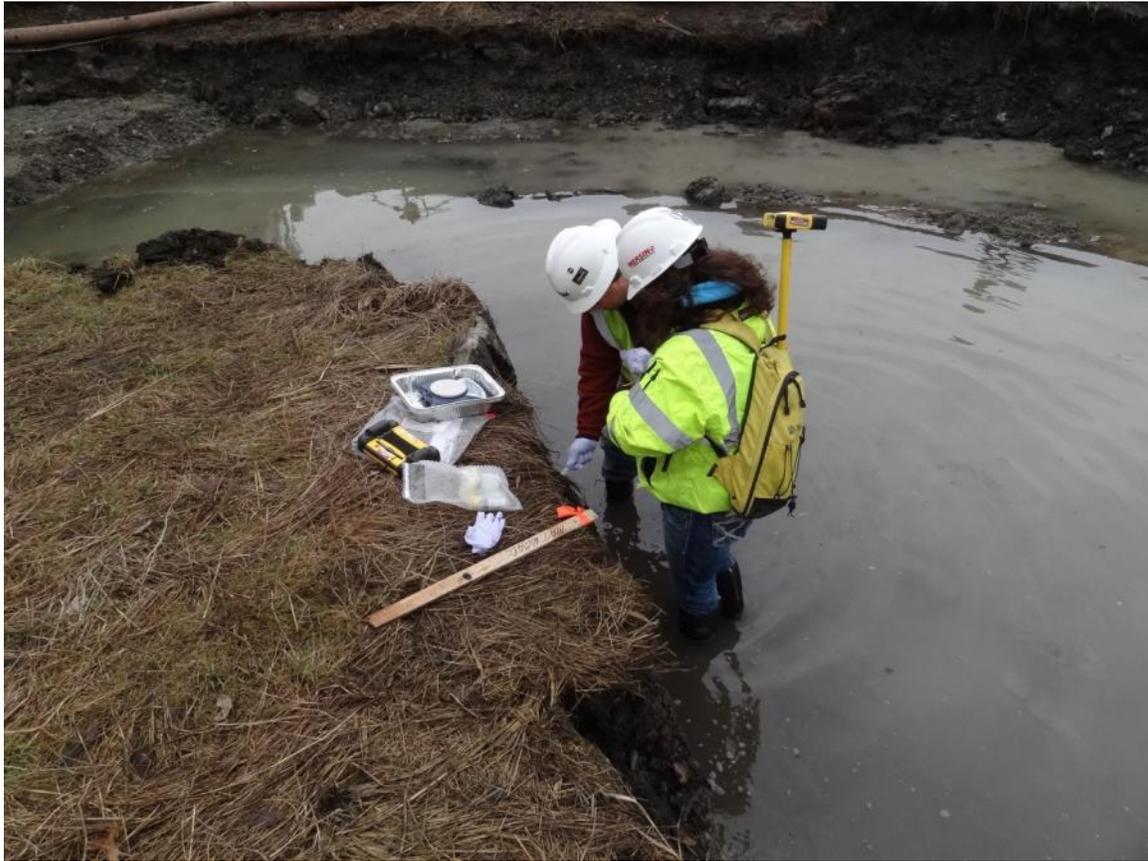
15. Talmadge Creek sampling crew near MP1.85.

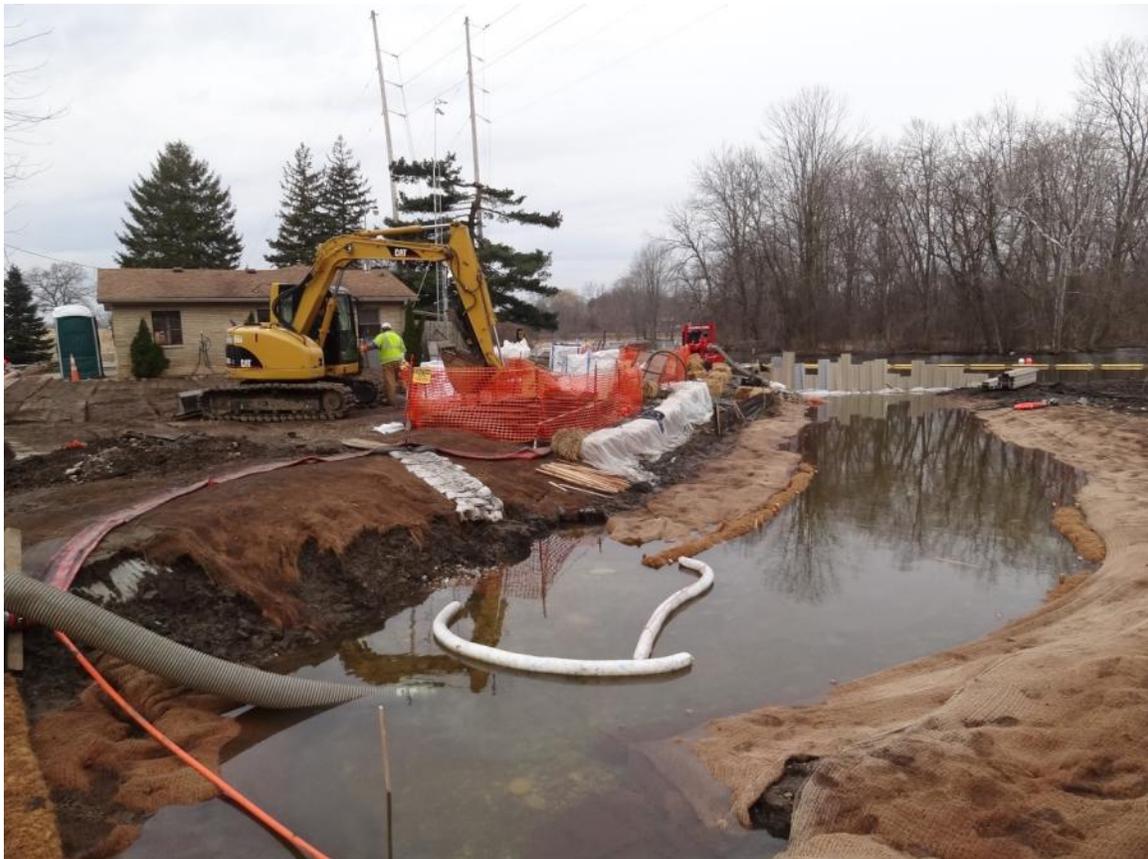
16. Talmadge Creek portion of the confluence.

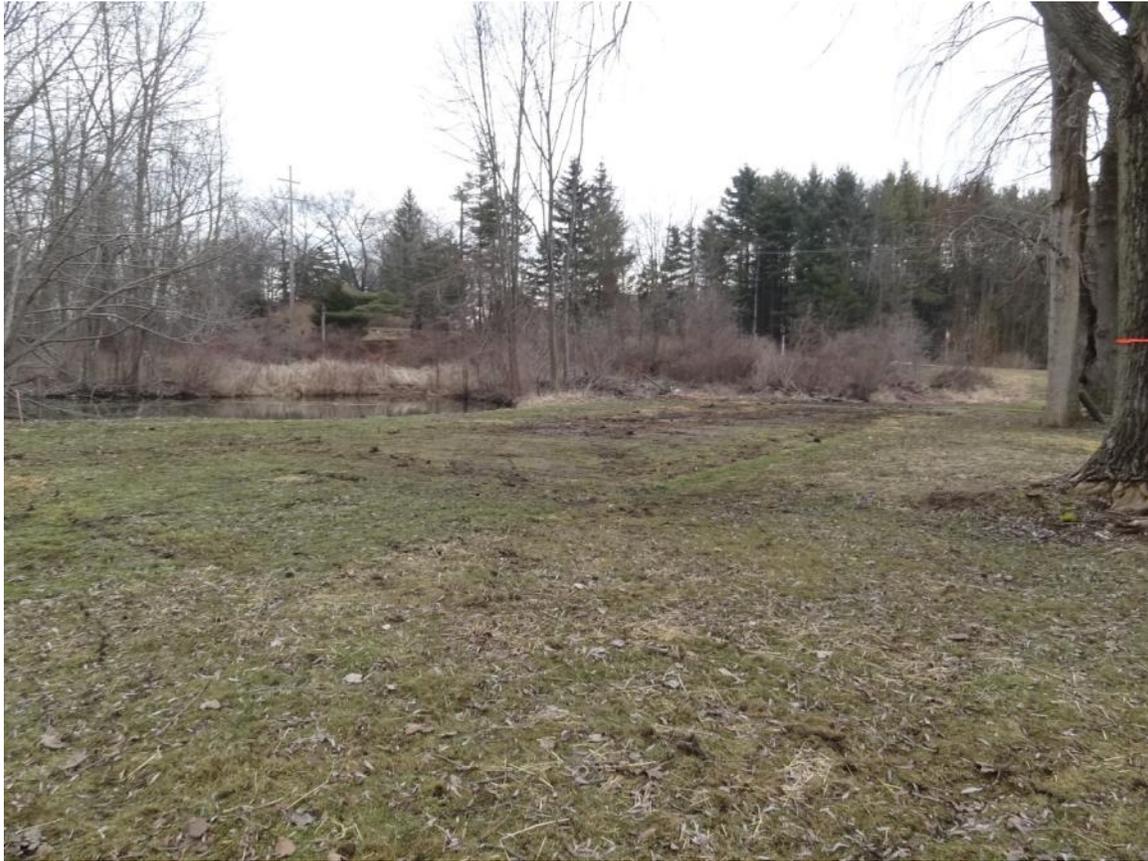
17. Former confluence bypass hay bale structure location.

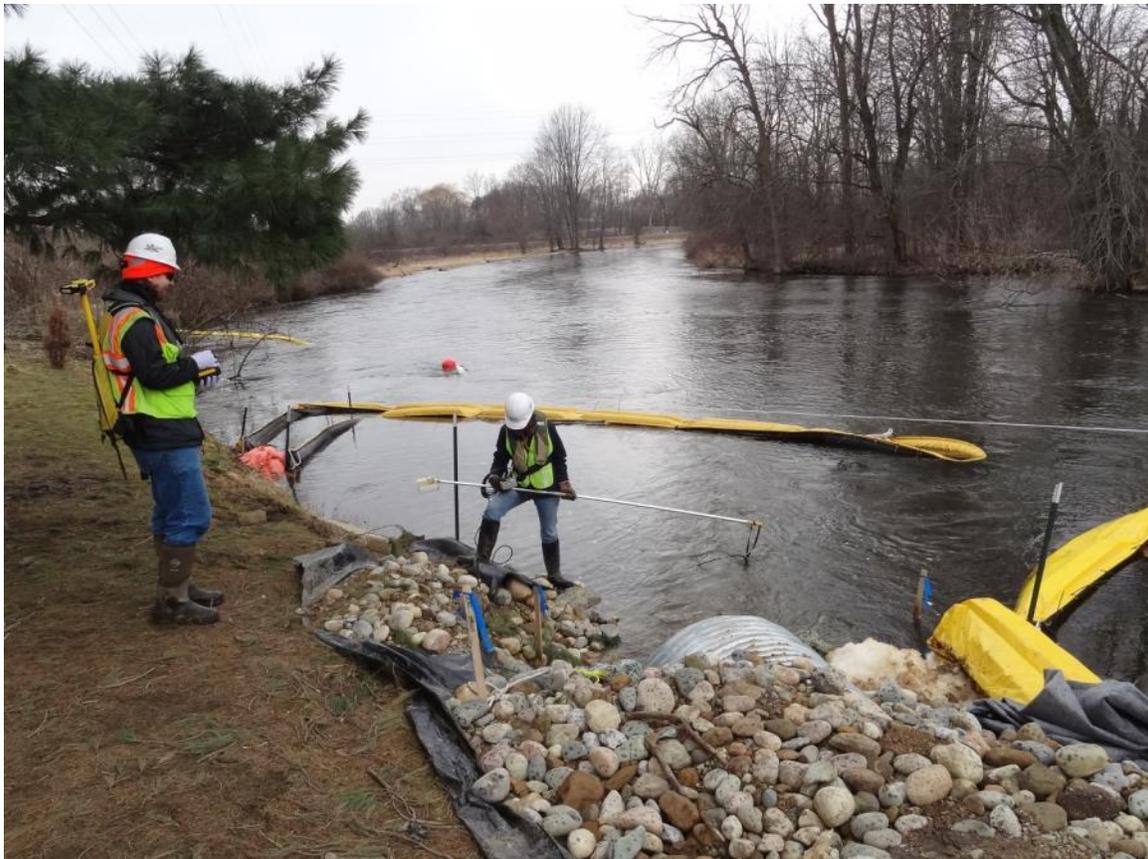
18. Talmadge Creek bypass discharge turbidity monitoring.

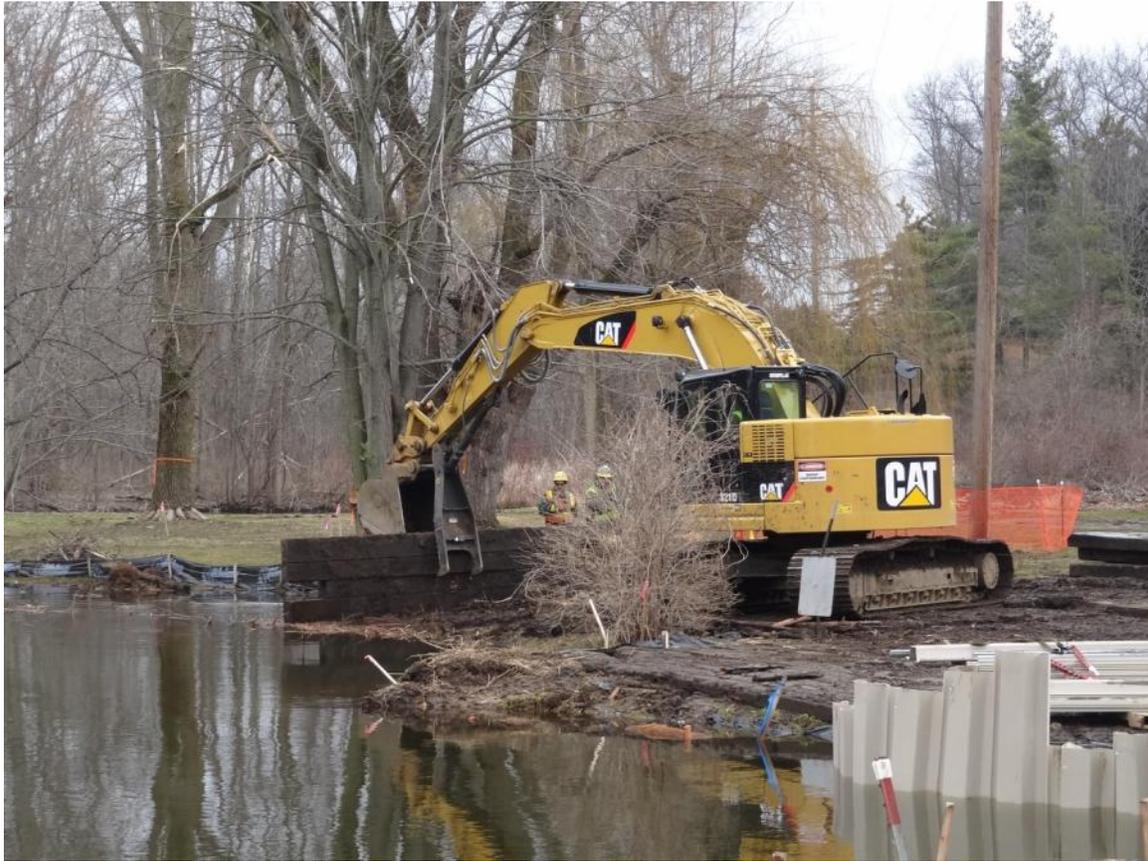
19. Confluence: Observed crews removing timber mats.

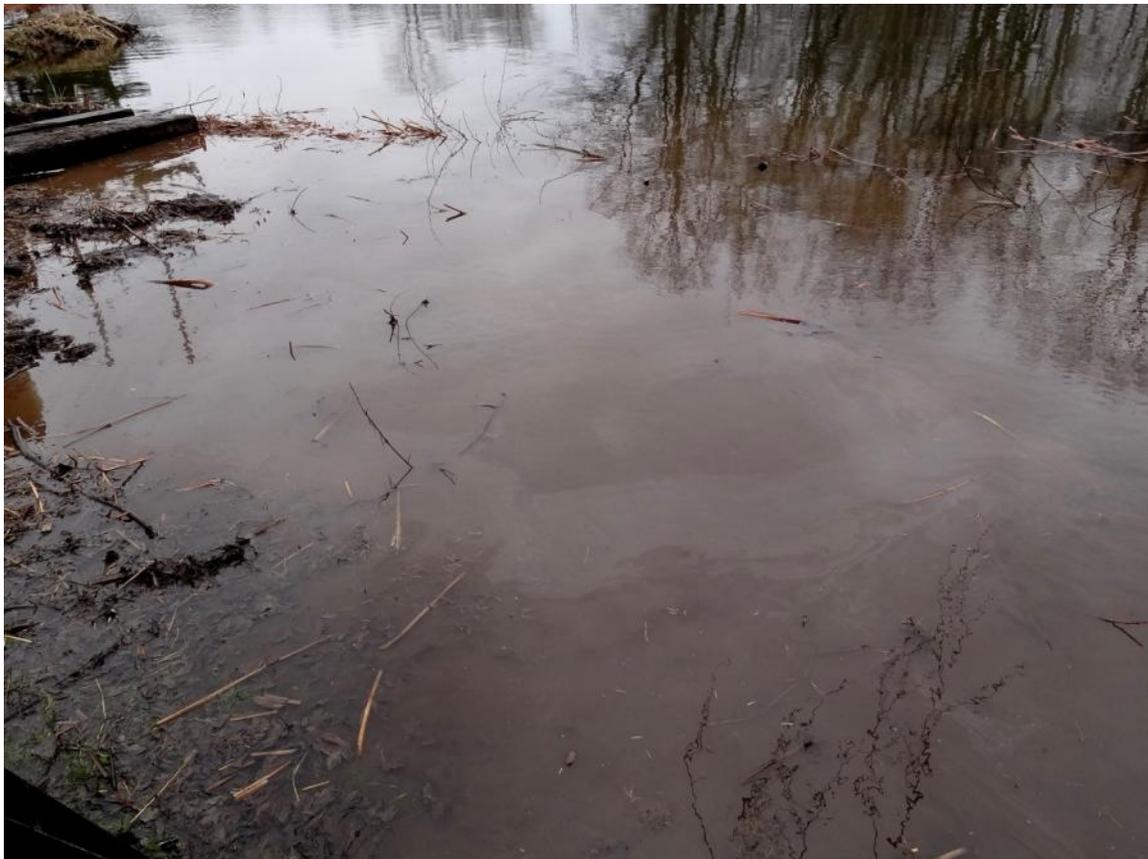
20. Confluence: Sheen observed during timber mat removal.

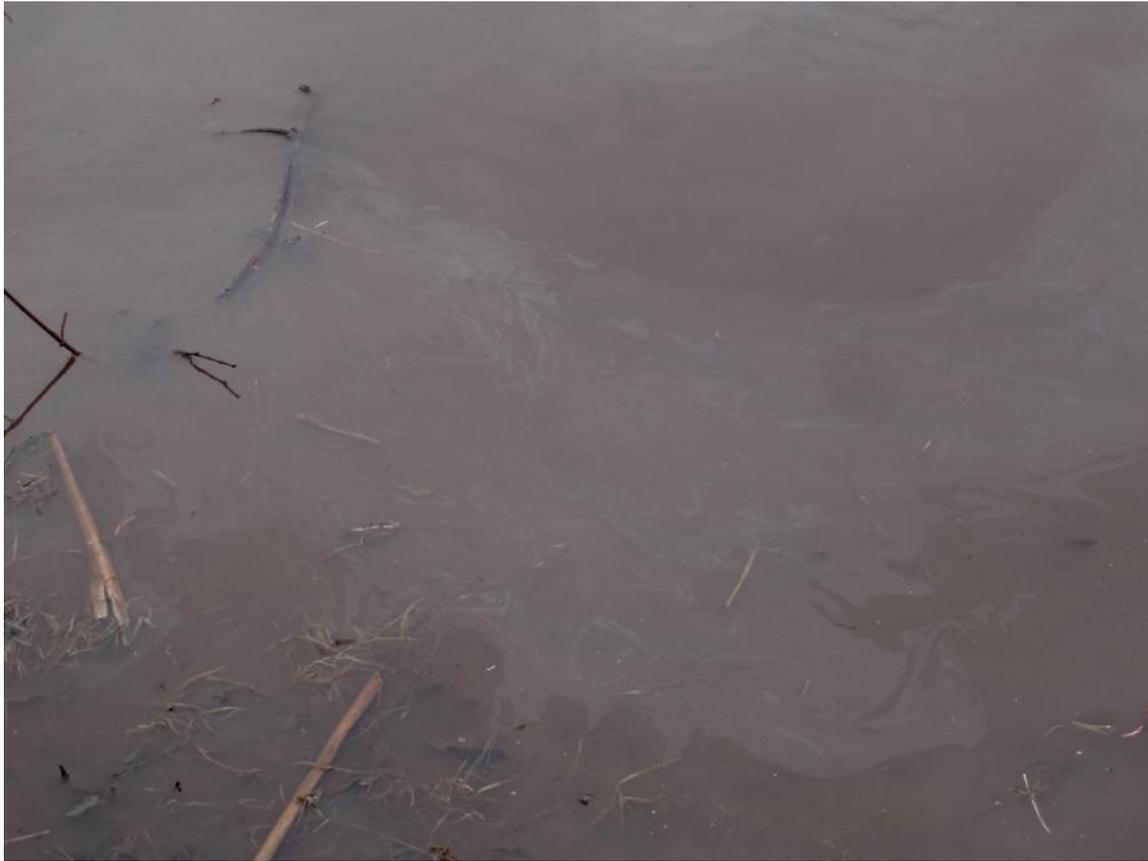
21. Confluence: Sheen observed during timber mat removal.

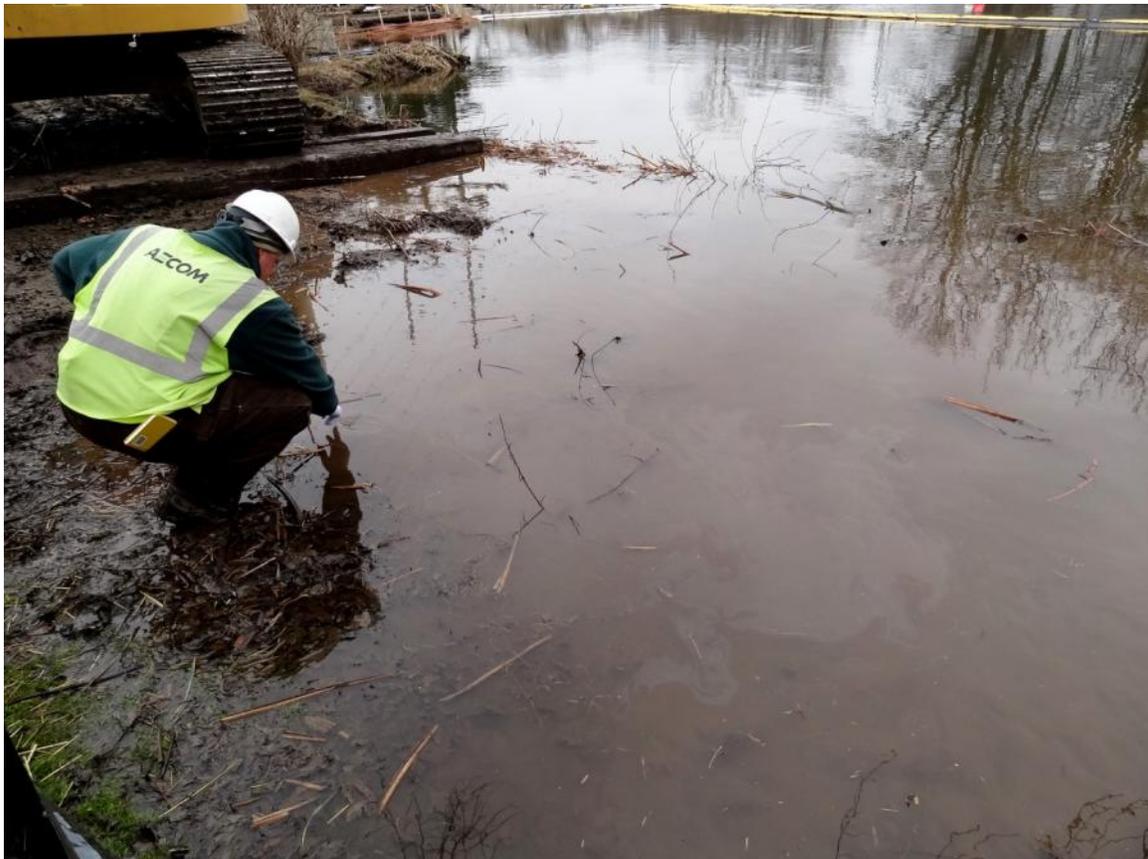
22. Confluence: Sheen observed during timber mat removal.

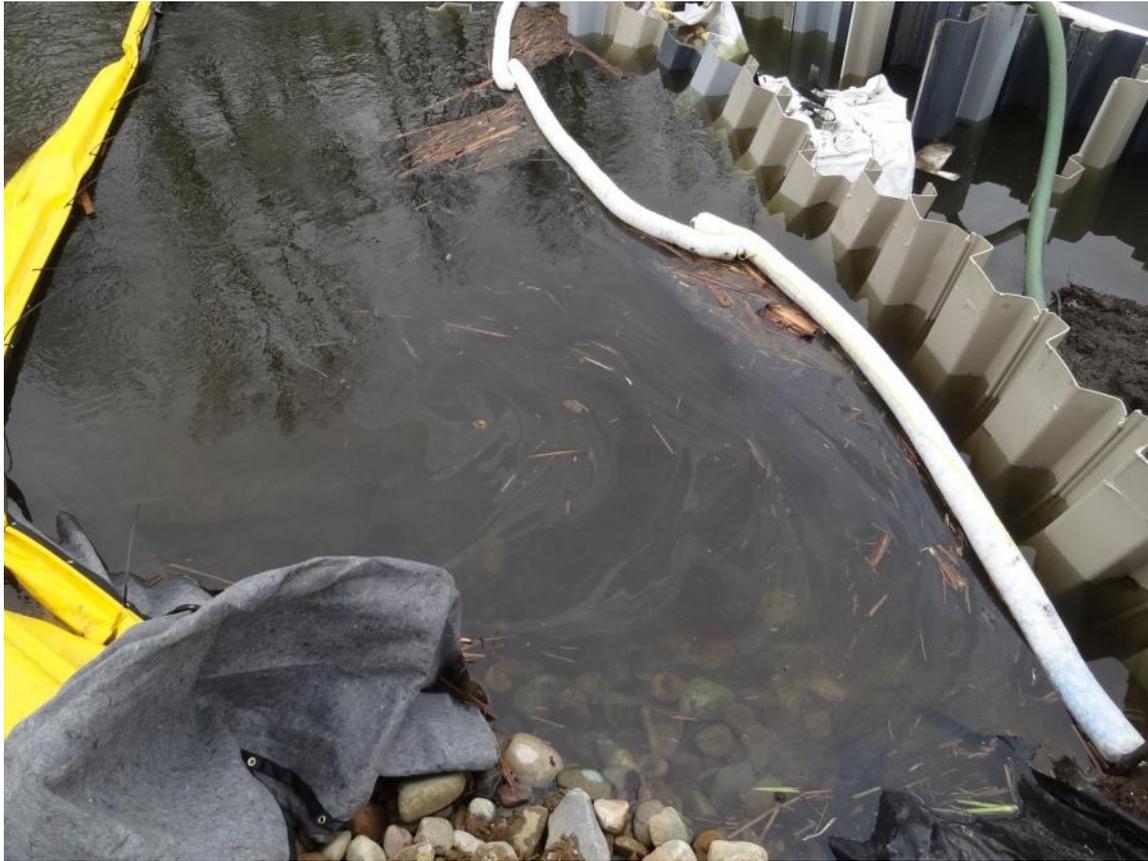
23. Confluence: Sheen observed within containment.
