# Situation Photo Log

Friday, March 2, 2012

Kalamazoo River / Enbridge Spill

Matthew Haak  
START-USEPA  
Situation Unit Leader

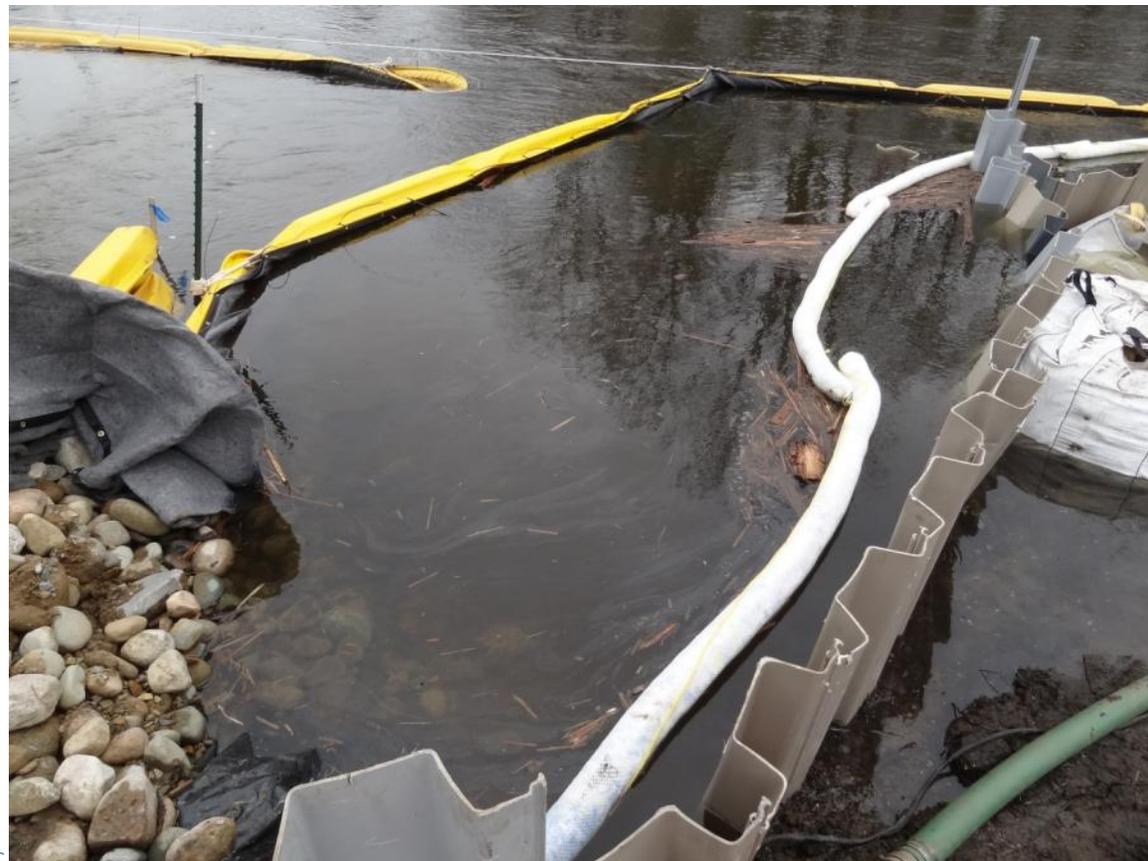
24. Confluence: Sheen observed within containment.

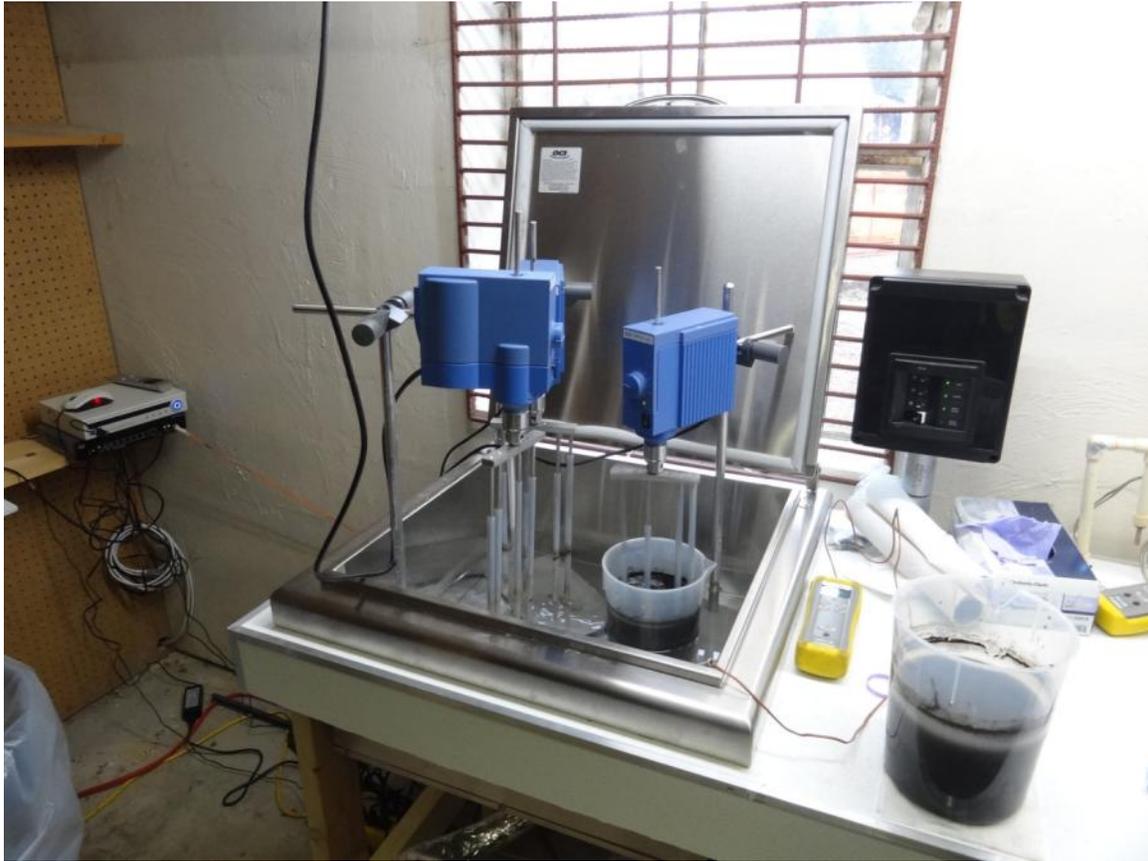
25. Temperature effects study.

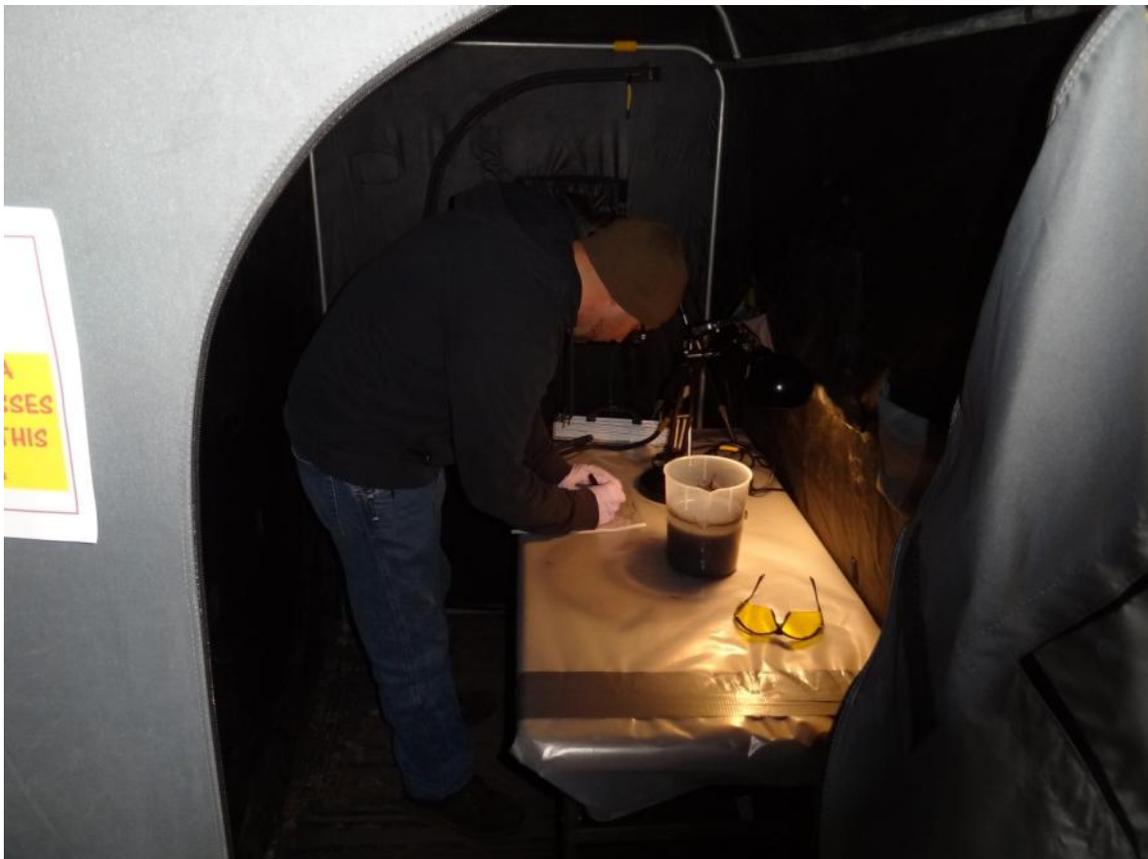
26. Temperature effects study.

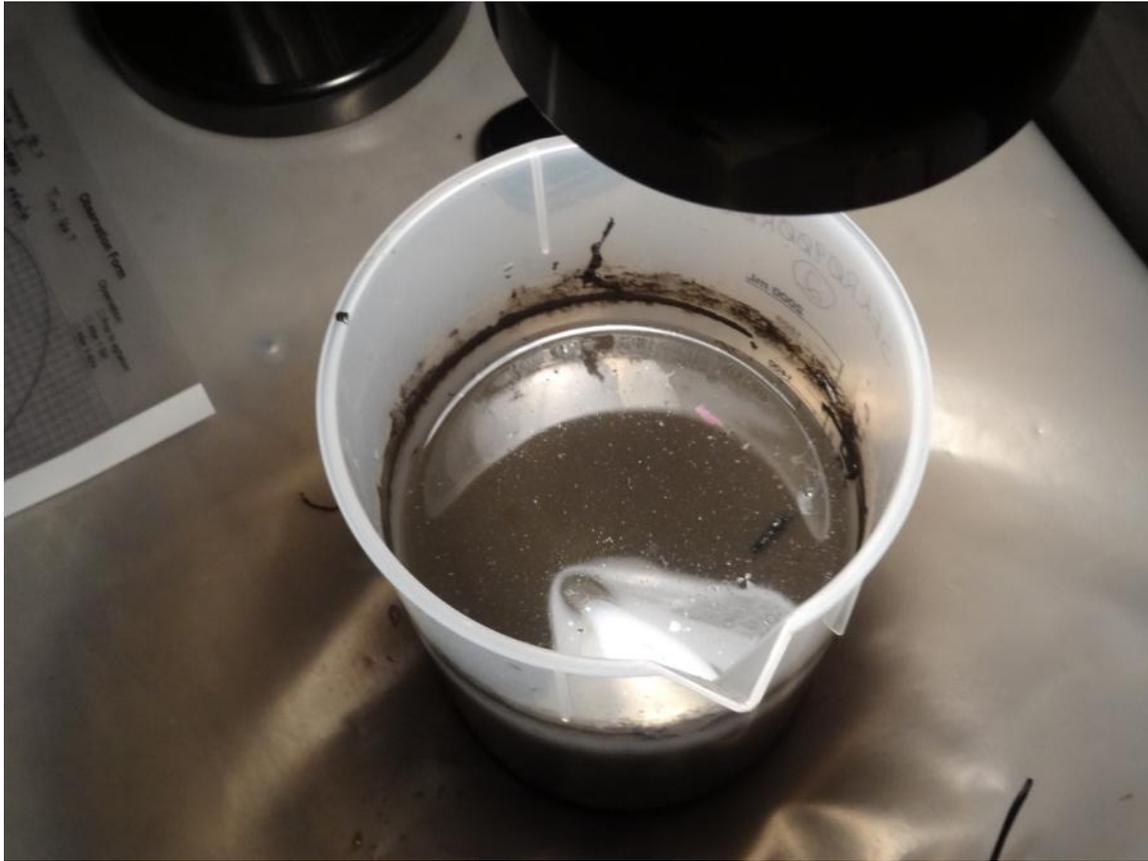
27. Temperature effects study.

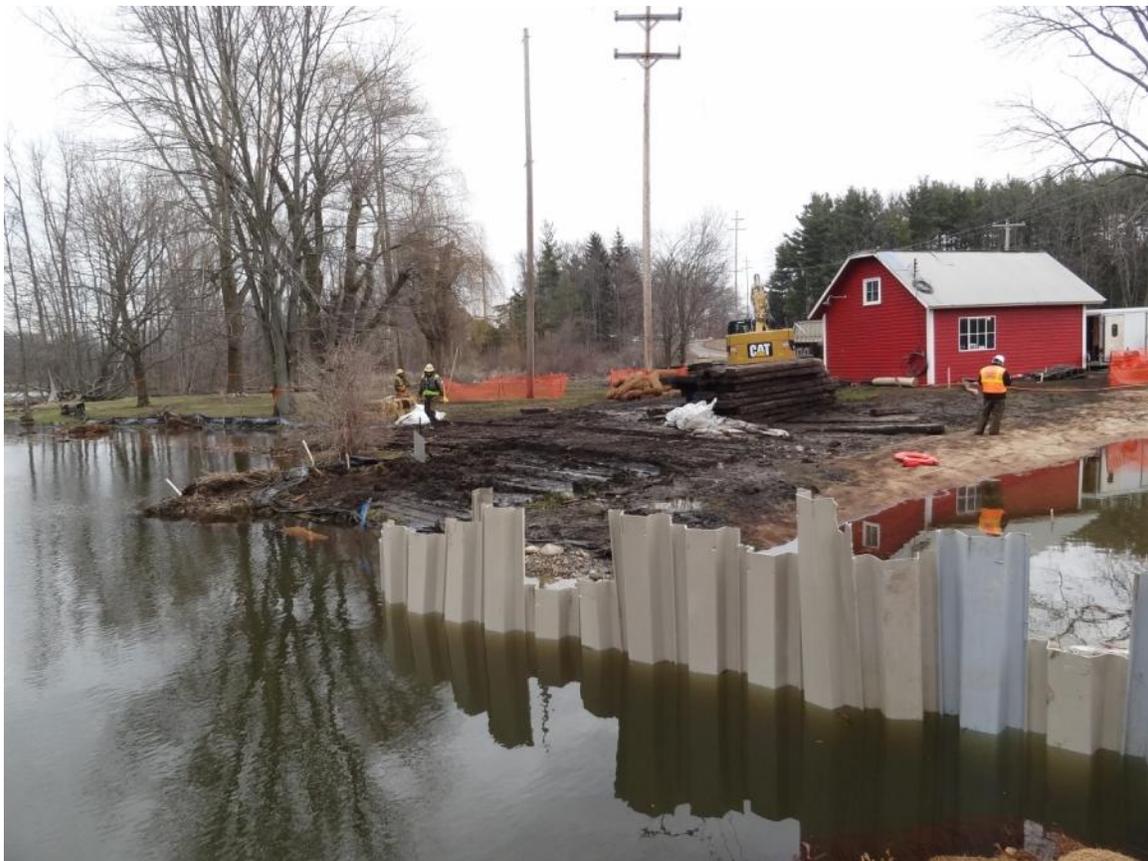
28. Confluence demobilization activities.

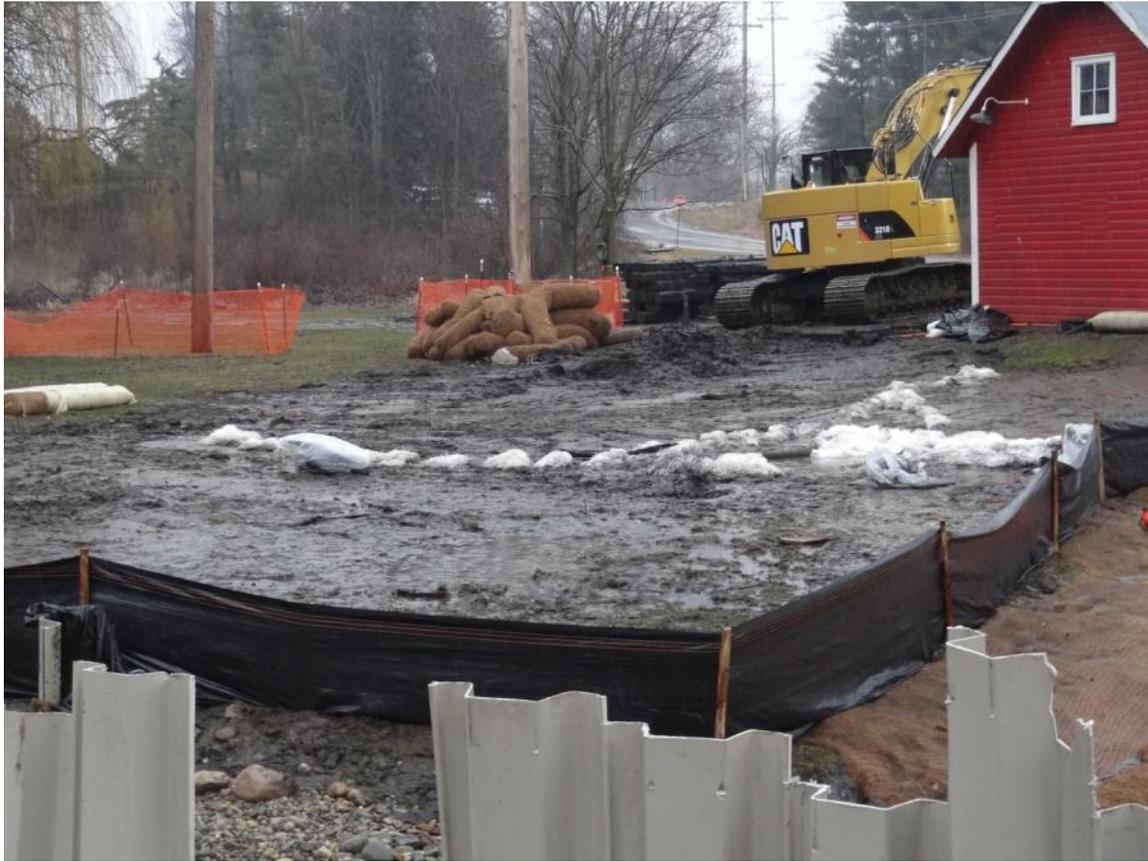
29. Timber mats removed at Confluence and snare absorbent observed.

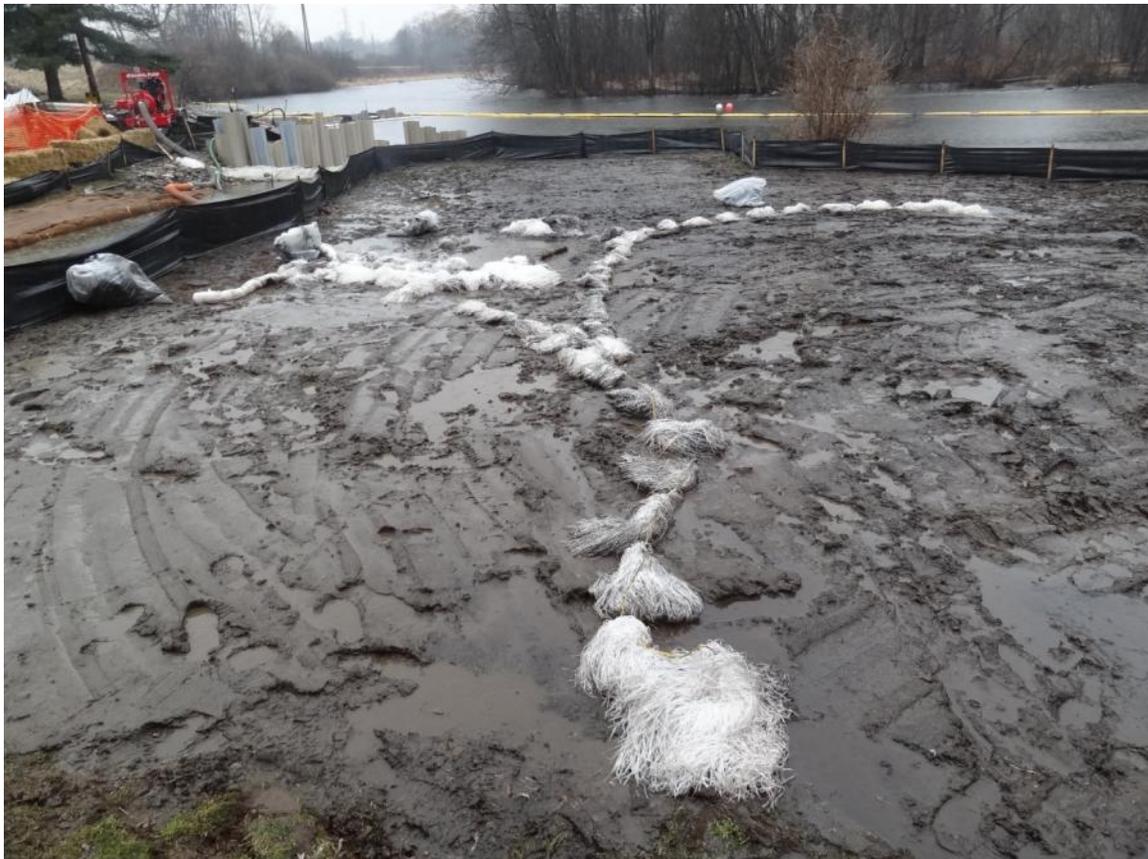
30. Timber mats removed at Confluence and snare absorbent observed.

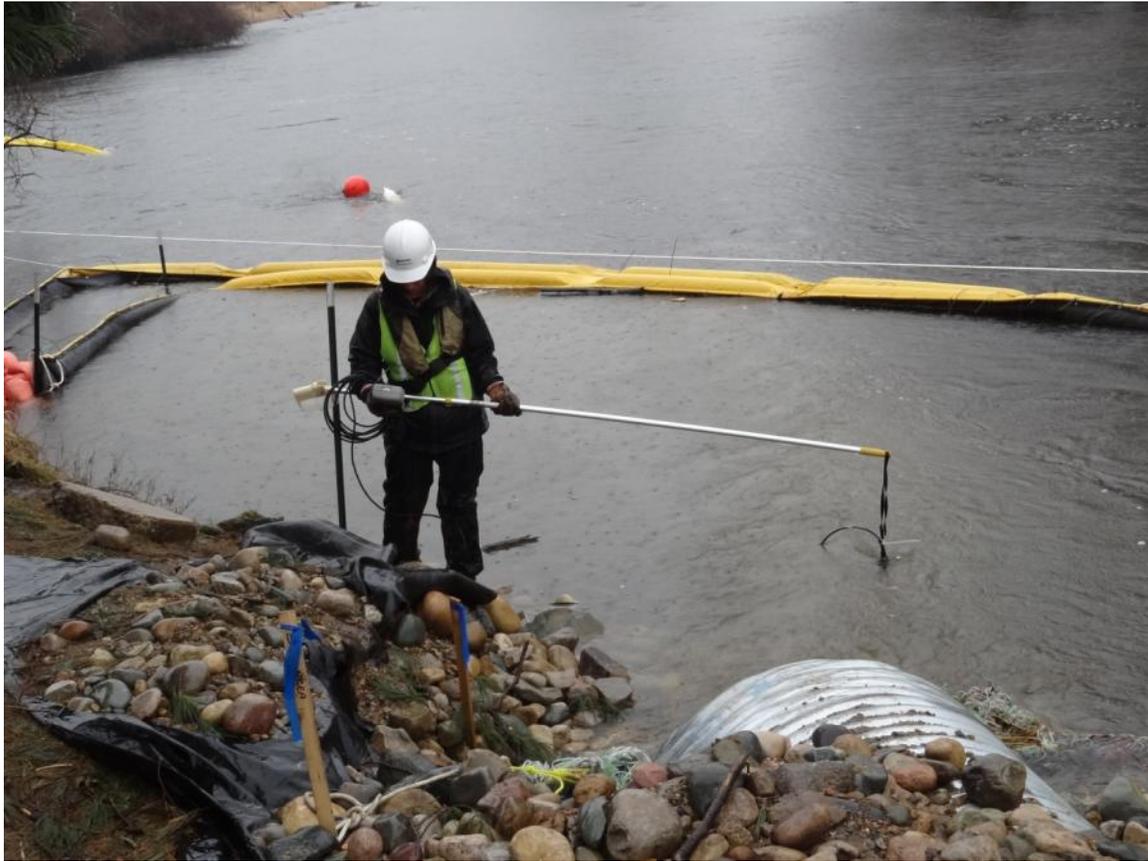
31. Bypass discharge turbidity reading just after rain began.

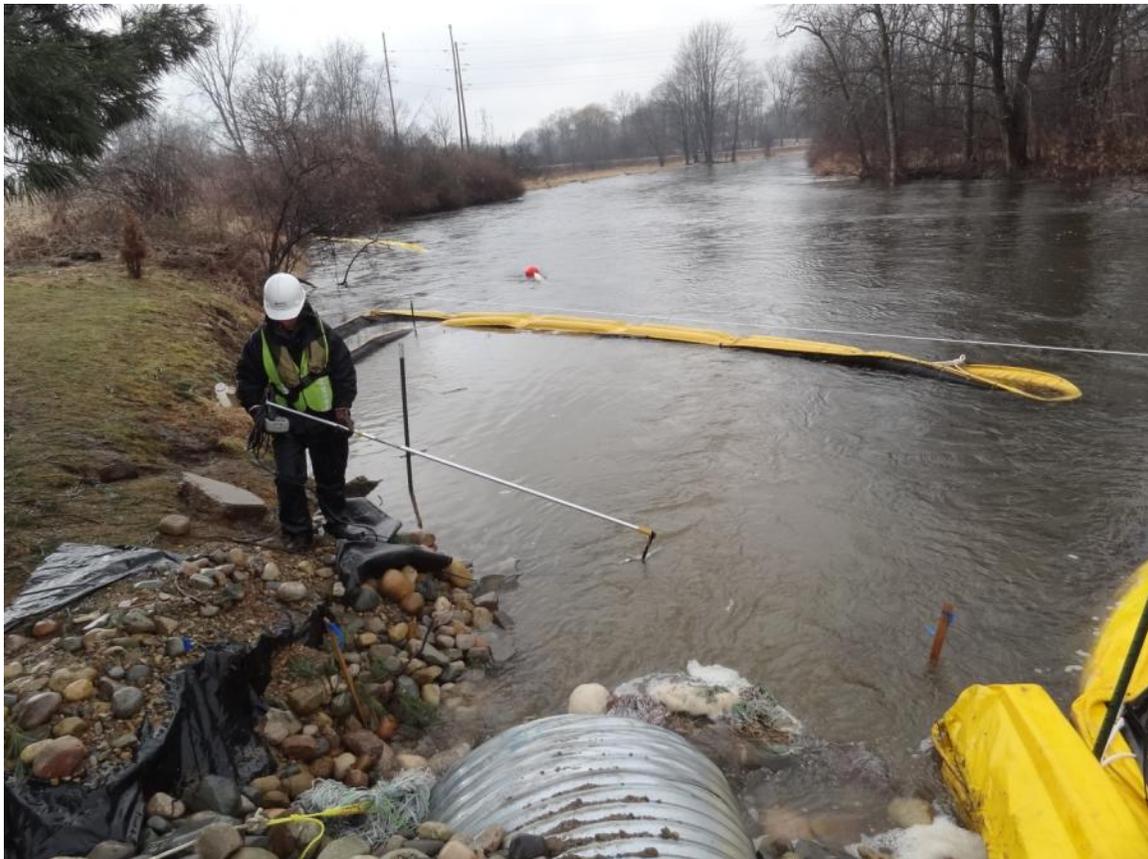
32. Bypass discharge turbidity reading two hours into rainfall.

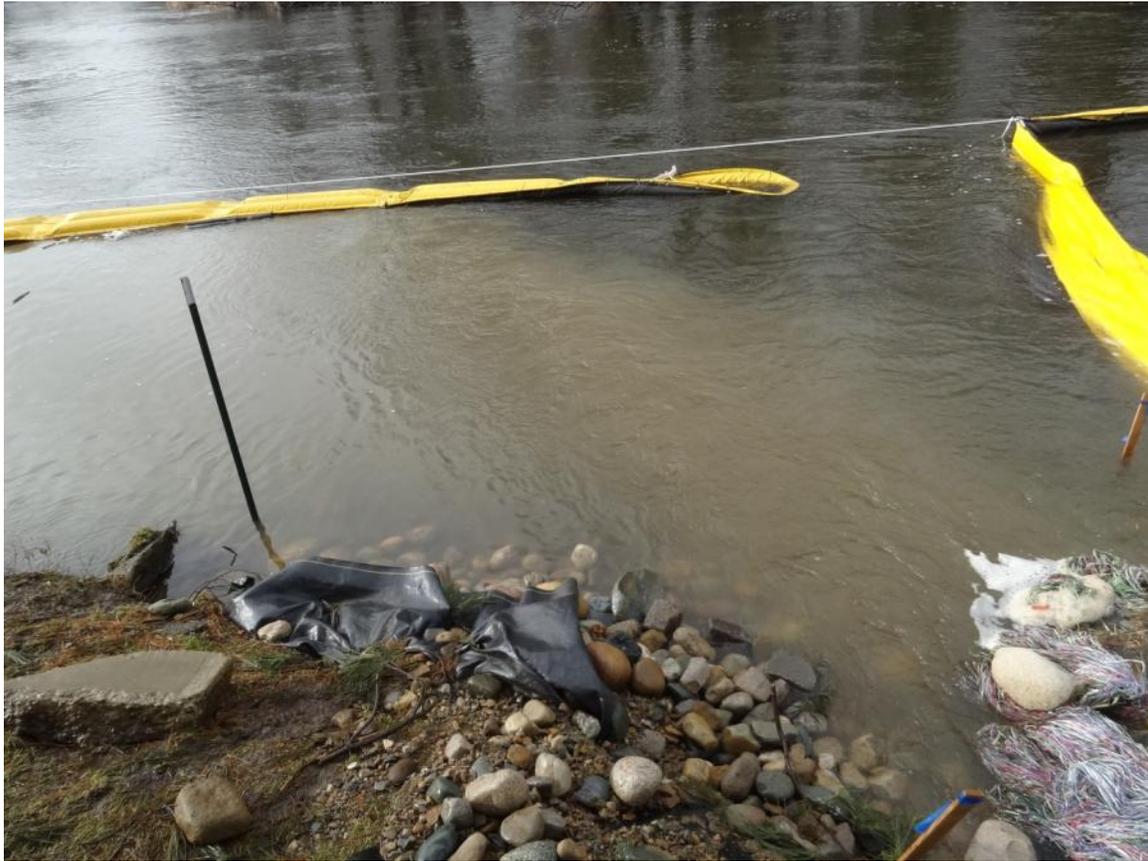
33. Talmadge Creek bypass turbidity observed.

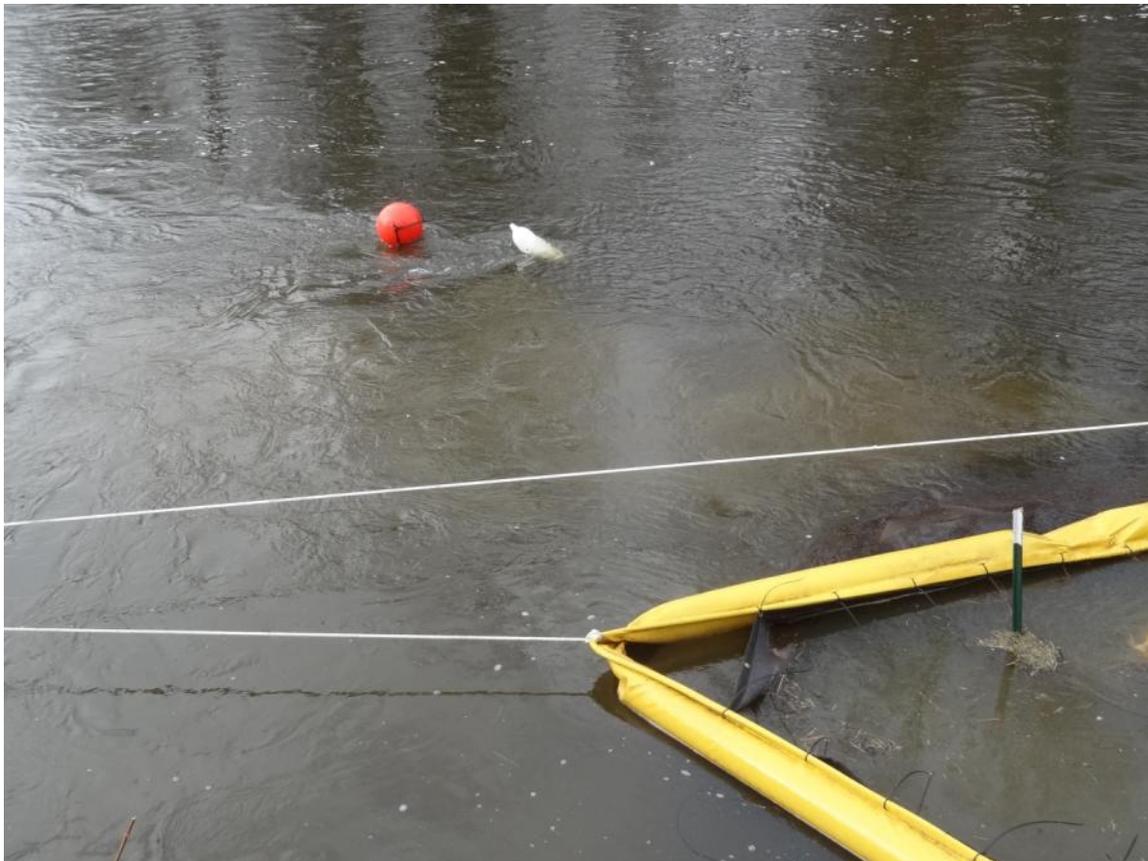
34. Talmadge Creek bypass discharge turbidity observed.

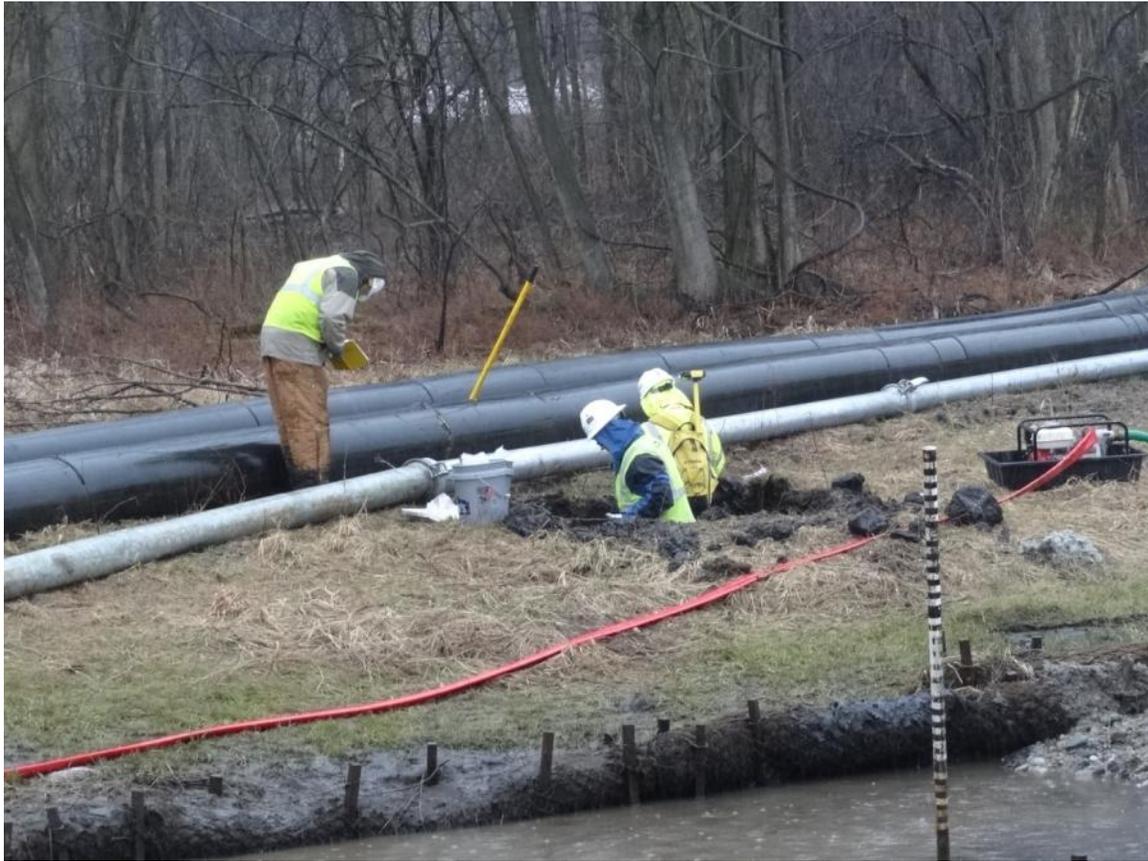
35. Talmadge Creek approximately MP1.9 crews observed sampling scrape area.

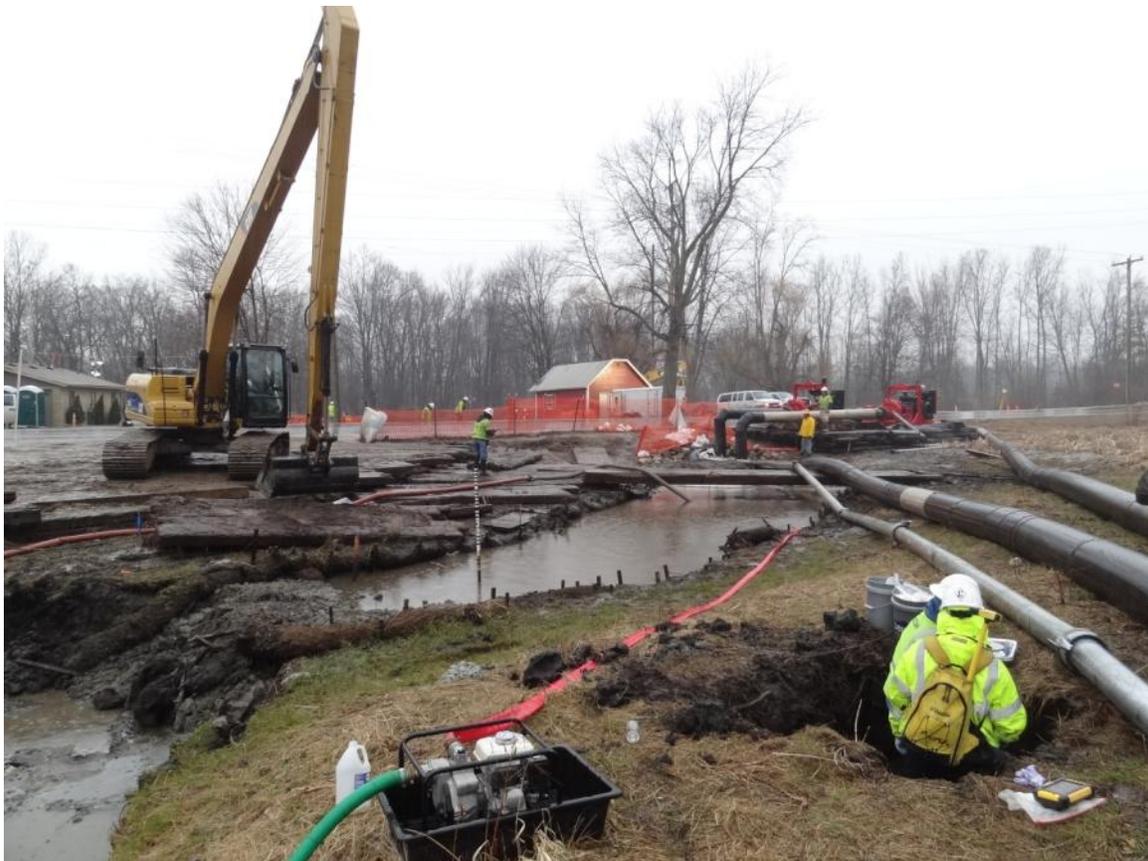
36. Talmadge Creek excavation work near approximately MP1.9.

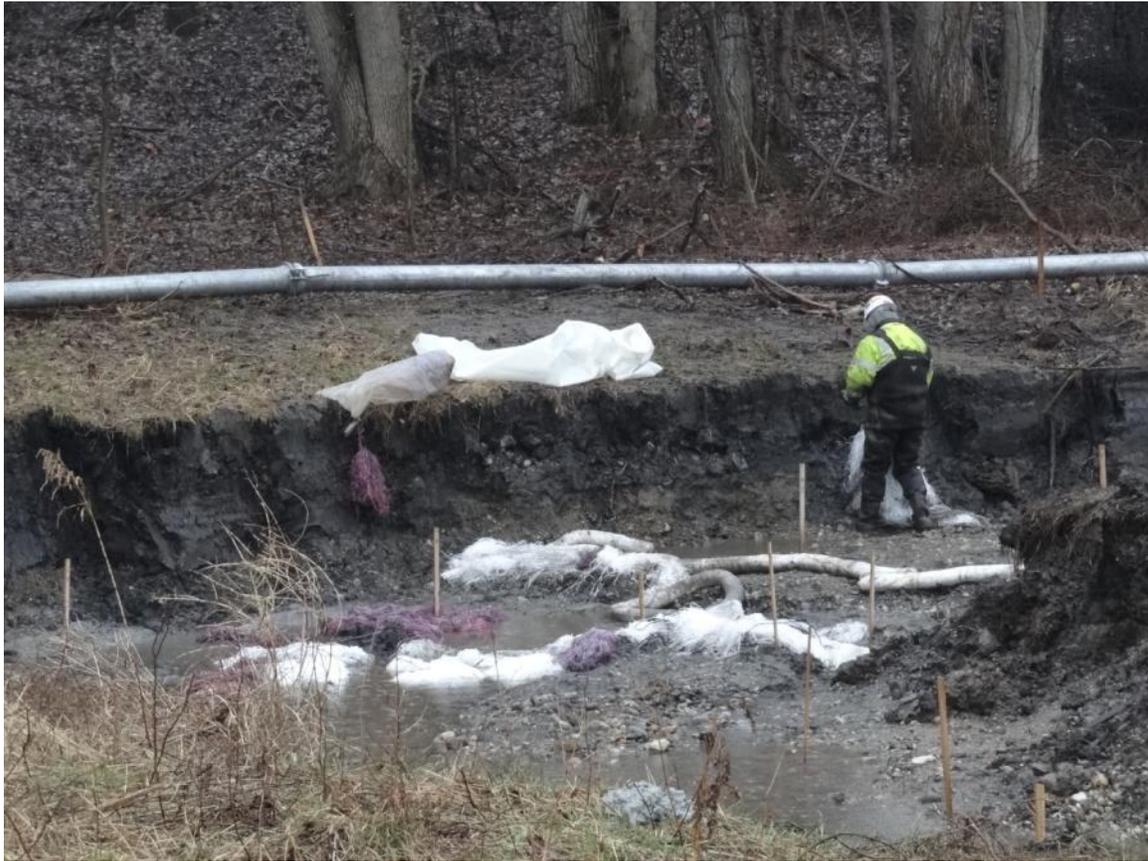
37. Talmadge Creek MP1.85 observed snare absorbent being used to touchup side wall of excavation.

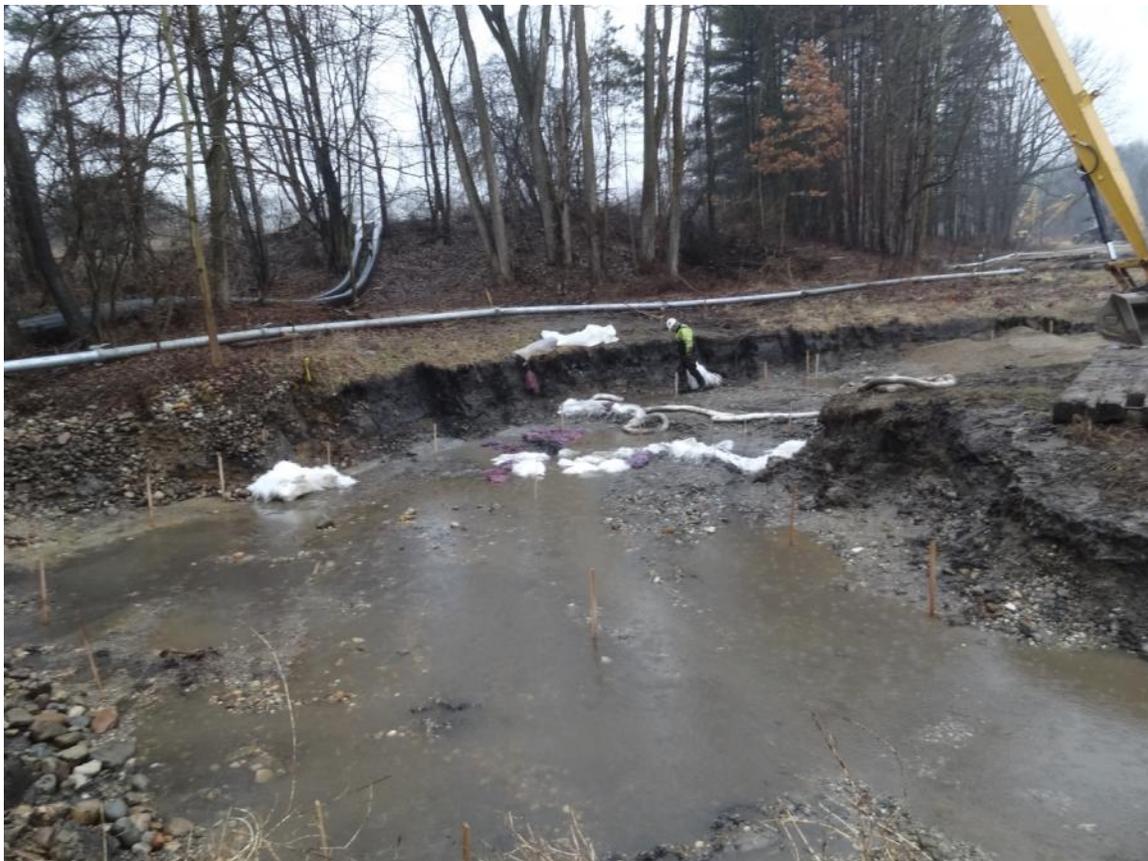
38. Talmadge Creek MP1.85 observed snare absorbent being used to touchup side wall of excavation.

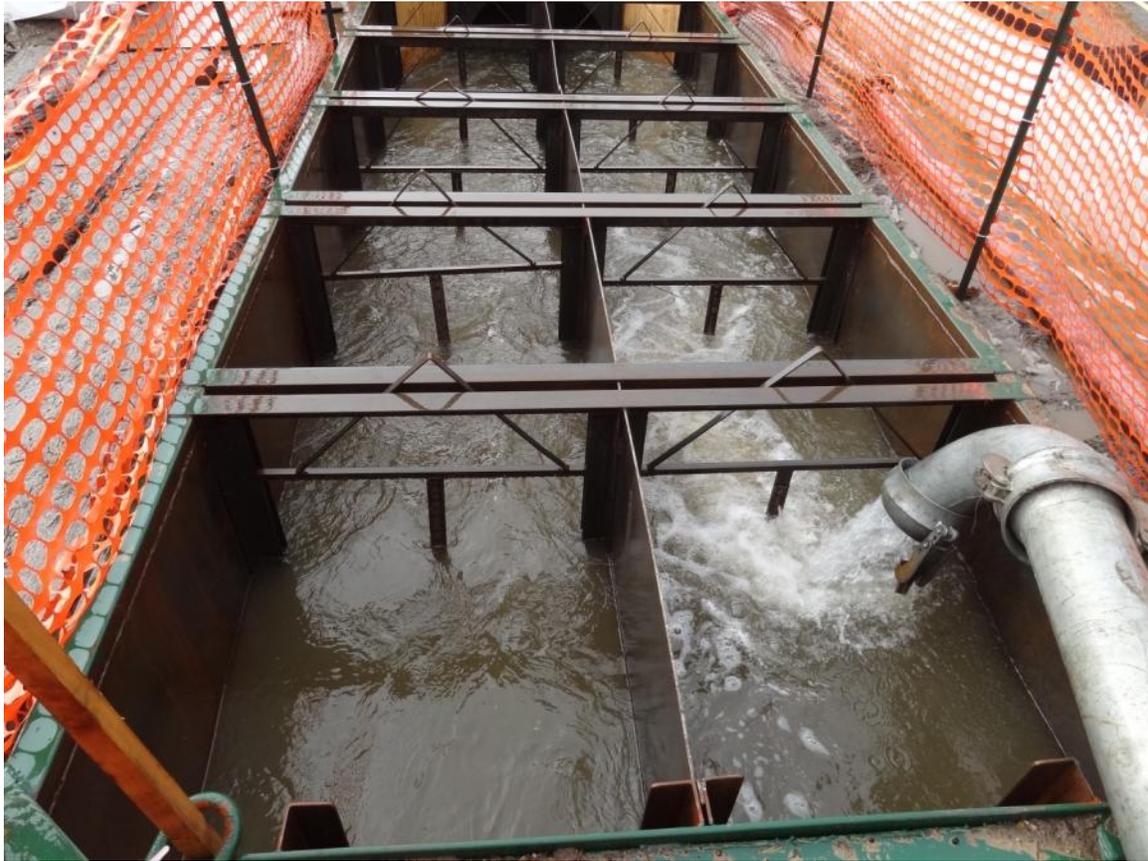
39. Talmadge Creek GAC discharging directly into bypass boxes.

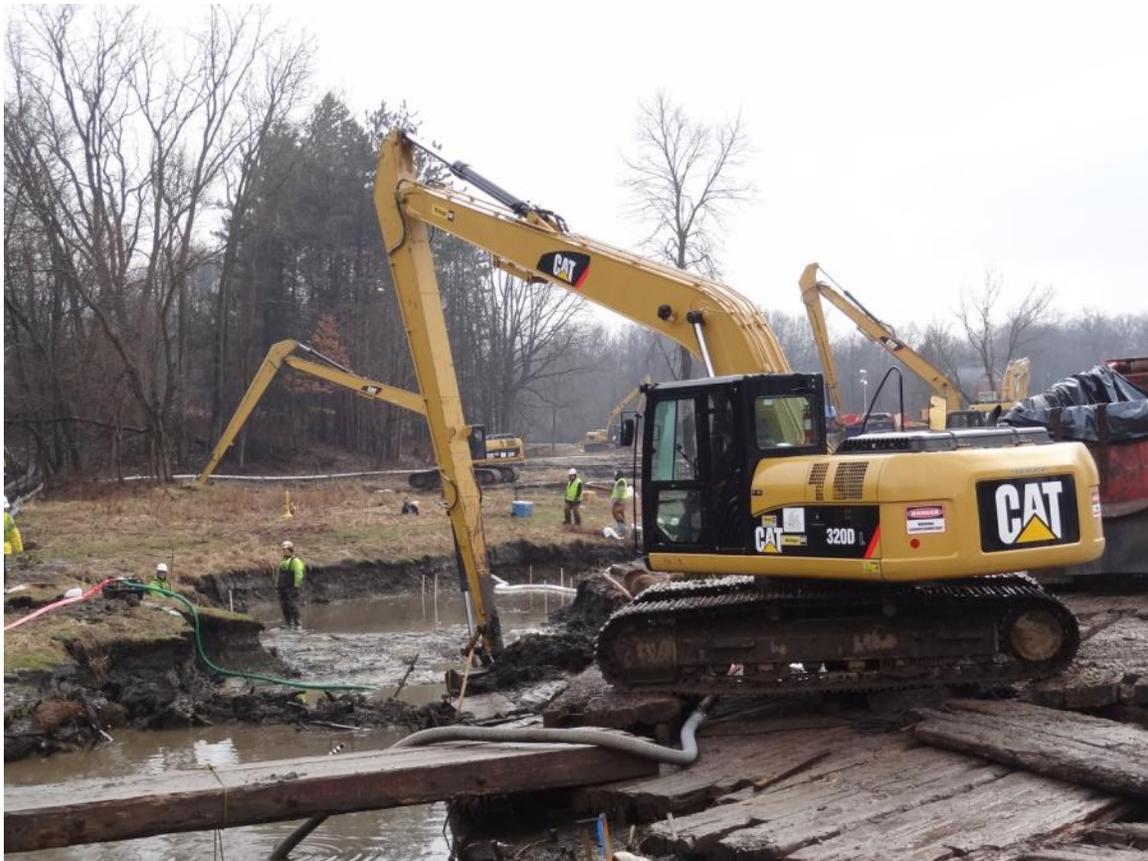
40. Talmadge Creek excavation work near MP1.9.
