# Situation Photo Log

Saturday, March 3, 2012

Kalamazoo River / Enbridge Spill

Matthew Haak  
START-USEPA  
Situation Unit Leader

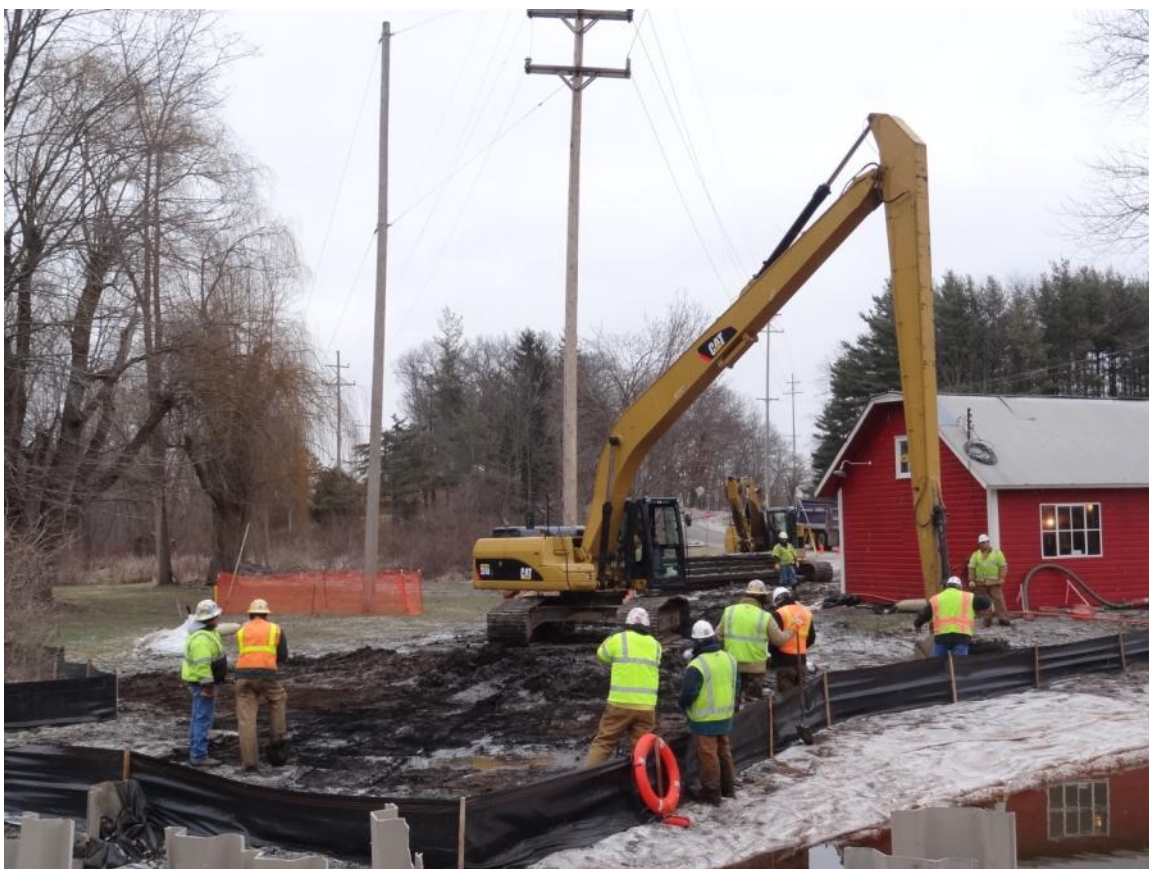
1. Talmadge Creek: additional scrape near confluence.

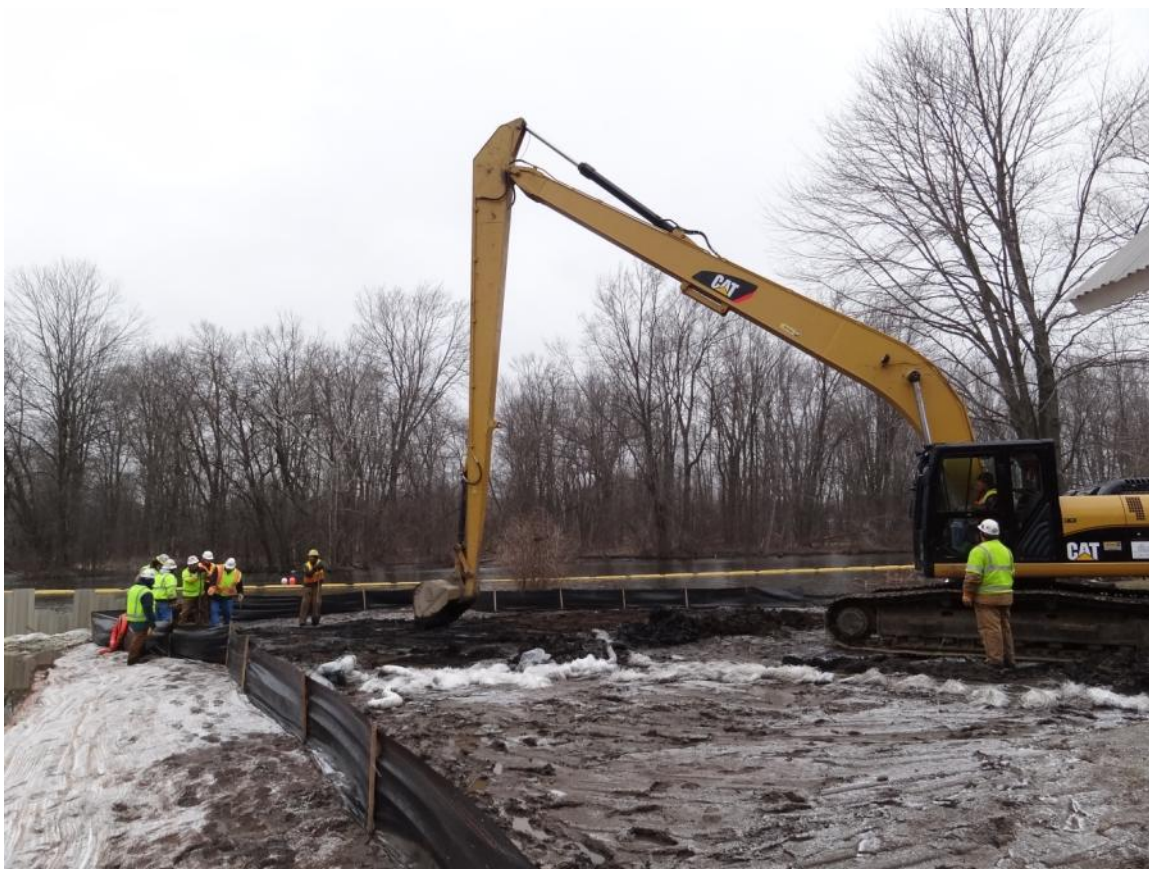
2. Talmadge Creek: additional scrape near confluence.

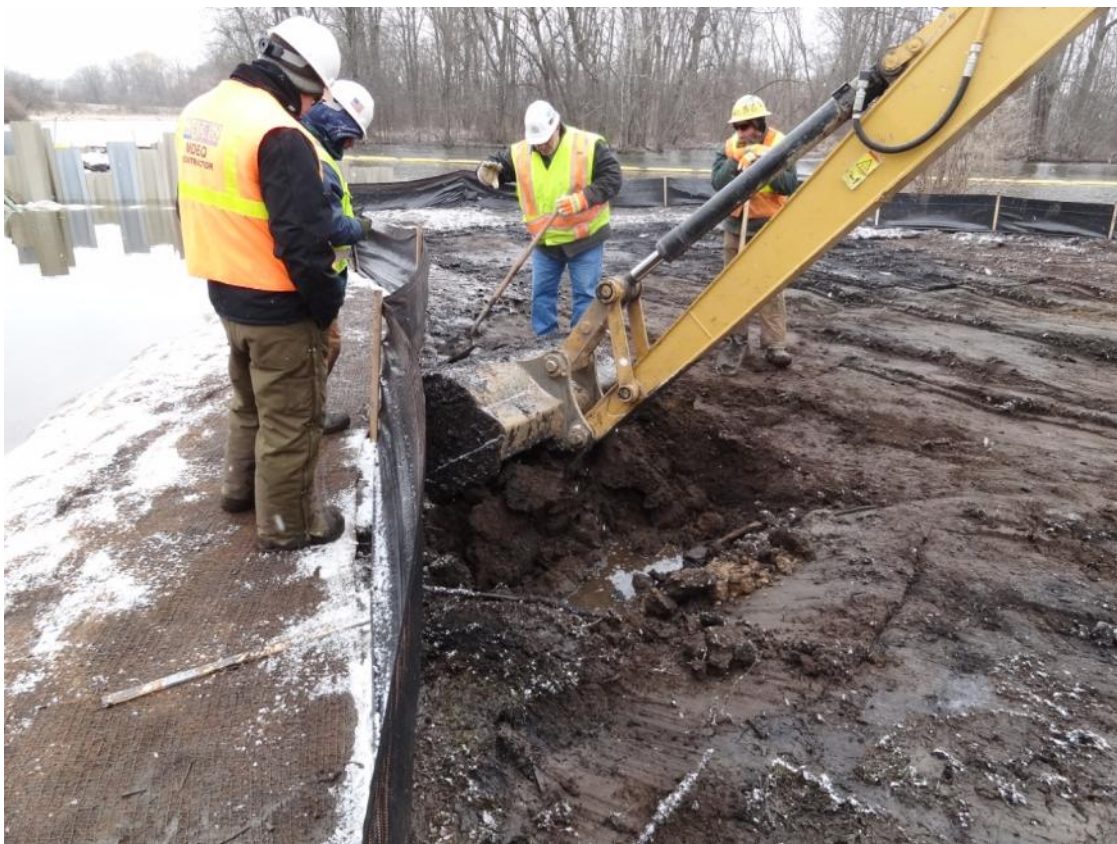
3. Talmadge Creek: additional scrape near confluence.

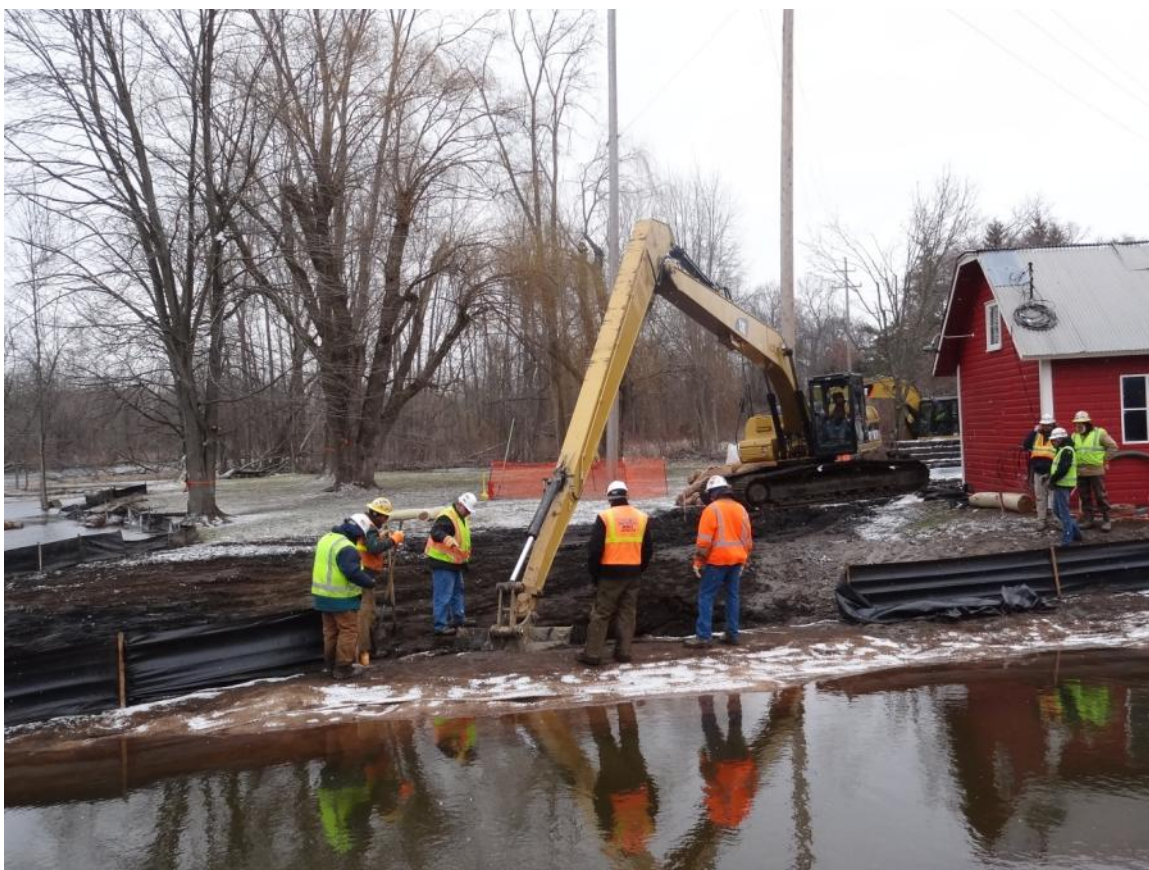
4. Talmadge Creek: additional scrape near confluence.

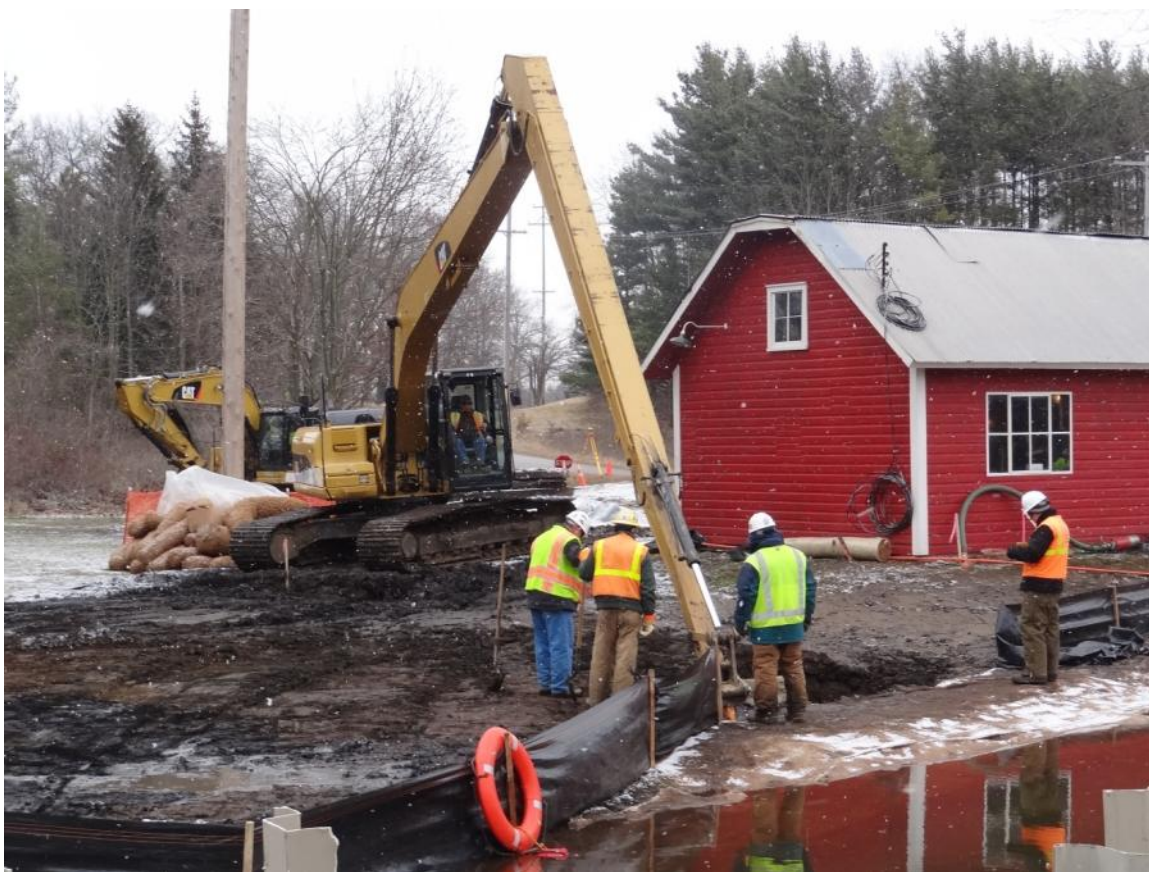
5. Talmadge Creek: additional scrape near confluence.

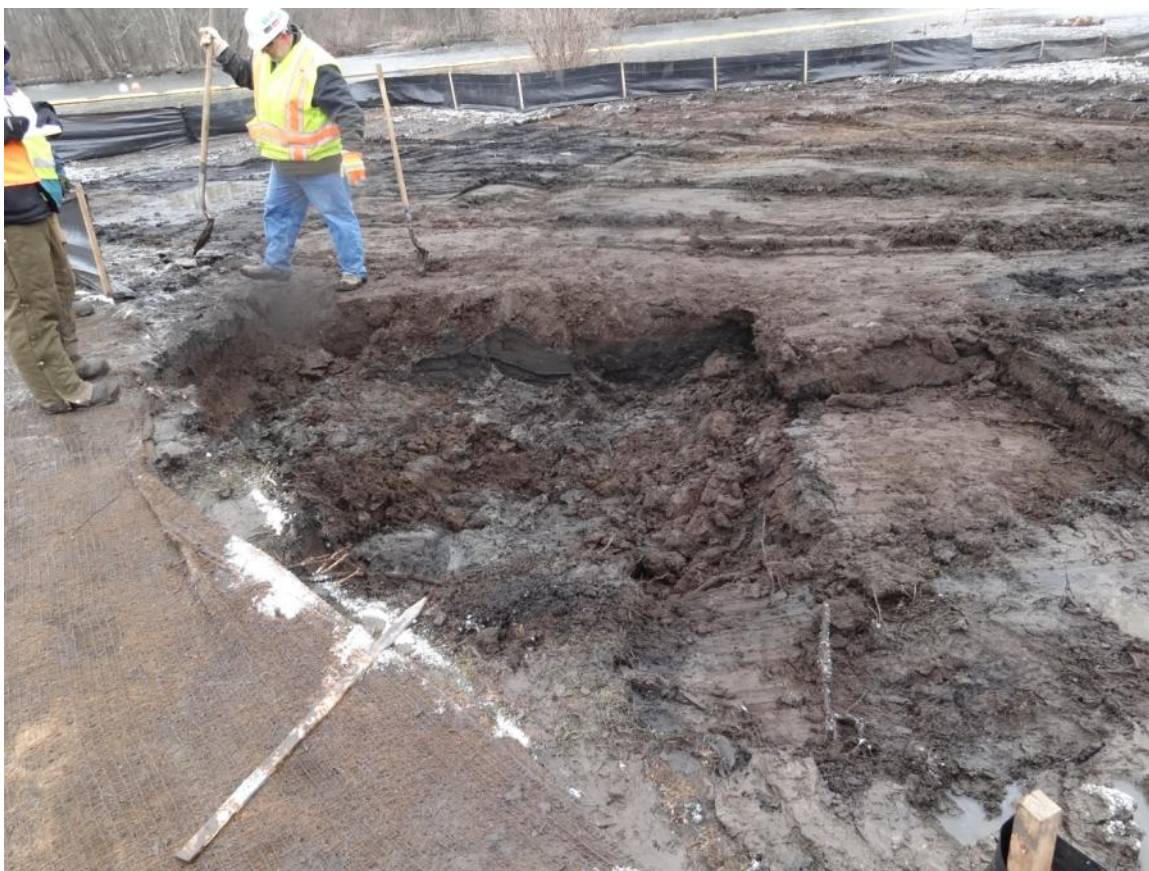
6. Talmadge Creek: additional scrape near confluence.

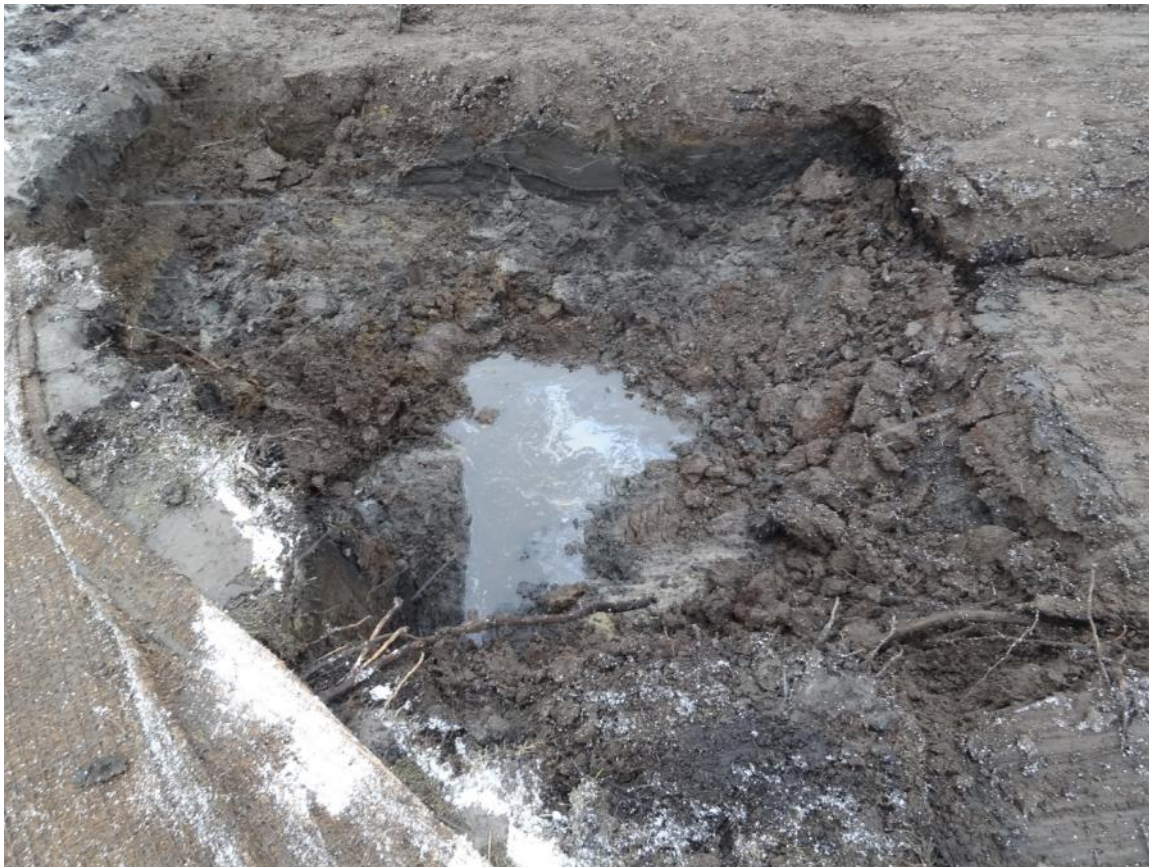
7. Talmadge Creek: additional scrape near confluence.

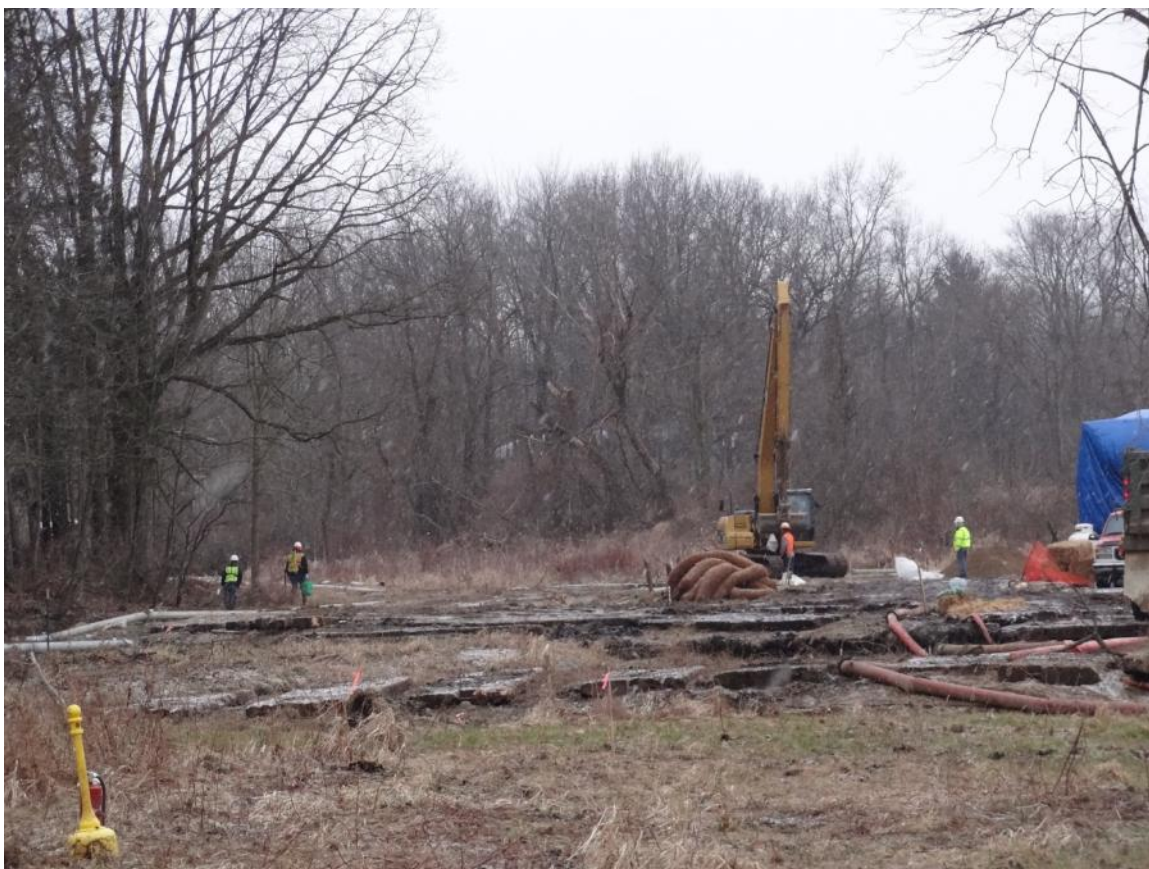
8. Talmadge Creek restoration work near MP1.85.

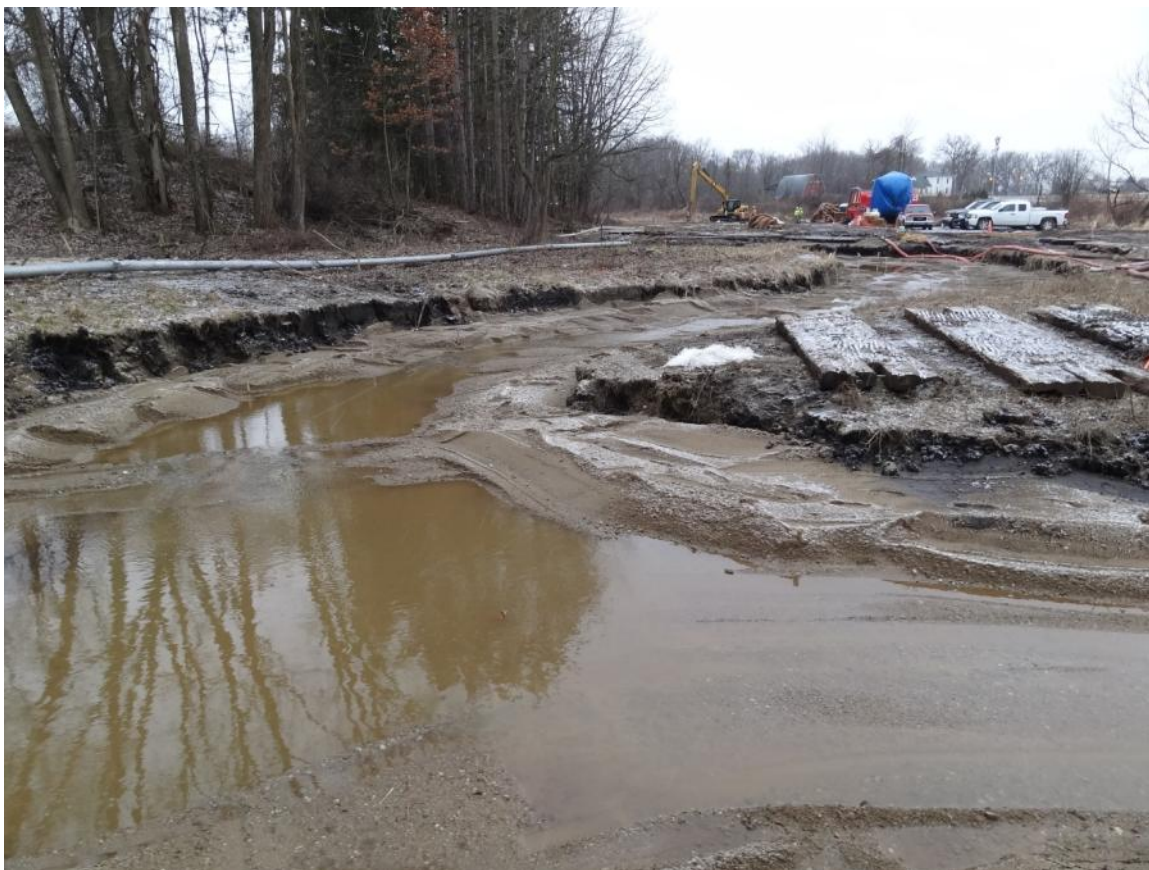
9. Talmadge Creek restoration work near MP1.85.

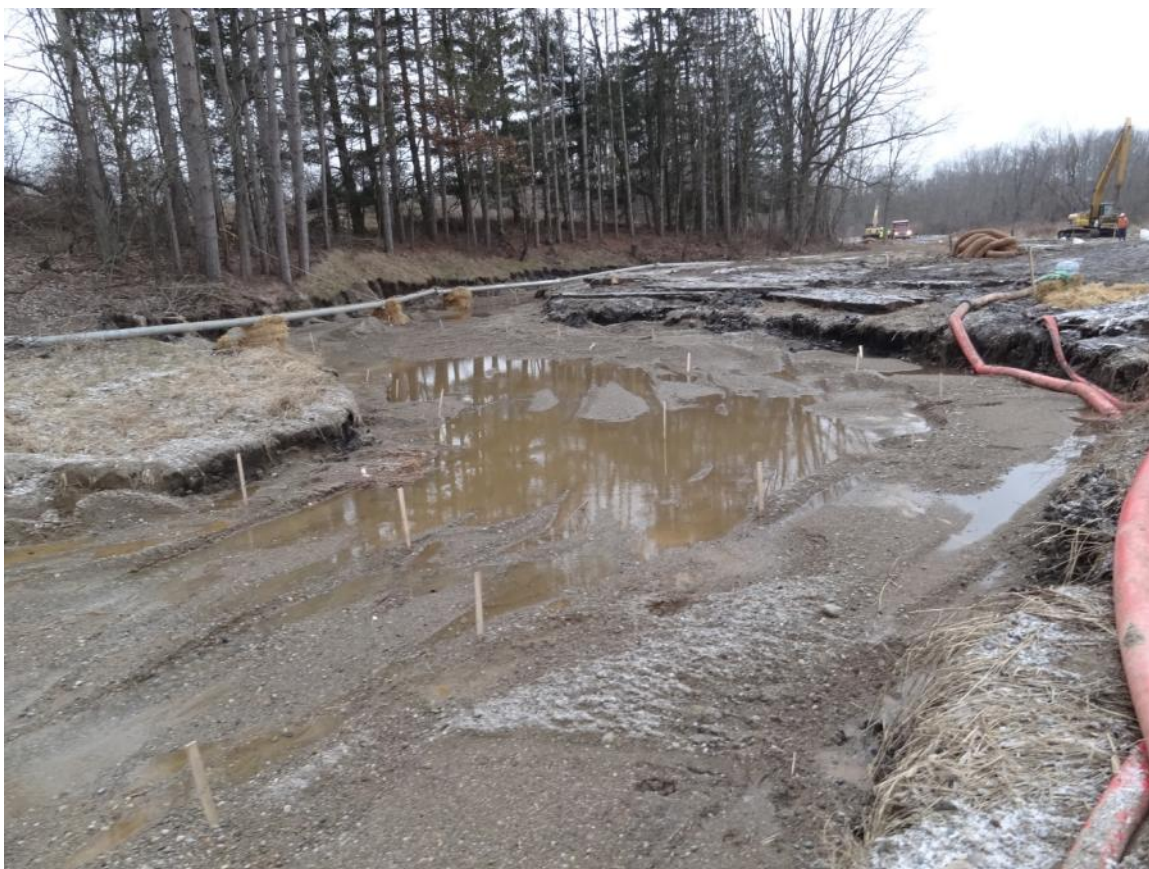
10. Talmadge Creek restoration work near MP1.85.

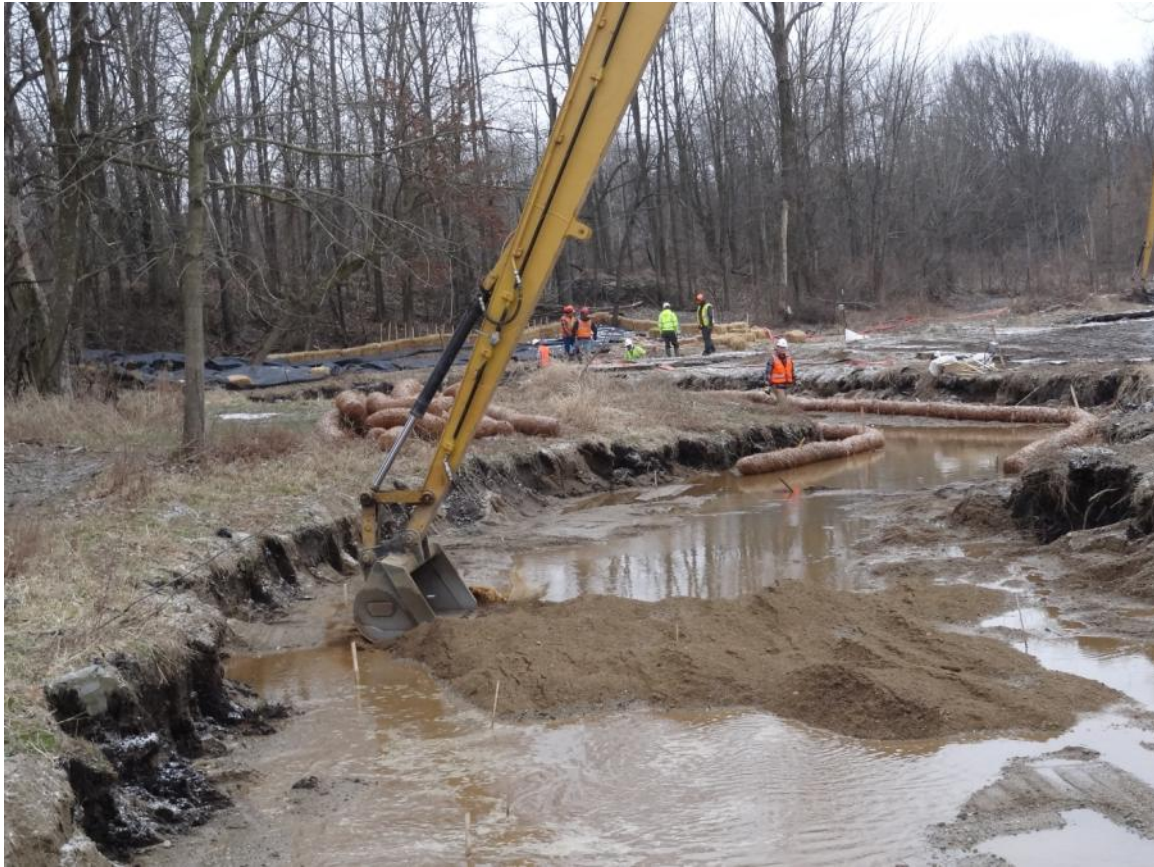
11. Talmadge Creek restoration work near MP1.85.

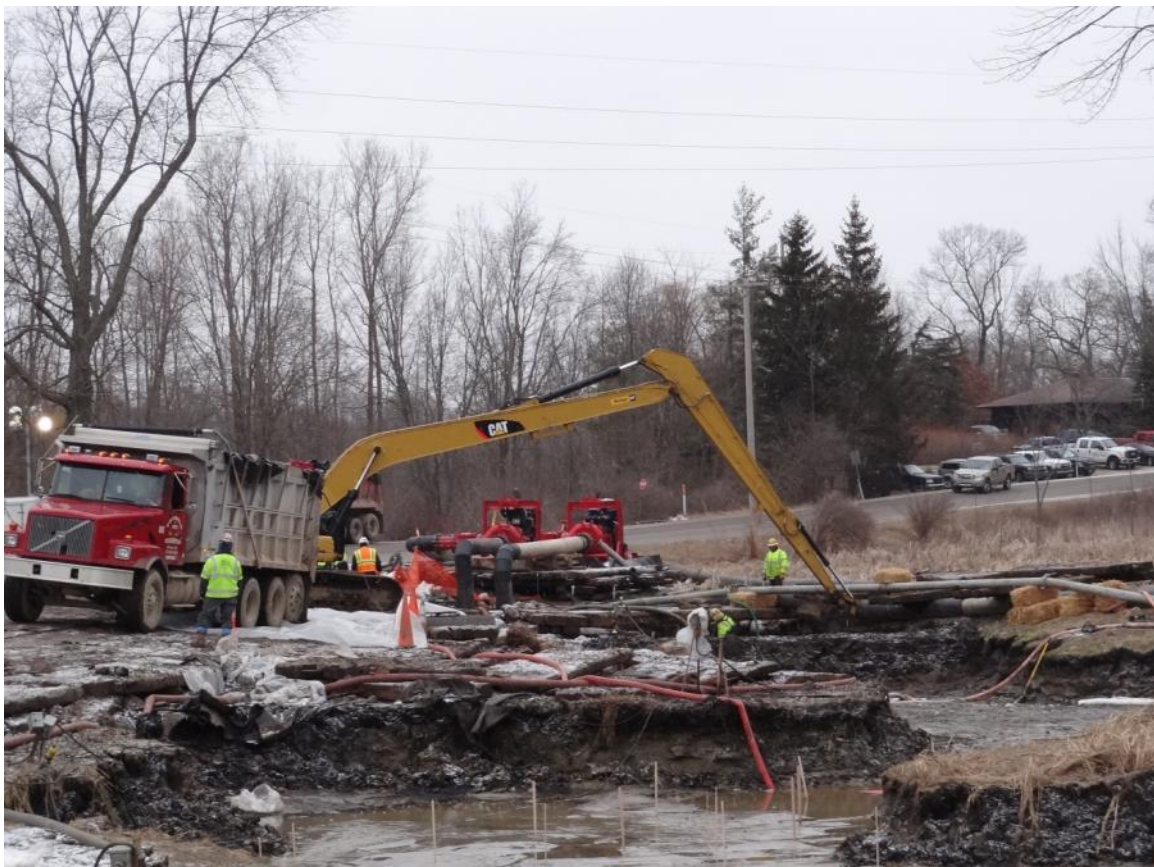
12. Talmadge Creek excavation work near A Drive.

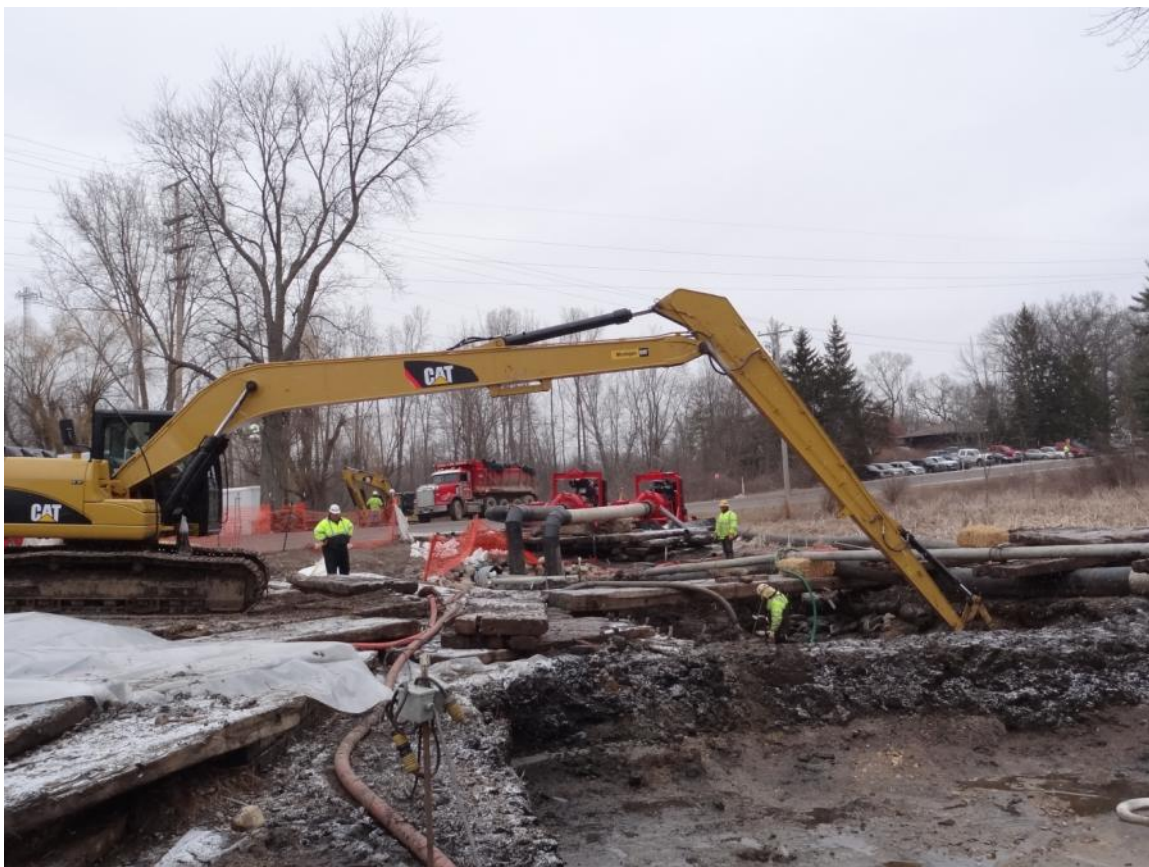
13. Talmadge Creek excavation work near A Drive.

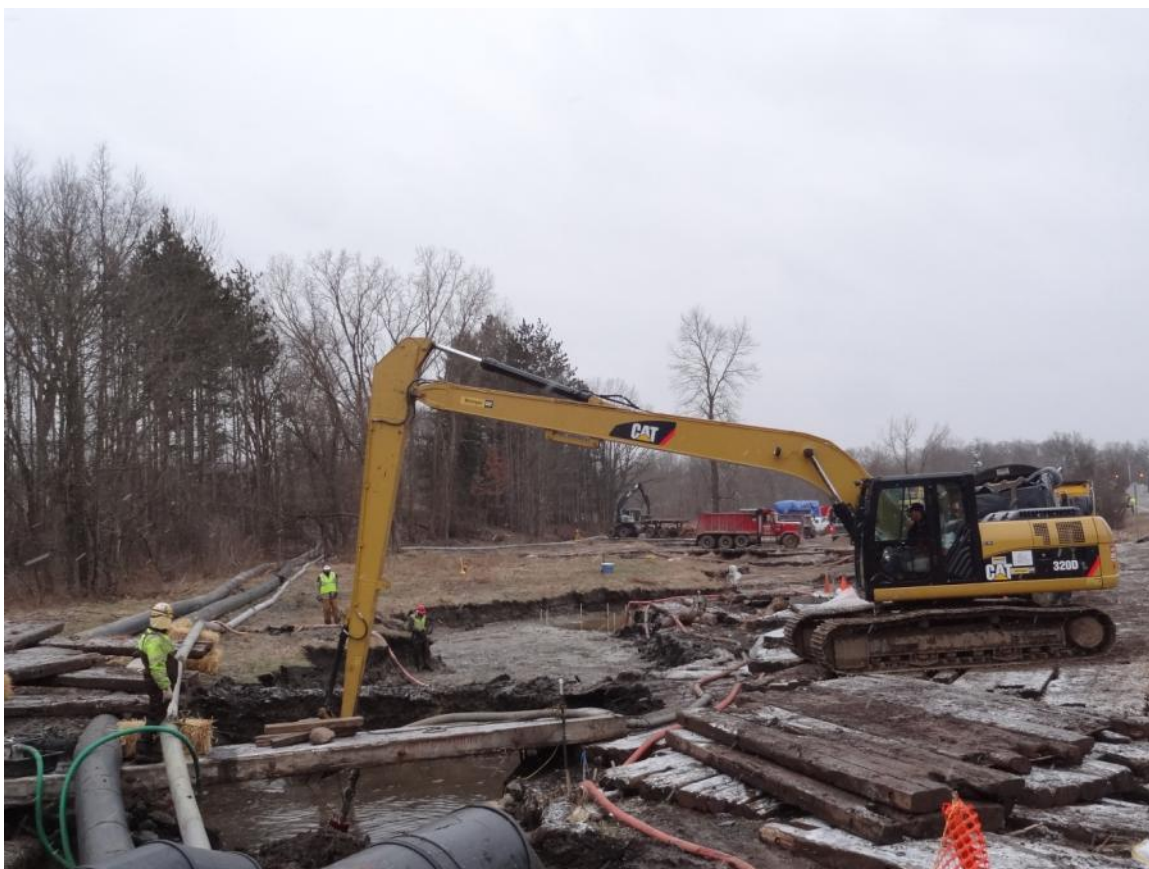
14. Talmadge Creek excavation work near A Drive.

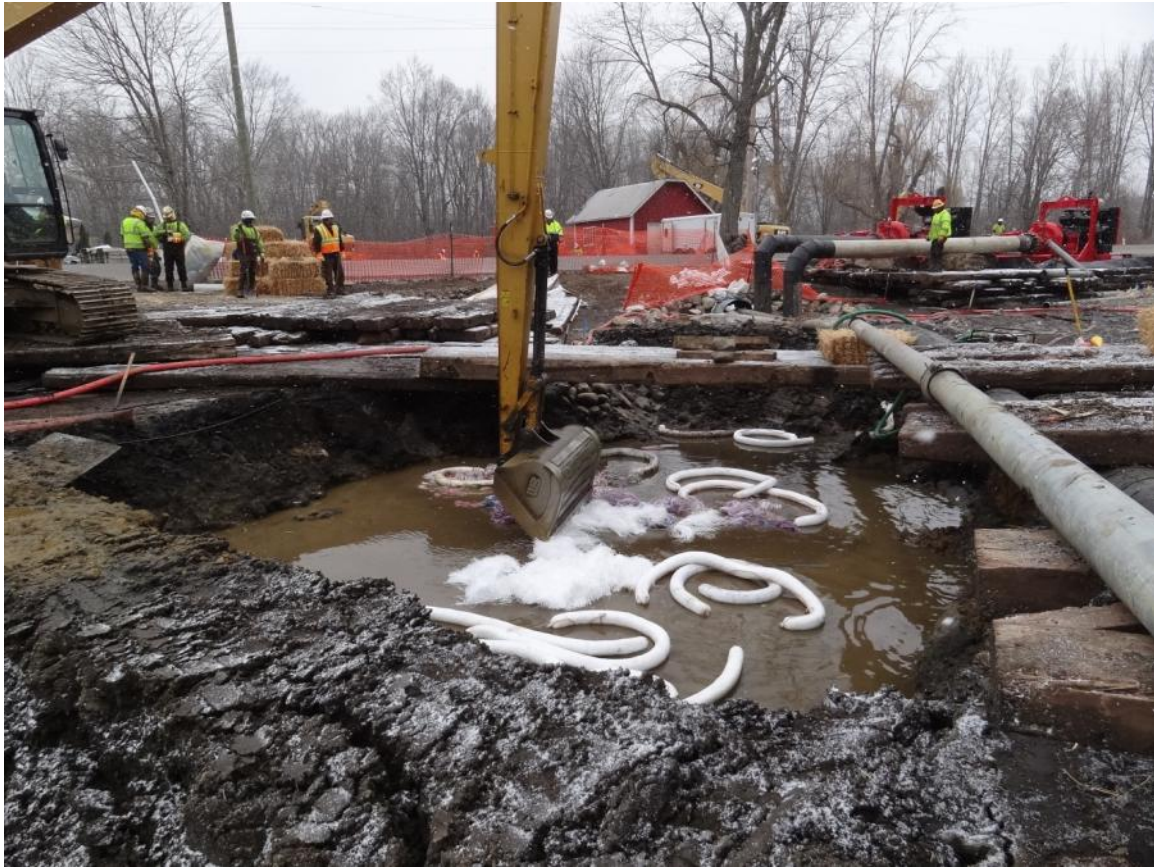
15. Talmadge Creek excavation work near A Drive.

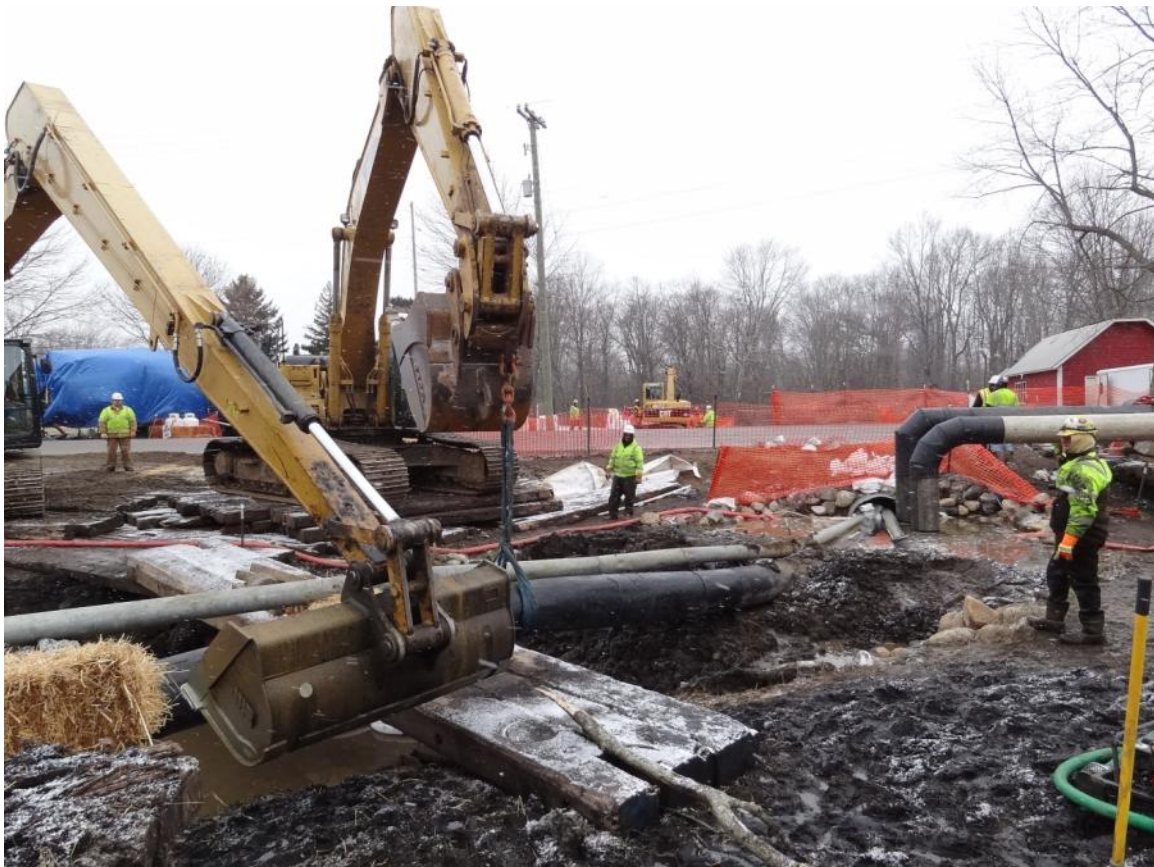
16. Talmadge Creek: observed site prep for excavation work near A Drive.

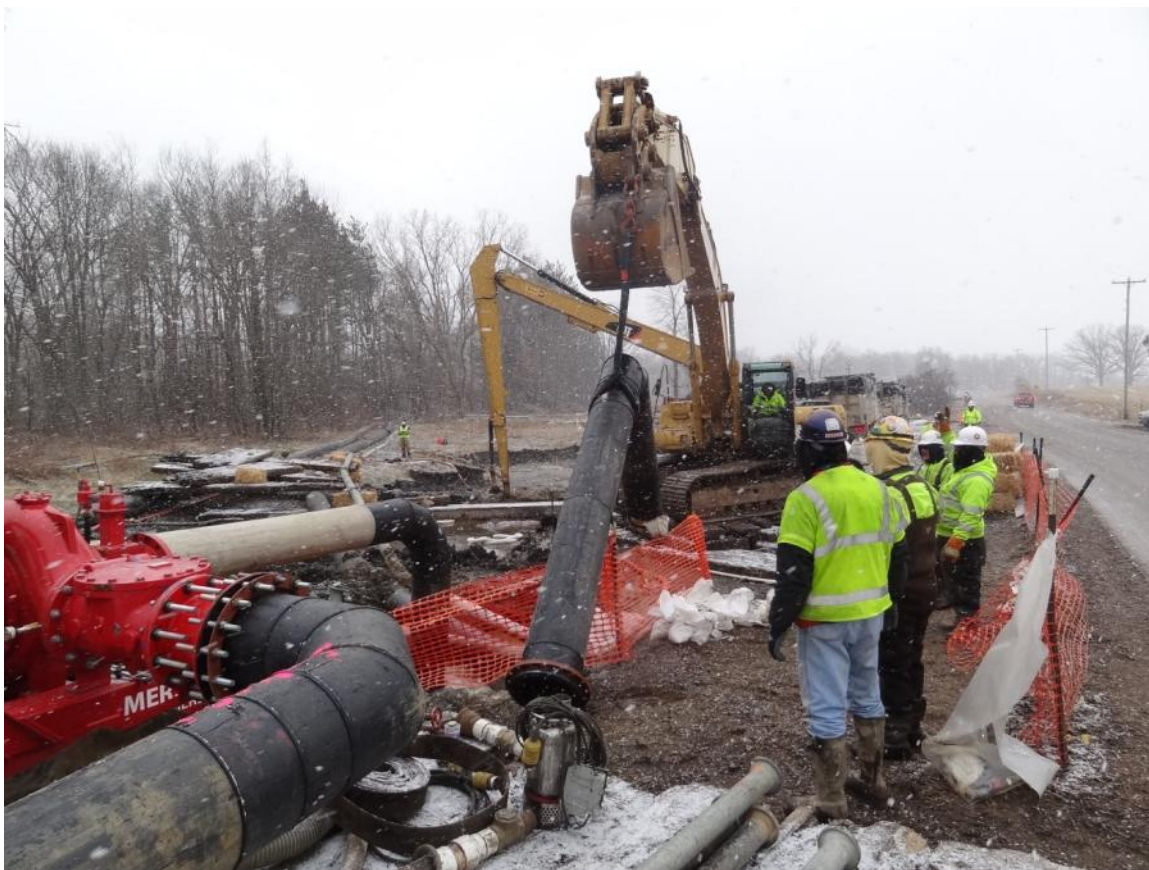
17. Talmadge Creek near A Drive: observed pump being modified.

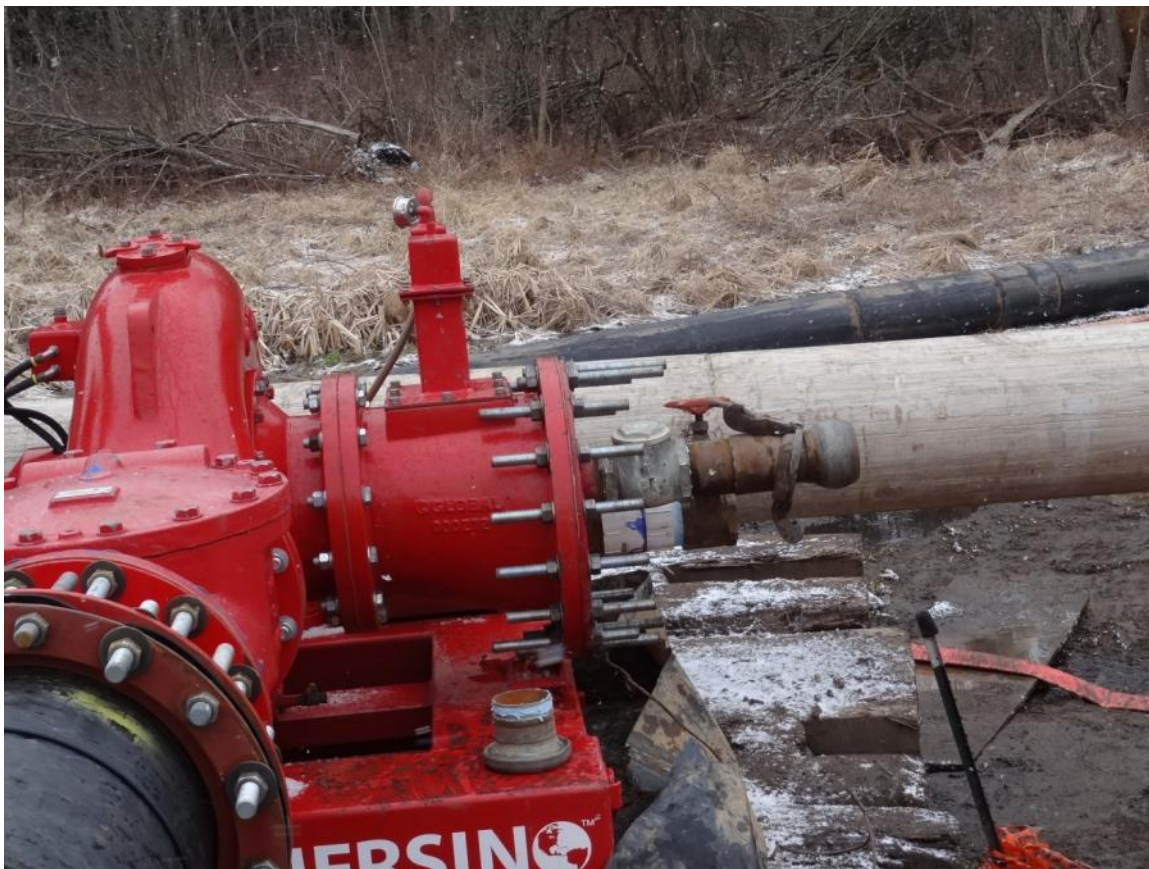
18. Talmadge Creek near A Drive: observed pump being modified.

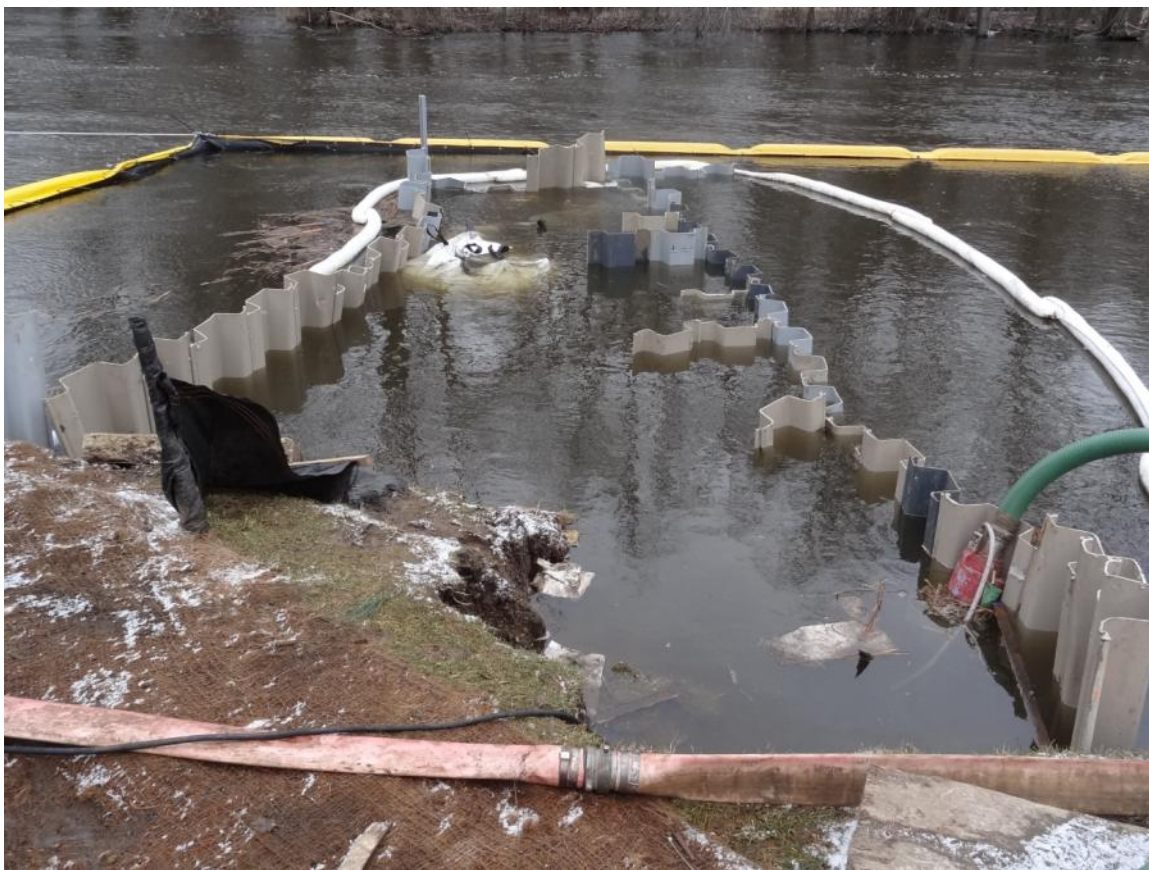
19. Confluence: river levels elevated.

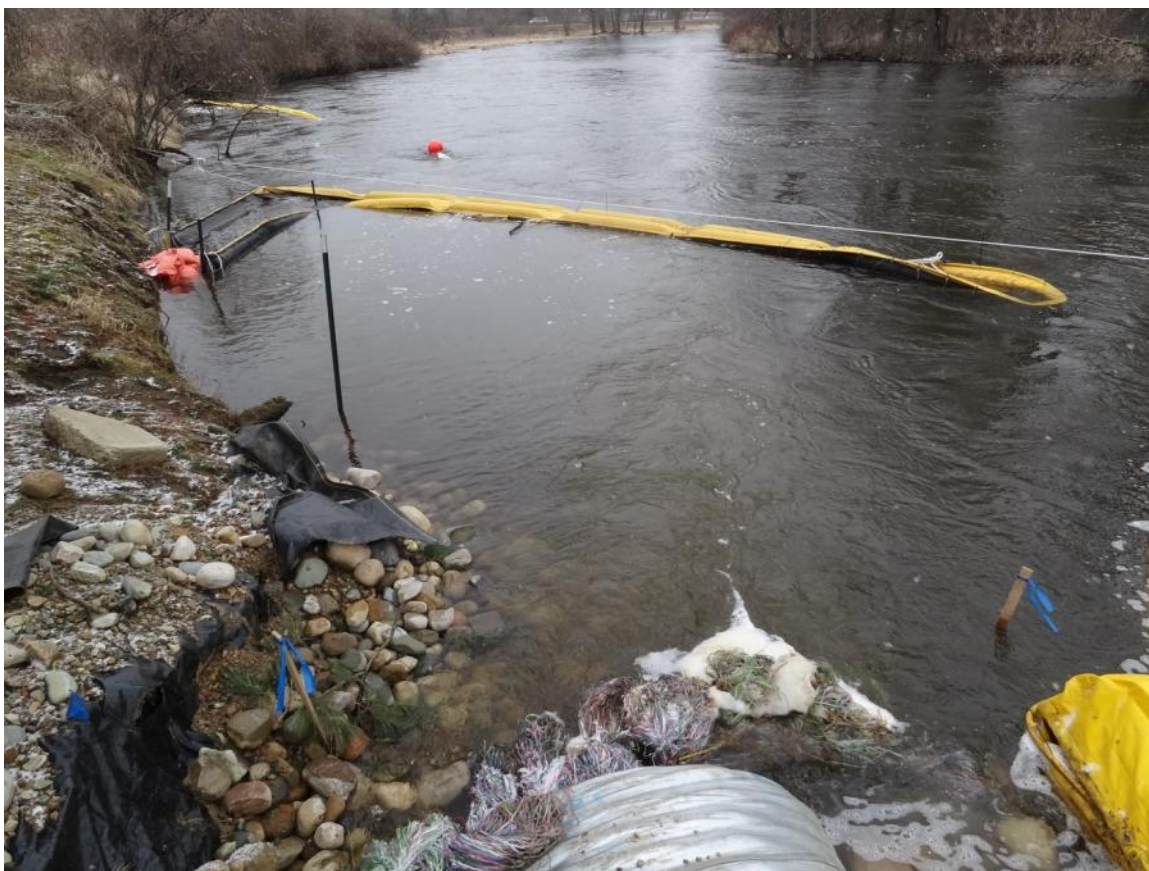
20. Confluence: bypass discharge.
