# Situation Photo Log

Wednesday, March 7, 2012

Kalamazoo River / Enbridge Spill

Matthew Haak  
START-USEPA  
Situation Unit Leader

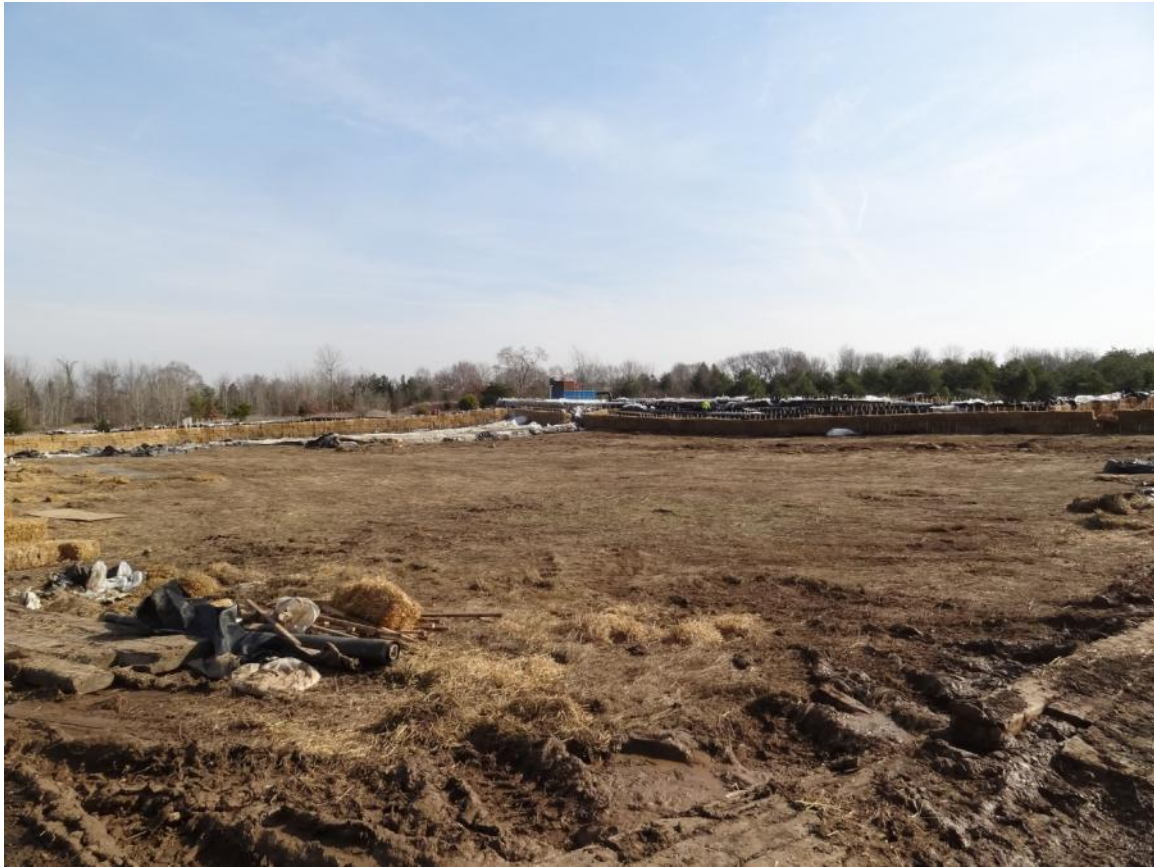
1. Turbidity Control Structure observed being demobilized.

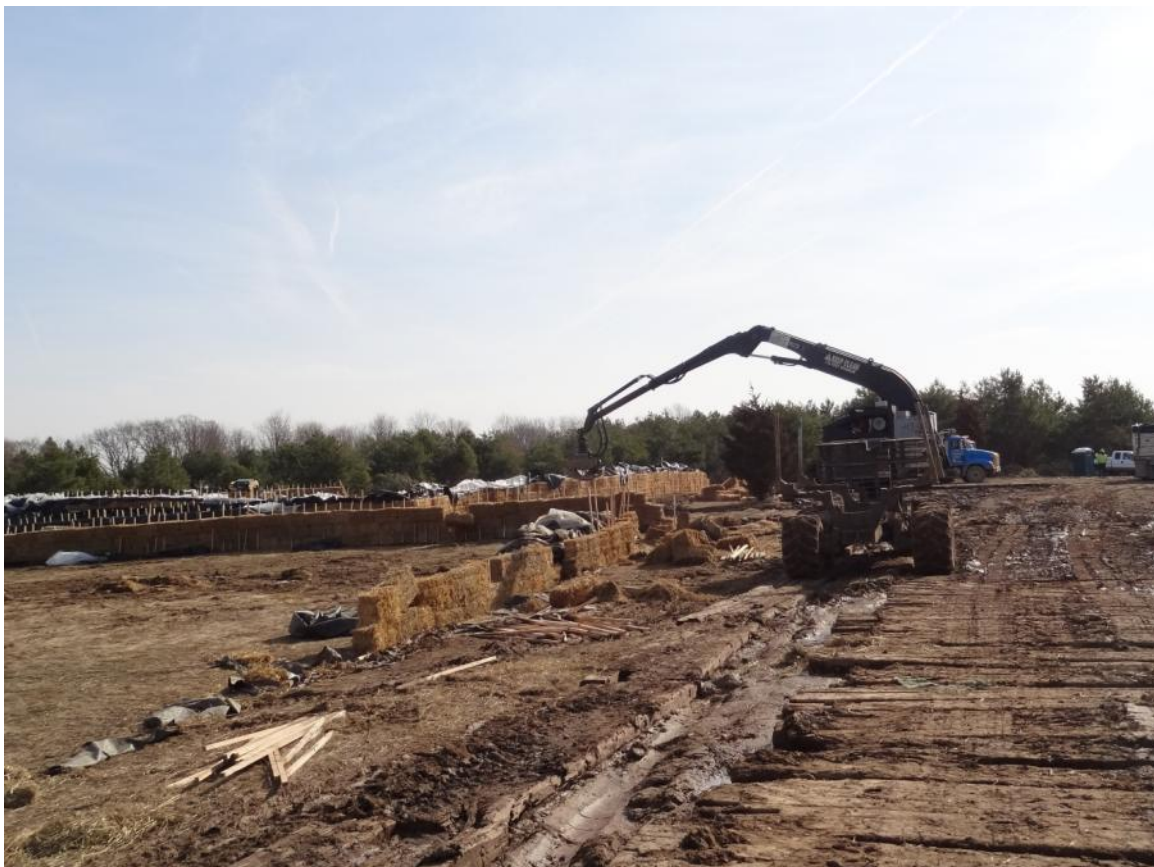
2. Turbidity Control Structure observed being demobilized.

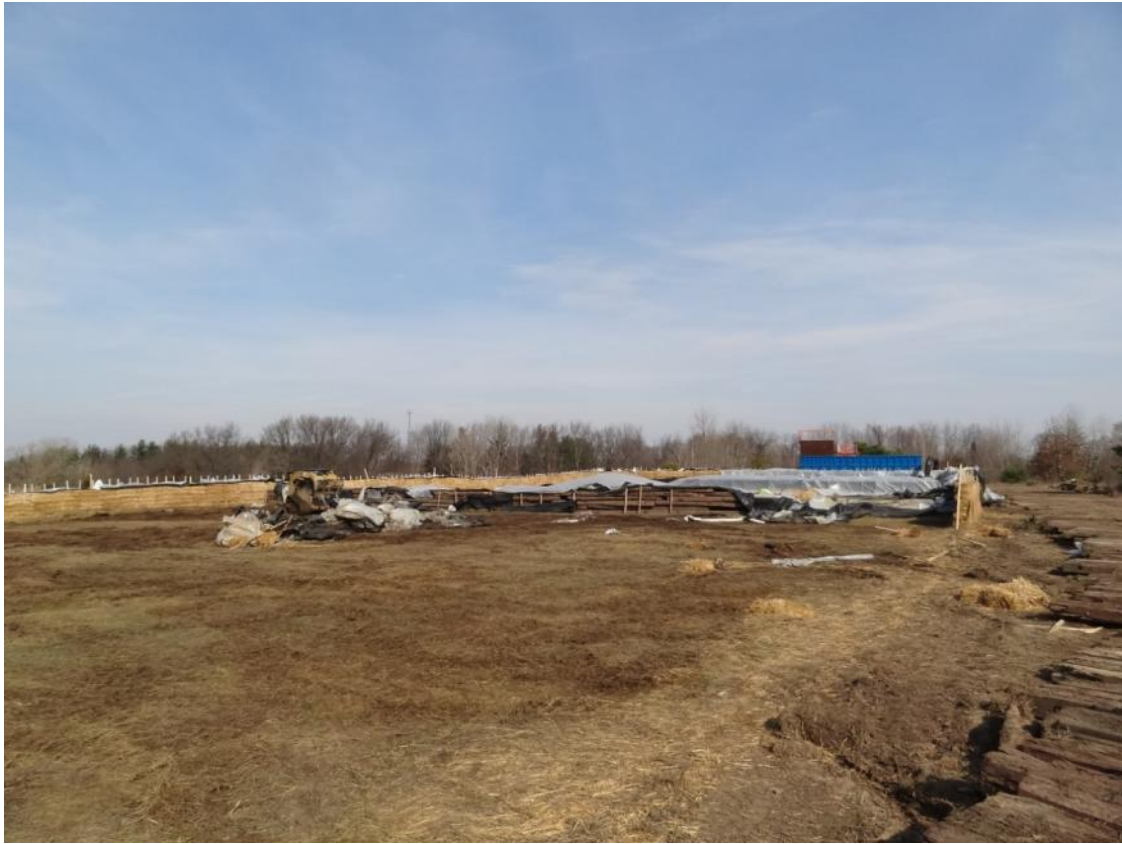
3. Turbidity Control Structure observed being demobilized.

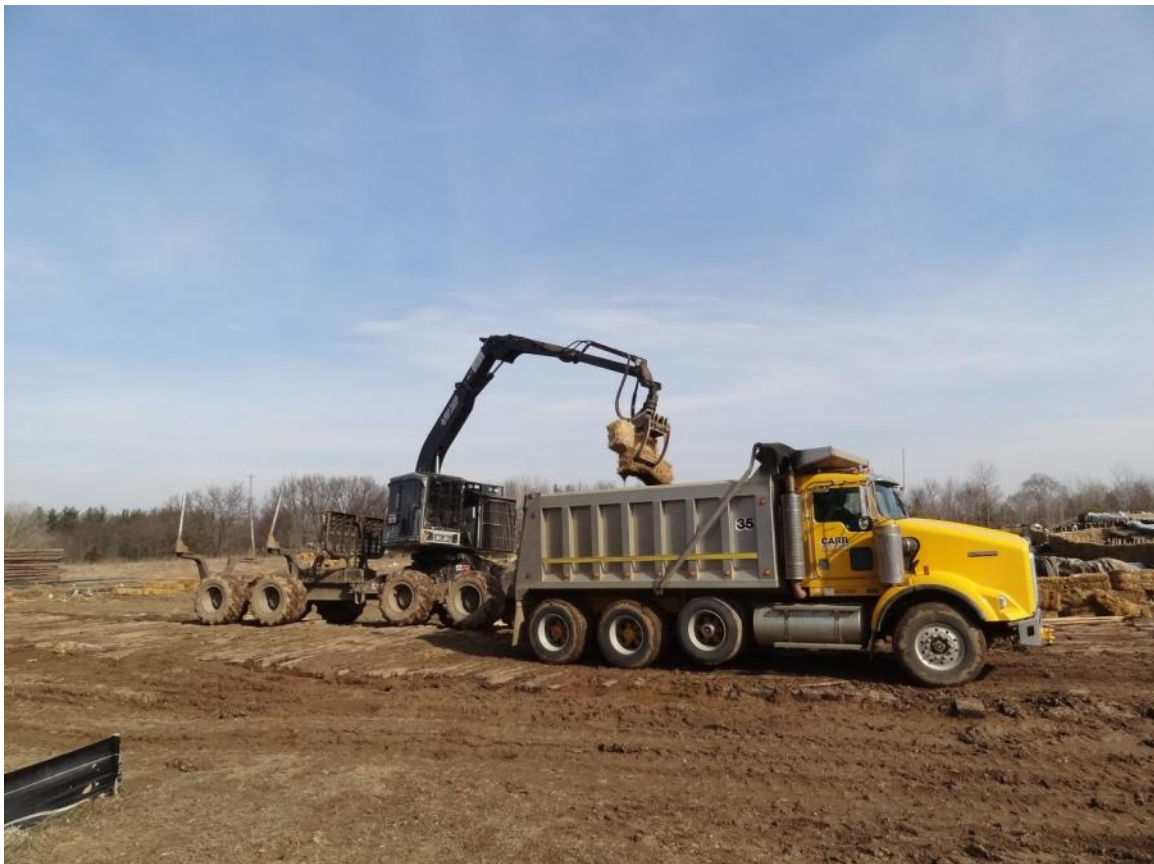
4. Turbidity Control Structure observed being demobilized.

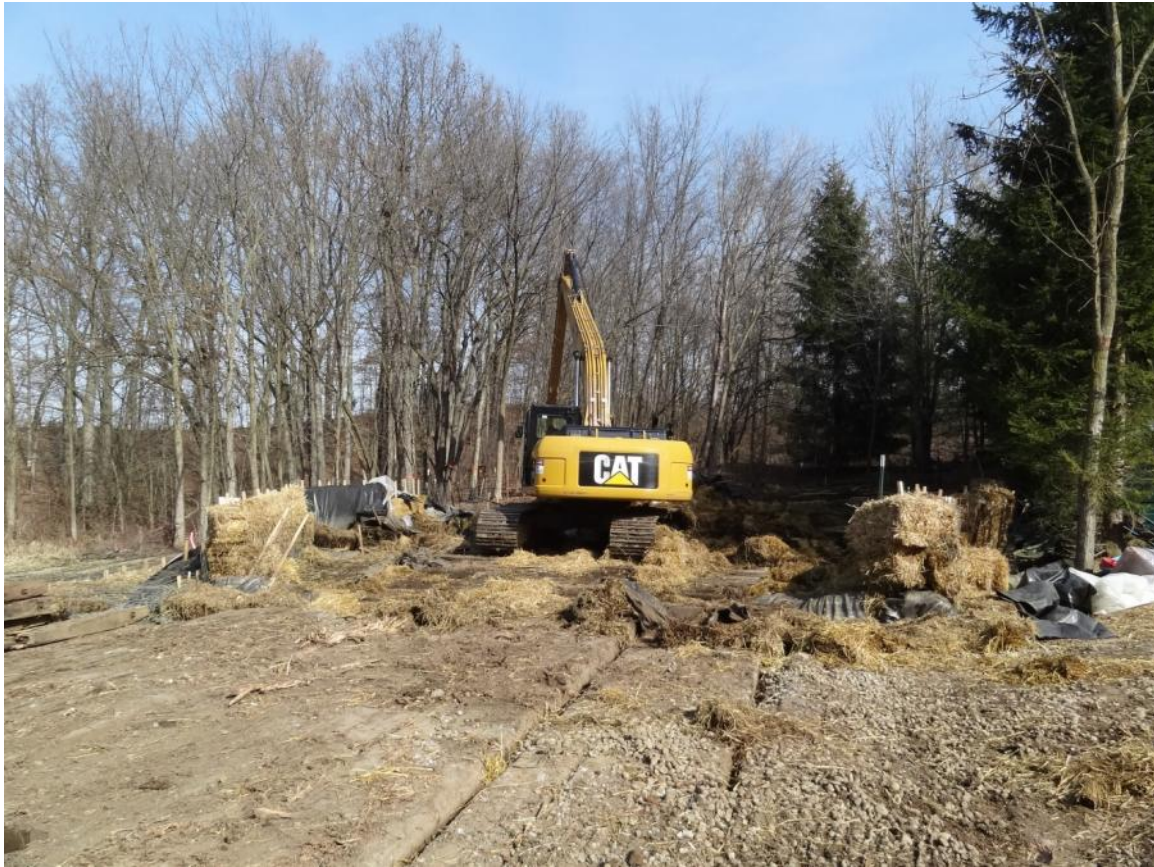
5. Talmadge Creek: demobilizing of bypass discharge near MP1.6.

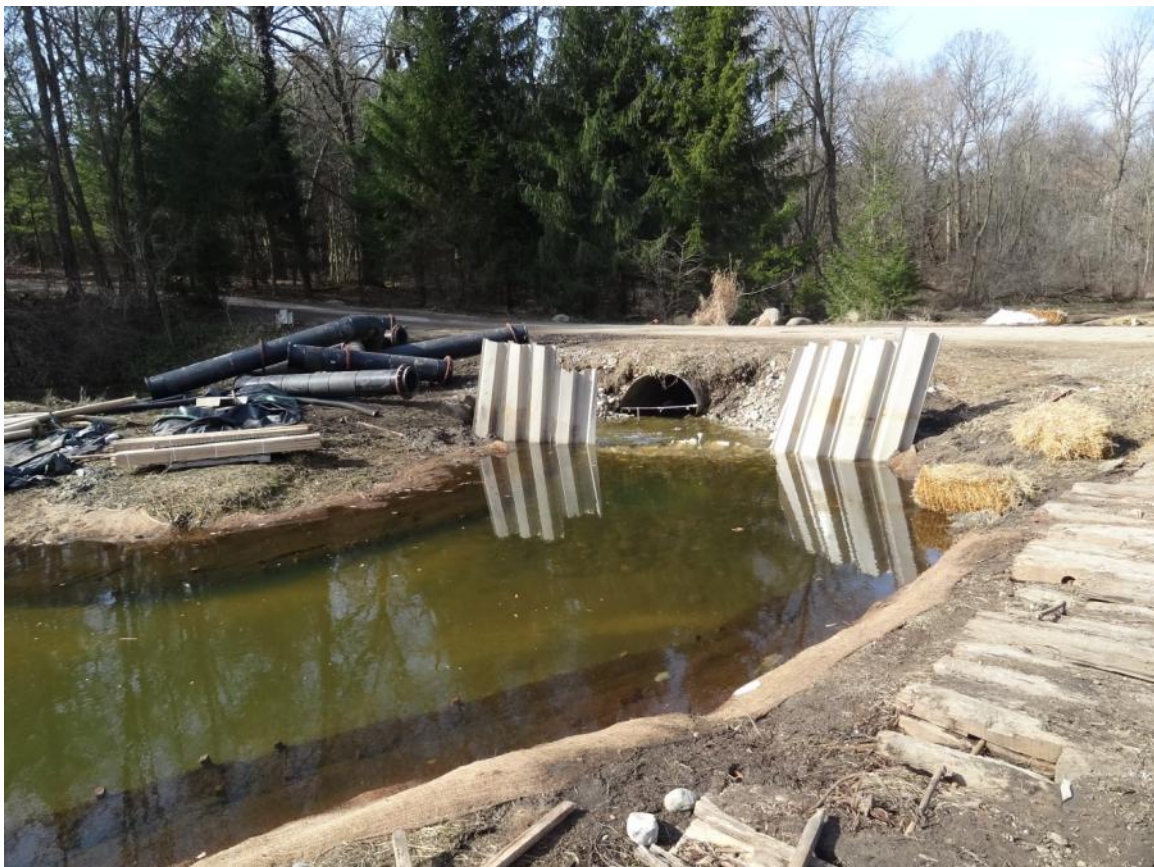
6. Talmadge Creek: weir structure near MP1.6.

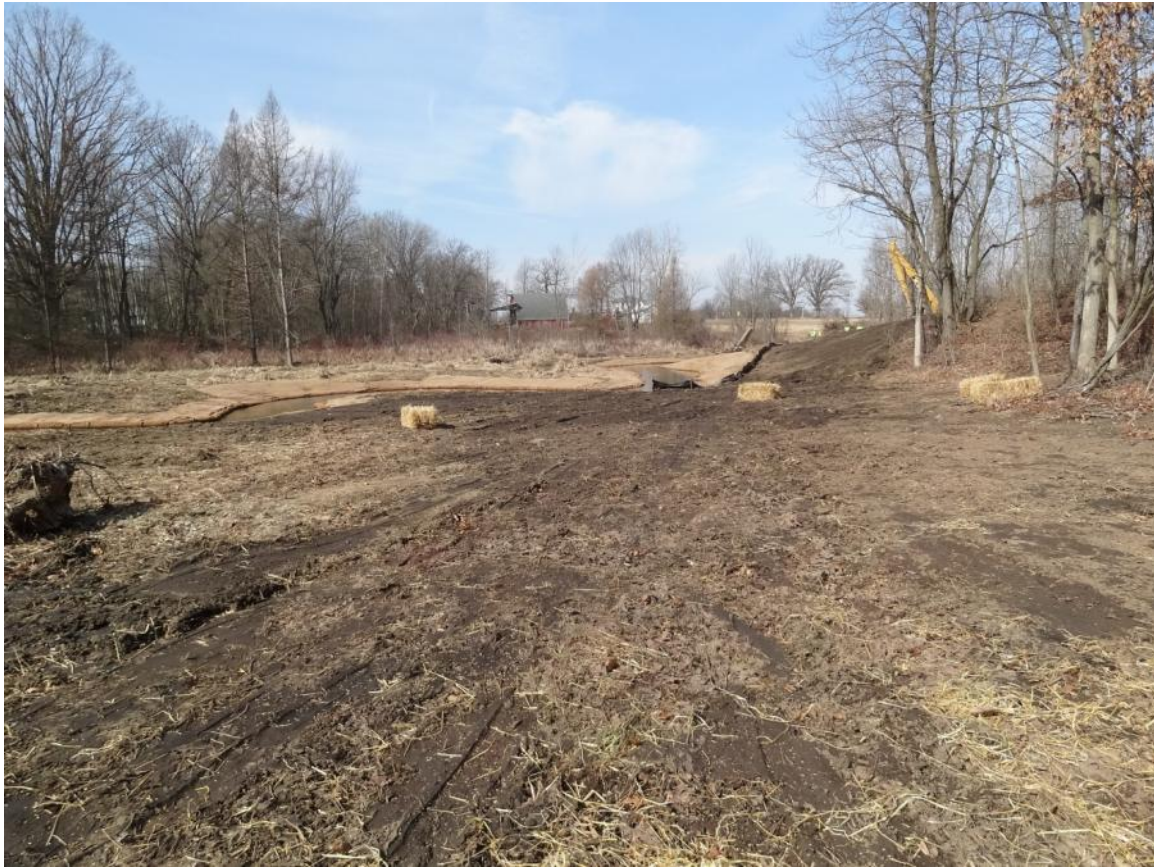
**7. Talmadge Creek: timber mats removed and restoration work near MP1.75.**

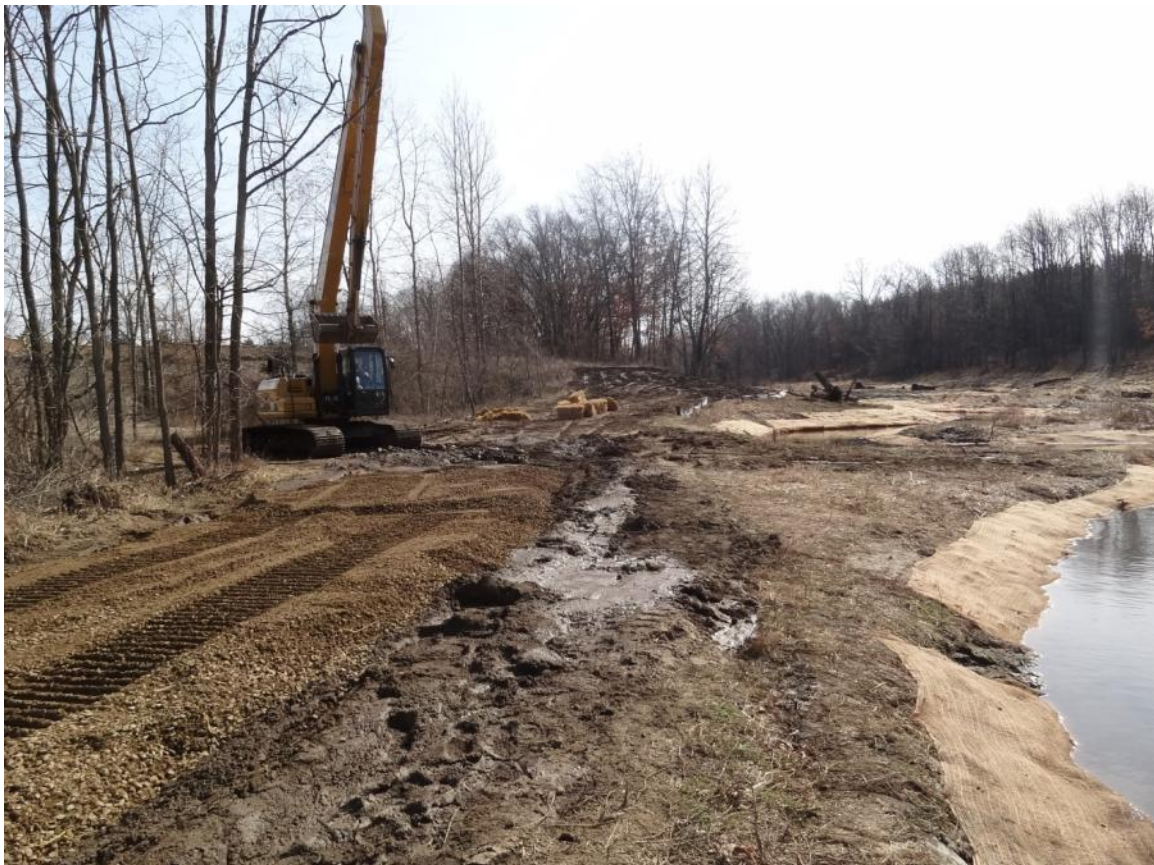
**8. Talmadge Creek: timber mats removed and restoration work near MP1.75.**

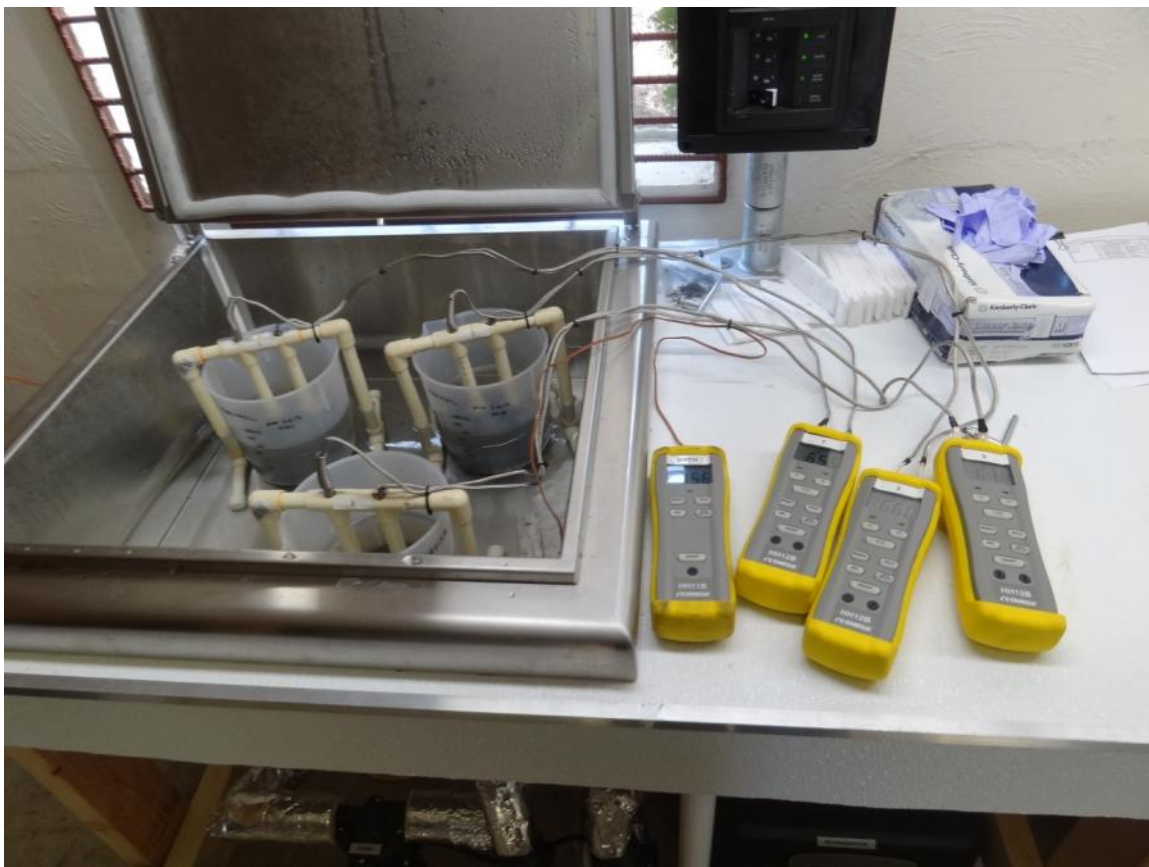
9. Temperature effects study.

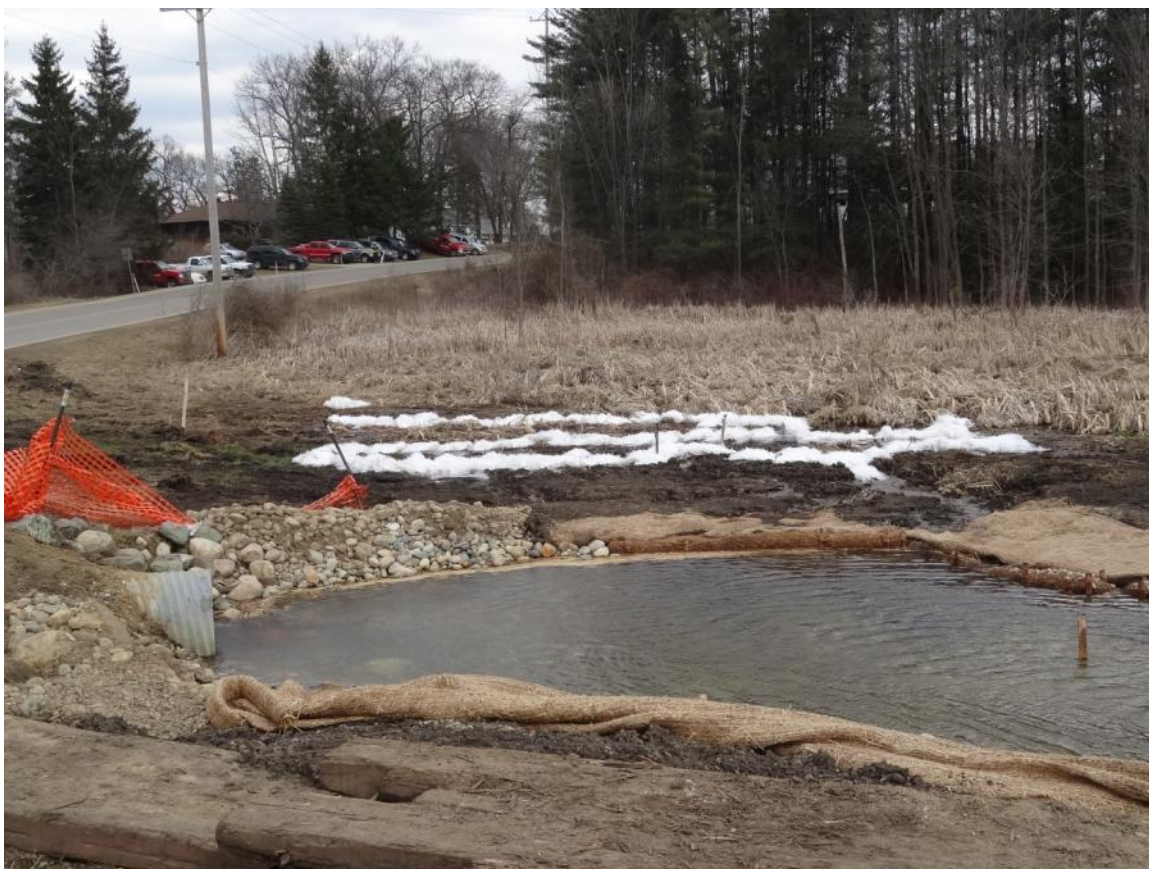
10. South of A Drive RDB overbank sheen observed.

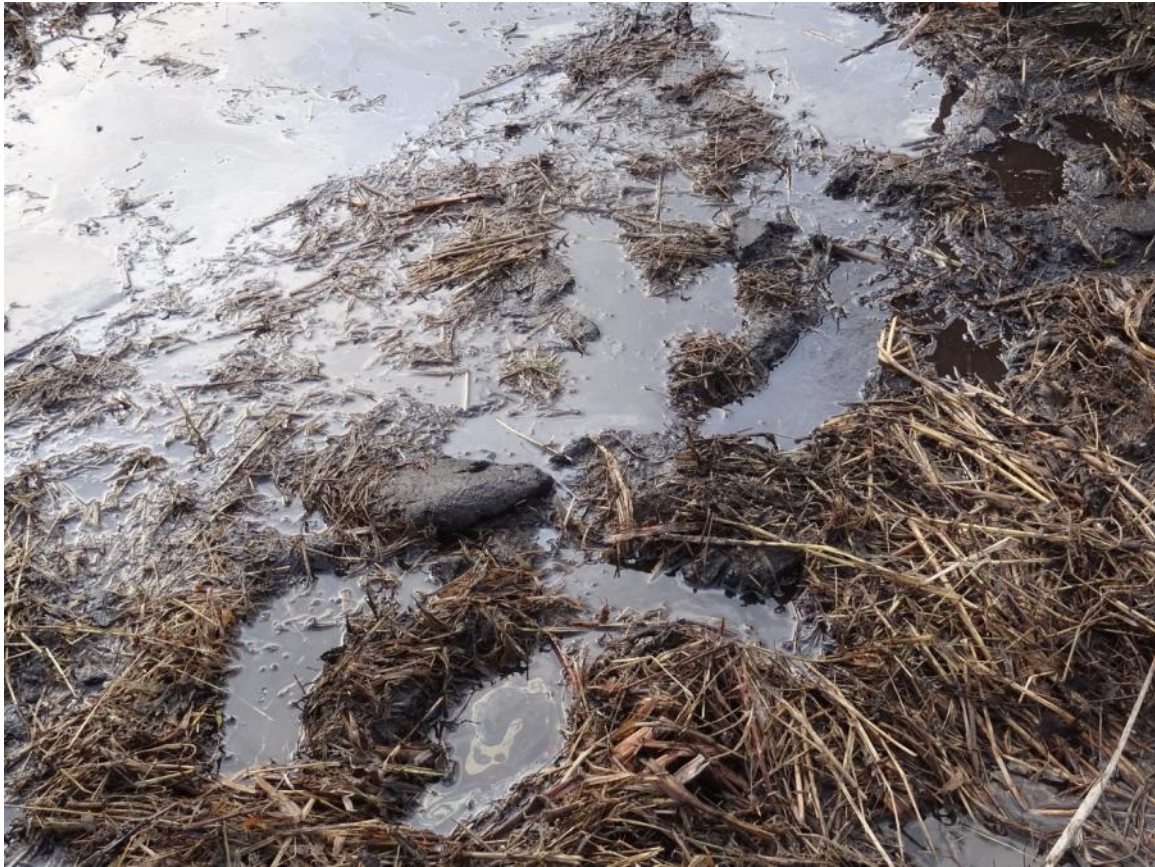
**11. South of A Drive RDB overbank sheen observed.**

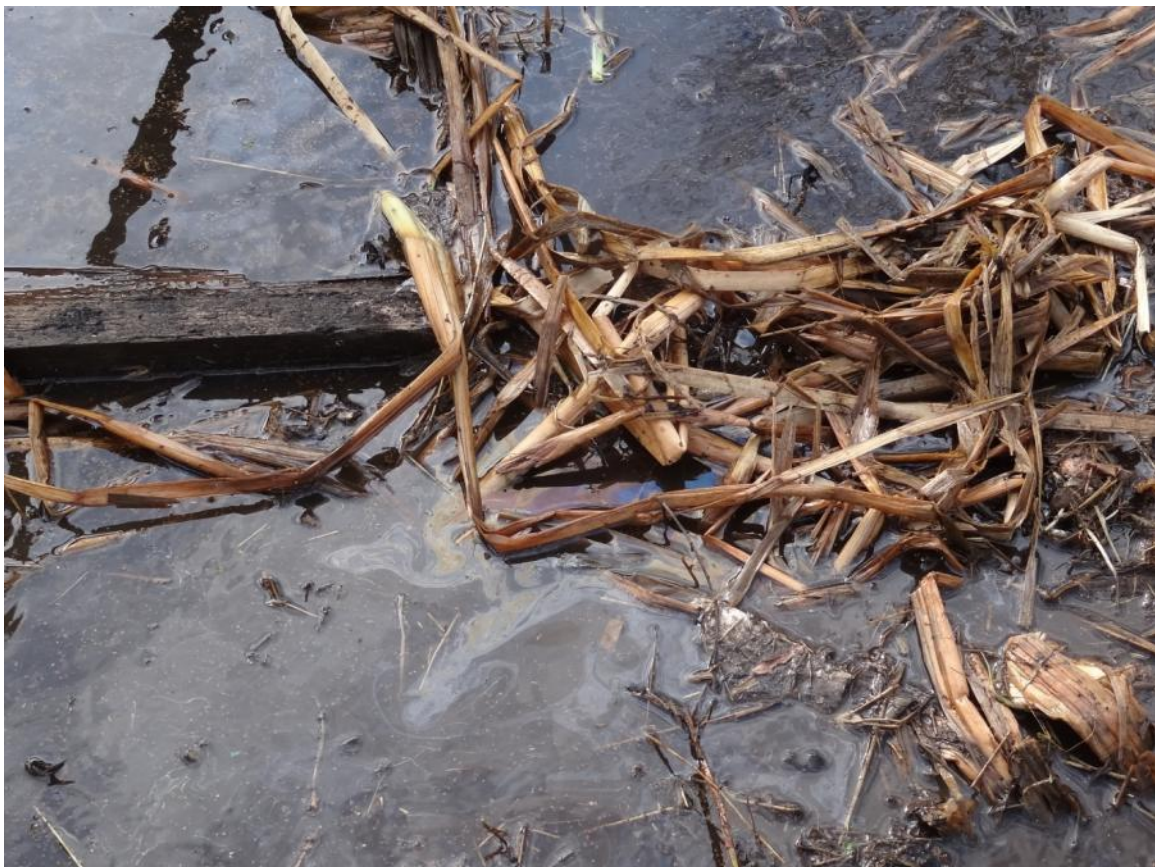
**12. South of A Drive RDB overbank sheen observed.**

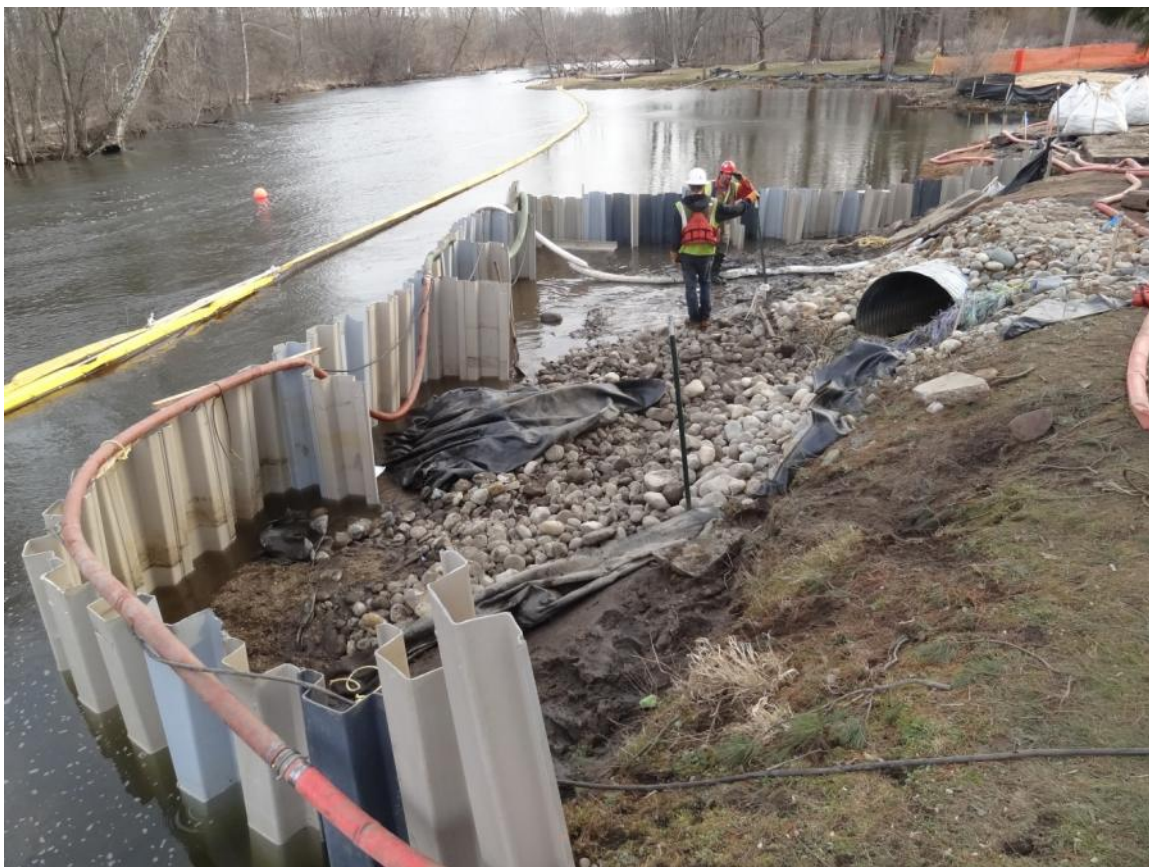
13. Confluence diversion outfall dewatered.

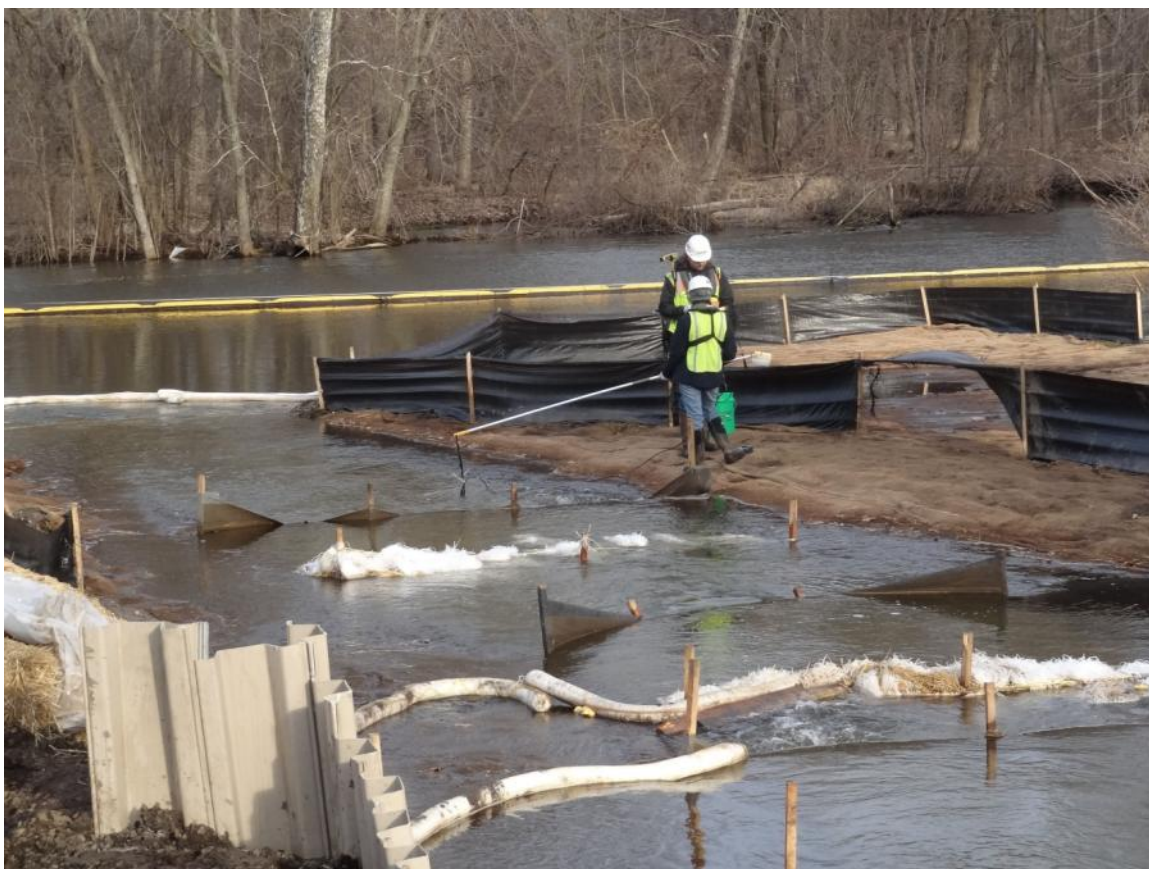
14. Confluence observed water quality monitoring.

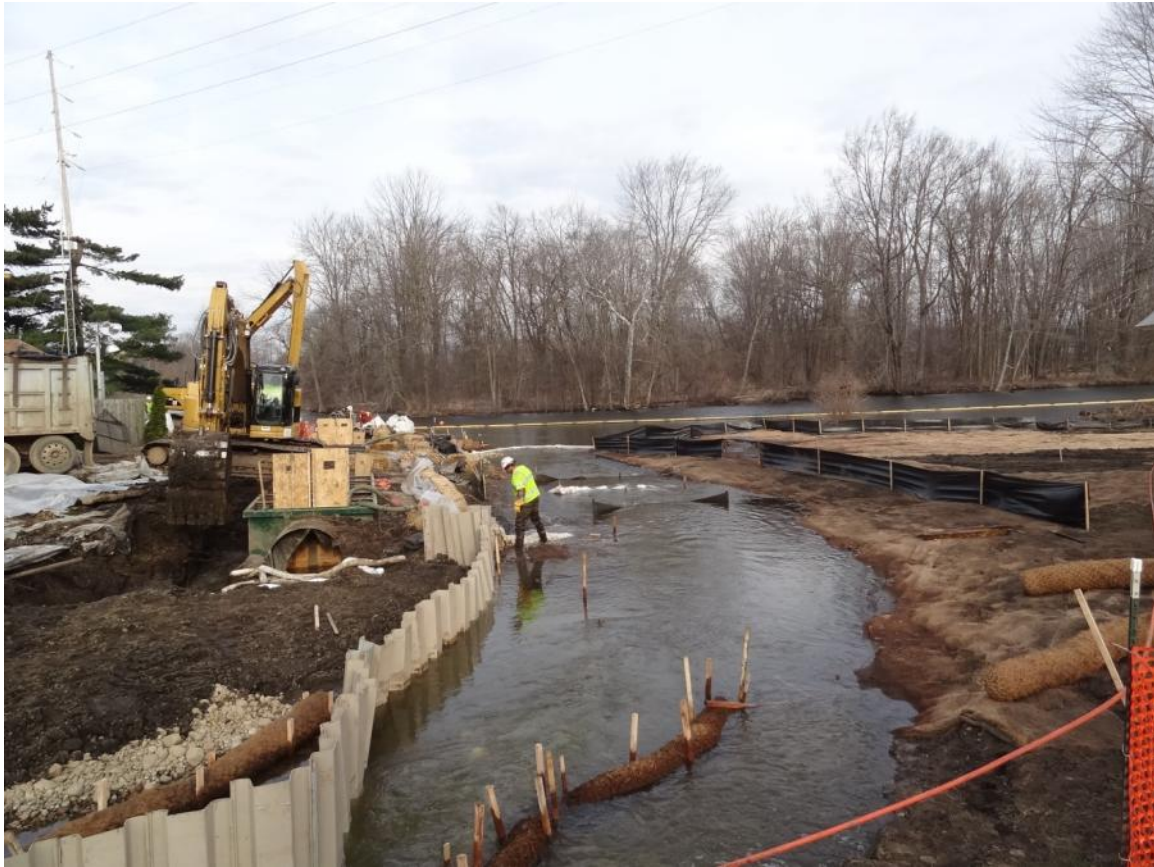
**15. Confluence: observed crew removing snare boom and sediment curtain from creek portion of Confluence.**

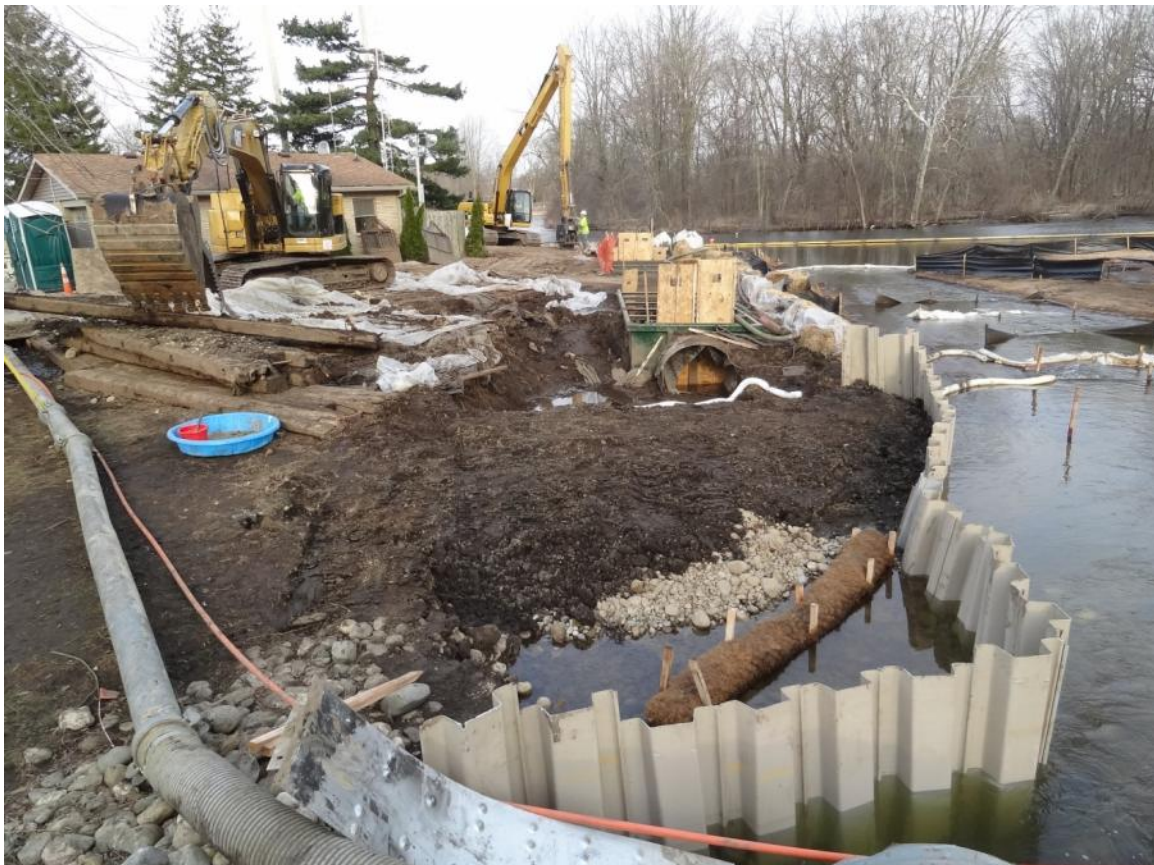
**16. Confluence: observed backfill and excavation work around first diversion box.**

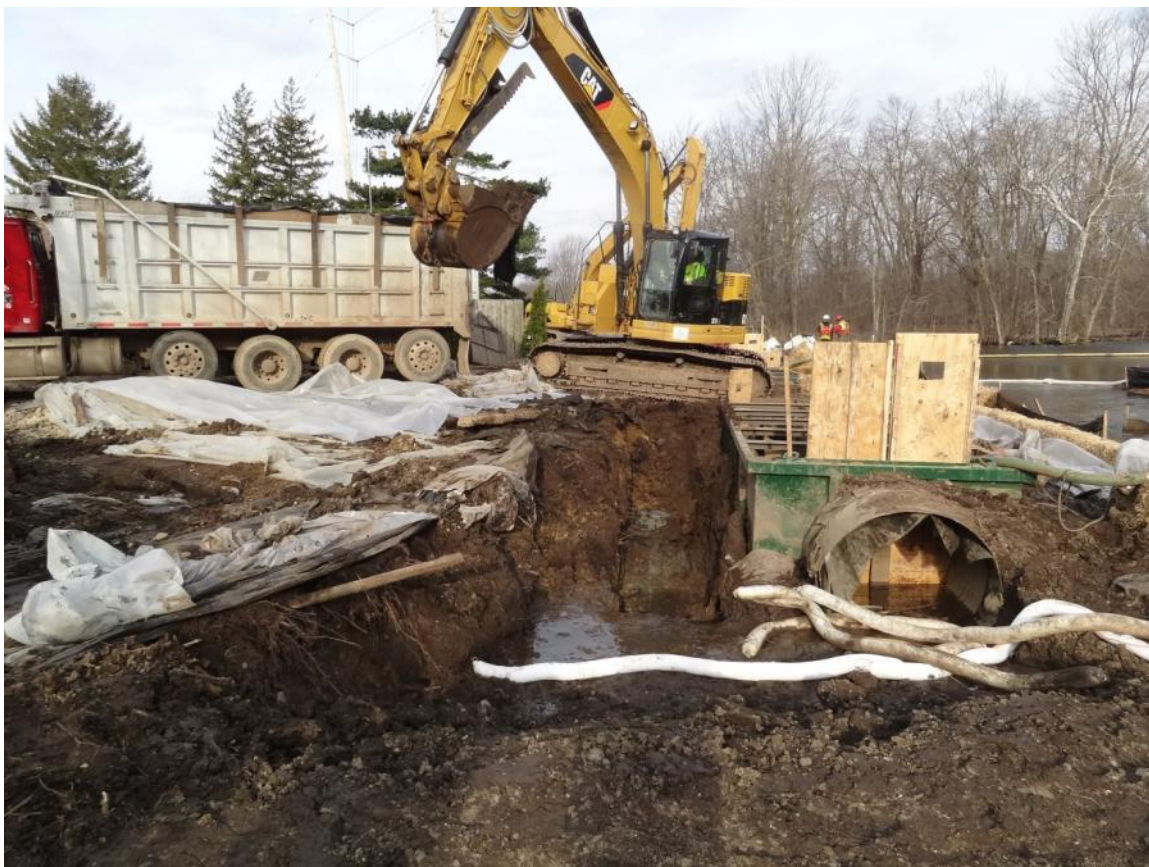
17. Confluence: observed excavation around the first diversion box.

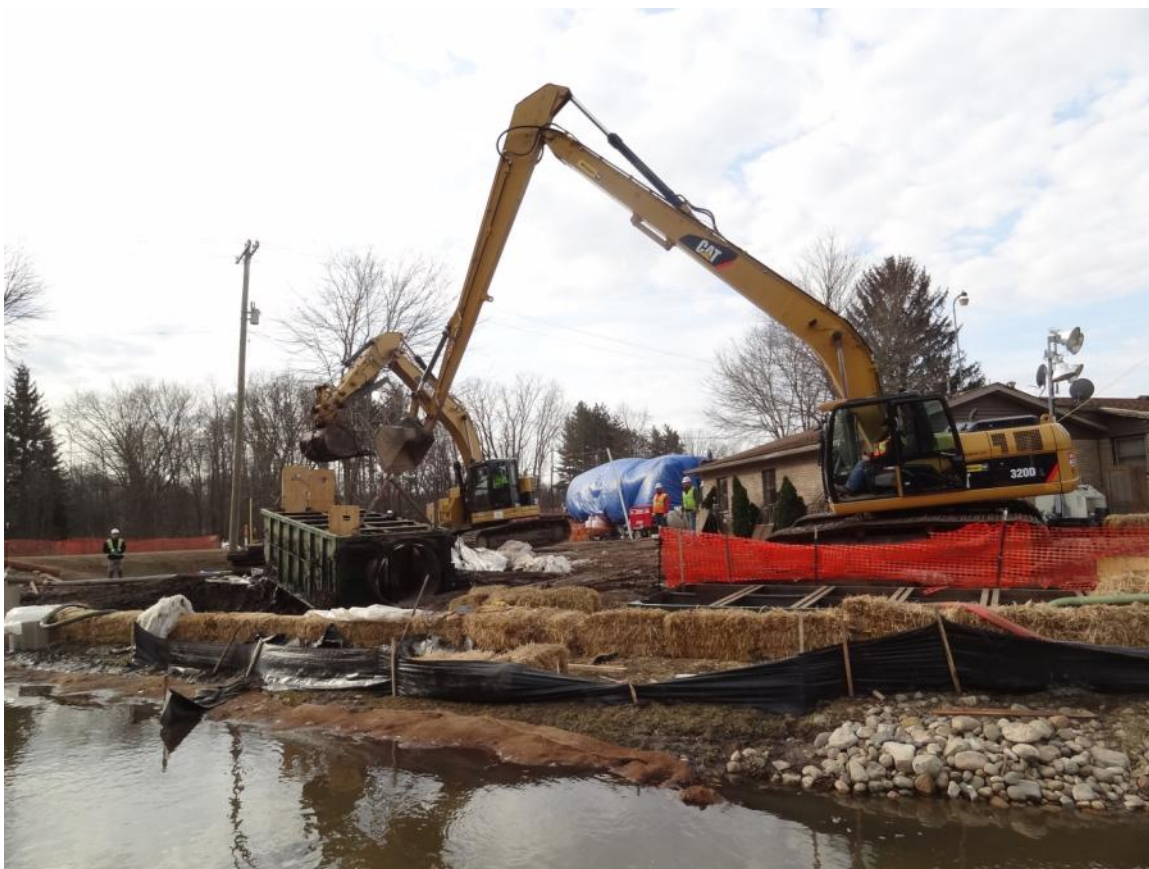
18. Confluence: observed the removal of the first diversion box.

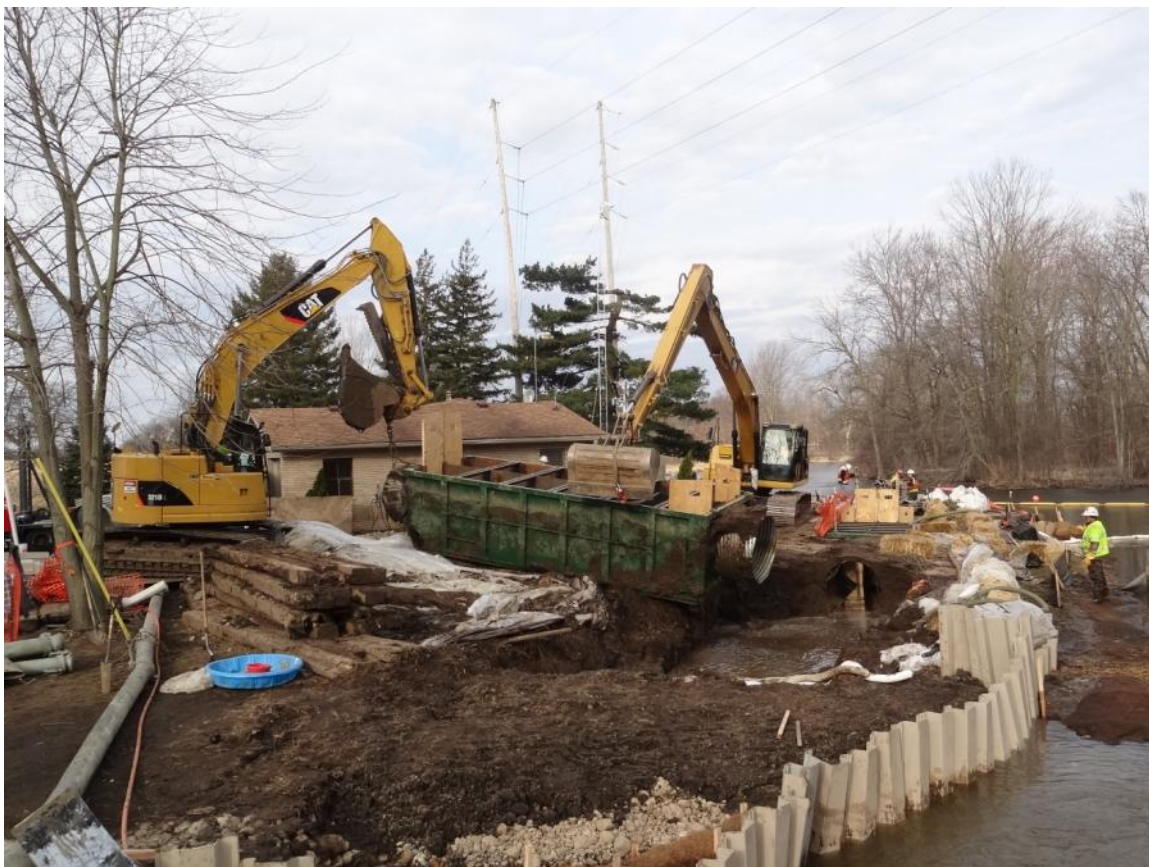
19. Confluence: observed the removal of the first diversion box.

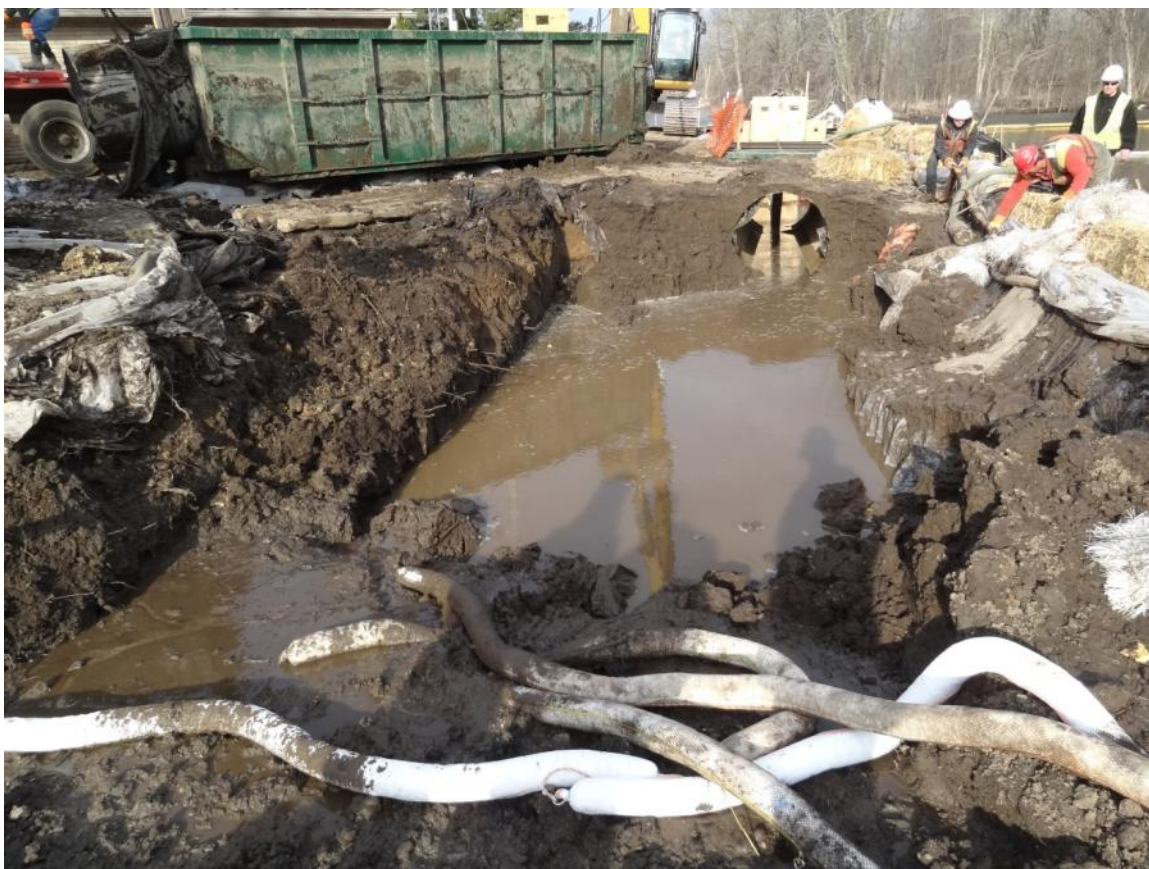
20. Confluence: observed the removal of the first diversion box.

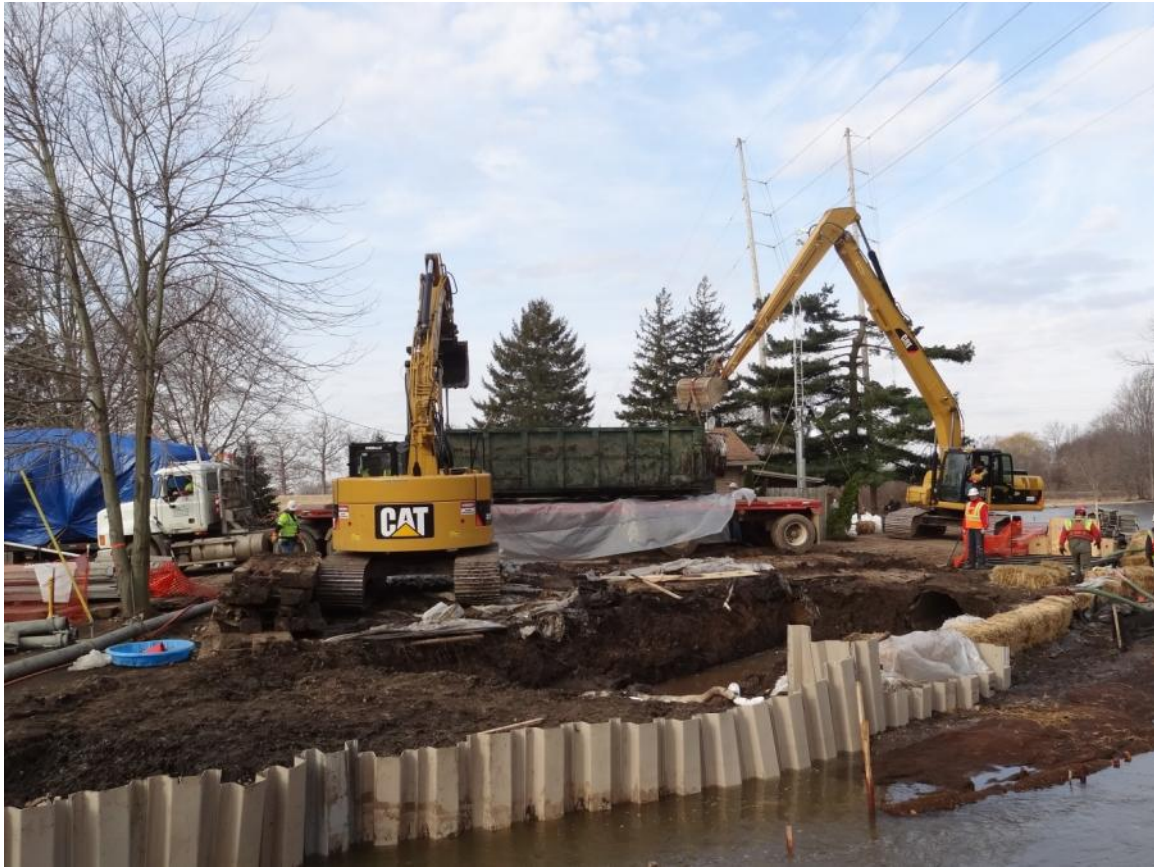
**21. Confluence: observed removal of the diversion structure.**

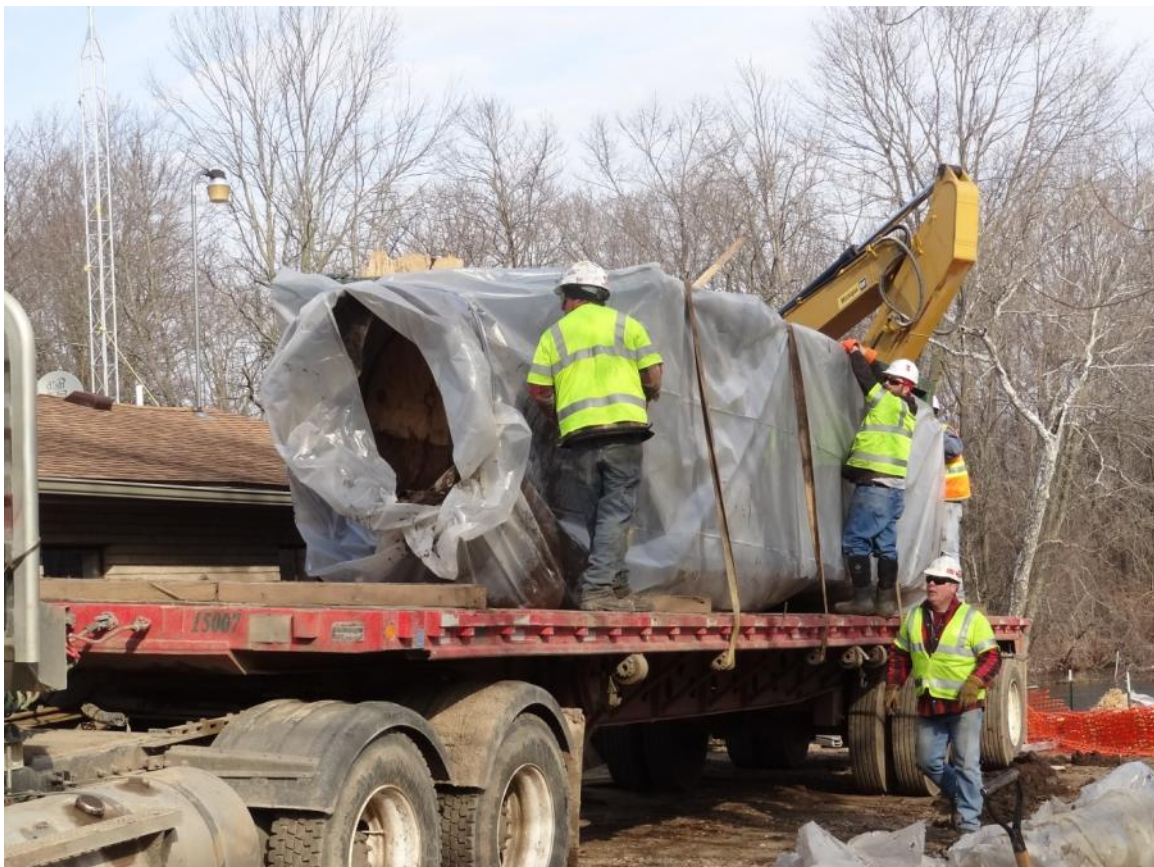
**22. Confluence: observed the removal of the first diversion box.**

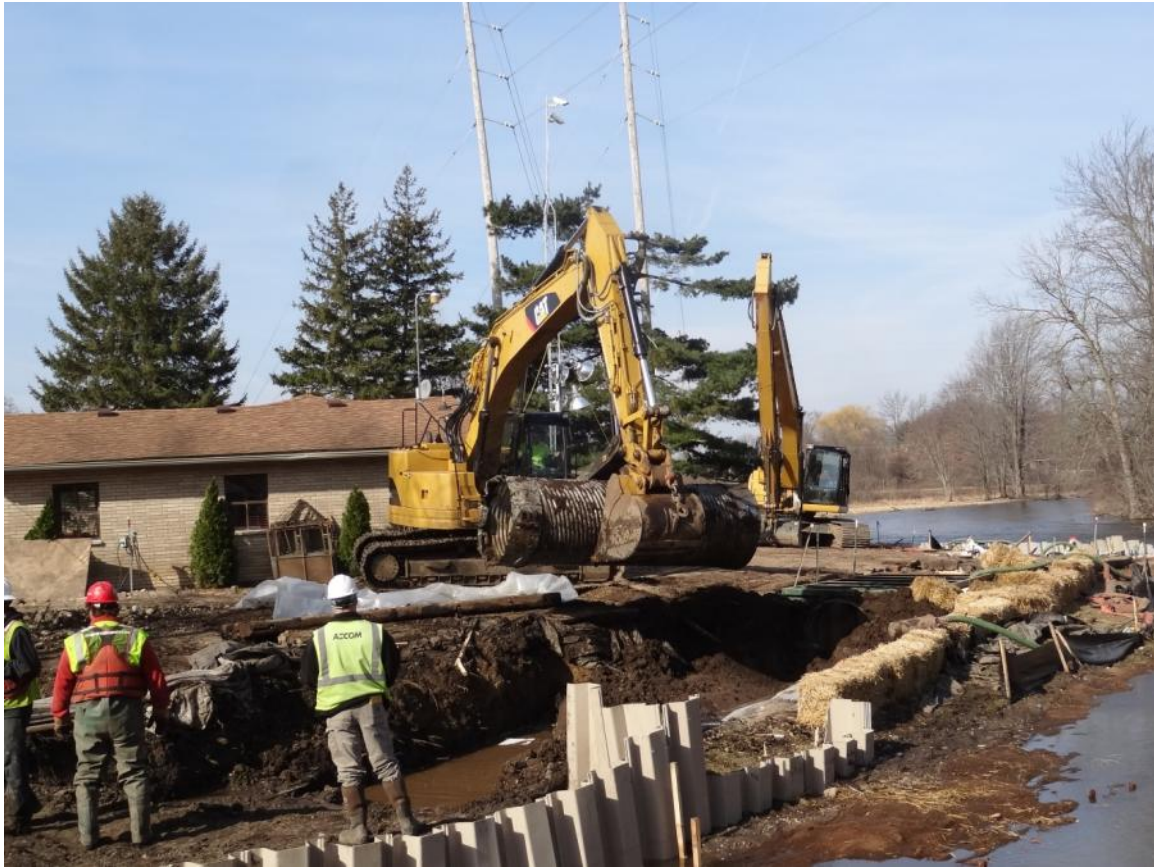
**23. Confluence: observed removal of the diversion structure culvert that connected the two boxes.**
