# Situation Photo Log

Wednesday, March 7, 2012

Kalamazoo River / Enbridge Spill

Matthew Haak  
START-USEPA  
Situation Unit Leader

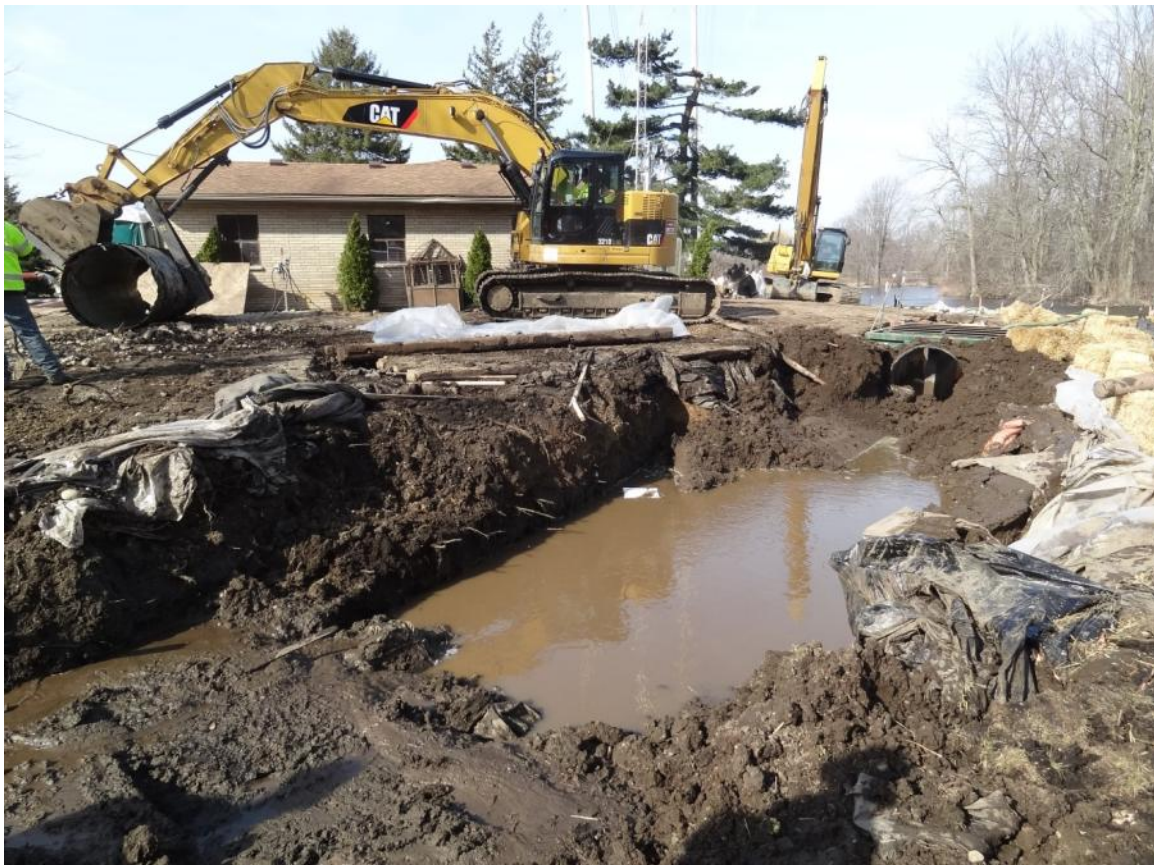
**24. Confluence: observed removal of the diversion structure culvert that connected the two boxes.**

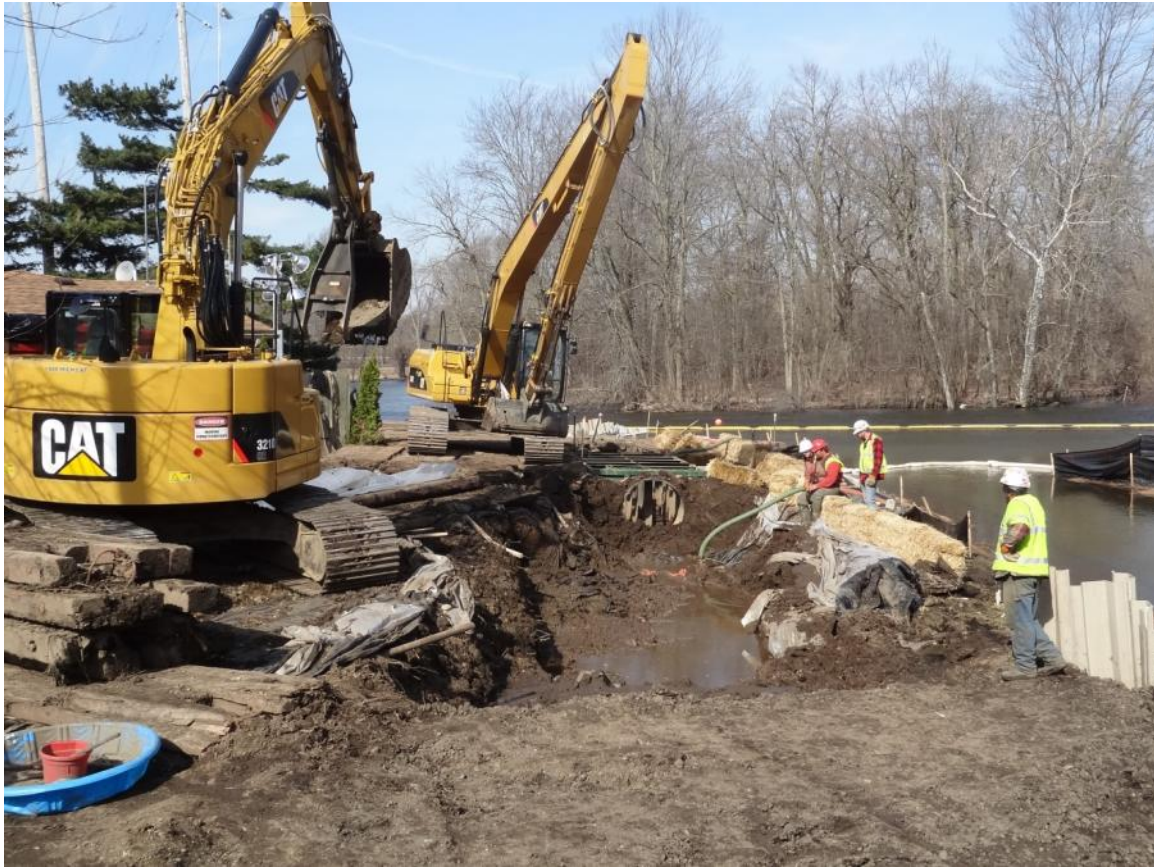
25. Confluence: observed removal of the diversion structure.

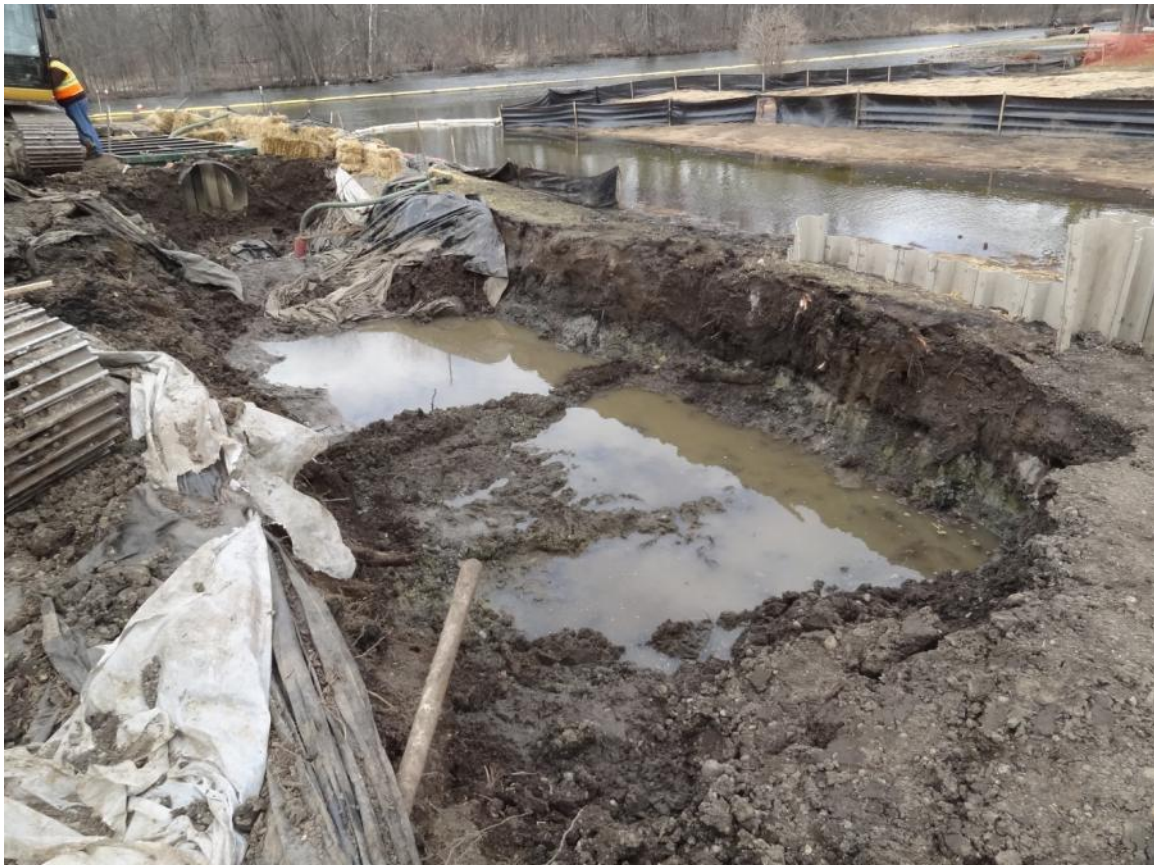
26. Confluence: removal of the diversion structure.

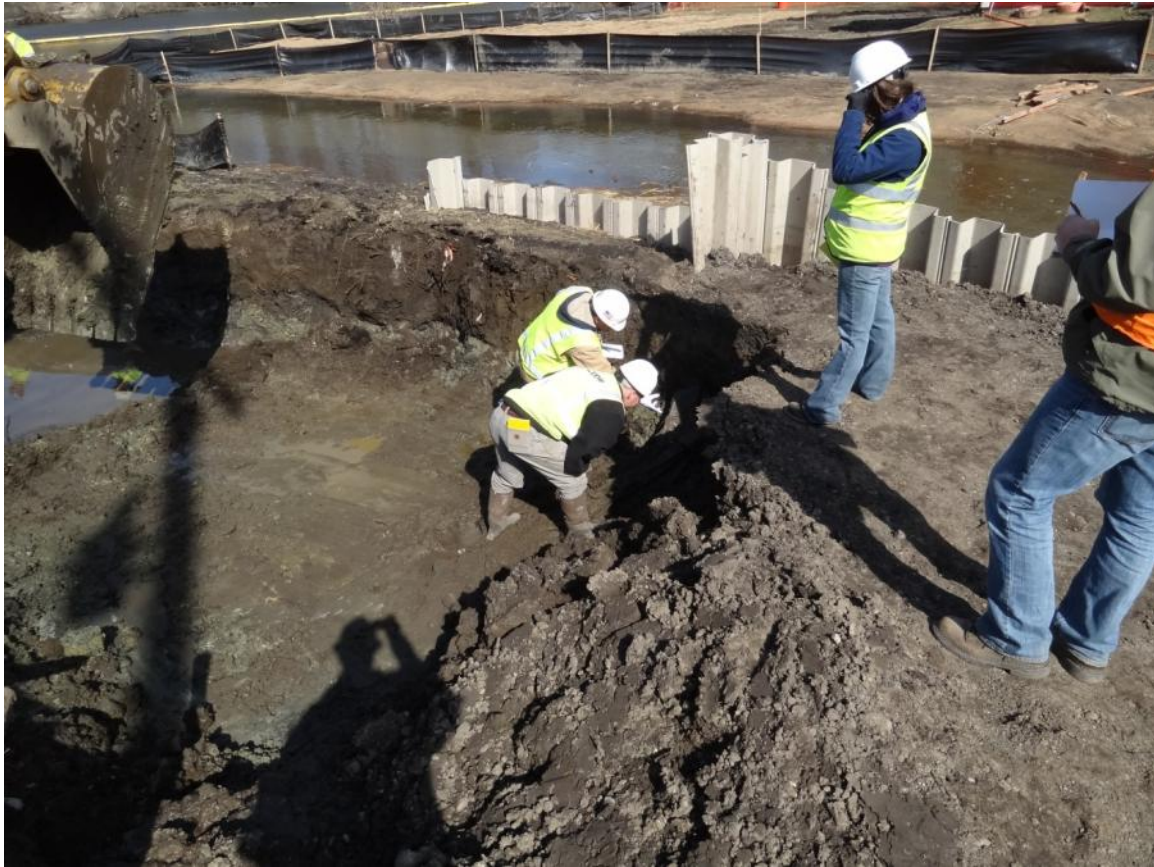
**27. Confluence: during the removal of the diversion structure crews cleared the excavation prior to sampling.**

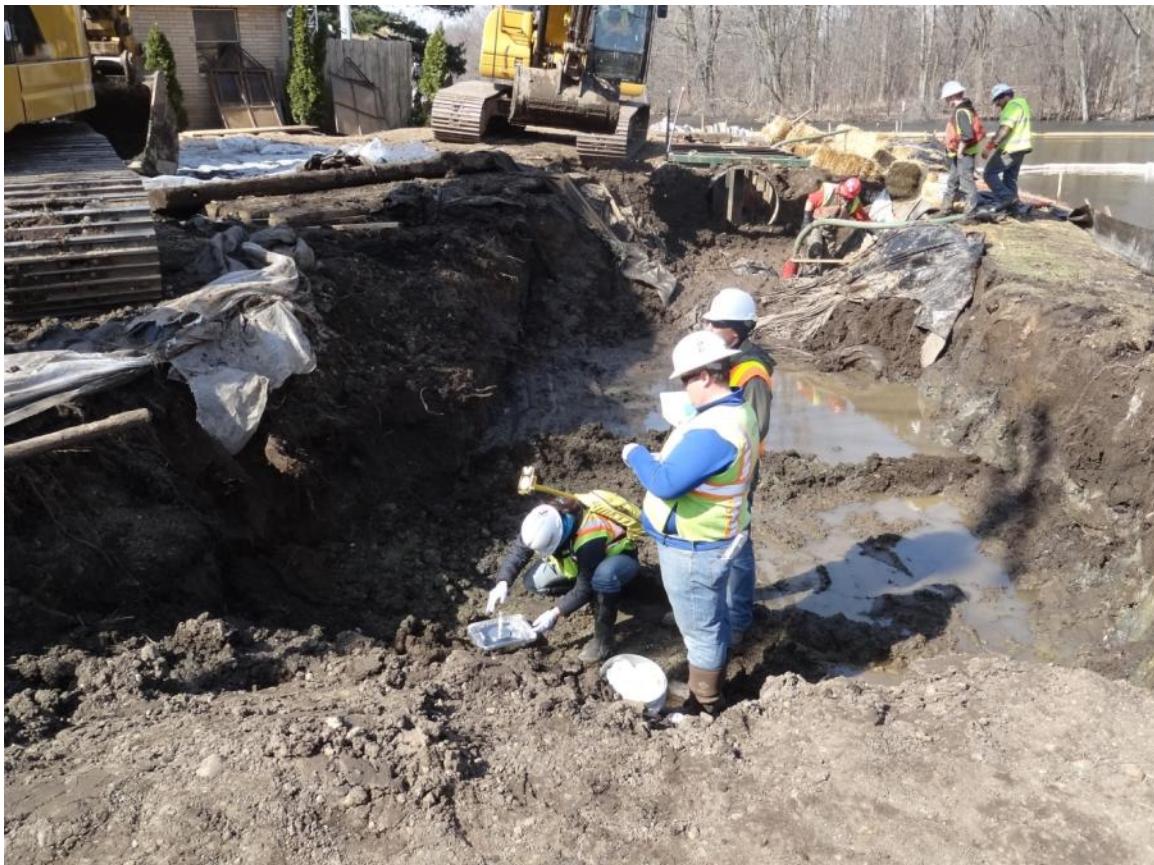
**28. Confluence: observed sampling of the excavation prior to restoration.**

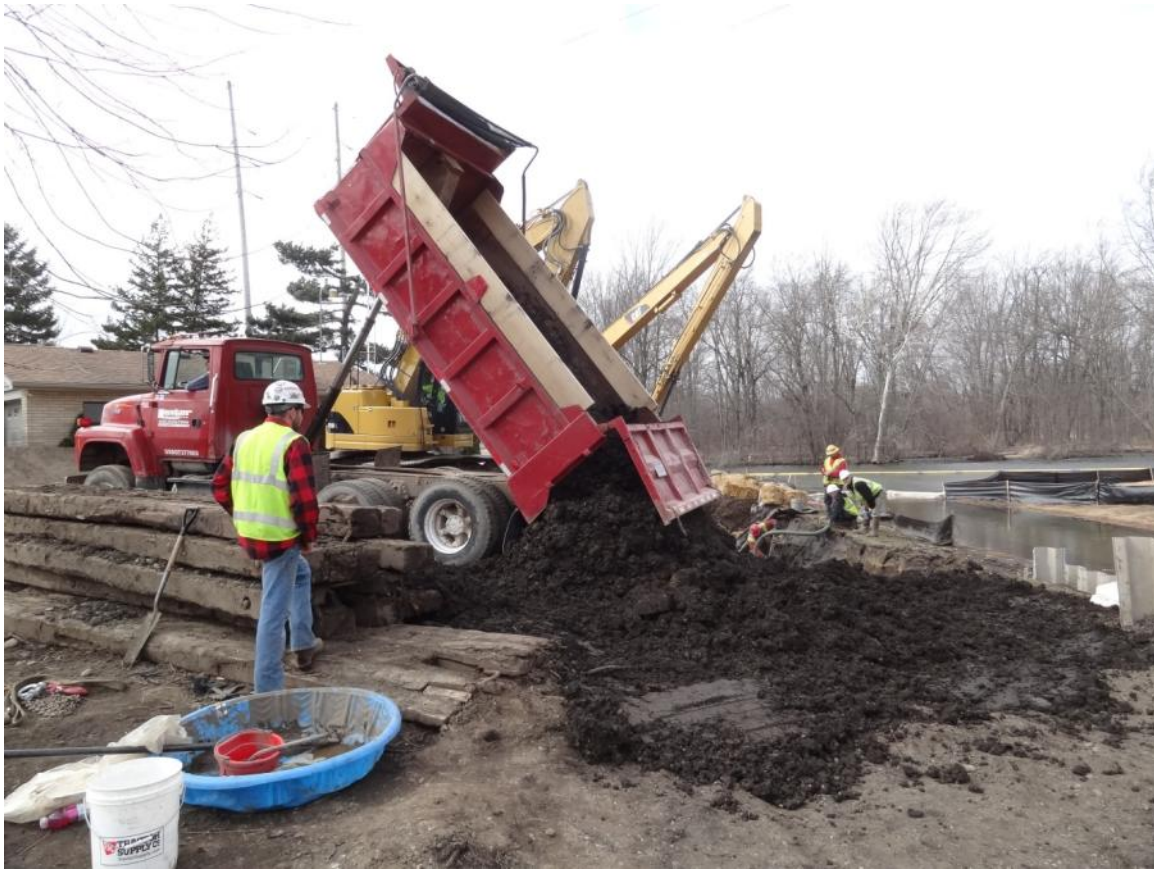
29. Confluence: observed restoration of cleared area.

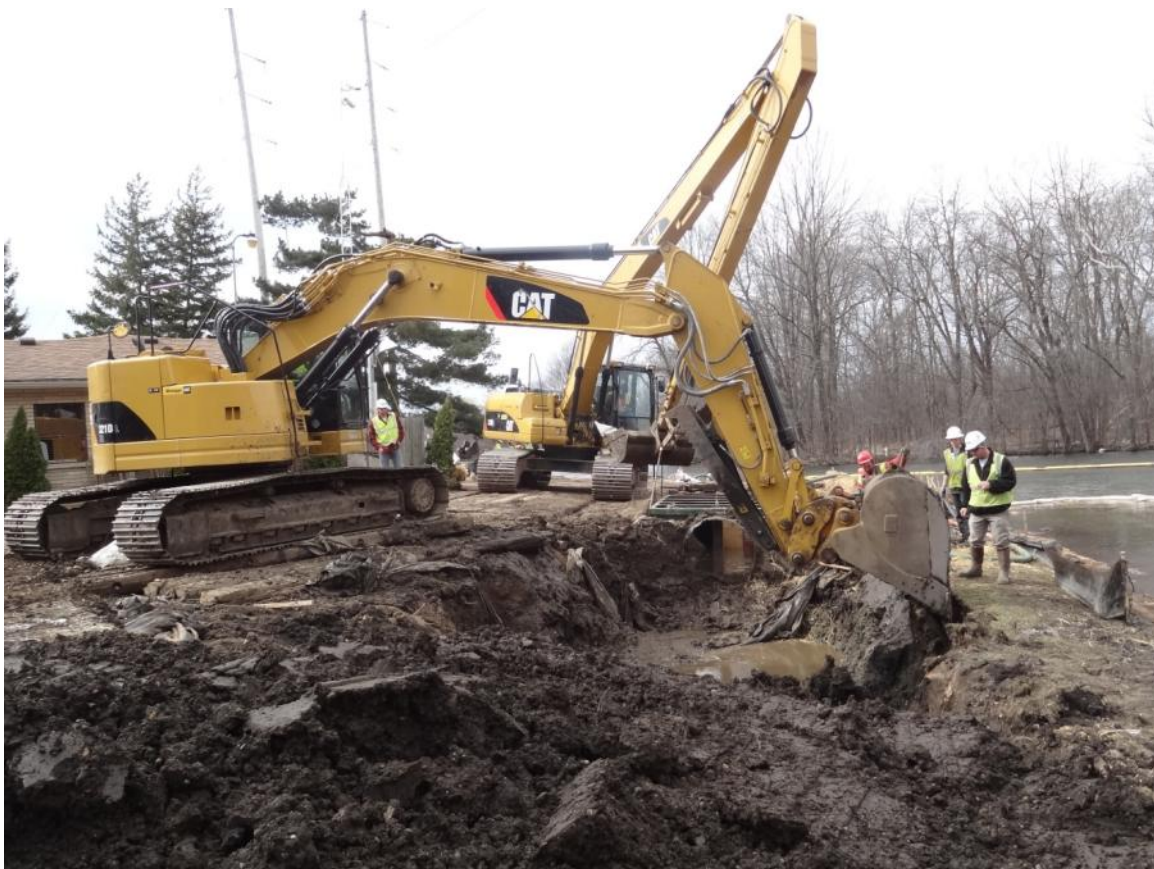
30. Confluence: excavation and removal of the diversion structure.

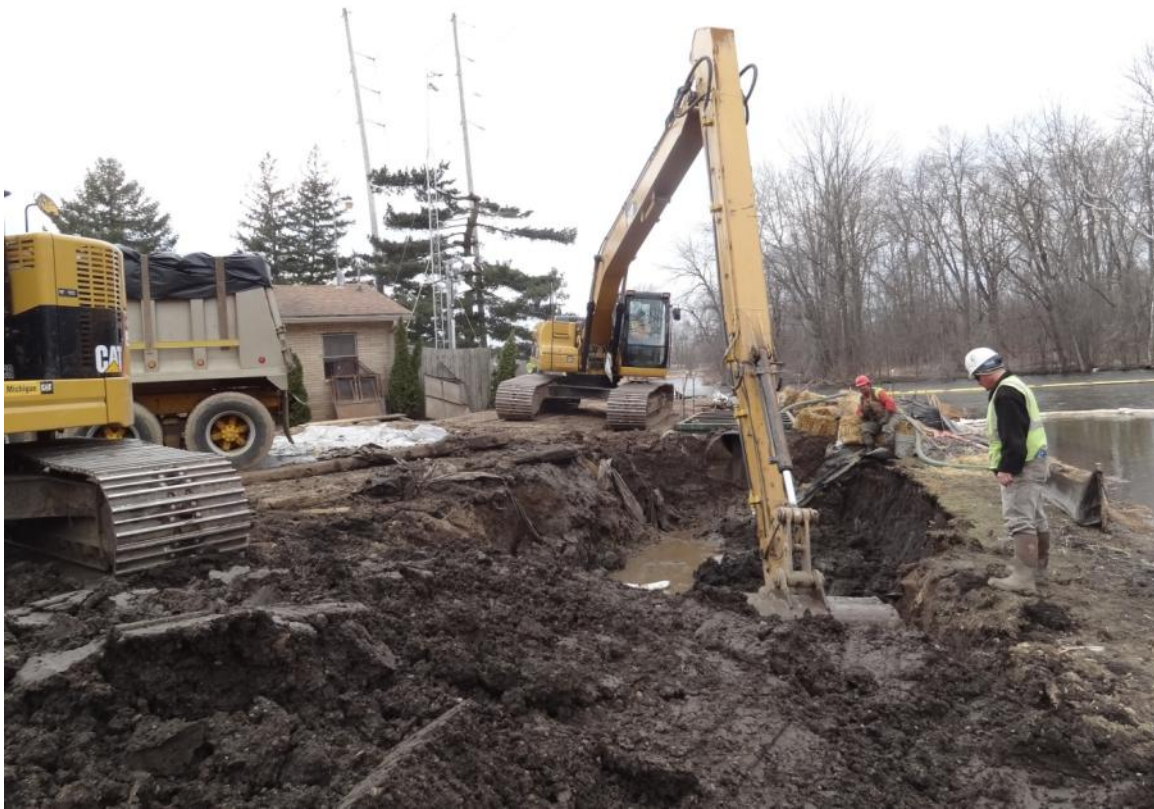
**31. Confluence: excavation and removal of the diversion structure.**

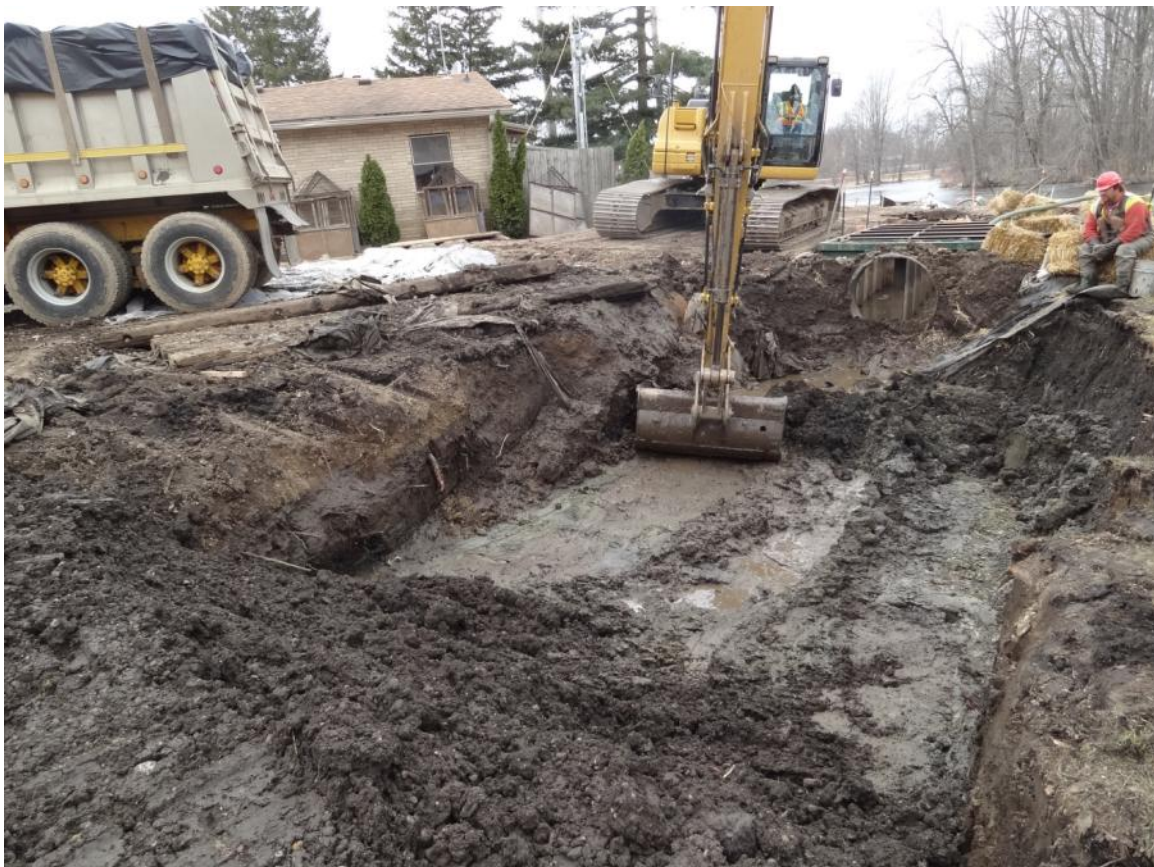
**32. Confluence: excavation and removal of the diversion structure.**

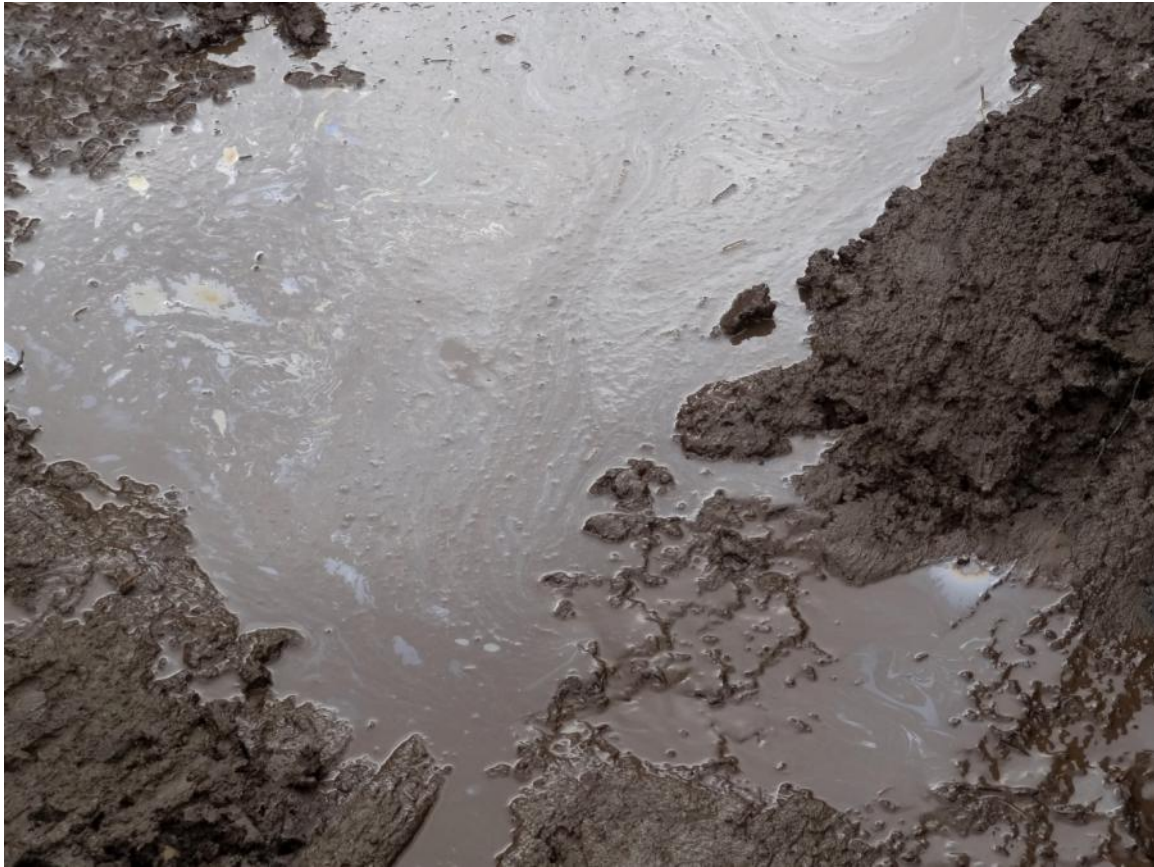
**33. Confluence: sheen observed during excavation and removal of the diversion structure.**

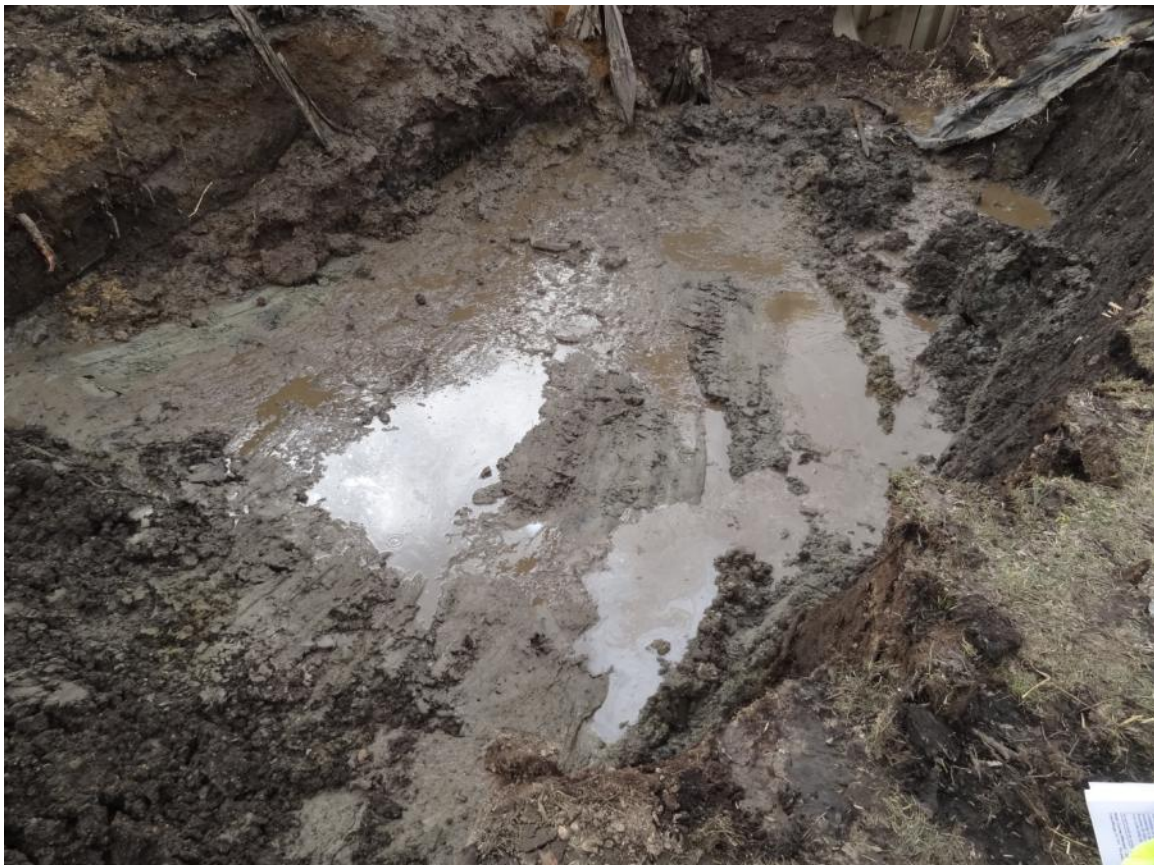
**34. Confluence: excavation and removal of the diversion structure.**

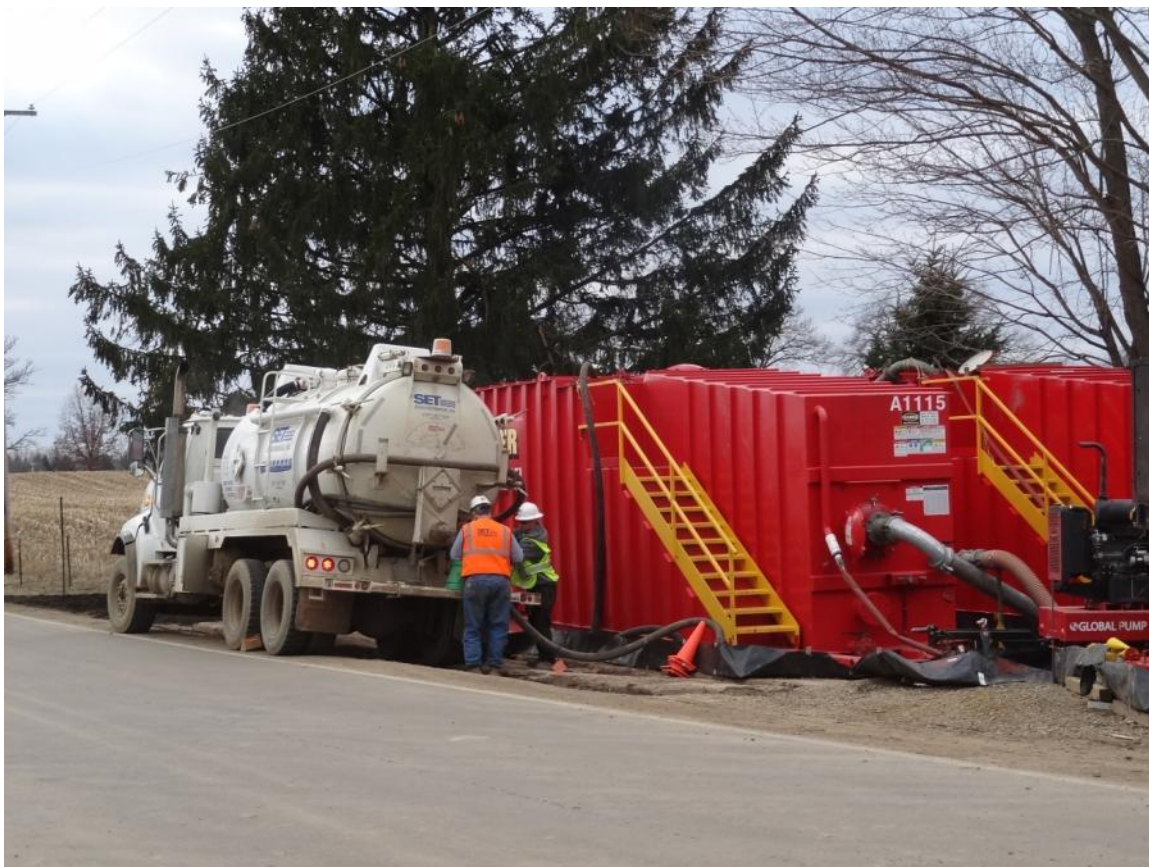
35. Confluence: Vac-truck observed at Frac-Tanks.

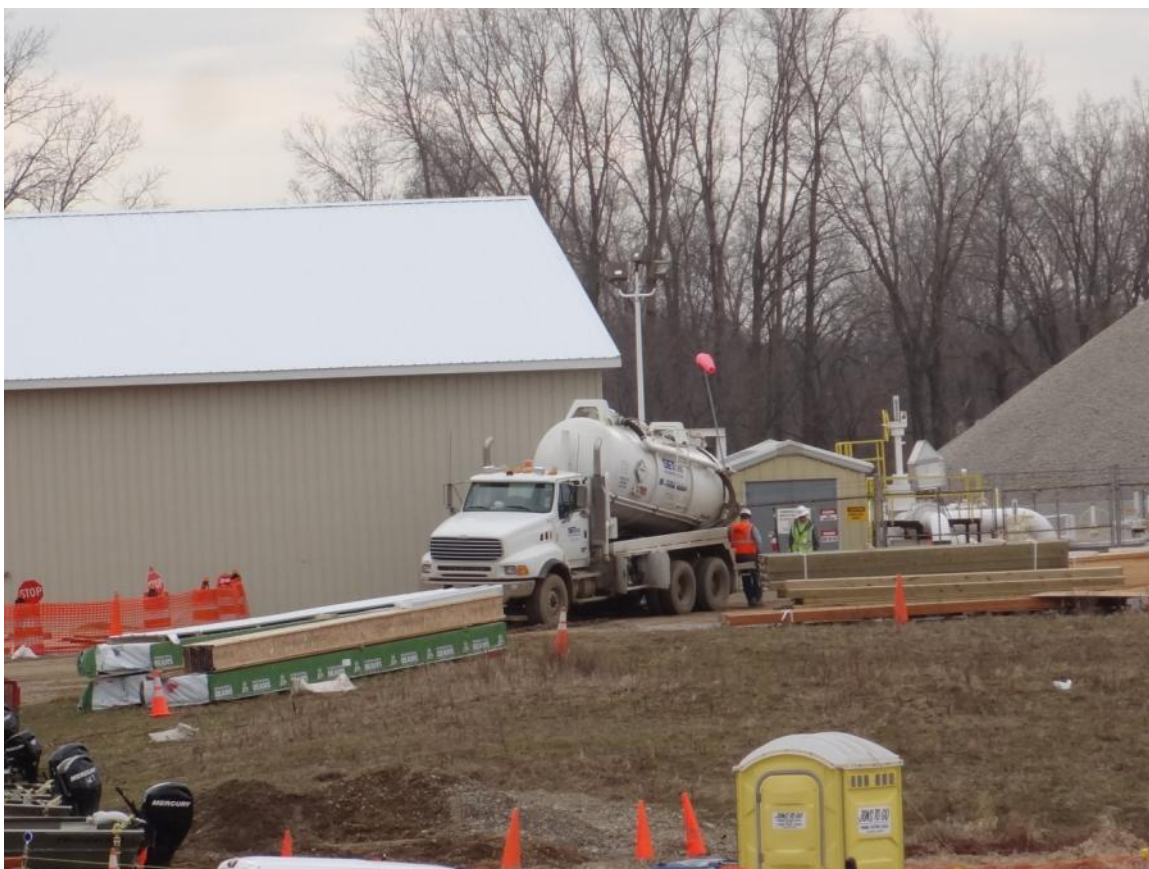
36. Frac-City offloading at pole barn.

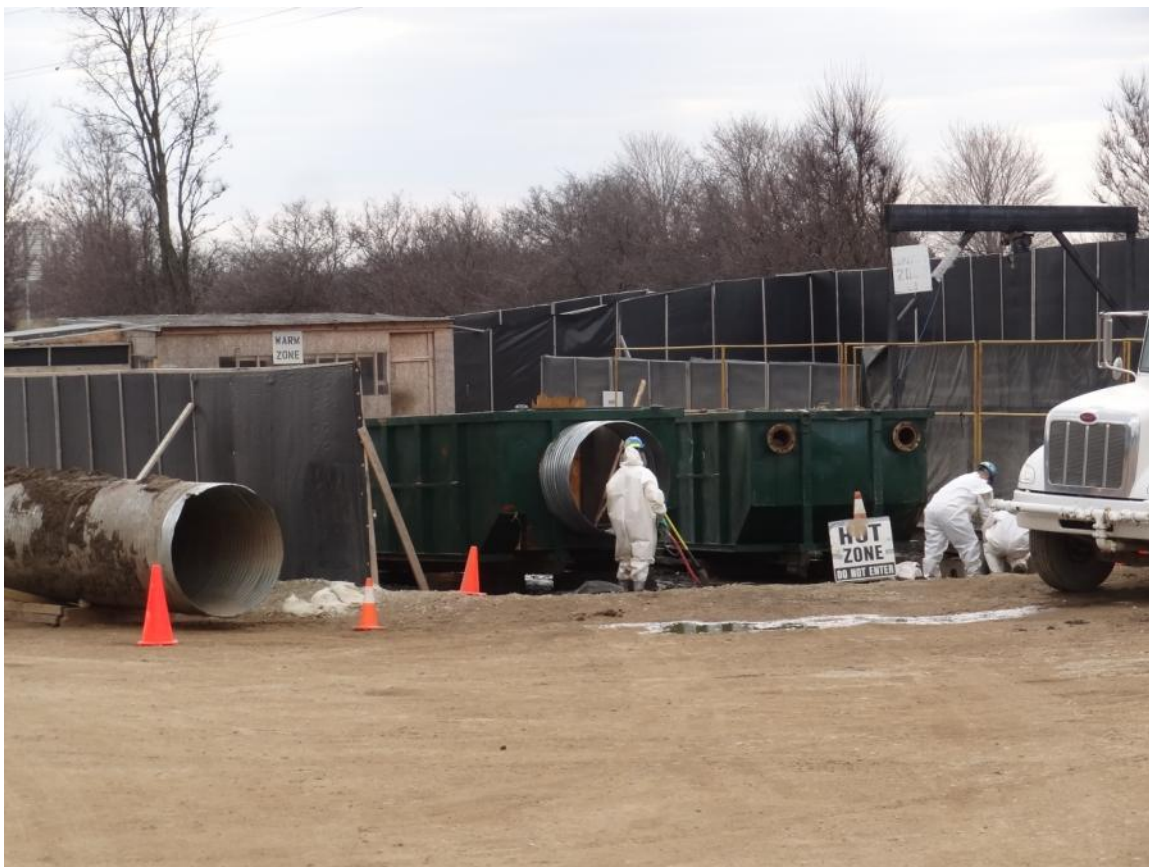
37. . Frac-City observed crews decontaminating diversion box.

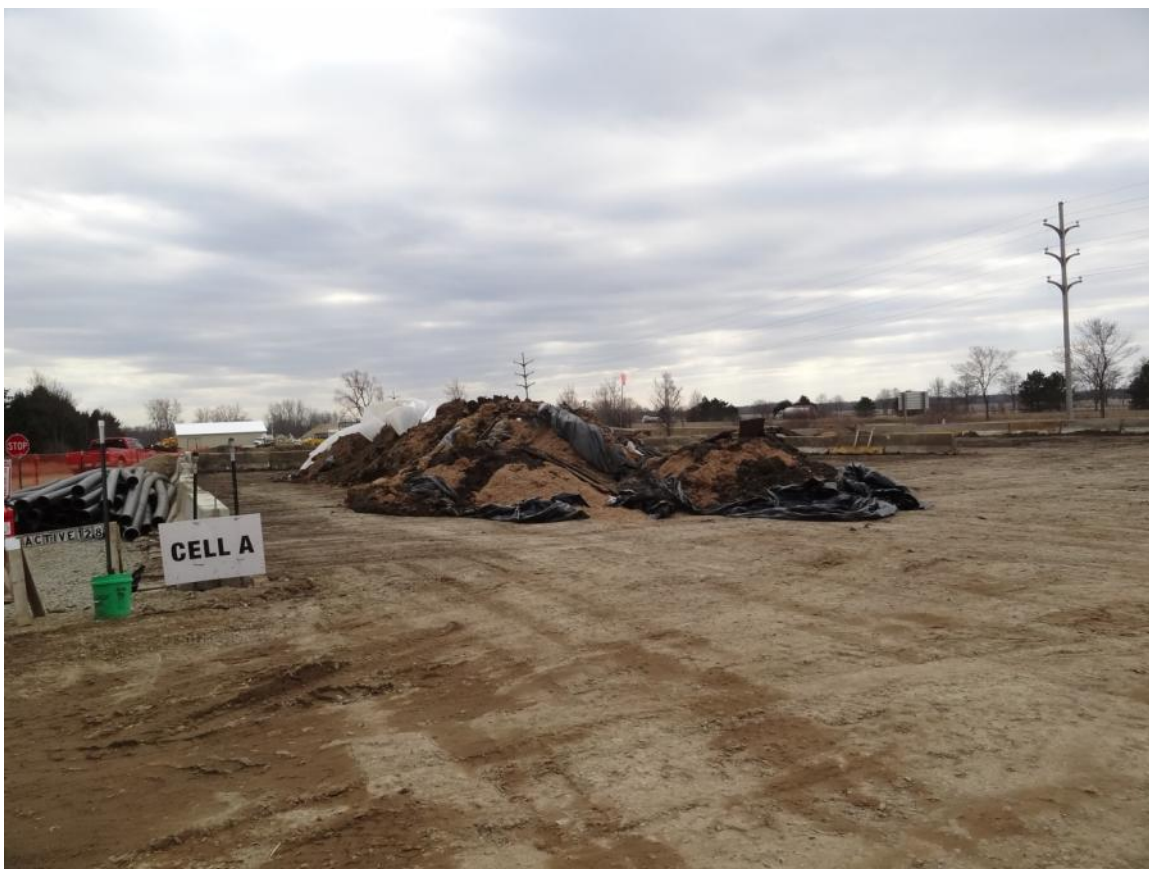
38. Frac-City Soil Cell A.
