Situation Photo Log

Thursday, March 8, 2012

Kalamazoo River / Enbridge Spill

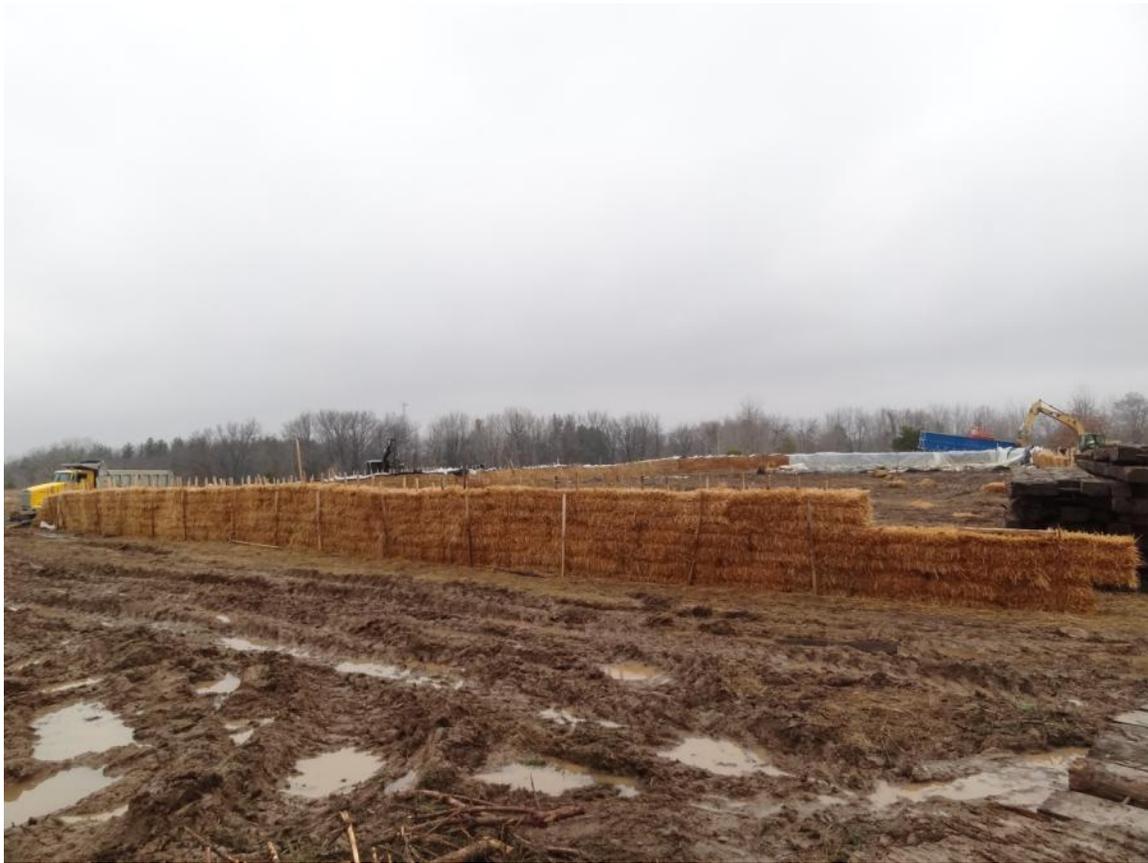
1. Turbidity Control Structure observed being demobilized.

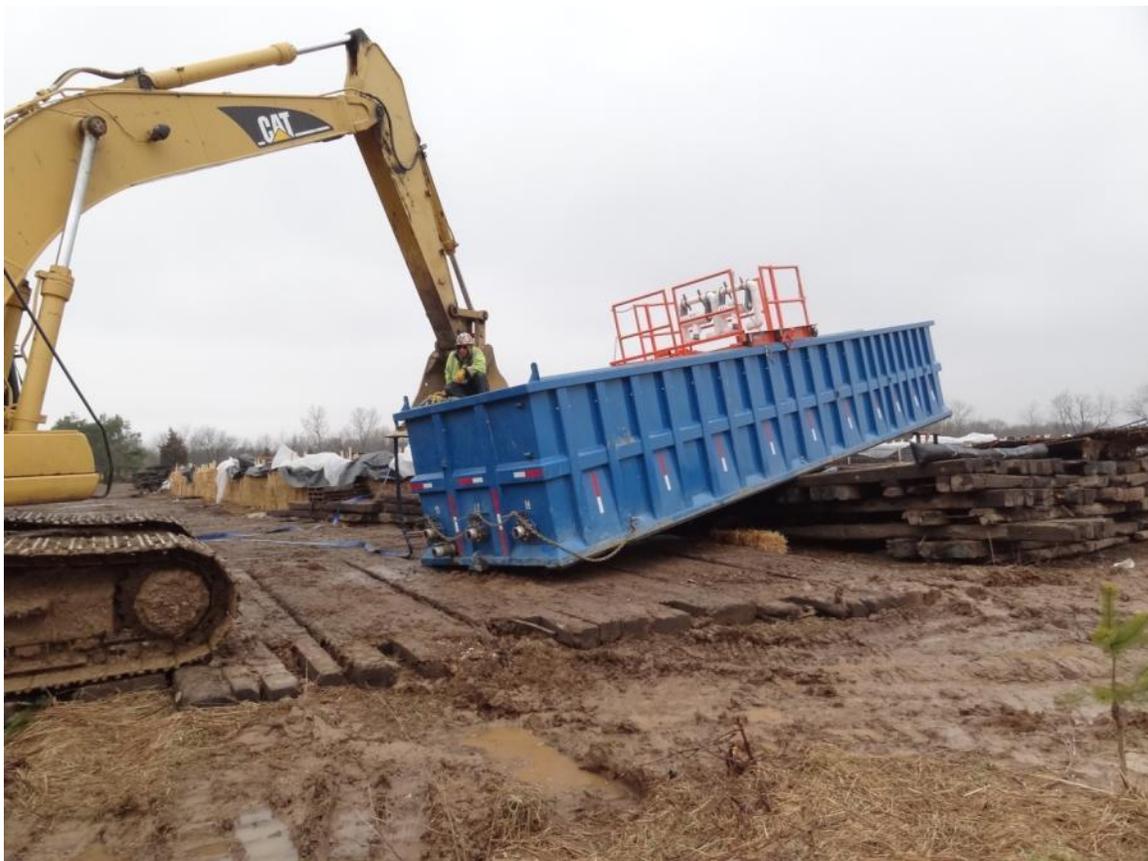
2. Turbidity Control Structure observed floc-box being demobilized.

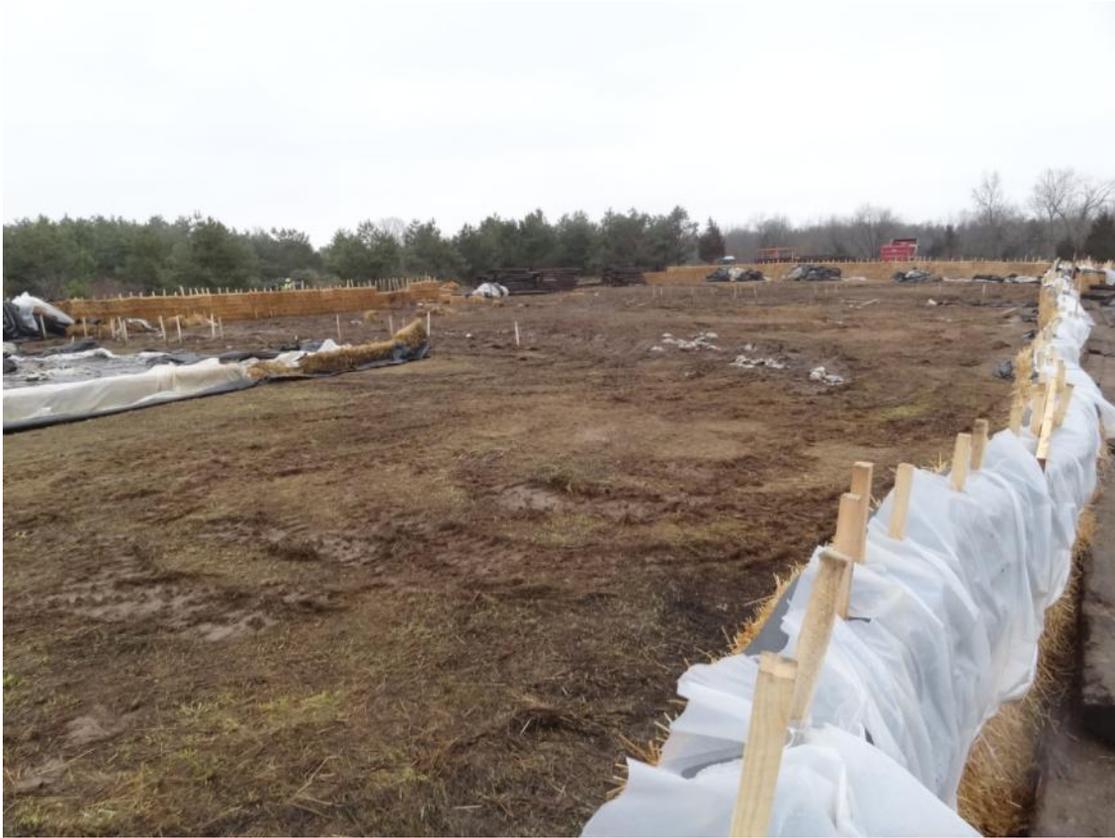
3. Turbidity Control Structure observed being demobilized.

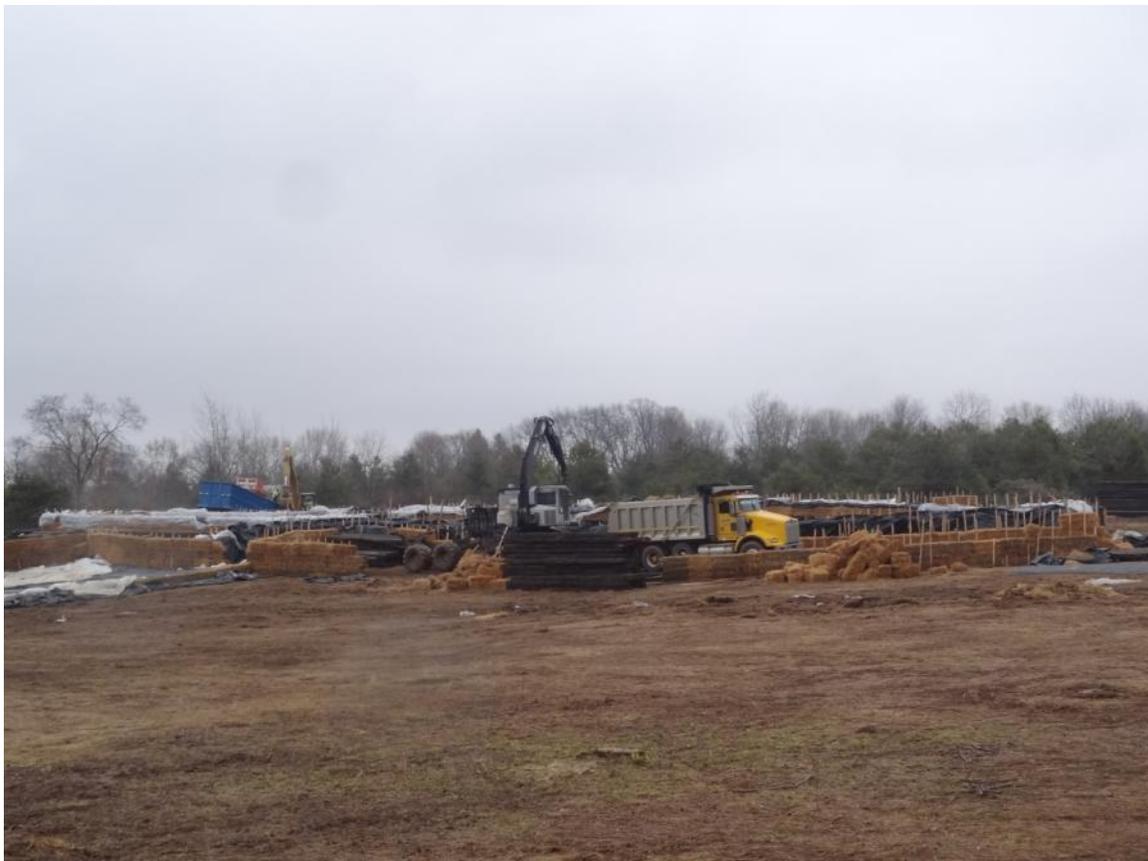
4. Turbidity Control Structure observed being demobilized.

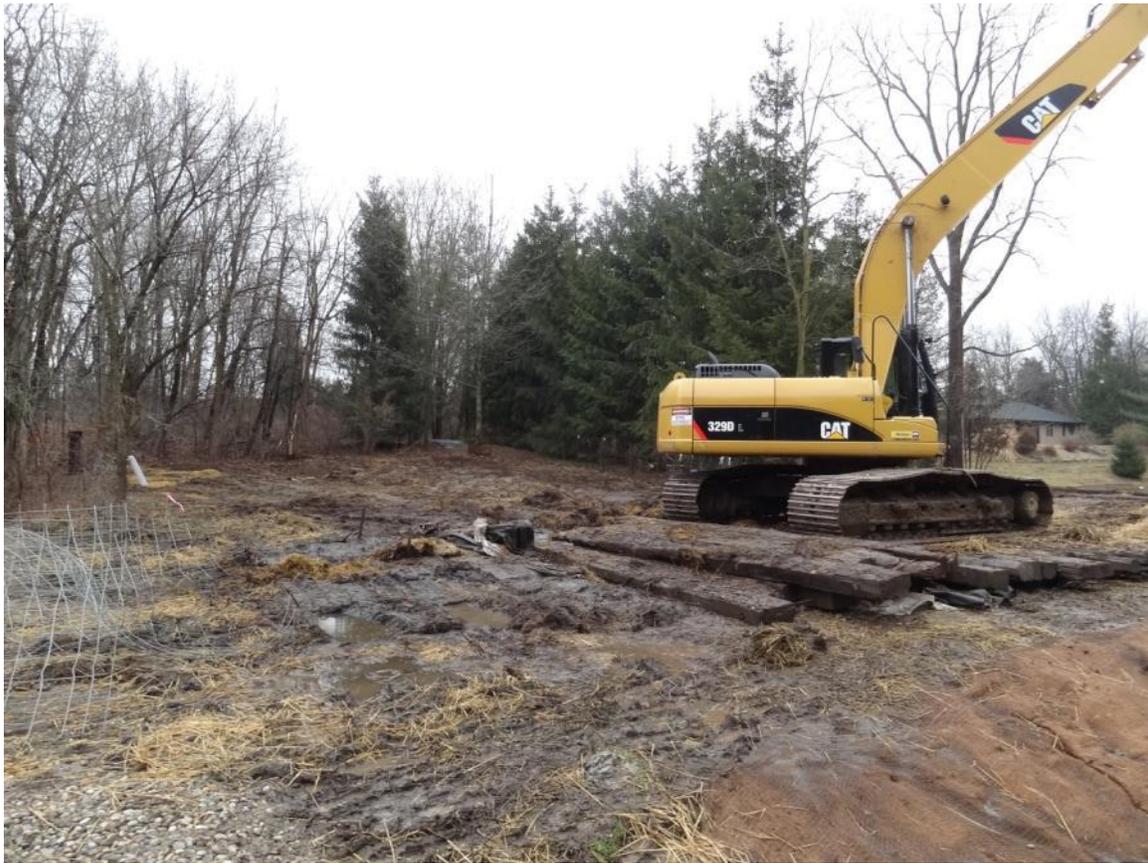
5. Talmadge Creek: demobilizing of bypass discharge near MP1.6.

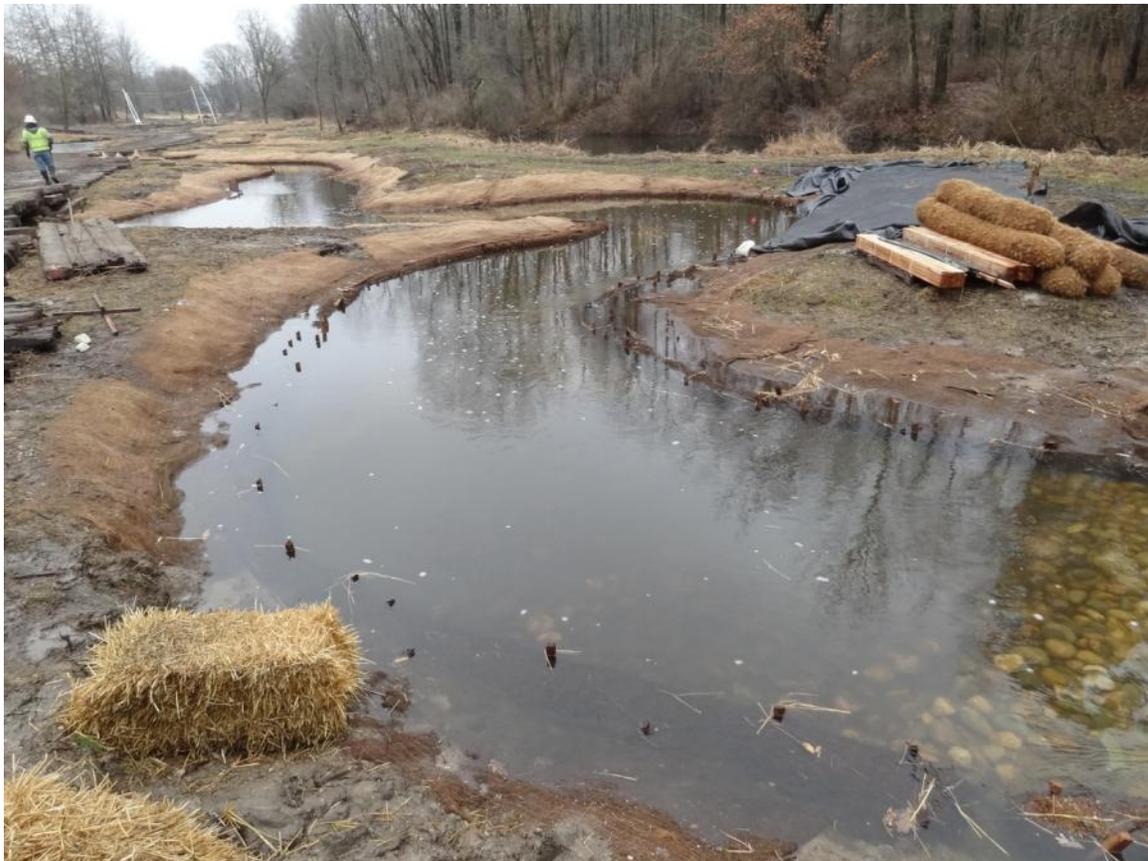
6. Talmadge Creek: the weir structure near MP1.6 has been removed.

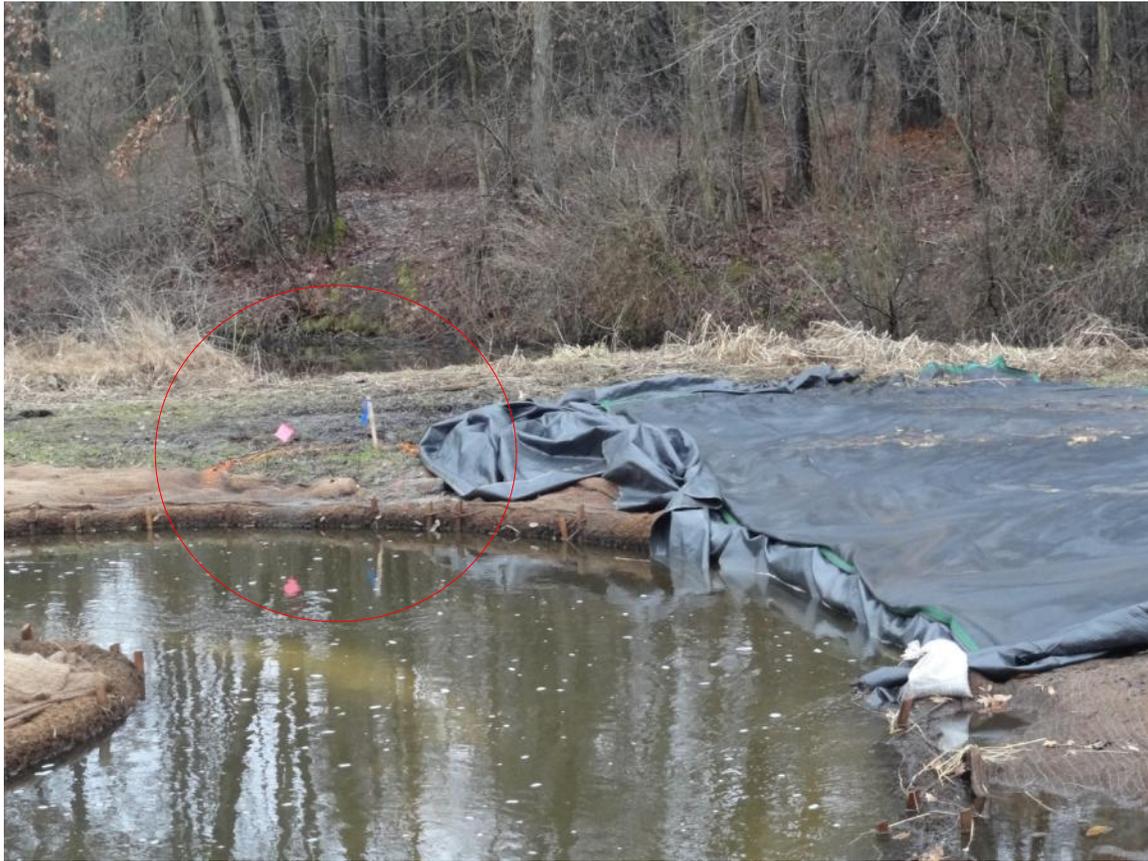
7. Talmadge Creek: one of three small scrape locations at approximately MP1.5.

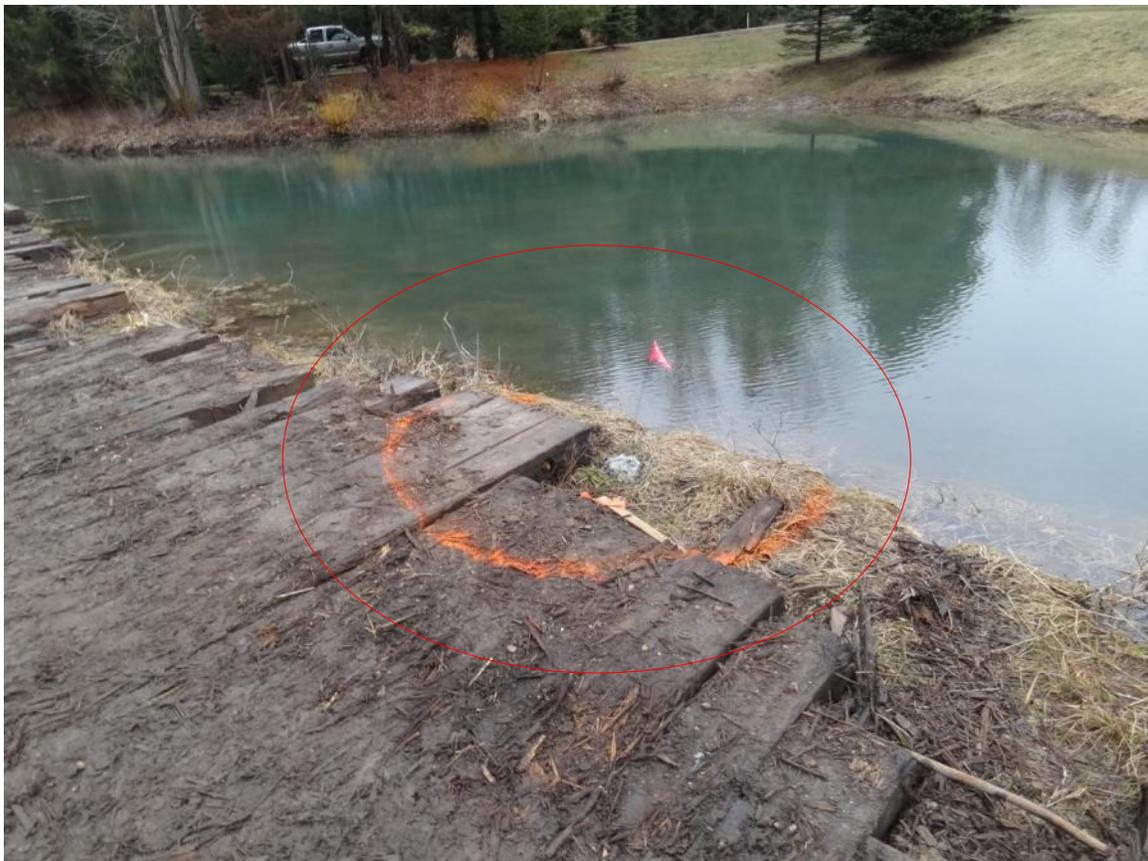
8. Talmadge Creek: one of three small scrape locations at approximately MP1.5.

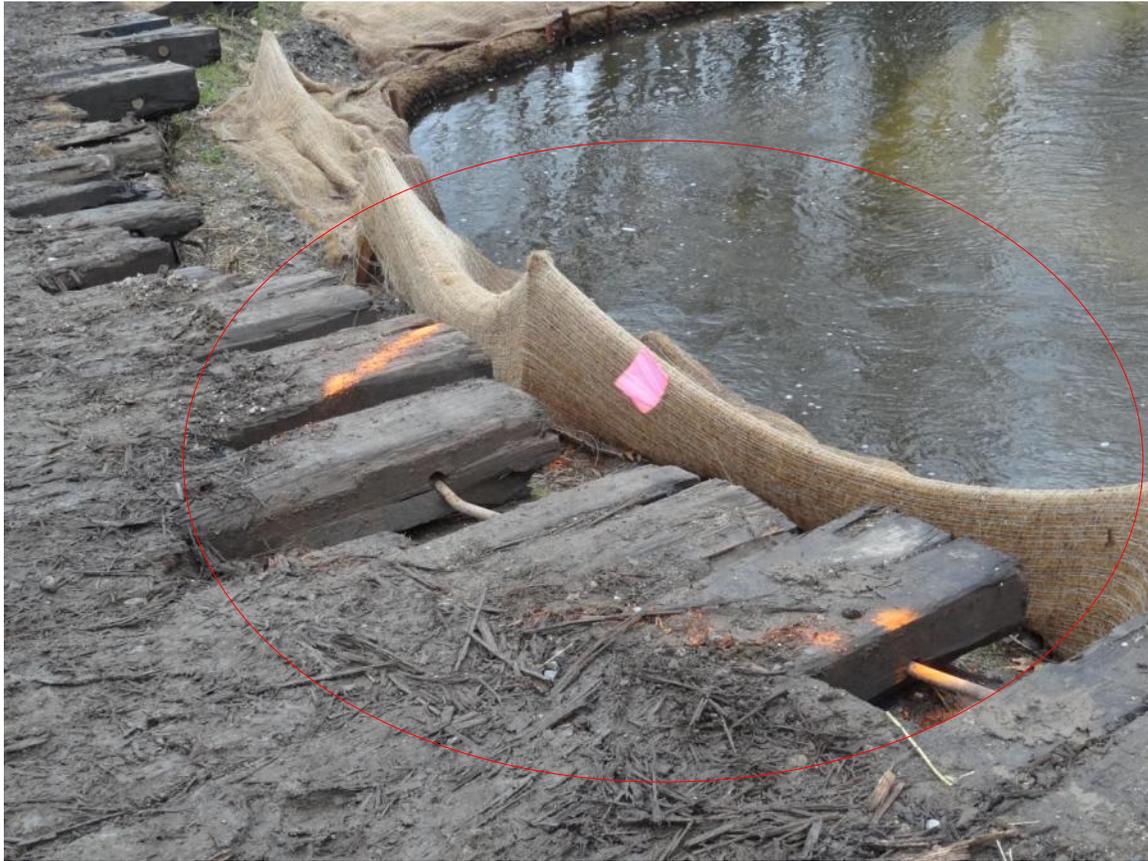
9. Talmadge Creek: one of three small scrape locations at approximately MP1.5.

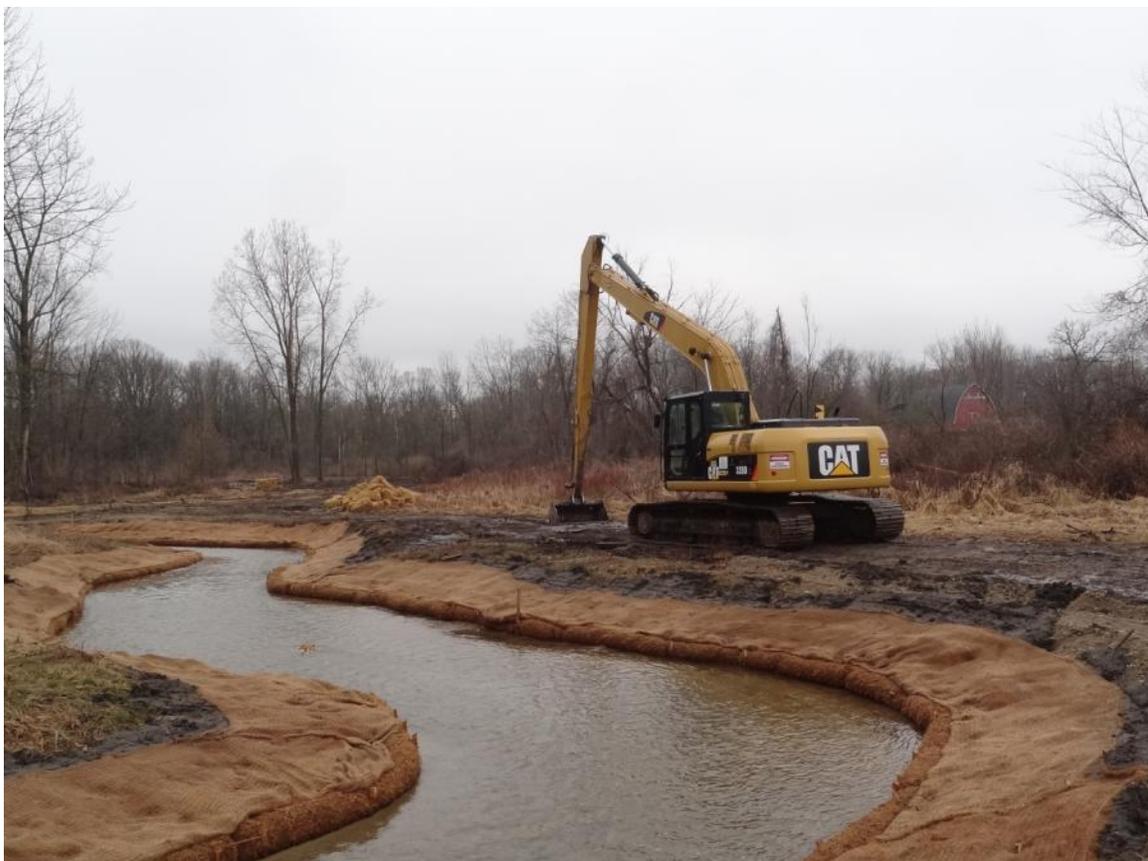
10. Talmadge Creek: Observed timber mat removal and restoration near MP1.8.

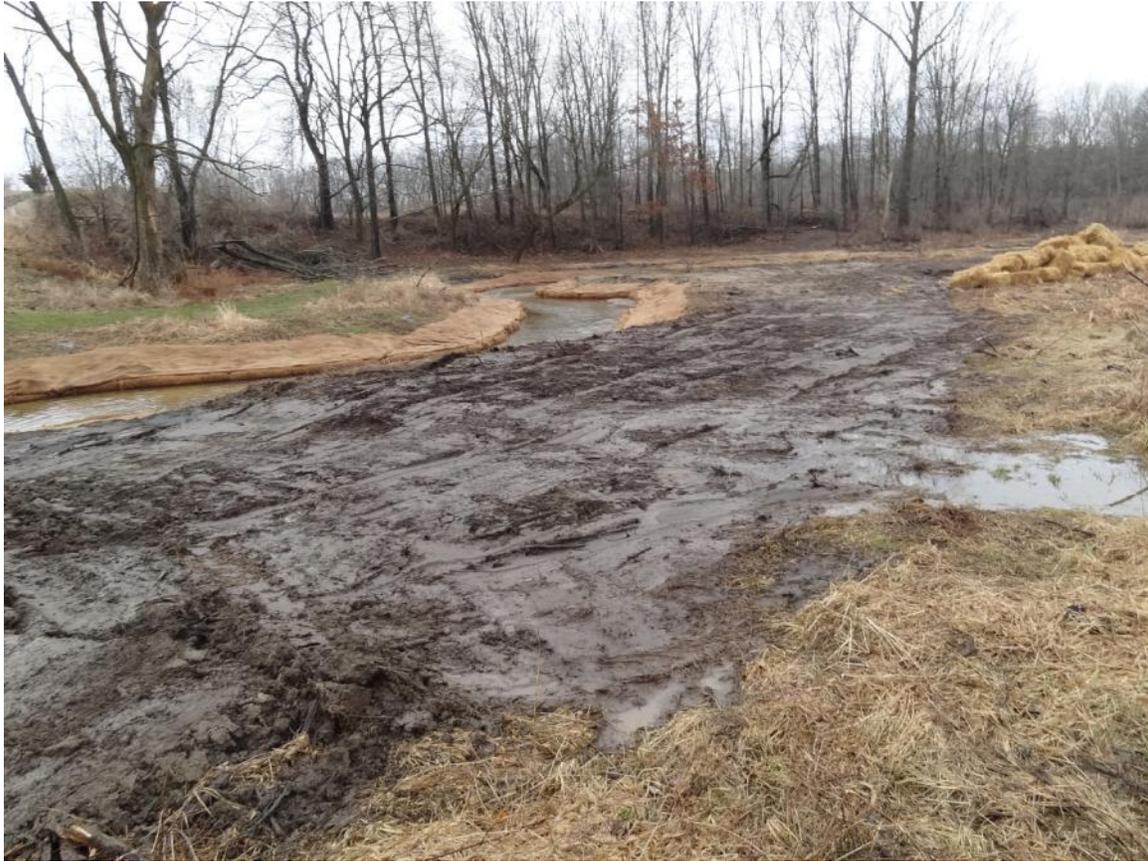
11. Talmadge Creek: Observed timber mat removal and restoration near MP1.8.

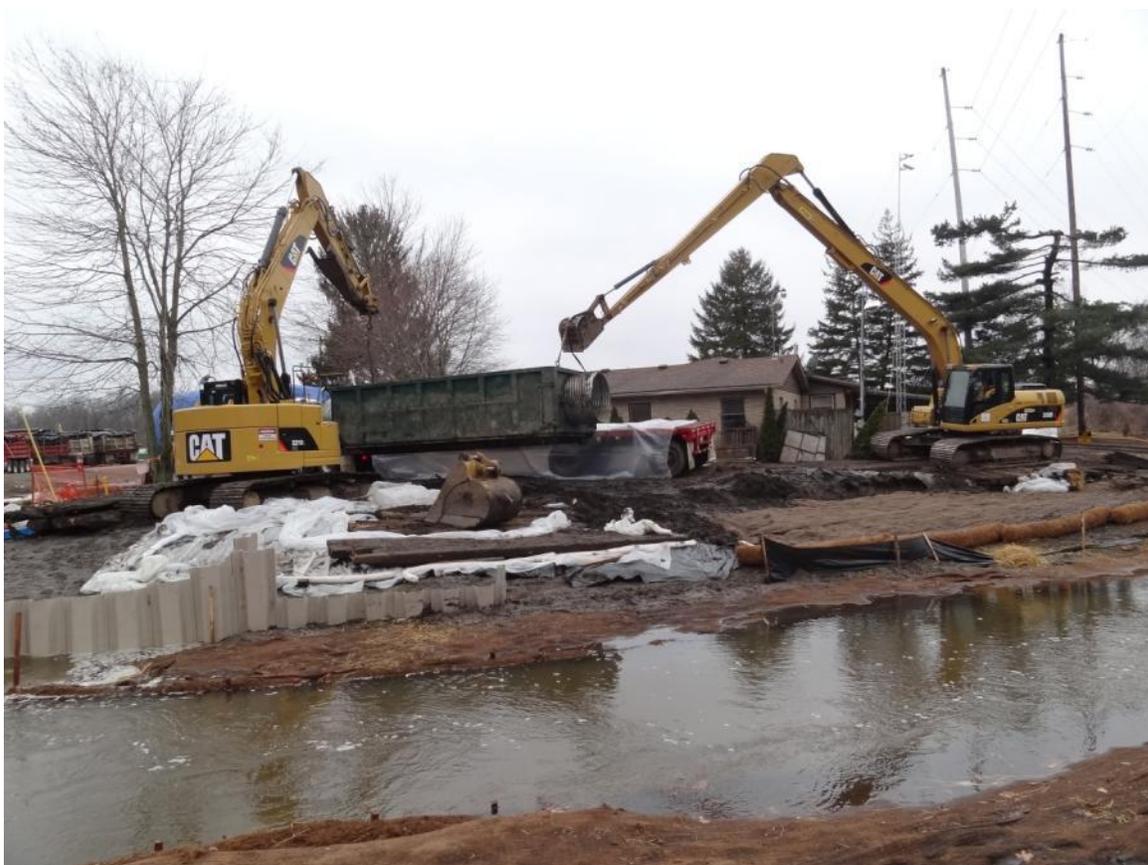
12. Confluence: observed the removal of the second diversion box.

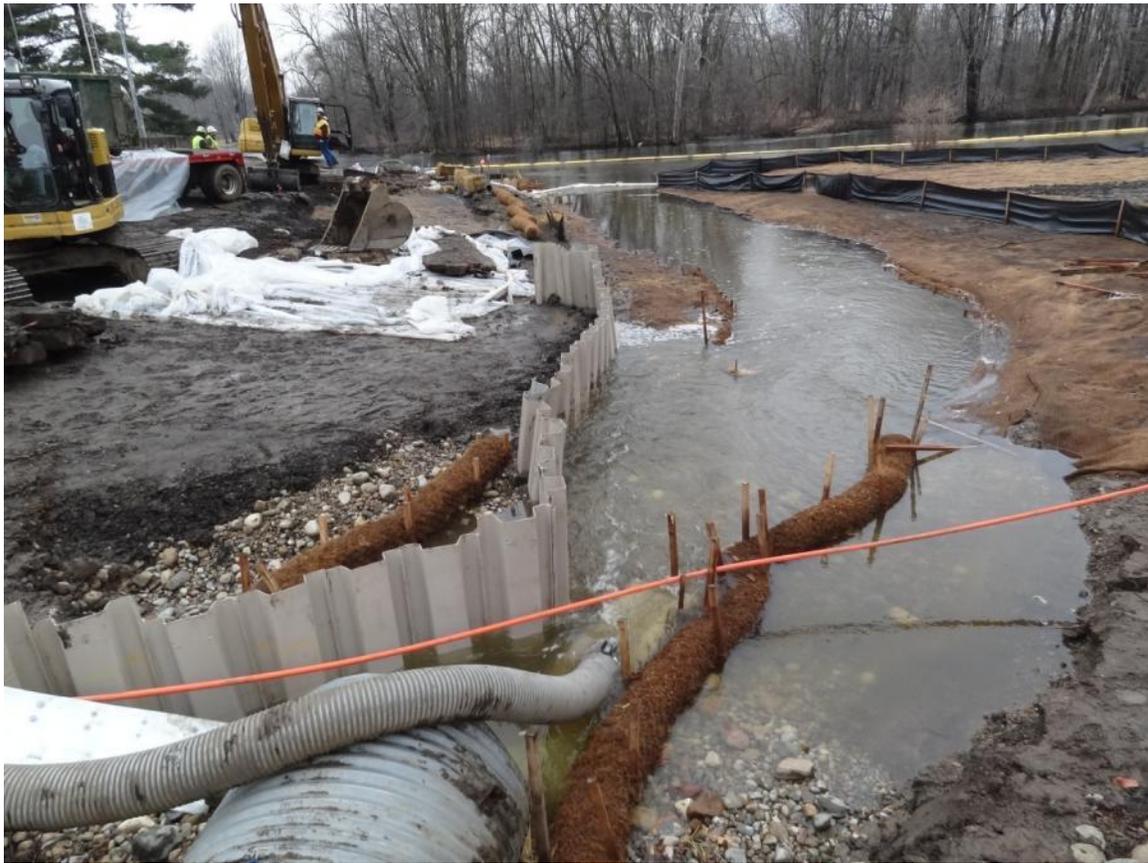
13. Confluence: observed sheet piling remaining.

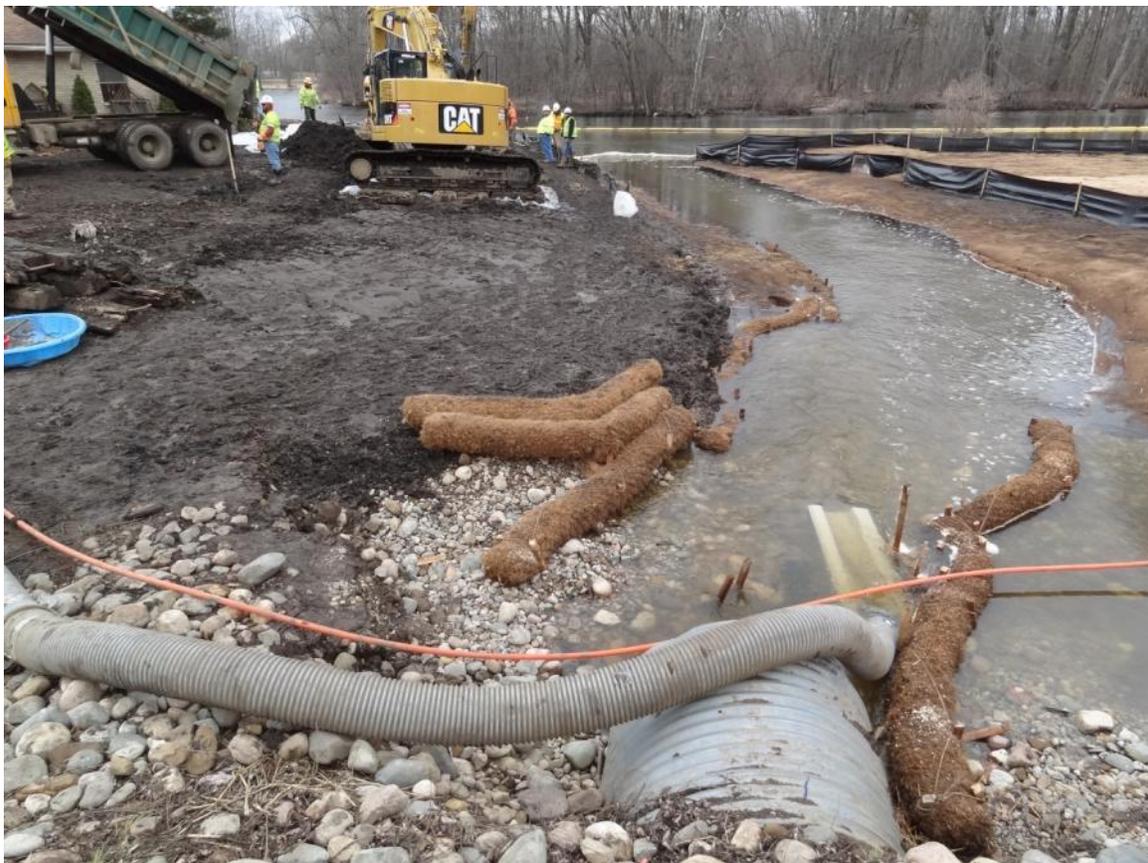
14. Confluence: sheet piling has been removed.

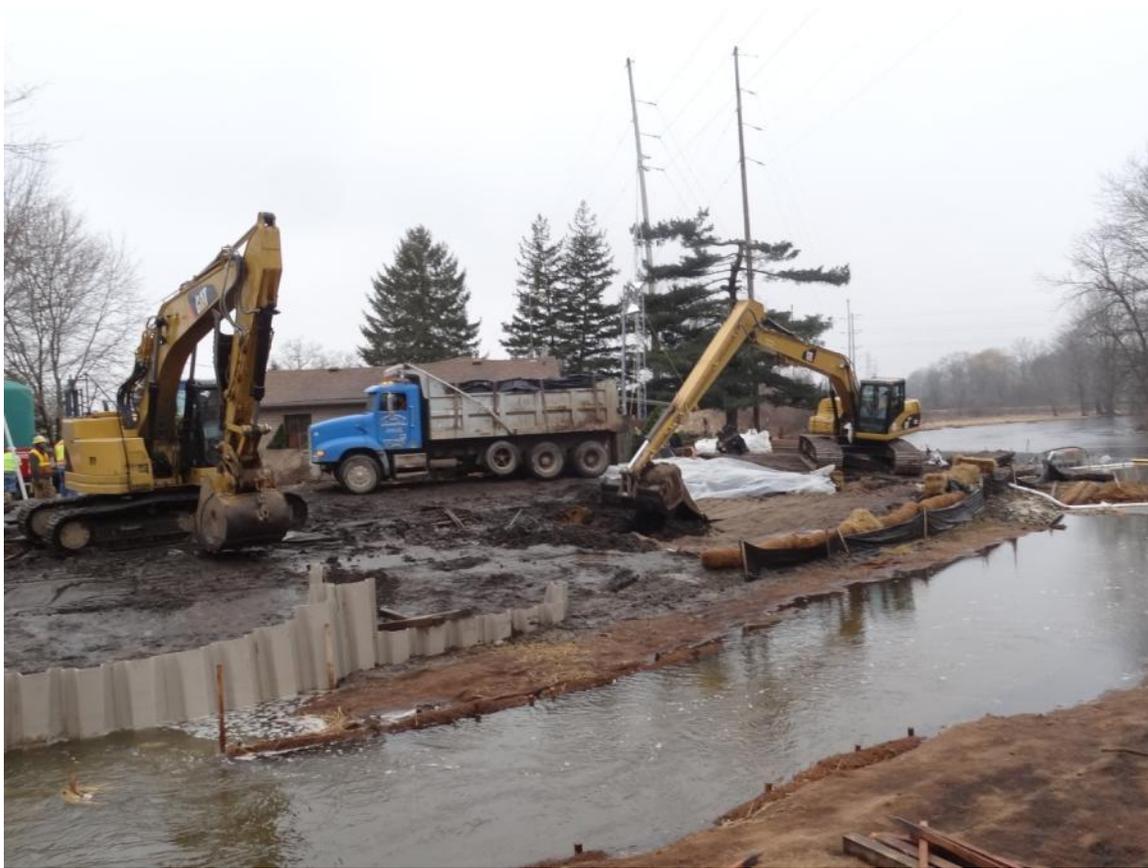
15. Confluence: observed excavation work.

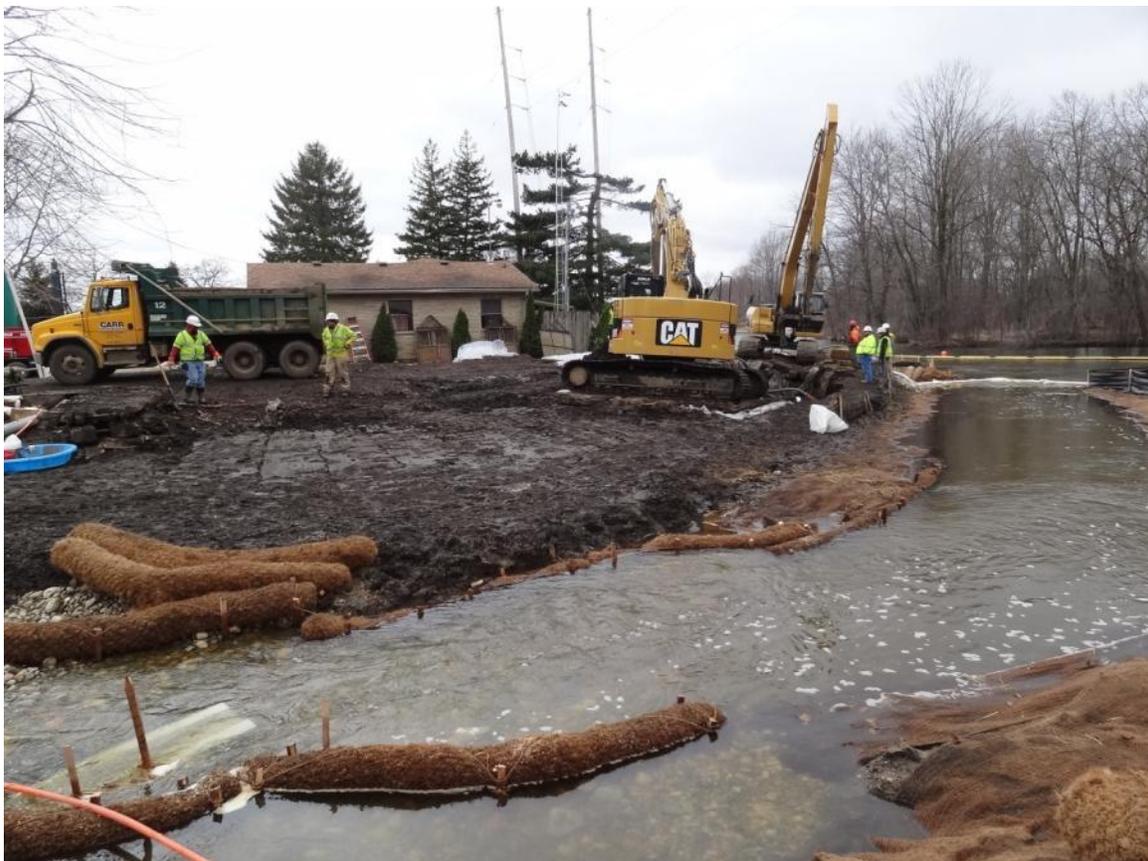
16. Confluence: observed excavation around the location of the second diversion box.

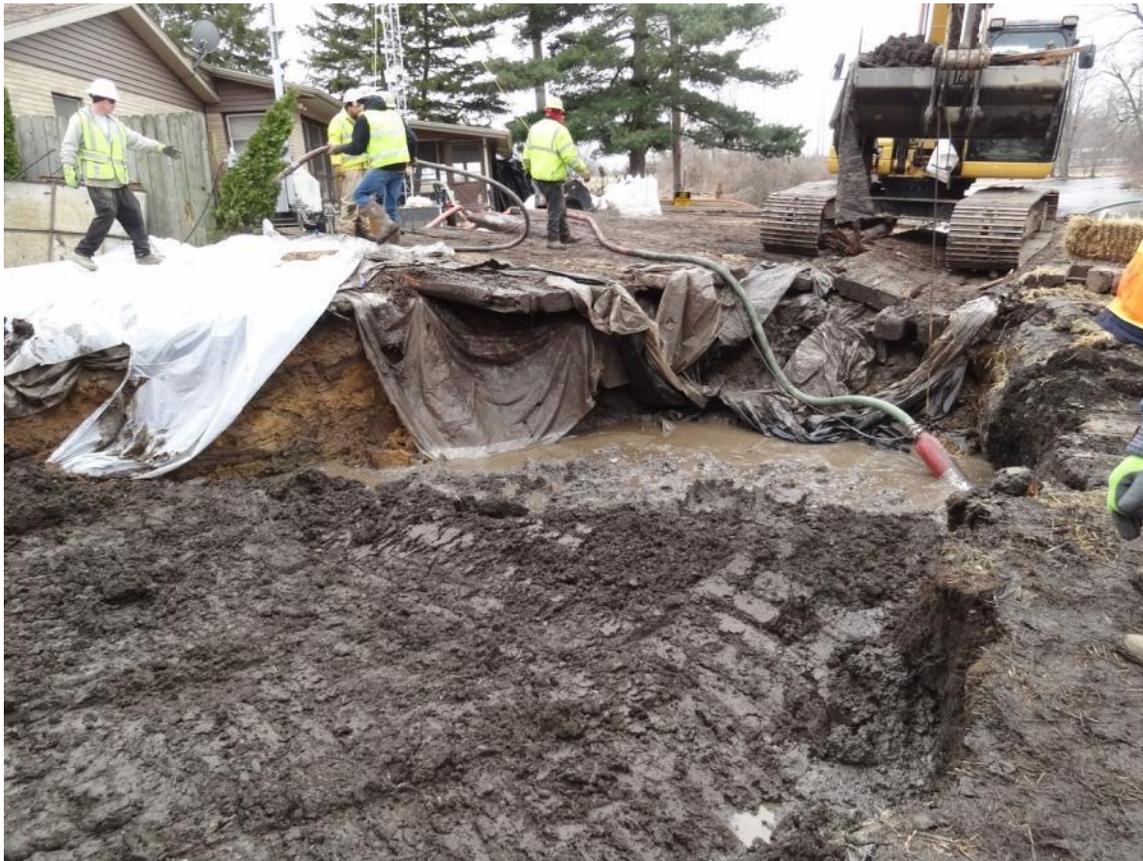
17. Confluence: observed excavation around the location of the second diversion box.

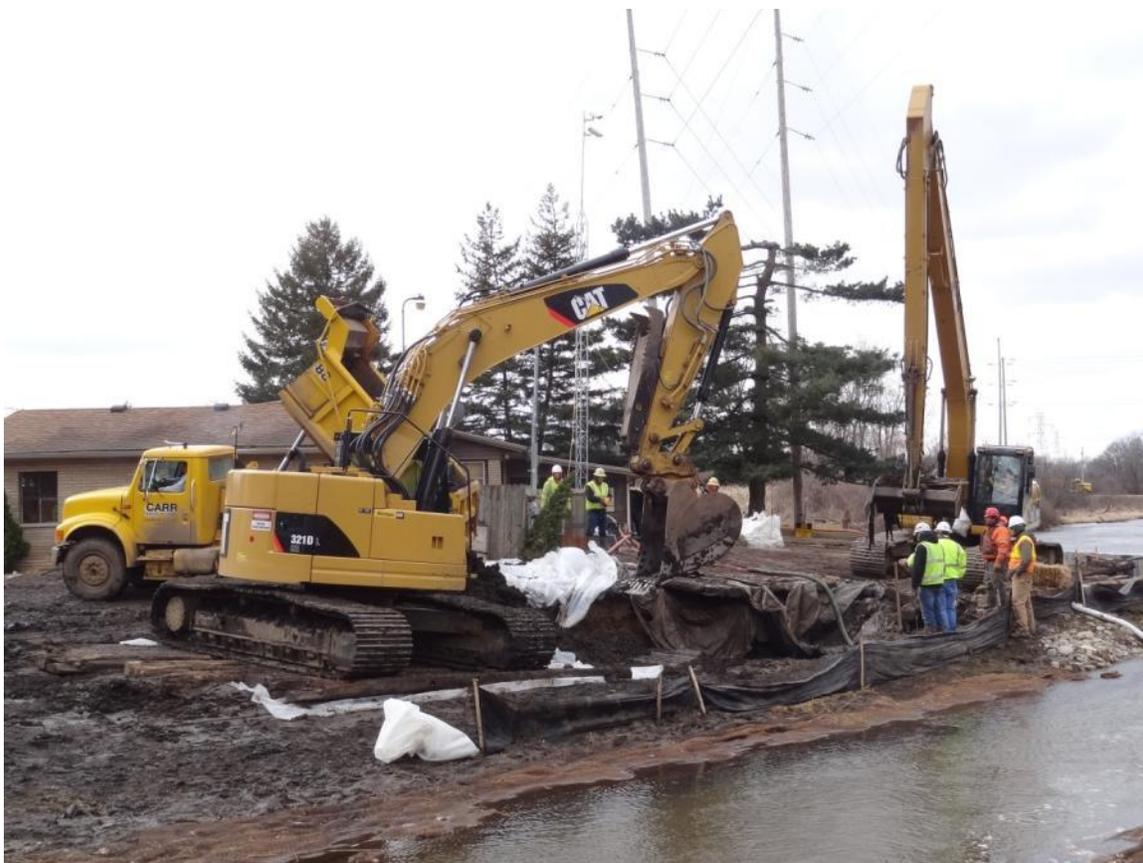
18. Confluence: observed excavation around the location of the second diversion box.

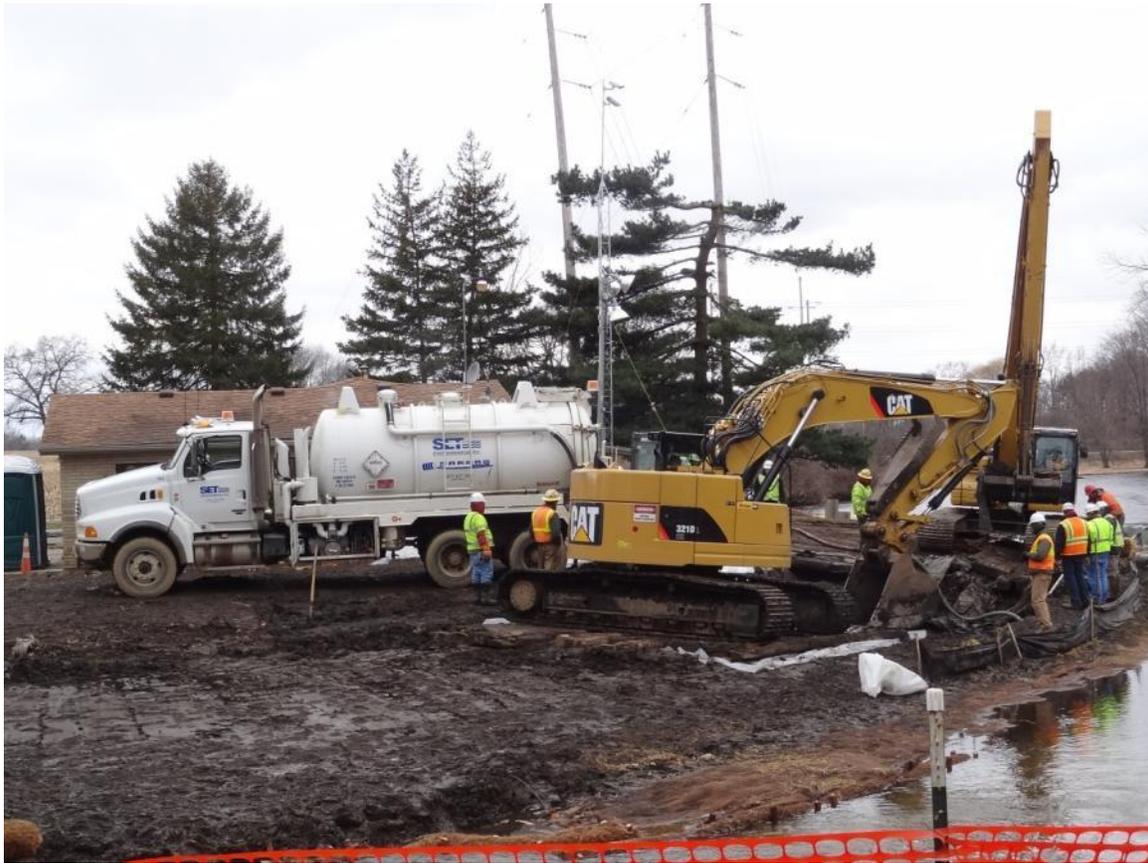
19. Confluence: observed vacuum truck dewatering excavation area.

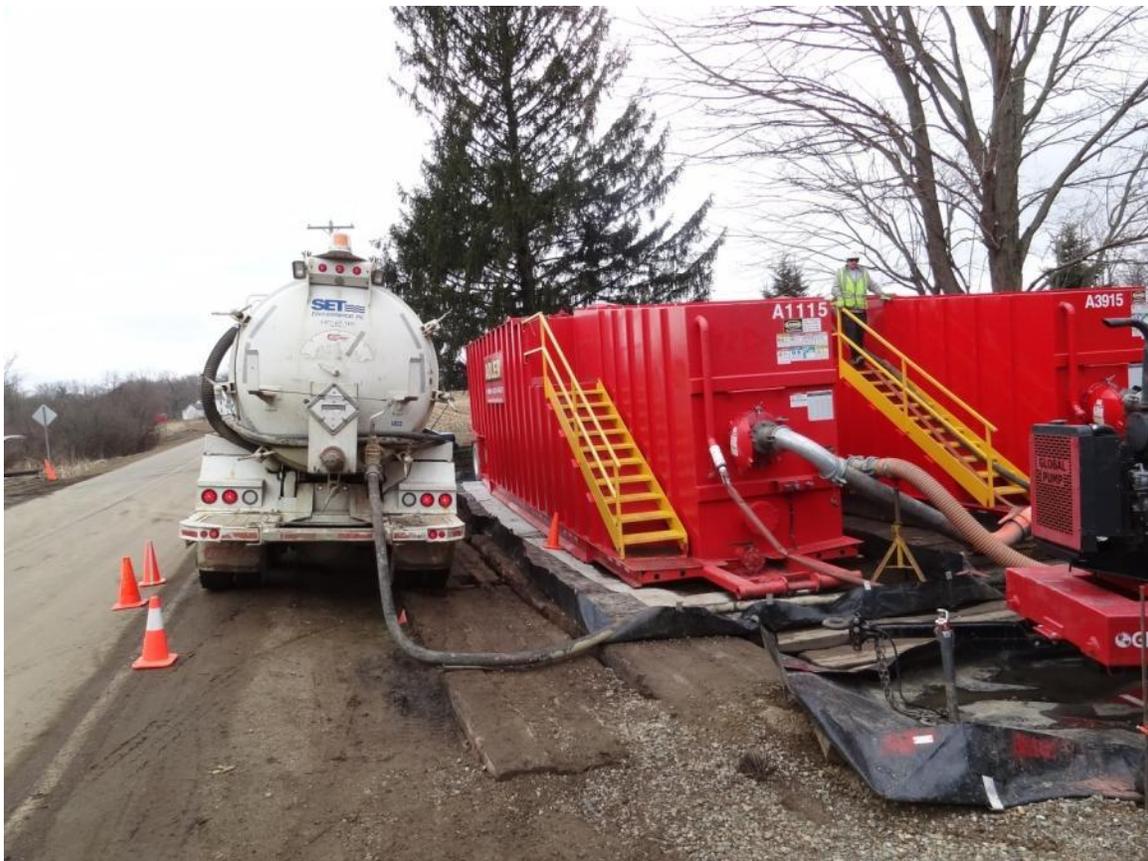
20. Confluence: observed vacuum truck off loading into frac-tanks.

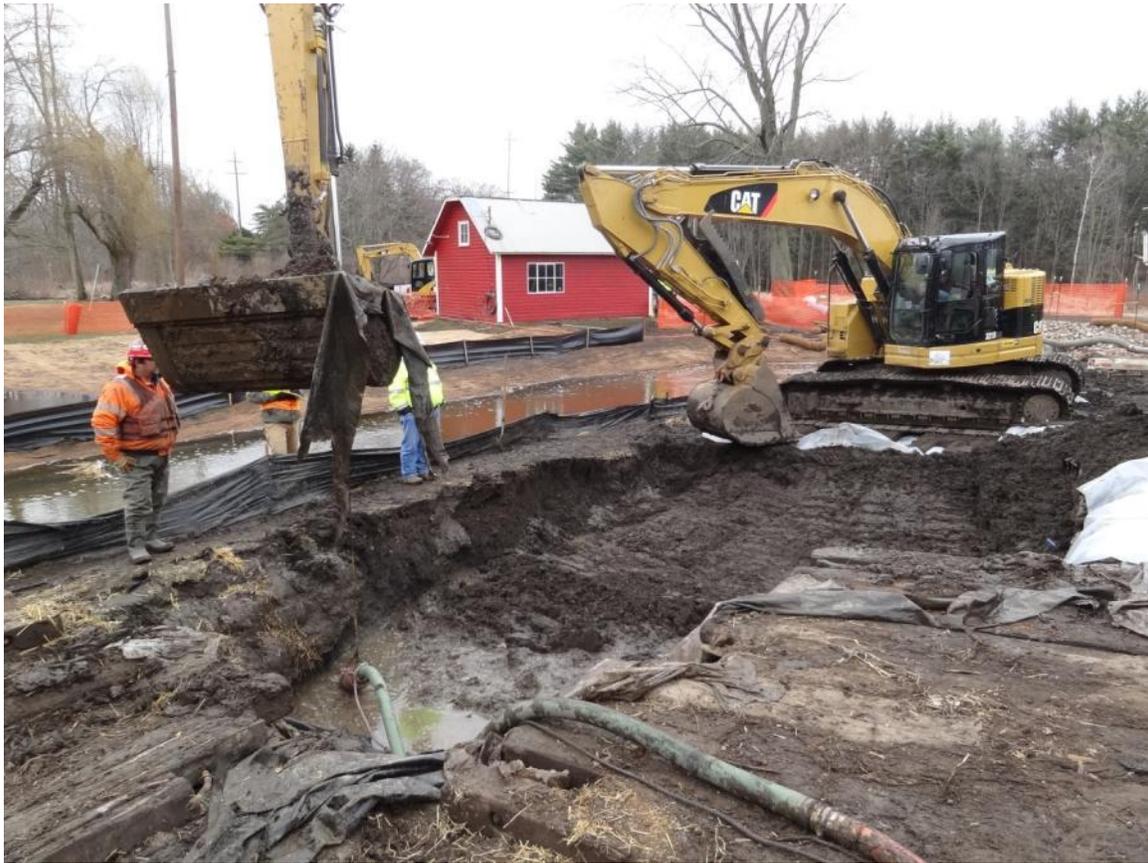
21. Confluence: observed excavation around the location of the second diversion box.

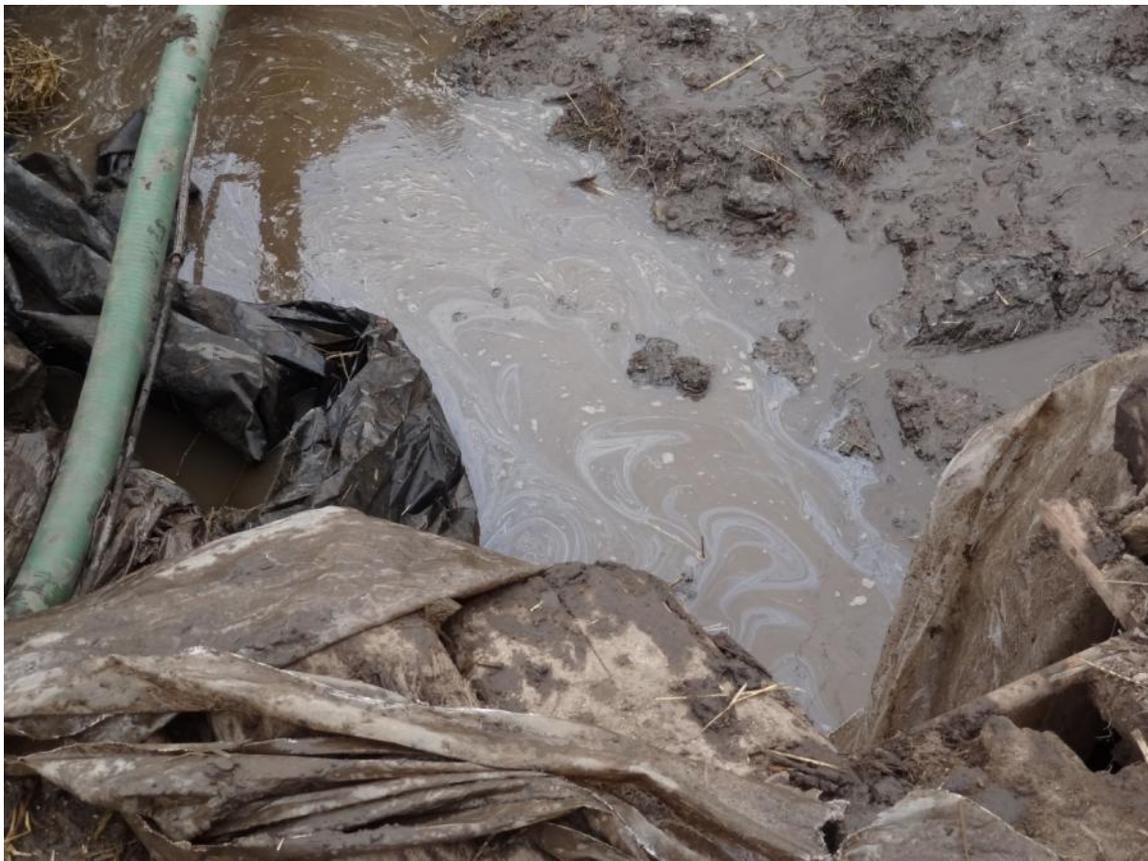
22. Confluence: observed excavation around the location of the second diversion box.

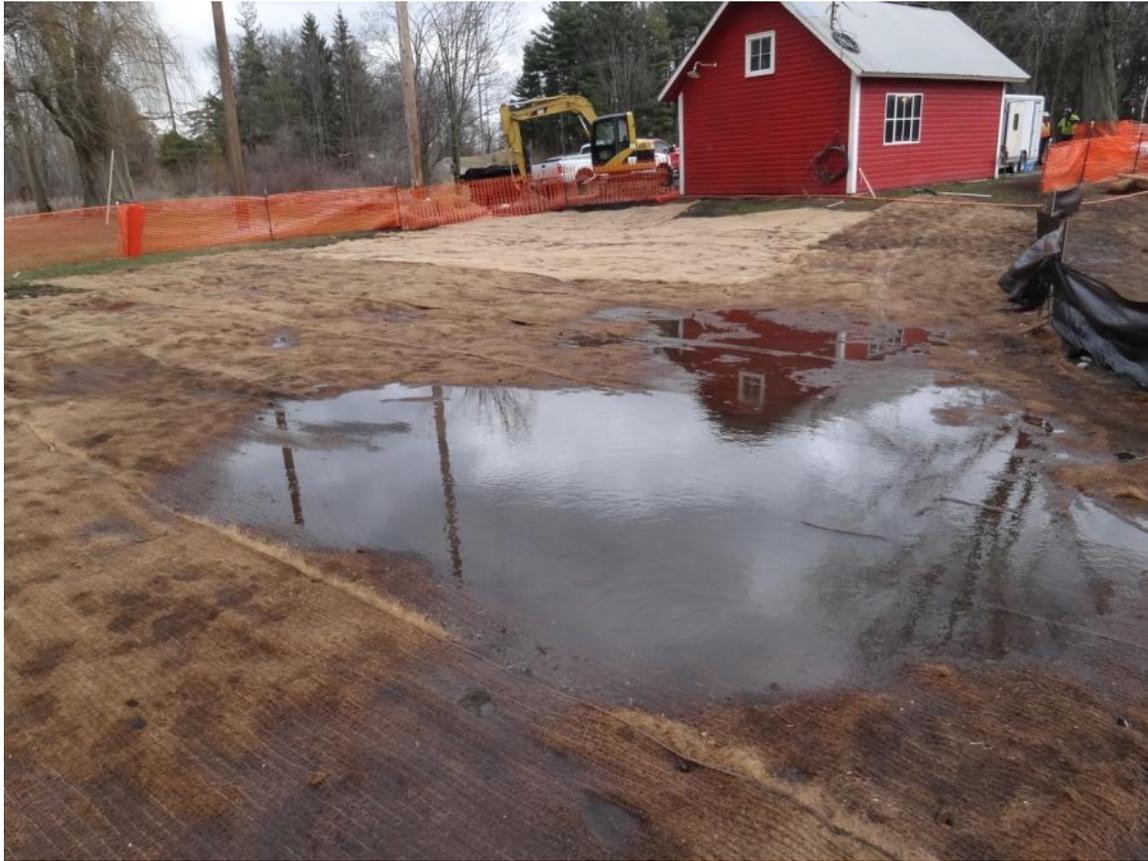
23. Confluence: observed restoration of the scrape area near the red barn.
