Situation Photo Log

Thursday, March 8, 2012

Kalamazoo River / Enbridge Spill

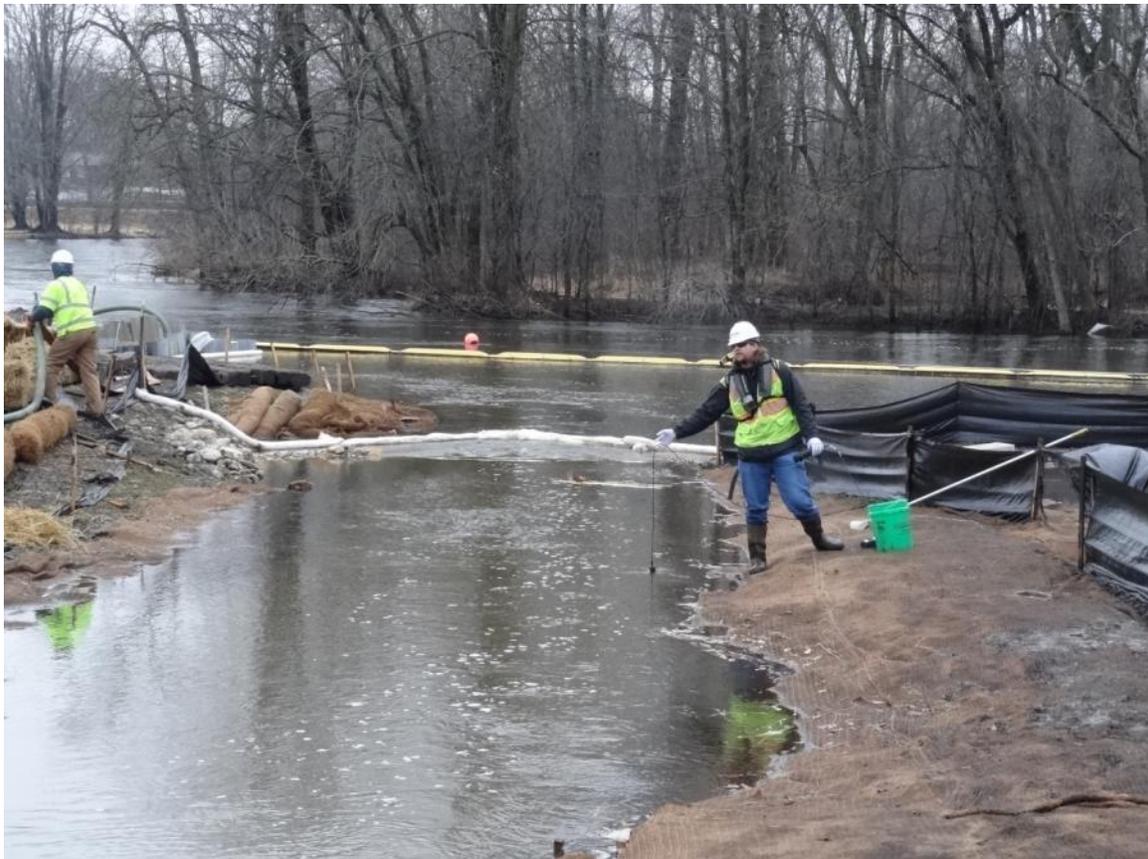
24. Confluence: observed water quality monitoring.

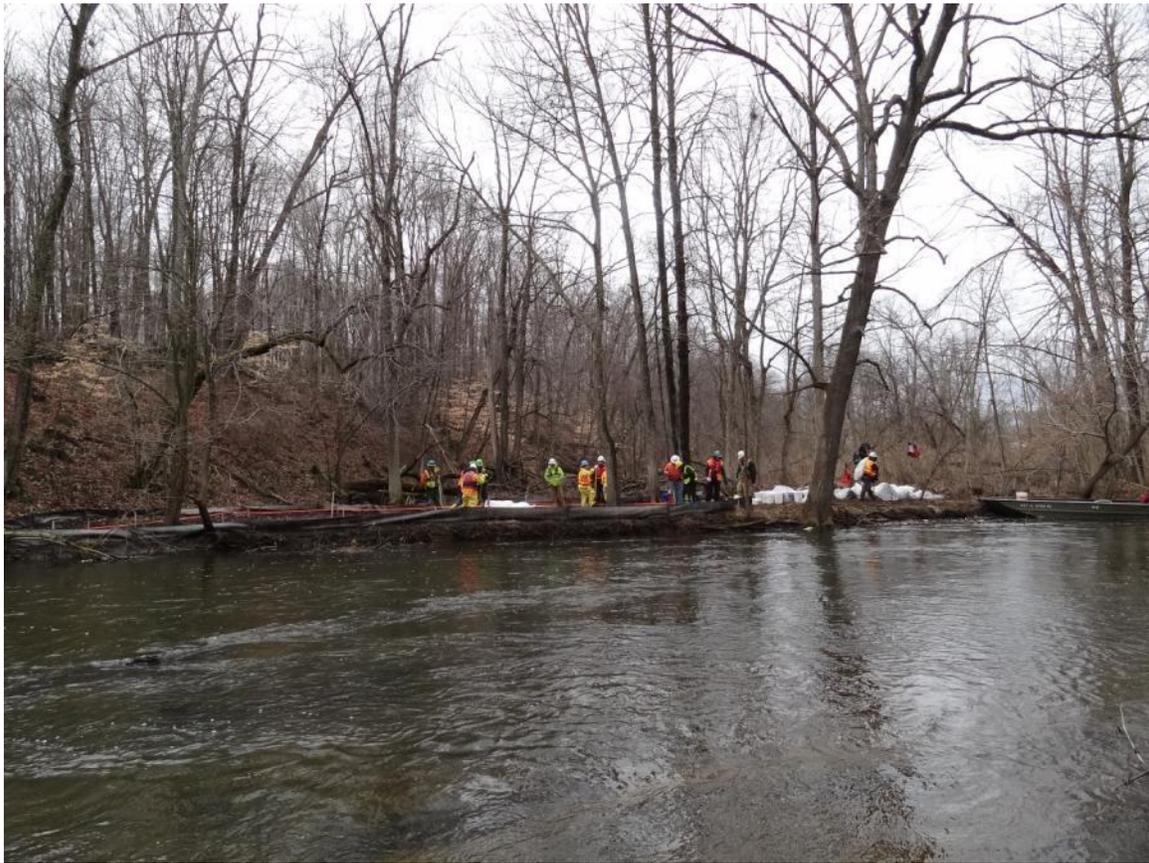
25. OB9.10 LDB: observed scraping operation.

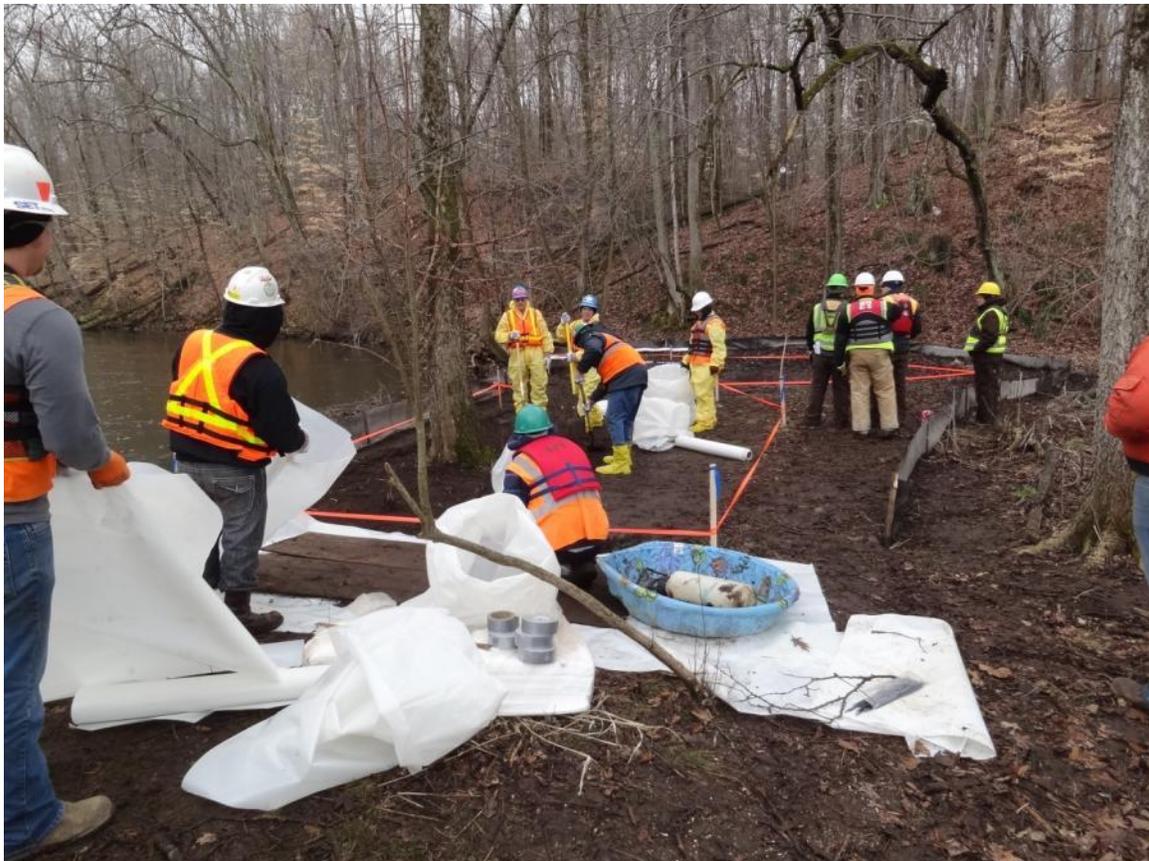
26. OB9.10 LDB: observed scraping operation.

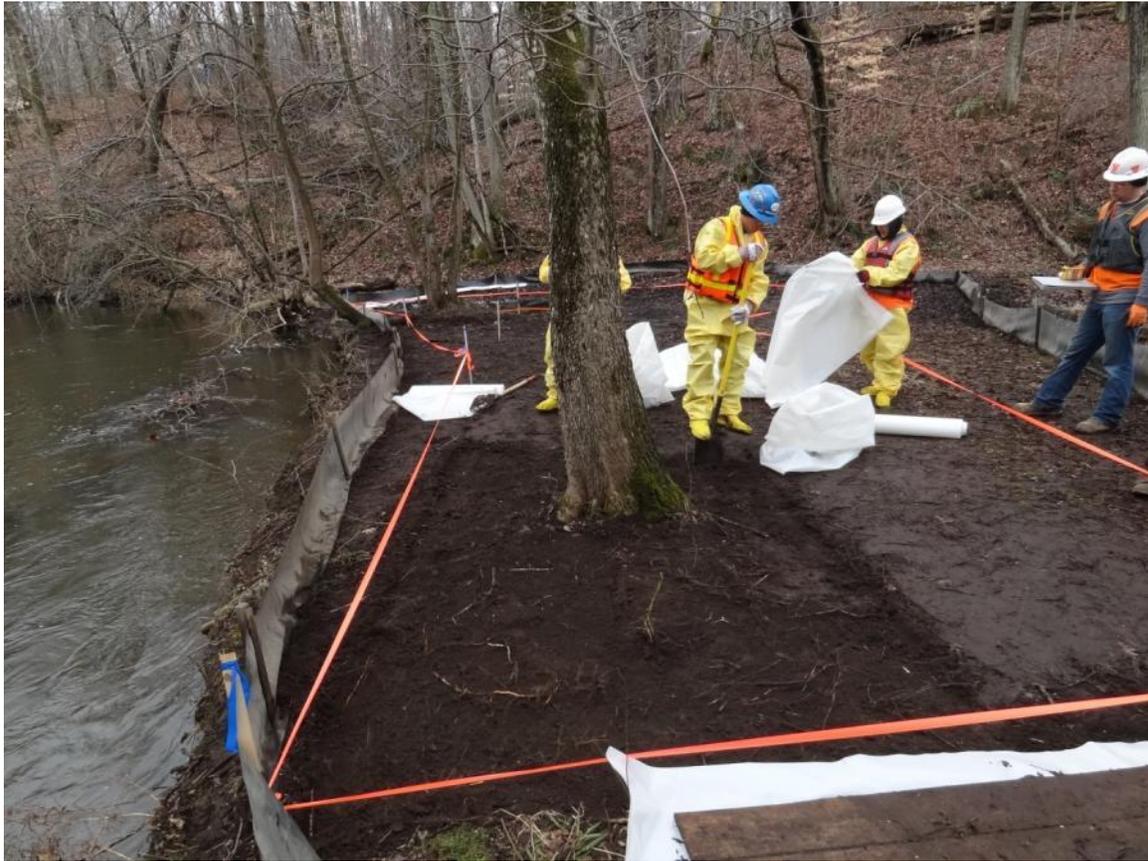
27. OB9.10 LDB: observed scraping operation.

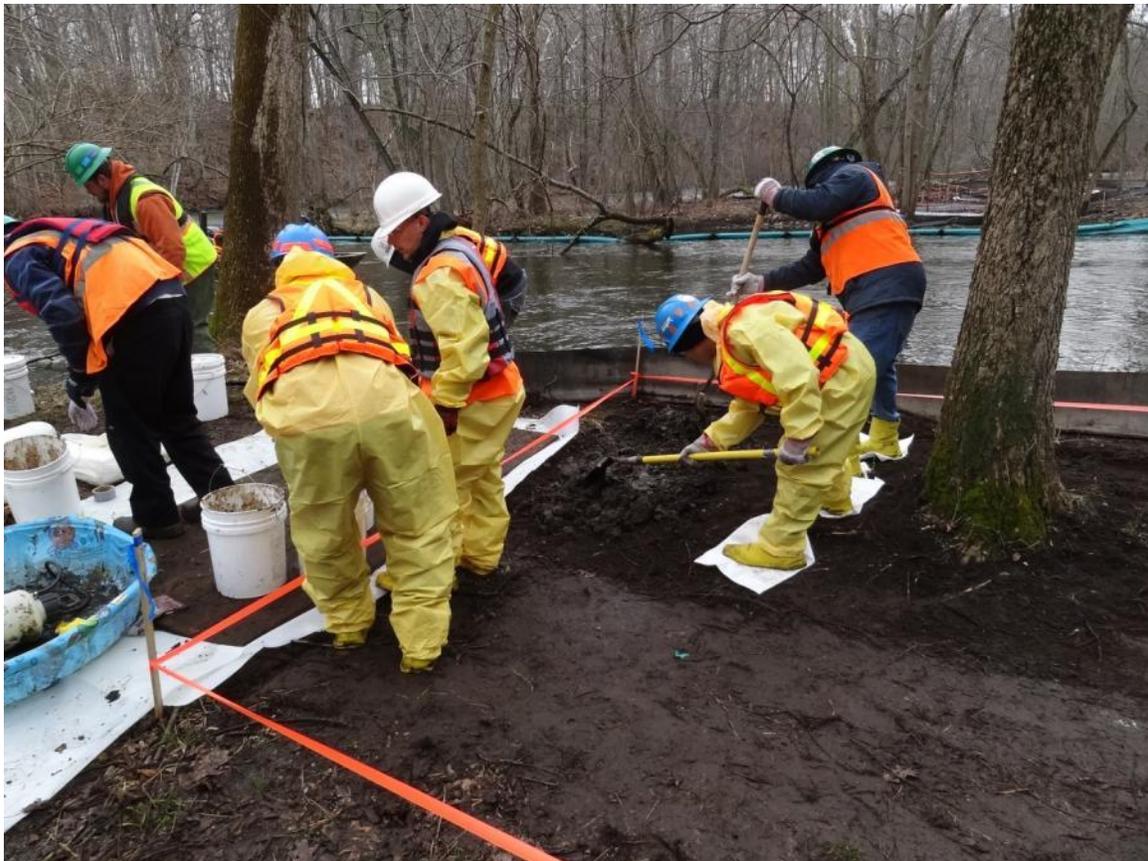
28. OB9.10 LDB: observed back filling of scraped area.

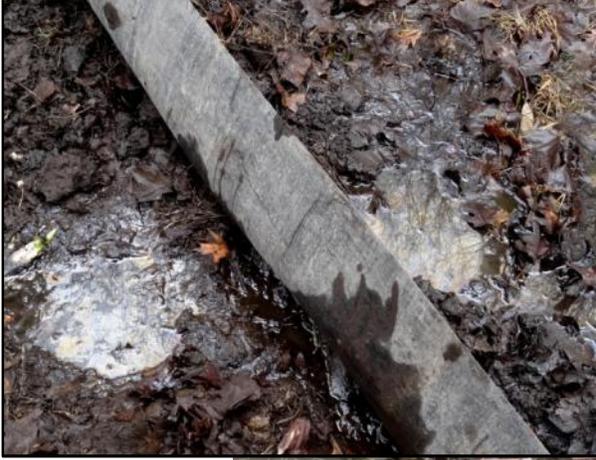
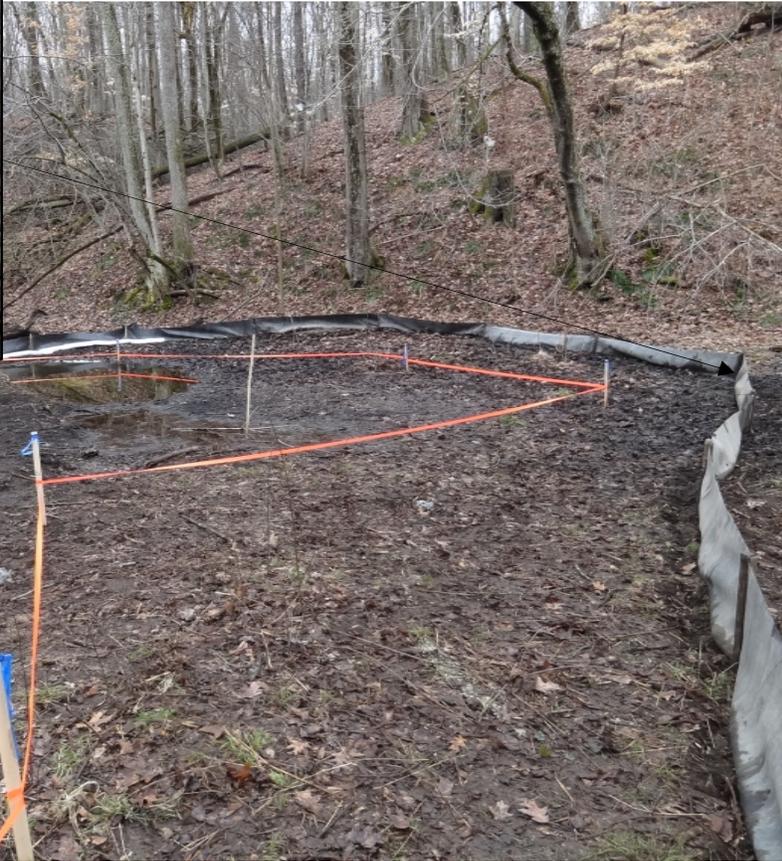
29. OB9.10 LDB: observed sheen outside of delineated scrape area.

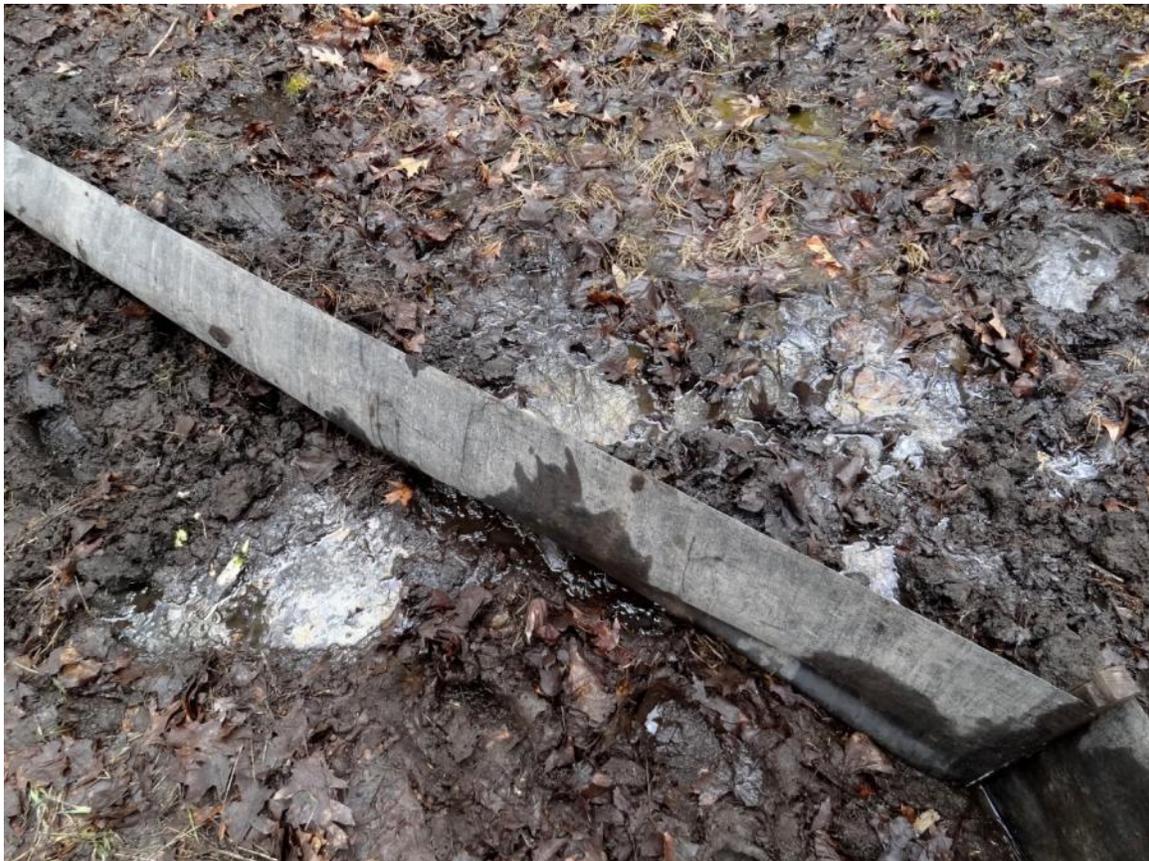
30. OB9.10 LDB: observed sheen outside of delineated scrape area.

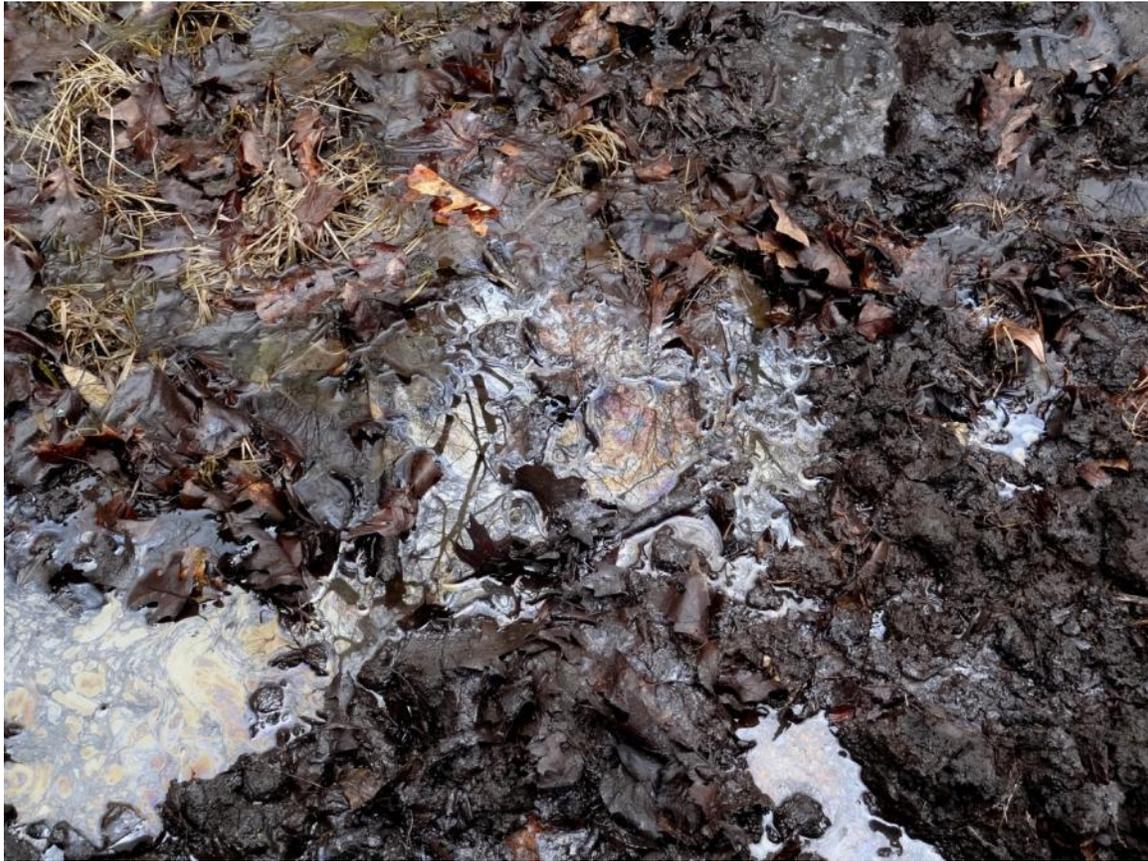
31. OB9.10 LDB: observed sheen outside of delineated scrape area.

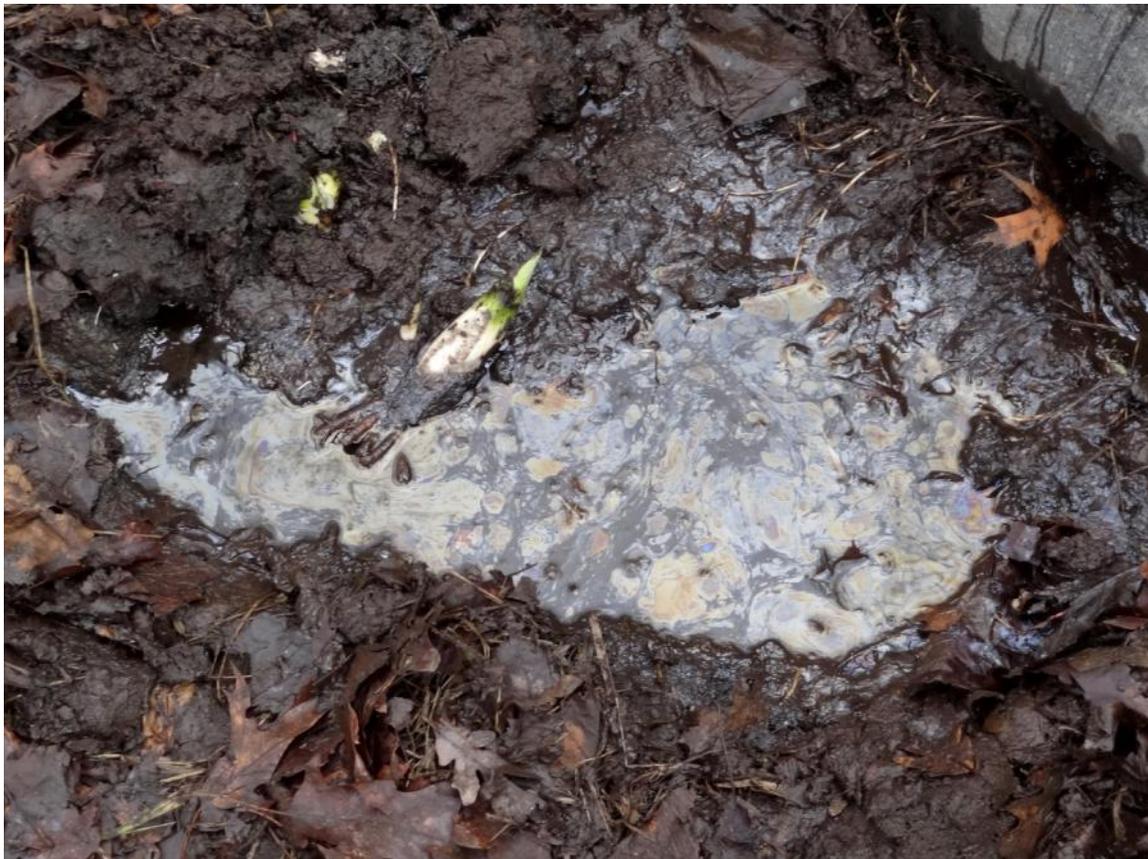
32. OB9.10 LDB: observed sheen outside of delineated scrape area.

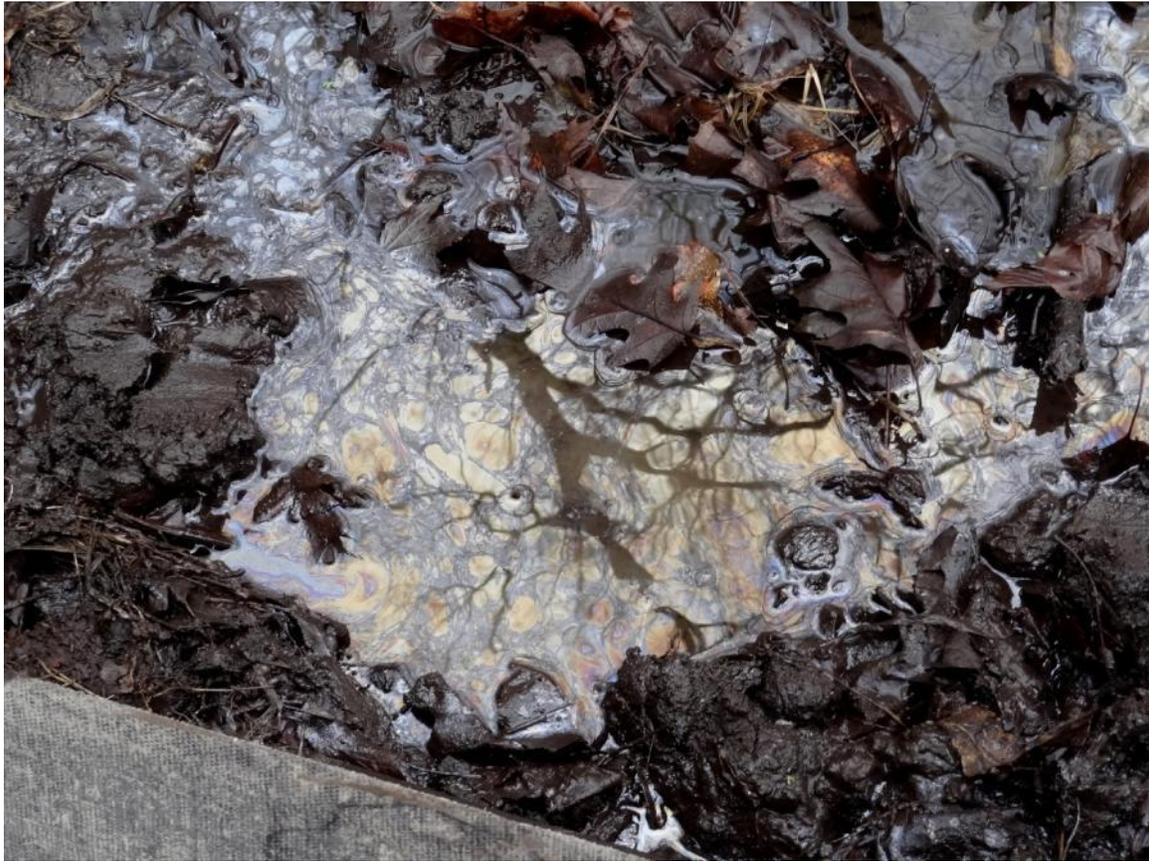
33. OB9.10 LDB: observed sheen outside of delineated scrape area.

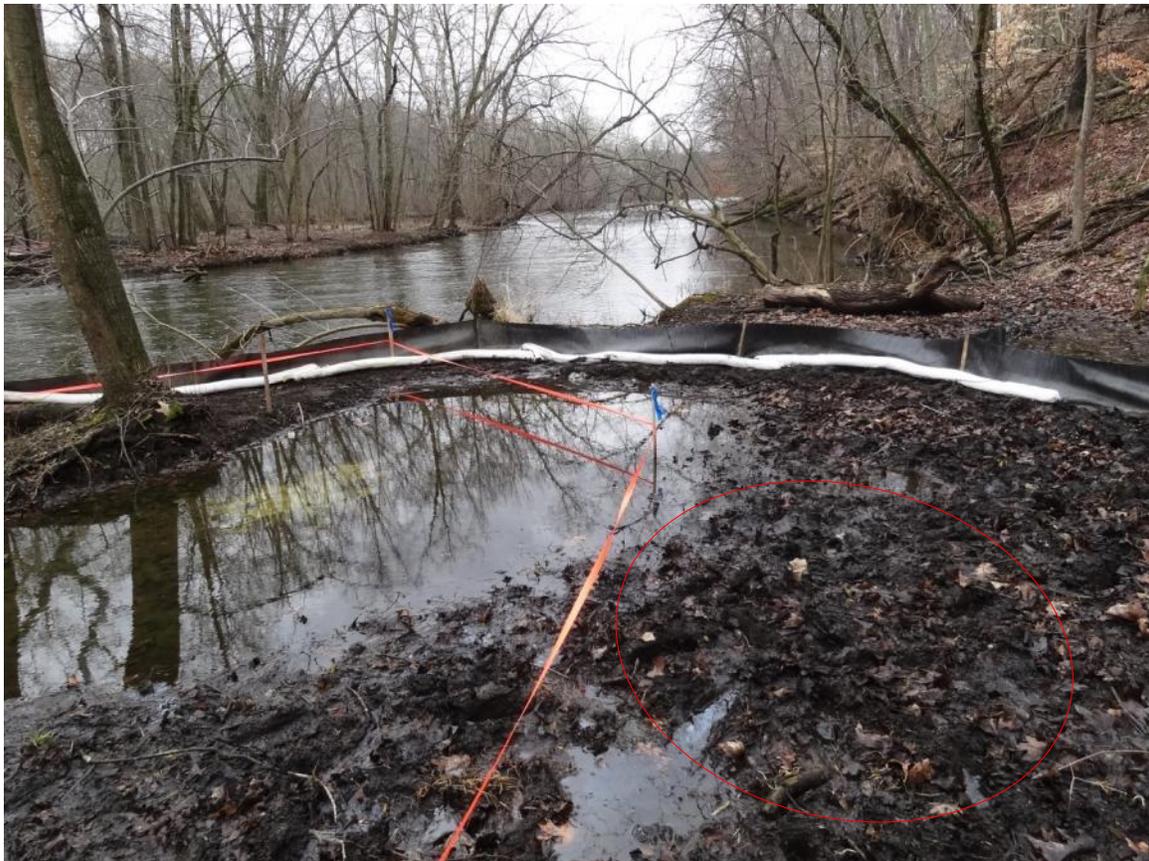
34. OB9.10 LDB: observed sheen outside of delineated scrape area.

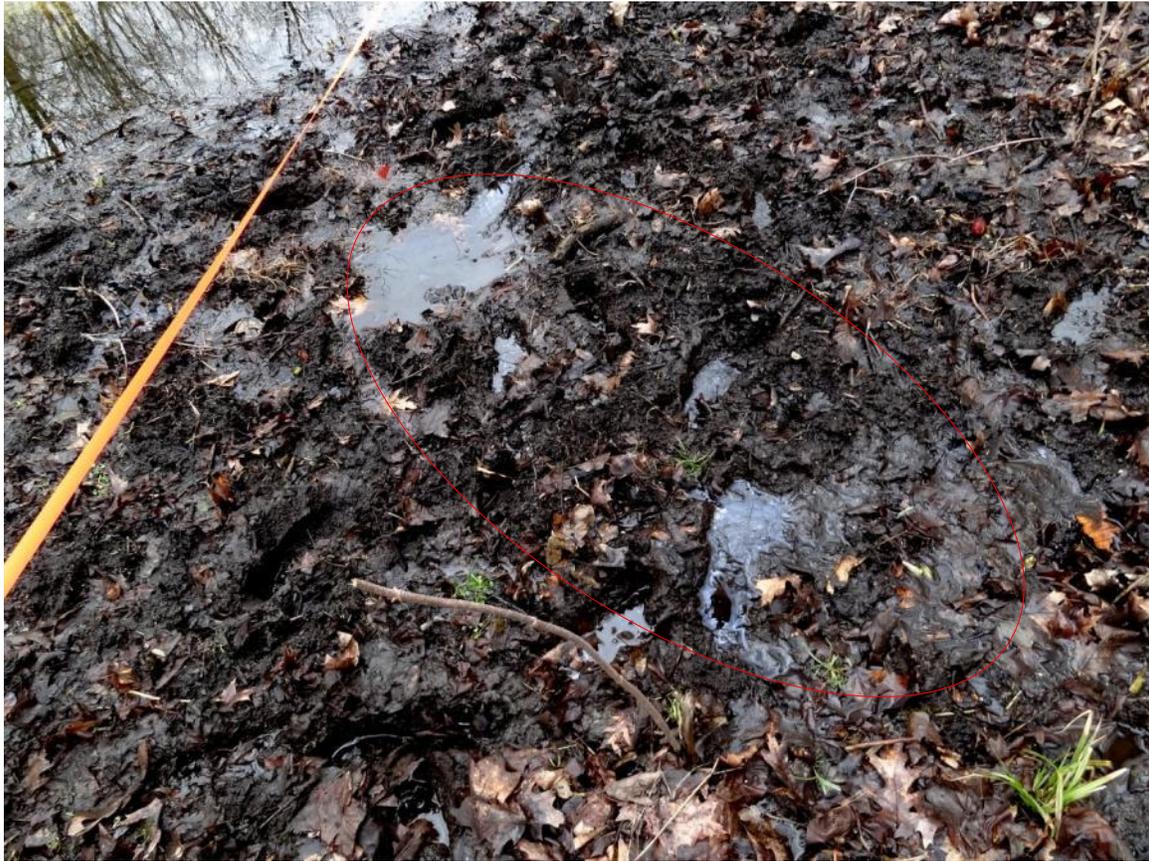
35. OB9.10 LDB: observed sheen outside of delineated scrape area.

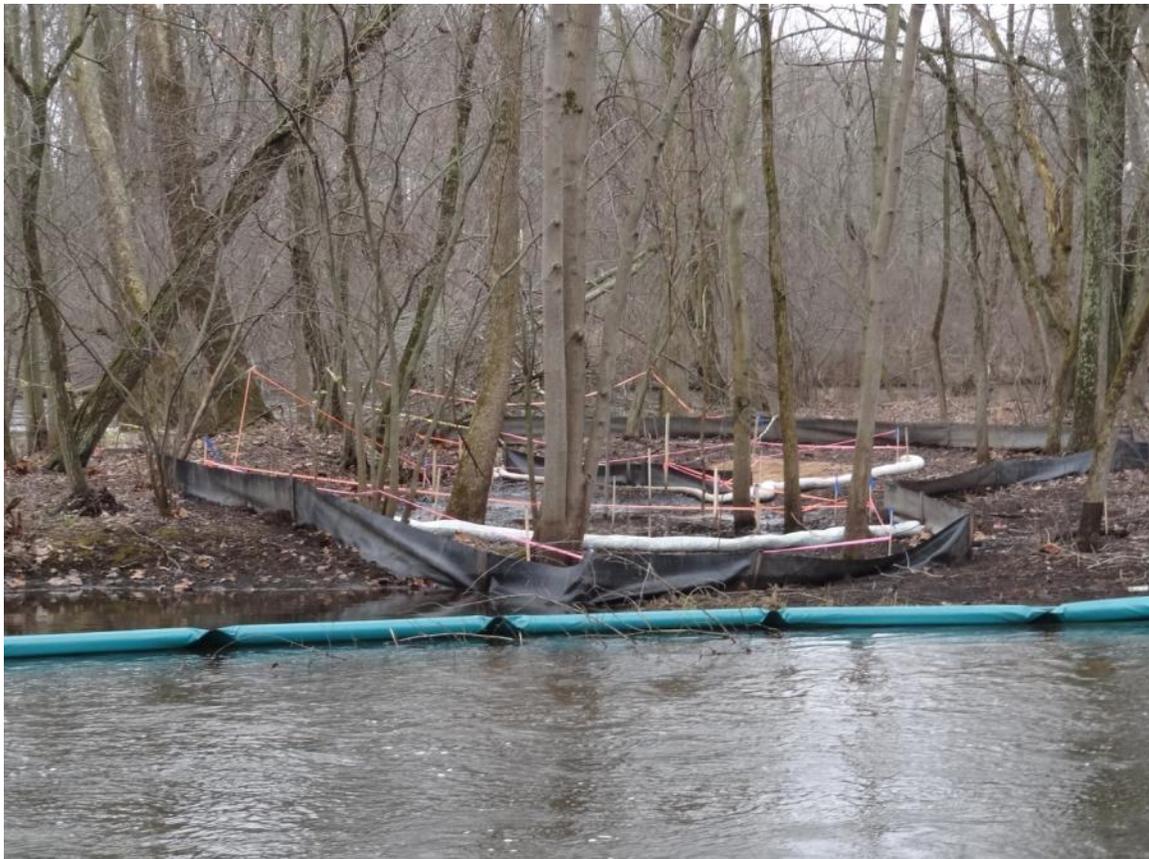
36. OB8.97 I observed standing water.

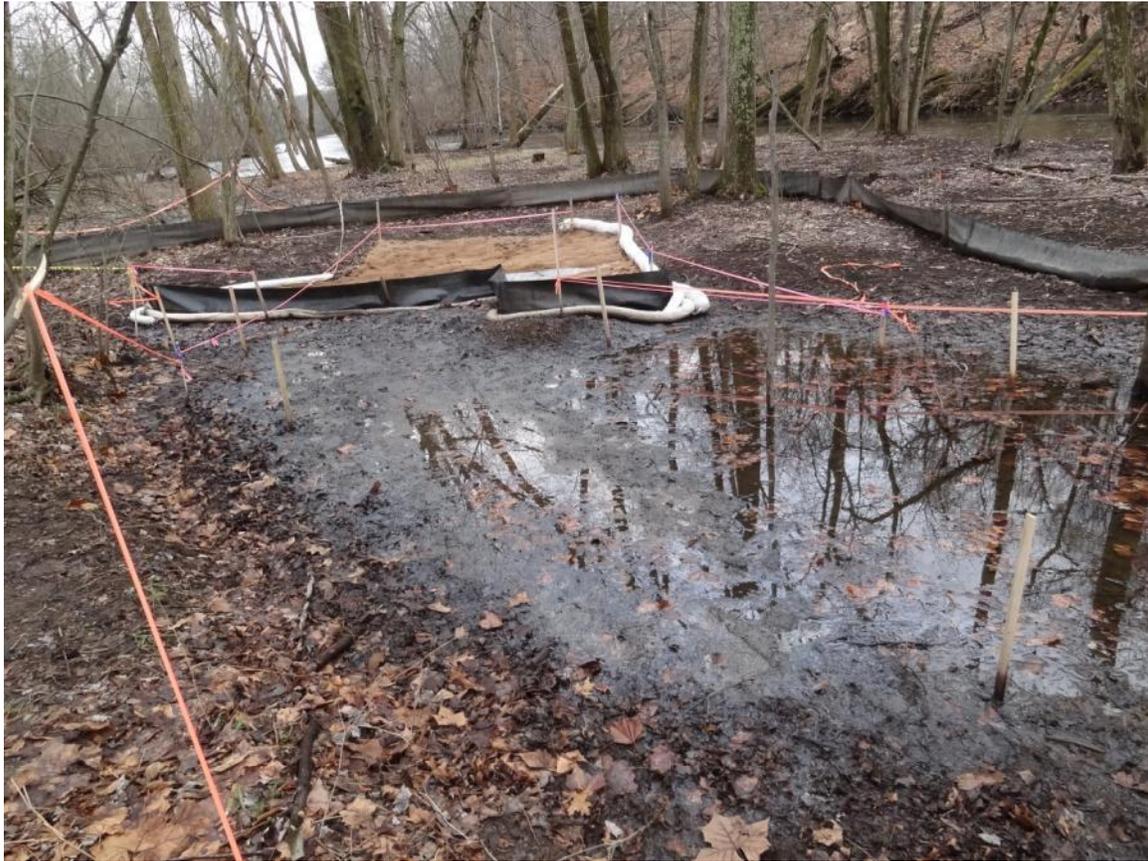
37. . OB8.97 I observed standing water.

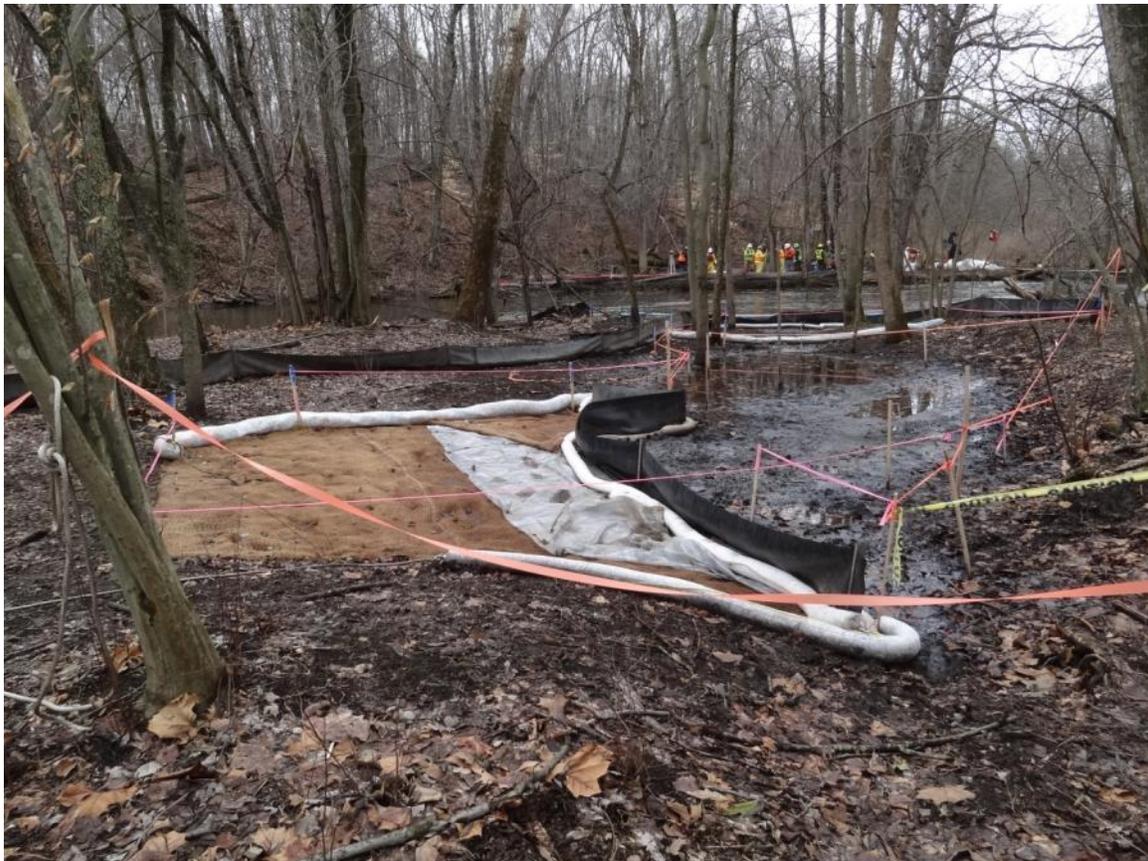
38. OB8.97 I observed standing water.
