# Situation Photo Log

Friday, March 9, 2012

Kalamazoo River / Enbridge Spill

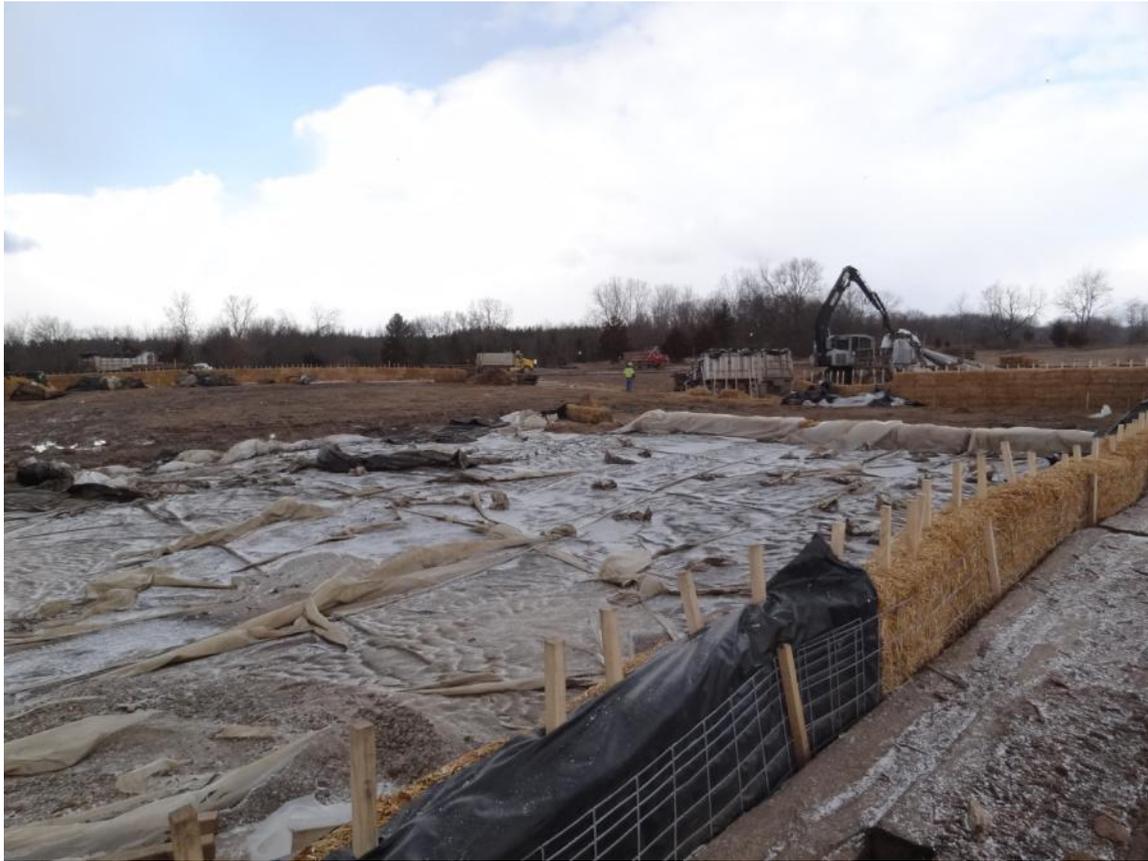
1. Turbidity Control Structure observed being demobilized.

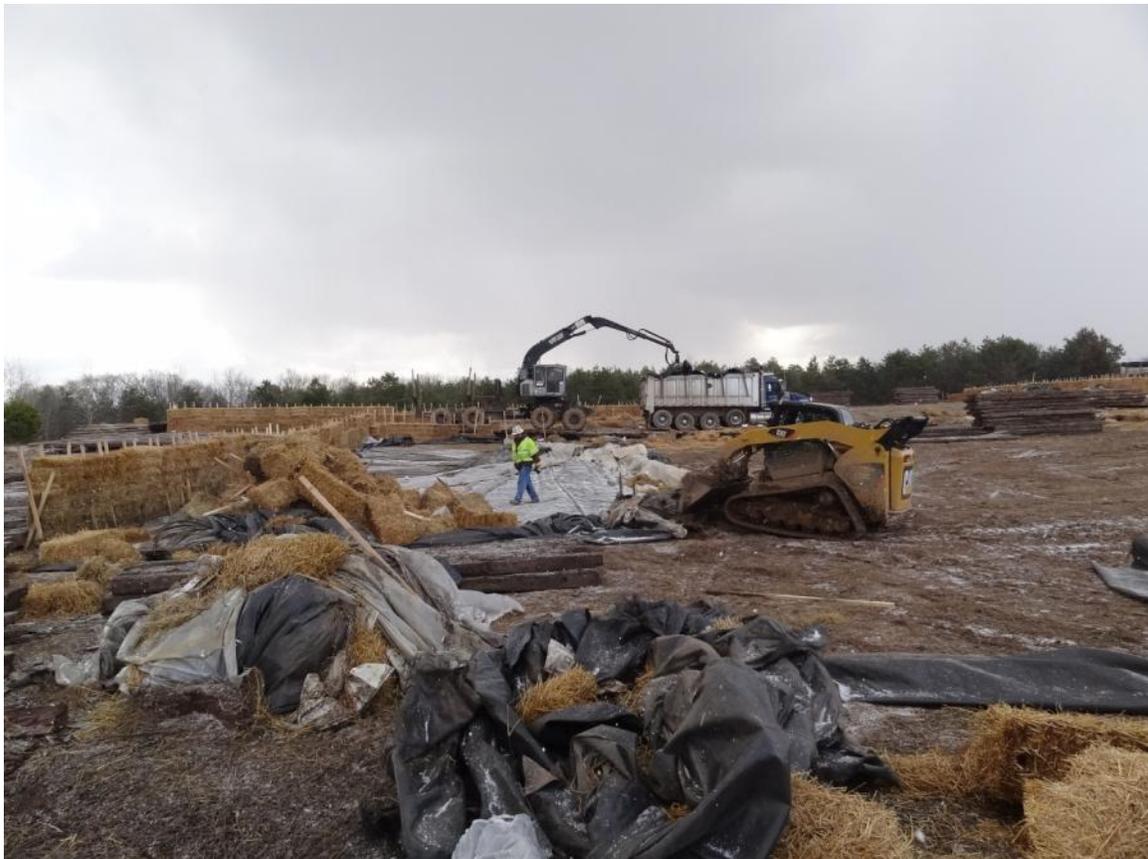
2. Turbidity Control Structure observed being demobilized.

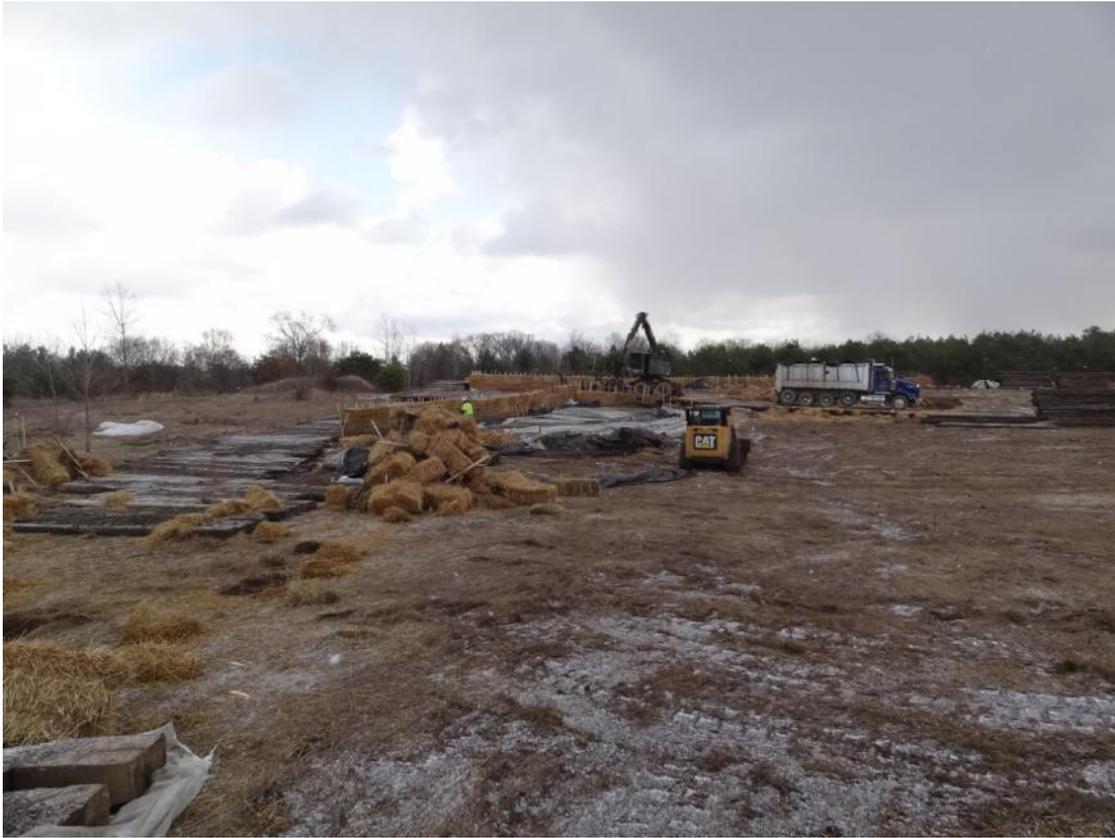
3. Turbidity Control Structure observed being demobilized.

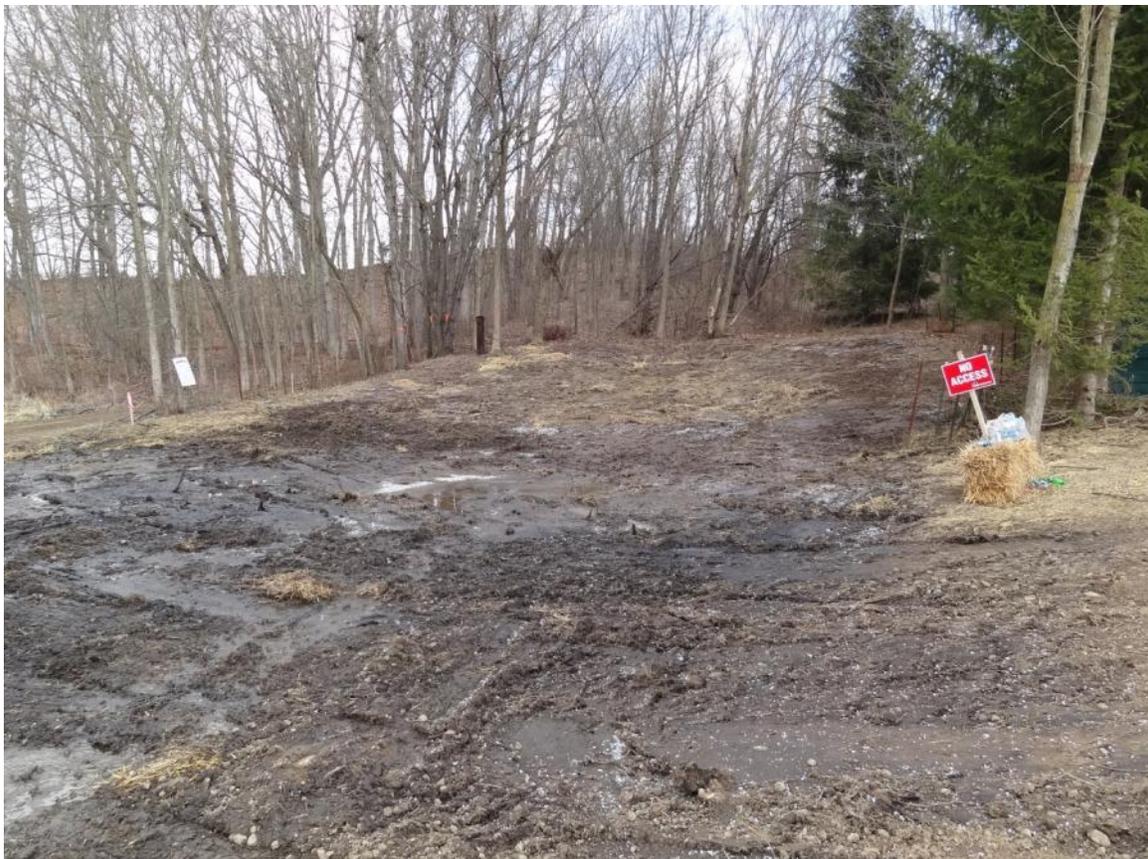
4. Talmadge Creek: restored area near the former bypass discharge at MP1.6.

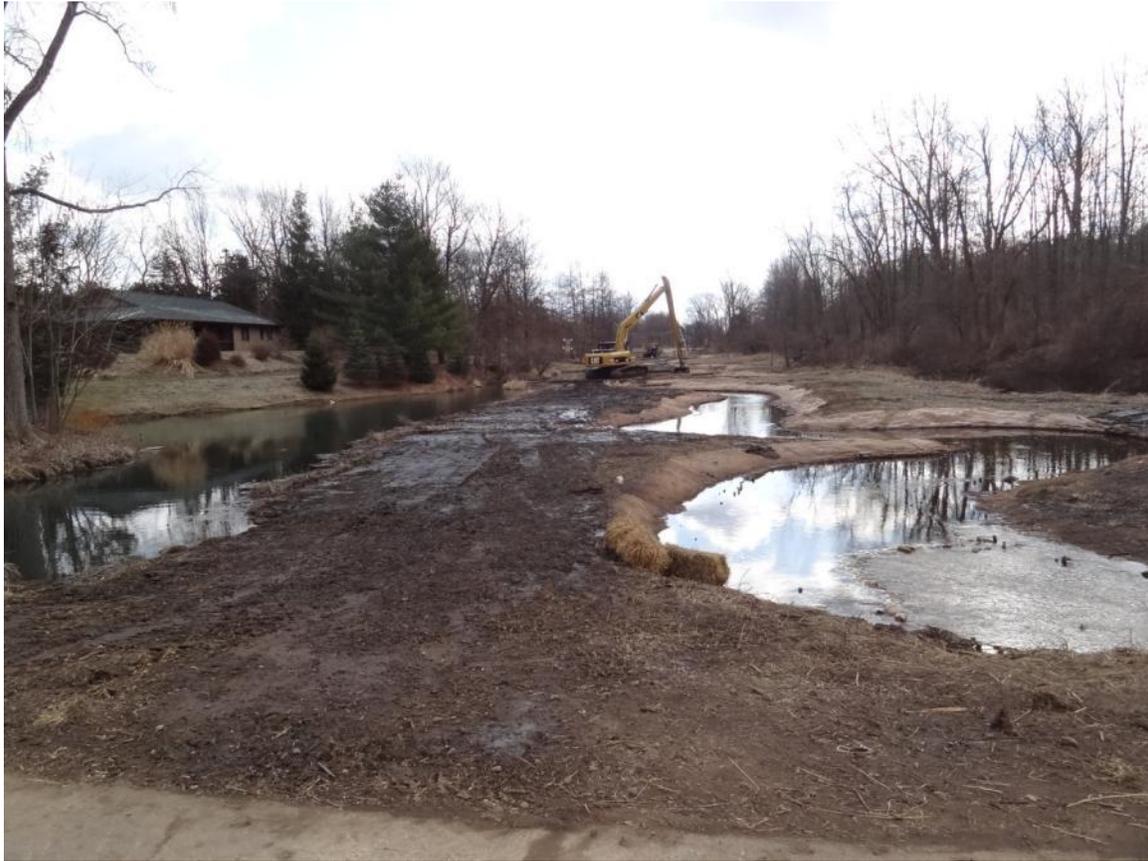
5. Talmadge Creek: demobilizing timber mats near MP1.5.

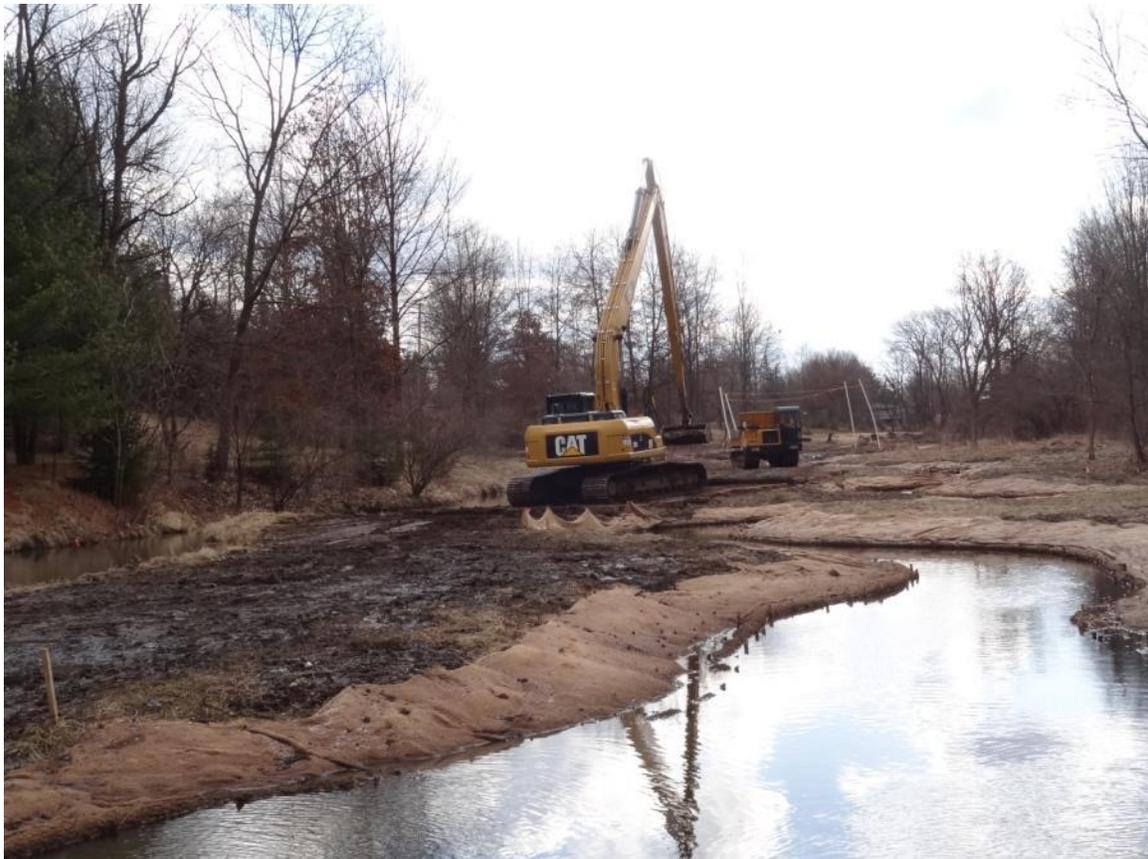
6. Talmadge Creek: demobilizing timber mats near MP1.5.

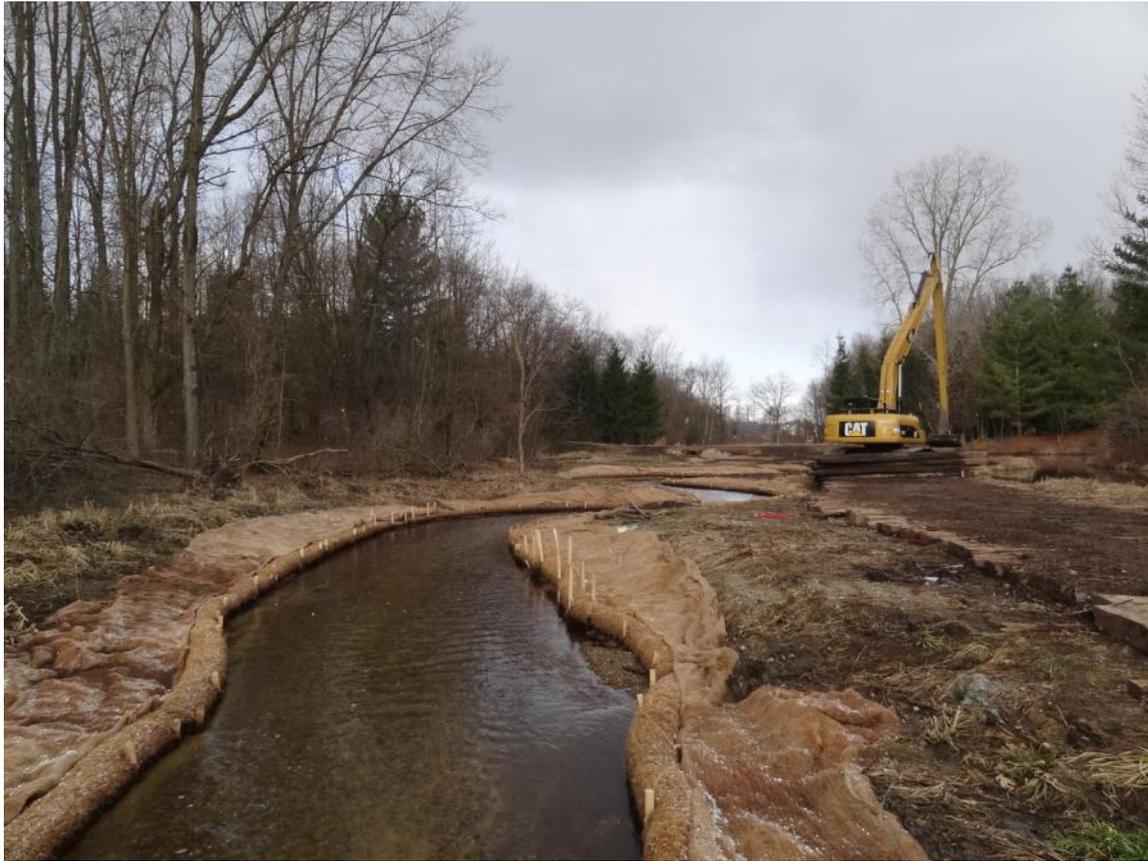
7. Talmadge Creek: demobilizing timber mats near MP1.5.

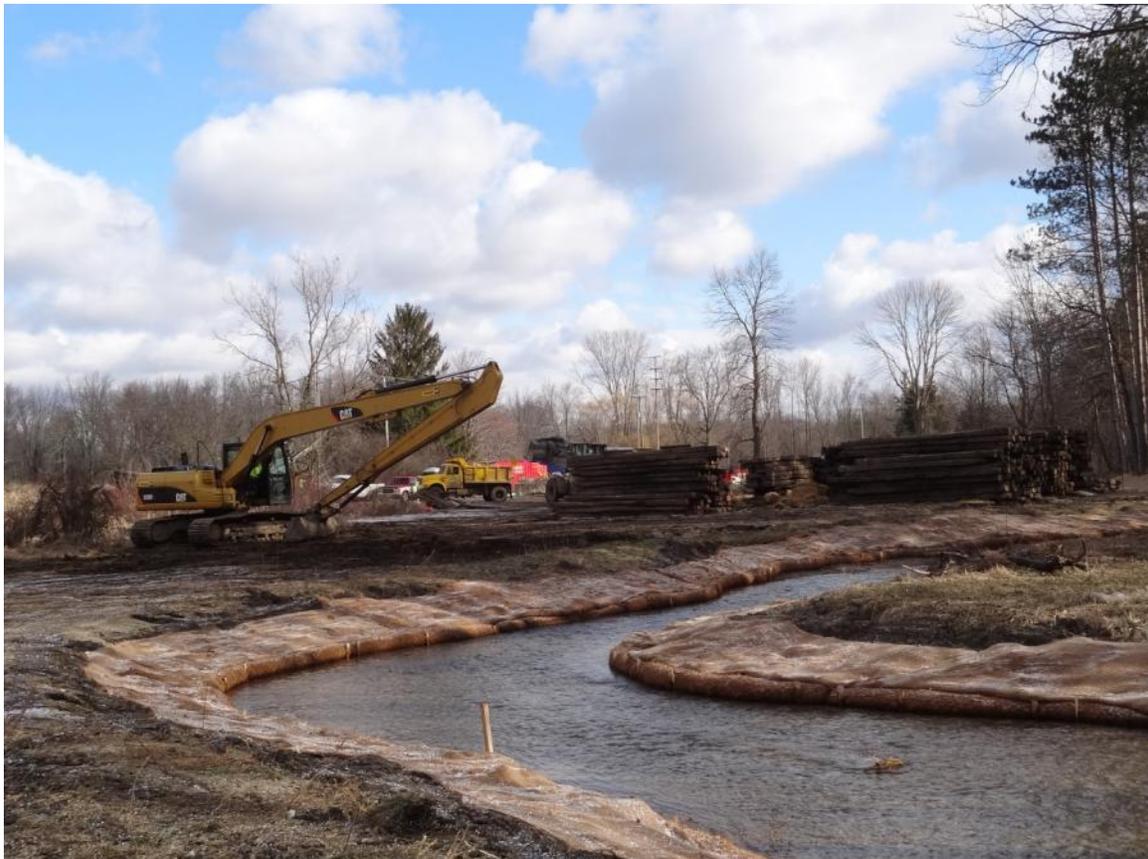
8. Talmadge Creek: observed demobilization of timber mats.

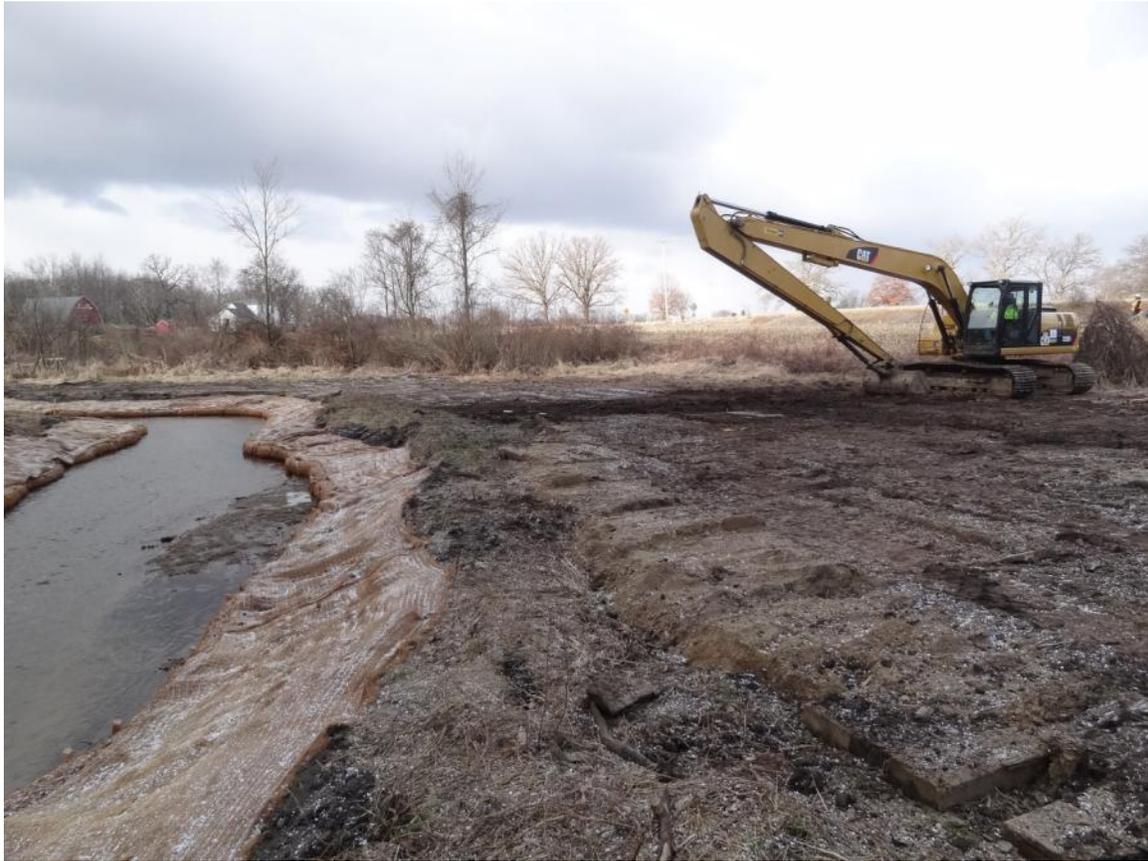
9. Talmadge Creek: observed demobilization of timber mats.

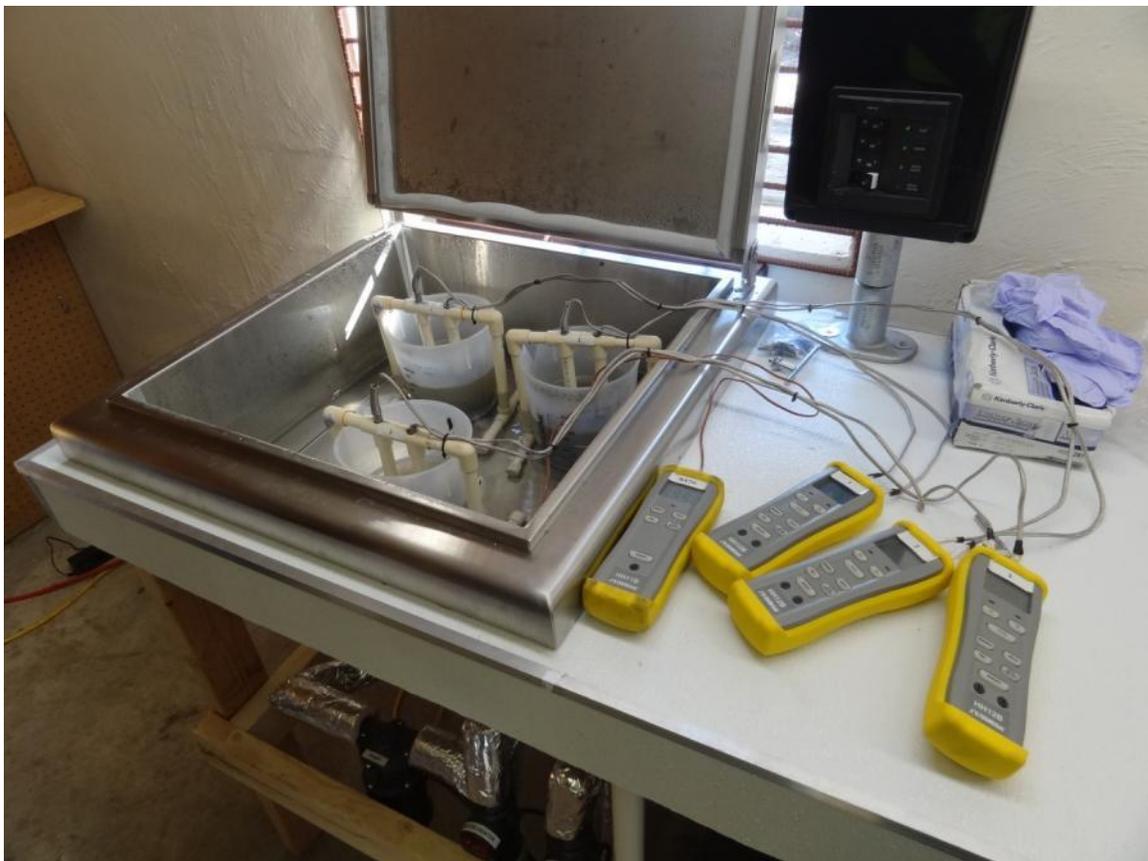
10. Temperature effect study.

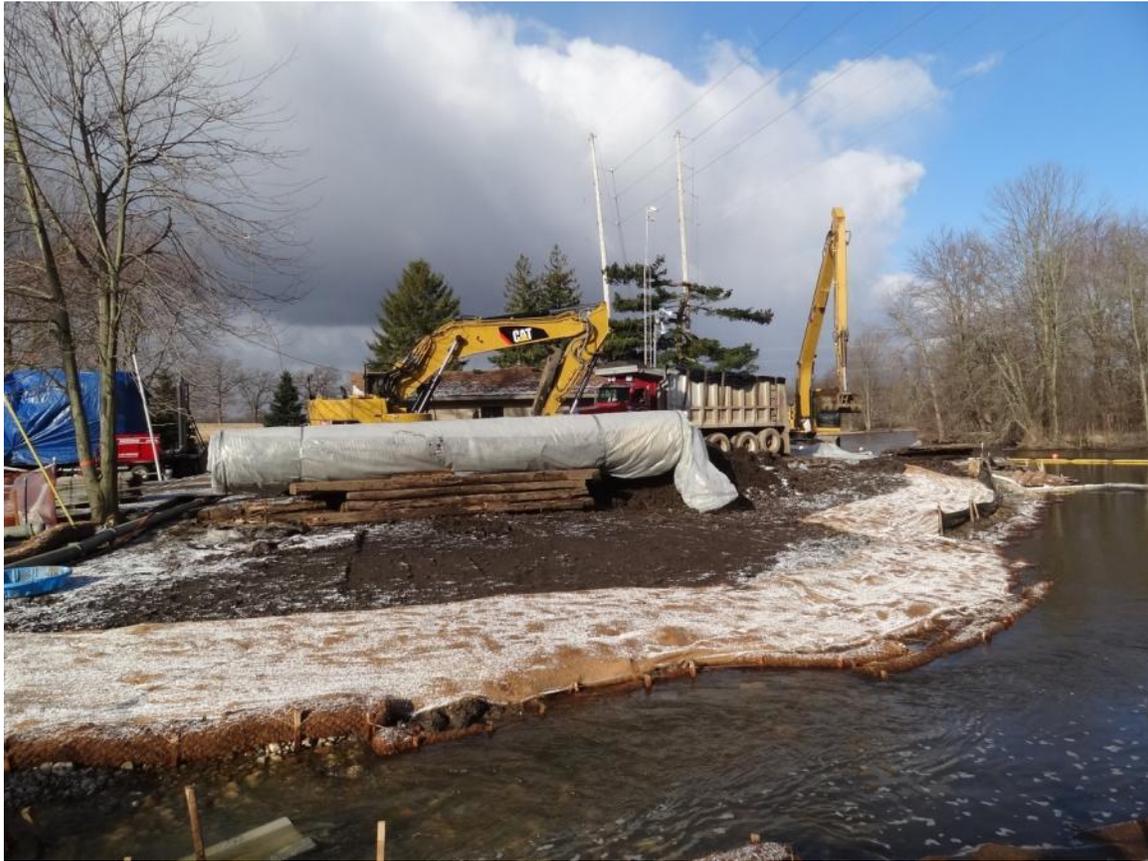
11. Talmadge Creek: Observed the removal of the diversion structure.

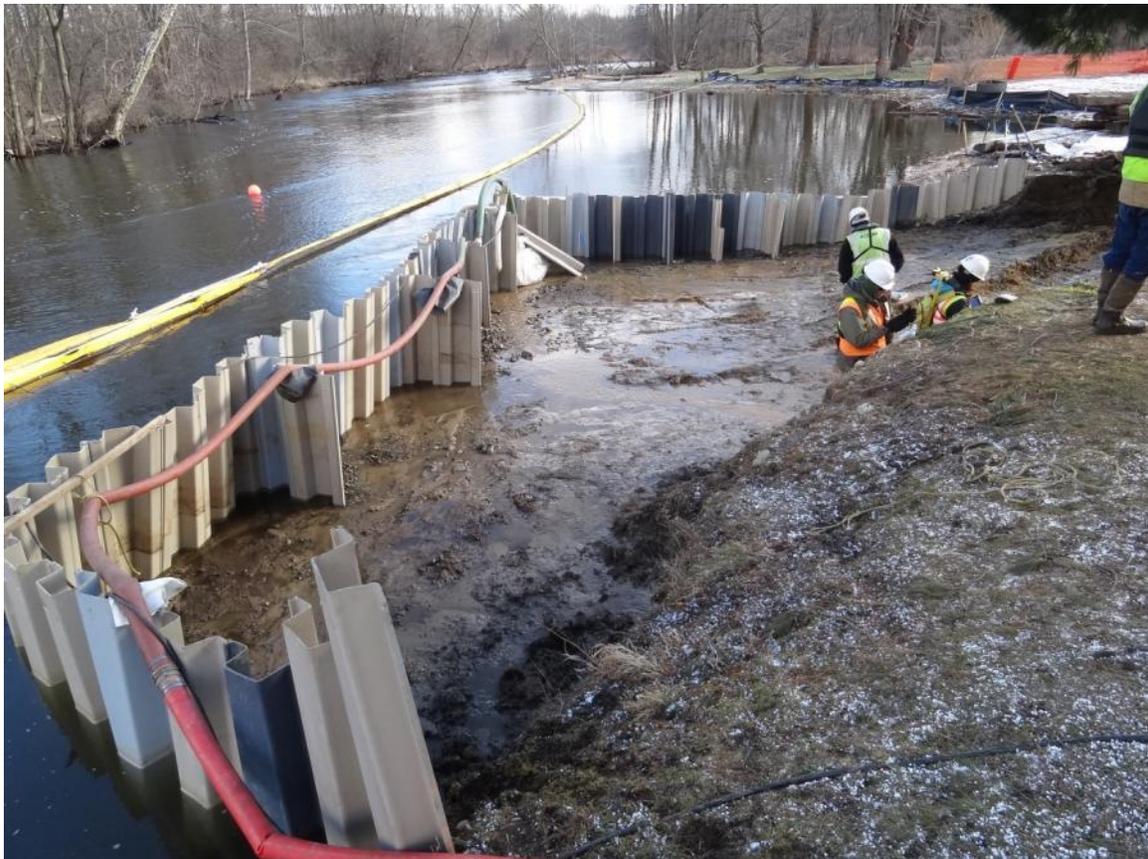
12. Confluence: observed the excavated area within the sheet piling.

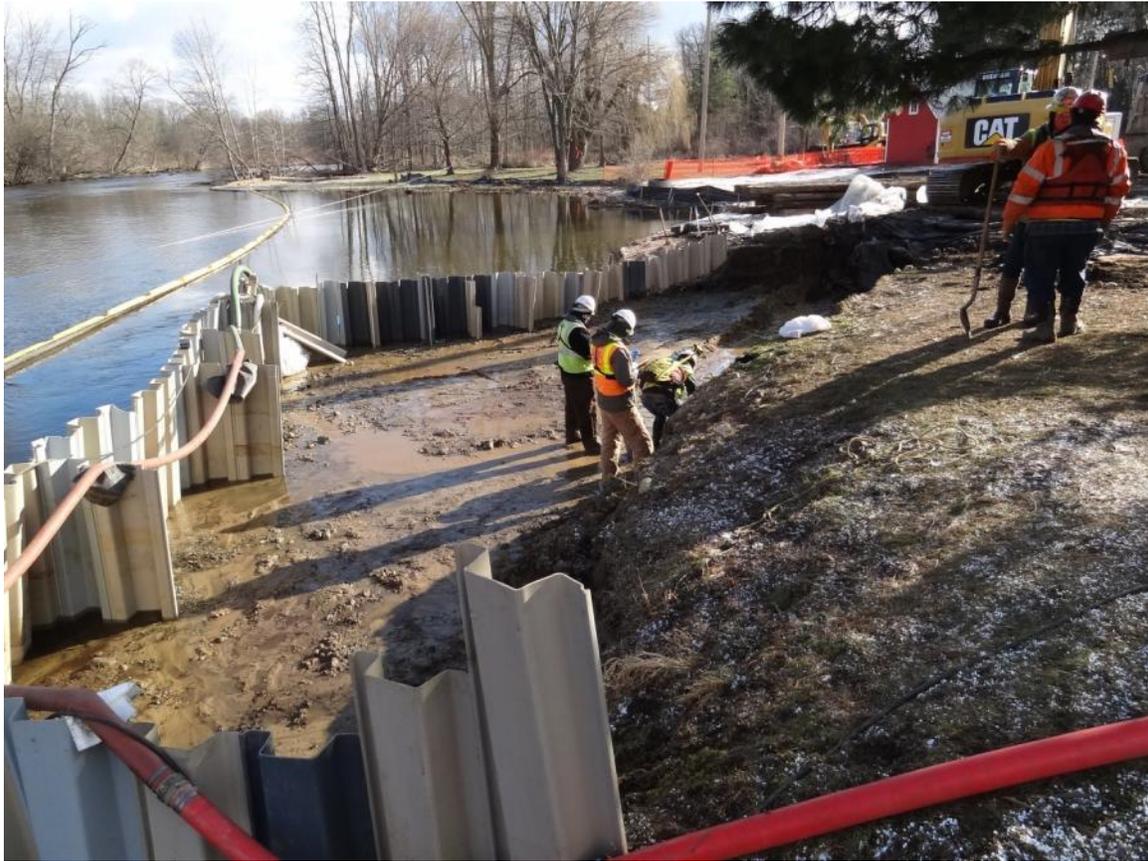
13. Confluence: observed sampling within the excavated area.

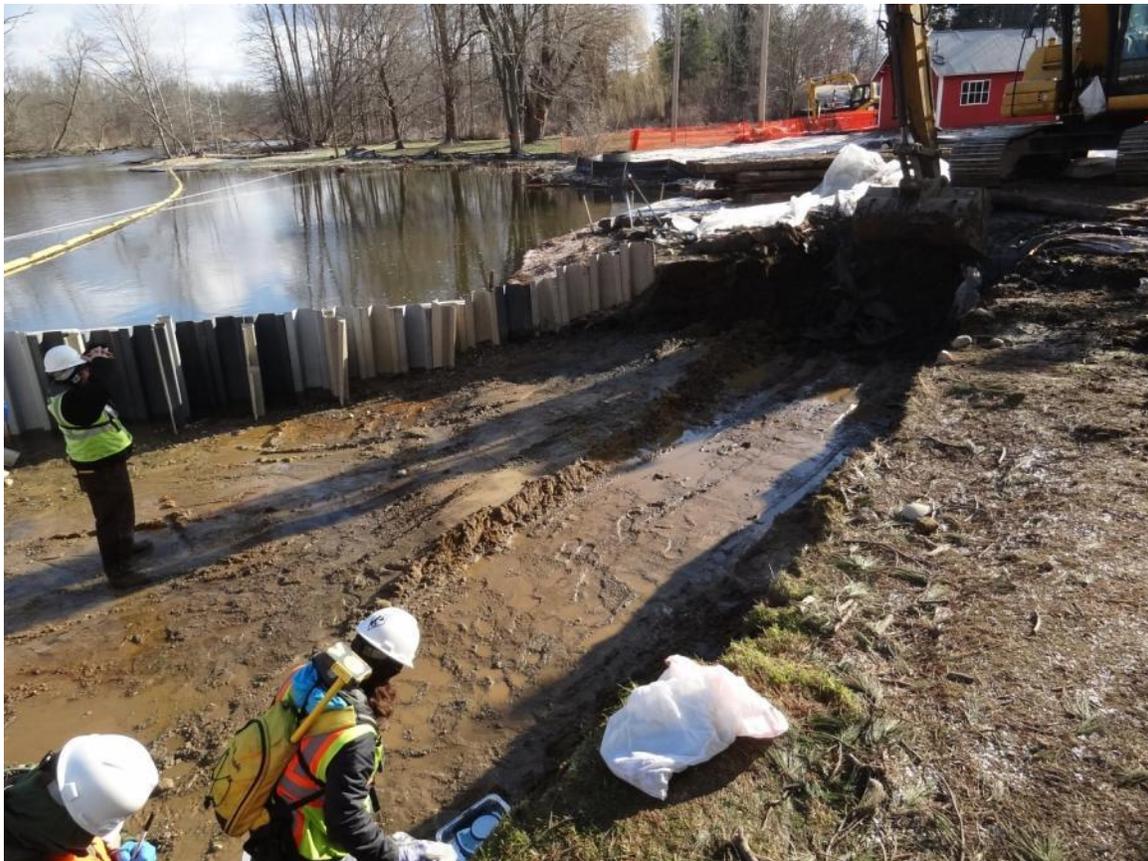
14. Confluence: observed excavating at the diversion outfall.

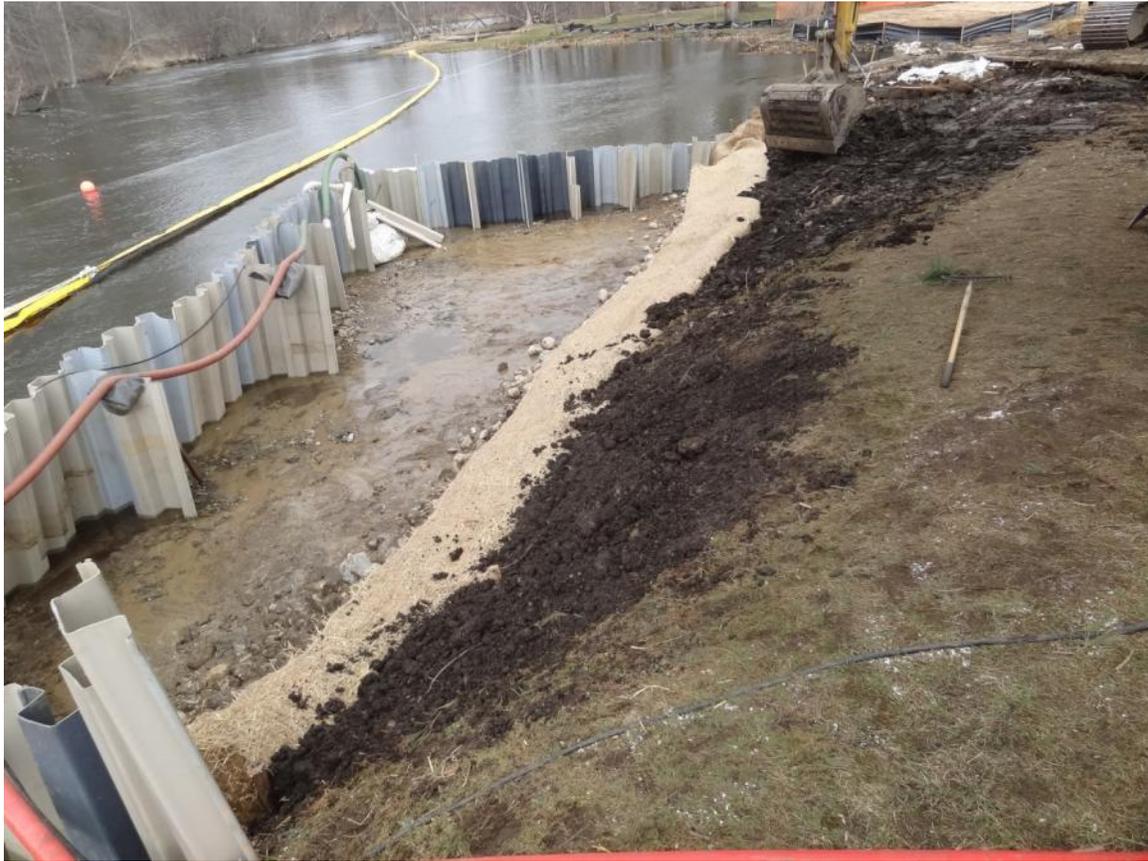
15. Confluence: observed restoration at the diversion outfall.

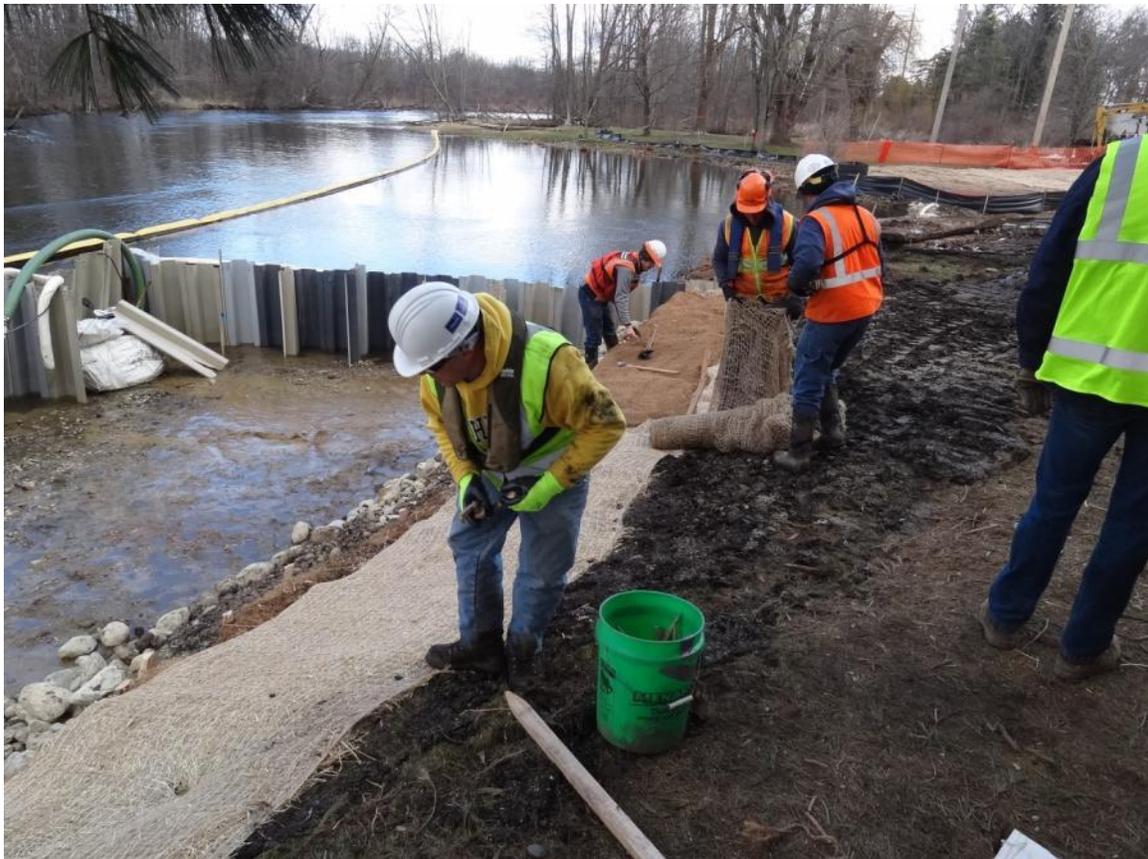
16. Confluence: observed restoration at the diversion outfall.

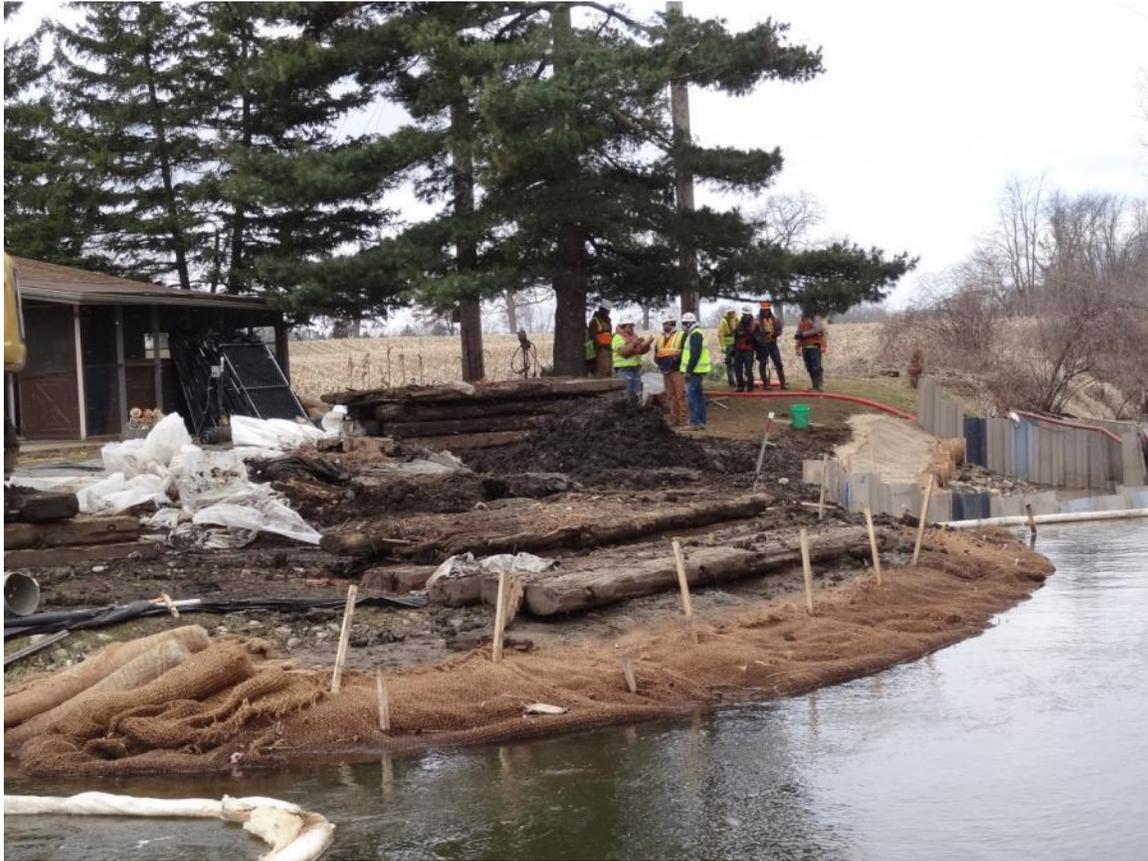
17. Confluence: observed restoration at the diversion outfall.

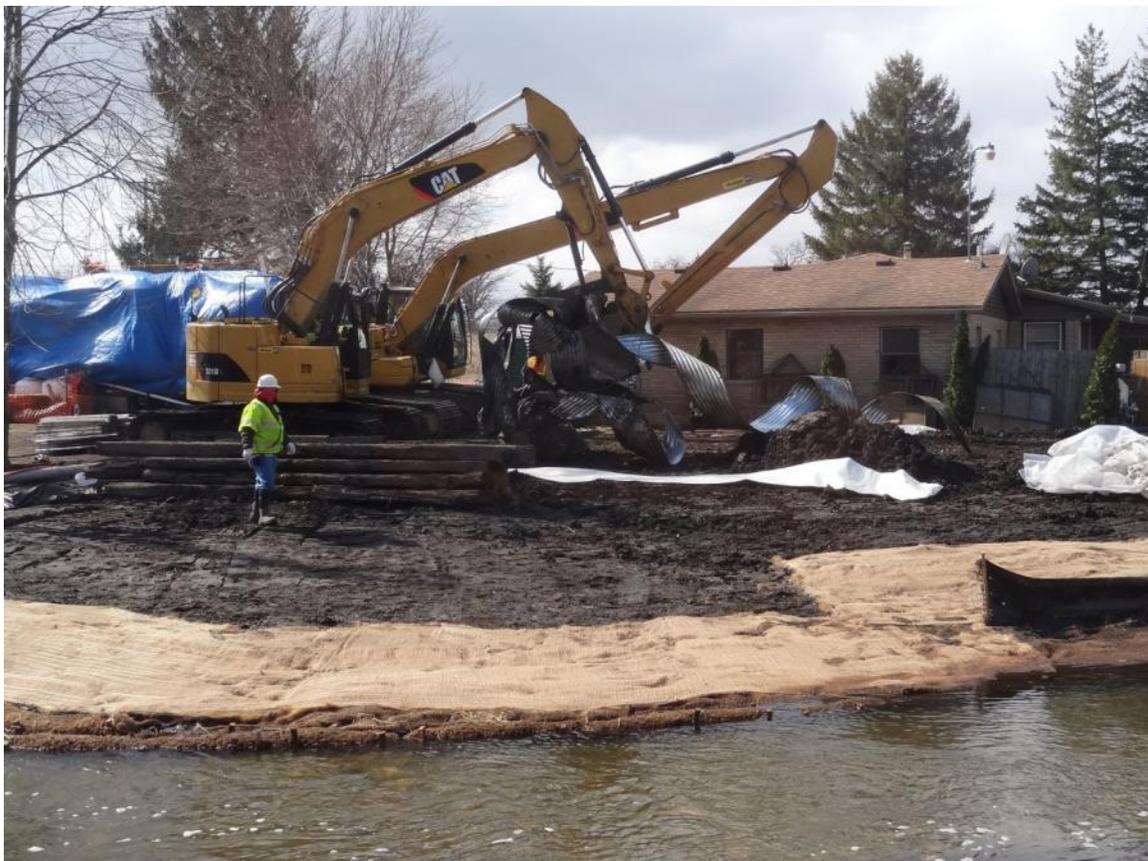
18. Confluence: observed the removal of the last section of culvert.

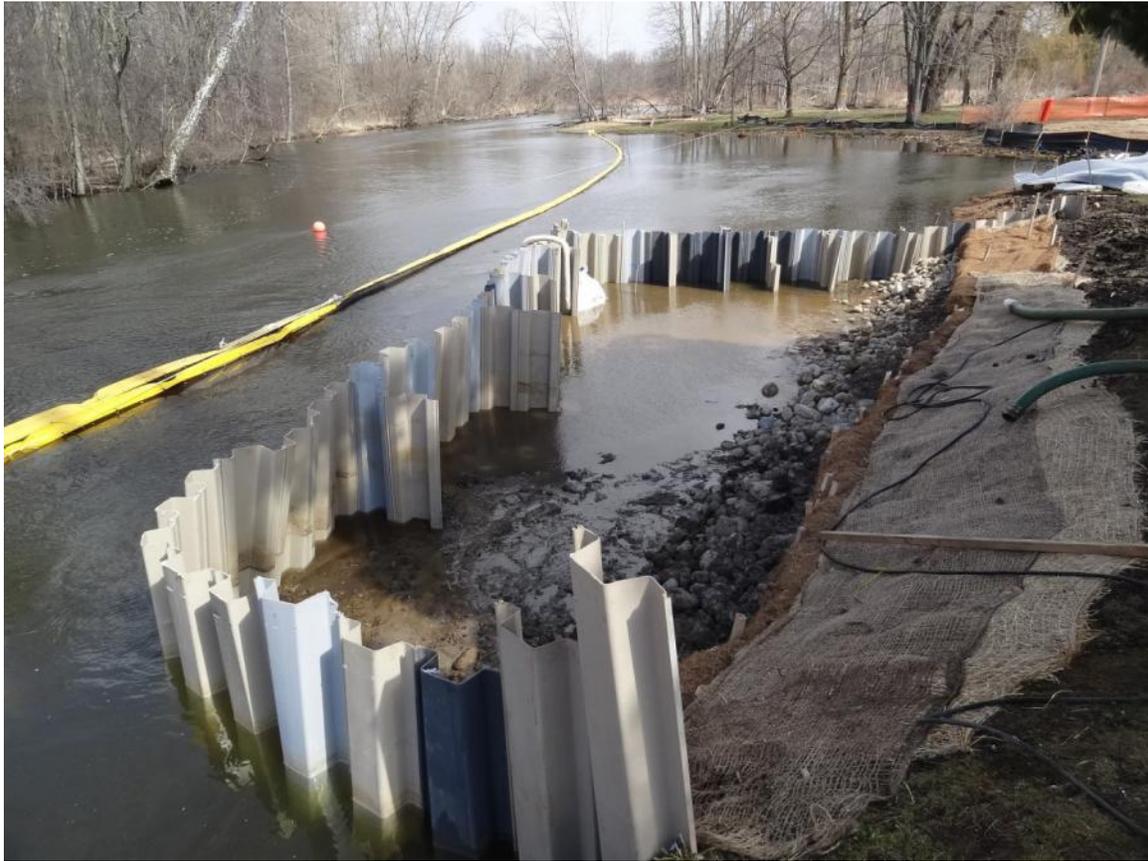
19. Confluence: observed the sheet piled area slowly filling with water.

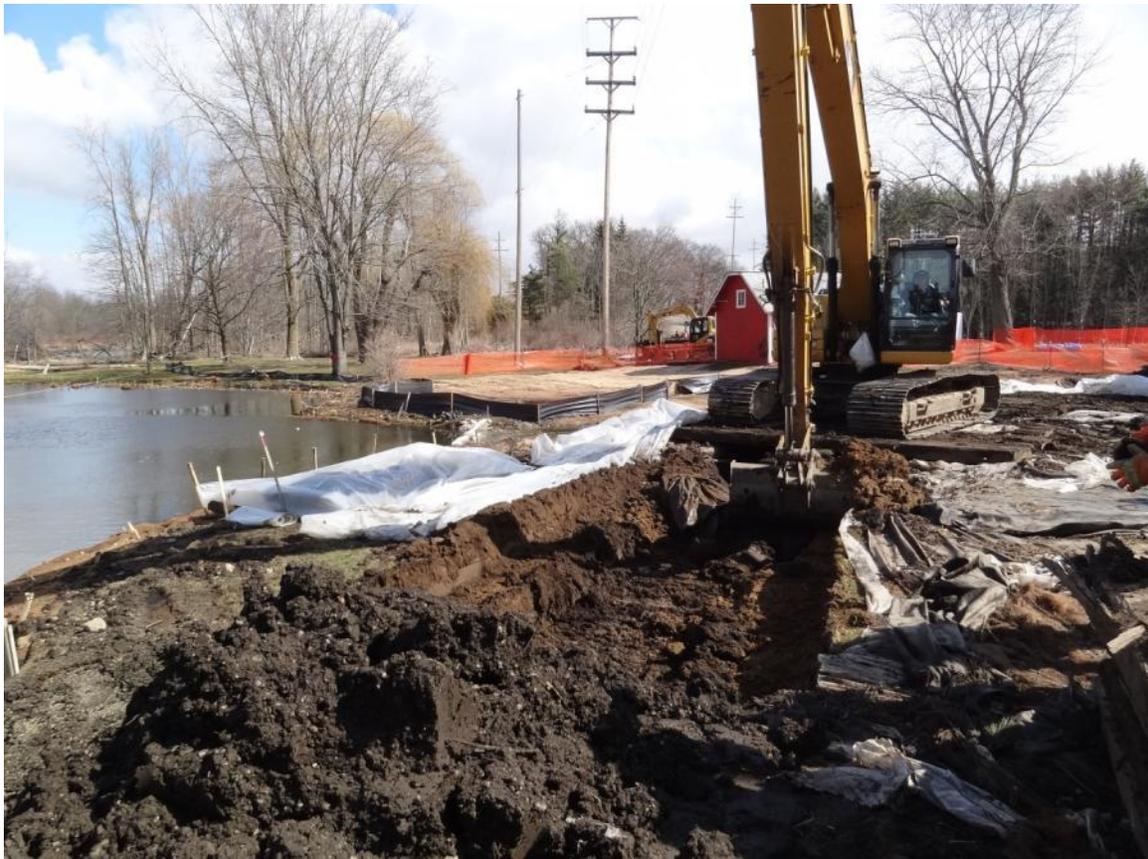
20. Confluence: observed excavation of the diversion structure.

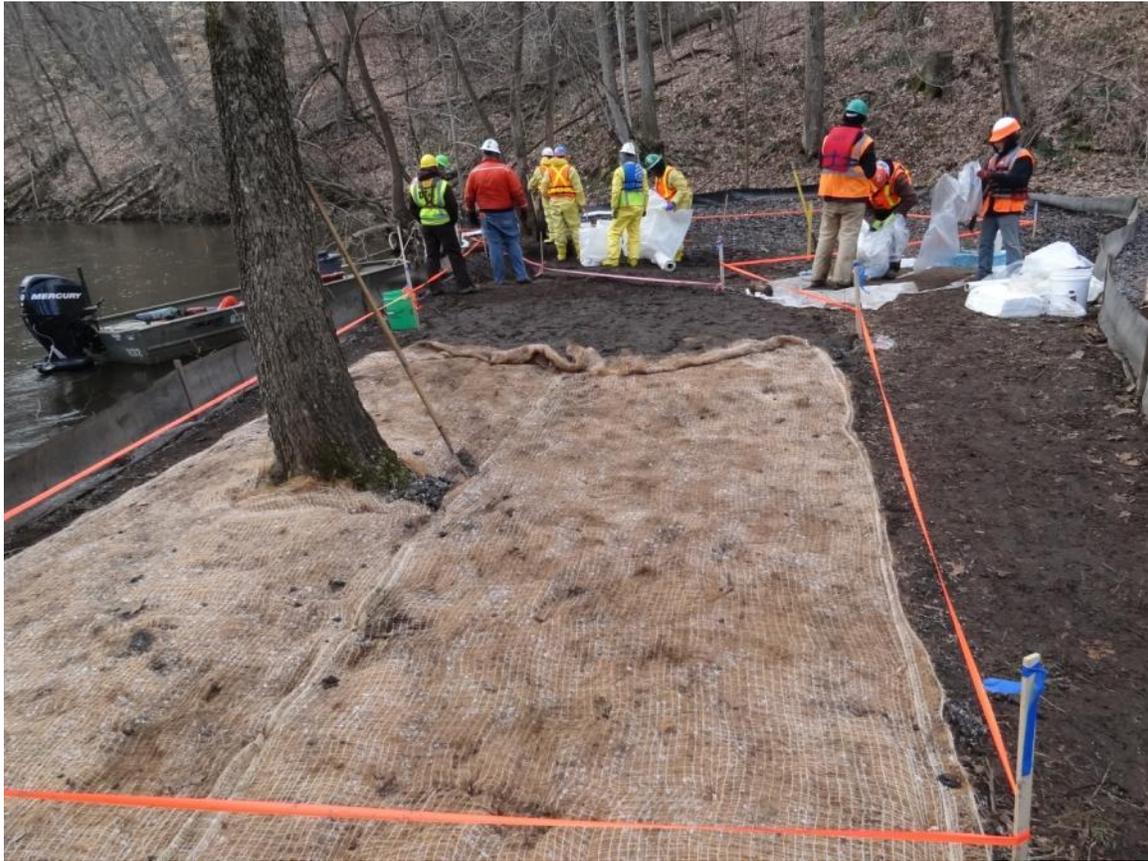
21. OB9.10 LDB: Scrape work.

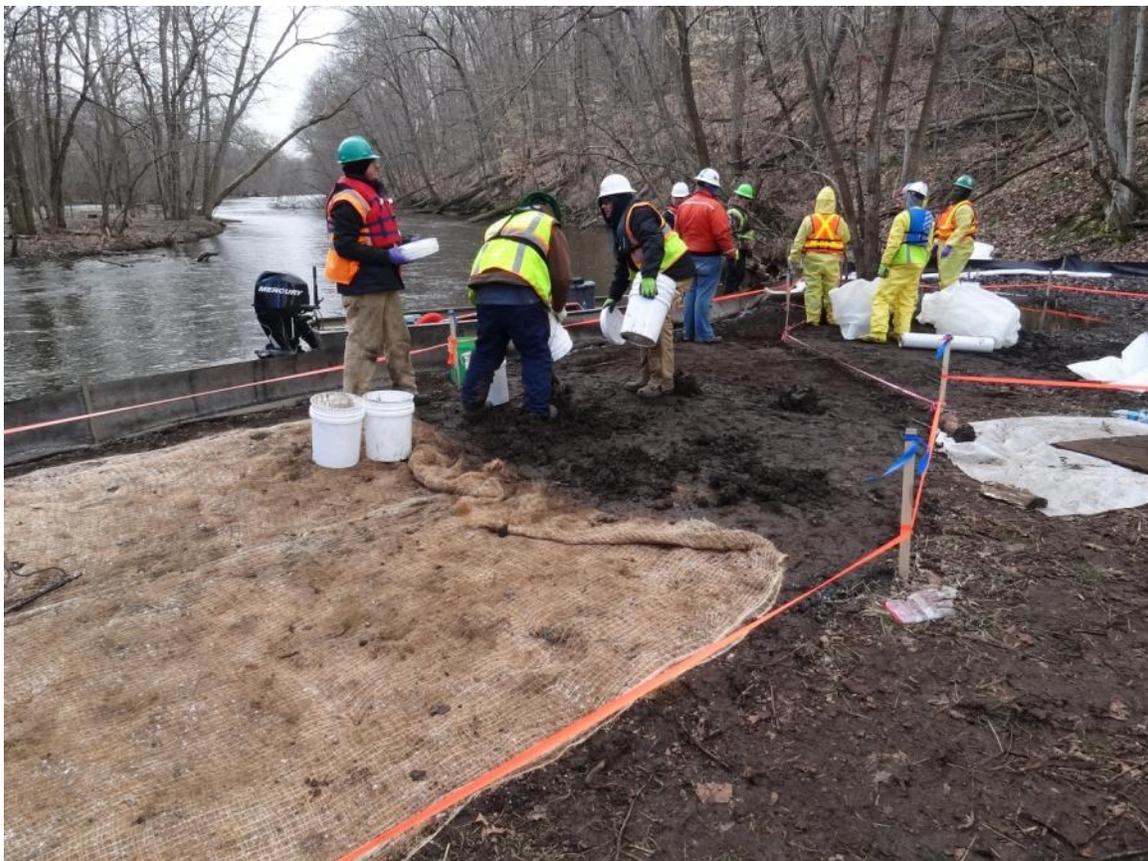
22. OB9.10 LDB: observed scrape area being backfilled.

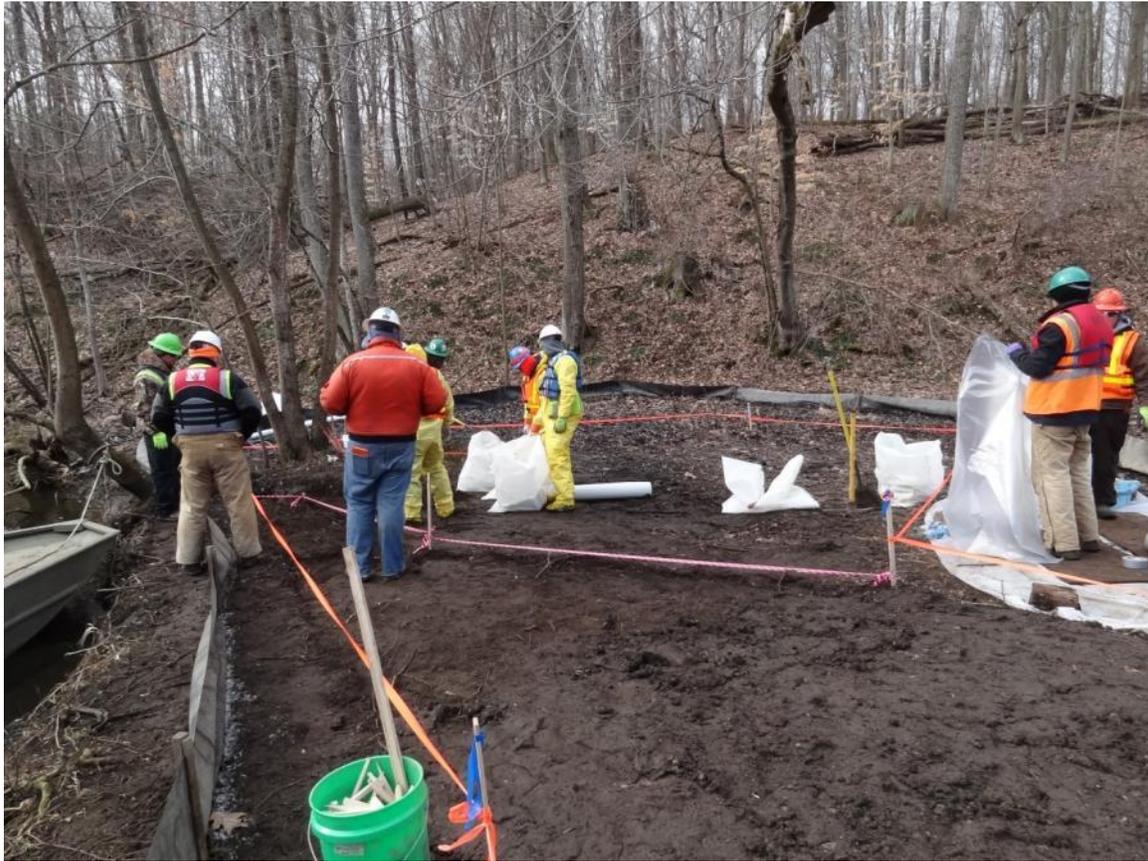
23. OB9.10 LDB: Scrape work.
