# Situation Photo Log

Friday, March 9, 2012

Kalamazoo River / Enbridge Spill

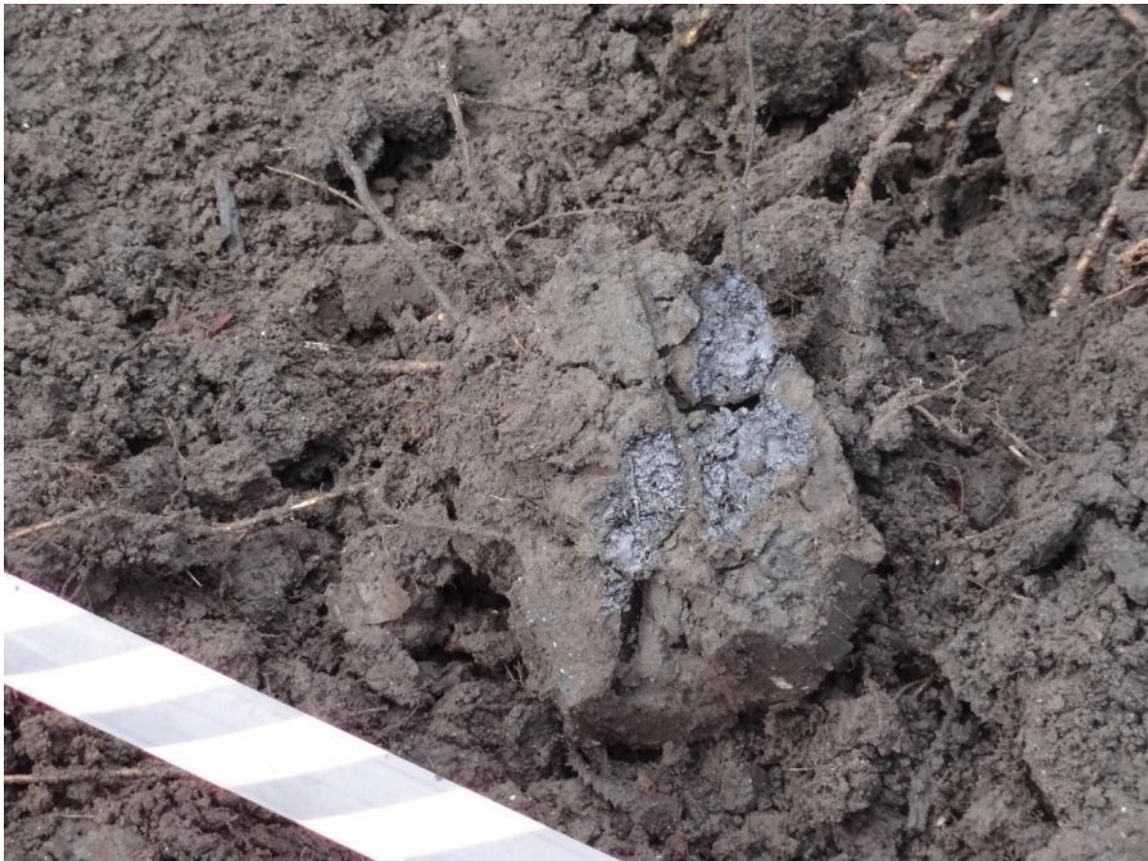
24. OB9.10 LDB: Scrape work oil in soil.

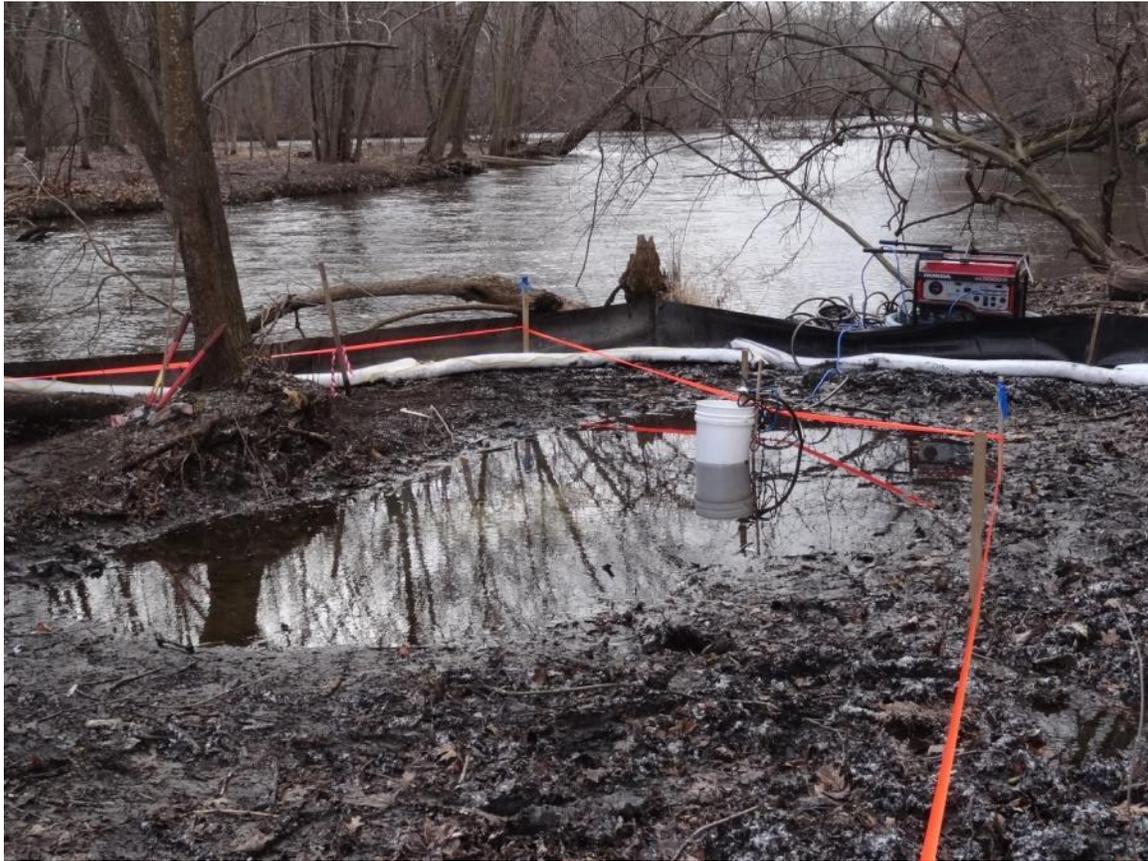
25. OB9.10 LDB: observed dewatering of scrape area.

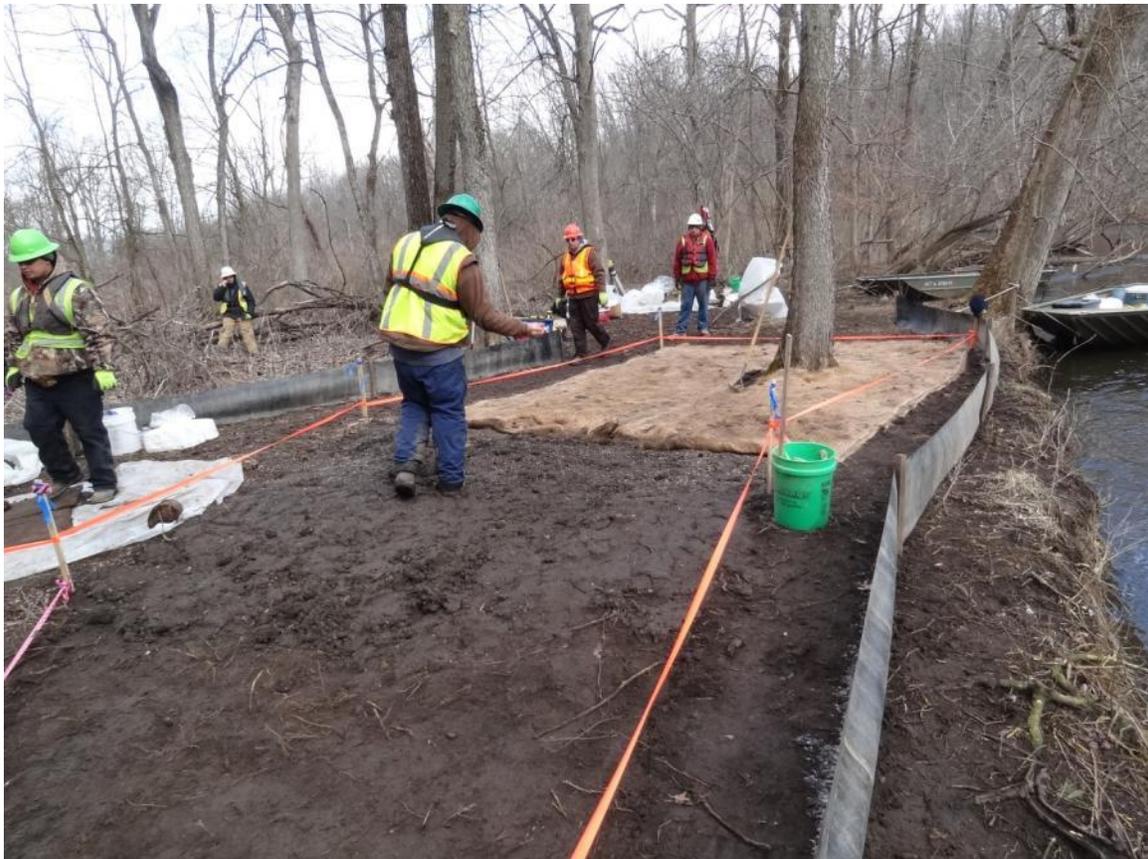
26. OB9.10 LDB: observed restoration work.
