# Situation Photo Log

Monday, March 12, 2012

Kalamazoo River / Enbridge Spill

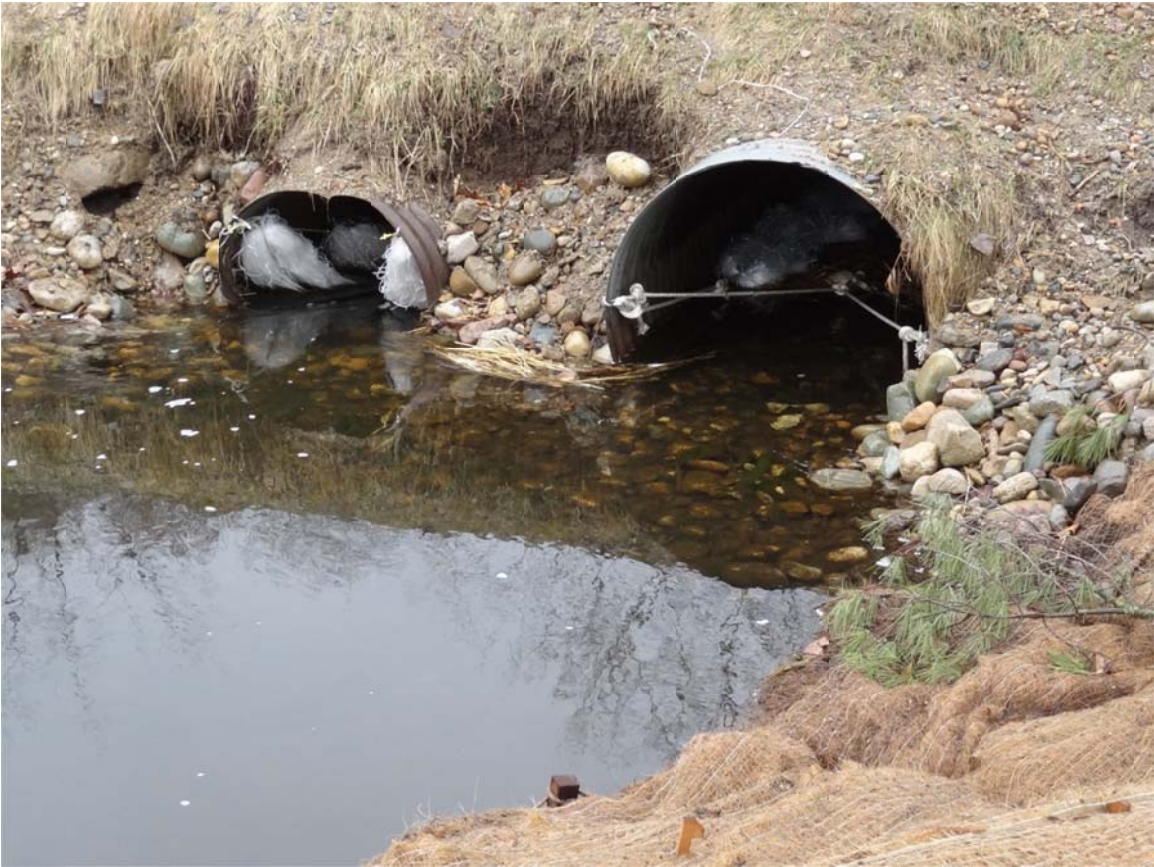
**1. Talmadge Creek, sweeper boom installed in culvert on east side of 15-1/2 Mile Road.**

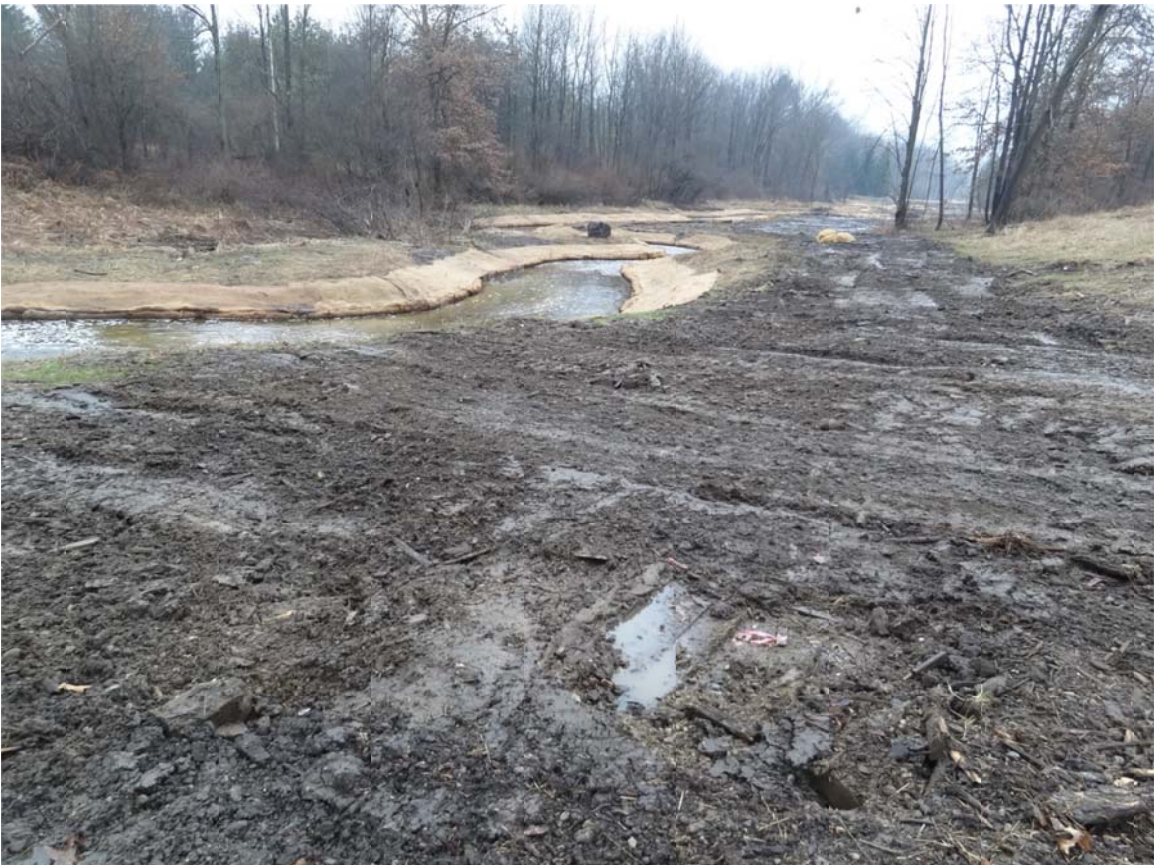
**2. Talmadge Creek, restoration along creek west of 15-1/2 Mile Road.**

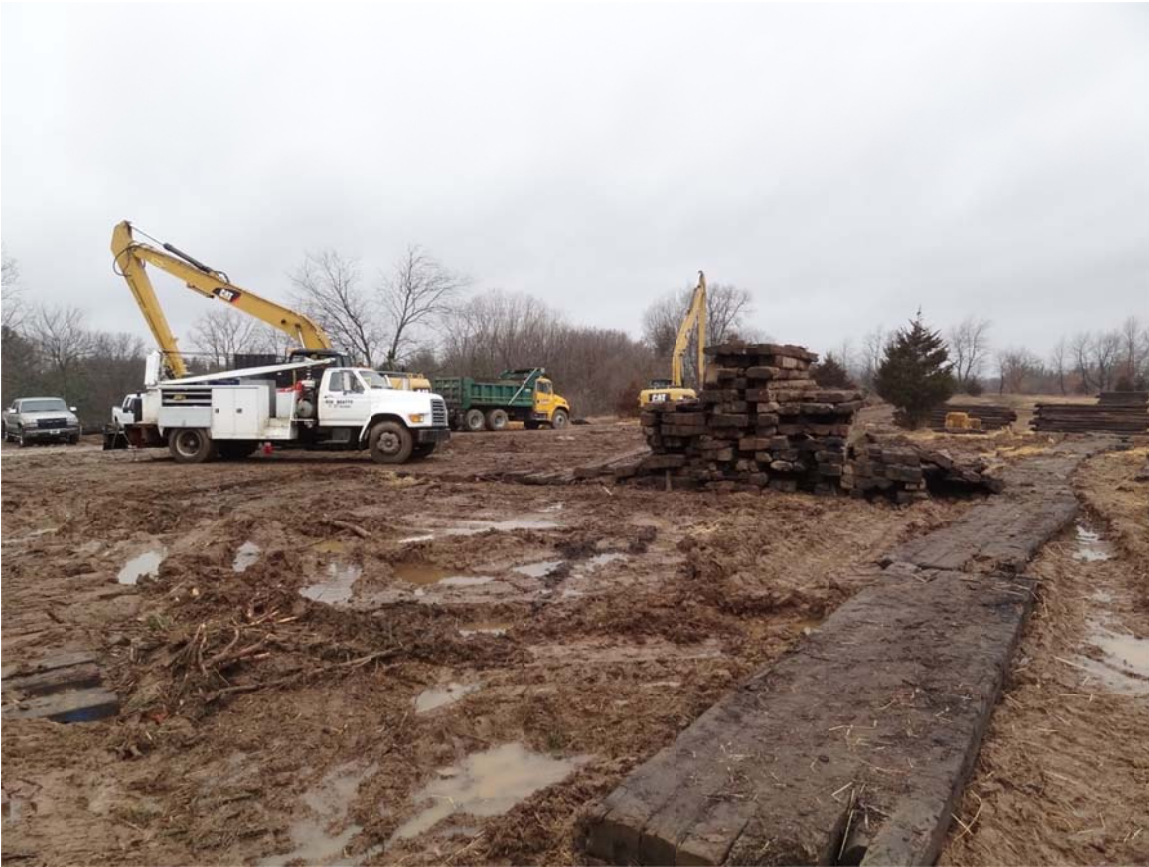
**3. Crews continue mat removal at former Turbidity Control Structure location.**

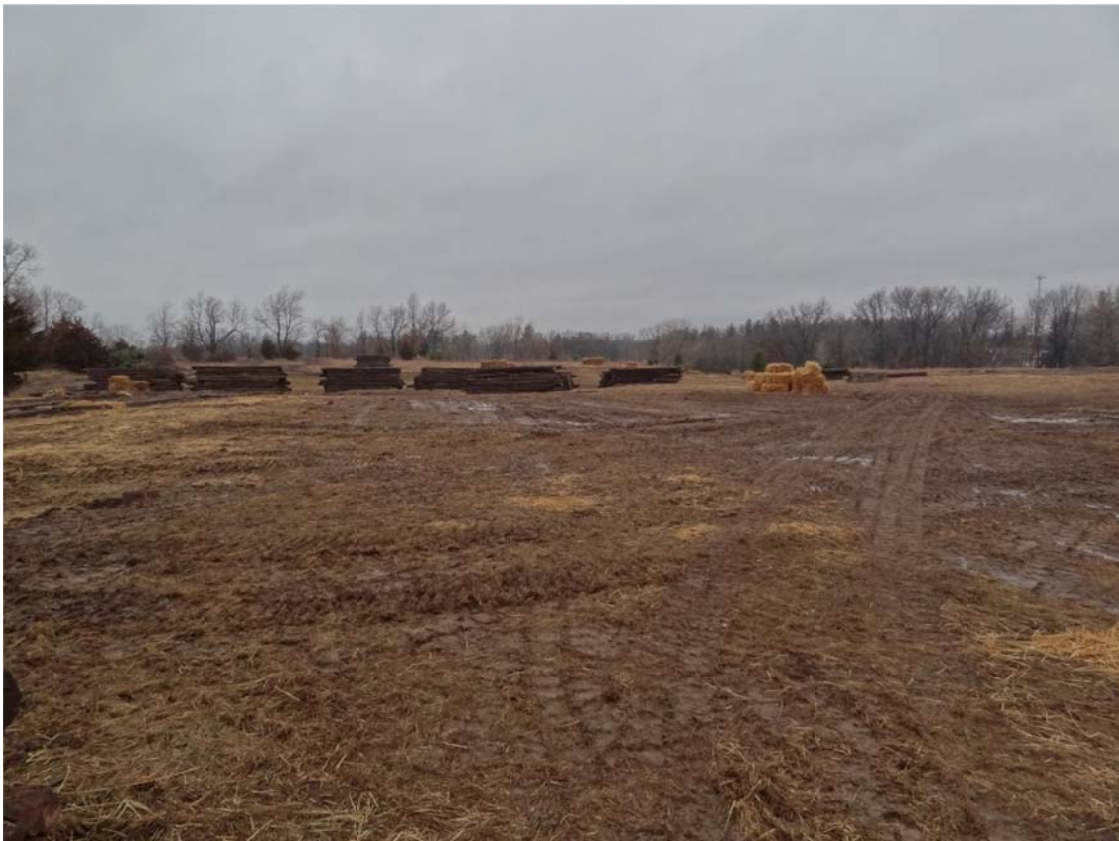
**4. Stacked mats at former Turbidity Control Structure location.**

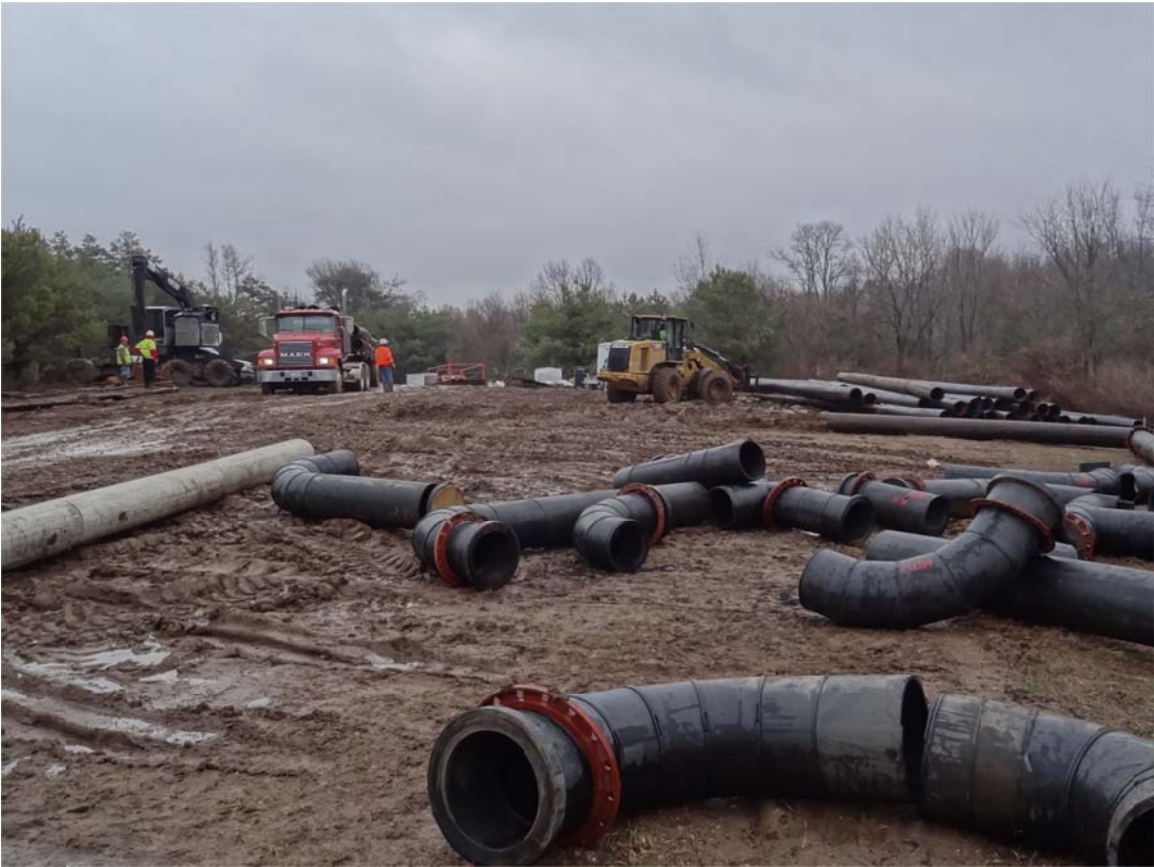
5. Crews loading Turbidity Control System piping onto trucks near 15-1/2 Mile Road.

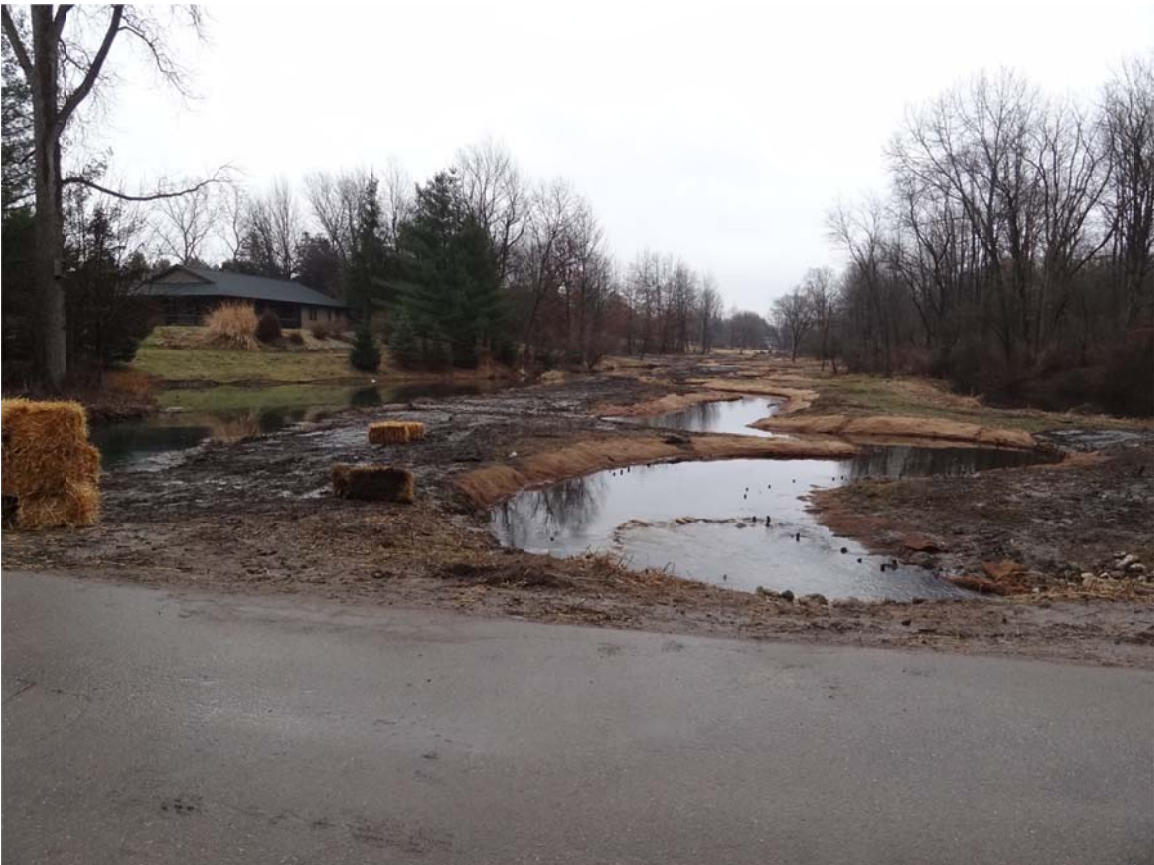
6. Talmadge Creek: restoration work near MP1.5.

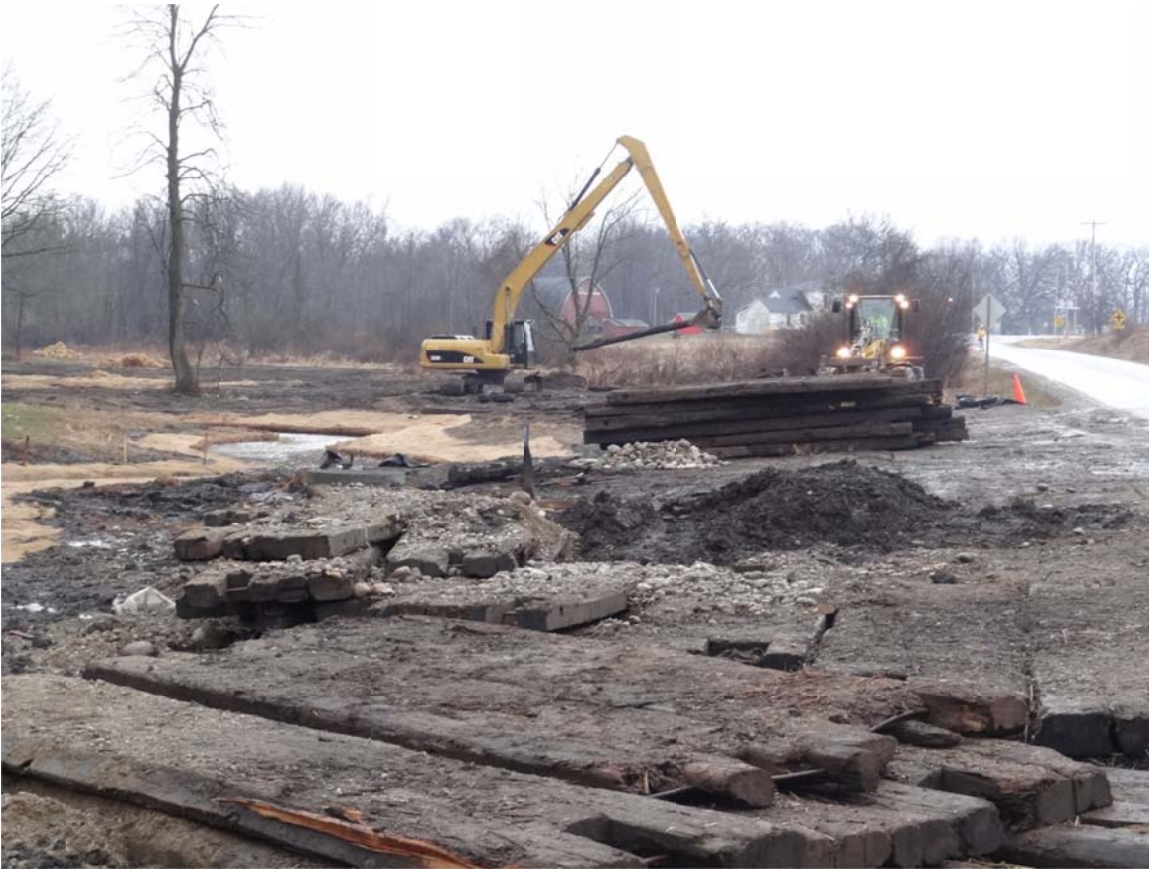
7. Mat road removal continues south of A Drive, upstream from Confluence.

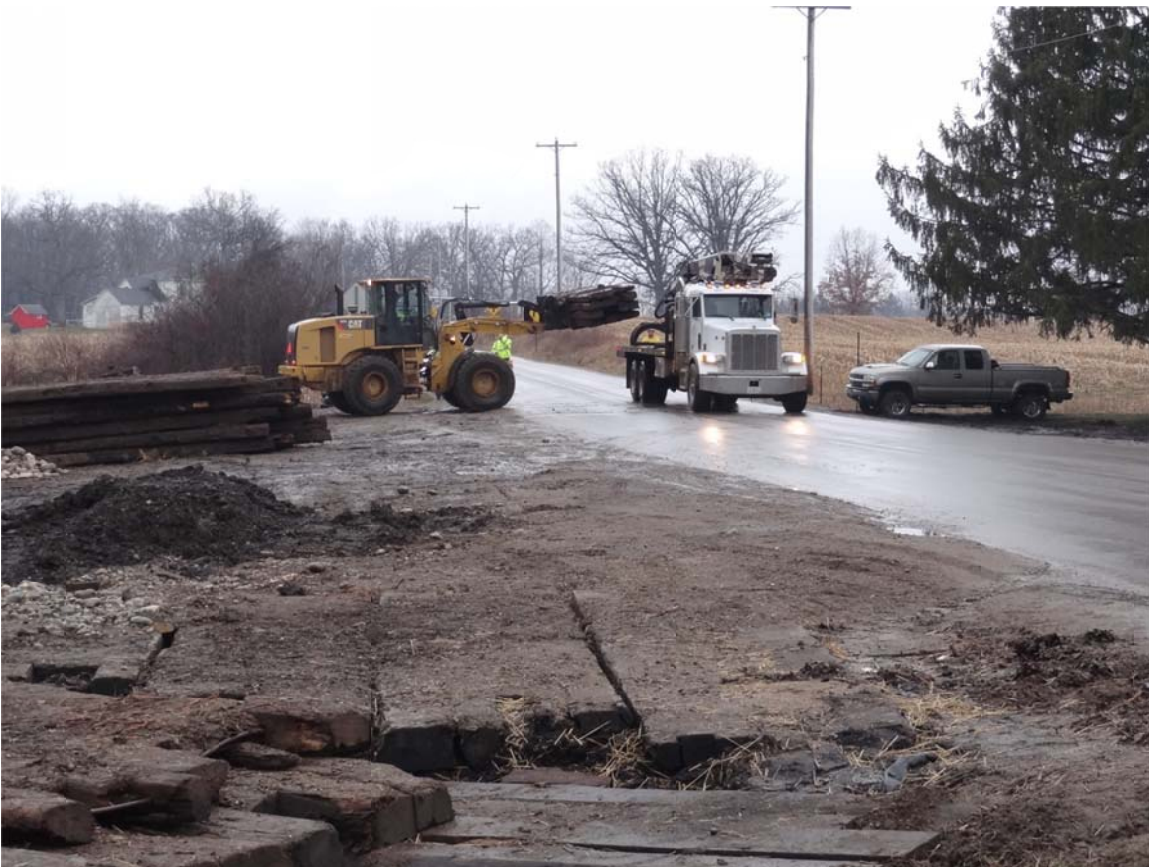
8. Talmadge Creek: crews loading mats onto truck on A Drive at Confluence.

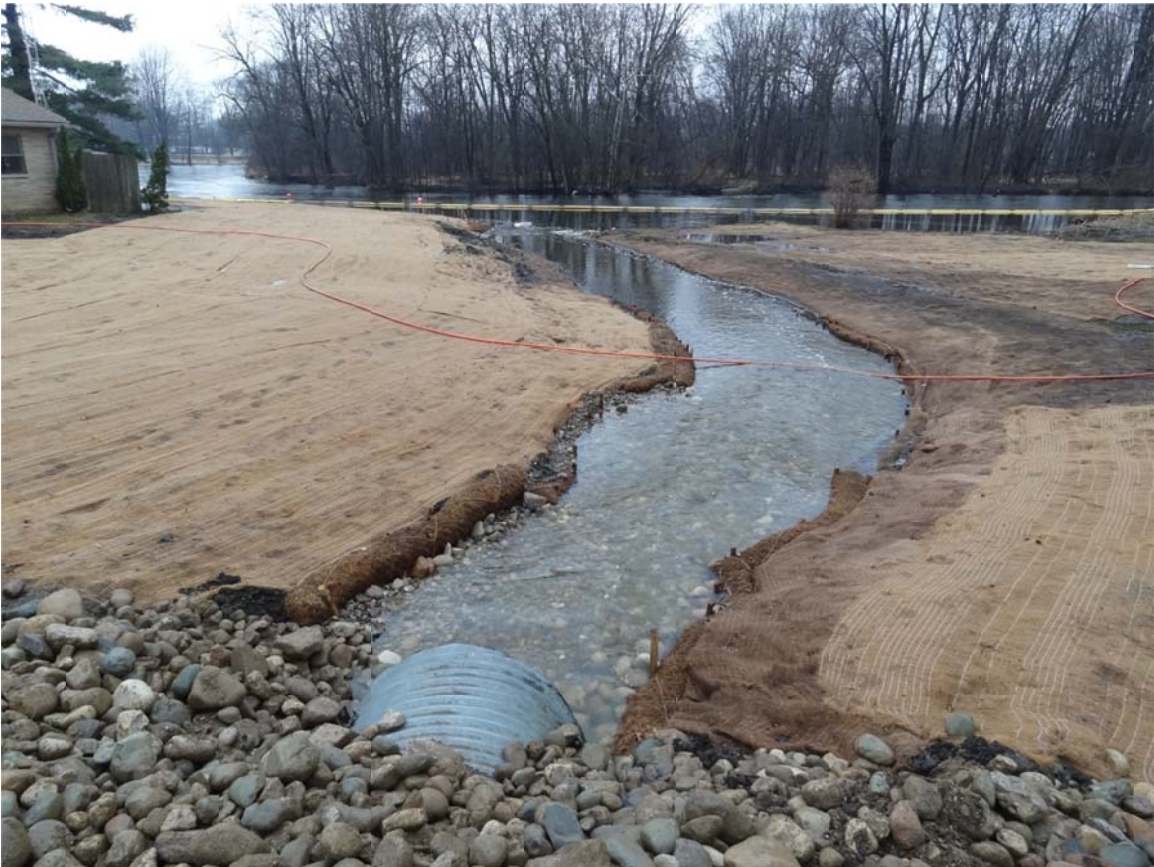
9. Talmadge Creek: restoration work continues at Confluence.

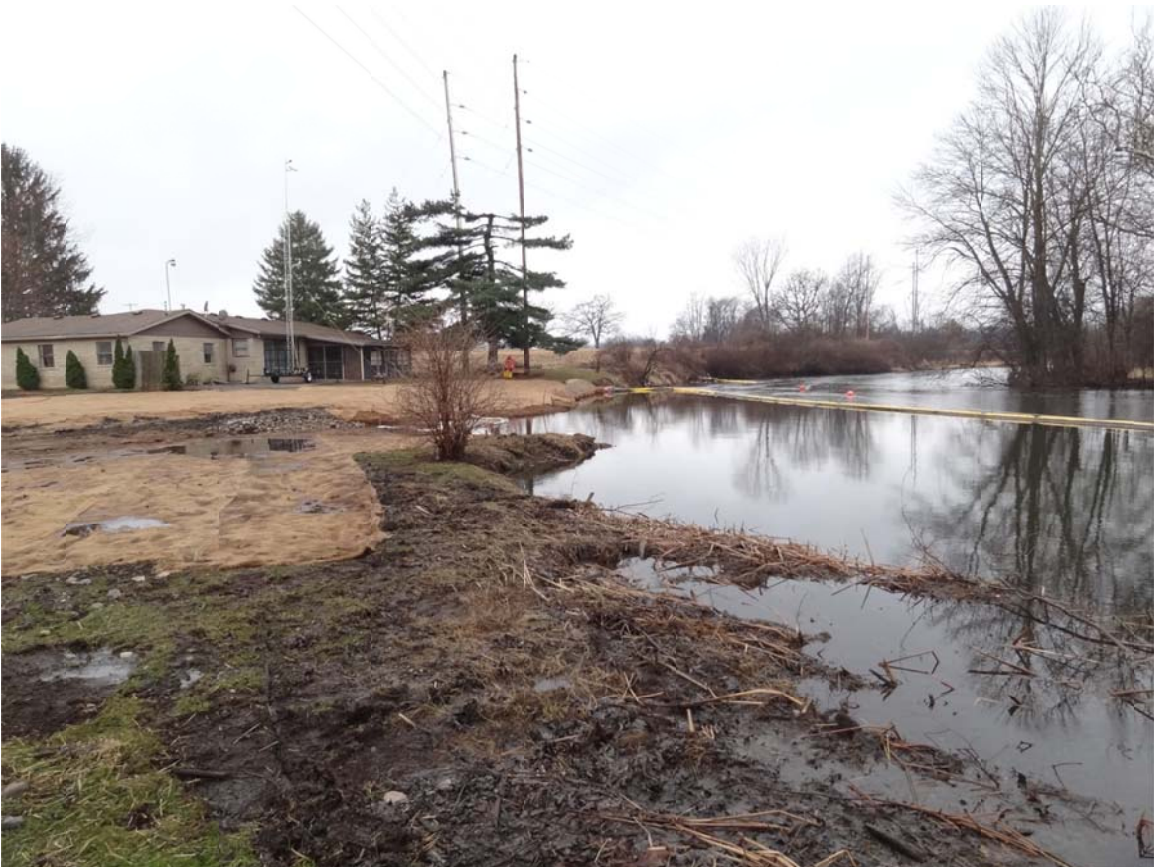
10. Confluence, restoration work almost complete.

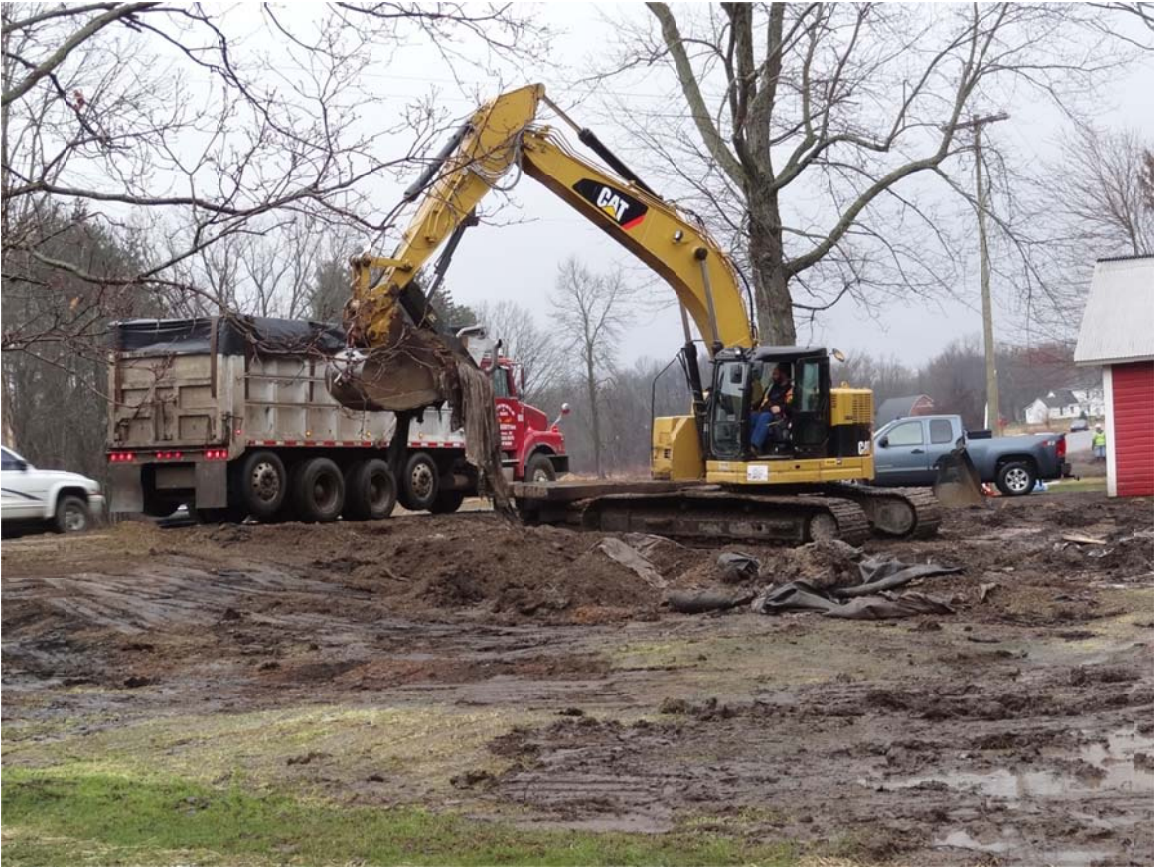
11. Confluence, crews excavating former soil mixing box location.

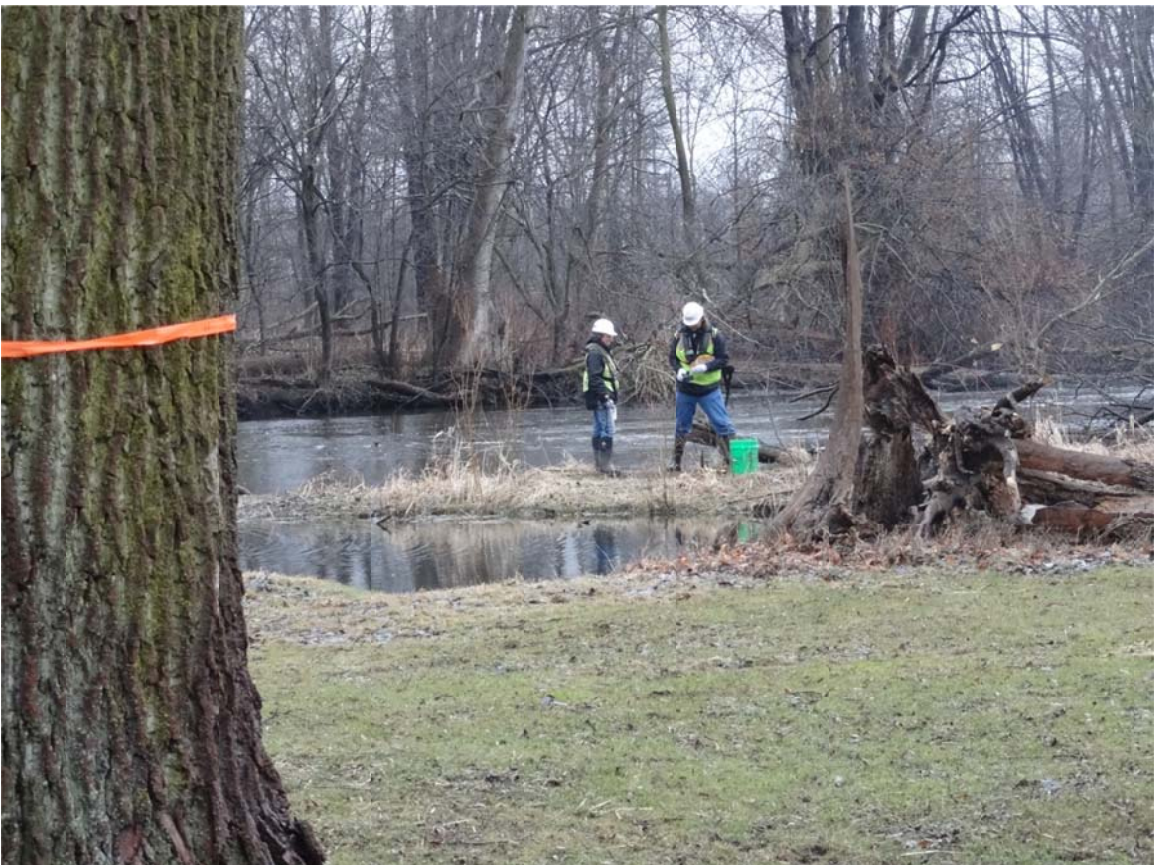
12. Crews conducting water quality monitoring just upstream from Confluence.

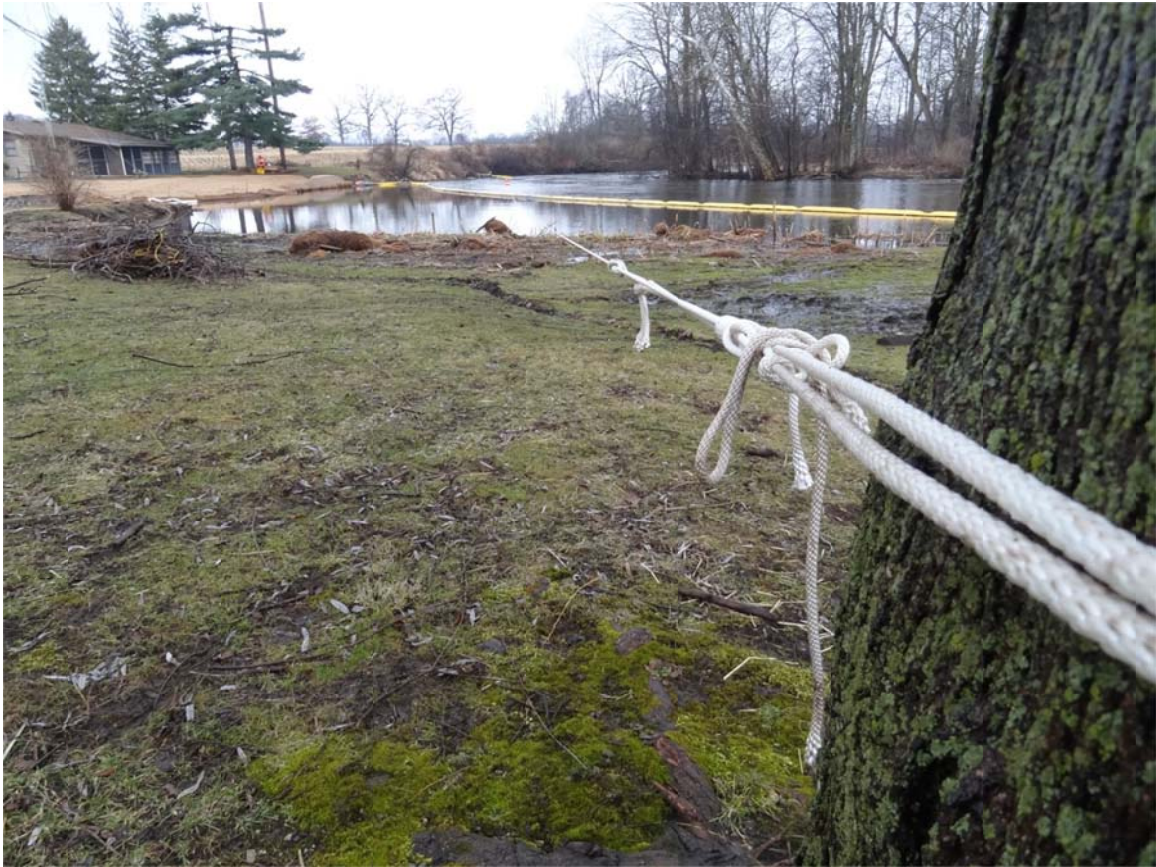
13. Confluence: marker buoys and containment boom remain in place.

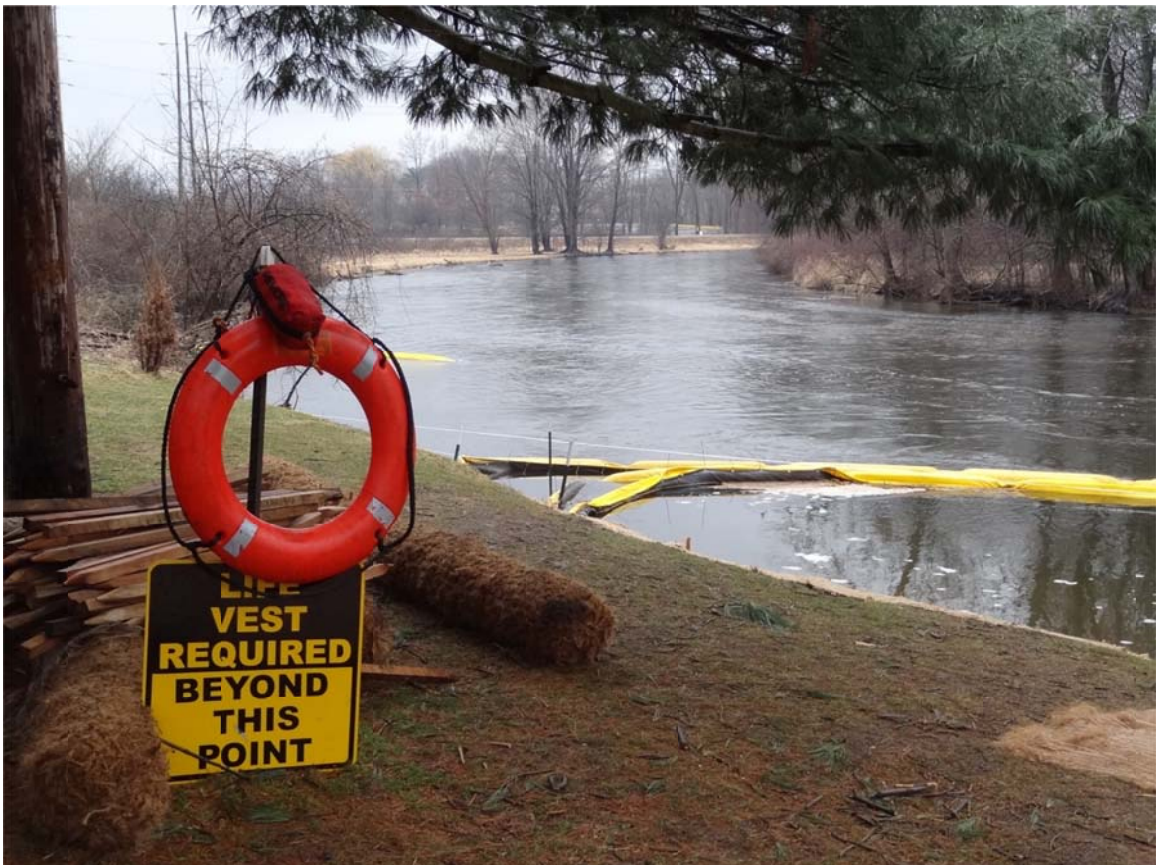
14. Confluence: containment boom and safety equipment just downstream from Talmadge Creek discharge.

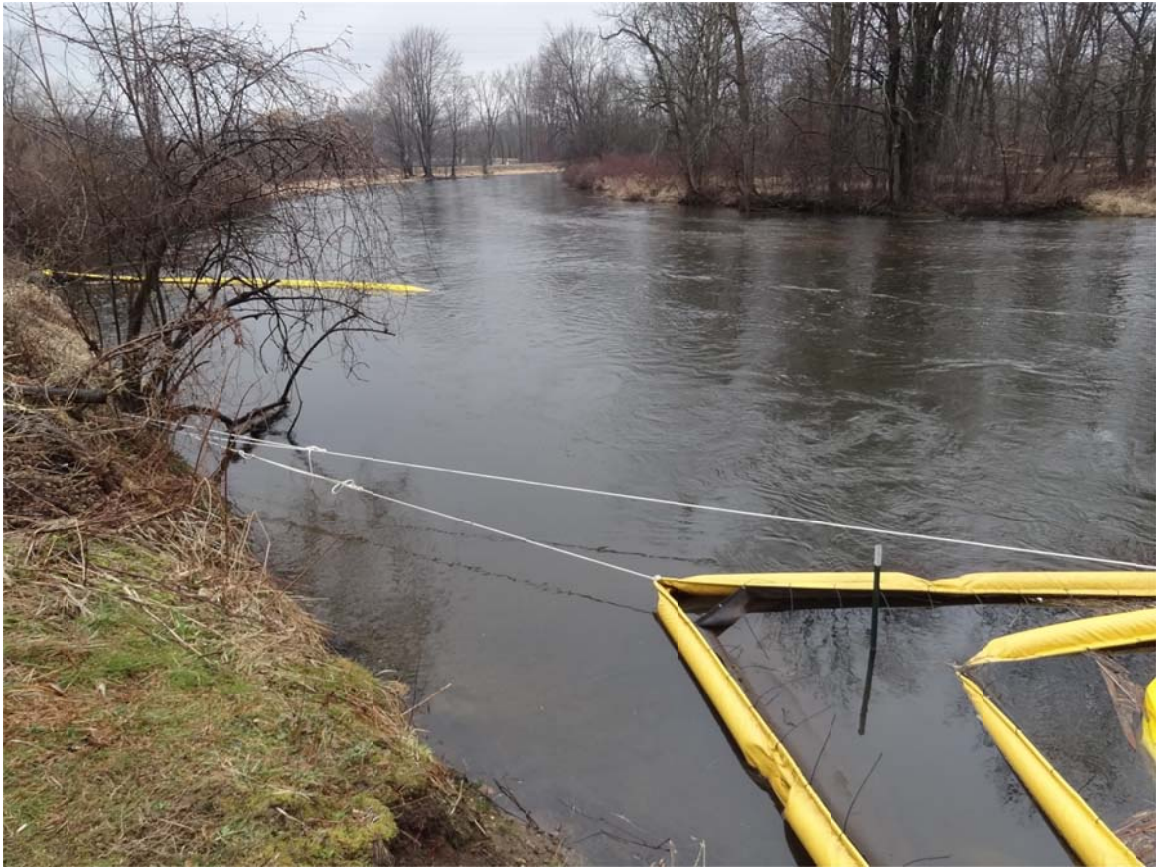
**15. Confluence: containment boom in place at Talmadge Creek discharge.**

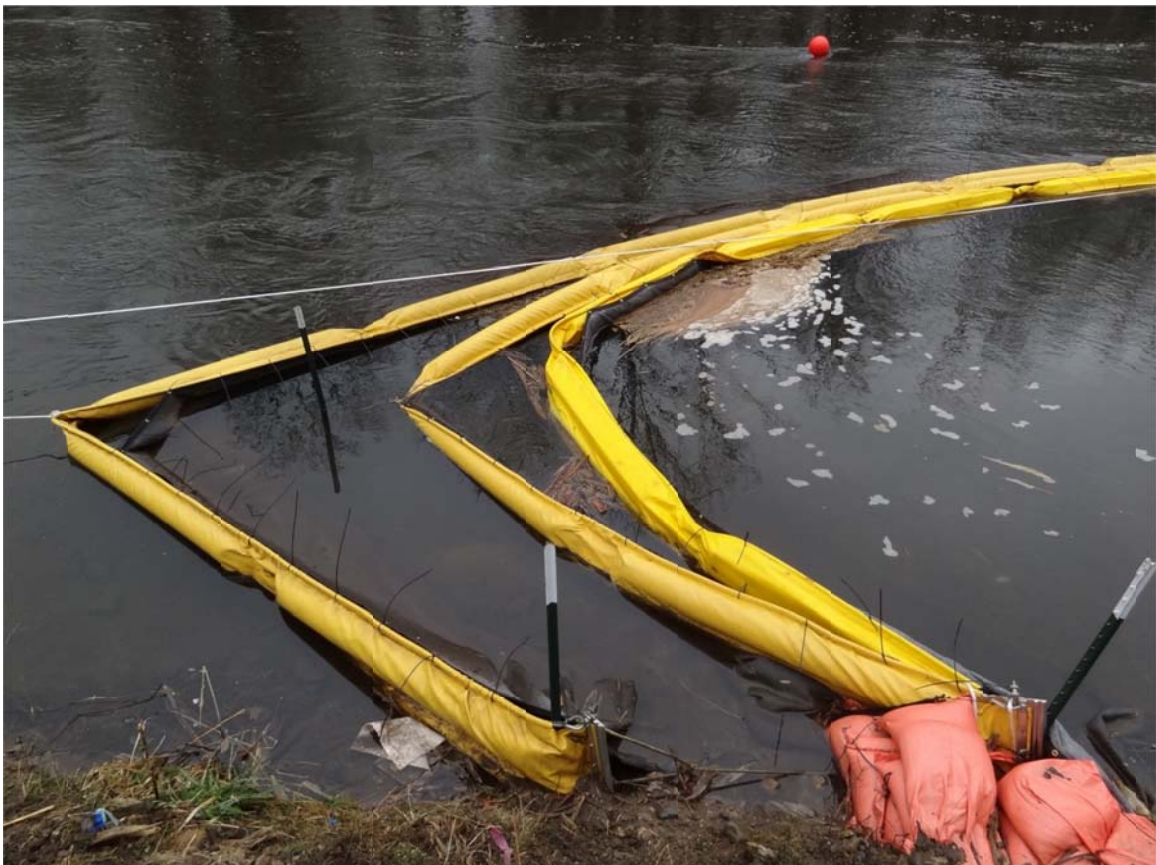
**16. Confluence: minor debris observed within containment boom.**

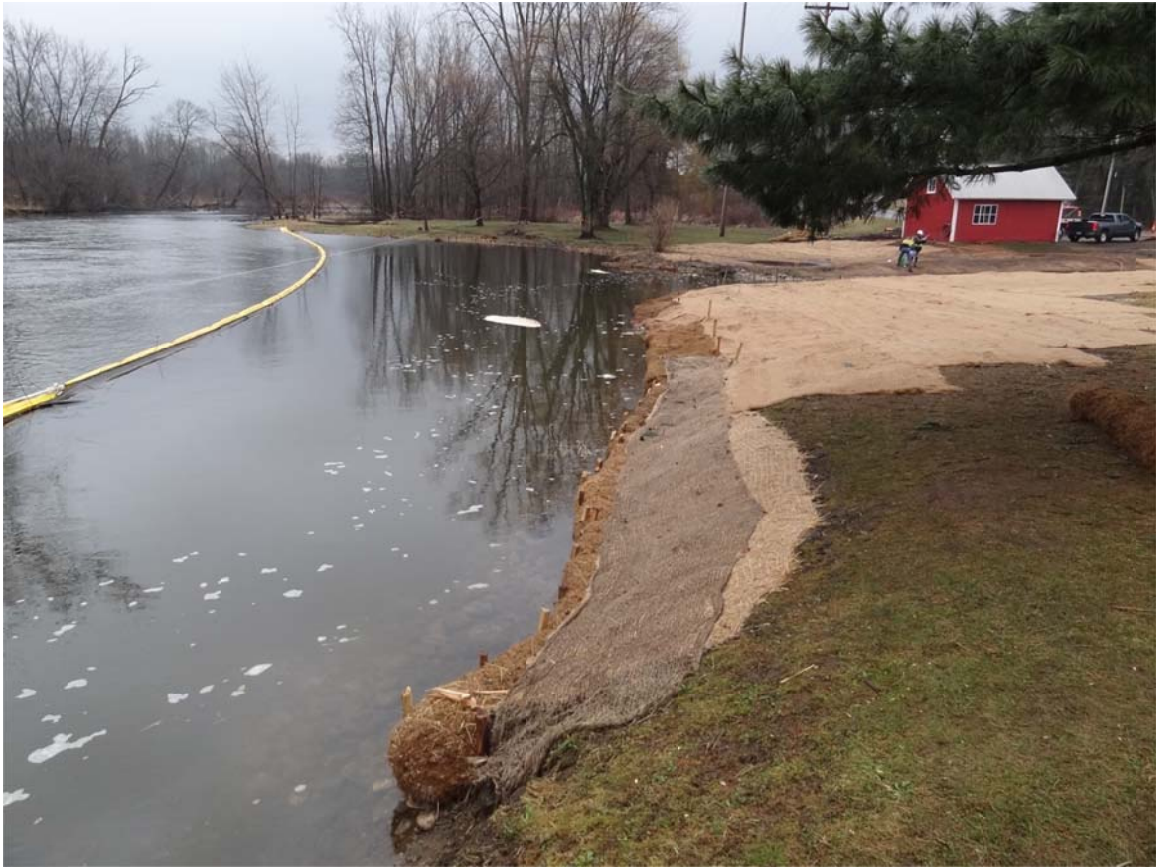
17. Confluence: restoration work along river shoreline.

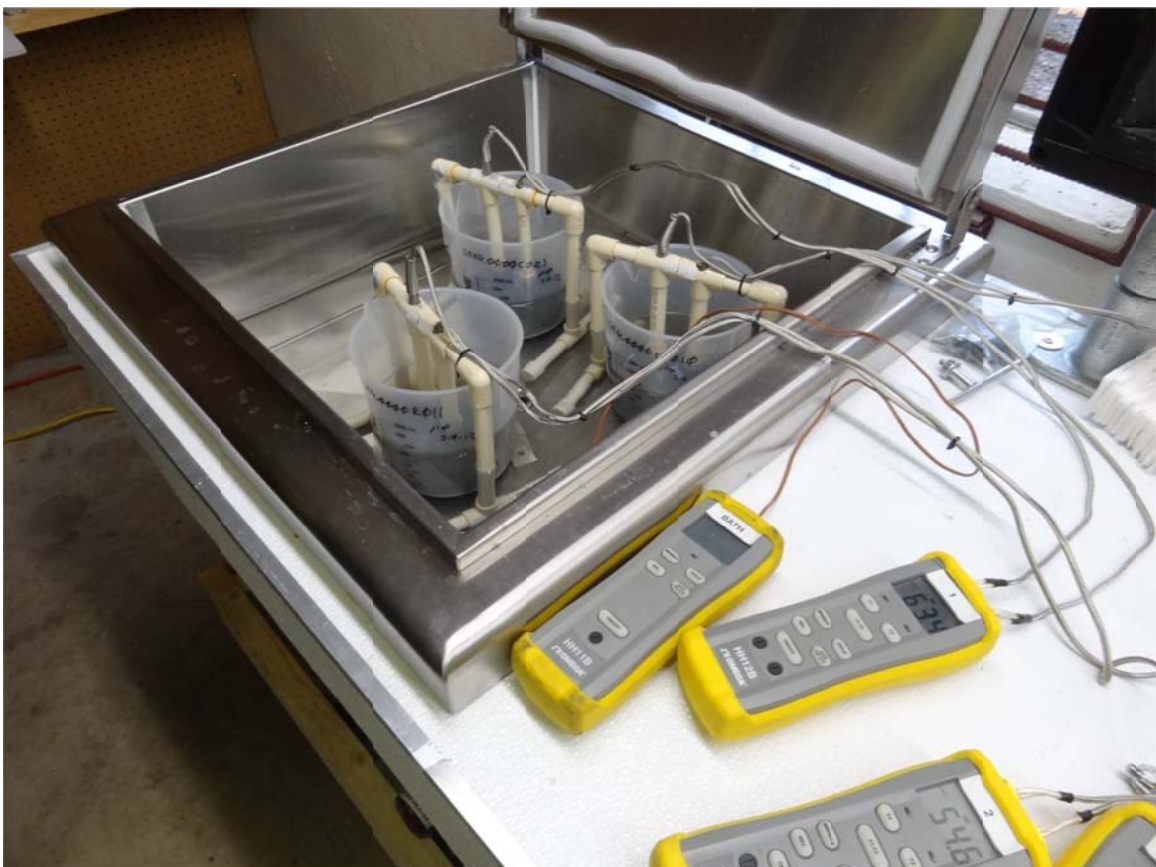
18. Temperature effects study continues.

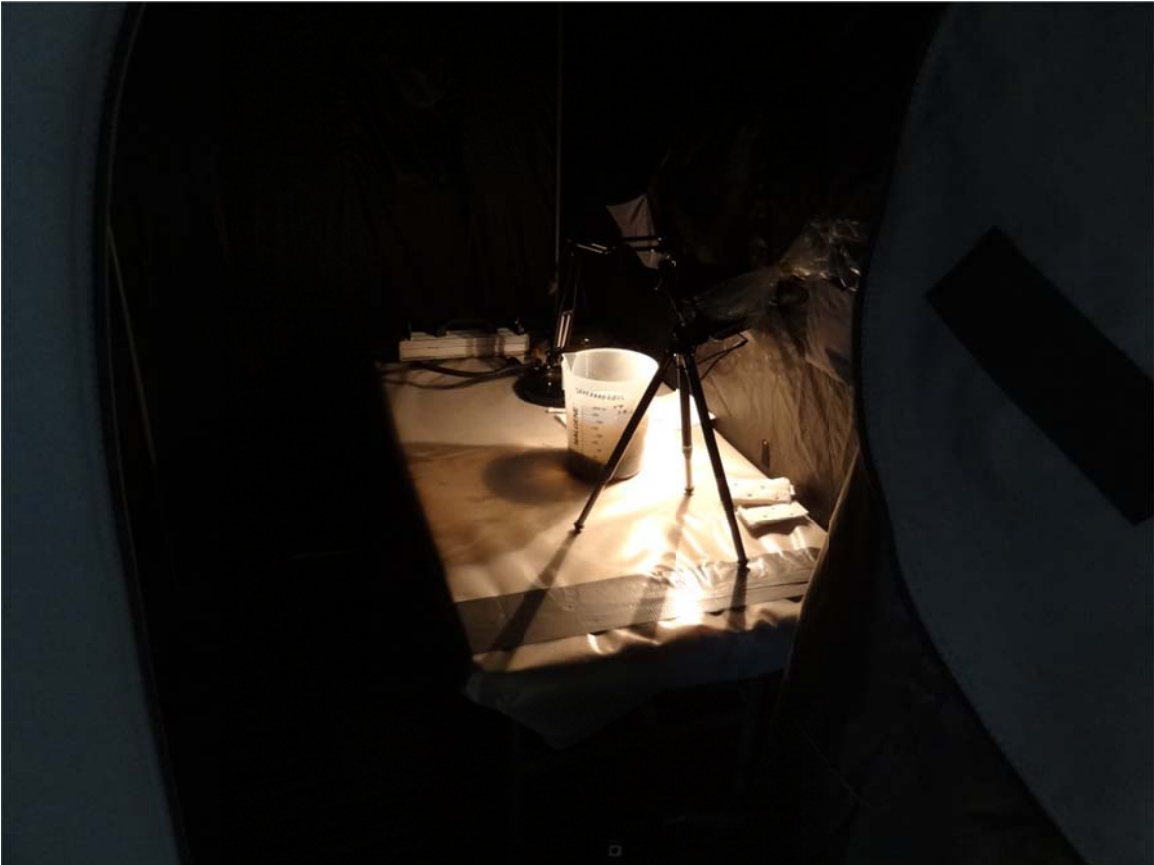
19. Darkroom for temperature effects study observations.

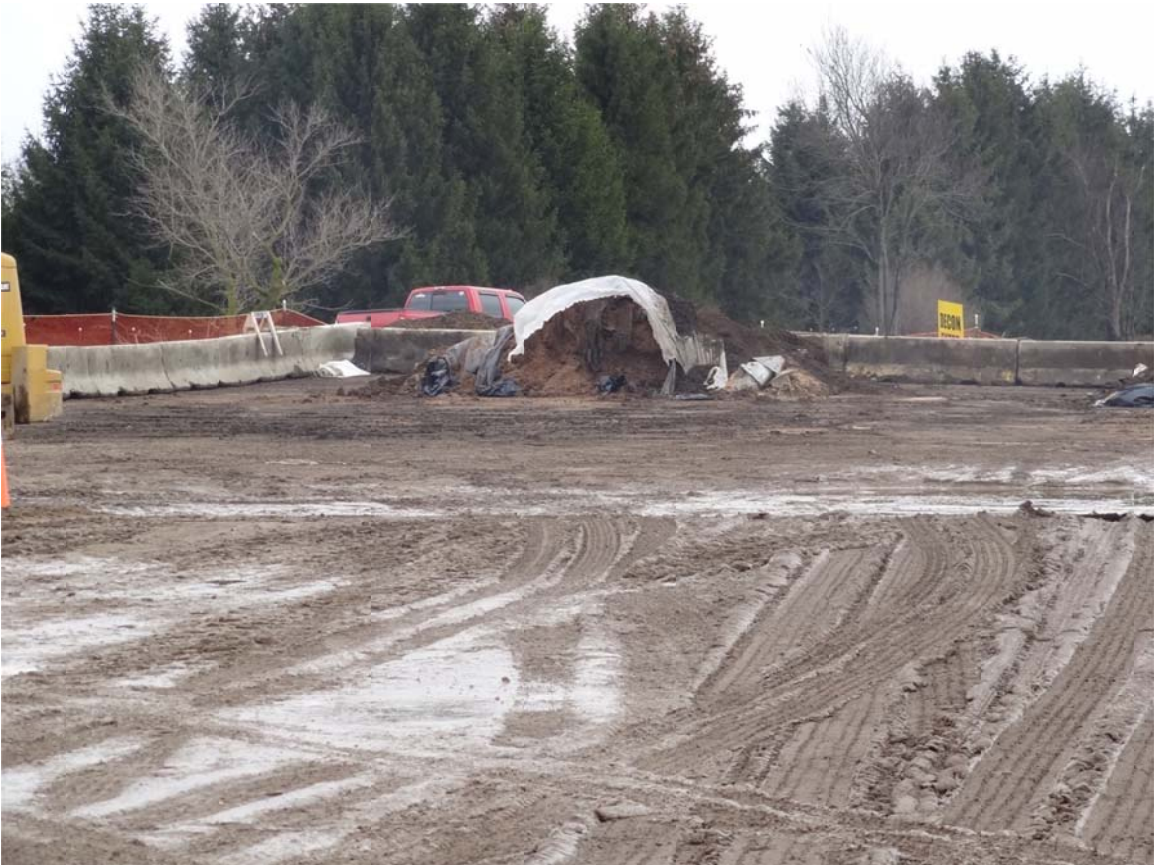
20. Frac Tank City Cell A, only two small piles of soil present in cell.

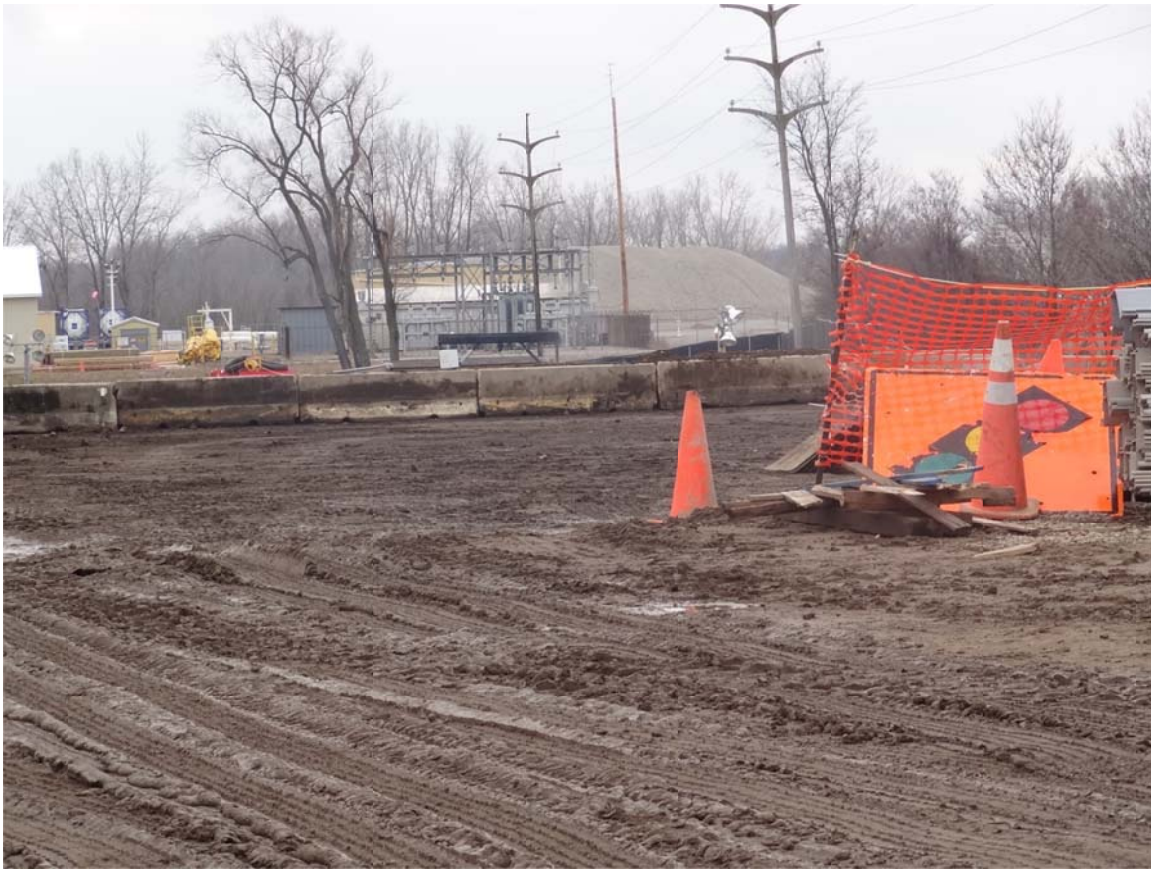
21. Frac Tank City Cell B, no material or activity observed.

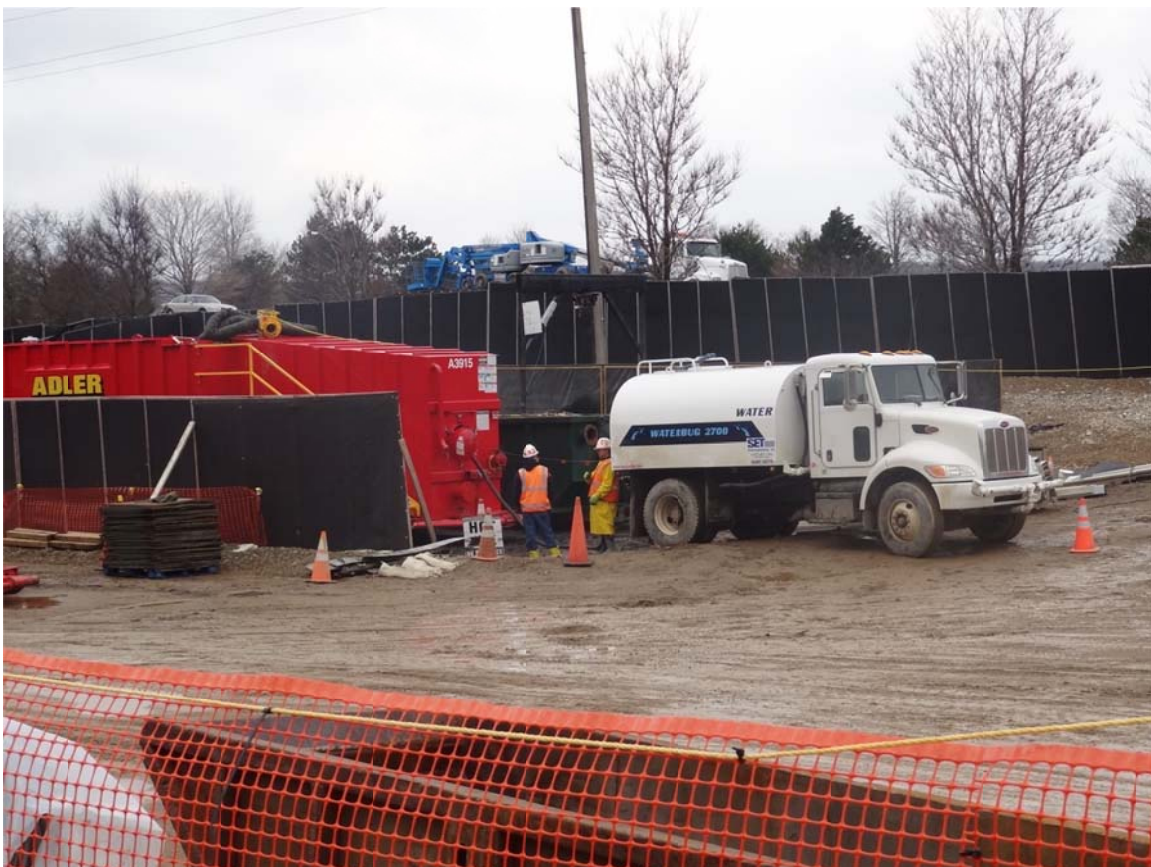
22. Frac Tank City southern decon pad, crews cleaning a frac tank and roll-off box.
