# Situation Photo Log

Tuesday, March 13, 2012

Kalamazoo River / Enbridge Spill

Larry Rader  
START-USEPA  
Situation Unit Leader

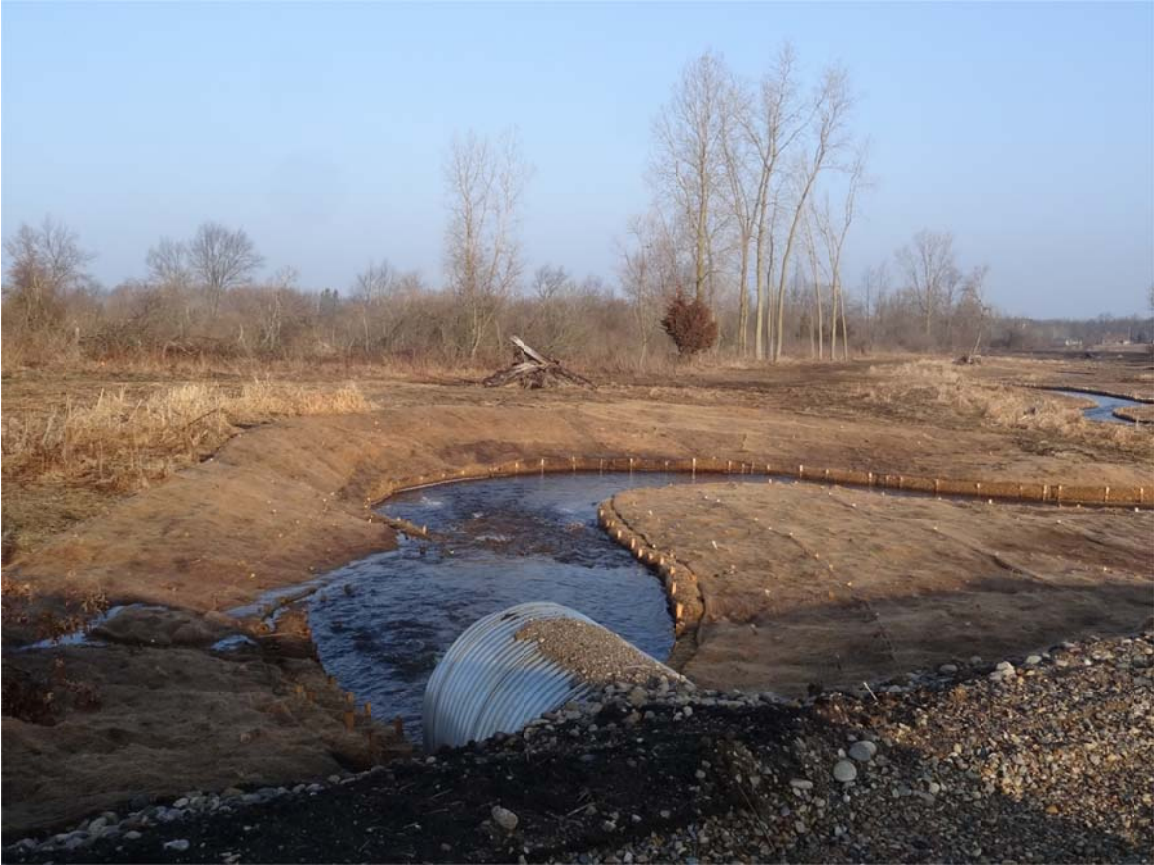
1. Talmadge Creek near MP 1.0, looking northwest.

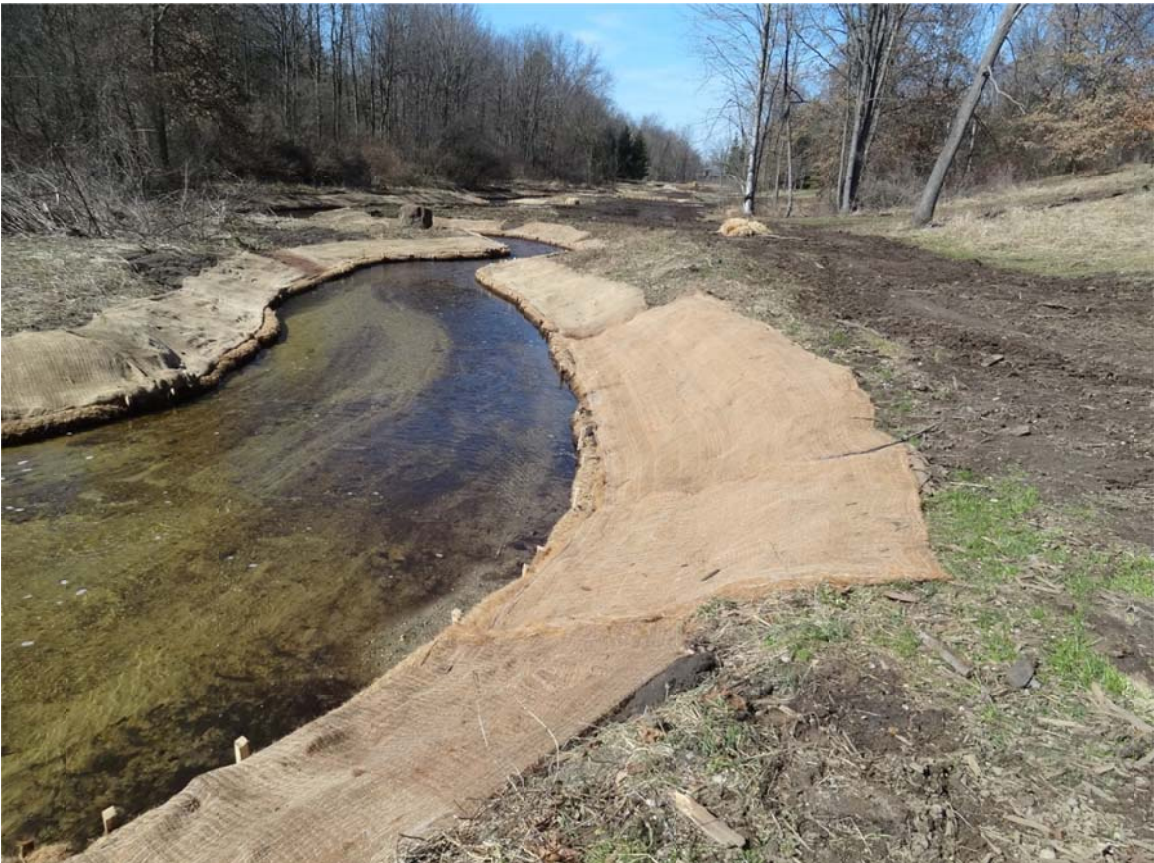
2. Talmadge Creek, restoration along creek west of 15-1/2 Mile Road.

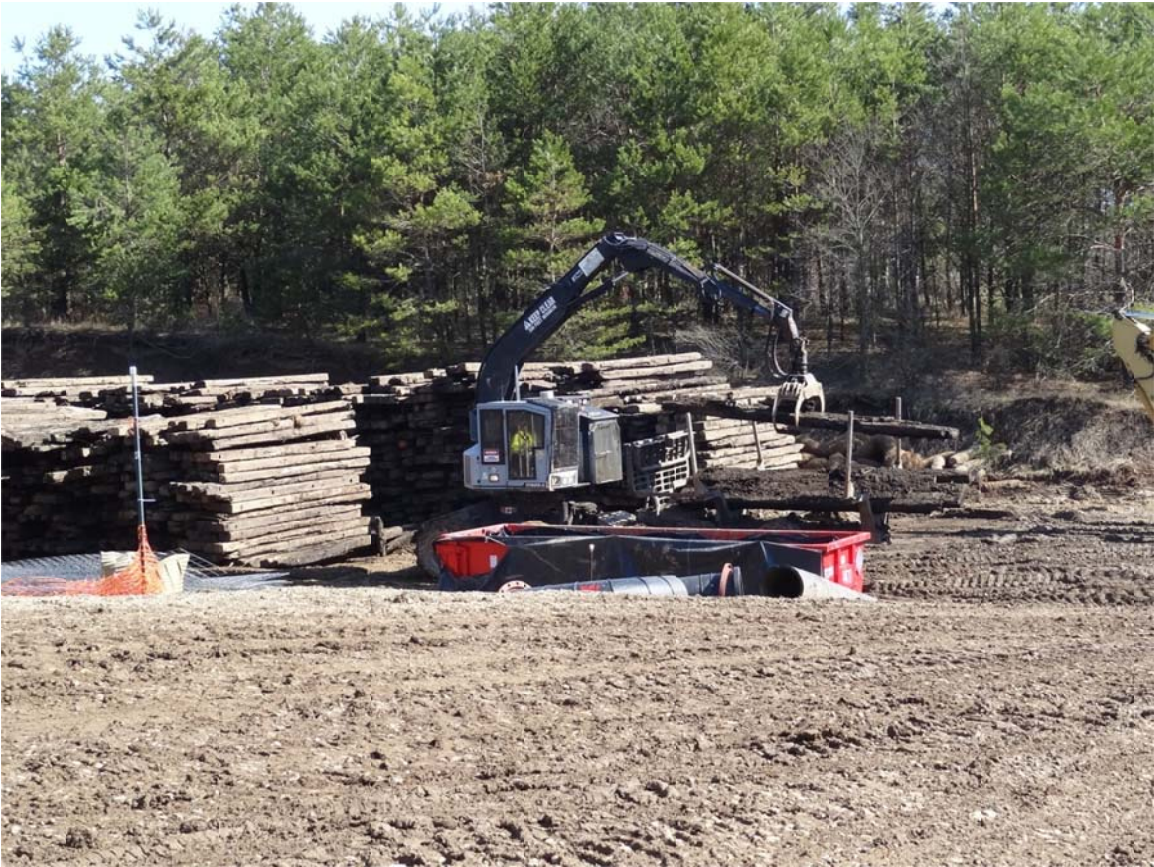
**3. Crews continue mat removal and staging at former Turbidity Control Structure location.**

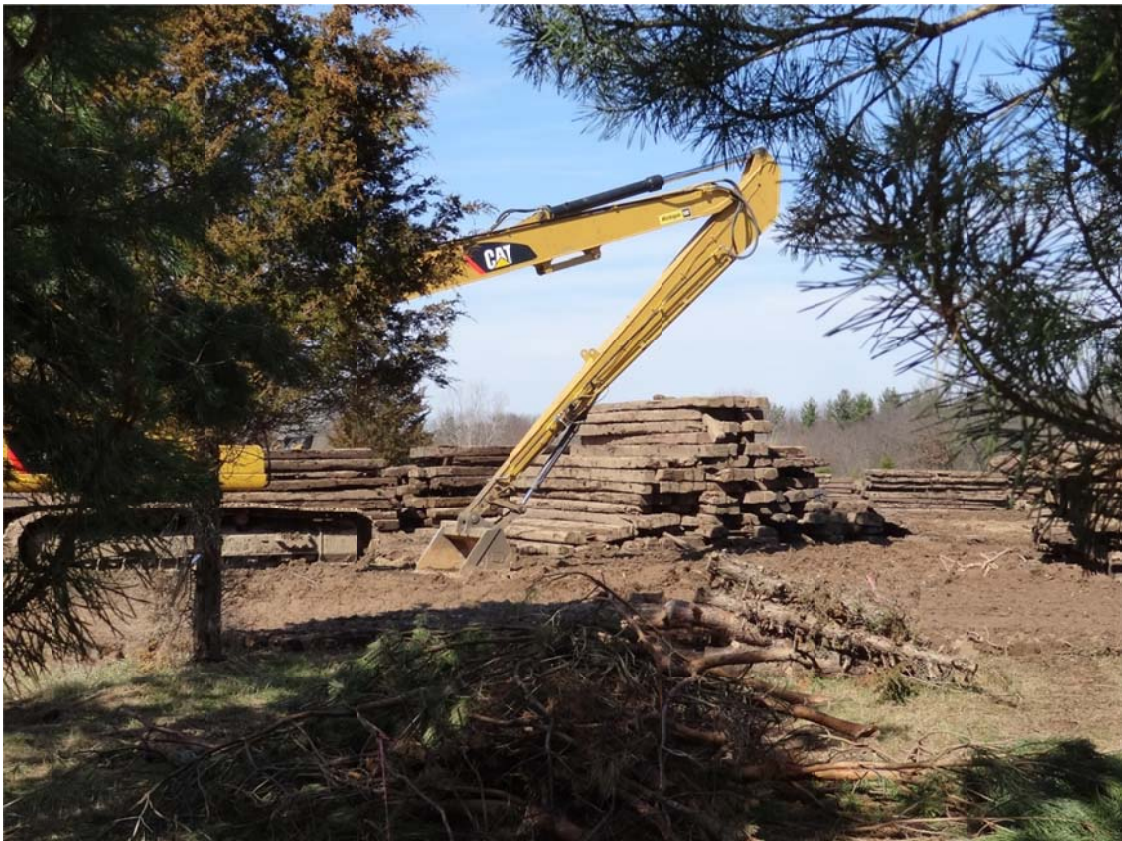
**4. Stacked mats at former Turbidity Control Structure location.**

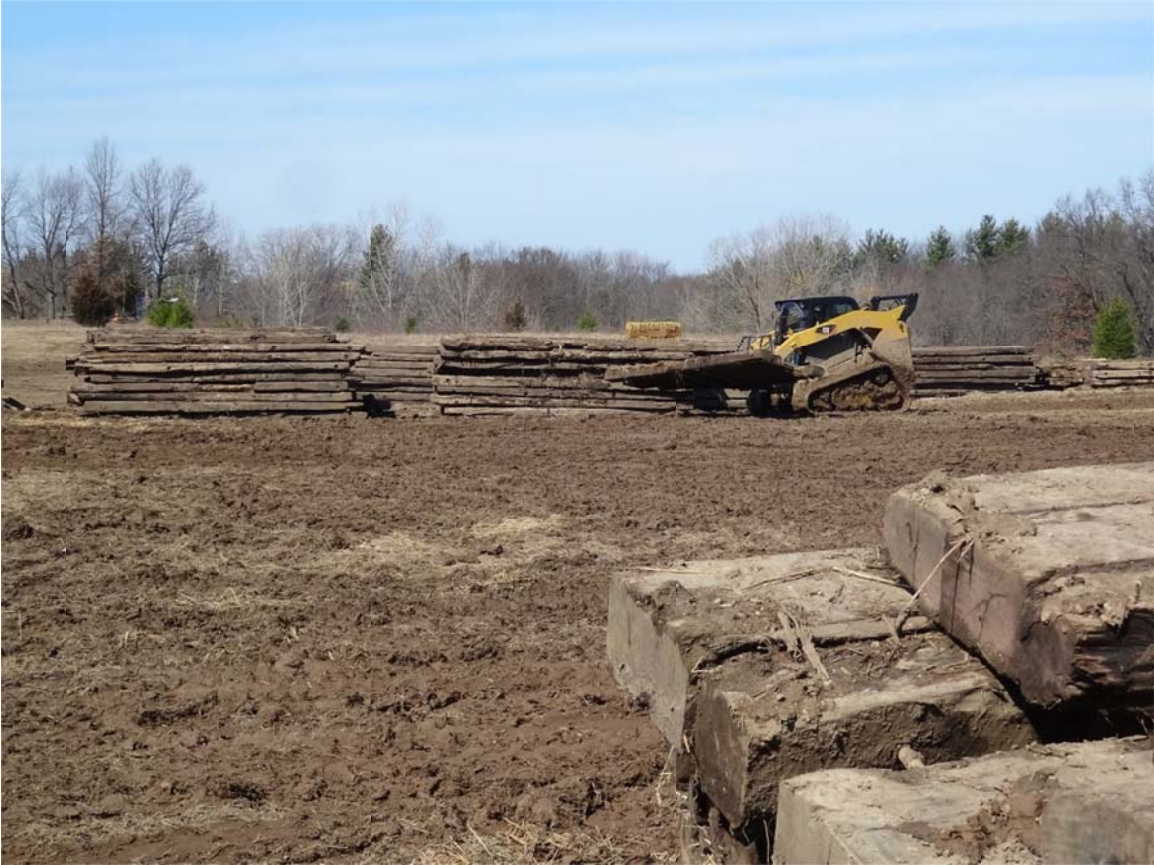
5. Crews stacking mats at Former Turbidity Control System location.

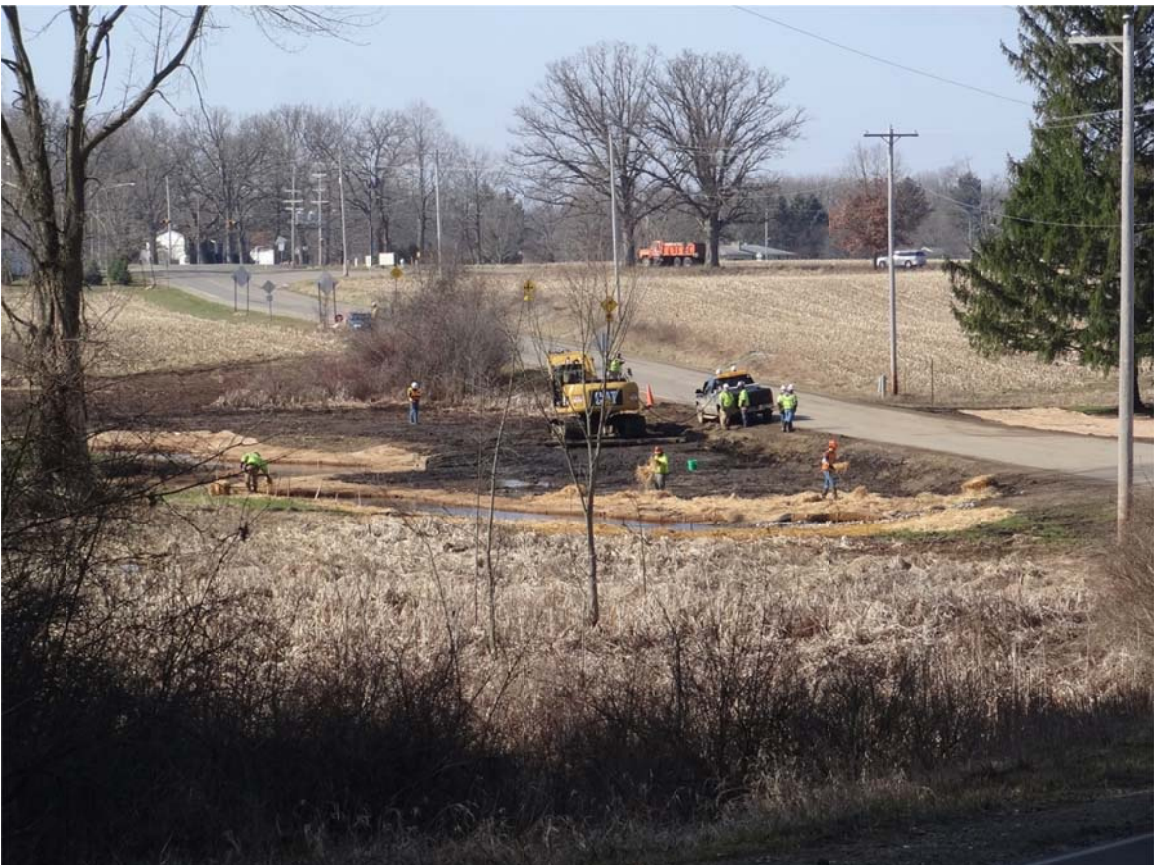
6. Restoration work south of A Drive, upstream from Confluence.

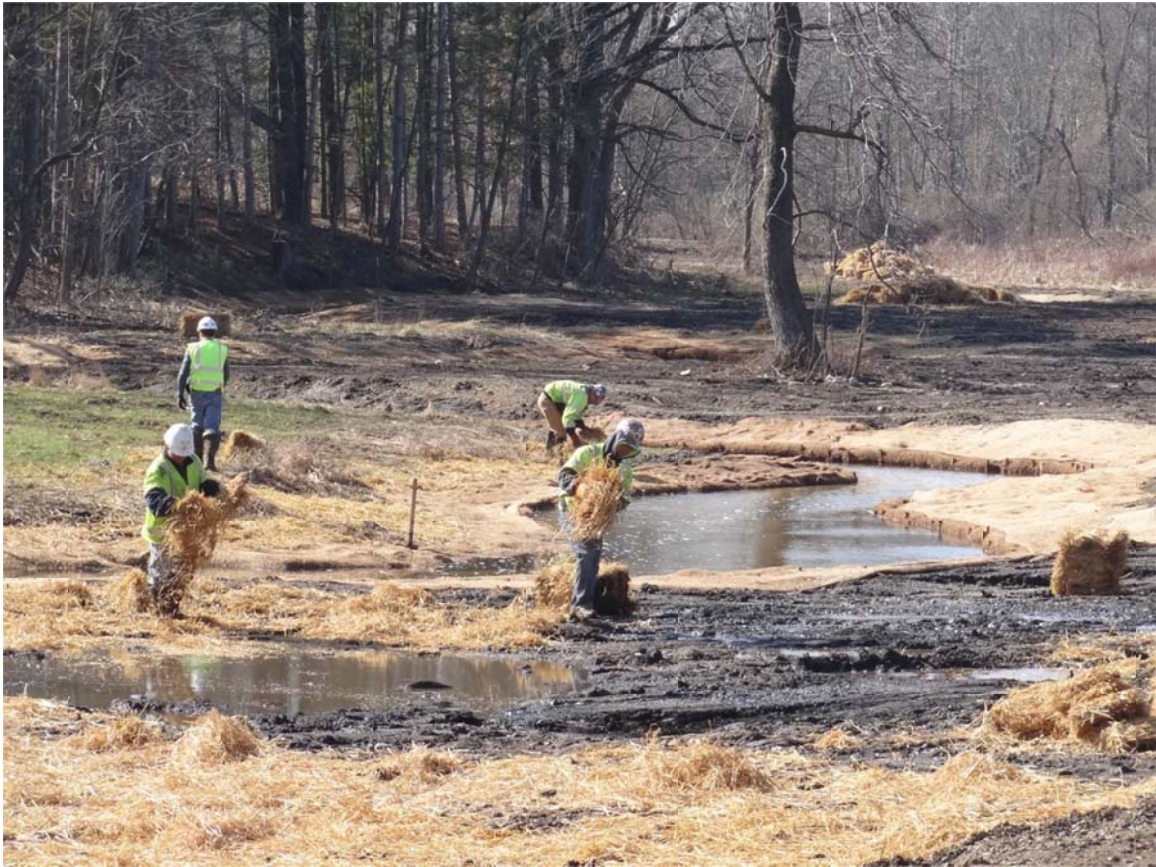
7. Talmadge Creek: crews spreading straw south of A Drive at Confluence.

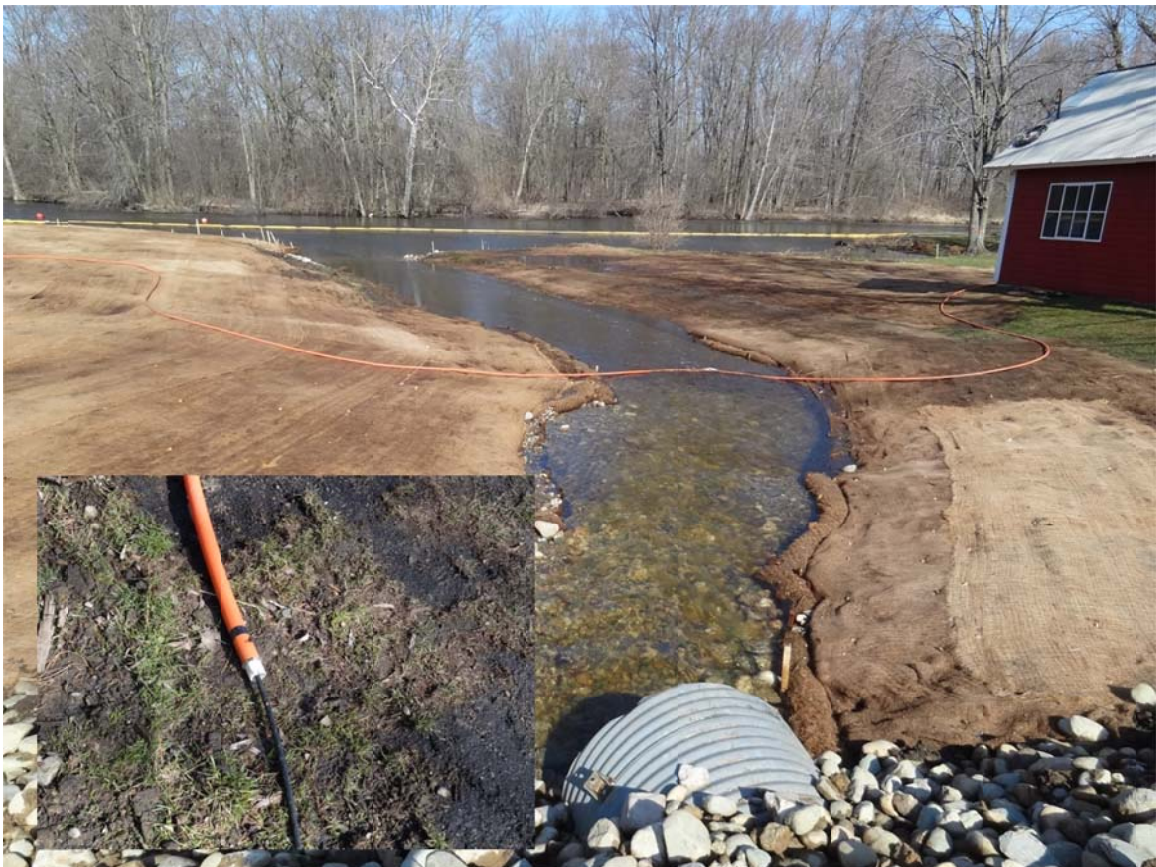
8. Talmadge Creek: coaxial cable running to house at Confluence.

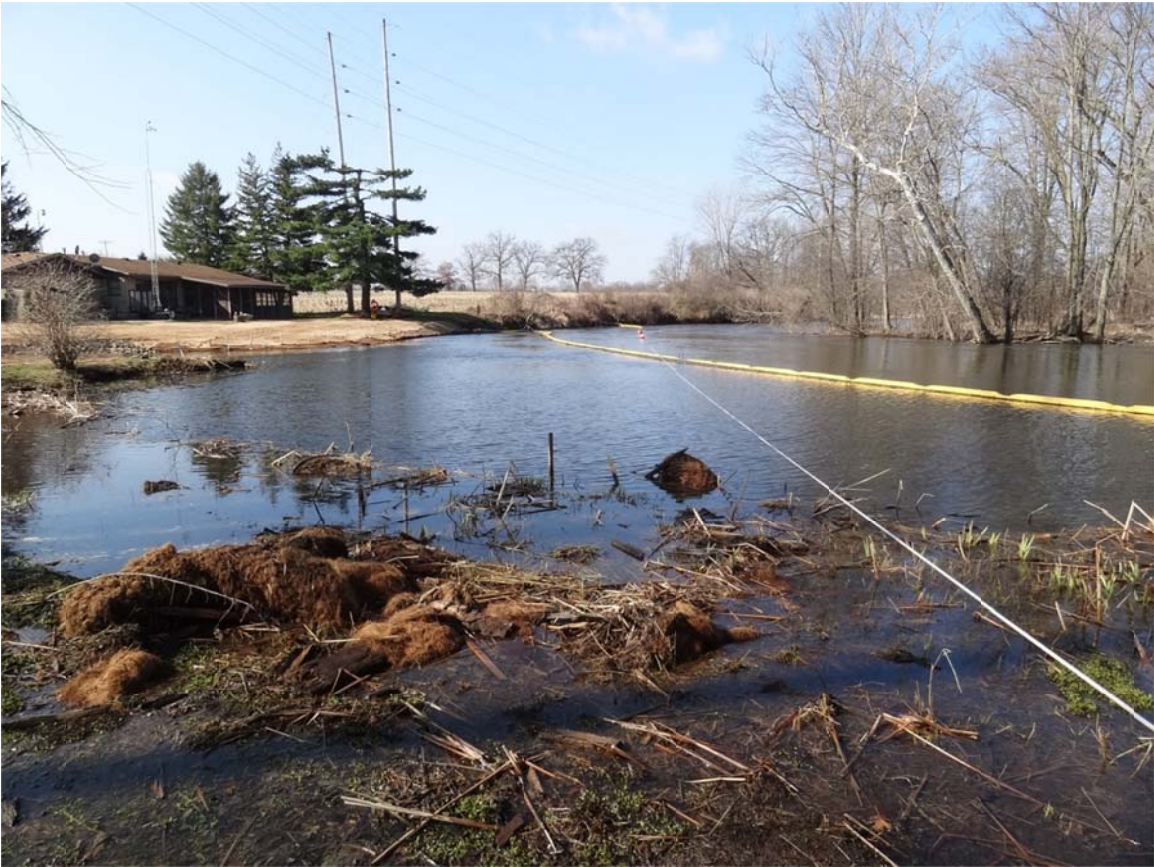
9. Confluence, restoration work complete.

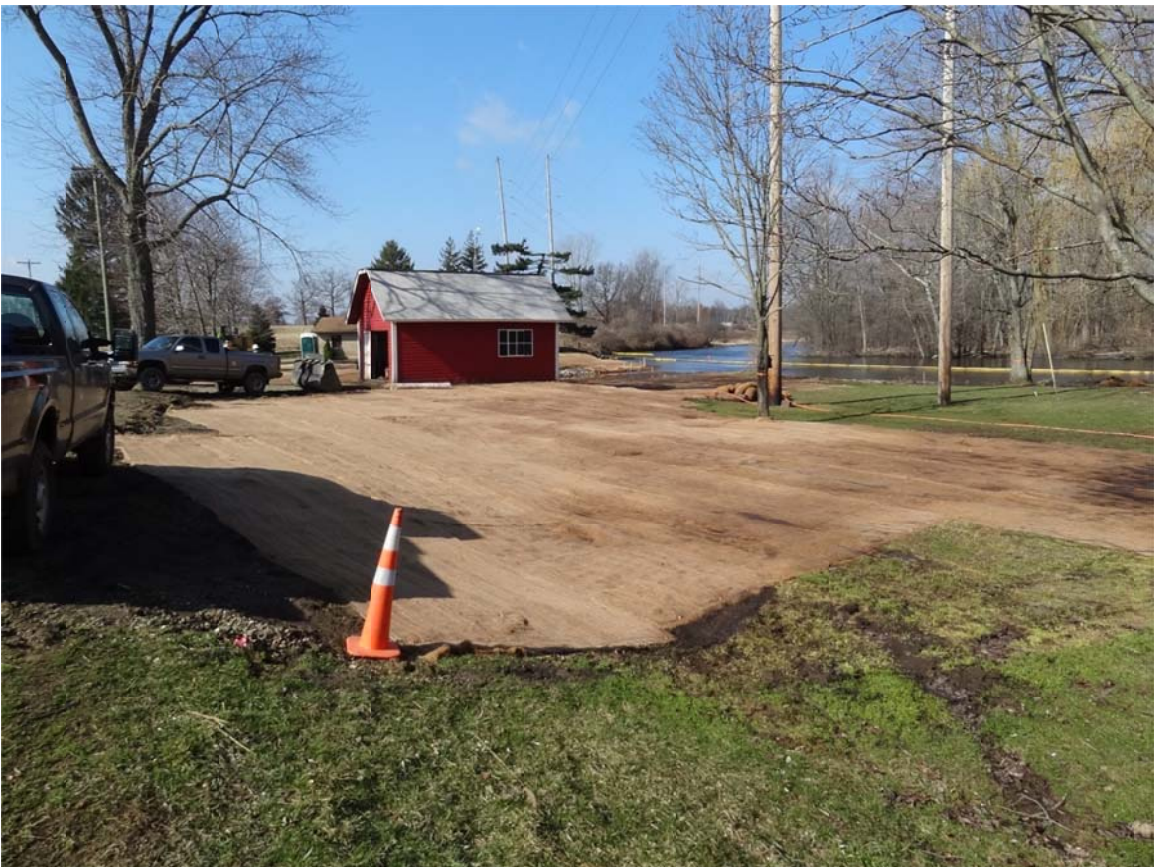
10. Confluence, former soil mixing box location.

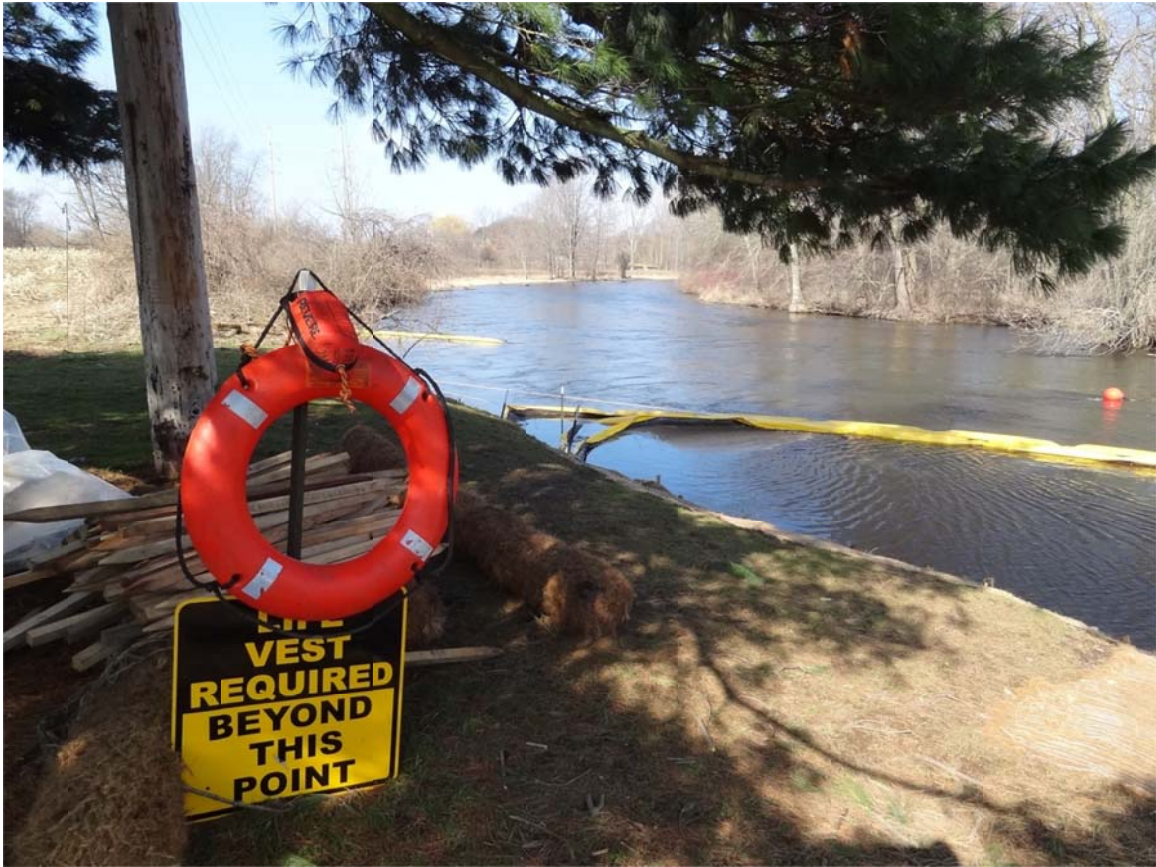
11. Boom configuration just downstream from Confluence.

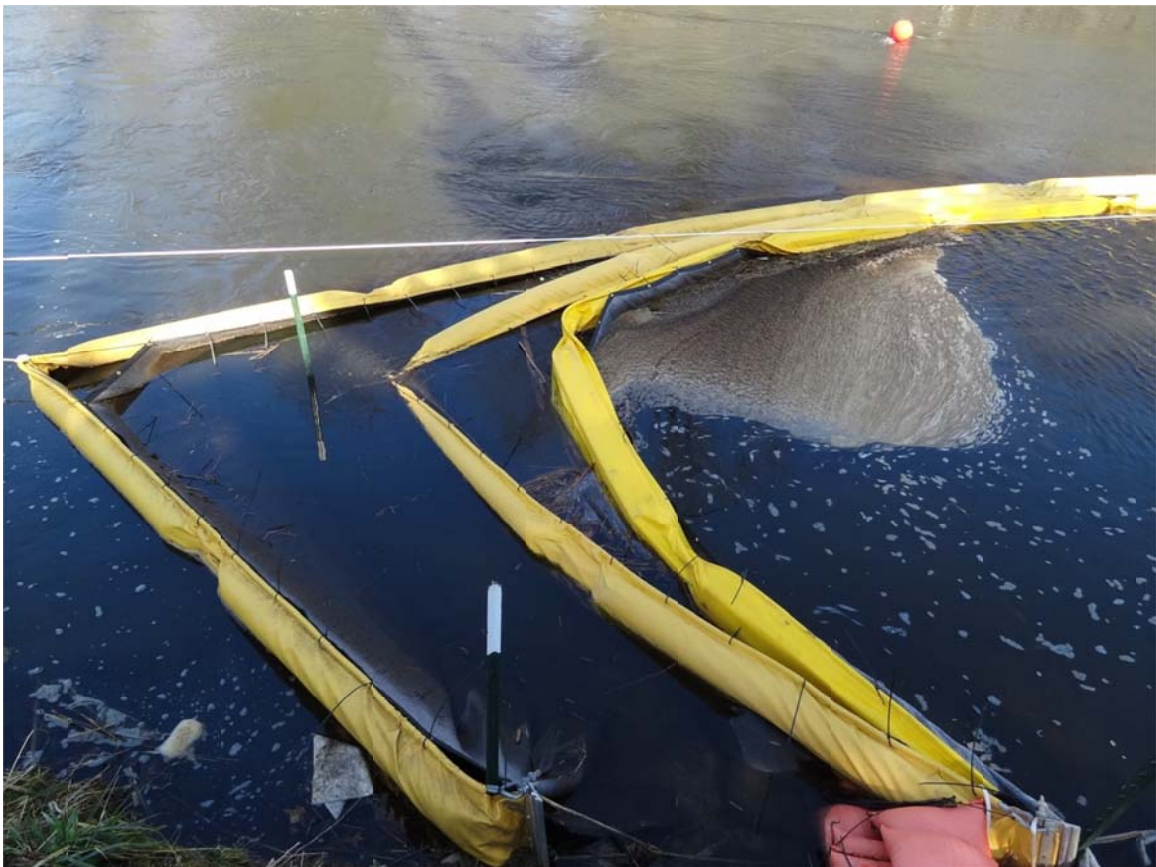
12. Confluence: minor debris and foam within containment boom.

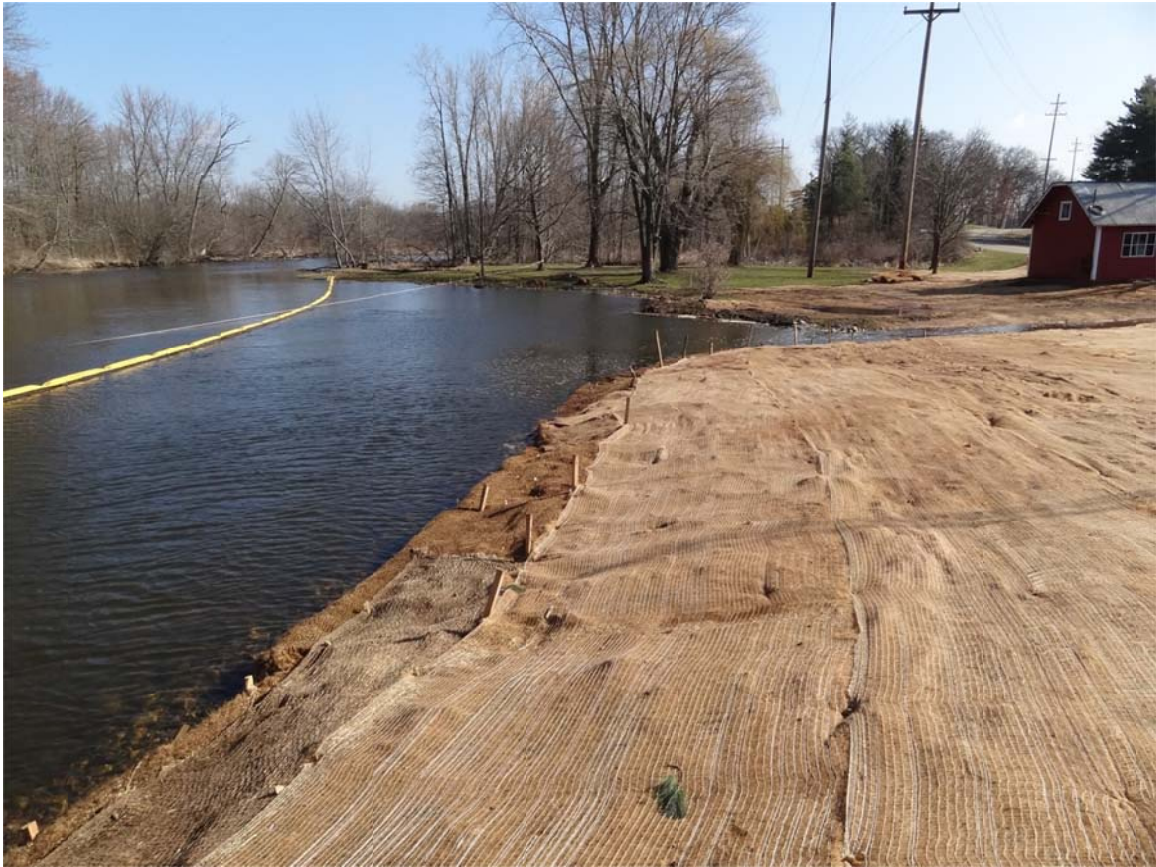
13. Restoration along shoreline at Confluence.

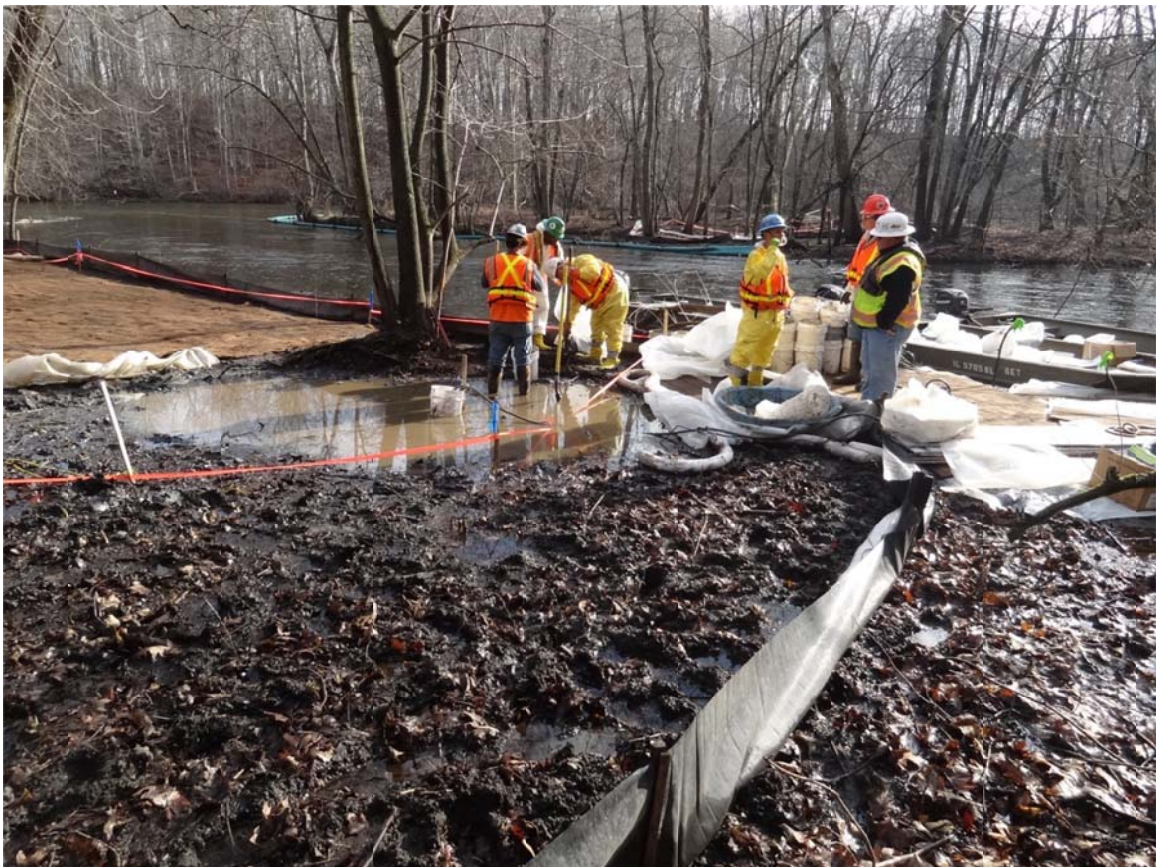
14. OB 9.10 LDB, scrape work continues.

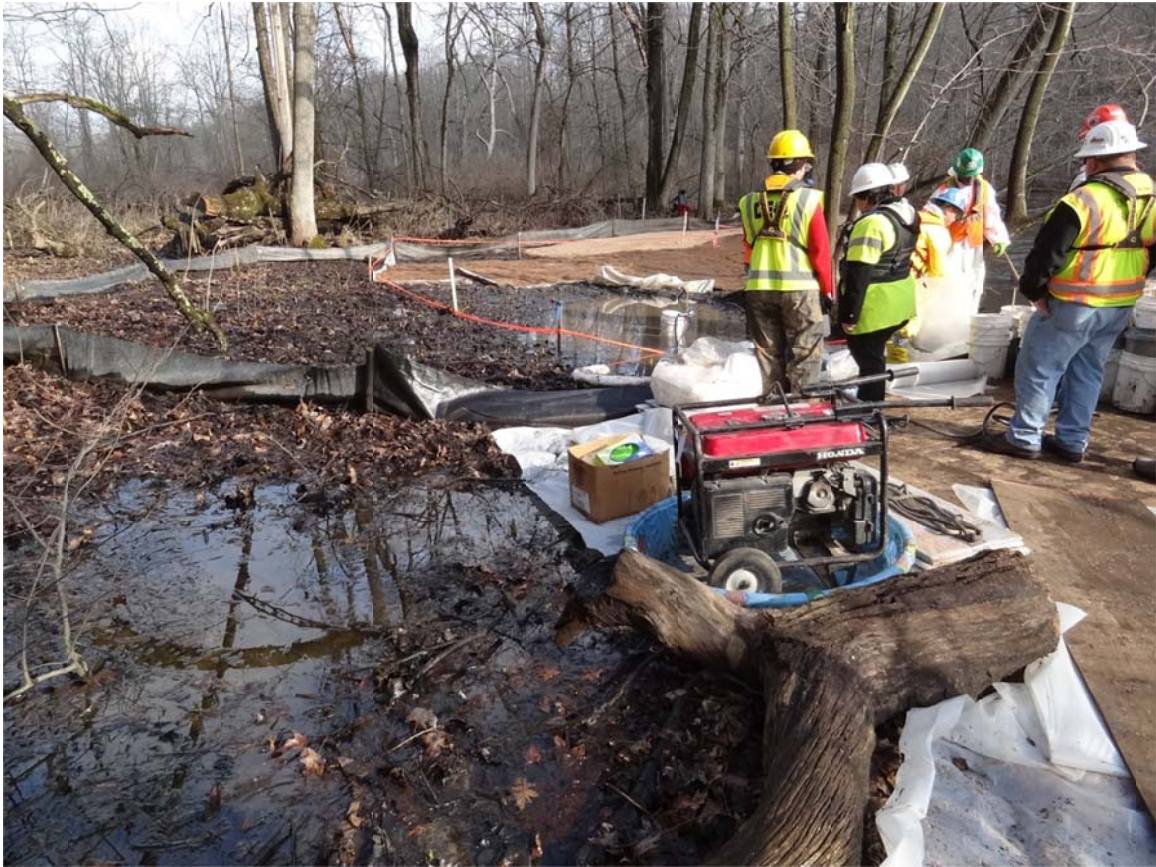
15. OB 9.10 LDB, scrape work continues.

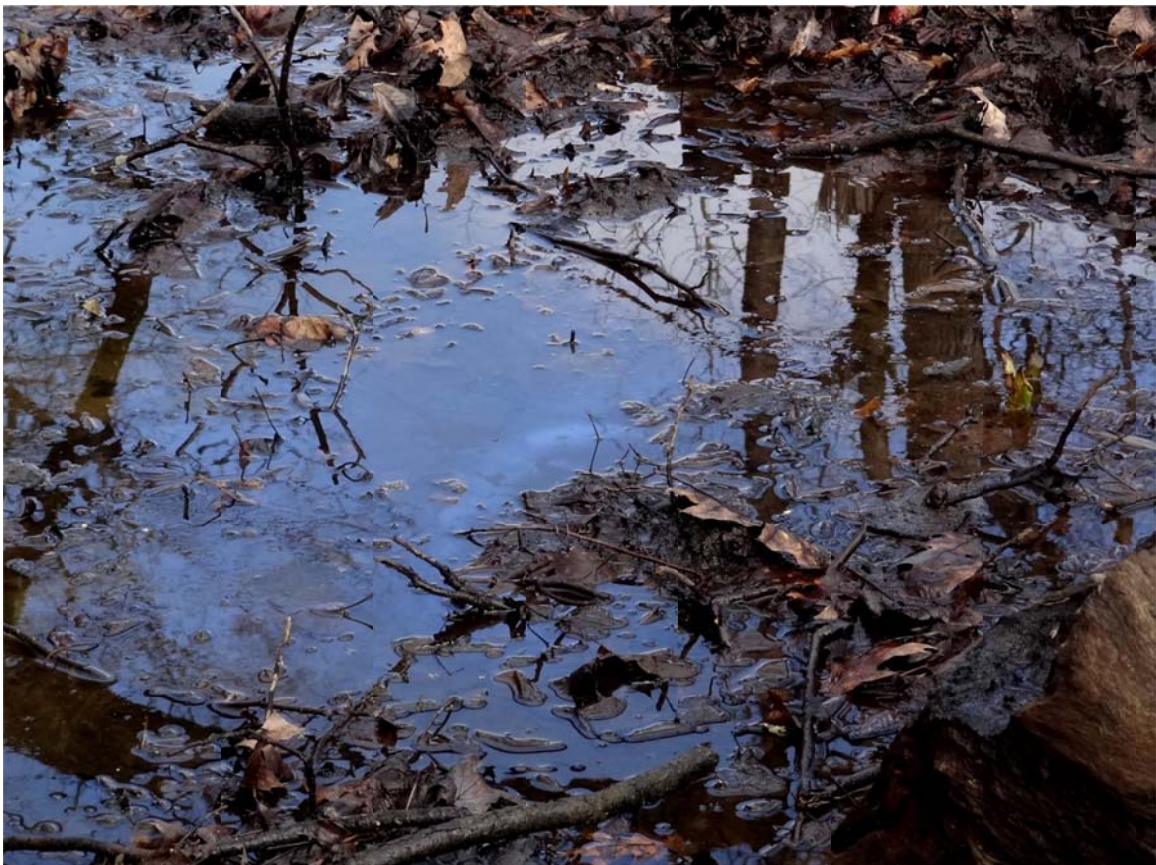
16. Sheen observed outside of scrape area at OB 9.10 LDB.

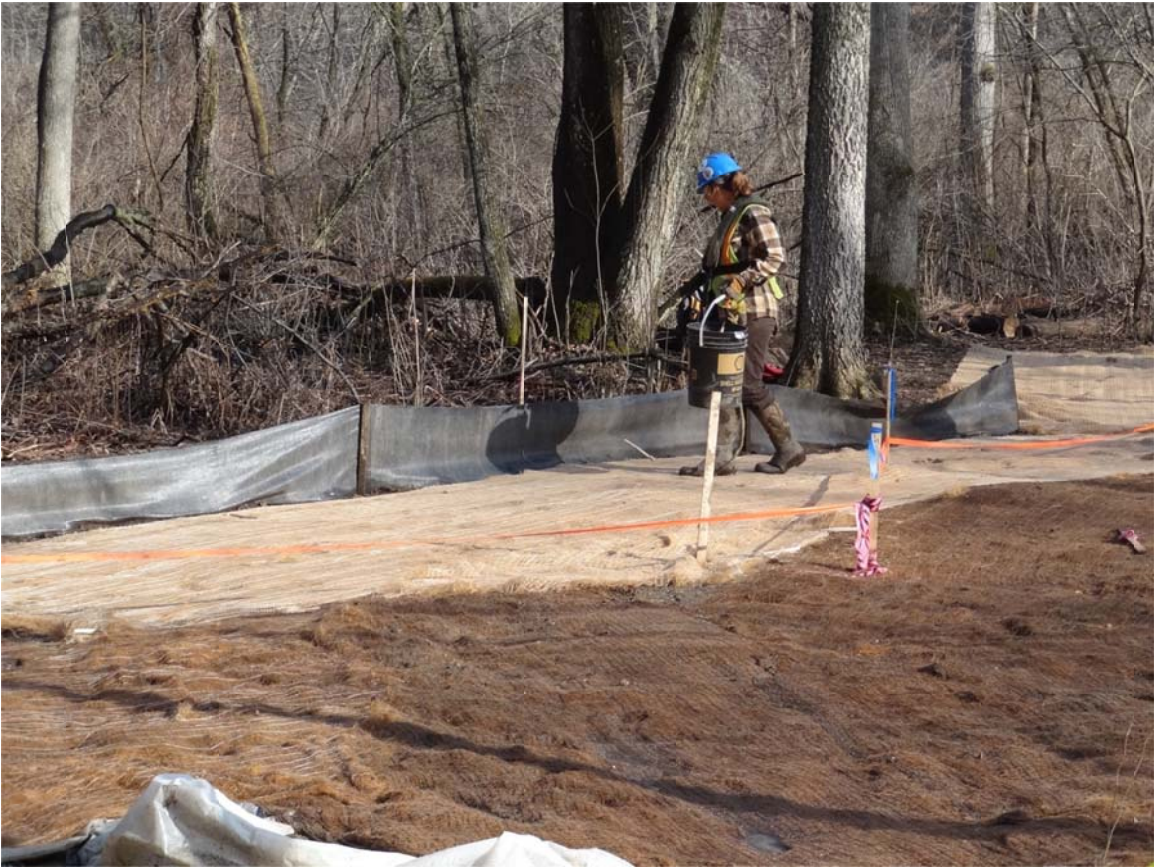
17. OB 9.10 LDB, restoration work.

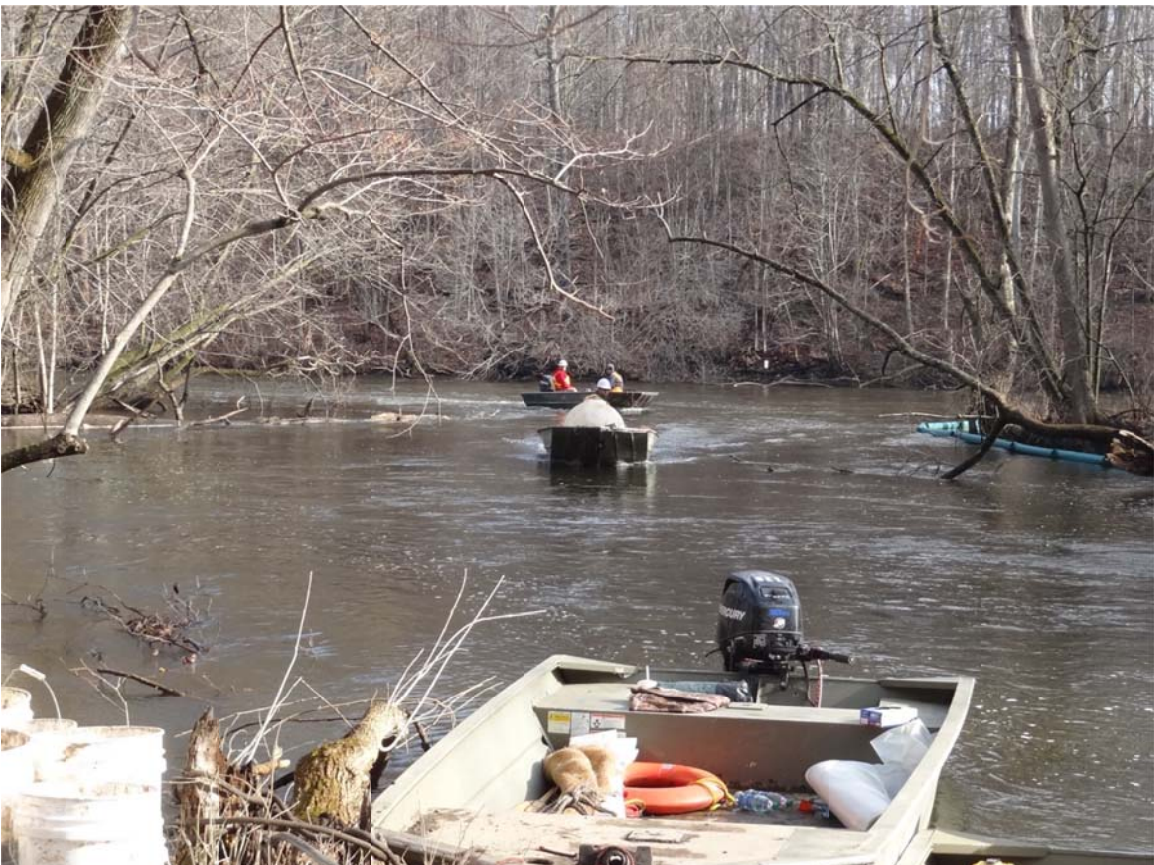
18. OB 9.10 LDB, crews delivering water tank for dewatering scrape area.

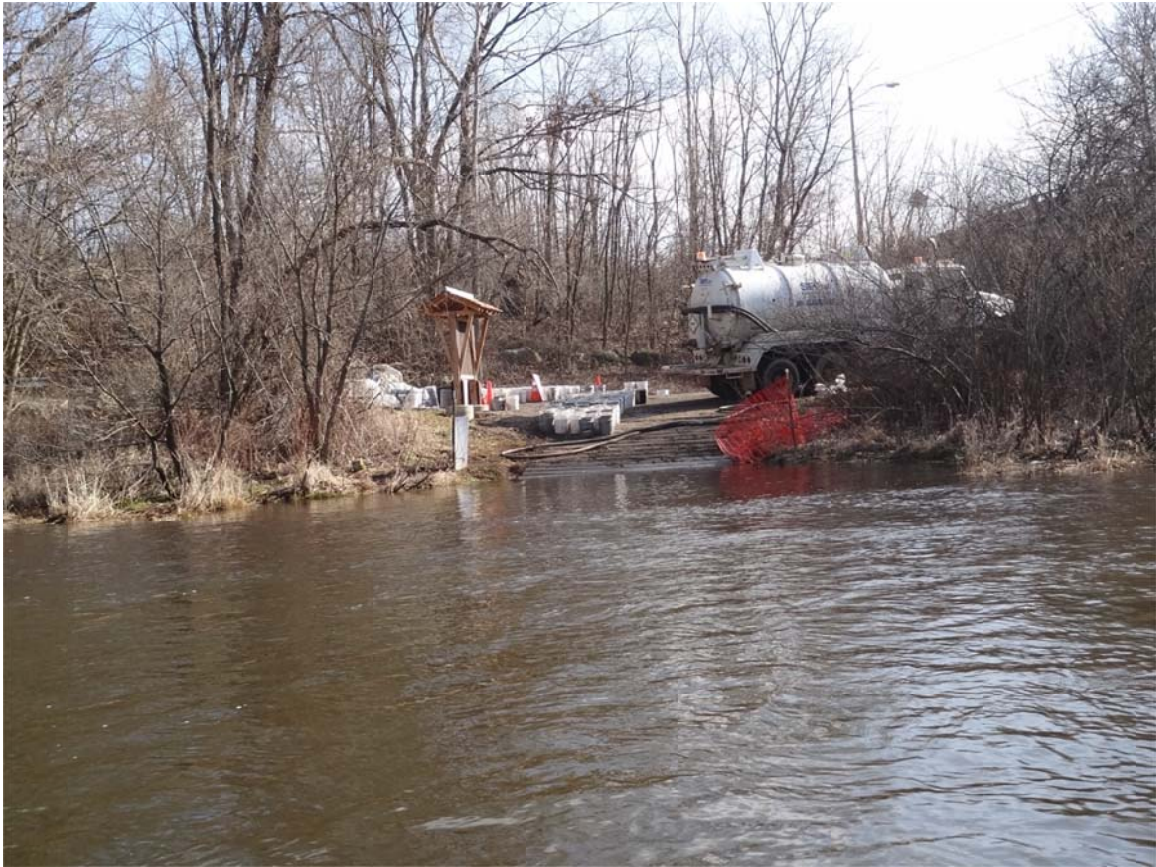
19. Historic Bridge Park, soil/water loading area for soils scraped from OB 9.10 LDB.

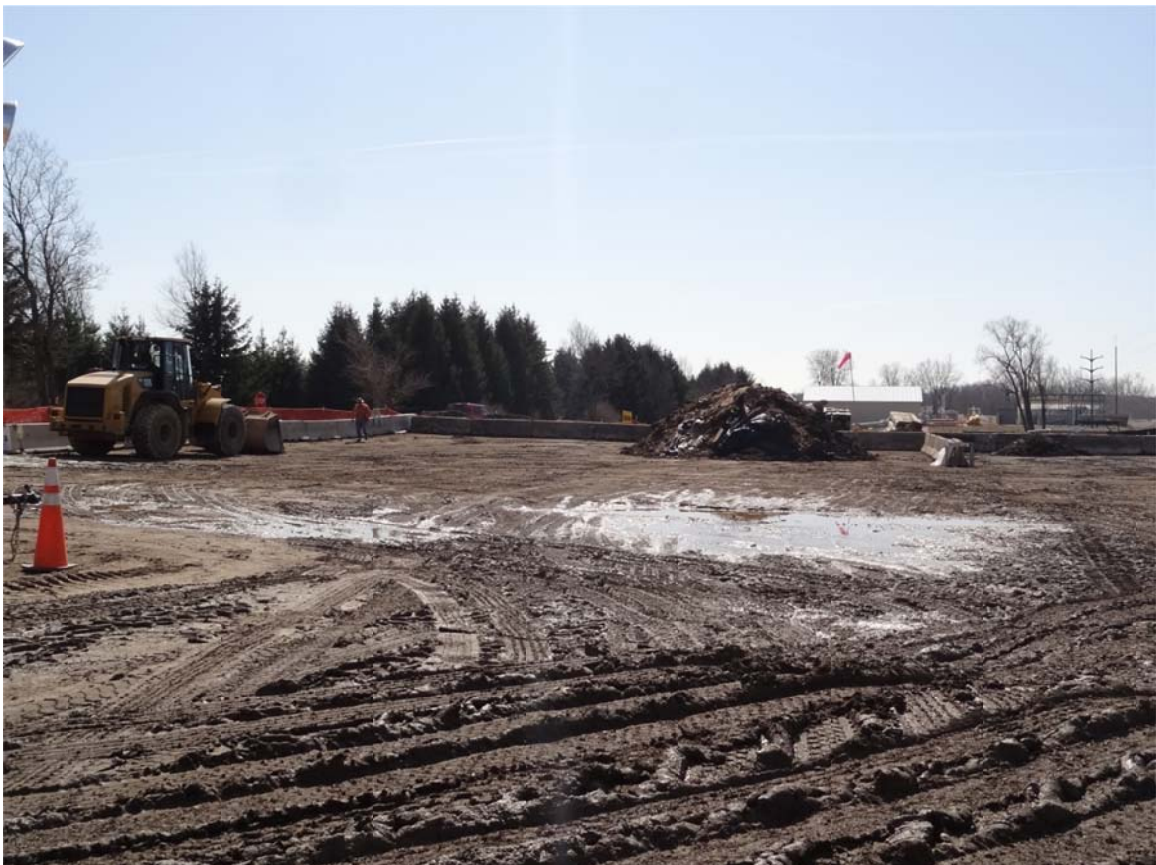
20. Frac Tank City cell A, one soil pile present.

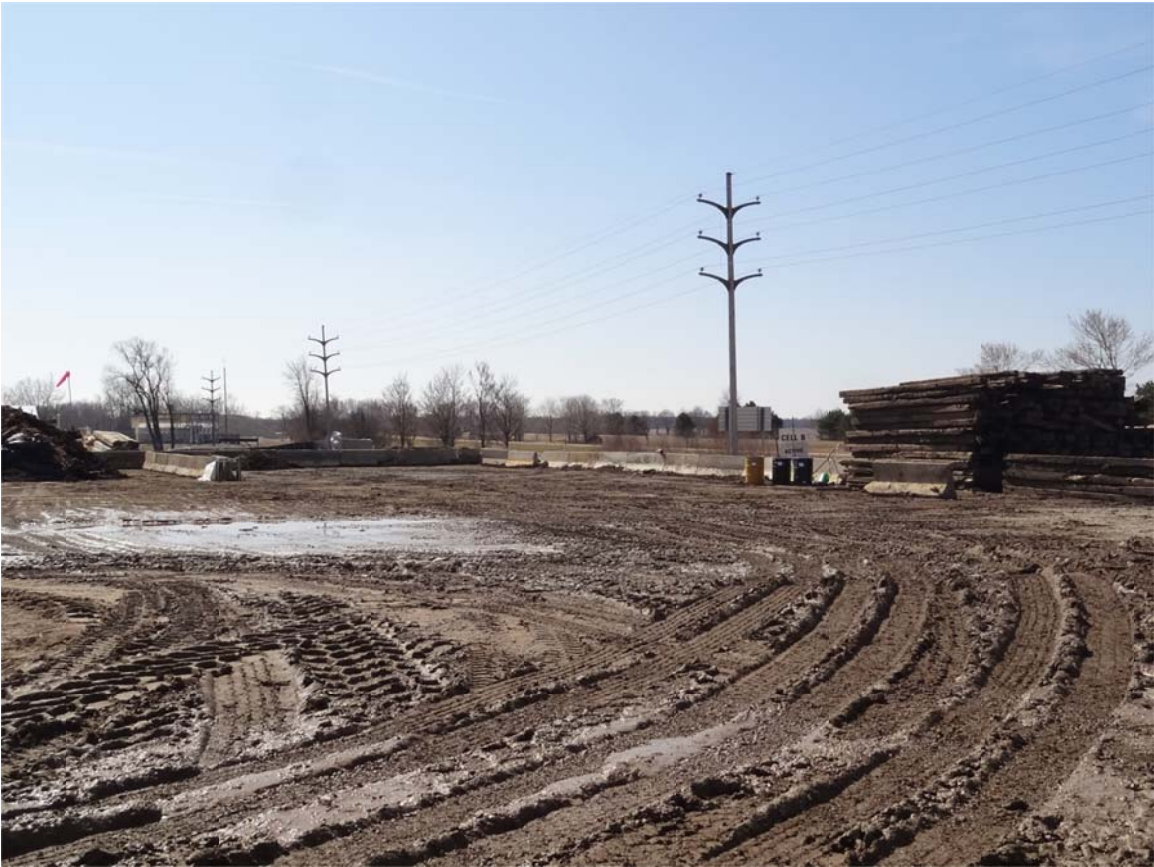
**21. Frac Tank City Cell B, no material or activity observed.**

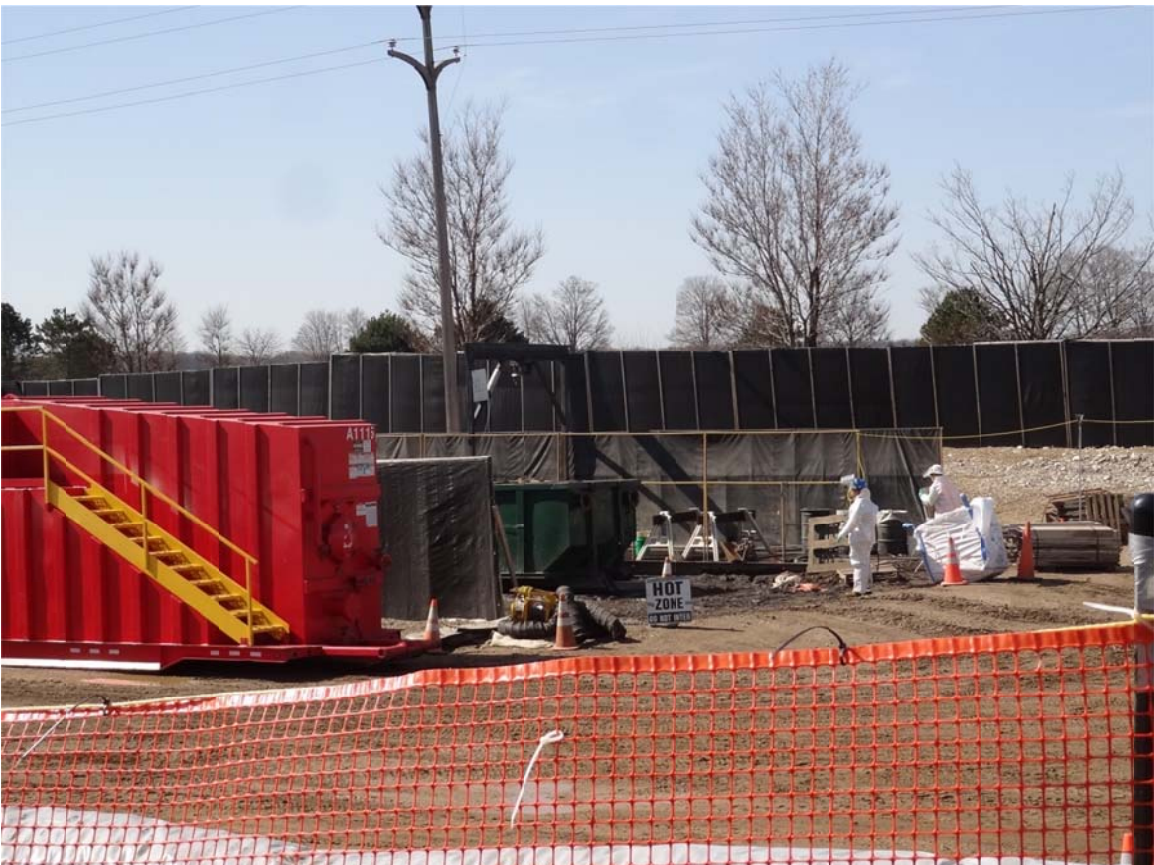
**22. Frac Tank City southern decon pad, crews cleaning sheet pile panels and equipment.**
