# Situation Photo Log

Thursday, March 15, 2012

Kalamazoo River / Enbridge Spill

Larry Rader  
START-USEPA  
Situation Unit Leader

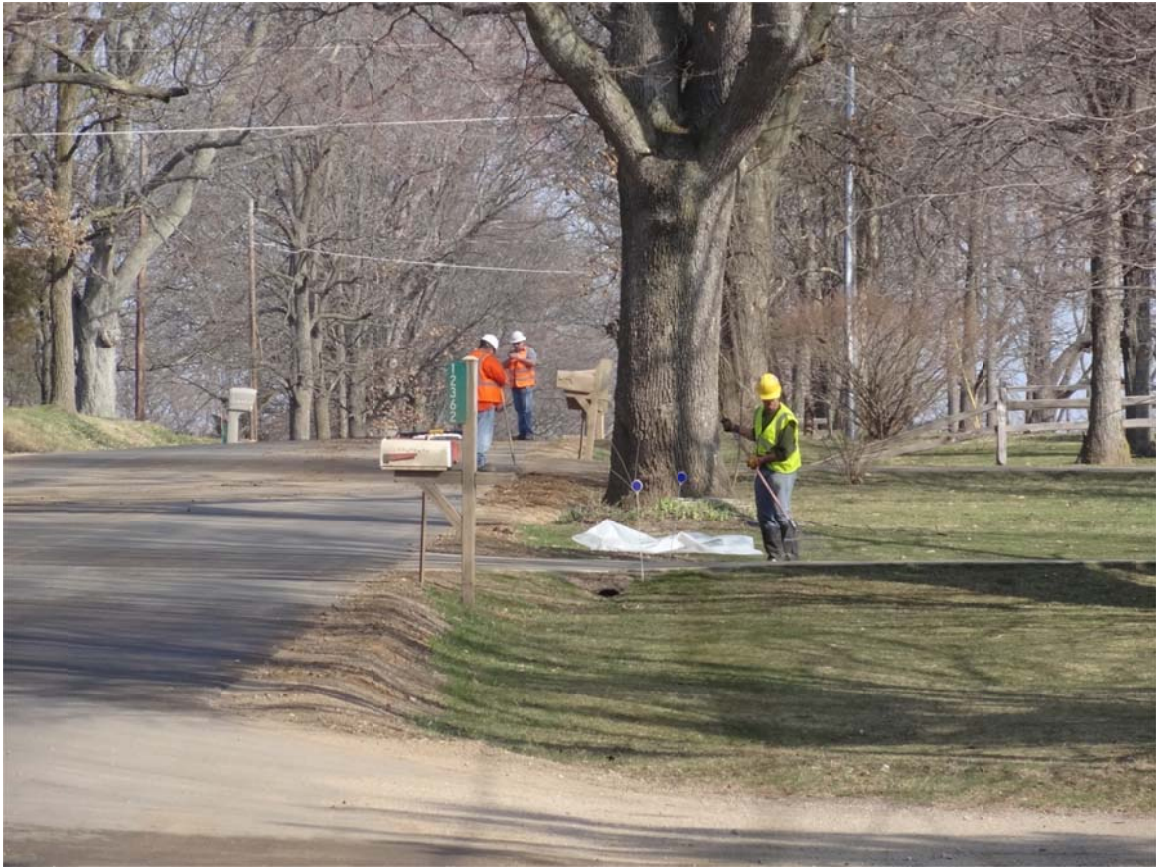
**1. Crews conducting roadside/mailbox cleanup along residences on 15-1/2 Mile Road.**

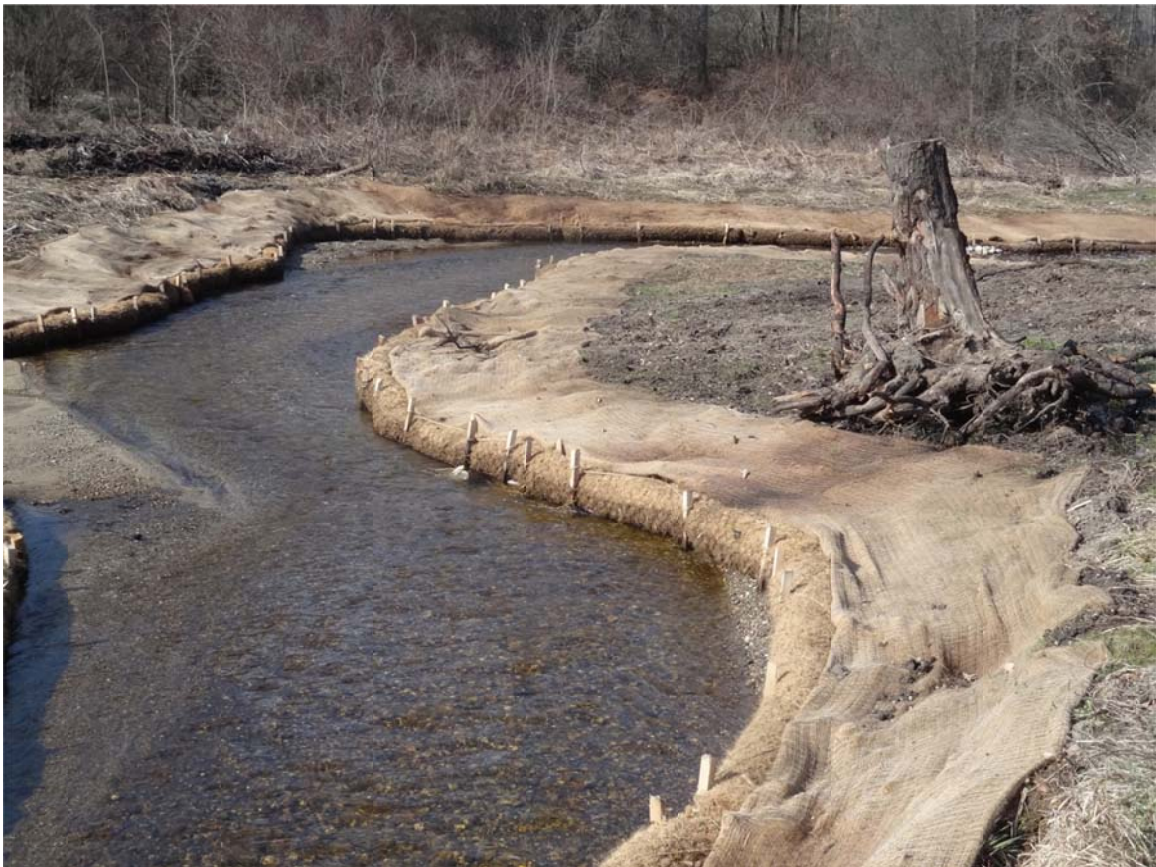
**2. Talmadge Creek, restoration along creek west of 15-1/2 Mile Road.**

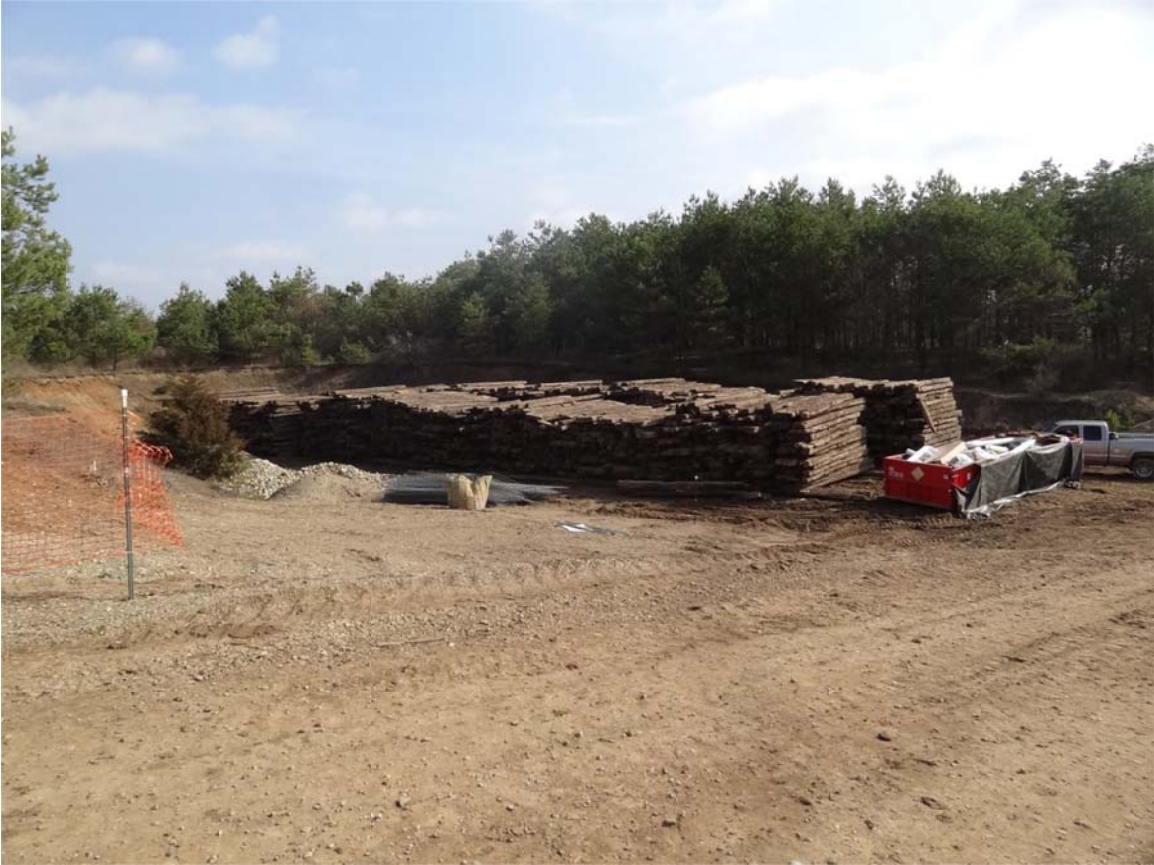
**3. Timber mats staged east of former Turbidity Control Structure location.**

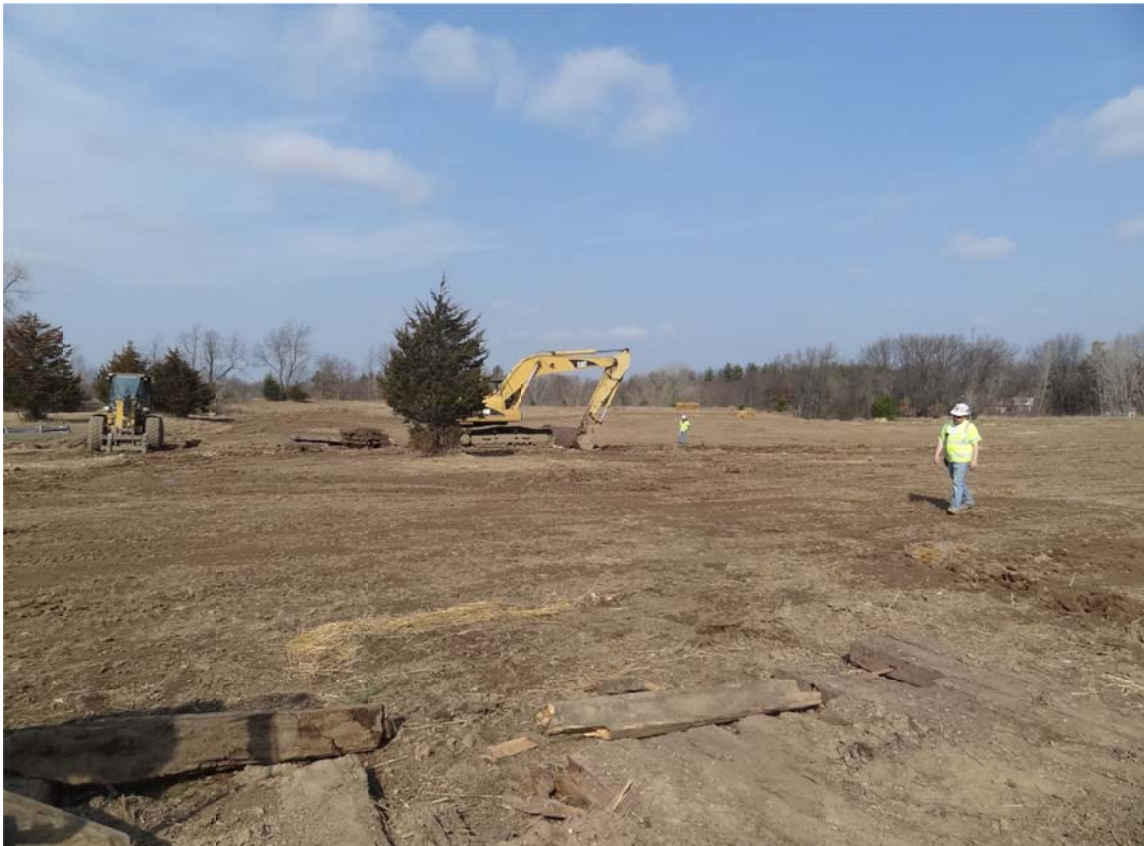
**4. Crews removing last of timber mats at Former Turbidity Control System location.**

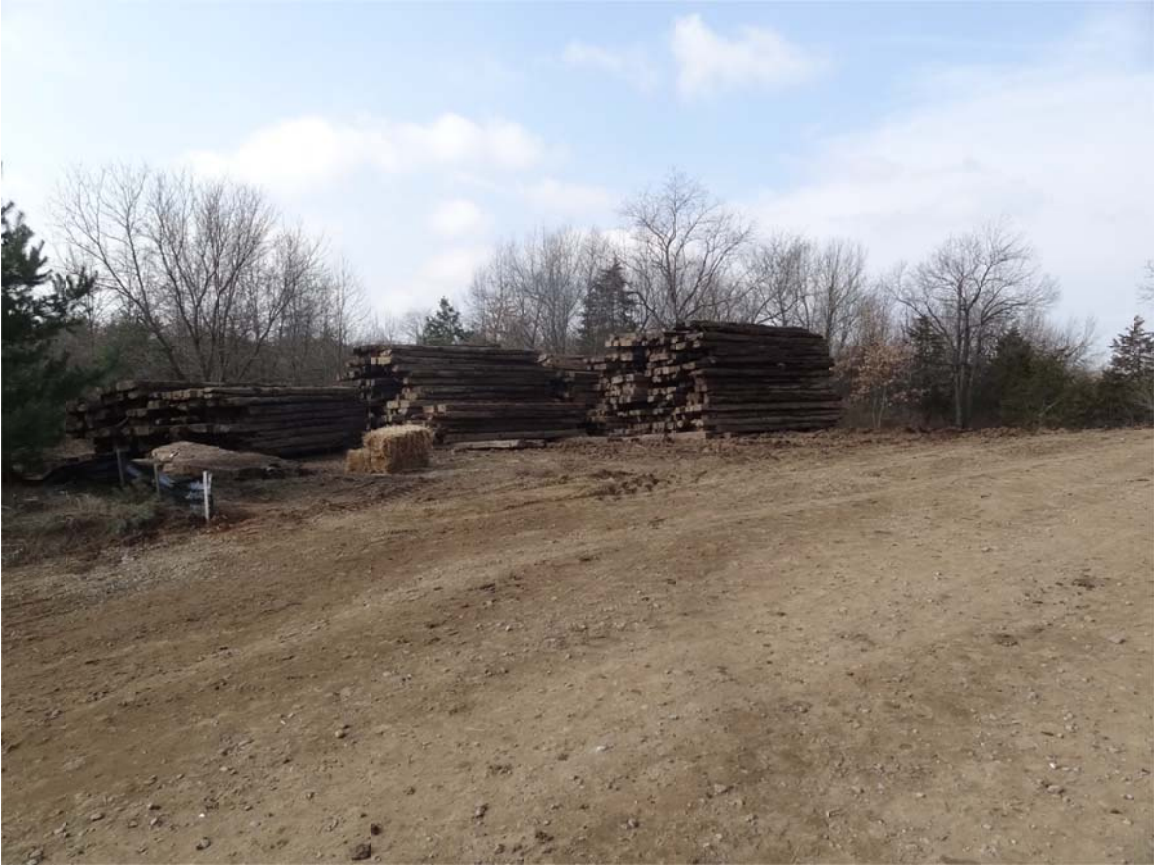
**5. Timber mats staged south of former Turbidity Control System.**

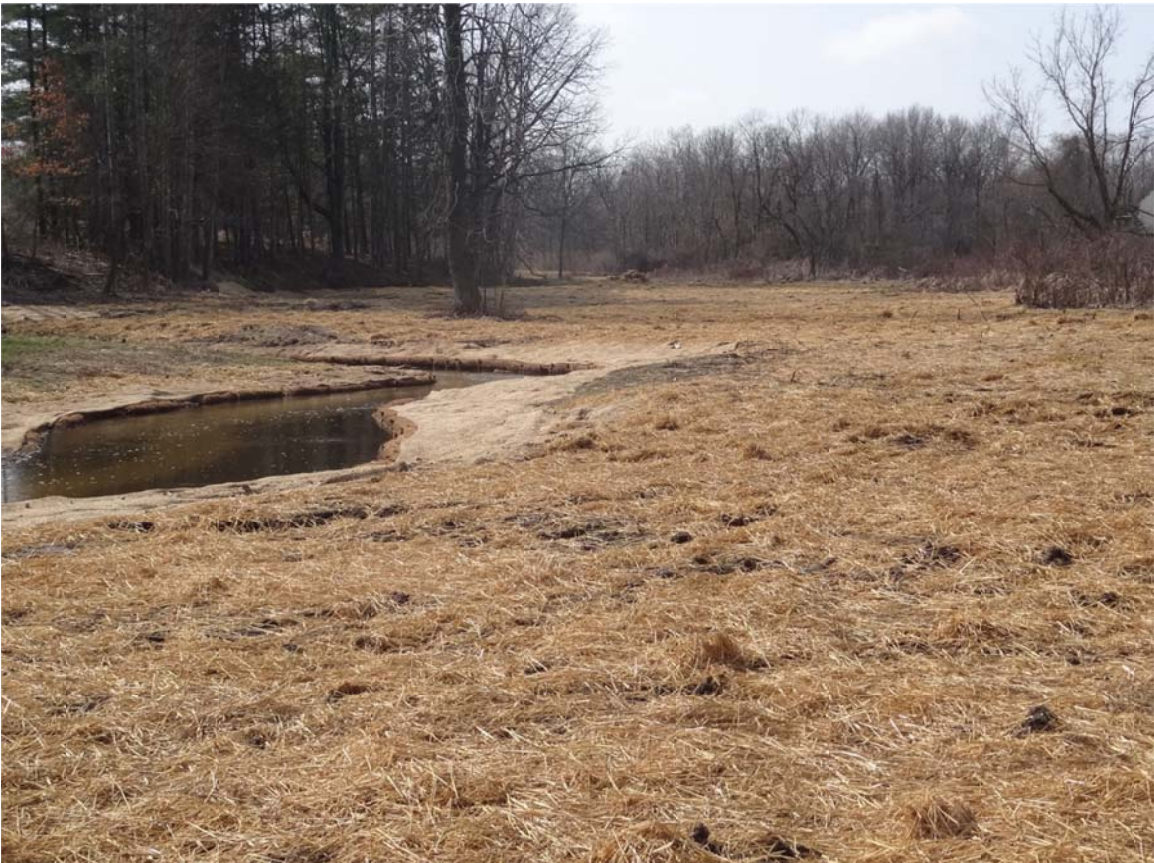
**6. Restoration work completed on Talmadge Creek south of A Drive, upstream from Confluence.**

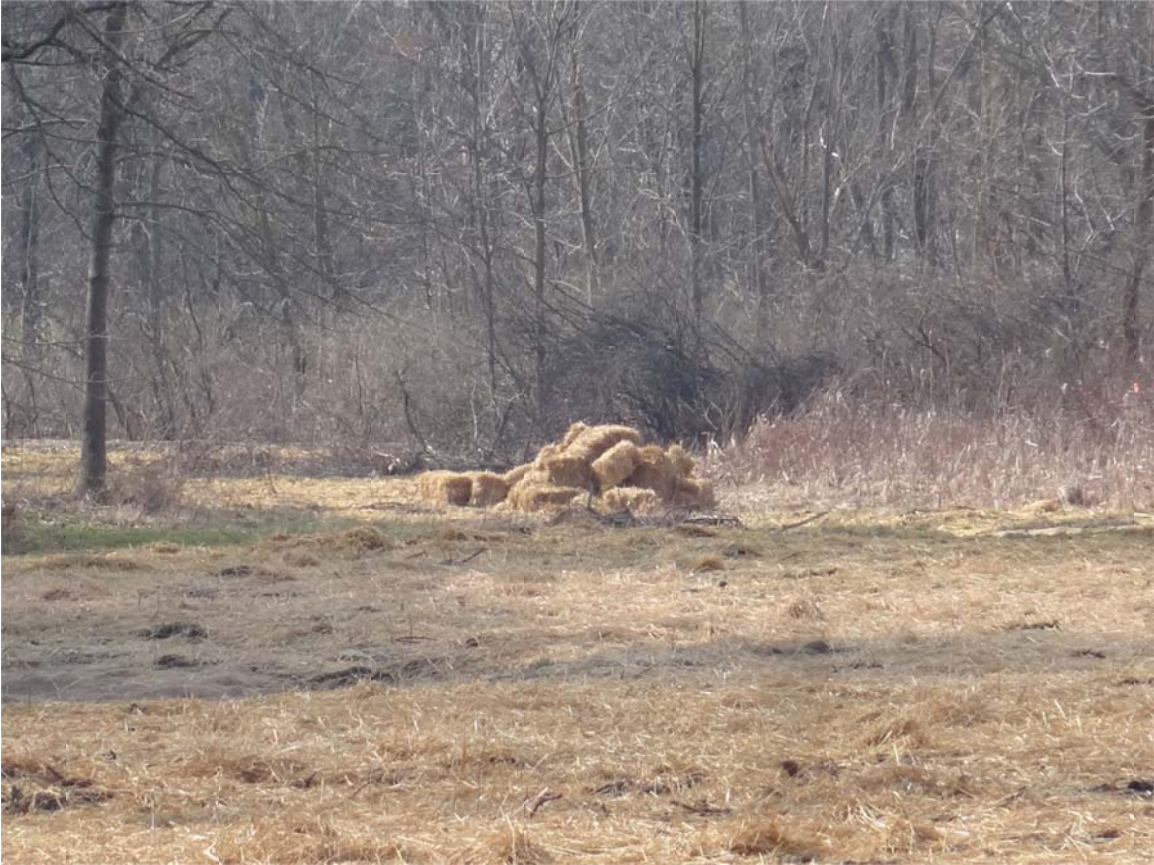
7. Talmadge Creek: additional straw bales staged on south side of creek.

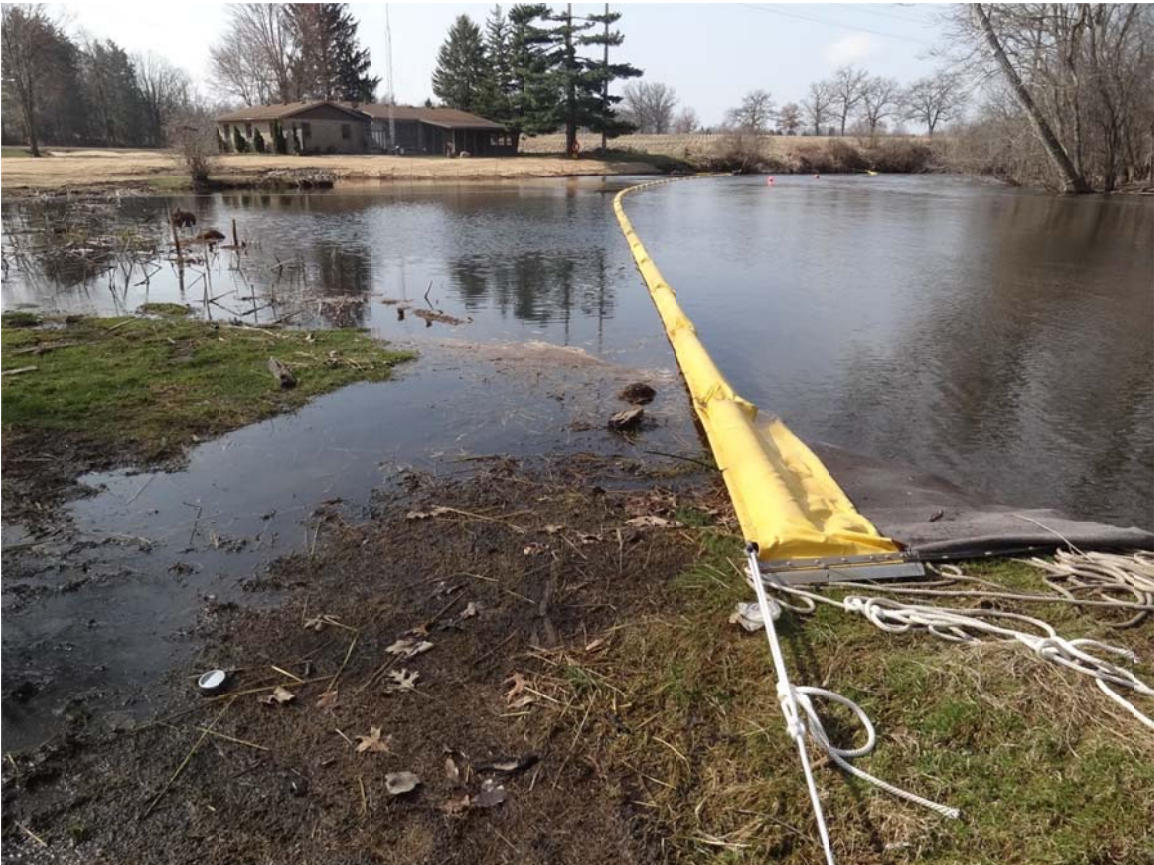
8. Confluence, no sheen or turbidity issues observed.

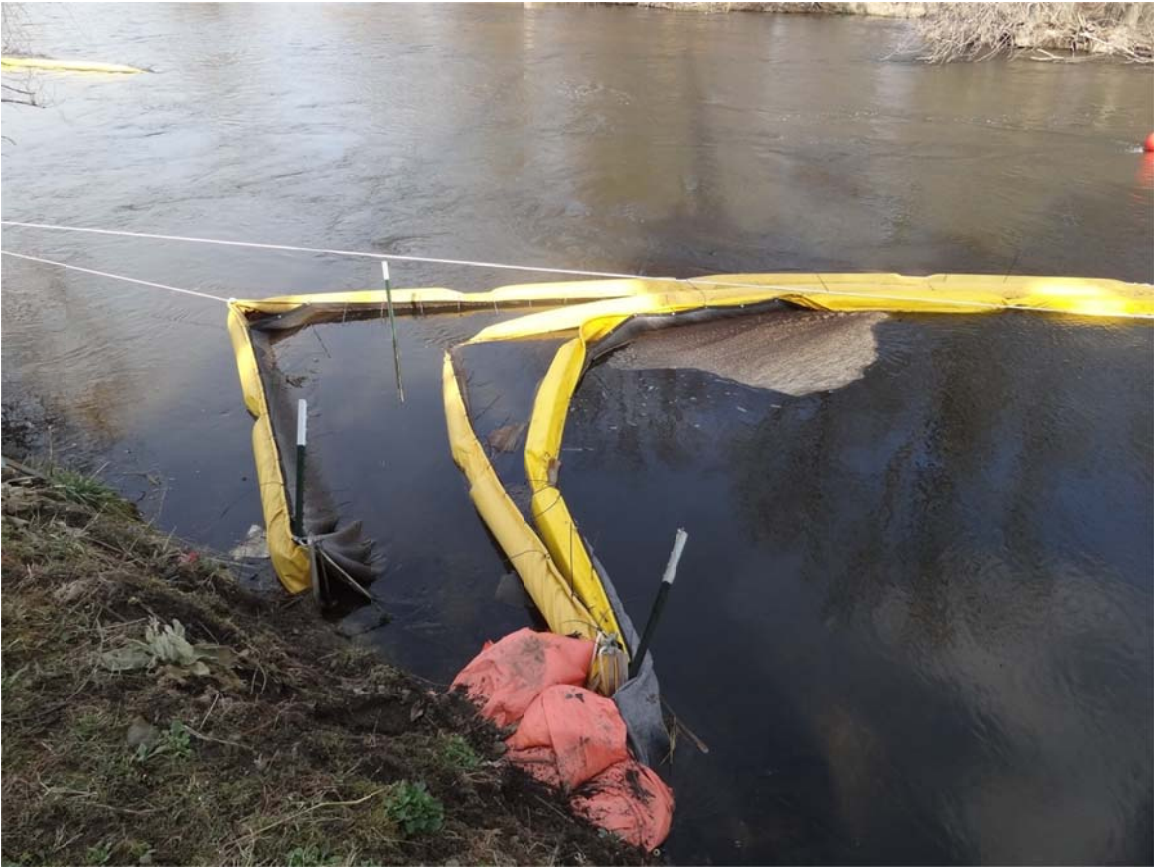
9. Confluence containment boom.

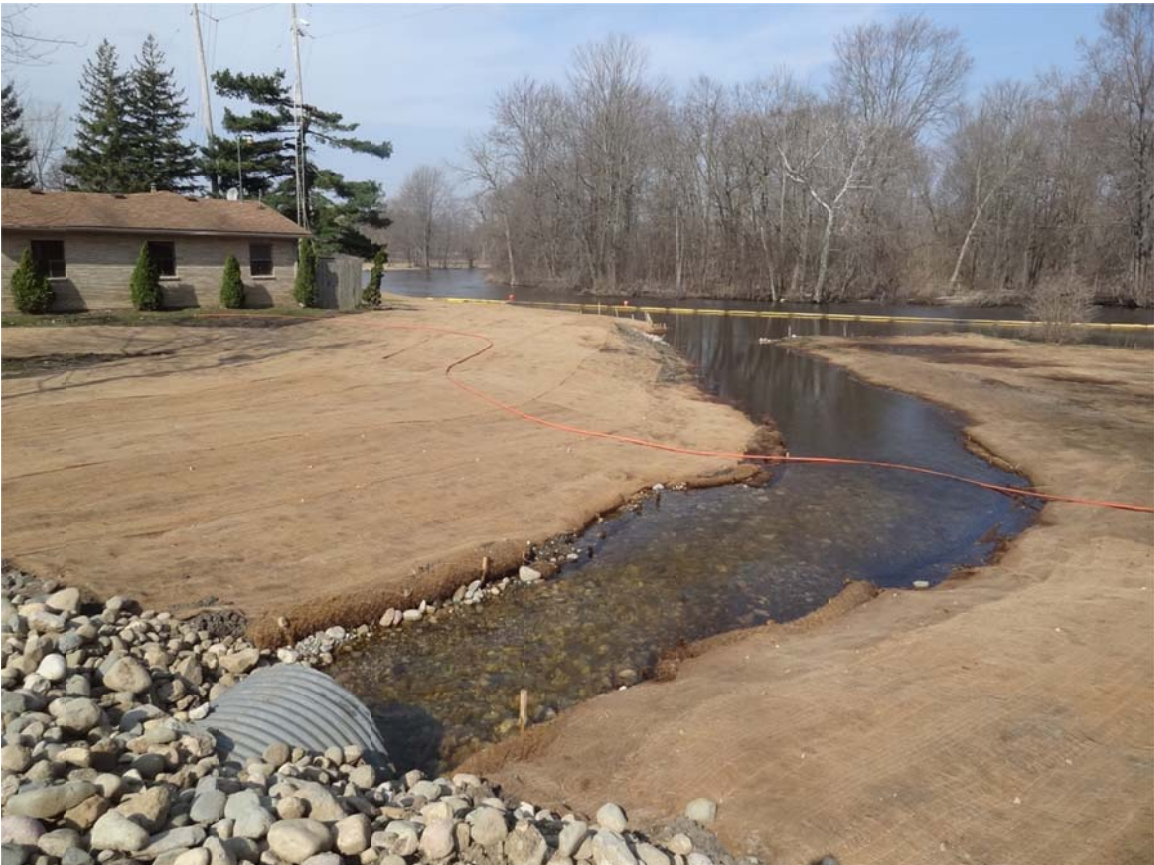
10. Confluence, no activity observed in morning.

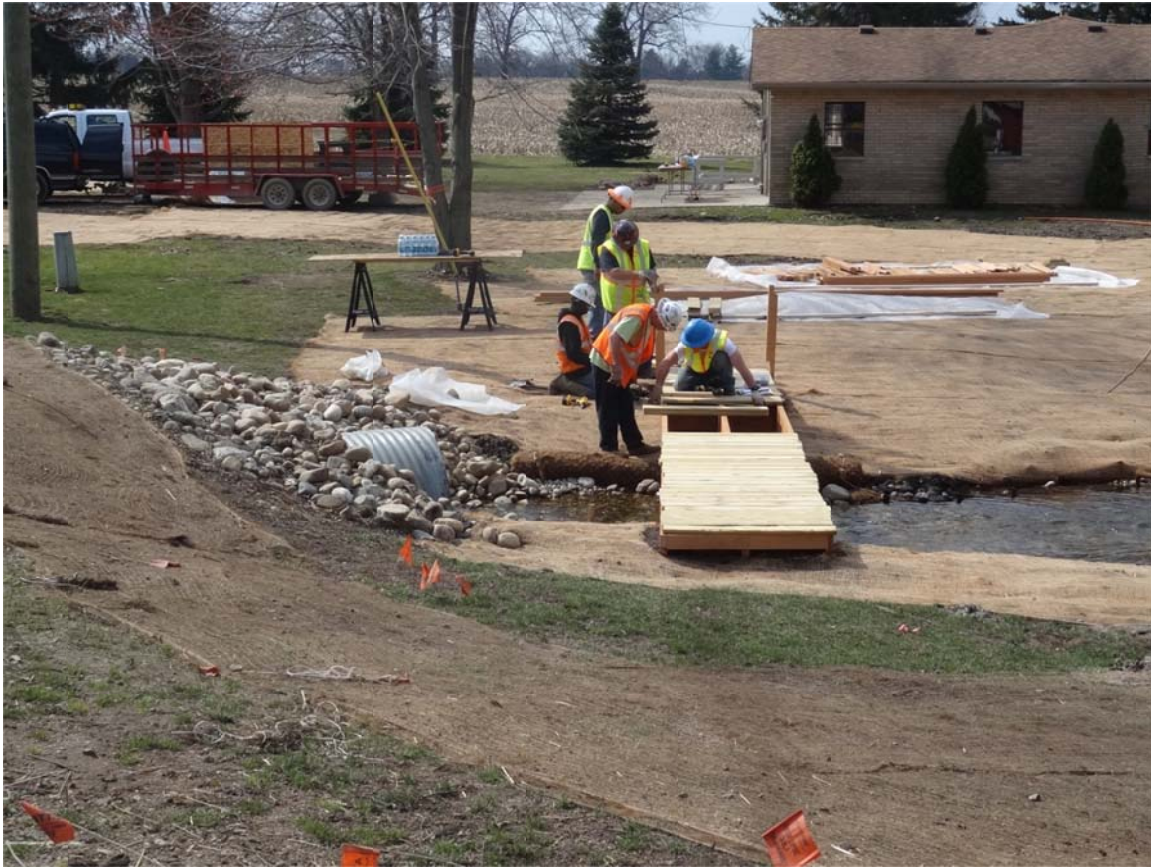
**11. Confluence, crews installing new bridge across Talmadge Creek in afternoon.**

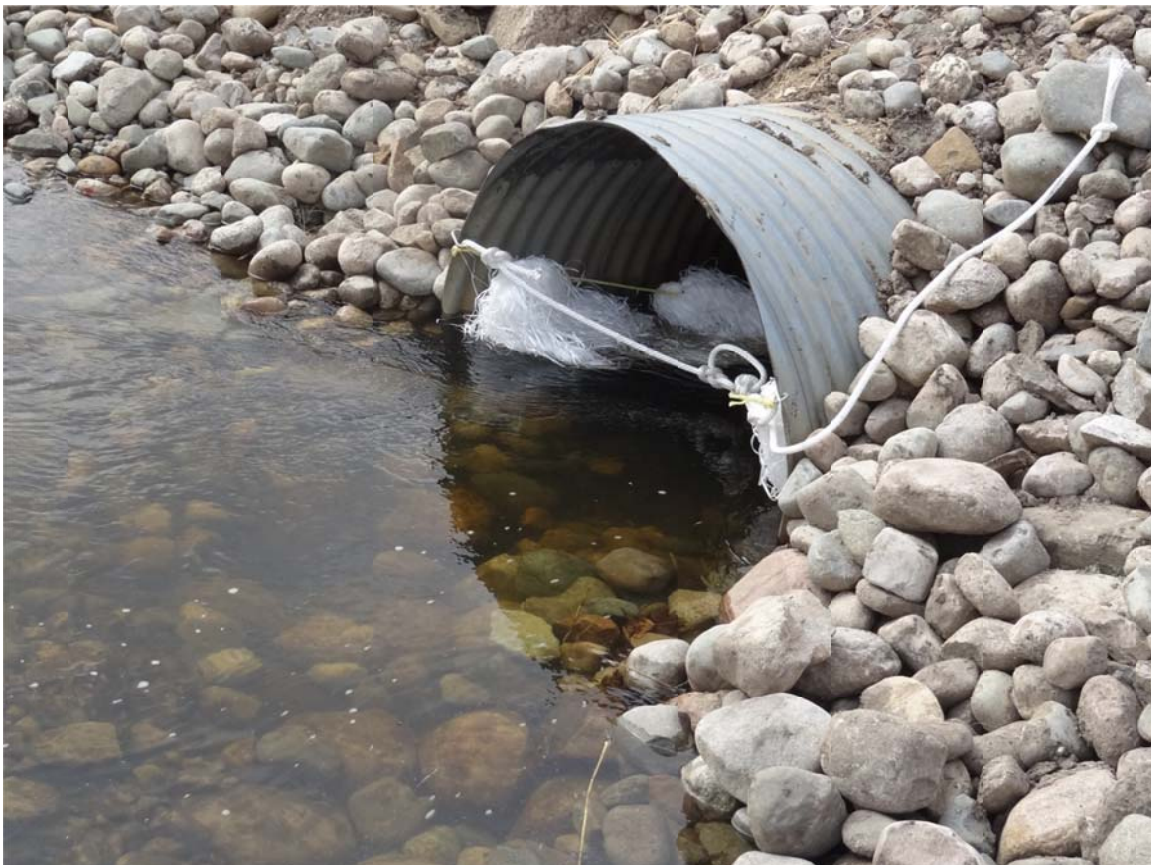
**12. Confluence, snare boom installed in culvert on south side of A Drive.**

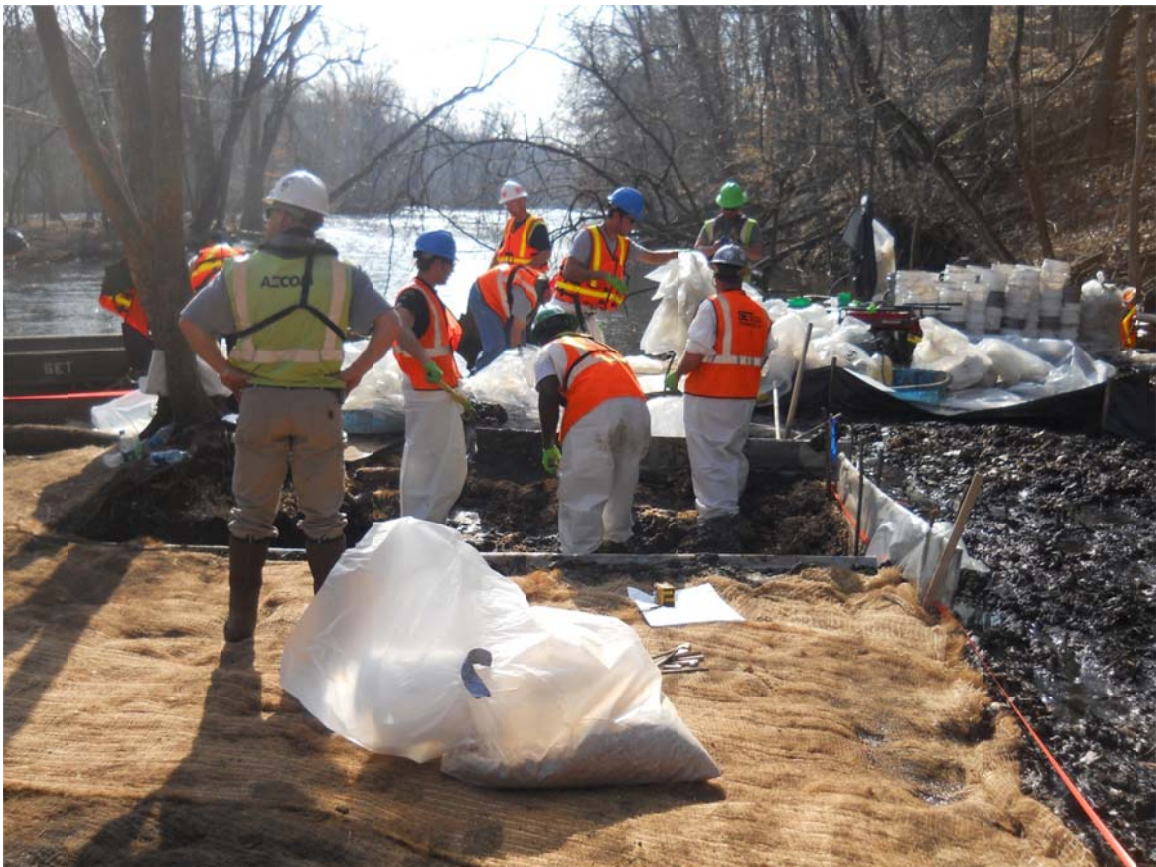
**14. OB 9.10 LDB, scrape work continues.**

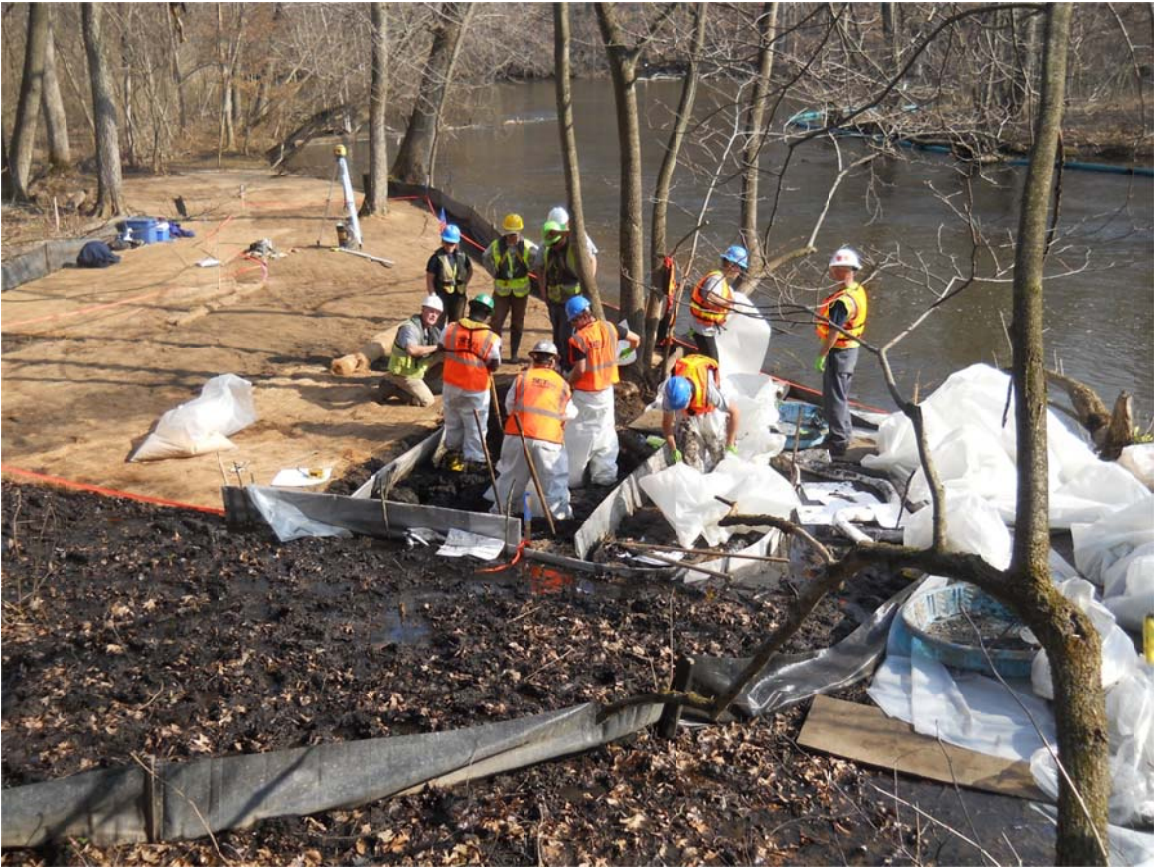
15. OB 9.10 LDB, scrape work continues.

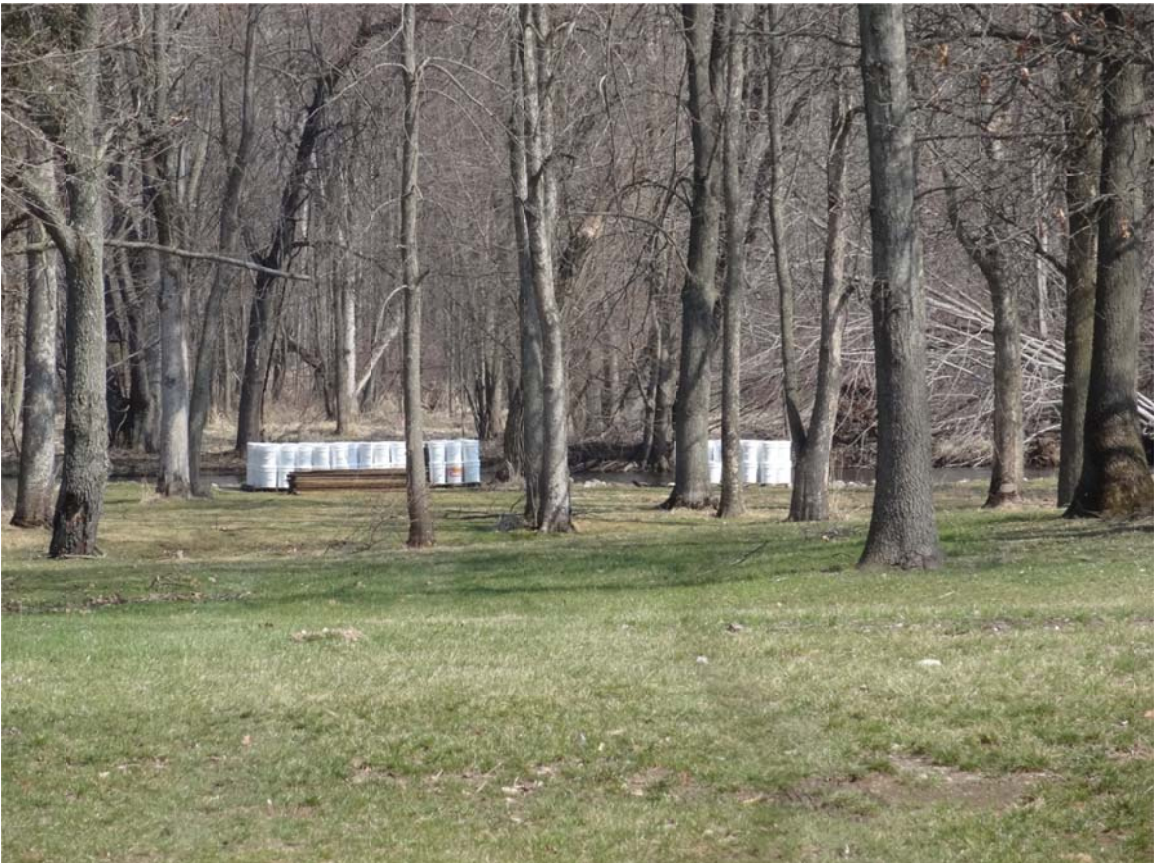
16. Material staged along LDB for planned scrape at OB 10.37 RDB.

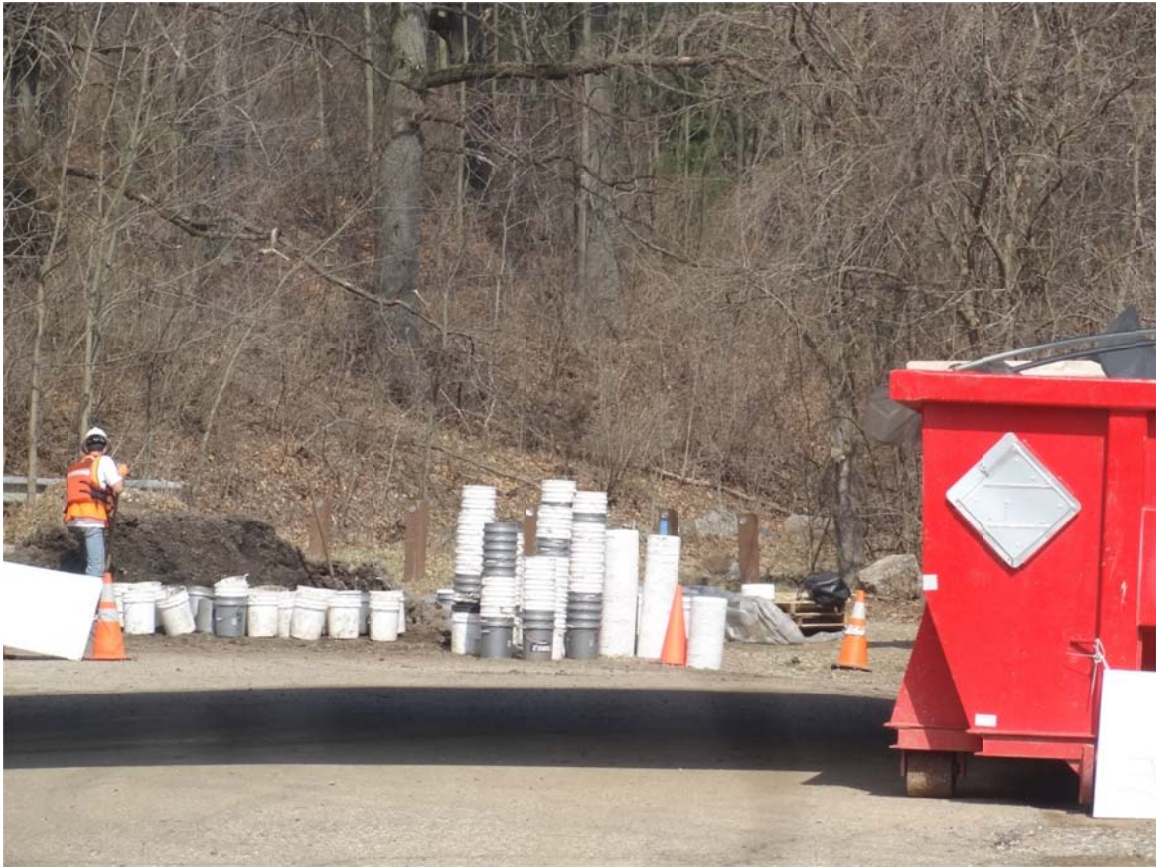
17. Historic Bridge Park, soil/water loading area for soils scraped from OB 9.10 LDB.

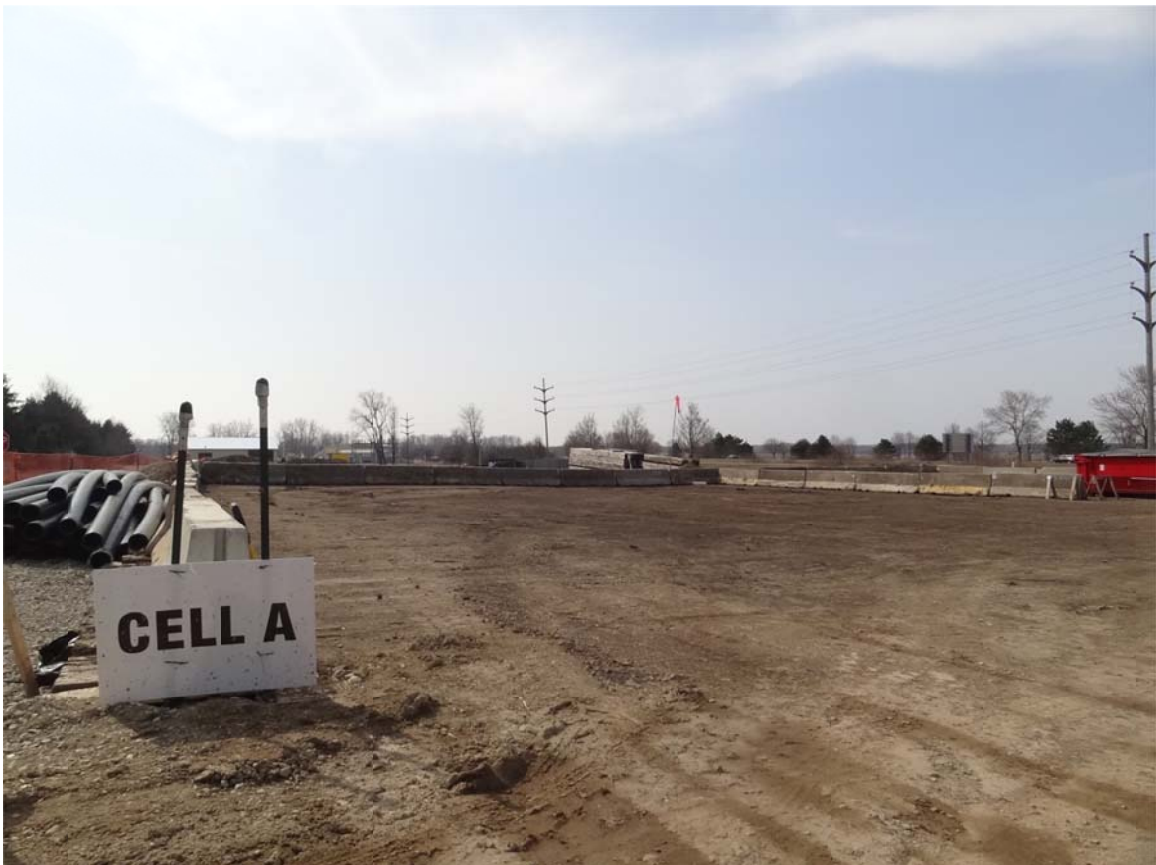
18. Frac Tank City cell A, cell is empty.

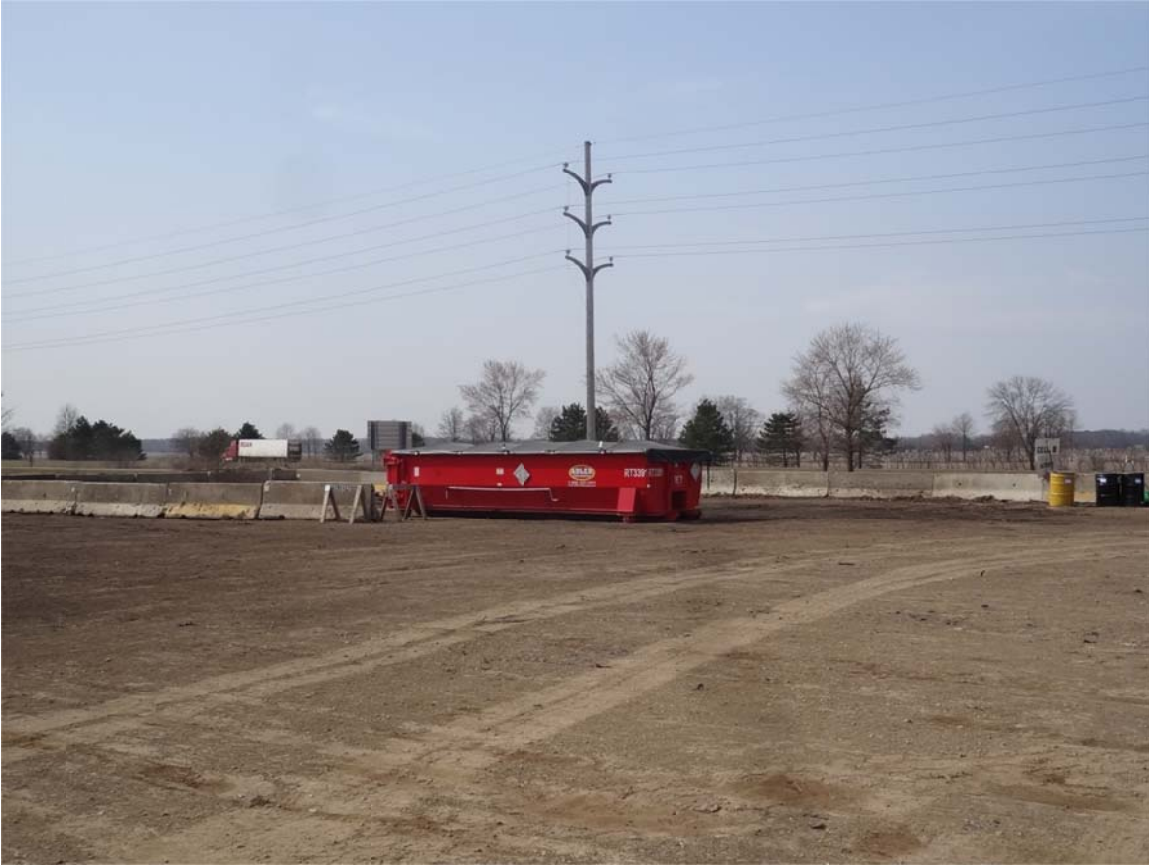
19. Frac Tank City Cell B, one roll-off box present.

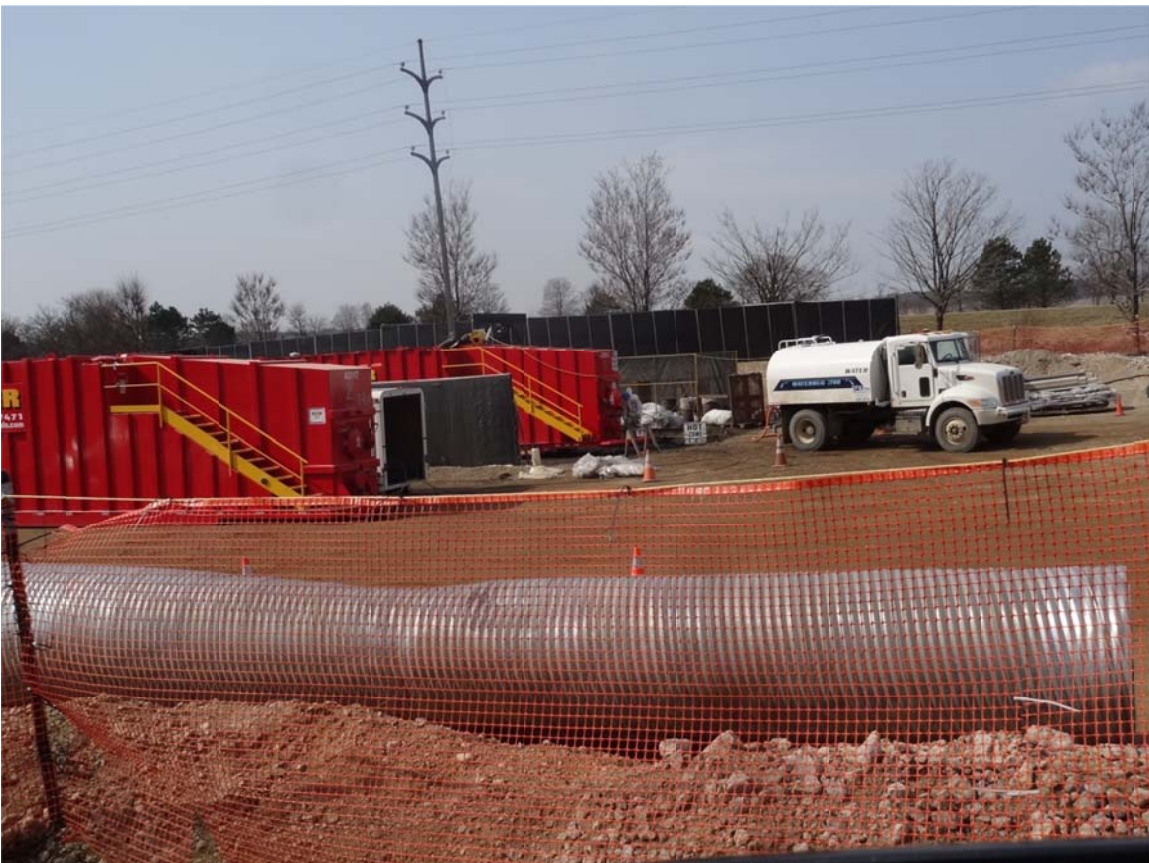
20. Frac Tank City southern decon pad, crews cleaning a frac tank.
