# Situation Photo Log

Monday, March 19, 2012

Kalamazoo River / Enbridge Spill

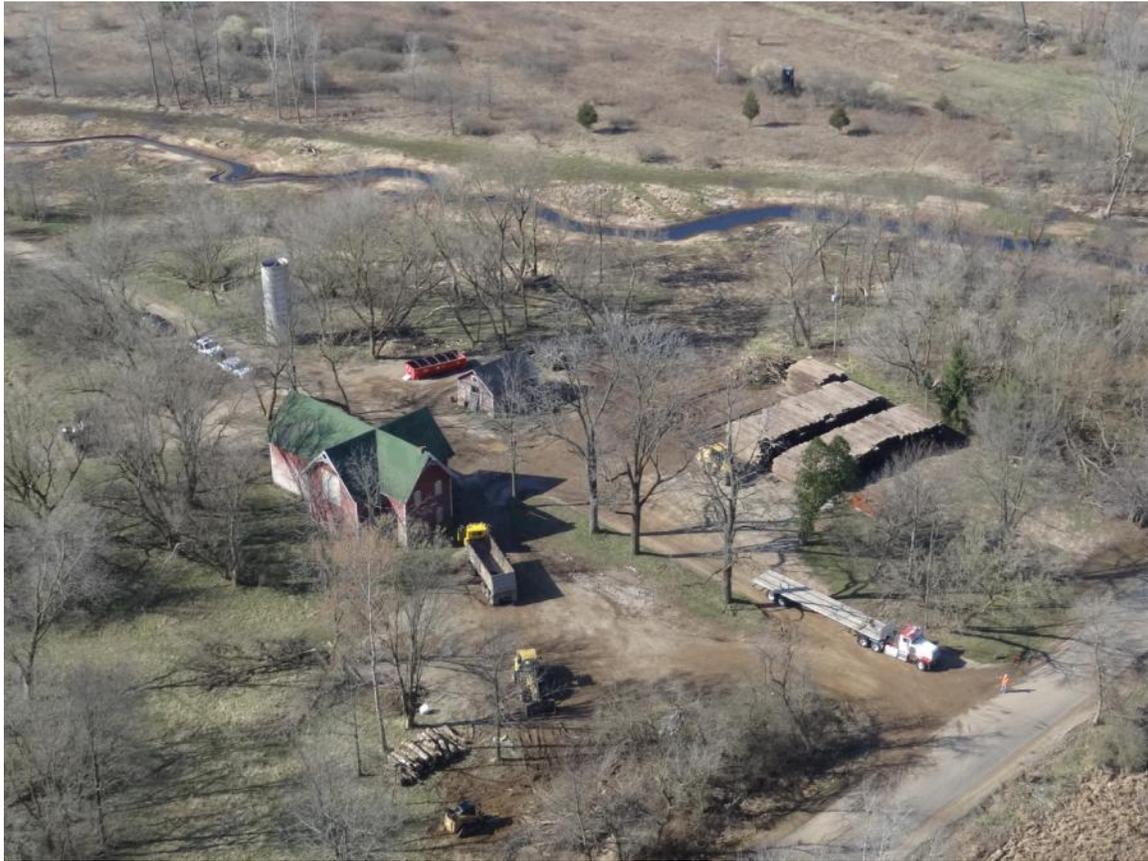
1. Demobilization of the staging area at the farmhouse on Division Drive.

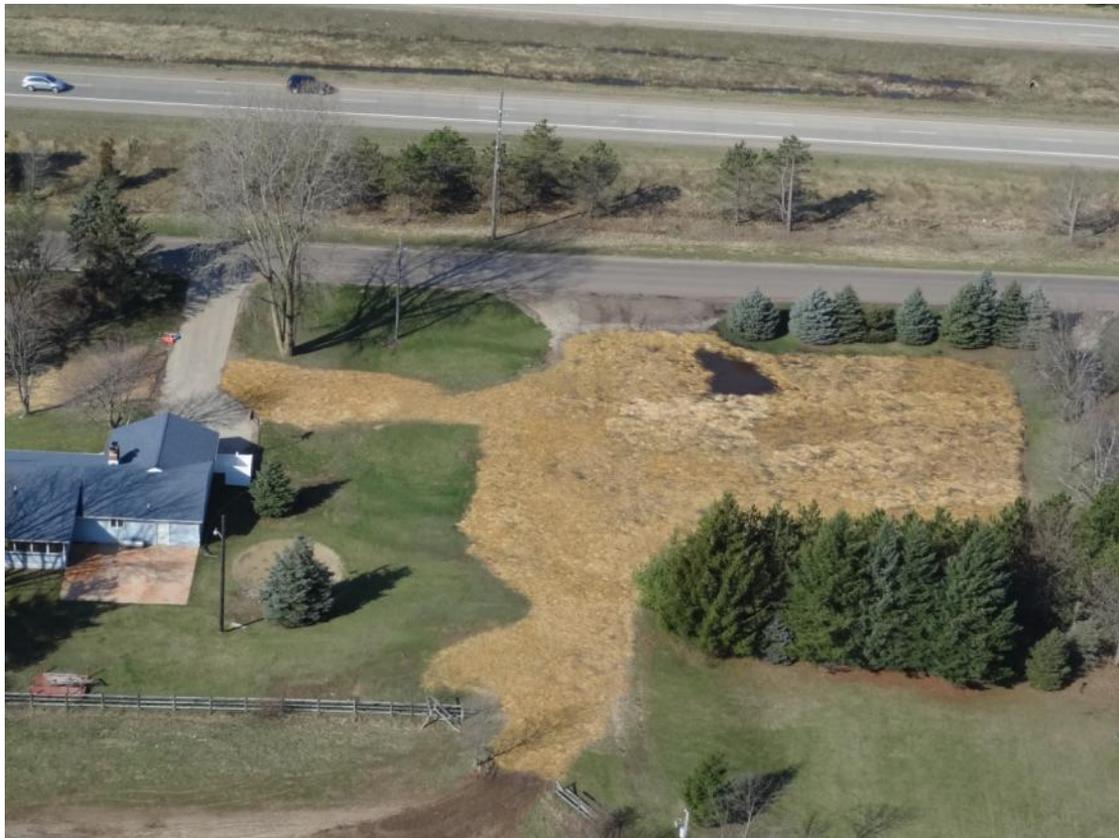
2. Restoration of staging area off 16 Mile Road.

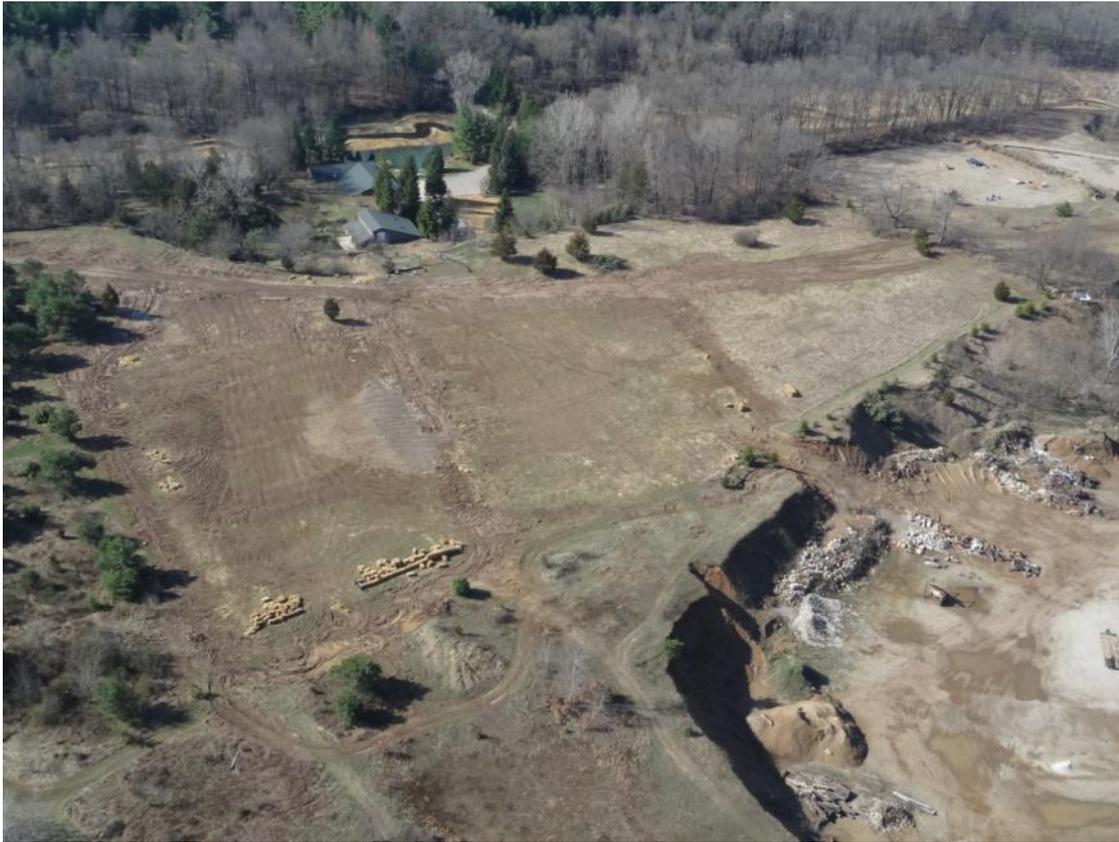
**3. Former Turbidity Control Structure area.**

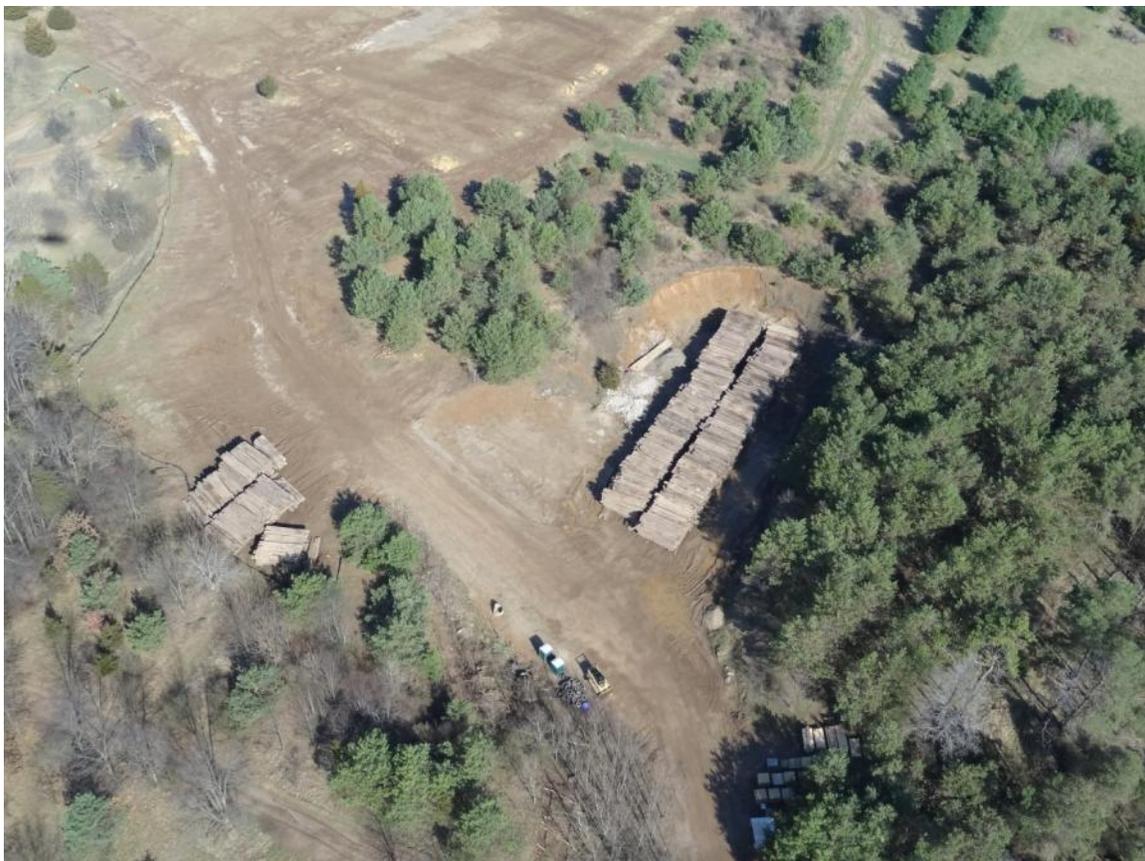
**4. Timber mat staging area just west of 15-1/2 Mile Road.**

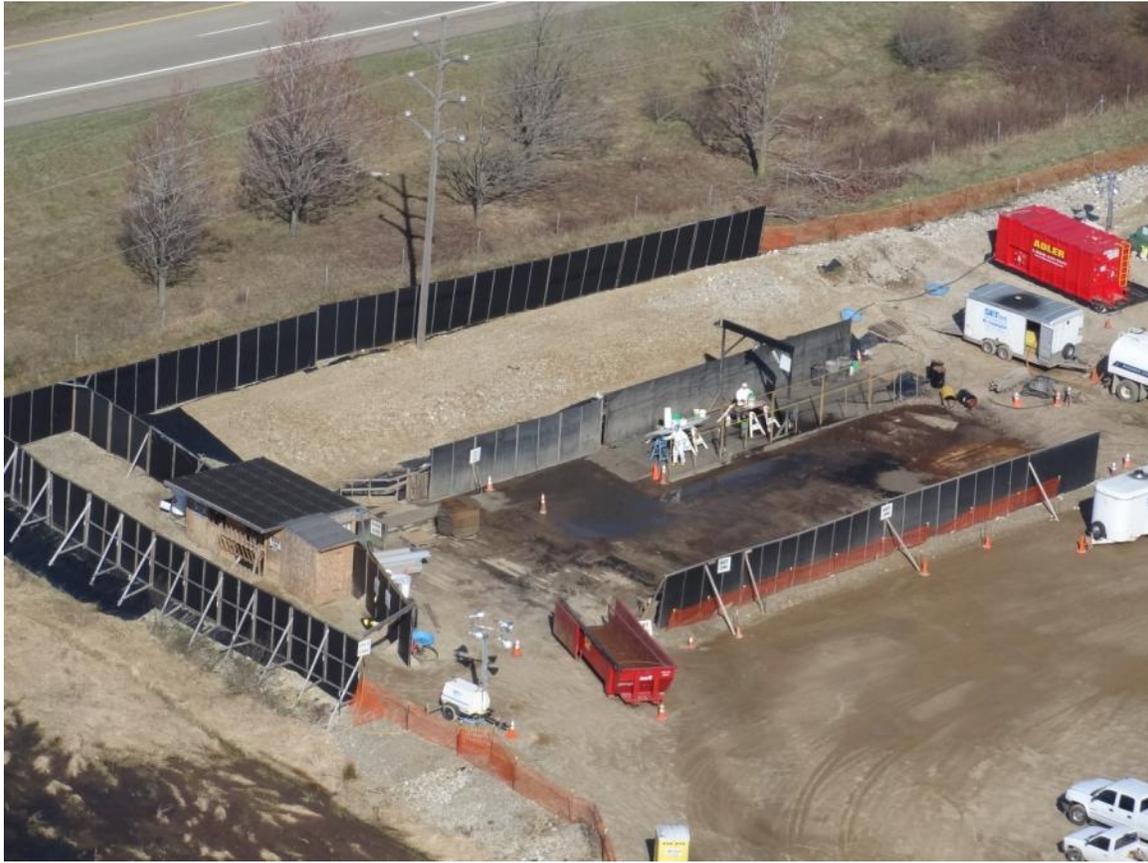
5. Frac-City decontamination activities.

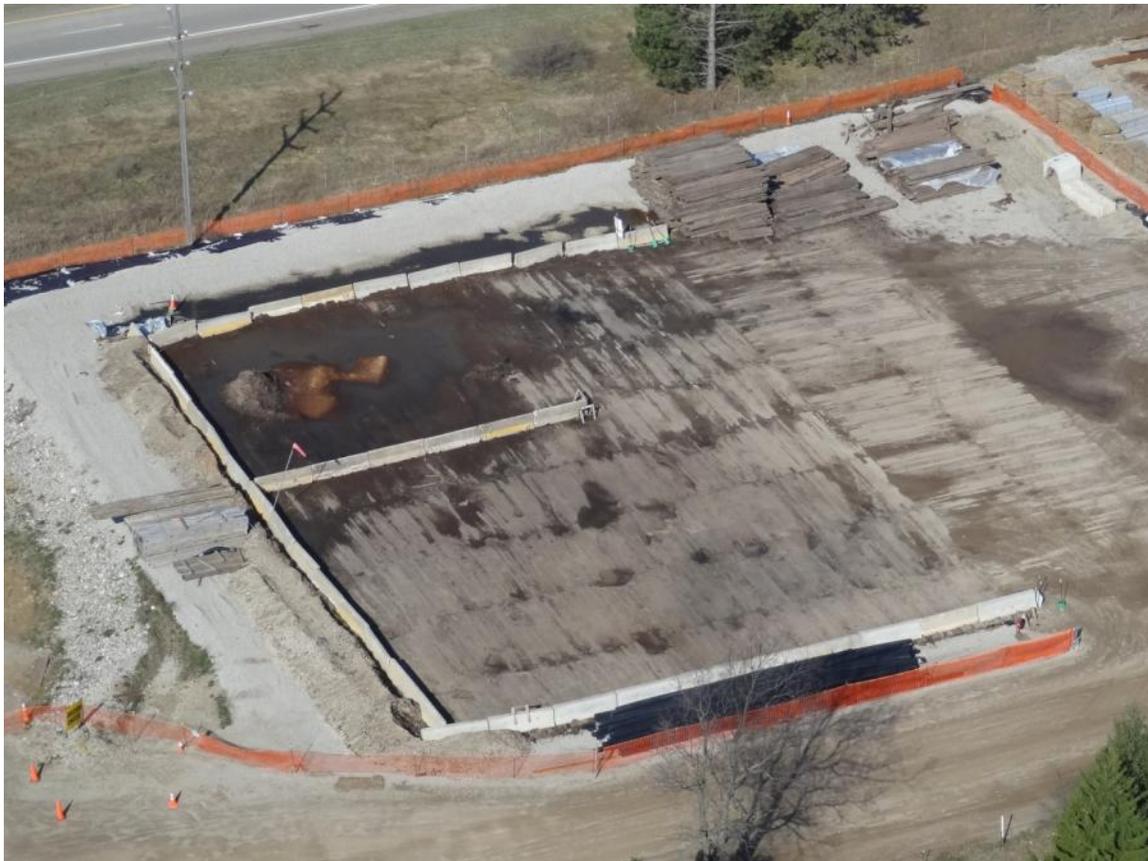
6. Frac-City Soil Cells A & B.

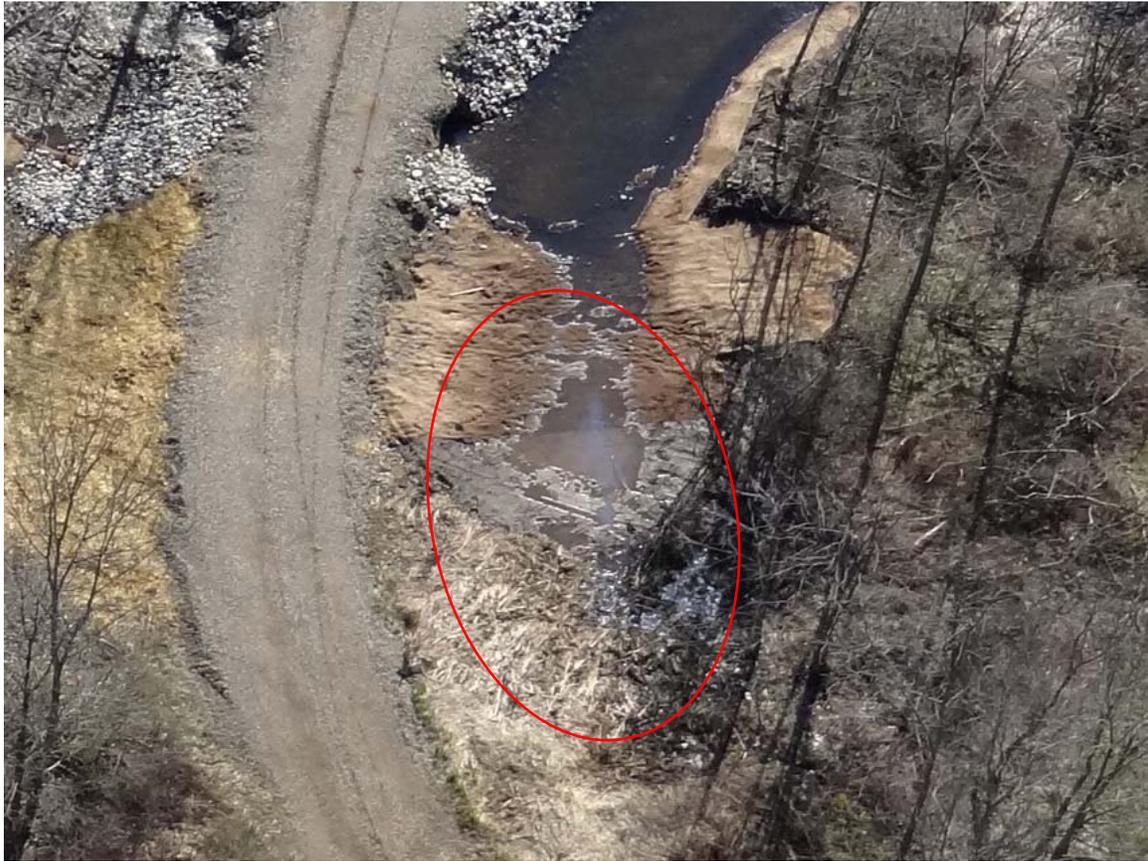
7. Talmadge Creek near MP1.75 sheen observed.

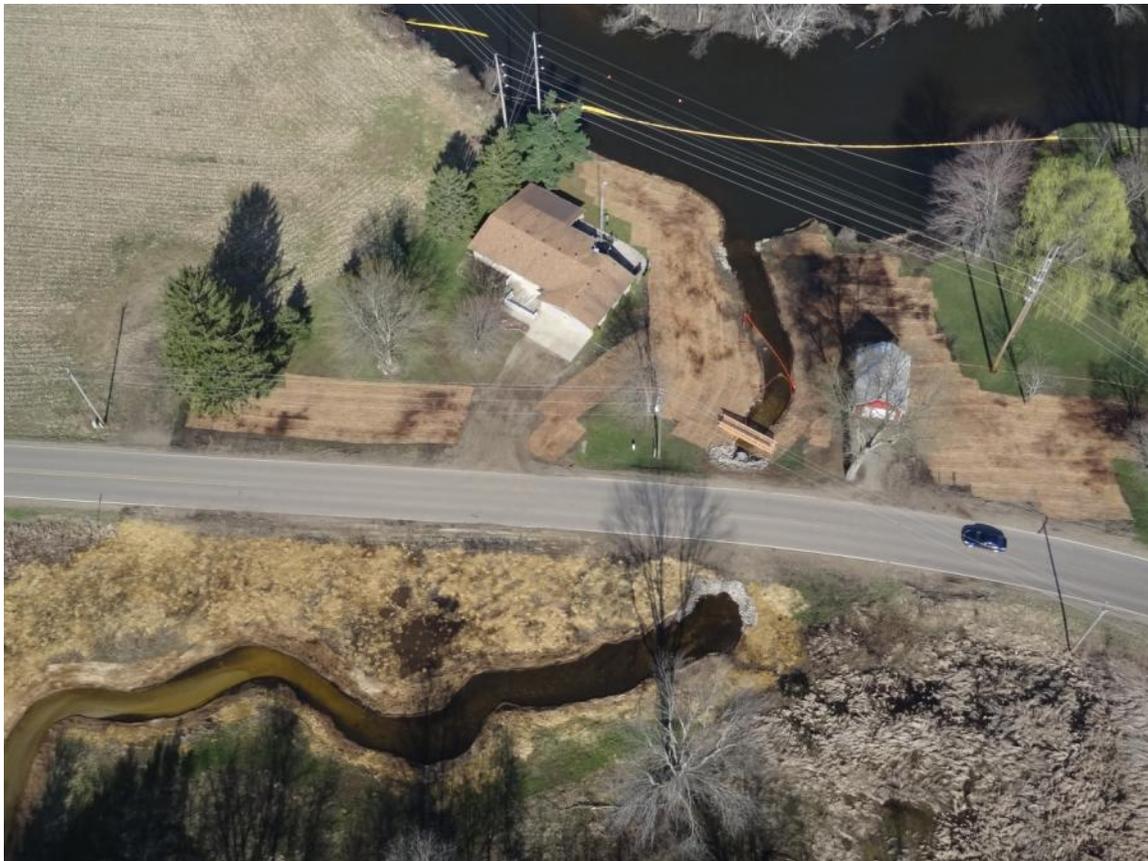
8. Confluence, no sheen or turbidity issues observed.

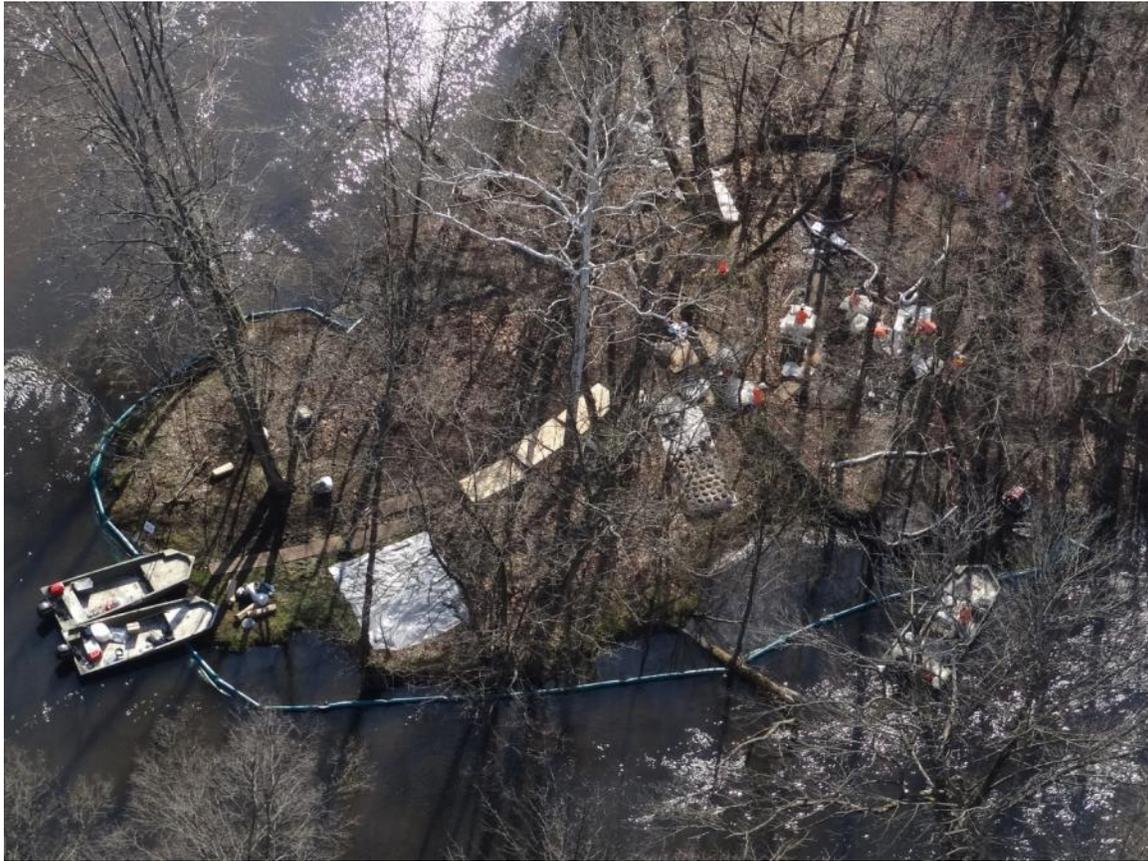
9. Scrape activities resumed at OB8.97.

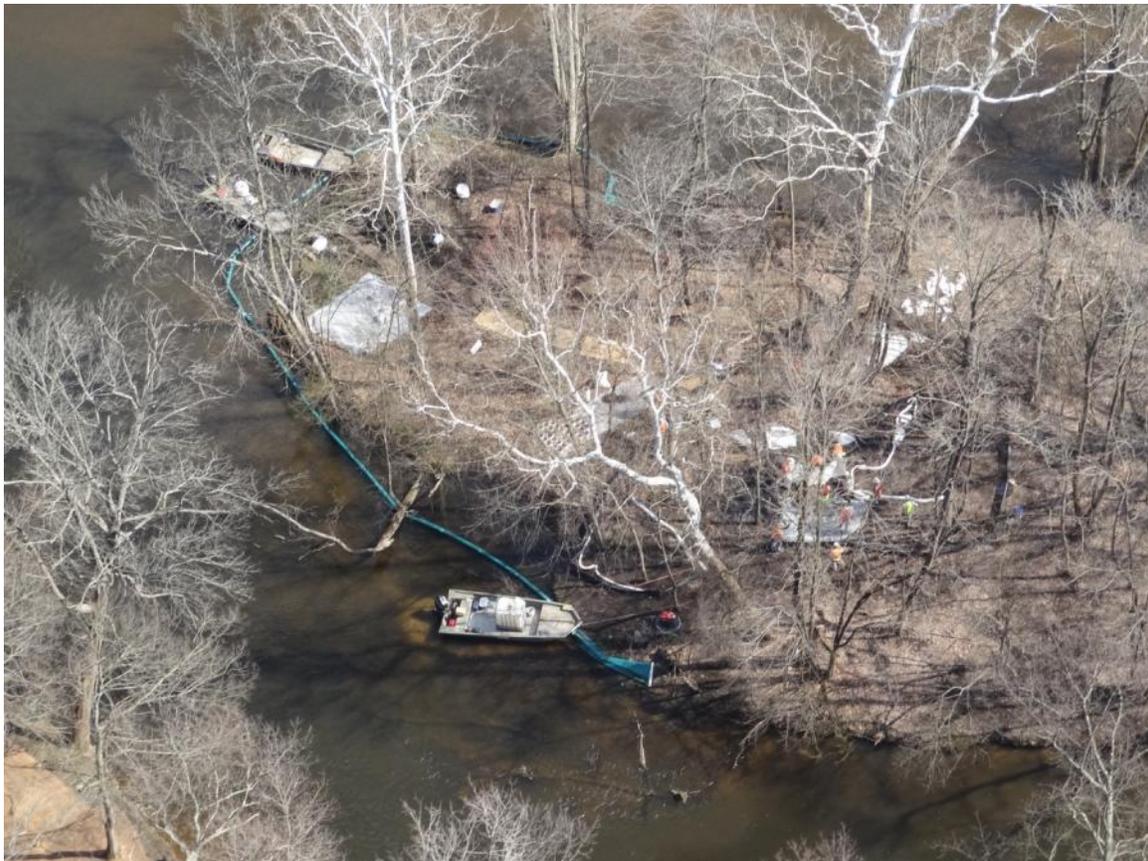
10. Scrape activities resumed at OB8.97.

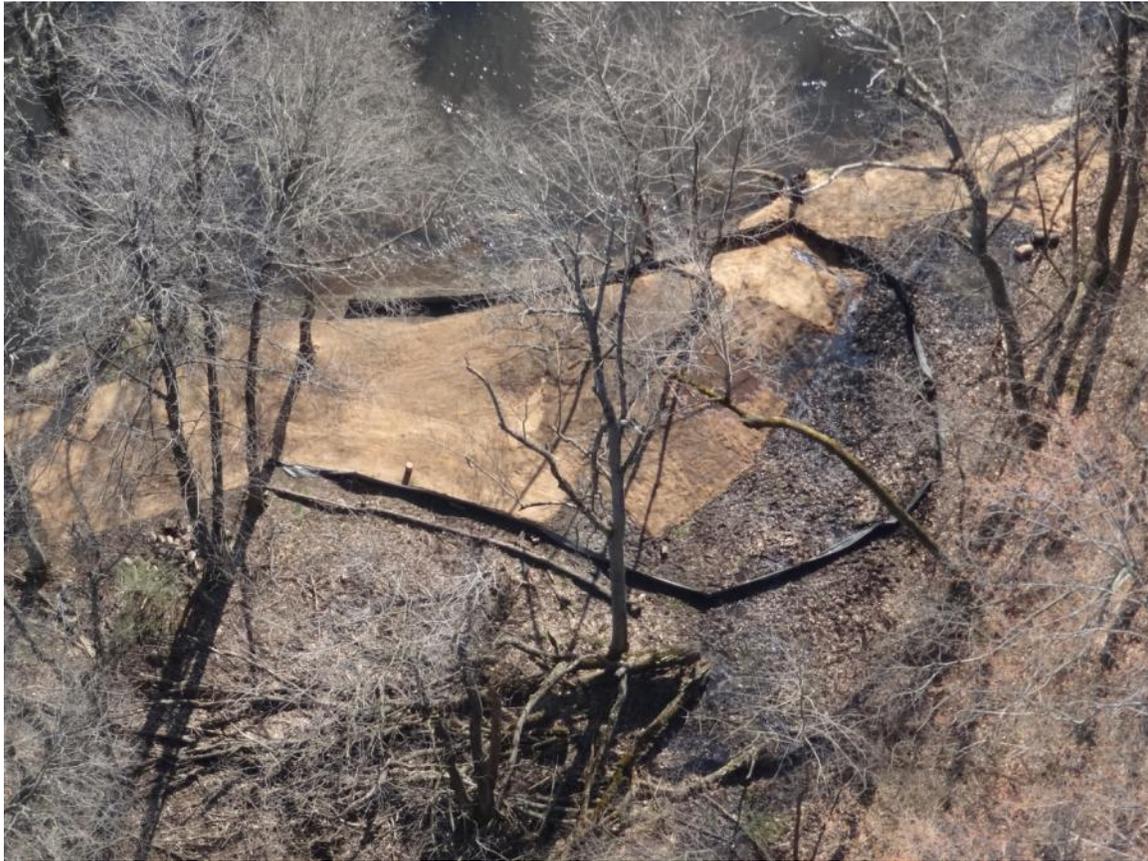
11. Scrape area at OB9.10 restored.

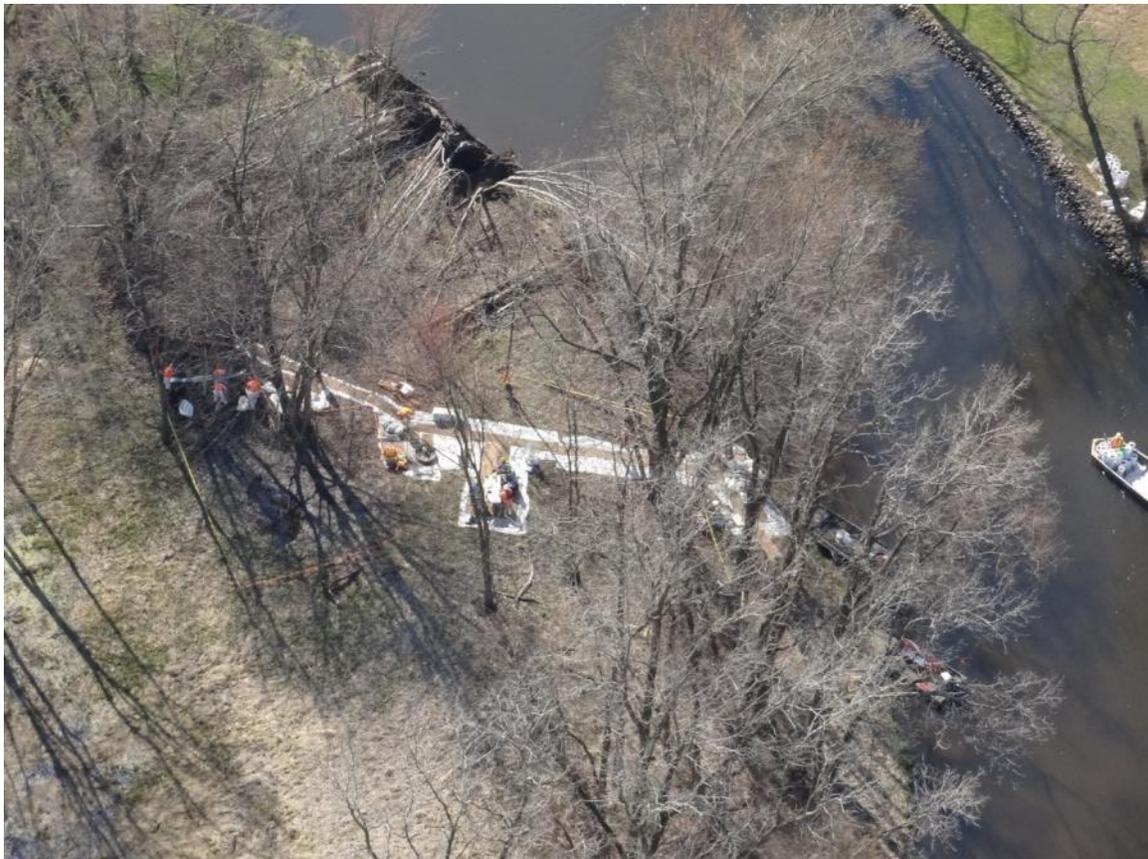
12. Scrape underway at OB 10.37 RDB.

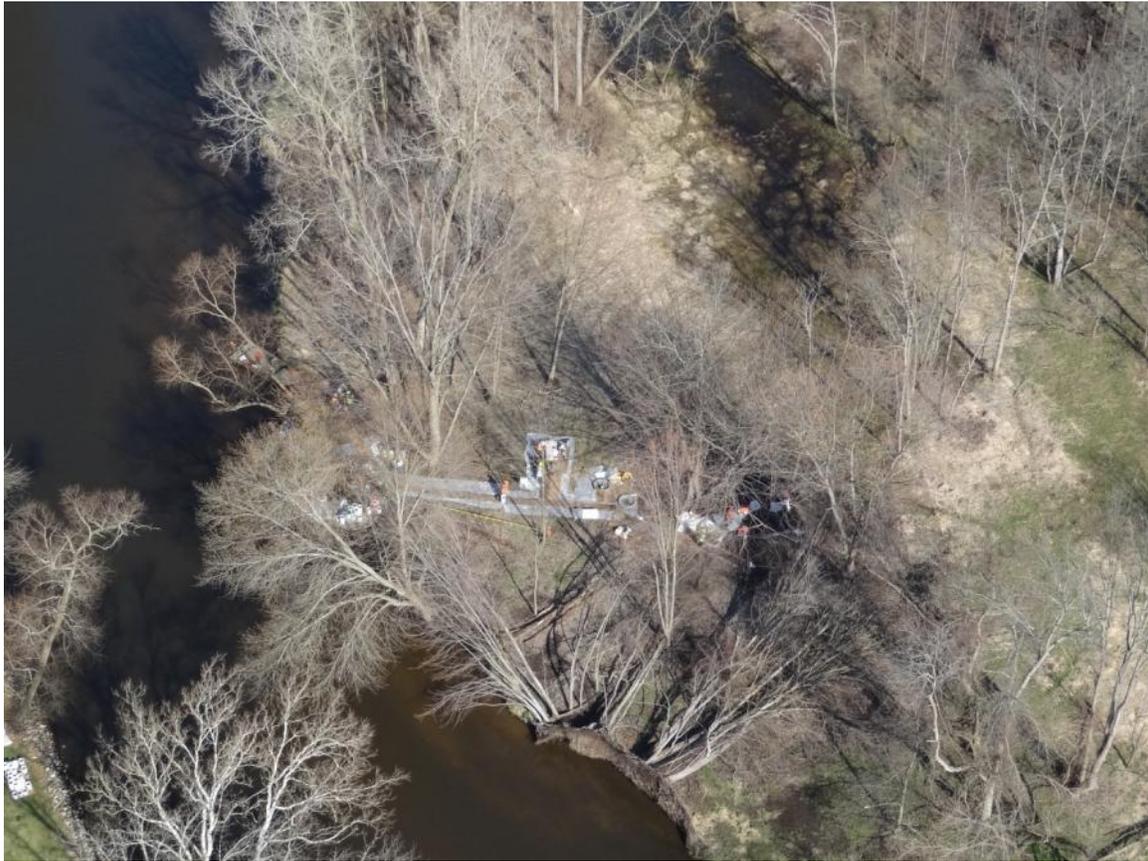
13. Scrape underway at OB 10.37 RDB.

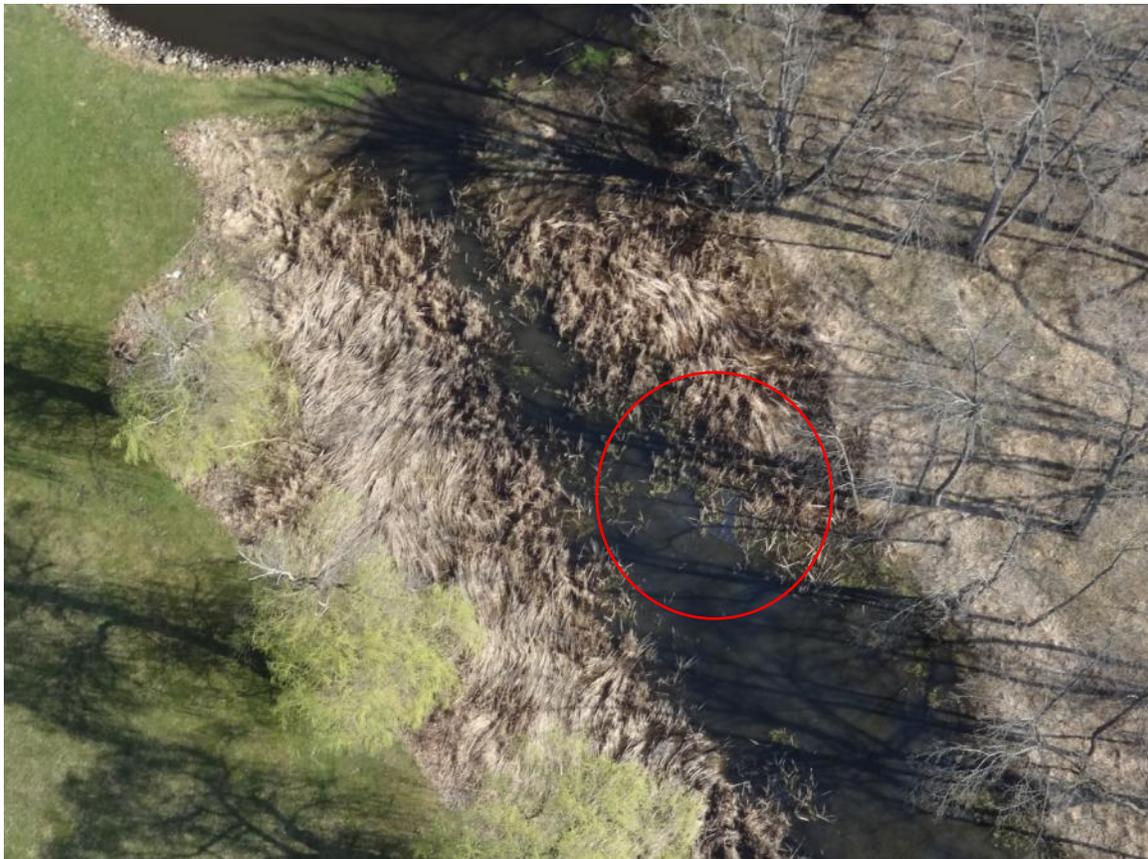
14. MP10.37 LDB overbank sheen observed.

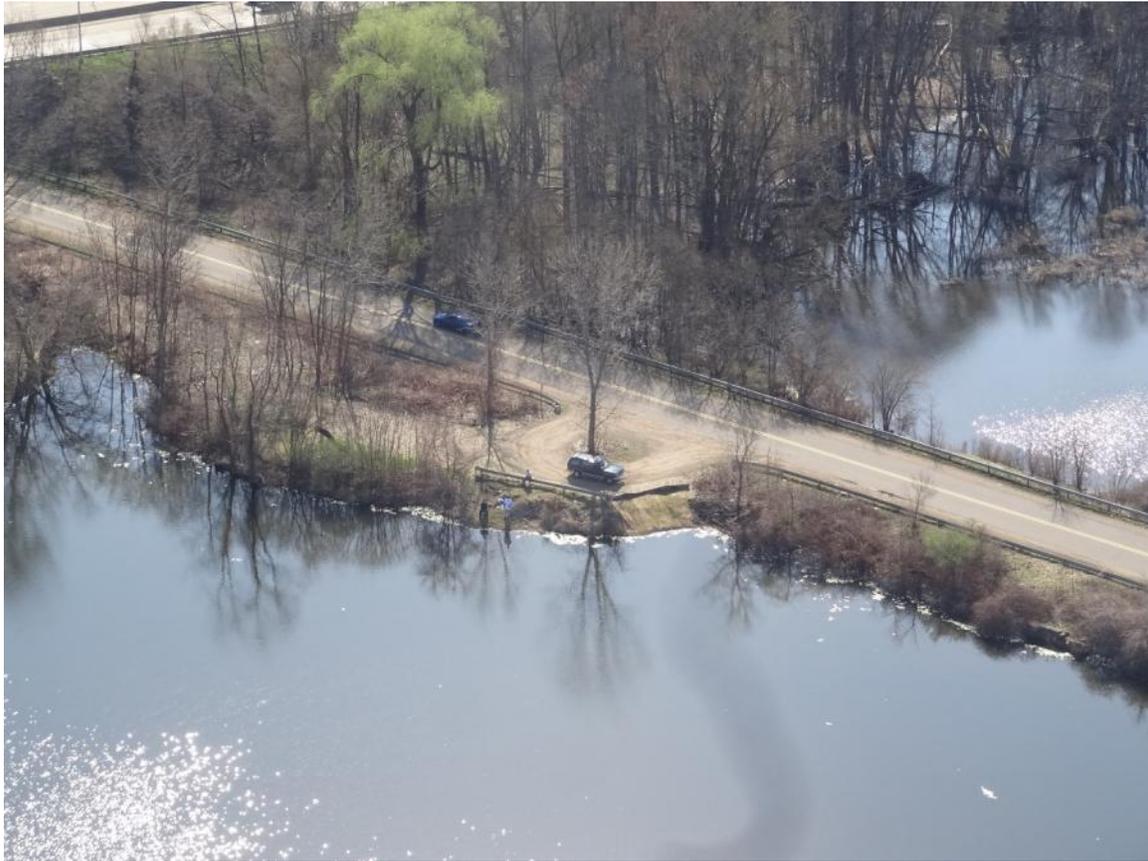
15. Mill Pond observed public fishing.

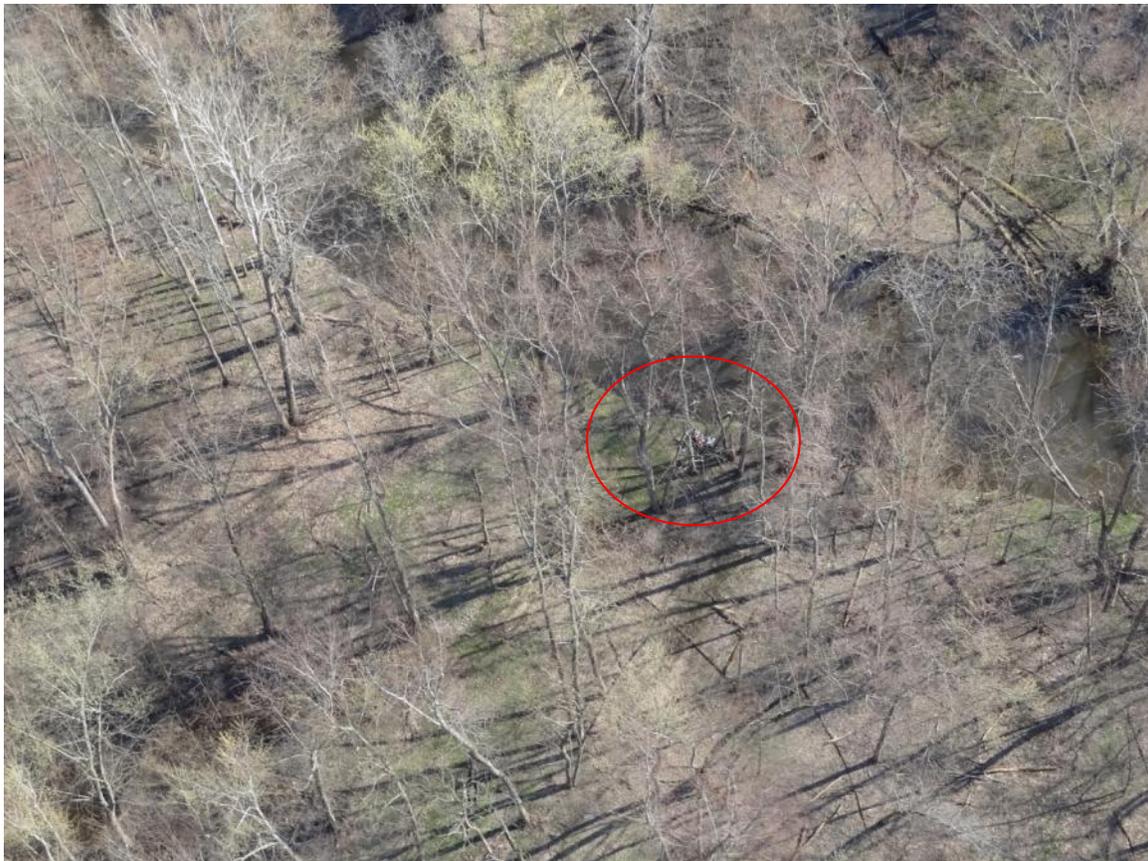
16. MP28.25 Oxbow observed public fishing.
