# Situation Photo Log

Wednesday, March 21, 2012

Kalamazoo River / Enbridge Spill

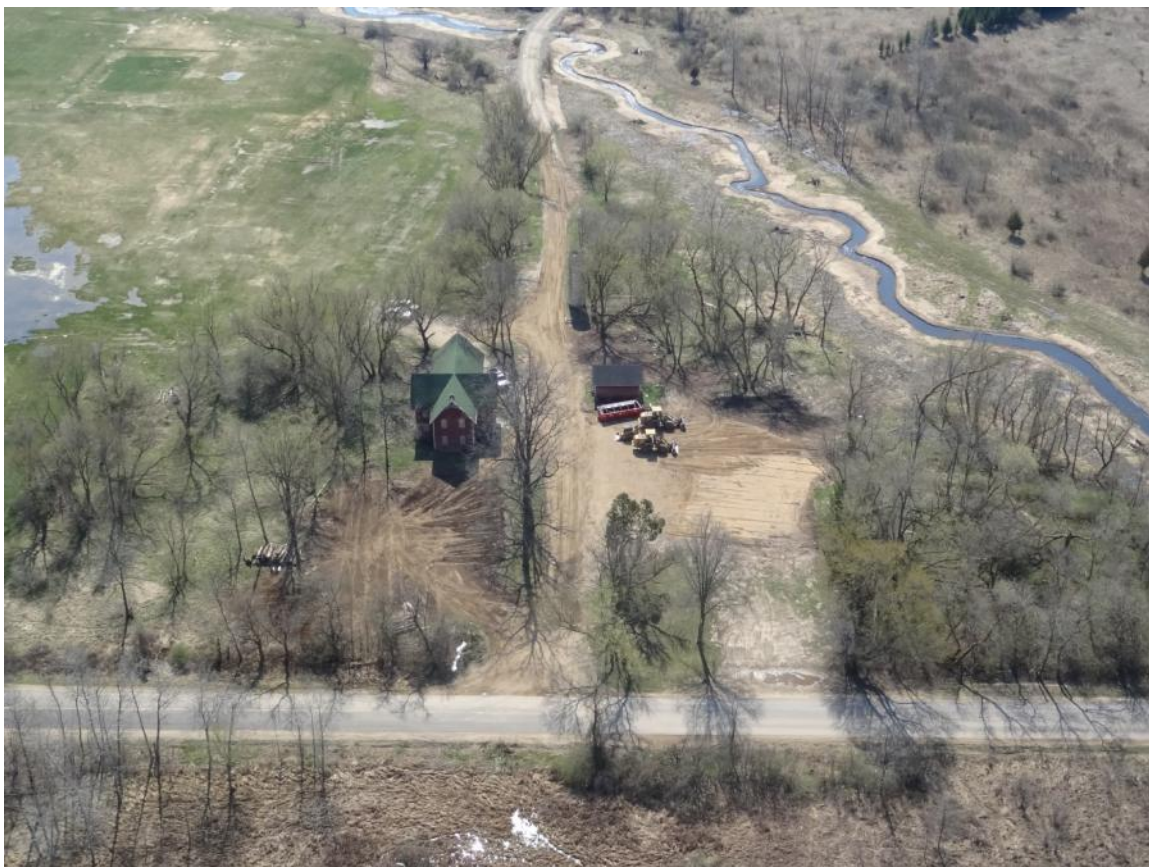
1. Demobilization of the staging area at the farmhouse on Division Drive appears complete.

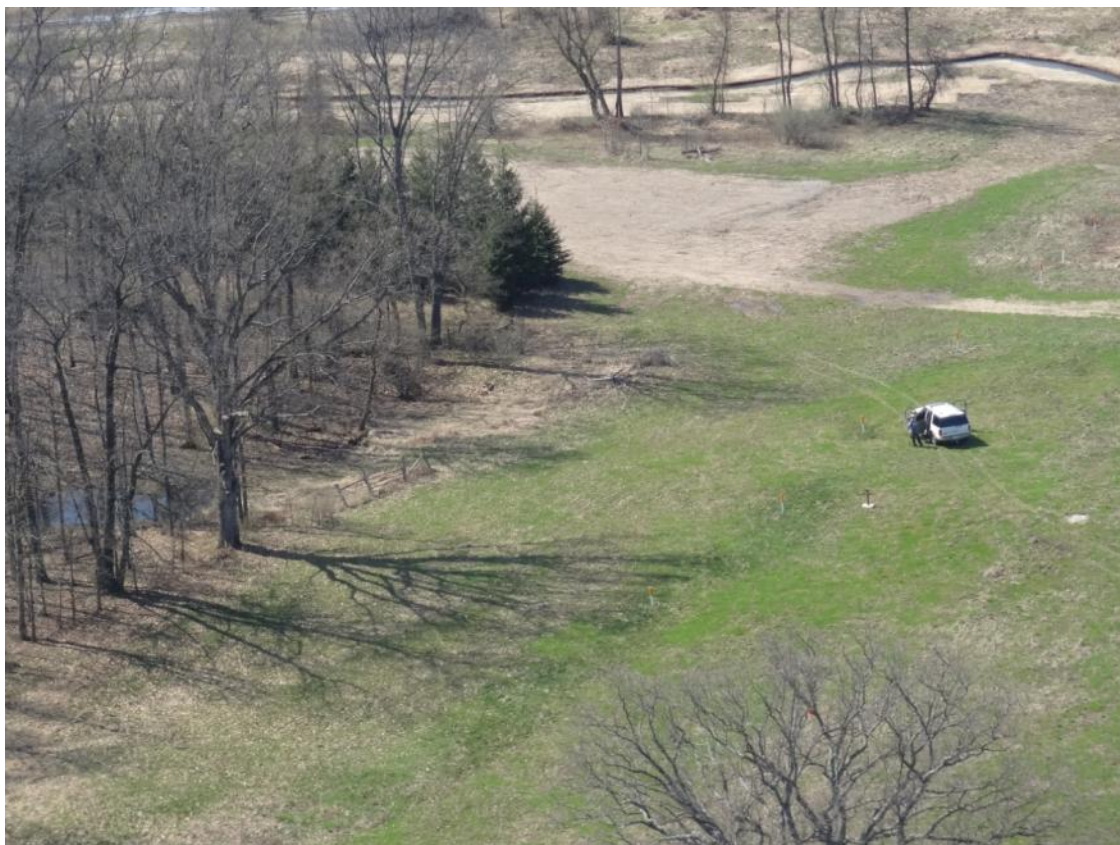
2. Talmadge Creek/Source Area local activist observed.

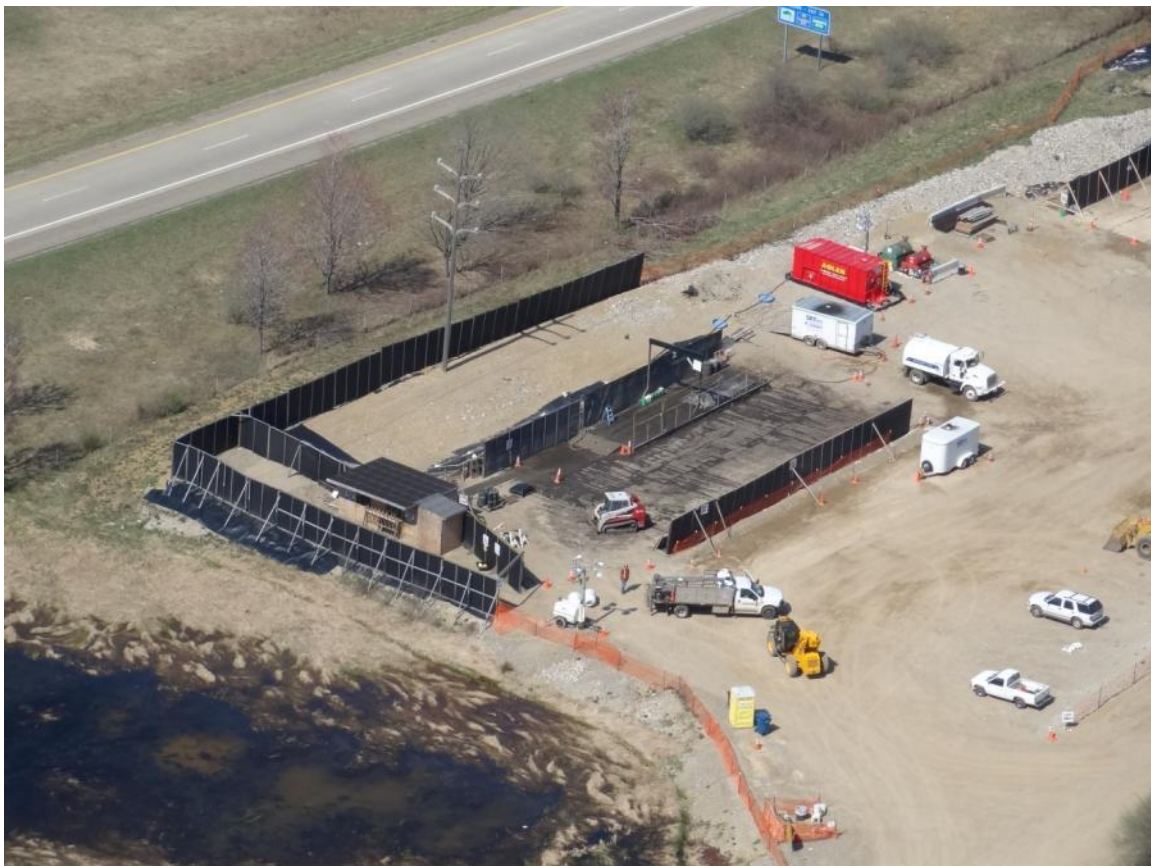
4. Frac-City decontamination activities.

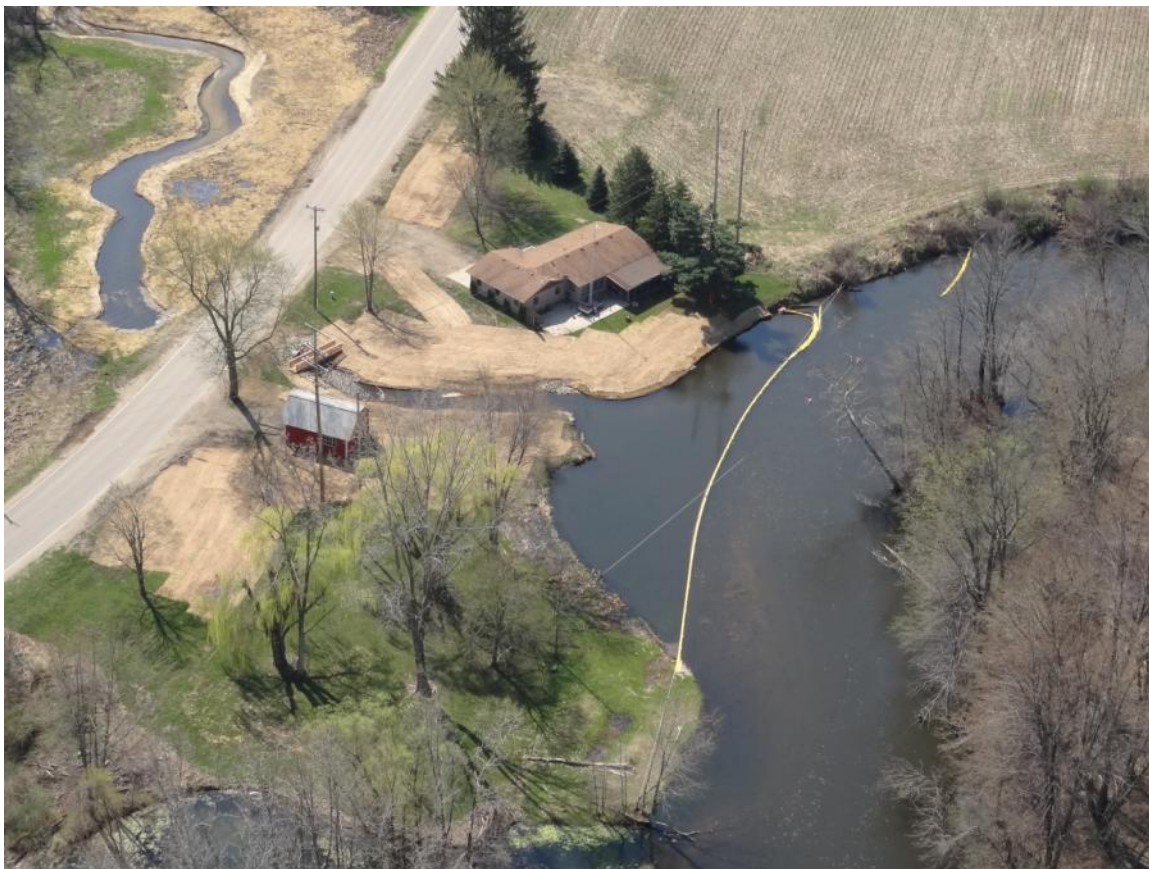
6. Confluence, observed no turbidity or sheen.

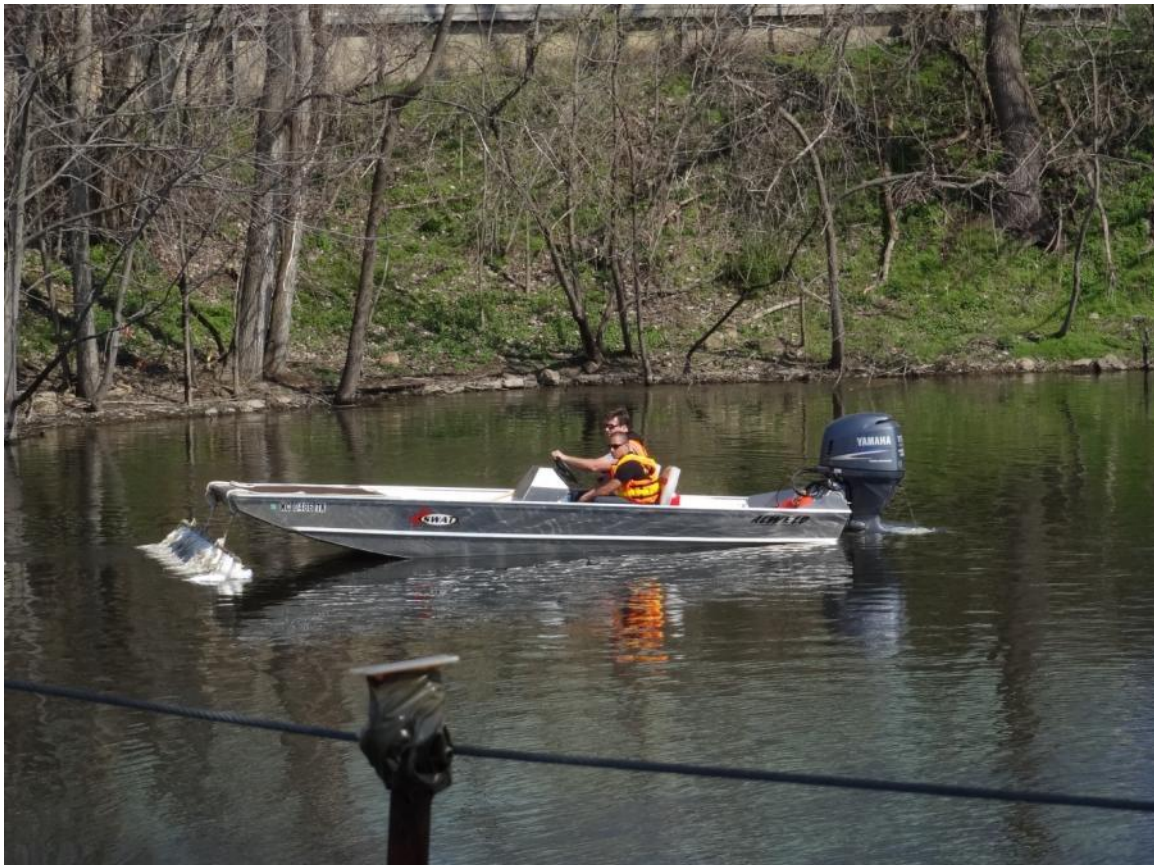
8. Ceresco Dam observed sweep boat.

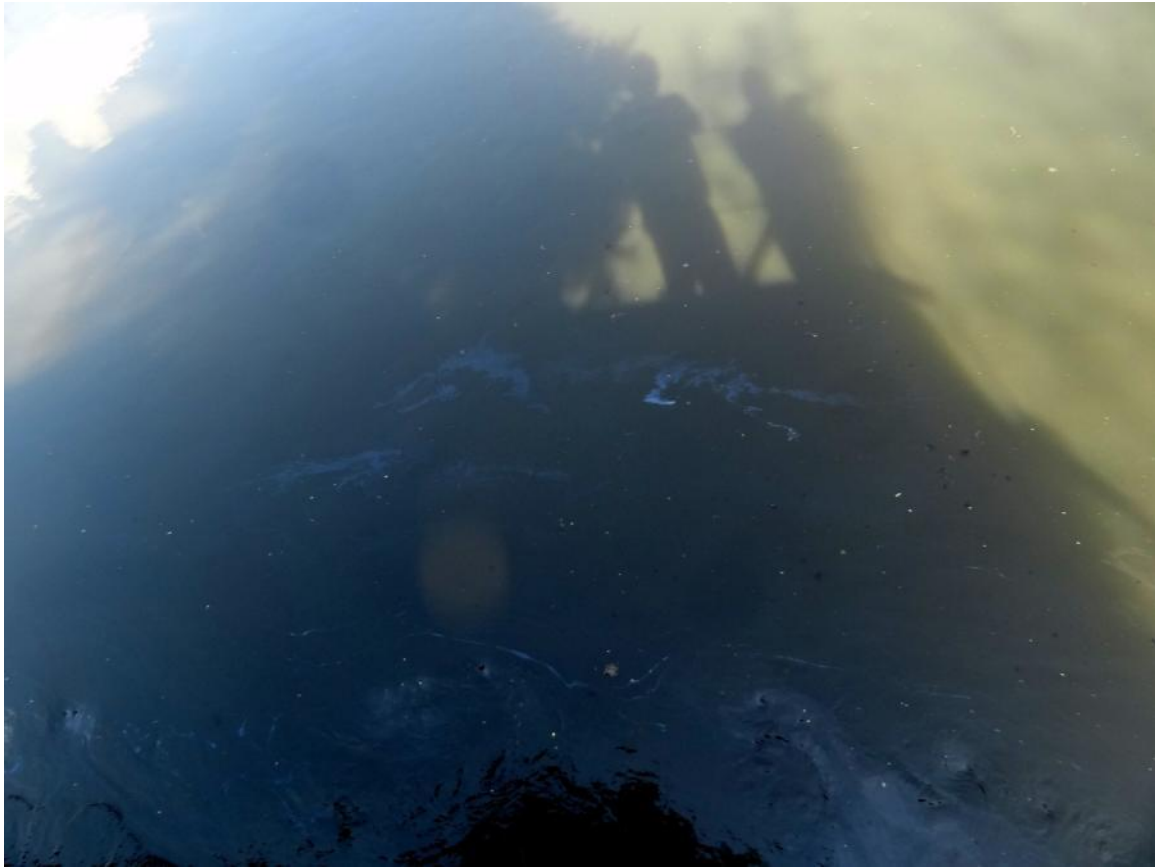
9. Ceresco Dam sheen observed flowing over spillway.

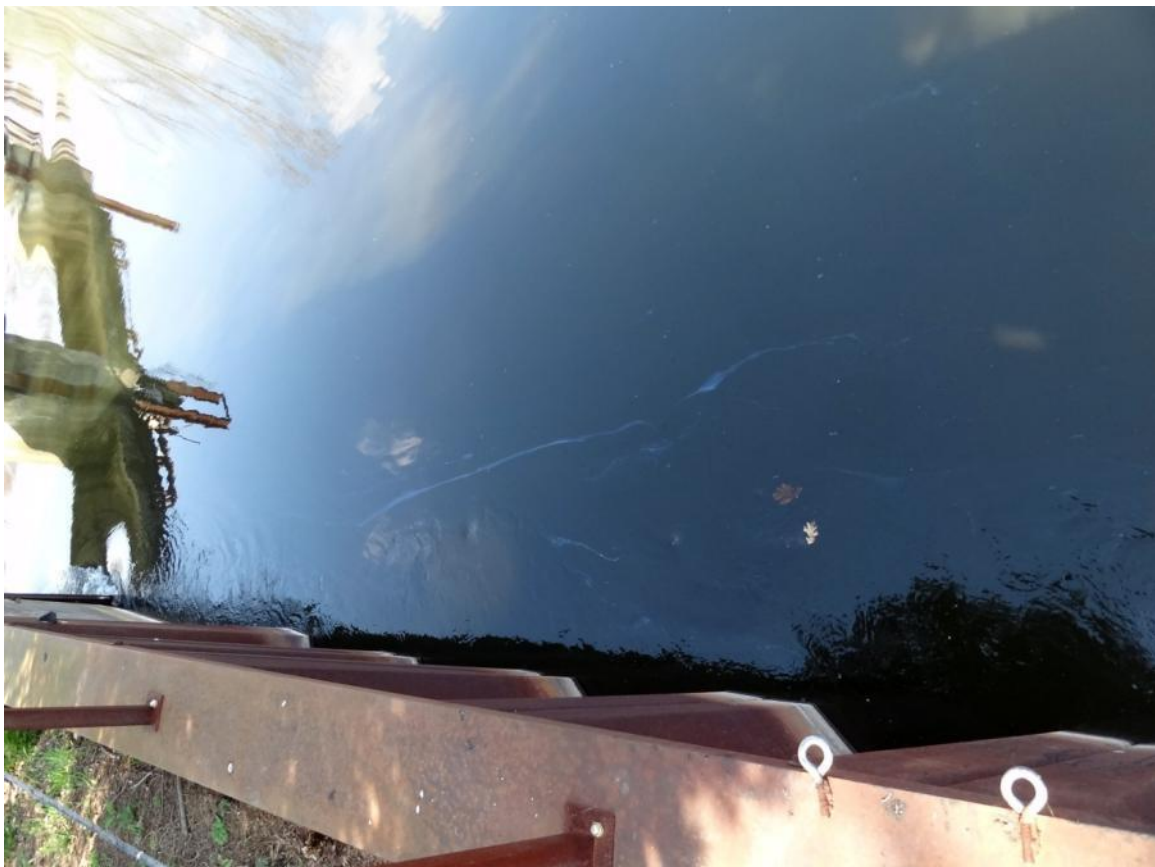
10. Ceresco Dam sheen observed flowing over spillway.

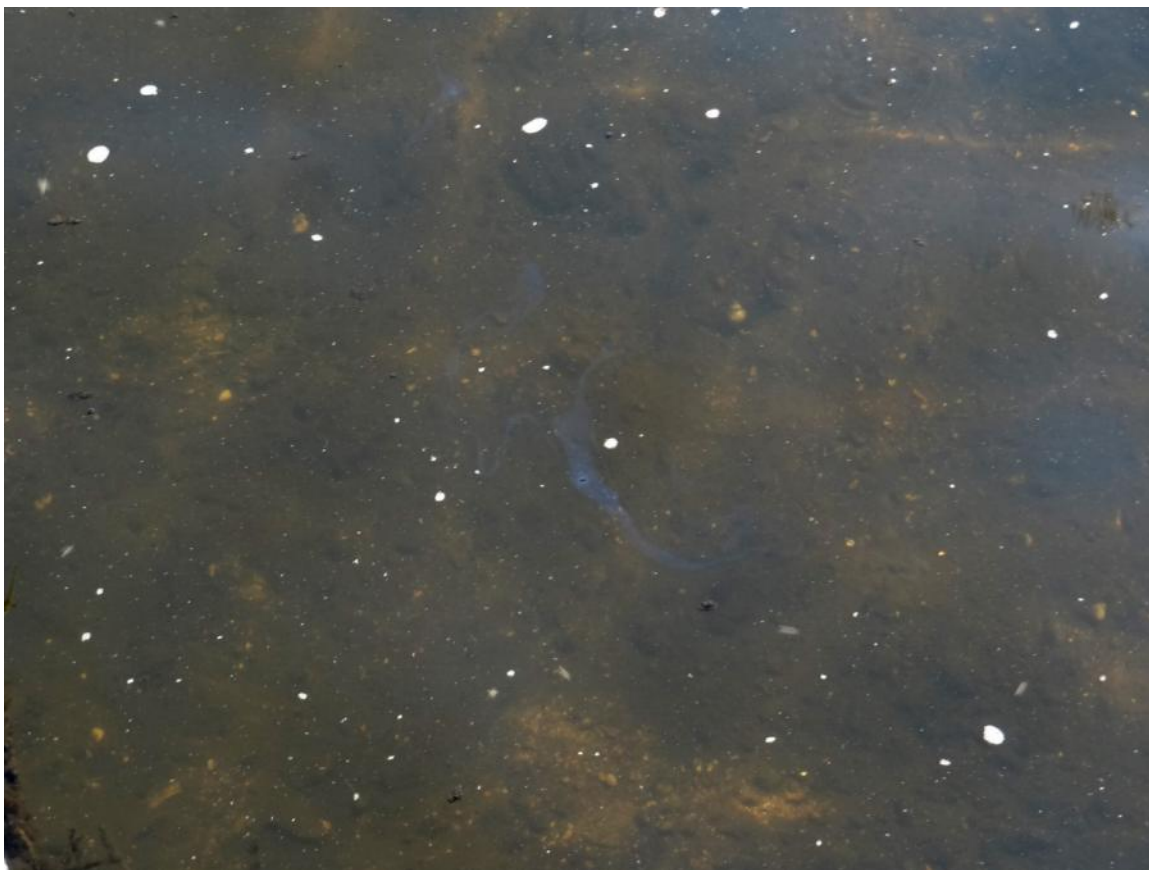
11. MP5.97 sheen and tar fleck observed downstream of Ceresco Dam.

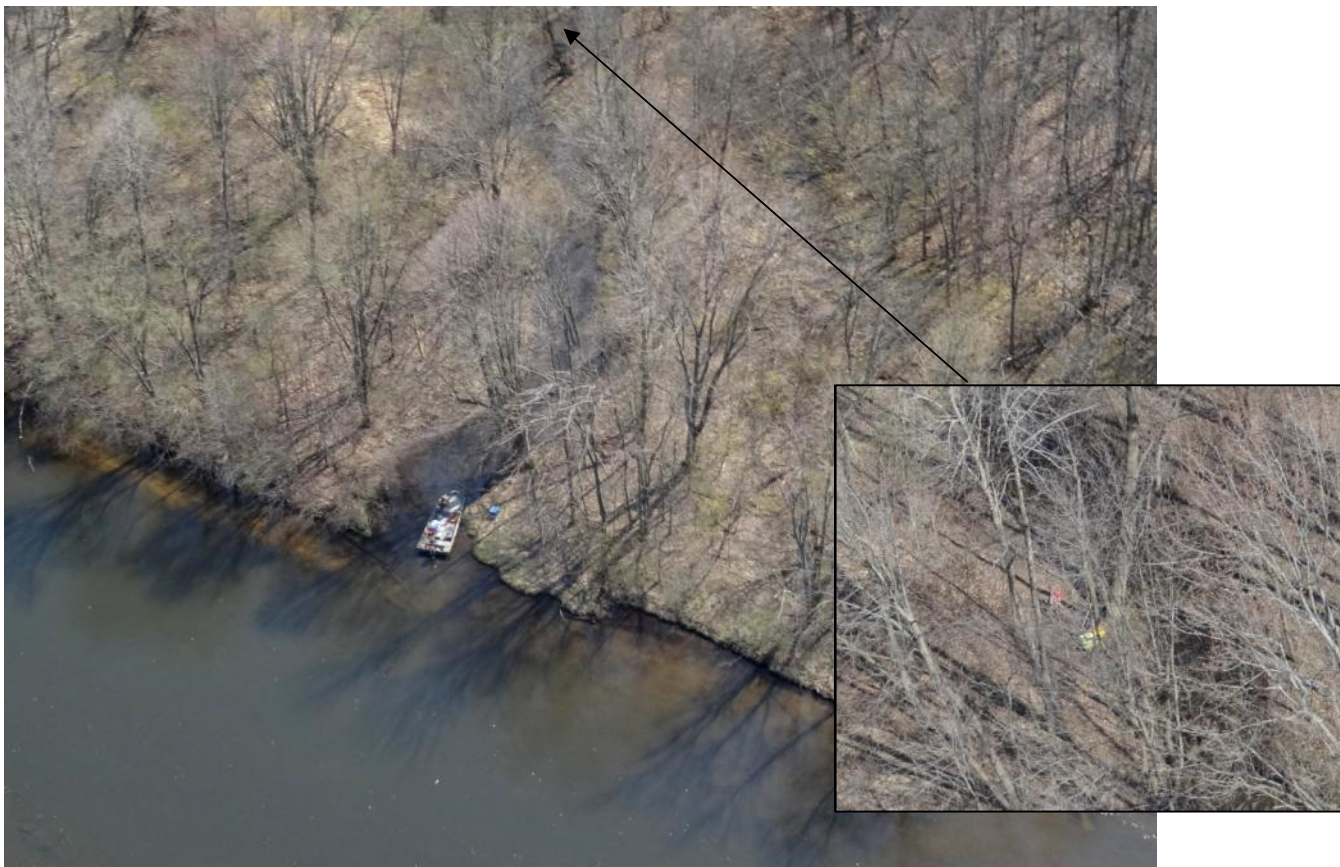
12. MP7.0 LDB overbank RI crew observed.

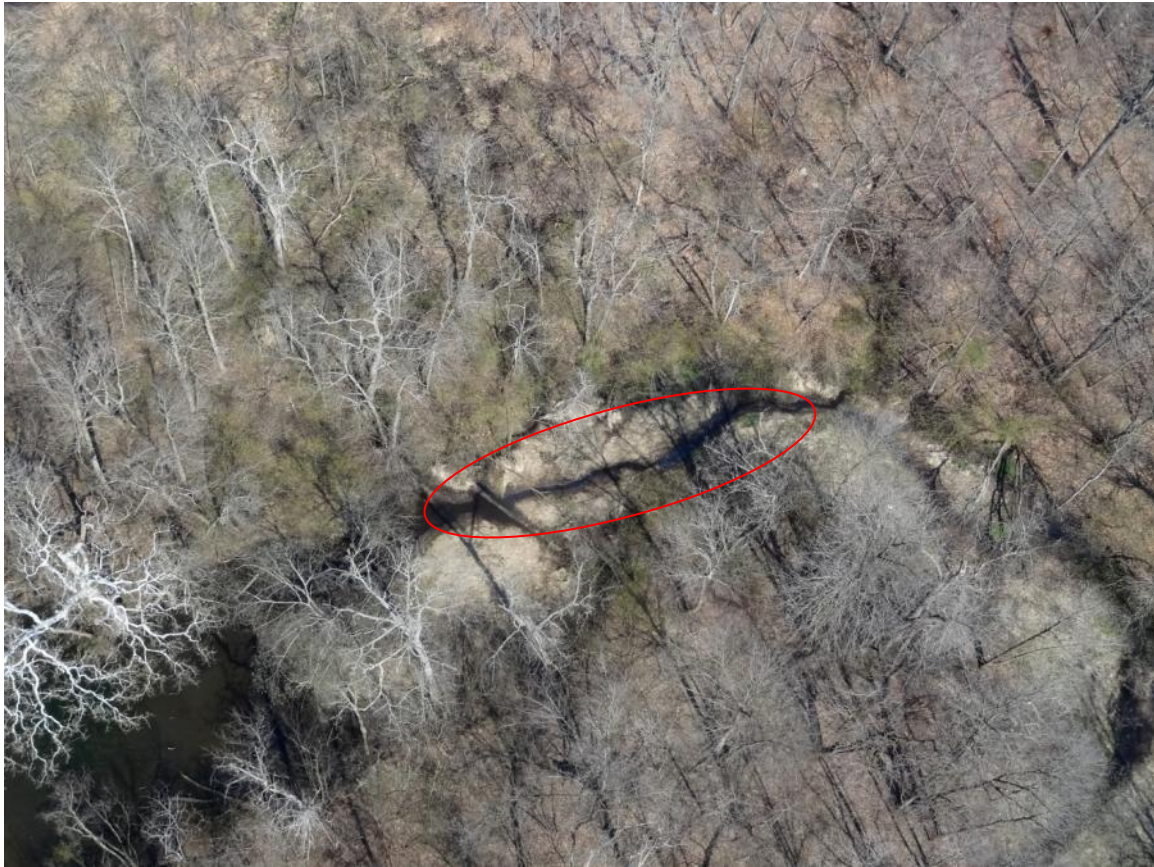
13. MP 8.8 RDB overbank sheen observed in channel.

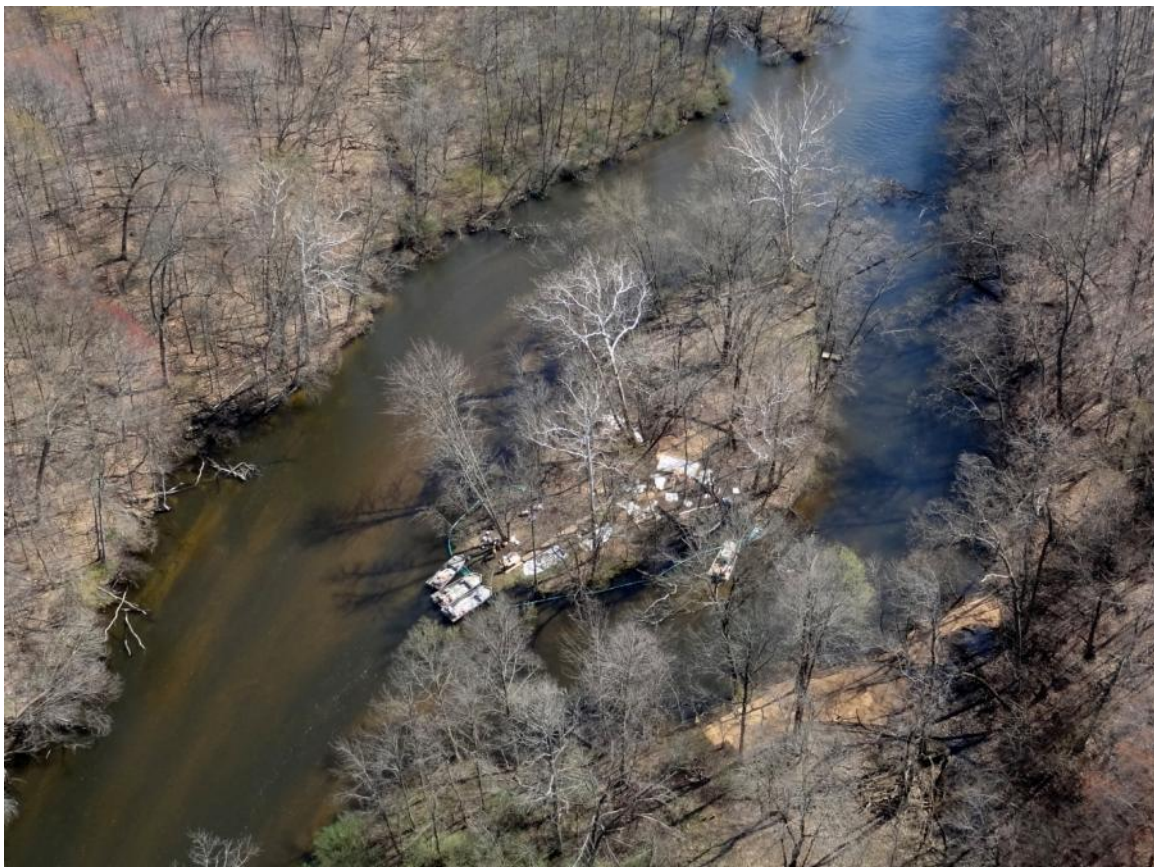
14. Scrape continuing at OB 8.97.

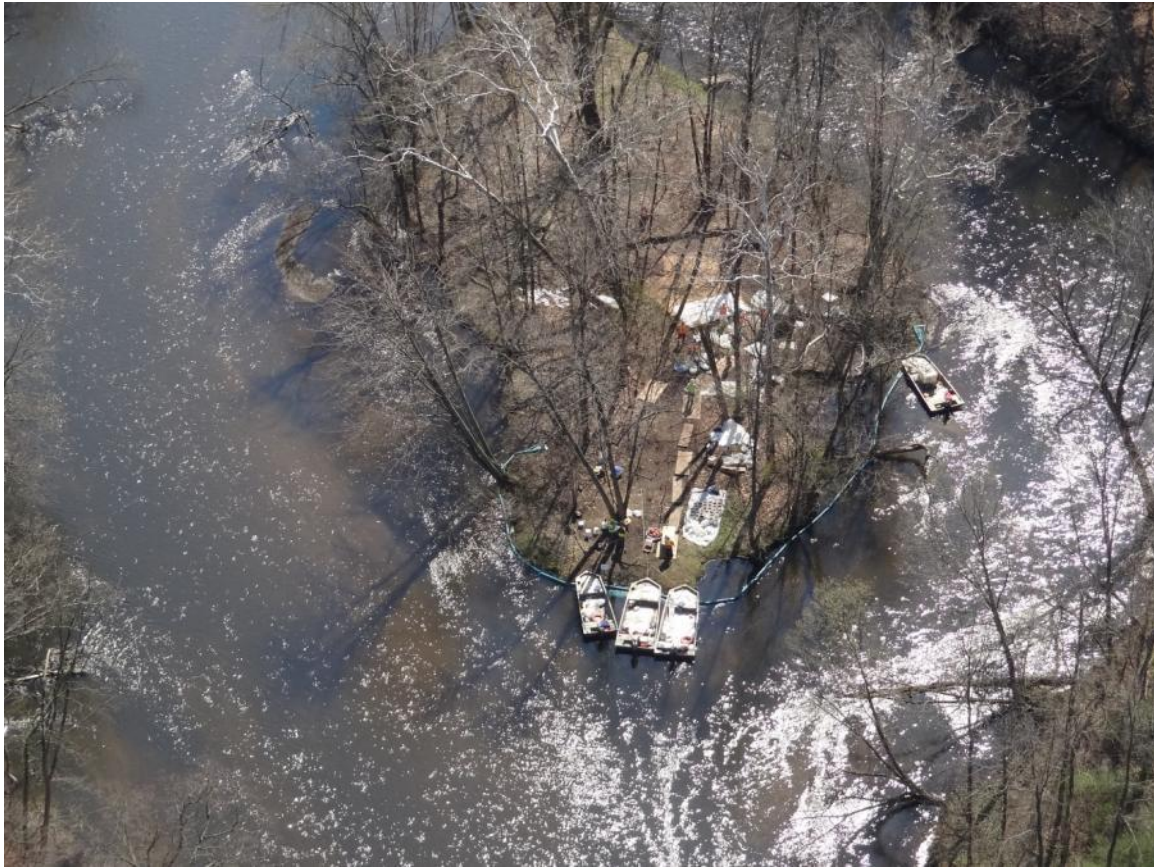
15. Scrape continuing at OB 8.97.

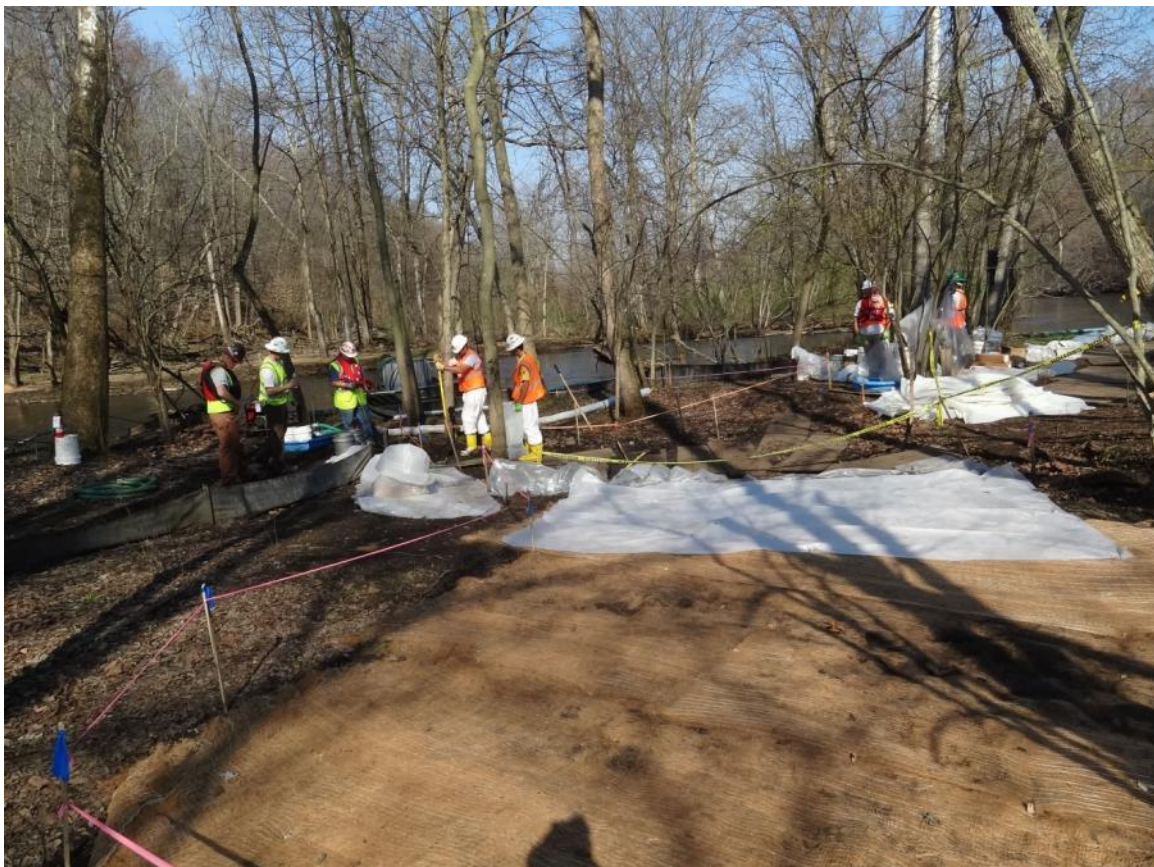
16. Scrape continuing at OB 8.97.

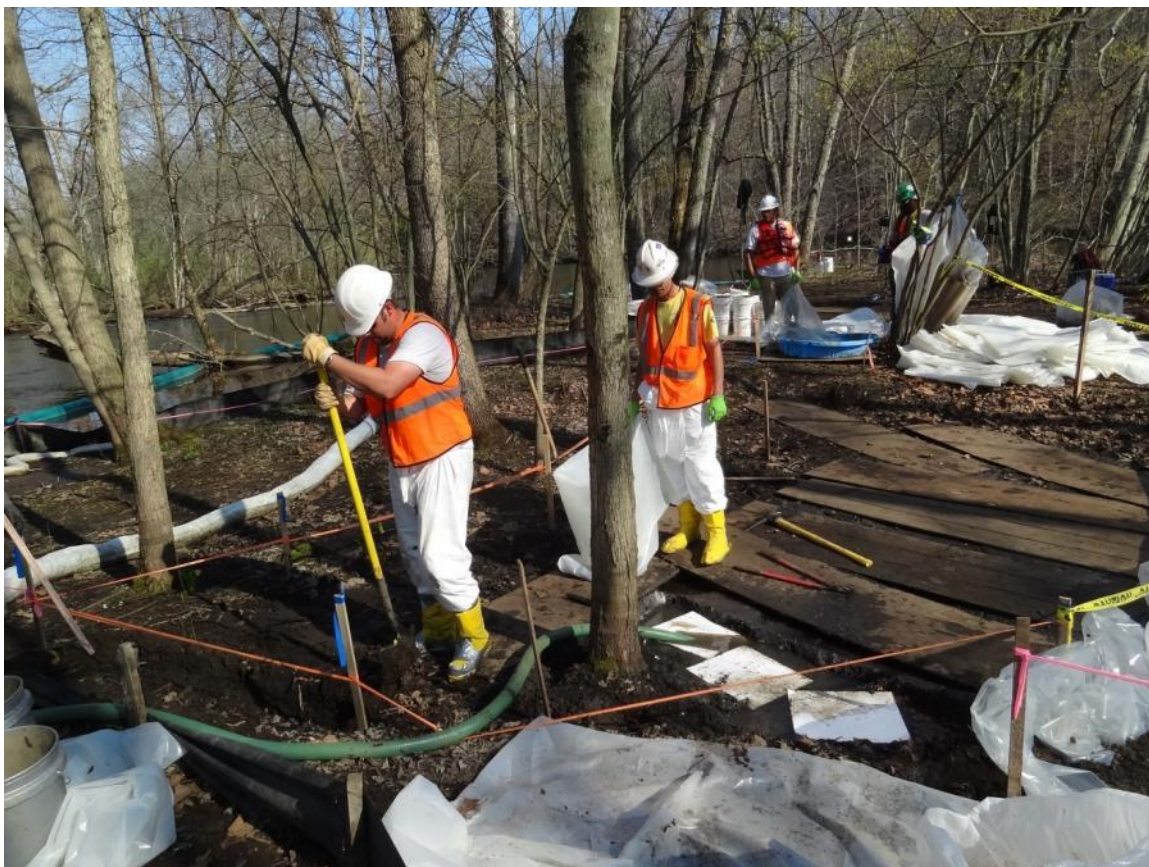
17. Scrape continuing at OB 8.97.

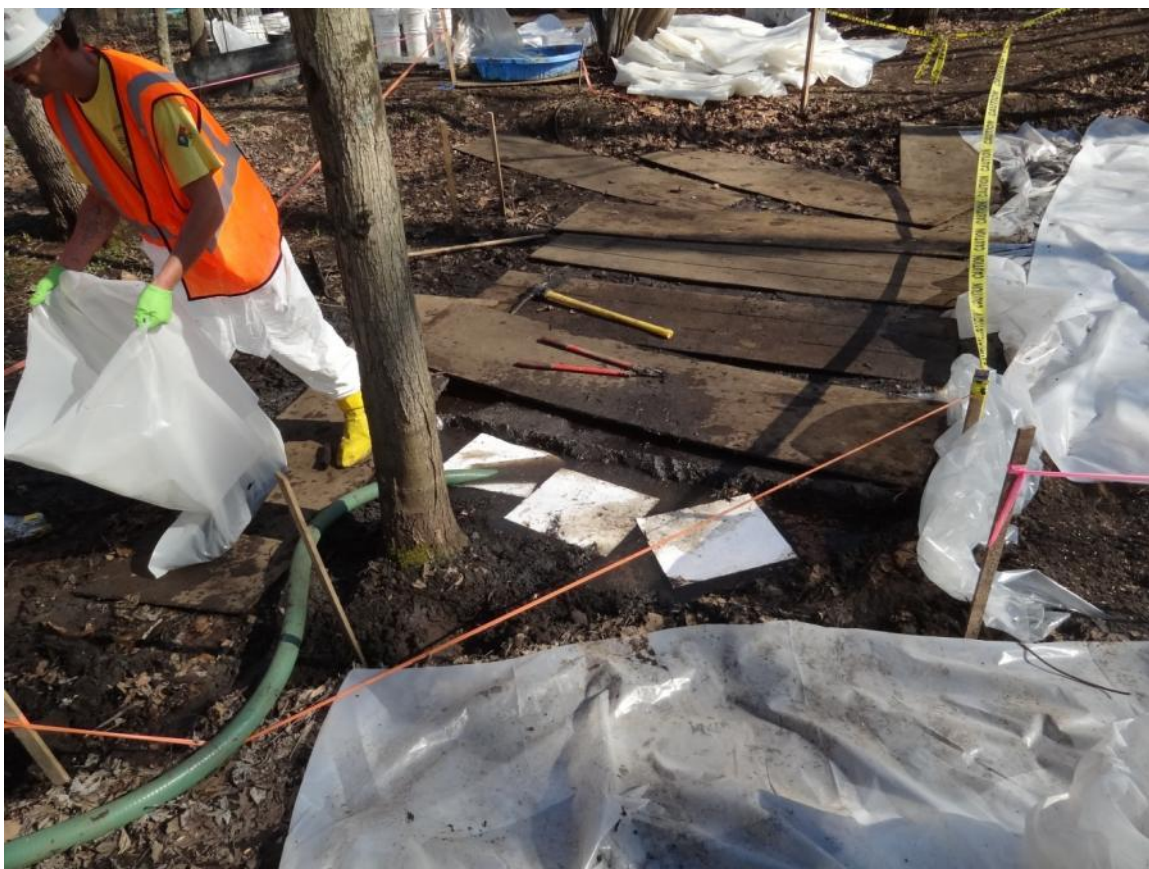
18. Scrape at OB 8.97 dewatering.

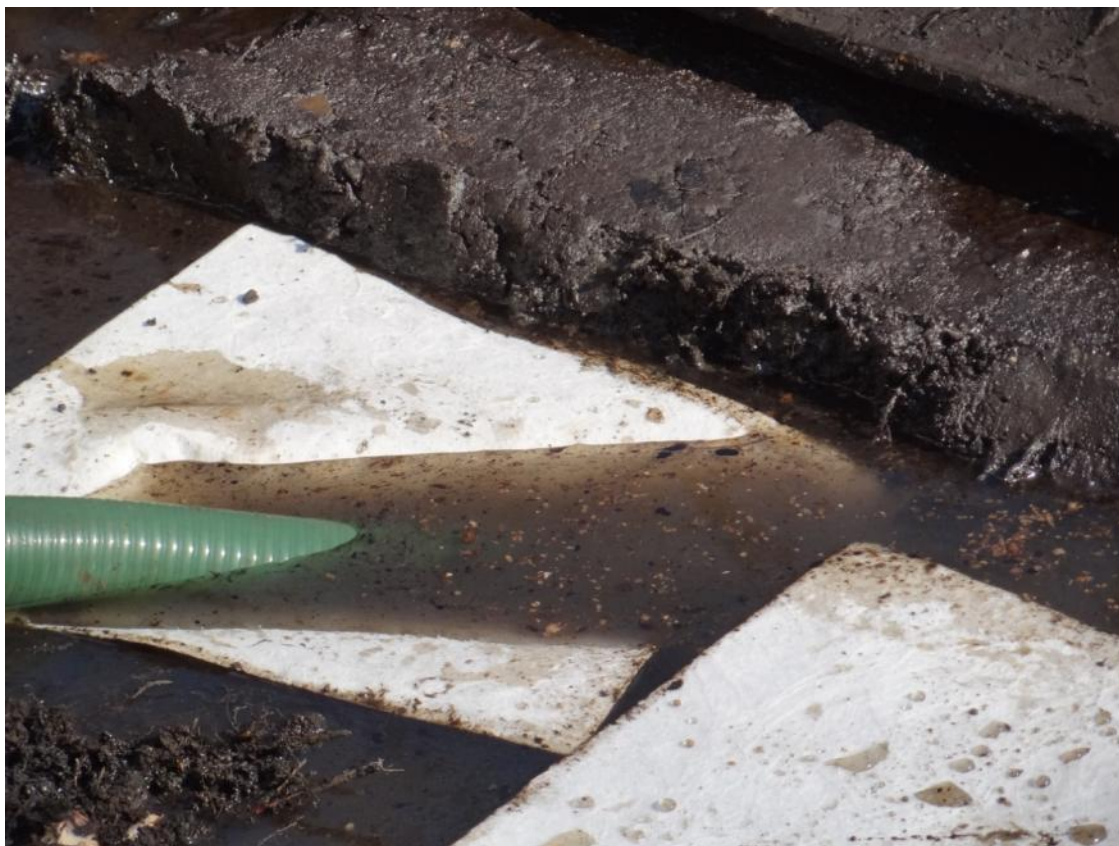
19. Scrape at OB 8.97 dewatering.

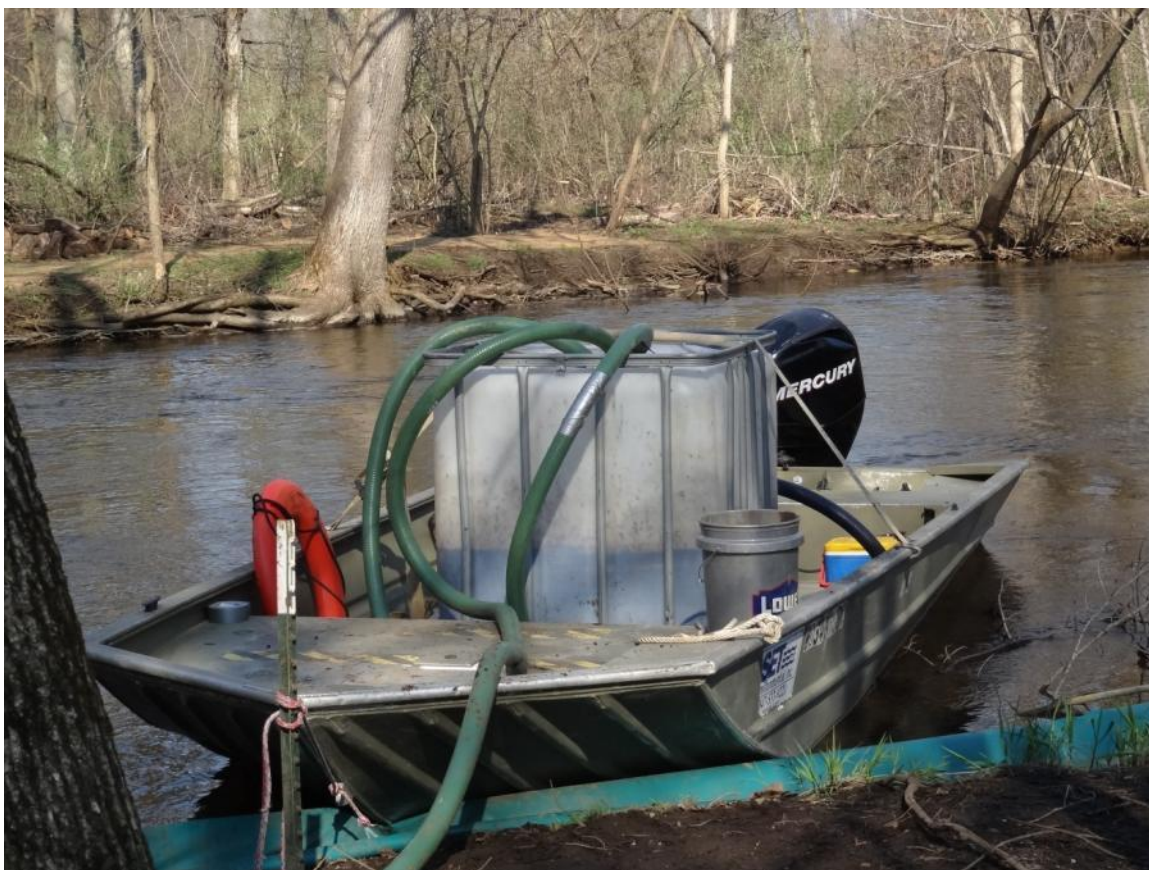
20. Scrape at OB 8.97 dewatering into tote on boat.

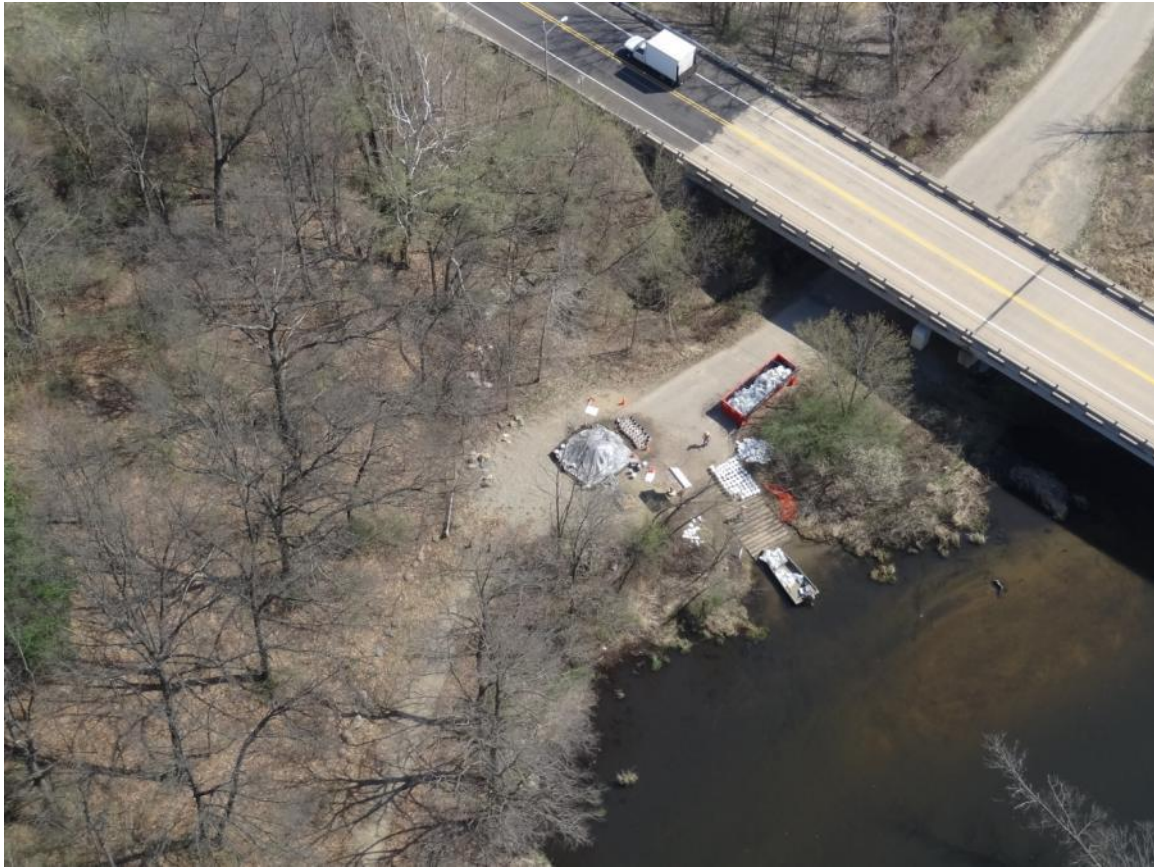
**21. Historic Bridge Park soil staging area for the OB8.97.**

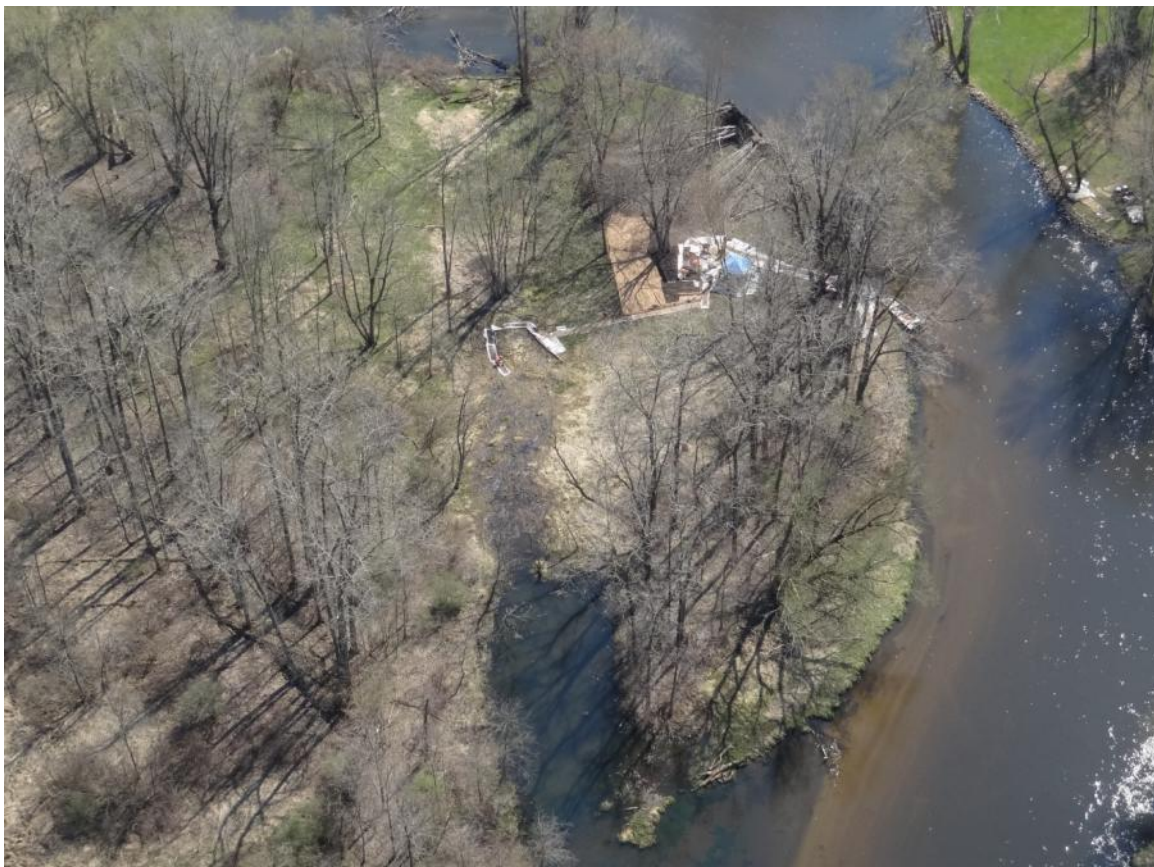
**22. Scrape work at OB10.37 continues.**

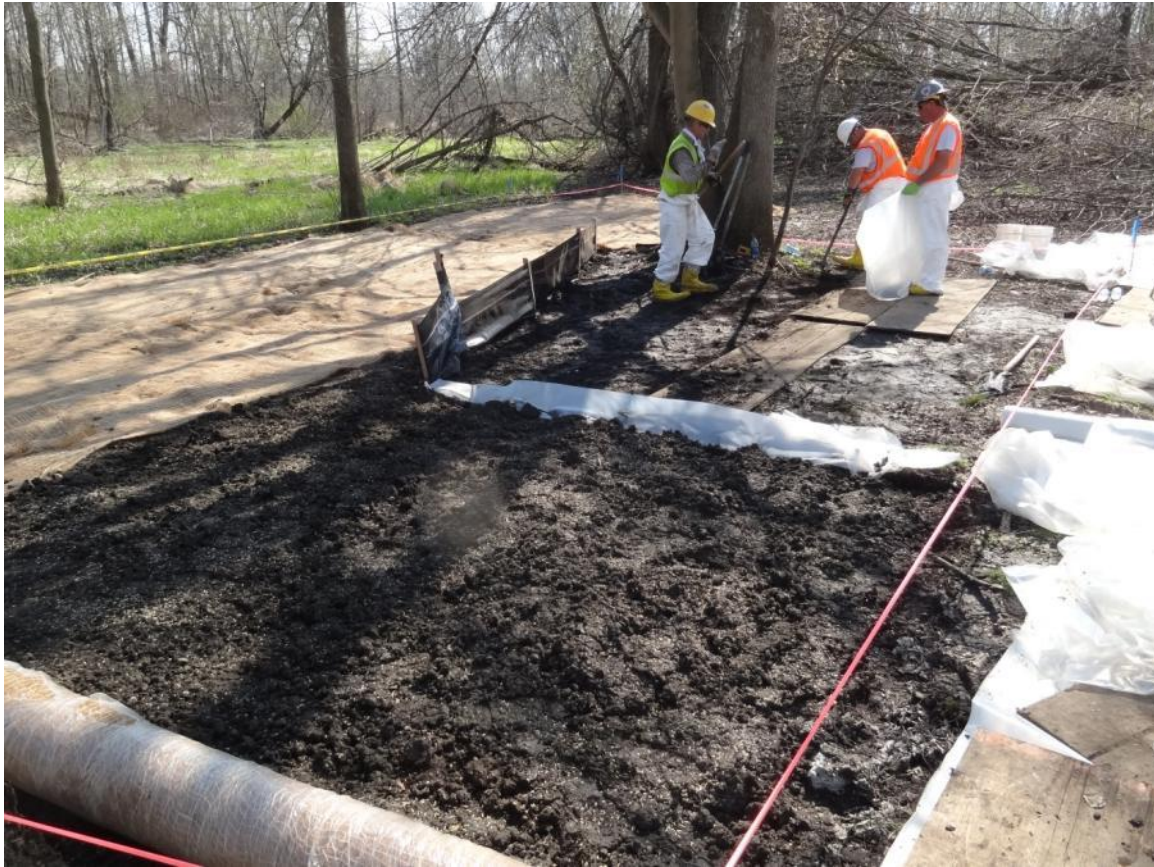
**23. Scrape activities continued at OB10.37 RDB.**

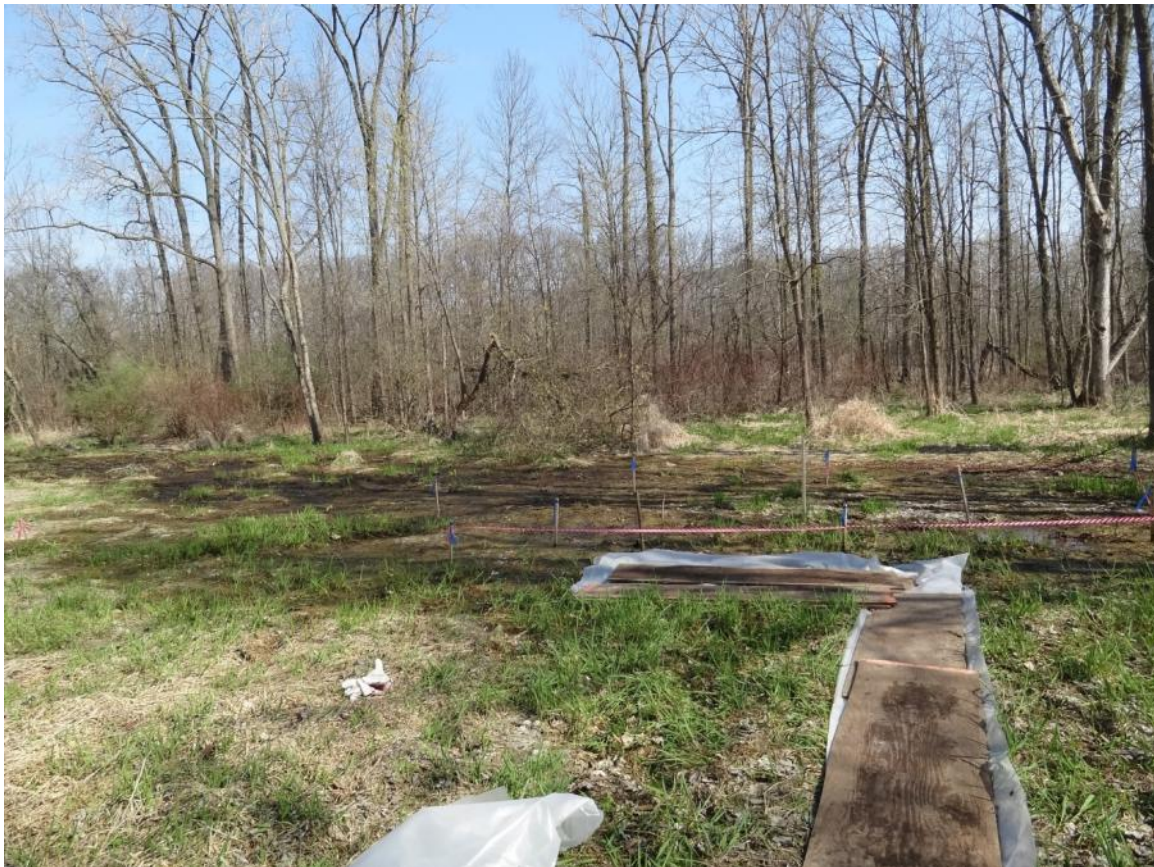
**24. Scrape work at OB10.37 RDB continues.**

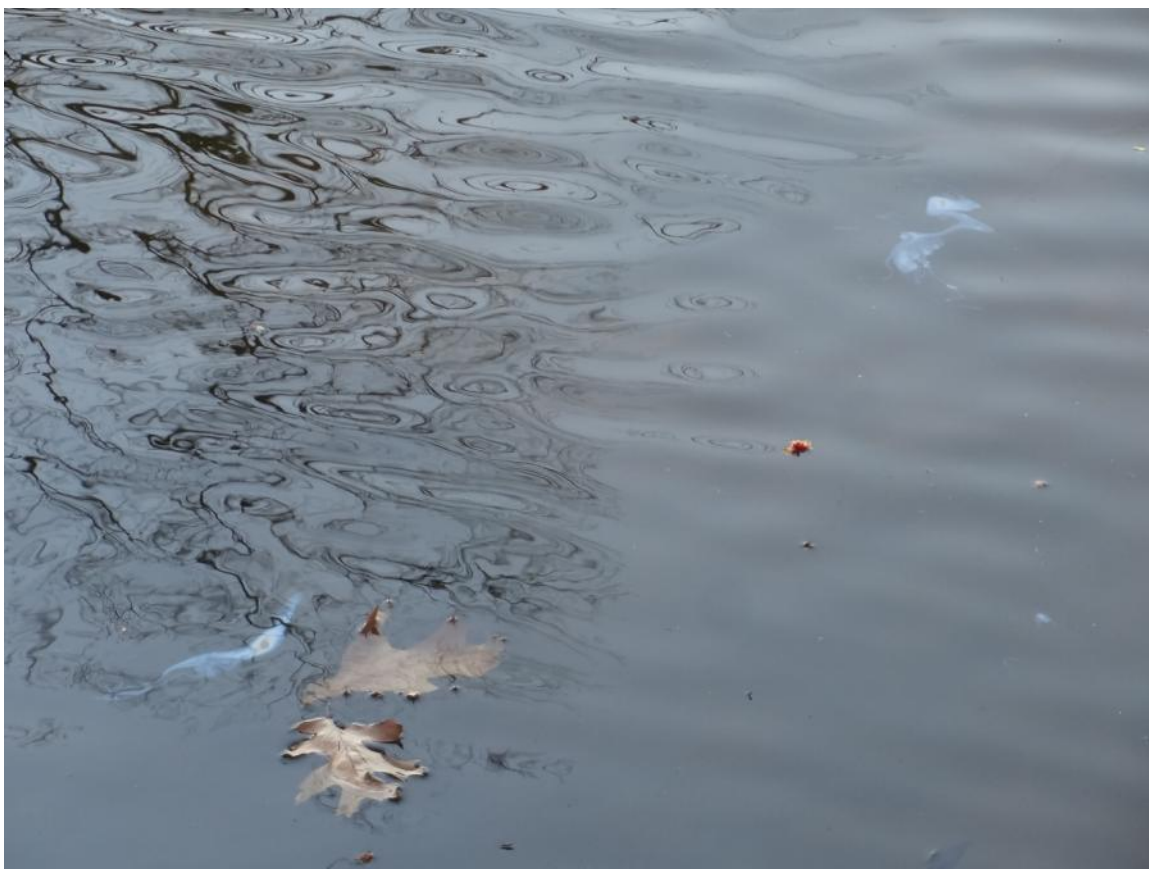
26. MP14.75 C5 Boat Launch sheen observed.

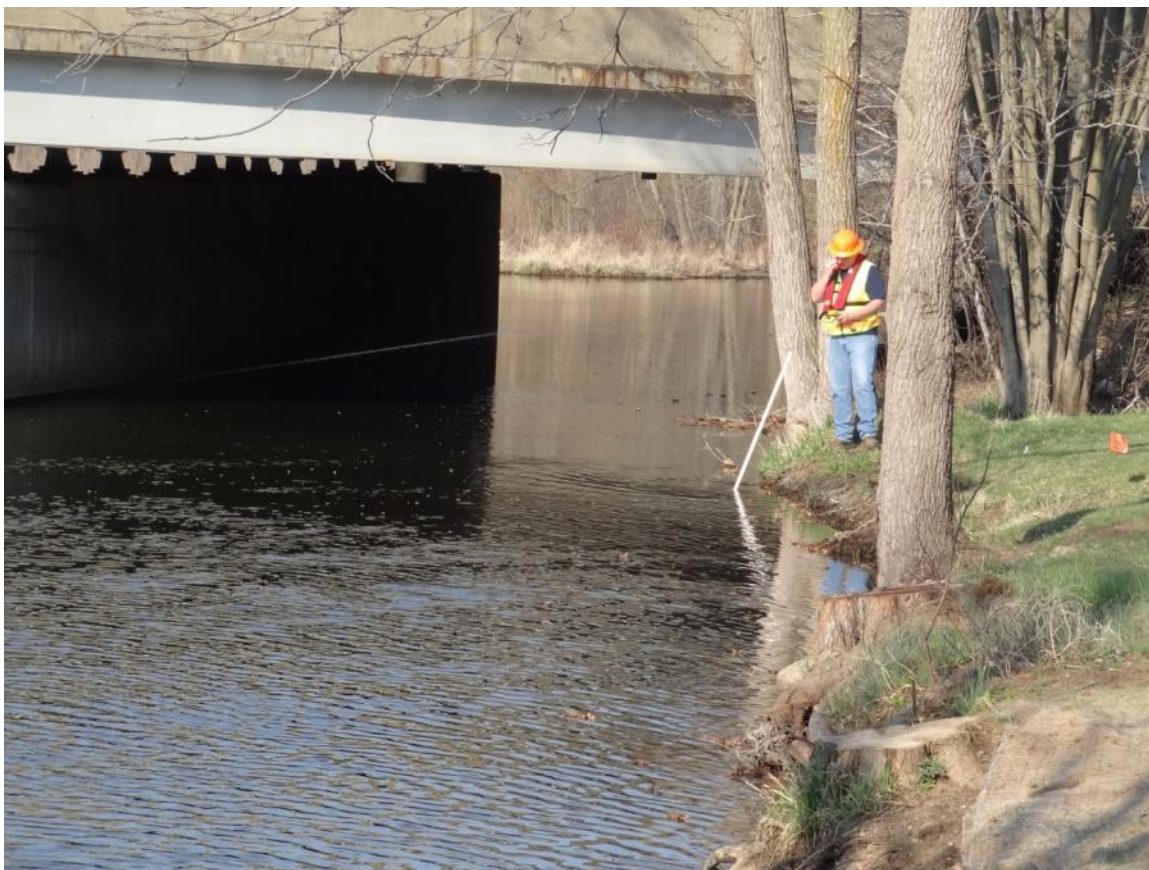
**27. MP14.75 C5 Boat Launch observed crew taking water and sediment temperatures.**
