# Situation Photo Log

Wednesday, March 21, 2012

Kalamazoo River / Enbridge Spill

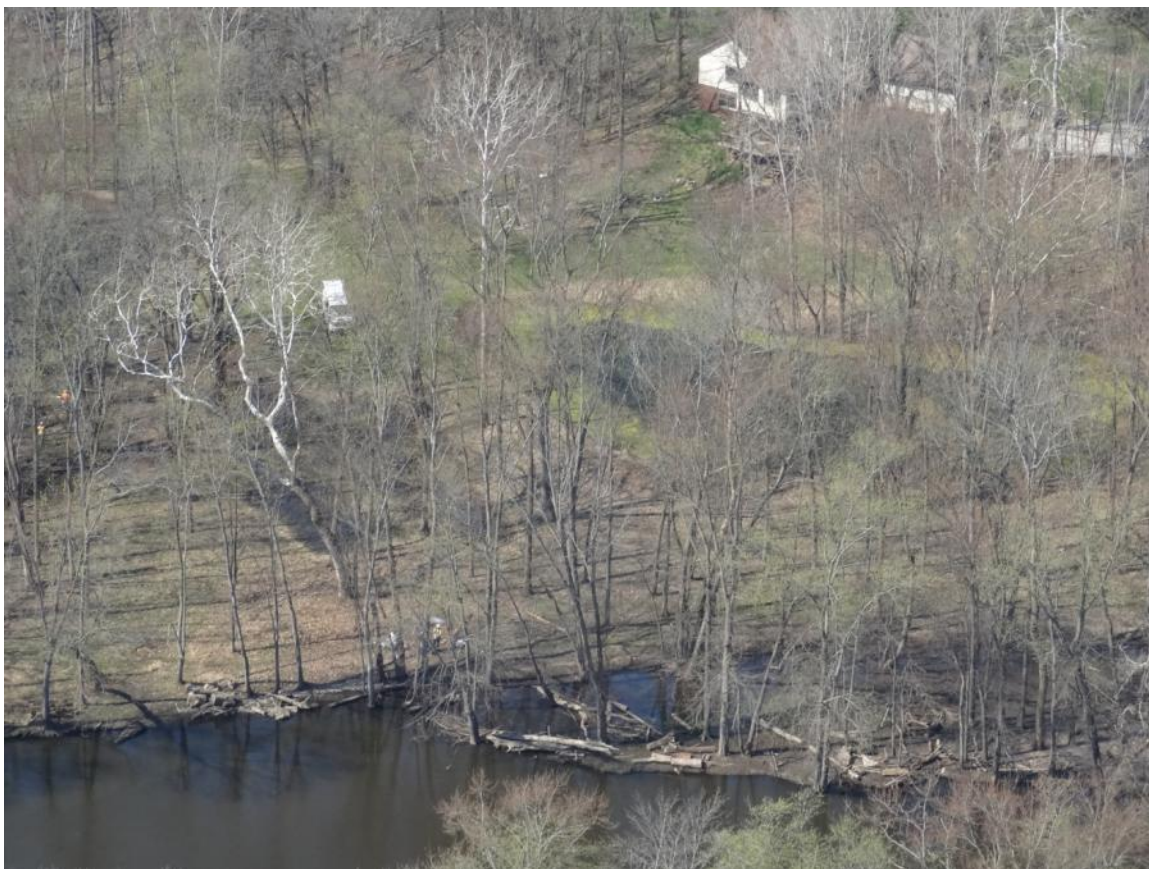
**28. MP27.5 observed sampling crews.**
