# Situation Photo Log

Thursday, March 22, 2012

Kalamazoo River / Enbridge Spill

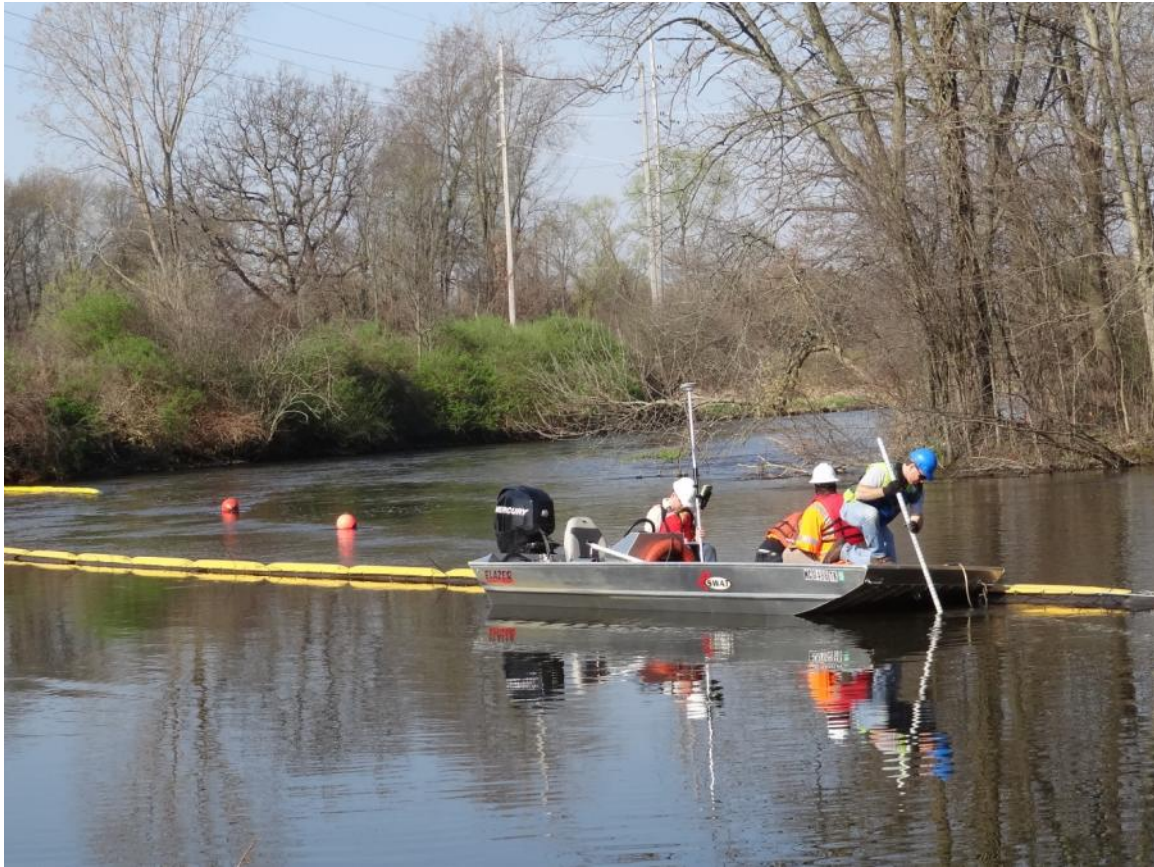
1. Confluence poling along the boom and curtain.

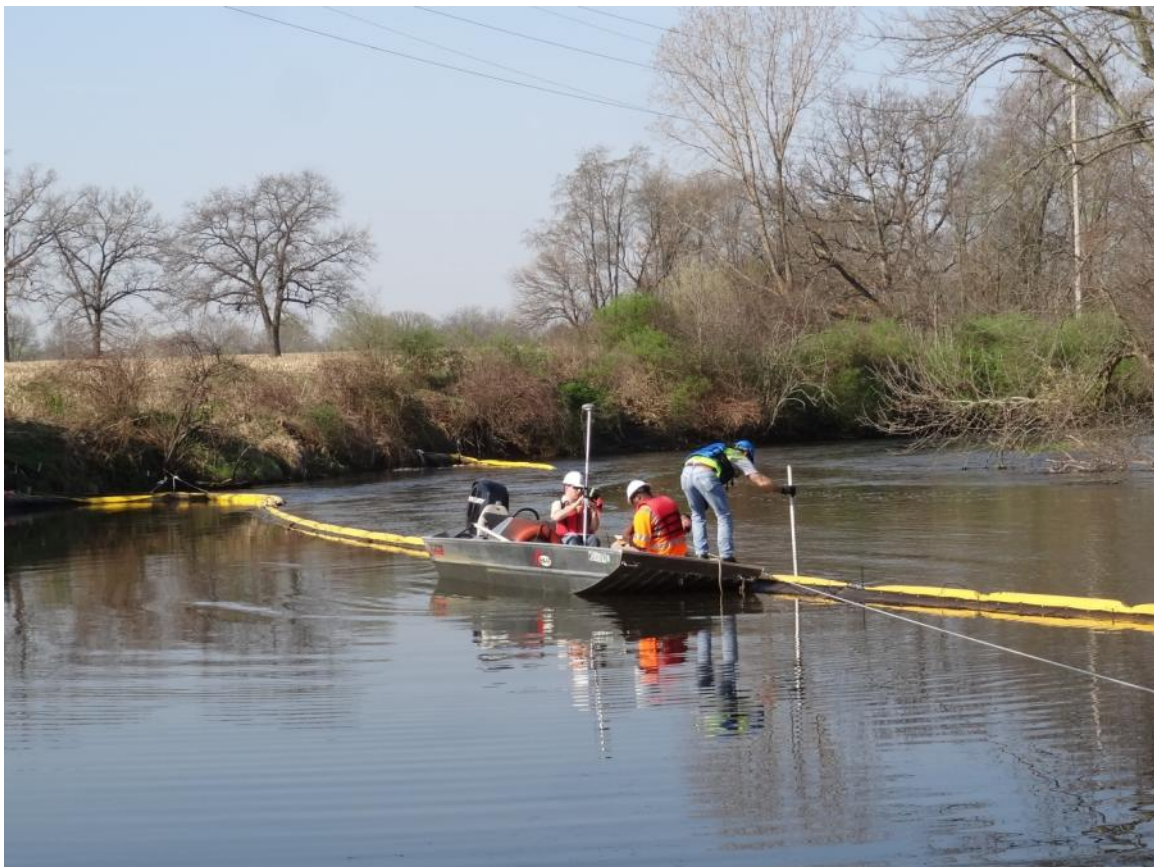
2. Confluence poling along the boom and curtain.

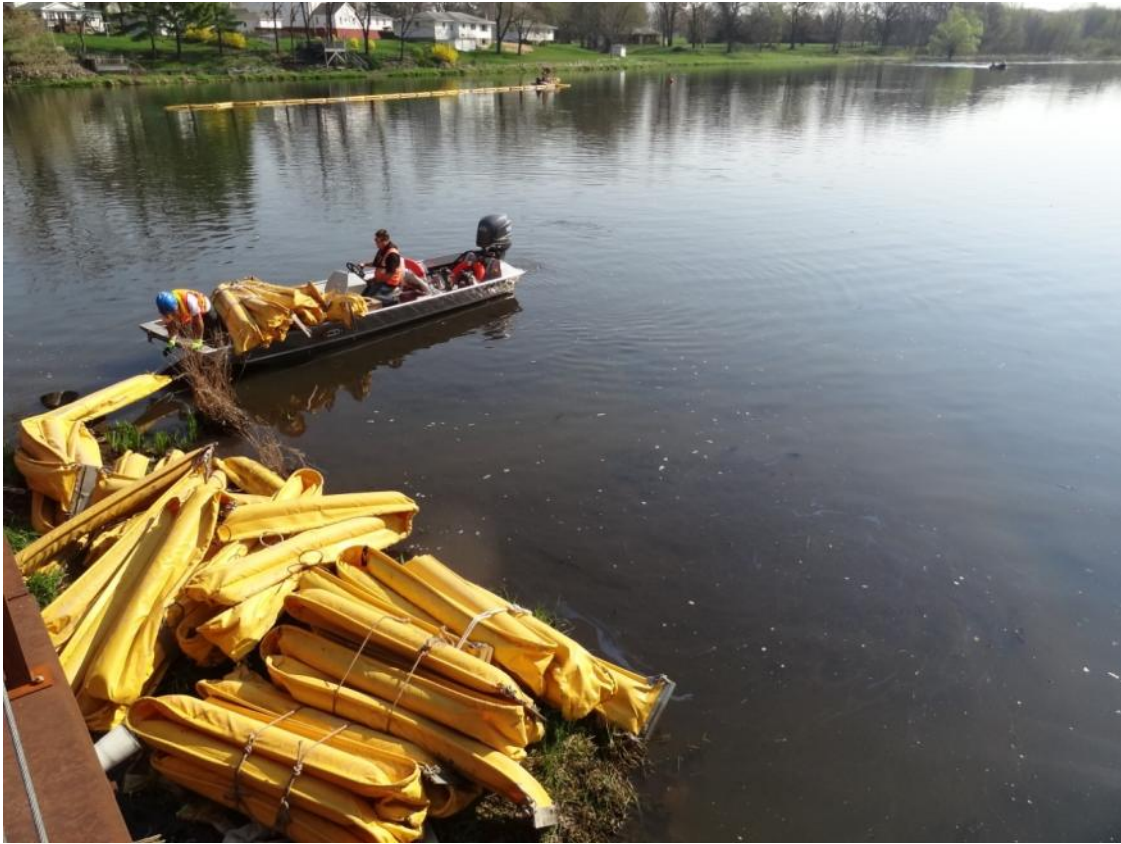
3. Ceresco Dam SWAT crew observed deploying boom.

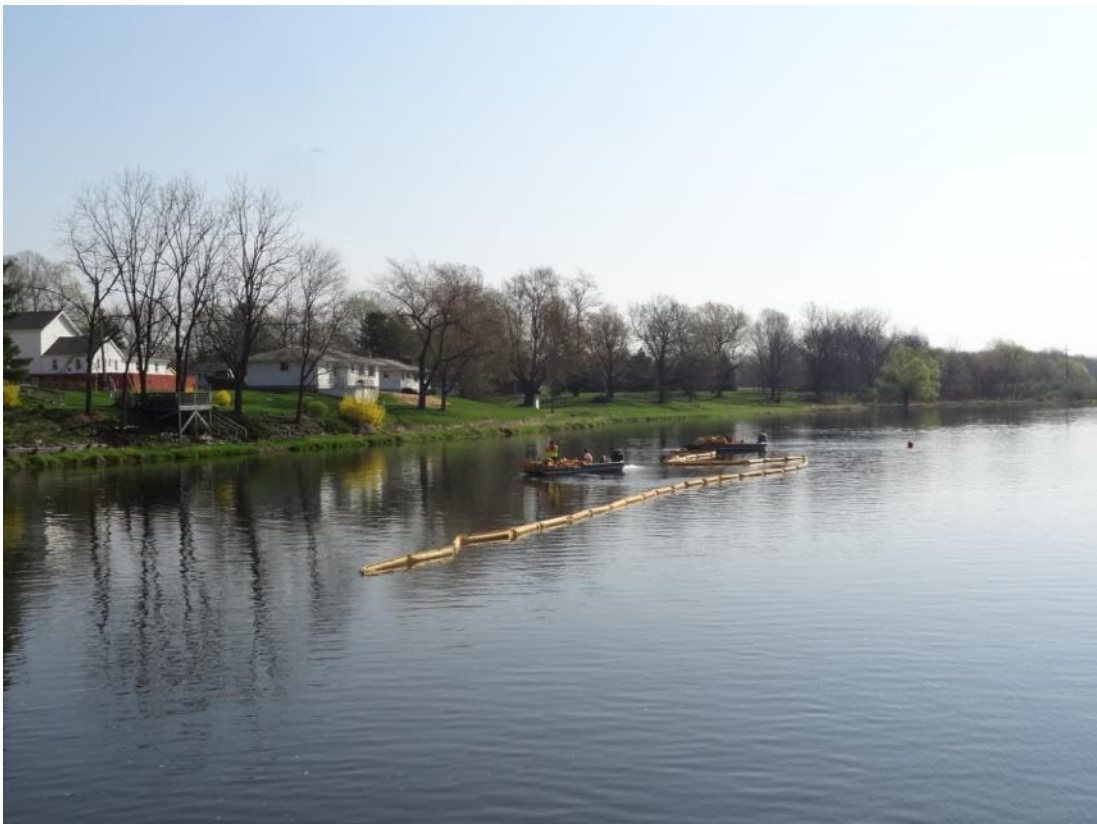
4. Ceresco Dam SWAT crew observed deploying boom.

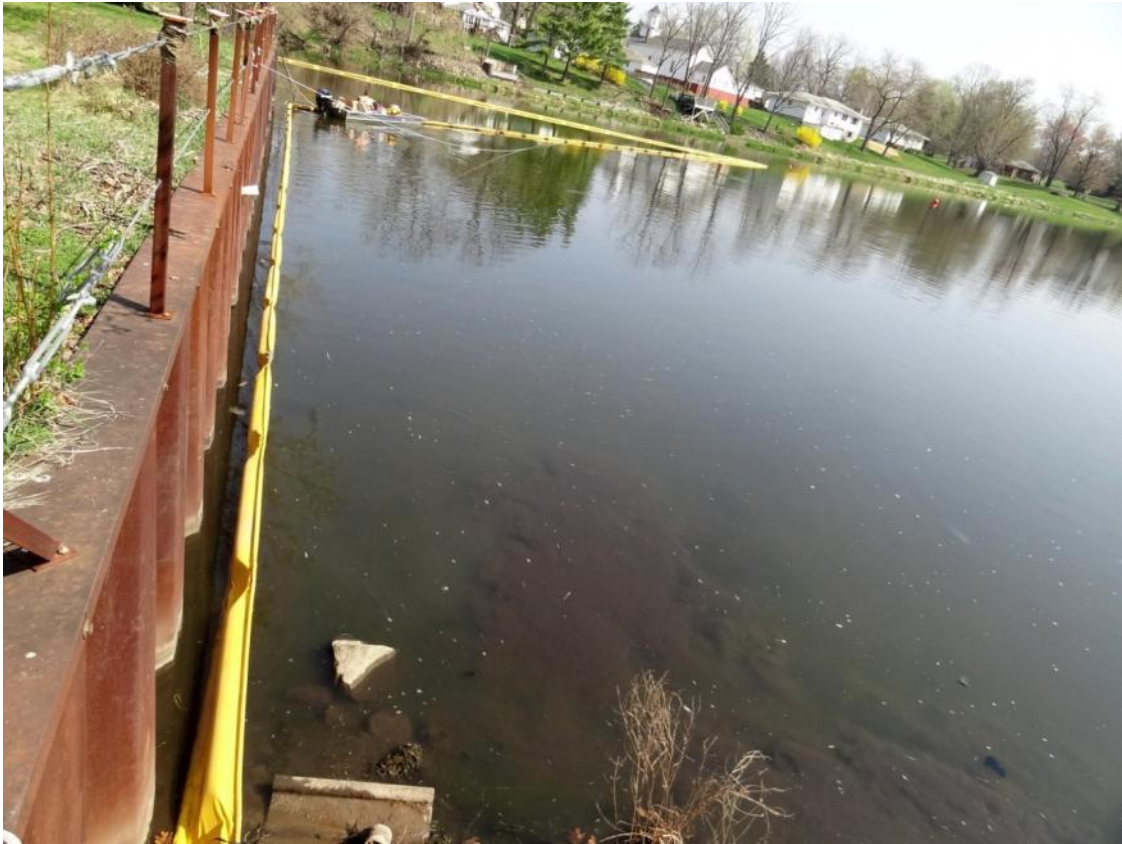
5. Ceresco Dam SWAT crew observed deploying boom.

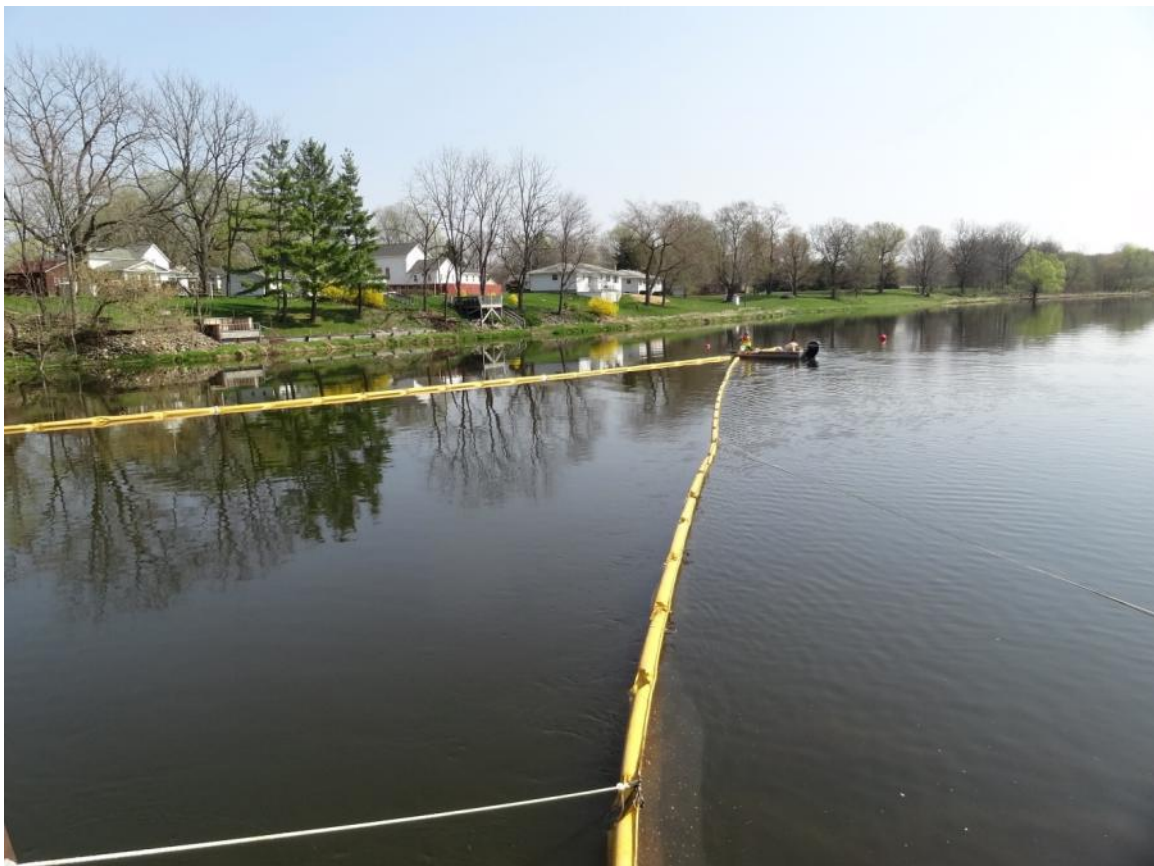
6. Ceresco Dam SWAT crew observed deploying boom.

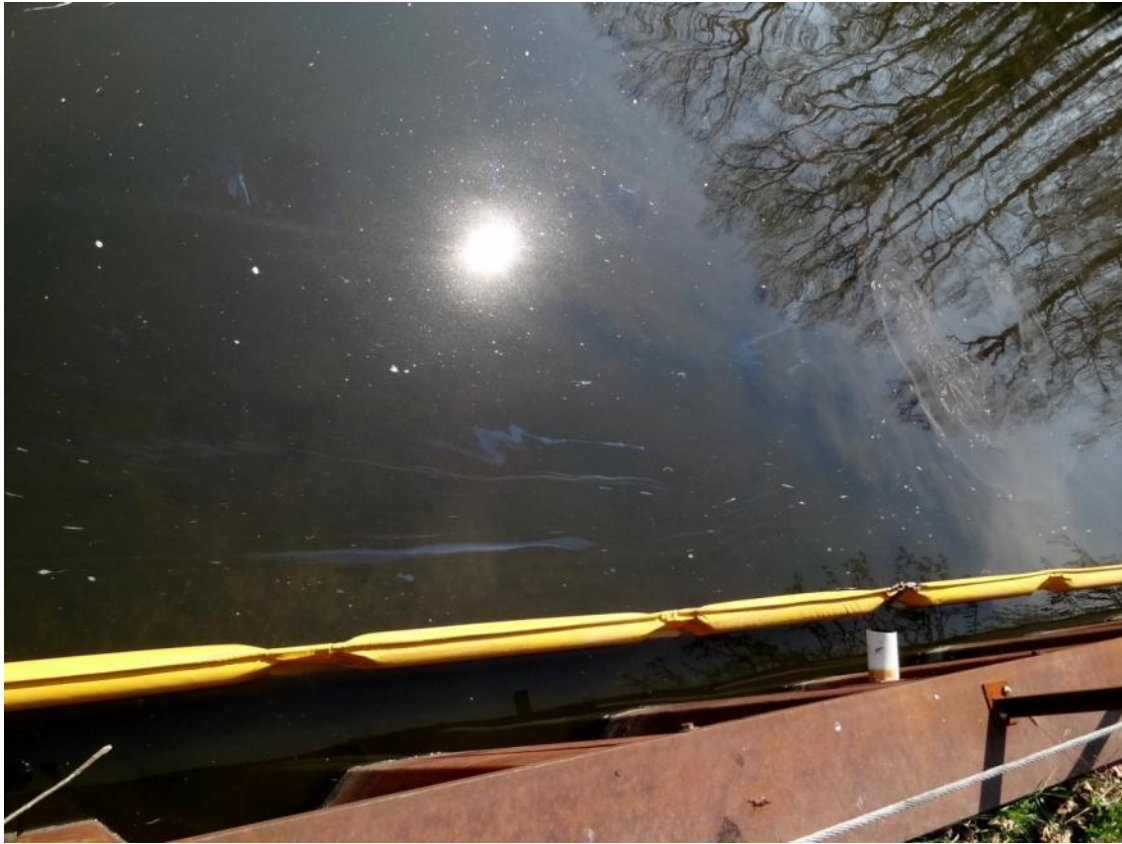
7. Ceresco Dam sheen collecting within boom.

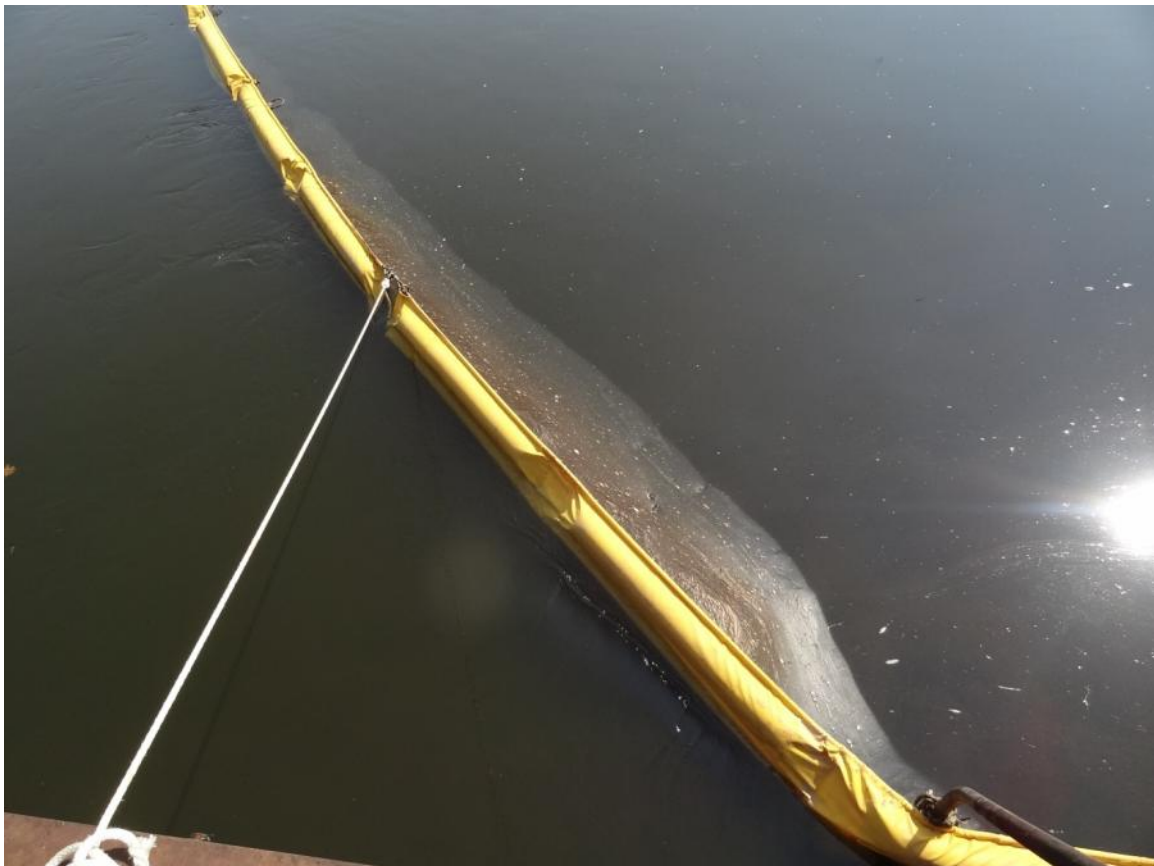
8. Ceresco Dam sheen collecting within boom.

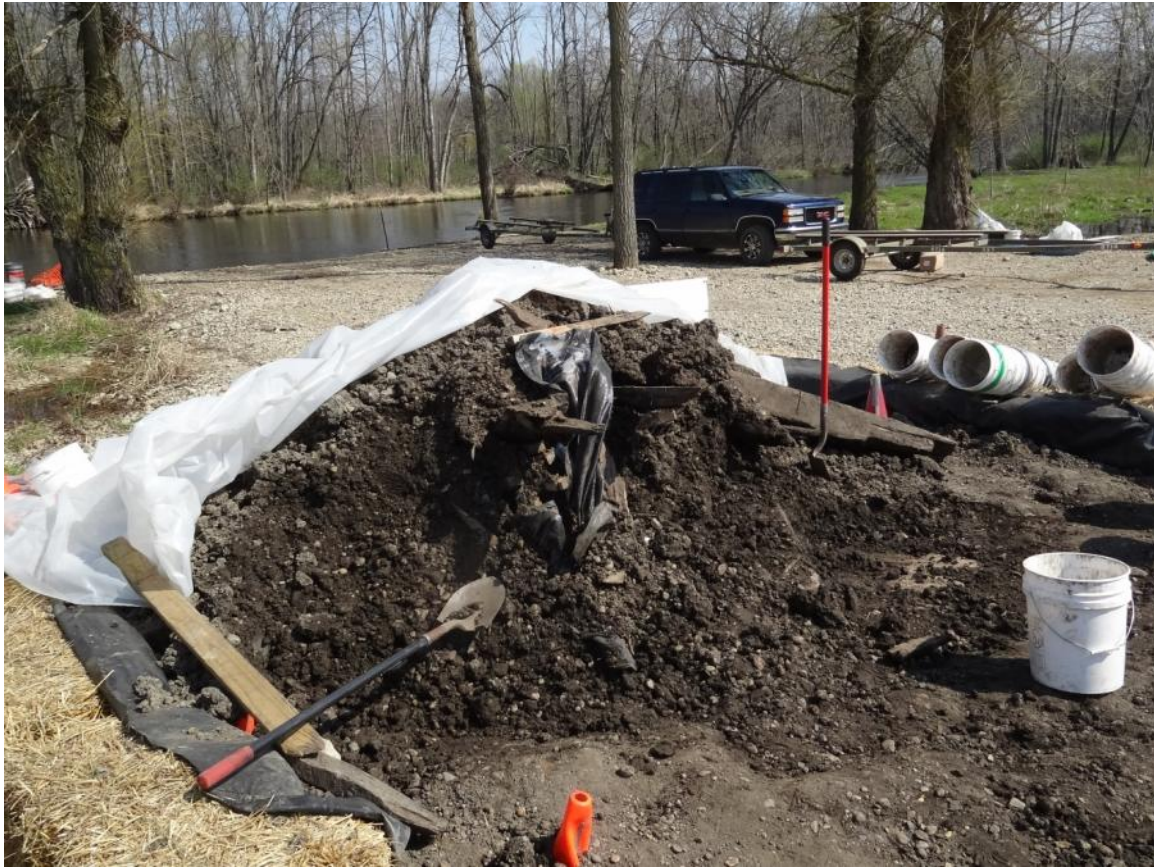
9. OB10.37RDB backfill being utilized.

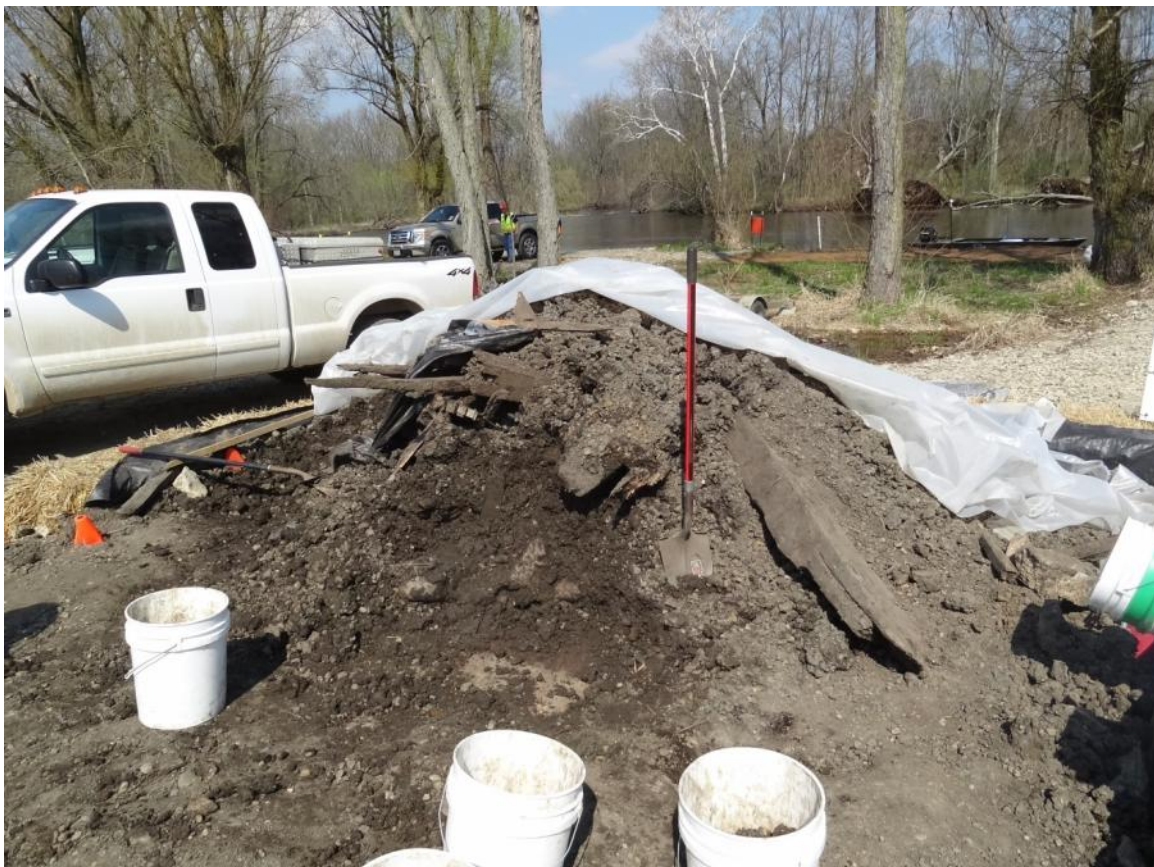
10. OB10.37RDB backfill being utilized.

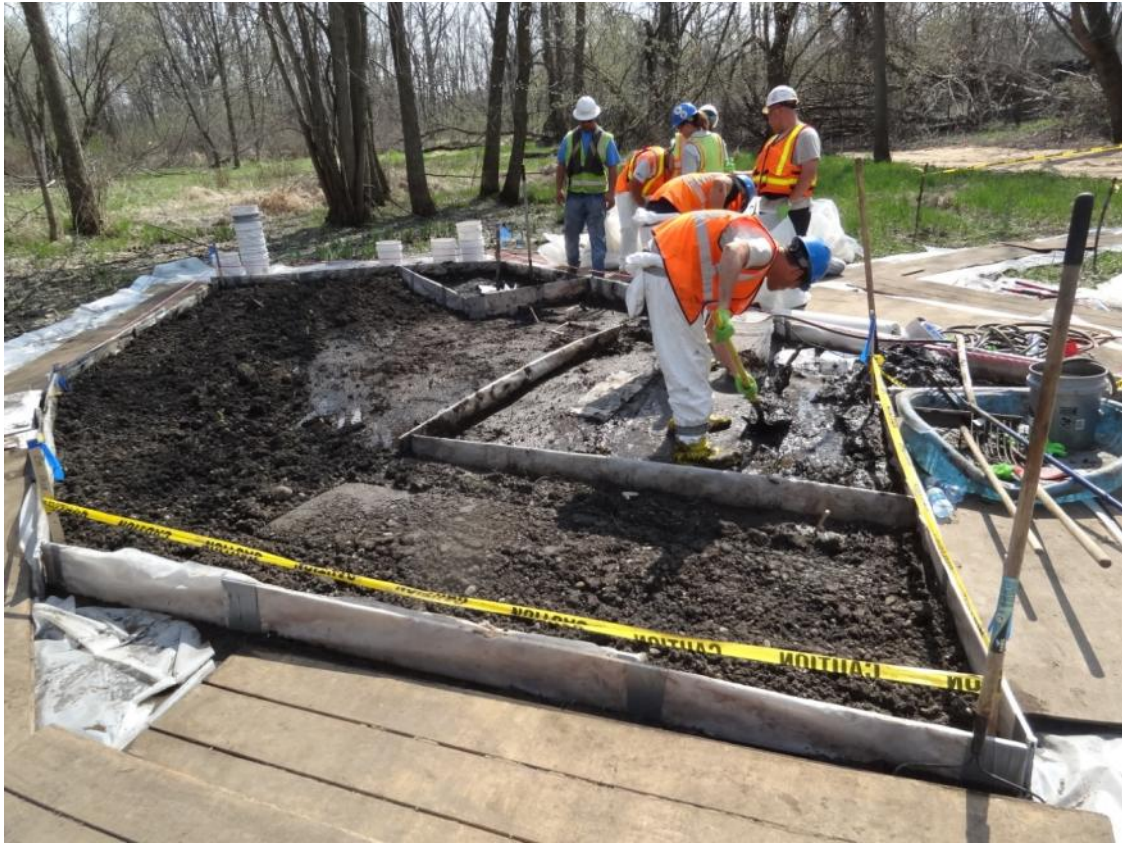
11. OB10.37 RDB scrape work continued.

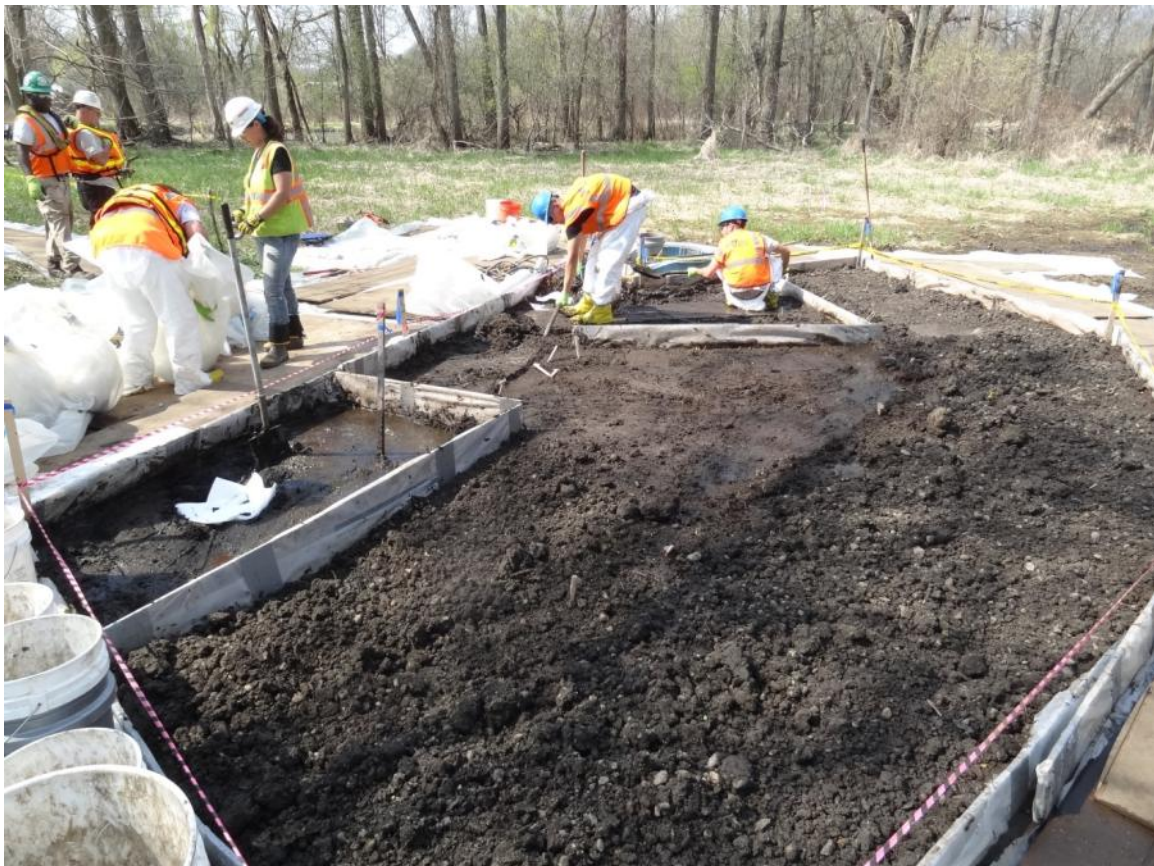
12. OB10.37 RDB scrape work continued.

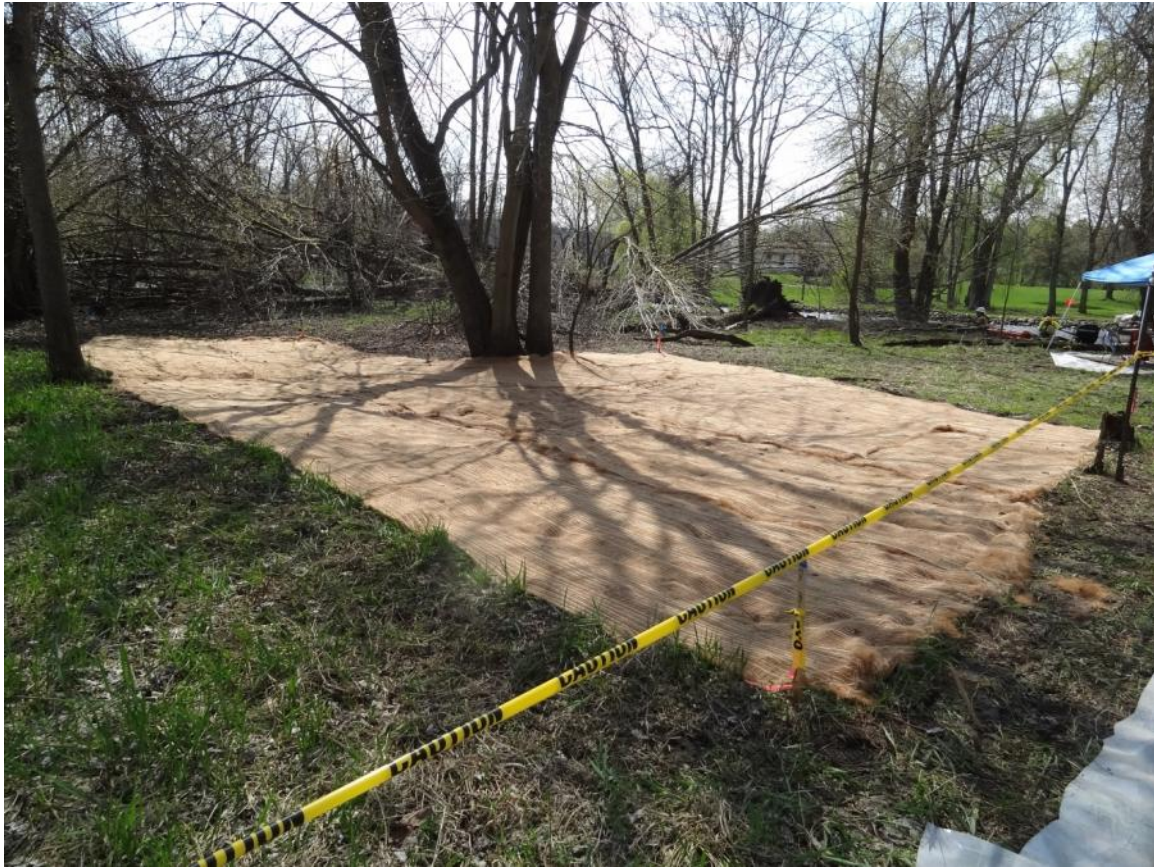
13. OB10.37 RDB restoration of scrape area.

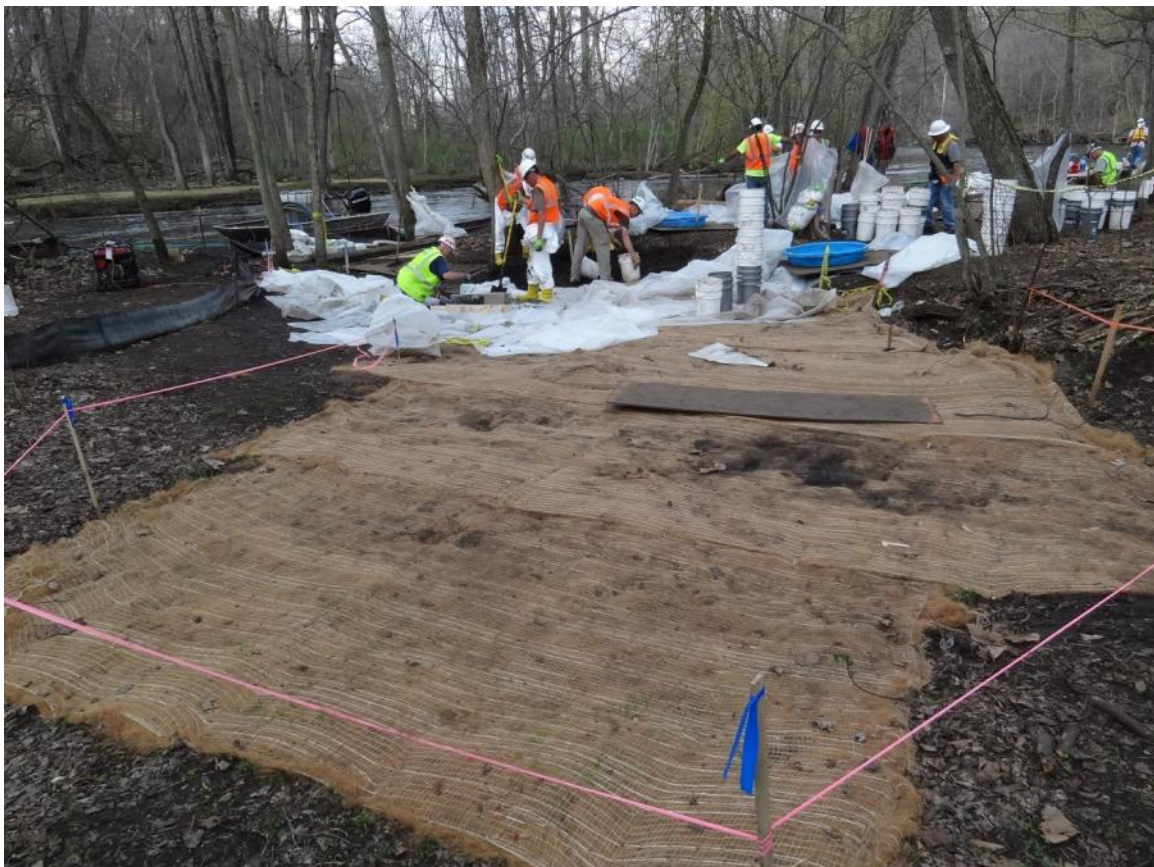
14. OB8.97 I scrape work continued.

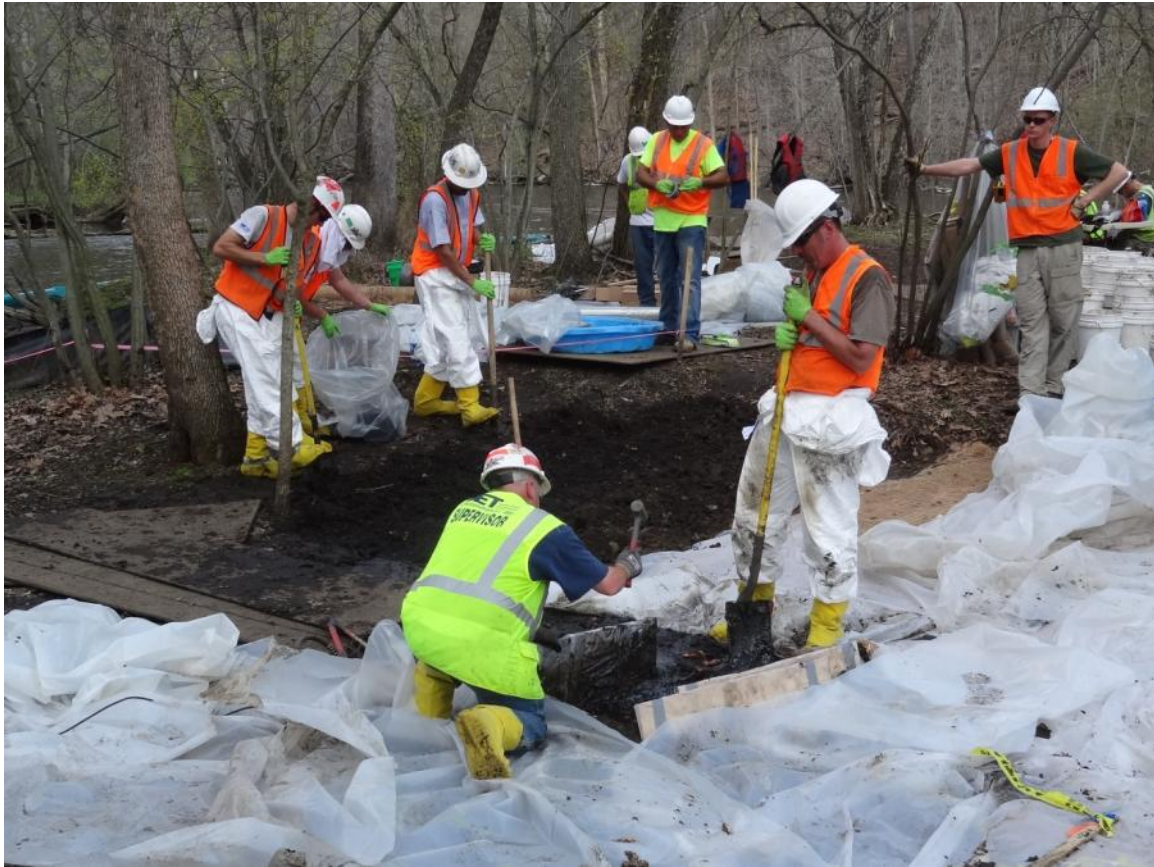
15. OB8.97 I scrape work continued.

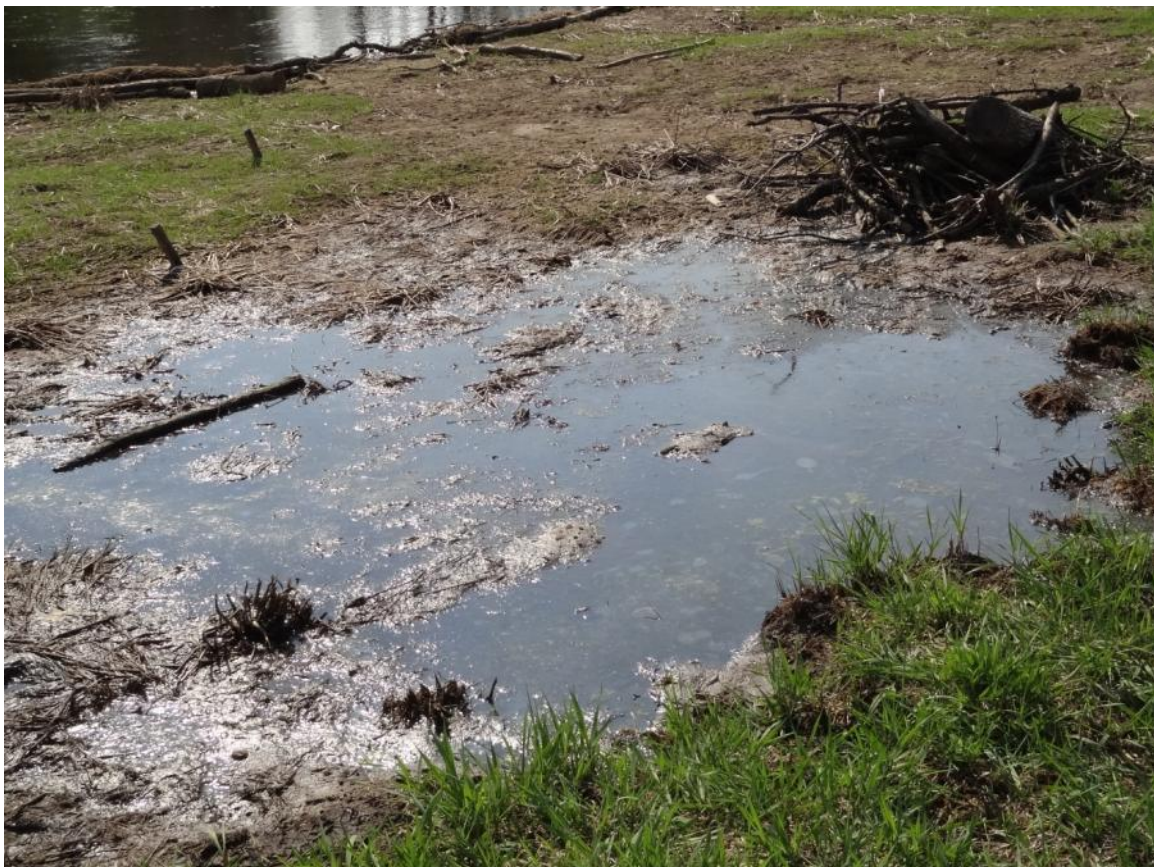
16. Island A tar globs and sheen observed.

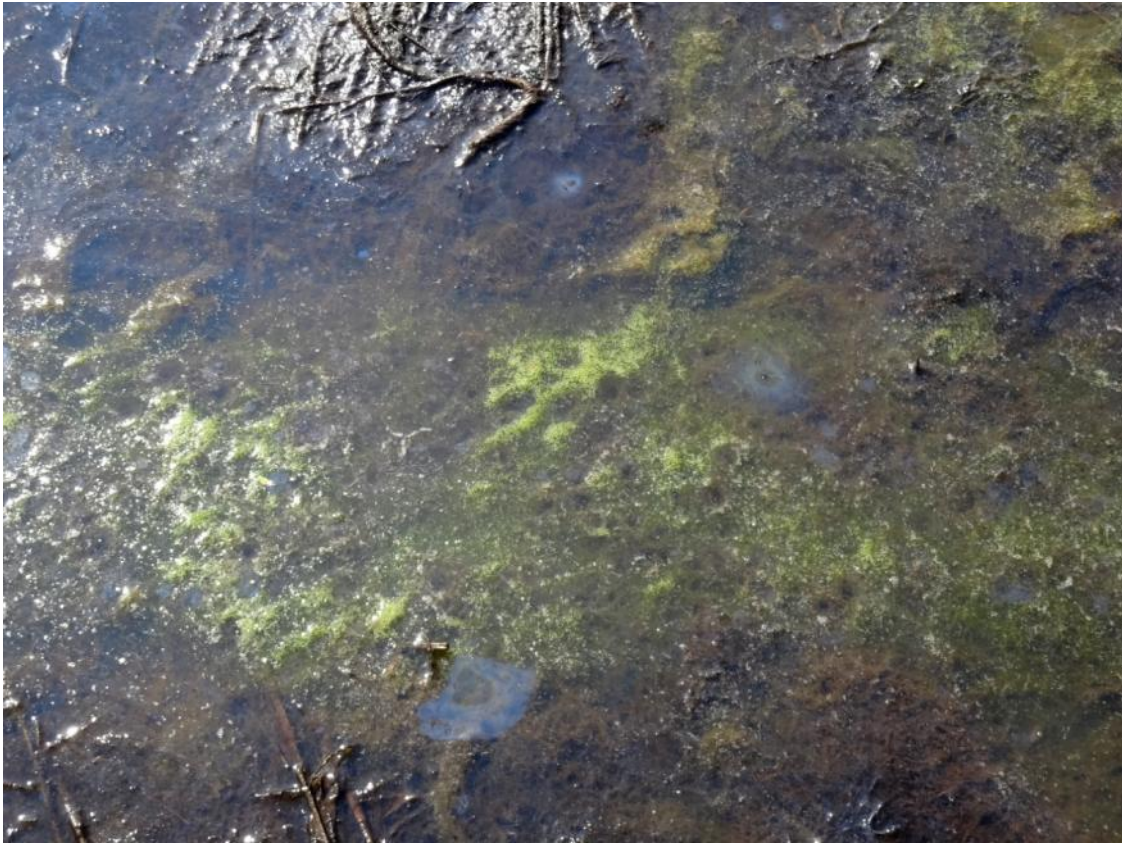
17. Island A tar globs and sheen observed.

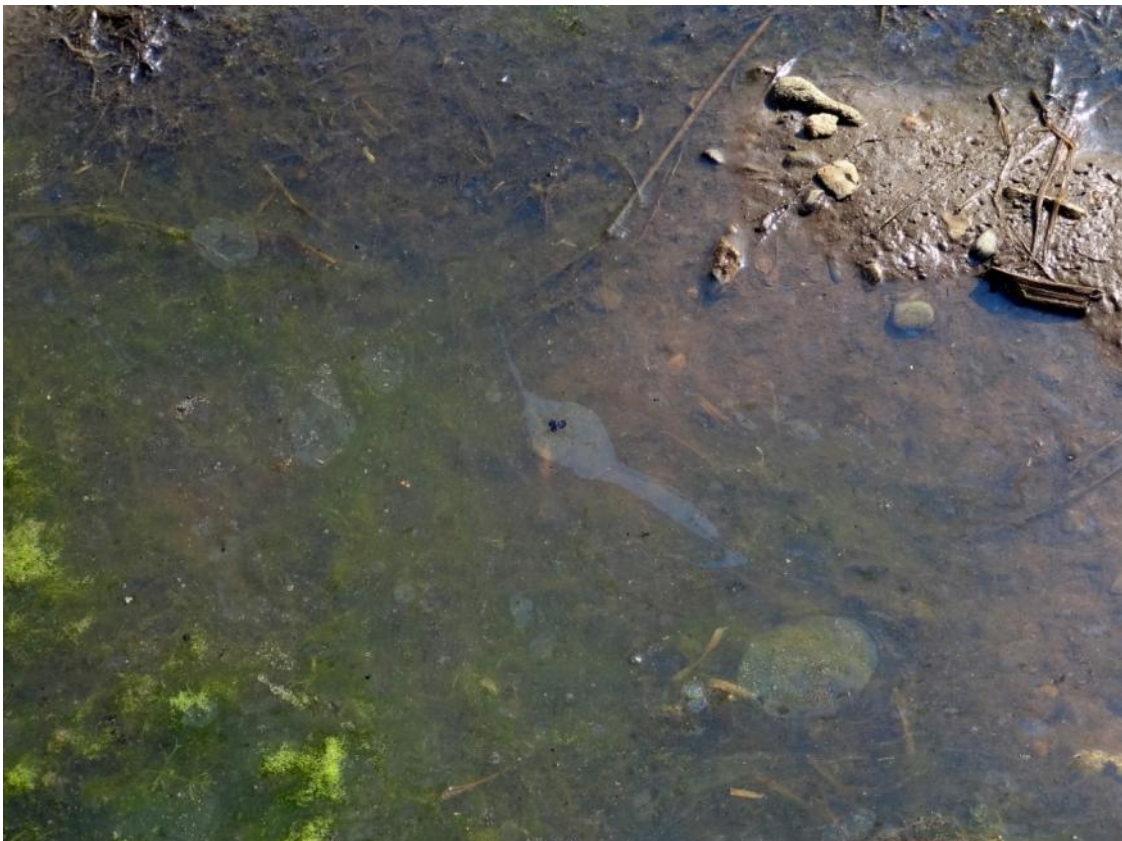
18. Island A tar globs and sheen observed.

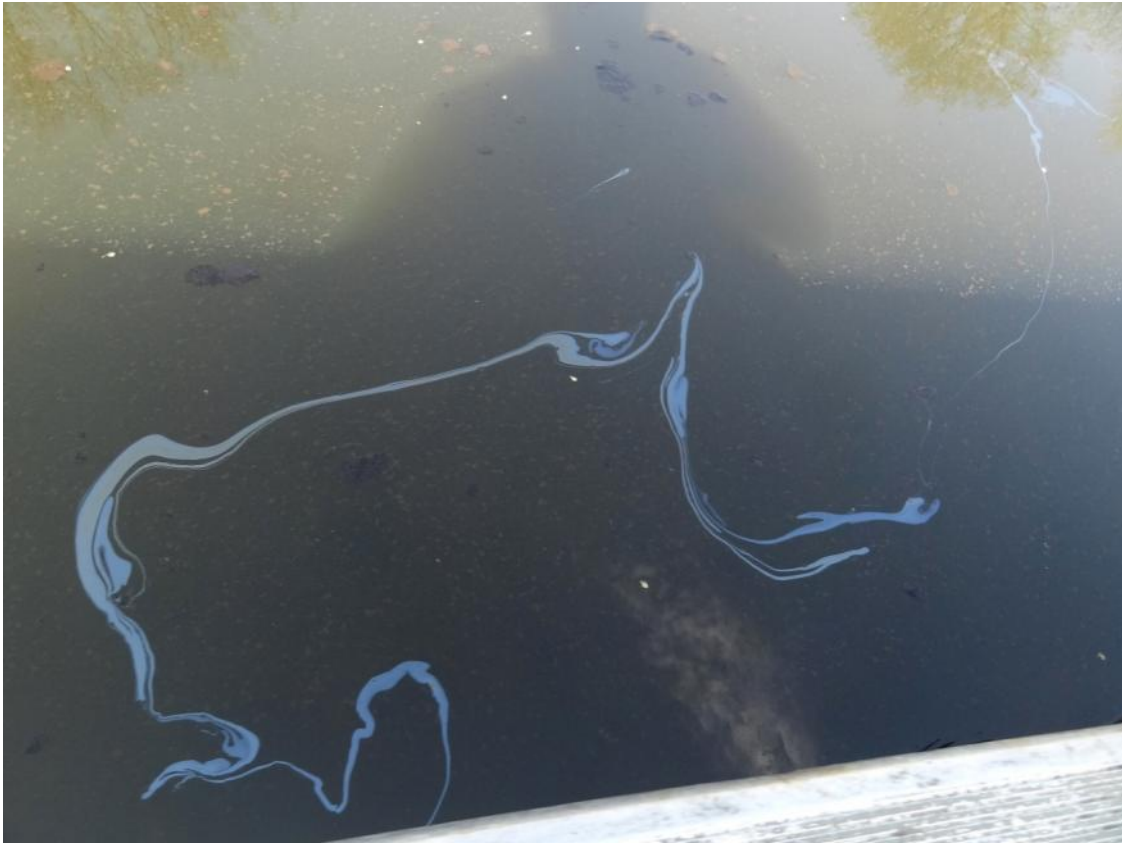
19. Sheen observed RDB above Ceresco Dam.

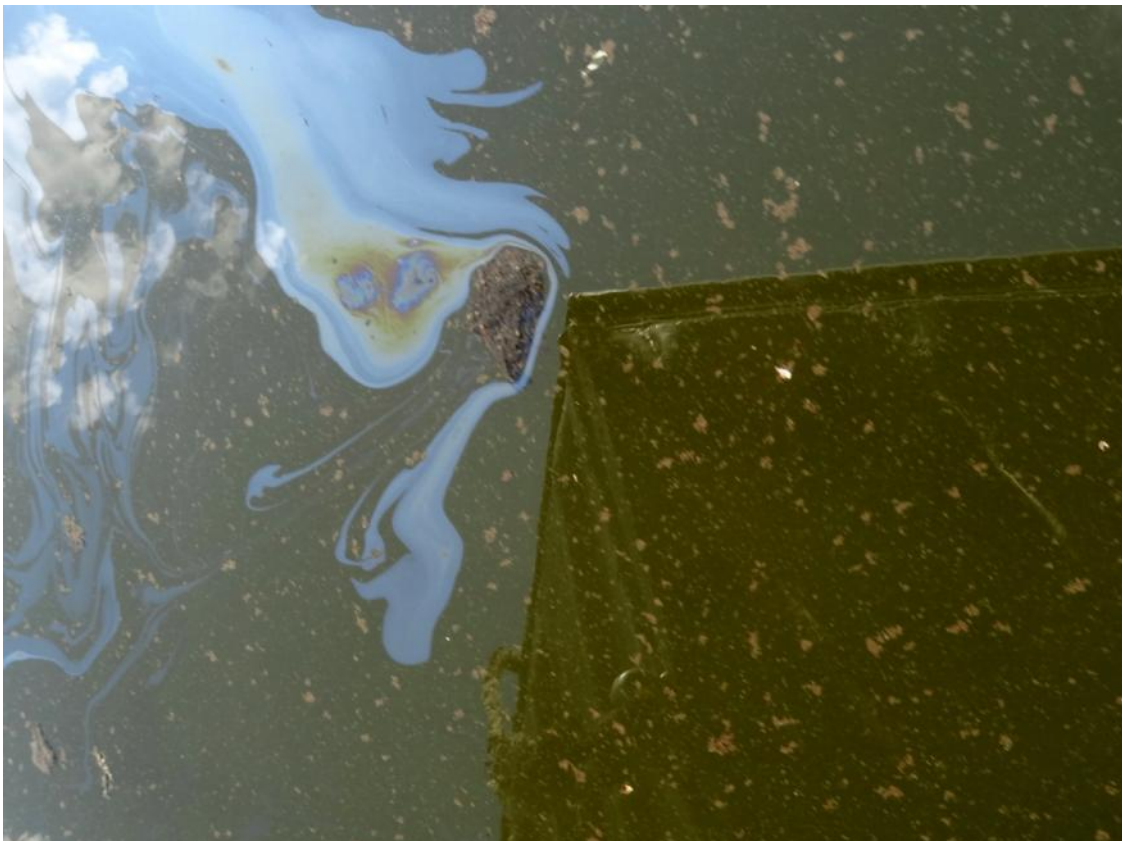
20. Sheen observed RDB above Ceresco Dam.
