# Situation Photo Log

Saturday, March 24, 2012

Kalamazoo River / Enbridge Spill

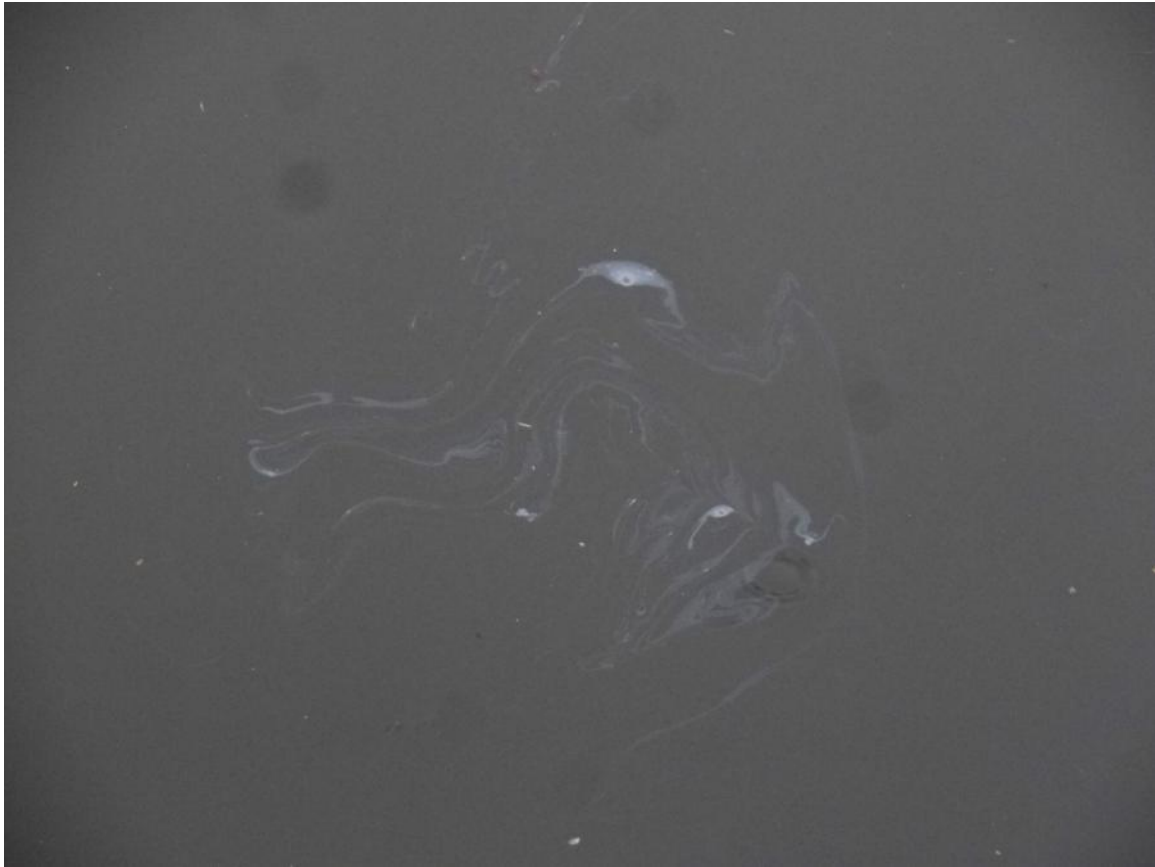
1. MP26.0 sheen observed.

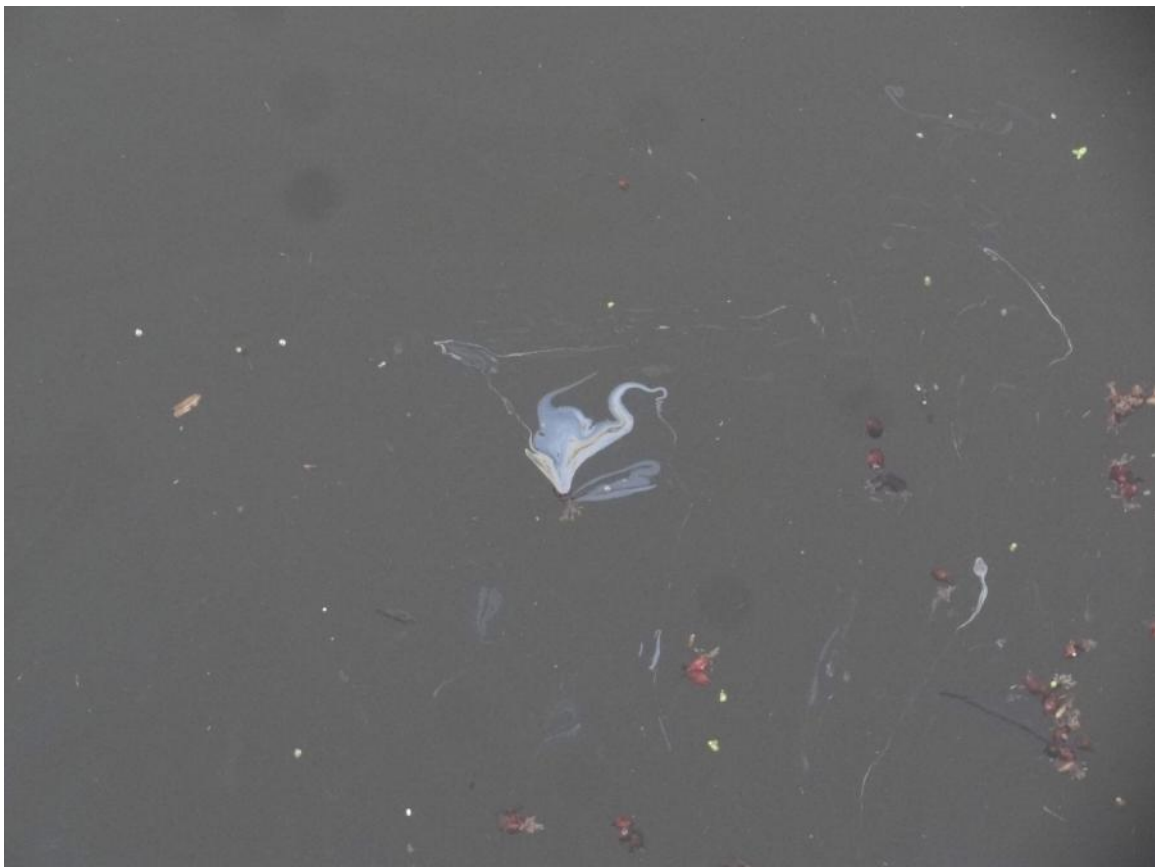
2. MP26.0 sheen observed.

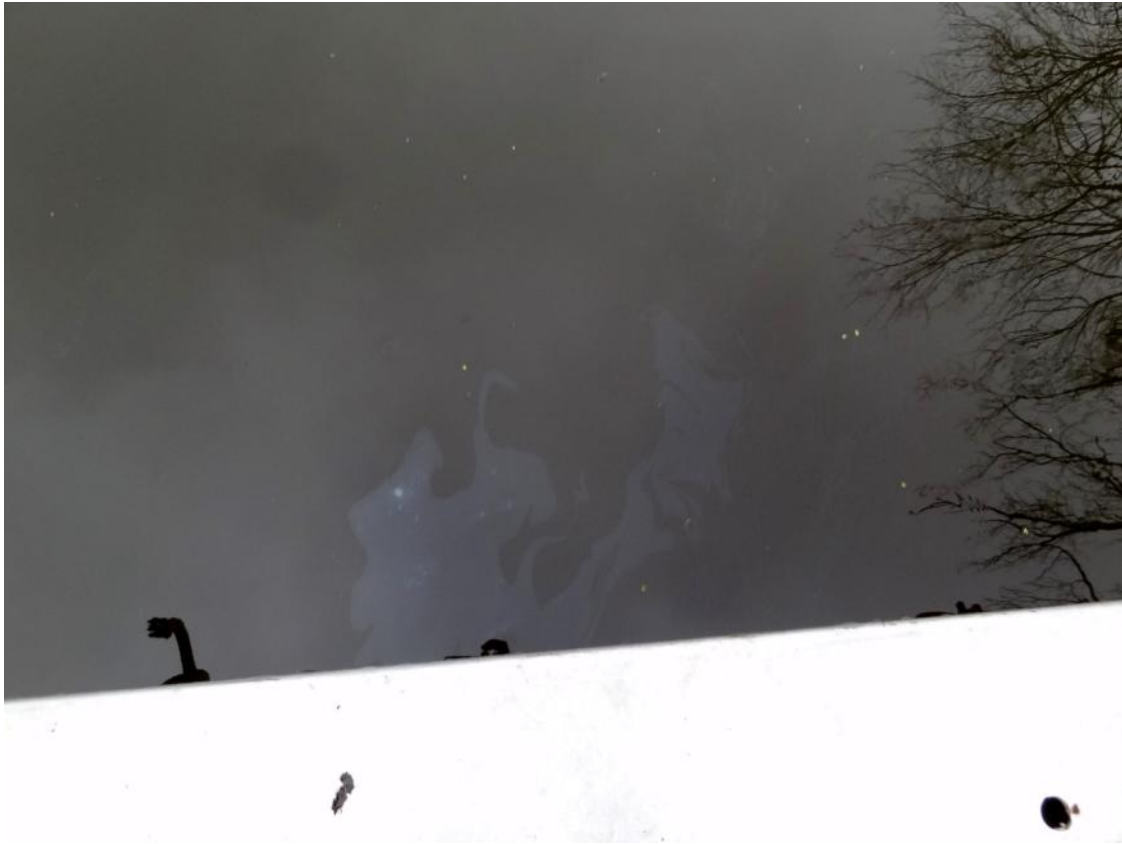
3. MP21.5 Oxbow sheen observed.

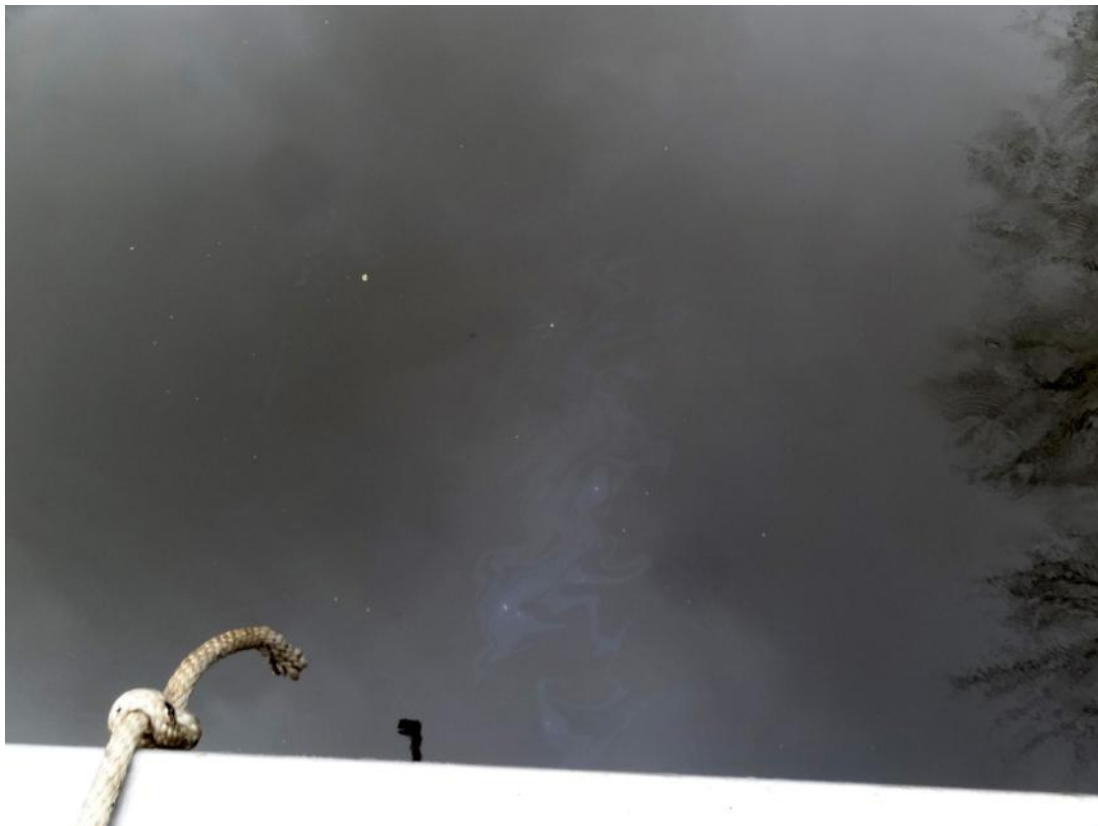
4. MP21.5 Oxbow sheen observed.

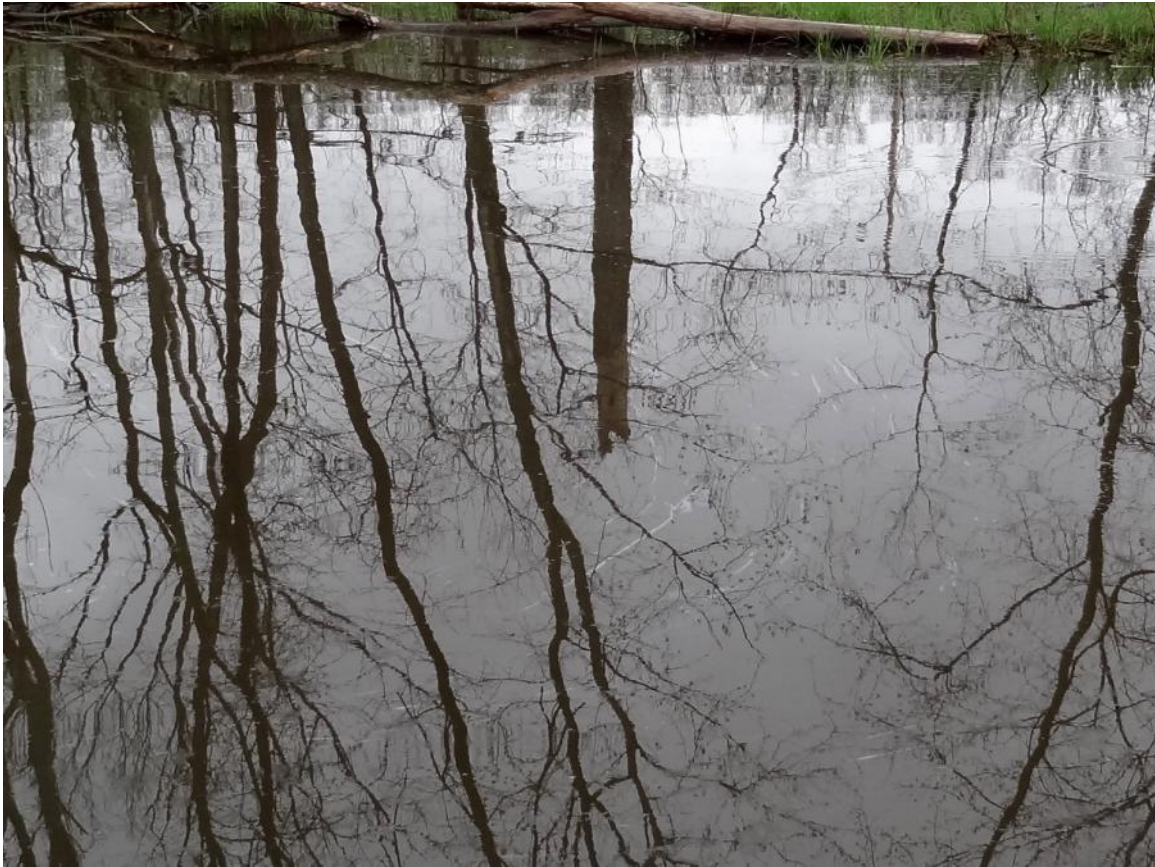
5. MP21.5 Oxbow sheen observed within the boom.

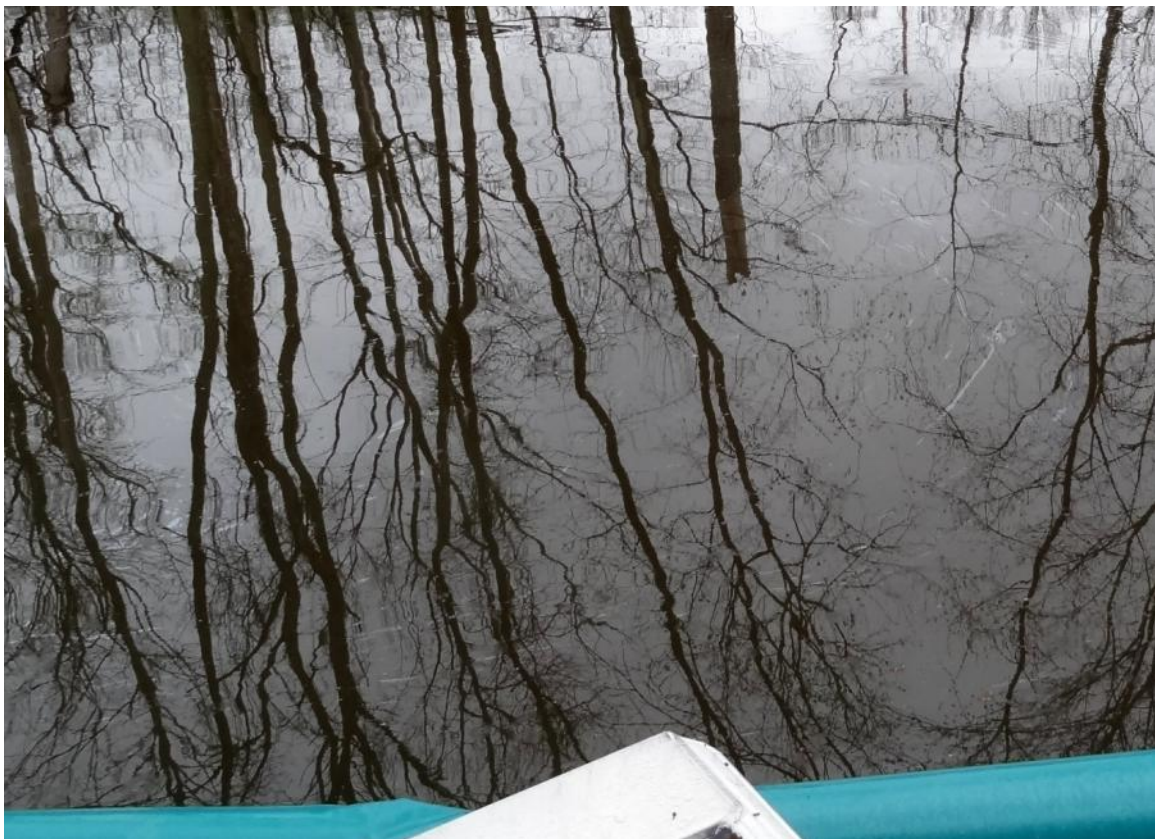
6. MP21.5 Oxbow sheen observed within the boom.

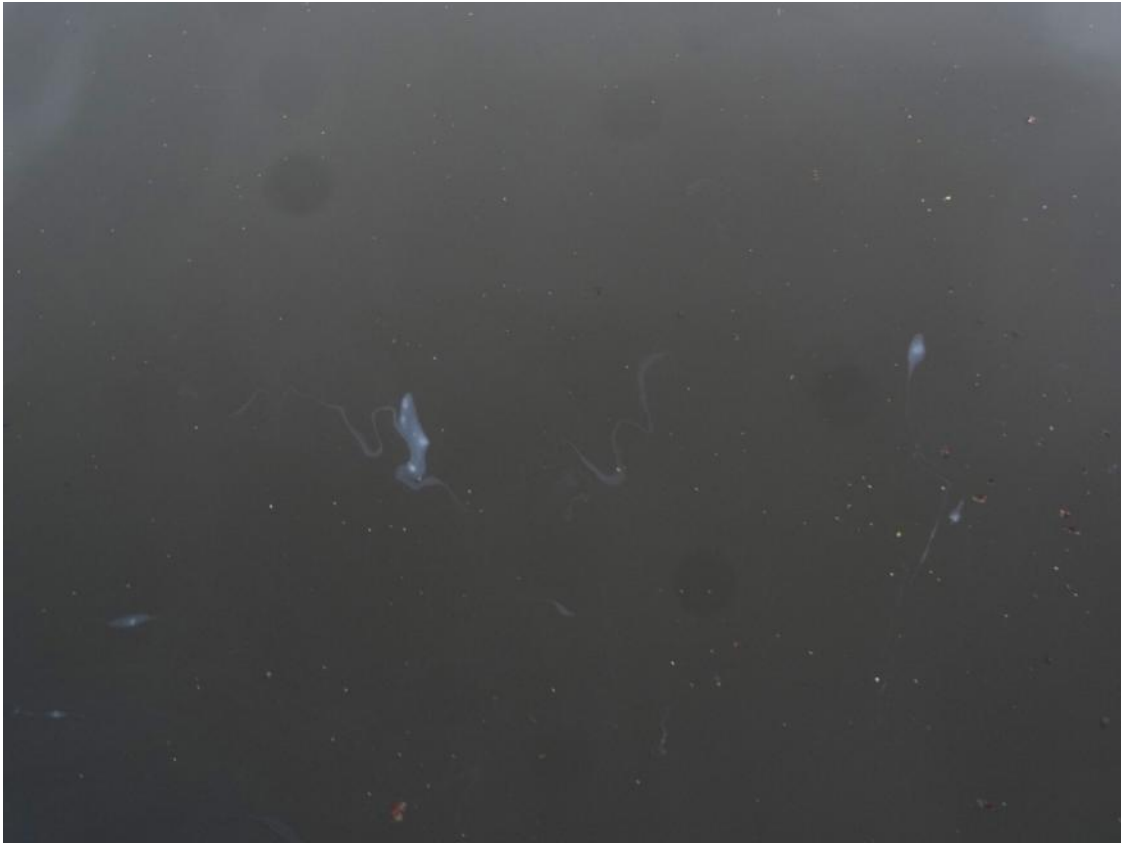
7. MP26.25 sheen observed.

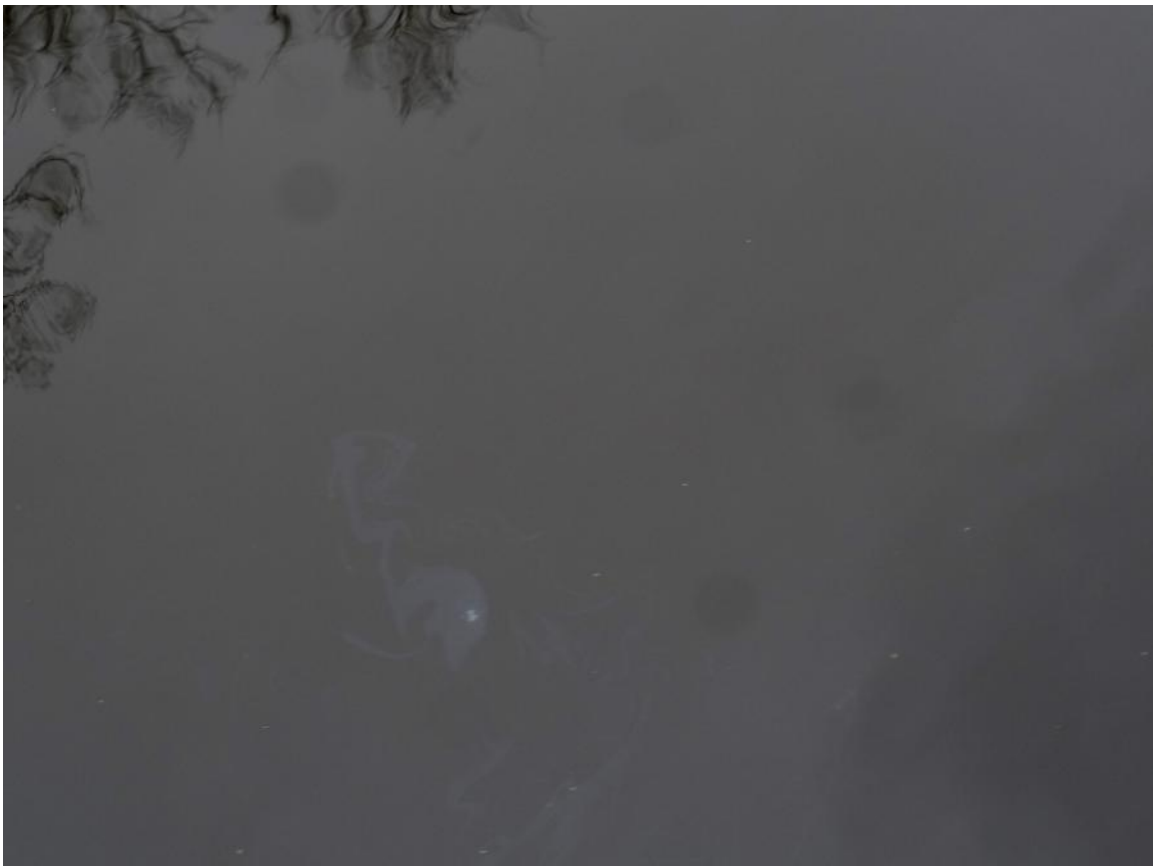
8. MP26.25 sheen observed.

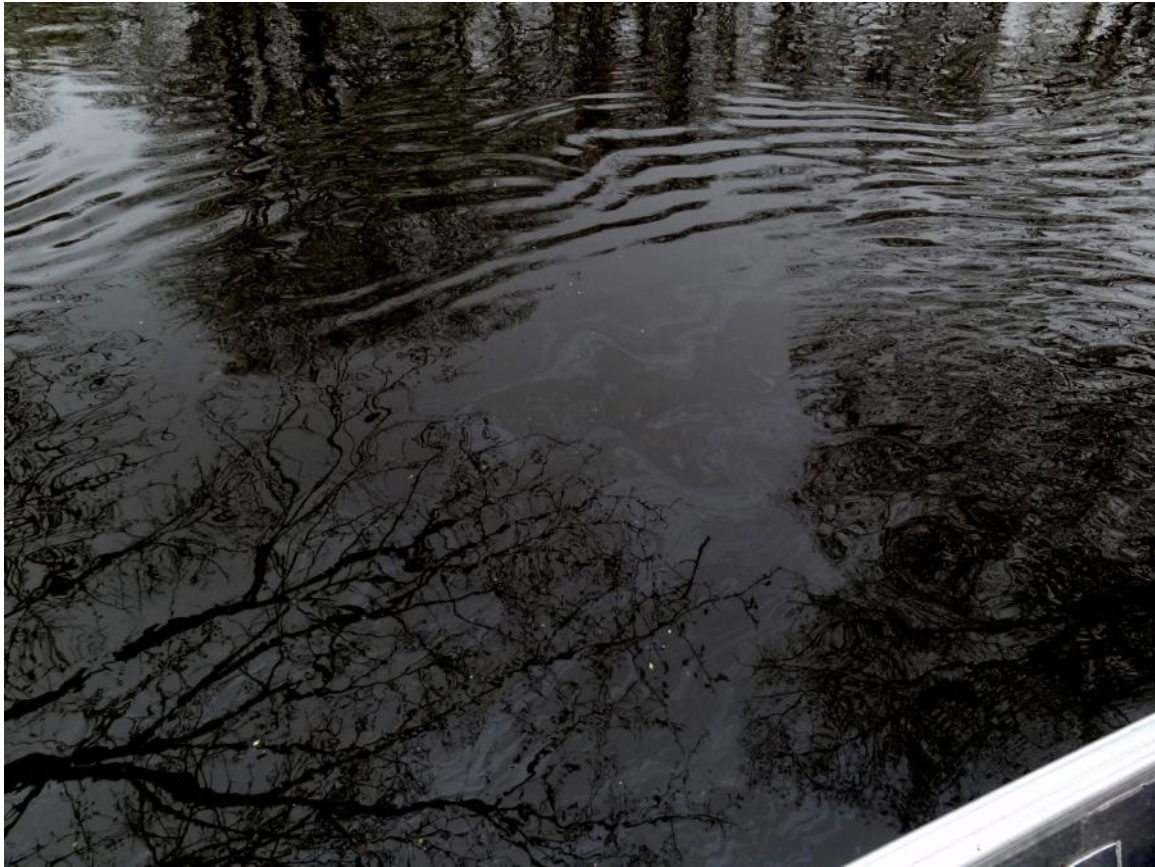
9. MP28.25 sheen observed.

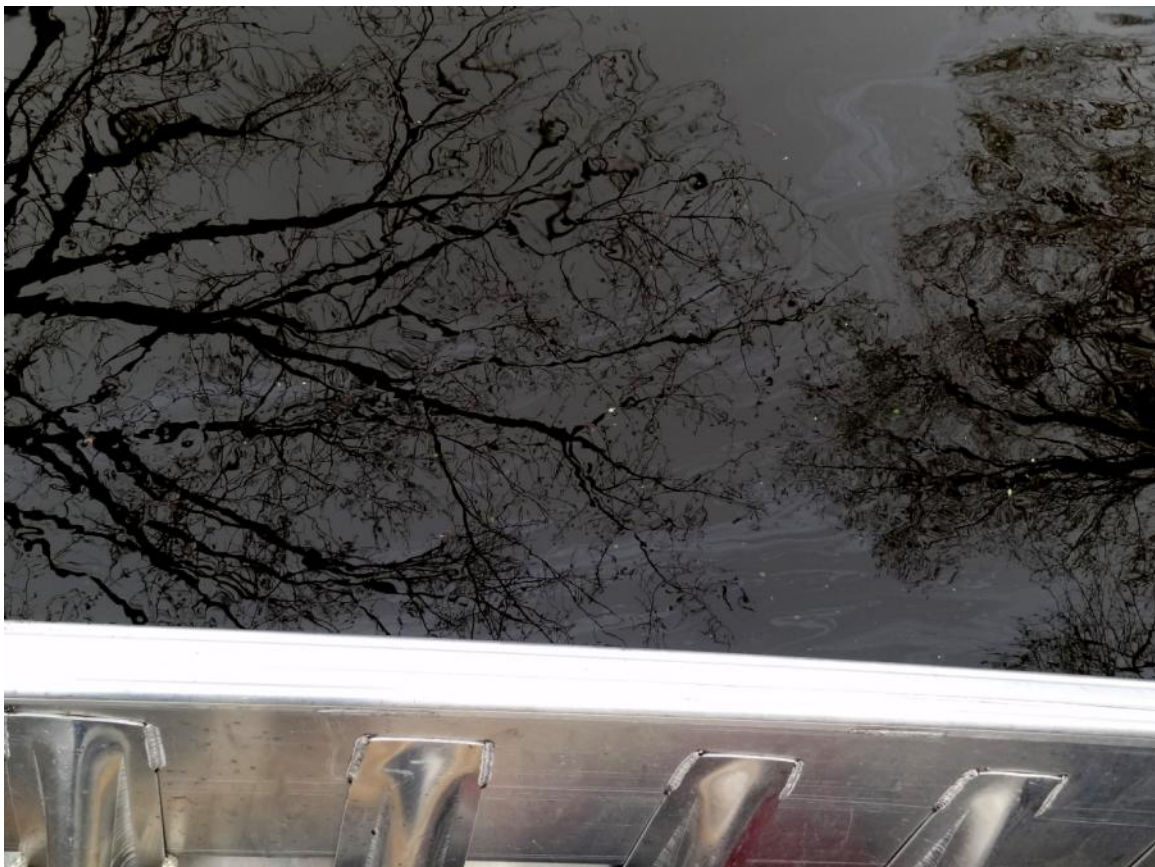
10. MP28.25 sheen observed.

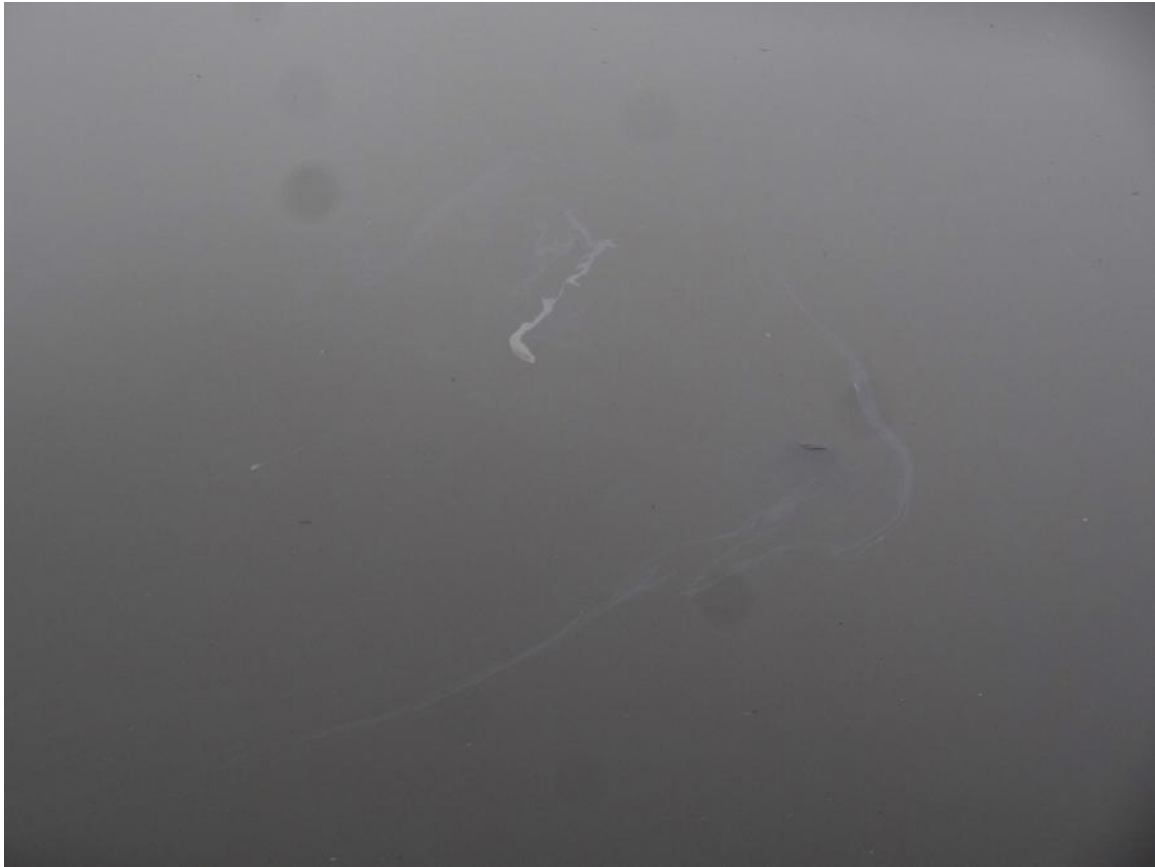
13. Ceresco Dam sheen observed.

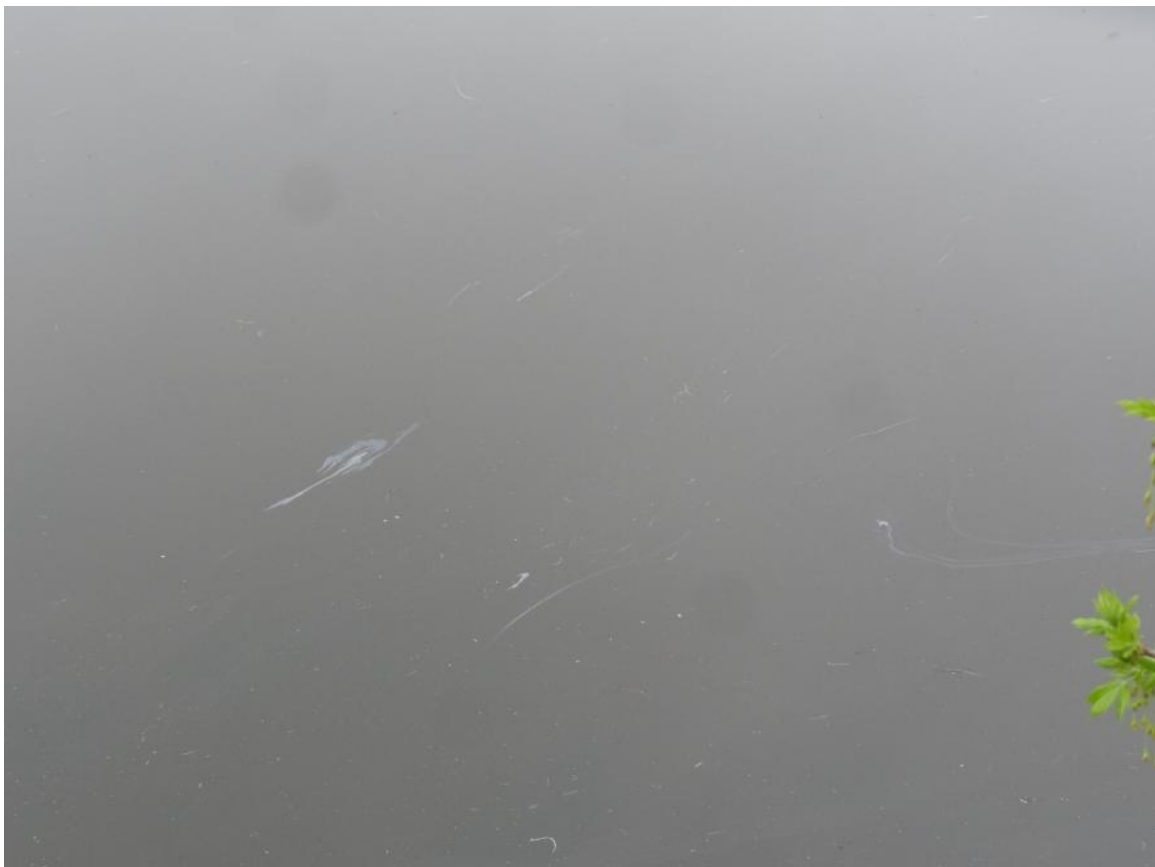
14. Ceresco Dam sheen observed.

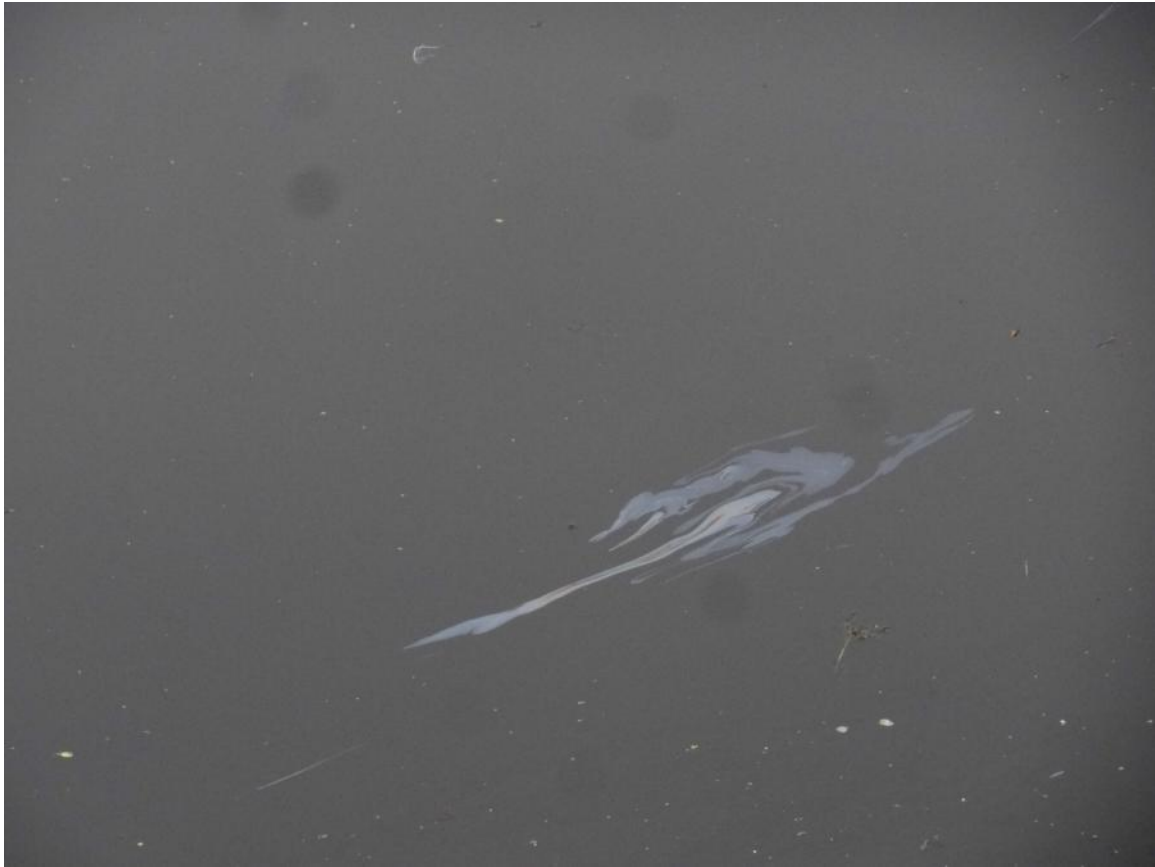
15. Ceresco Dam sheen observed.

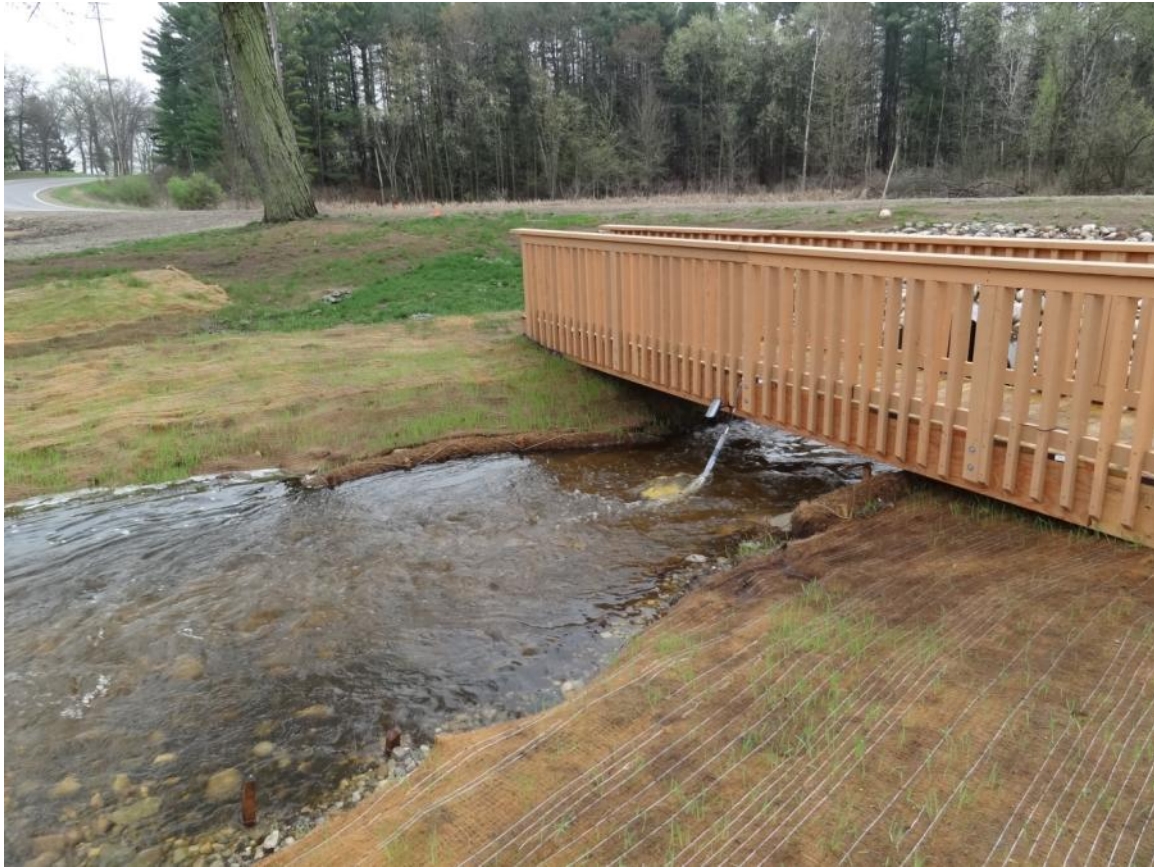
17. Talmadge Creek no sheen or turbidity observed.

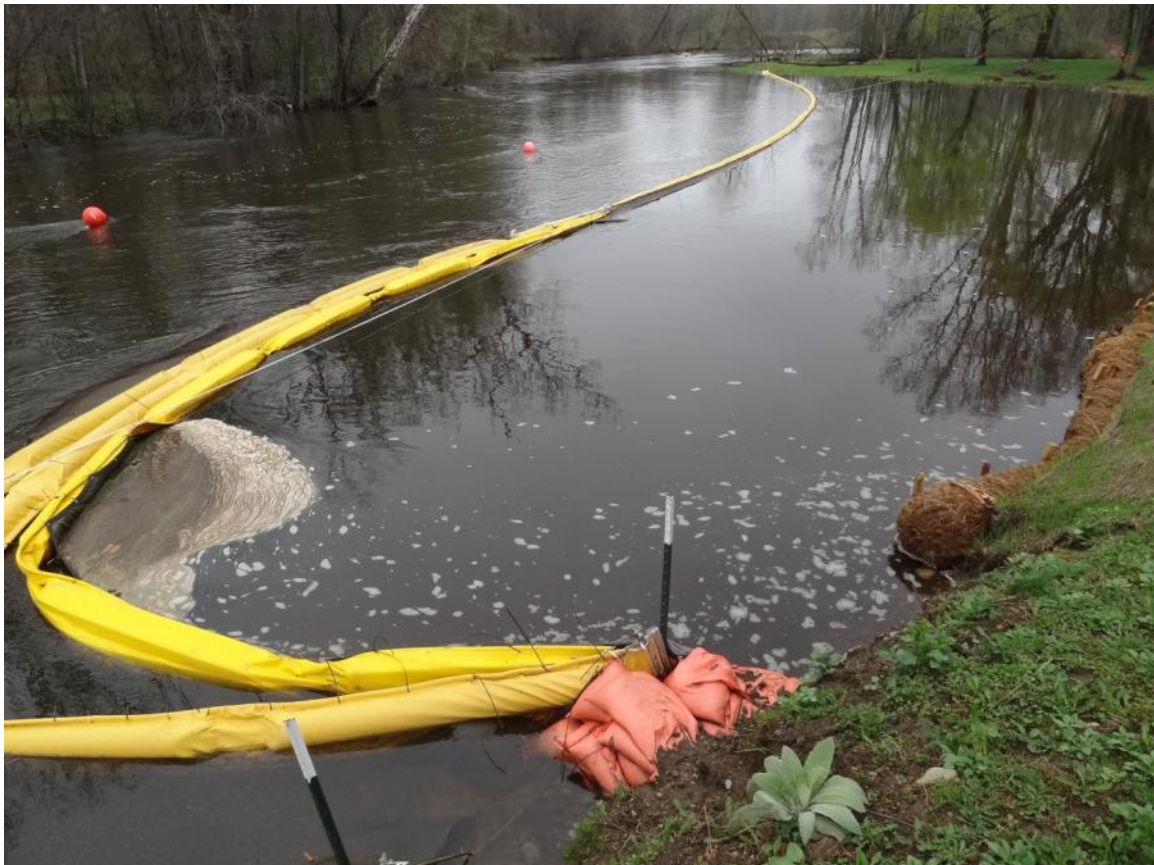
18. Confluence no turbidity or sheen observed.

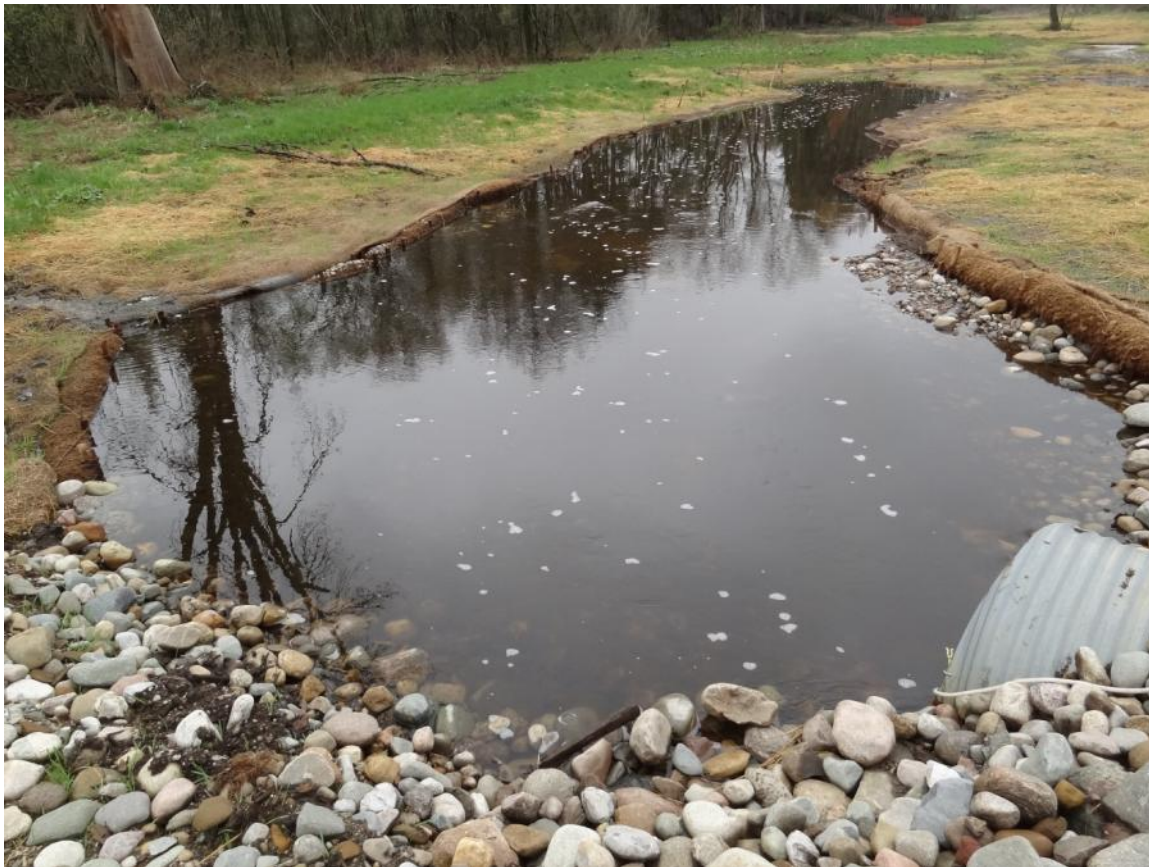
19. Talmadge Creek south of A Drive, no turbidity or sheen observed.

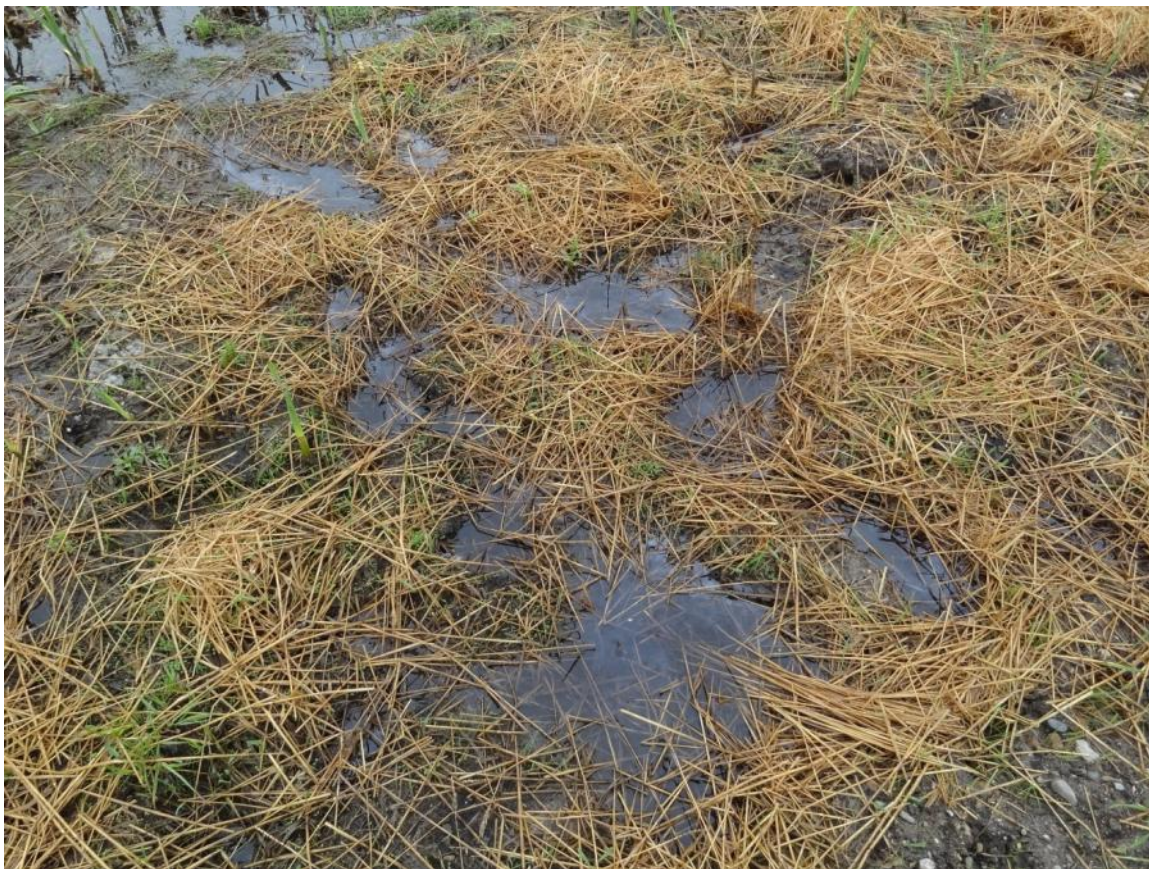
20. Talmadge Creek south of A Drive, RDB overbank sheen observed.

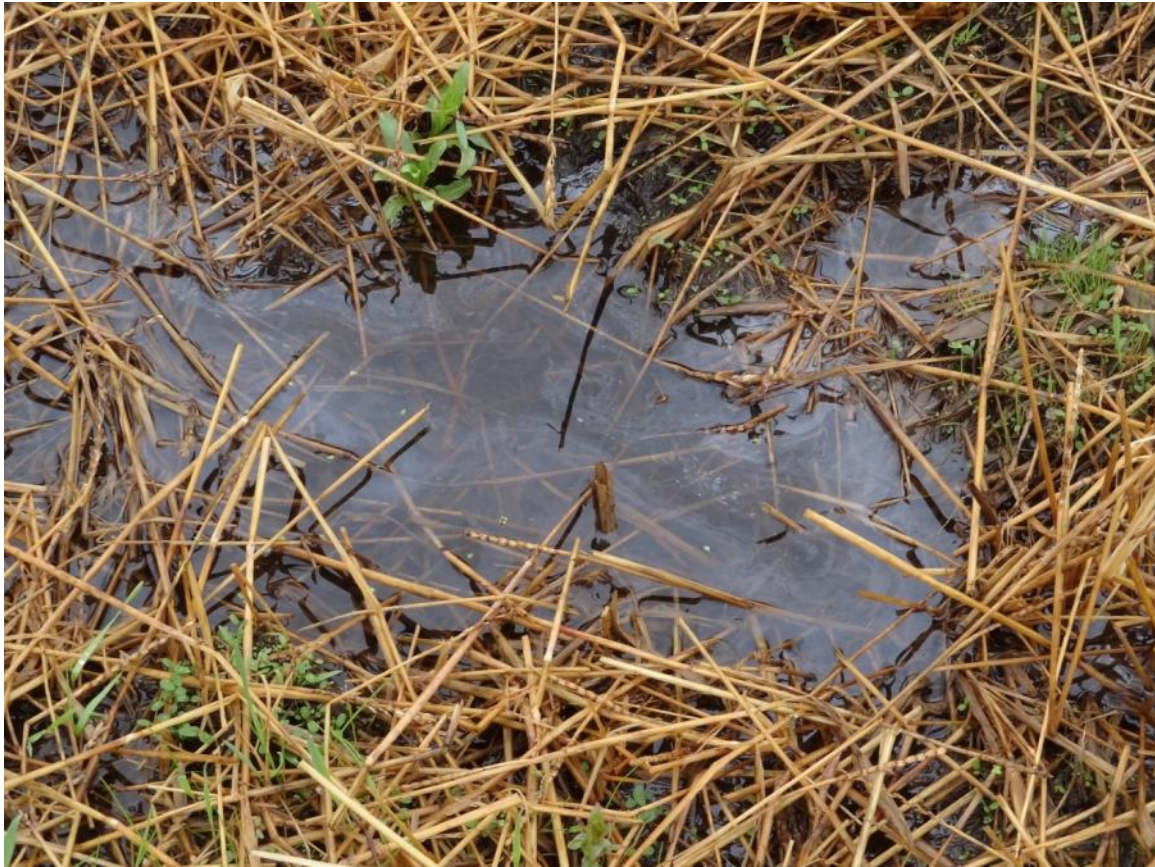
21. Talmadge Creek south of A Drive, RDB overbank sheen observed.

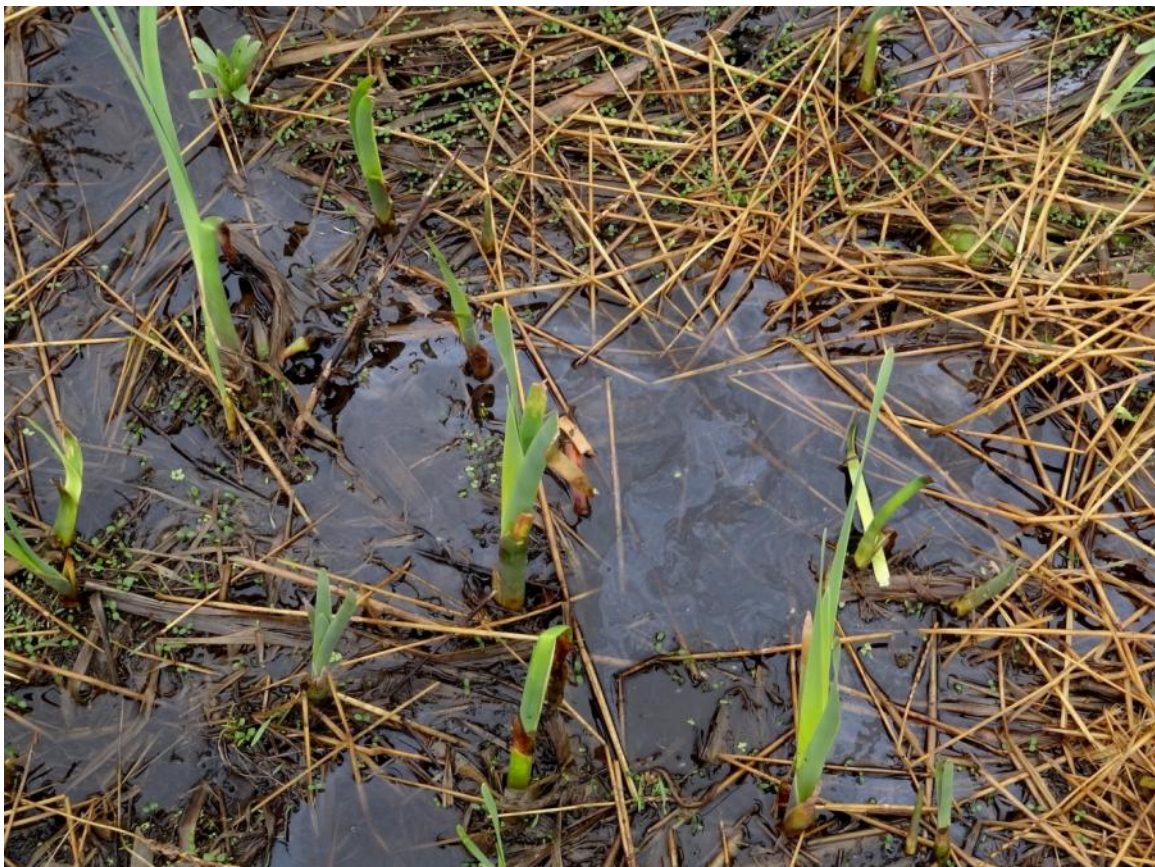
22. Talmadge Creek south of A Drive, RDB overbank sheen observed.

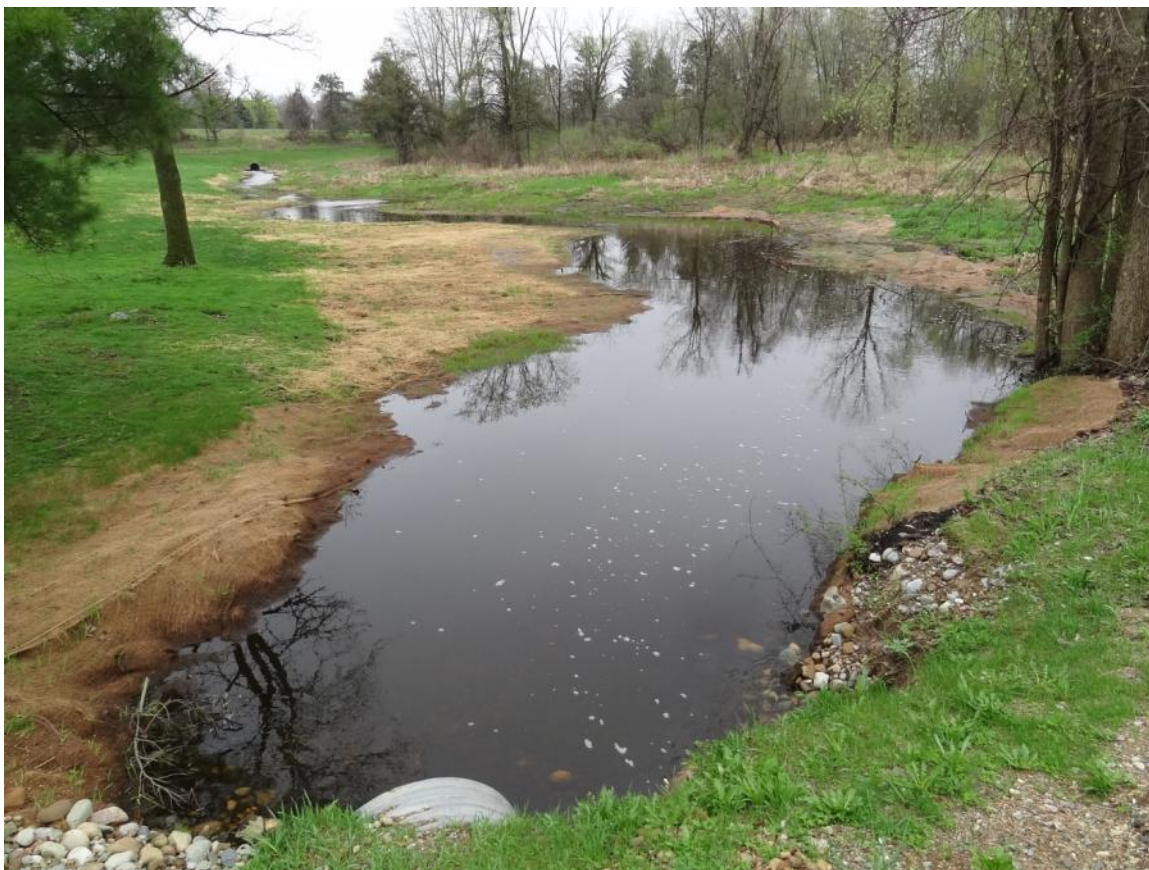
23. Talmadge Creek east of 15 ½ Mile no turbidity or sheen observed.

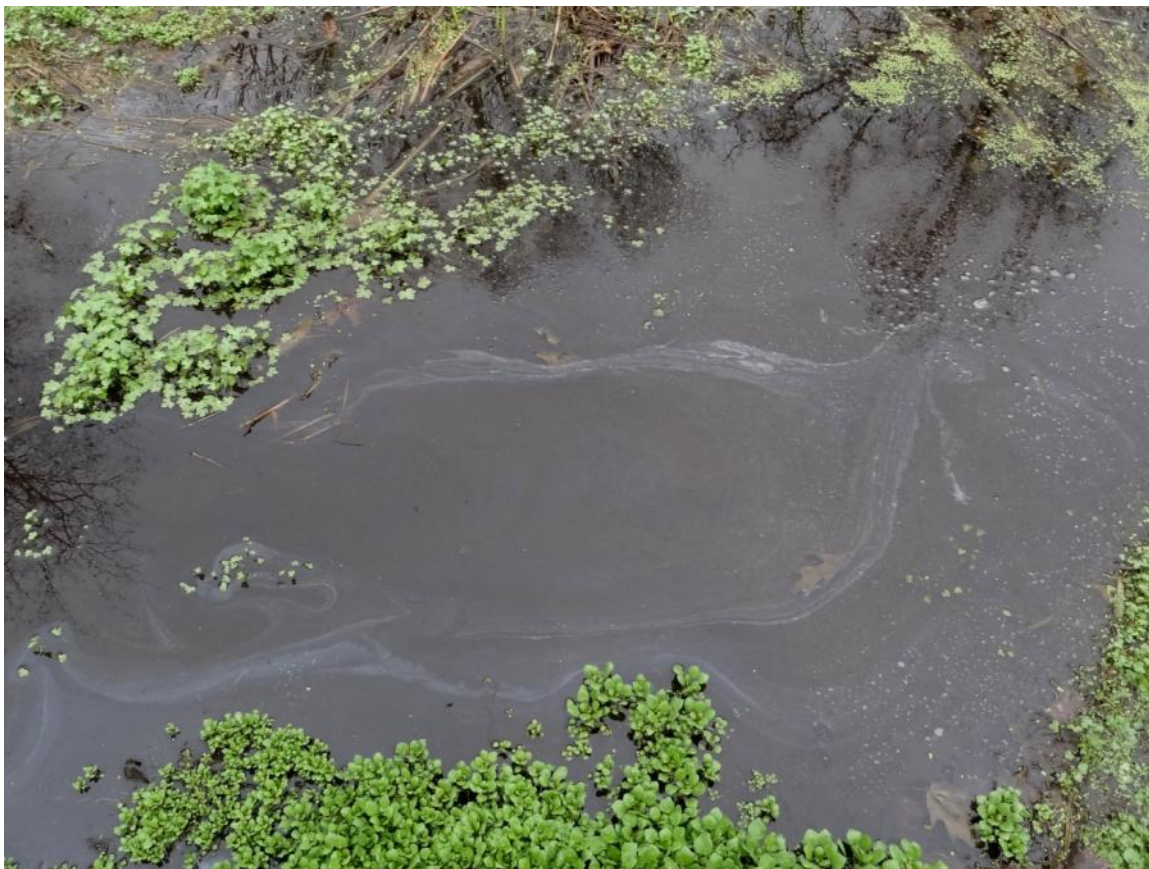
24. Talmadge Creek east of 15 ½ Mile Rd sheen observed LDB overbank.

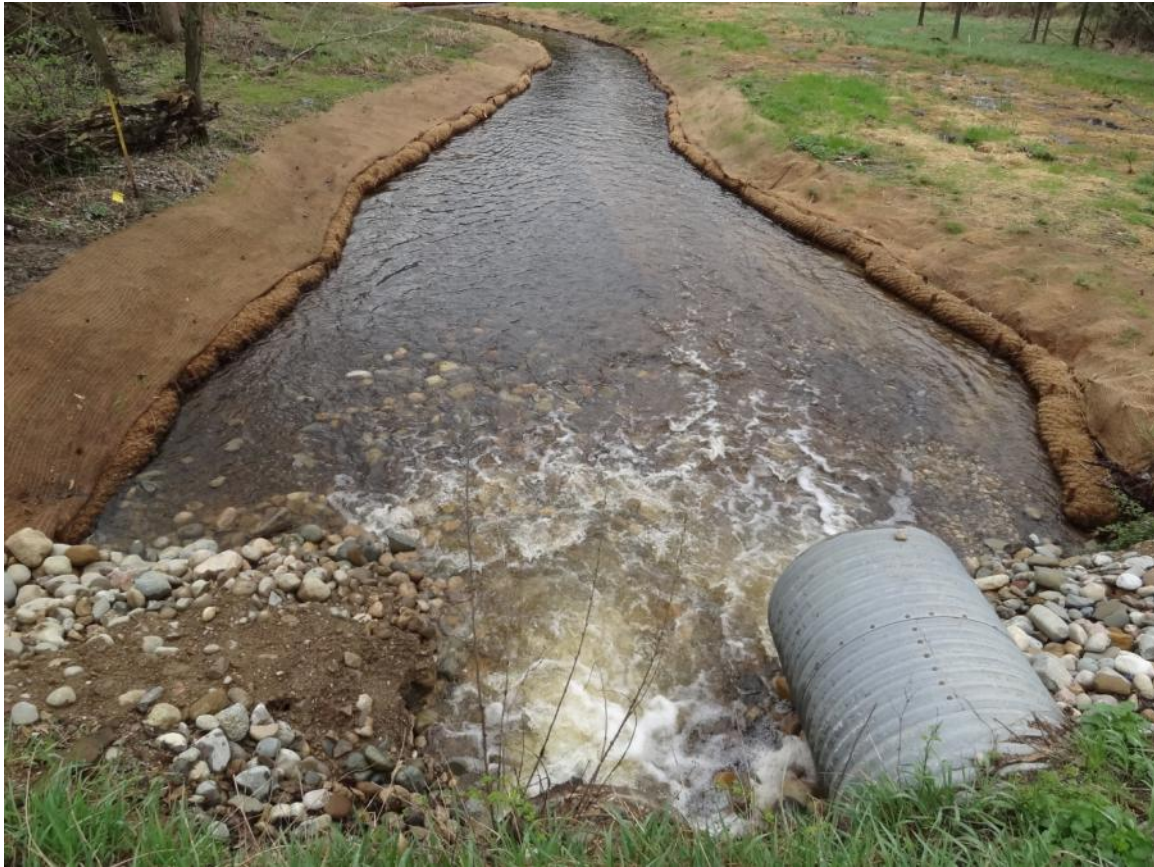
**25. Talmadge Creek west of 15 ½ Mile Rd no turbidity or sheen observed.**

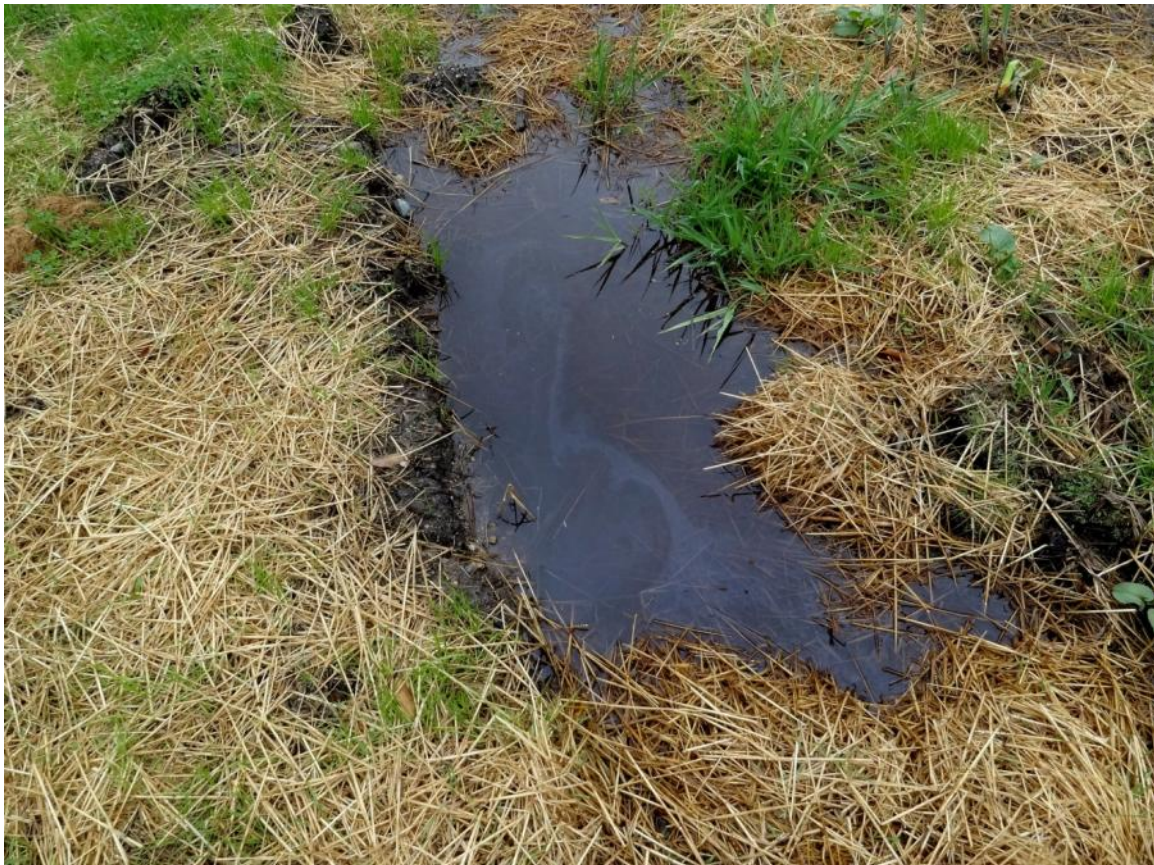
**26. Talmadge Creek west of 15 ½ Mile Rd, RDB overbank sheen observed.**
